[Authorize the Director of Public Works to Execute Agreements - Third Street Bridge Rehabilitation Project - \$18,369,975]

Application for HBRRP funds to Rehabilitate Third Street Bridge (34C0025) In San Francisco

Re: Application for Highway Bridge Replacement and Rehabilitation Program Third Street Bridge (34C0025) Rehabilitation Project

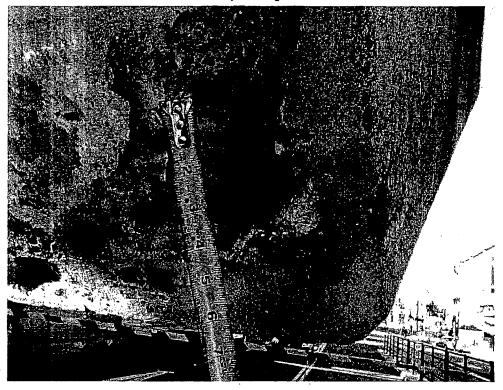
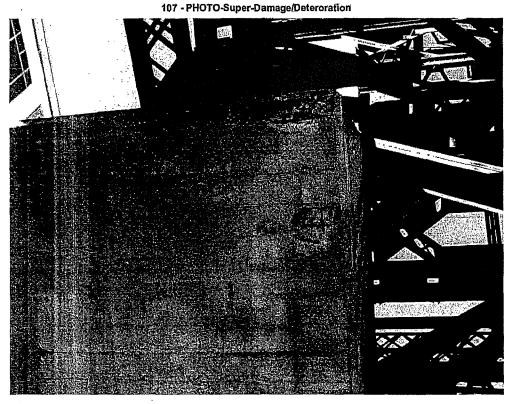
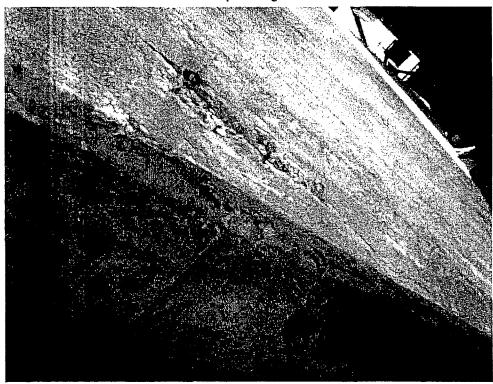
The concrete counterweights are cracking with efflorescent staining in areas and have areas with spalls with exposed corroded reinforcement up to 3 square feet in surface size. The cracked and delaminated areas easily spalled off with a light rock hammer. An estimated area of 10% of the surface area of the 2 counterweights is cracked and spalling.

Photo No. 4 Cracking and spalling on the above ground counterweights, typical

The recommended repairs for concrete support piles consist of utilizing a repair system such as Simpson FX-50 pile cladding. All spalled concrete should be removed and any rebars that are found with more than 25% loss of cross section should be reinforced with additional rebars.

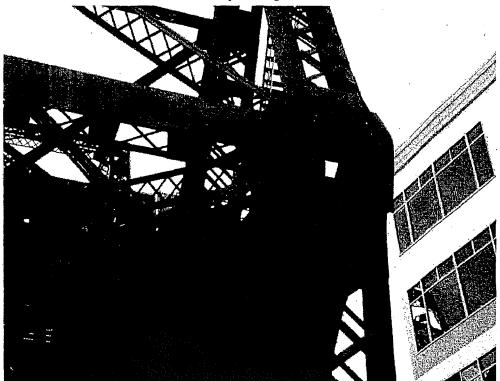
The top surface of the trunion portion of the truss is corroding with surface rust and surface pitting. The lift portion of the deck has a vertical offset of ½ of an inch as measured along the centerline of the two way traffic lanes. The underside of the superstructure in the lift span exhibits corrosion, pack rust and general distress along the bottom flanges of the bottom cord of the truss, the floor beams and the girders. The end bearing area of the bottom cord of the lift span along the left bay side has significant corrosion and pack rust for an area approximately 5 square yards at pier 3. There is a loss of section for an estimated area at 4 square feet along the built up bottom flange of the bottom cord of the truss along the bay side at this location.

Photo No. 11 Top corroding surface of the counterweight trunion portion of the truss, typical

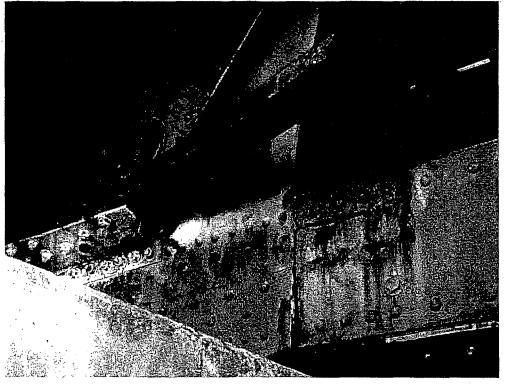
Photo No. 19 Distress and deterioration to the left bottom flange at Pier 3

Repair work for corroded members depend on the degree of loss of section and include replacement of the existing member with similar new member or repair damaged existing flange or exiting web with new cover plates of equal or larger thickness.
