**ALLANA BUICK & BERS**

**Re: The Millennium Tower – Residential Unit 31B, Odor Transfer Investigation  
Progress Report - DRAFT**

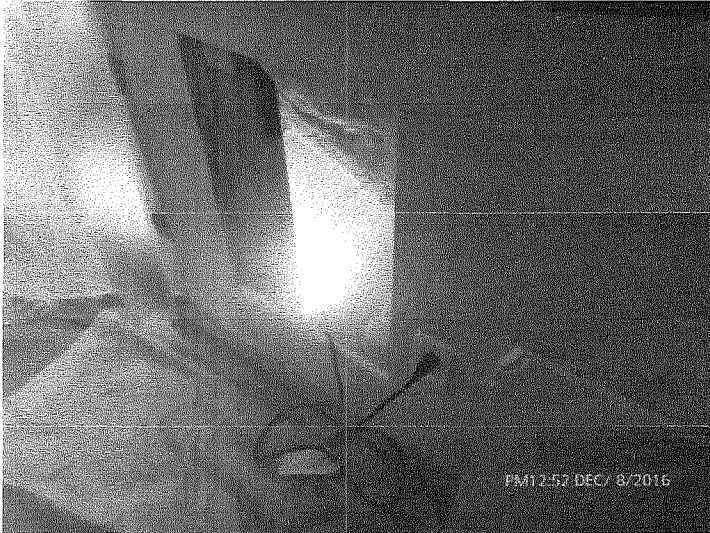
Test access opening in bedroom wall at site ST1 in unit 31B

1. At site ST1;  
Seal the air gaps on the interior surface of the exterior wall (curtain wall) within the cavity behind the heat pump [HP-C]. This condition exists on both floors 30B and 31B:
  - Provide sufficient access opening in bedroom wall to perform work in subject area.
  - Prep, patch and seal exterior wall gaps in curtain wall, air tight.
  - Patch, seal and finish access opening.
2. At site ST5;

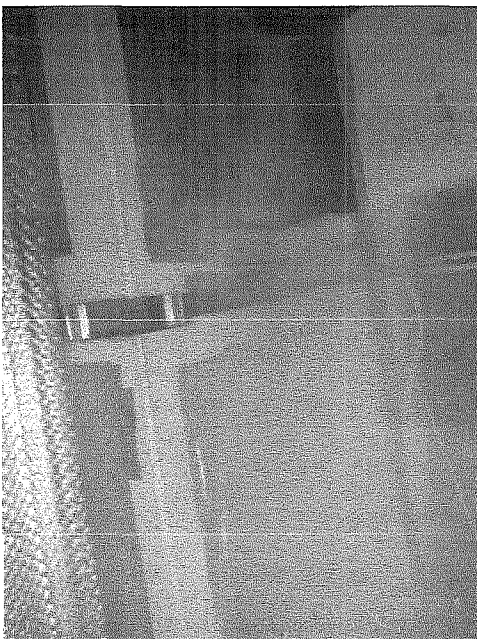
- 11:40 AM (1) smoke emitter cartridge was setoff in Unit 30B at ST1
- Significant amount of smoke streaming out of gaps in exterior wall (curtain wall) within the cavity behind the heat pump.

- 12:00 PM (2) smoke emitter cartridges was setoff in Unit 30B at ST1
- Significant amount of smoke streaming out of gaps in exterior wall (curtain wall) within the cavity behind the heat pump.
  - Similar to Test 2 but resulting in more intense smoke transfer.

1. At site ST1;  
Large gaps on the interior surface of the exterior wall (curtain wall) within the cavity behind the heat pump [HP-C]. This condition exists on both floors 30B and 31B. The location of air leak is directly across from the intake of the forced air heat pump unit. The odor transfer is enhanced and further distributed into the residence with the operation of the heat pump fan.
2. At site ST5;  
Gaps around the hydronic-piping floor penetrations in the closet of heat pump [HP-B]. Here too the location of air leaks are close to the intake of the forced air heat pump unit. The odor transfer again is enhanced and further distributed into the residence with the operation of the heat pump fan.

**AIR GAP IN CURTAIN  
WALL**

Smoke test site ST1 in unit 31B

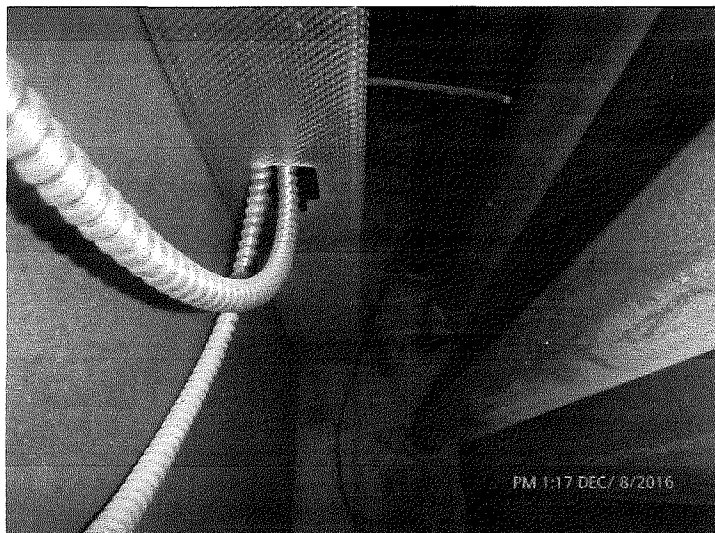
Pre-Test Conditions:  
Test site ST5 in unit 31B heat pump closet.  
Note pipe risers routed through closet floor

Seal the gaps around the hydronic-piping floor penetrations in the closet of heat pump [HP-B]:

- Provide sufficient access opening in hallway wall to perform work in subject area.
- Remove any existing fire stopping sealant at riser pipes.
- Apply new fire-stopping sealant to the full circumference of each riser pipe penetrating the floor of the heat pump closet of unit 31B and each riser pipe penetrating the ceiling of the heat pump closet of unit 30B
- Patch, seal and finish access opening.

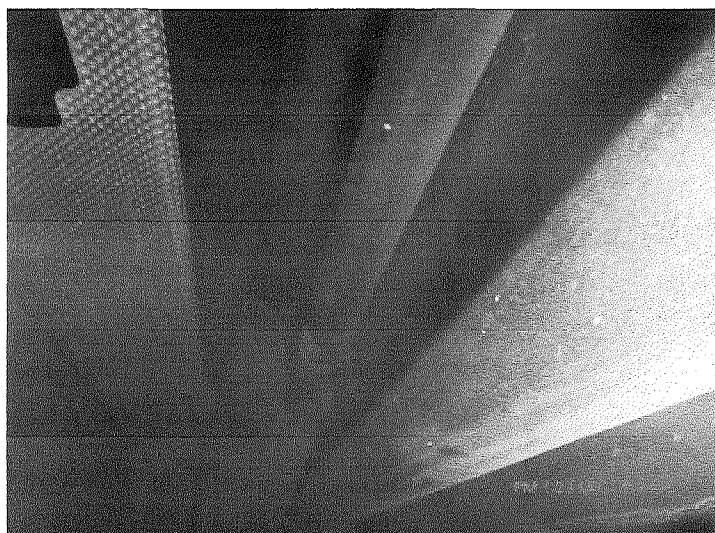
- (1) smoke emitter cartridge was setoff in Unit 30B at ST5
  - Significant amount of smoke streaming out of hydronic piping floor penetrations in heat pump closet.
  - Similar to Test 2 but resulting in more intense smoke transfer.

During Smoke Test Conditions – 1/2 minute from start:  
Test site ST5 in unit 31B heat pump closet.  
Note white test smoke at pipe risers routed through closet floor

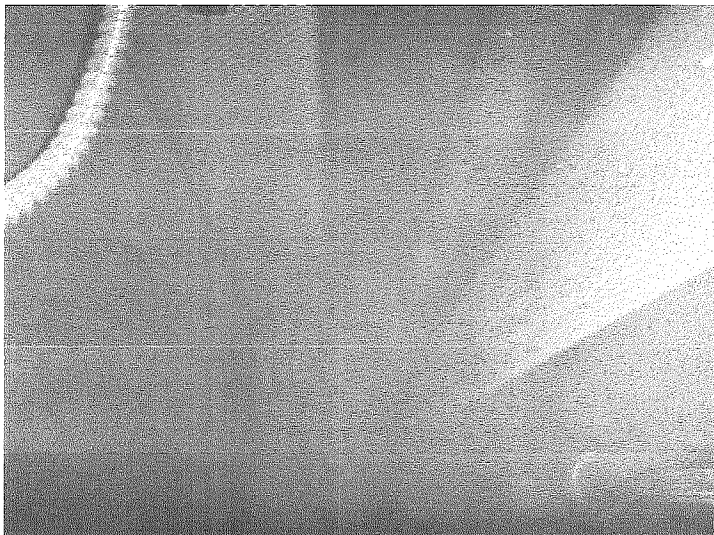
- (2) smoke emitter cartridges was setoff in Unit 30B at ST5
  - Significant amount of smoke streaming out of hydronic-piping floor penetrations in heat pump closet.
  - Similar to Test 5 but resulting in more intense smoke transfer.

During Smoke Test Conditions- 1 minute from start:  
Test site ST5 in unit 31B heat pump closet.  
Note white test smoke completely filling closet

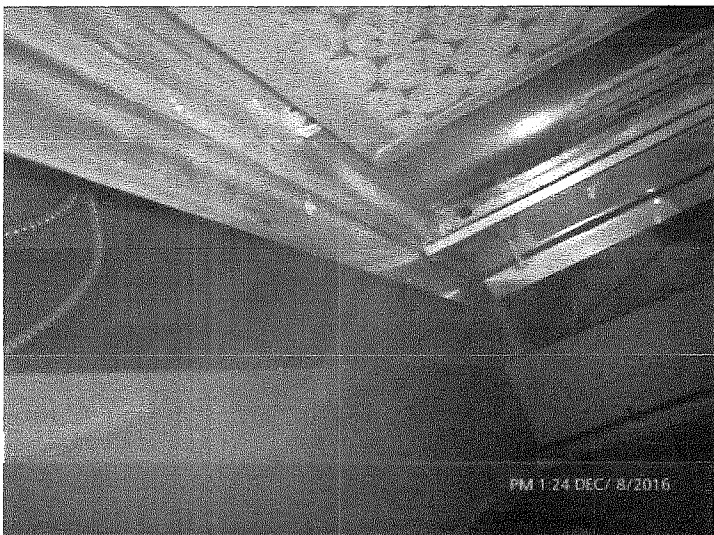
Test site ST5 in unit 31B heat pump closet.  
Note test smoke flowing up through heat pump closet door opening
