SUBJECT: Emergency Hearing on 301 Mission – August 1, 2017

Supplemental Report for Foundation Settlement Investigation

The building at 301 Mission Street, San Francisco, California is a fifty-eight-story residential structure founded on a pile-supported mat foundation. The building, which was completed in 2009, has experienced and continues to experience significant foundation settlement. Paul Hastings, LLP retained Simpson Gumpertz & Heger Inc. in 2014 to conduct an evaluation of the impact of site settlement on the building's structural stability and earthquake resistance. We performed initial evaluations in 2014 and updated these in 2016 to consider additional settlement that occurred in the interim period. In an October 2016 report we concluded that settlement had not compromised the building's stability or its ability to resist strong earthquakes.

SUPPLEMENTAL REPORT
FOUNDATION SETTLEMENT INVESTIGATION
301 MISSION STREET
SAN FRANCISCO, CALIFORNIA

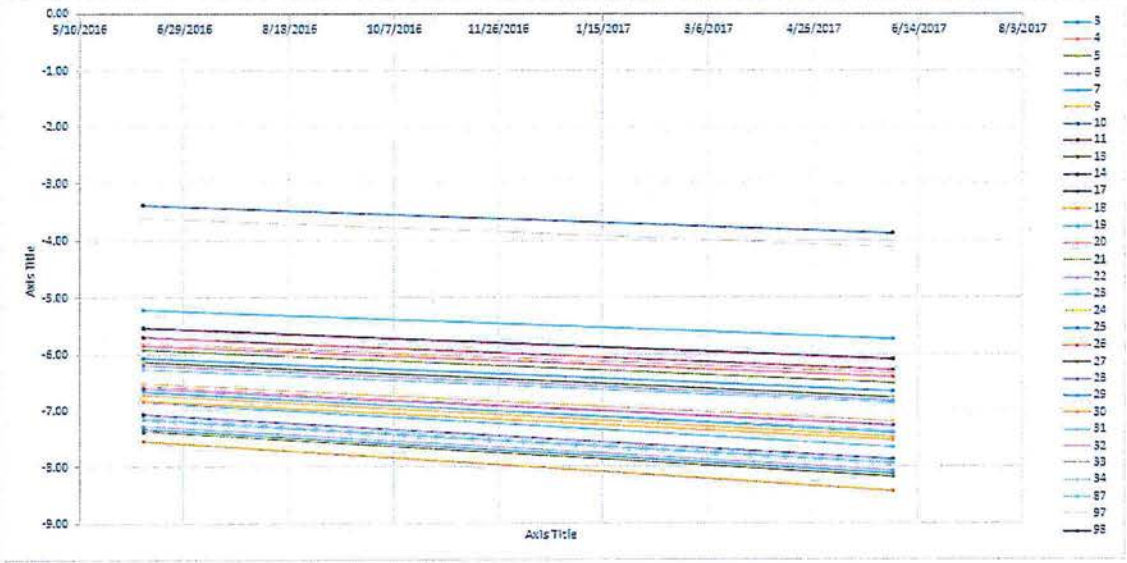
Figure 11. Settlement data, June 2016 through June 2017

Figure 11 of this report compares the settlement of 31 of the 33 measurement points during the period between June 2016 and June 2017. The profiles indicate continued motion of the building as a rigid body without noticeable difference from linear differential settlement across the mat. In this period approximately 1/2 in. additional settlement occurred at the west edge of the mat than at the east edge. Given the 100-foot width of the mat, this amounts to an incremental tilting of the building of 0.04%. This amount is negligible and has not caused any significant impact on stress in the structure.

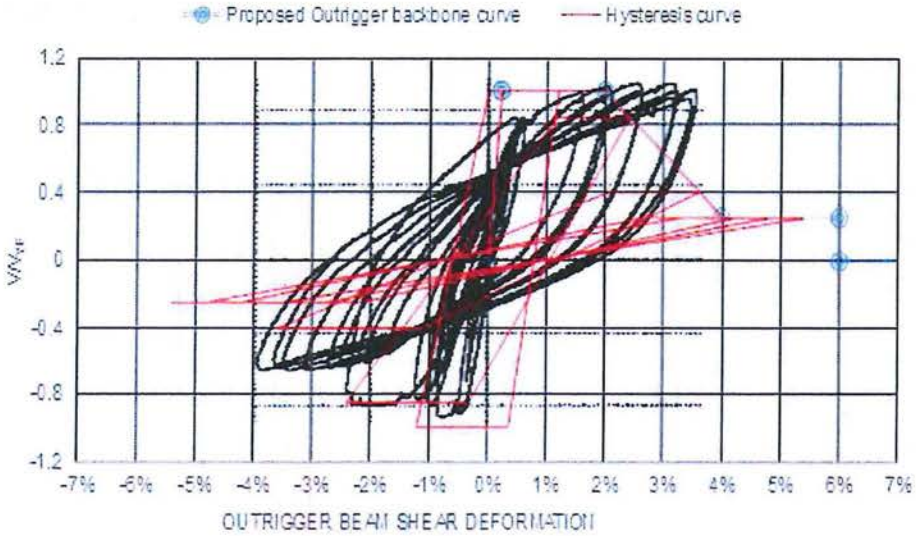
Figure 13. Coupling Beam Degrading Hysteretic Model

For these elements, we implemented the degrading hysteretic model illustrated in Figure 13. The cyclic backbone for this model maintains elastic-perfectly-plastic behavior through a shear deformation of 2% radians then degrades to a residual strength equal to 25% of the yield strength at a shear deformation of 4% radians. The model retains this residual displacement through shear deformation of 6% radians, after which it has nil residual strength. Figure 14 shows an overlay of the response obtained from this hysteretic model with that recorded in the University of Michigan testing discussed in Section 2.1.2 of this report. The hysteretic model conservatively represents the behavior obtained in the test and exhibits greater strength and stiffness degradation than did the tested specimen.

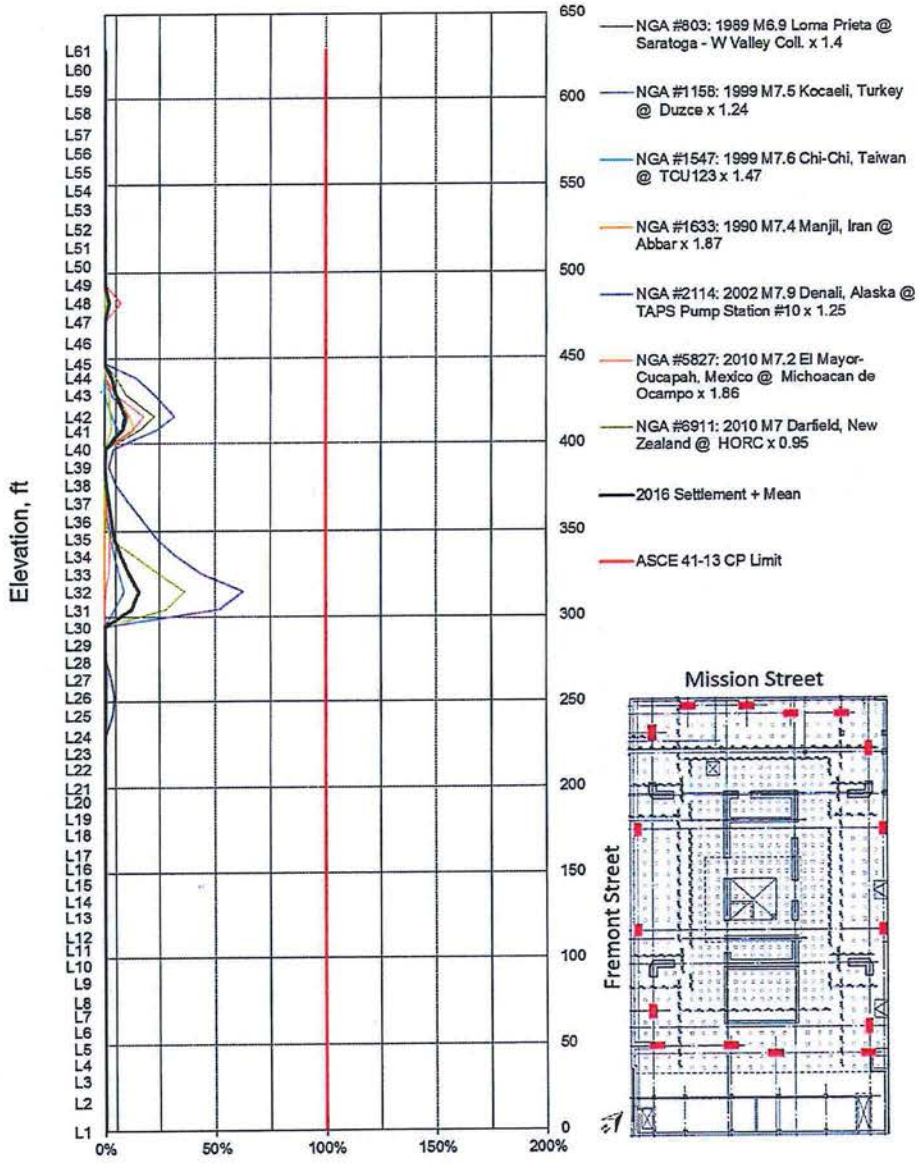
Figure 27. Demand to Capacity Ratios, Column Plastic Rotation, Fixed Translation Model

Figure 27 presents the demand to capacity ratios, in percent, for column plastic rotation. A value of 100% represents the ASCE 41-13 CP limit, which ranges from 0.008 to 0.009 radians for columns in this structure. The figure shows the maximum predicted value for any of the columns at each story, for each ground motion, and also the average peak value for all ground motions.

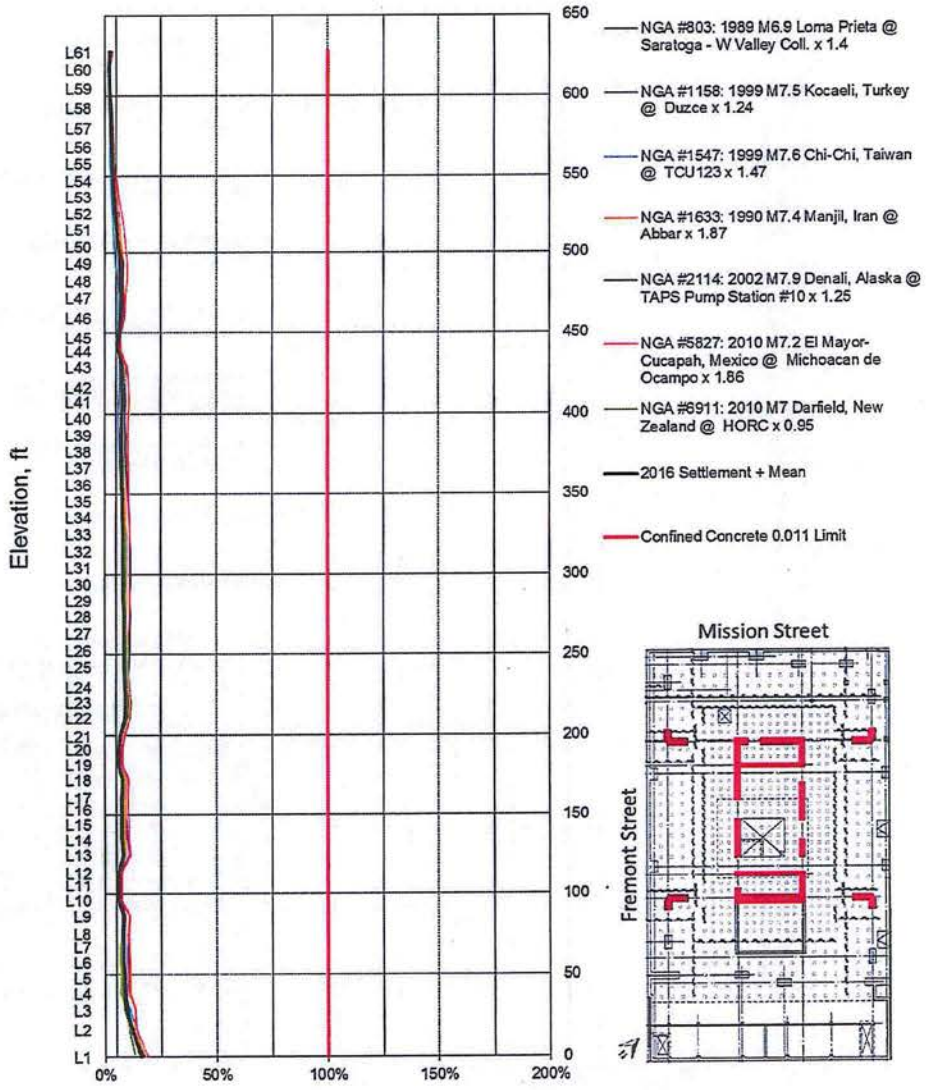
Figure 28. Demand to Capacity Ratio, Core Wall and Outrigger Column Compressive Strain, Fixed Translation Model

Figure 28Figure 28 presents the demand to capacity ratios, in percent, for compressive strains in concrete walls and also outrigger columns, which were also modeled using shell elements. As extreme fibers of the walls and the columns at all levels are confined, an acceptable value of strain is taken as 0.011. Demands are substantially below these values at all levels and for all ground motions.

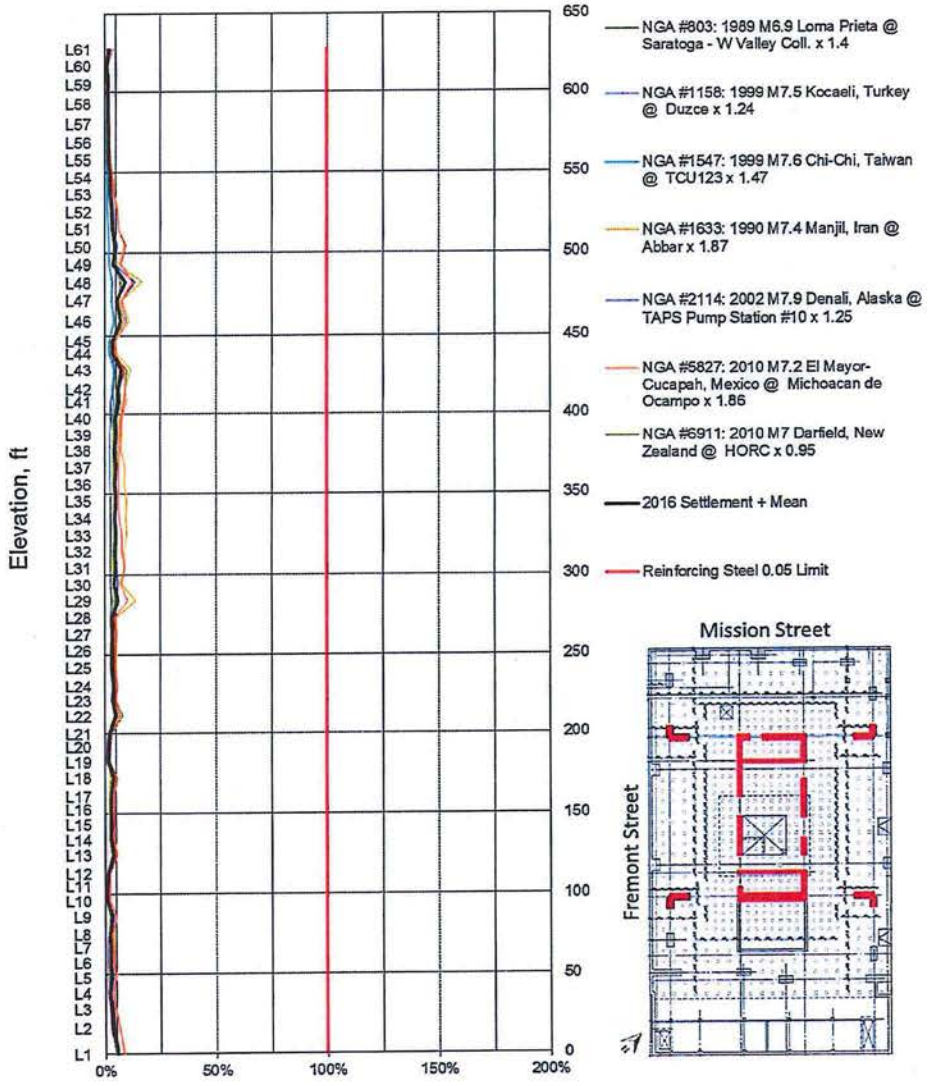
Figure 29. Demand to Capacity Ratio, Core Wall and Outrigger Column Tensile Strain, Fixed Translation Model

Figure 29Figure 29 presents the demand to capacity ratios, in percent, for concrete core wall and outrigger column reinforcing tensile strains. An acceptable value of 0.05 is used. Demands are substantially below these values at all levels and for all ground motions.

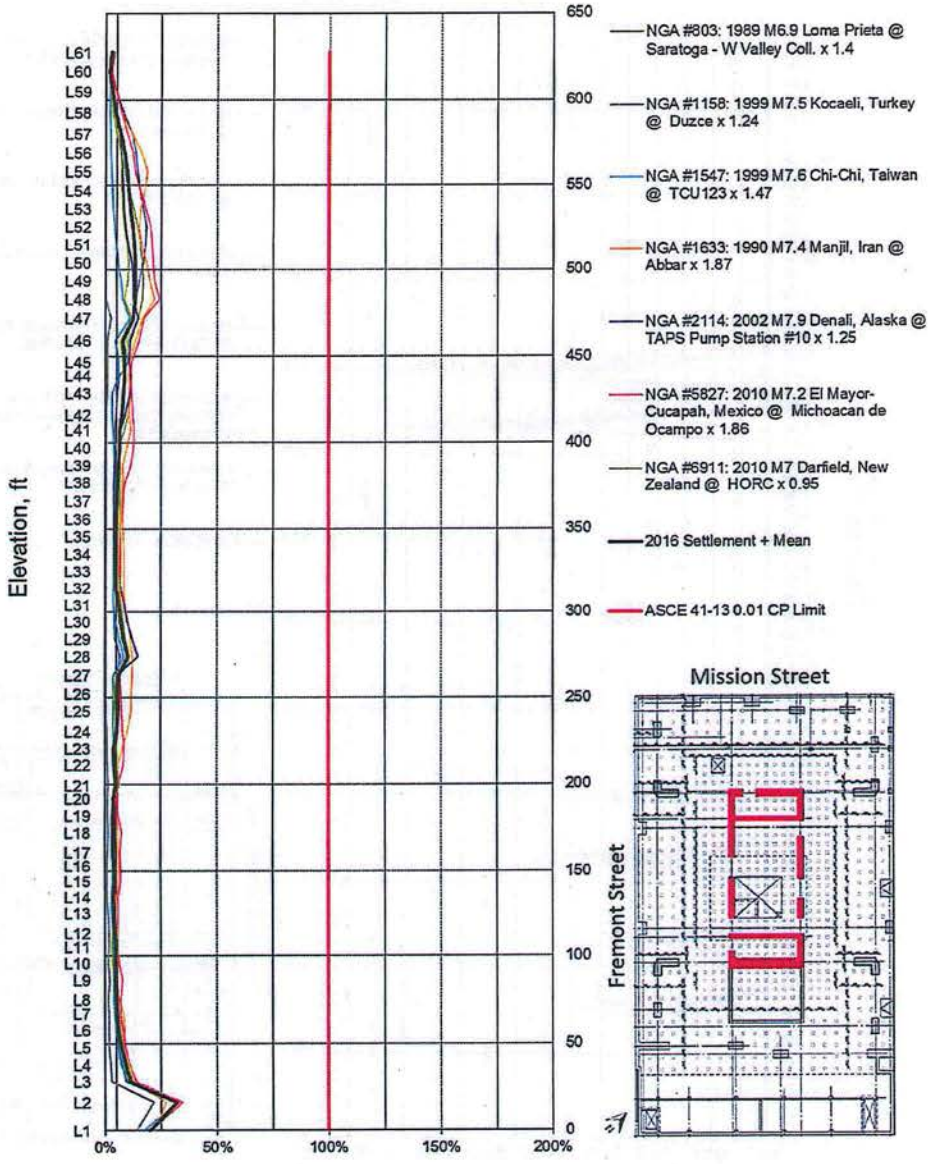
Figure 30. Demand to Capacity Ratio, Core Wall Shear Strain

Figure 30 shows the demand to capacity ratios for core wall shear strain. Strain for all records is substantially less than the 0.01 permitted by ASCE 41.

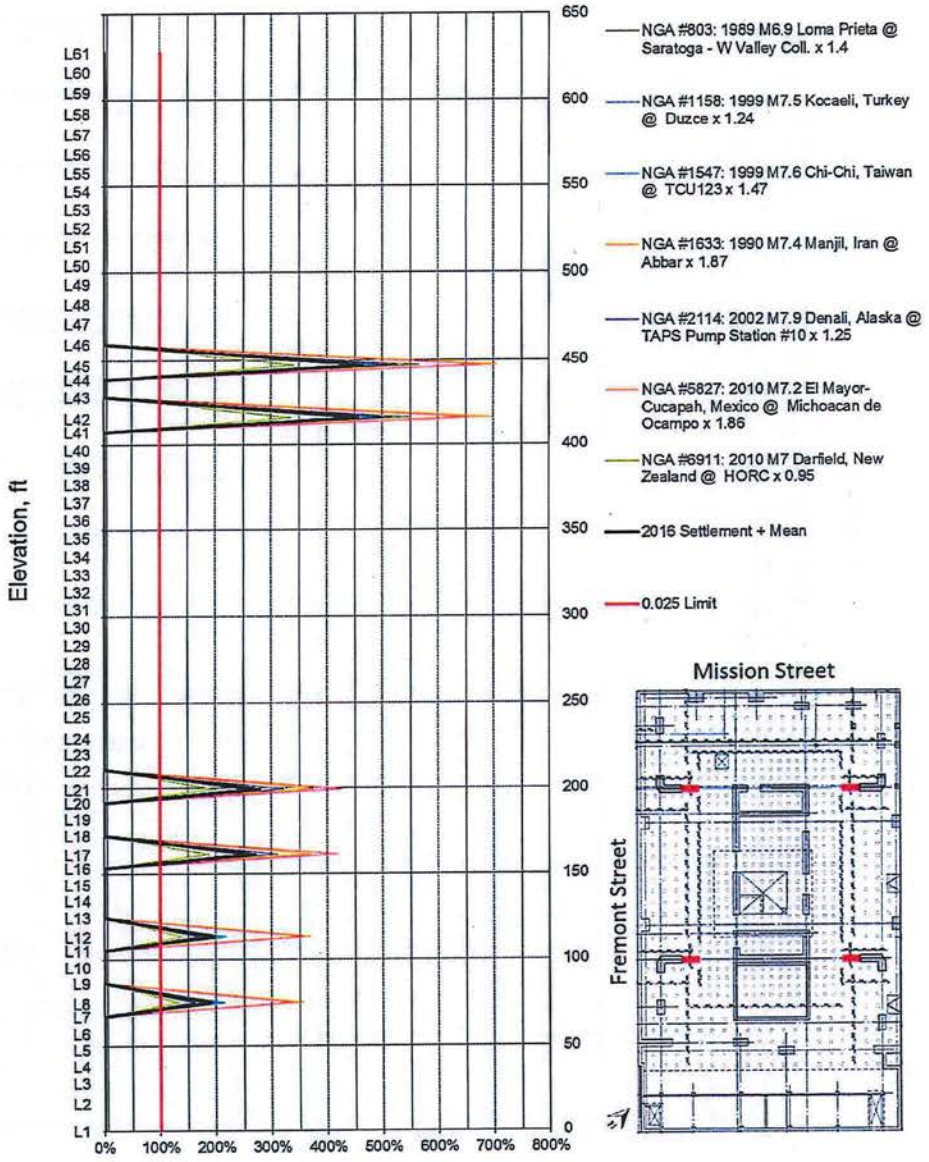
Figure 31. Demand to Capacity Ratios, Outrigger Coupling Beam Rotation, Fixed Translation Model

Figure 31 shows the demand to capacity ratios for coupling beams in outriggers. A value of 100% represents a chord rotation of 0.025 radian and the hysteretic relationship illustrated in Figure 13. All coupling beams degrade in strength without negative impact on other elements or overall stability.

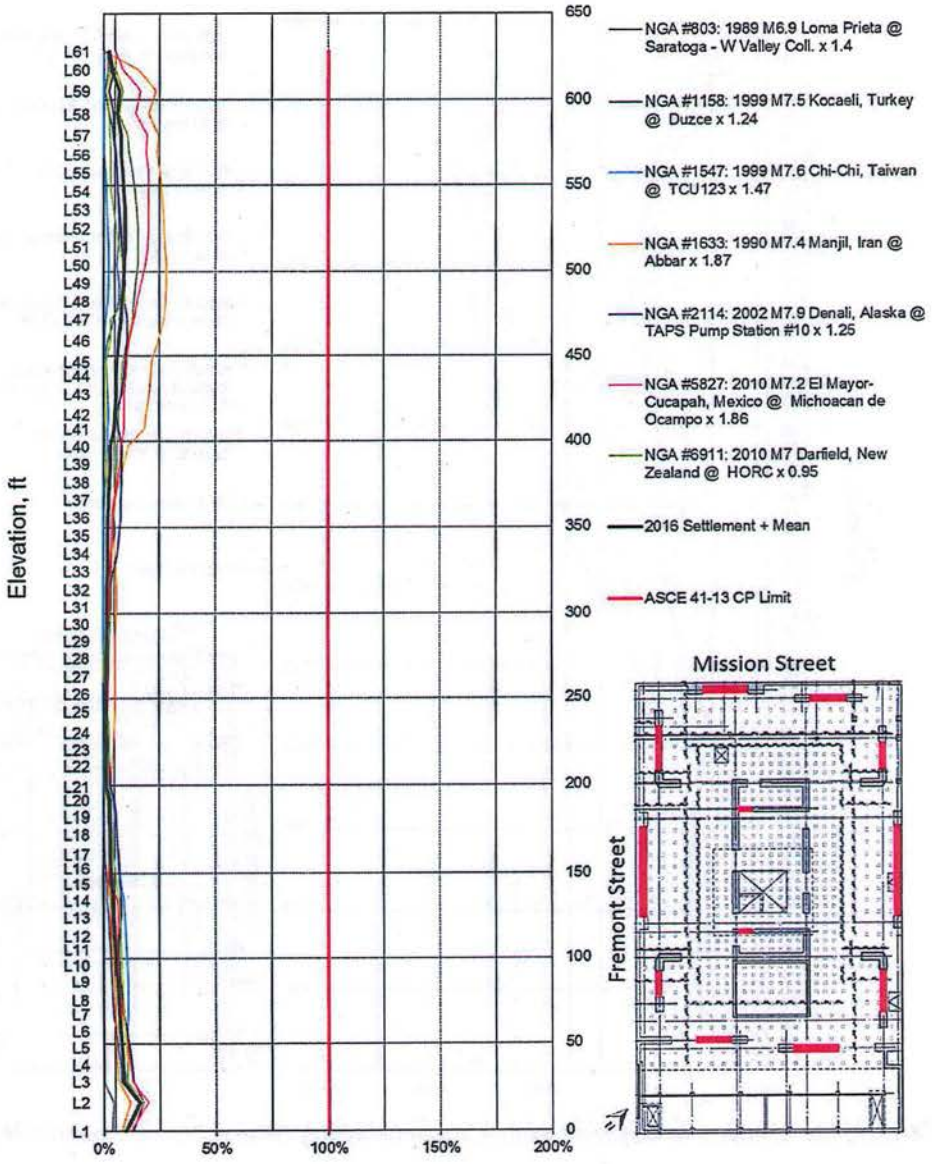
Figure 32. Demand to Capacity Ratios, Concrete Beams, Fixed Translation Model

Figure 32 presents demand to capacity ratios for reinforced concrete beams in moment frames and core walls. Acceptable values range from 0.03 radians to 0.05 radians depending on the

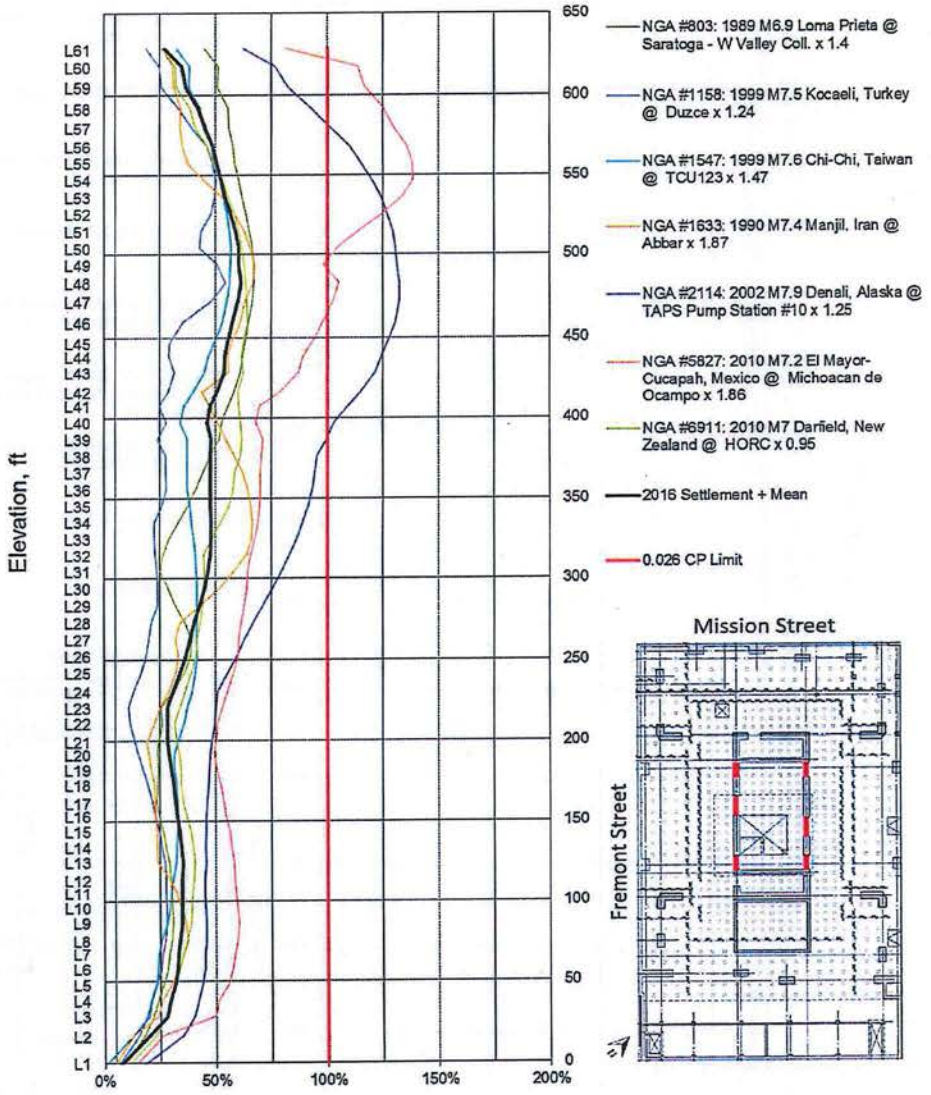
Figure 33. Demand to Capacity Ratios, Steel Coupling Beams, Fixed Translation Model

Figure 33 presents demand to capacity ratios for steel coupling beams. A value of 100% corresponds to a plastic hinge rotation of 0.03 radians. Mean demands are substantially less than this amount although two ground motions do produce locally somewhat higher demands at upper levels. The predicted demands are within the valid modeling range at all levels for all ground motions.

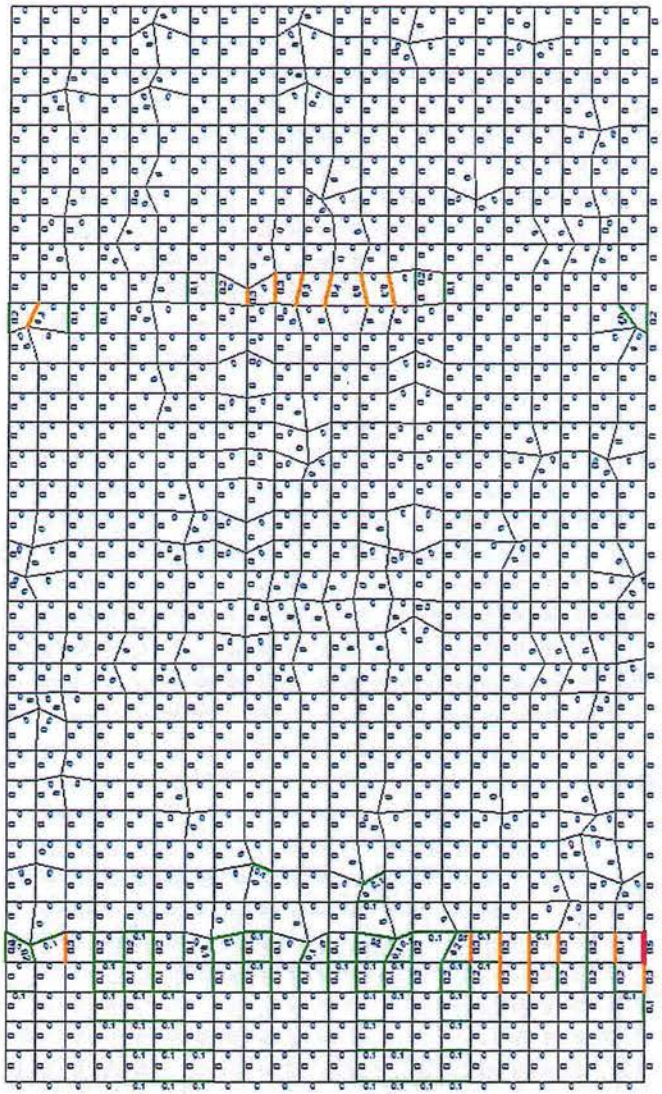
Figure 34. Peak Plastic Hinge Rotations (1999 Chi Chi, TCU3), Mat Grillage, Fixed Translation Model

Figure 34 shows the peak mat grillage beam plastic rotation demands from the 1999 Chi Chi Taiwan, TCU3 record, which of the suite of records evaluated, was the most taxing on the mat. The peak value at any location is 0.003 radians. A value of 0.01 is taken as acceptable. All values are substantially less than this.

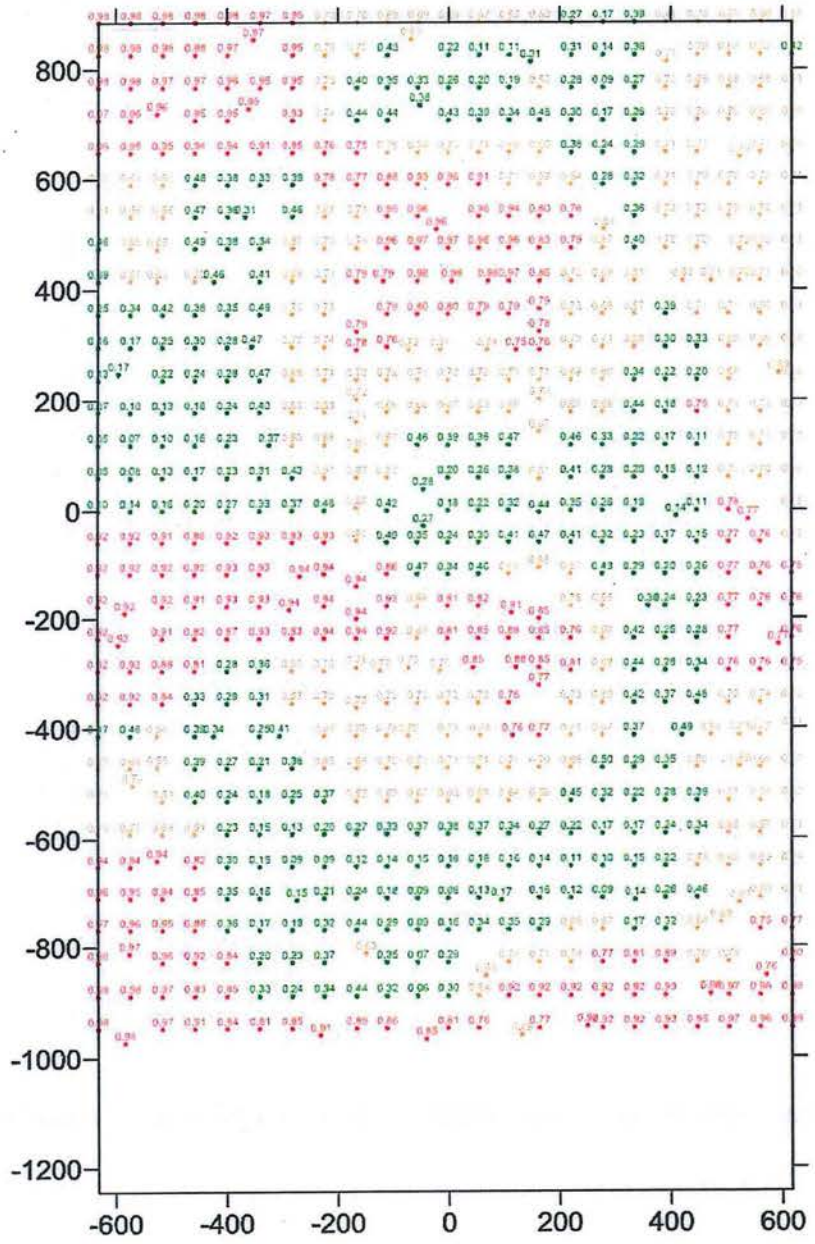
Figure 35. Pile Compressive Demand to Capacity Ratios, Maximum of Seven Ground Motions, Fixed Translation Model

Figure 35 shows the peak compressive demand to capacity ratio for piles. A value of 1.0 indicates that a pile has achieved its estimated geotechnical capacity as indicated in Figure 8 and Figure 9. It is important to note that this plot shows the peak value obtained for all ground motions. Individual ground motions would have lower peak values at most piles. Regardless, no piles exceed a value of 0.98. Also, since pile geotechnical capacity exceeds pile structural capacity, a value of 1.0 would indicate the onset of a yielding mode of behavior, rather than failure.

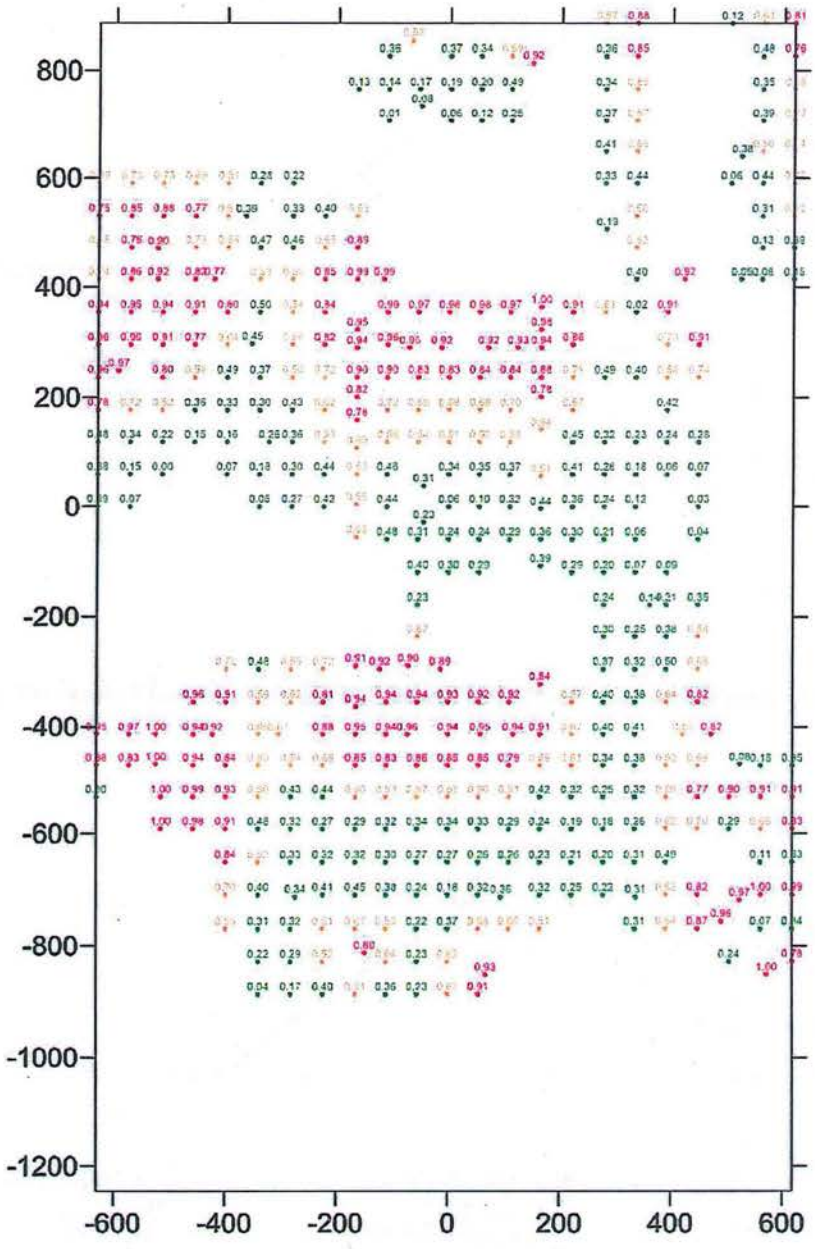
Figure 36. Peak Pile Tensile Demands to Capacity Ratios, Maximum of Seven Ground Motions, Fixed Translation Model

Figure 36 indicates peak pile uplift demand to capacity ratios for all ground motions. As with Figure 35, any one ground motion will produce lower values for most piles. For an individual pile spring, a value of 1.0 represents the lesser of the pile geotechnical seismic capacity, as given by Figure 8 and Figure 9 or the steel yield strength, whichever is less. Several piles are predicted to have a peak demand equal to their capacity. This is suggestive of a benign yielding mode of behavior.

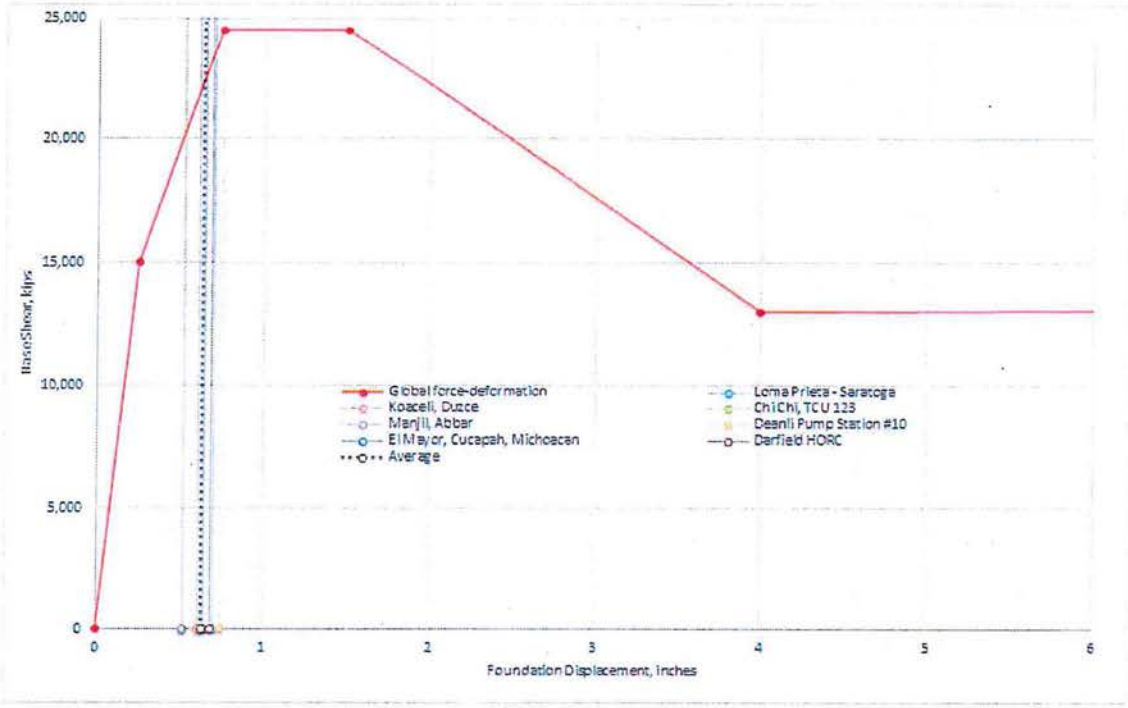
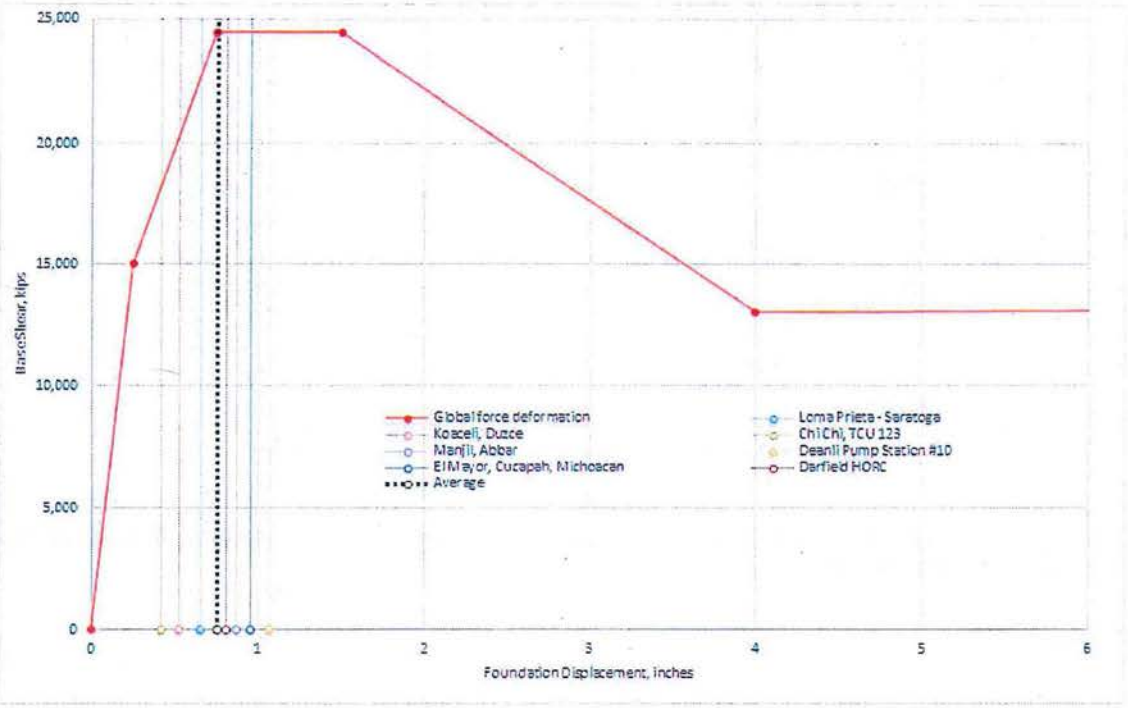
Figure 37 and Figure 38 respectively present the peak lateral displacement demands on the pile cap in the east-west and north-south directions, overlain on the global pile nonlinear force-displacement behavior previously shown in Figure 22. Predicted pile lateral displacement is typically less than 1 inch and does not approach the displacement at which foundation strength degradation initiates.

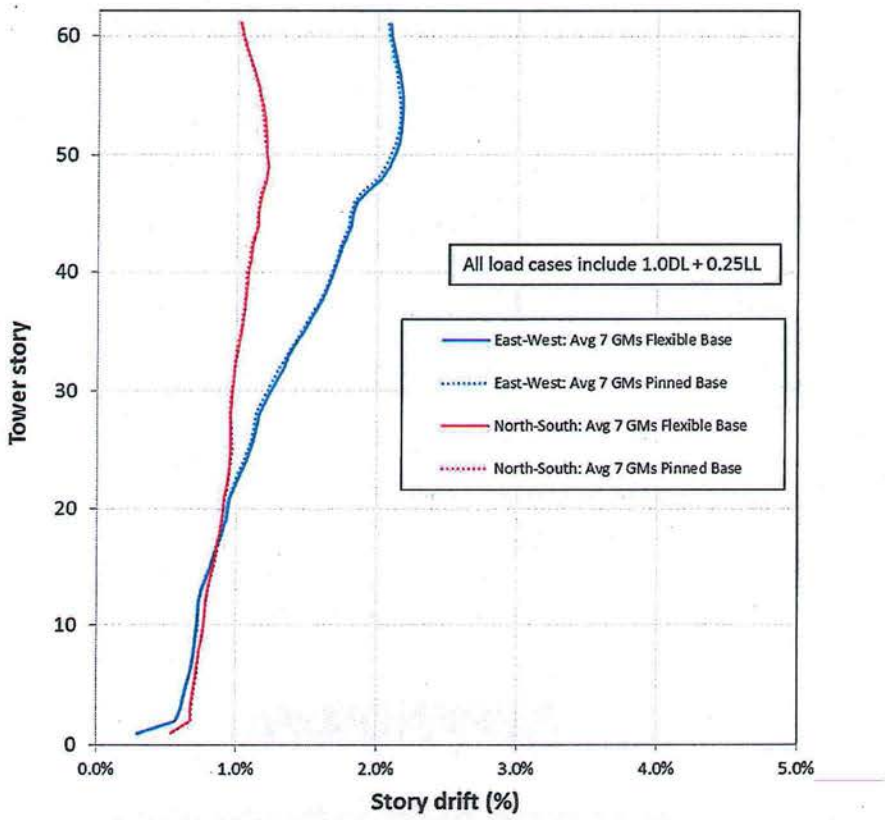
Figure 39. Comparison of Story Drift Ratios for Fixed Translation and Nonlinear Pile Models

Figure 39 compares plots of mean story drift in the east-west and north-south directions for the model fixed against lateral translation at the base and the model with nonlinear lateral translational pile springs. In each of the two directions, the story drift predicted by our analyses is nearly identical for the two models.
