File No. 160975 **Committee Item No.** 7
Board Item No. ________

AGENDA PACKET CONTENTS LIST

TALL BUILDINGS SAFETY STRATEGY

October 2018

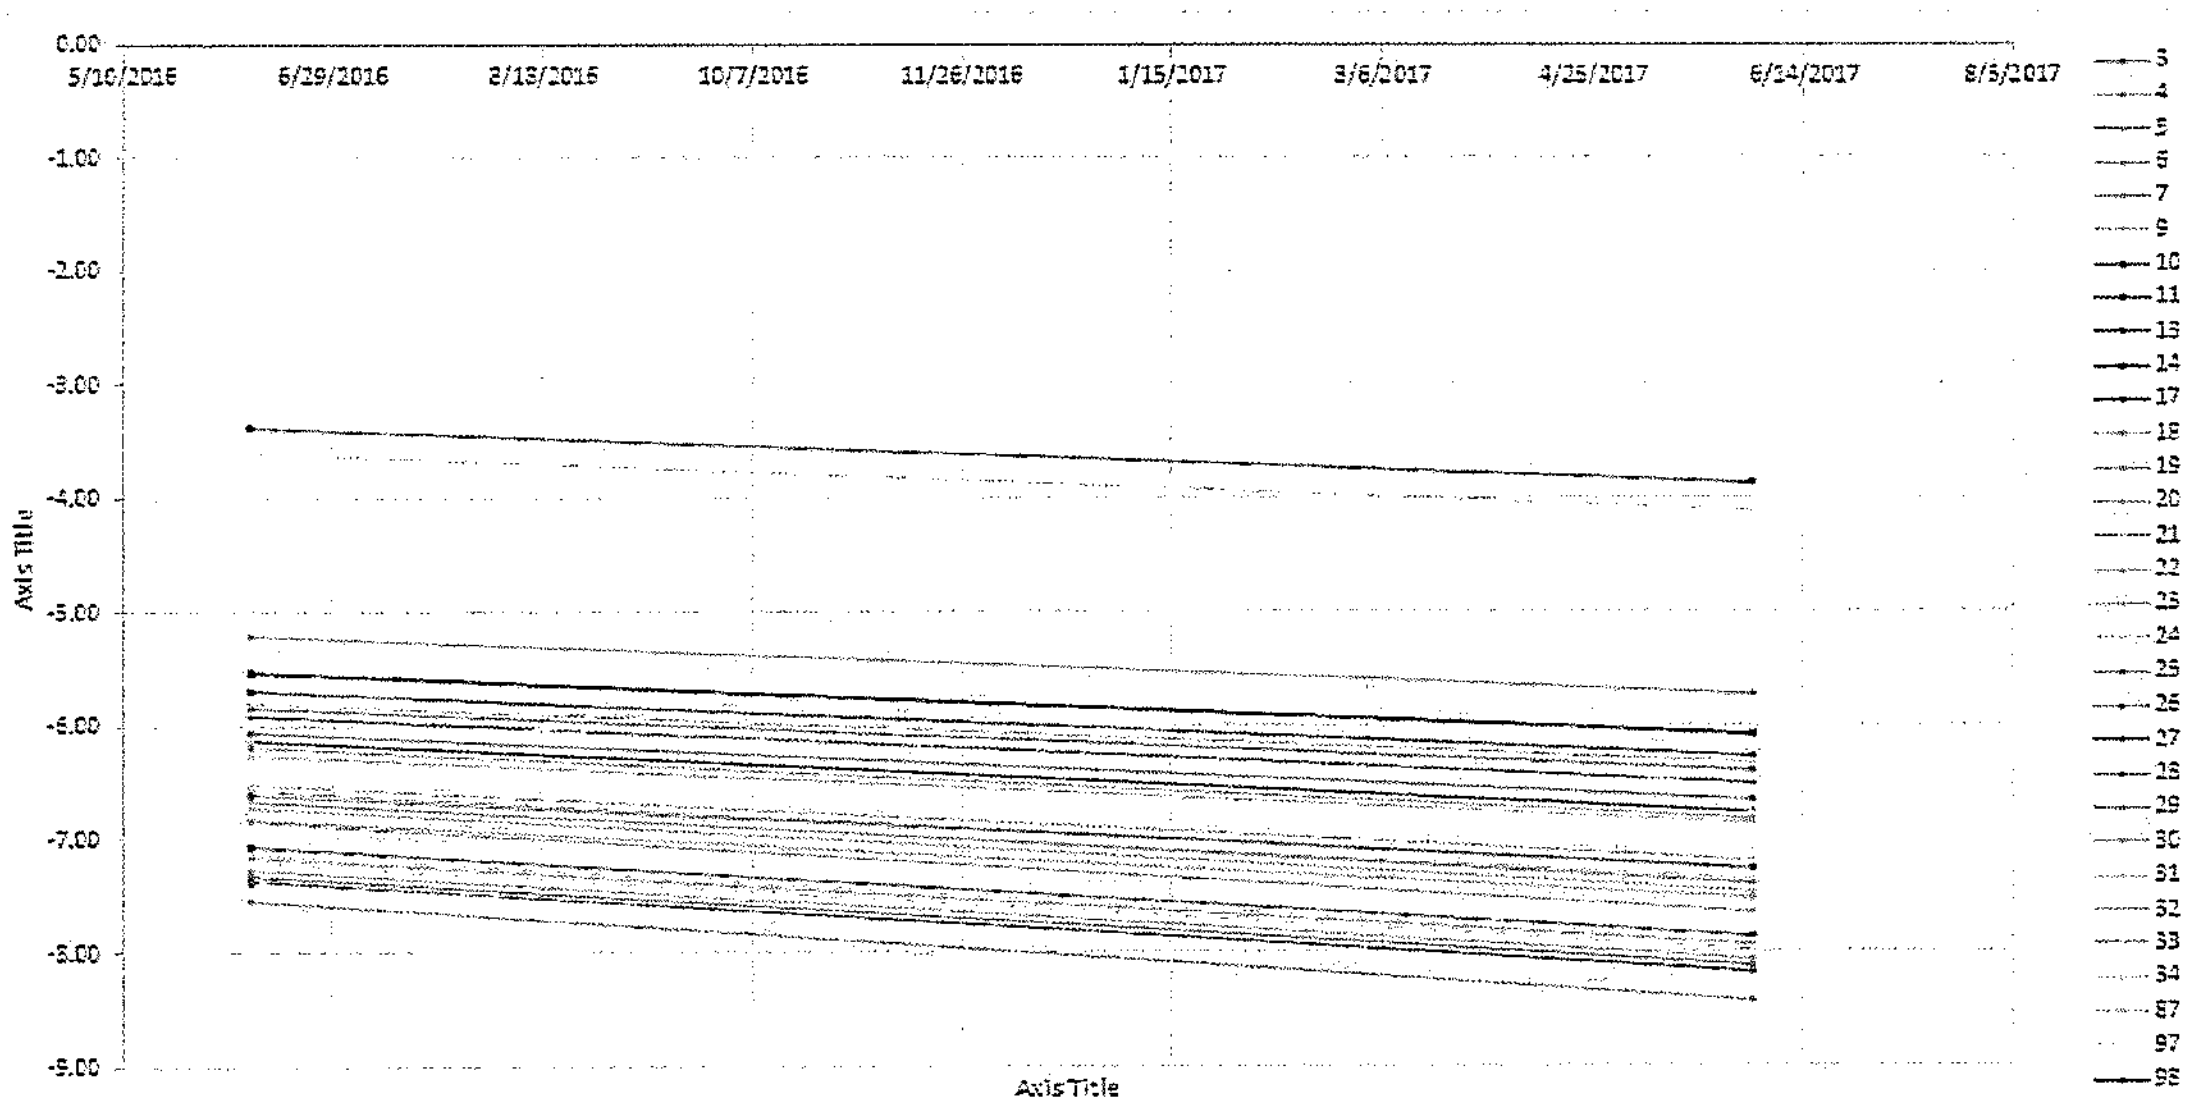
Figure 11. Settlement data, June 2016 through June 2017

Figure 11 of this report compares the settlement of 31 of the 33 measurement points during the period between June 2016 and June 2017. The profiles indicate continued motion of the building as a rigid body without noticeable difference from linear differential settlement across the mat. In this period approximately 1/2 in. additional settlement occurred at the west edge of the mat than at the east edge. Given the 100-foot width of the mat, this amounts to an incremental tilting of the building of 0.04%. This amount is negligible and has not caused any significant impact on stress in the structure.

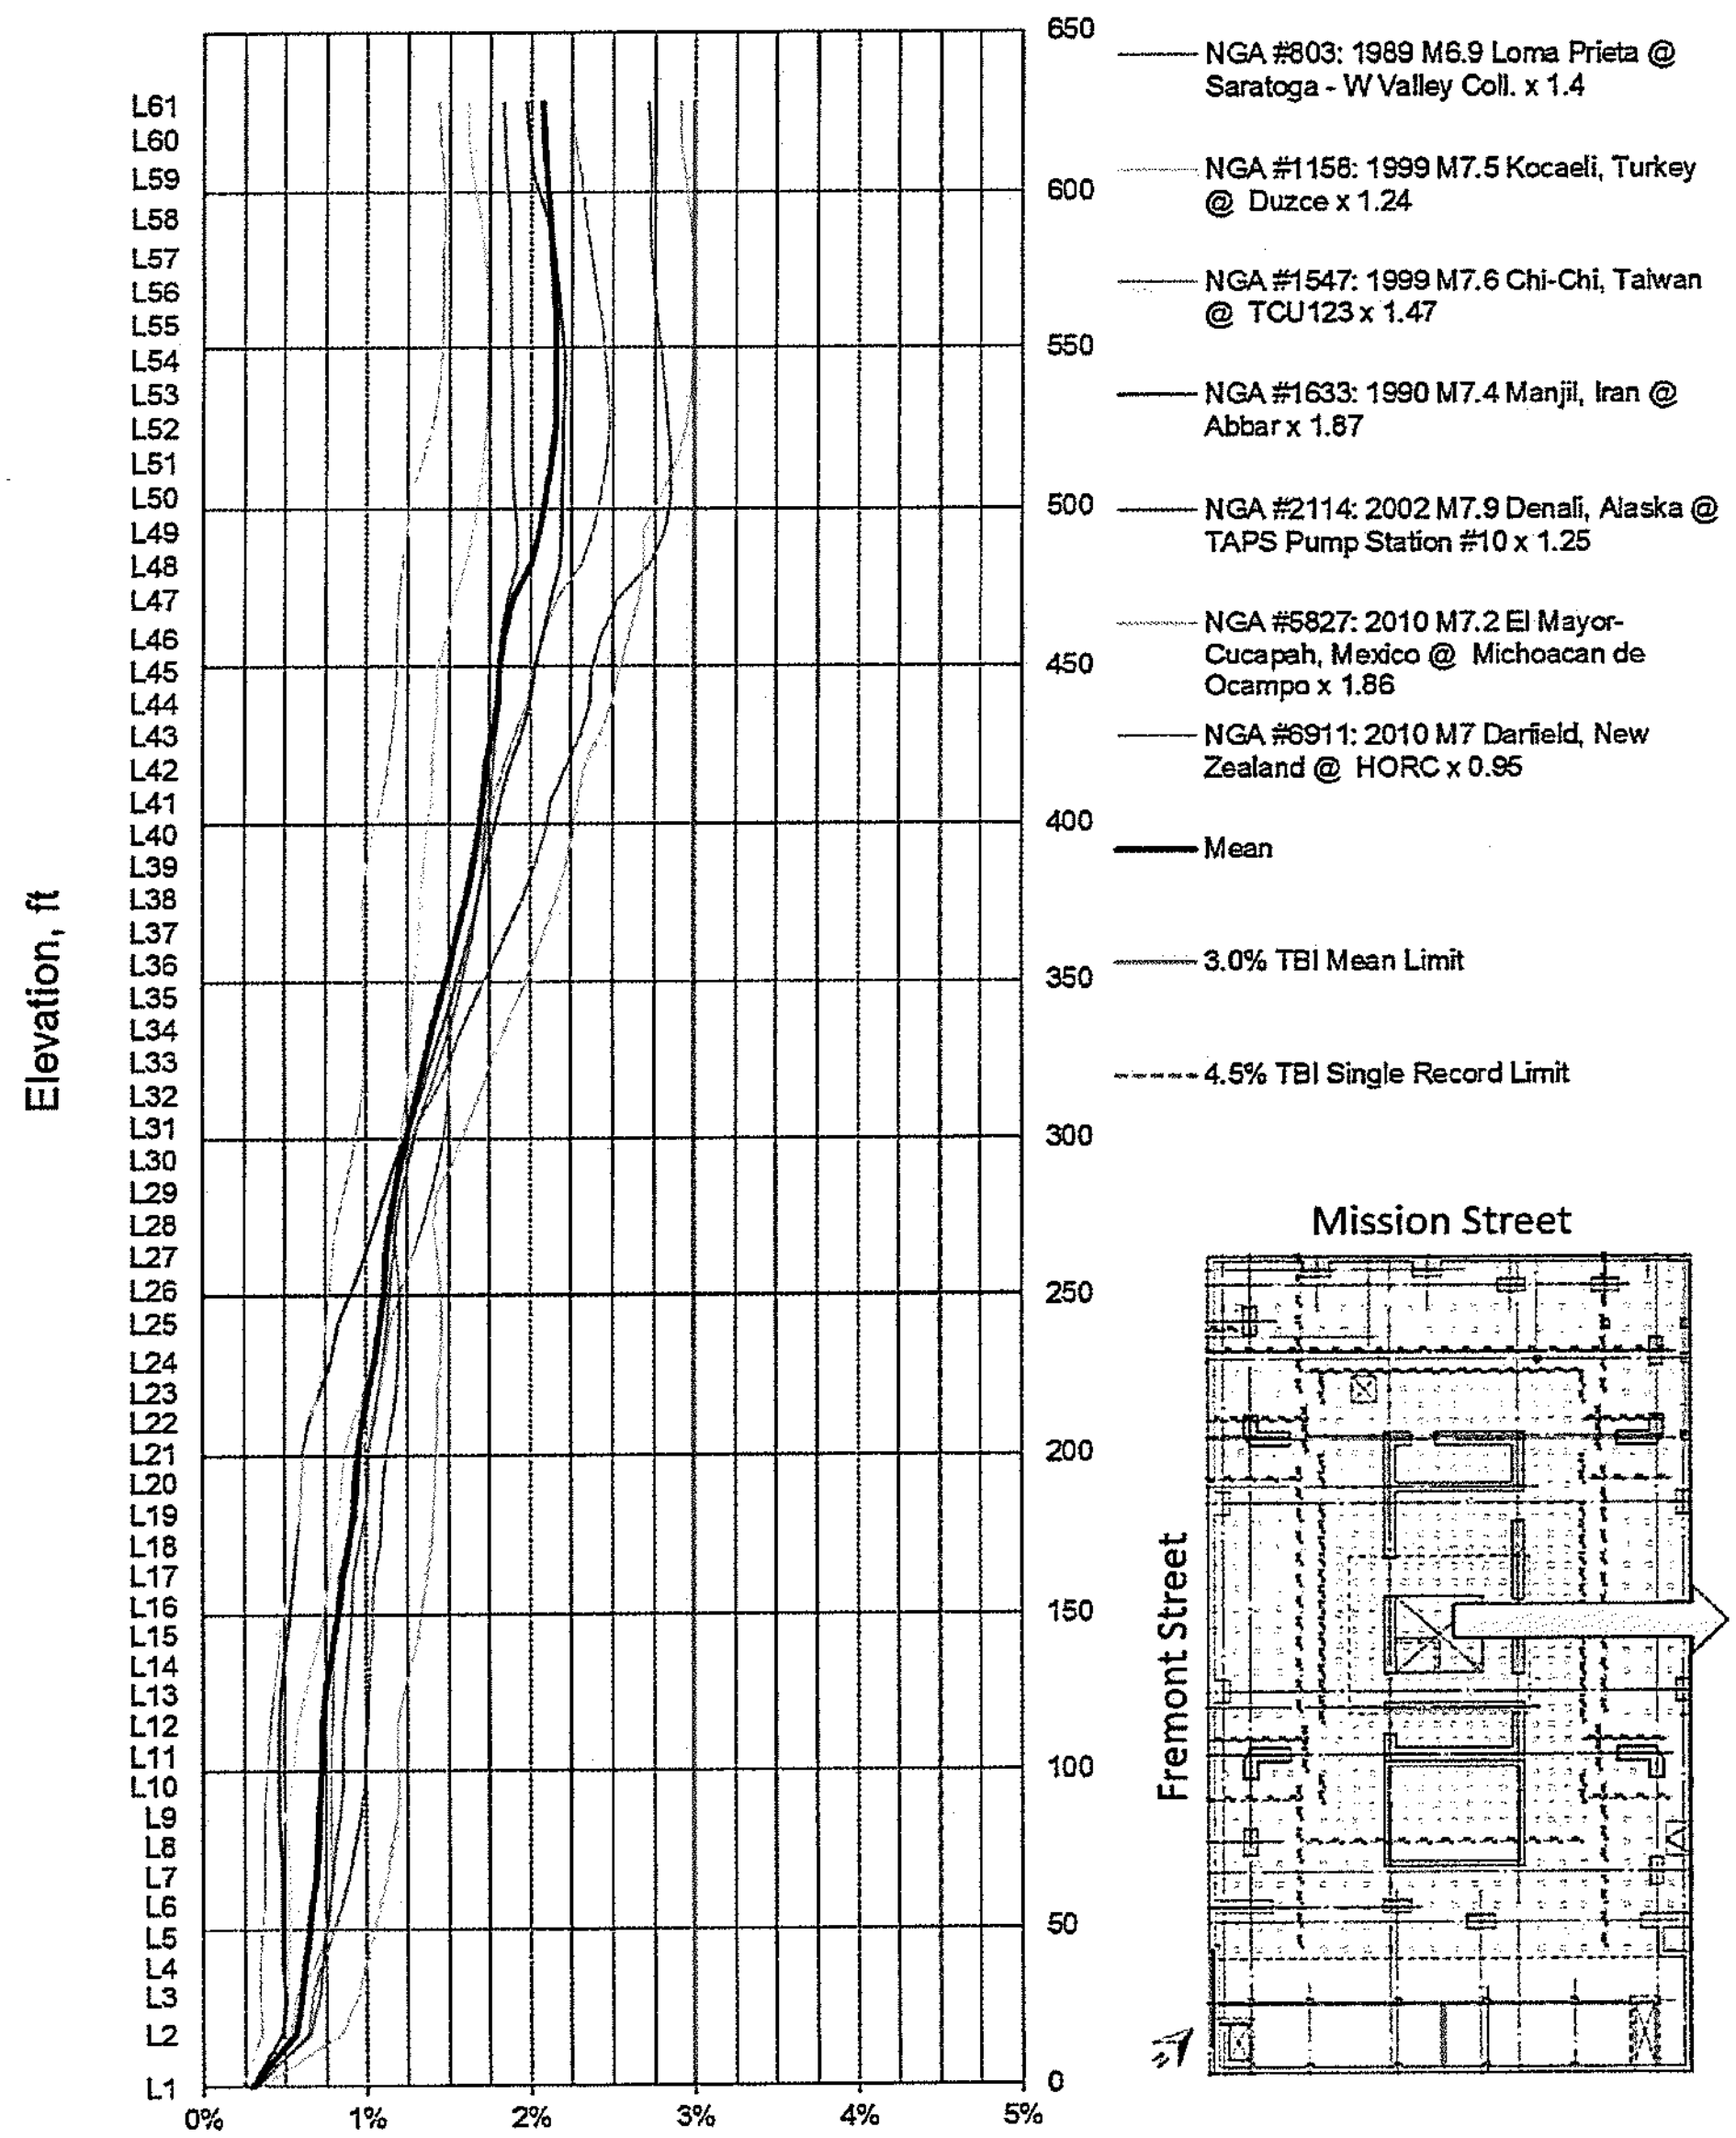
Figure 23. East-West Transient Story Drift, Fixed Translation Model

Figure 23 and Figure 24 respectively present the predicted peak absolute value story drift obtained from the analysis in the east-west and north-south directions. Mean drift in each direction is substantially below the 3% limit recommended by the PEER Tall Buildings Design

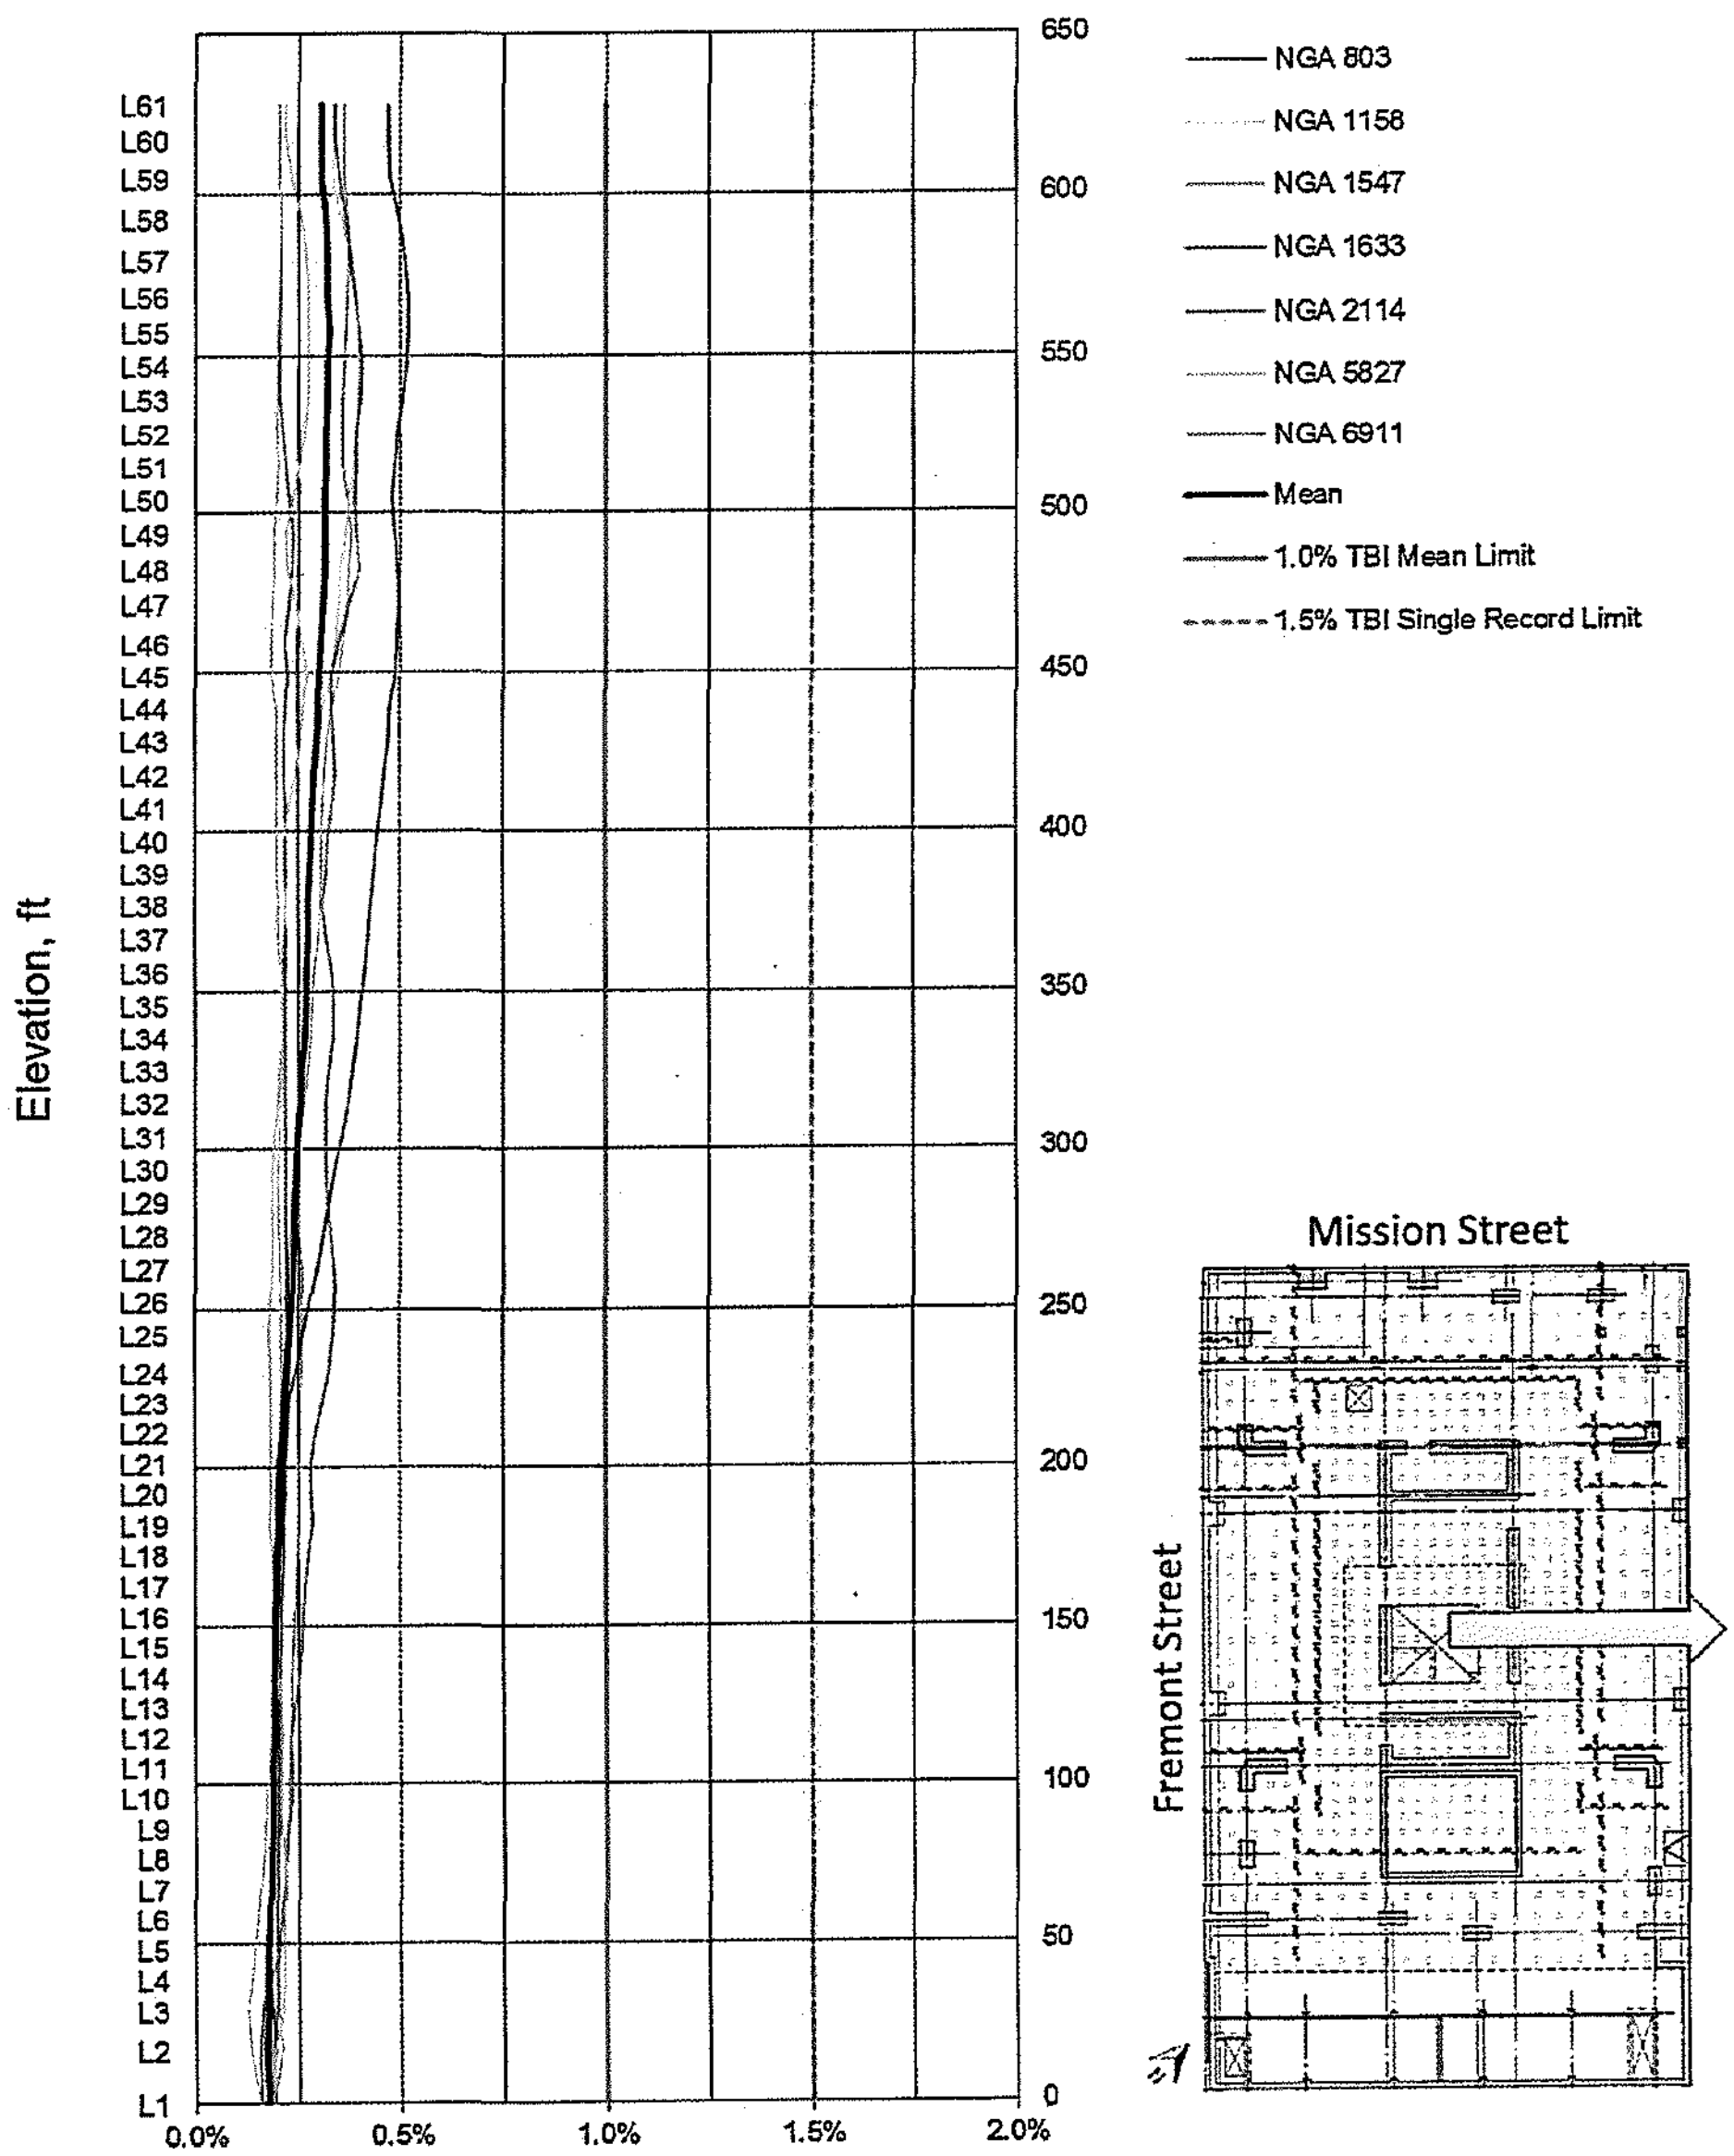
Figure 25. Residual Story Drift East-West Response

Figure 25 and Figure 26 present the residual drift obtained for each of the seven ground motions for response in the east-west and north-south directions, respectively. Average and individual drifts for the seven records are all substantially less than the 1% limit for mean residual drift recommended by the PEER Guidelines.

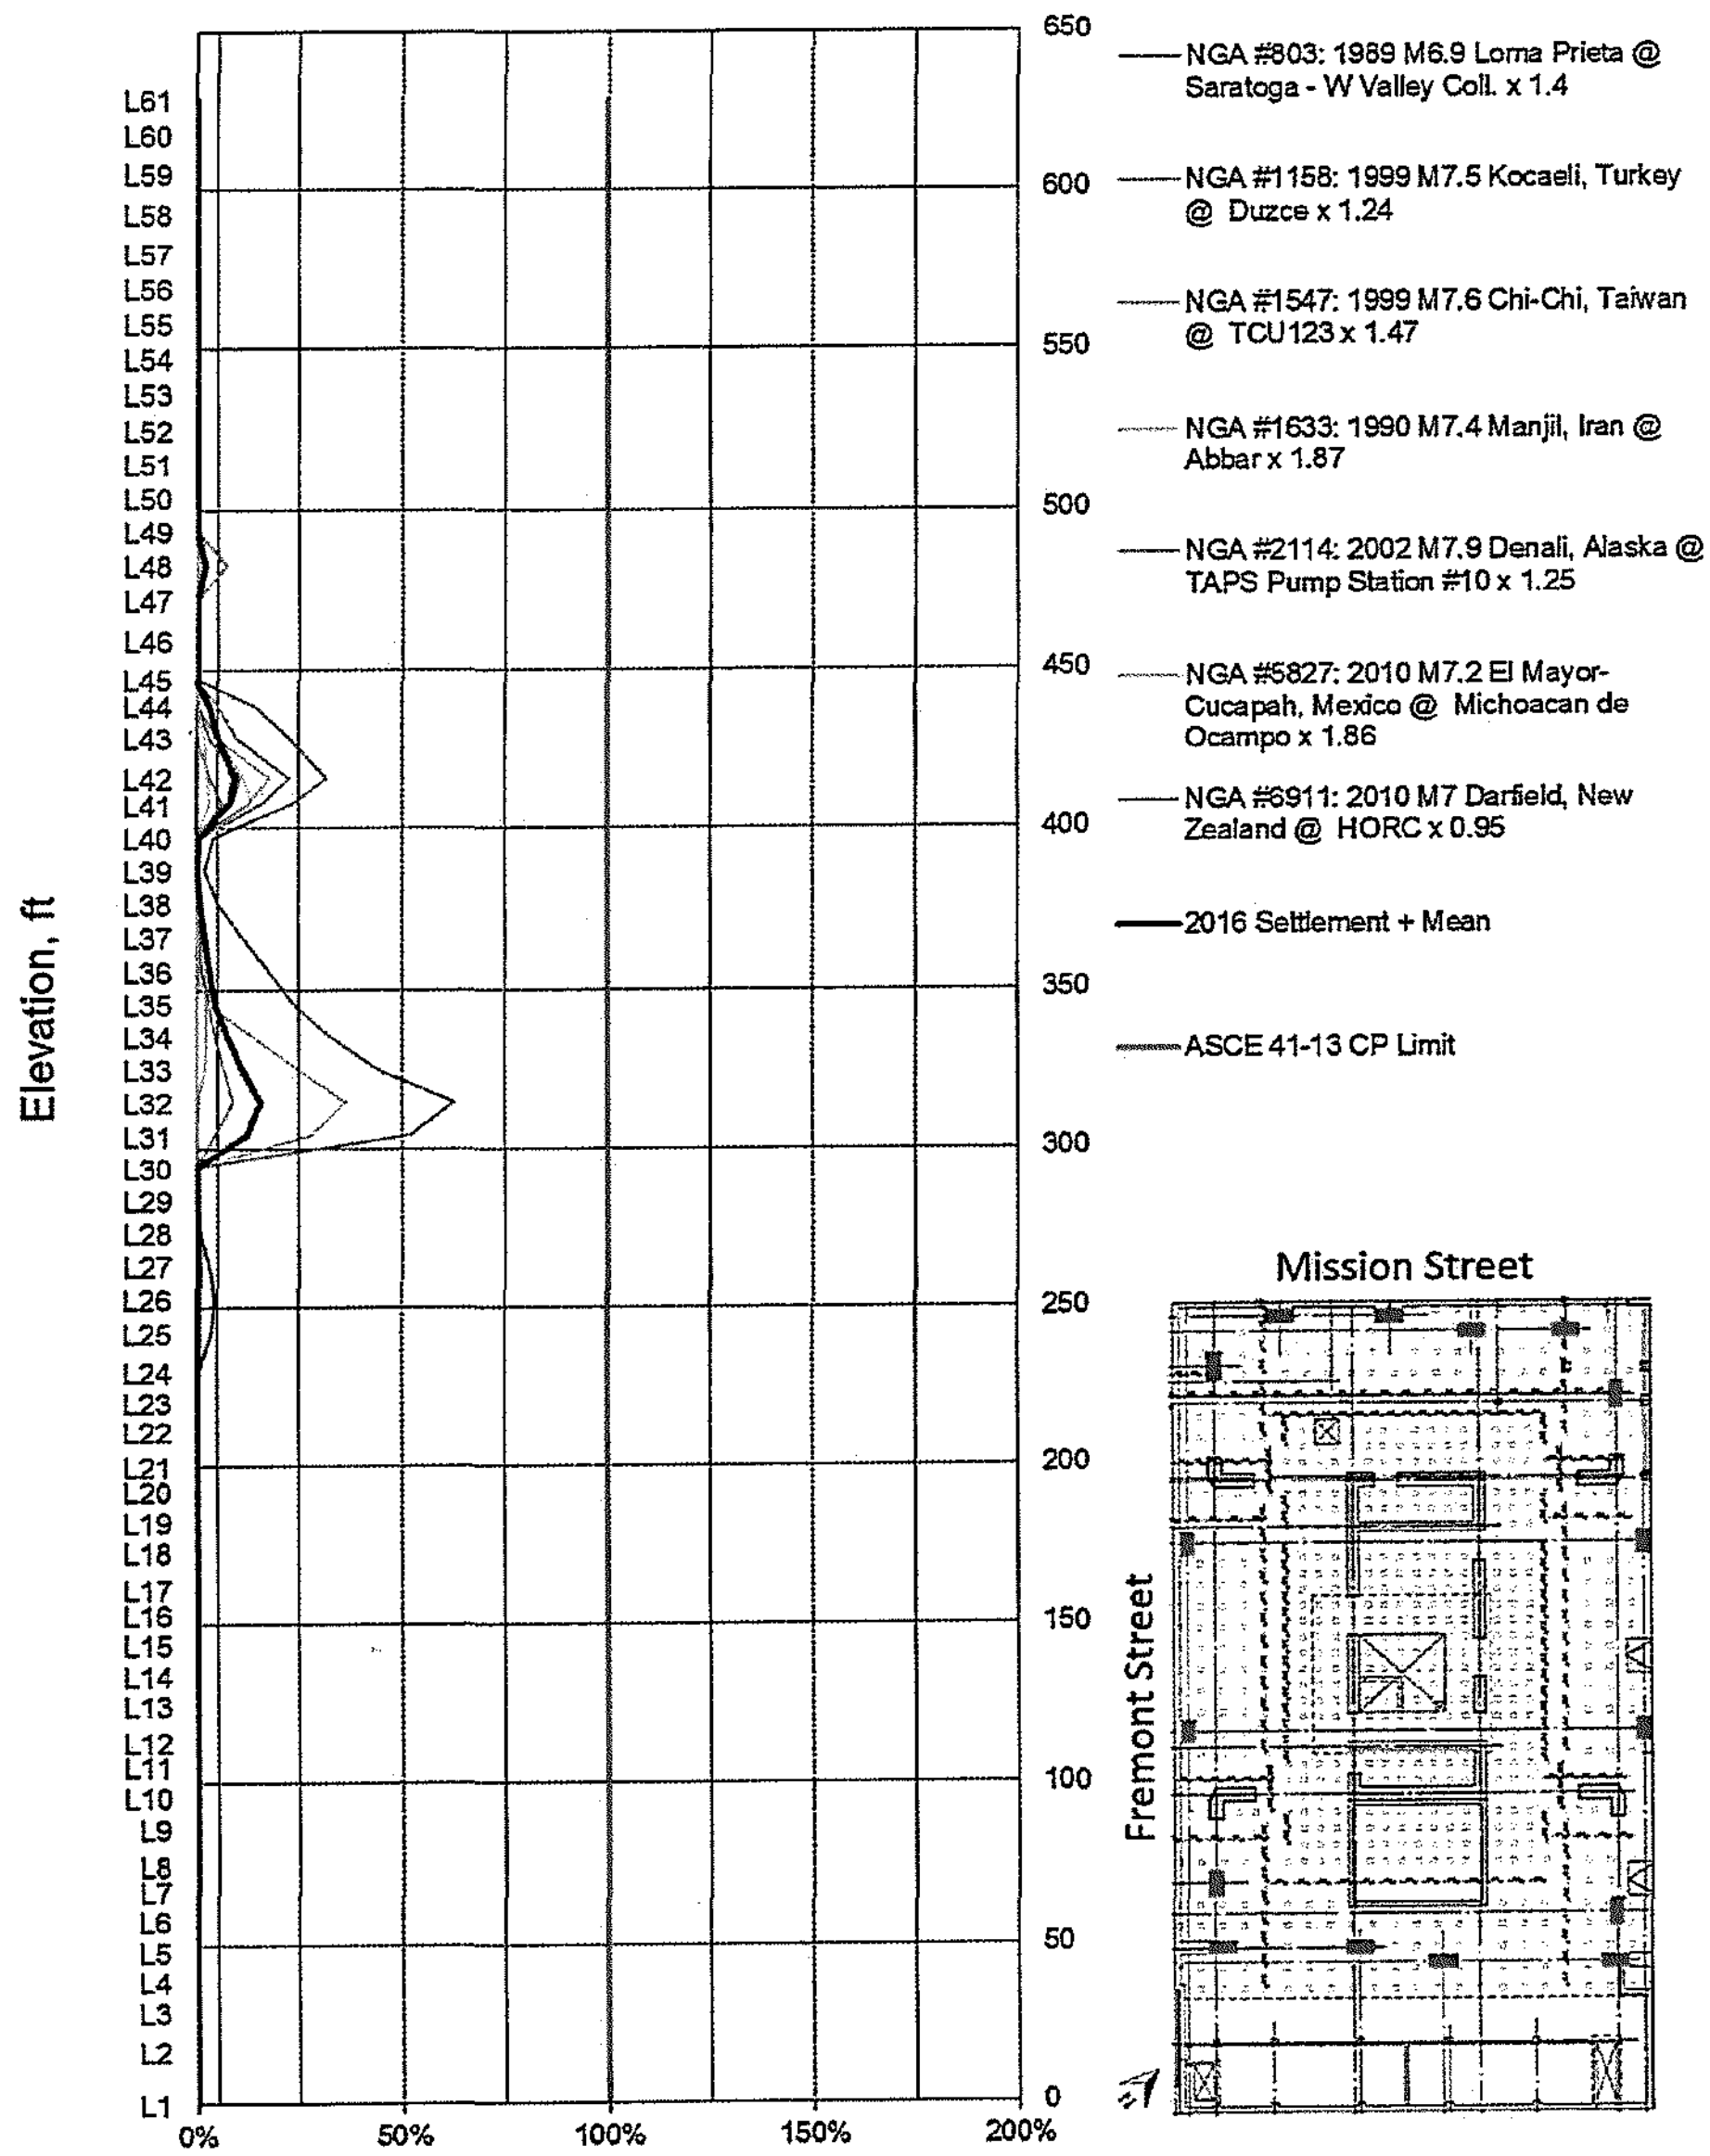
Figure 27. Demand to Capacity Ratios, Column Plastic Rotation, Fixed Translation Model

Figure 27 presents the demand to capacity ratios, in percent, for column plastic rotation. A value of 100% represents the ASCE 41-13 CP limit, which ranges from 0.008 to 0.009 radians for columns in this structure. The figure shows the maximum predicted value for any of the columns at each story, for each ground motion, and also the average peak value for all ground motions.

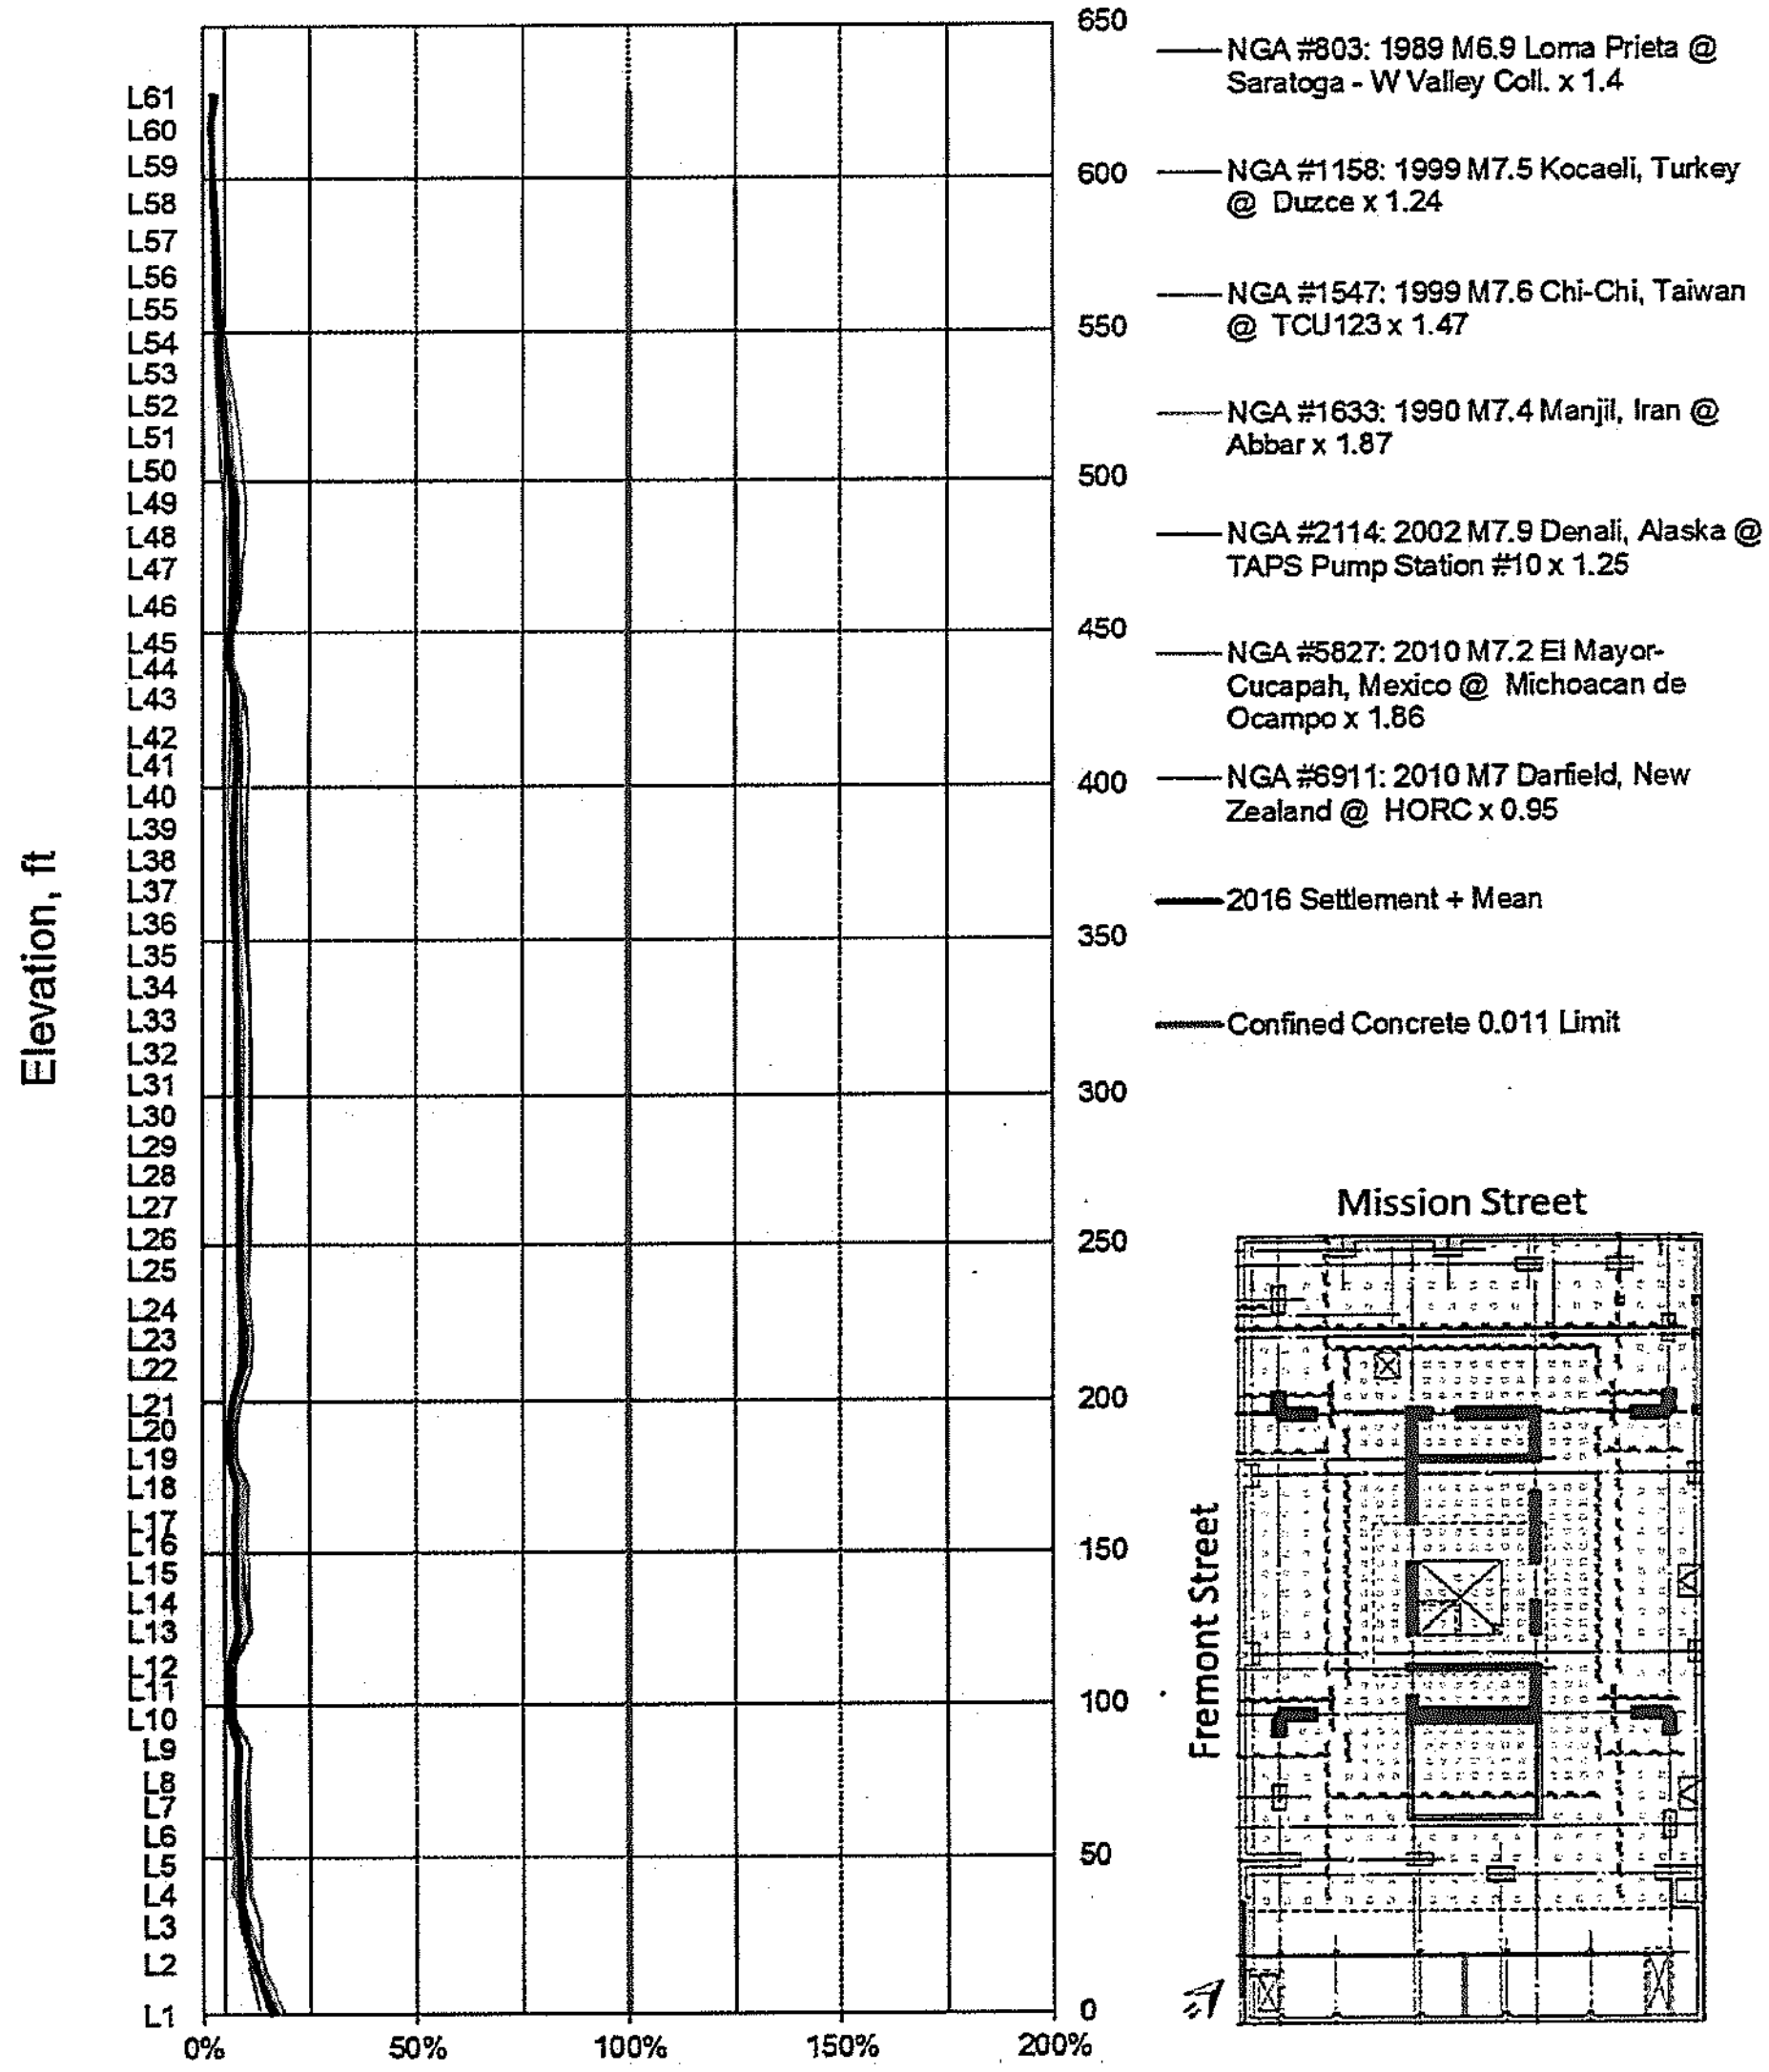
Figure 28. Demand to Capacity Ratio, Core Wall and Outrigger Column Compressive Strain, Fixed Translation Model

Figure 28Figure 28 presents the demand to capacity ratios, in percent, for compressive strains in concrete walls and also outrigger columns, which were also modeled using shell elements. As extreme fibers of the walls and the columns at all levels are confined, an acceptable value of strain is taken as 0.011. Demands are substantially below these values at all levels and for all ground motions.

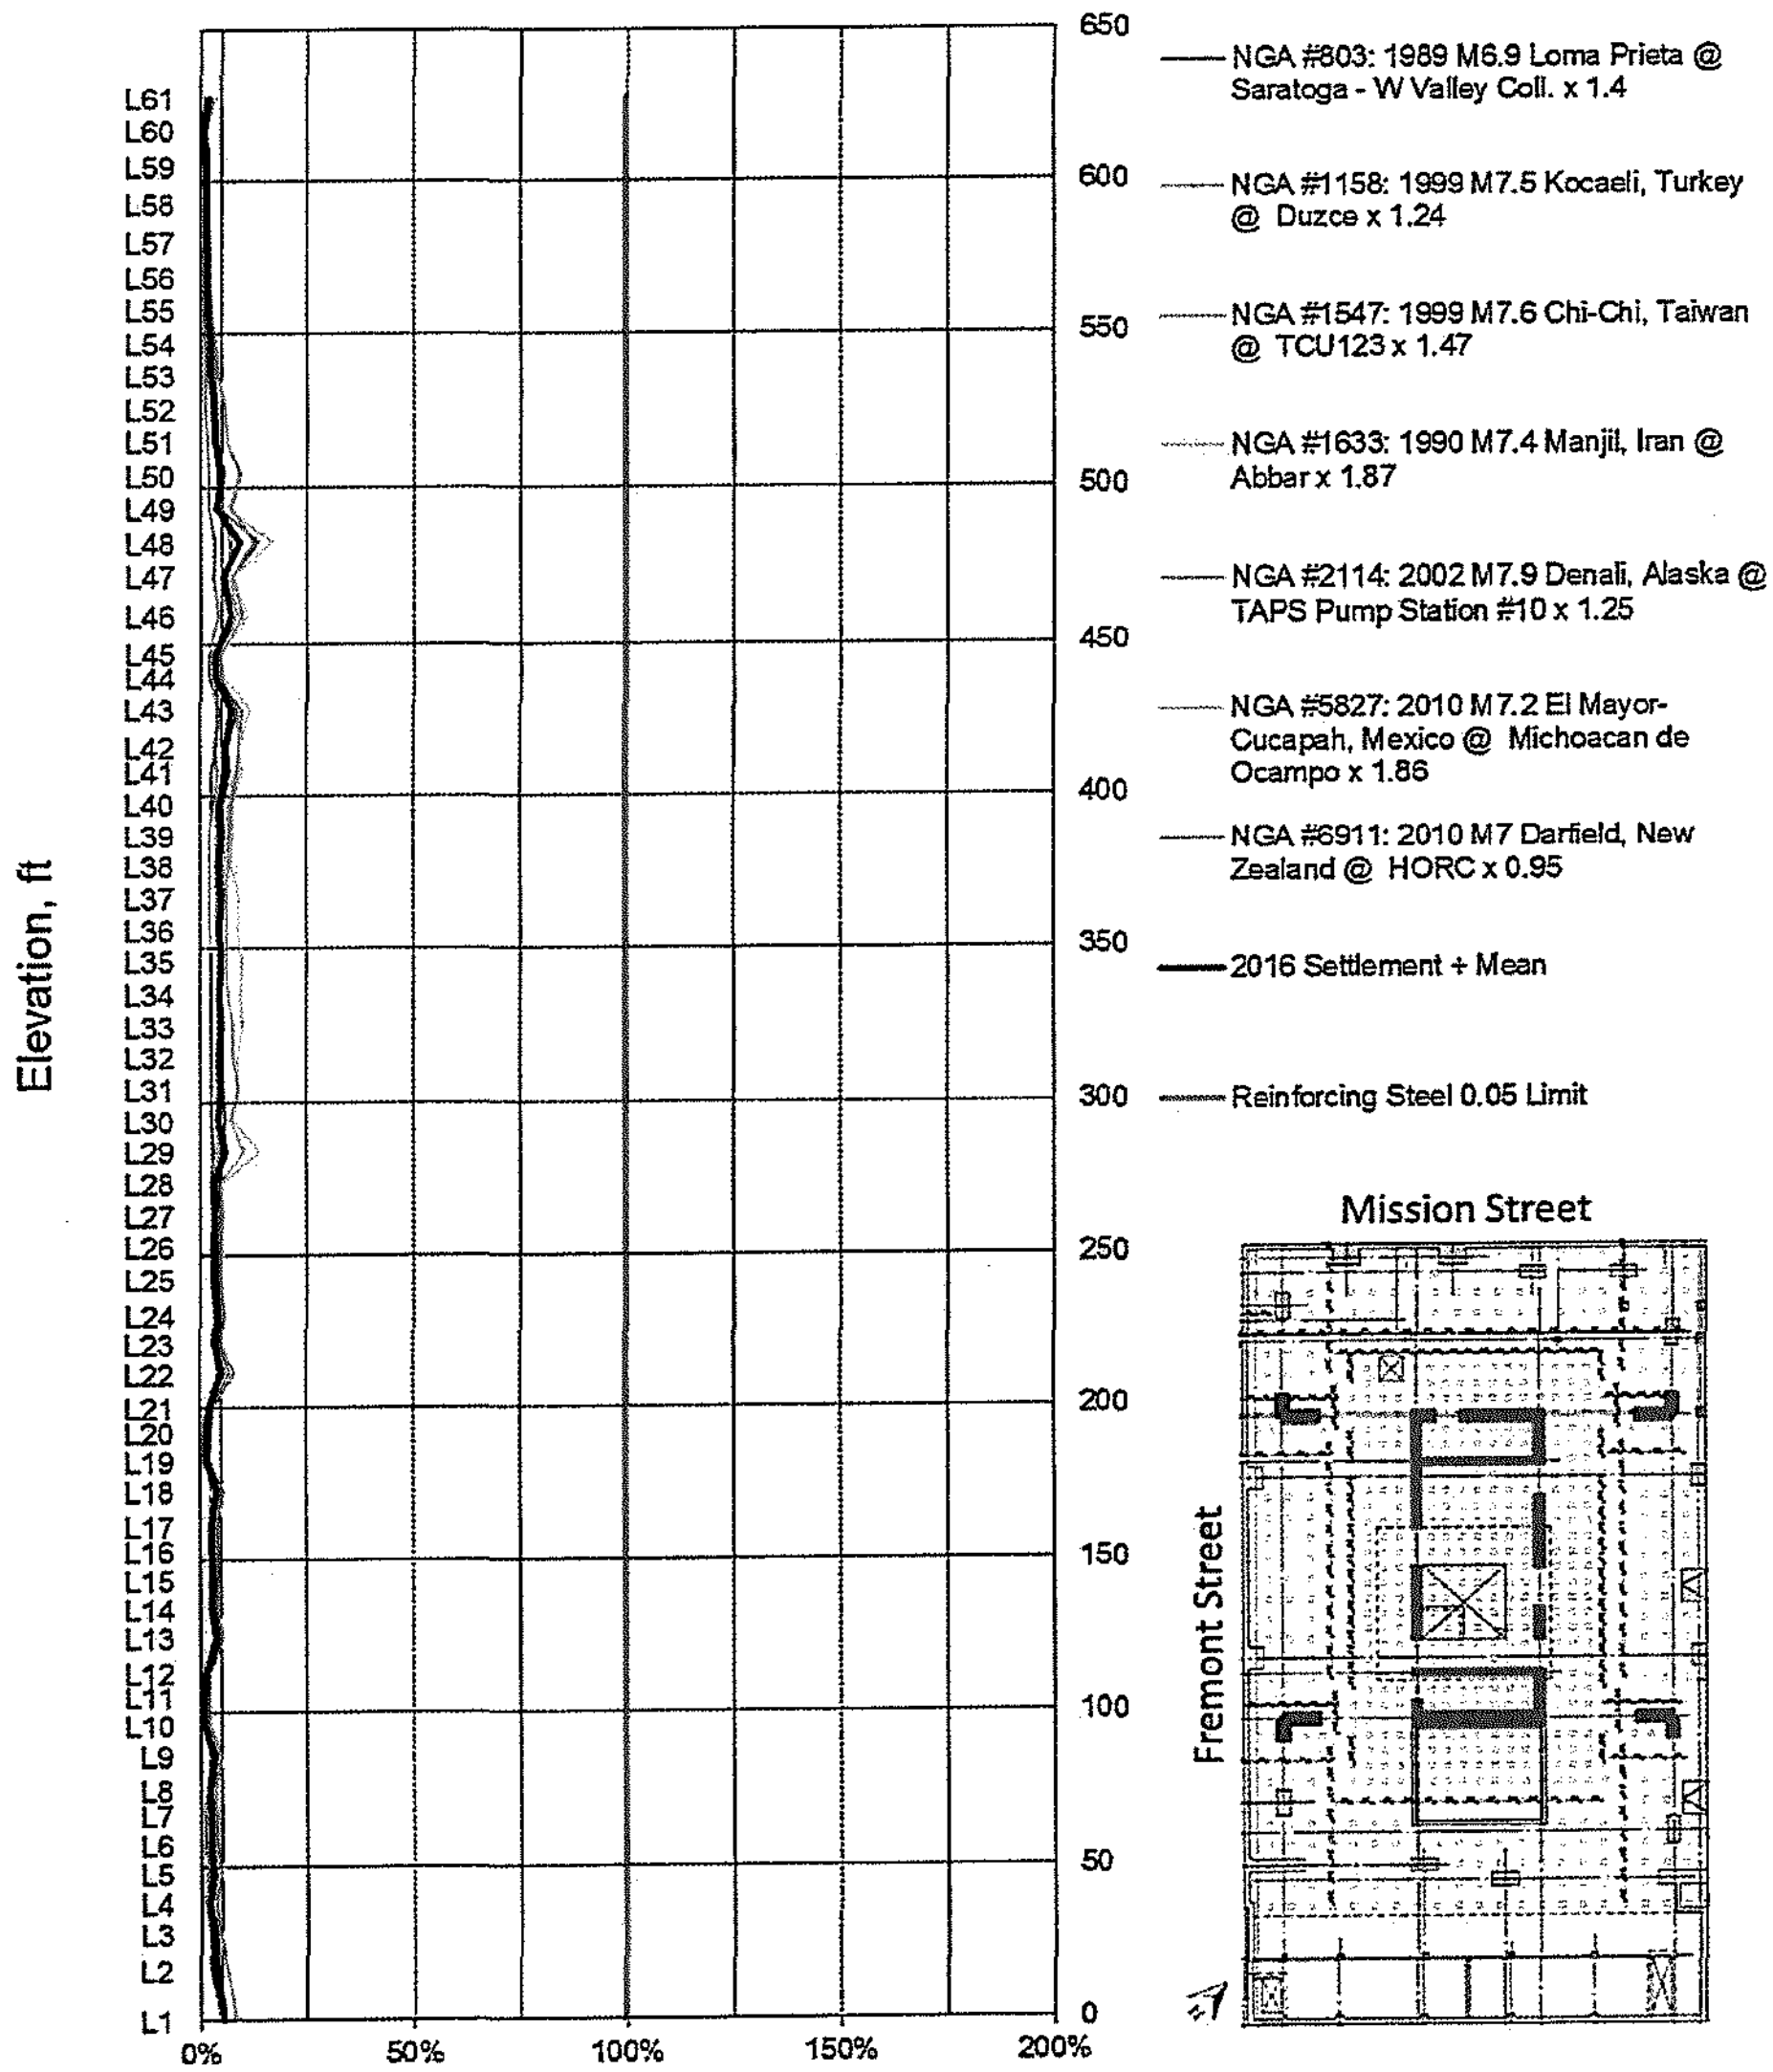
Figure 29. Demand to Capacity Ratio, Core Wall and Outrigger Column Tensile Strain, Fixed Translation Model

Figure 29Figure 29 presents the demand to capacity ratios, in percent, for concrete core wall and outrigger column reinforcing tensile strains. An acceptable value of 0.05 is used. Demands are substantially below these values at all levels and for all ground motions.
