File No. 160975 **Committee Item No.** 7
Board Item No. ________

AGENDA PACKET CONTENTS LIST

TALL BUILDINGS SAFETY STRATEGY

October 2018

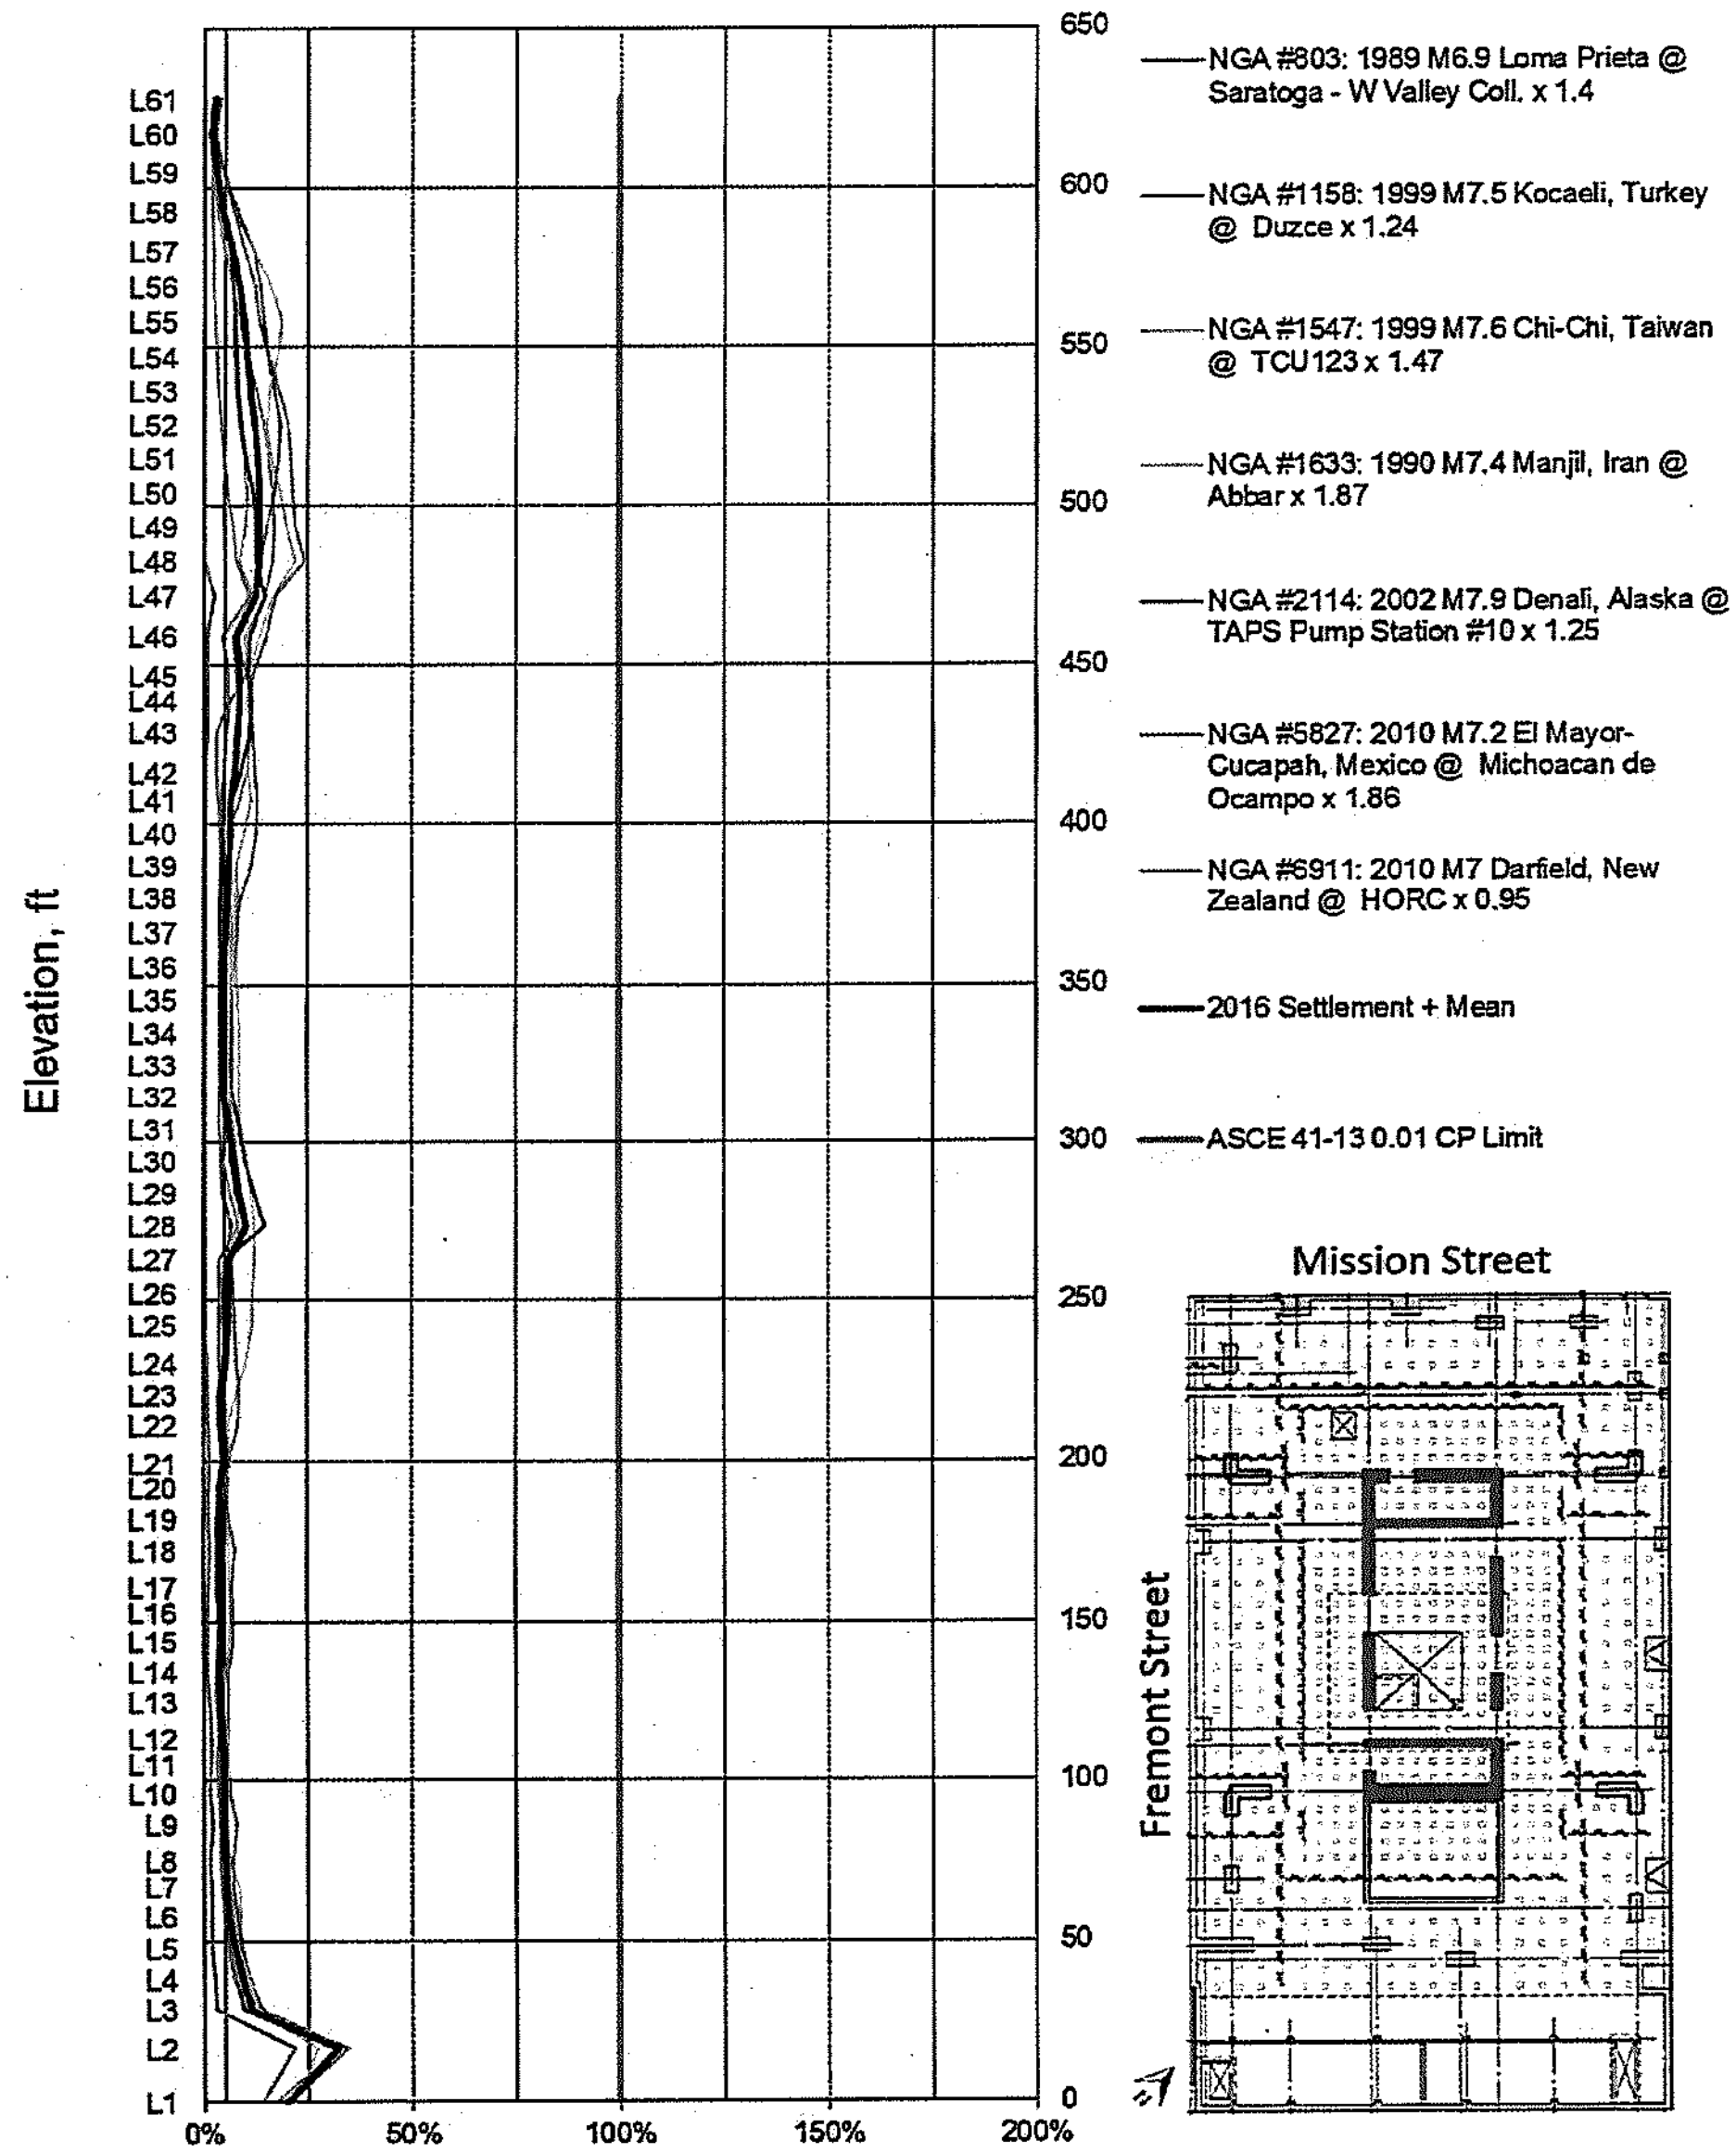
Figure 30. Demand to Capacity Ratio, Core Wall Shear Strain

Figure 30 shows the demand to capacity ratios for core wall shear strain. Strain for all records is substantially less than the 0.01 permitted by ASCE 41.

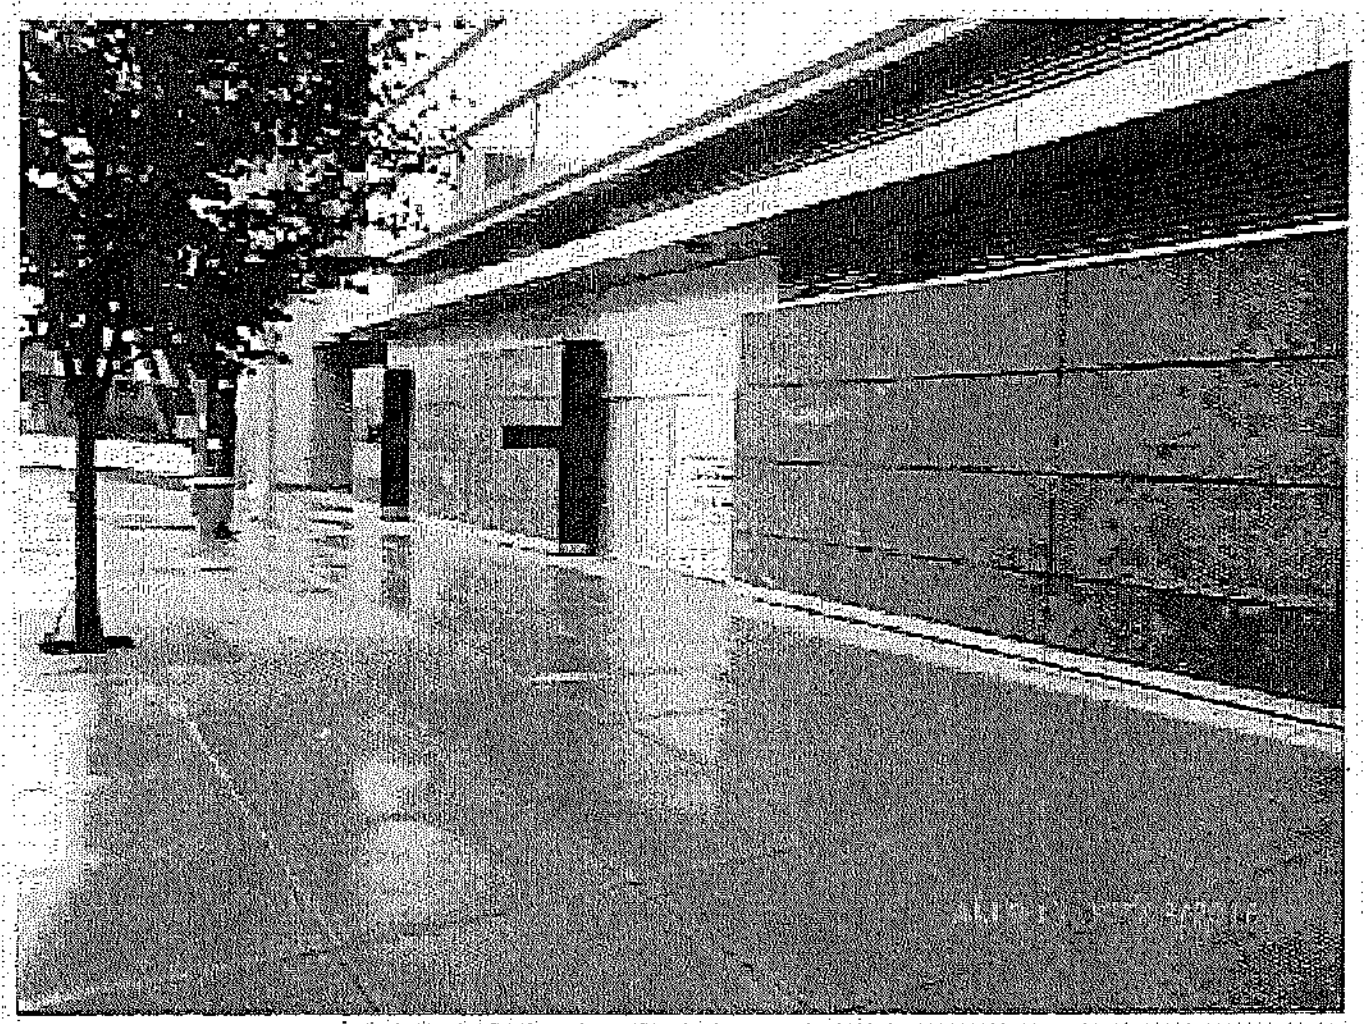
UP-1 Beale Street Elevation: Storm, Sanitary and Natural Gas

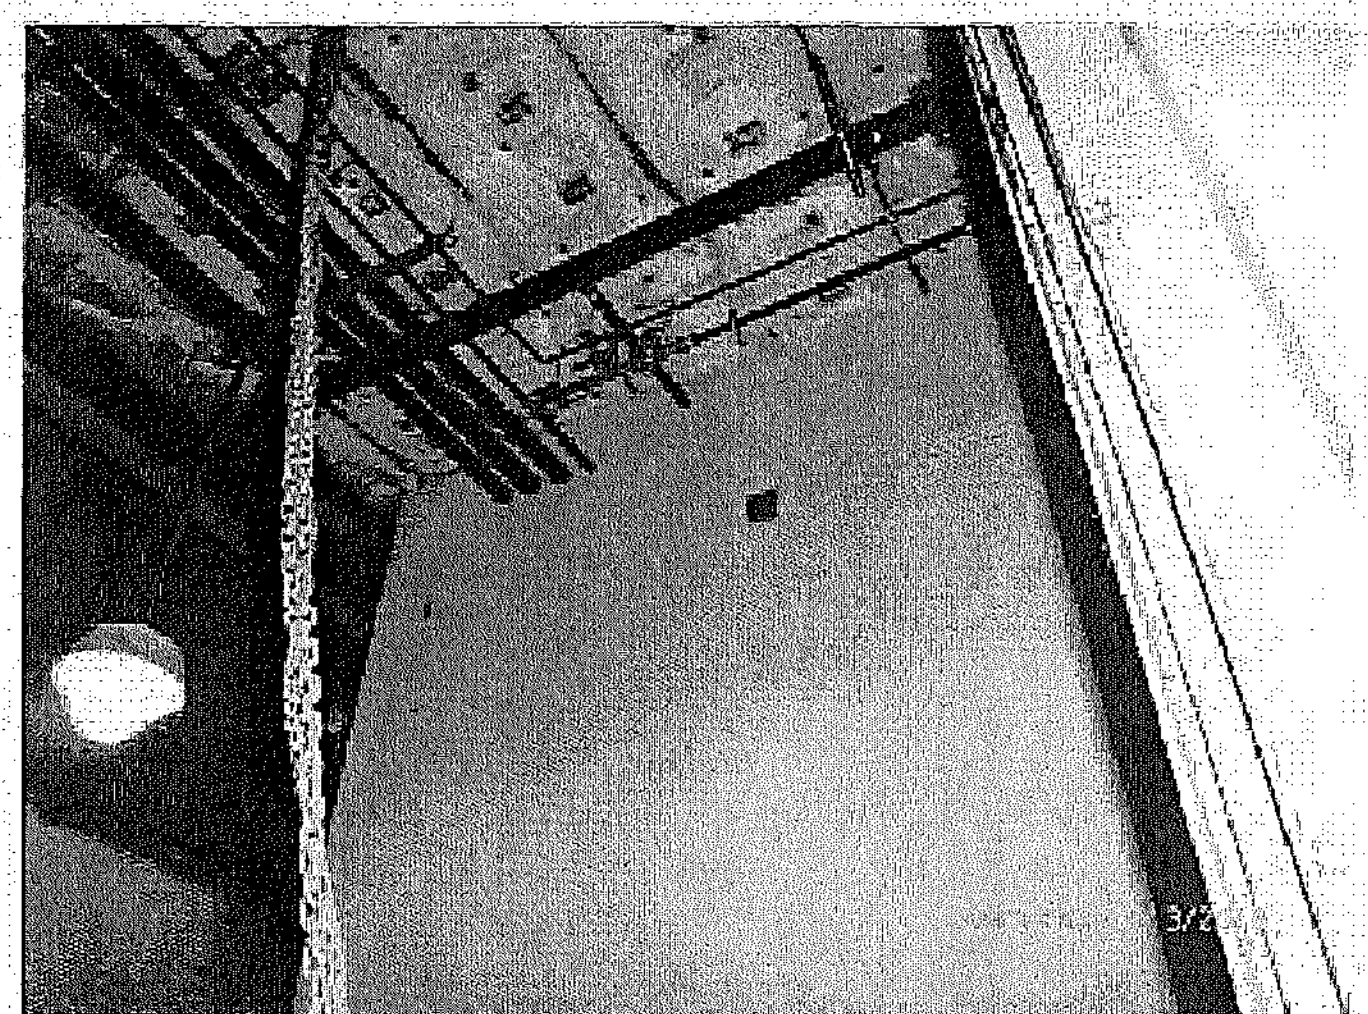
UP-1 Beale Street Elevation: Garage View

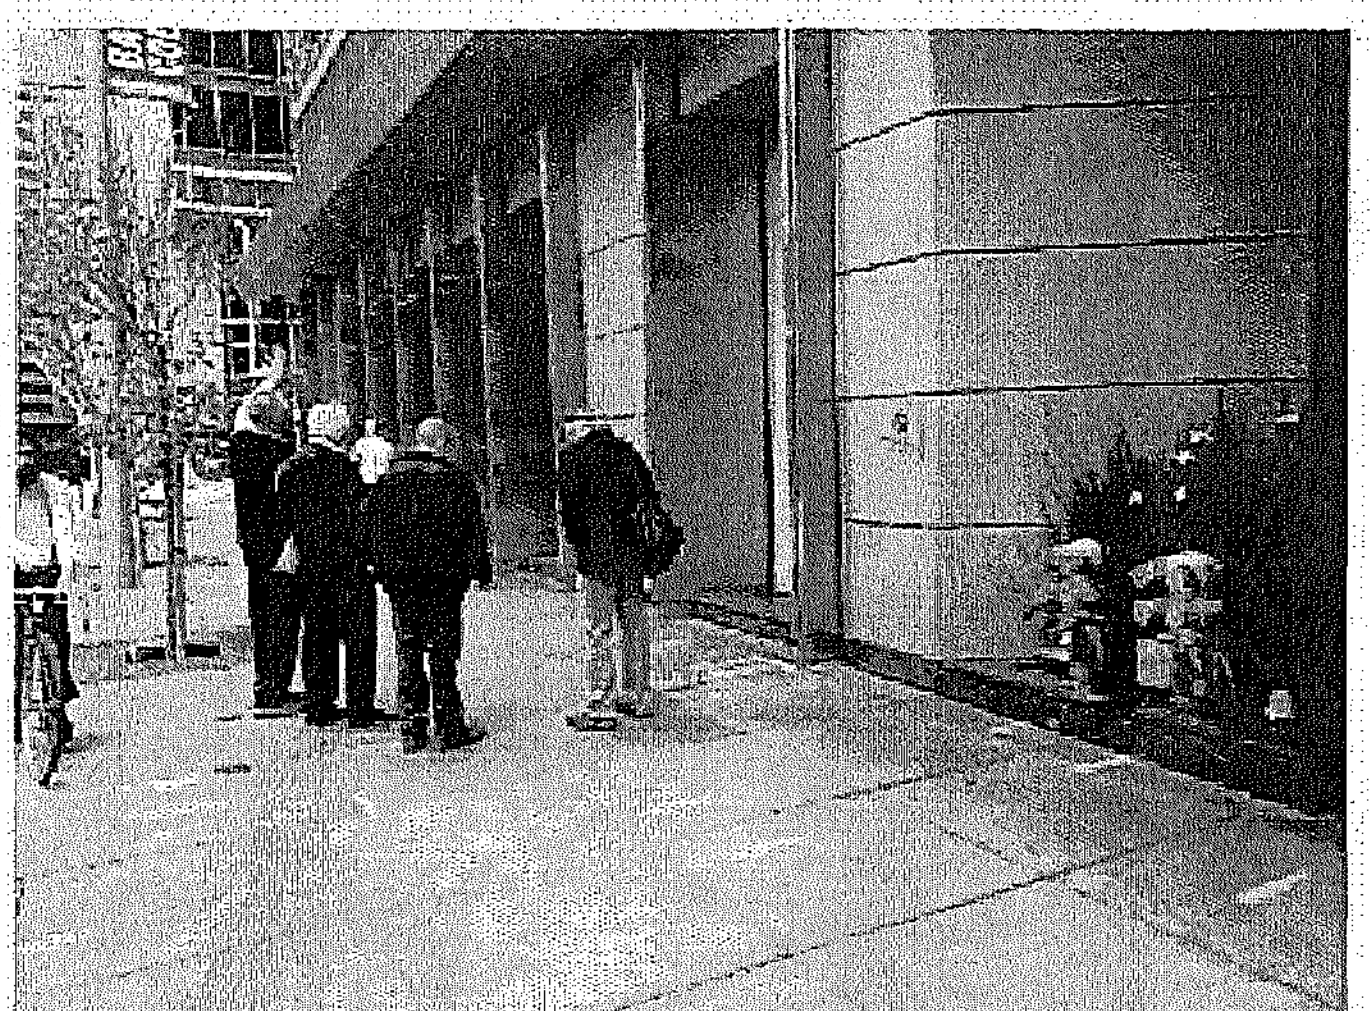
UP-2 Fremont Street: Storm, Sanitary Drains

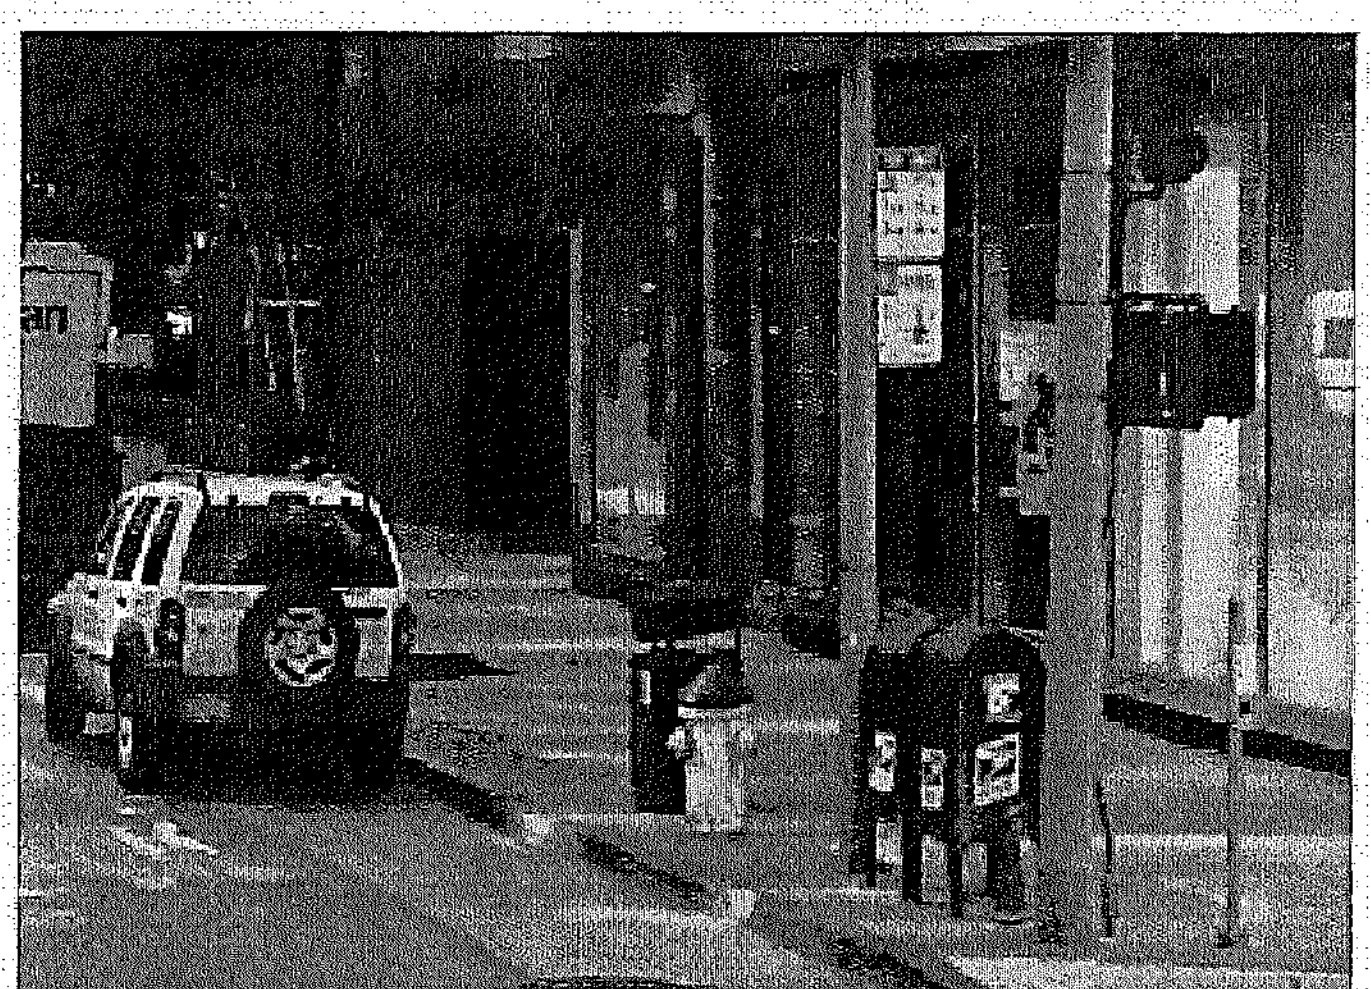
UP-3 Mission Street: Domestic Water and Fire

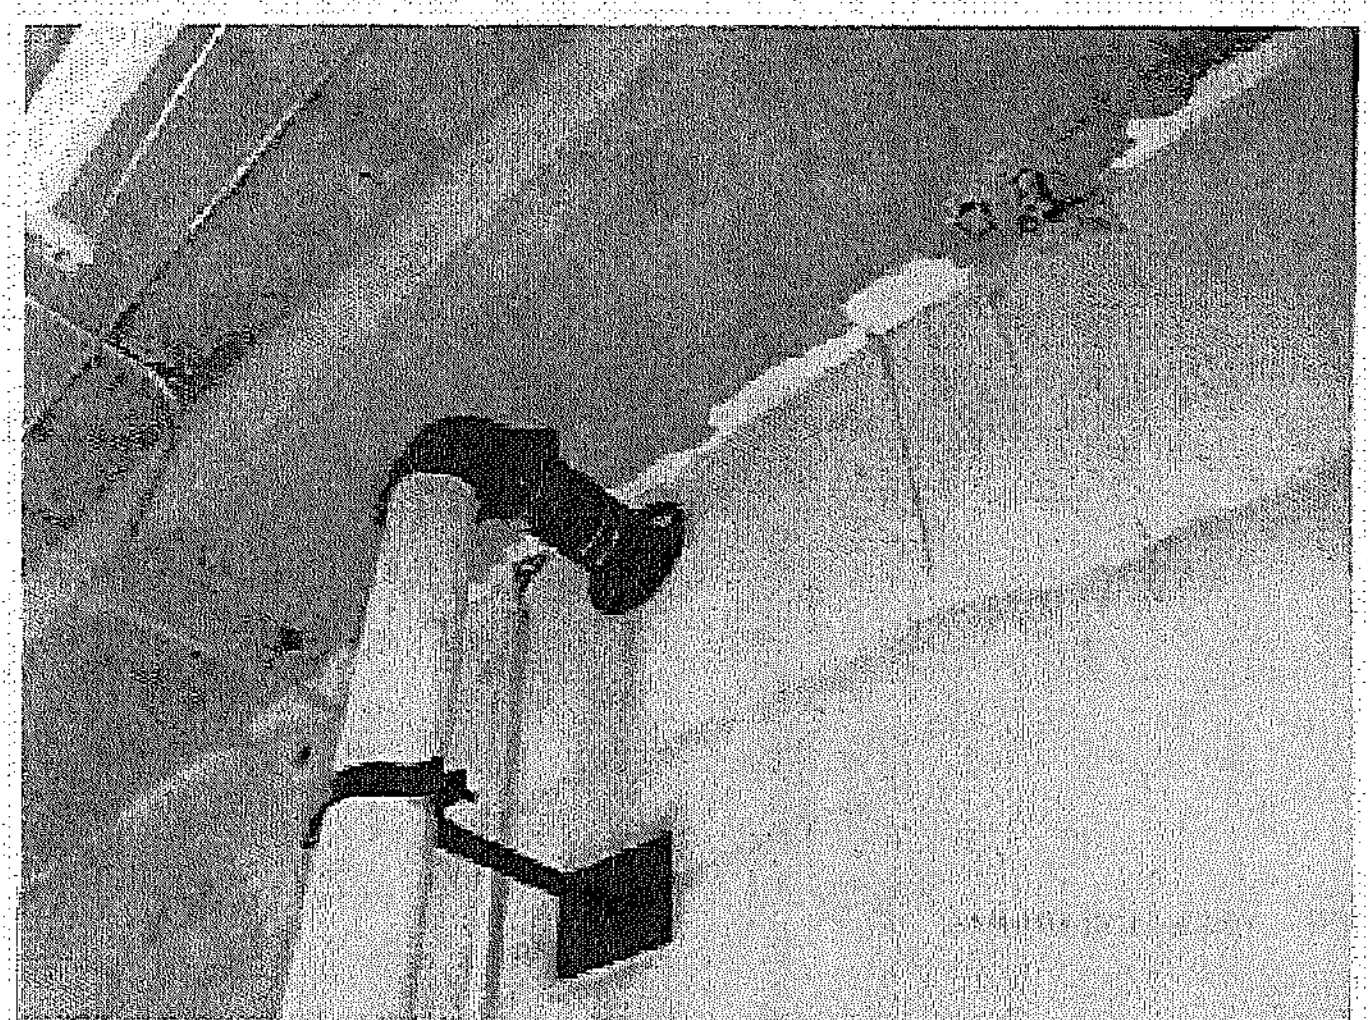
UP-3 Mission Street: Garage View

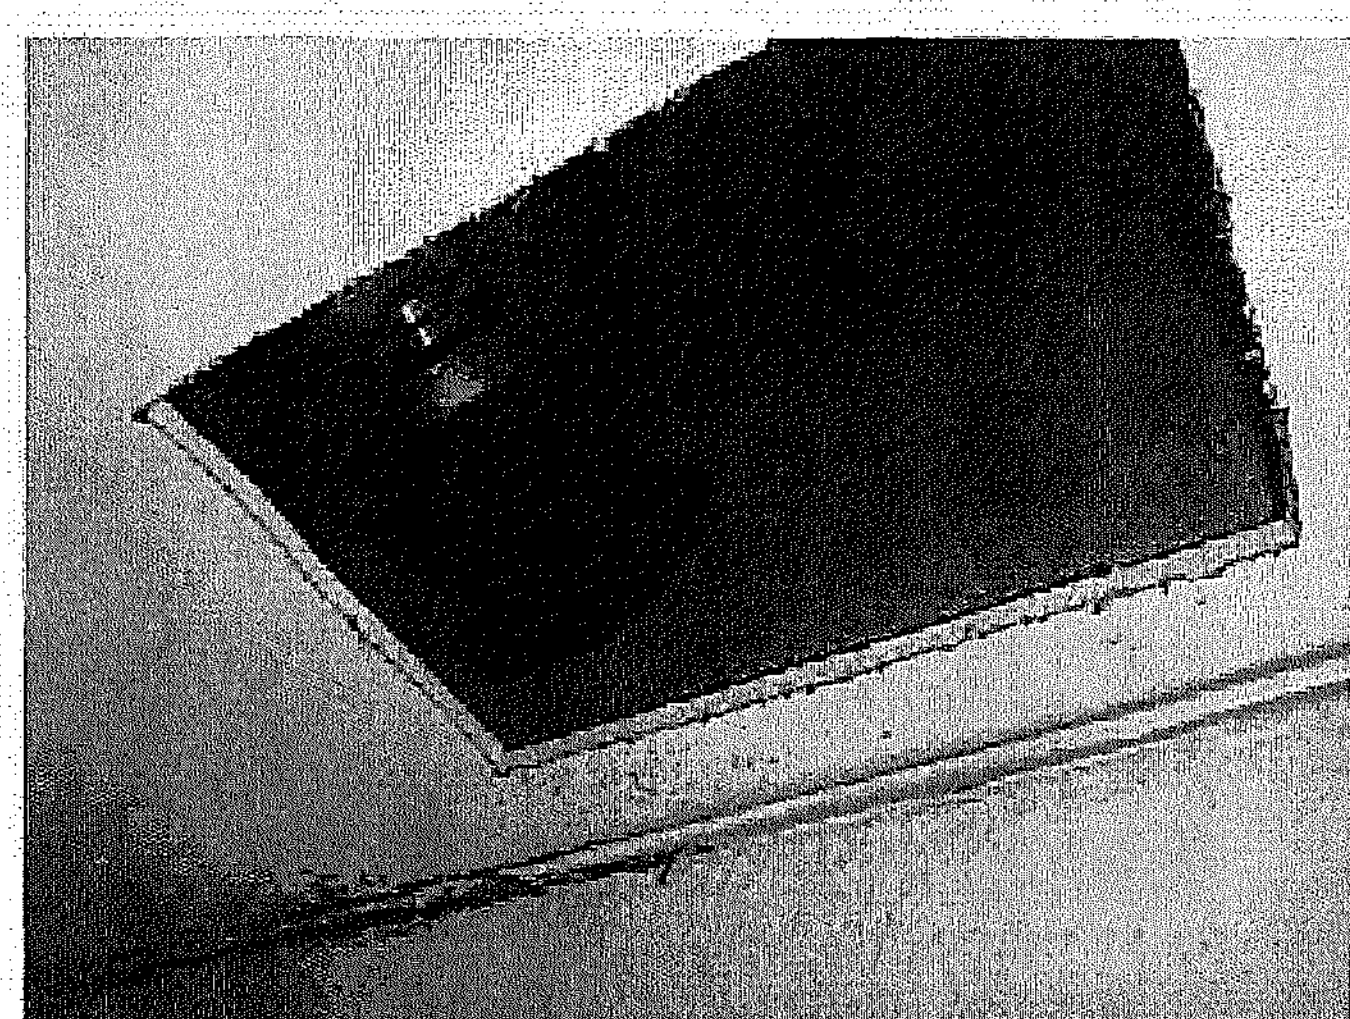
UP-5 Mission Street: Garage View

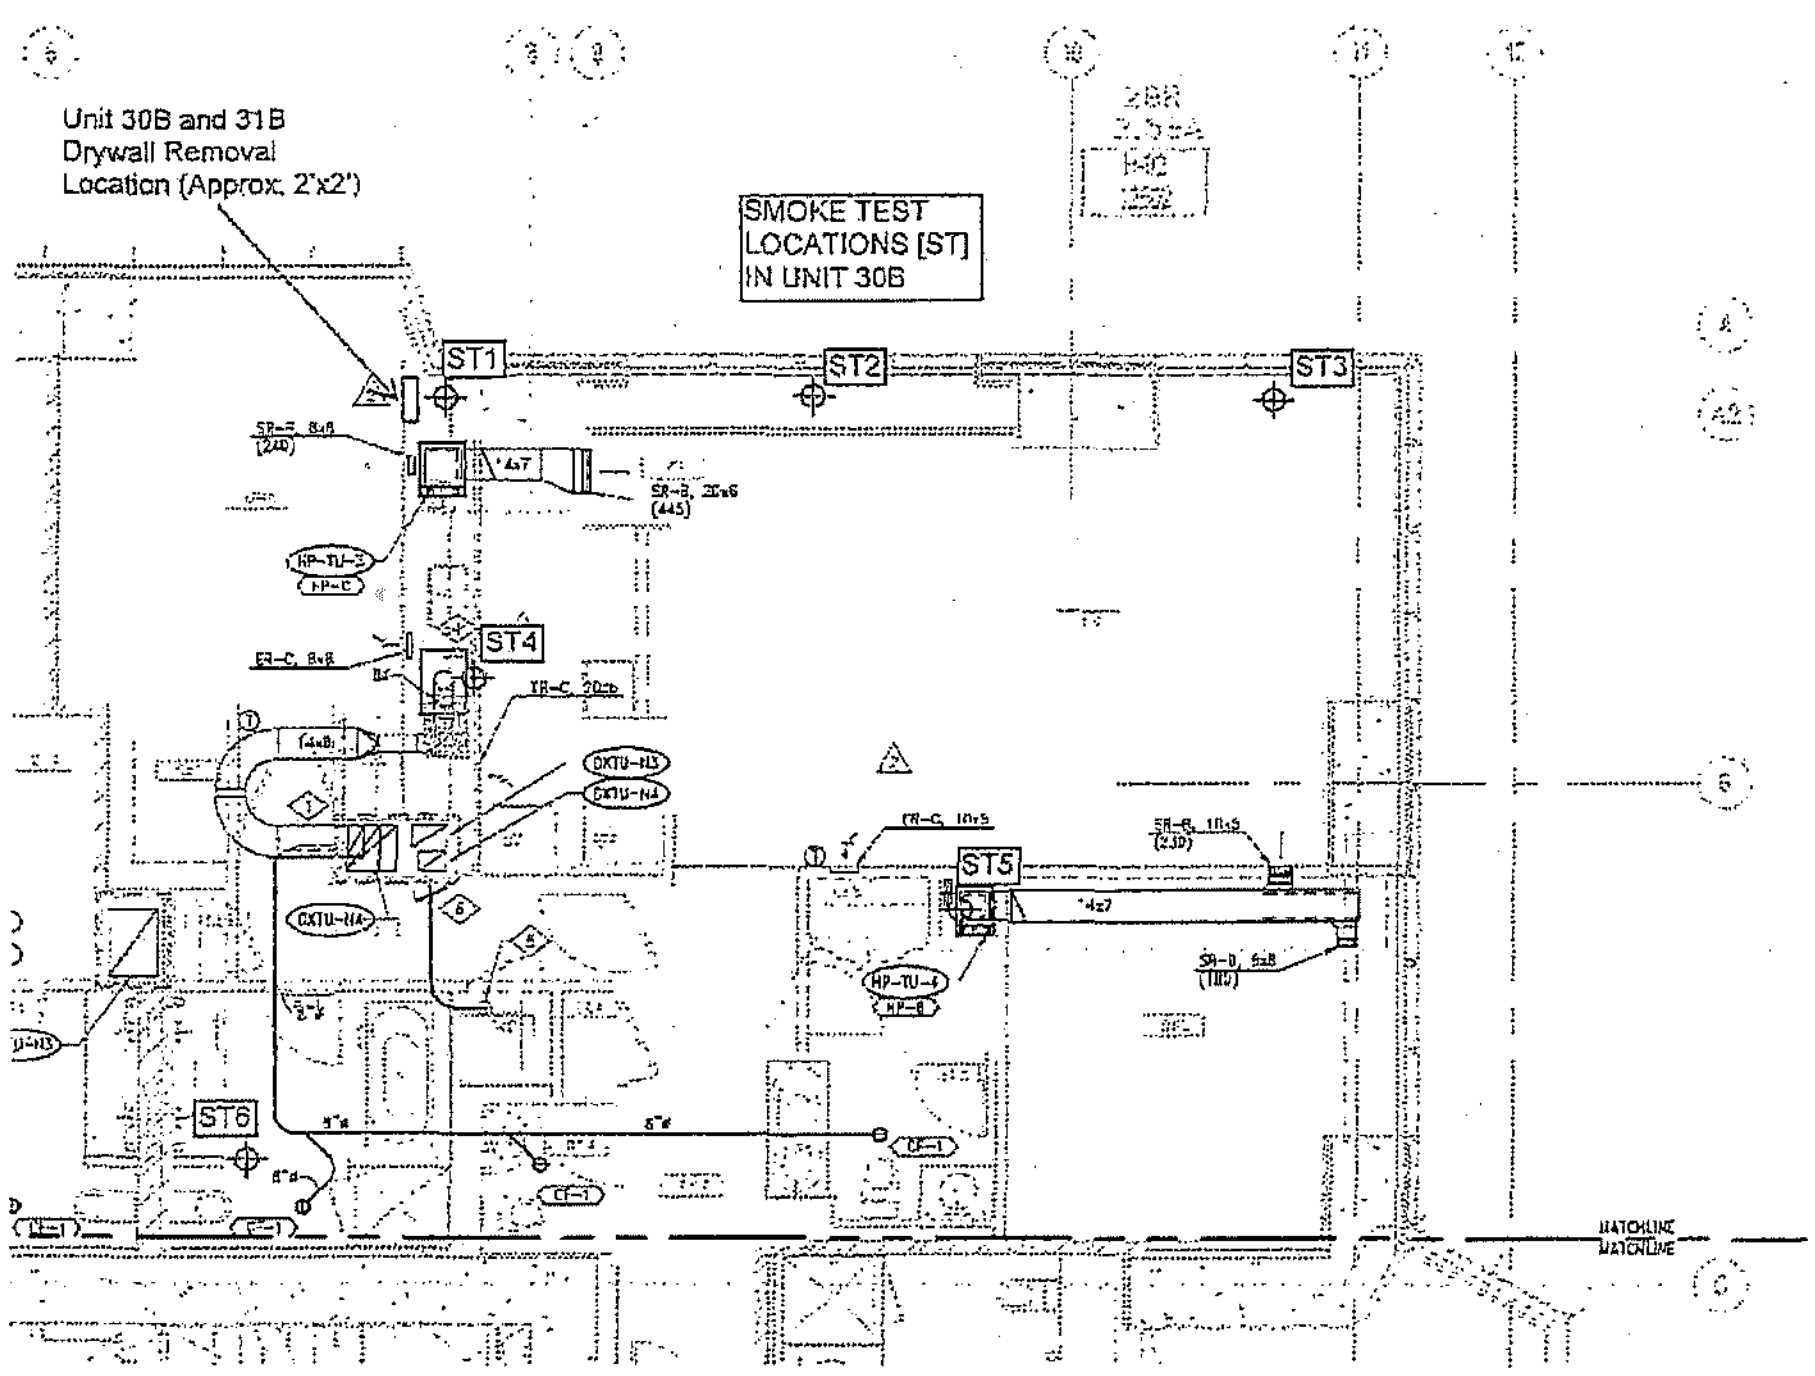
Test 7
1:45 PM (1) smoke emitter cartridge was setoff in Unit 30B at ST4

- Odor detected in Unit 31B kitchen area.
- Faint smoke haze in same area.

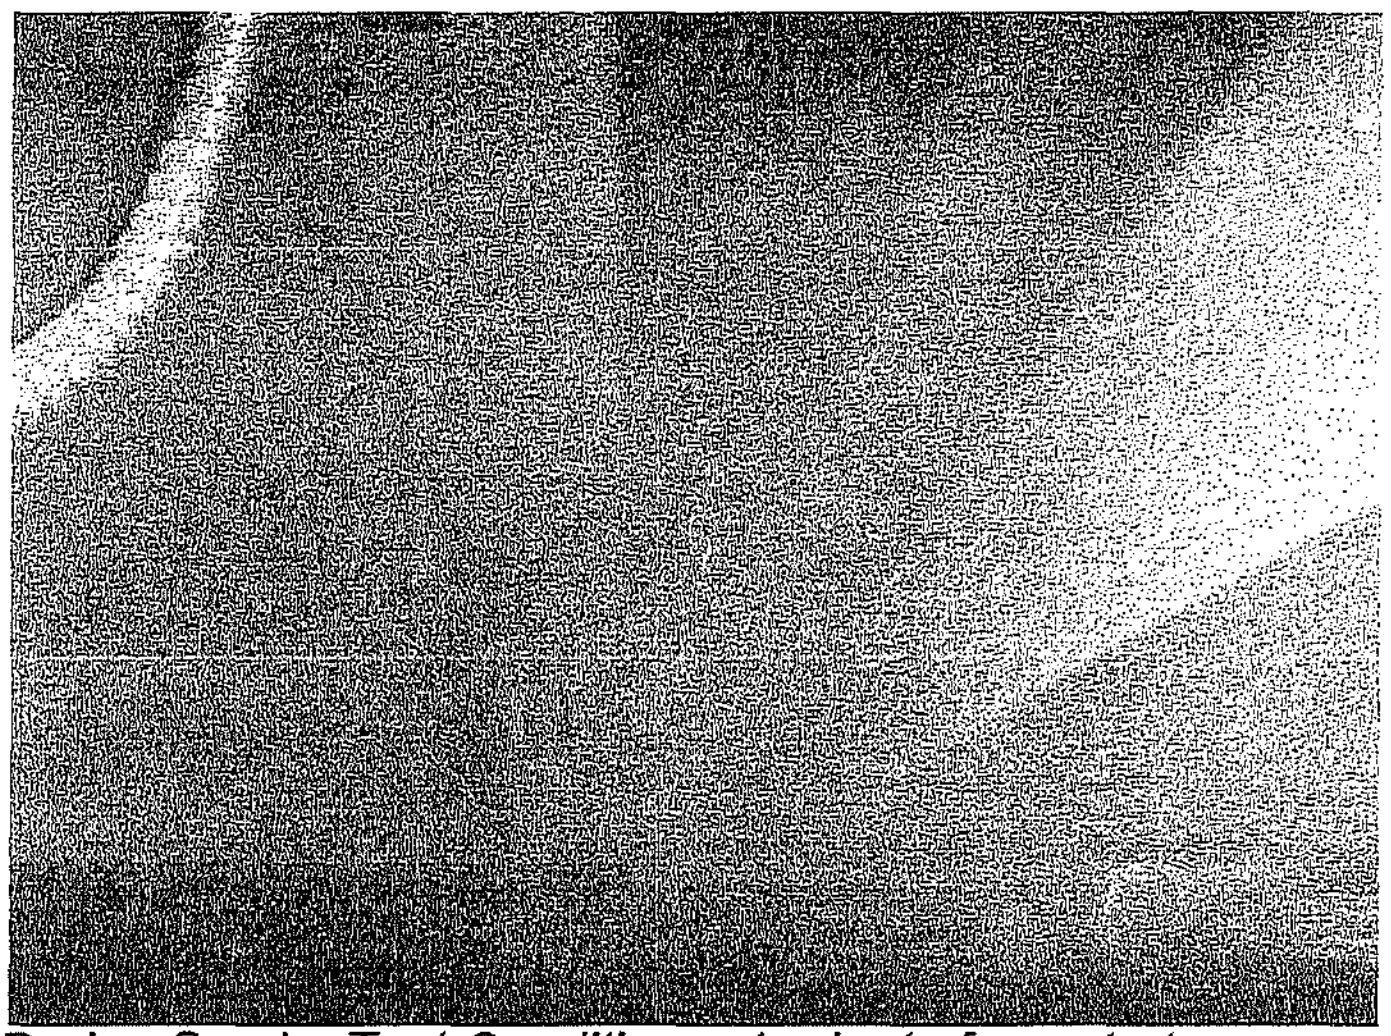
The smoke test results clearly verified the existence of air transfer pathways between Unit 30B and Unit 31B. Suspended particles in the air can communicate between these neighboring residences through the same air transfer pathways, resulting in odors from one unit detected in the adjoining unit.

During Smoke Test Conditions – 1/2 minute from start:
Test site ST5 in unit 31B heat pump closet.
Note white test smoke at pipe risers routed through closet floor

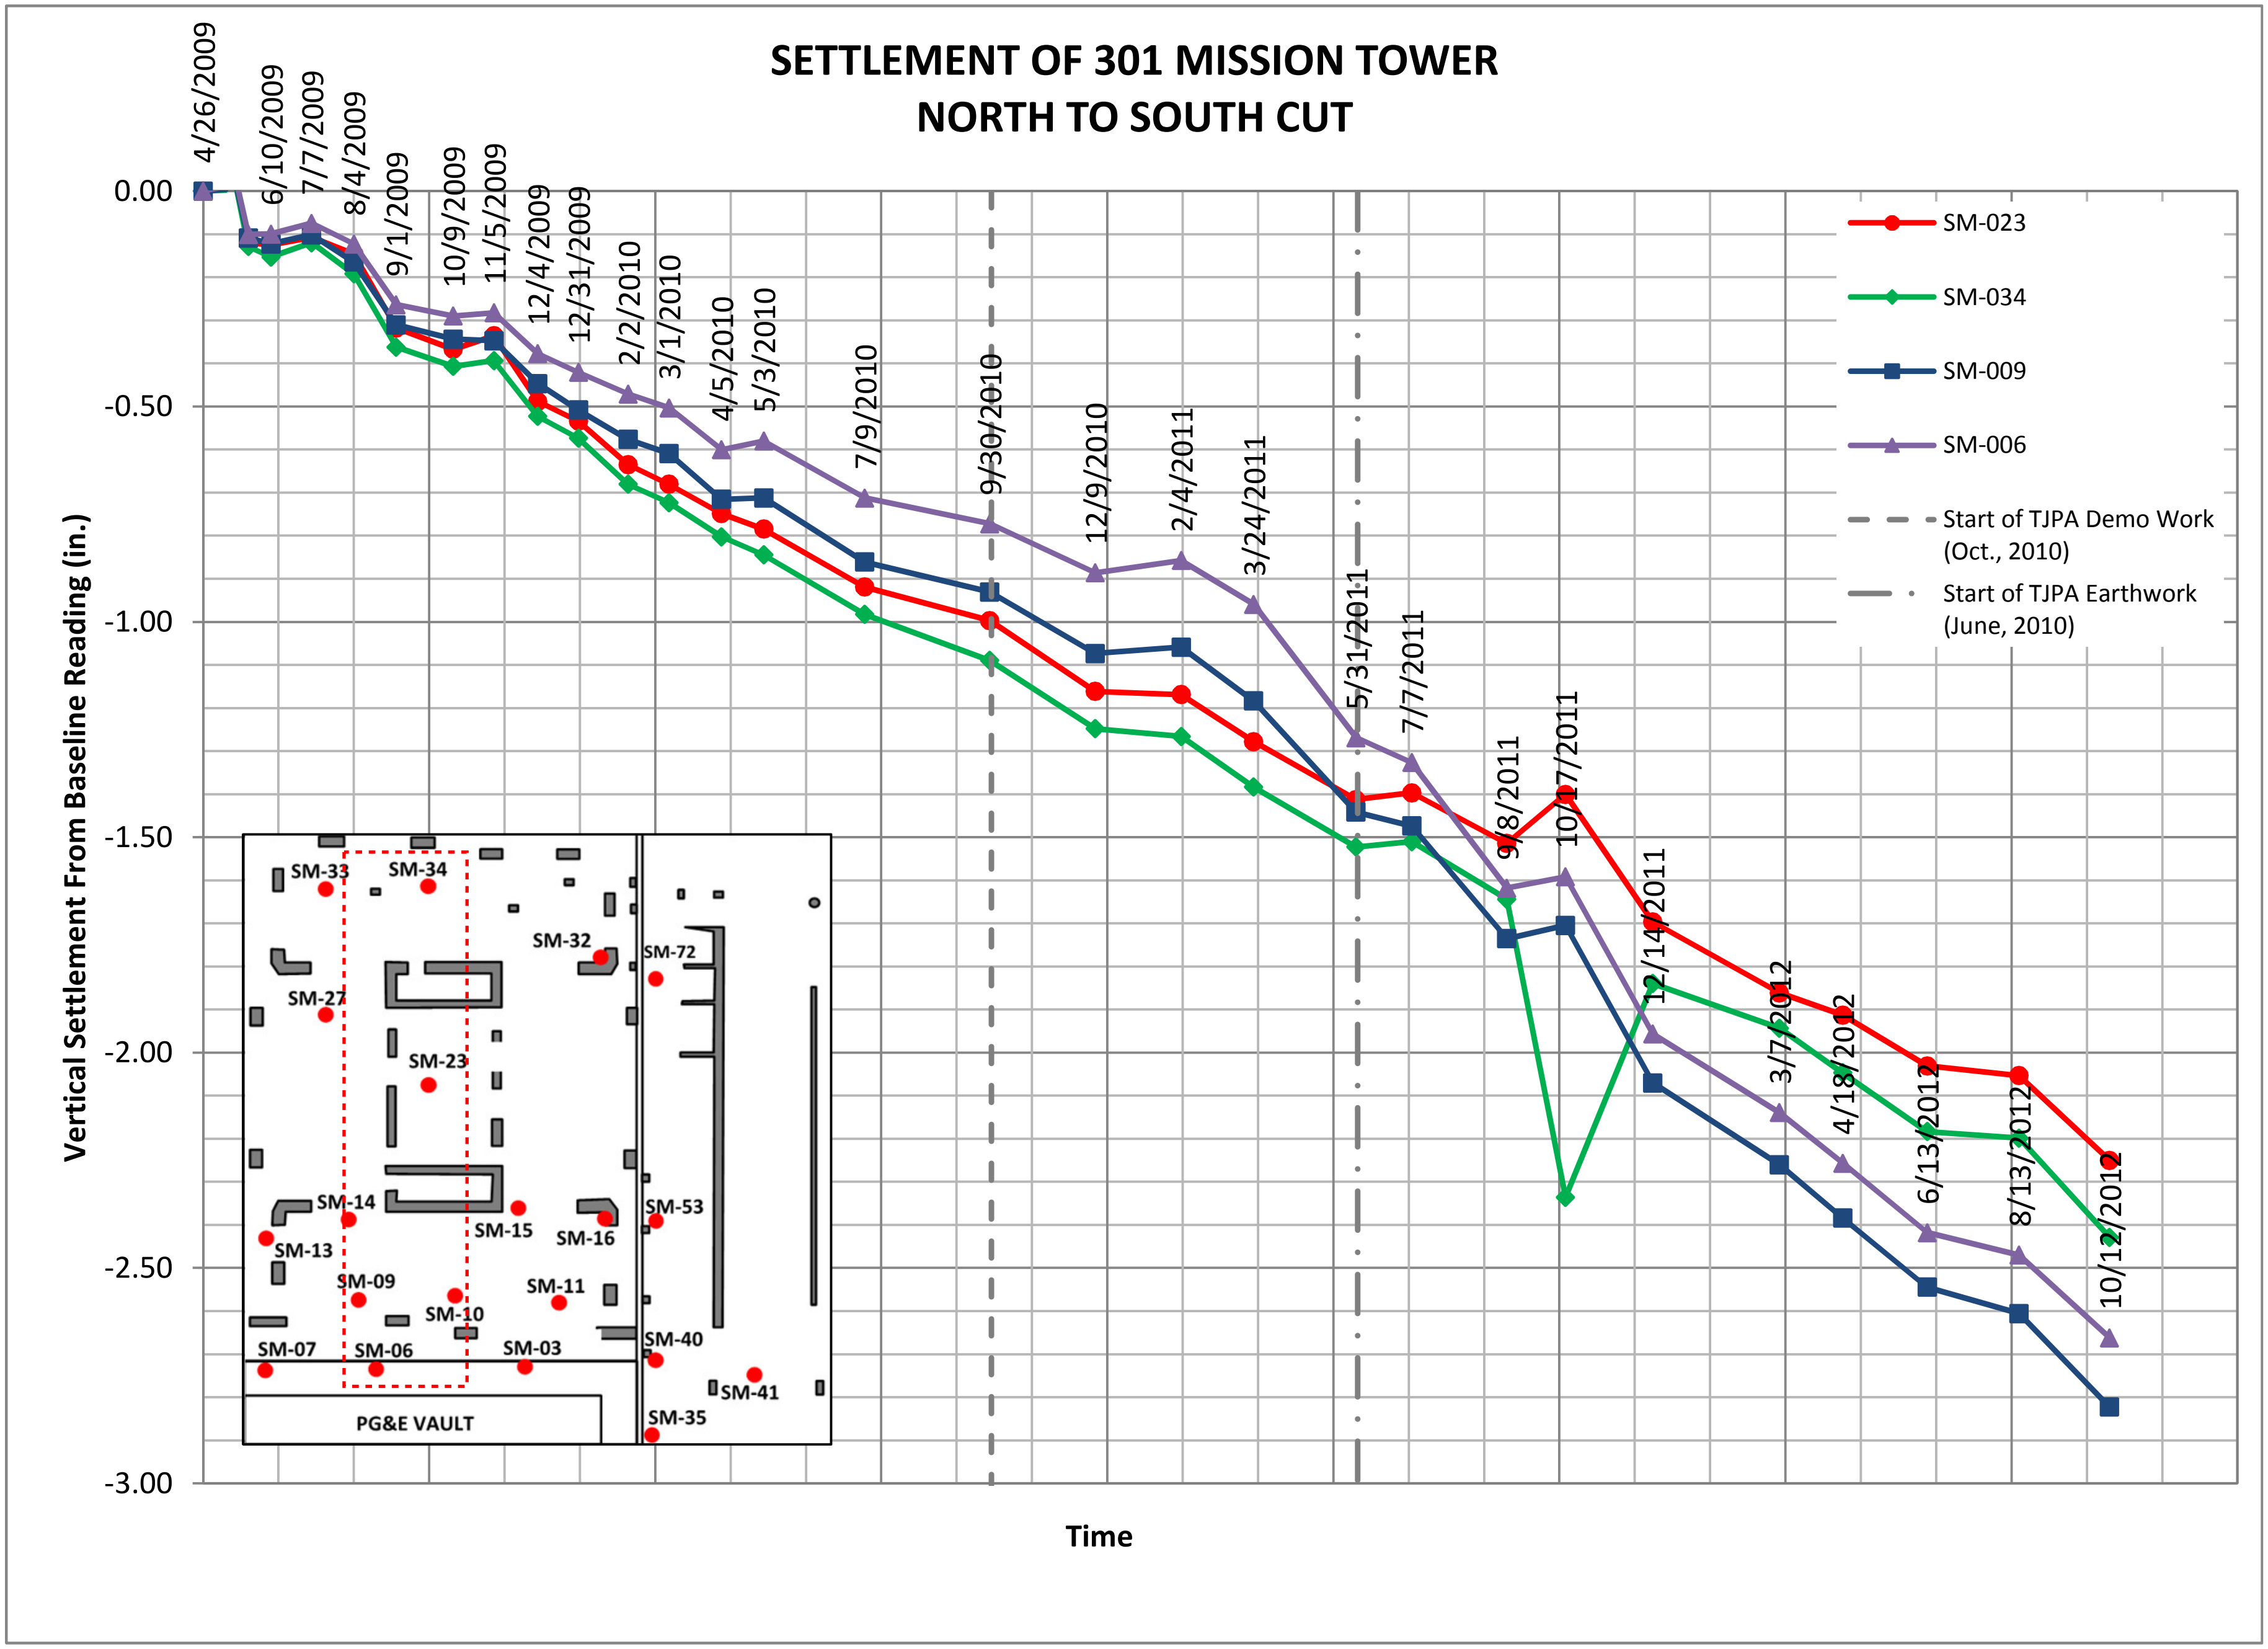
Figure 4

<u>Settlement of the North vs. South Side of the Foundation (Figure 4)</u>
Before construction at Transbay began, the North Side was settling more, and now, after construction has been going for some time, the south side is settling more. This seems to clearly show that the construction is causing settlement. It is recommended that Millennium seek an explanation for this from Transbay.

It should also be noted that this figure shows differential movement across the foundation causing a tilt to the building. This kind of moment can cause damage to the structure of the building as opposed to uniform settlement which would typically not cause damage. However, 0.24” of differential accorss the site is a small enough value to make damage unlikely.
