File No. 160975 **Committee Item No.** 7
Board Item No. ________

AGENDA PACKET CONTENTS LIST

TALL BUILDINGS SAFETY STRATEGY

October 2018

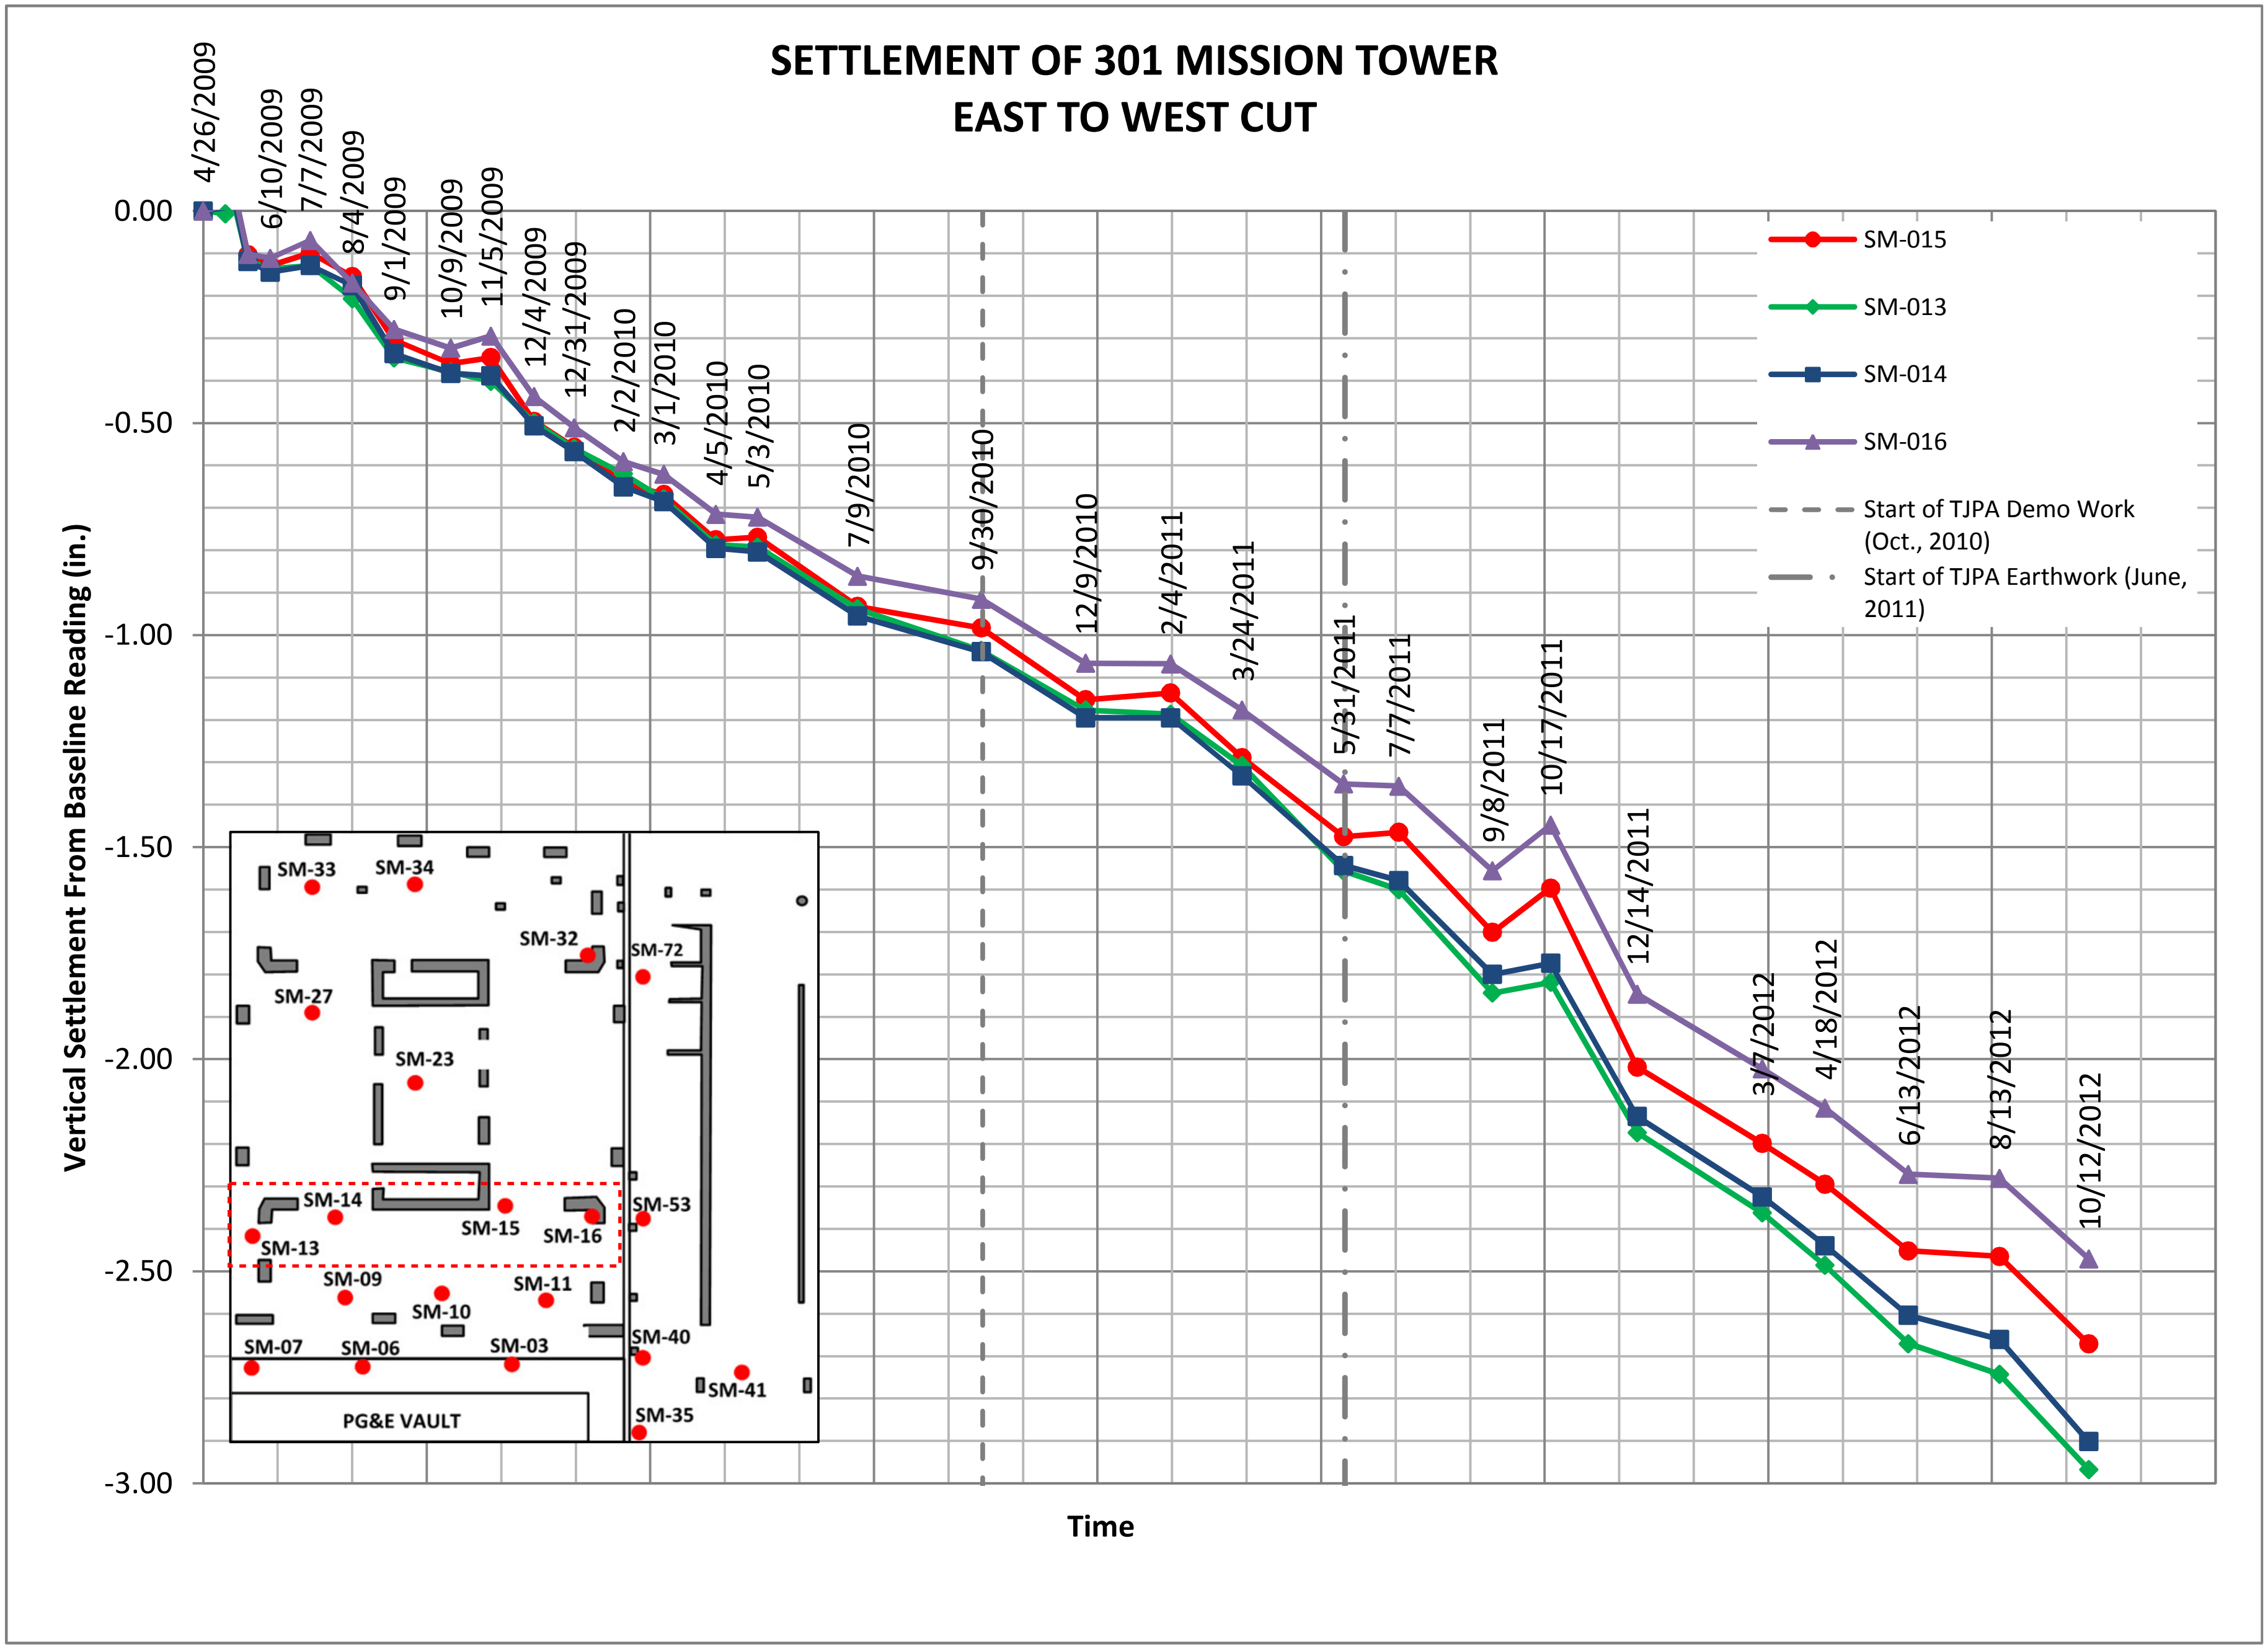
Figure 5

<u>Settlement Across a North-South Slice of the Foundation (Figure 5)</u>
Before construction, the building was settling more in the North and in a consistent linear pattern. Once construction began, the points in the south started settling faster than the ones in the north.

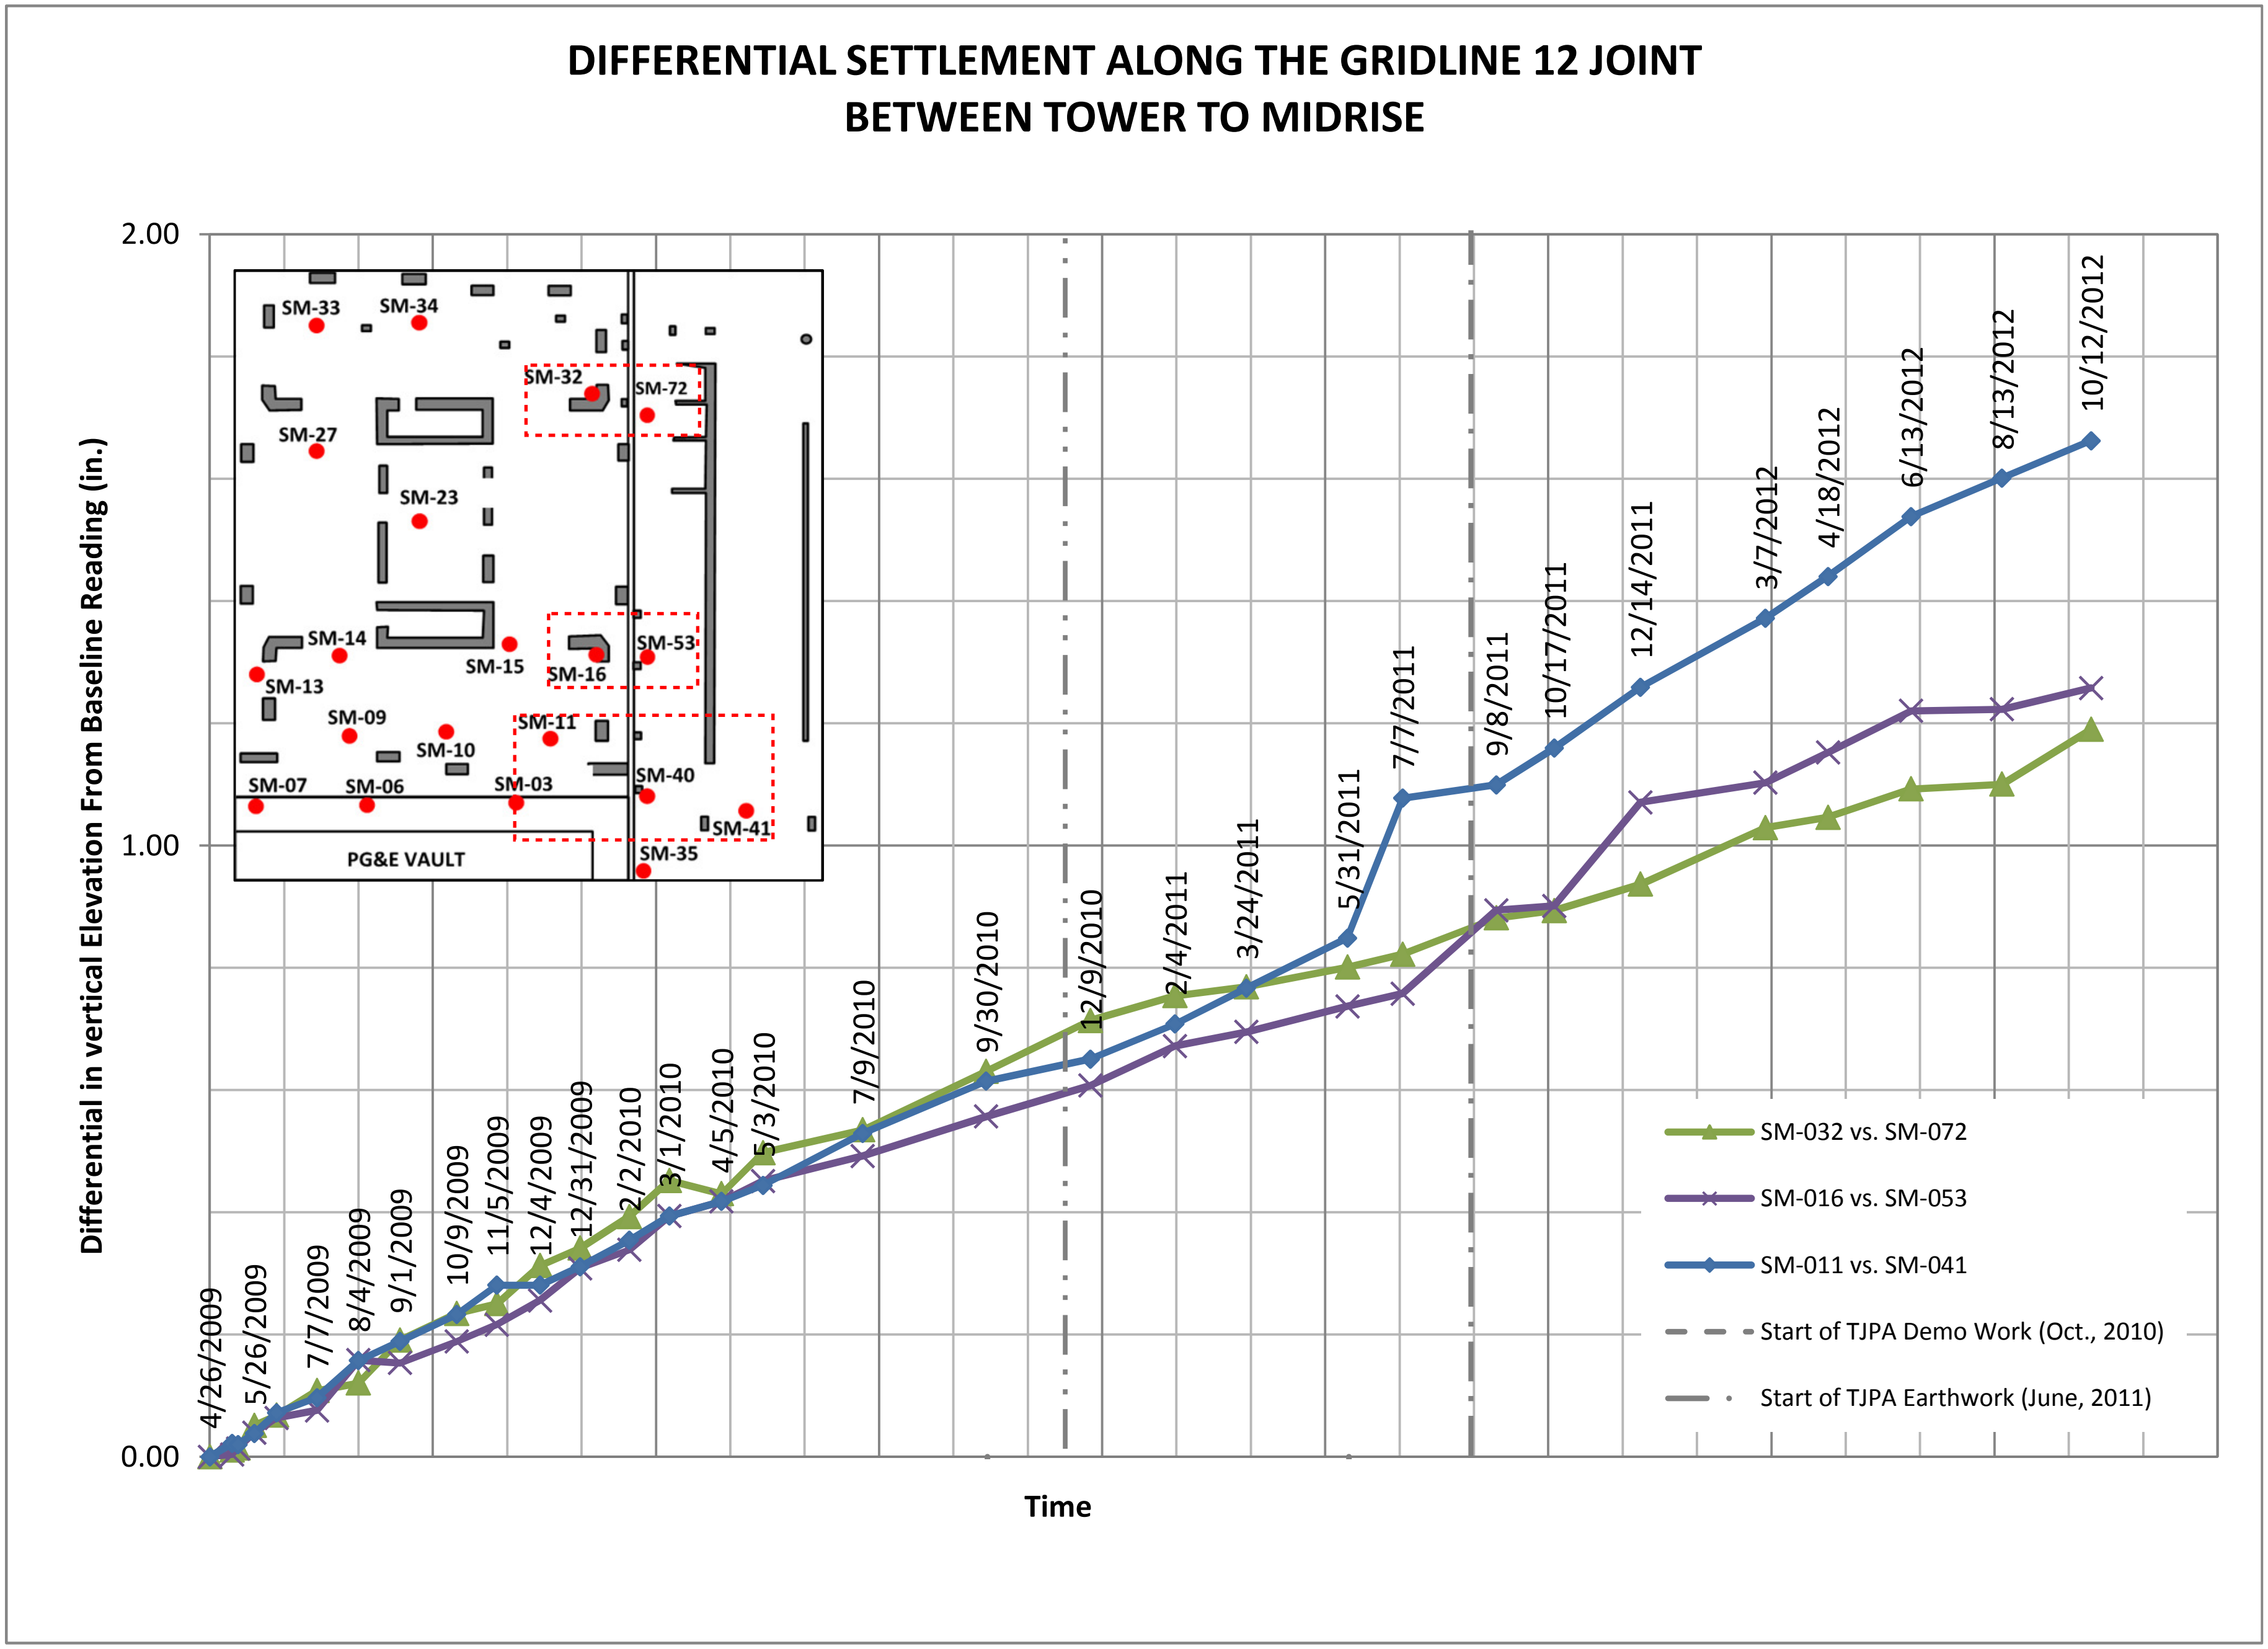
Figure 6

<u>Settlement Across an East-West Slice of the Foundation (Figure 6)</u>
The construction does not seem to have affected the settlement in the east-west direction. The

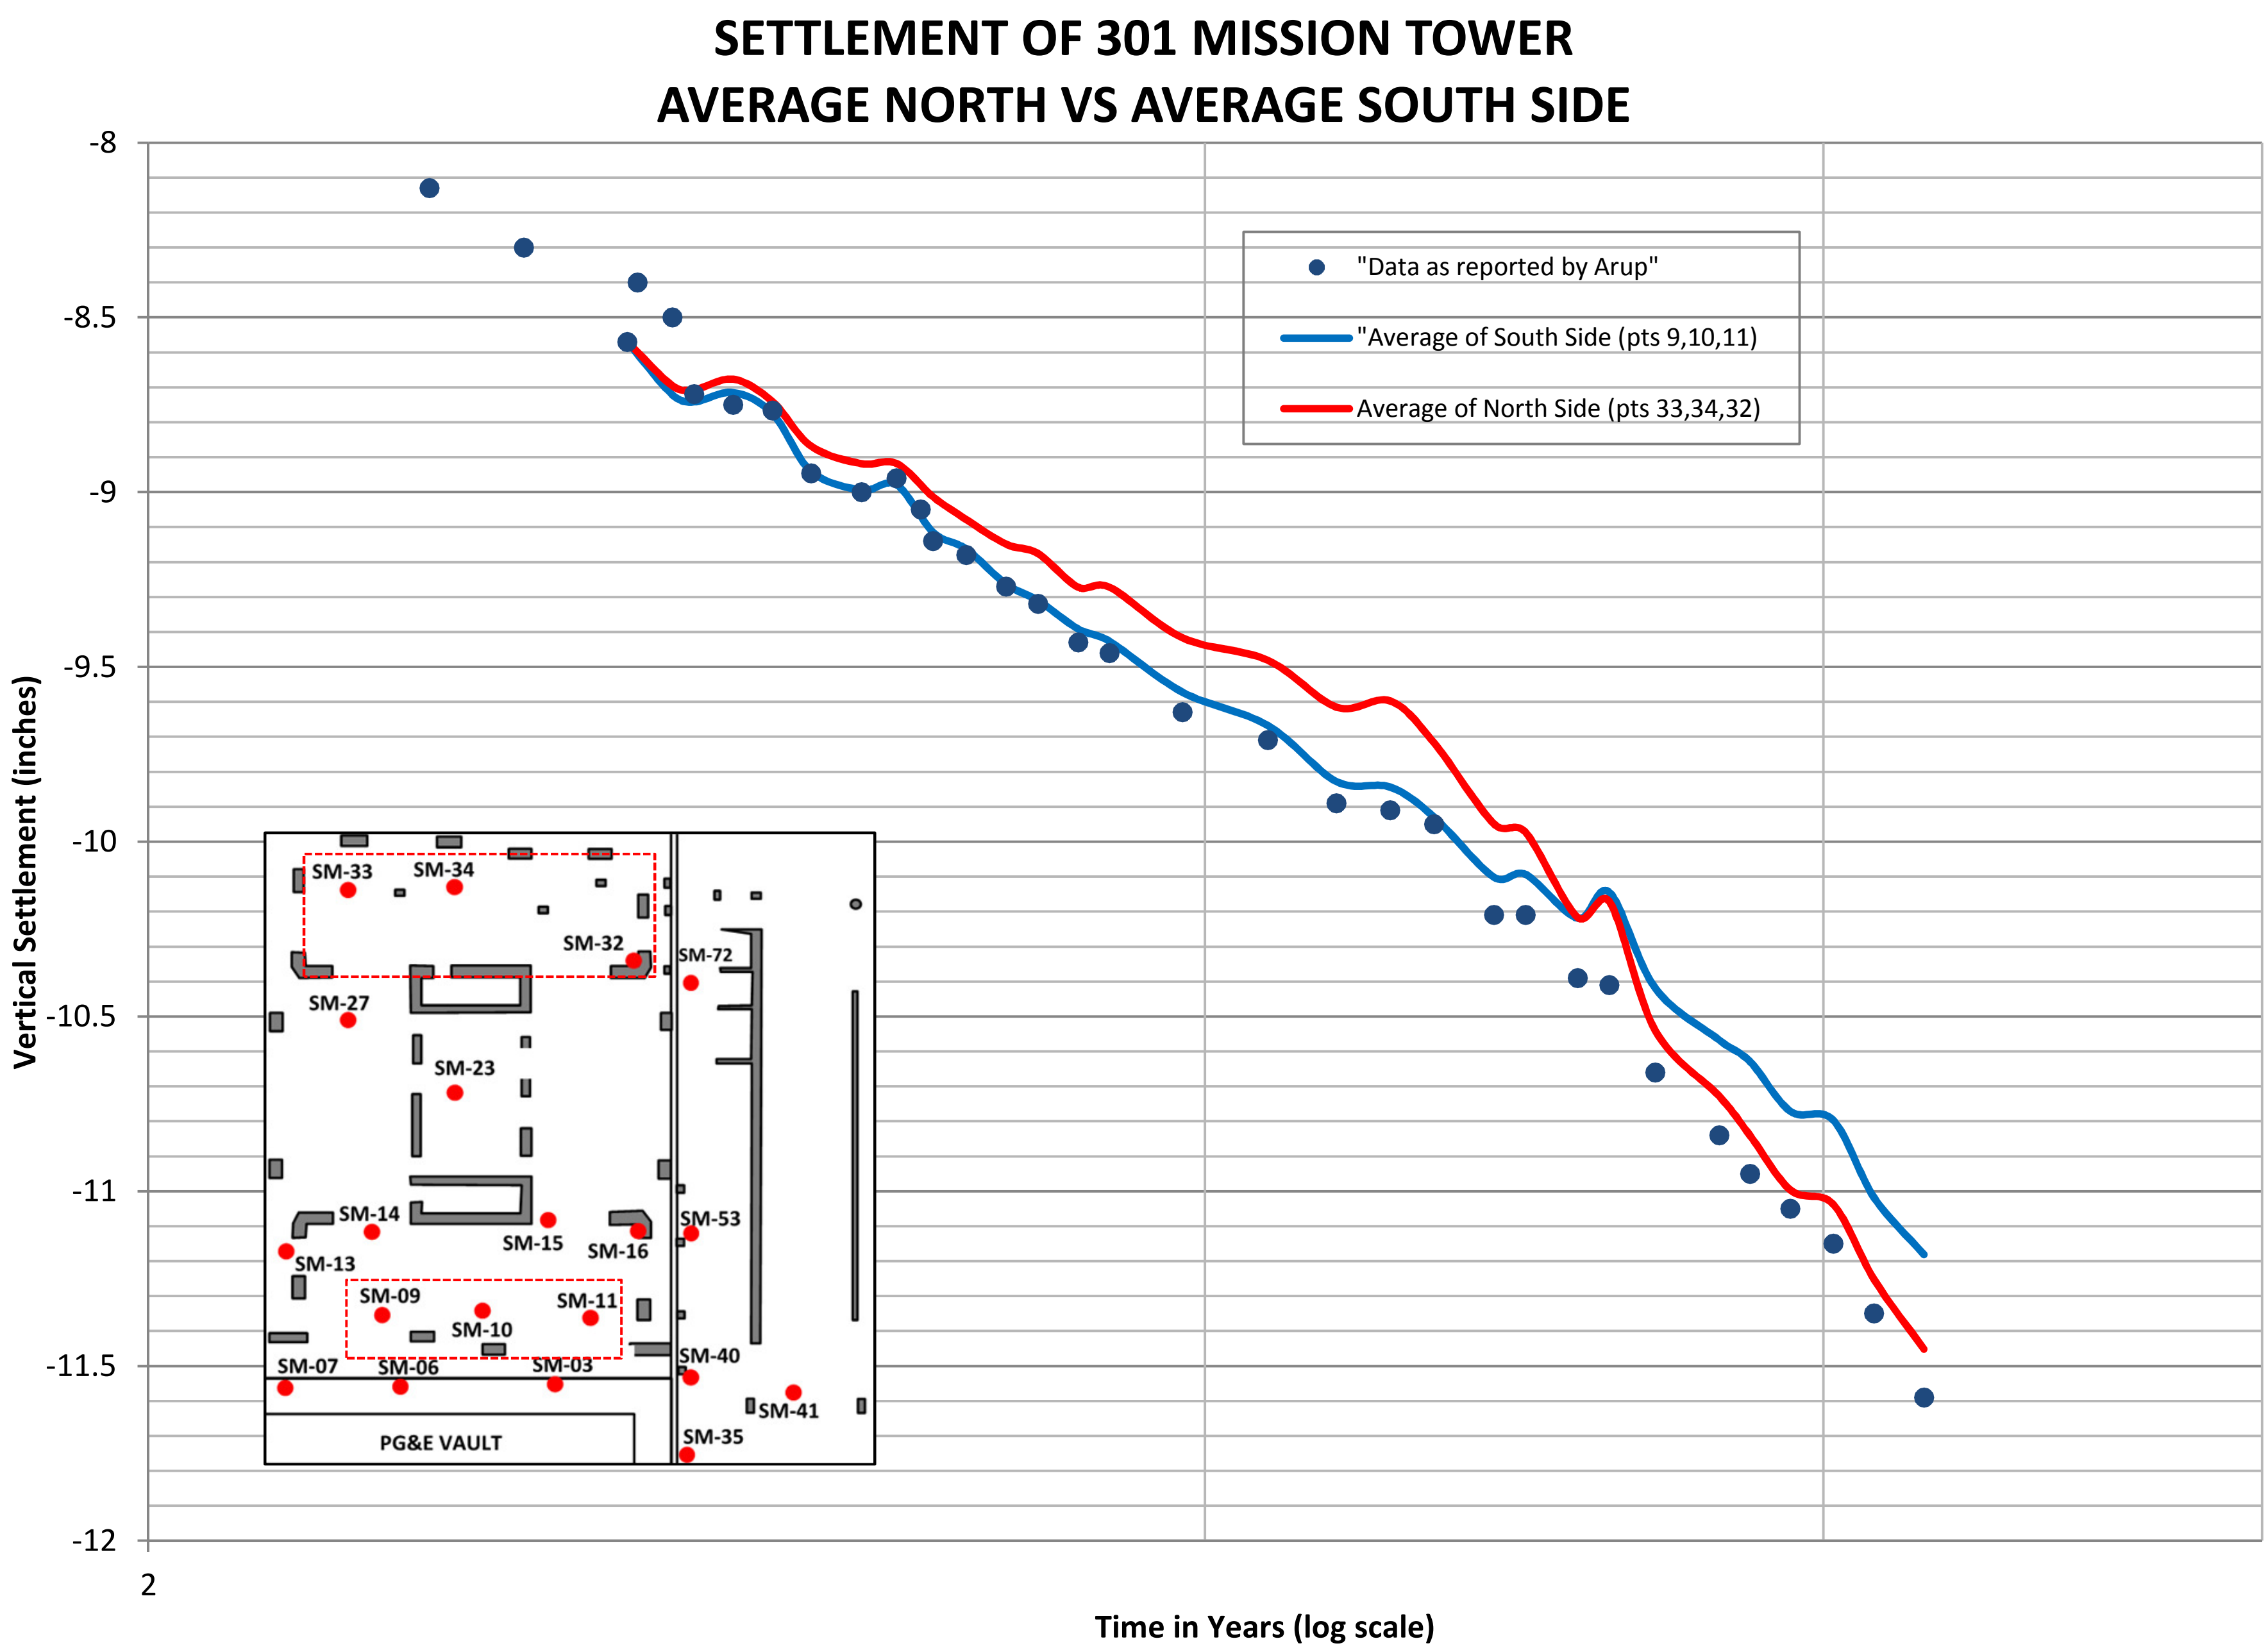
Figure 2 includes an average of settlement on the north side of the tower and on the south end of the tower. Before construction activities began at Transbay we observe that the north side had settled at a greater rate than the south. After construction activities started, we now observe a greater rate of settlement on the south side. The foundation has rotated slightly towards the Transbay project. Since the south end of the foundation seems now to be moving faster than the north, it follows that the activities at Transbay have caused the additional settlement.

Figure 2 also shows that the overall settlement reported by ARUP (and duplicated in Figure 1) is the worst case settlement anywhere across the foundation (about 11.85") and does not represent the average. Based on this plot, the average overall settlement on the site is currently about 11.5 overall inches.

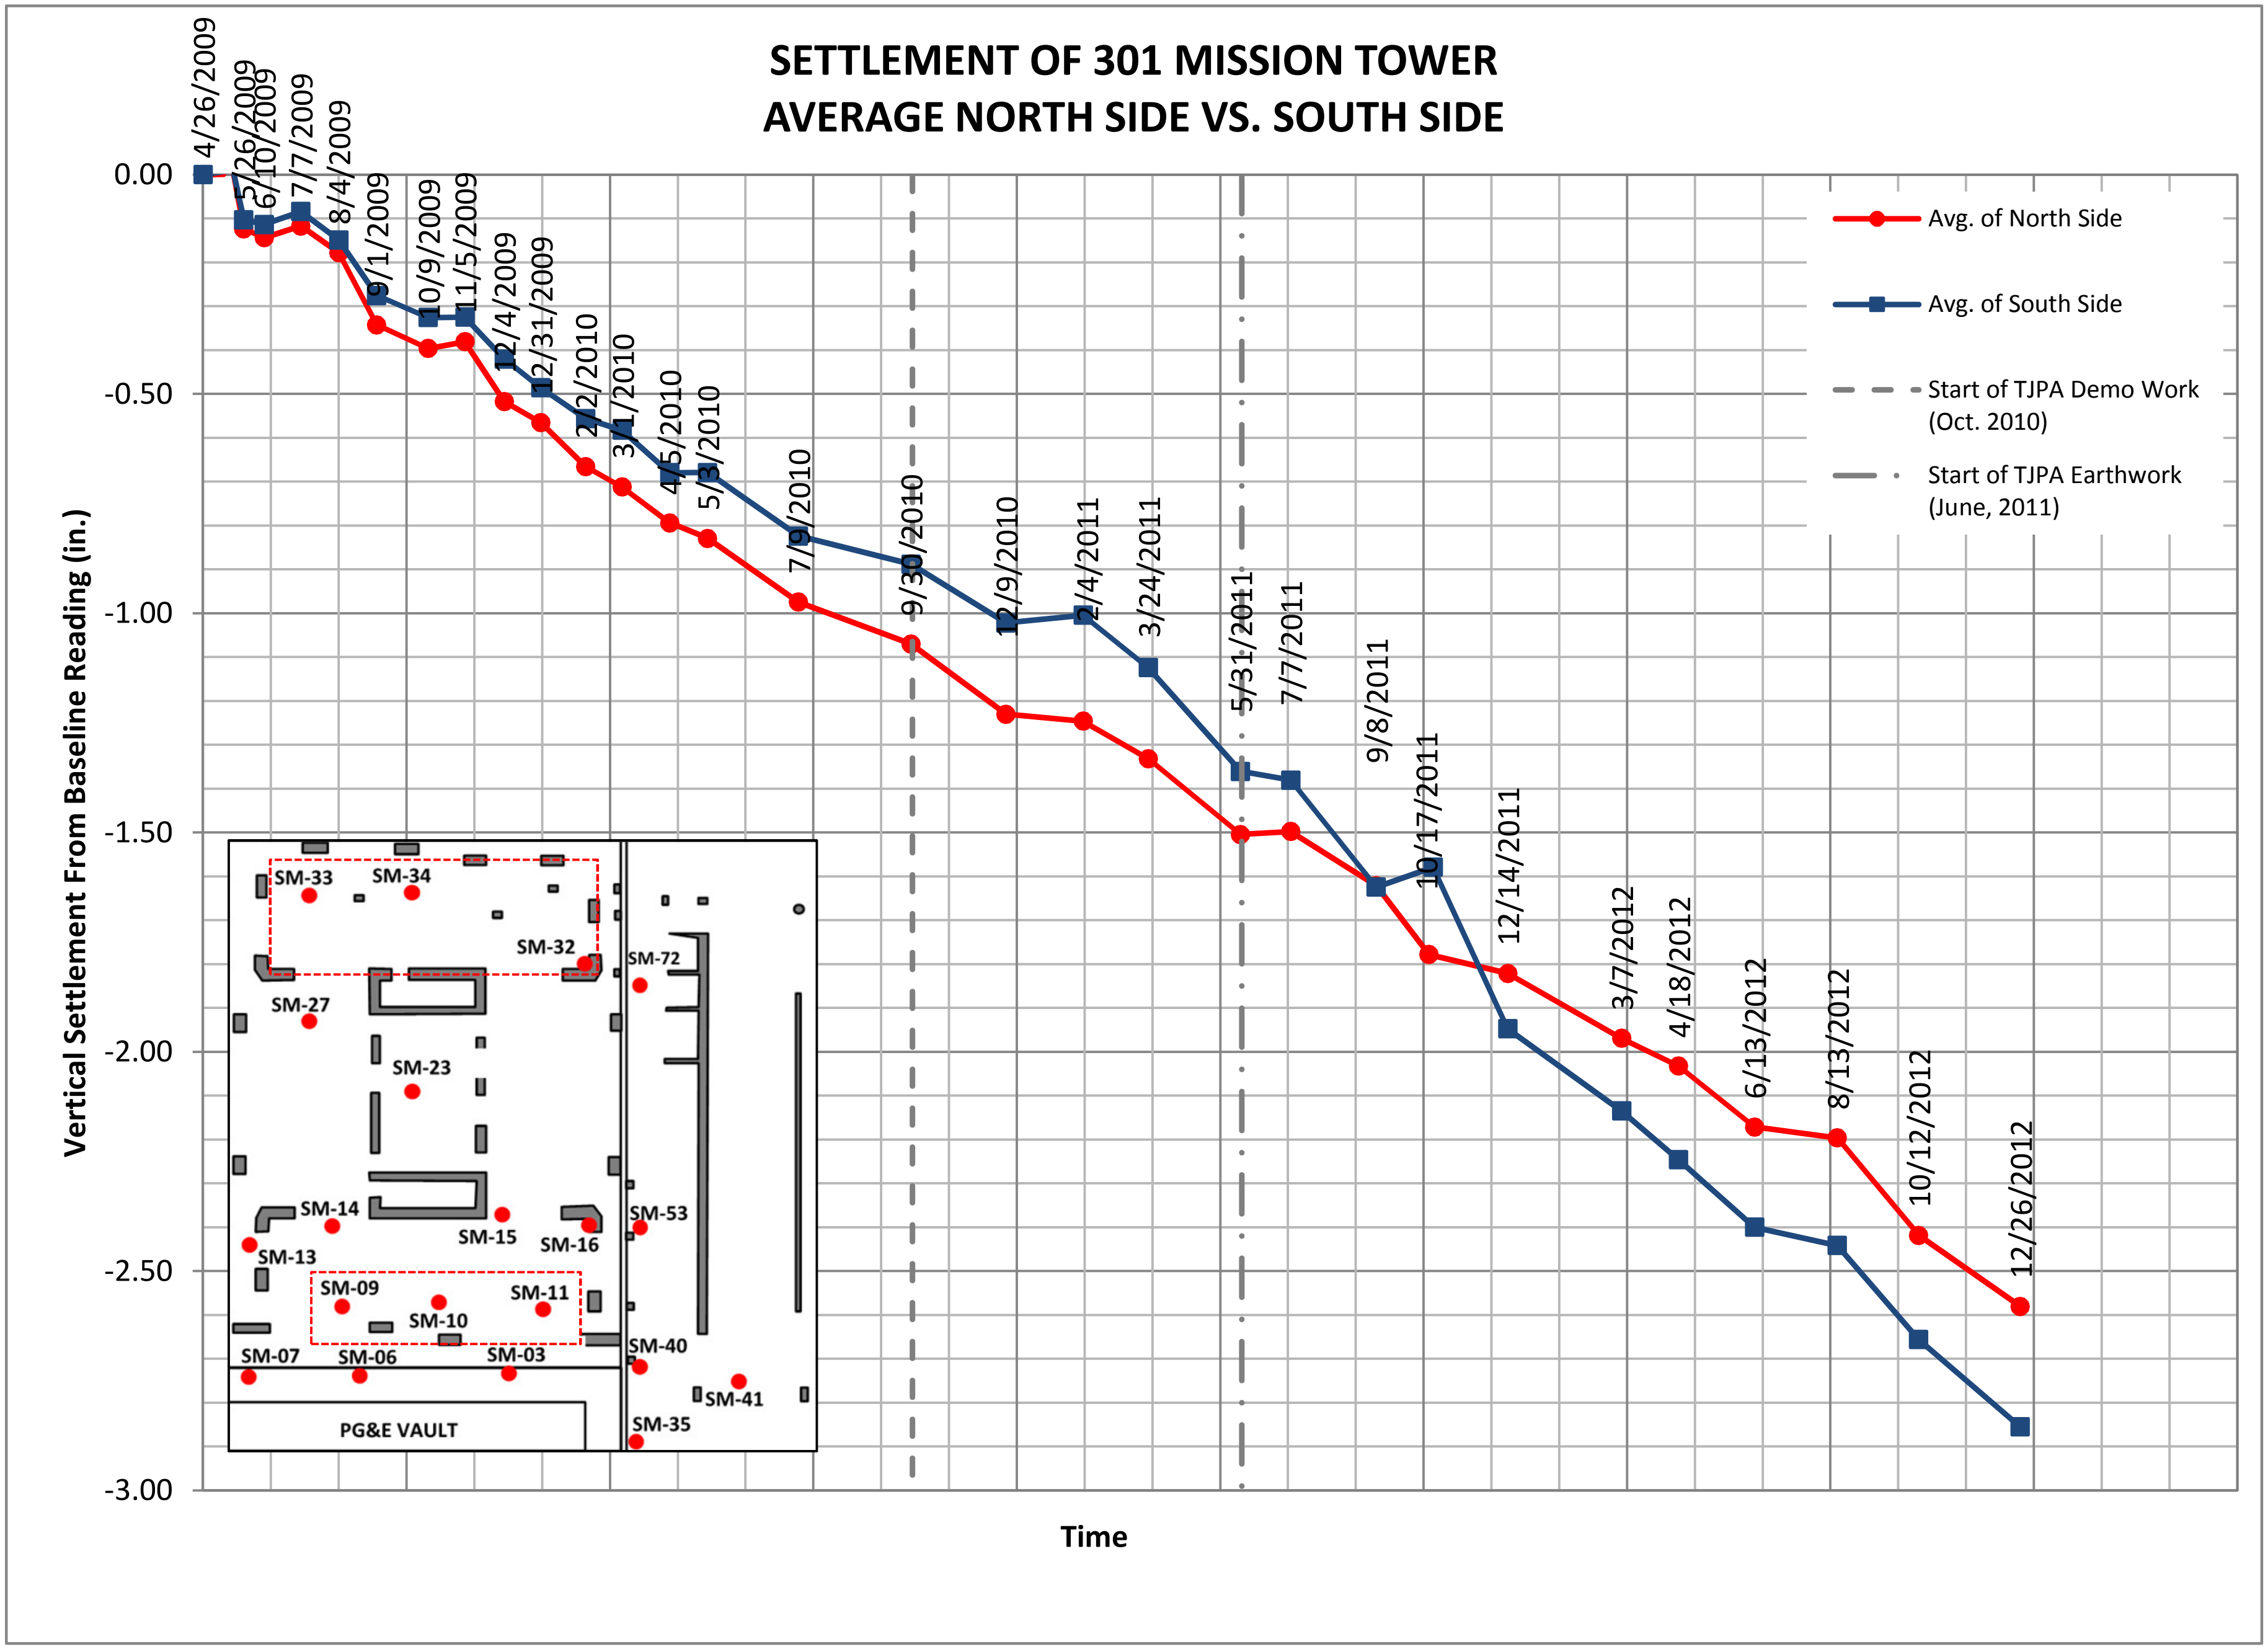
Figure 4

<u>Settlement of the North vs. South Side of the Foundation (Figure 4)</u>
Before construction at Transbay began, the North Side was settling more, and now, after construction has been going for some time, the south side is settling more. This seems to clearly show that the construction has caused a change. It is recommended that Millennium seek an explanation for this from Transbay.

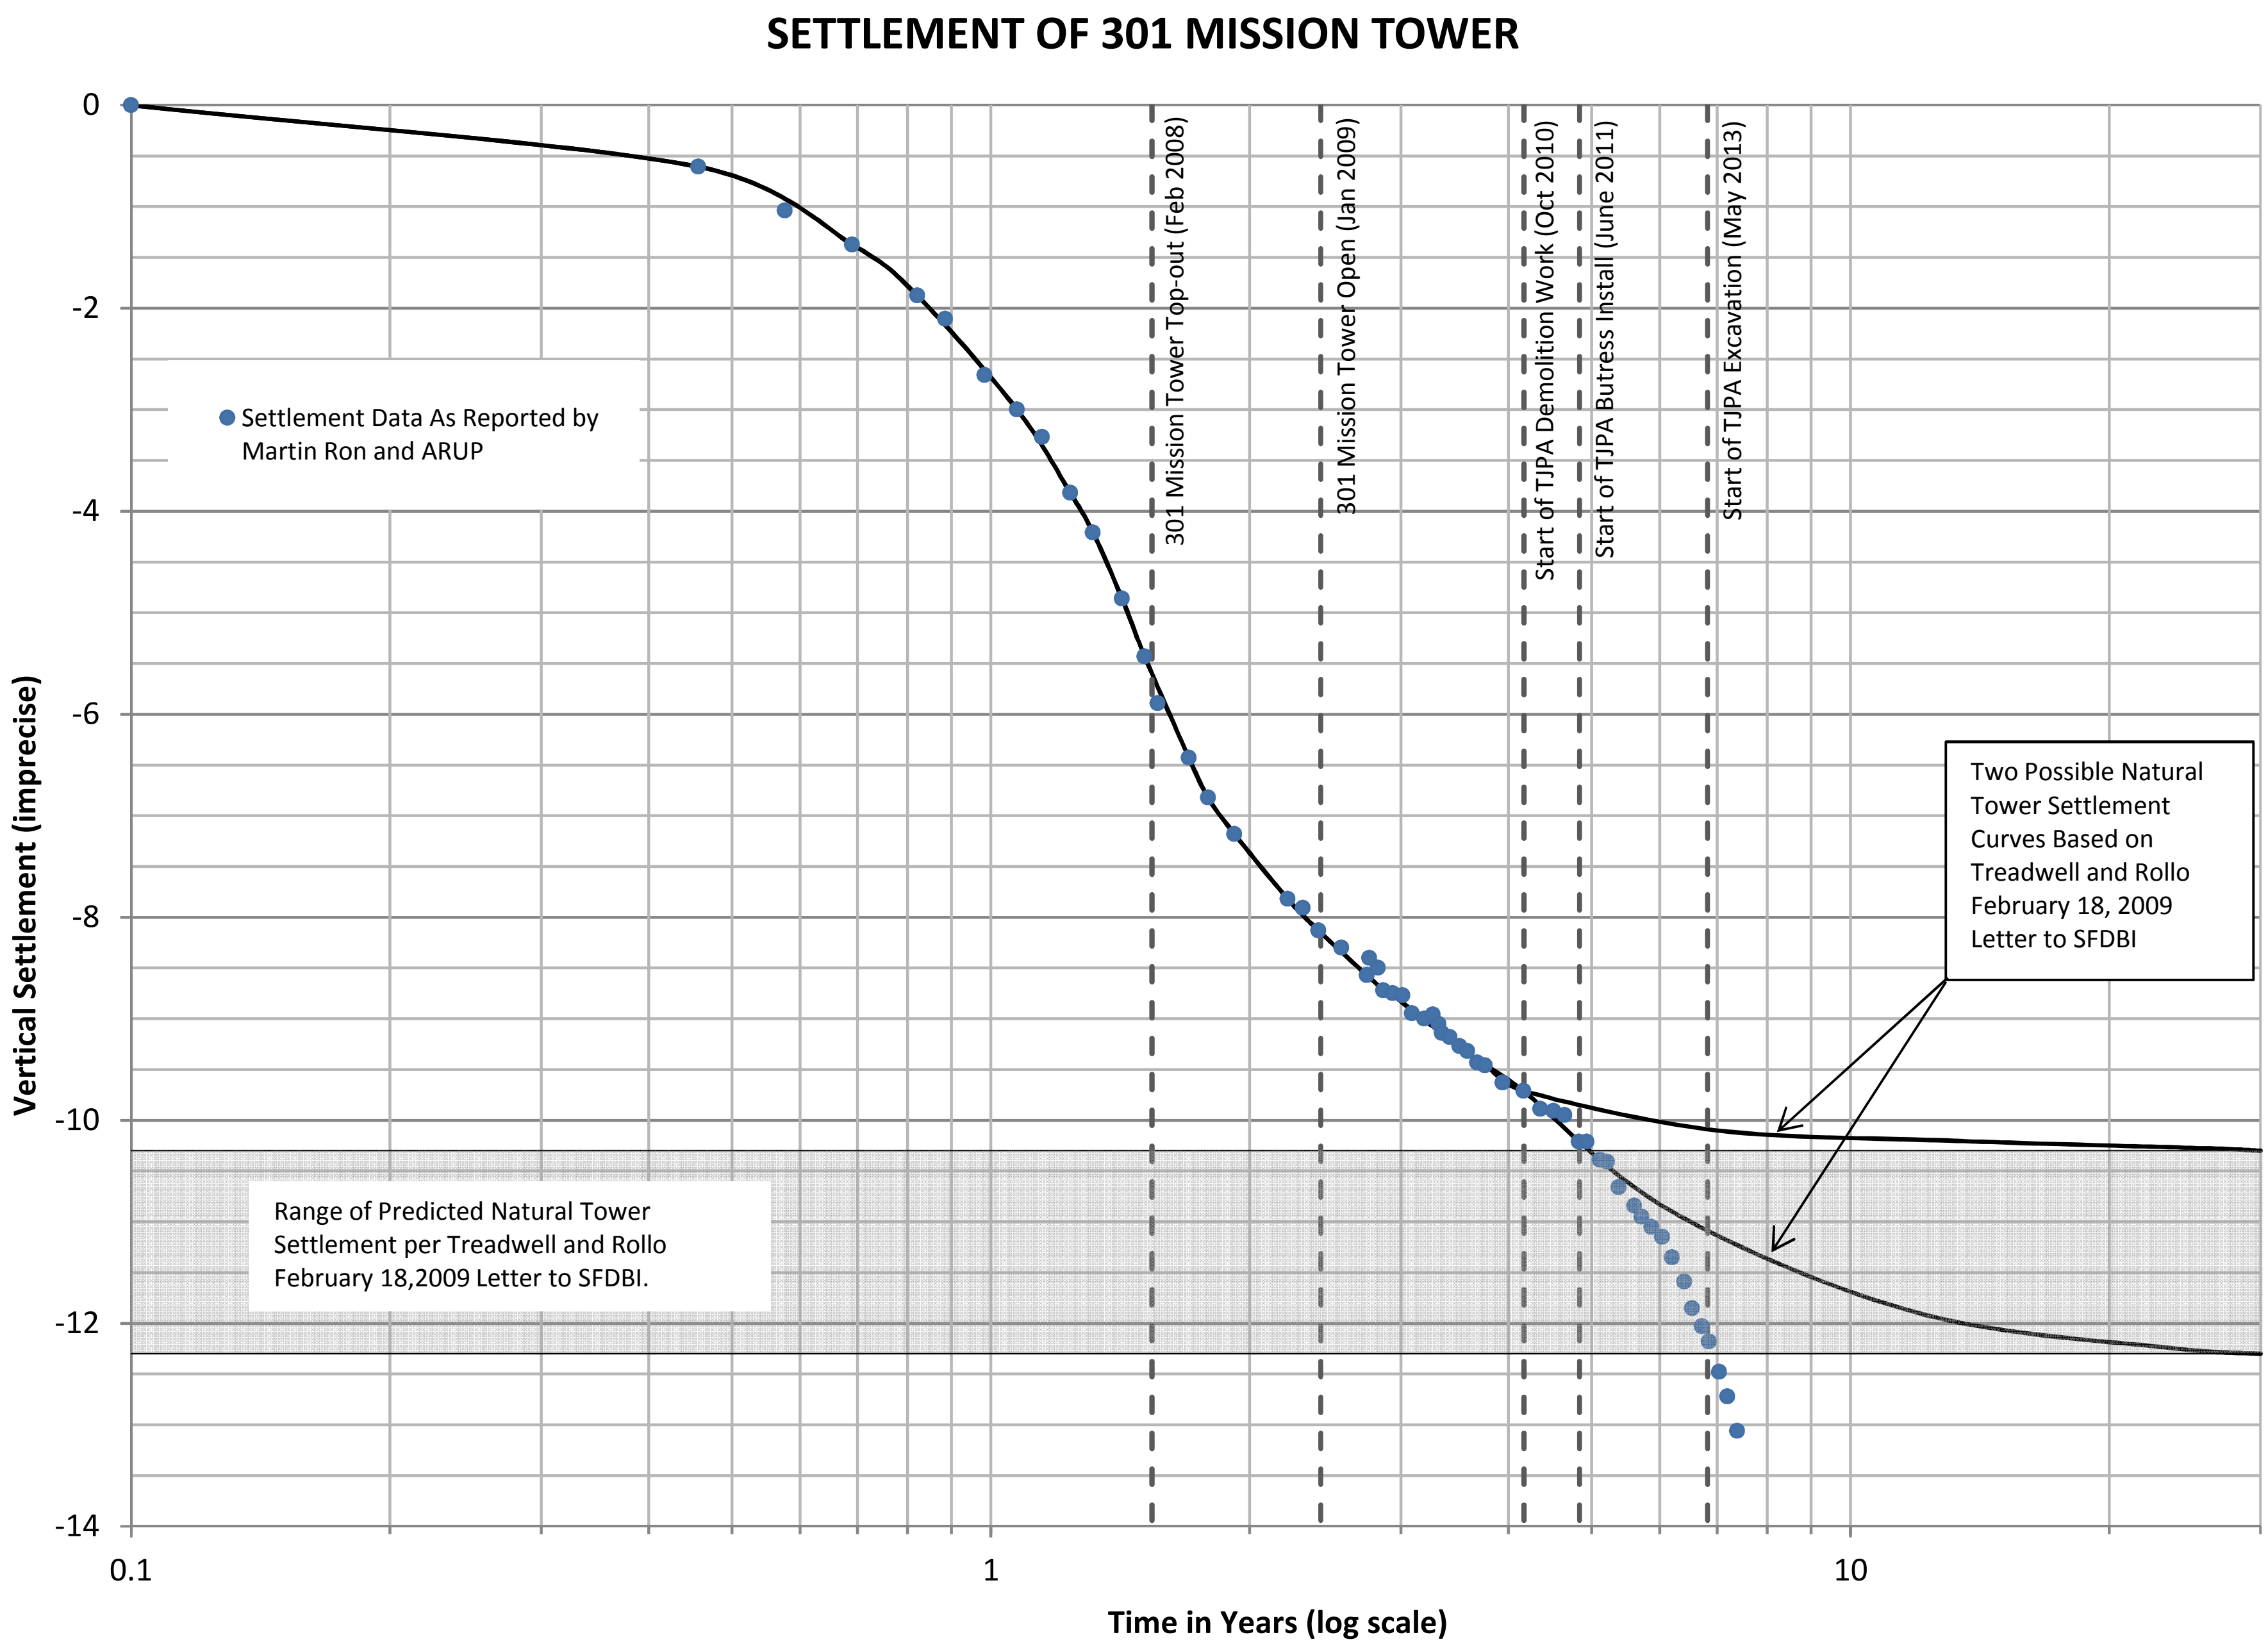
Figure 1

If we use Langan Treadwell Rollo's predicted range of total settlement and read the difference between the measured displacement data points and the settlement prediction curves (Figure 1), the additional settlement is between 1.8 to 3.0 inches. Since 0.75 inches is the "Action Trigger Level" for "other buildings" as described in the Transbay Specification, it is recommended, as we had recommended in earlier reports, that Millennium Partners (Millennium) obtain a response from Transbay regarding this discrepancy in predicted settlement. Furthermore, Transbay revised their specification (the Dec 10, 2010 version) to exclude the 301 Mission Tower from all action trigger levels. It is unclear why Transbay would have changed their specification after construction had begun. The rationale behind this action should be both understood and carefully considered by Millennium.
