File No. 160975 **Committee Item No.** 7
Board Item No. ________

AGENDA PACKET CONTENTS LIST

TALL BUILDINGS SAFETY STRATEGY

October 2018

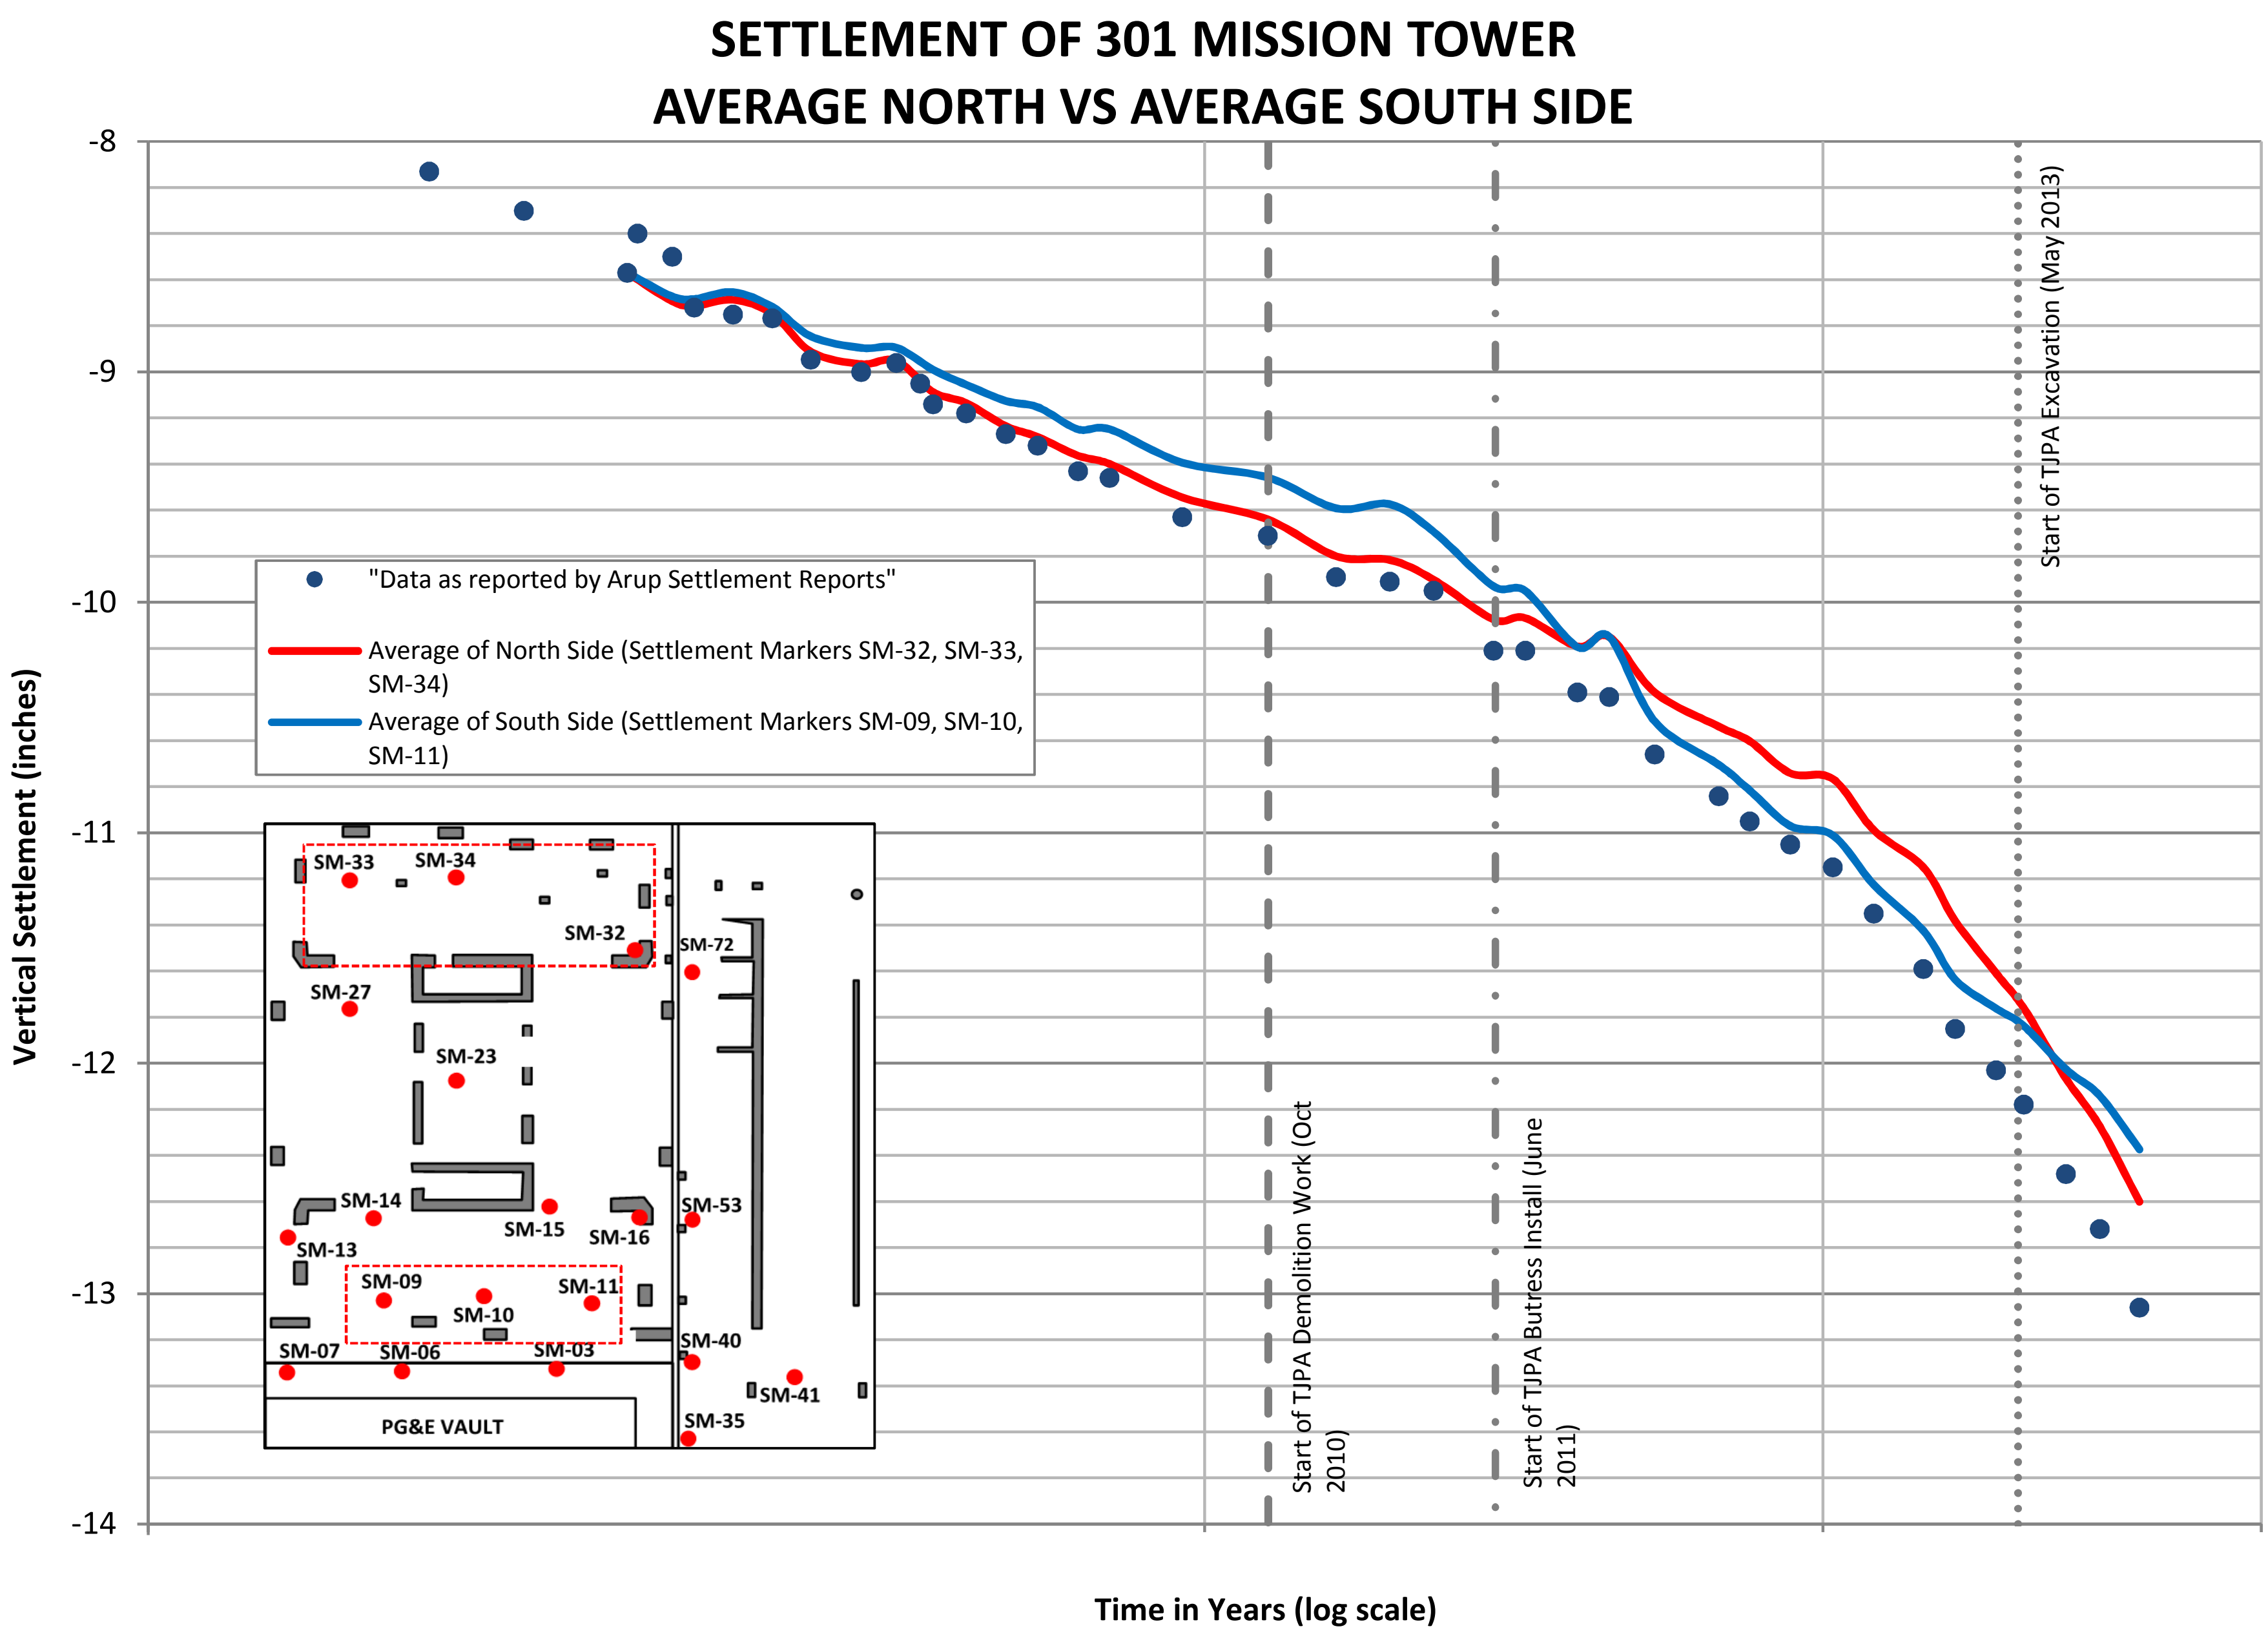
Figure 2 presents an average of settlement on the north side of the tower versus the south end of the tower, as measured in logarithmic scale. Before construction activities began at Transbay we observed that the north side had settled at a greater rate than the south. After buttress installation activities started, we observed a greater rate of settlement on the south side. After June 2013, the north side again shows a higher rate of settlement than the south side. The foundation has rotated slightly away from the south side. Since the south end of the foundation now seems to be moving faster than the north, this suggests that the activities at Transbay have caused the additional settlement.

Figure 2 also shows that the overall settlement reported by ARUP (duplicated in Figure 1) is the worst case settlement anywhere across the foundation (13.1 inches) and does not accurately represent the average. The average overall settlement for the north side currently shows about 12.6 inches. The average overall settlement for the south side currently shows about 12.4 inches.

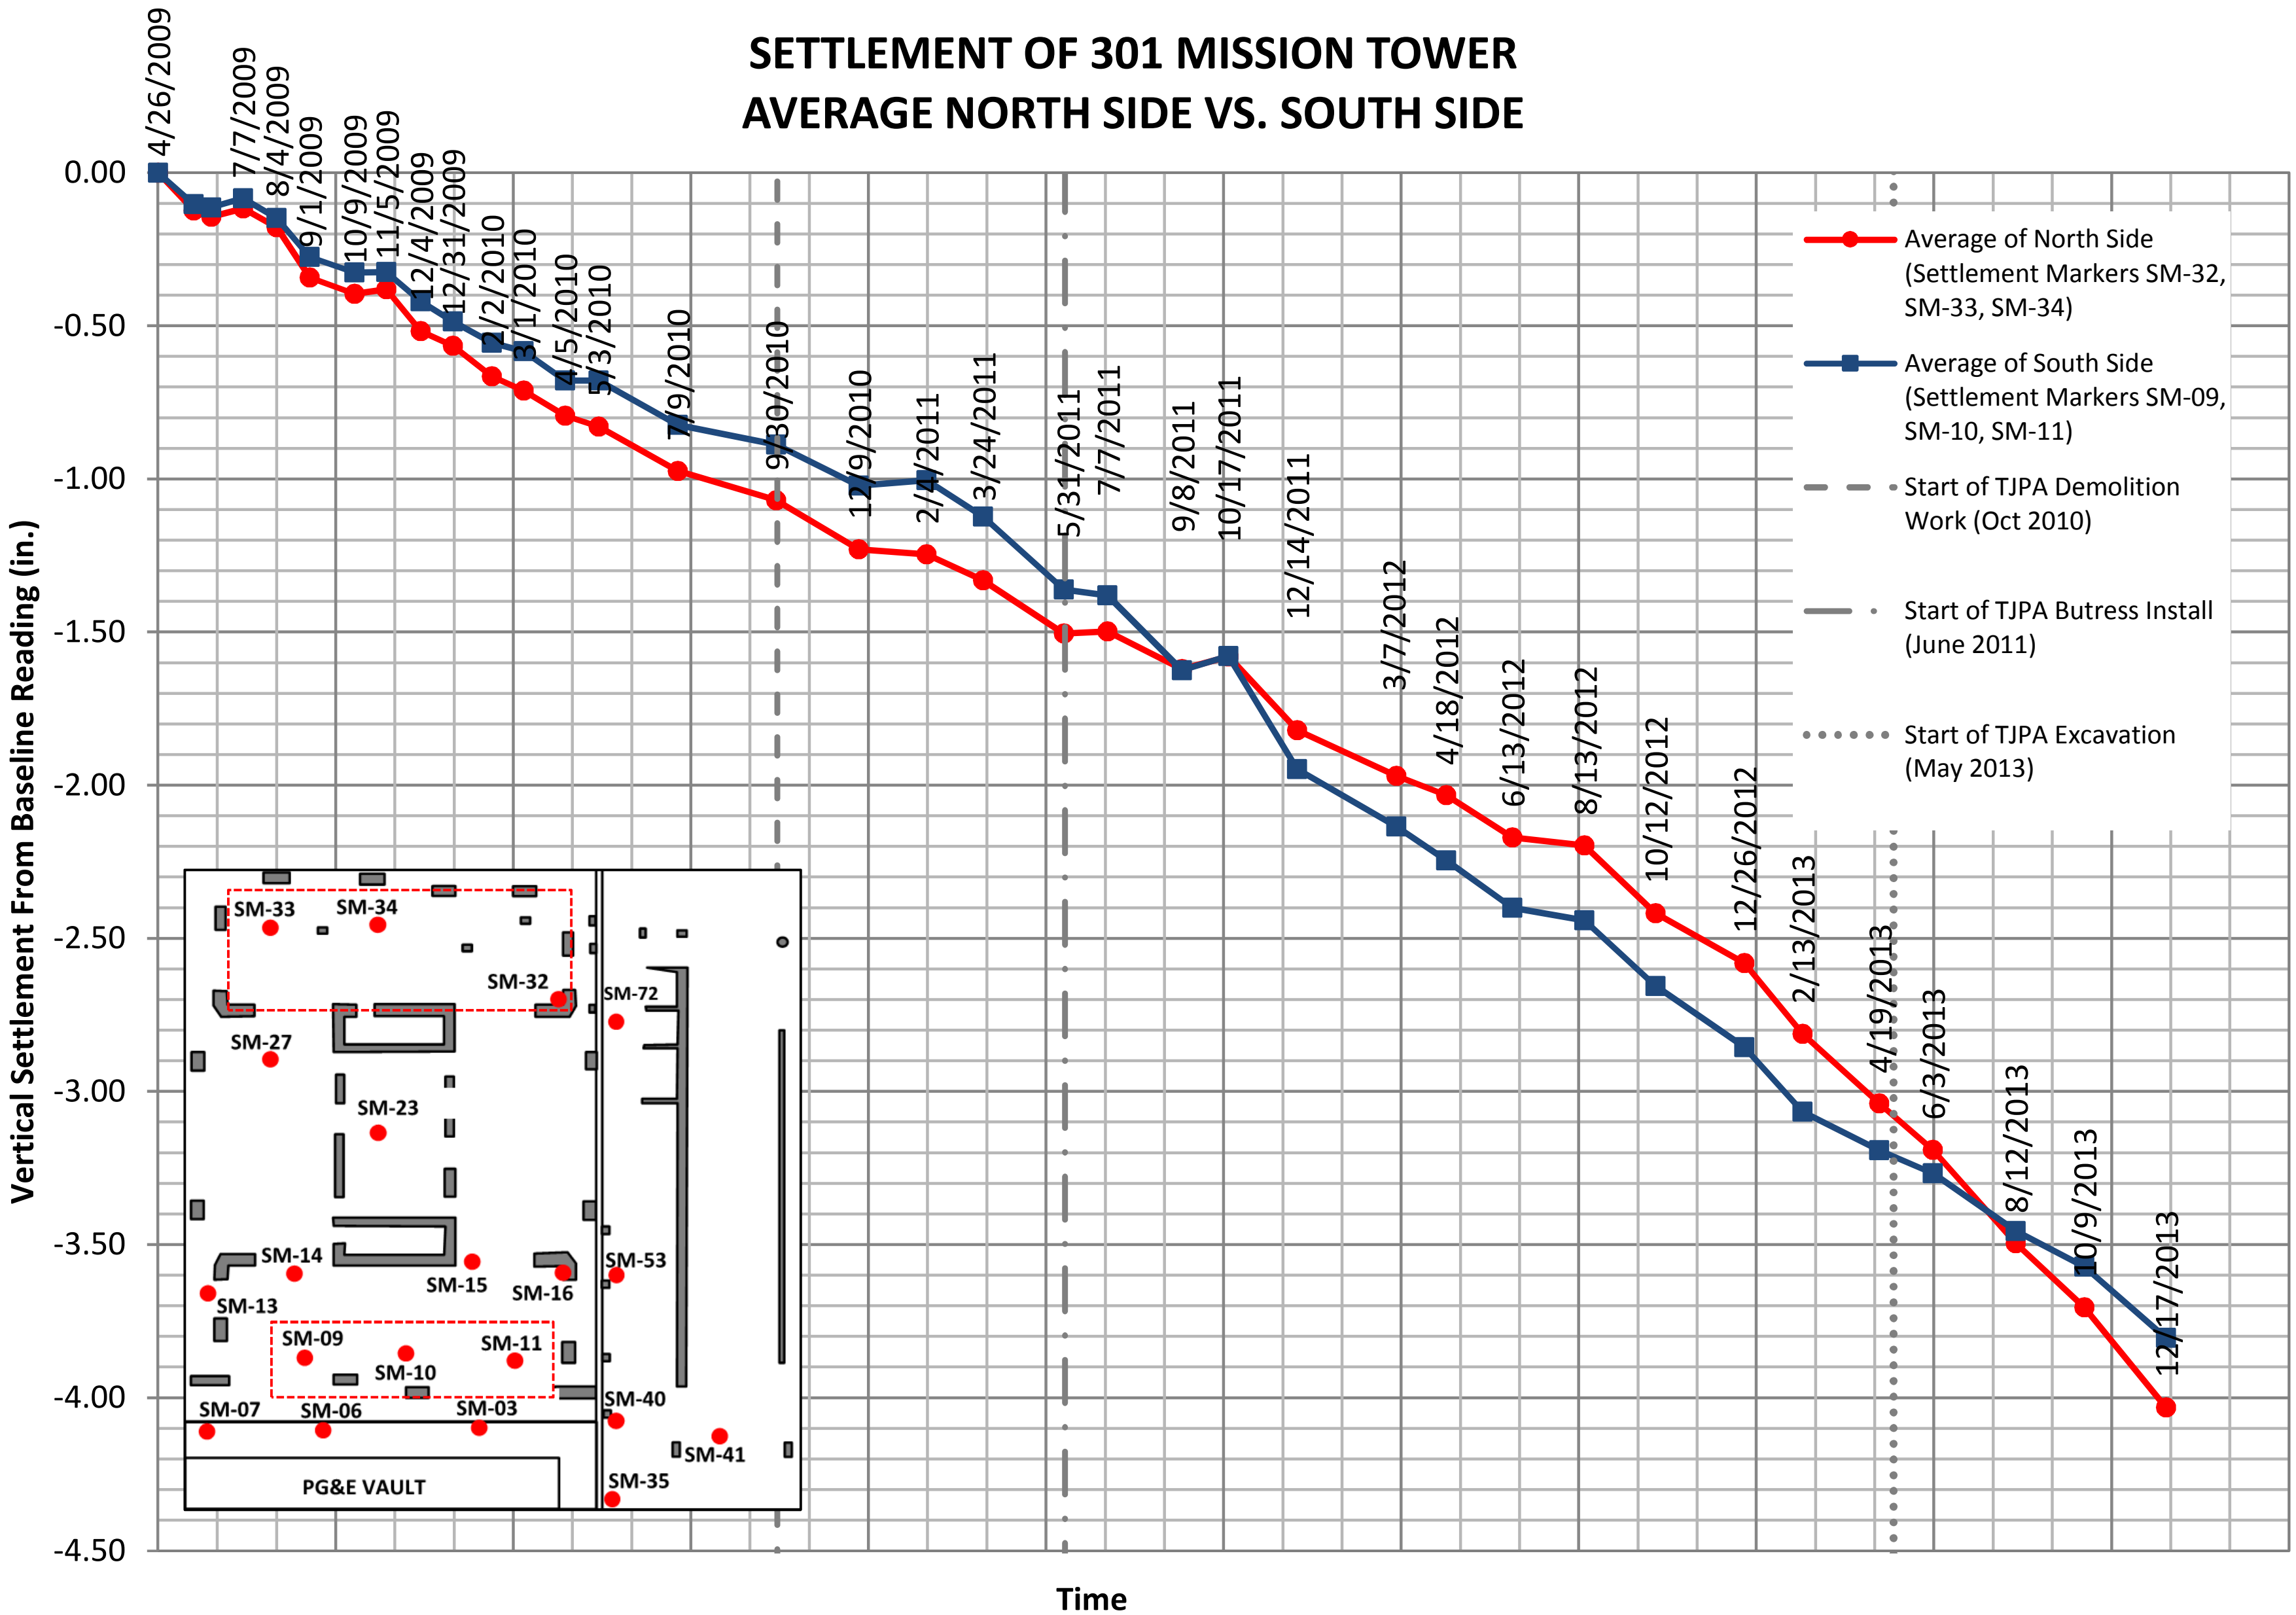
Figure 4

Settlement of the North vs. South Side of the Foundation (Figure 4)
Before Transbay buttress installation began, the north Side was settling more than the south side, but since August, 2011 the south side has been settling more than the north side. This seems to indicate that the Transbay buttress installation activities affected the overall direction of tilt. Beginning in June 2013, the north side is again showing a greater amount of settlement than the south side. This change is coincidental with the completion of the Transbay buttress installation, along with the start of excavation at both the Transbay site and the 350 Mission site.

It should also be noted that this figure indicates differential movement across the foundation in the north-south direction causing a slight tilt to the building. If this movement was larger, damage to the structure can occur. In general the tilt, while measurable, is generally small and not of the type which would cause damage.

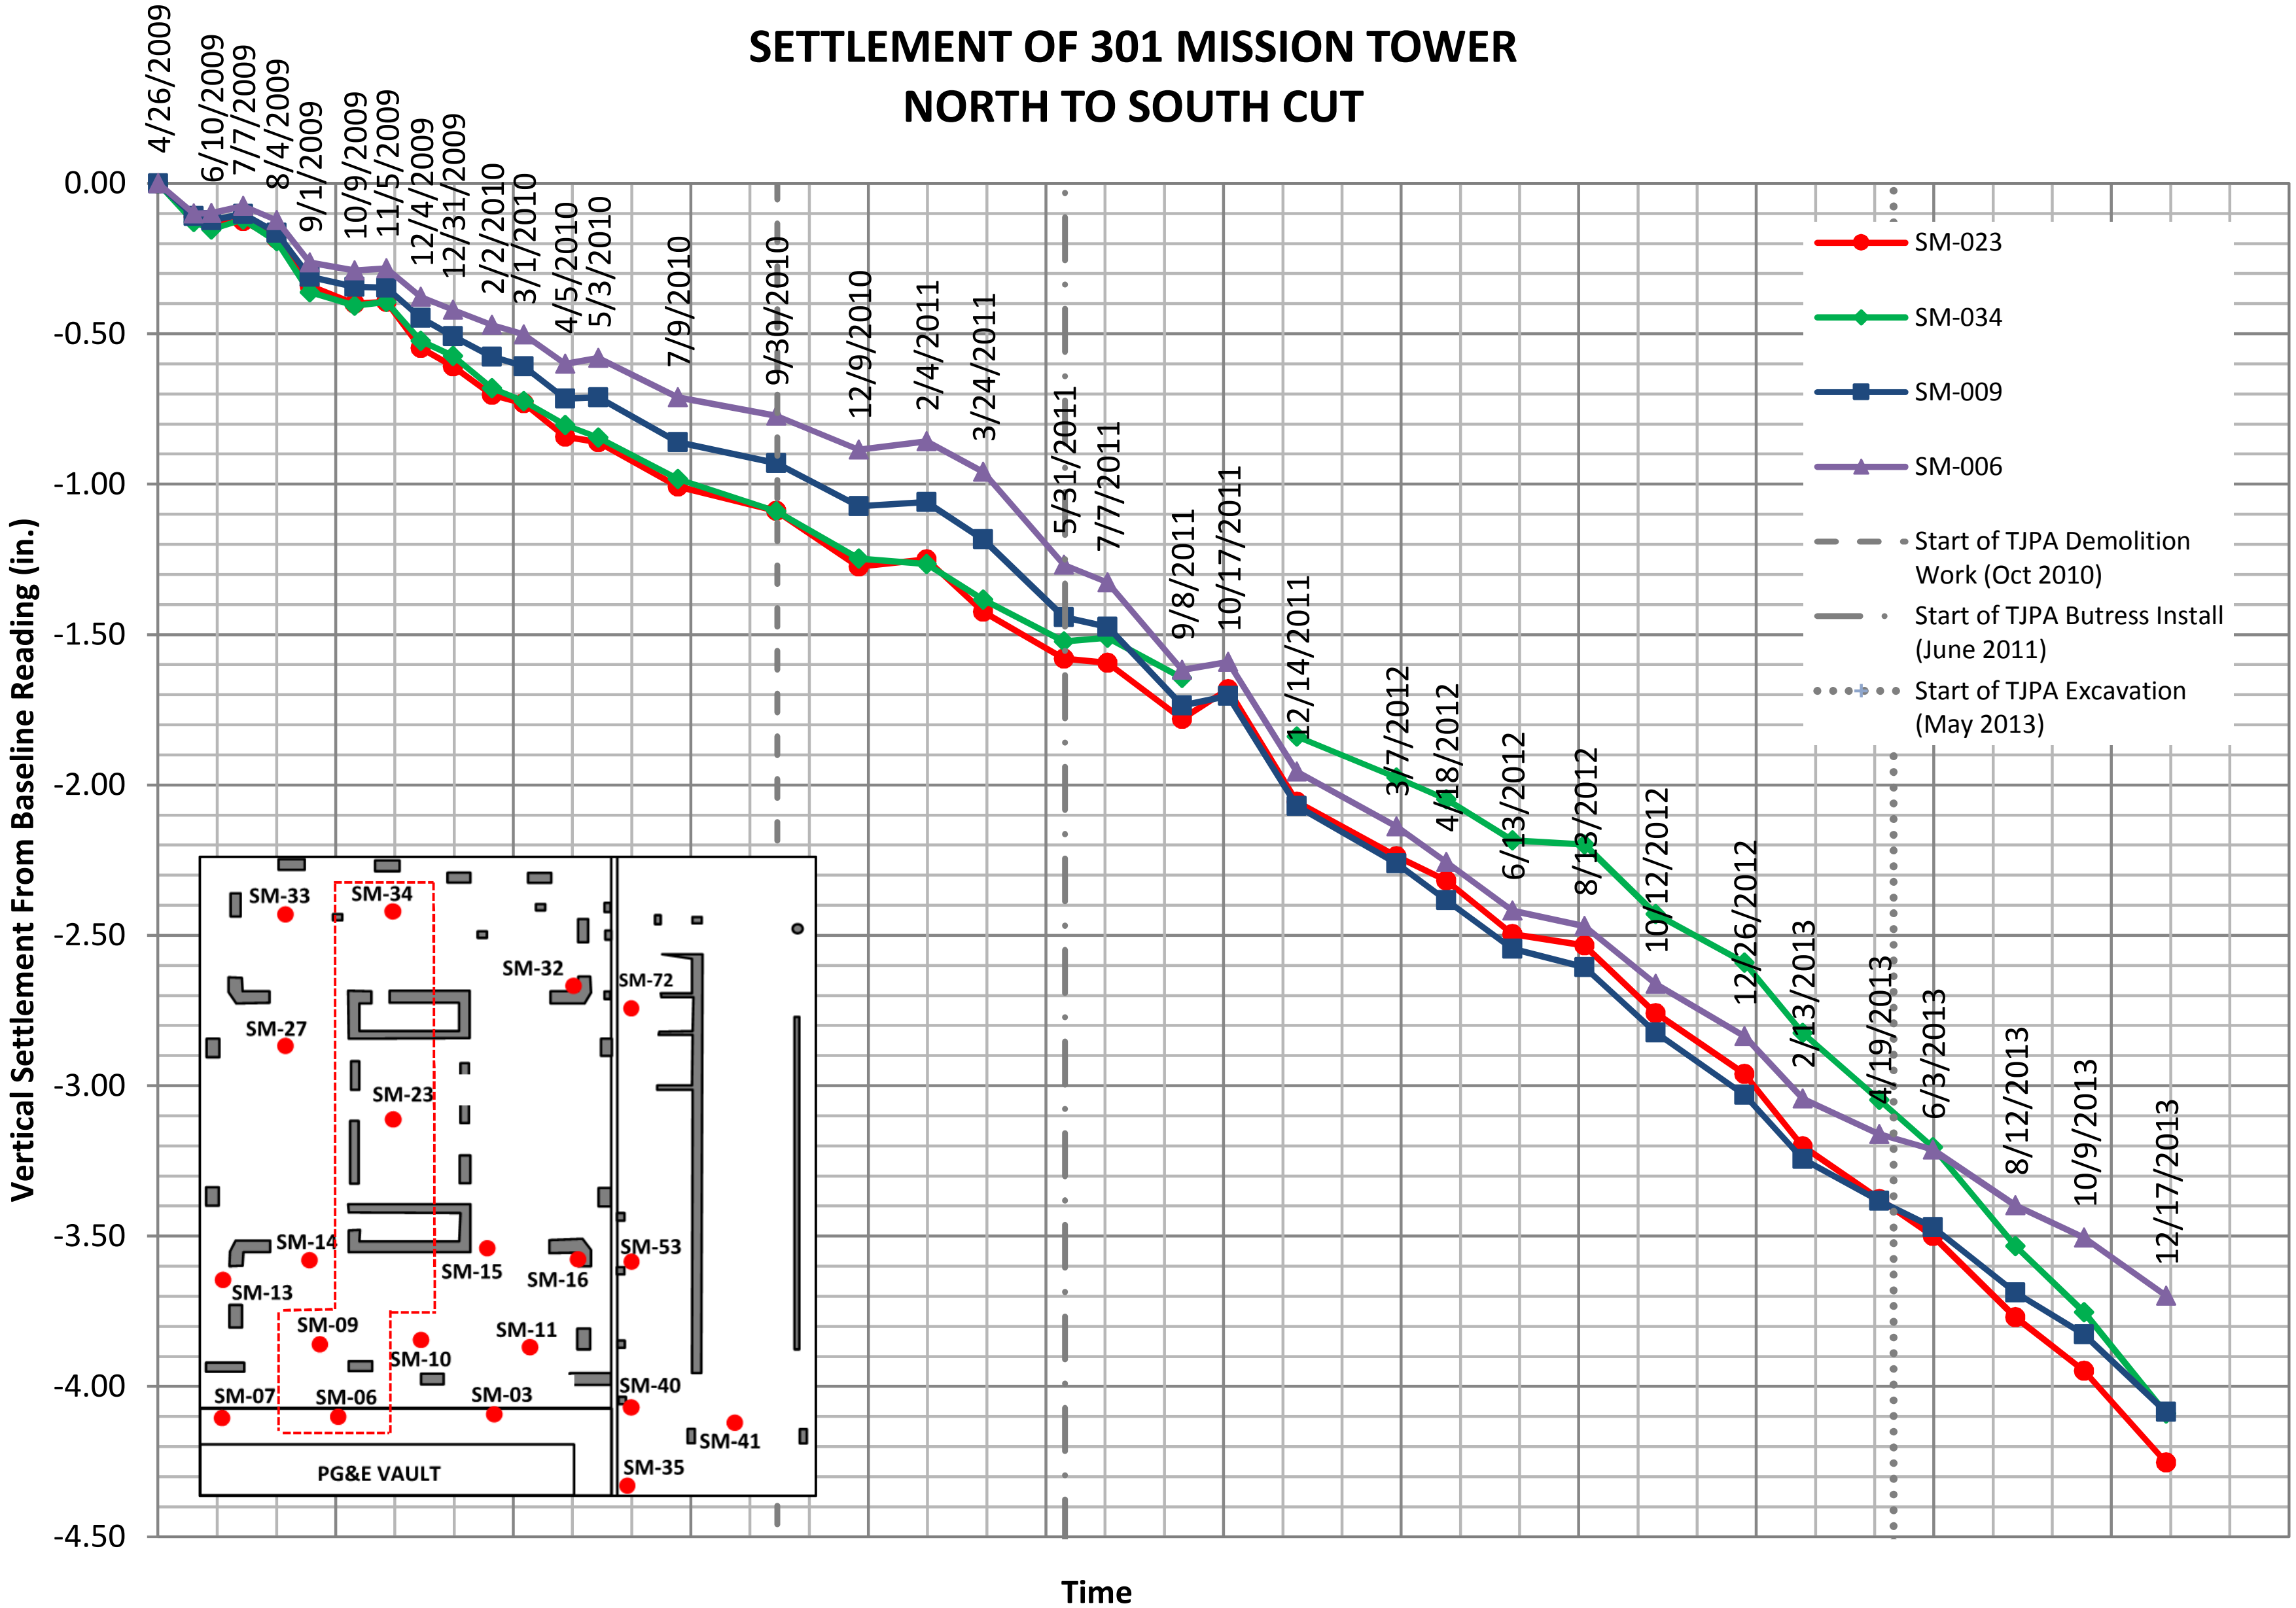
Figure 5

Settlement across a North-South Section of the Foundation (Figure 5)
Before buttress installation activities began, the Tower was settling more at the north side and at a consistent rate. After buttress installation activities began, the settlement in the south started settling faster than the ones in the north. At present time, following the last of the buttress installation, the highest settlement along the north-south direction is nearly at the center of the foundation. DeSimone considers the change in location of highest settlement as directly correlated to the Transbay buttress installation activities.

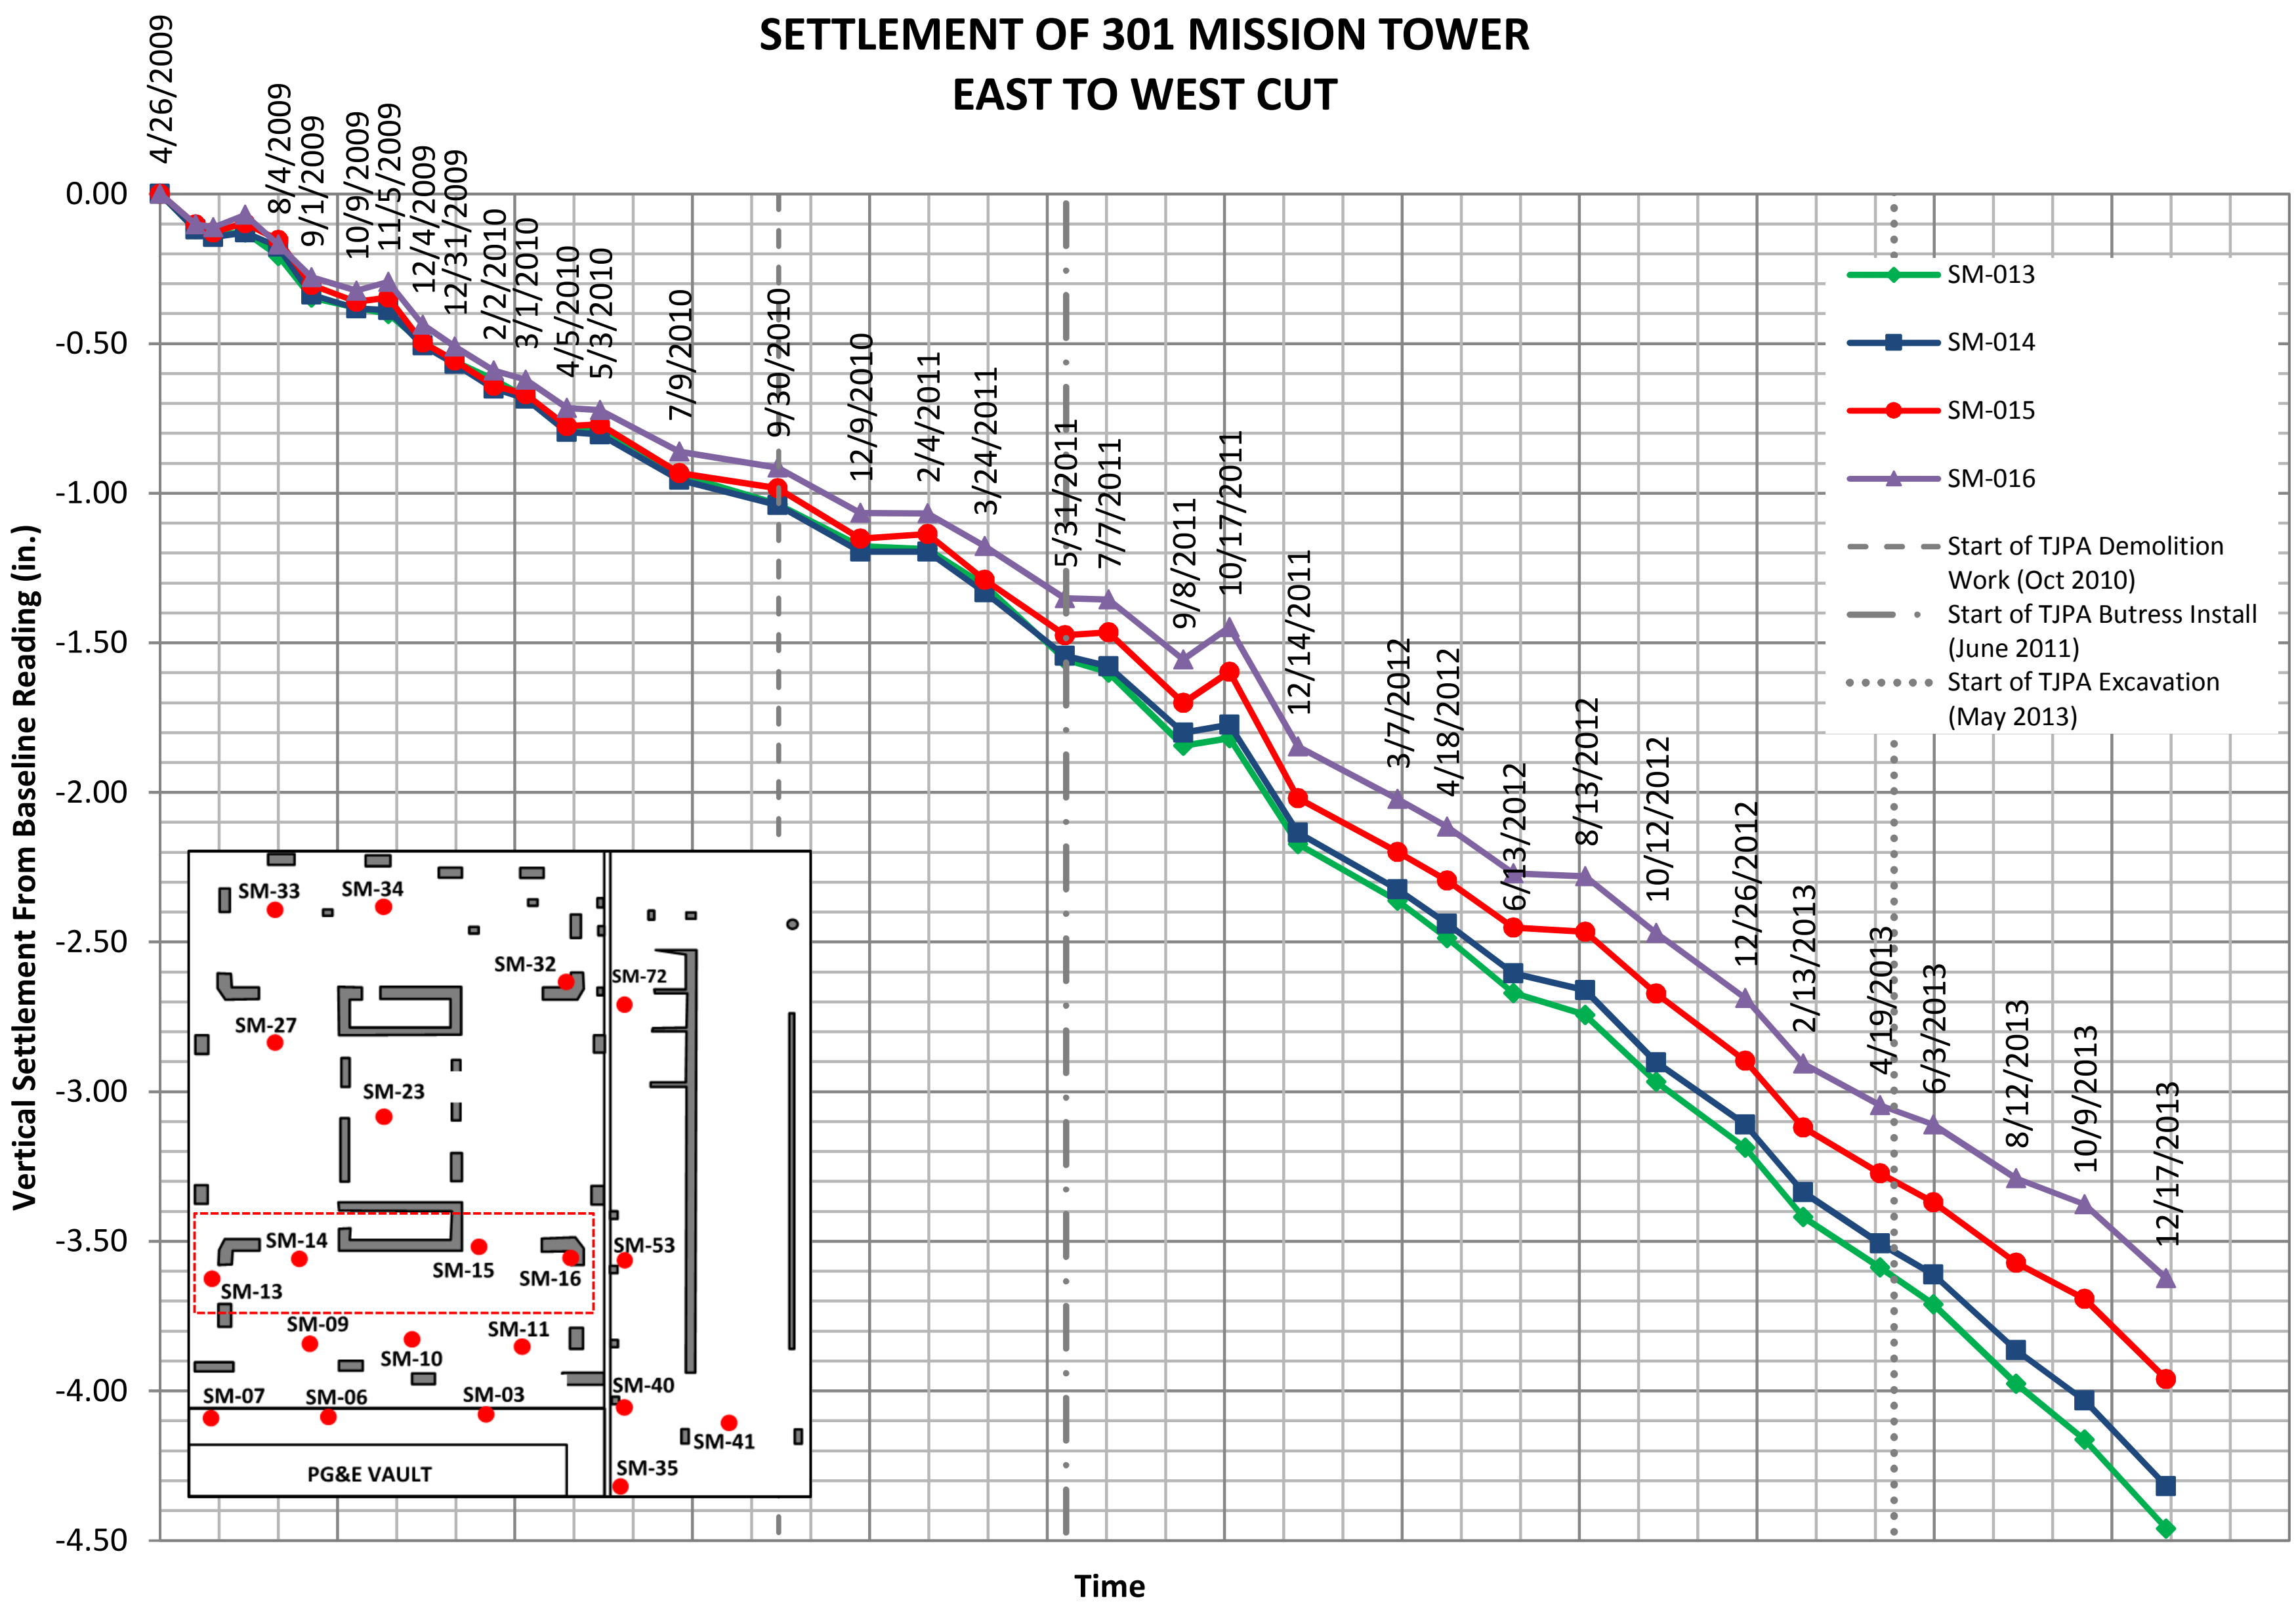
Figure 6

Settlement across the East-West Section of the Foundation (Figure 6)
The construction does not seem to have affected the settlement in the east-west direction. The settlement along this cut seems to be close to linear, with the west side settling slightly more than the east. The total differential is about 0.9 inches.

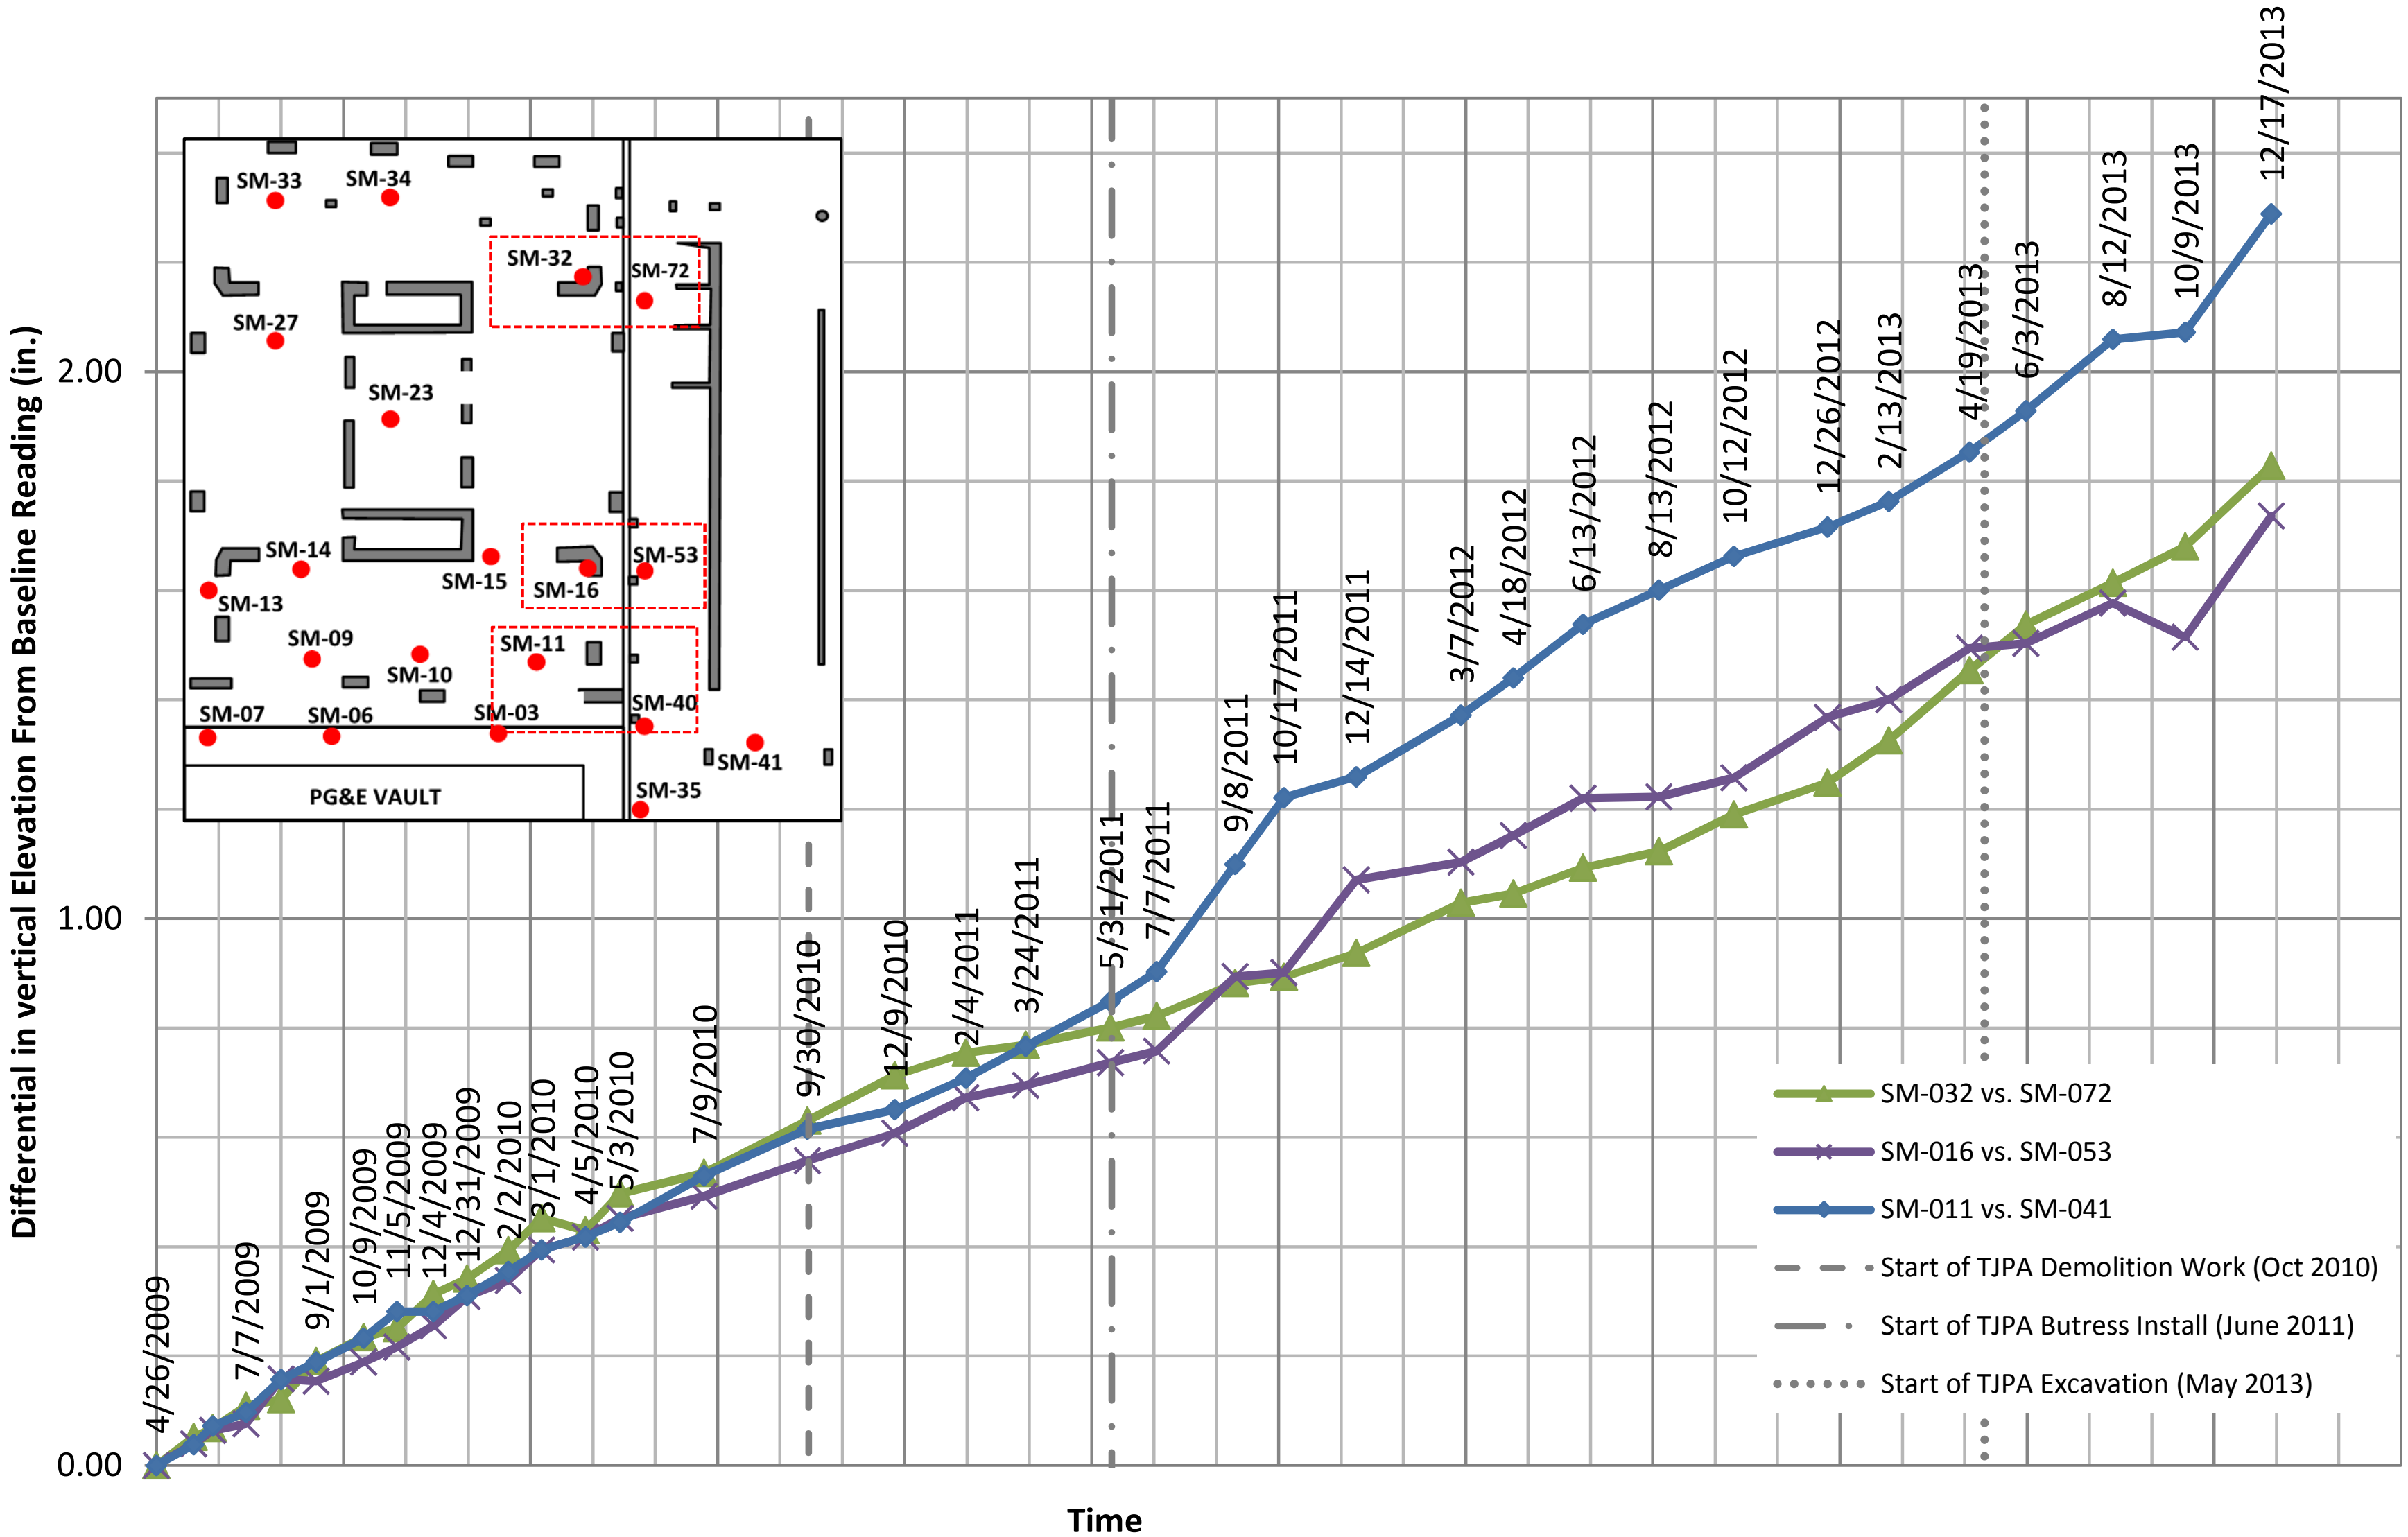
Between the Tower and Mid-Rise along Gridline 12 Joint (Figure 7)
Several settlement markers were reviewed at the building separation joint between the Tower and Mid-Rise along gridline 12. It can be clearly observed in Figure 7 that since Transbay buttress installation activities have begun, that there is increasing differential settlement (increase in rate of settlement) across the joint. This settlement is more than what was naturally occurring prior to the beginning of Transbay construction.

The largest observed differential settlement across the joint is near the south side of the building, and less differential settlement on the north side. It does appear that the joint is performing as expected and allowing free movements between both structures. Continued on-site observation of the joint should be made to ensure its intended performance is being met.

DIFFERENTIAL SETTLEMENT ALONG THE GRIDLINE 12 JOINT BETWEEN TOWER TO MIDRISE
