File No. 160975 **Committee Item No.** 7
Board Item No. ________

AGENDA PACKET CONTENTS LIST

TALL BUILDINGS SAFETY STRATEGY

October 2018

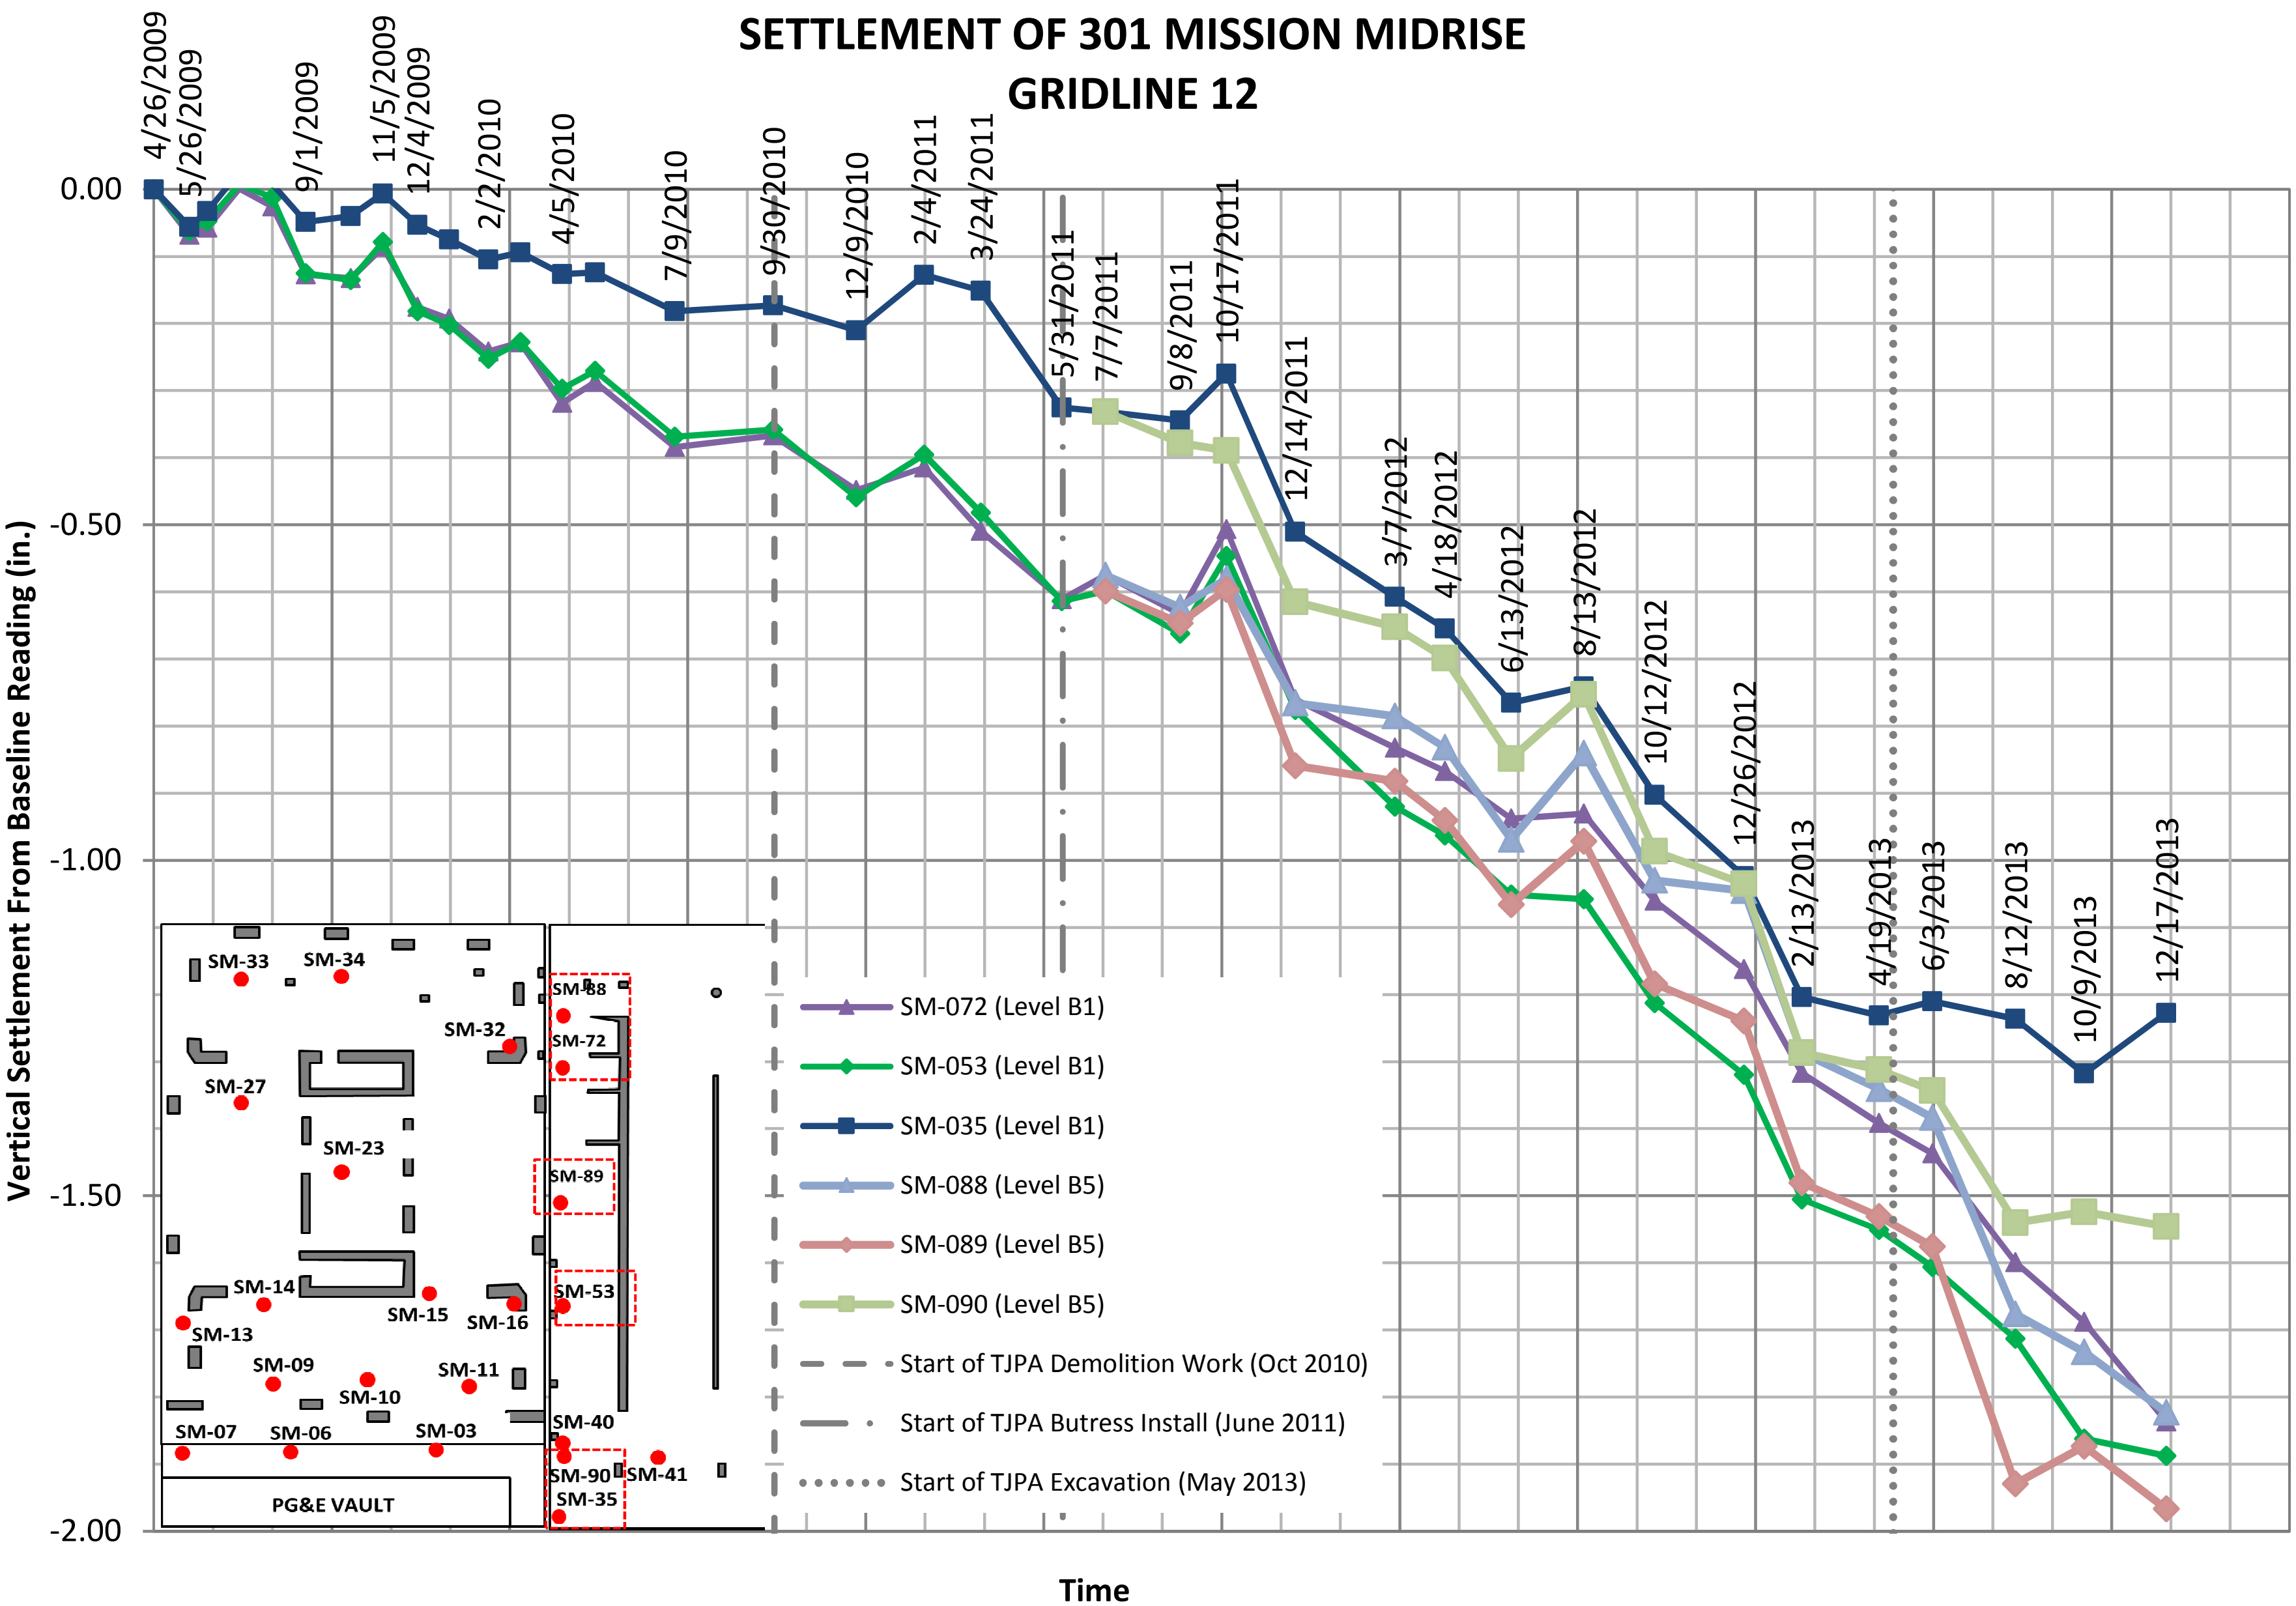
Figure 10

As can be seen in Figure 10, the foundation has settled along gridline 12 of the Mid-Rise since 2009. The highest level of settlement occurs near the middle of the site, with slightly less at the north and south edges. The settlement is of such a magnitude that the tie-downs may no longer be functioning as intended. DeSimone recommends that Langan Treadwell Rollo address this issue.

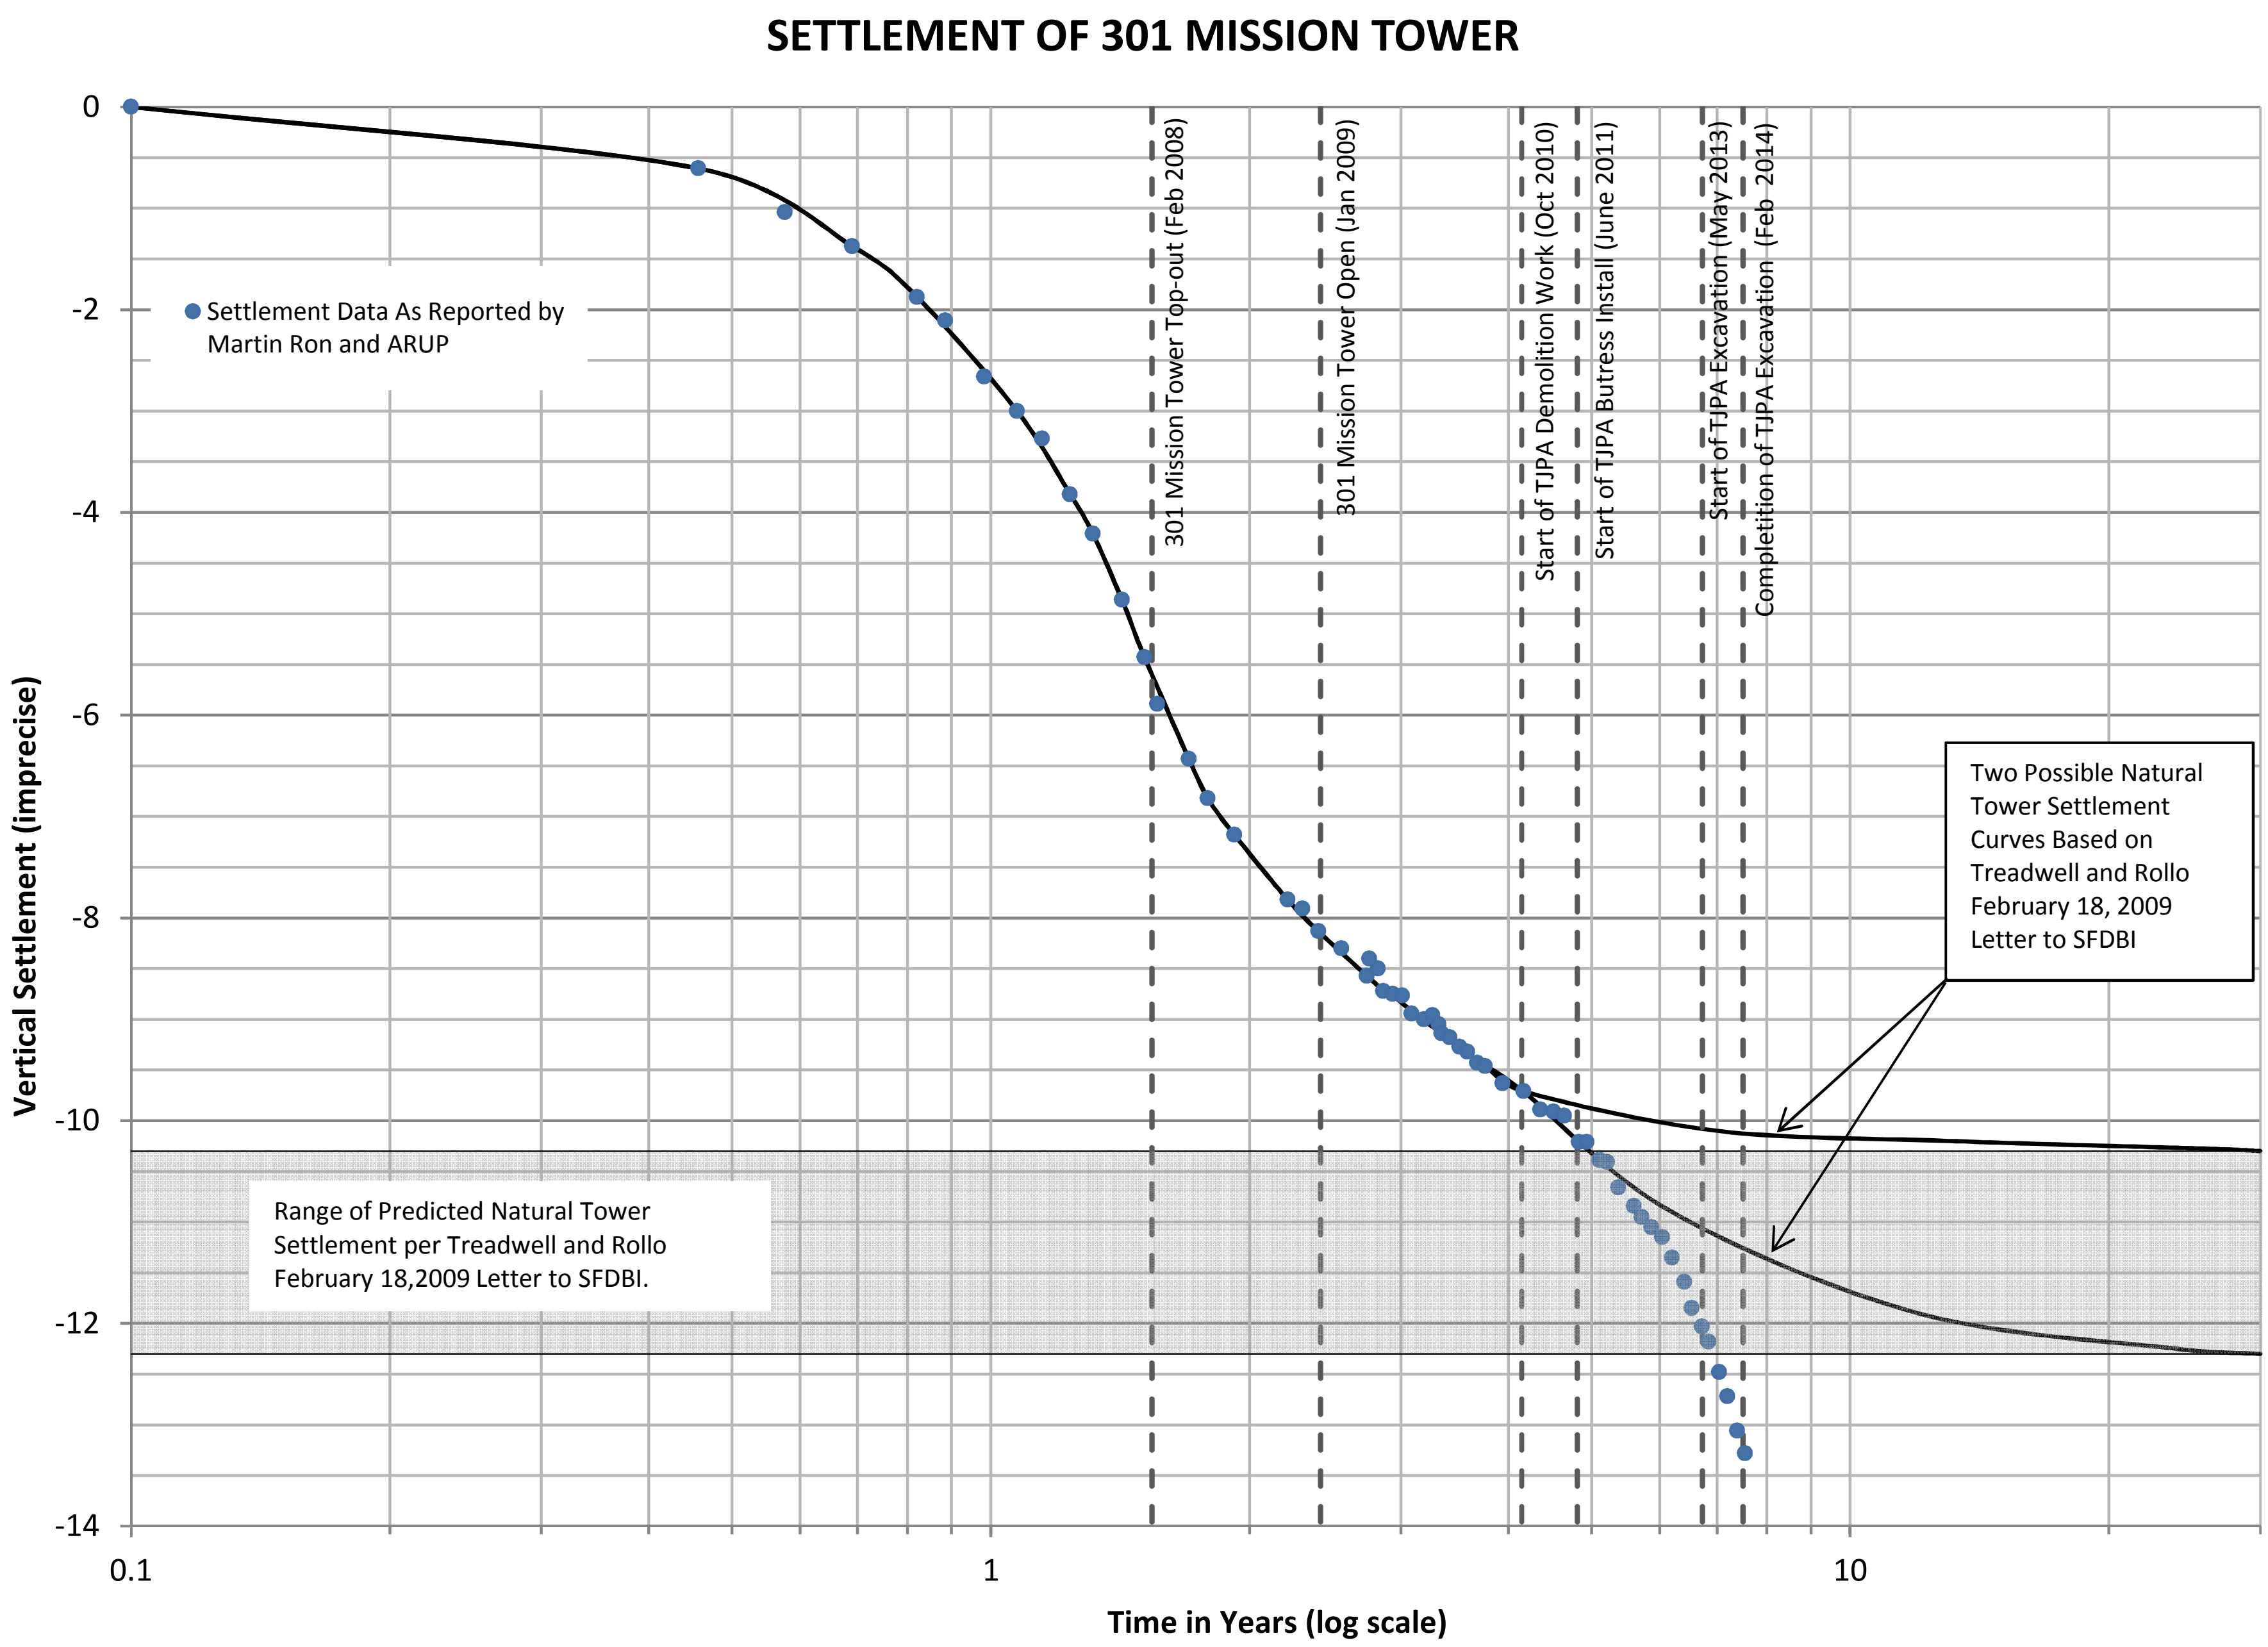
Figure 1

Comparison of Predicted Settlement to Measured Settlement (Figure 1)
If we use Langan Treadwell Rollo's predicted range of total settlement and read the difference between the measured displacement data points and the settlement prediction curves (Figure 1), the additional settlement is between 2.0 to 3.3 inches. Since 0.75 inches is the "Action Trigger Level" for "other buildings" as described in the Transbay Specification, it is recommended, as we had recommended in earlier reports, that Millennium Partners (Millennium) obtain a response from Transbay regarding this discrepancy in predicted settlement. Furthermore, Transbay revised their specification (the Dec 10, 2010 version) to exclude the 301 Mission Tower from all action trigger levels. It is unclear why Transbay would have changed their specification after construction had begun and why no action trigger limit for this site has since been published by TJPA.

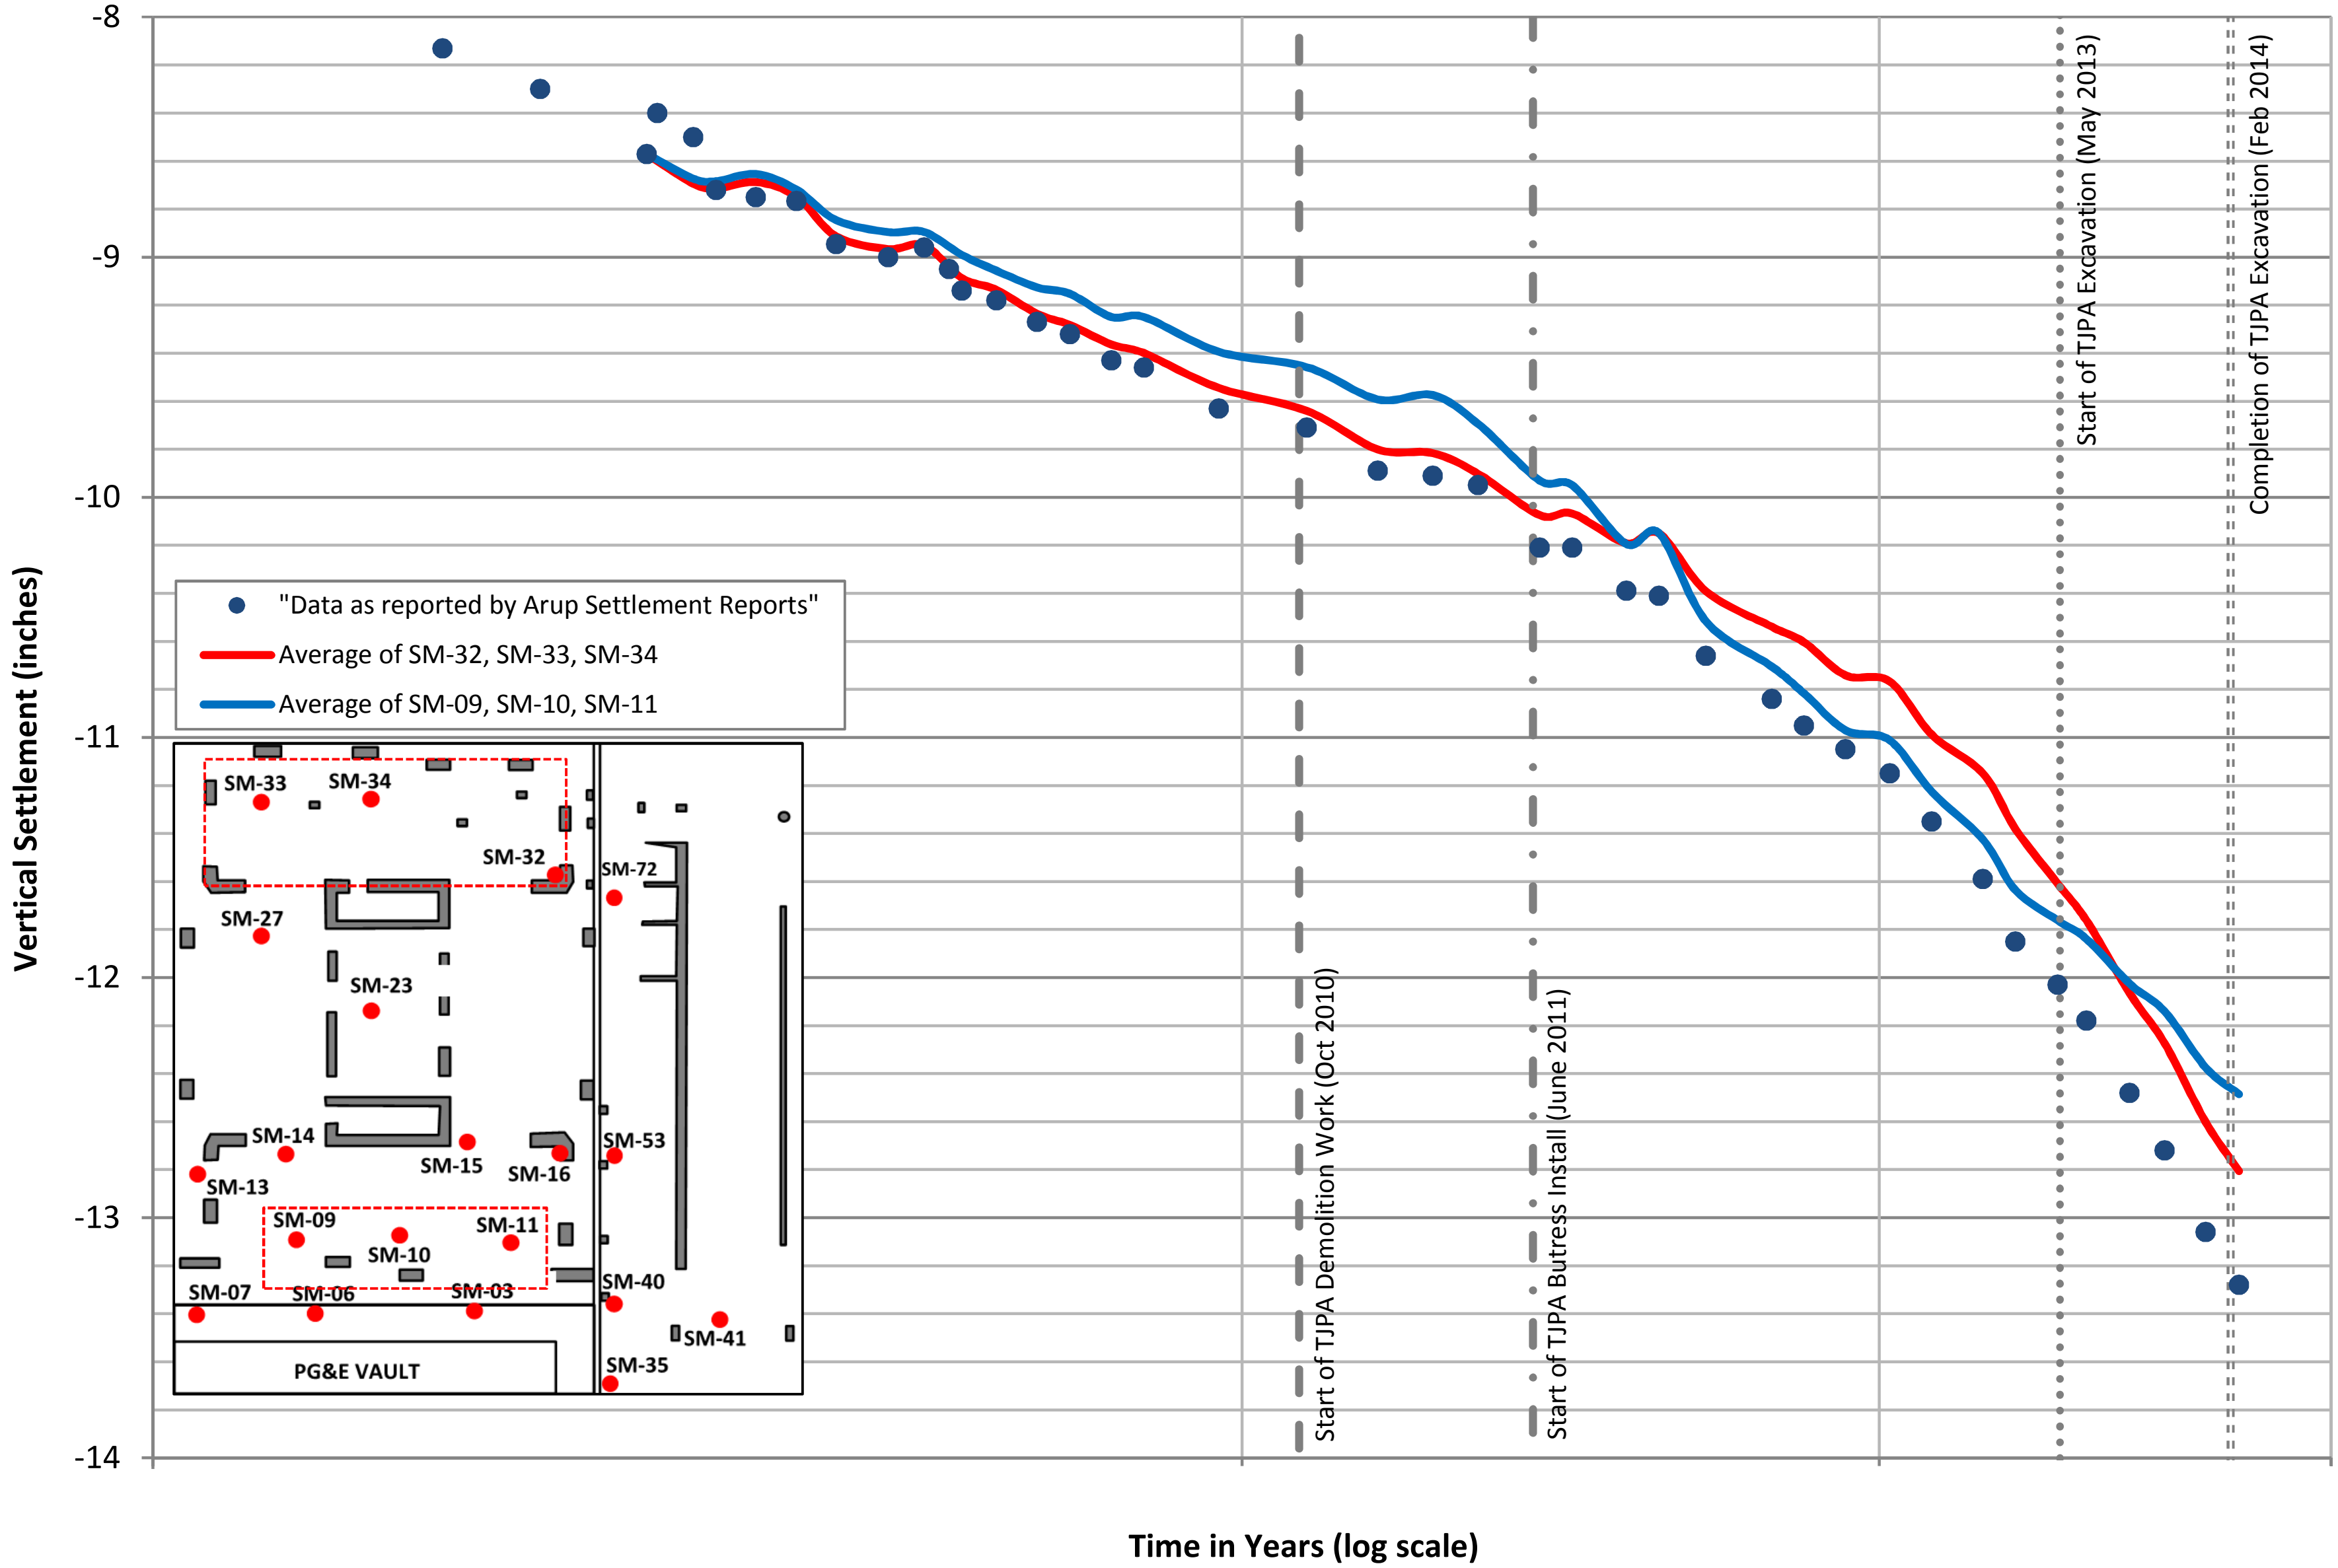
Settlement of the North vs. South Side of the Foundation - Logarithmic Scale (Figure 2)
Figure 2 presents an average of settlement on the north side of the tower versus the south end of the tower, as measured in logarithmic scale. Before construction activities began at Transbay we observed that the north side had settled at a greater rate than the south. After buttress installation activities started, we observed a greater rate of settlement on the south side. After June 2013, the north side again shows a higher rate of settlement than the south side. The foundation has rotated slightly away from the south side.

Figure 2 also shows that the overall settlement reported by ARUP (duplicated in Figure 1) is the worst case settlement anywhere across the foundation (13.1 inches) and does not accurately represent the average. The average overall settlement for the north side currently shows about 12.8 inches. The average overall settlement for the south side currently shows about 12.5 inches.

SETTLEMENT OF 301 MISSION TOWER
AVERAGE NORTH VS AVERAGE SOUTH SIDE

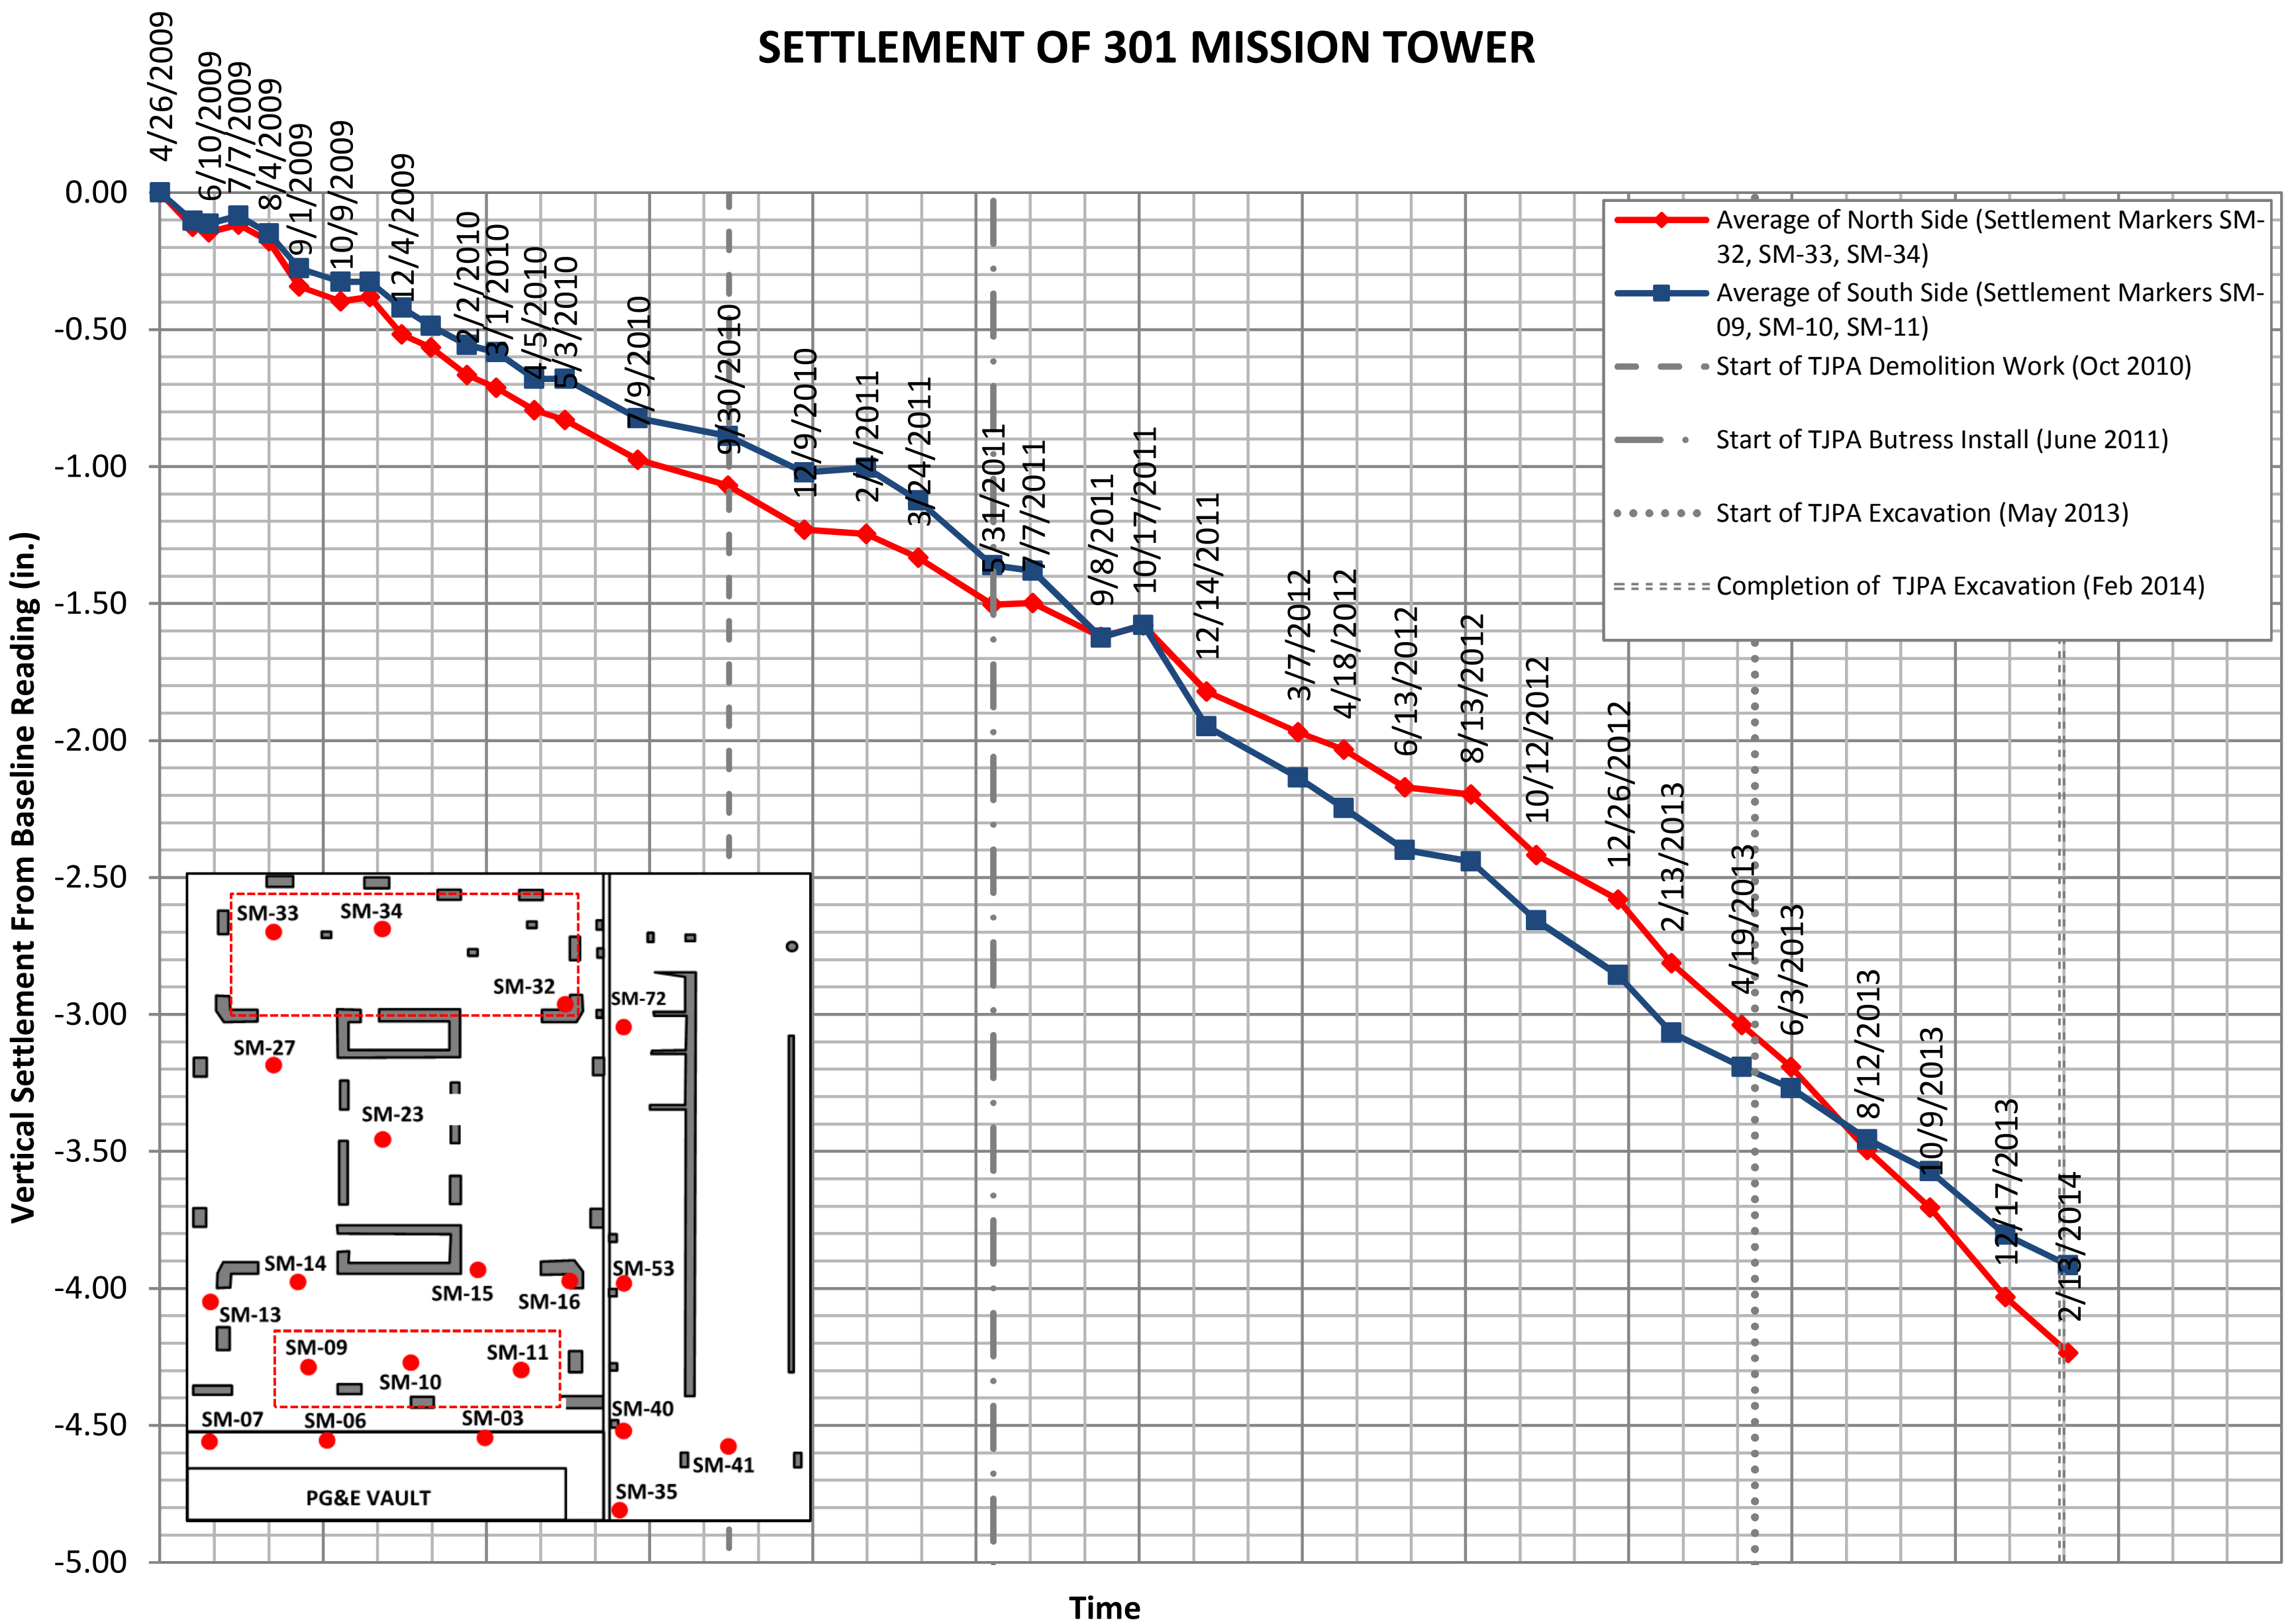
Figure 4

Settlement of the North vs. South Side of the Foundation (Figure 4)
Before Transbay buttress installation began, the north Side was settling more than the south side, but starting in August, 2011 the south side was settling more than the north side. This seems to indicate that the Transbay buttress installation activities affected the overall direction of tilt. Beginning in June 2013, the north side is again showing a greater amount of settlement than the south side. This change is coincidental with the completion of the Transbay buttress installation, along with the start of excavation at both the Transbay site and the 350 Mission site.

It should also be noted that this figure indicates differential movement across the foundation in the north-south direction causing a slight tilt to the building. If this movement was larger, damage to the structure can occur. In general the tilt, while measurable, is generally small and not of the type which would cause damage.

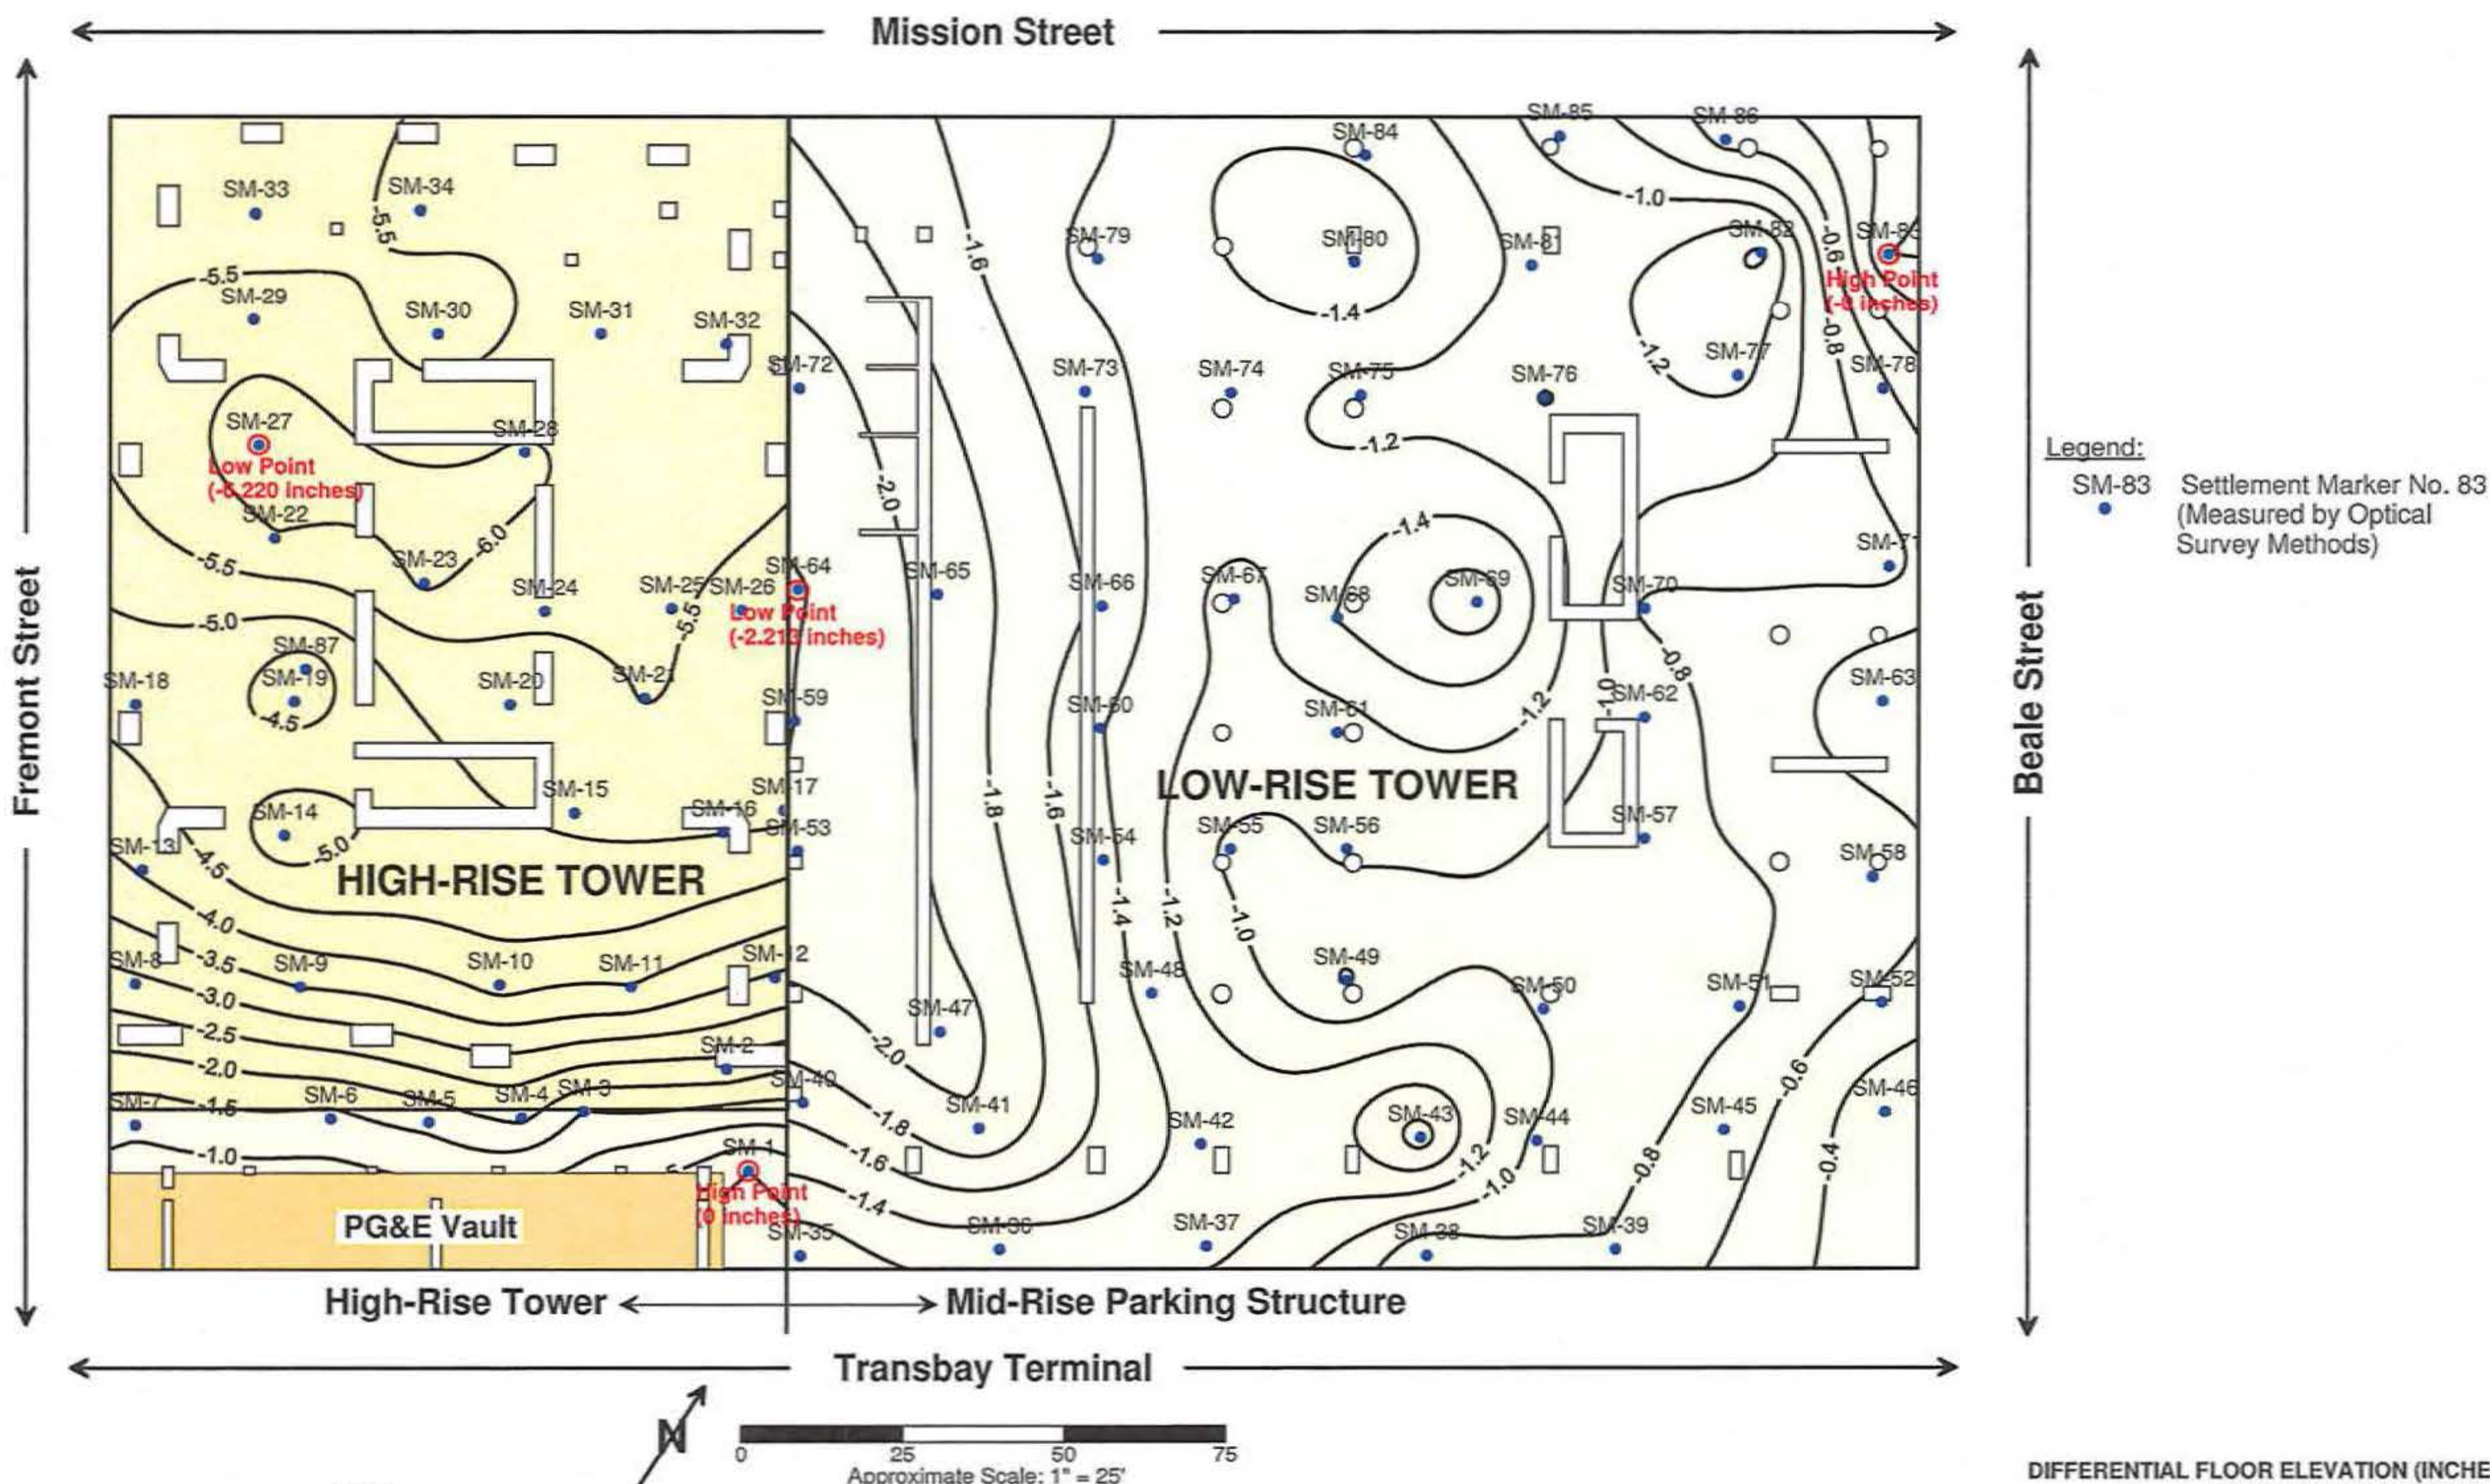
PLATE 1

Contours represent differential elevation, in inches, between the highest point and all other points taken on February 4, 2011.
