File No. 160975 **Committee Item No.** 7
Board Item No. ________

AGENDA PACKET CONTENTS LIST

TALL BUILDINGS SAFETY STRATEGY

October 2018

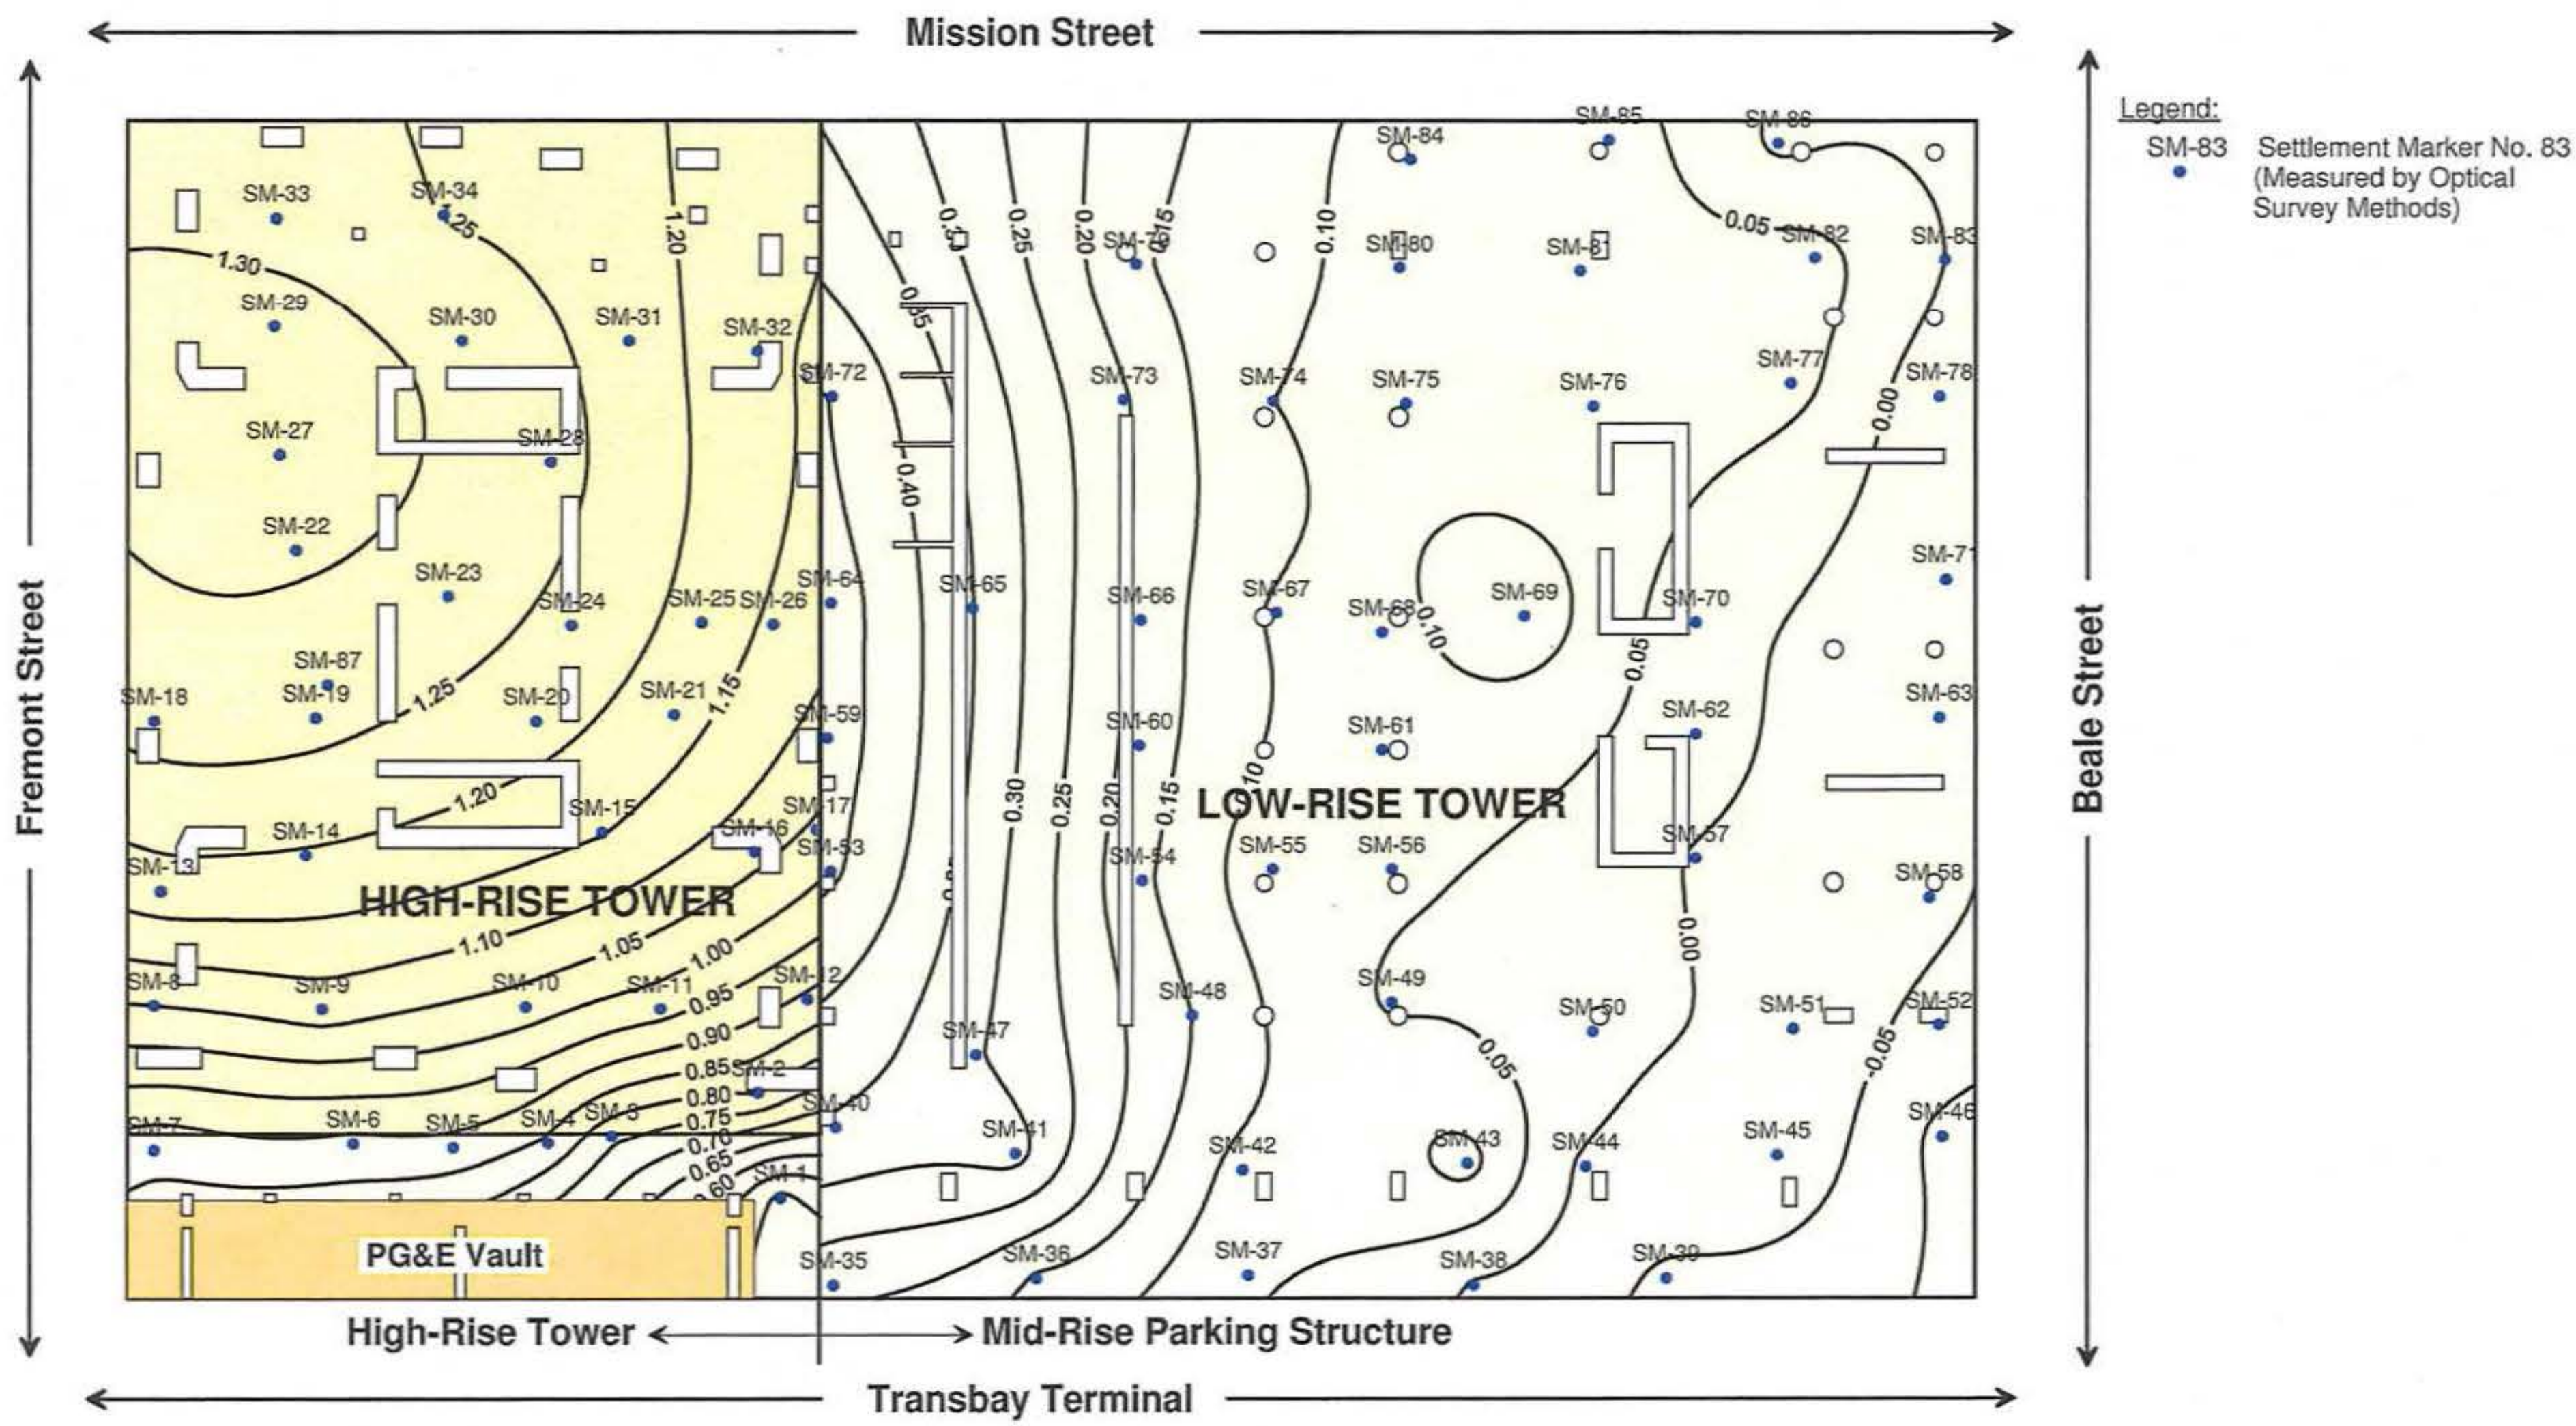
PLATE 2

Contours represent elevation change, in inches, between Baseline survey (April 30, 2009) and readings taken on February 4, 2011.

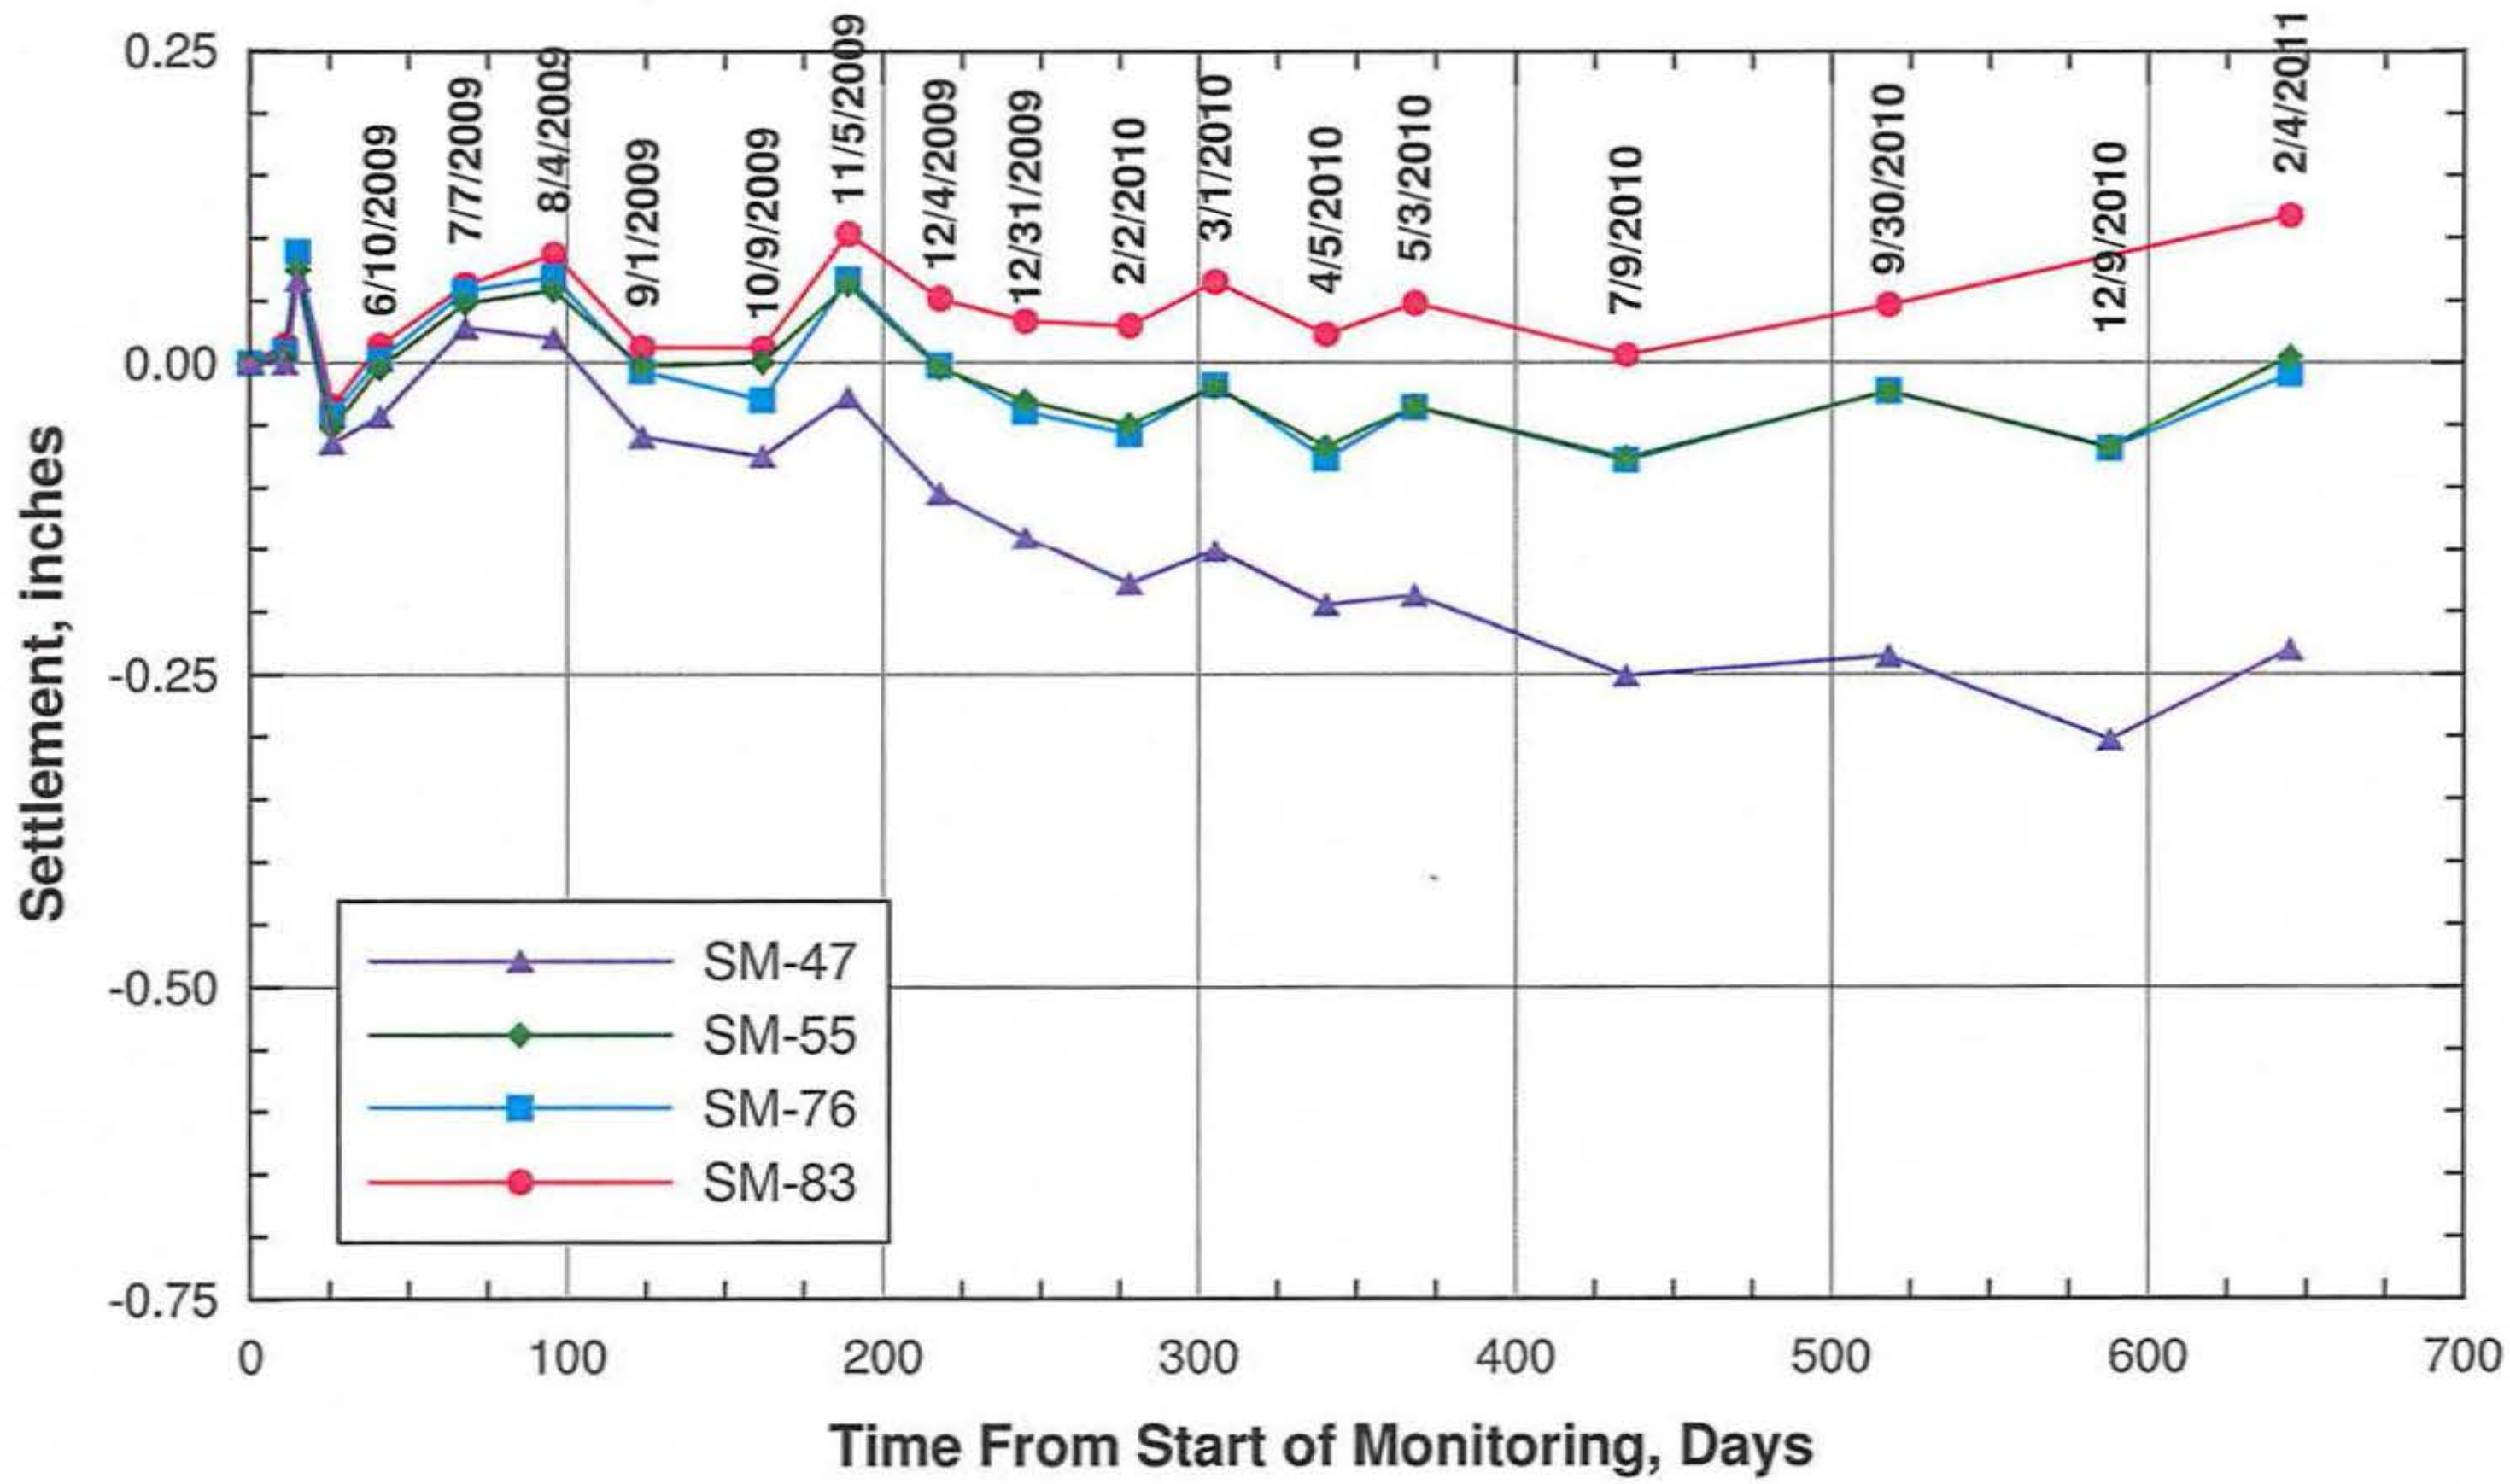
PLATE 4

The information shown on Plate 4 indicates that the rate of settlement of the points has changed over time. In particular we observed different rates of movement during three distinct time intervals. The intervals are: 30 April 2009 to 3 May 2010; 3 May 2010 to 24 March 2011;

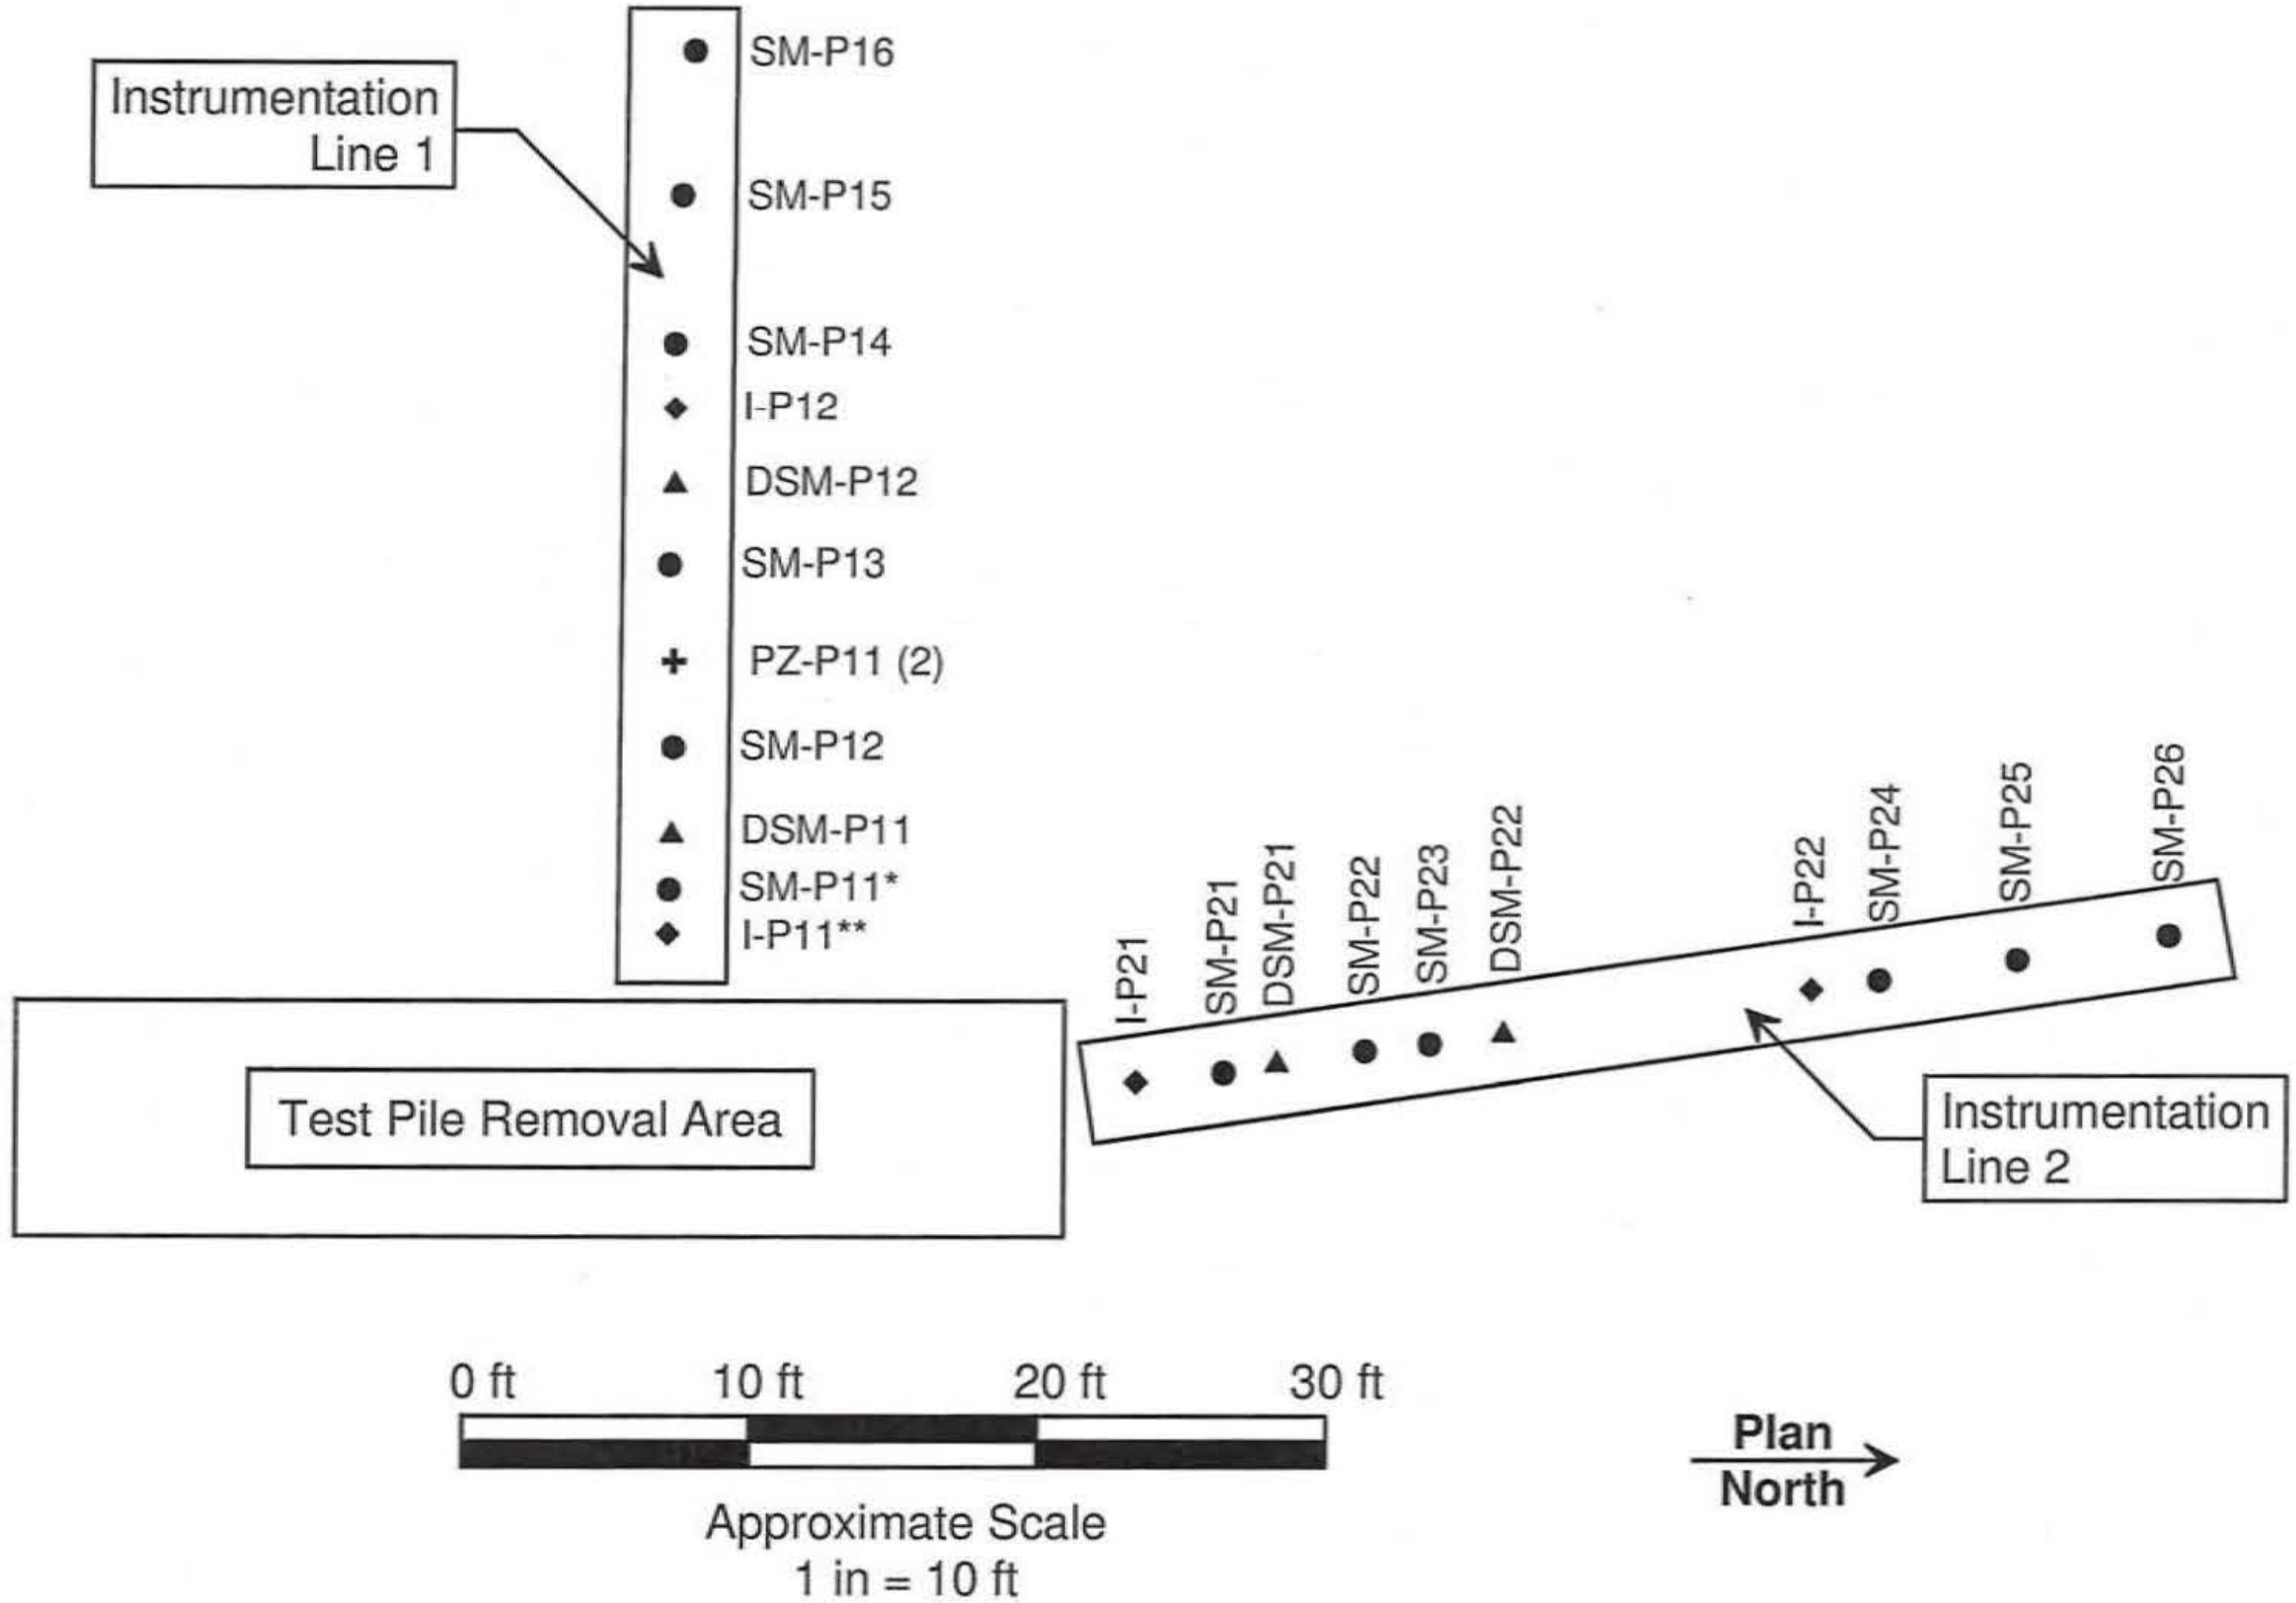
PLATE 1

*SM-P11 was destroyed due to the excavation for the pile removal on 4/4/2011.
**I-P11 was damaged due to the excavation for the pile removal on 4/4/2011.
This inclinometer was uncovered about 6 feet below original grade and recovered.
A new baseline was recorded in the afternoon of 4/4/2011 once it was repaired.

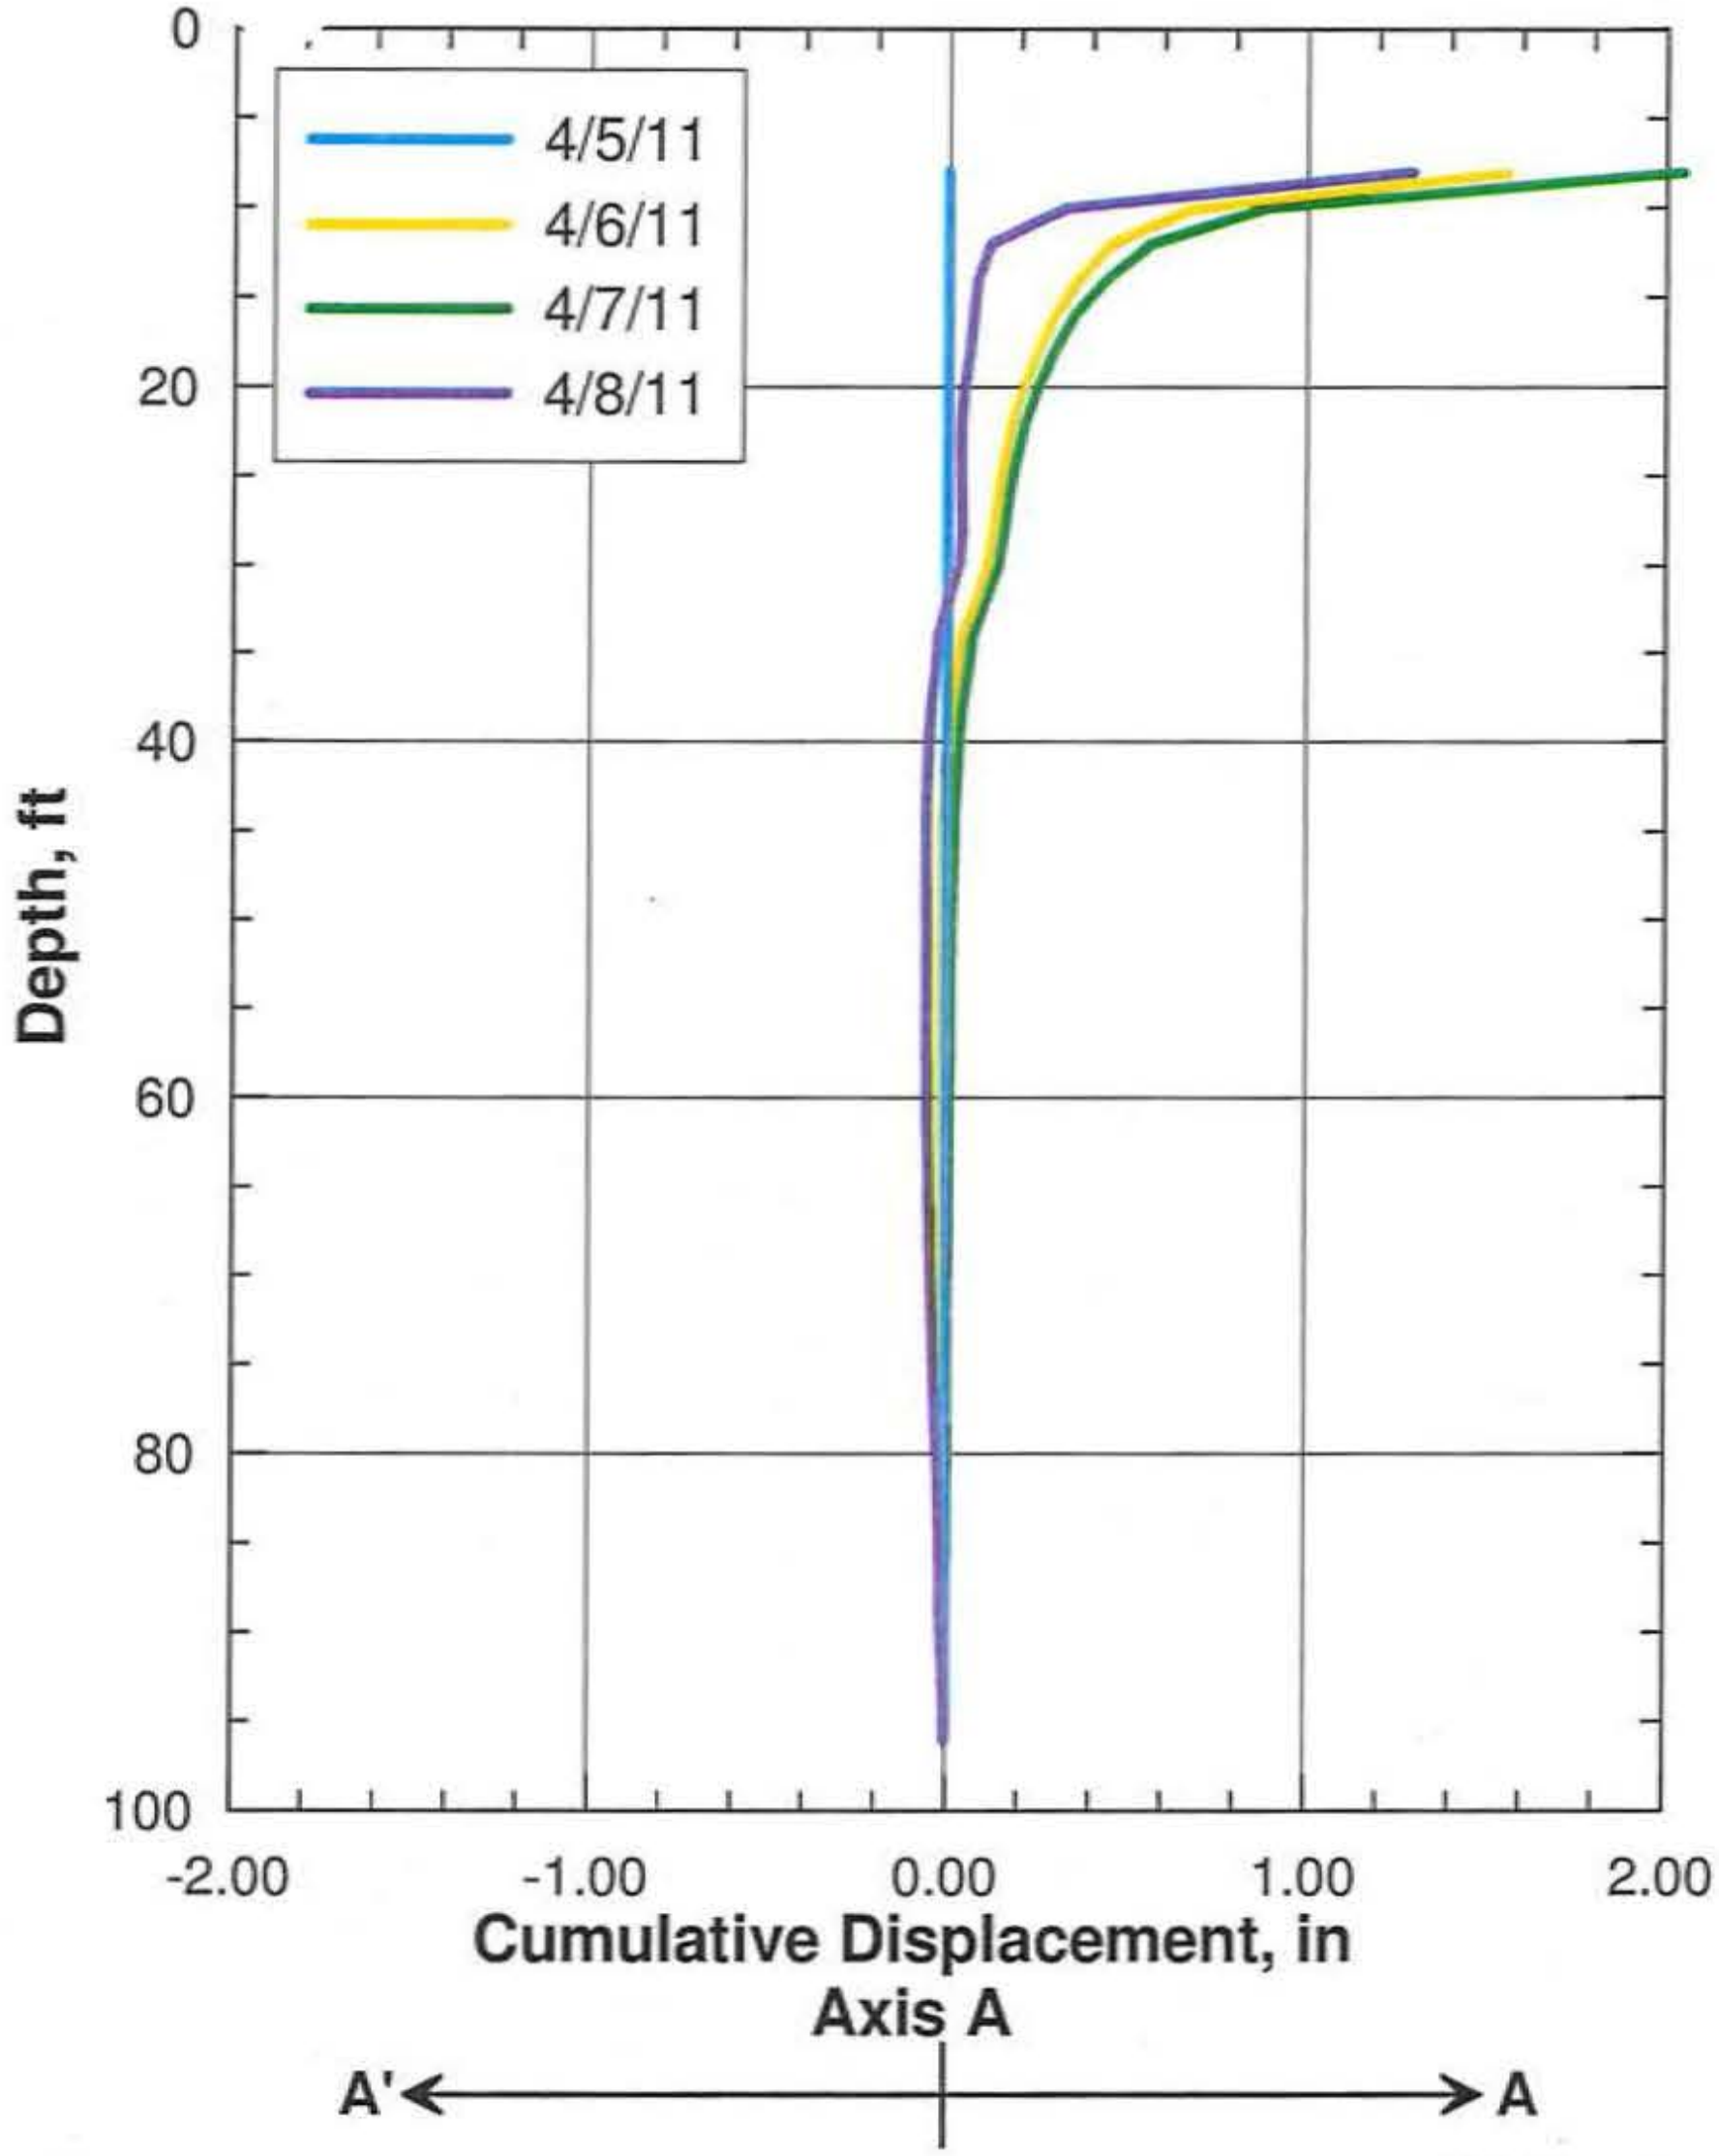
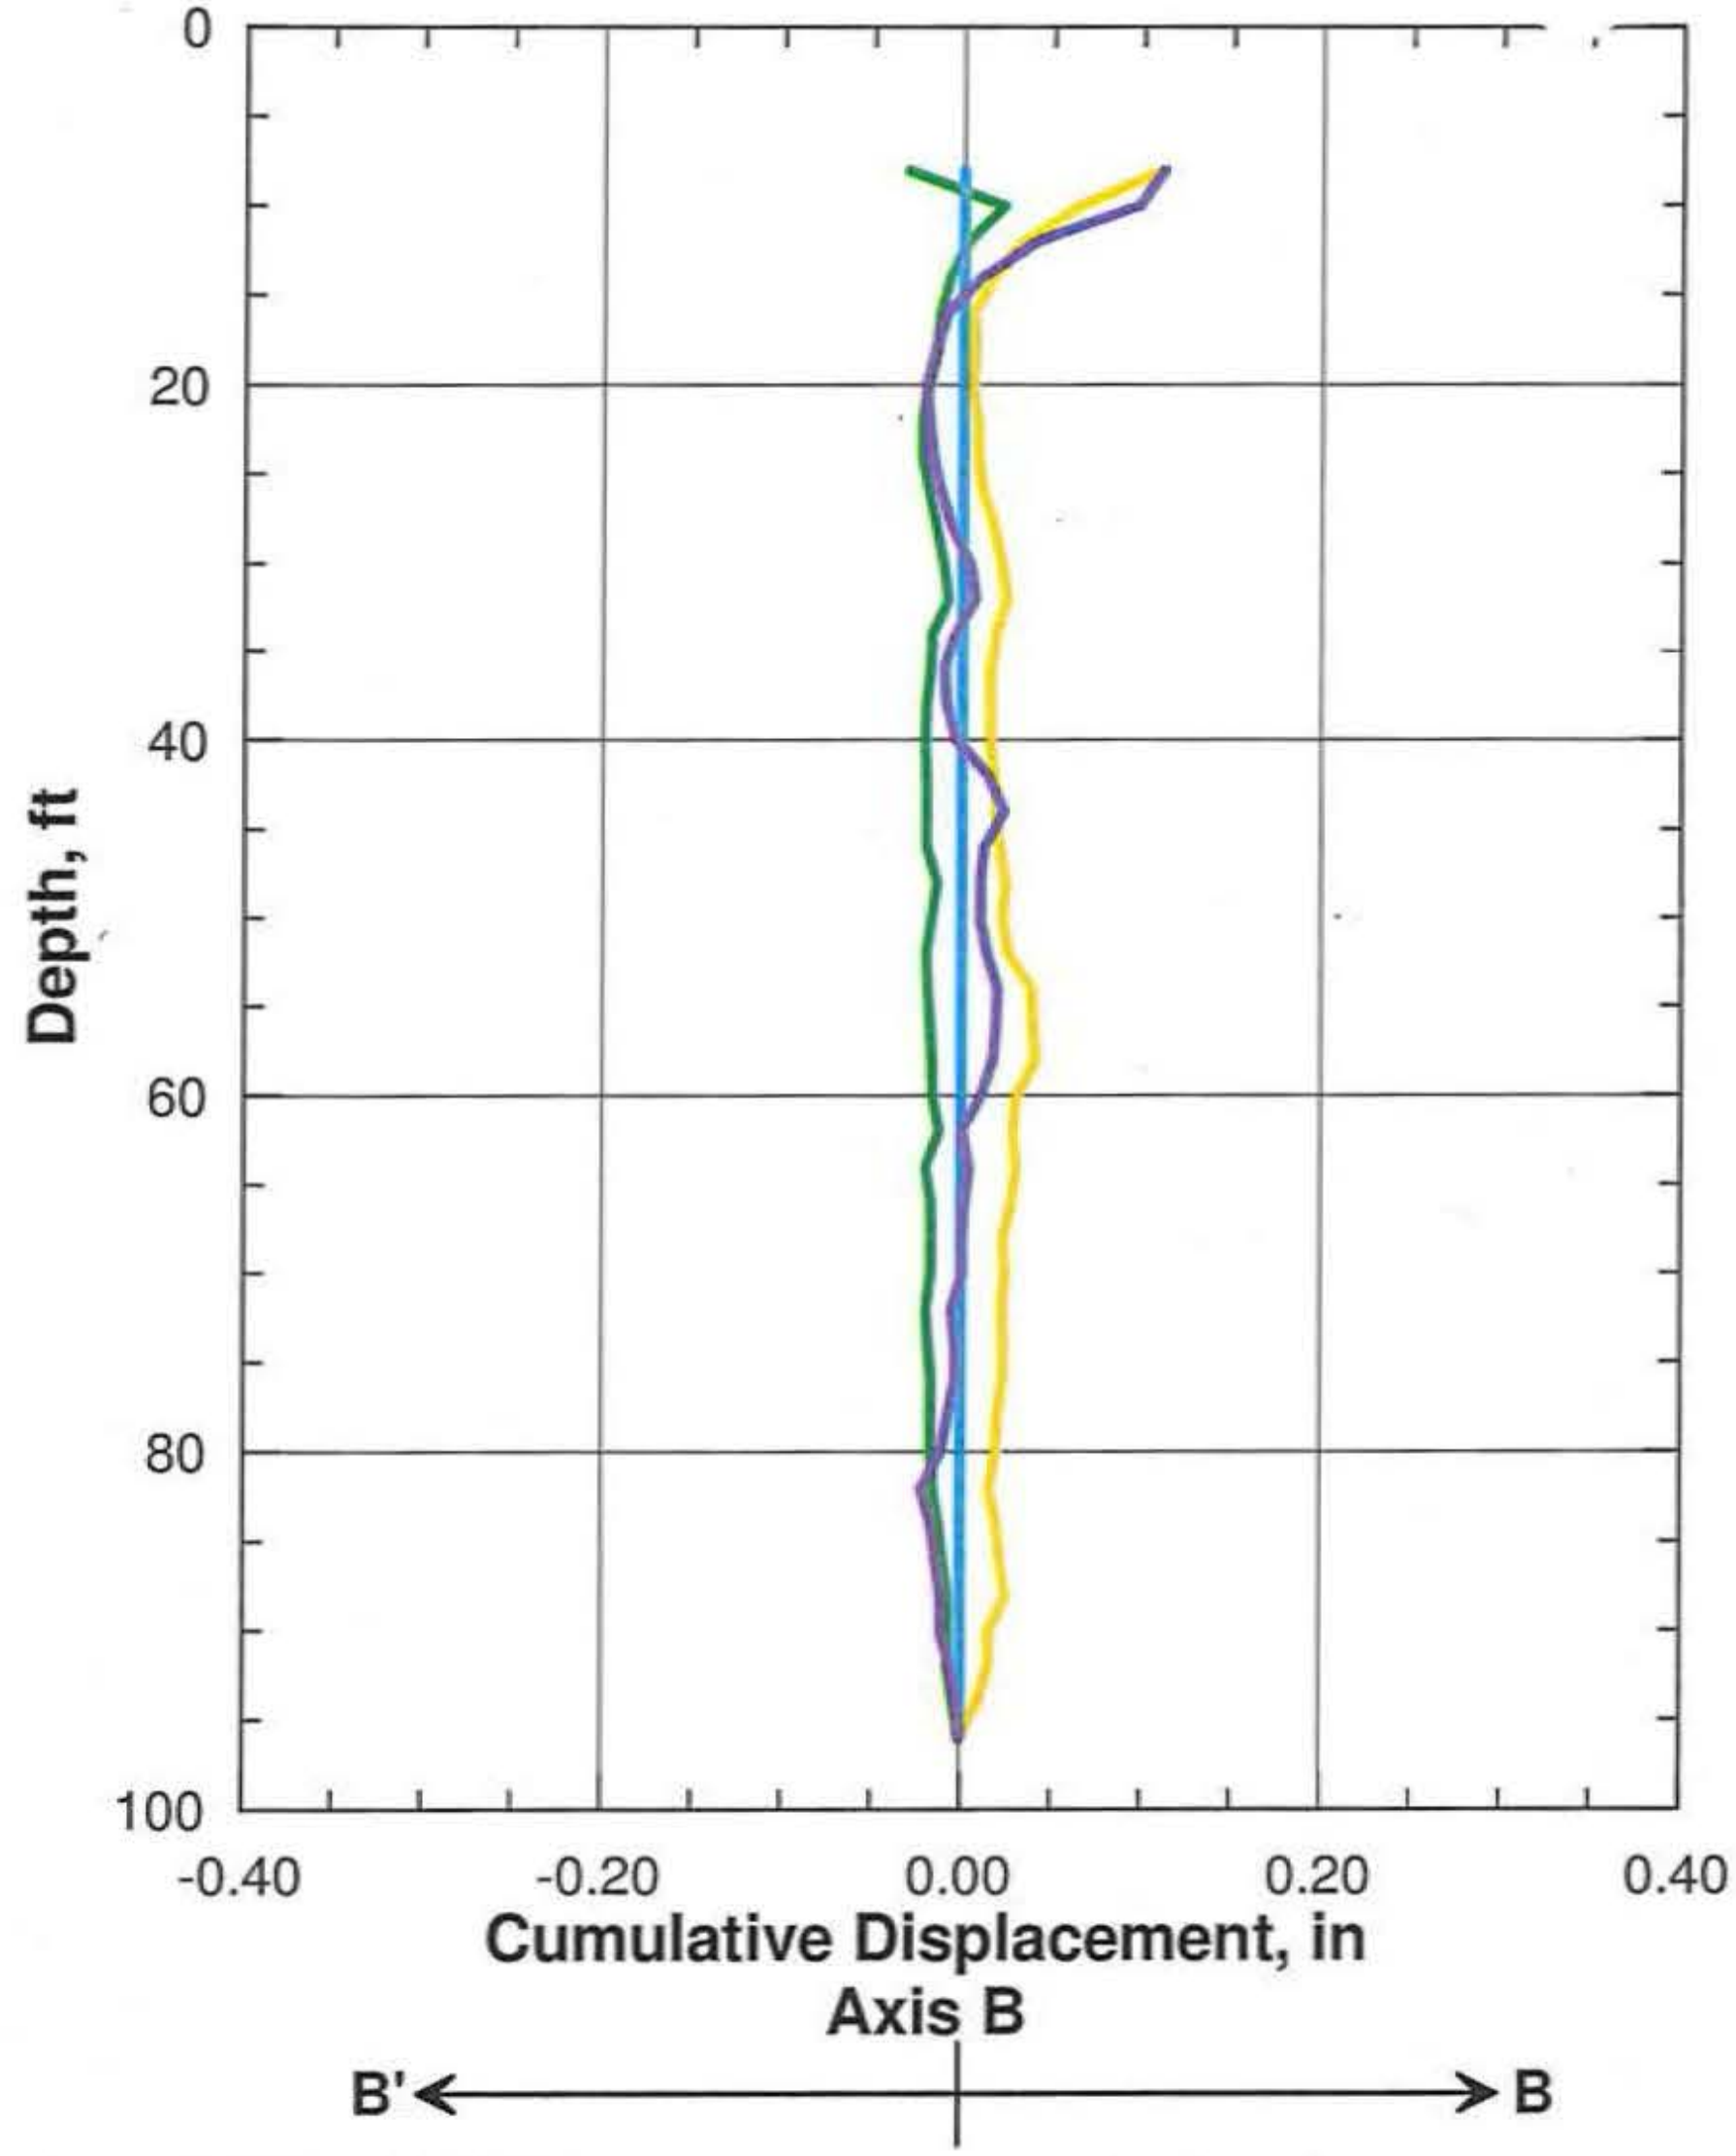
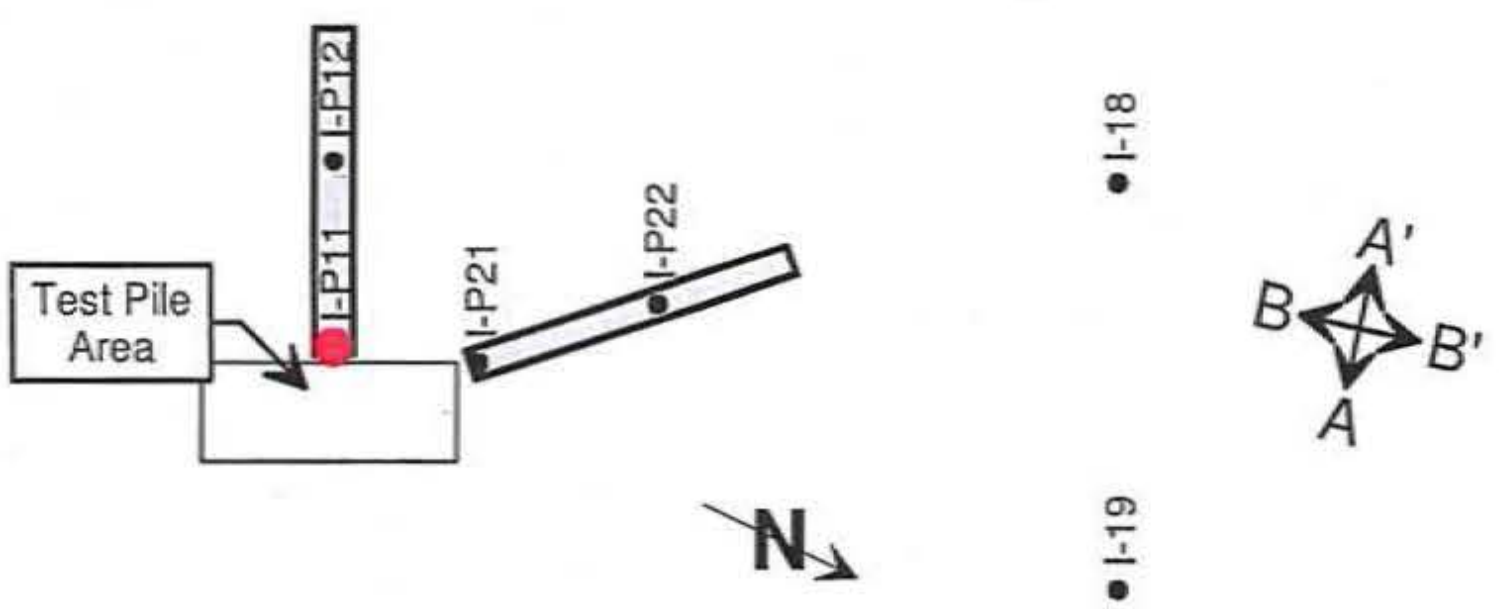
PLATE 4-1

NOTE: Inclinometer was damaged during work on 4/5/11. It collasped about 7 feet below the surface.
The inclinometer was dug out and cut-off. A new baseline reading was taken after it was fixed on 4/5/11.
Large movements may be from it not being protected at the surface and sloughing ground due to excavation for pile removal.

INCLINOMETER DATA FOR PILE EXTRACTION
TEST SITE INCLINOMETER READING I-P11
