File No. 160975 **Committee Item No.** 7
Board Item No. ________

AGENDA PACKET CONTENTS LIST

TALL BUILDINGS SAFETY STRATEGY

October 2018

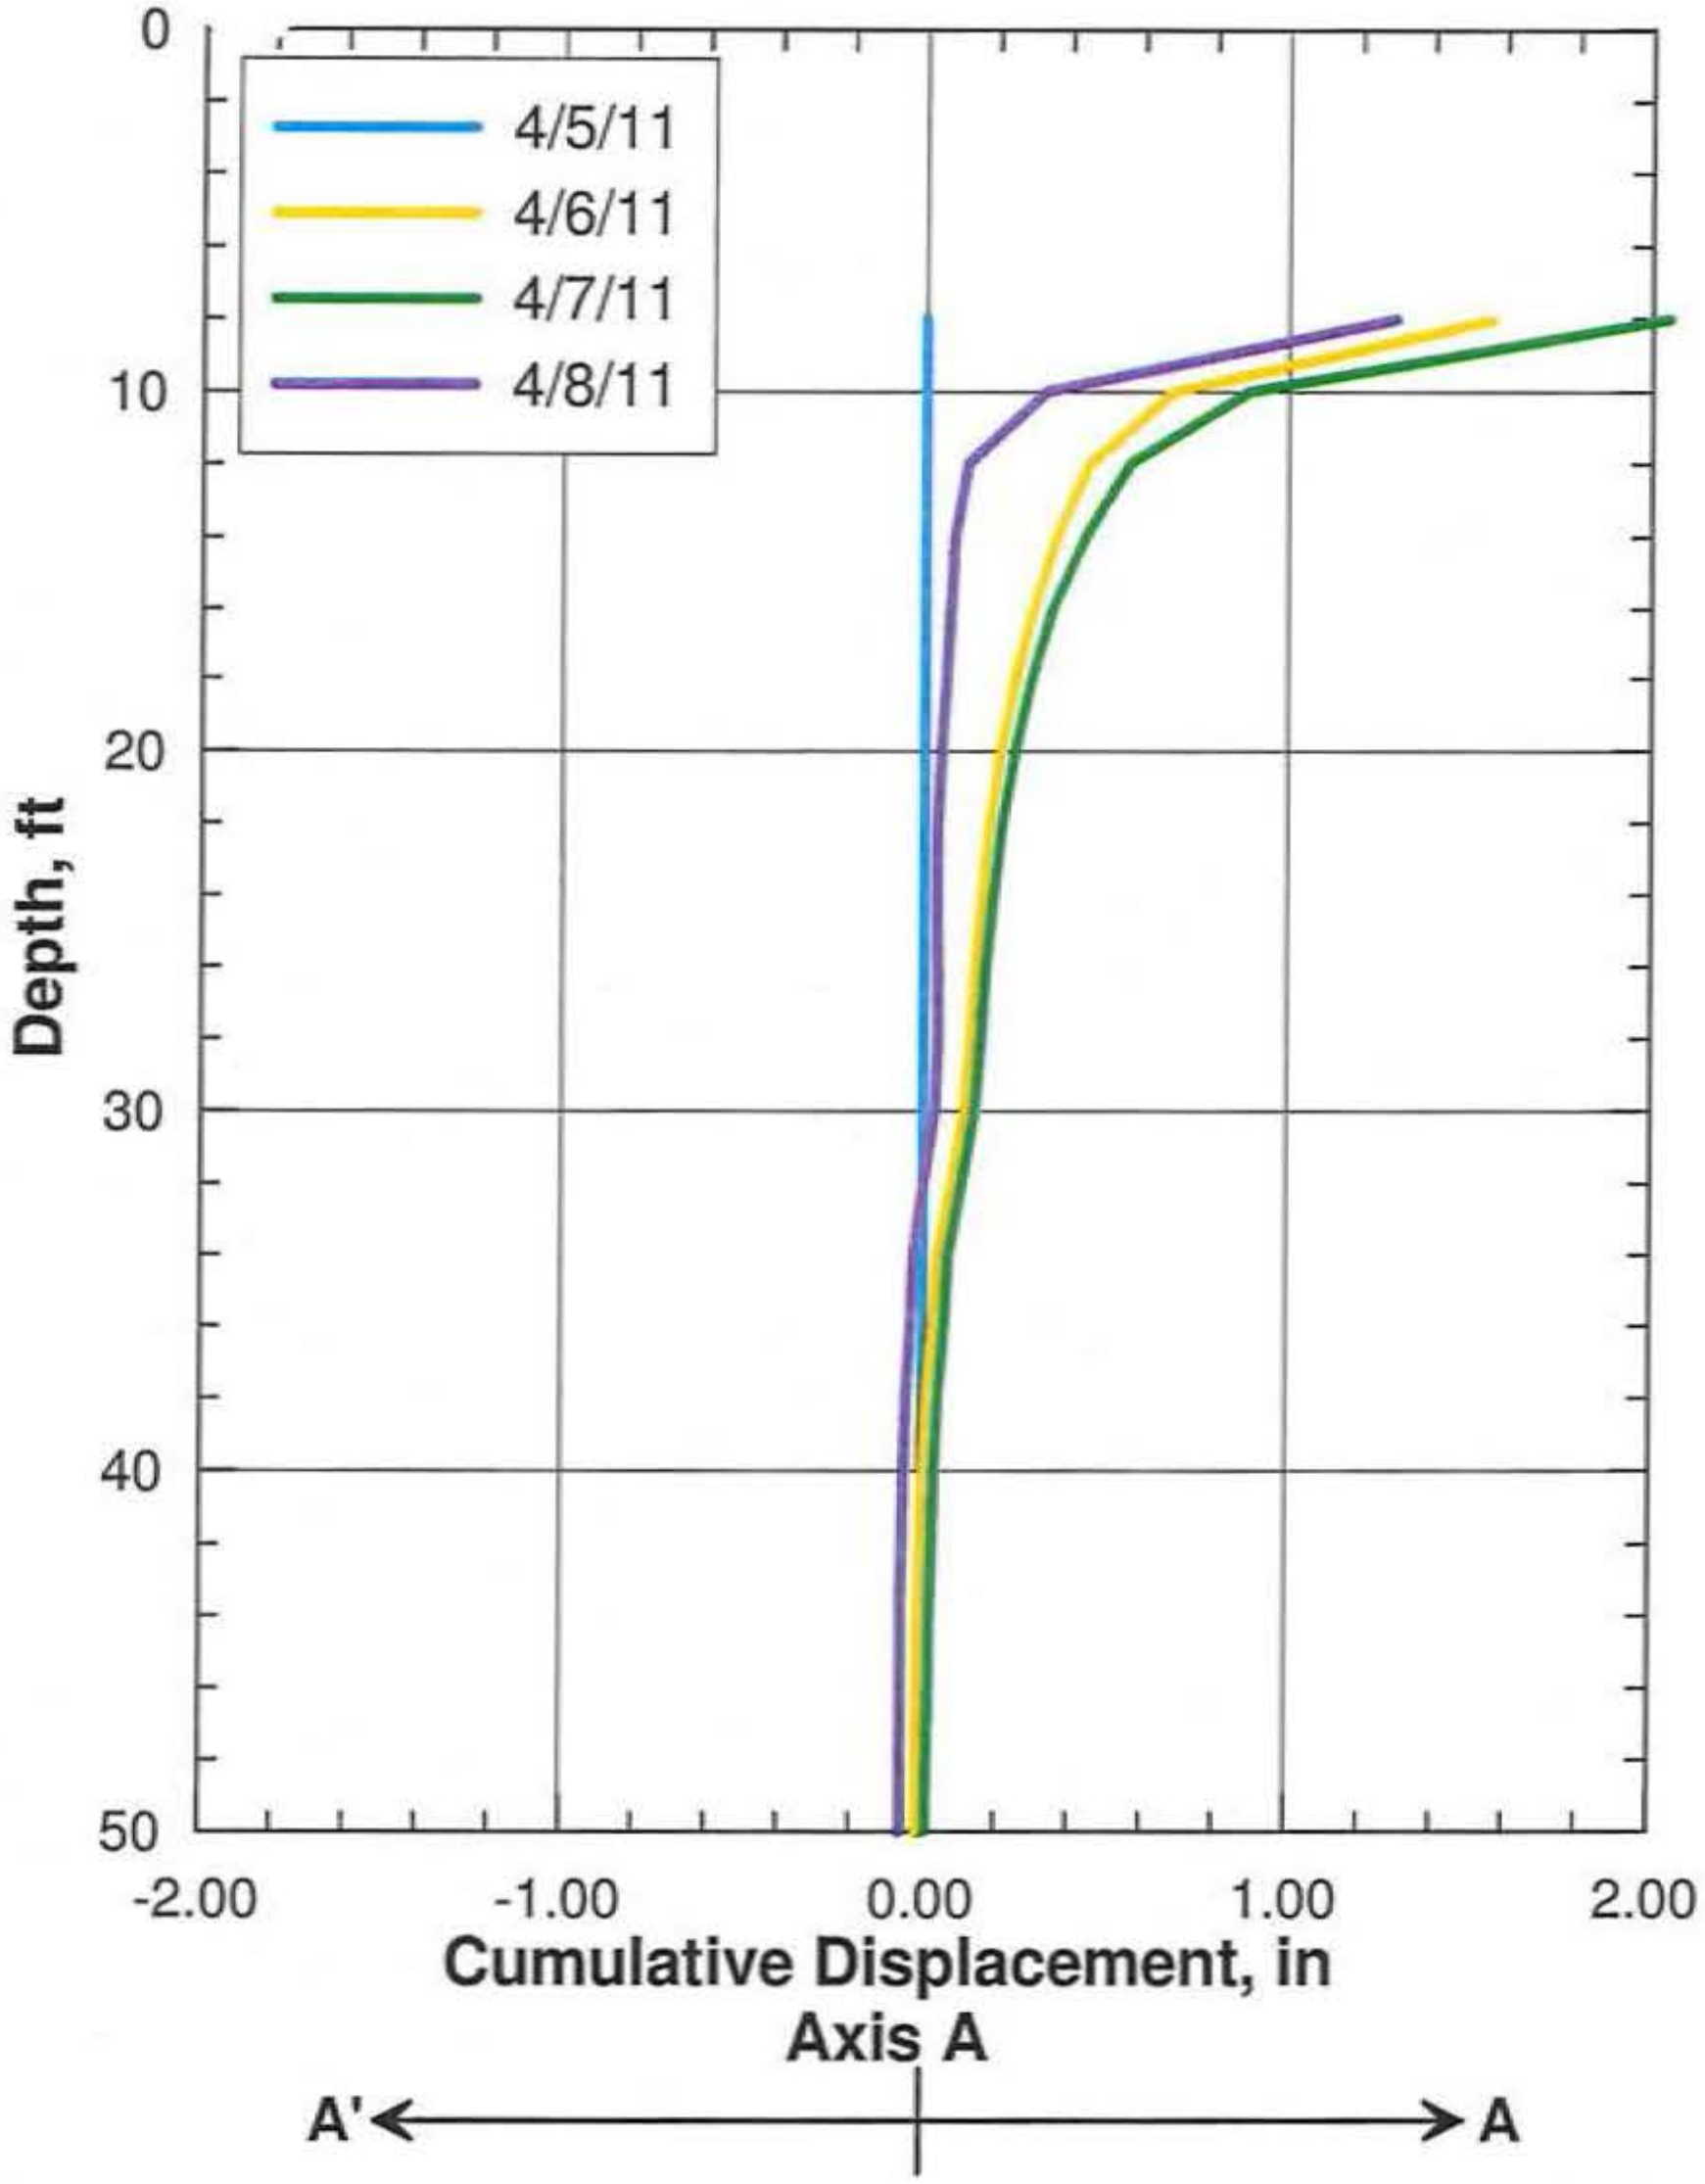
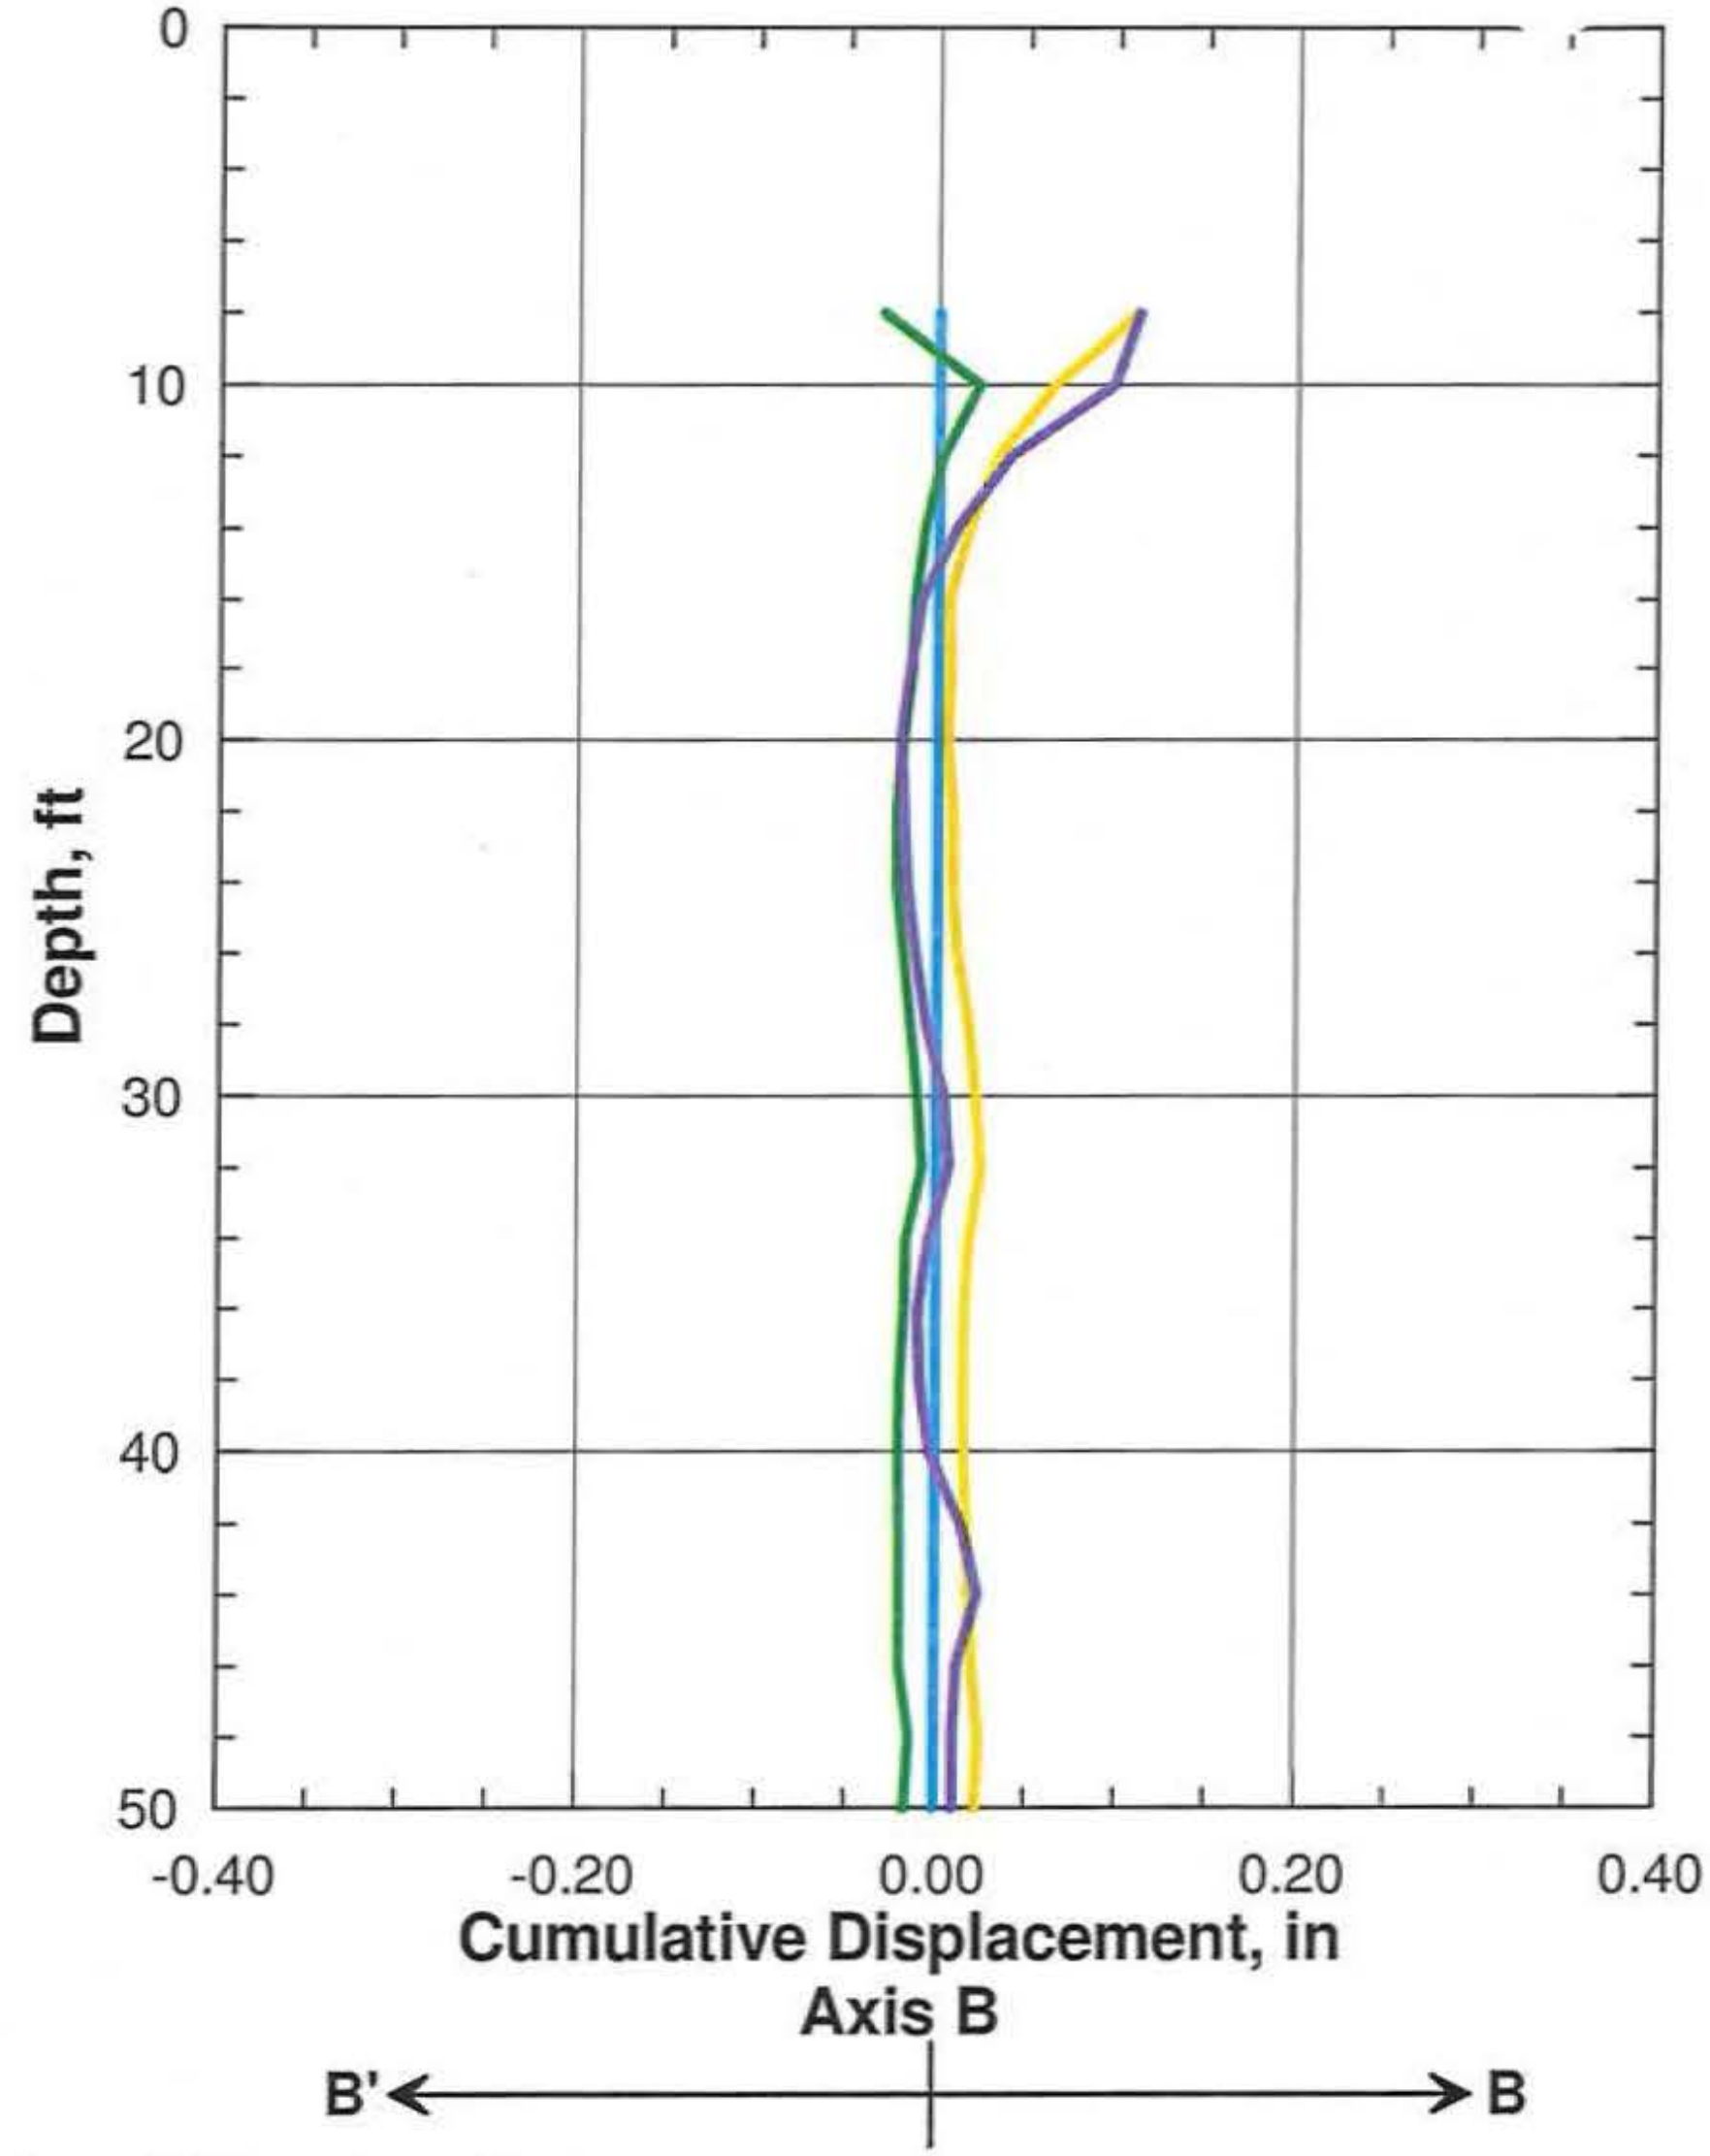
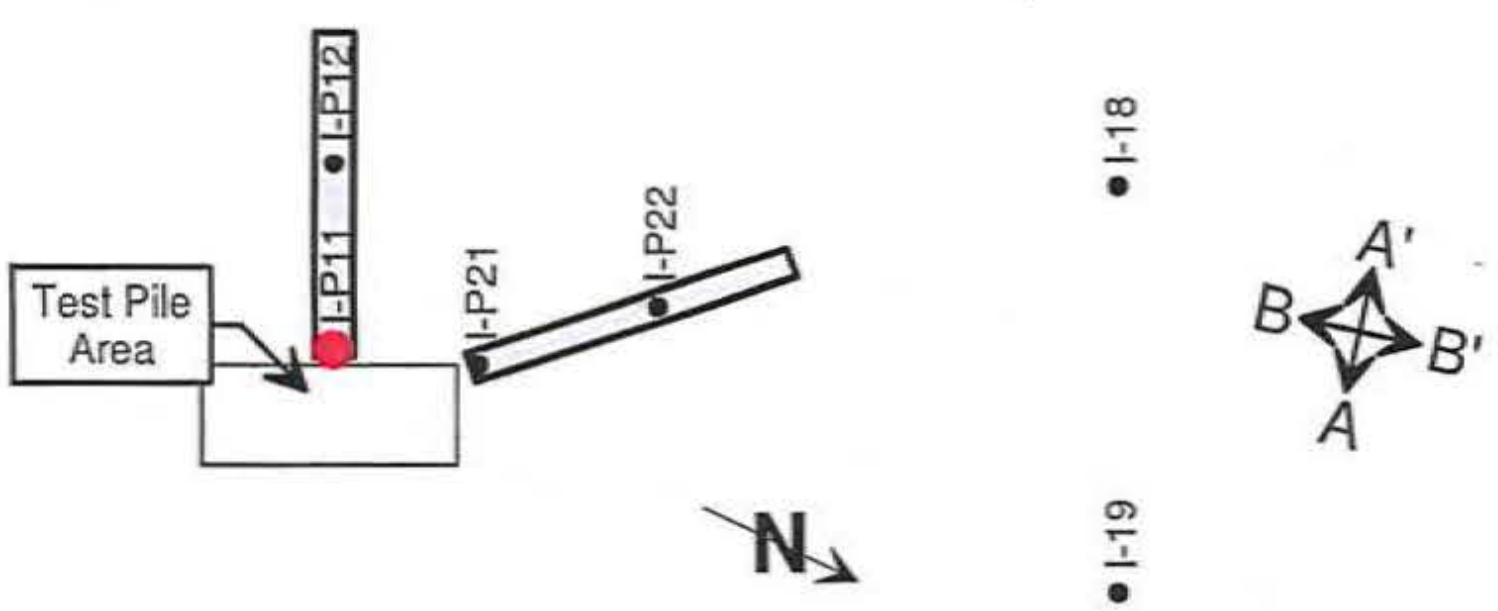
PLATE 4-2

NOTE: Inclinometer was damaged during work on 4/5/11. It collasped about 7 feet below the surface.
The inclinometer was dug out and cut-off. A new baseline reading was taken after it was fixed on 4/5/11.
Large movements may be from it not being protected at the surface and sloughing ground due to excavation for pile removal.

INCLINOMETER DATA FOR PILE EXTRACTION TEST SITE INCLINOMETER READING I-P11: TOP 50 FEET OF THE INCLINOMETER ONLY

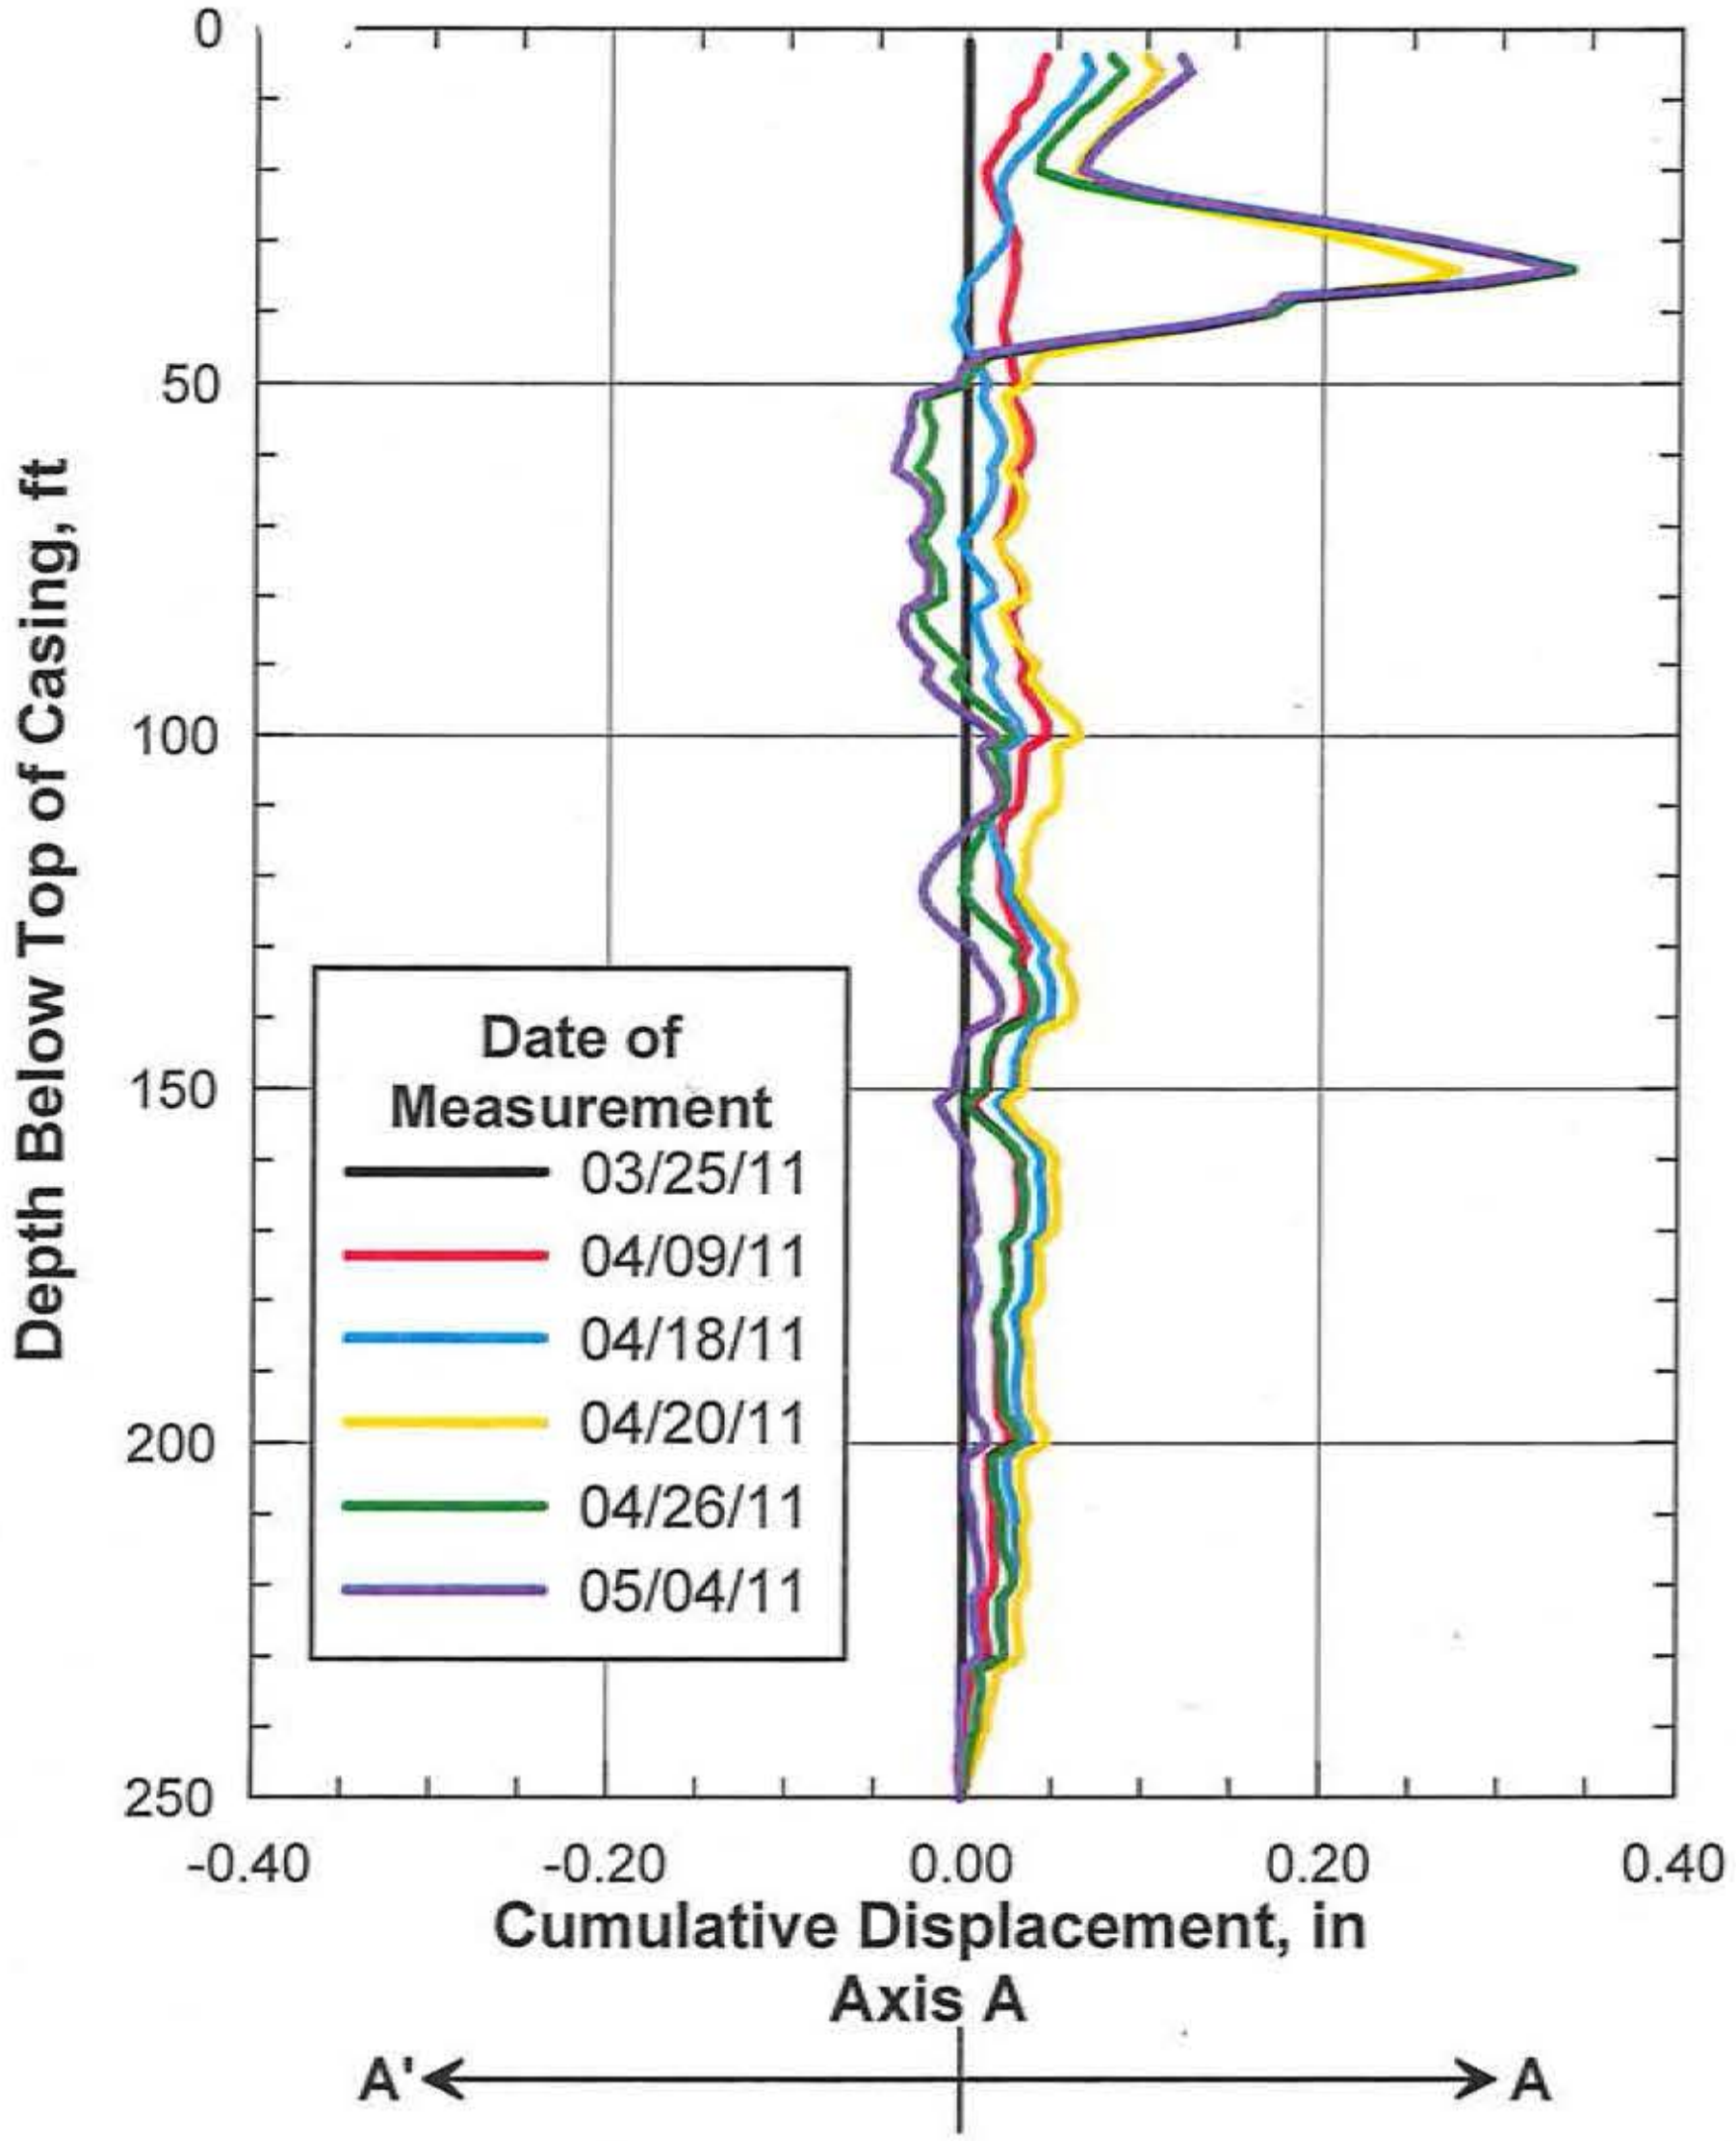
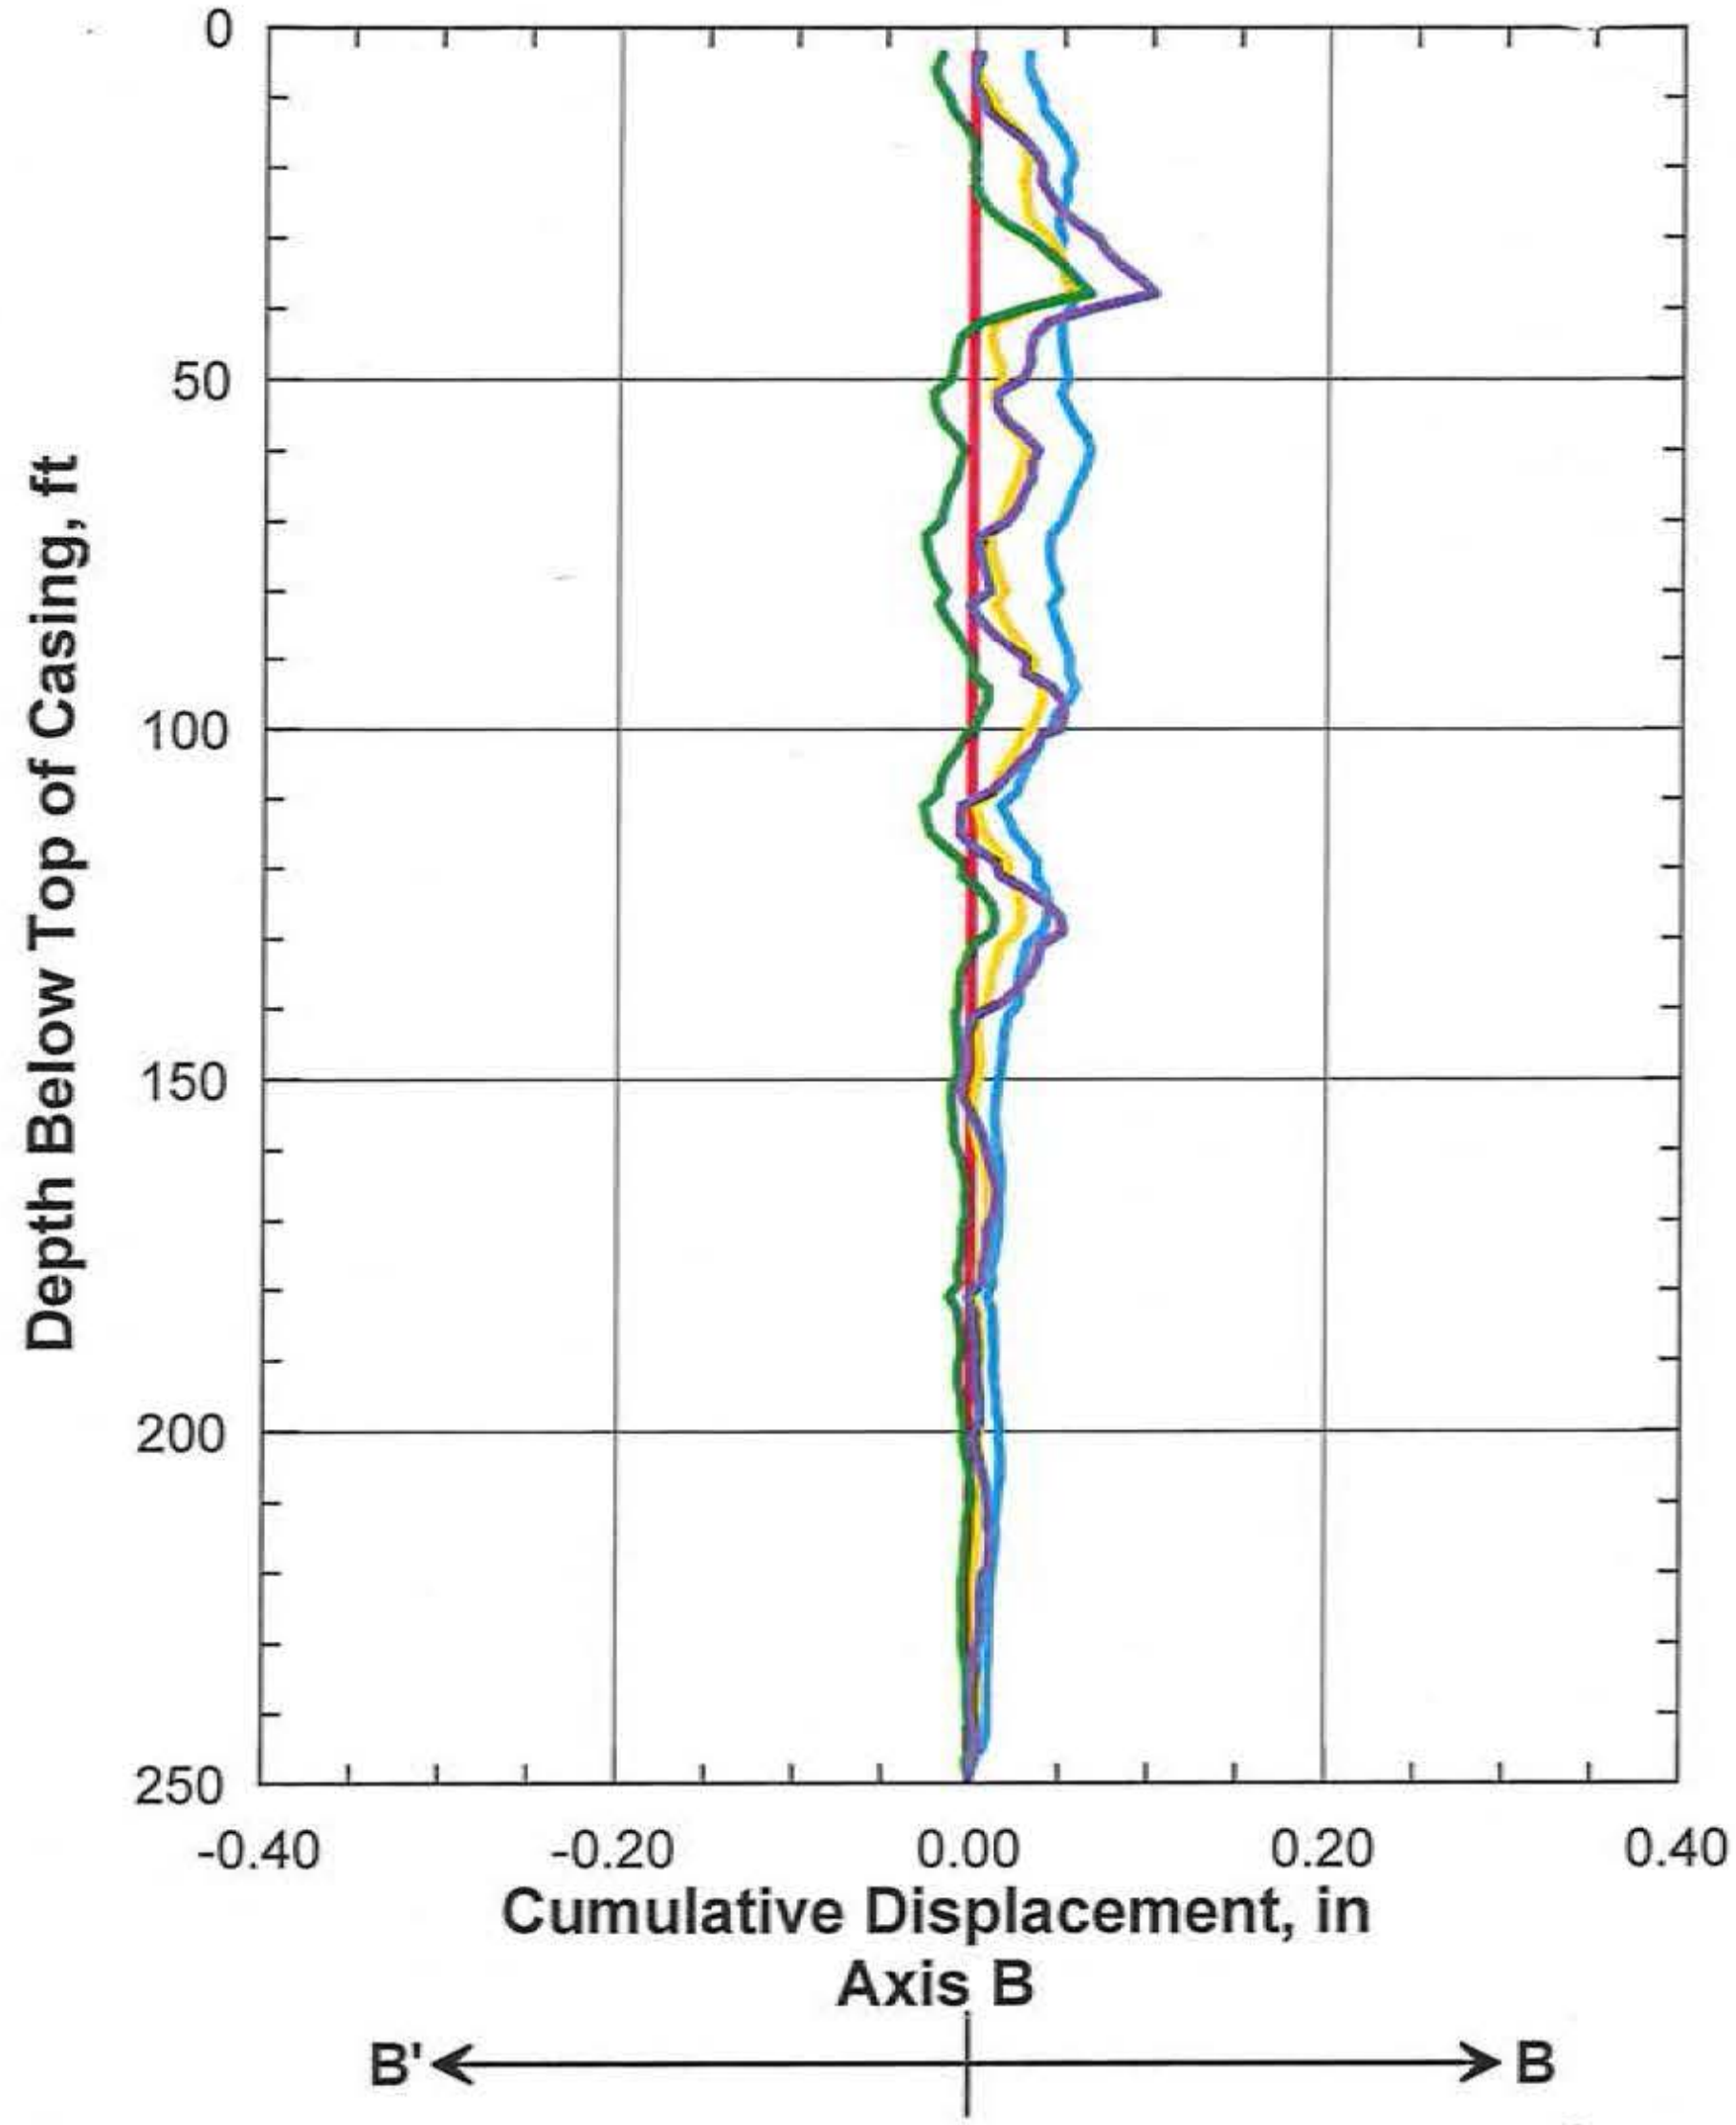
PLATE 1-1

Plates 1-1 and 2-1 illustrate the lateral deflection measured in each inclinometer. The movements are measured over two axes described as A-A' and B-B'. The orientations of these axes are shown in the small figure at the bottom of the plate.

Overall, the lateral movements recorded to date are within the tolerances prescribed in the Specification.

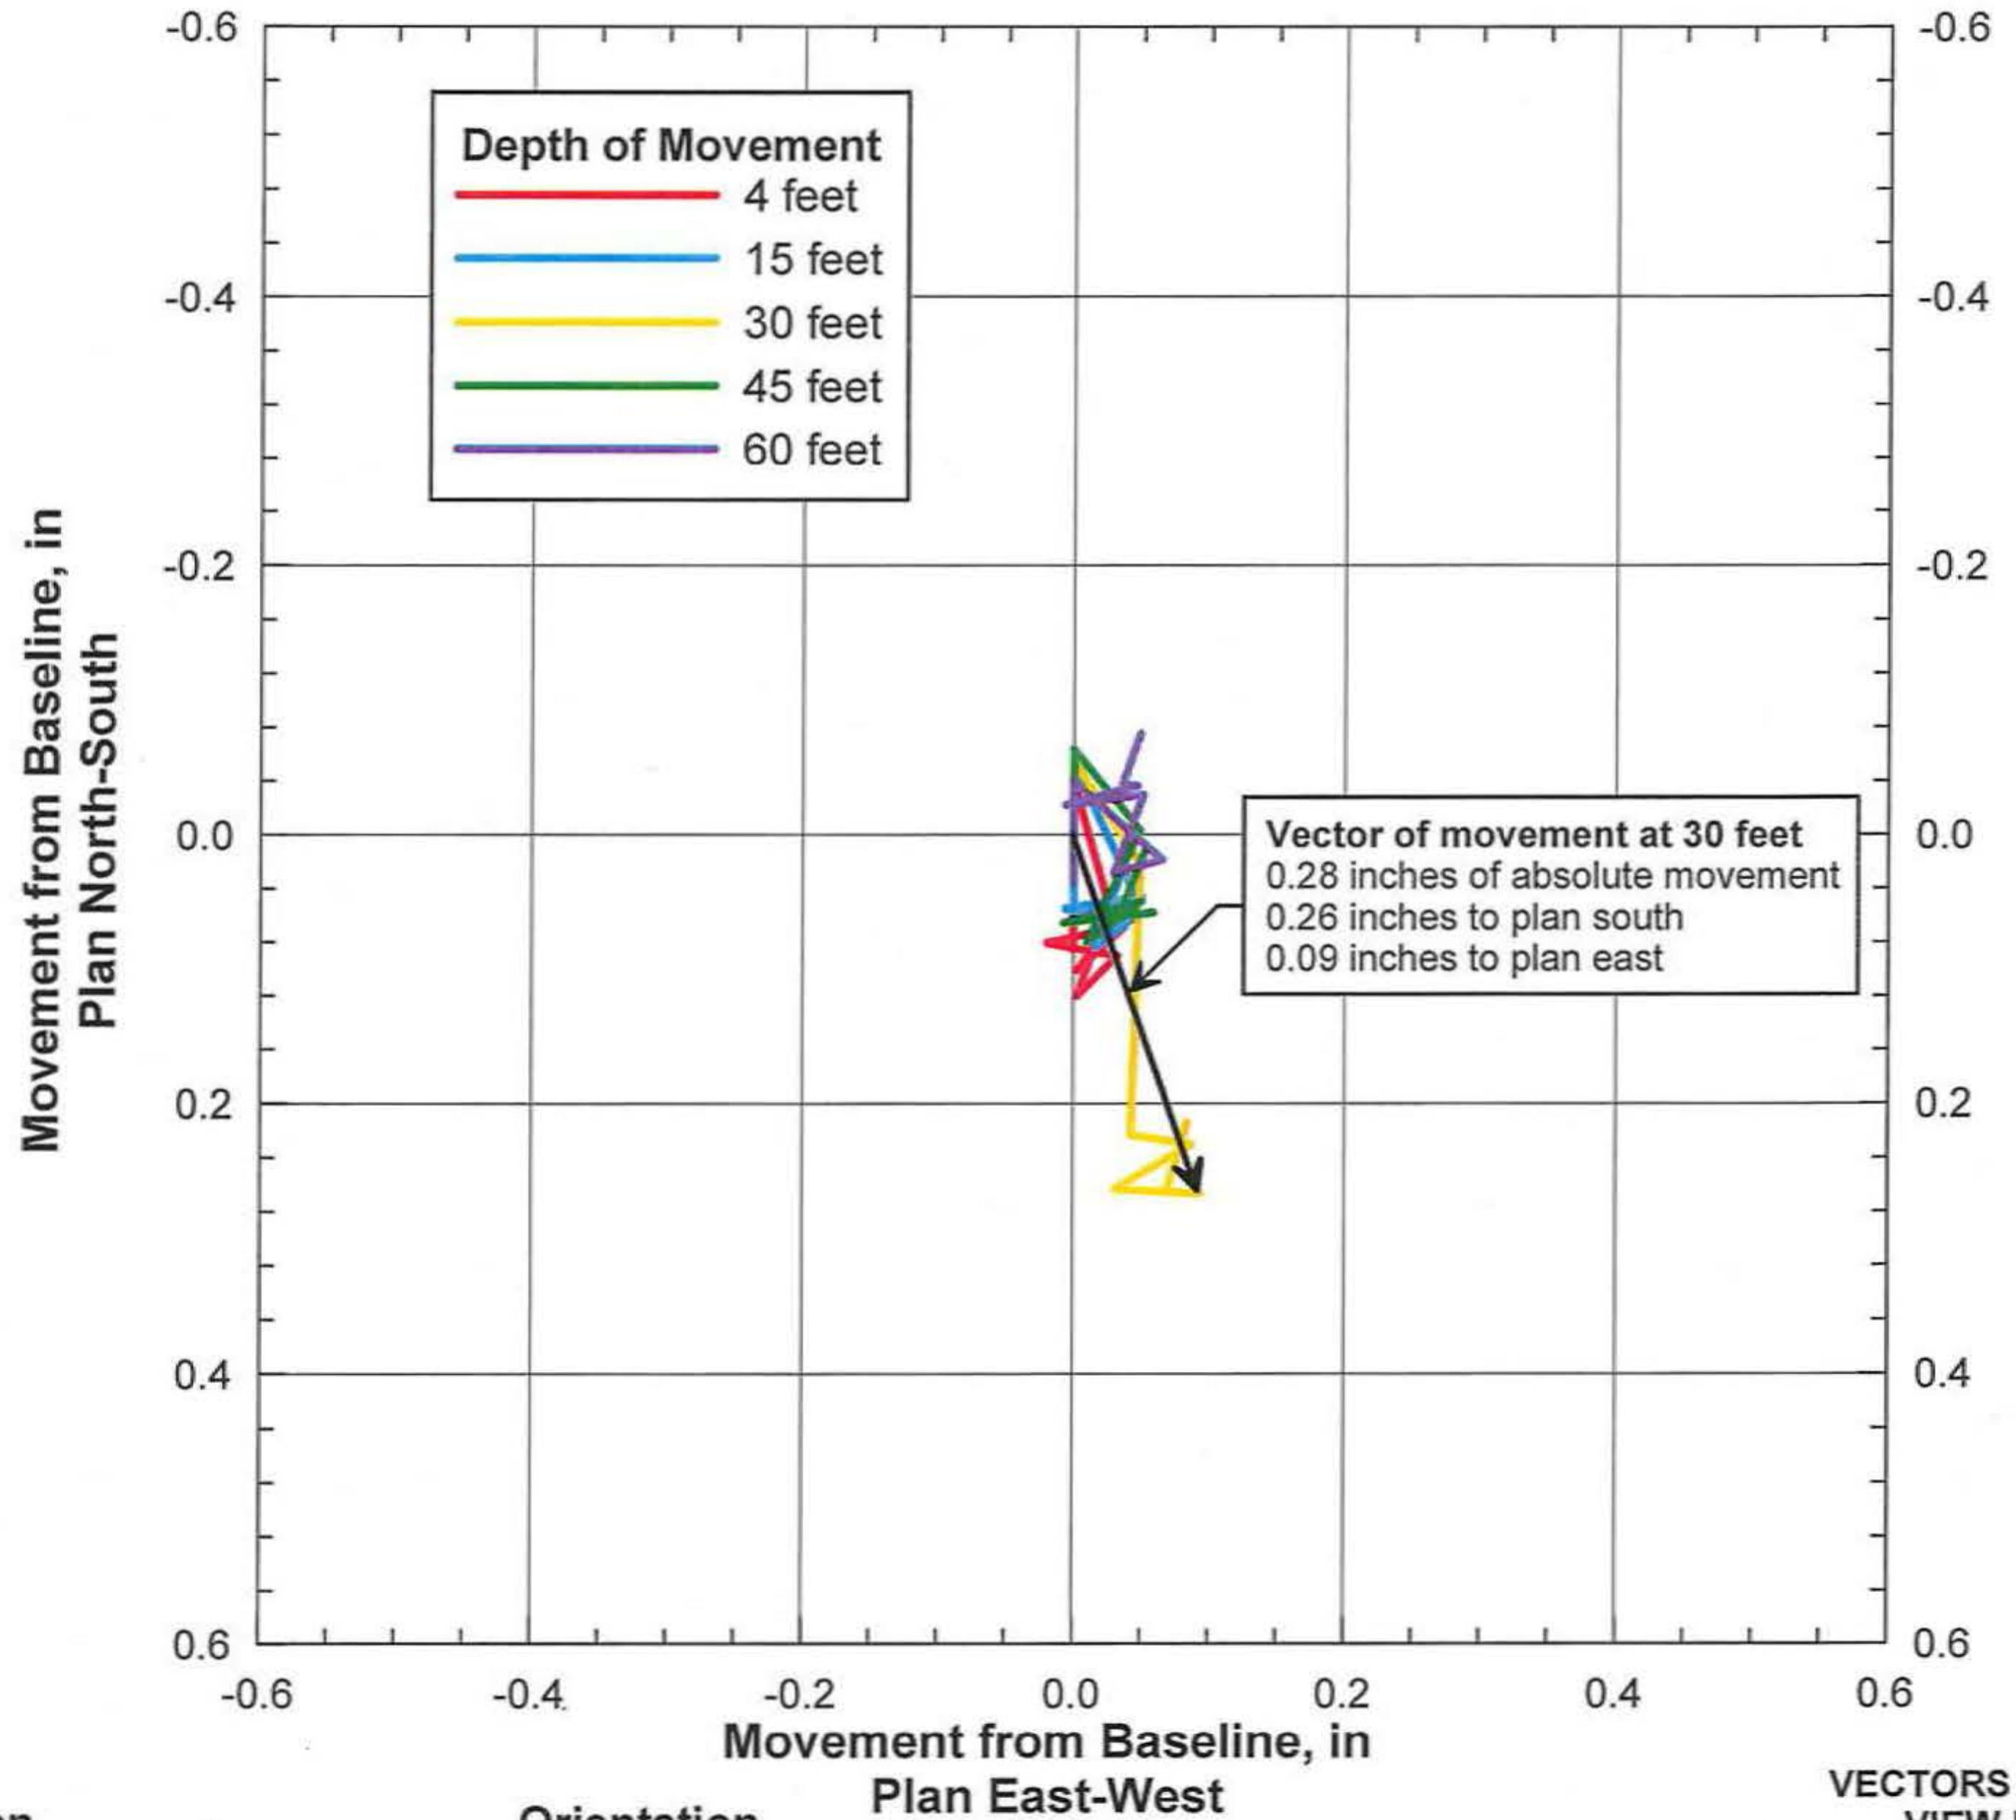
PLATE 1-2

Plates 1-2 and 2-2 show two-dimensional vectors of movement at different depths. These vectors represent the movement as viewed from above over time. Each curve begins at the center or baseline reading and move along the line drawn until the final location which is represented as the end of the line.
