File No. 160975 **Committee Item No.** 7
Board Item No. ________

AGENDA PACKET CONTENTS LIST

TALL BUILDINGS SAFETY STRATEGY

October 2018

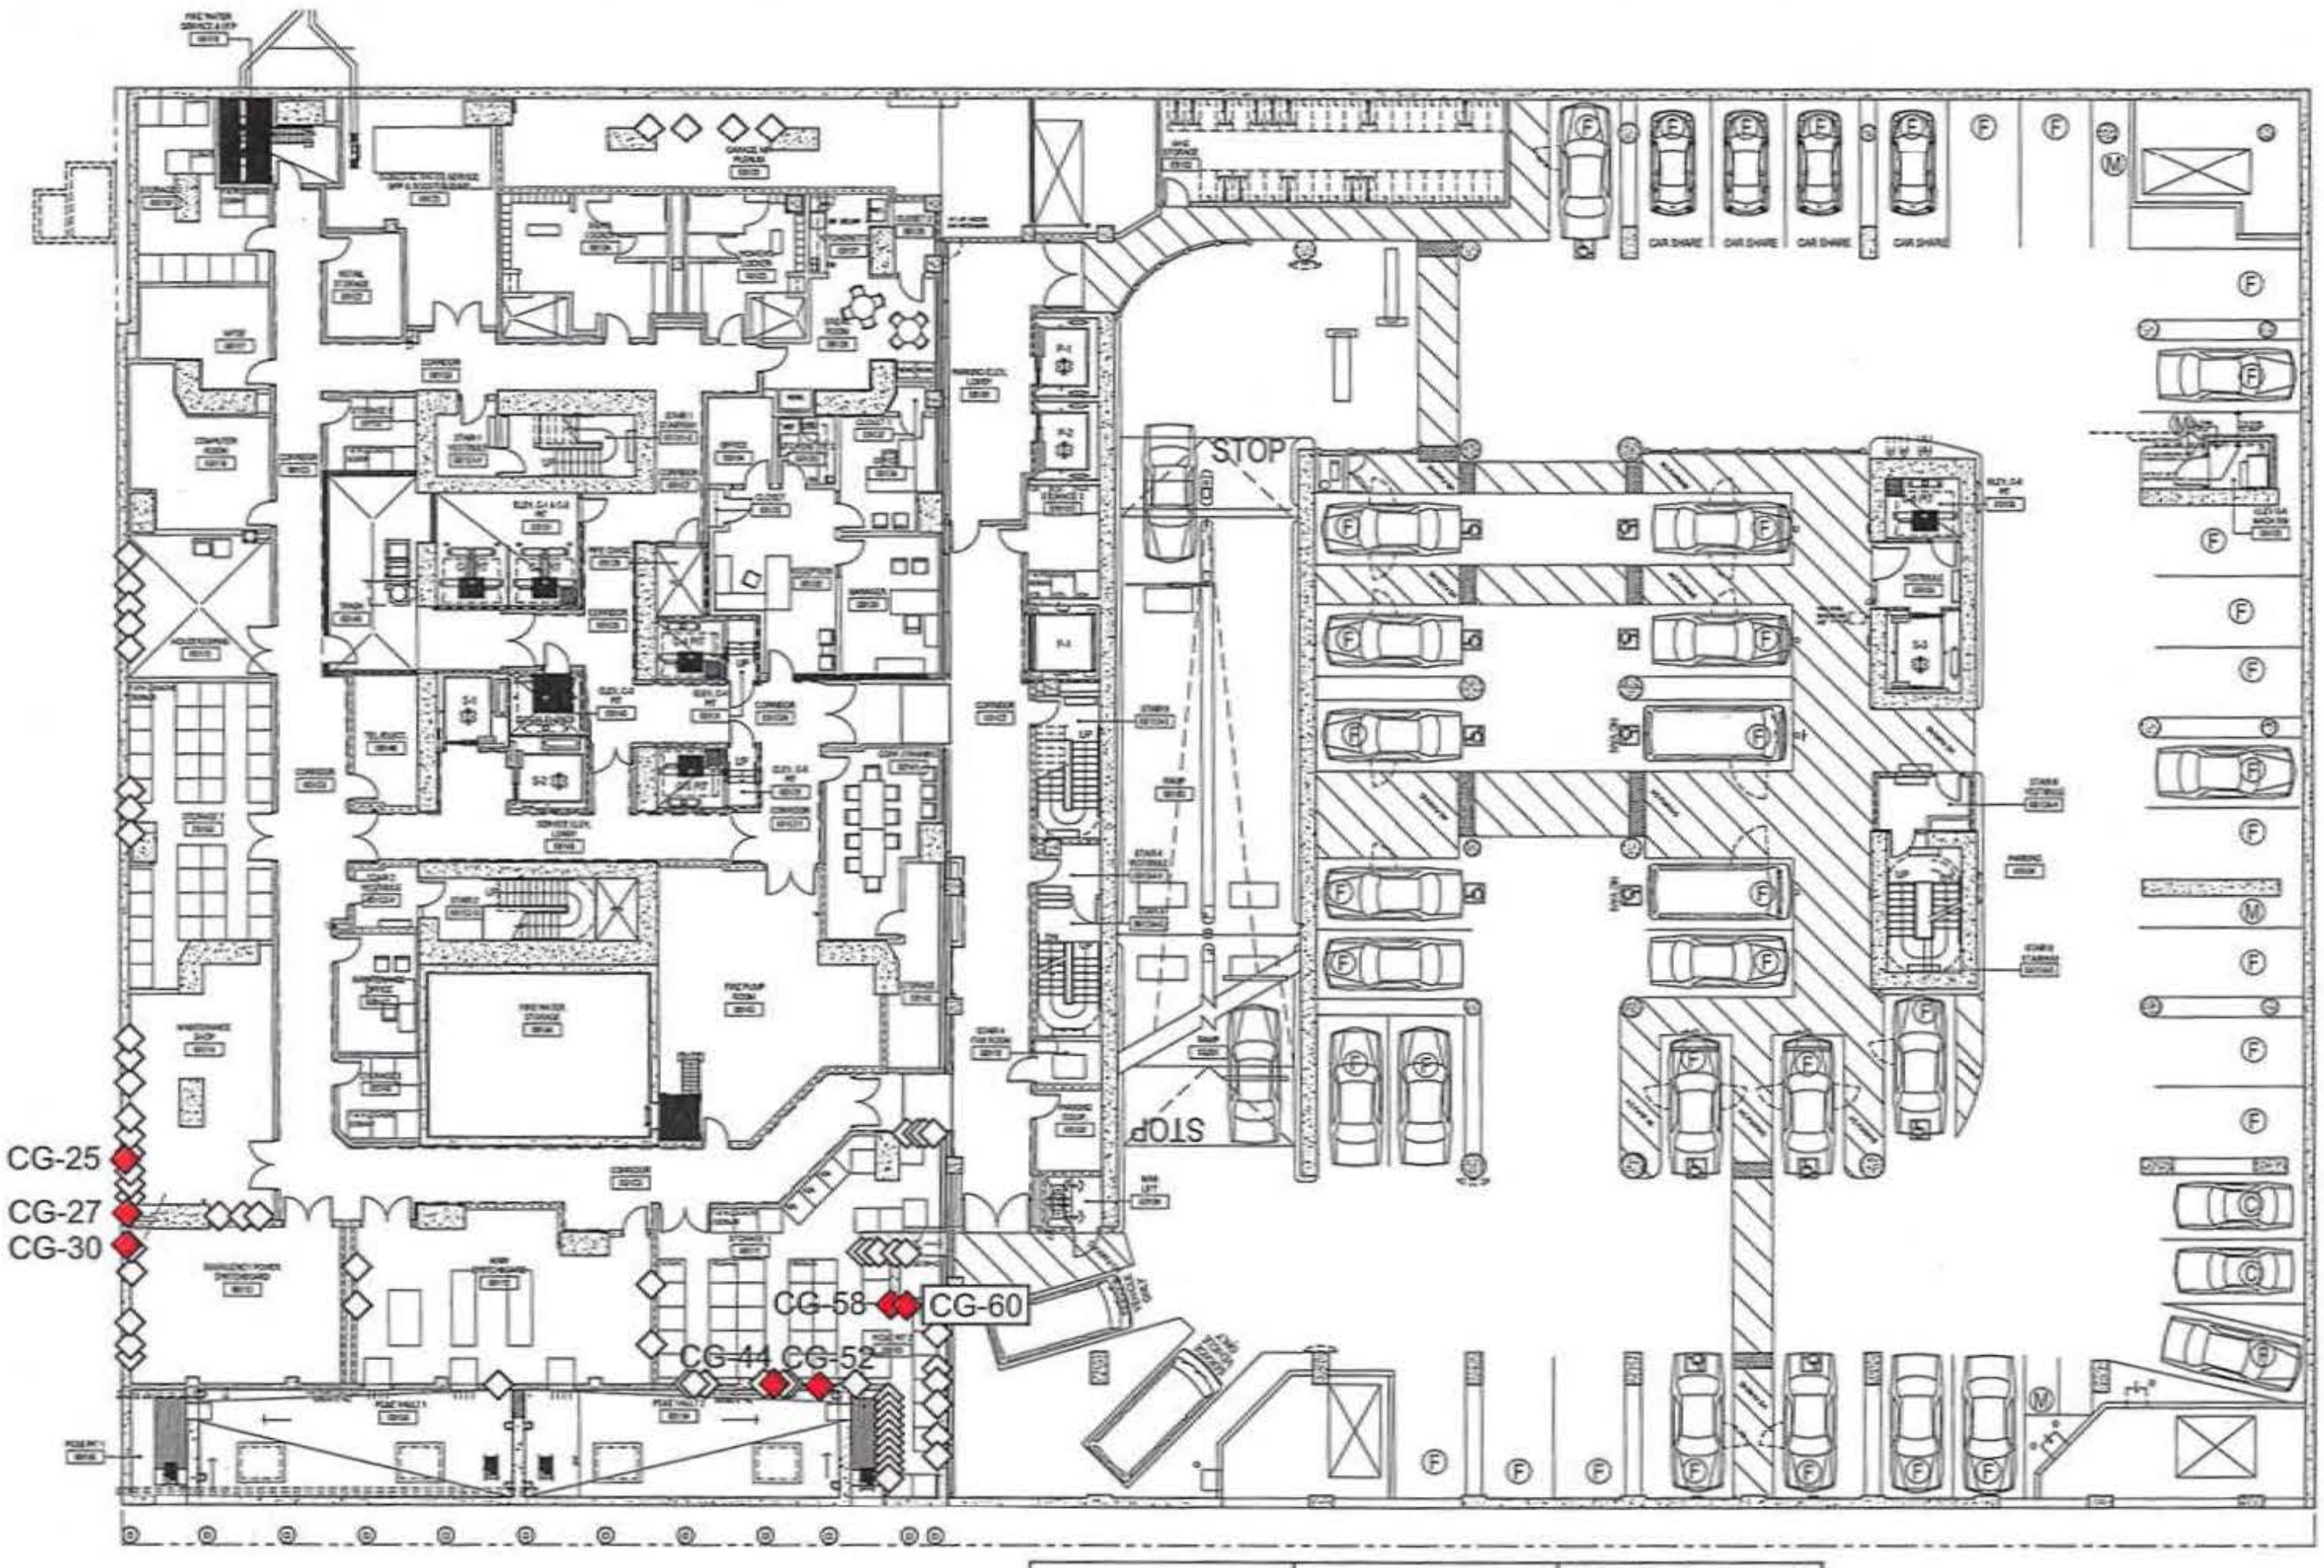
CRACK GAUGES SHOWING MOVEMENT:
301 MISSION STREET BASEMENT LEVEL B-1

The movement recorded was less than 0.1 millimeters on all of the gauges except for seven of the gauges. For these seven gauges, the attached plate and table describe their location and the recorded movements.

Crack Gauge	Distance of Movement	Direction of movement, relative to the Crack
CG-25	0.2 mm 0.4 mm	Perpendicular Parallel
CG-27	0.4 mm	Parallel
CG-30	0.4 mm	Parallel
CG-44	0.2 mm	Perpendicular
CG-52	0.4 mm	Parallel
CG-58	0.2 mm	Perpendicular
CG-60	0.1 mm	Perpendicular

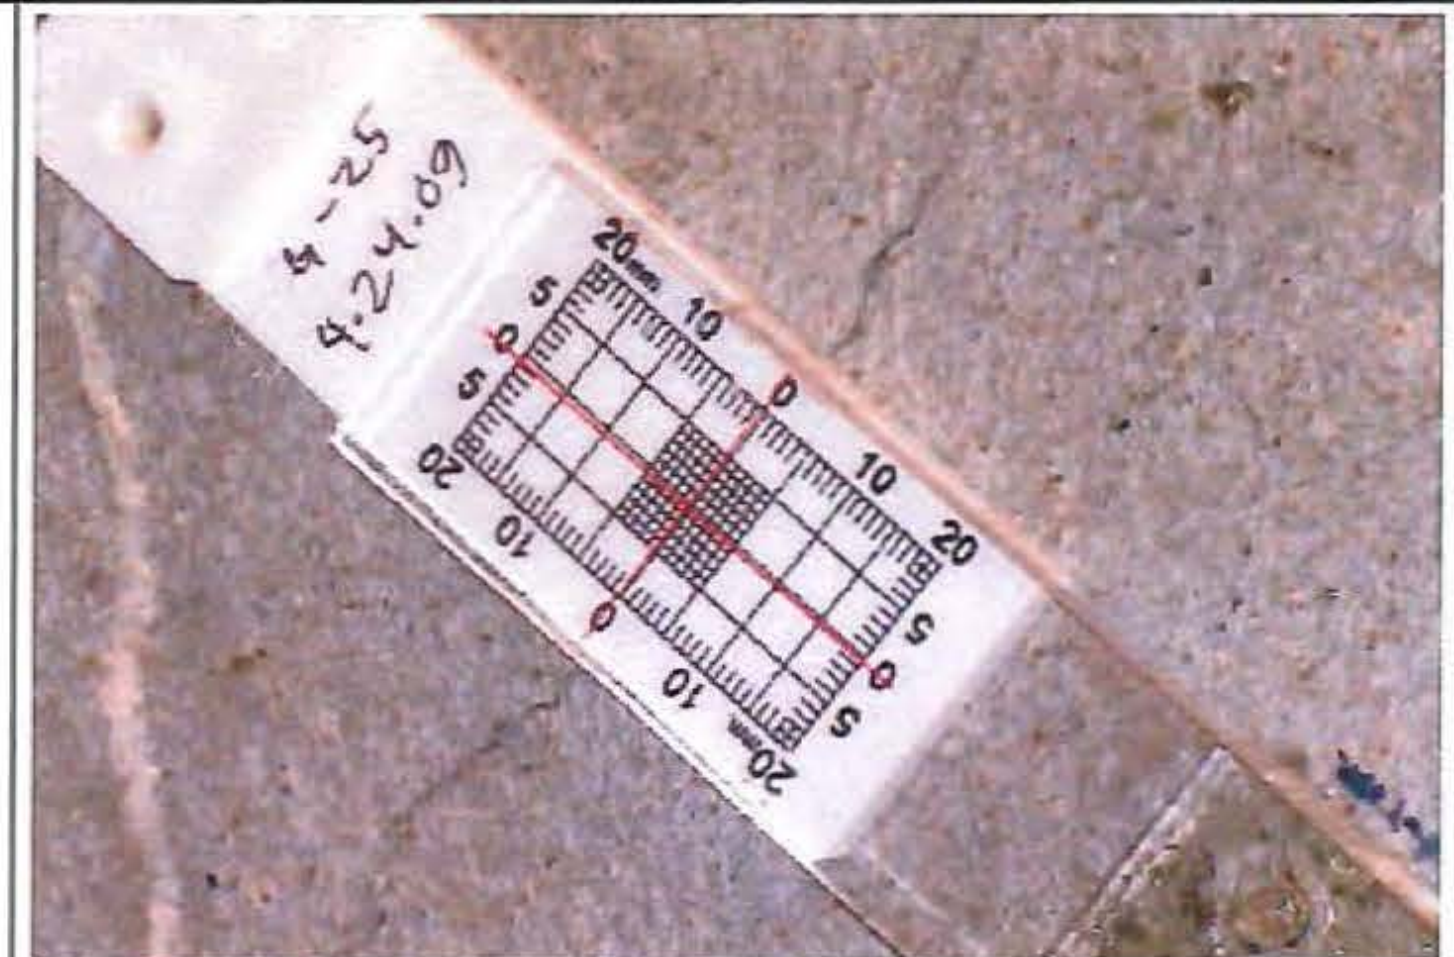
Crack Gauge	Distance of Movement	Direction of movement, relative to the Crack	Picture of Movement
CG-25	0.2 mm 0.4 mm	Perpendicular Parallel

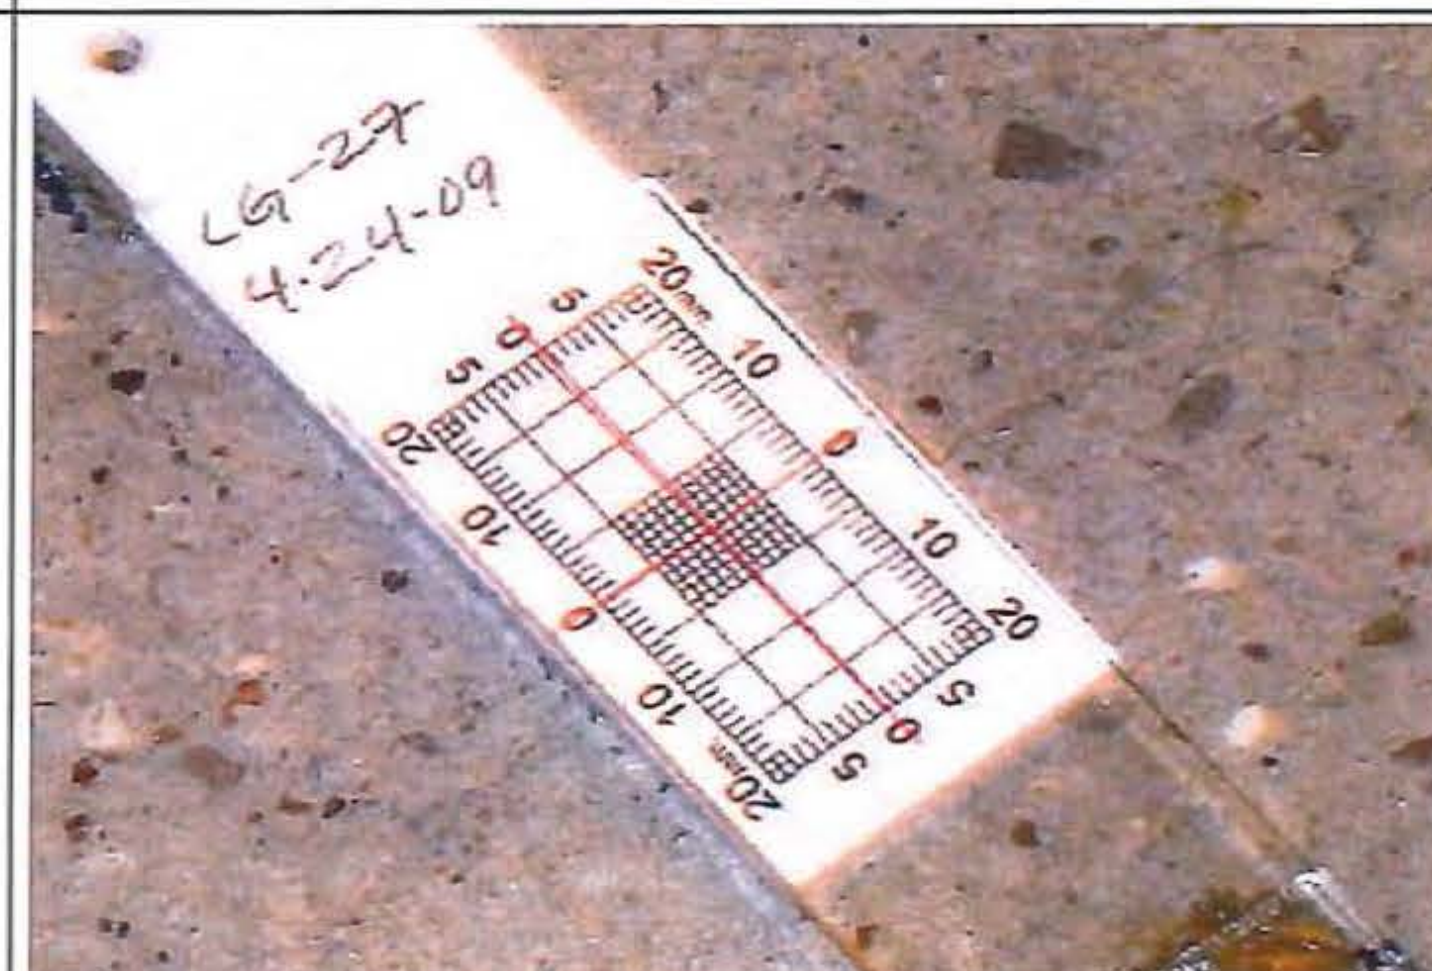
CG-27	0.4 mm	Parallel

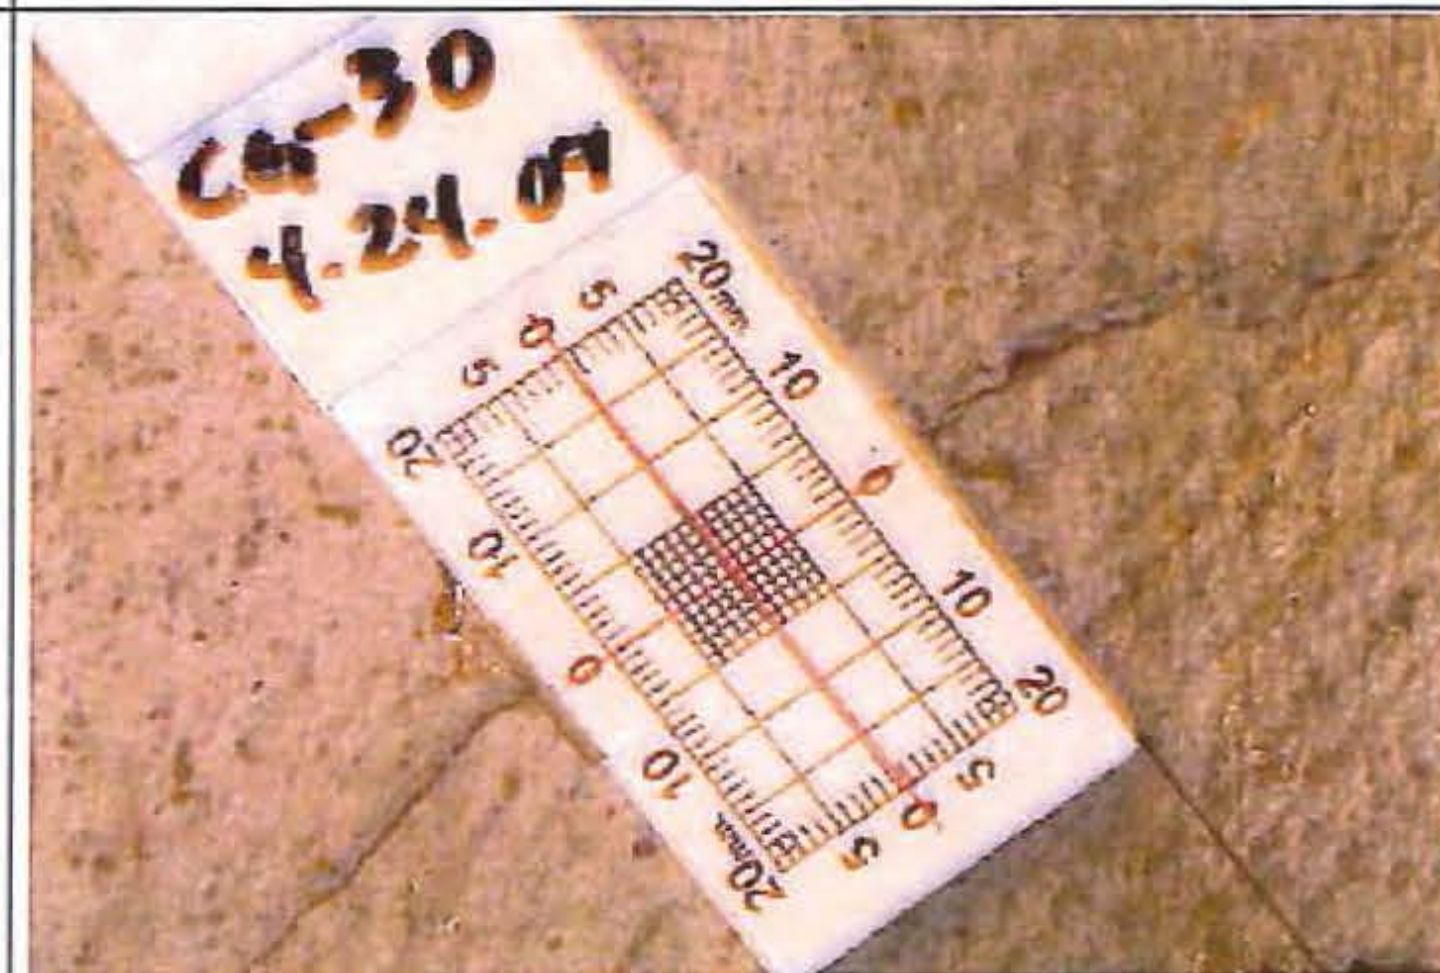
TABLE 1 SUMMARY OF CRACK GAUGES SHOWING MOVEMENT: DECEMBER 9, 2010			
Crack Gauge	**Distance of Movement**	**Direction of movement, relative to the Crack**	**Picture of Movement**
CG-30	0.4 mm	Parallel

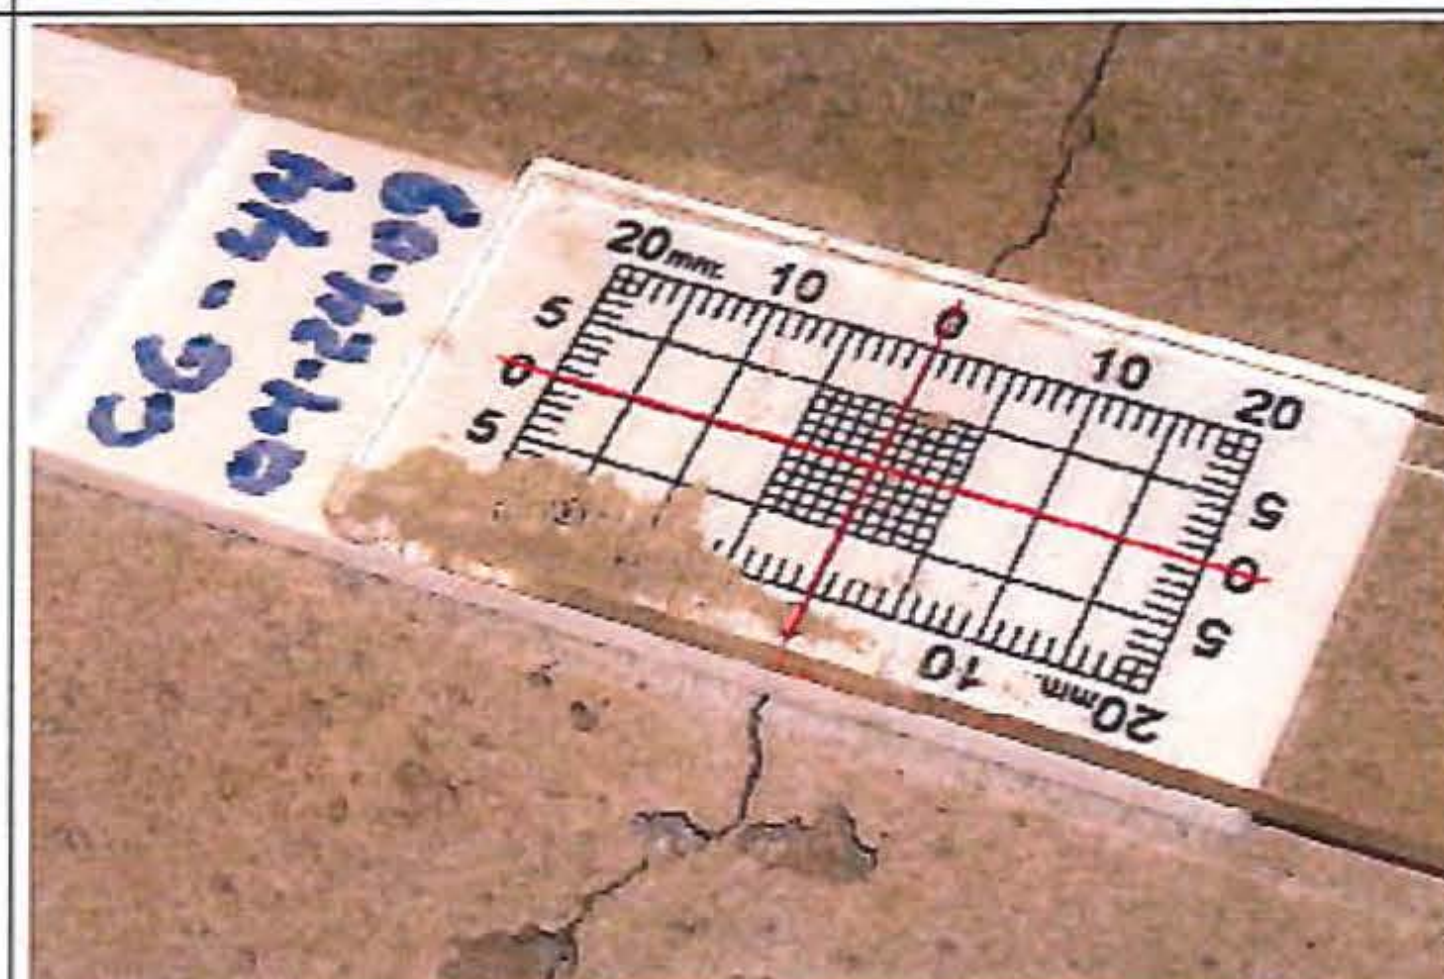
CG-44	0.2 mm	Perpendicular

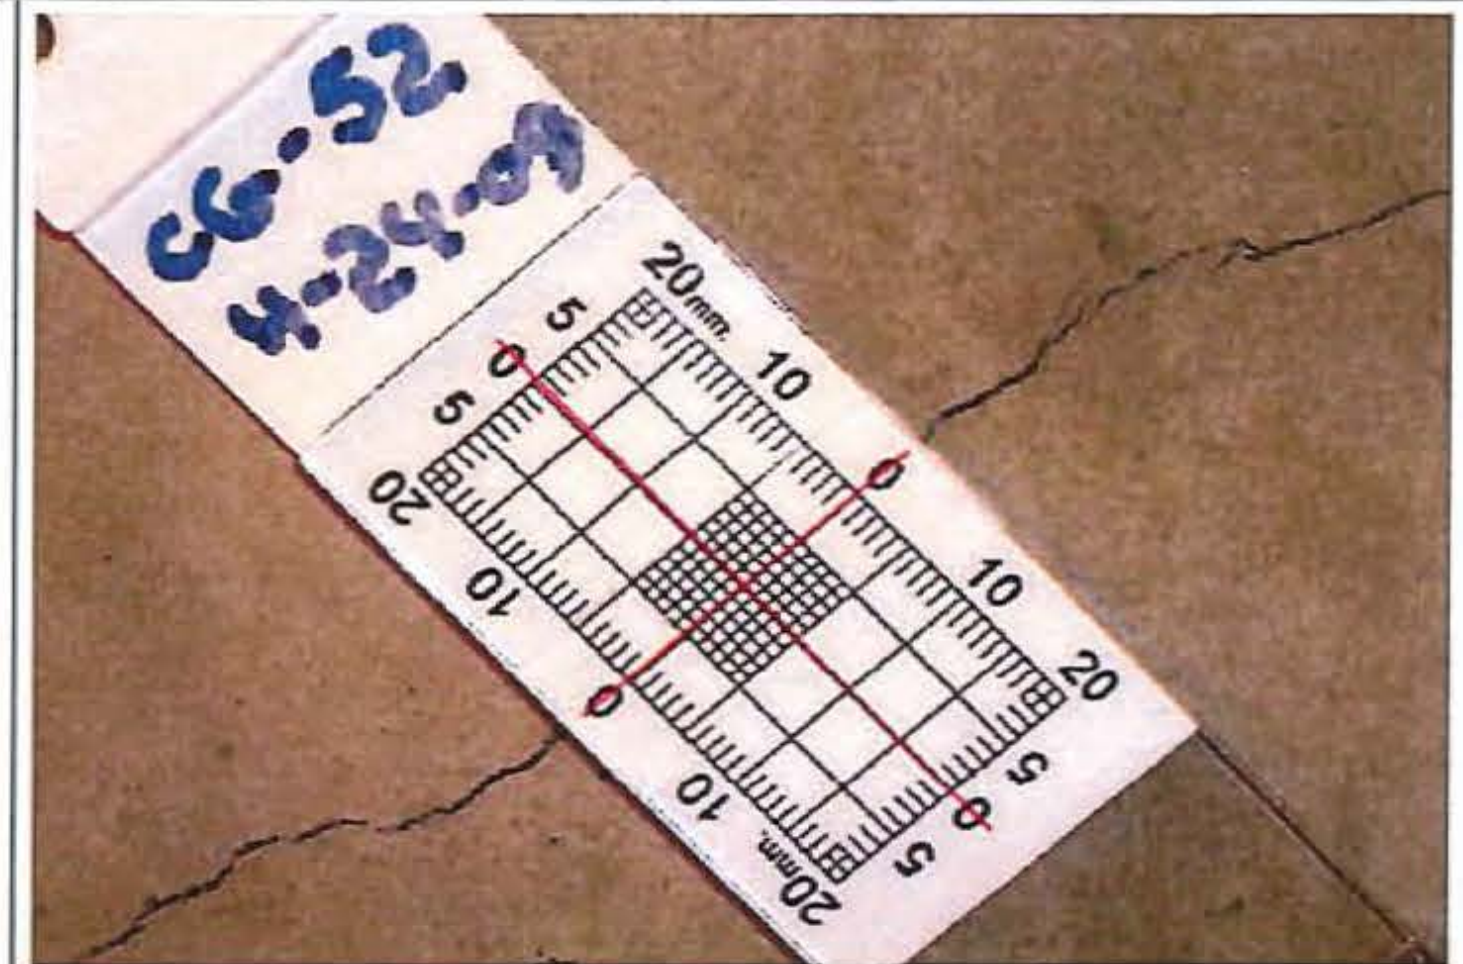
TABLE 1 SUMMARY OF CRACK GAUGES SHOWING MOVEMENT: DECEMBER 9, 2010			
Crack Gauge	**Distance of Movement**	**Direction of movement, relative to the Crack**	**Picture of Movement**
CG-52	0.4 mm	Parallel

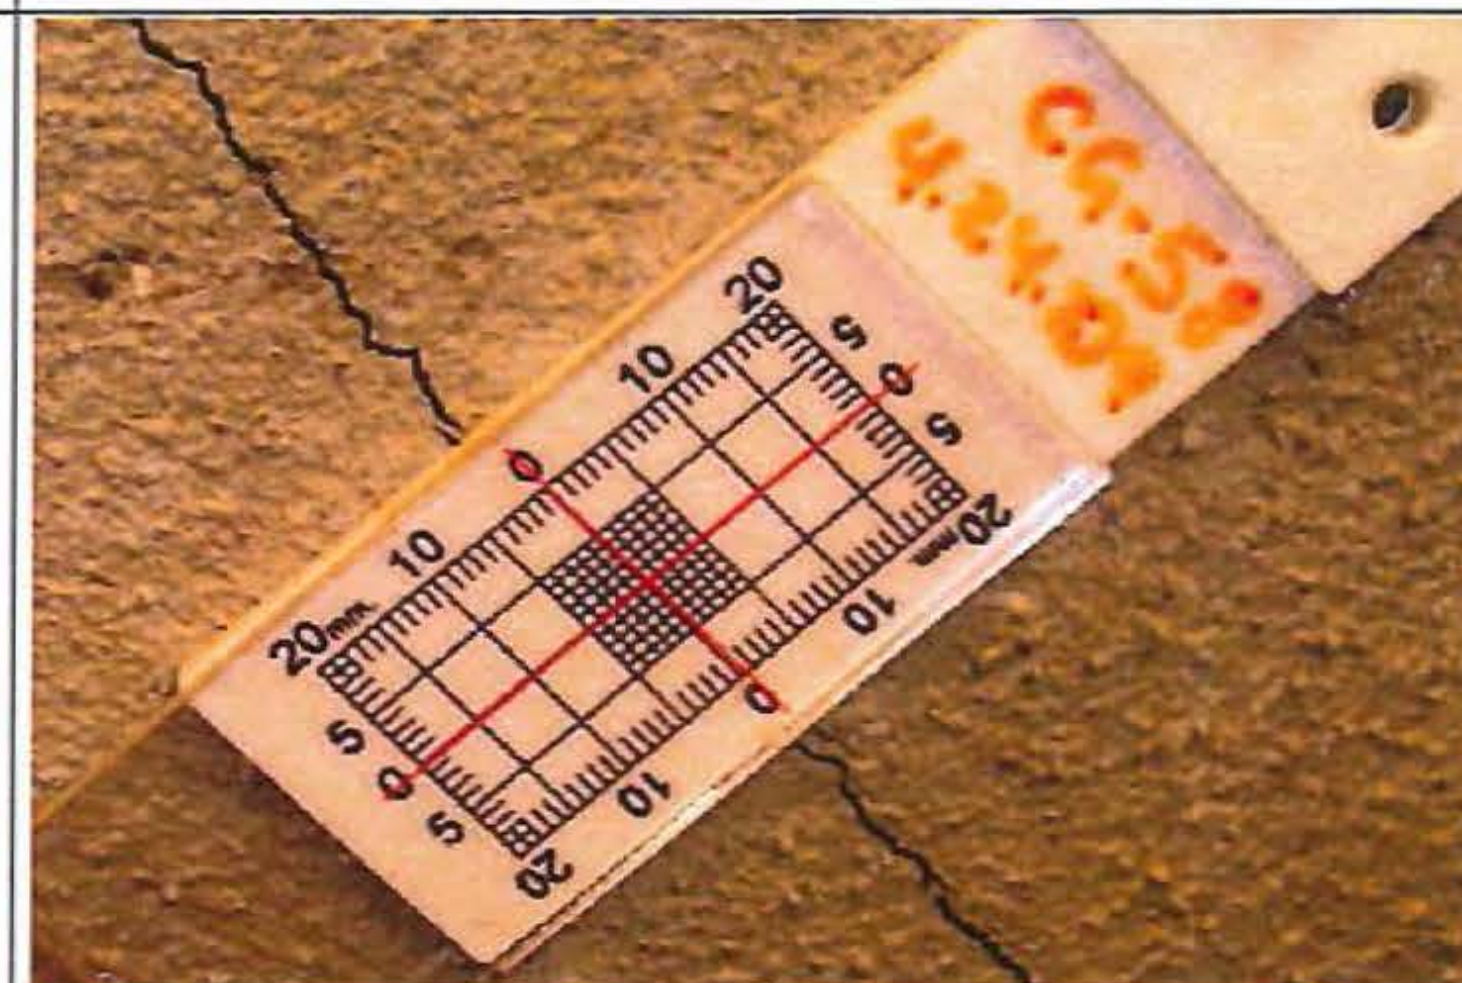
CG-58	0.2 mm	Perpendicular

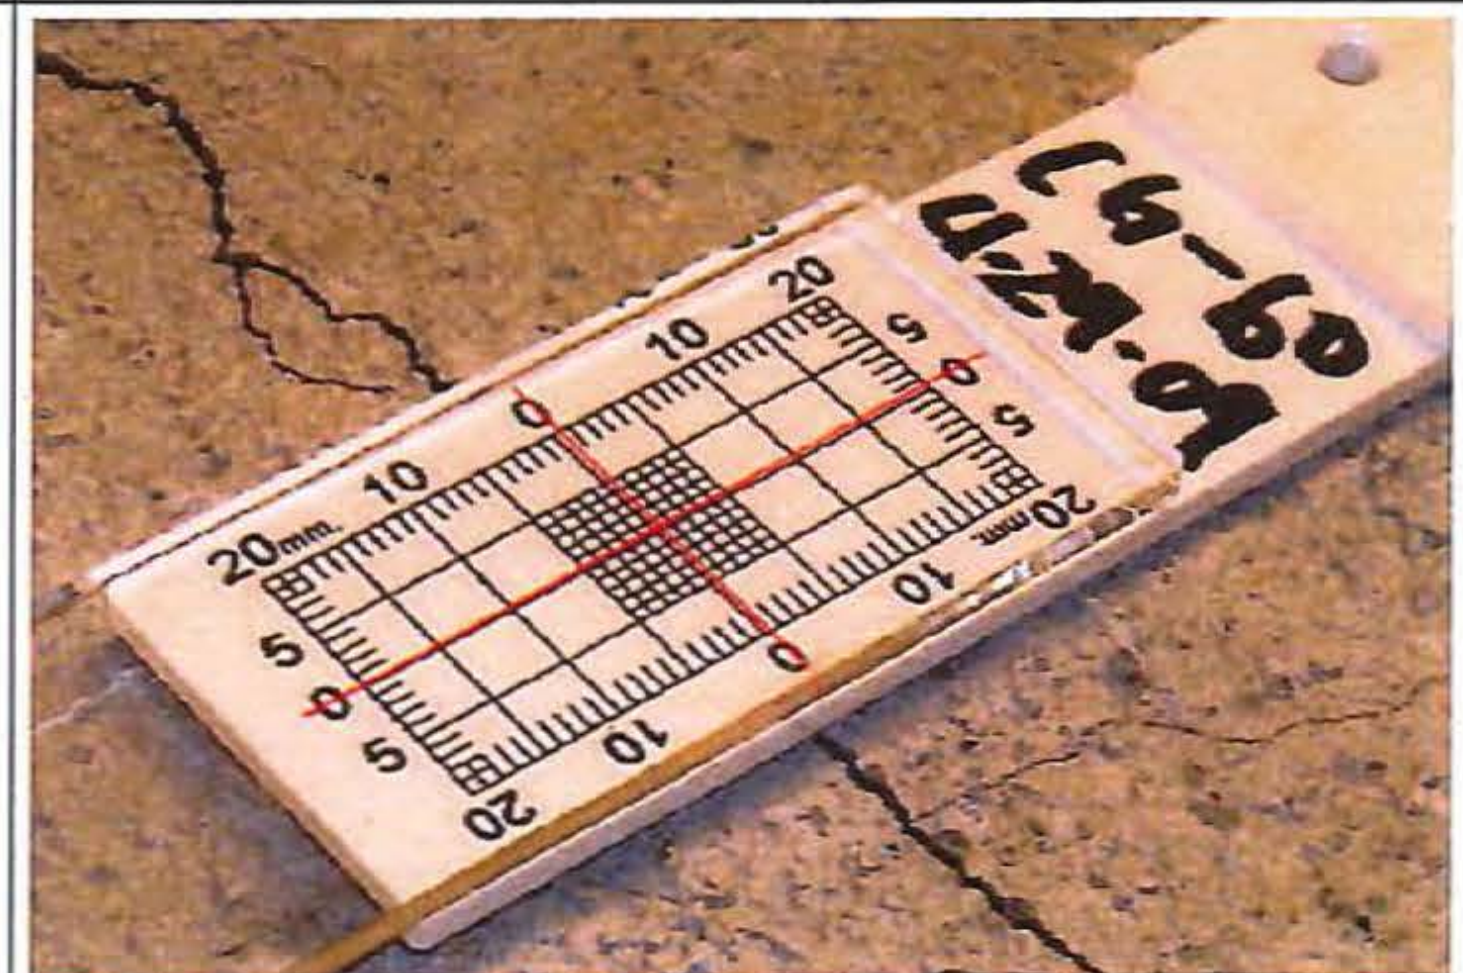
TABLE 1 SUMMARY OF CRACK GAUGES SHOWING MOVEMENT: DECEMBER 9, 2010			
Crack Gauge	Distance of Movement	Direction of movement, relative to the Crack	Picture of Movement
CG-60	0.1 mm	Perpendicular

Head on photograph was not available.

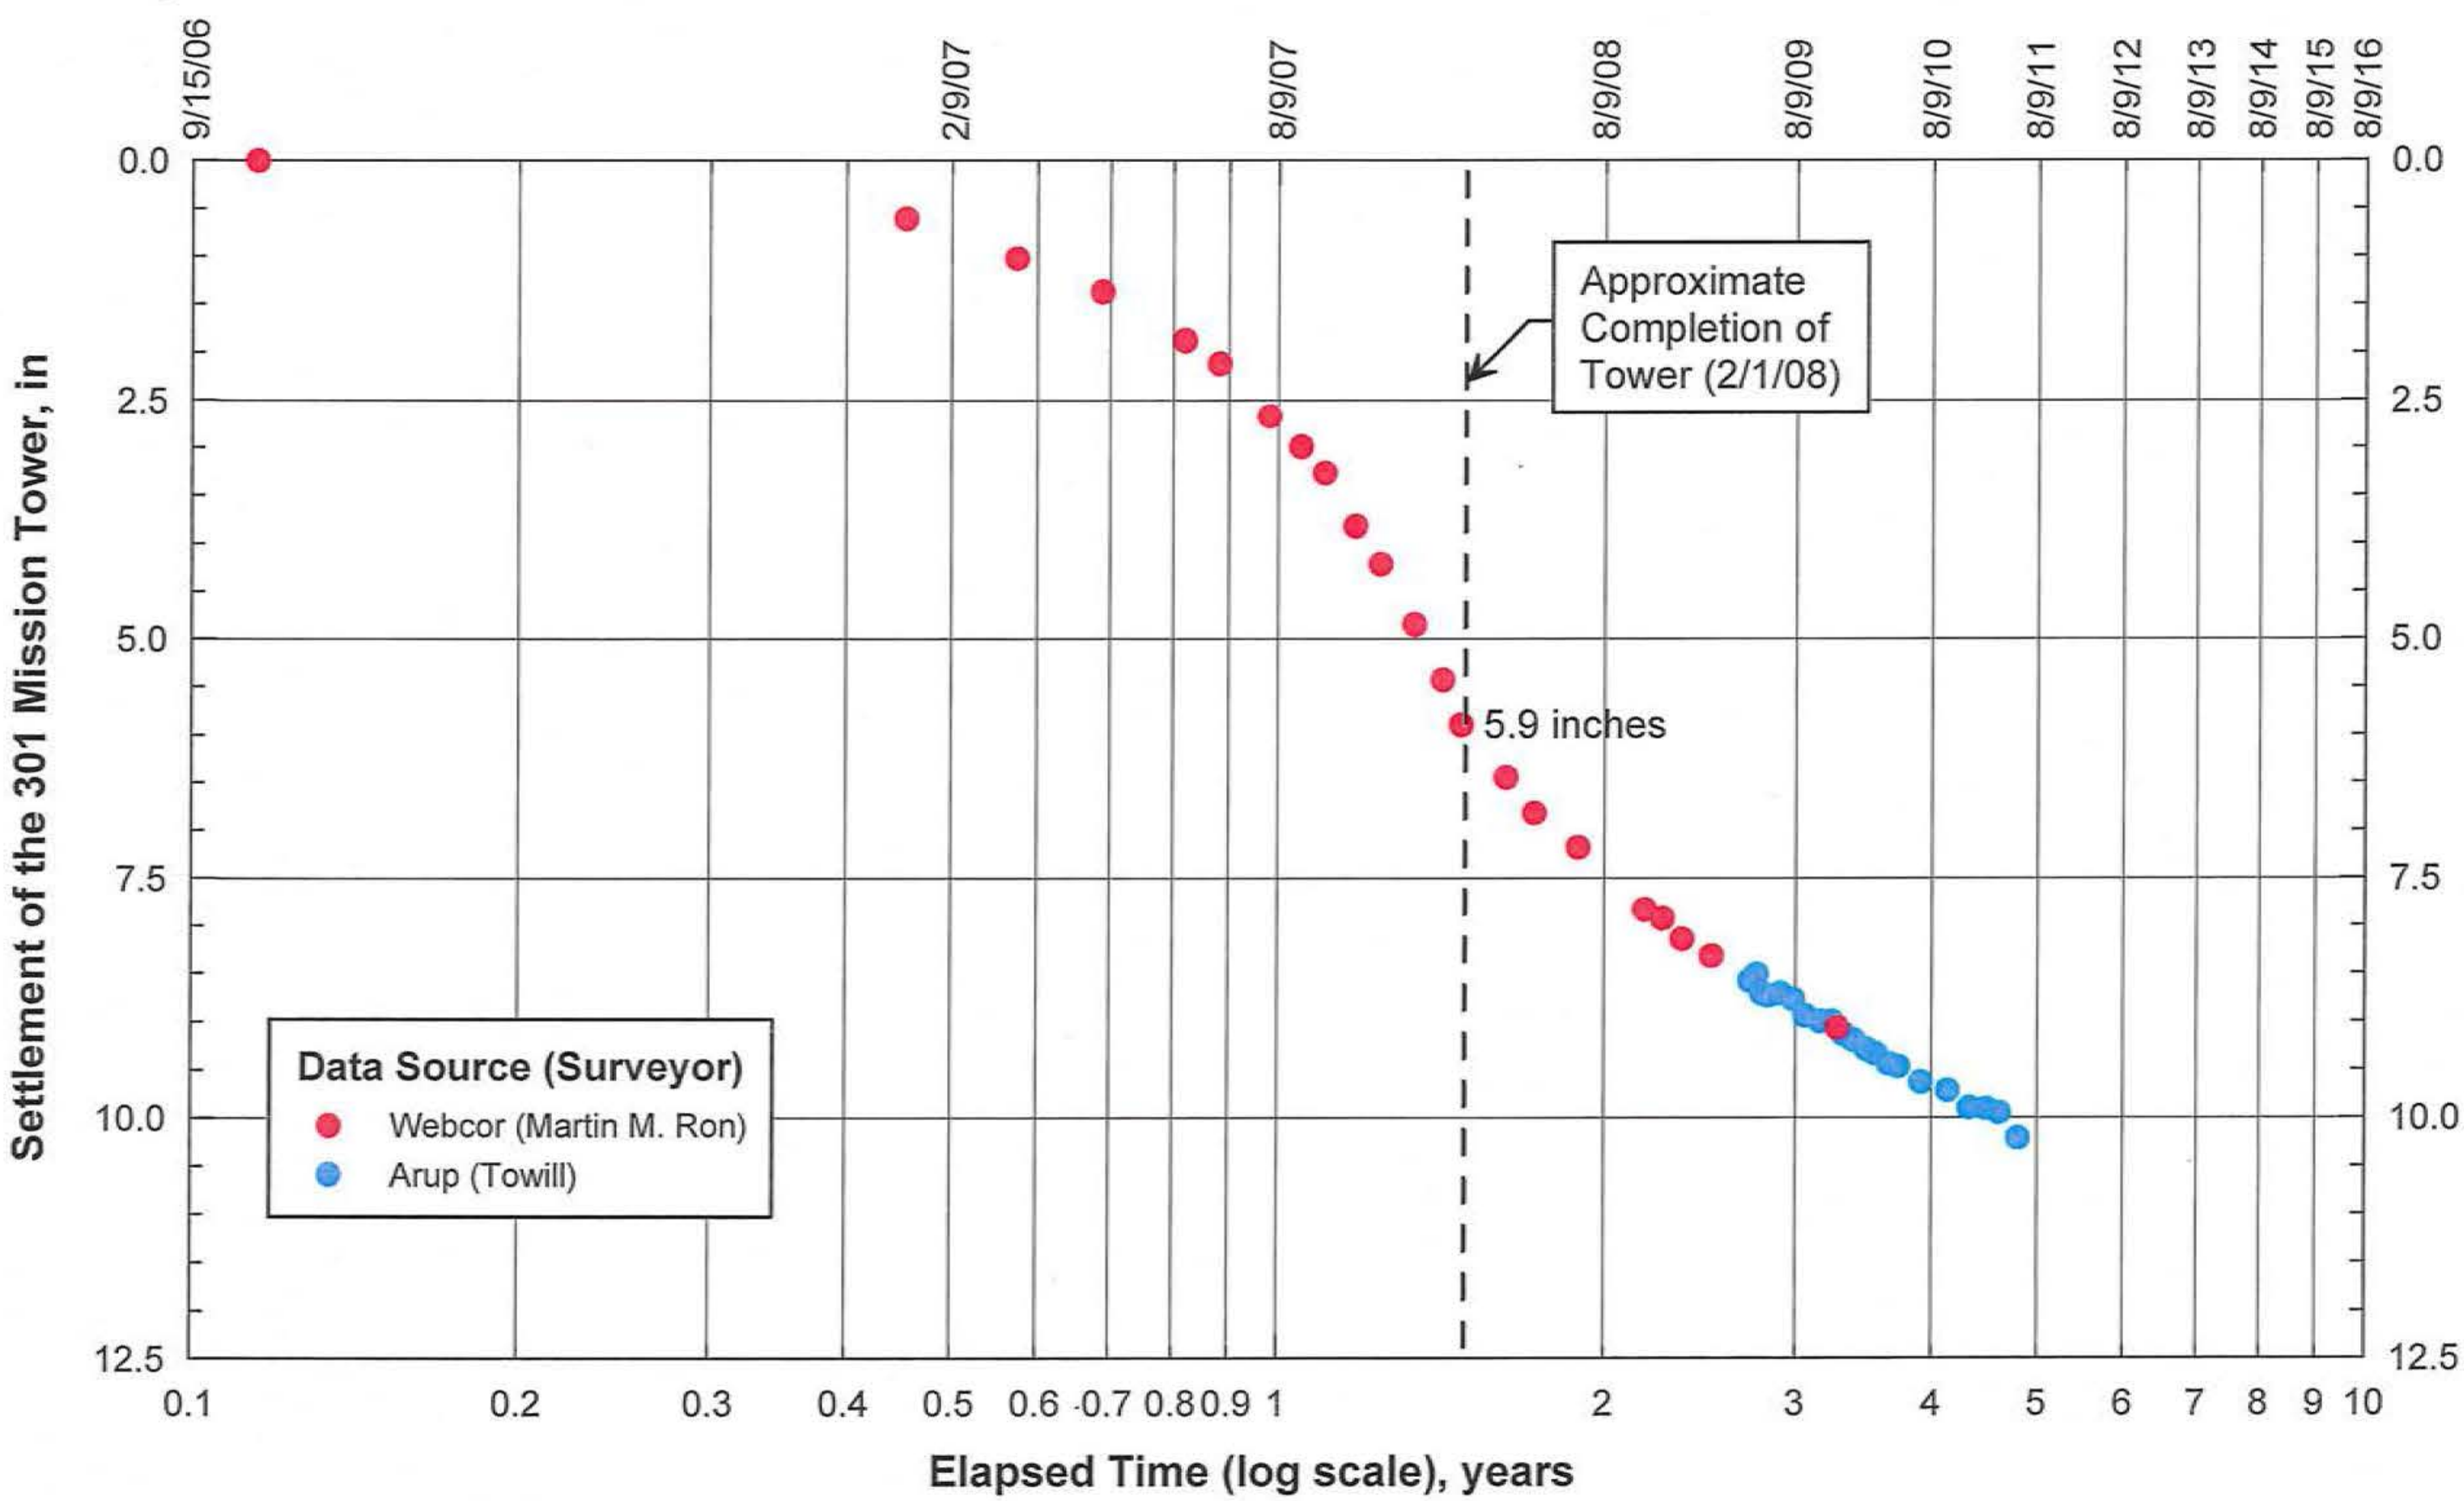
Begining of Tower Construction: 8/9/06
End of Tower Construction: 2/1/08
Construction Duration: 542 days (1.5 years)

SETTLEMENTS OF THE 301 MISSION TOWER INCLUDING MONITORING DURING CONSTRUCTION
