File No. 160975 **Committee Item No.** 7
Board Item No. ________

AGENDA PACKET CONTENTS LIST

TALL BUILDINGS SAFETY STRATEGY

October 2018

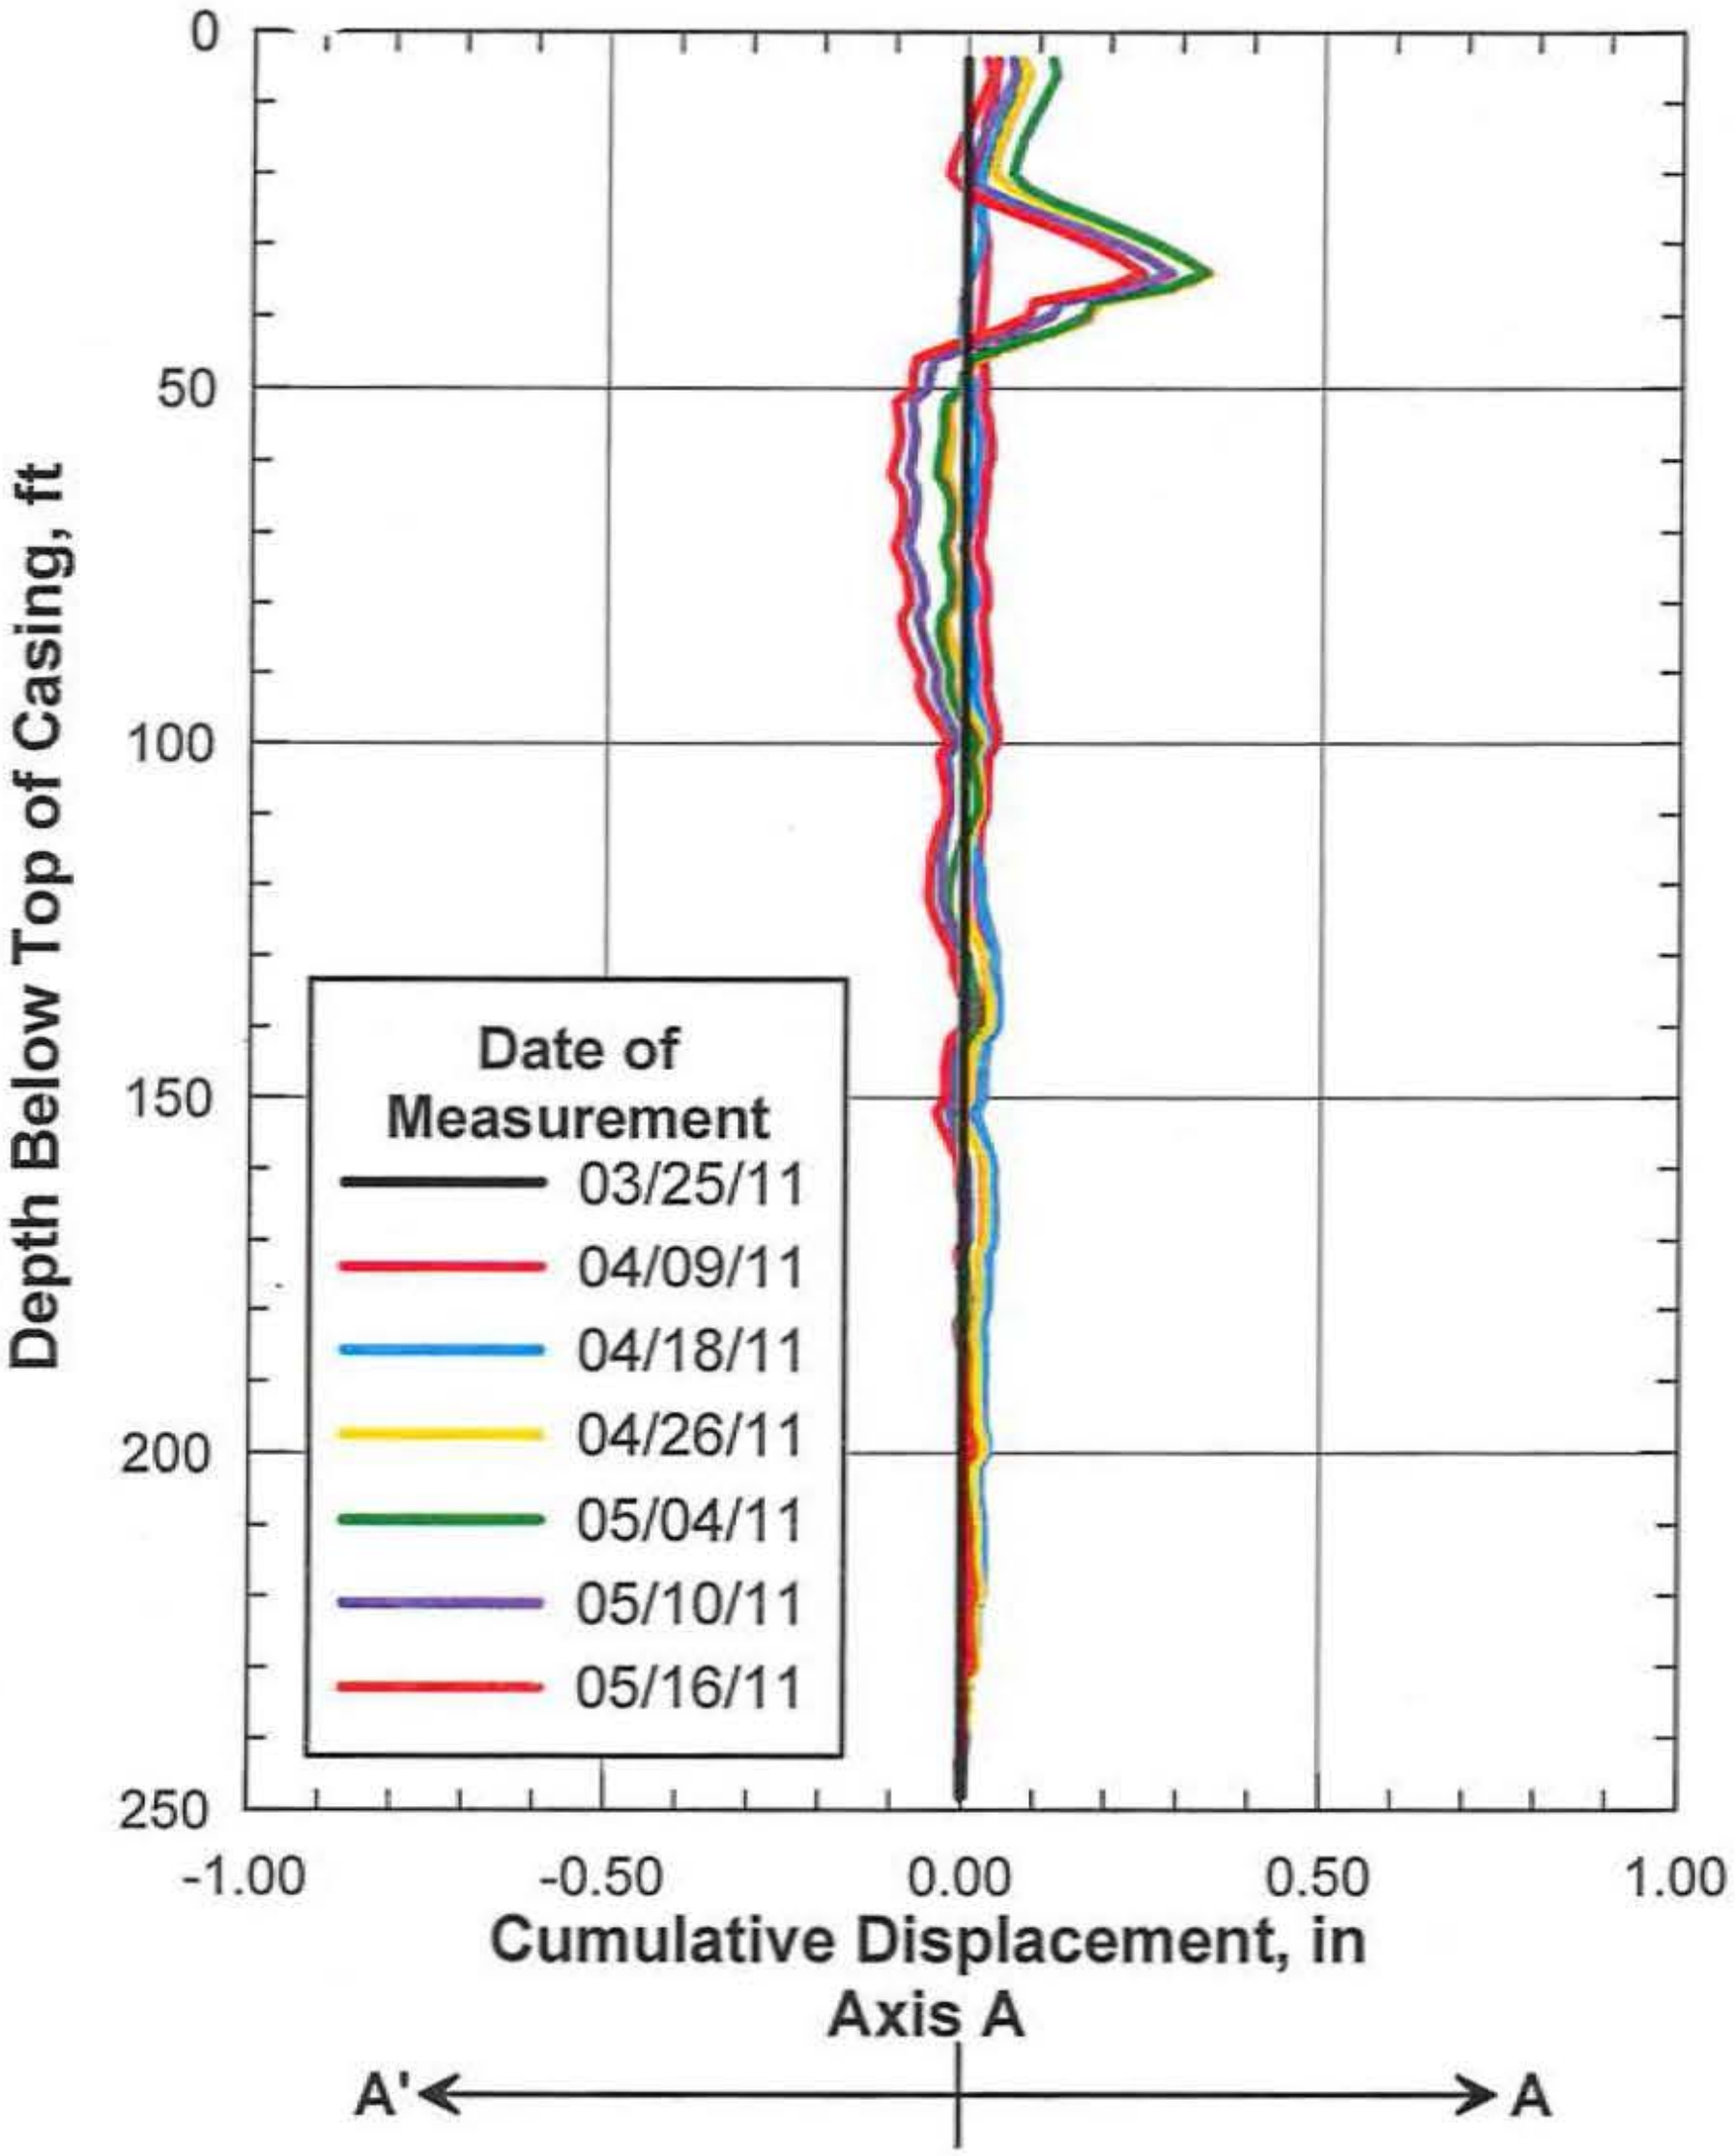
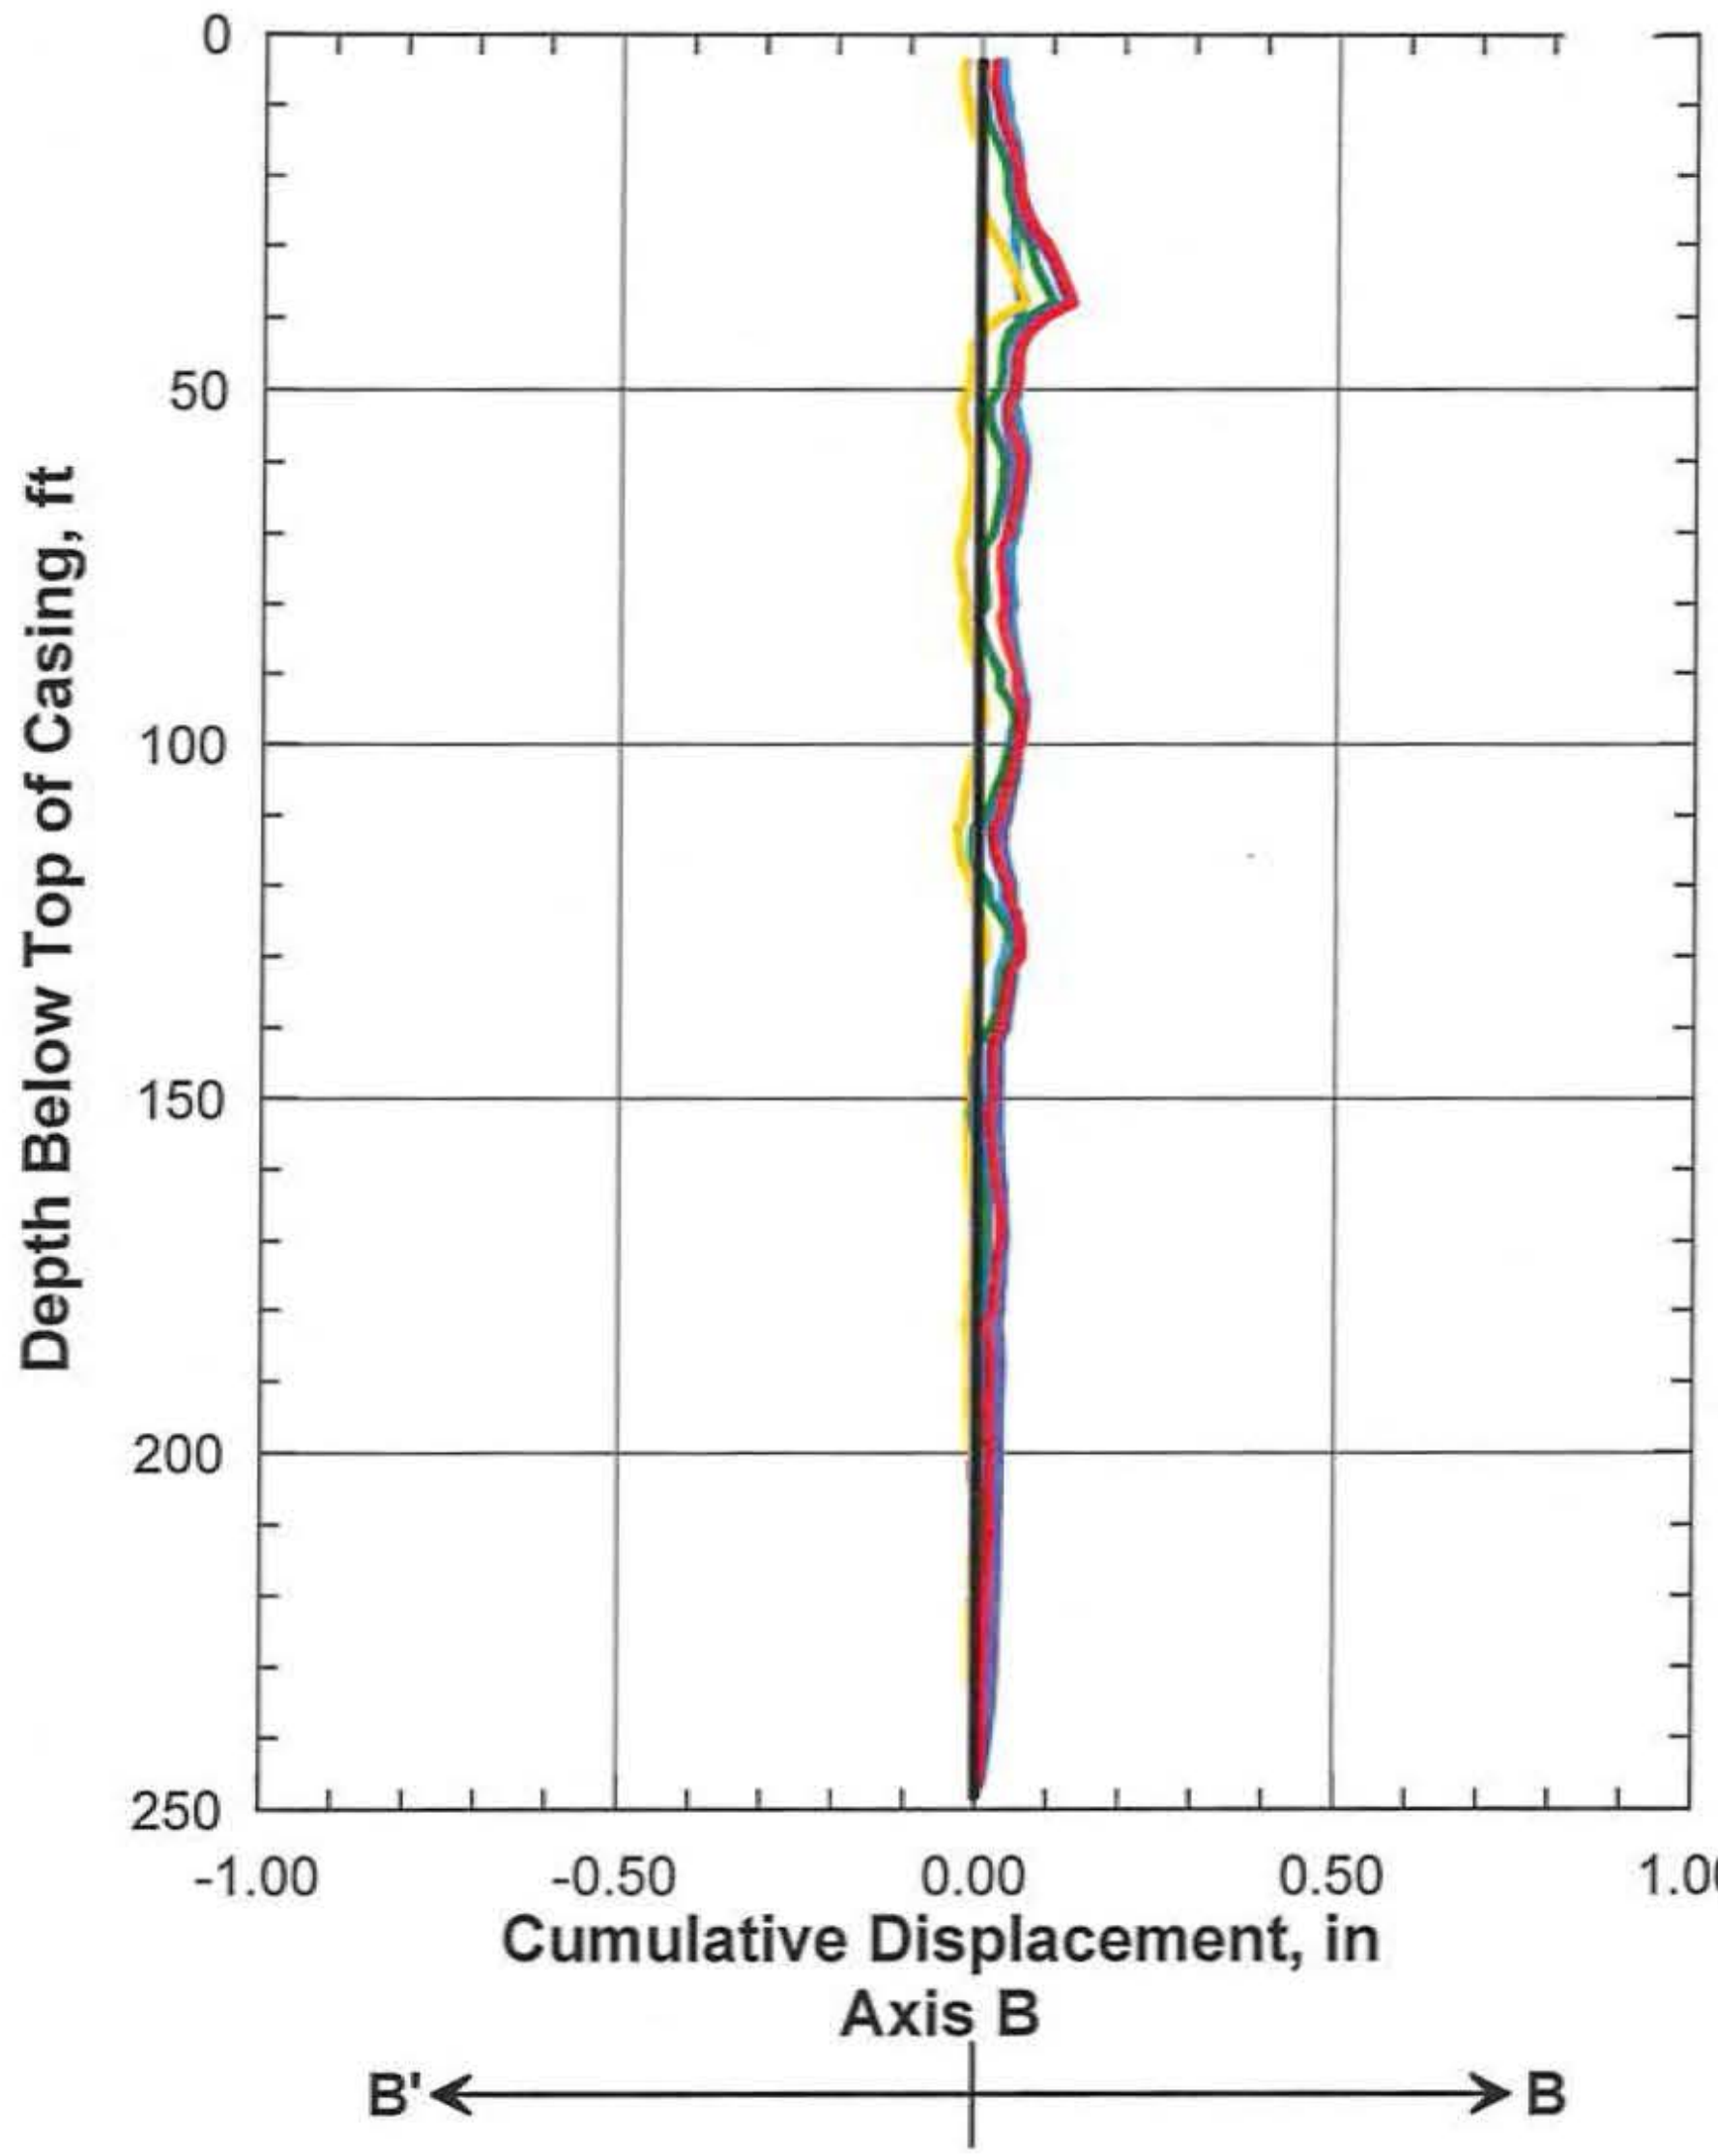
PLATE 1

Overall, the lateral movements recorded to date are within the tolerances prescribed in the Specification.

INCLINOMETER DATA FOR PILE EXTRACTION
TEST SITE INCLINOMETER READING I-18

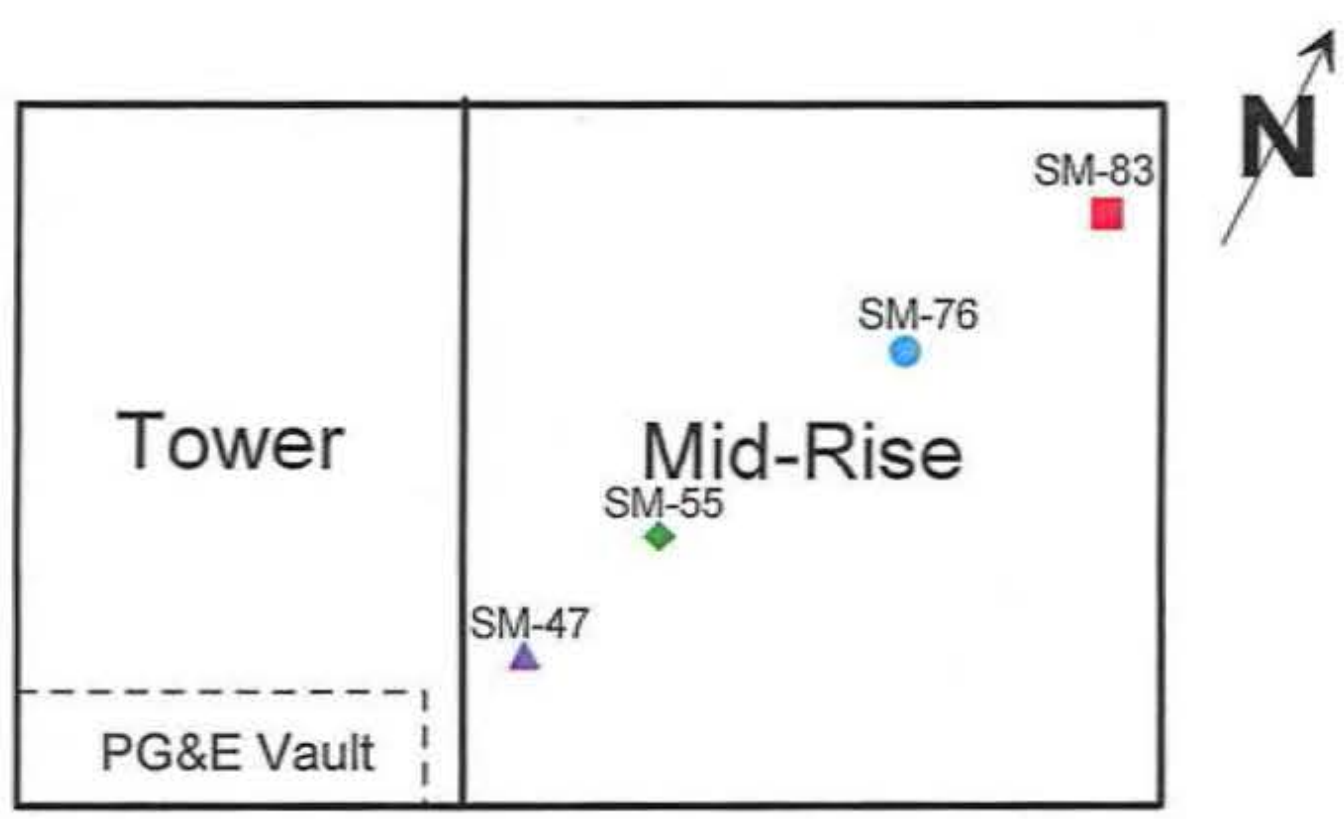
SETTLEMENT OVER TIME
FLOOR ELEVATIONS AT LEVEL B-1
OF 301 MISSION PROPERTY- MID-RISE:
APRIL 30, 2009 THROUGH JULY 7, 2011

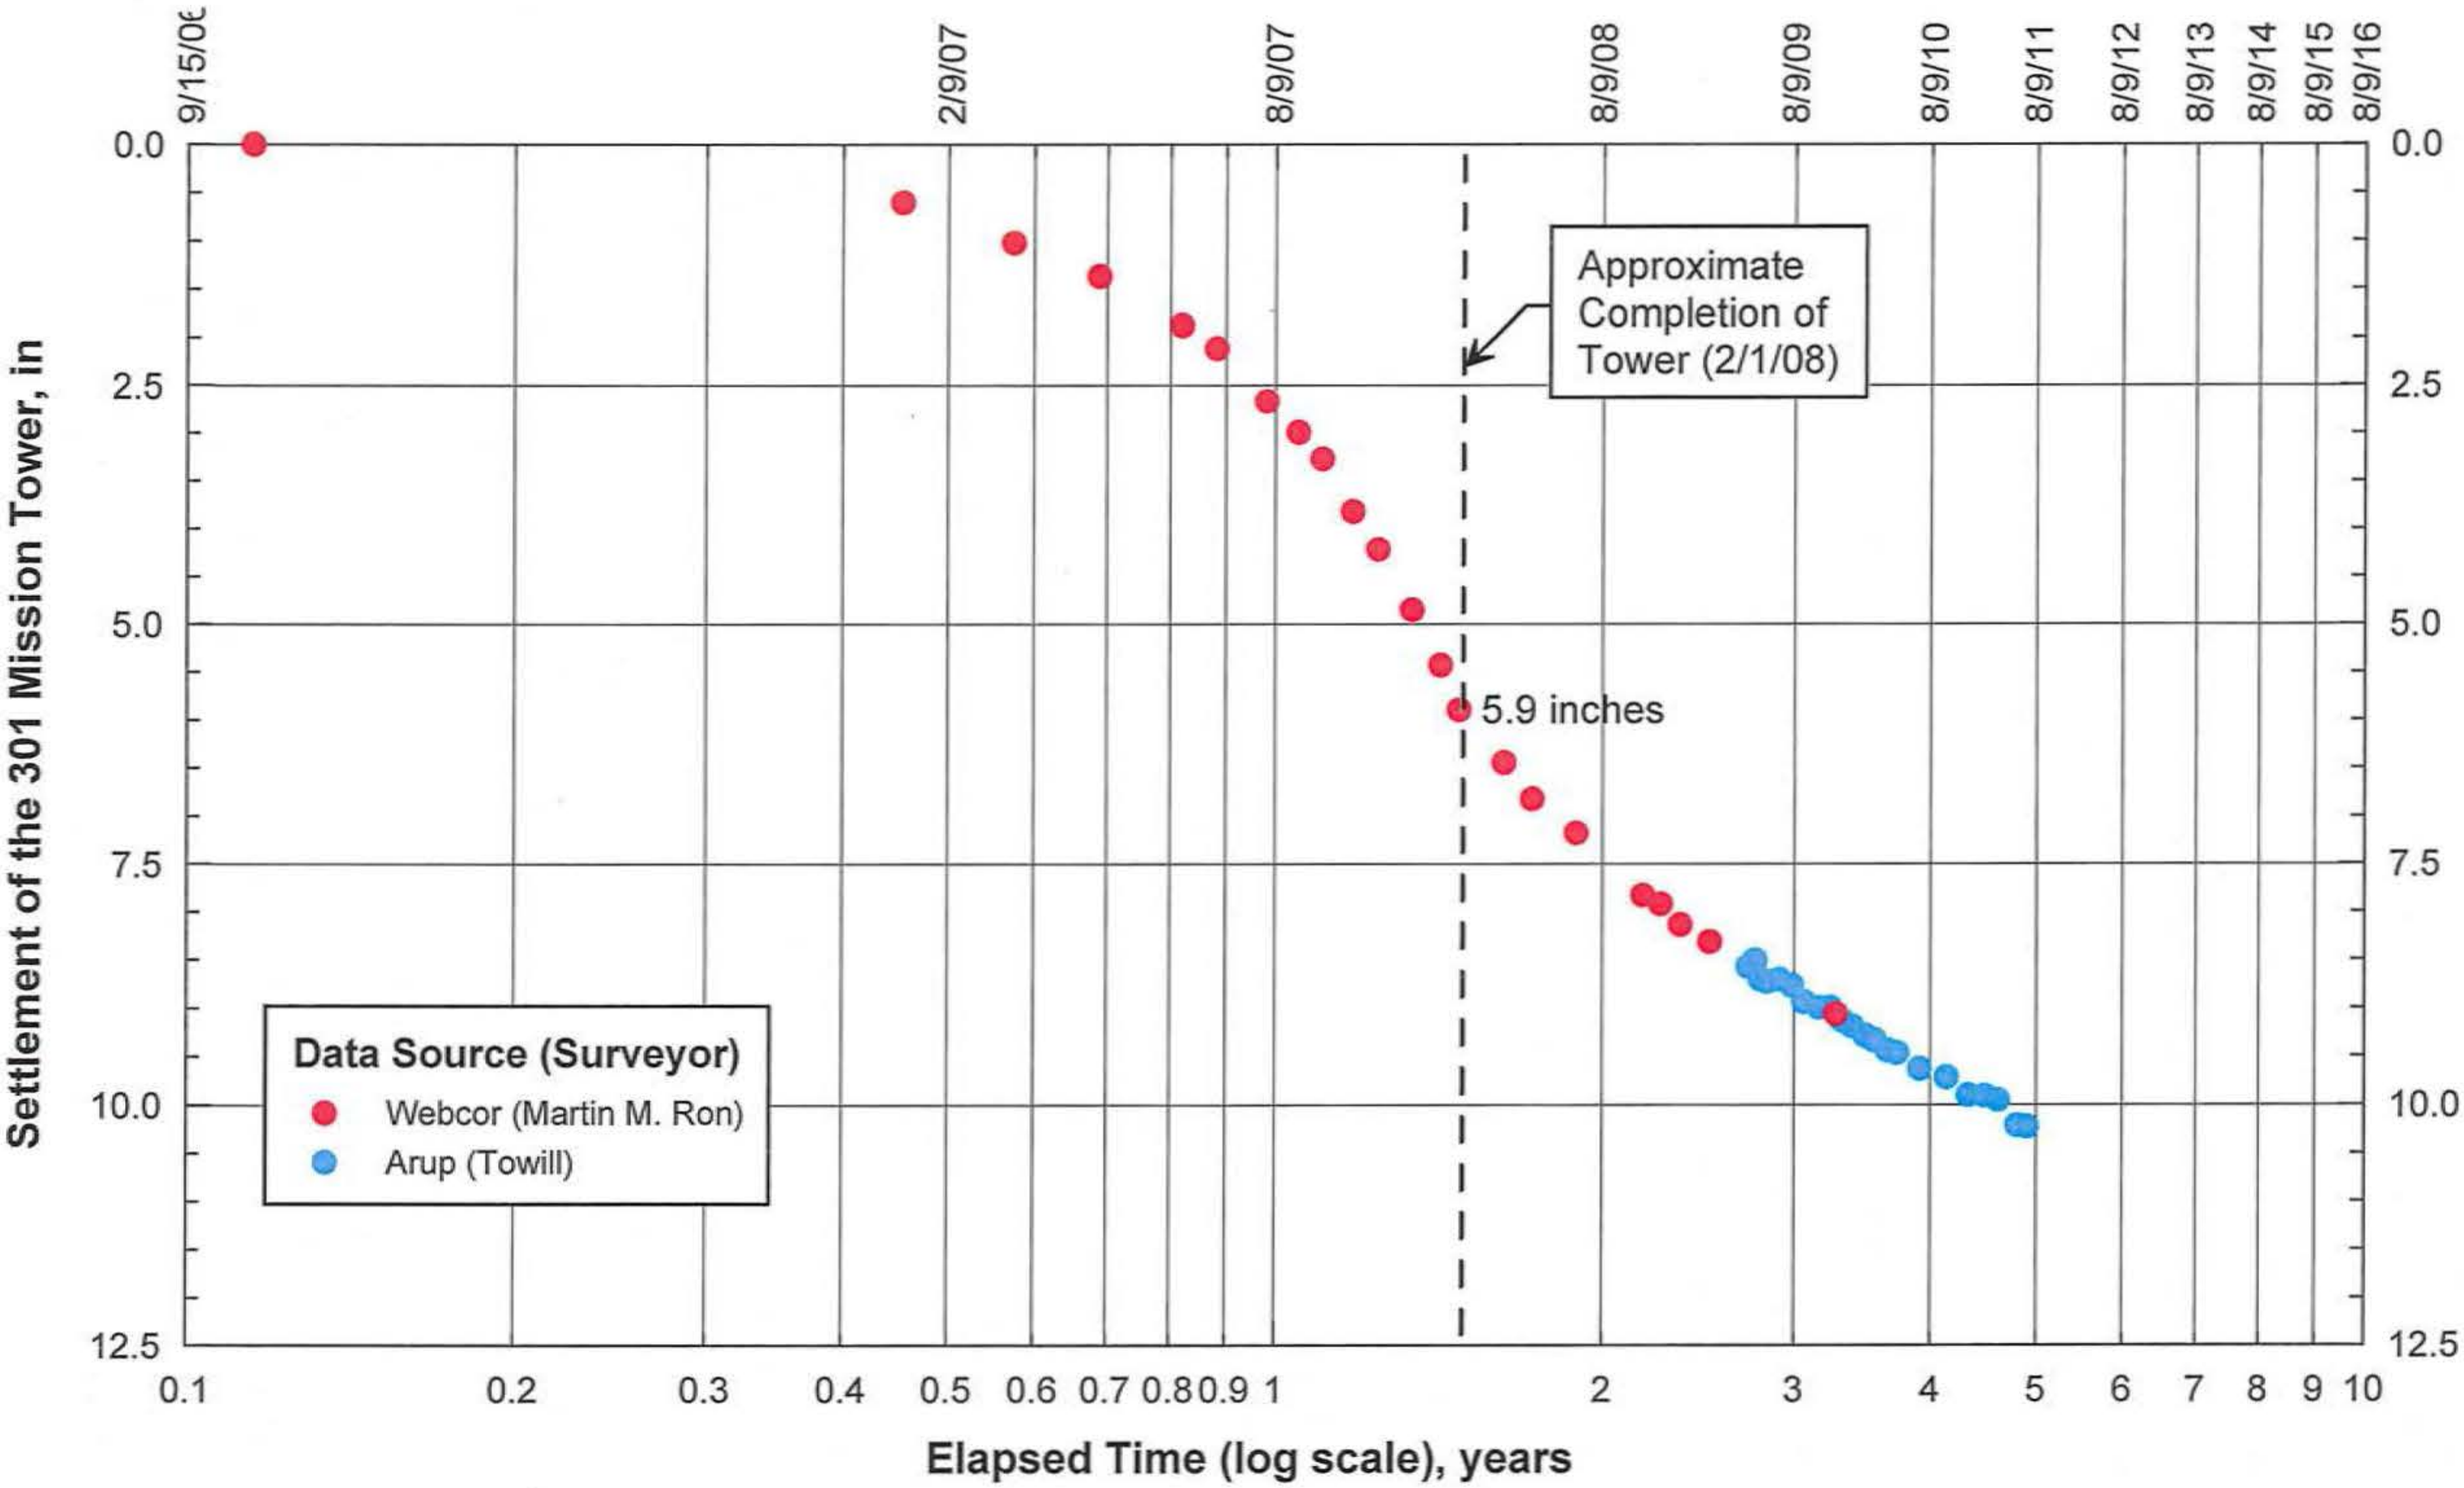
PLATE 6

Begining of Tower Construction: 8/9/06
End of Tower Construction: 2/1/08
Construction Duration: 542 days (1.5 years)

SETTLEMENTS OF THE 301 MISSION TOWER INCLUDING MONITORING DURING CONSTRUCTION

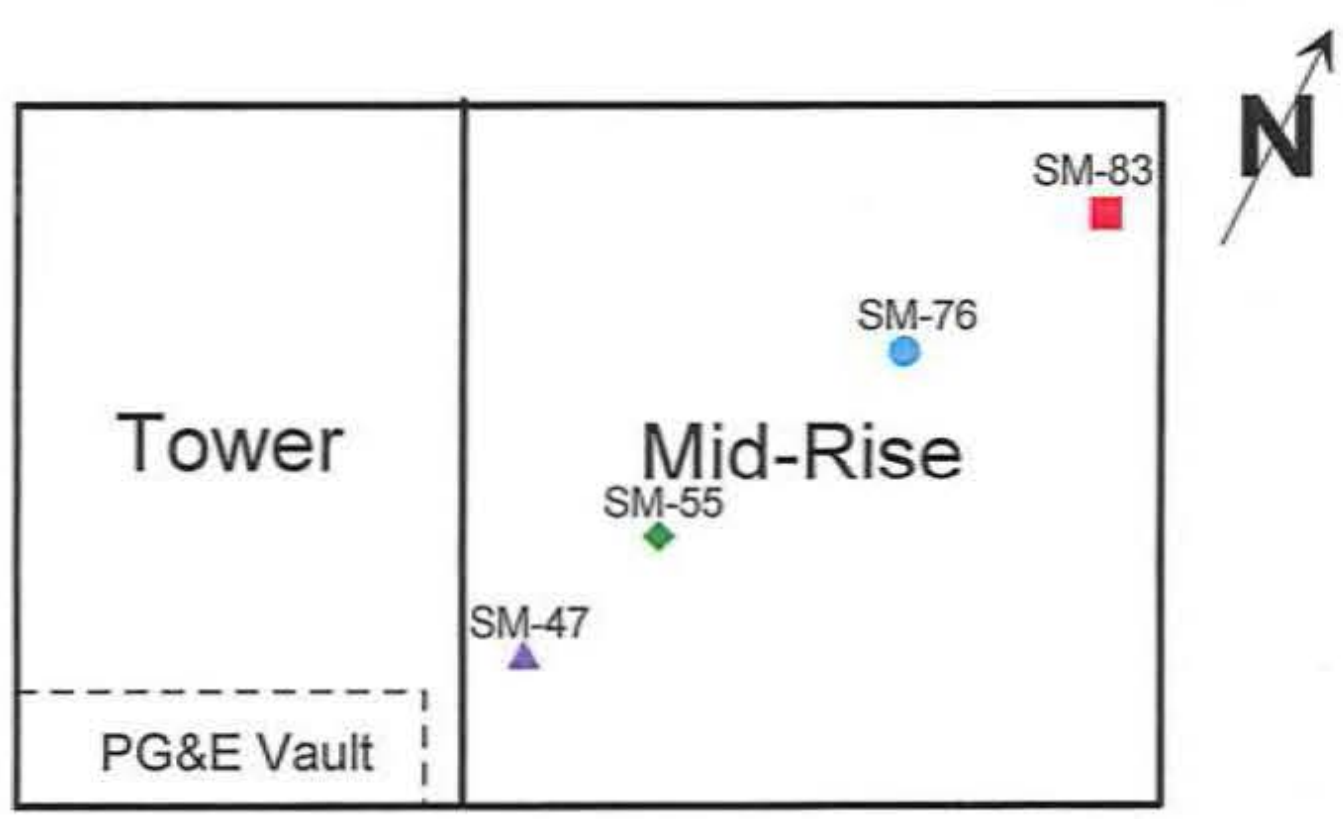
SETTLEMENT OVER TIME
FLOOR ELEVATIONS AT LEVEL B-1
OF 301 MISSION PROPERTY- MID-RISE:
APRIL 30, 2009 THROUGH SEPTEMBER 8, 2011

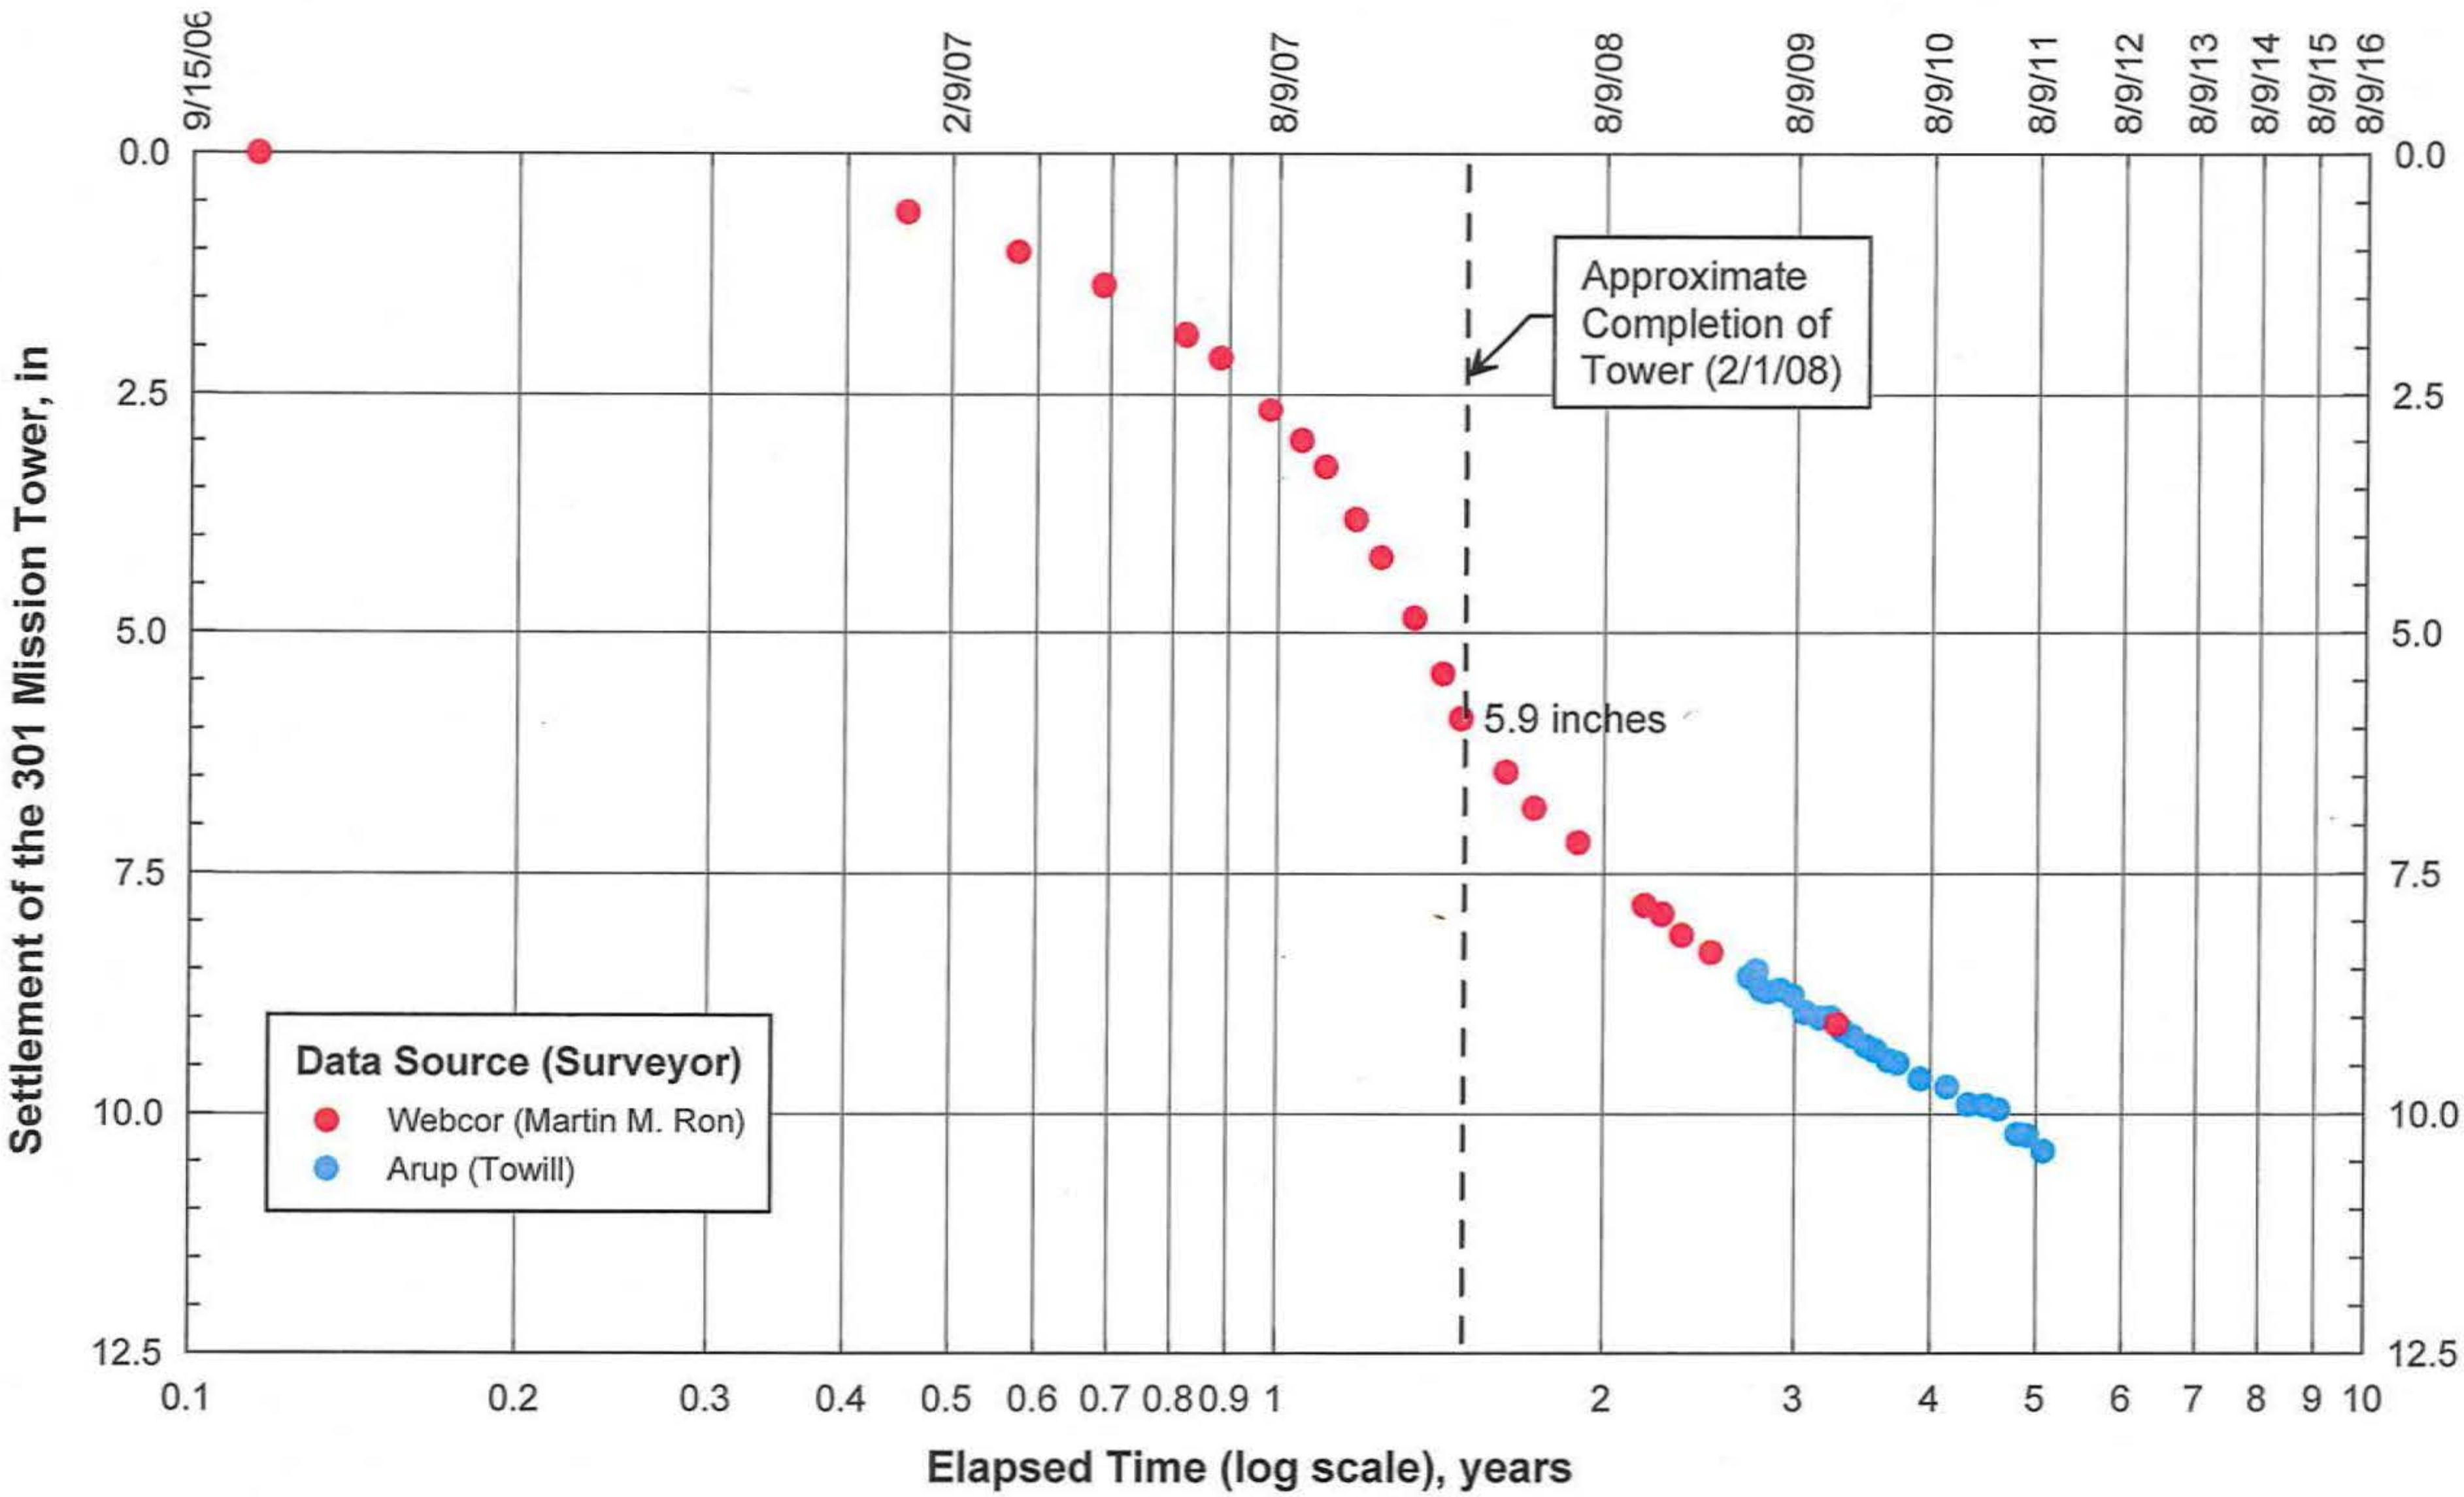
PLATE 6

Begining of Tower Construction: 8/9/06
End of Tower Construction: 2/1/08
Construction Duration: 542 days (1.5 years)

SETTLEMENTS OF THE 301 MISSION TOWER INCLUDING MONITORING DURING CONSTRUCTION

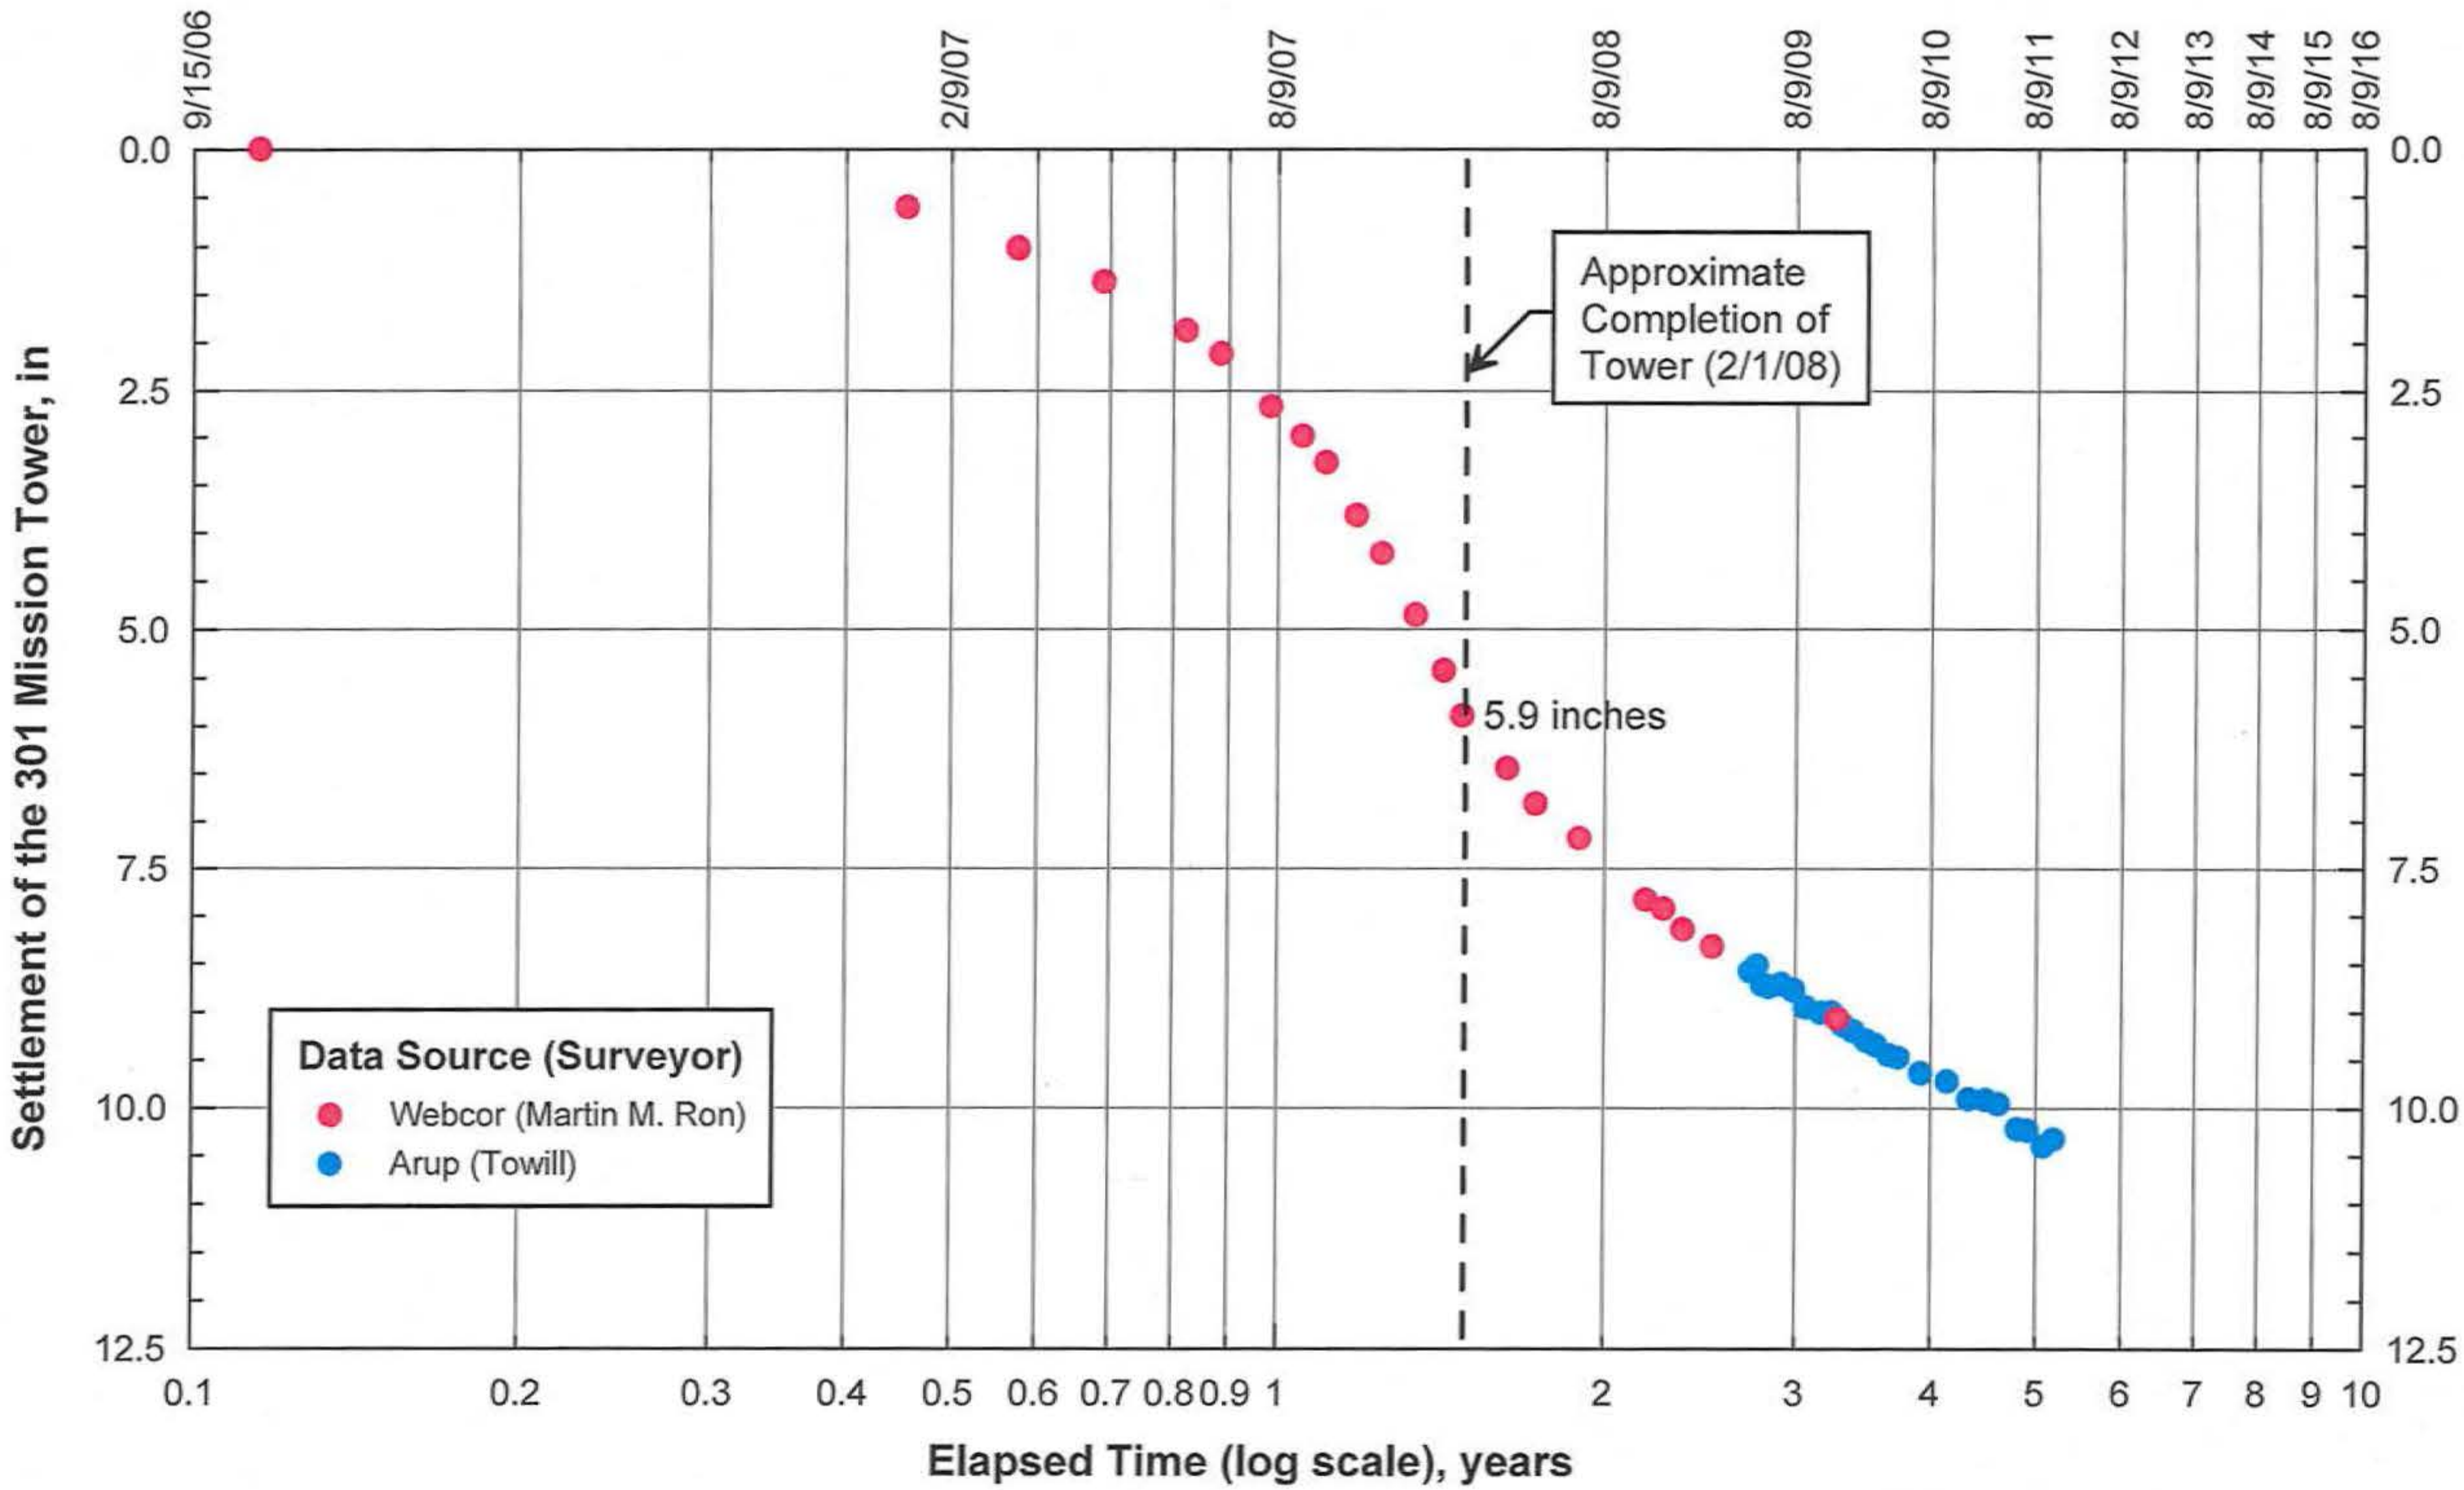
PLATE 6

Begining of Tower Construction: 8/9/06
End of Tower Construction: 2/1/08
Construction Duration: 542 days (1.5 years)

SETTLEMENTS OF THE 301 MISSION TOWER INCLUDING MONITORING DURING CONSTRUCTION

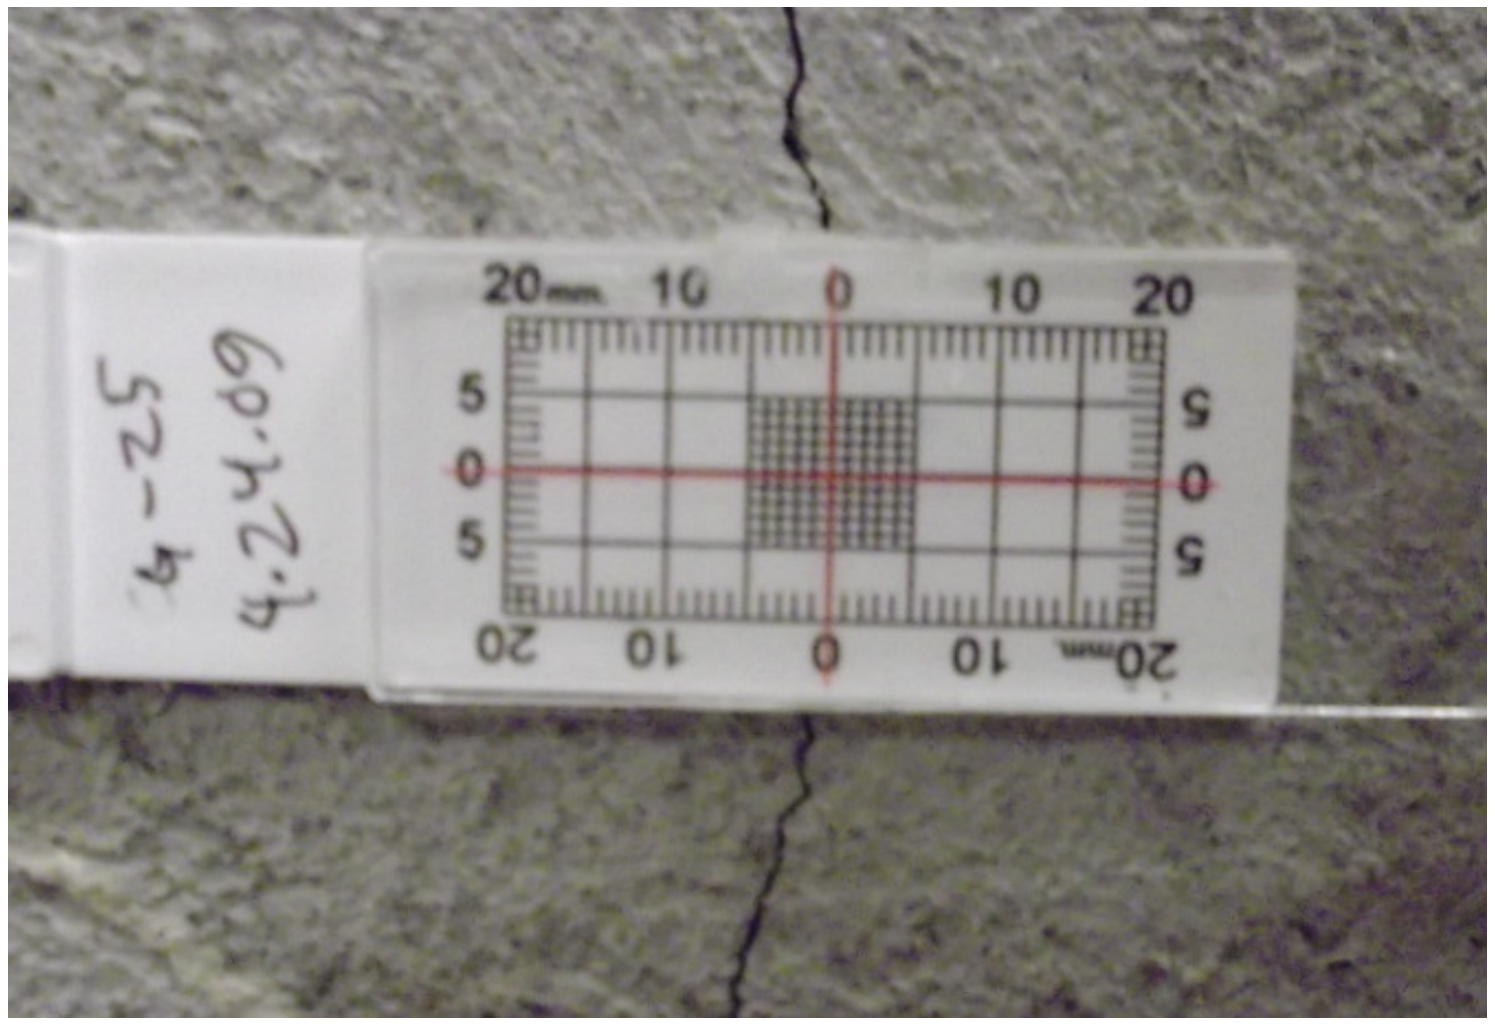
TABLE 1 SUMMARY OF CRACK GAUGES SHOWING MOVEMENT: DECEMBER 2011 - JANUARY 2012				
Crack Gauge	**Distance of Movement**	**Direction of movement, relative to the Crack**	**Variation from previous reading**	**Picture of Movement**
CG-25	0.5 mm	Parallel	+0.1 mm
