File No. 160975 **Committee Item No.** 7
Board Item No. ________

AGENDA PACKET CONTENTS LIST

TALL BUILDINGS SAFETY STRATEGY

October 2018

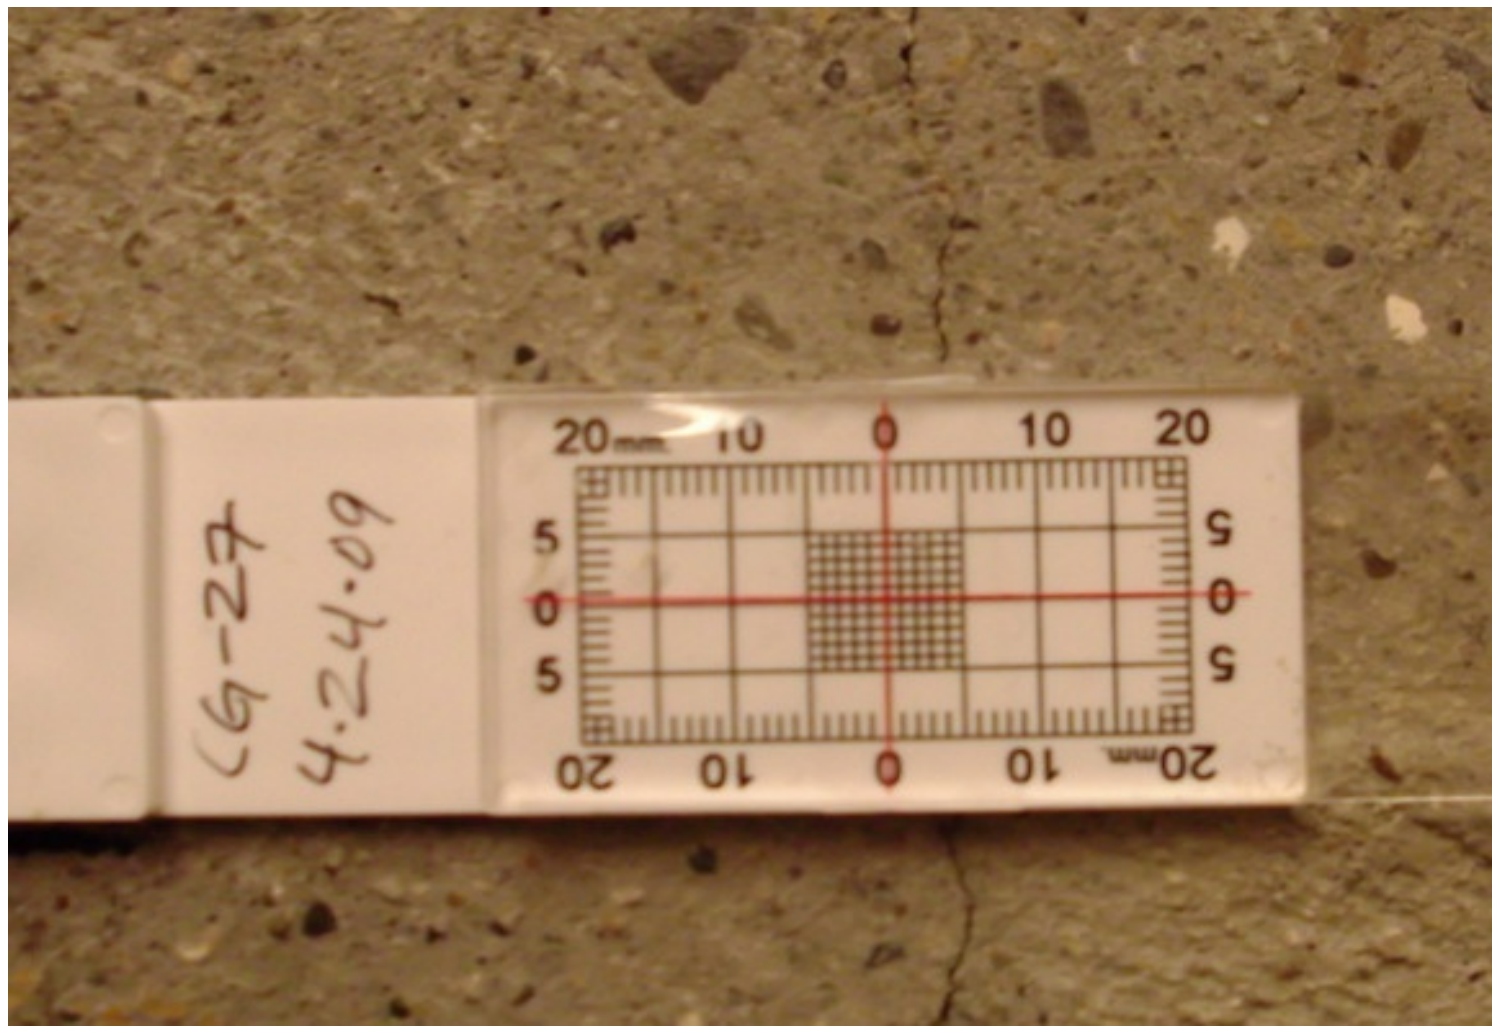
CG-27	0.5 mm	Parallel	Same as previous reading

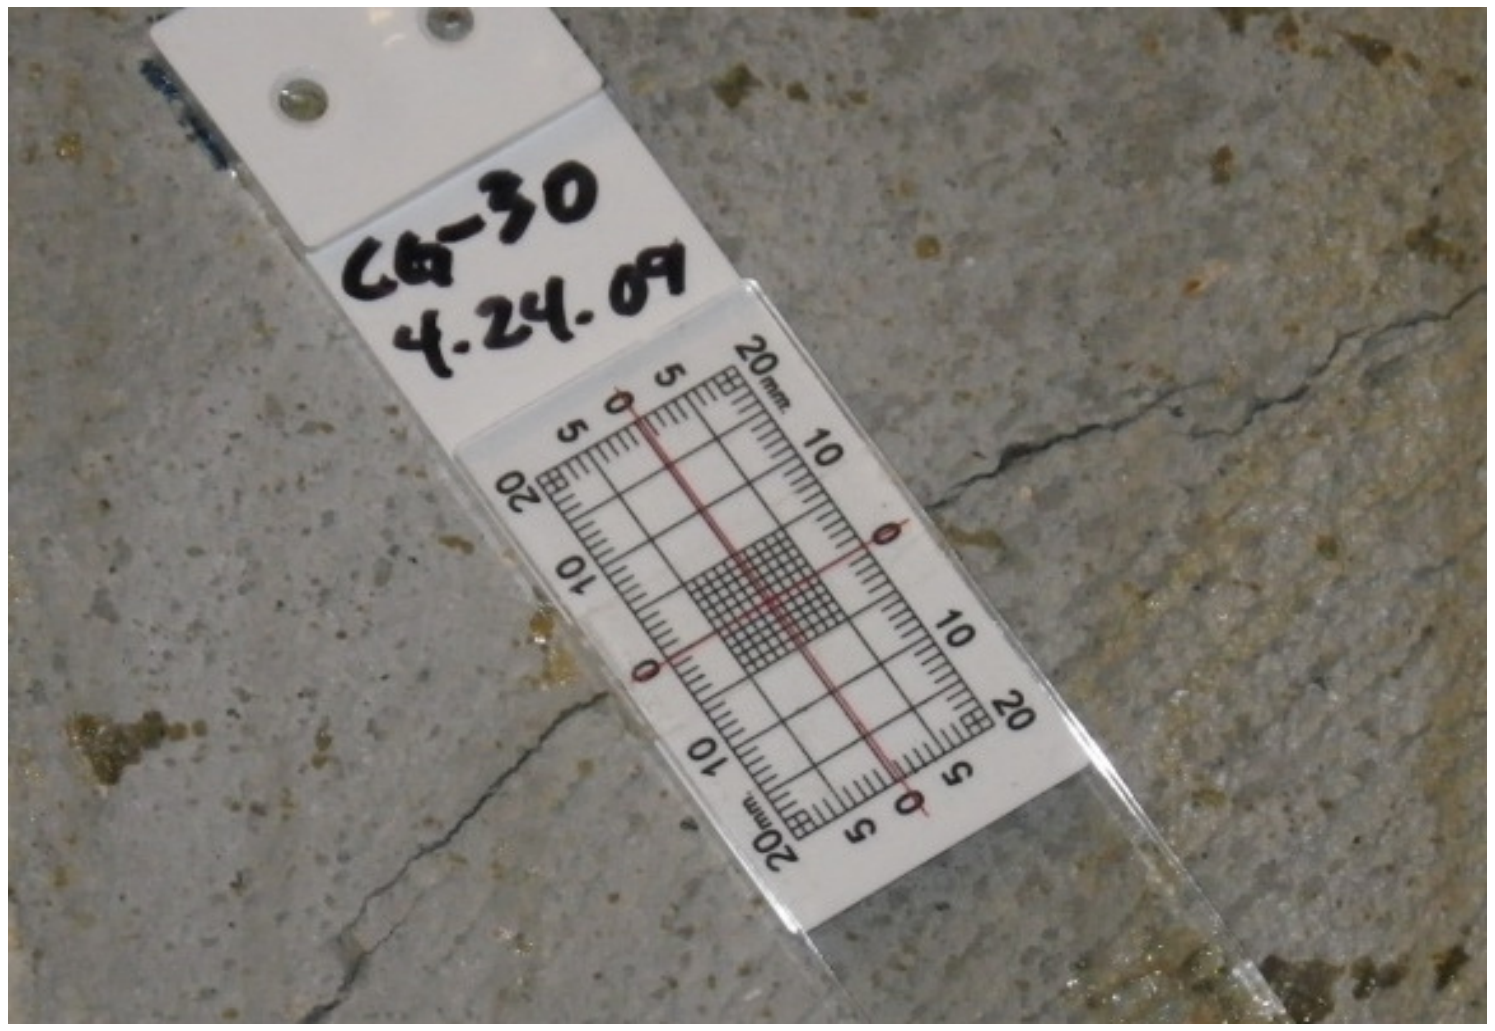
TABLE 1 SUMMARY OF CRACK GAUGES SHOWING MOVEMENT: DECEMBER 2011 - JANUARY 2012				
Crack Gauge	**Distance of Movement**	**Direction of movement, relative to the Crack**	**Variation from previous reading**	**Picture of Movement**
CG-30	0.5 mm	Parallel	+0.1 mm

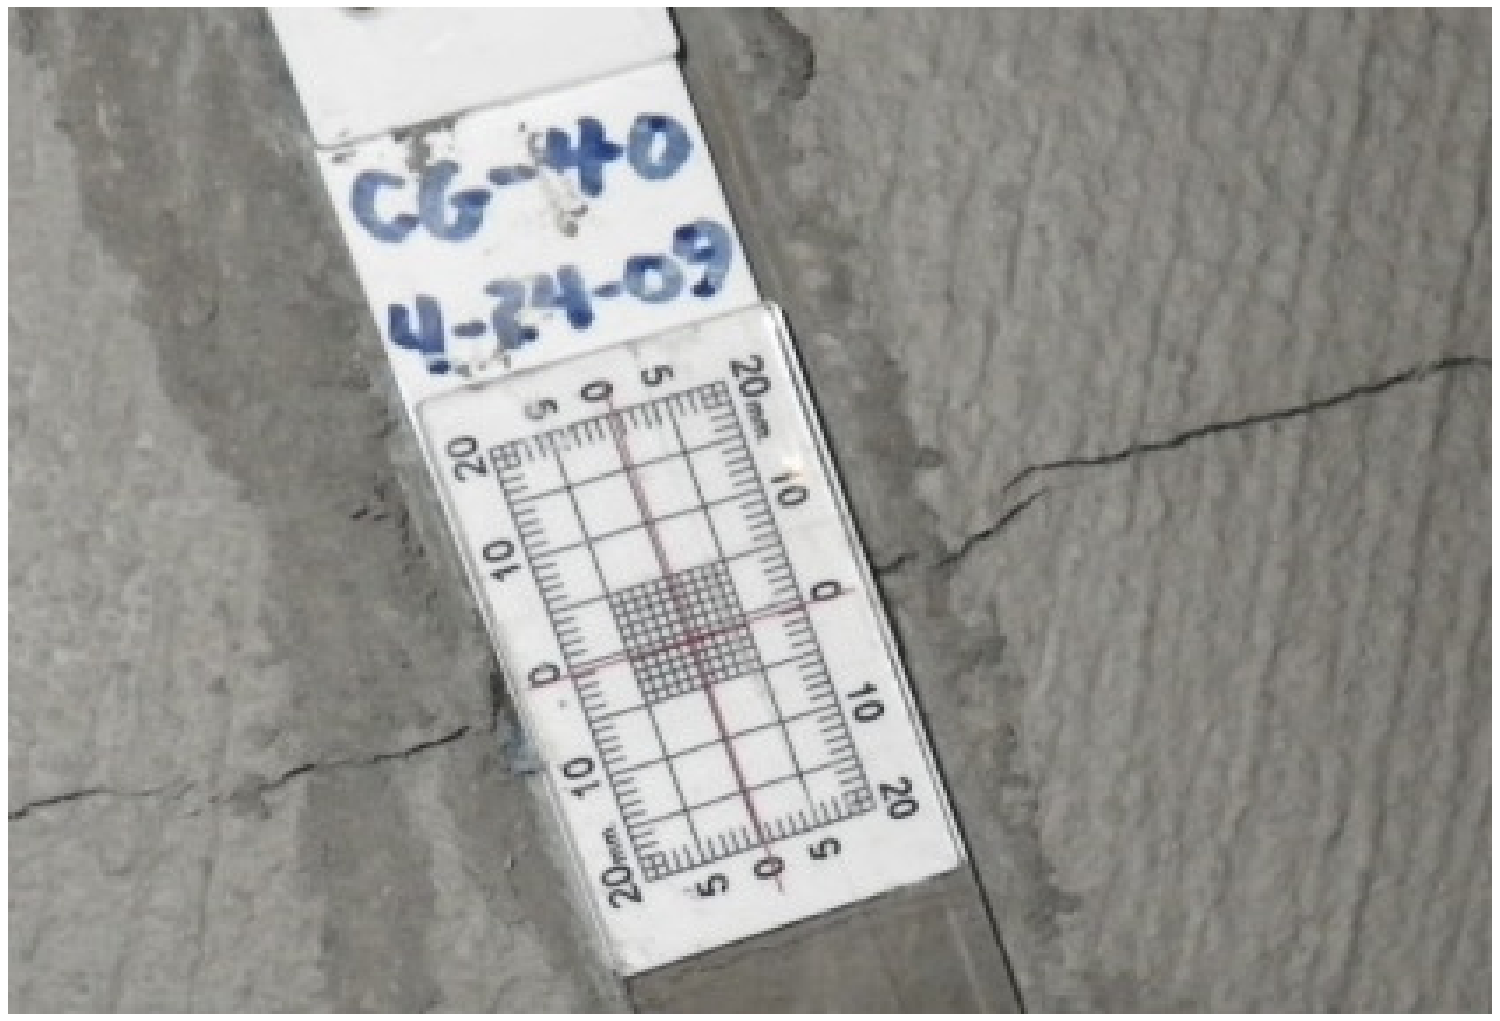
CG-40	0.9 mm 0.7 to 0.2 mm	Parallel Perpendicular	+0.9 mm +0.7 to +0.1 mm

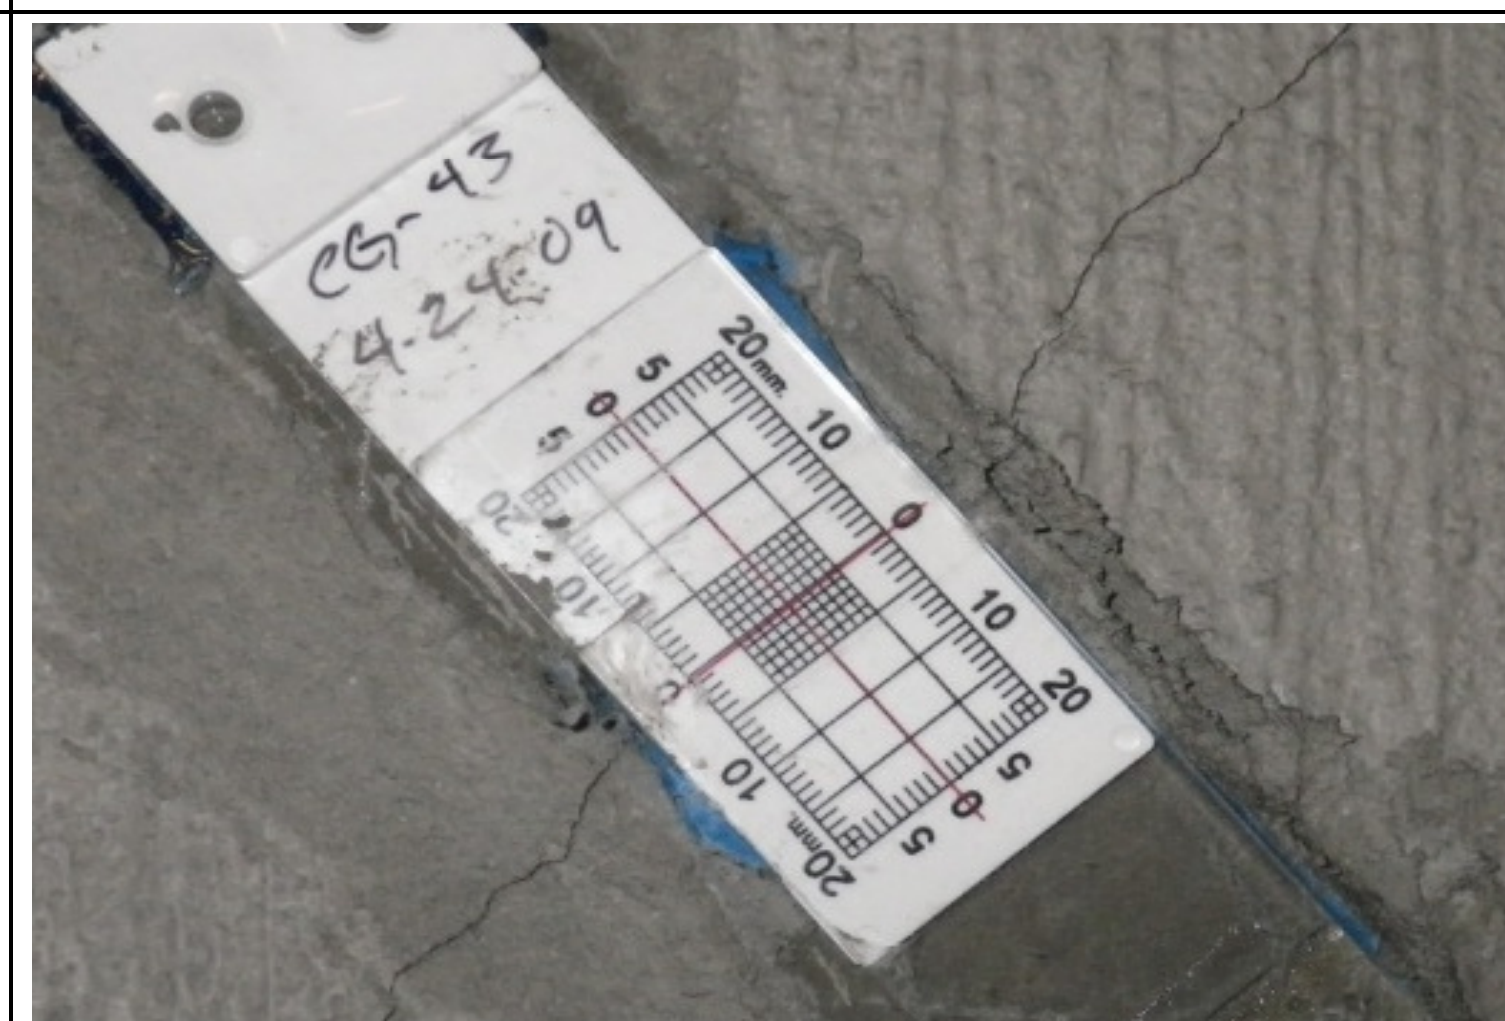
TABLE 1 SUMMARY OF CRACK GAUGES SHOWING MOVEMENT: DECEMBER 2011 - JANUARY 2012				
Crack Gauge	**Distance of Movement**	**Direction of movement, relative to the Crack**	**Variation from previous reading**	**Picture of Movement**
CG-41	0.5 mm	Parallel	+0.5 mm	
CG-43	0.3 mm	Perpendicular	Same as previous reading

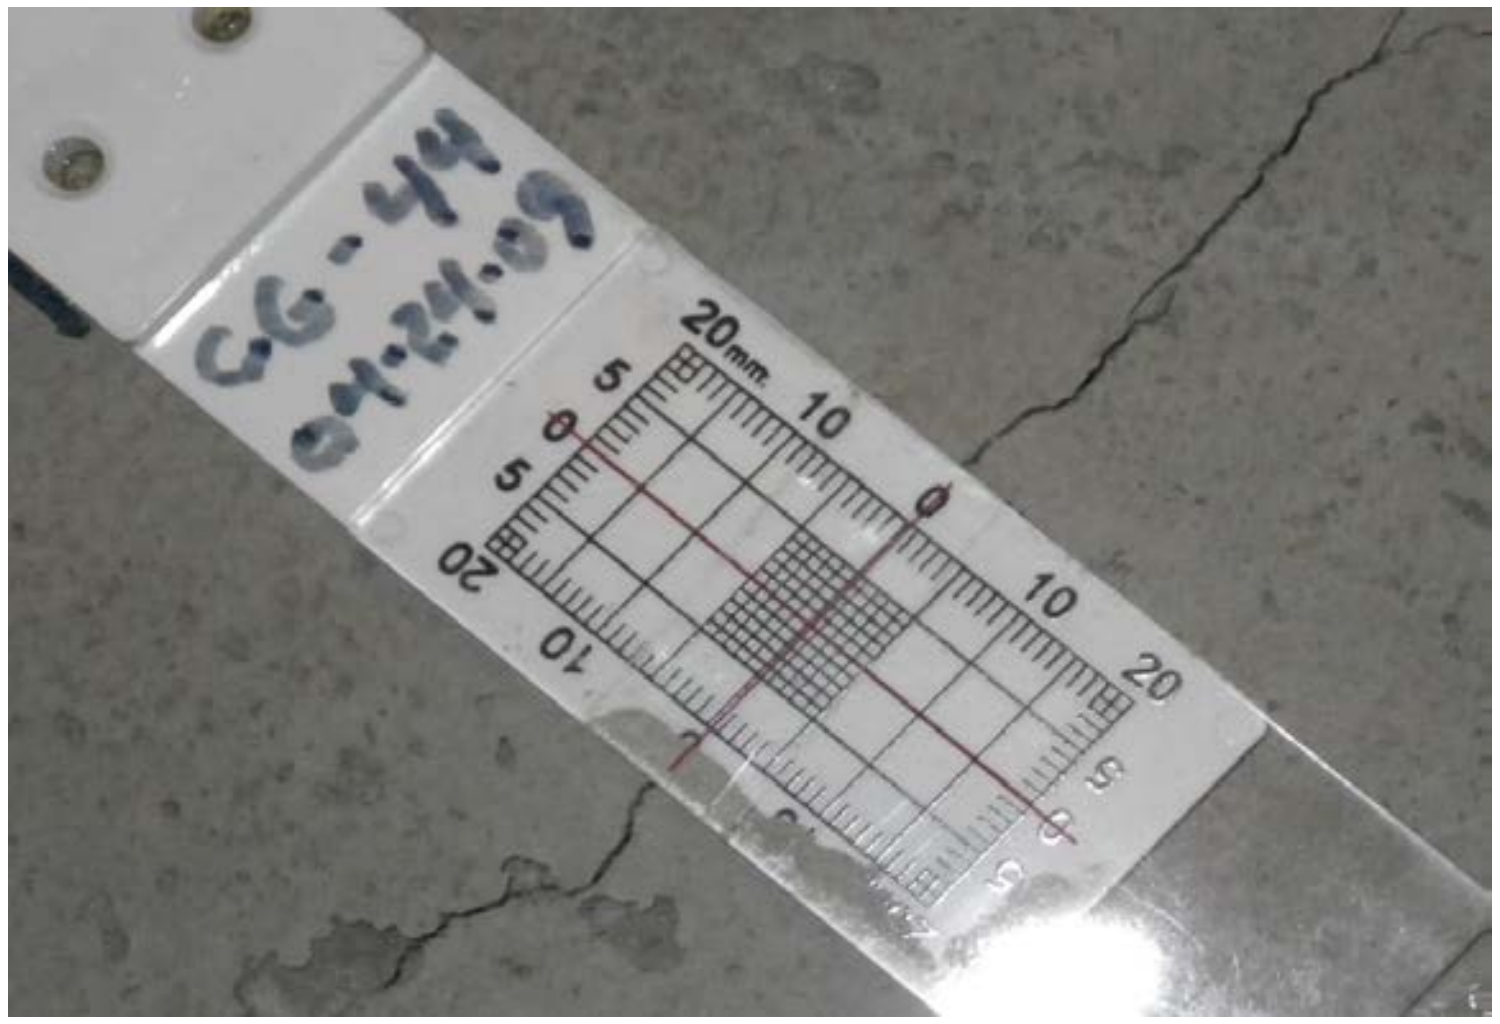
TABLE 1 SUMMARY OF CRACK GAUGES SHOWING MOVEMENT: DECEMBER 2011 - JANUARY 2012				
Crack Gauge	**Distance of Movement**	**Direction of movement, relative to the Crack**	**Variation from previous reading**	**Picture of Movement**
CG-44	0.3 mm	Perpendicular	+0.3 mm

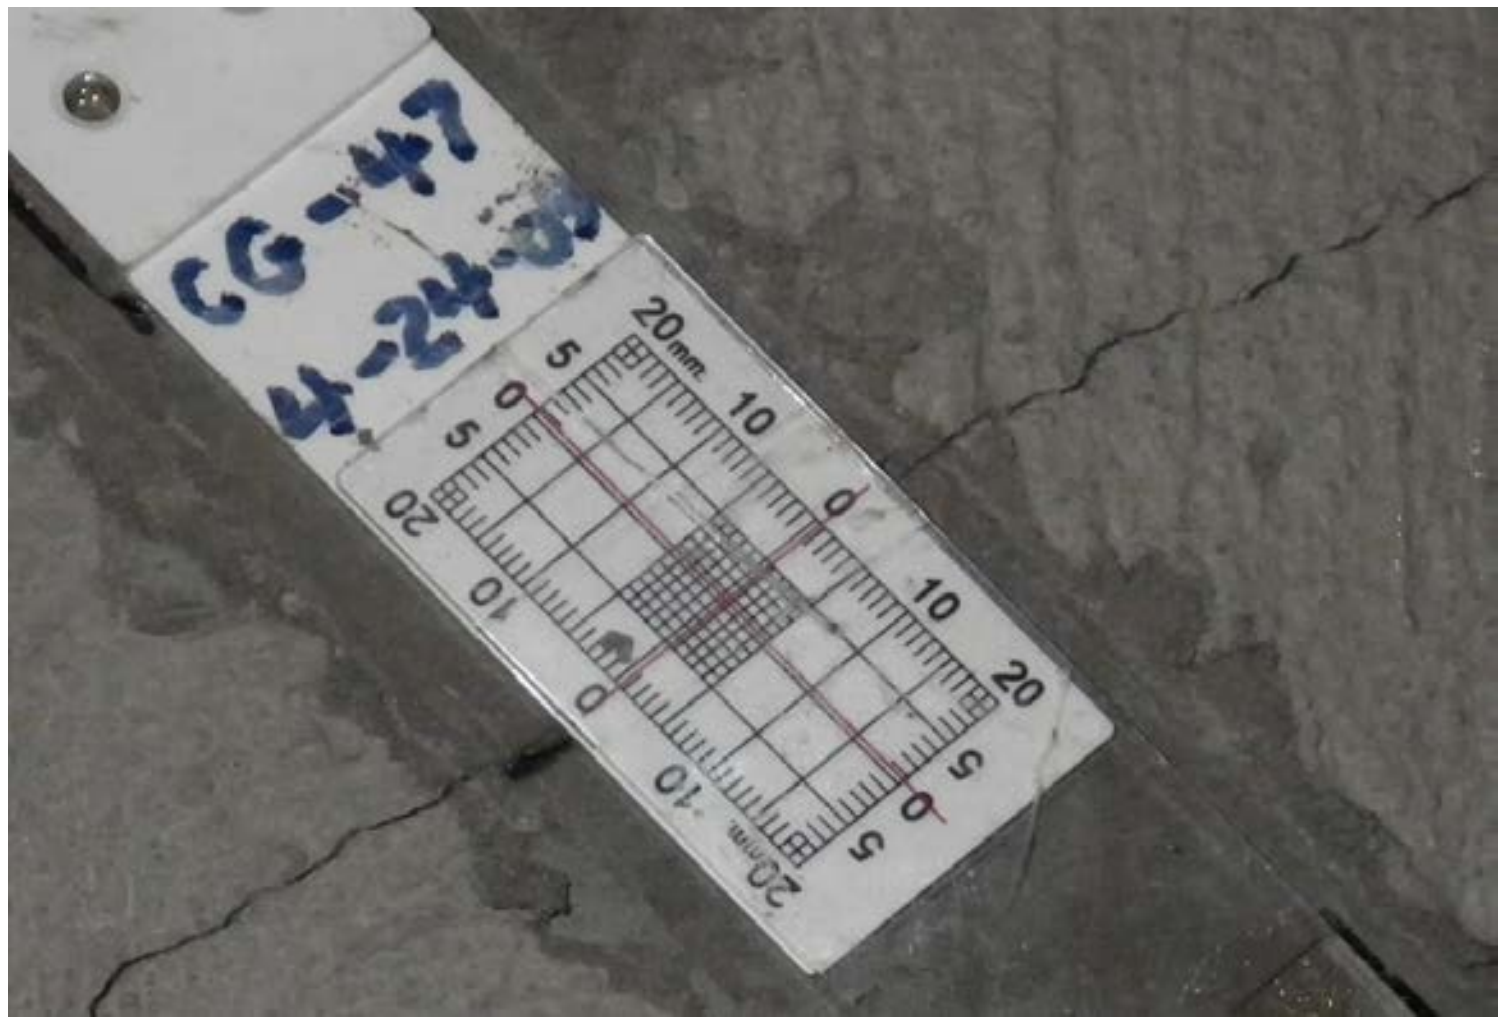
TABLE 1 SUMMARY OF CRACK GAUGES SHOWING MOVEMENT: DECEMBER 2011 - JANUARY 2012				
Crack Gauge	**Distance of Movement**	**Direction of movement, relative to the Crack**	**Variation from previous reading**	**Picture of Movement**
CG-47	0.5 to 0.8 mm 0.5 to 0.8 mm	Parallel Perpendicular	+0.5 to +0.8 mm +0.5 to +0.8 mm

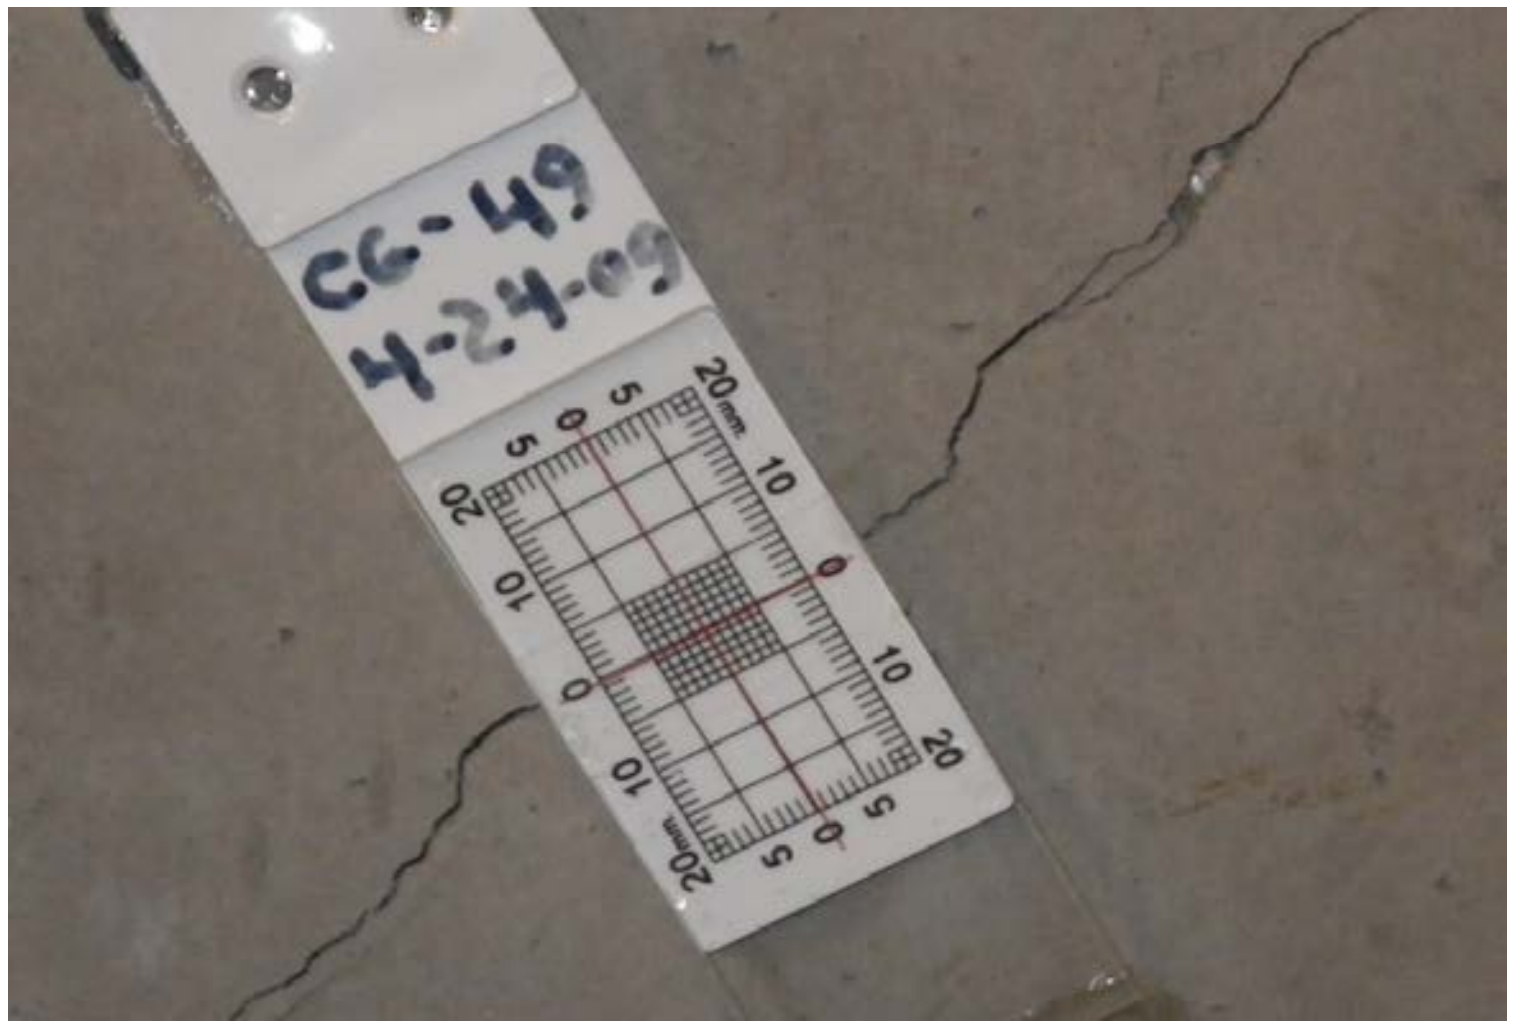
CG-49	0.4 mm	Perpendicular	+0.4 mm

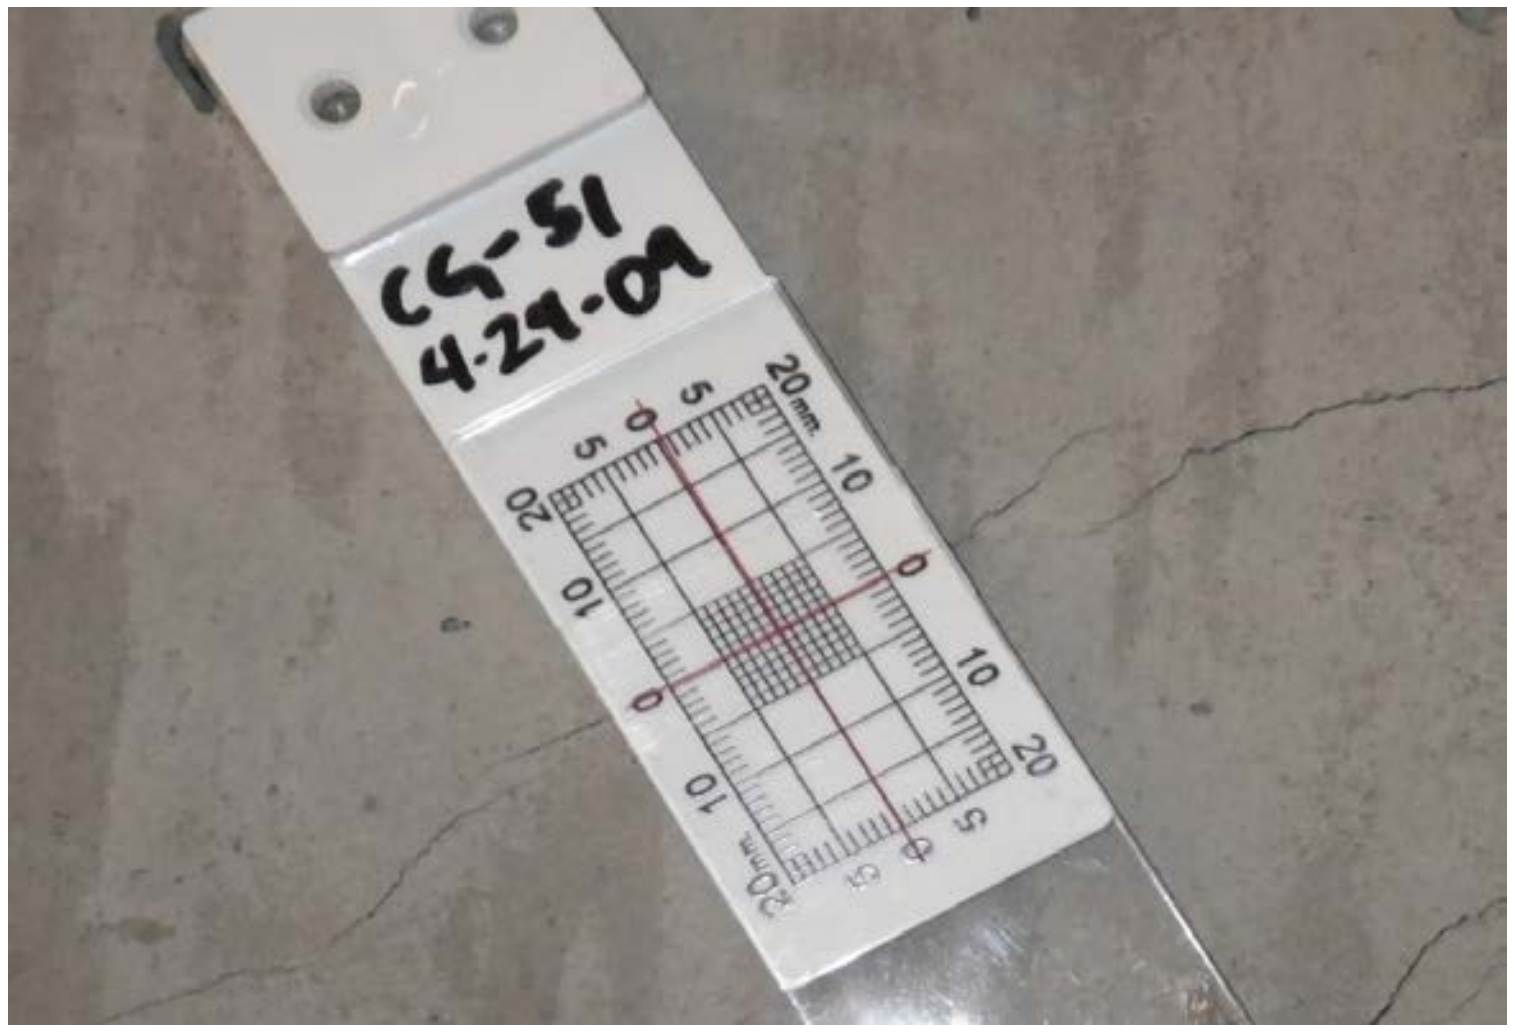
TABLE 1 SUMMARY OF CRACK GAUGES SHOWING MOVEMENT: DECEMBER 2011 - JANUARY 2012				
Crack Gauge	**Distance of Movement**	**Direction of movement, relative to the Crack**	**Variation from previous reading**	**Picture of Movement**
CG-51	0.5 mm	Parallel	Same as previous reading

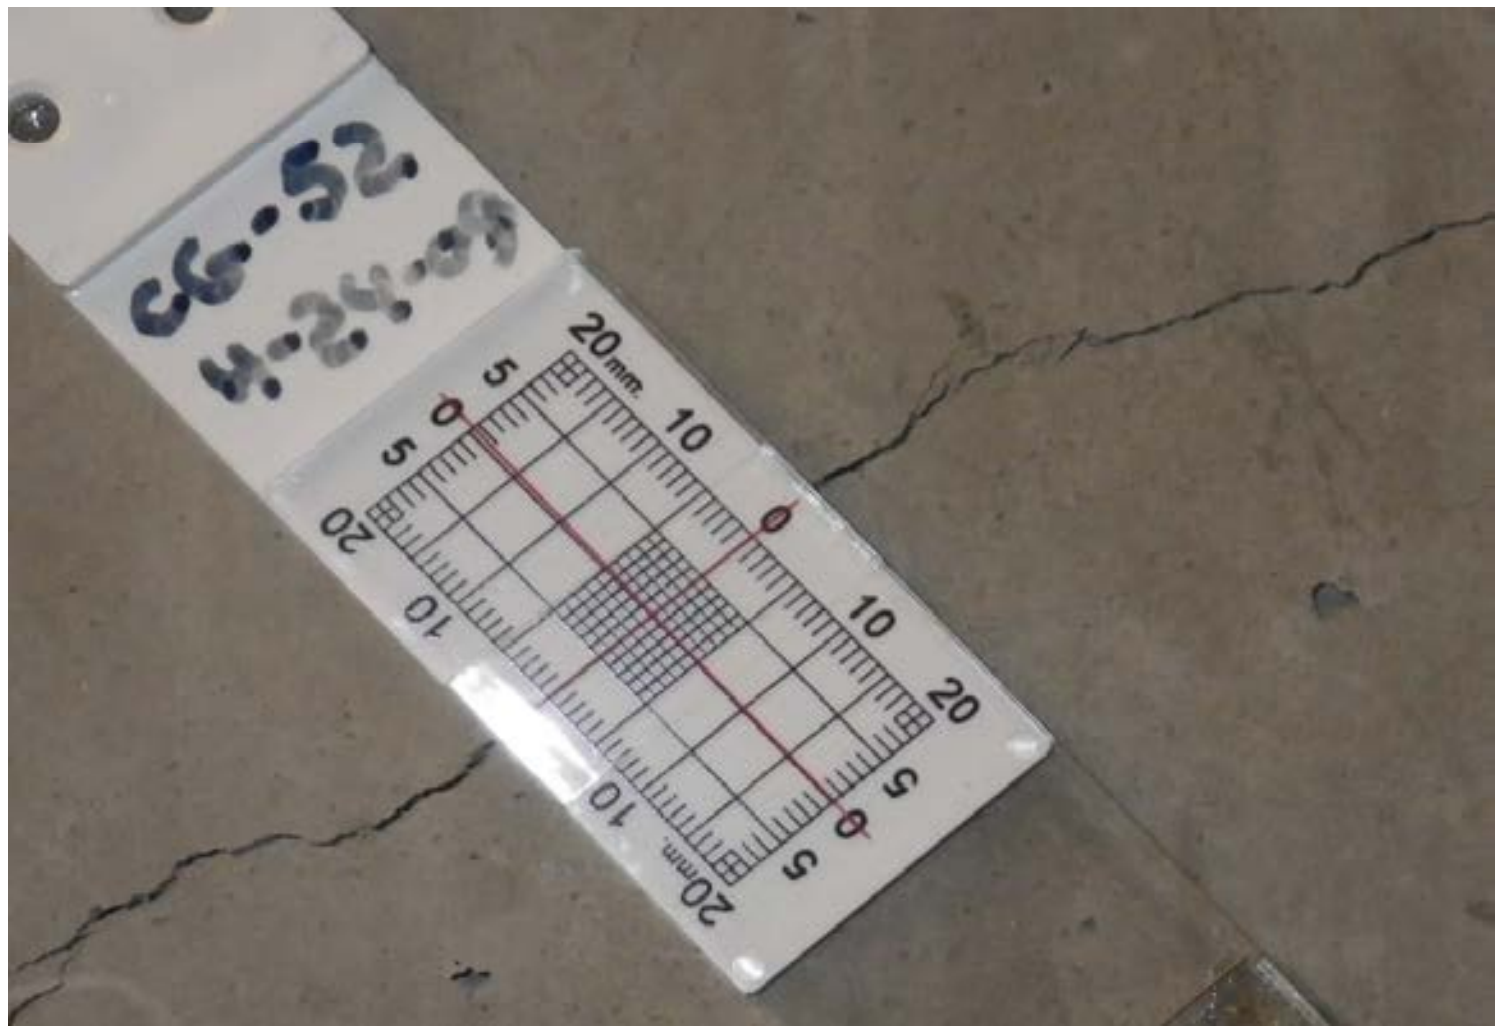
CG-52	0.5 mm	Parallel	Same as previous reading

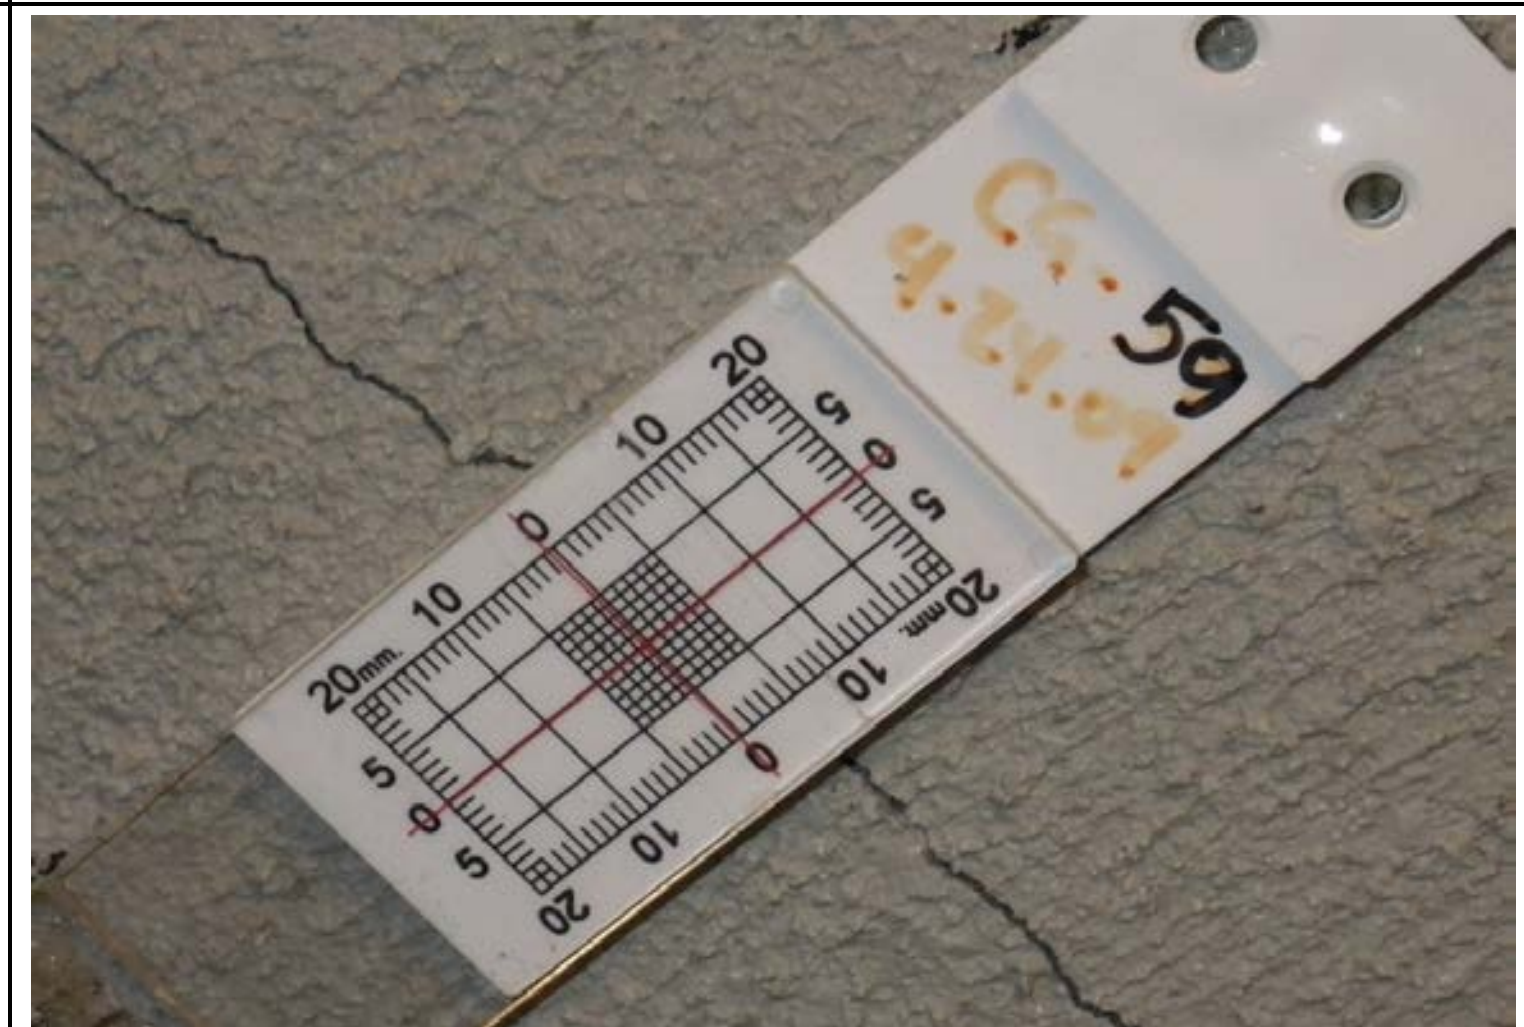
Crack Gauge	Distance of Movement	Direction of movement, relative to the Crack	Variation from previous reading	Picture of Movement
CG-59	0.5 mm	Perpendicular	+0.5 mm

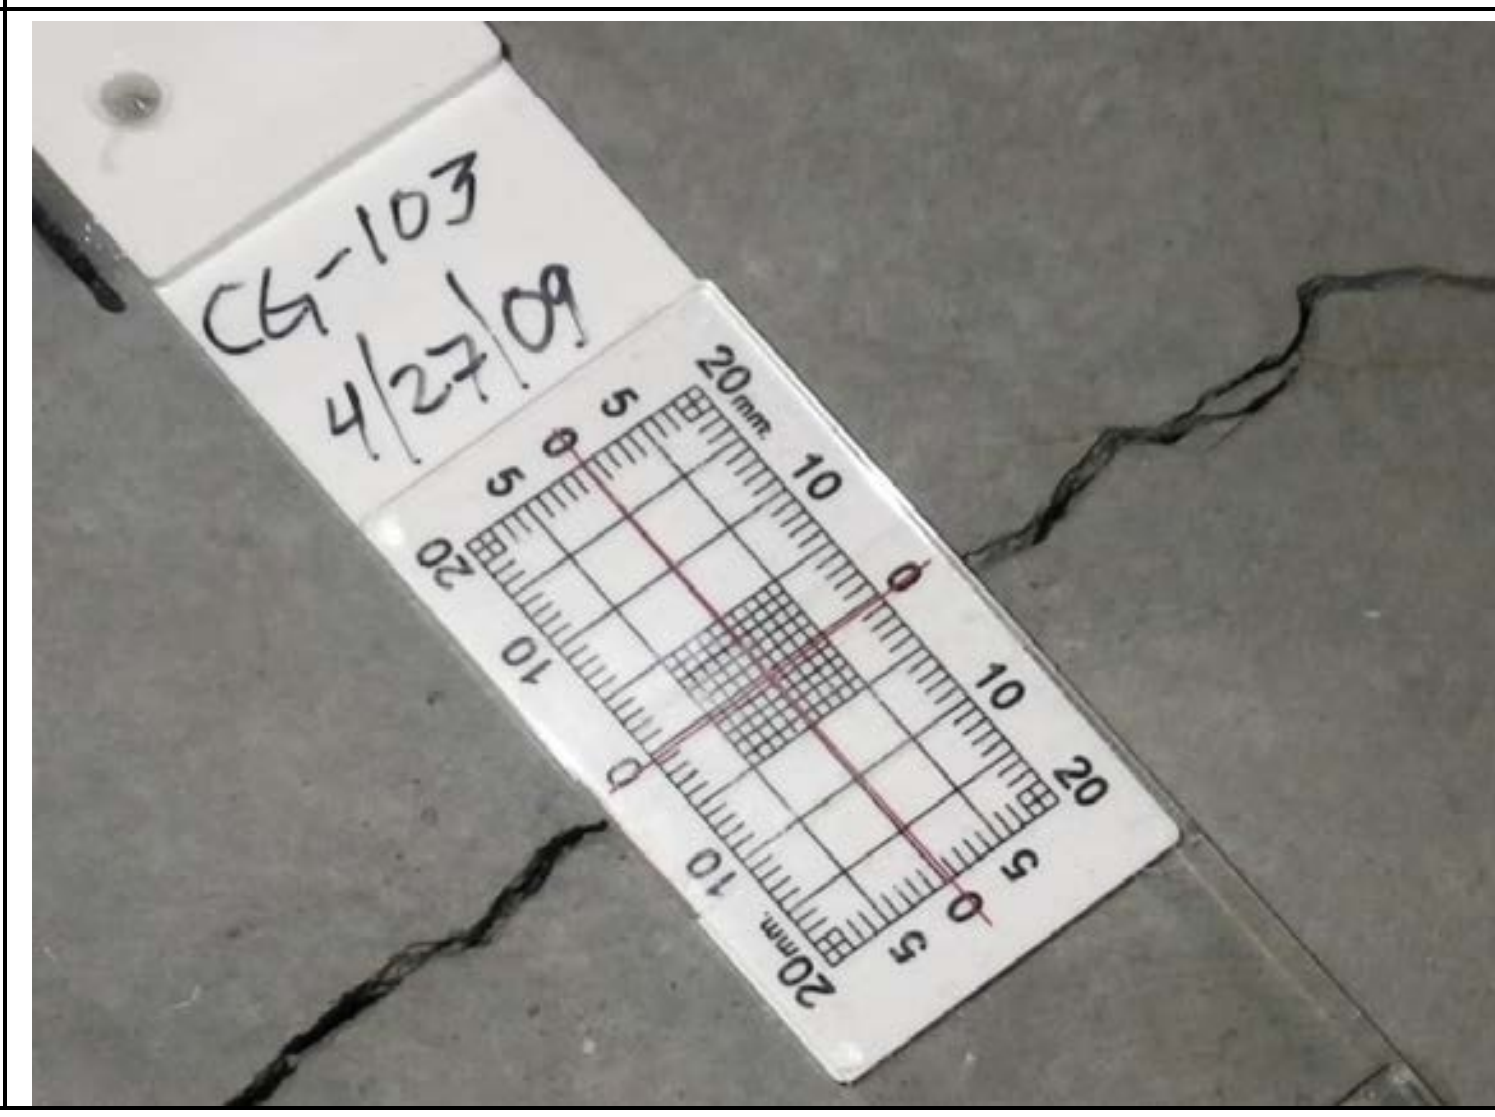
Crack Gauge	Distance of Movement	Direction of movement, relative to the Crack	Variation from previous reading	Picture of Movement
CG-76	0.5 mm	Perpendicular	+0.5 mm	
CG-103	0.5 mm 0.1 to 0.4 mm	Perpendicular Parallel	+0.5 mm +0.1 to +0.4 mm

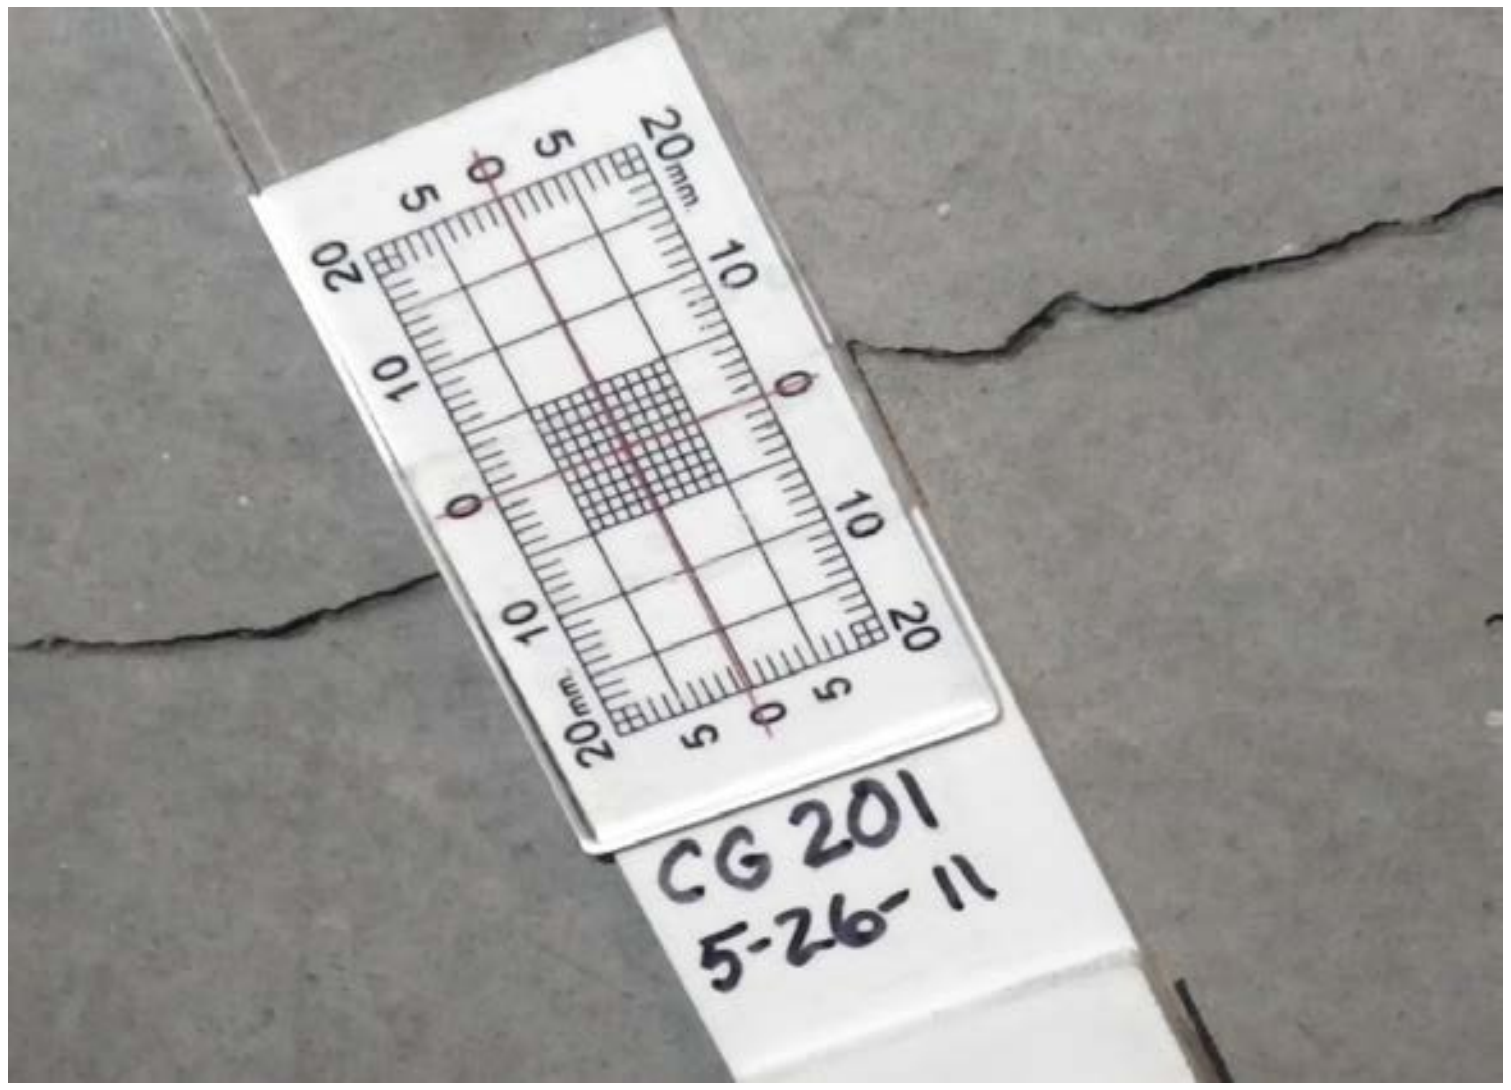
TABLE 1 SUMMARY OF CRACK GAUGES SHOWING MOVEMENT: DECEMBER 2011 - JANUARY 2012				
Crack Gauge	**Distance of Movement**	**Direction of movement, relative to the Crack**	**Variation from previous reading**	**Picture of Movement**
CG-201	0.4 mm	Parallel	+0.4 mm (from installation reading)

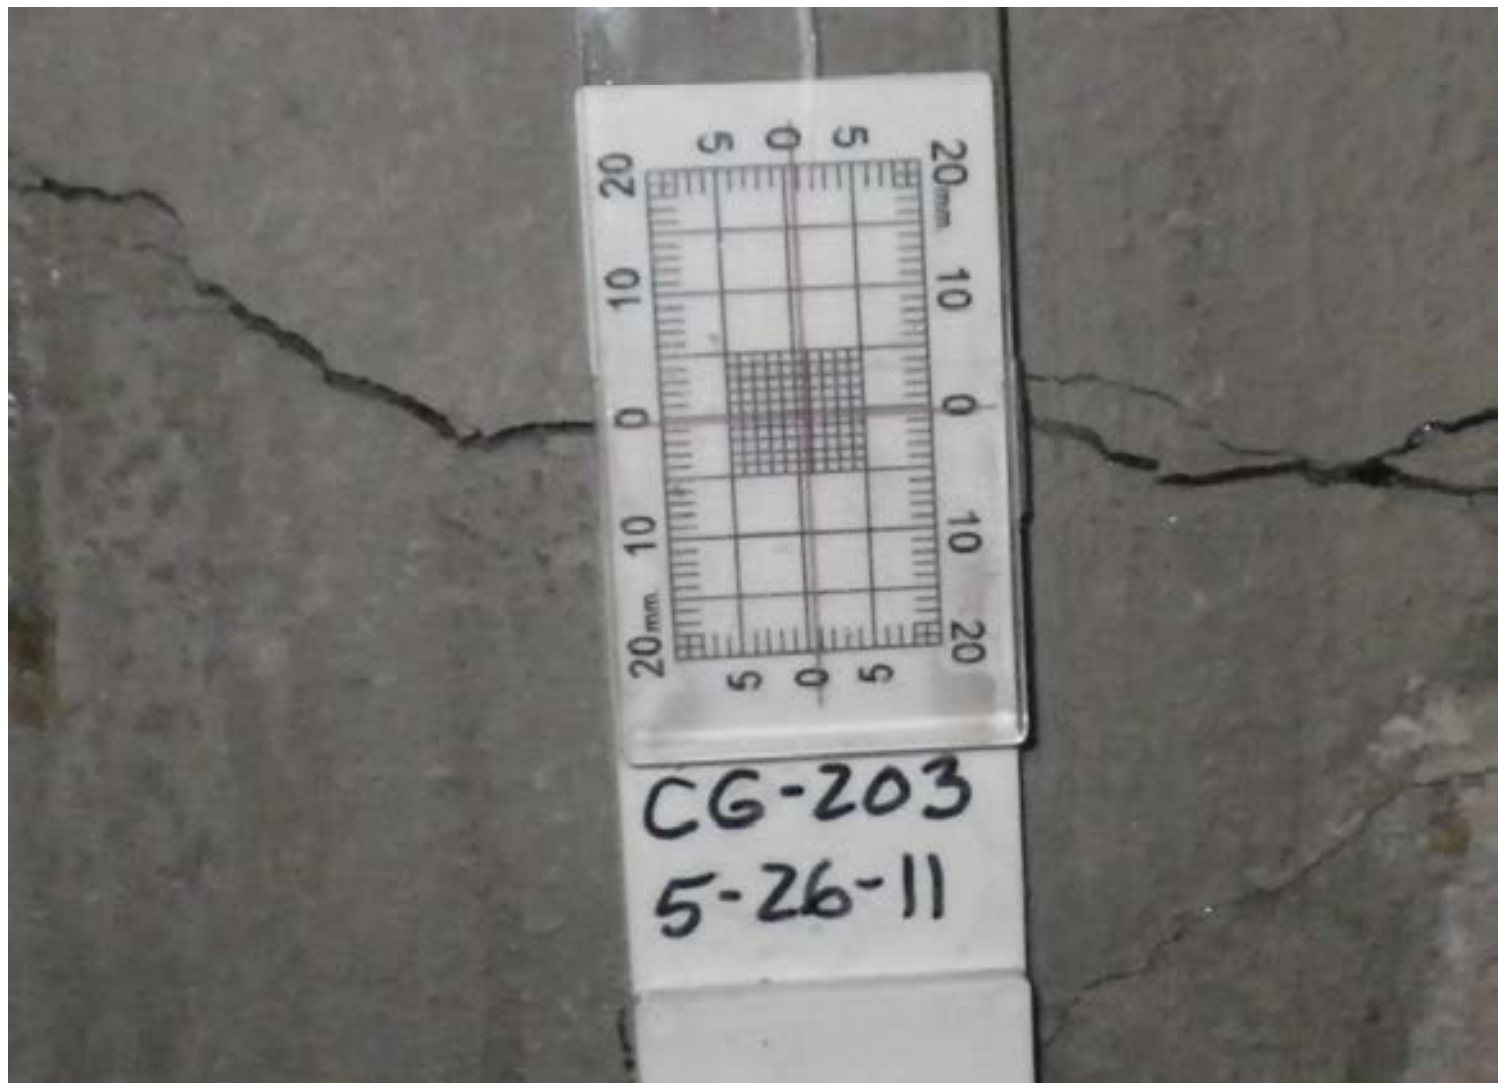
CG-203	0.3 mm 0.8 mm	Perpendicular Parallel	+0.3 mm +0.8 mm (from installation reading)

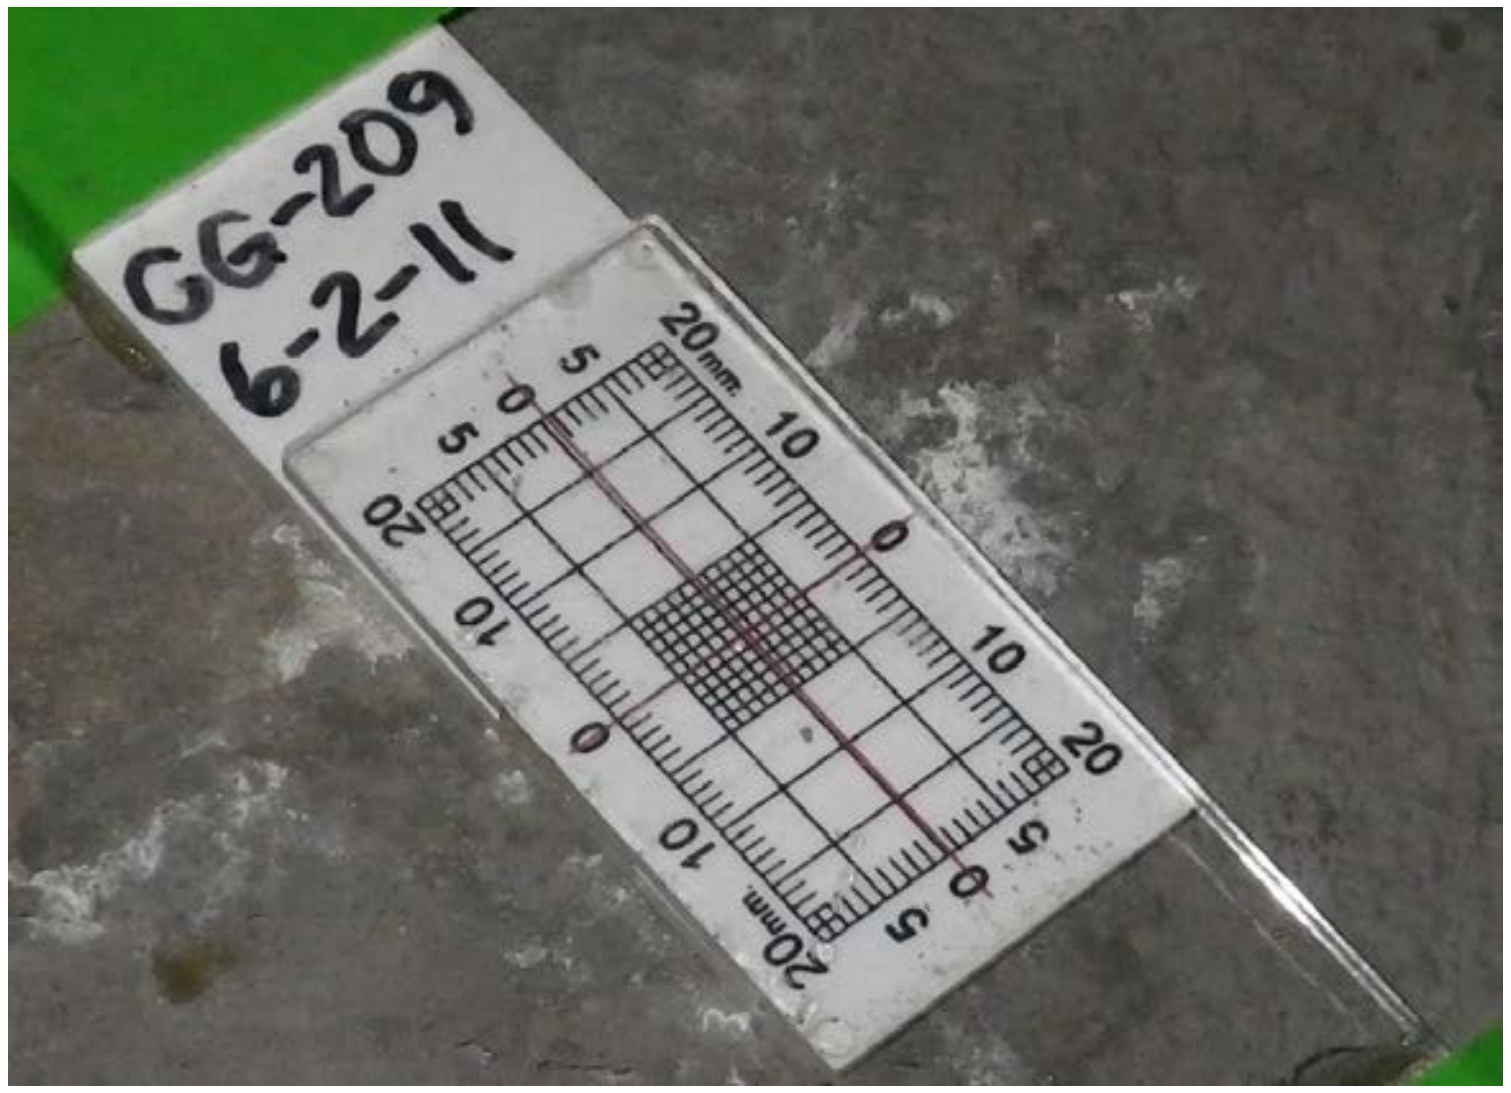
Crack Gauge	Distance of Movement	Direction of movement, relative to the Crack	Variation from previous reading	Picture of Movement
CG-209	0.5 mm	Parallel	+0.5 mm (from installation reading)
