File No. 160975 **Committee Item No.** 7
Board Item No. ________

AGENDA PACKET CONTENTS LIST

TALL BUILDINGS SAFETY STRATEGY

October 2018

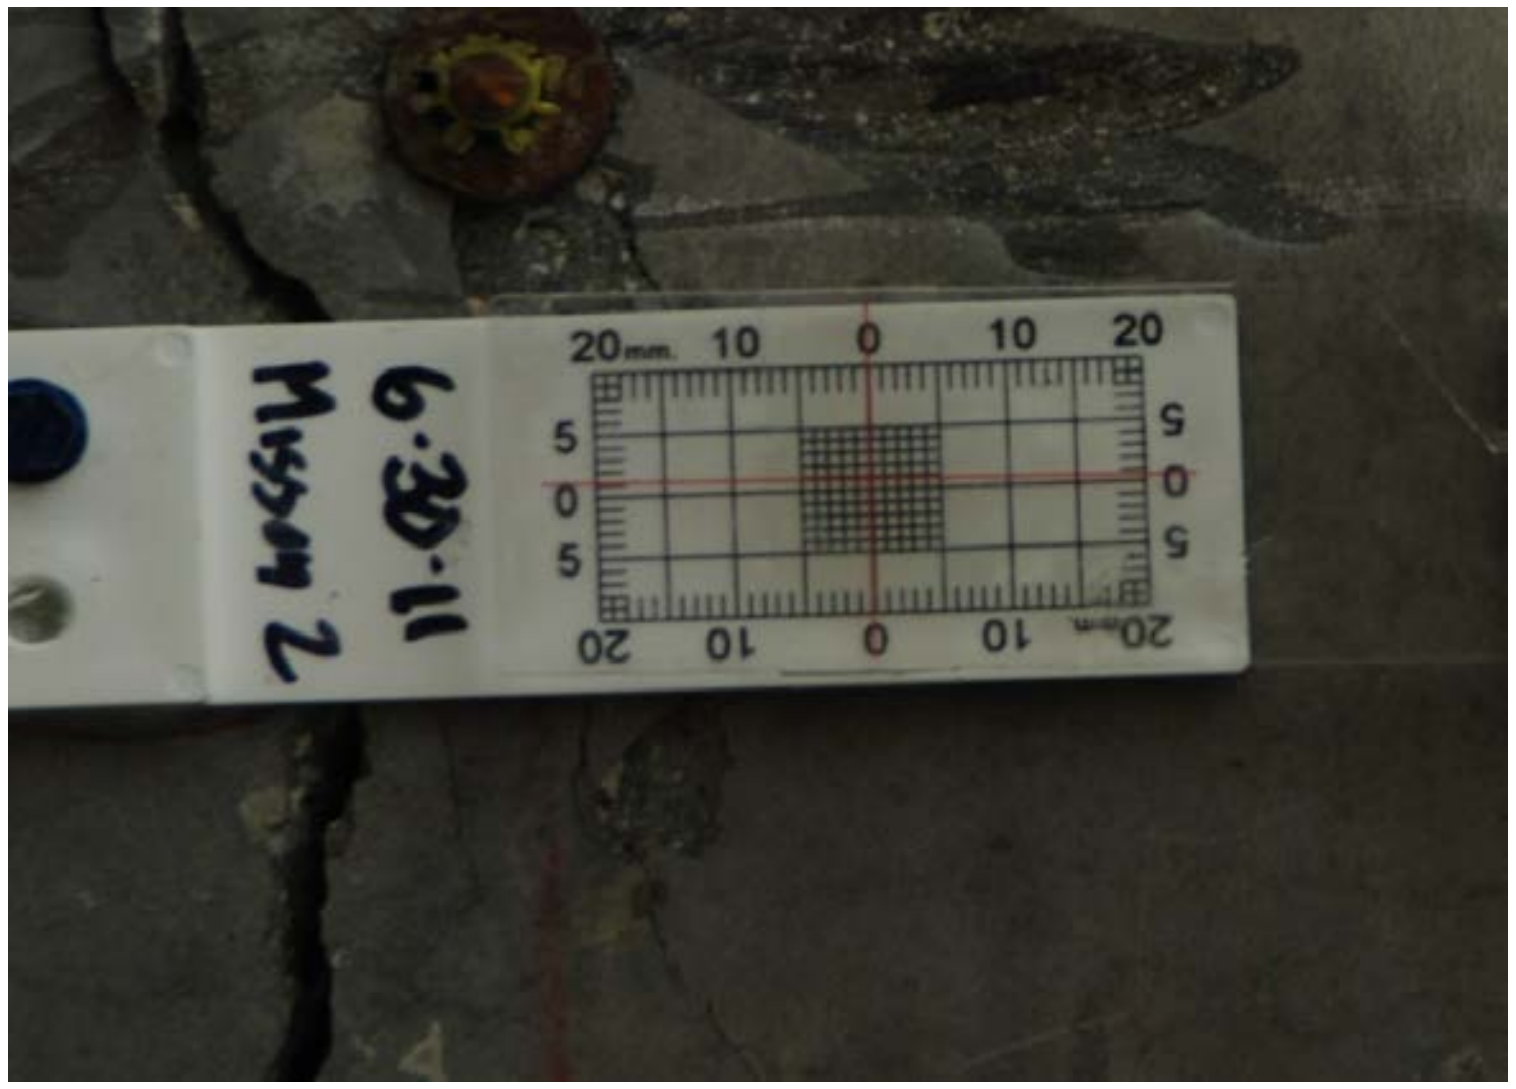
TABLE 1 SUMMARY OF CRACK GAUGES SHOWING MOVEMENT: DECEMBER 2011 - JANUARY 2012				
Crack Gauge	**Distance of Movement**	**Direction of movement, relative to the Crack**	**Variation from previous reading**	**Picture of Movement**
MISSION 2	0.7 to 1.1 mm	Parallel	+0.7 to 1.1 mm (from installation reading)

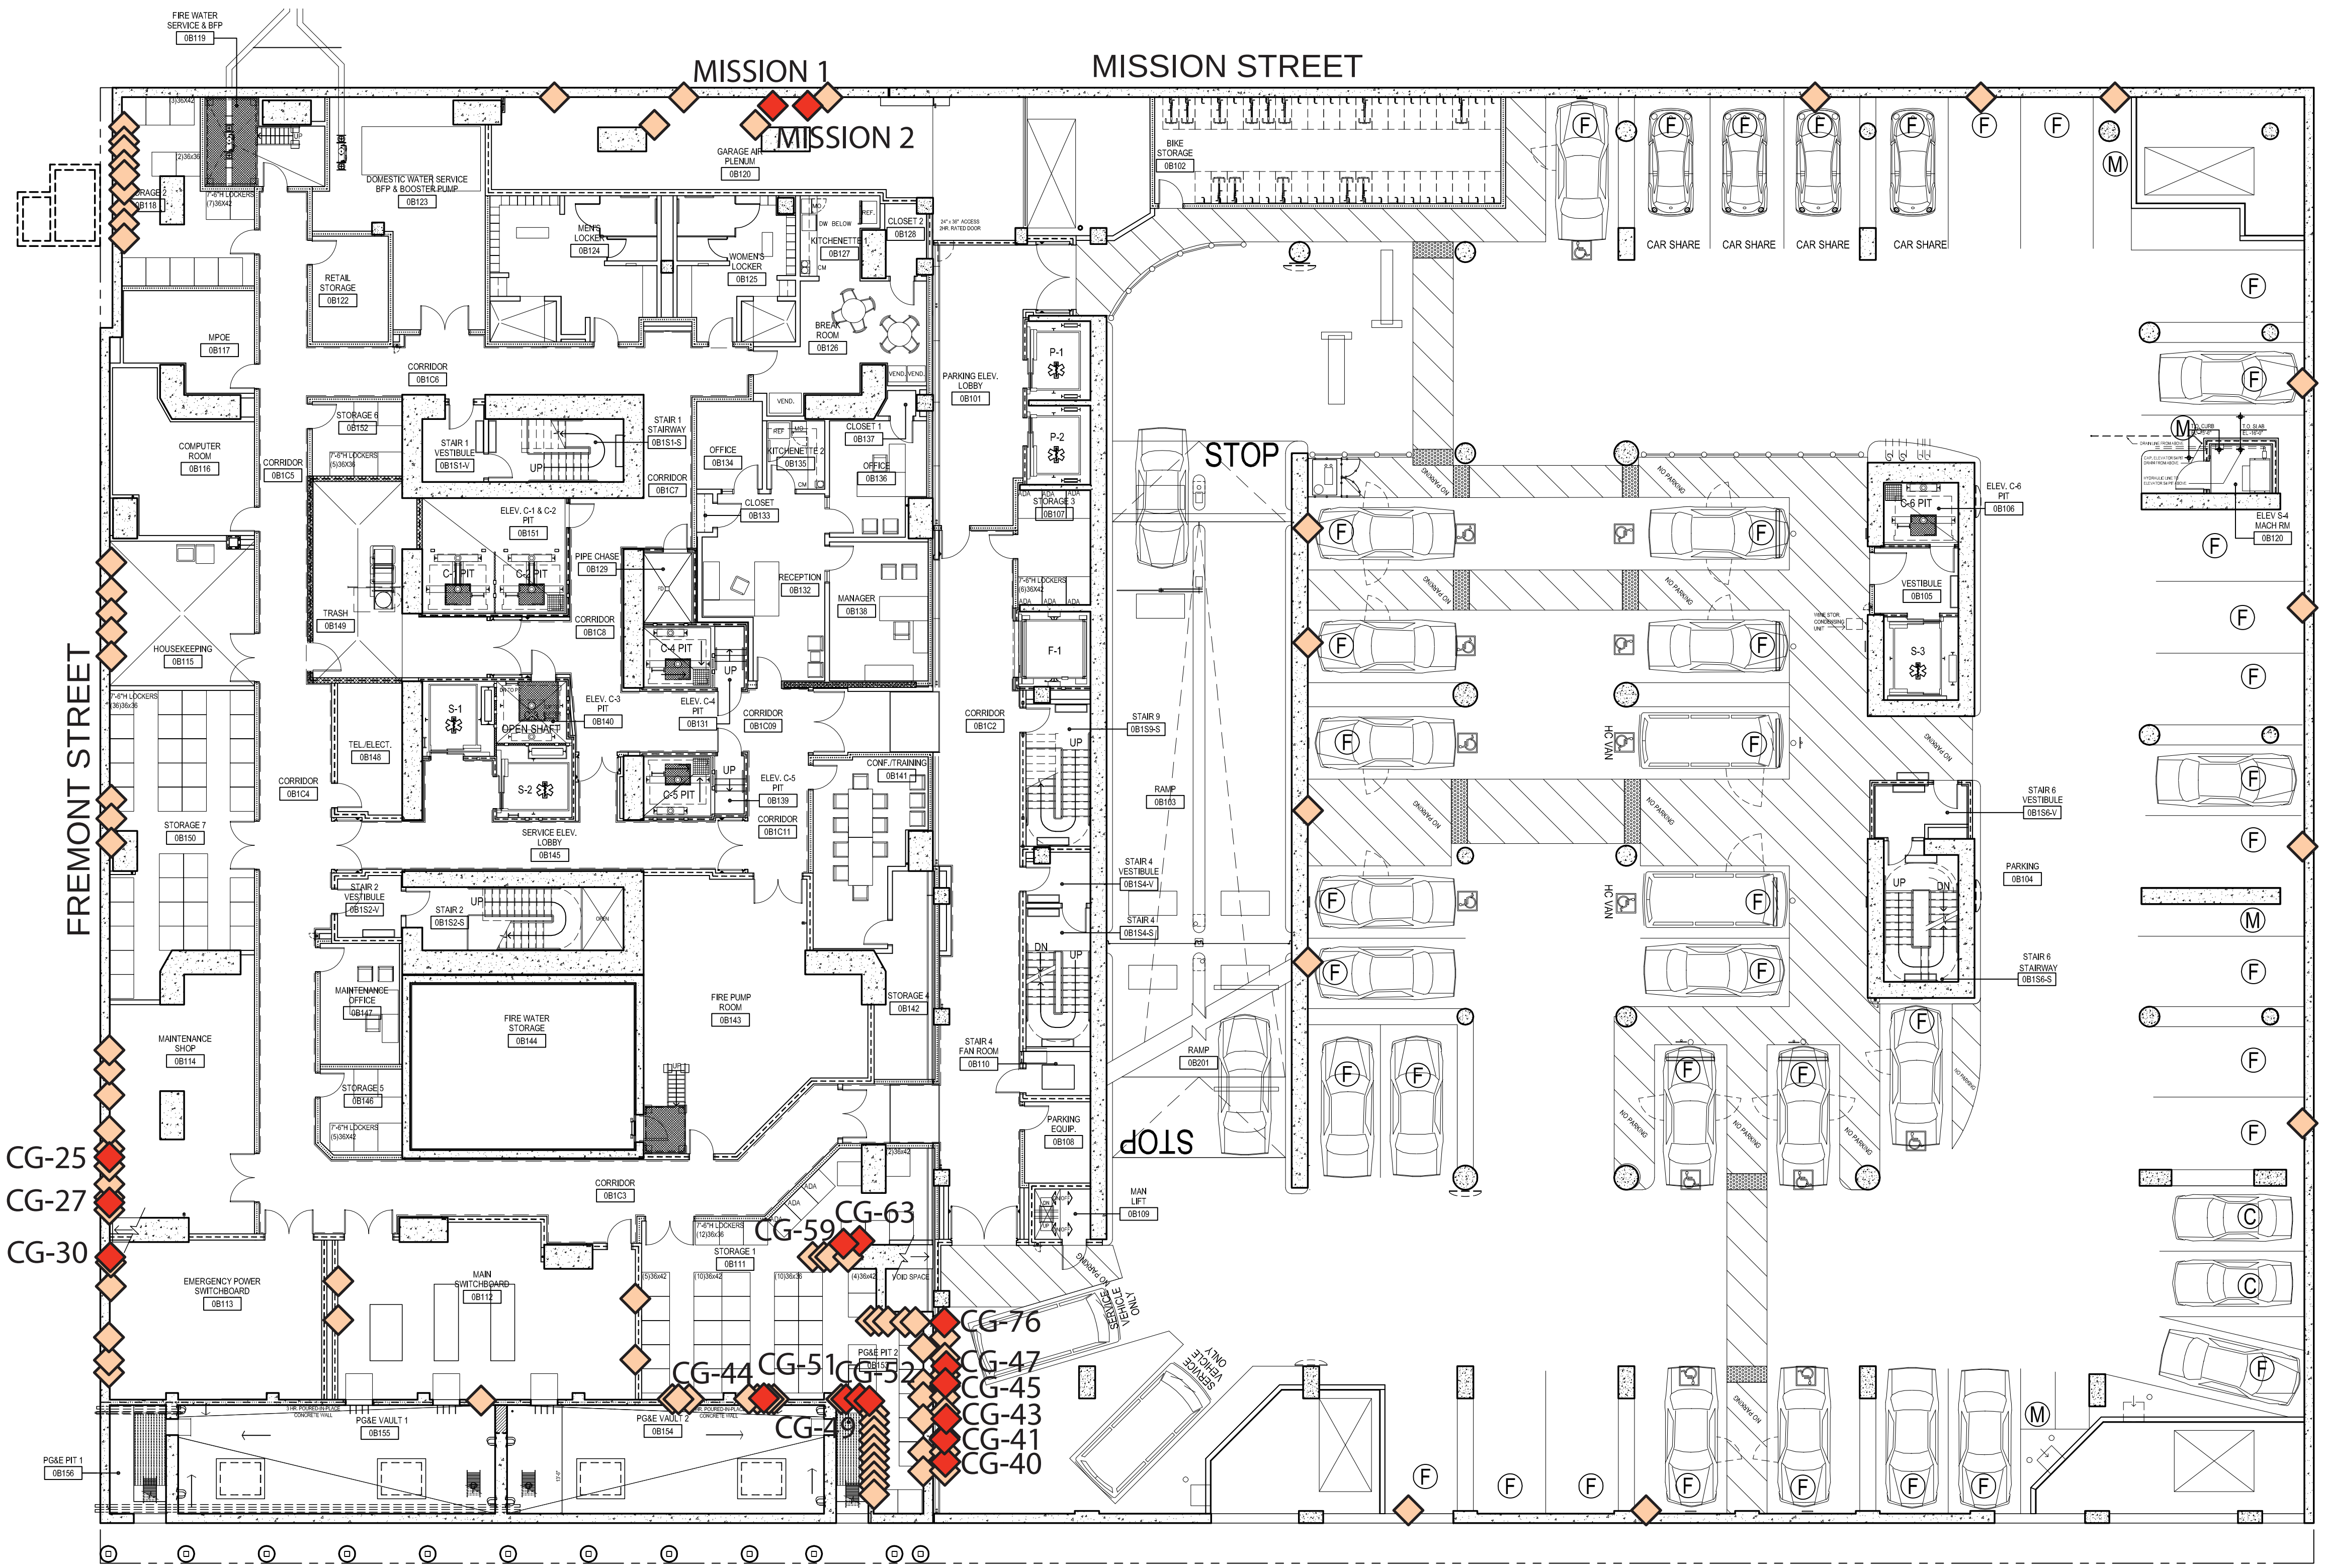
PLATE 1

CRACK GAUGES SOWING MOVEMENT:
301 MISSION STREET BASEMENT LEVEL B-1

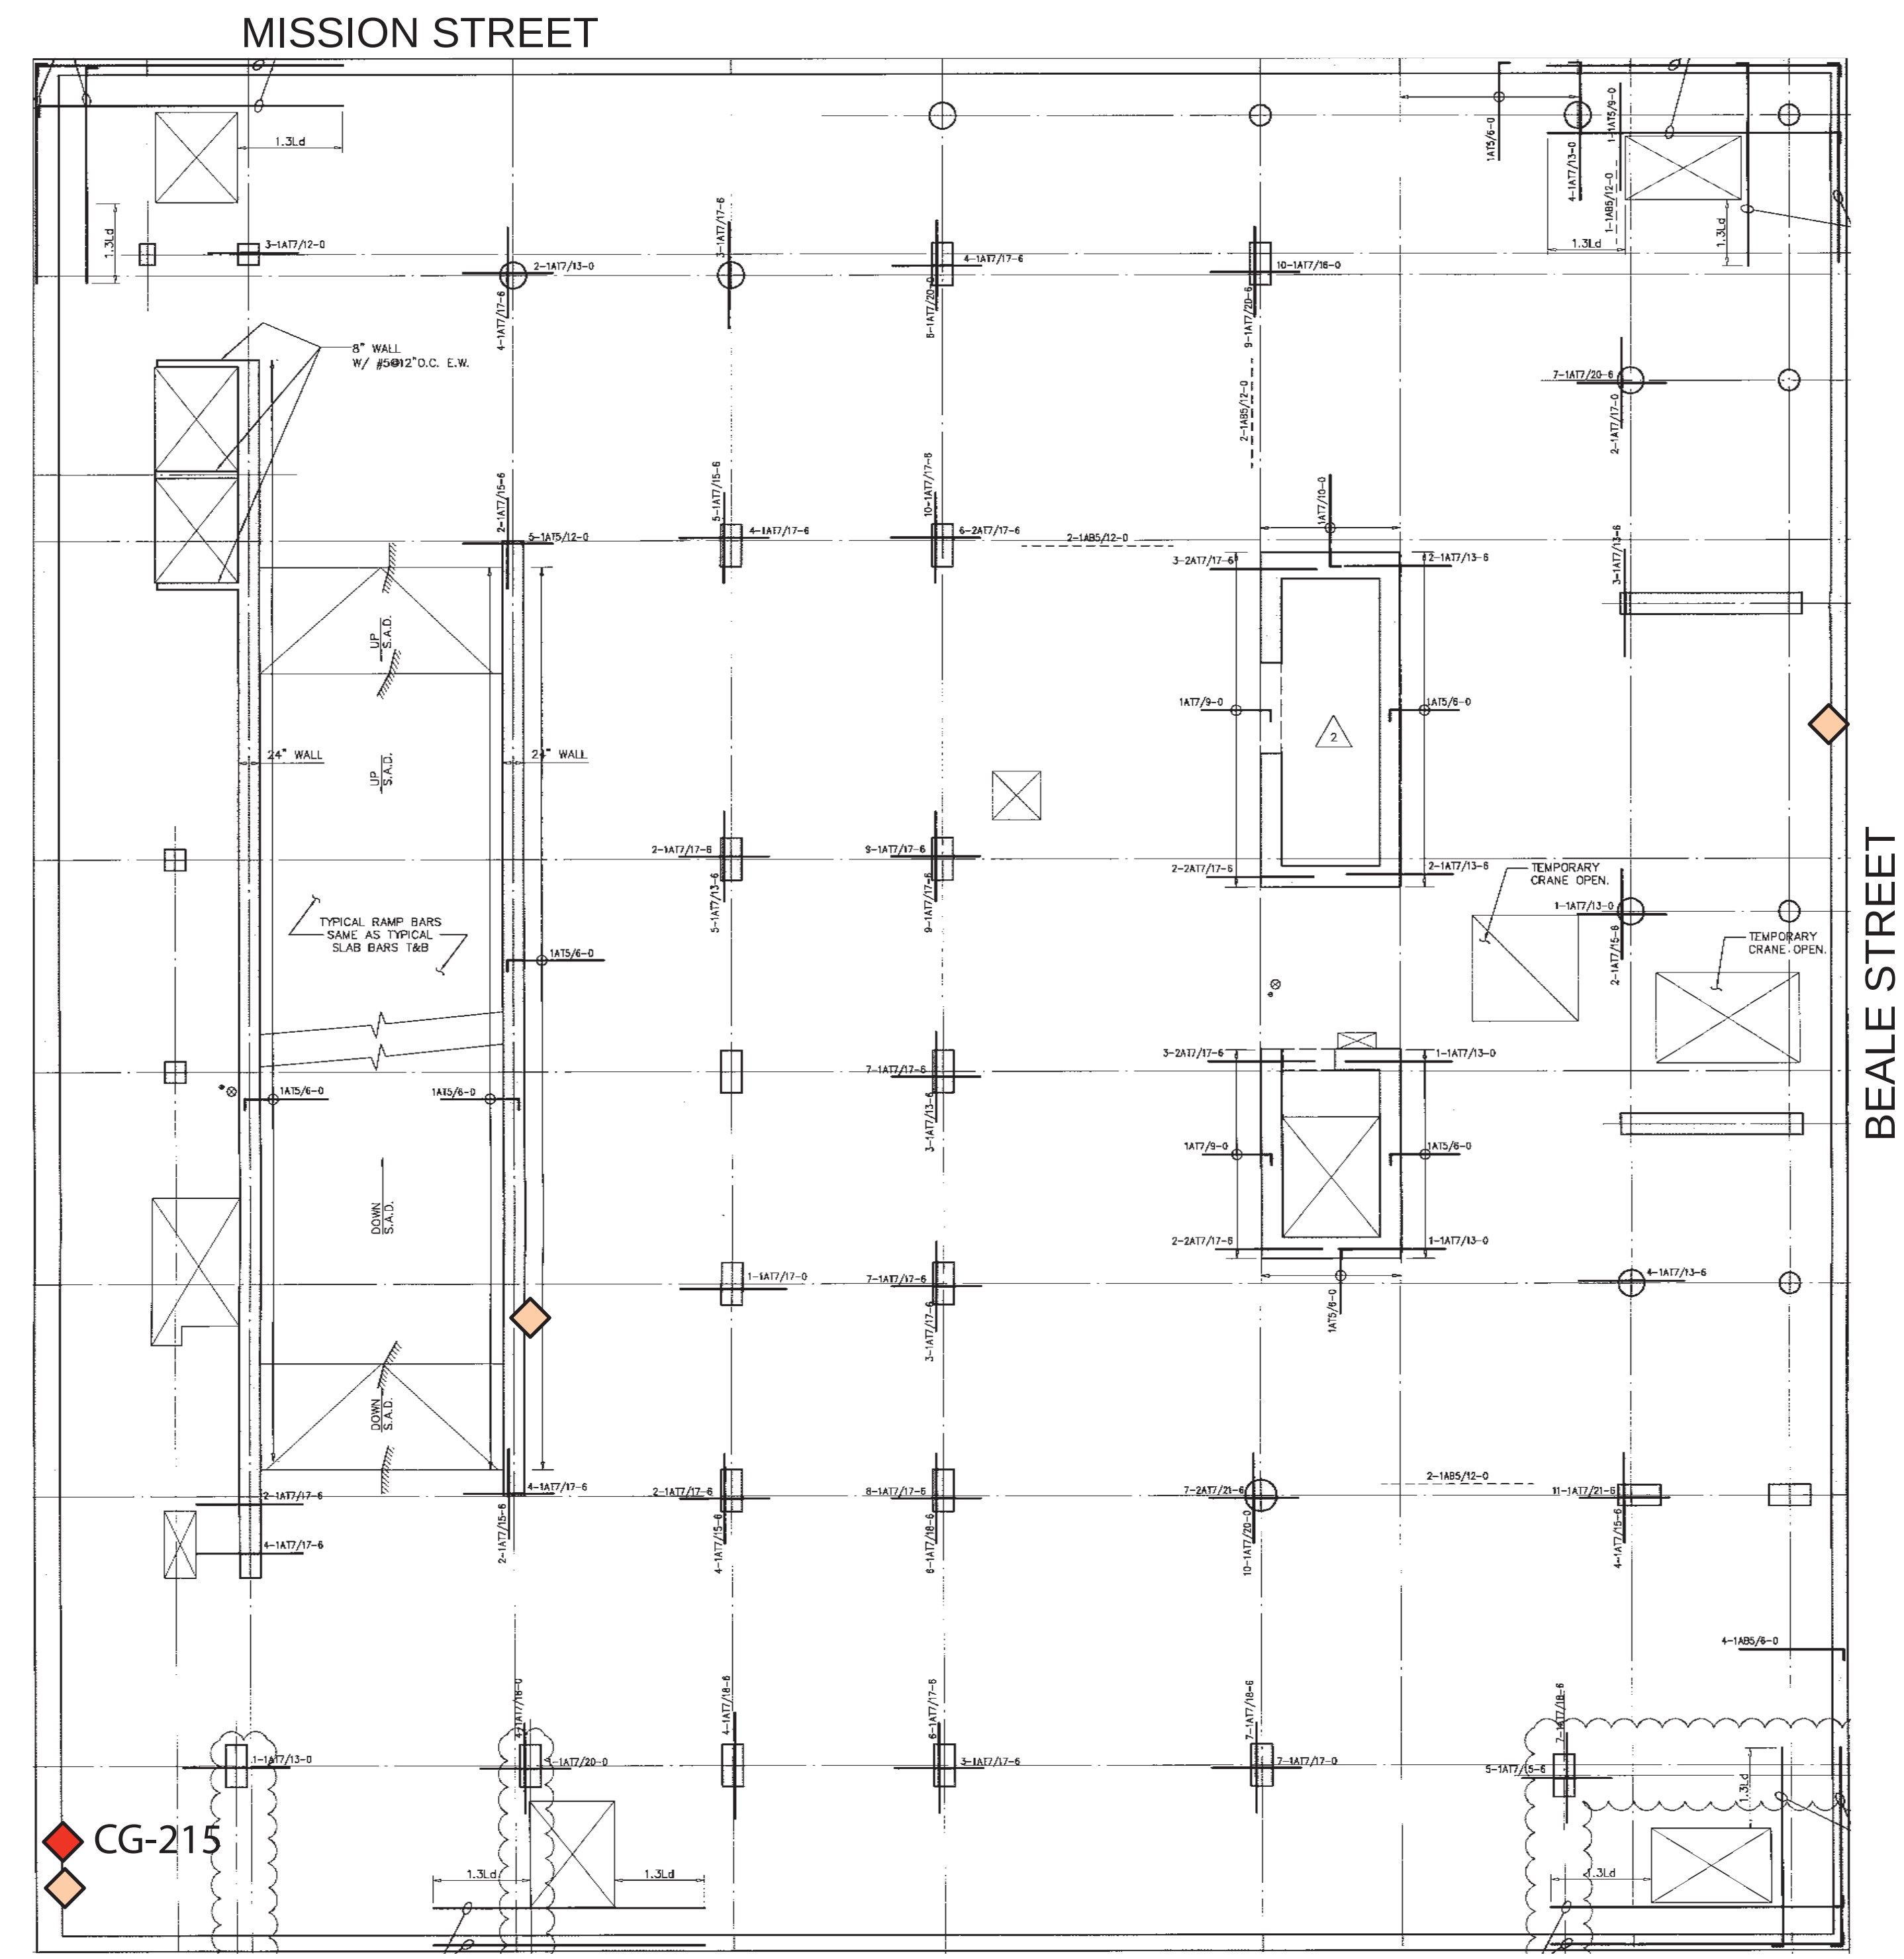
PLATE 2

CRACK GAUGES SHOWING MOVEMENT:
301 MISSION STREET BASEMENT LEVEL B-3

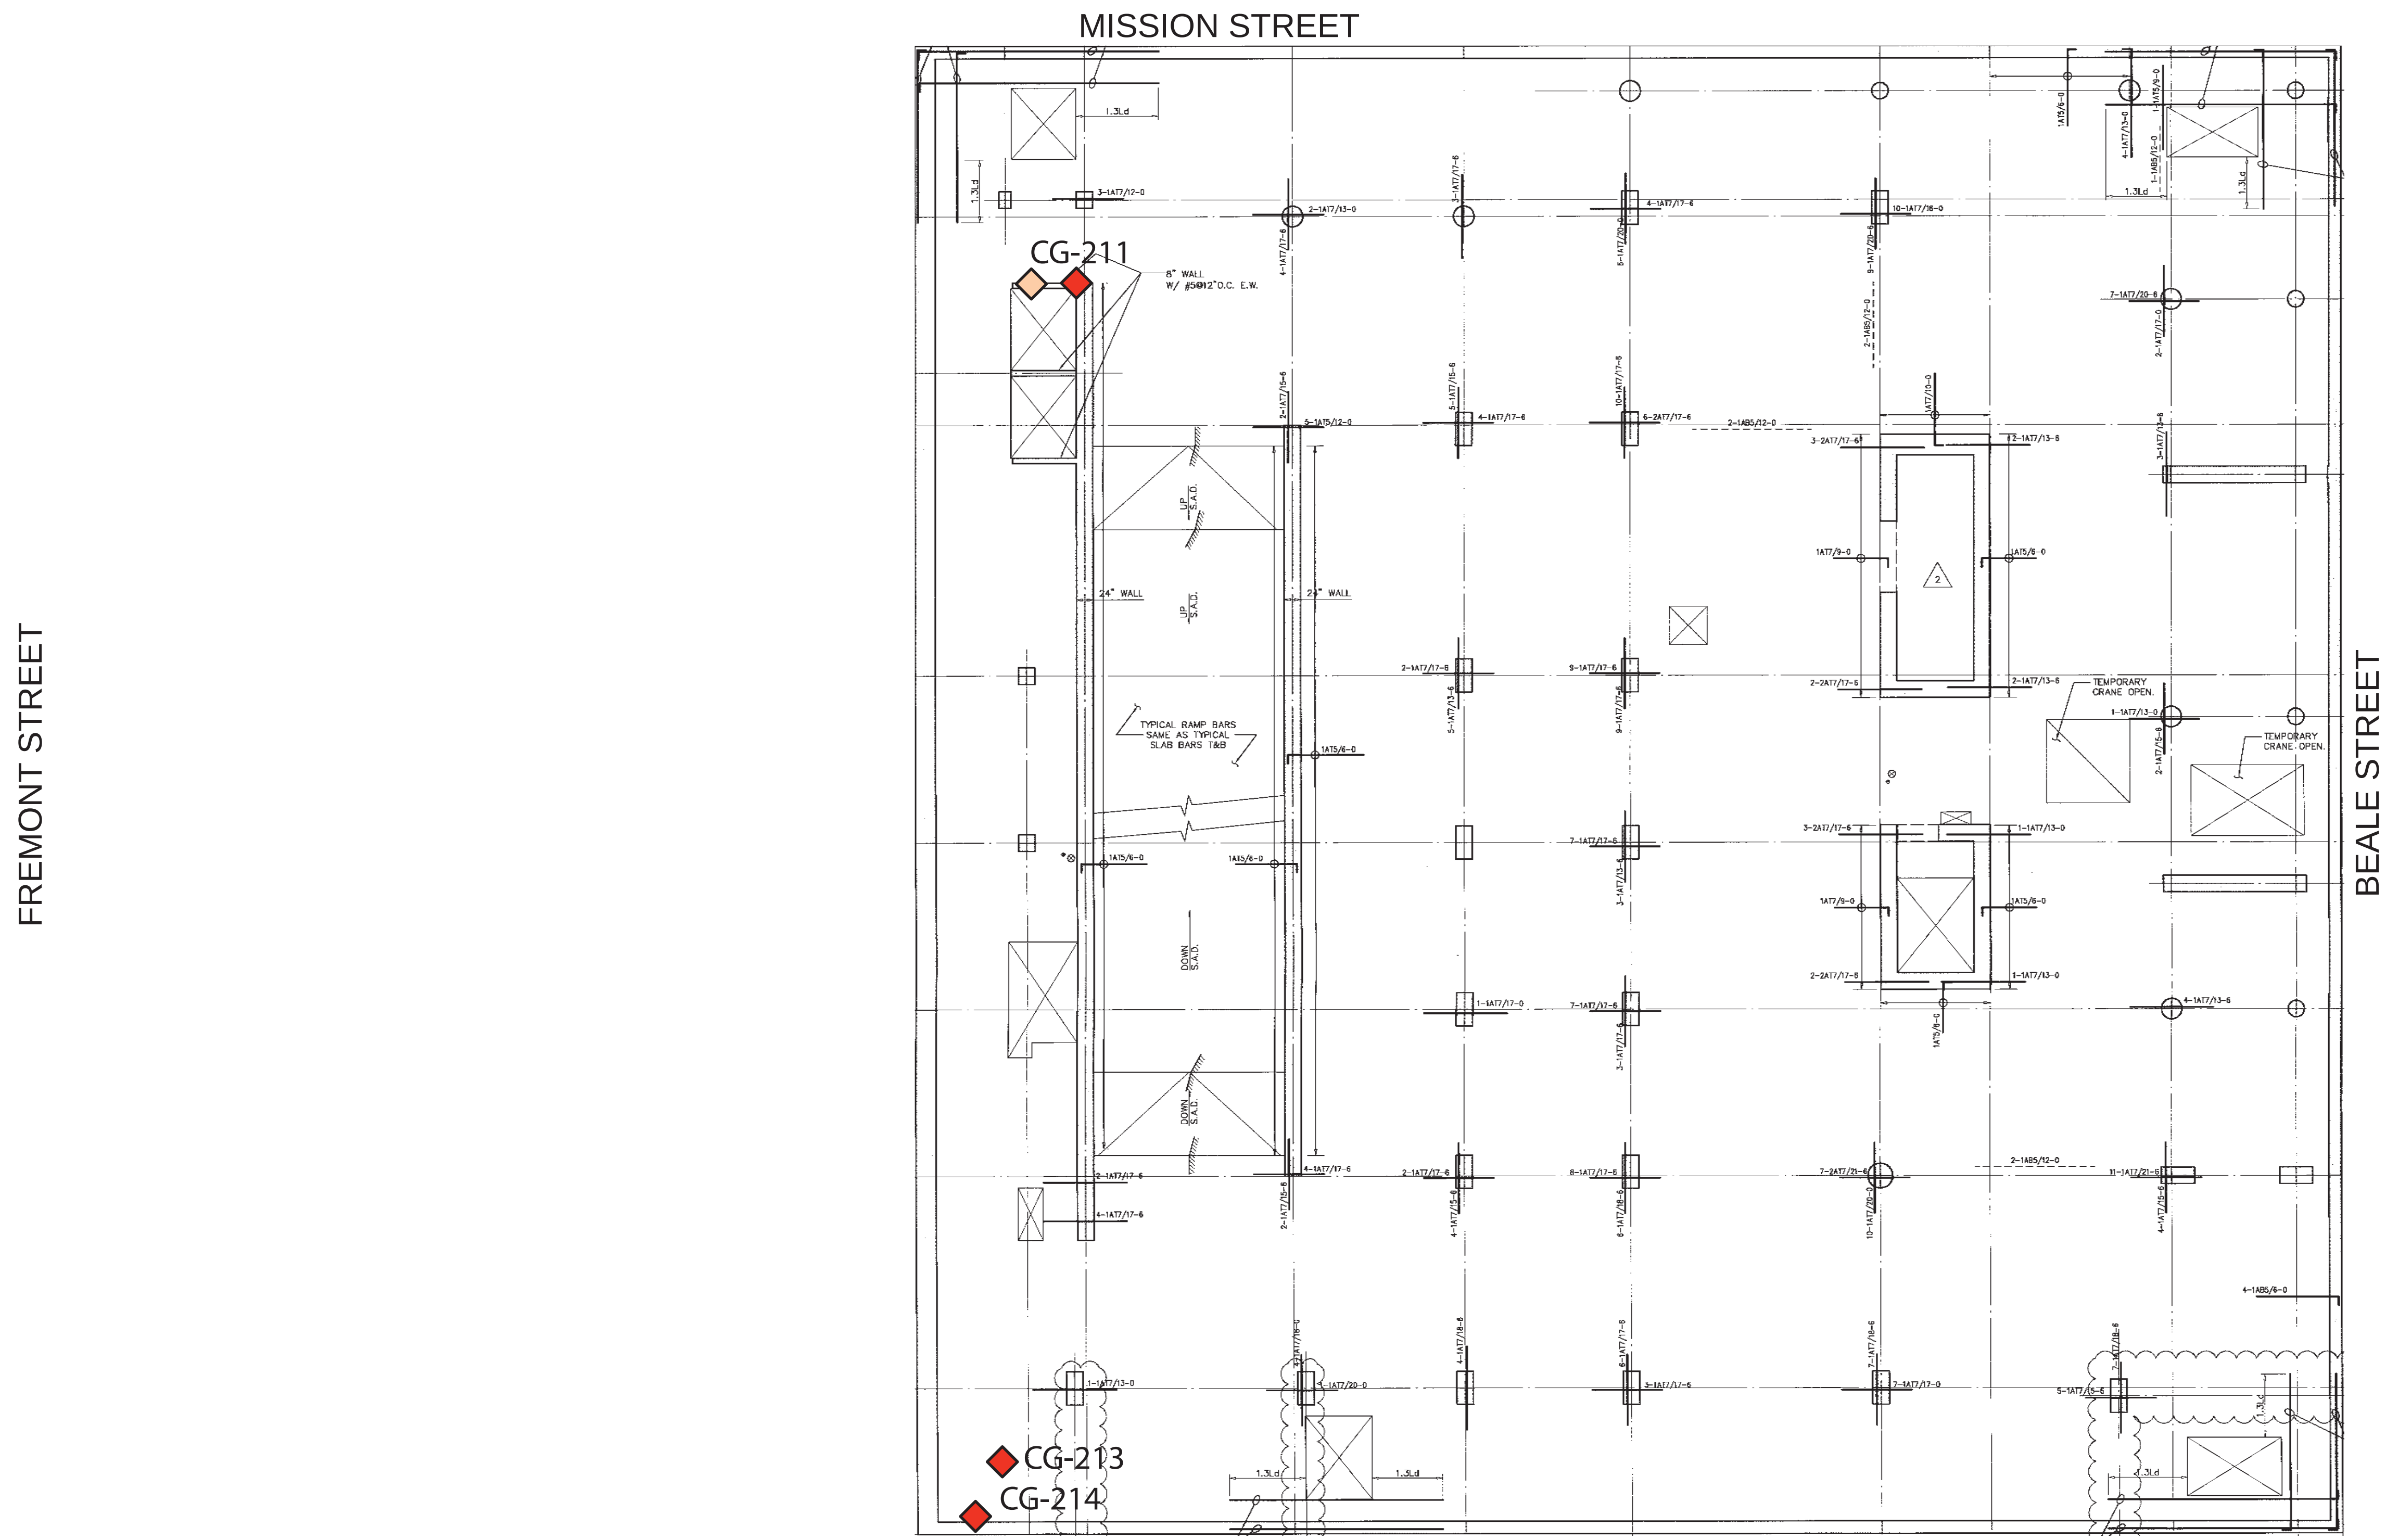
PLATE 3

CRACK GAUGES SHOWING MOVEMENTS:
301 MISSION STREET BASEMENT LEVEL B-4

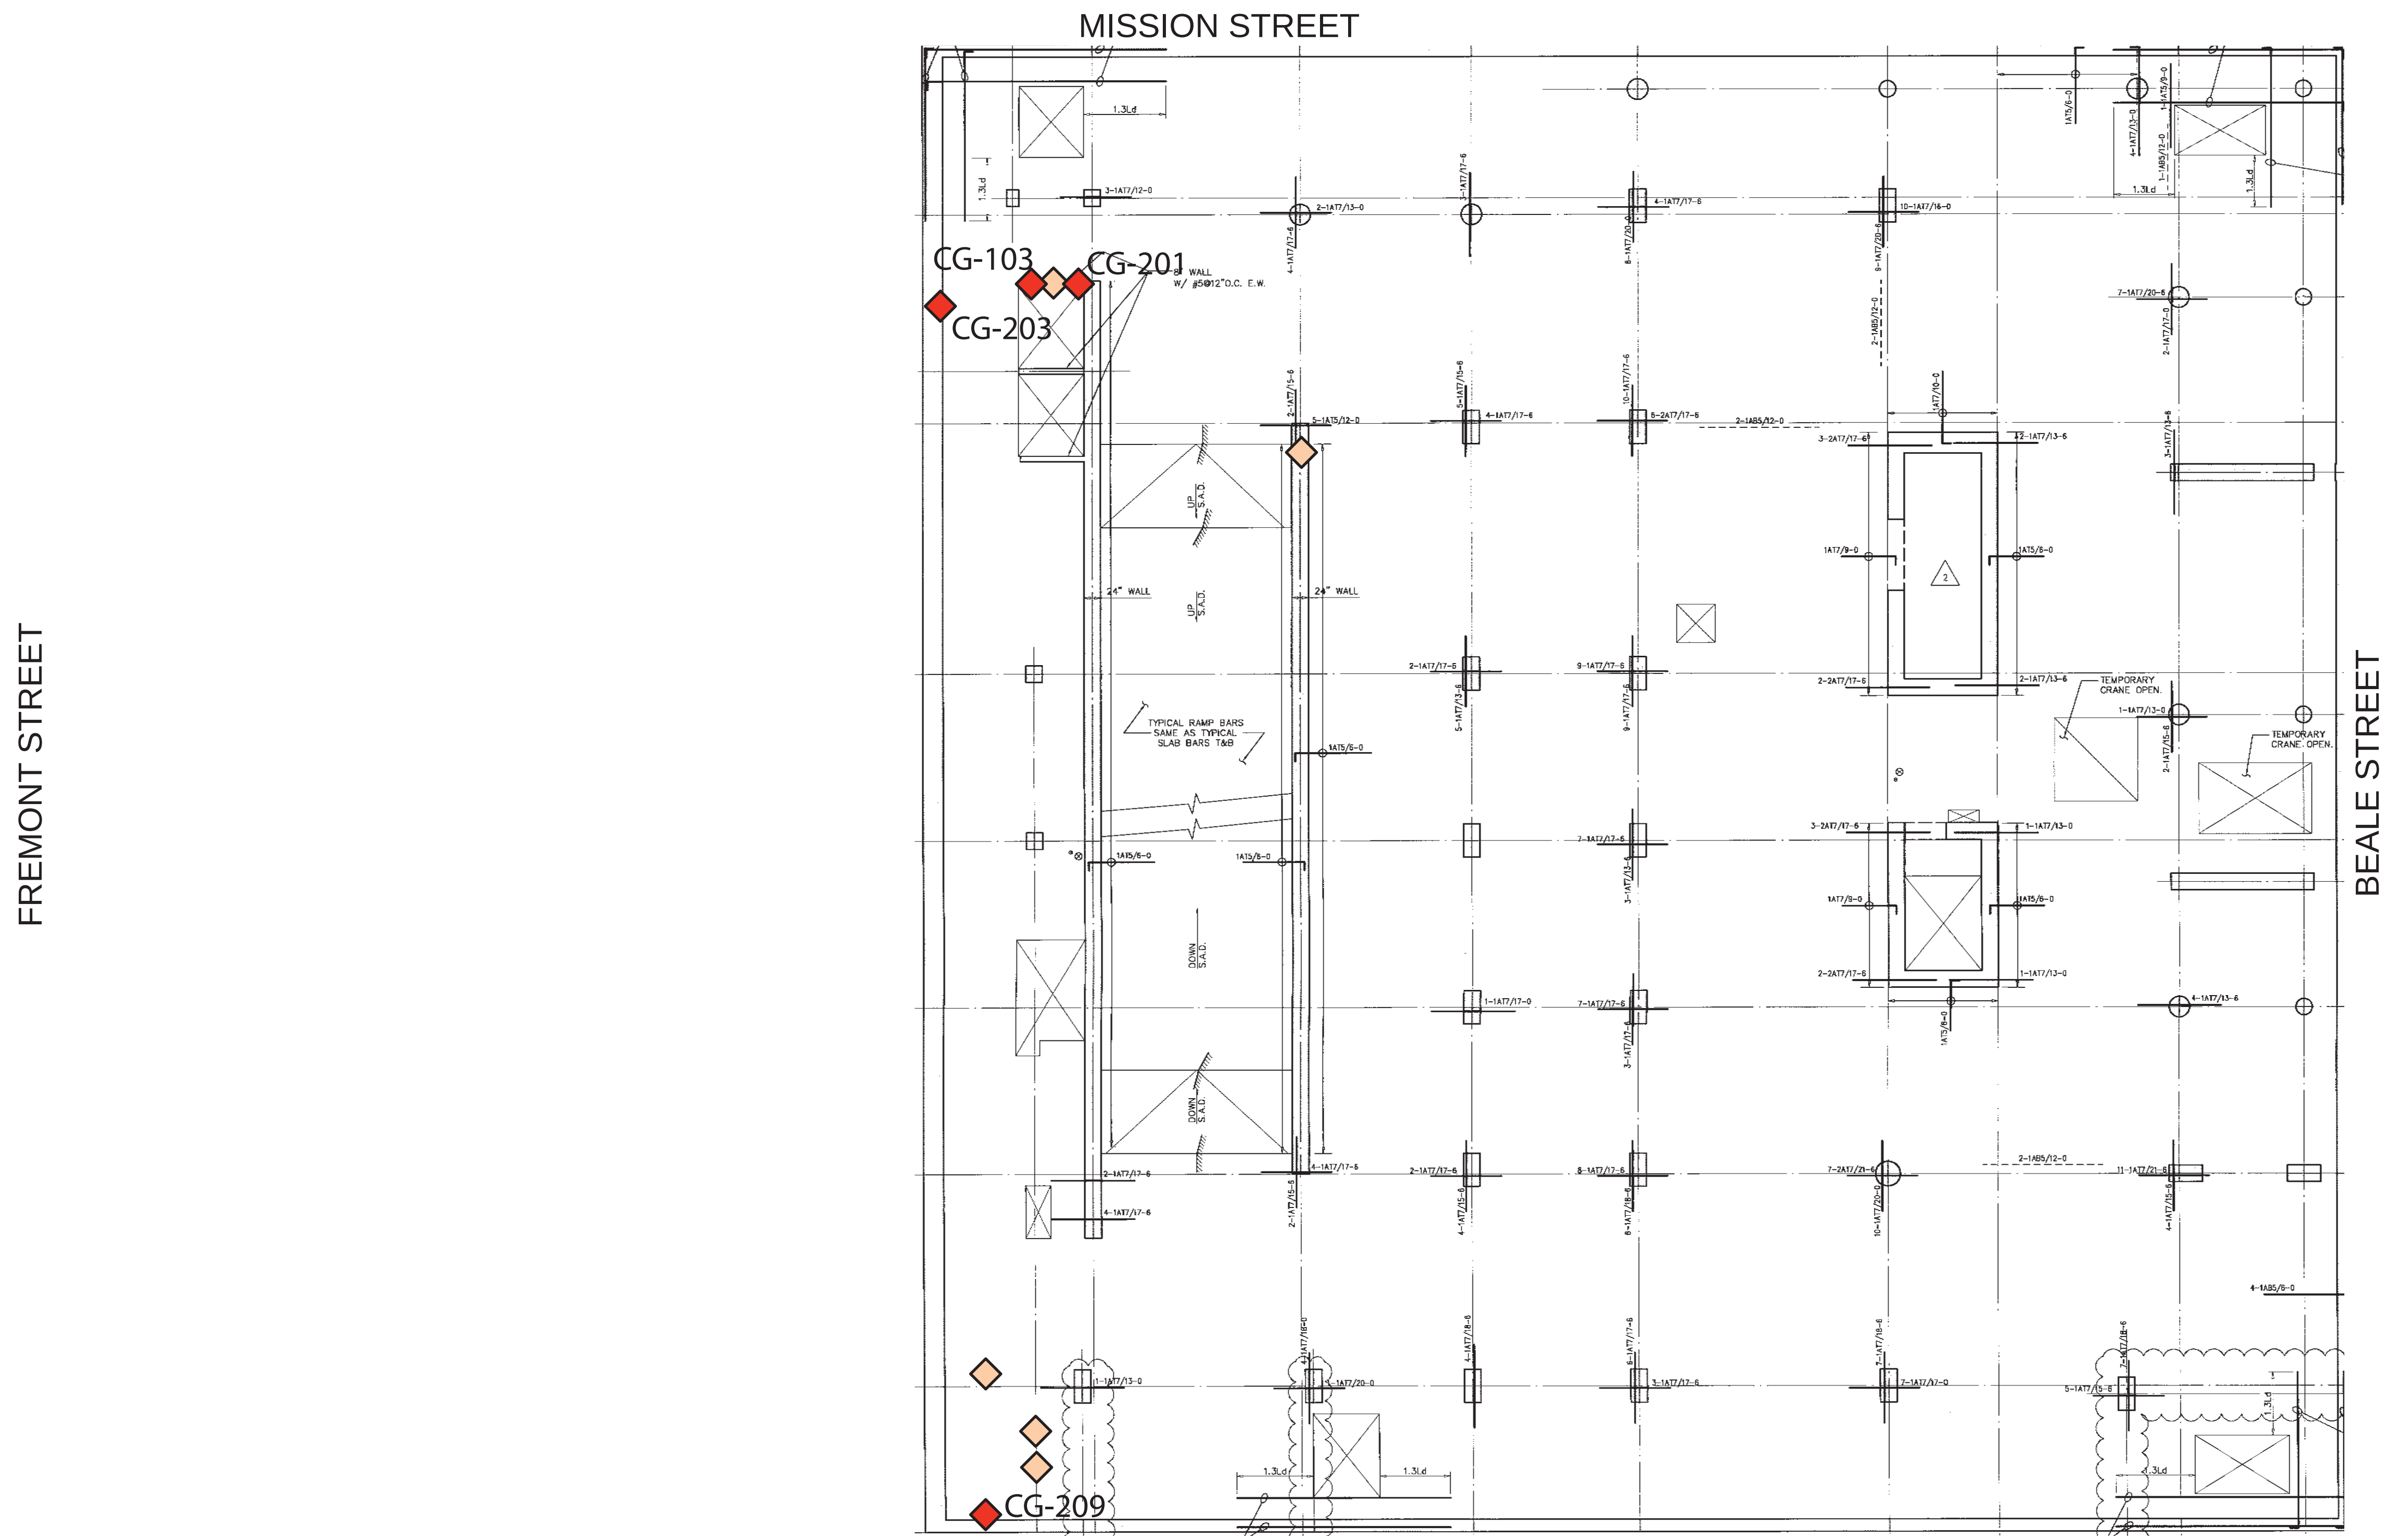
CRACK GAUGES SHOWING MOVEMENTS: 301 MISSION STREET BASEMENT LEVEL B-5

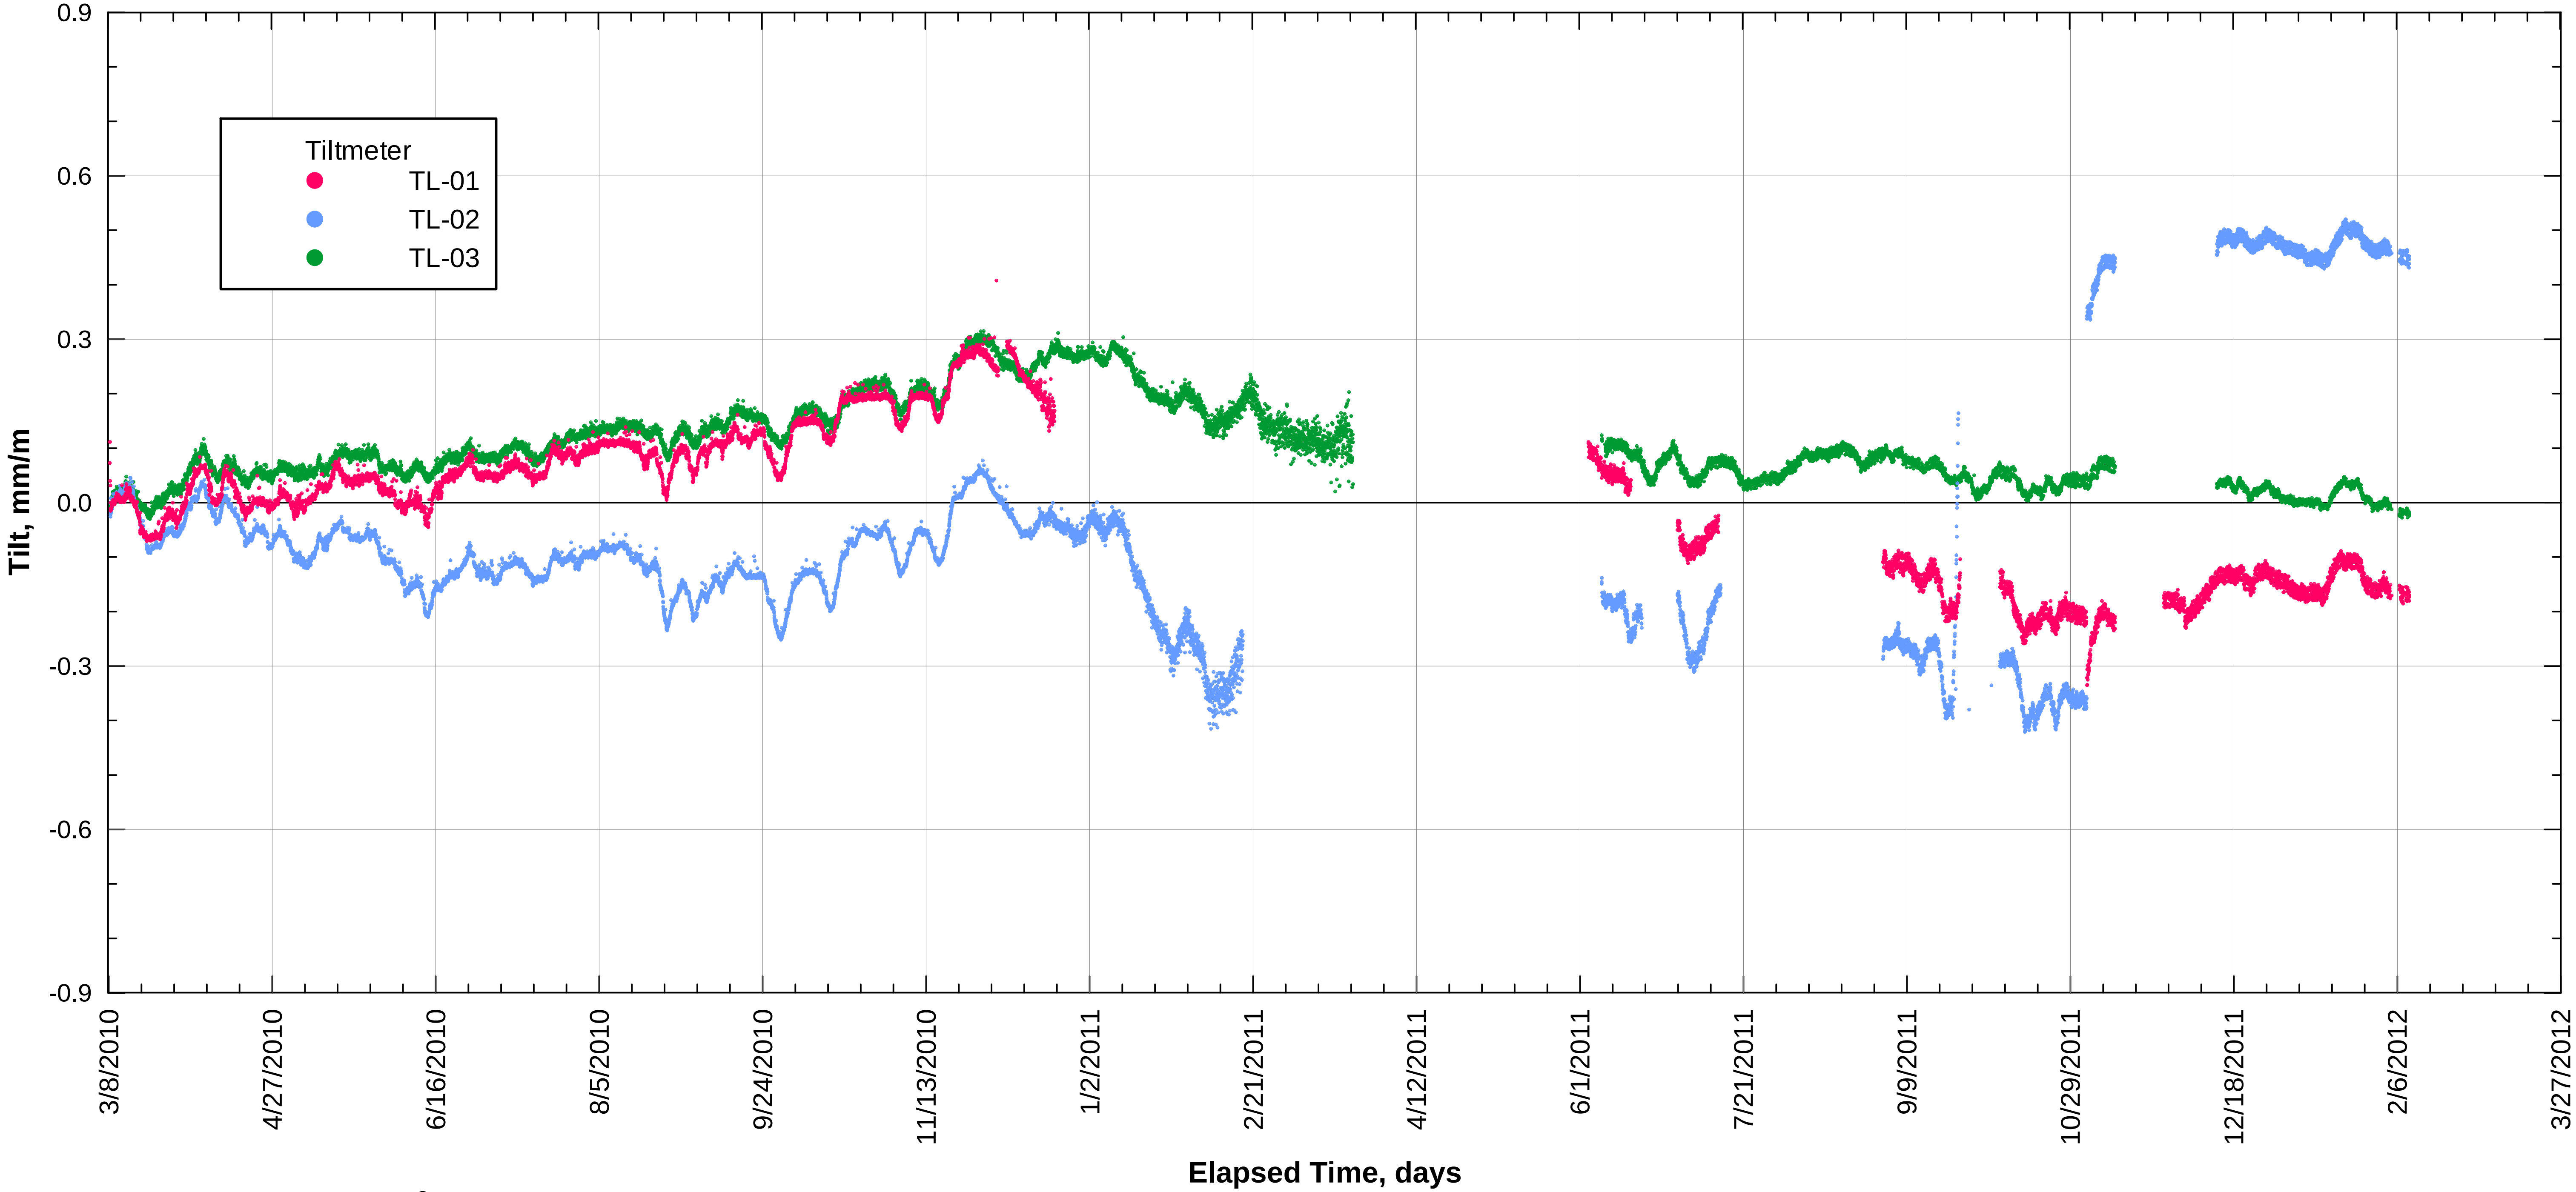
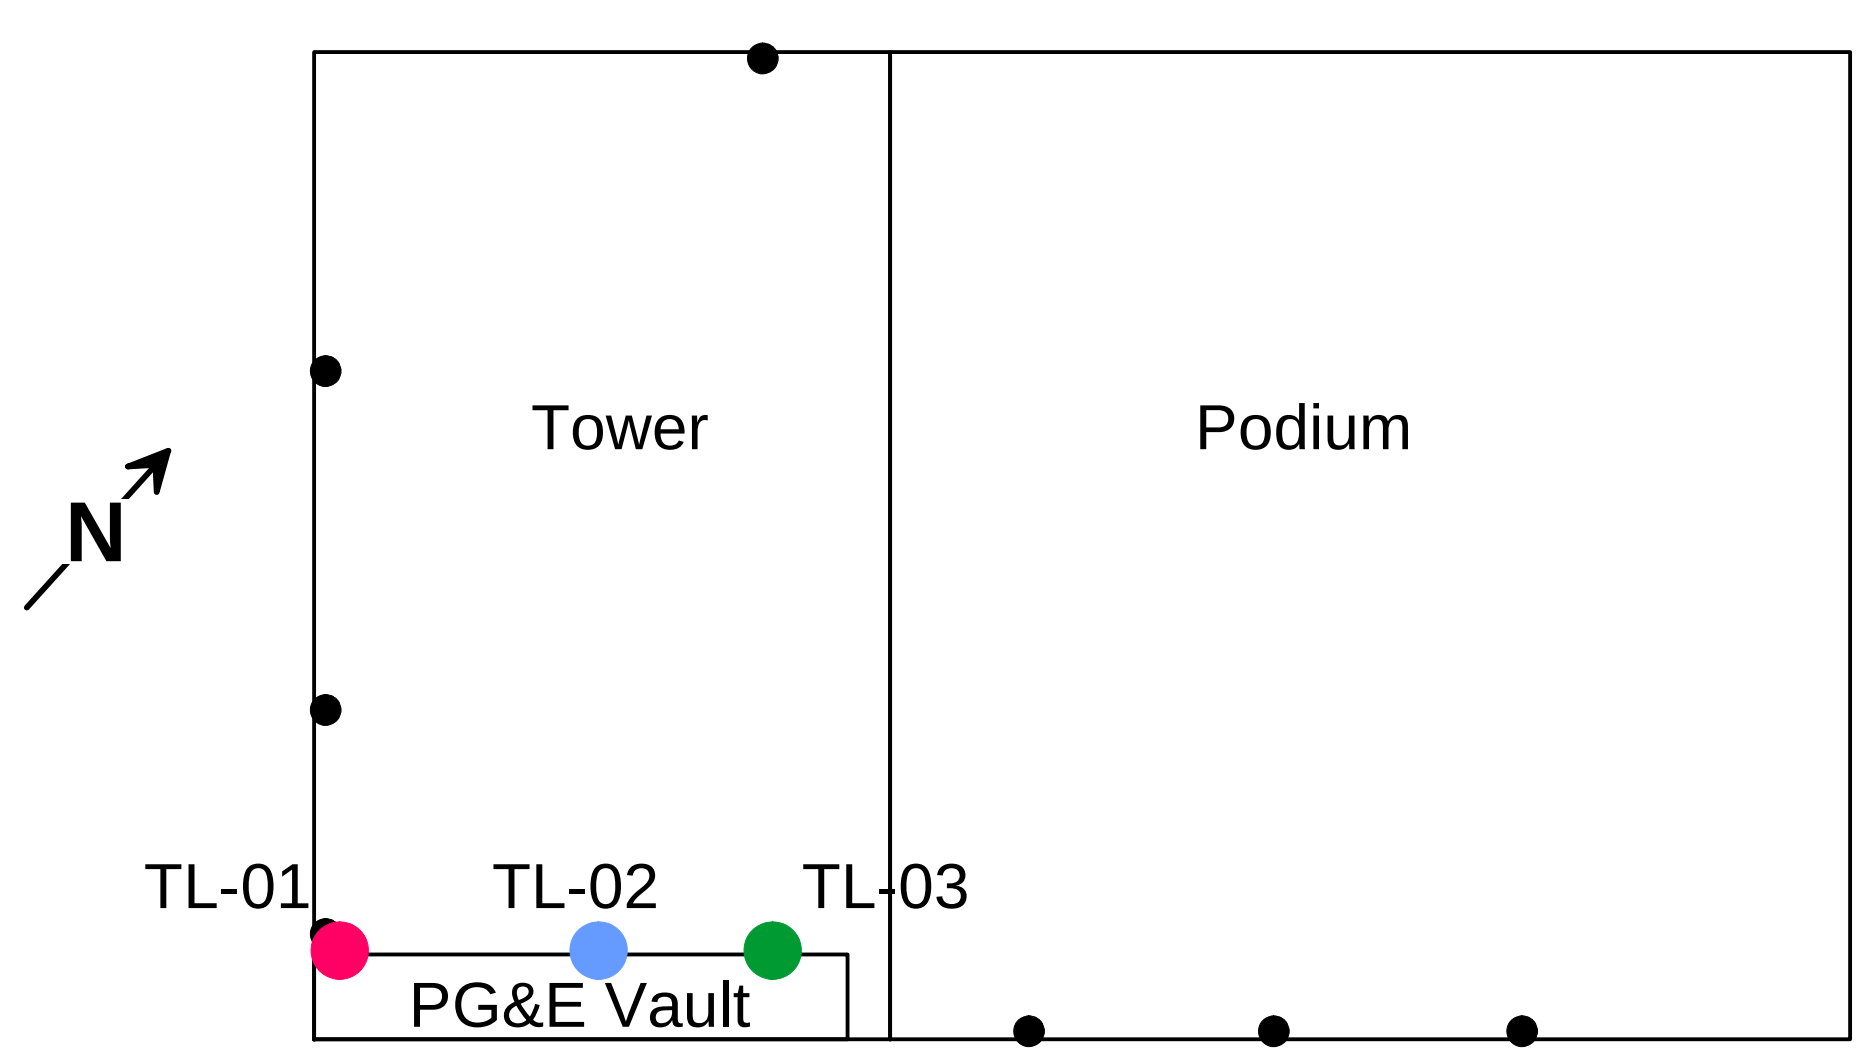
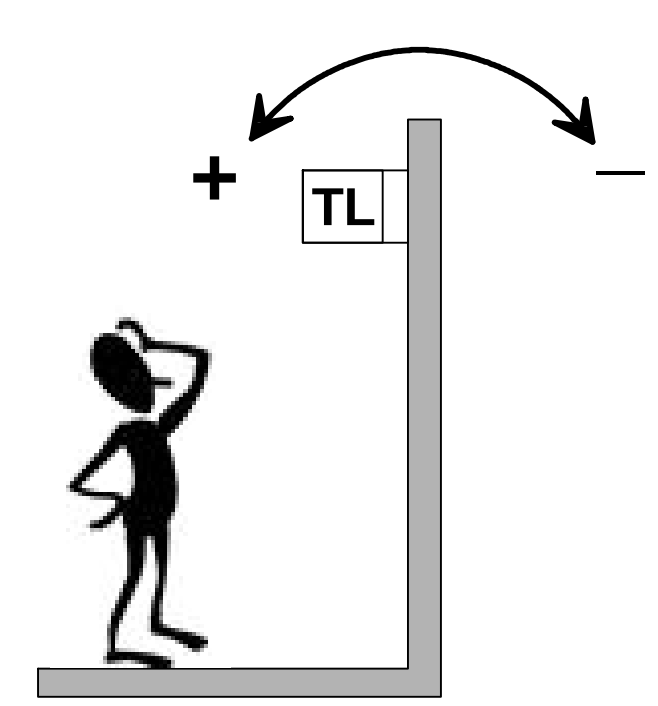
PLATE 2

Positive tilt represents movement of the top of the wall towards the inside of the room.

TILT RECORDED IN TILTMETERS TL-01, TL-02, AND TL-03: BASEMENT LEVEL B-1
