File No. 160975 **Committee Item No.** 7
Board Item No. ________

AGENDA PACKET CONTENTS LIST

TALL BUILDINGS SAFETY STRATEGY

October 2018

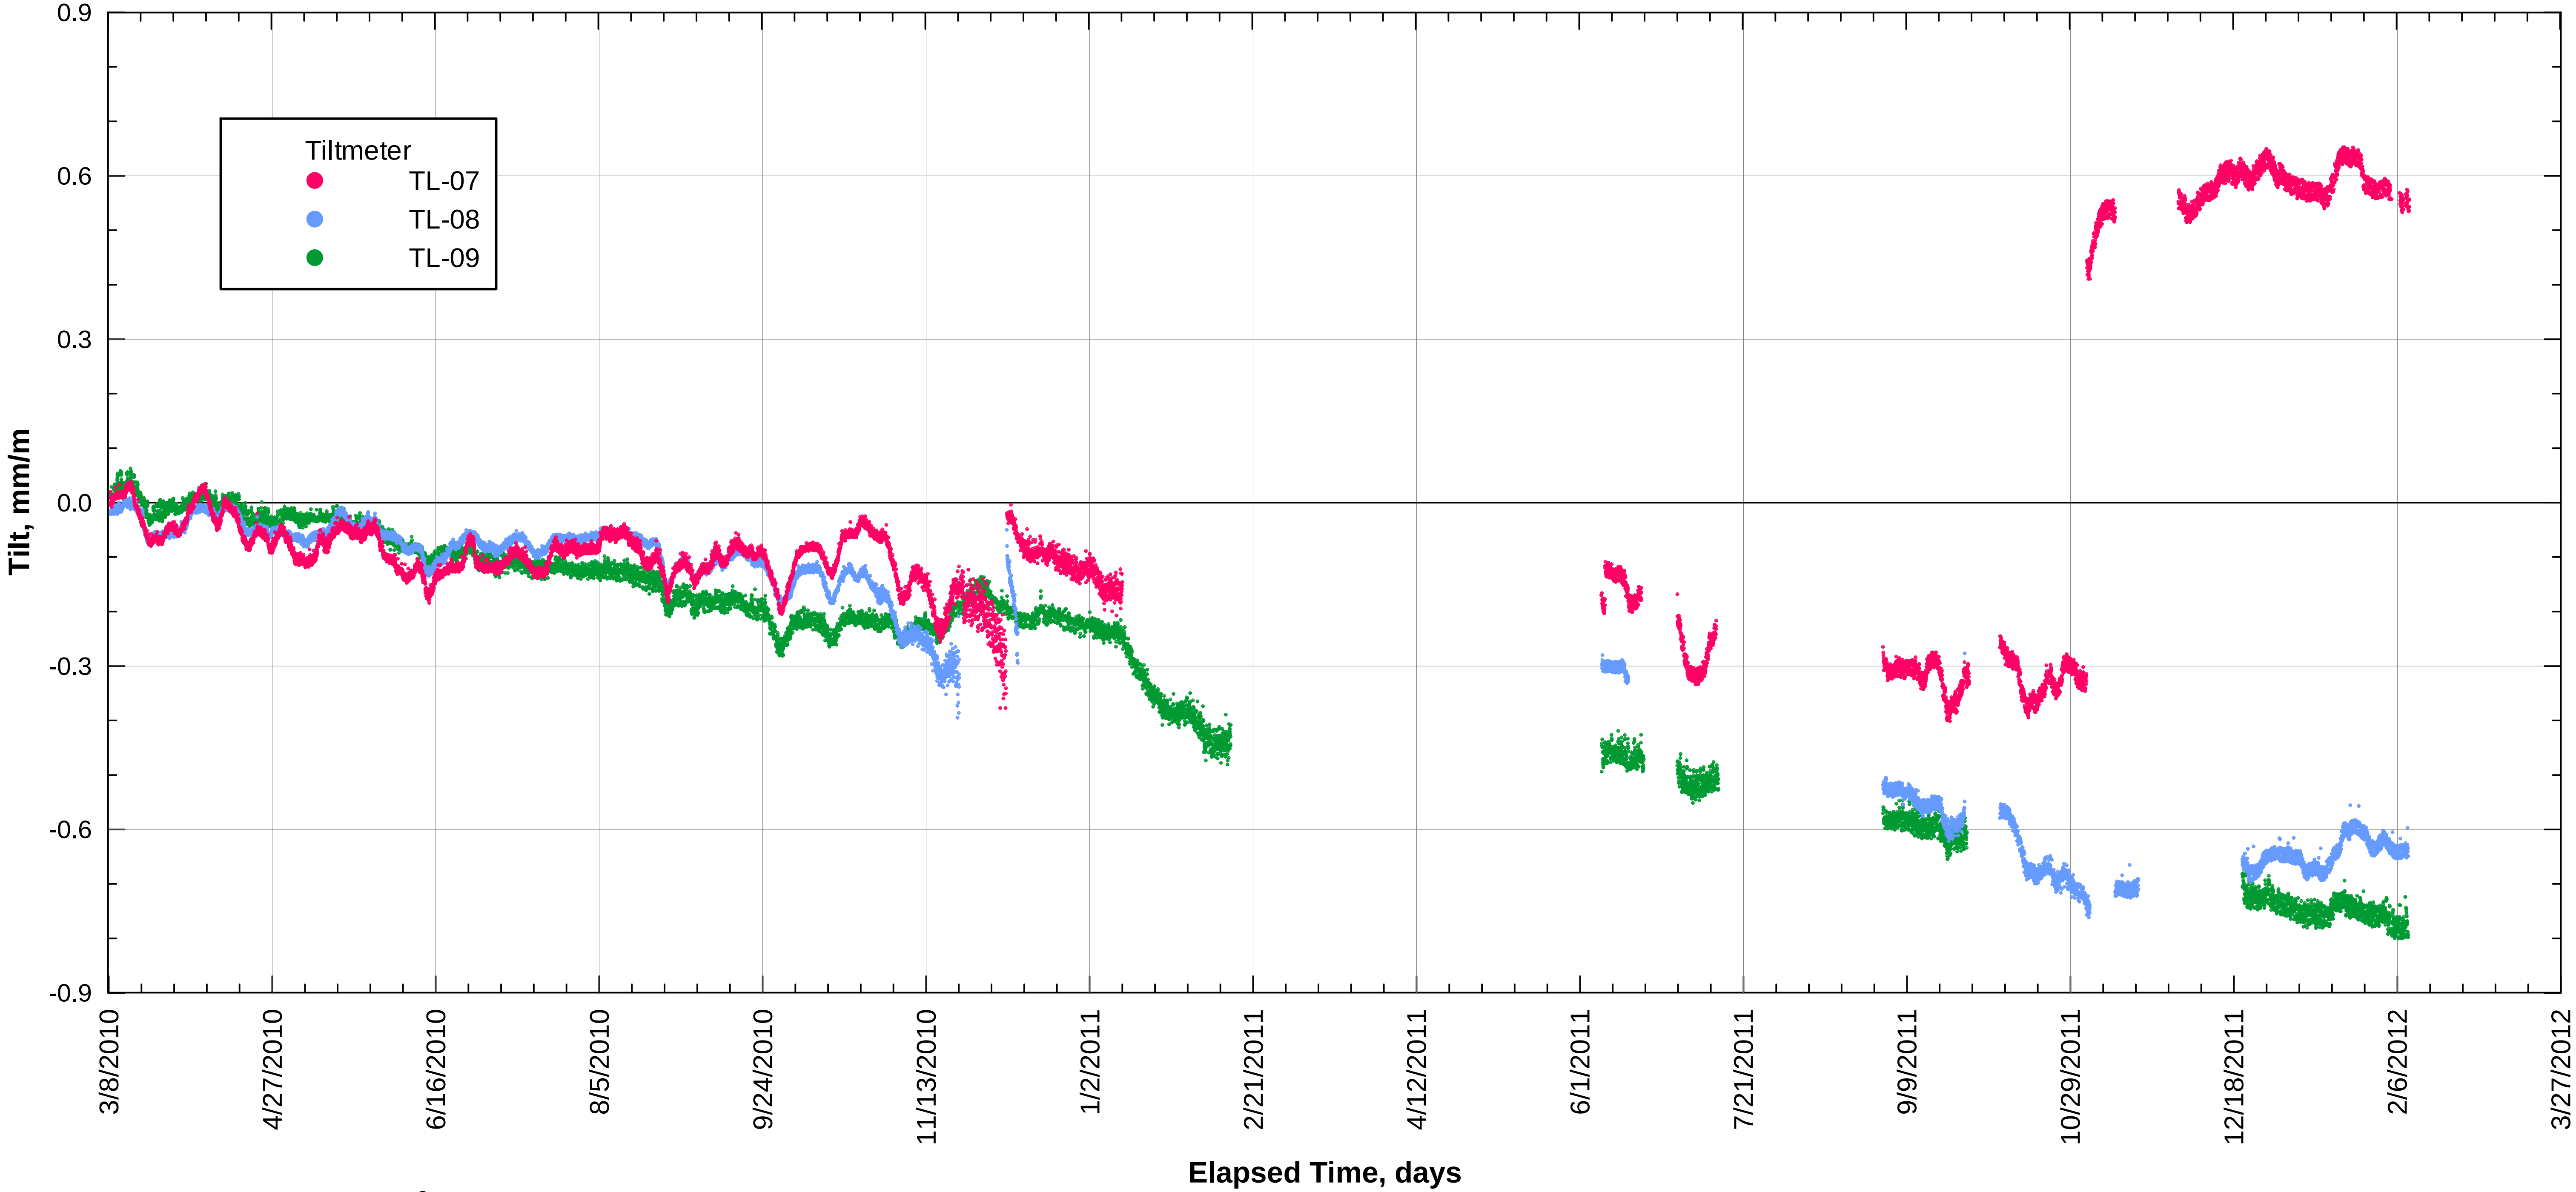
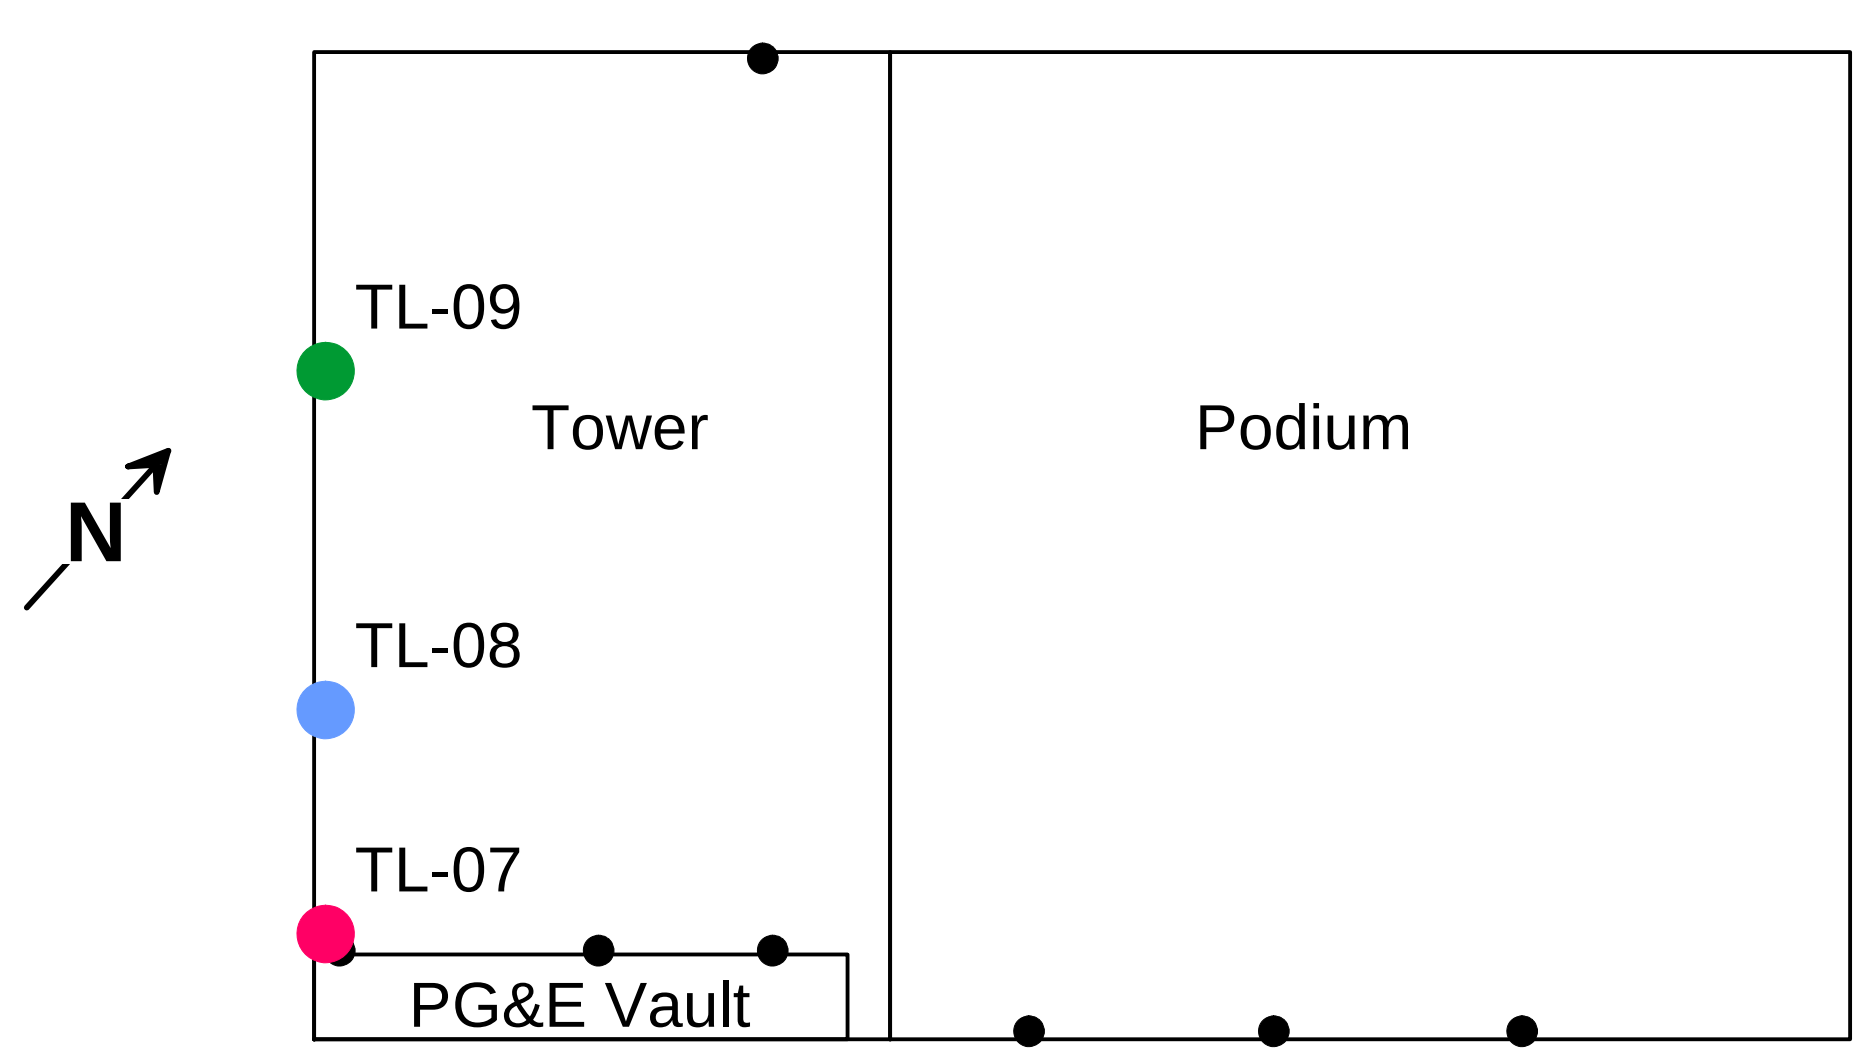
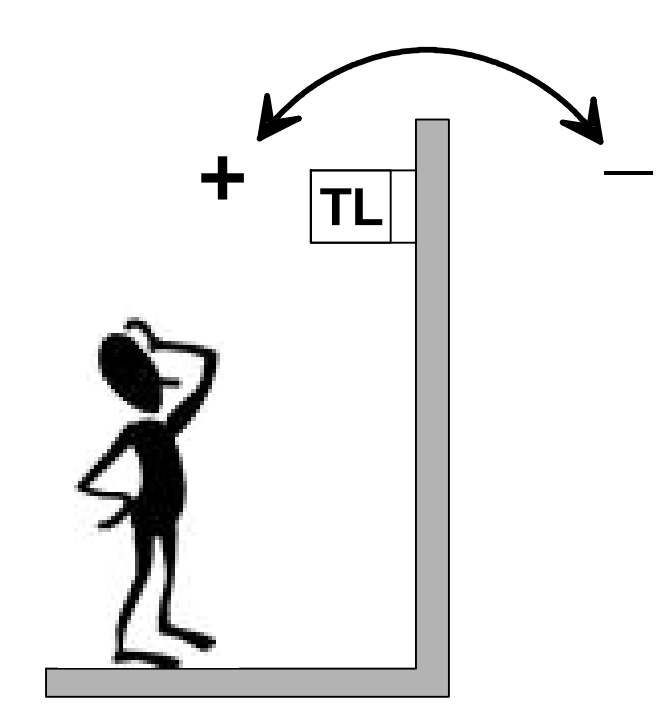
PLATE 4

Positive tilt represents movement of the top
of the wall towards the inside of the room.

TILT RECORDED IN TILTMETERS TL-07,
TL-08, AND TL-09: BASEMENT LEVEL B-1

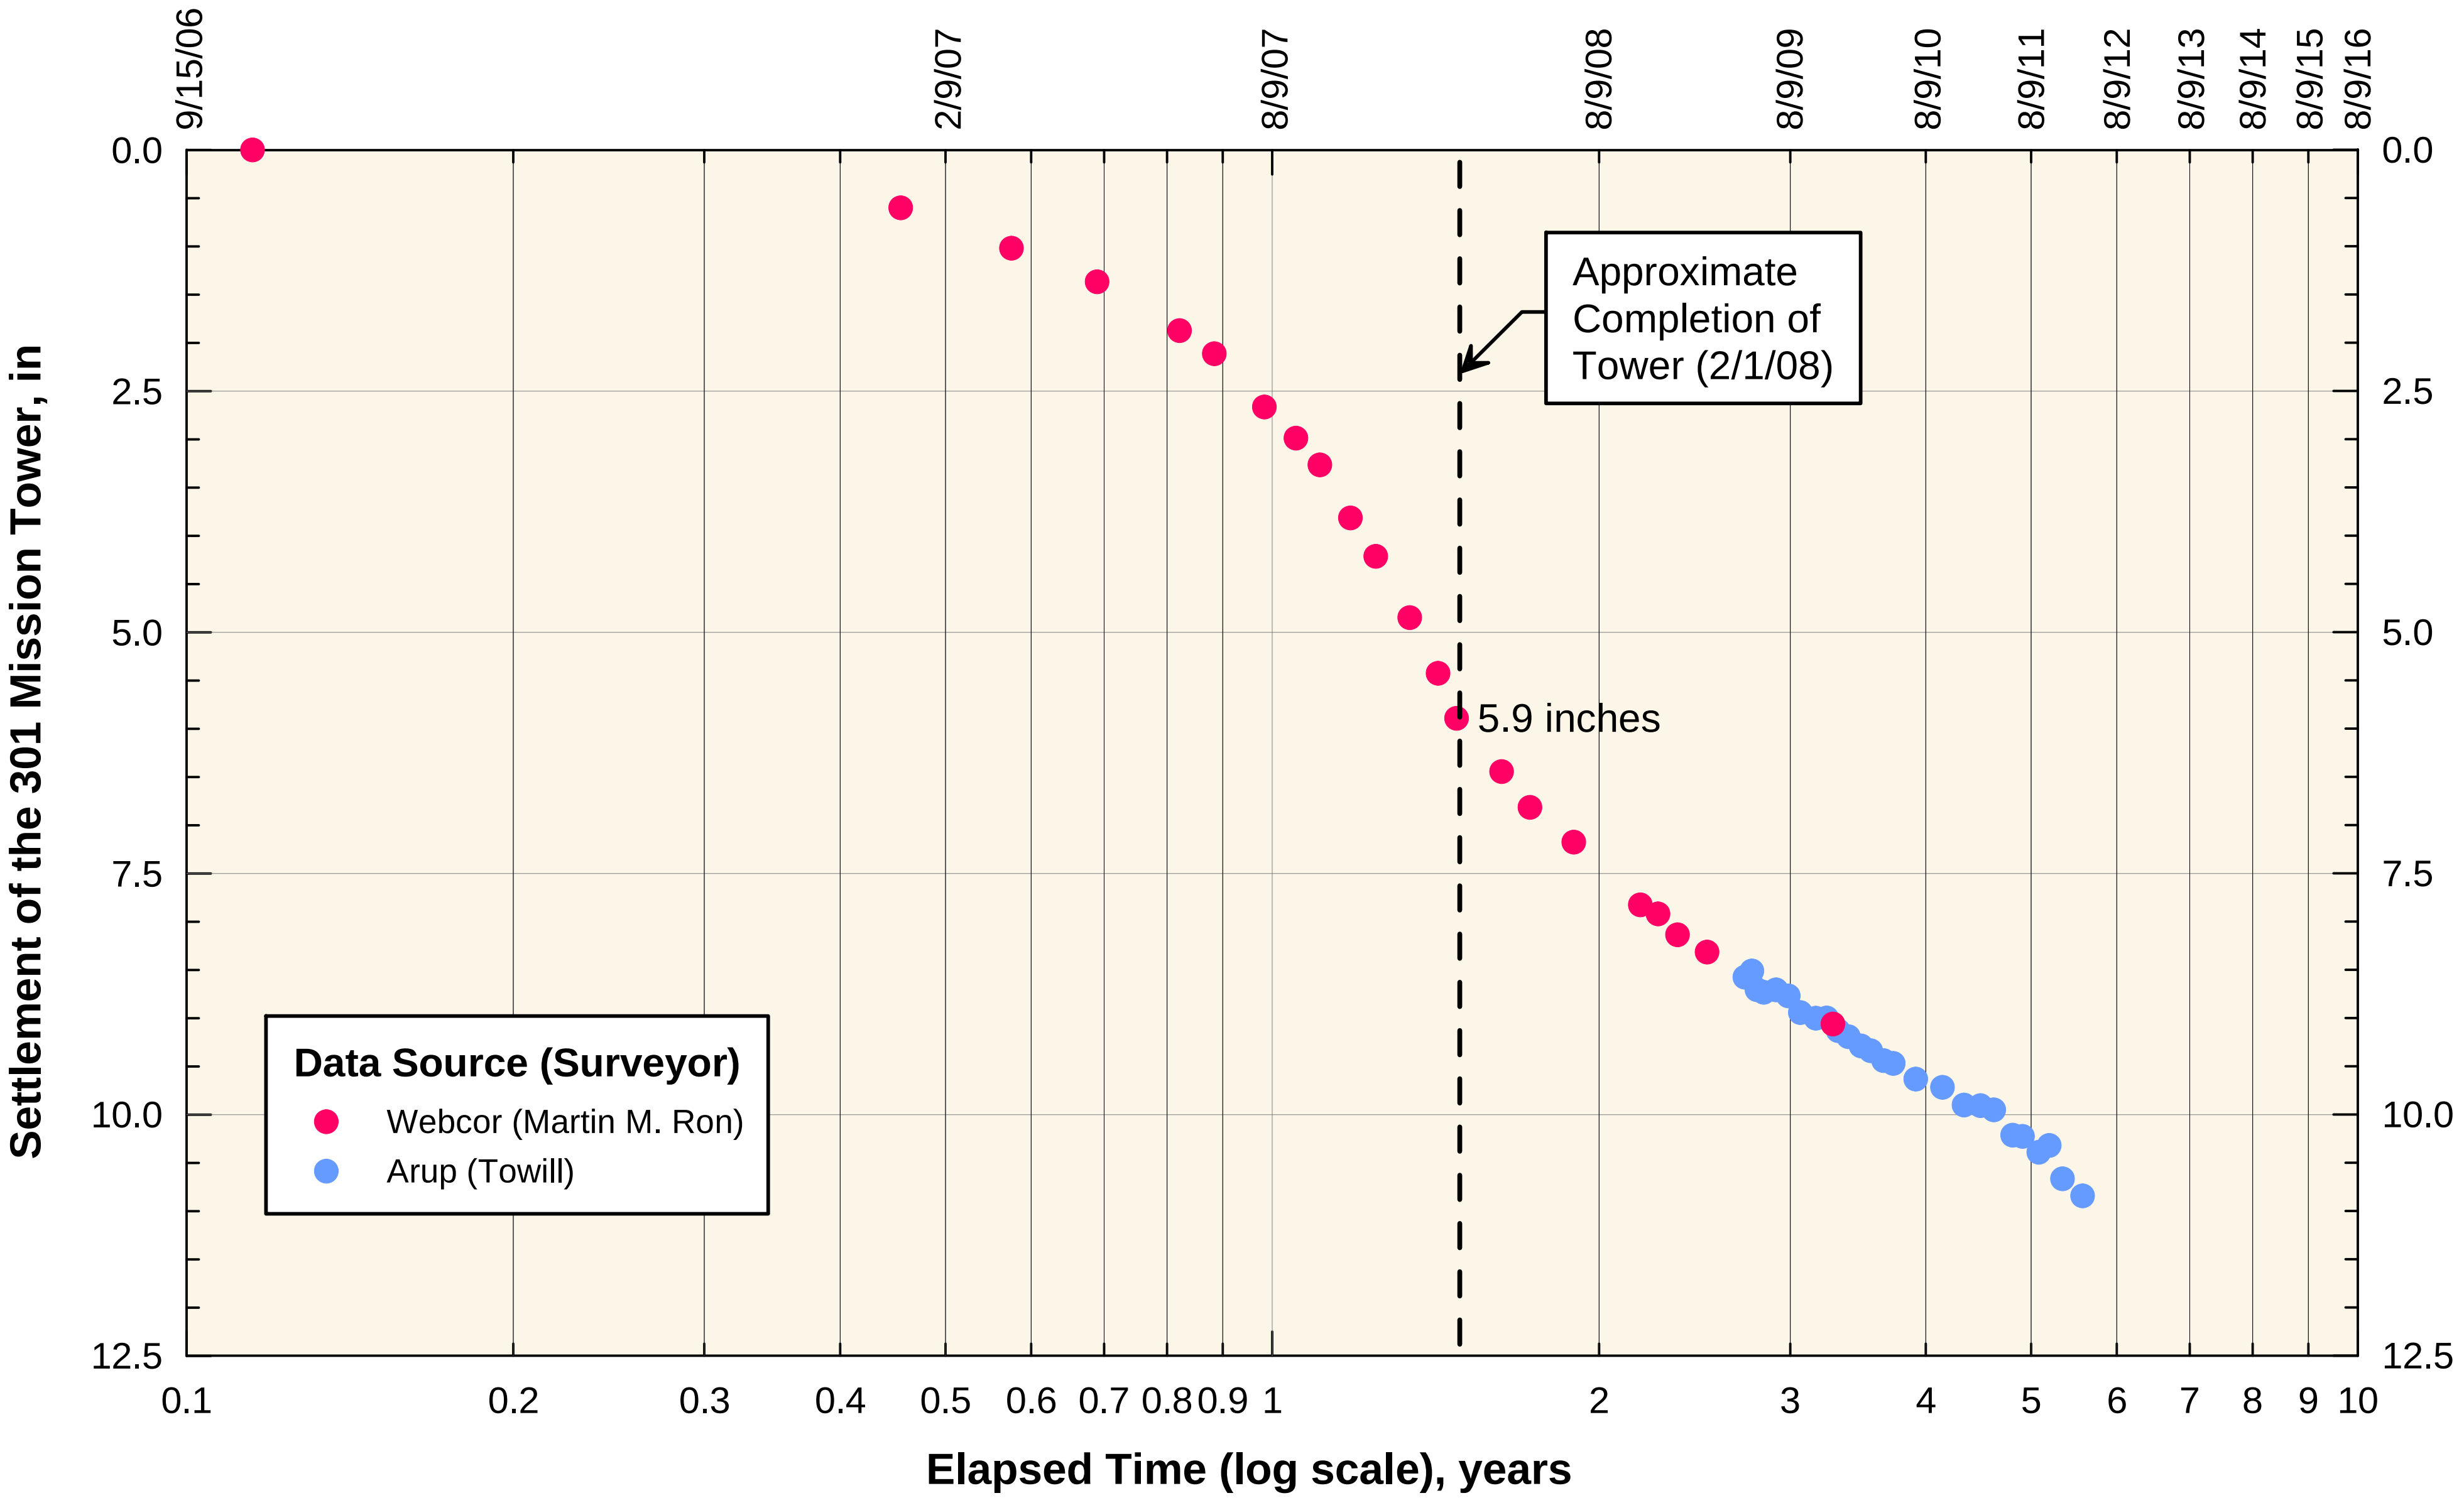
PLATE 5

SETTLEMENTS OF THE 301 MISSION TOWER INCLUDING MONITORING DURING CONSTRUCTION

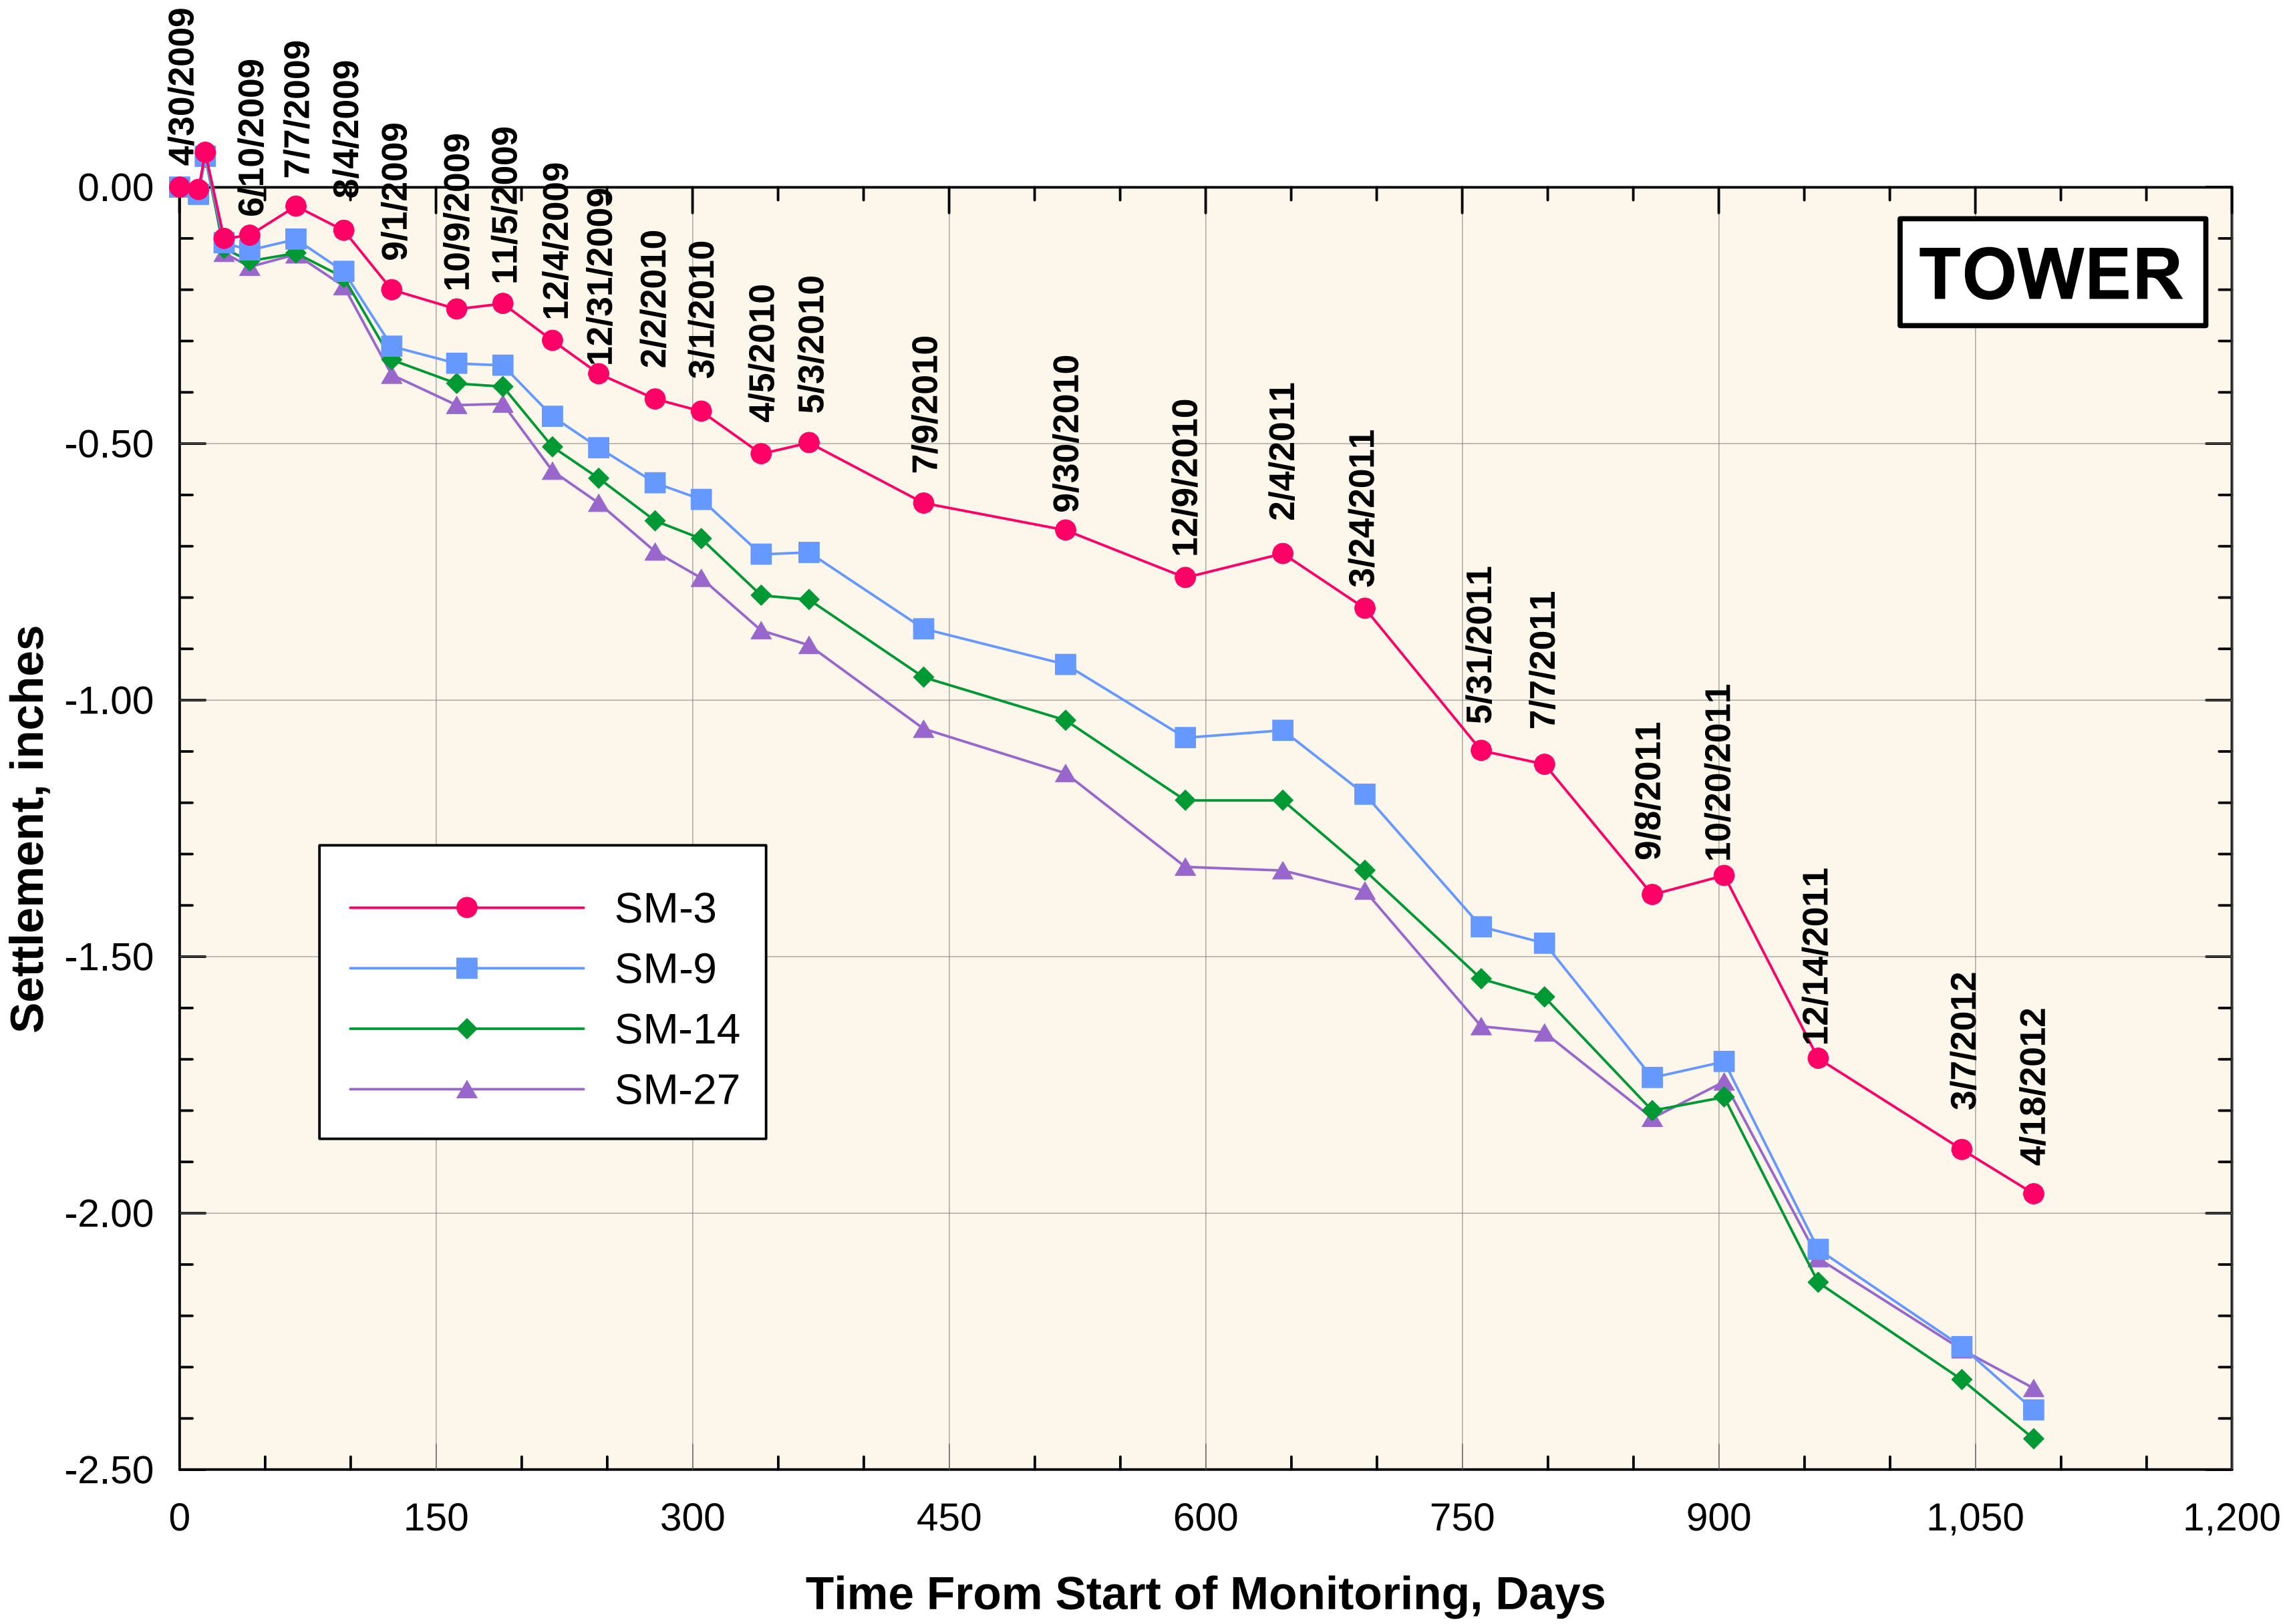
PLATE 3

SETTLEMENT OVER TIME
FLOOR ELEVATIONS AT LEVEL B-1
OF 301 MISSION PROPERTY- TOWER:
APRIL 30, 2009 THROUGH APRIL 18, 2012

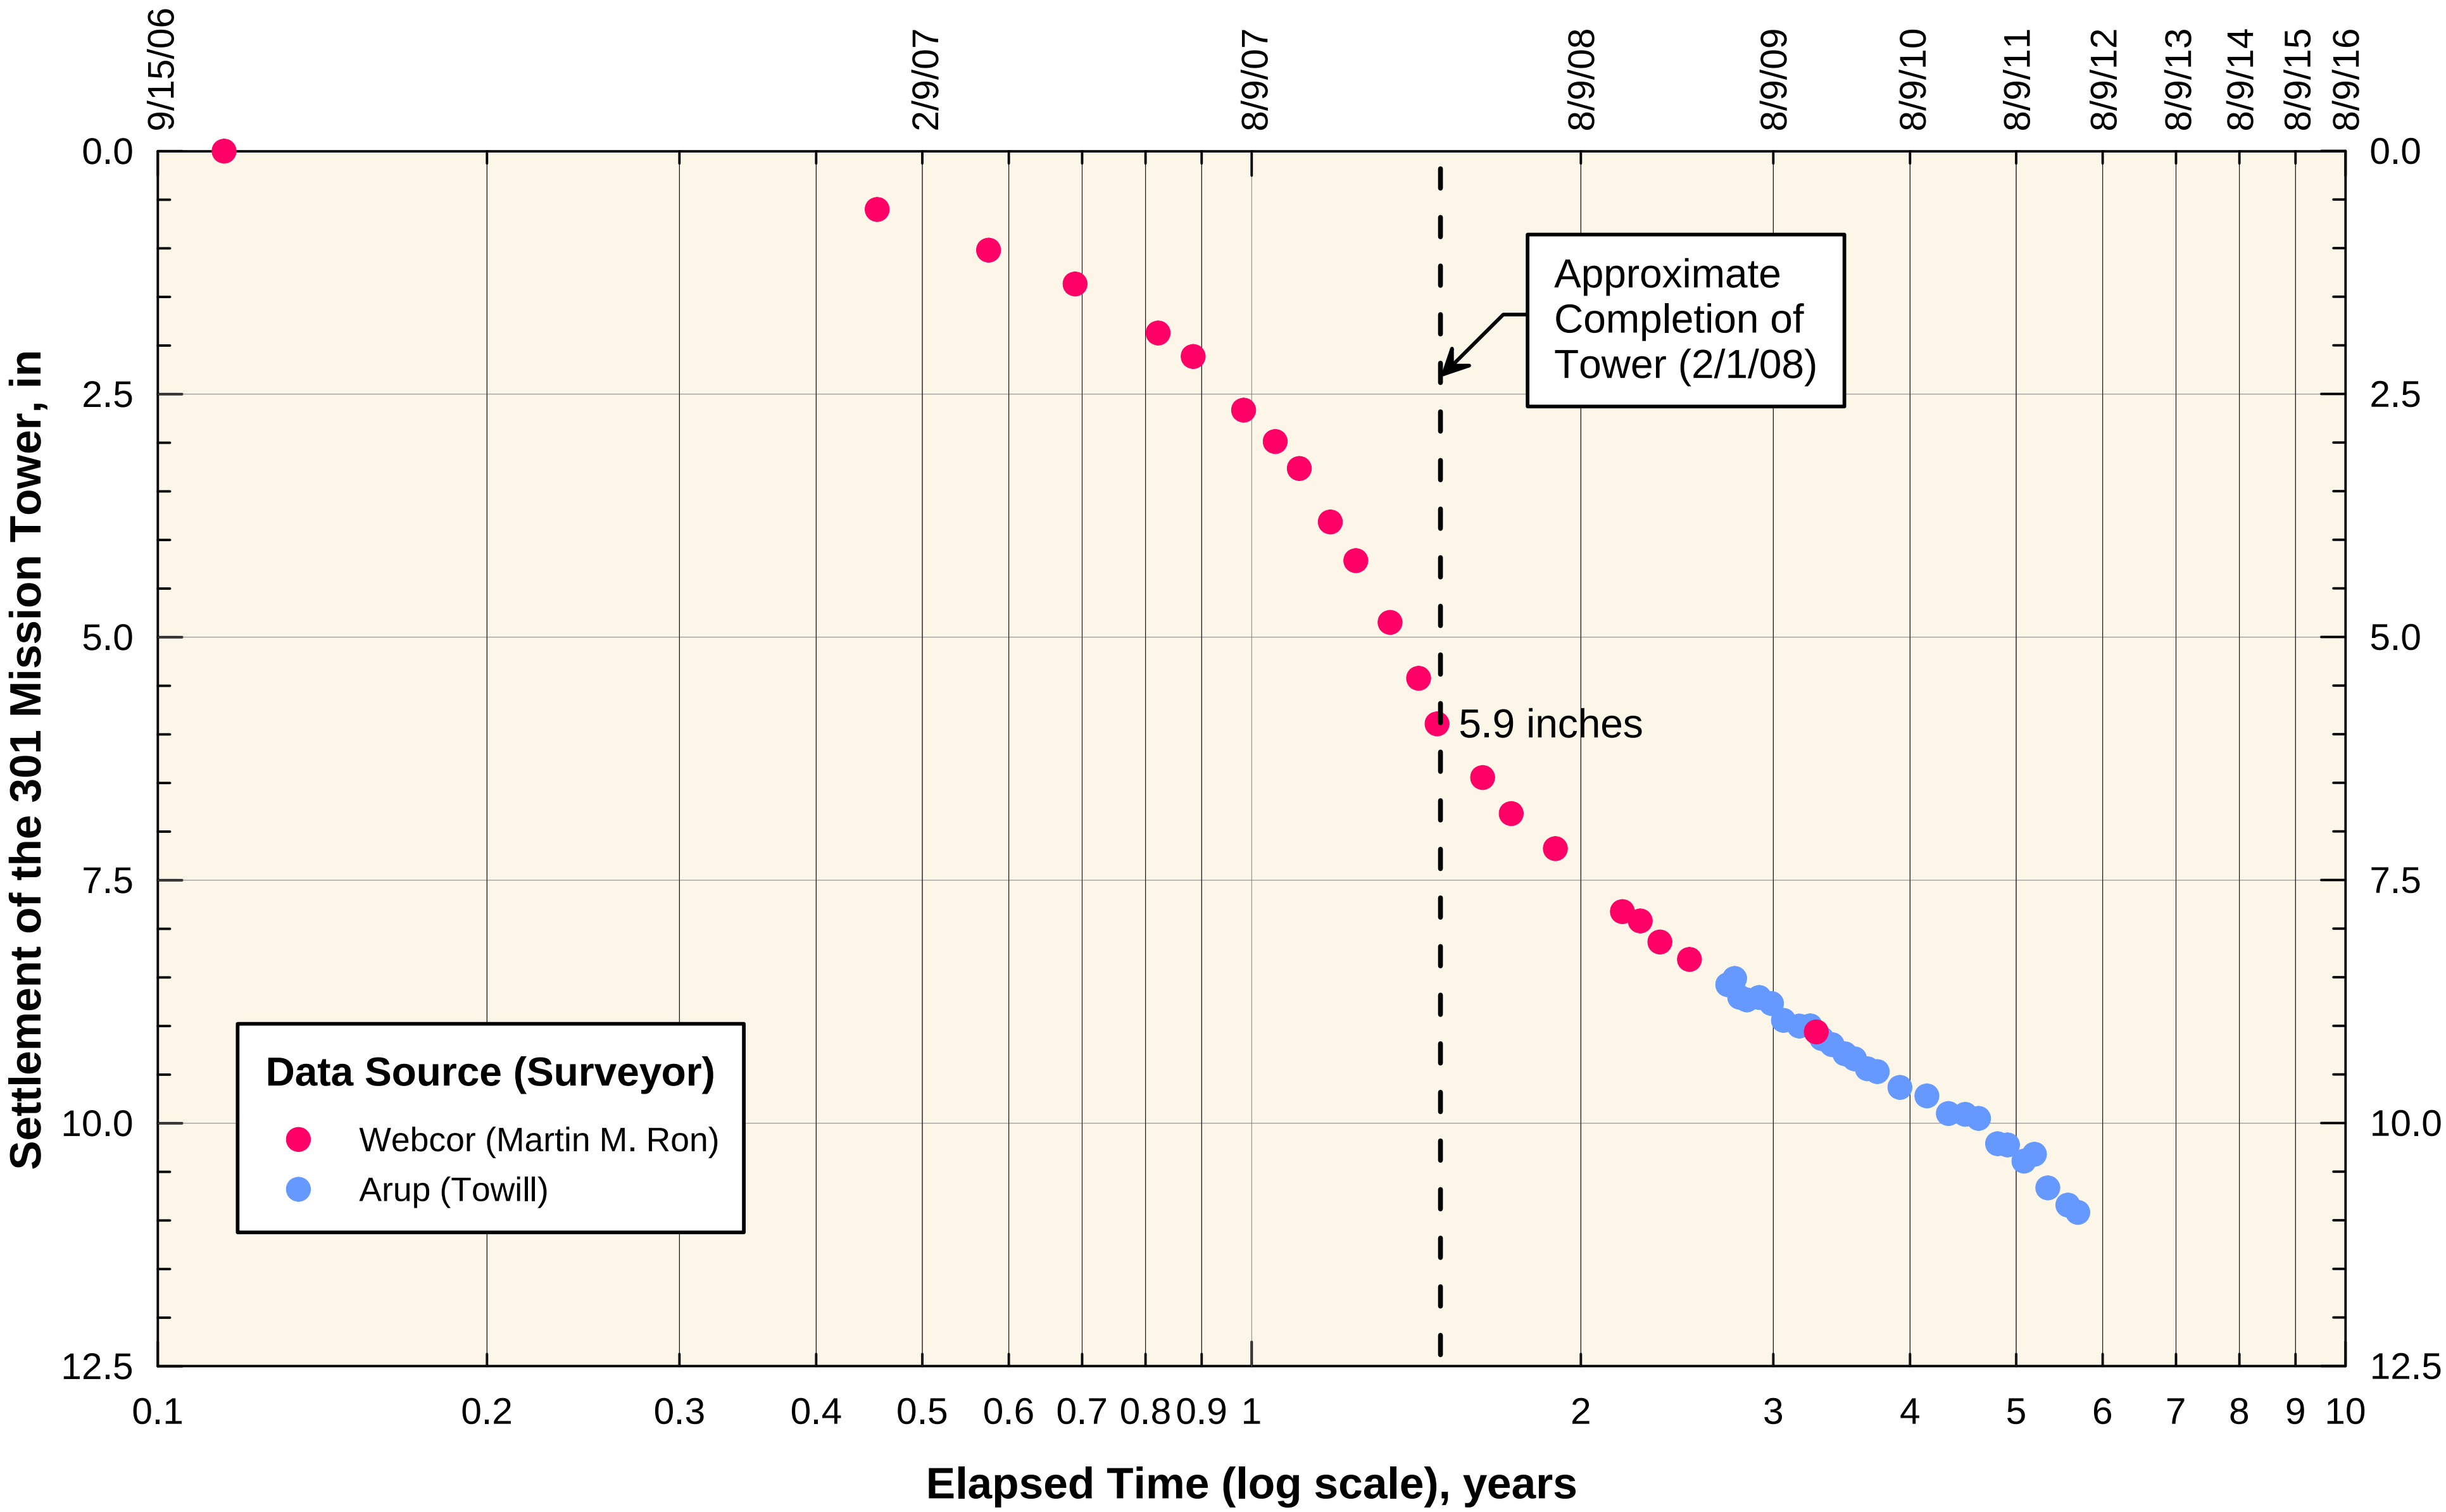
PLATE 5

SETTLEMENTS OF THE 301 MISSION TOWER
INCLUDING MONITORING DURING CONSTRUCTION

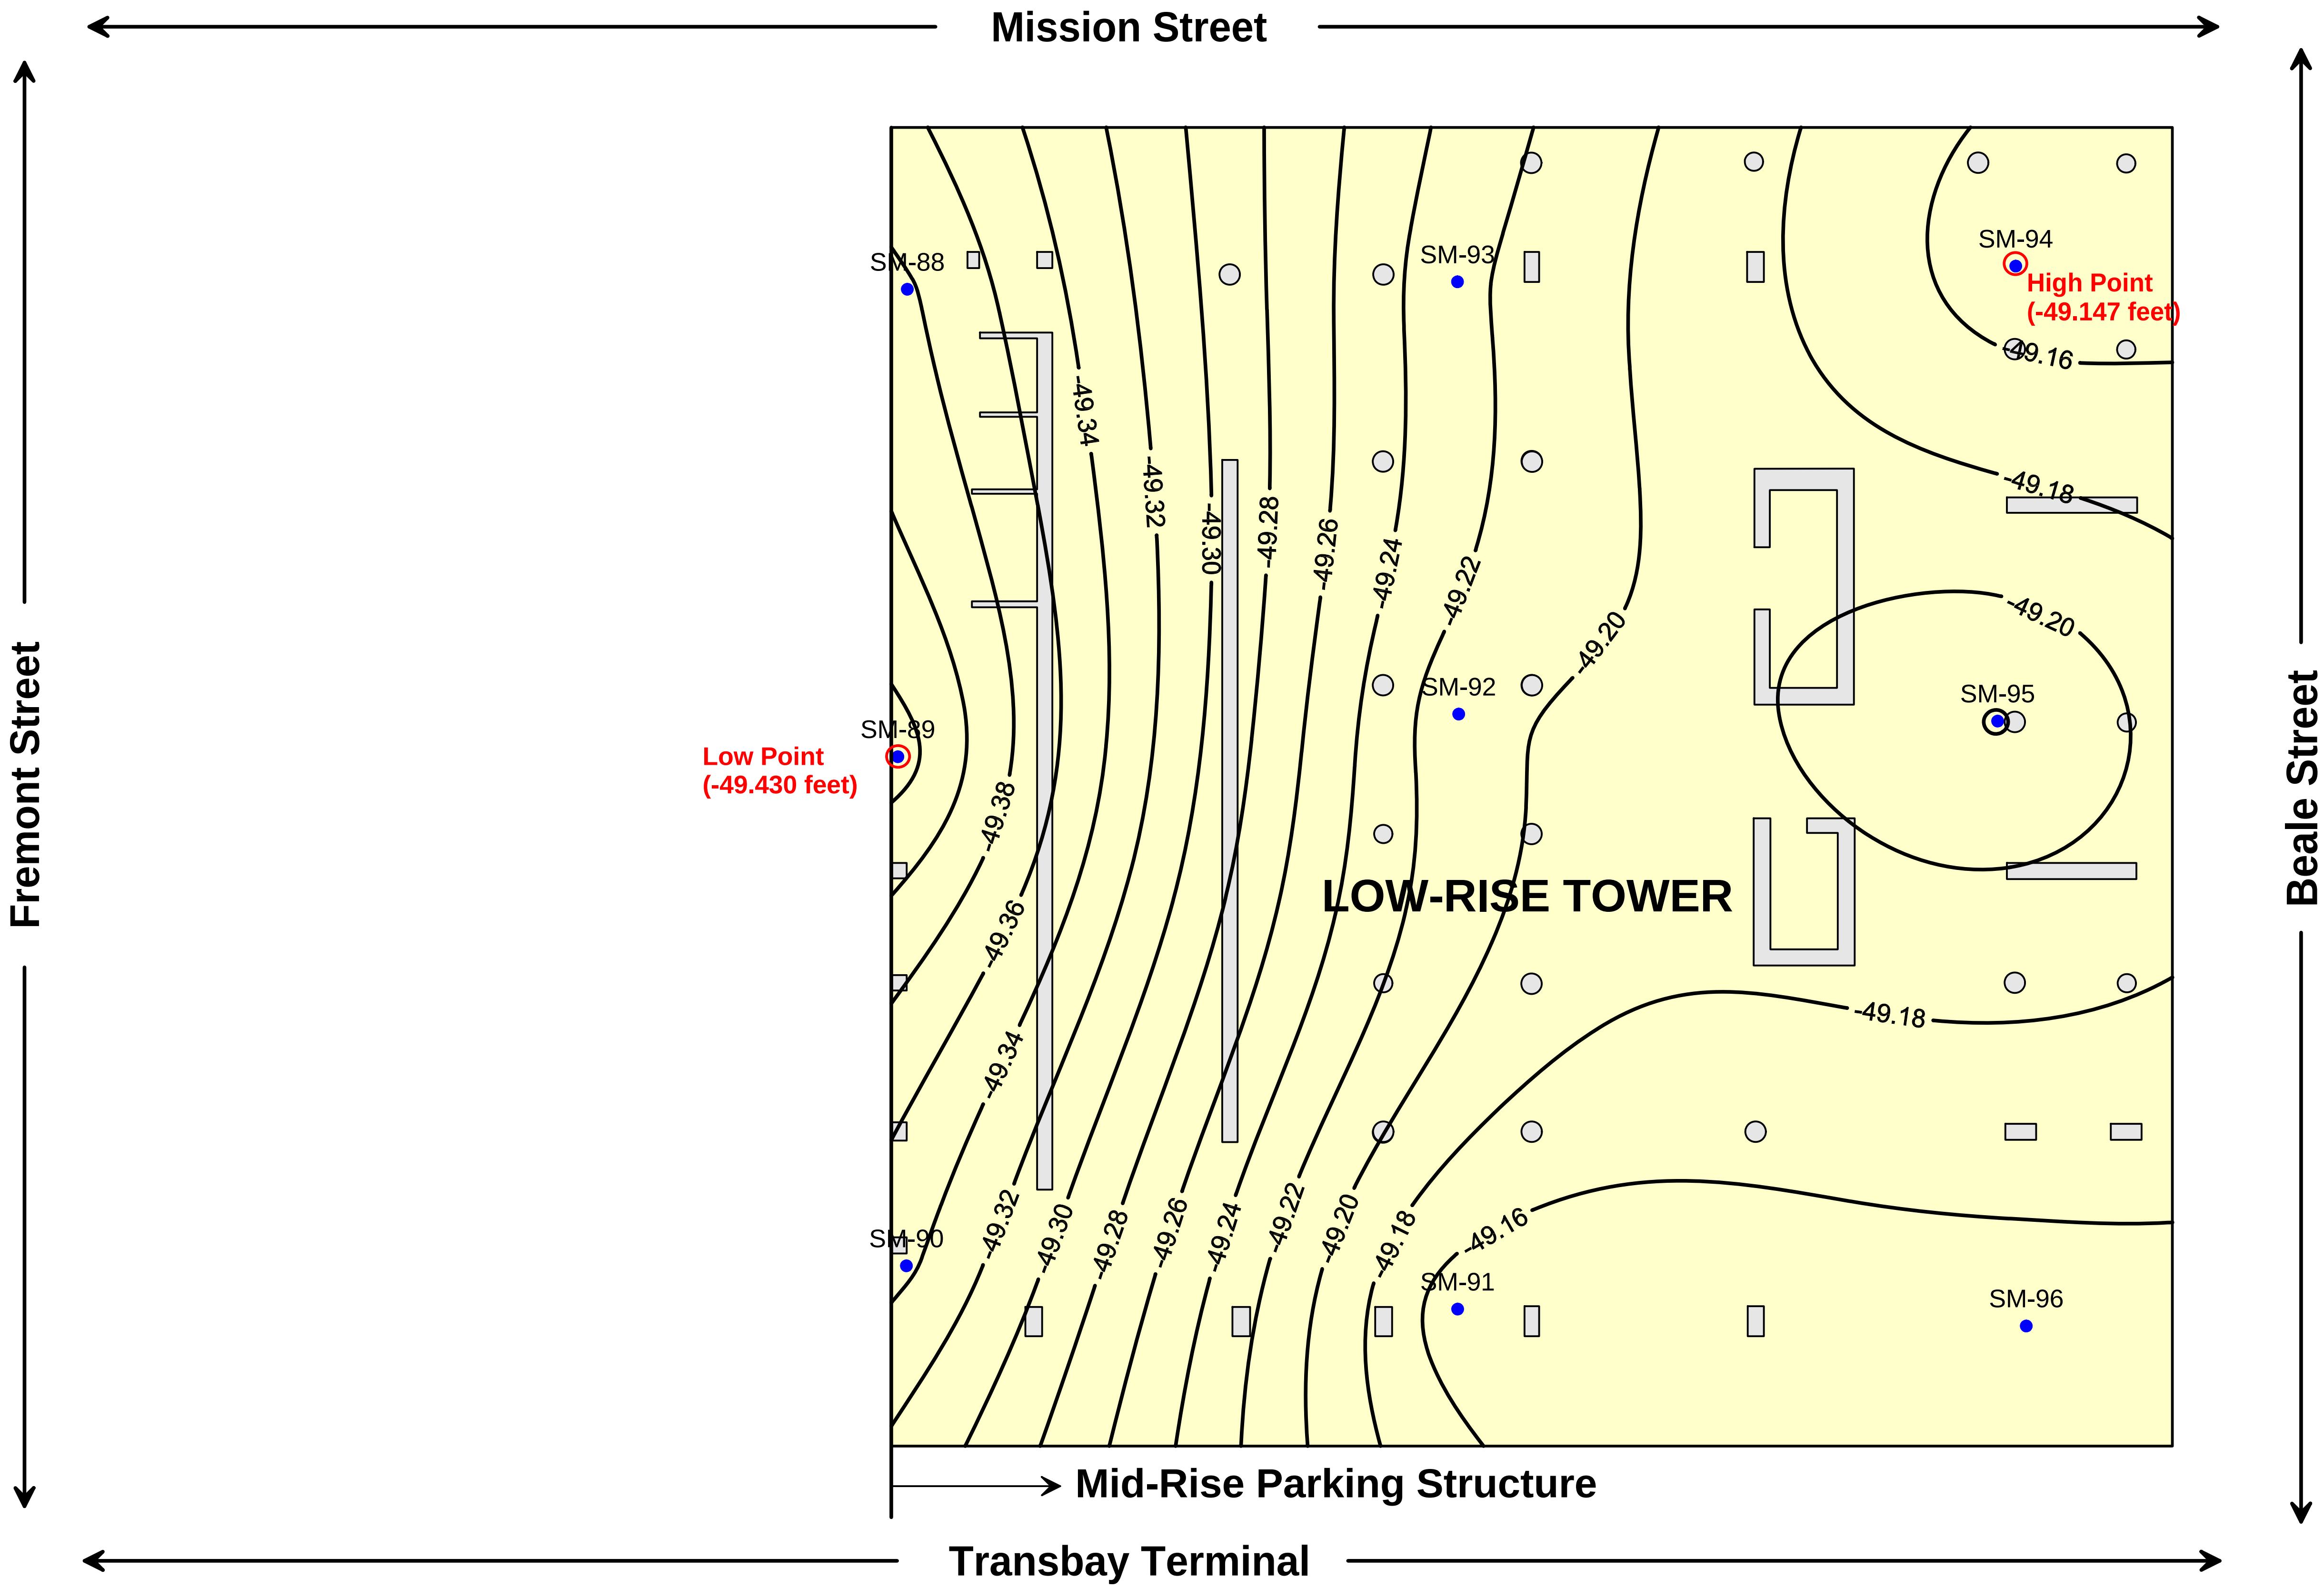
PLATE 6

Maximum Differential
B-5 Level Basement
0.283 feet (3.394 inches)
