File No. 160975 **Committee Item No.** 7
Board Item No. ________

AGENDA PACKET CONTENTS LIST

TALL BUILDINGS SAFETY STRATEGY

October 2018

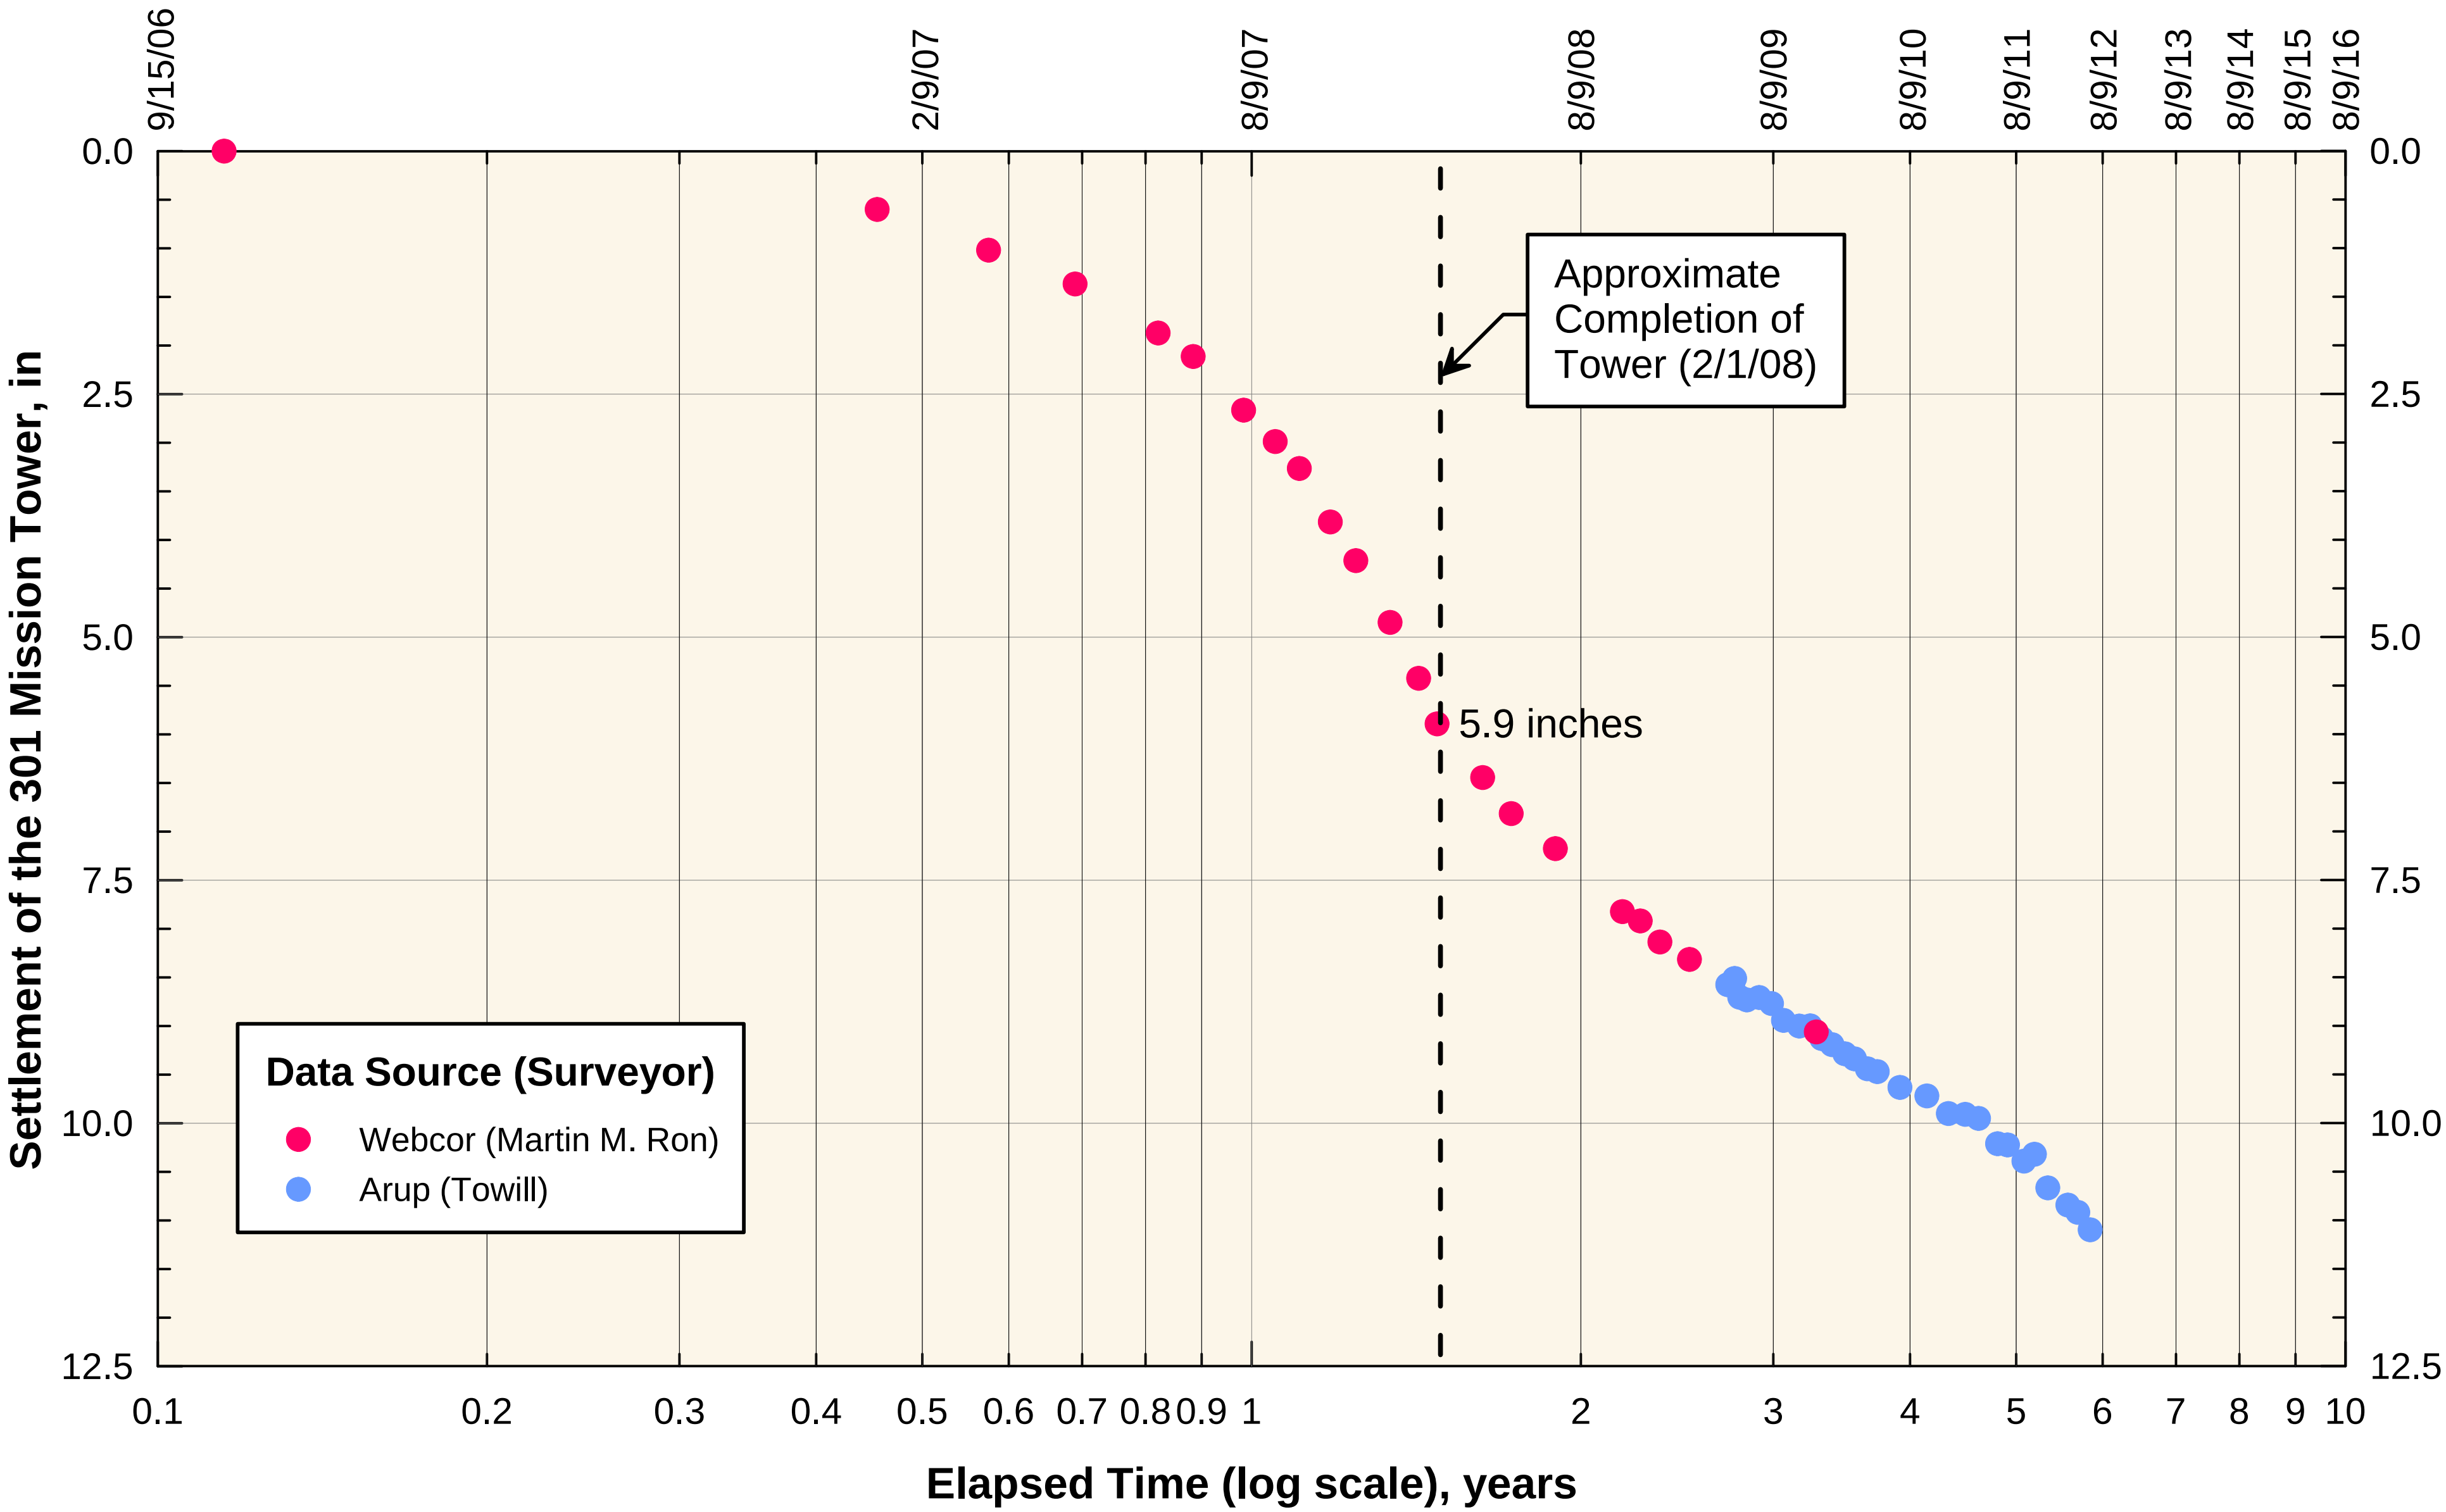
PLATE 5

SETTLEMENTS OF THE 301 MISSION TOWER INCLUDING MONITORING DURING CONSTRUCTION

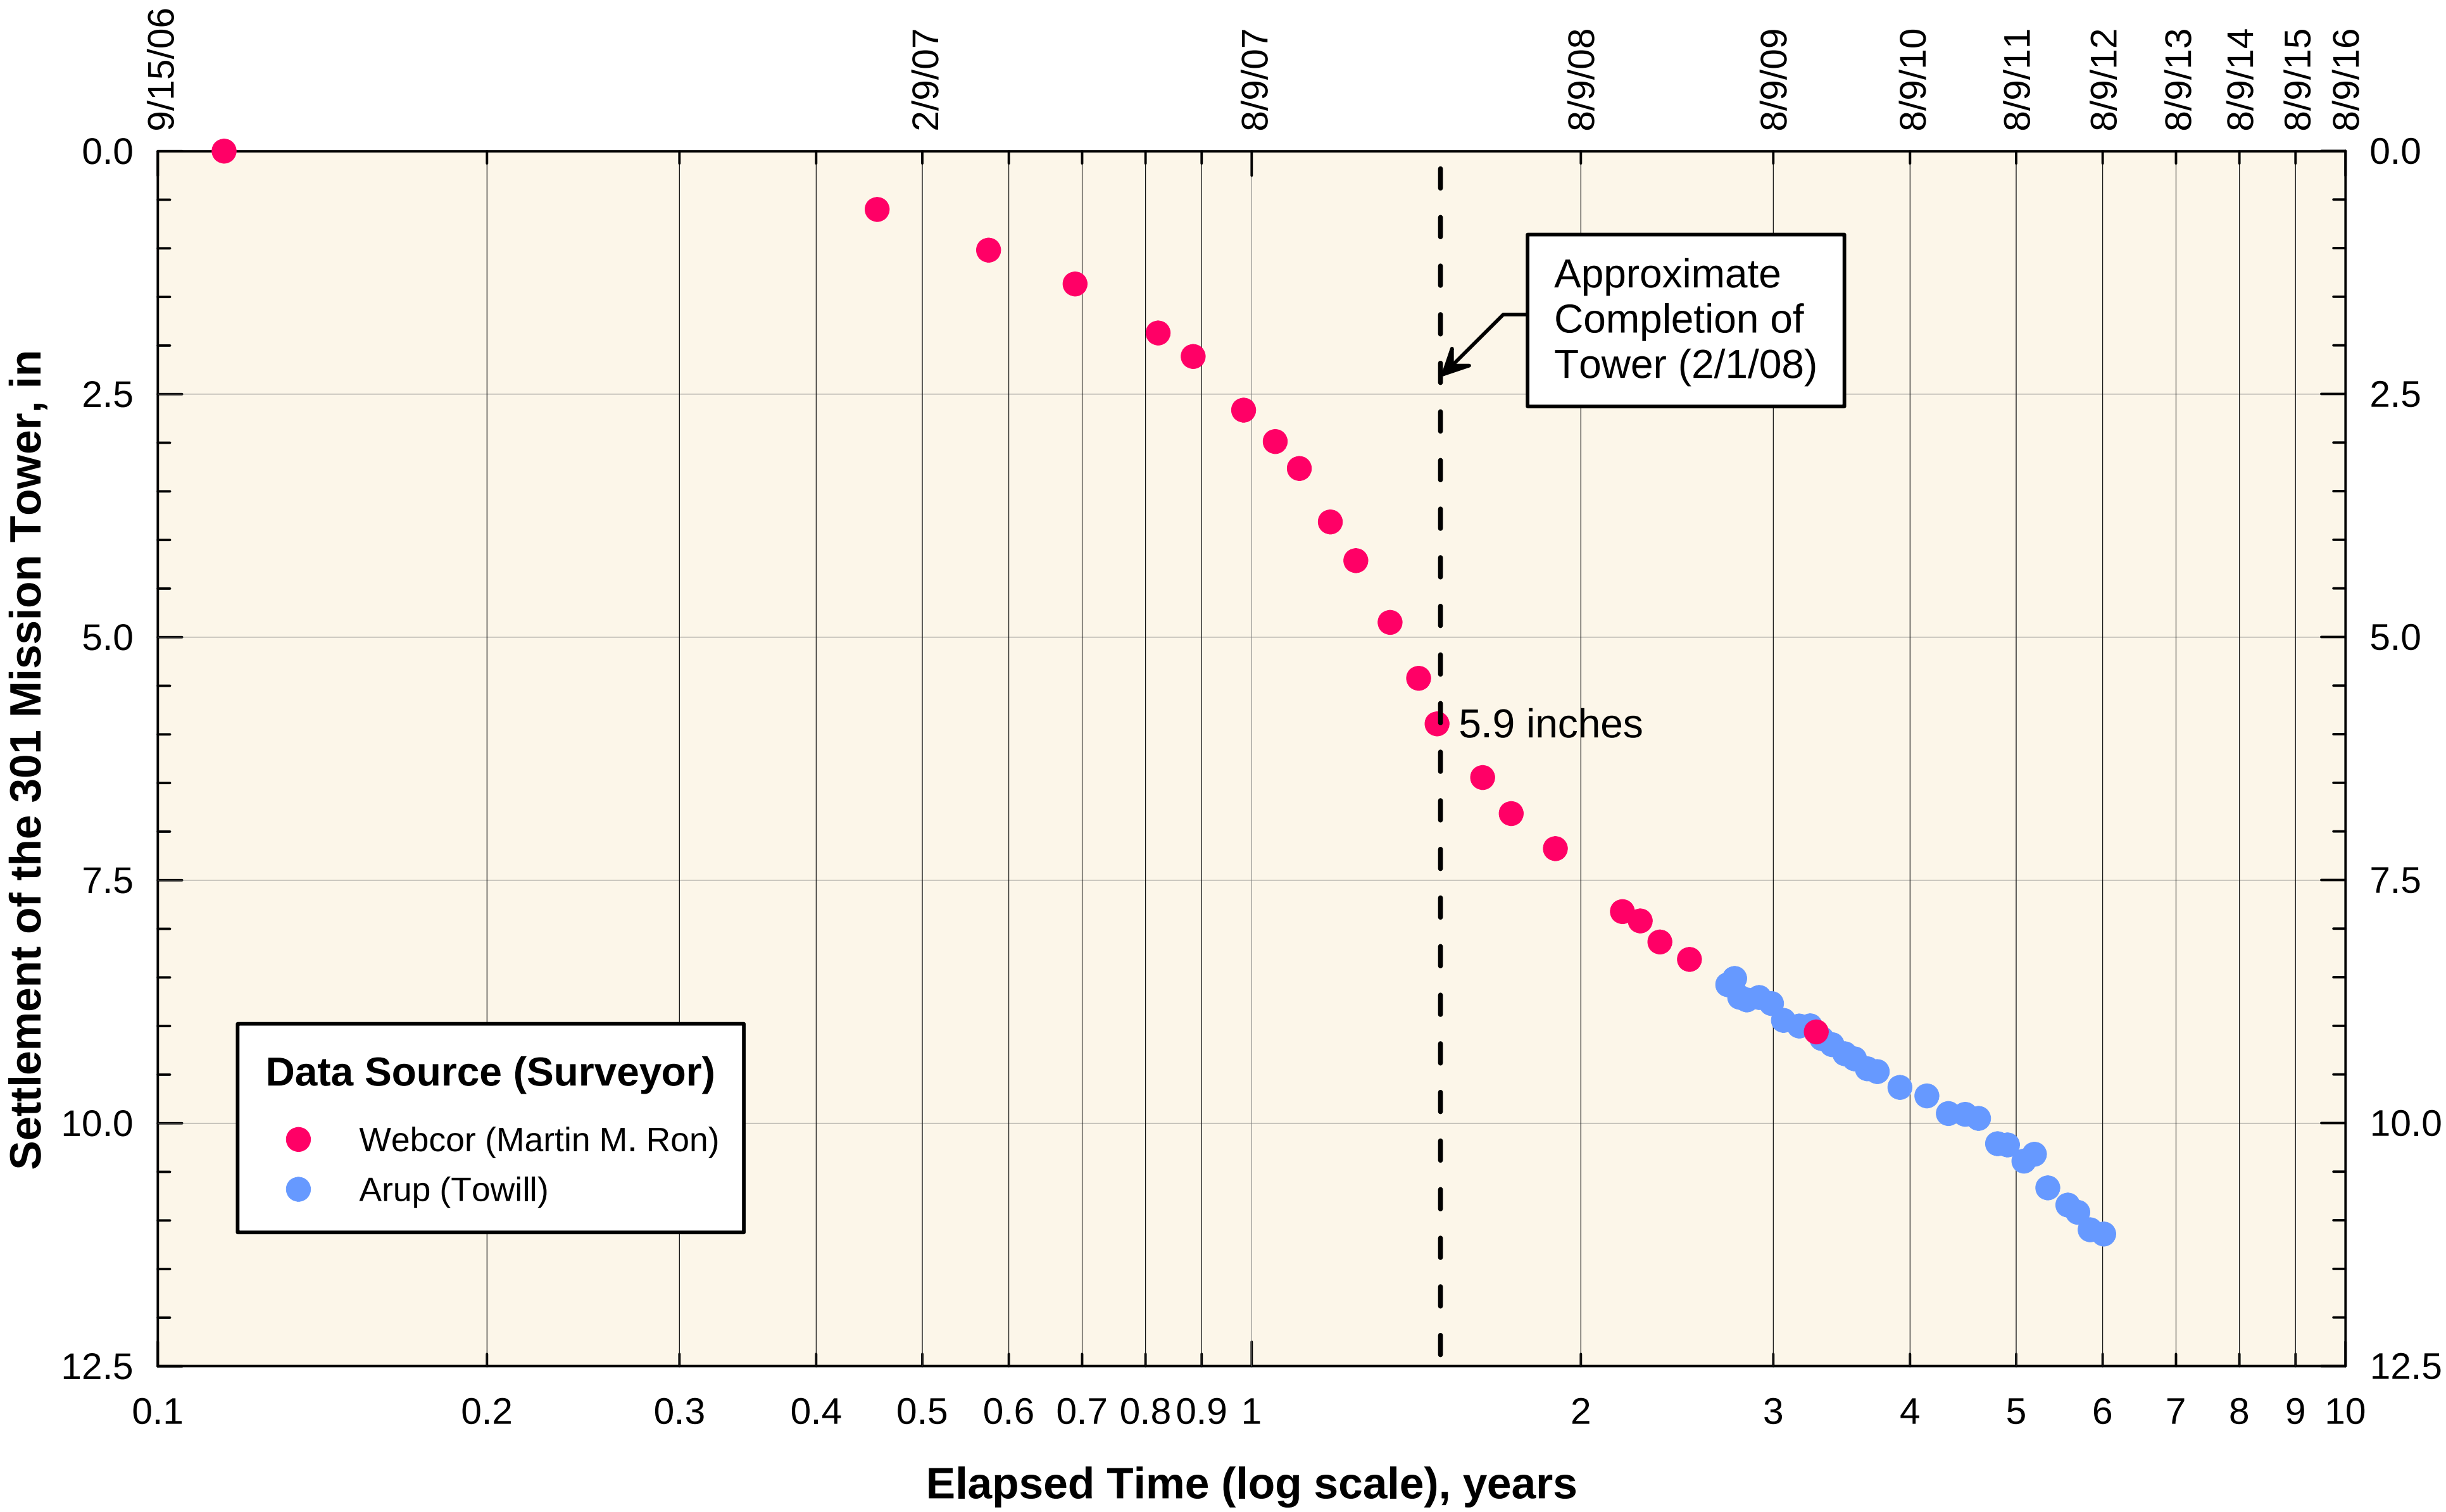
PLATE 5

SETTLEMENTS OF THE 301 MISSION TOWER
INCLUDING MONITORING DURING CONSTRUCTION

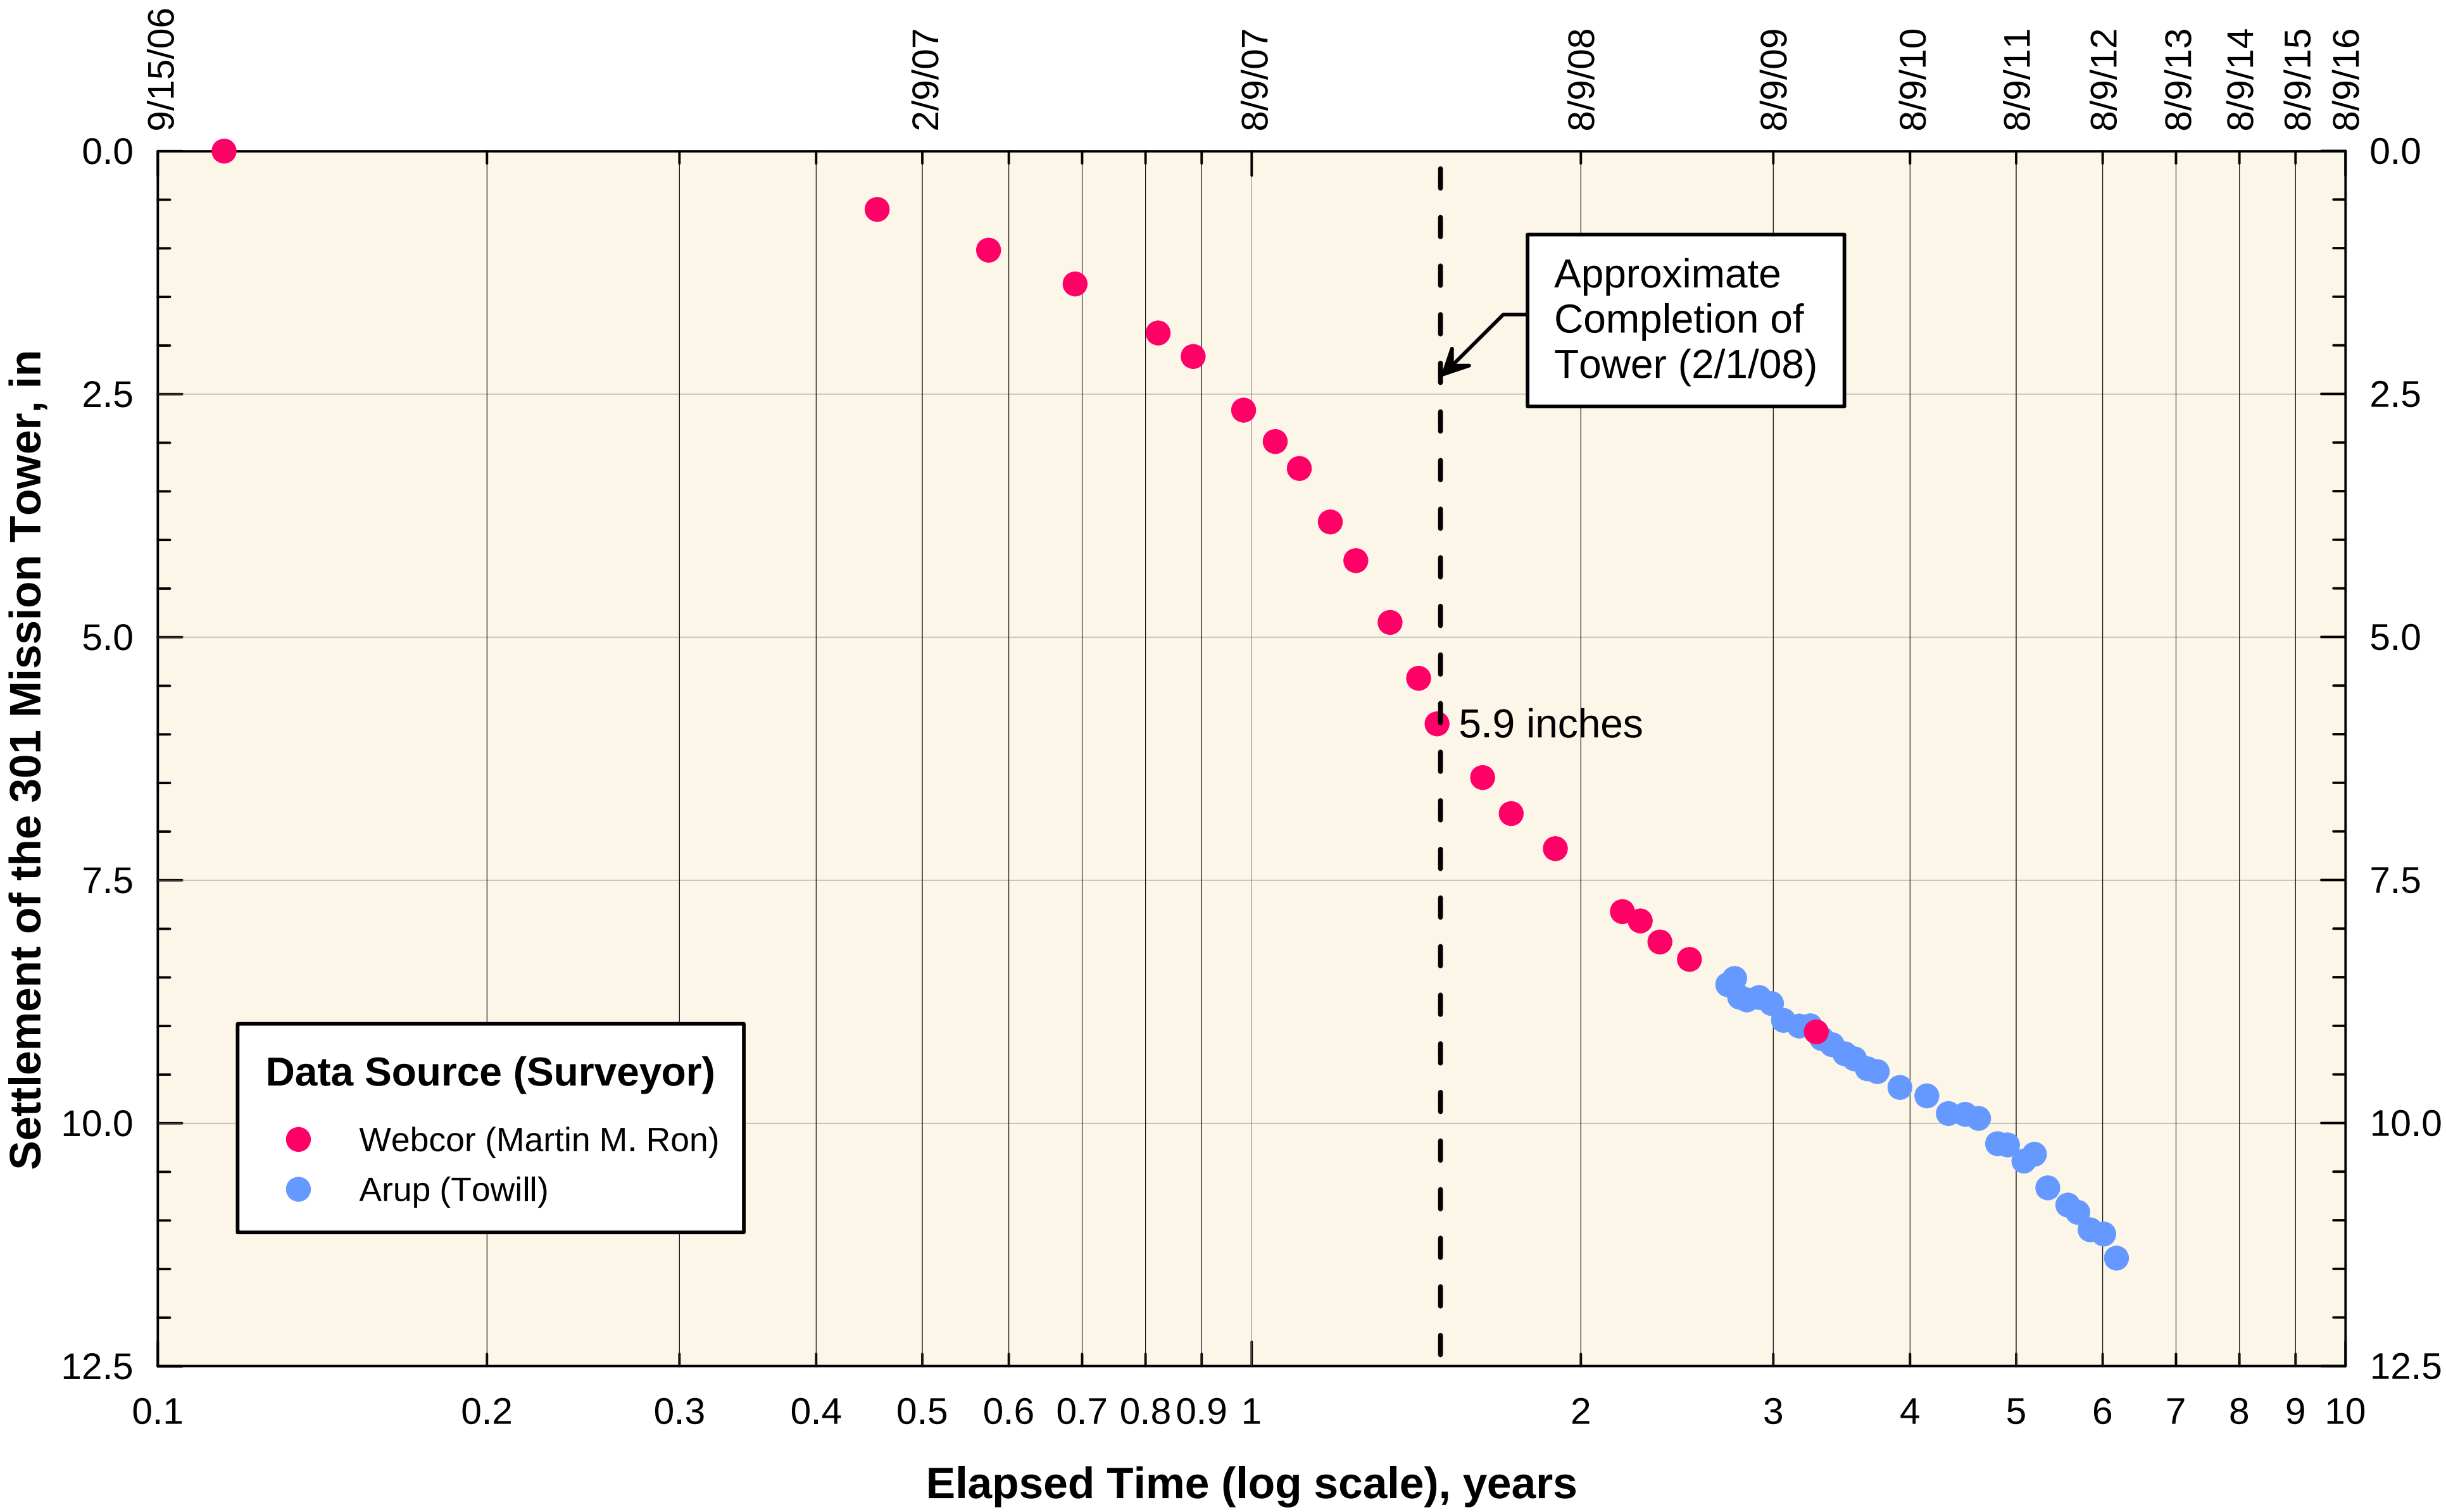
PLATE 5

SETTLEMENTS OF THE 301 MISSION TOWER INCLUDING MONITORING DURING CONSTRUCTION

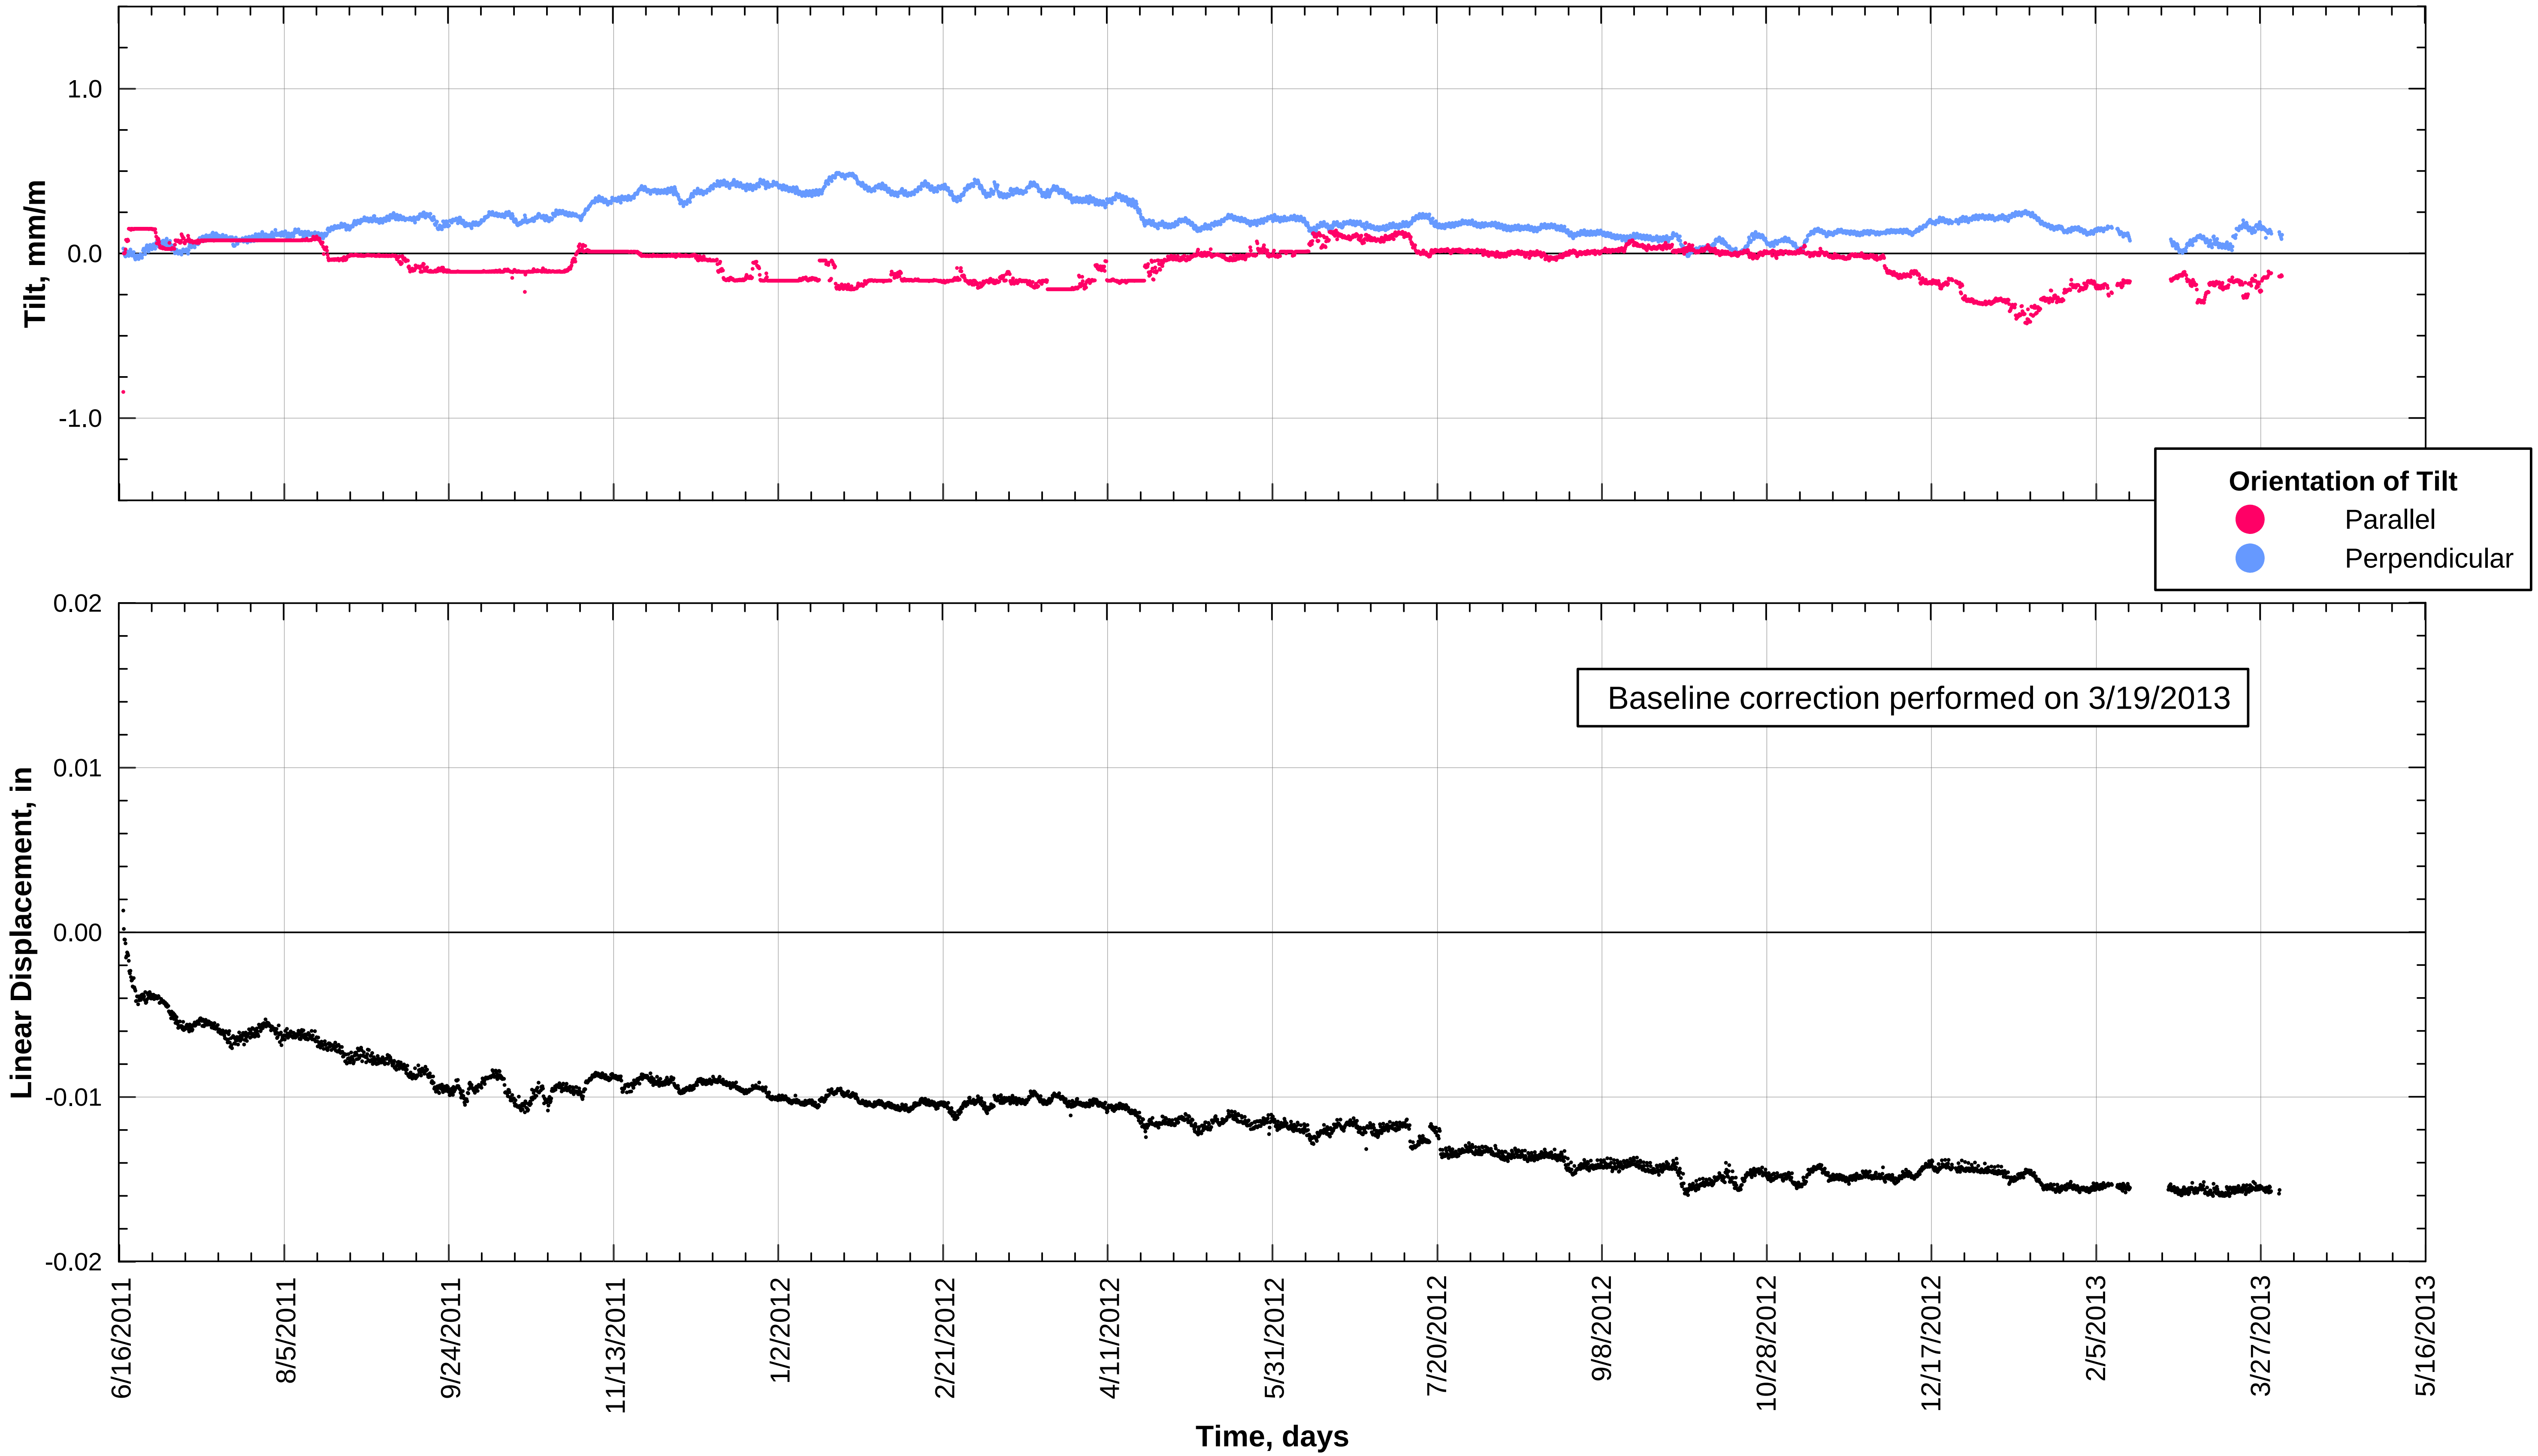
PLATE 9

UTILITY CROSSING MONITORING DATA: UC-07

Baseline corrections were performed in the data sets of UC-01, UC-03, UC-07 and UC-09 to remove erroneous jumps in the readings, the dates of which are recorded on the plots. The instruments in these utility crossings exhibited a one-time jump of a magnitude several times greater than the movement recorded before or after. Before adjusting the baseline for the data following the jump, physical measurements of the gauge length of the instruments were taken on 3/19/2013 to compare to the indicated movement. Comparing these measurements to the original gauge length for the instruments, the four instruments listed above were identified as having jumps in their data files that did not reflect actual movement at the utility crossing. Based on this information, the value of the jump was subtracted from all readings following the jump time to adjust the subsequent readings back to the original baseline. An example of the baseline correction for UC-01 is presented on Plate 13 which displays the raw and corrected data as well as the magnitude of the jump. The jump on UC-01 and UC-03 occurred on the same day and was likely caused by the same event given their proximity. The jump on UC-07 occurred during the manual gauge length measurements on 3/19/2013 and was likely inadvertently bumped while the measurement was taken.

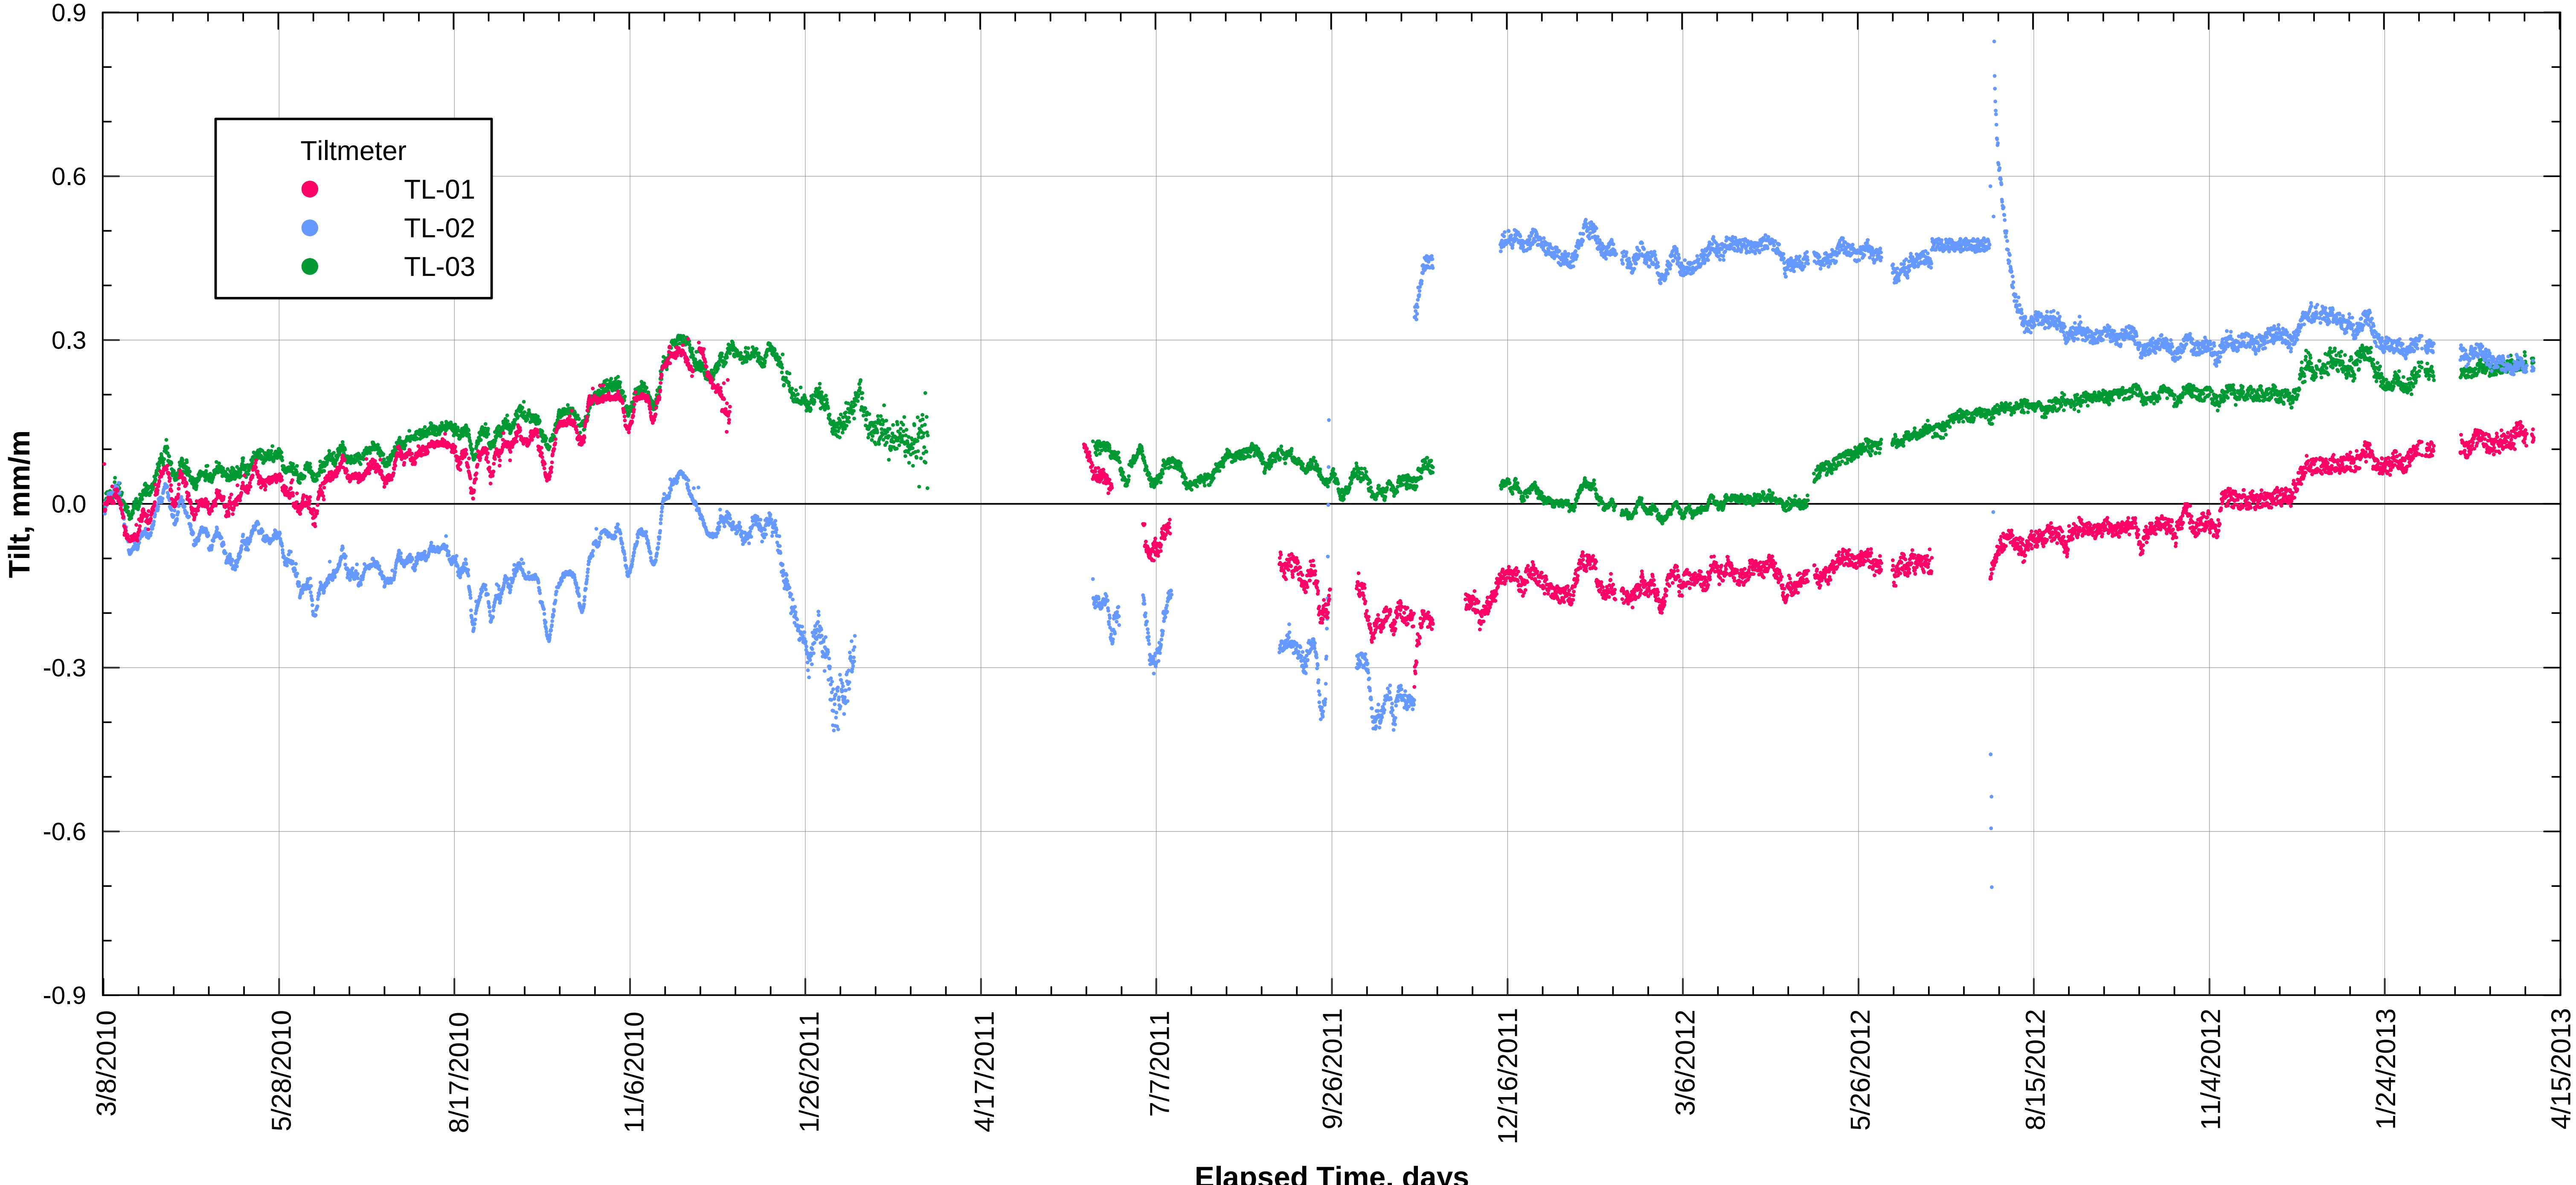
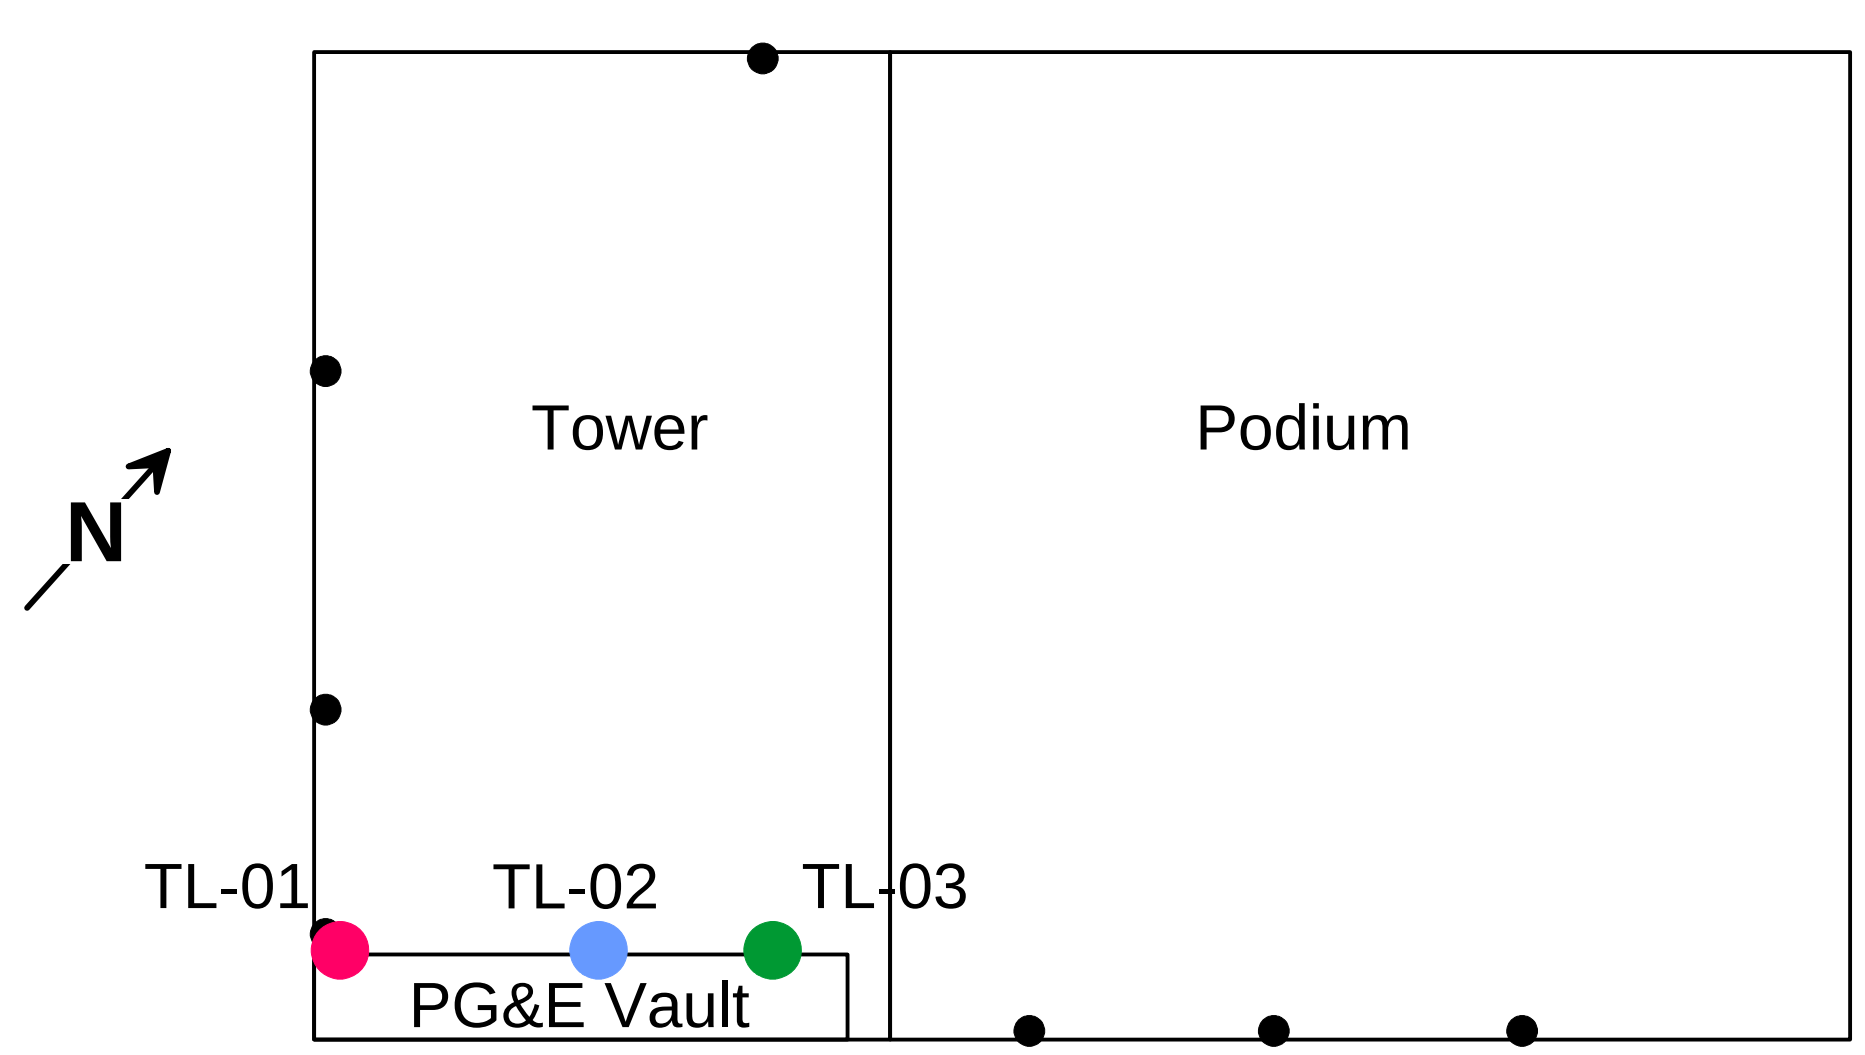
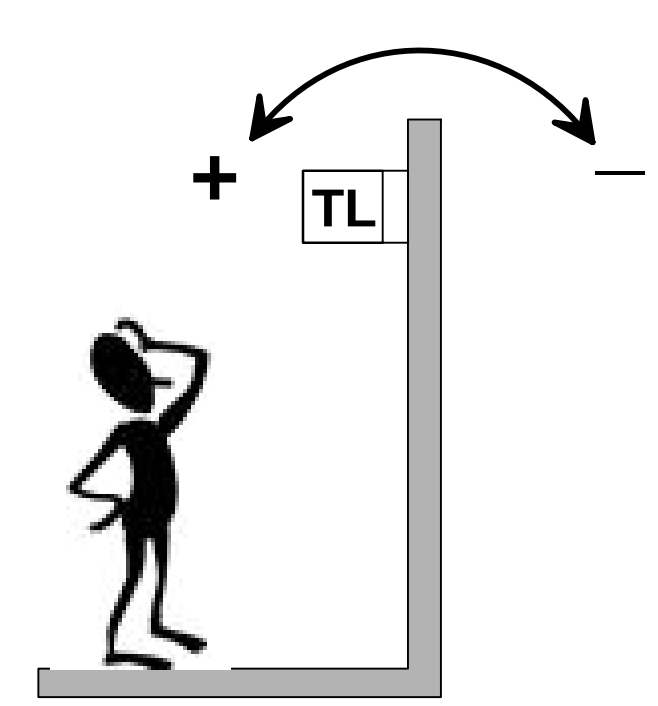
PLATE 14

Positive tilt represents movement of the top of the wall towards the inside of the room.

TILT RECORDED IN TILTMETERS TL-01, TL-02, AND TL-03: BASEMENT LEVEL B-1
