File No. 160975 **Committee Item No.** 7
Board Item No. ________

AGENDA PACKET CONTENTS LIST

TALL BUILDINGS SAFETY STRATEGY

October 2018

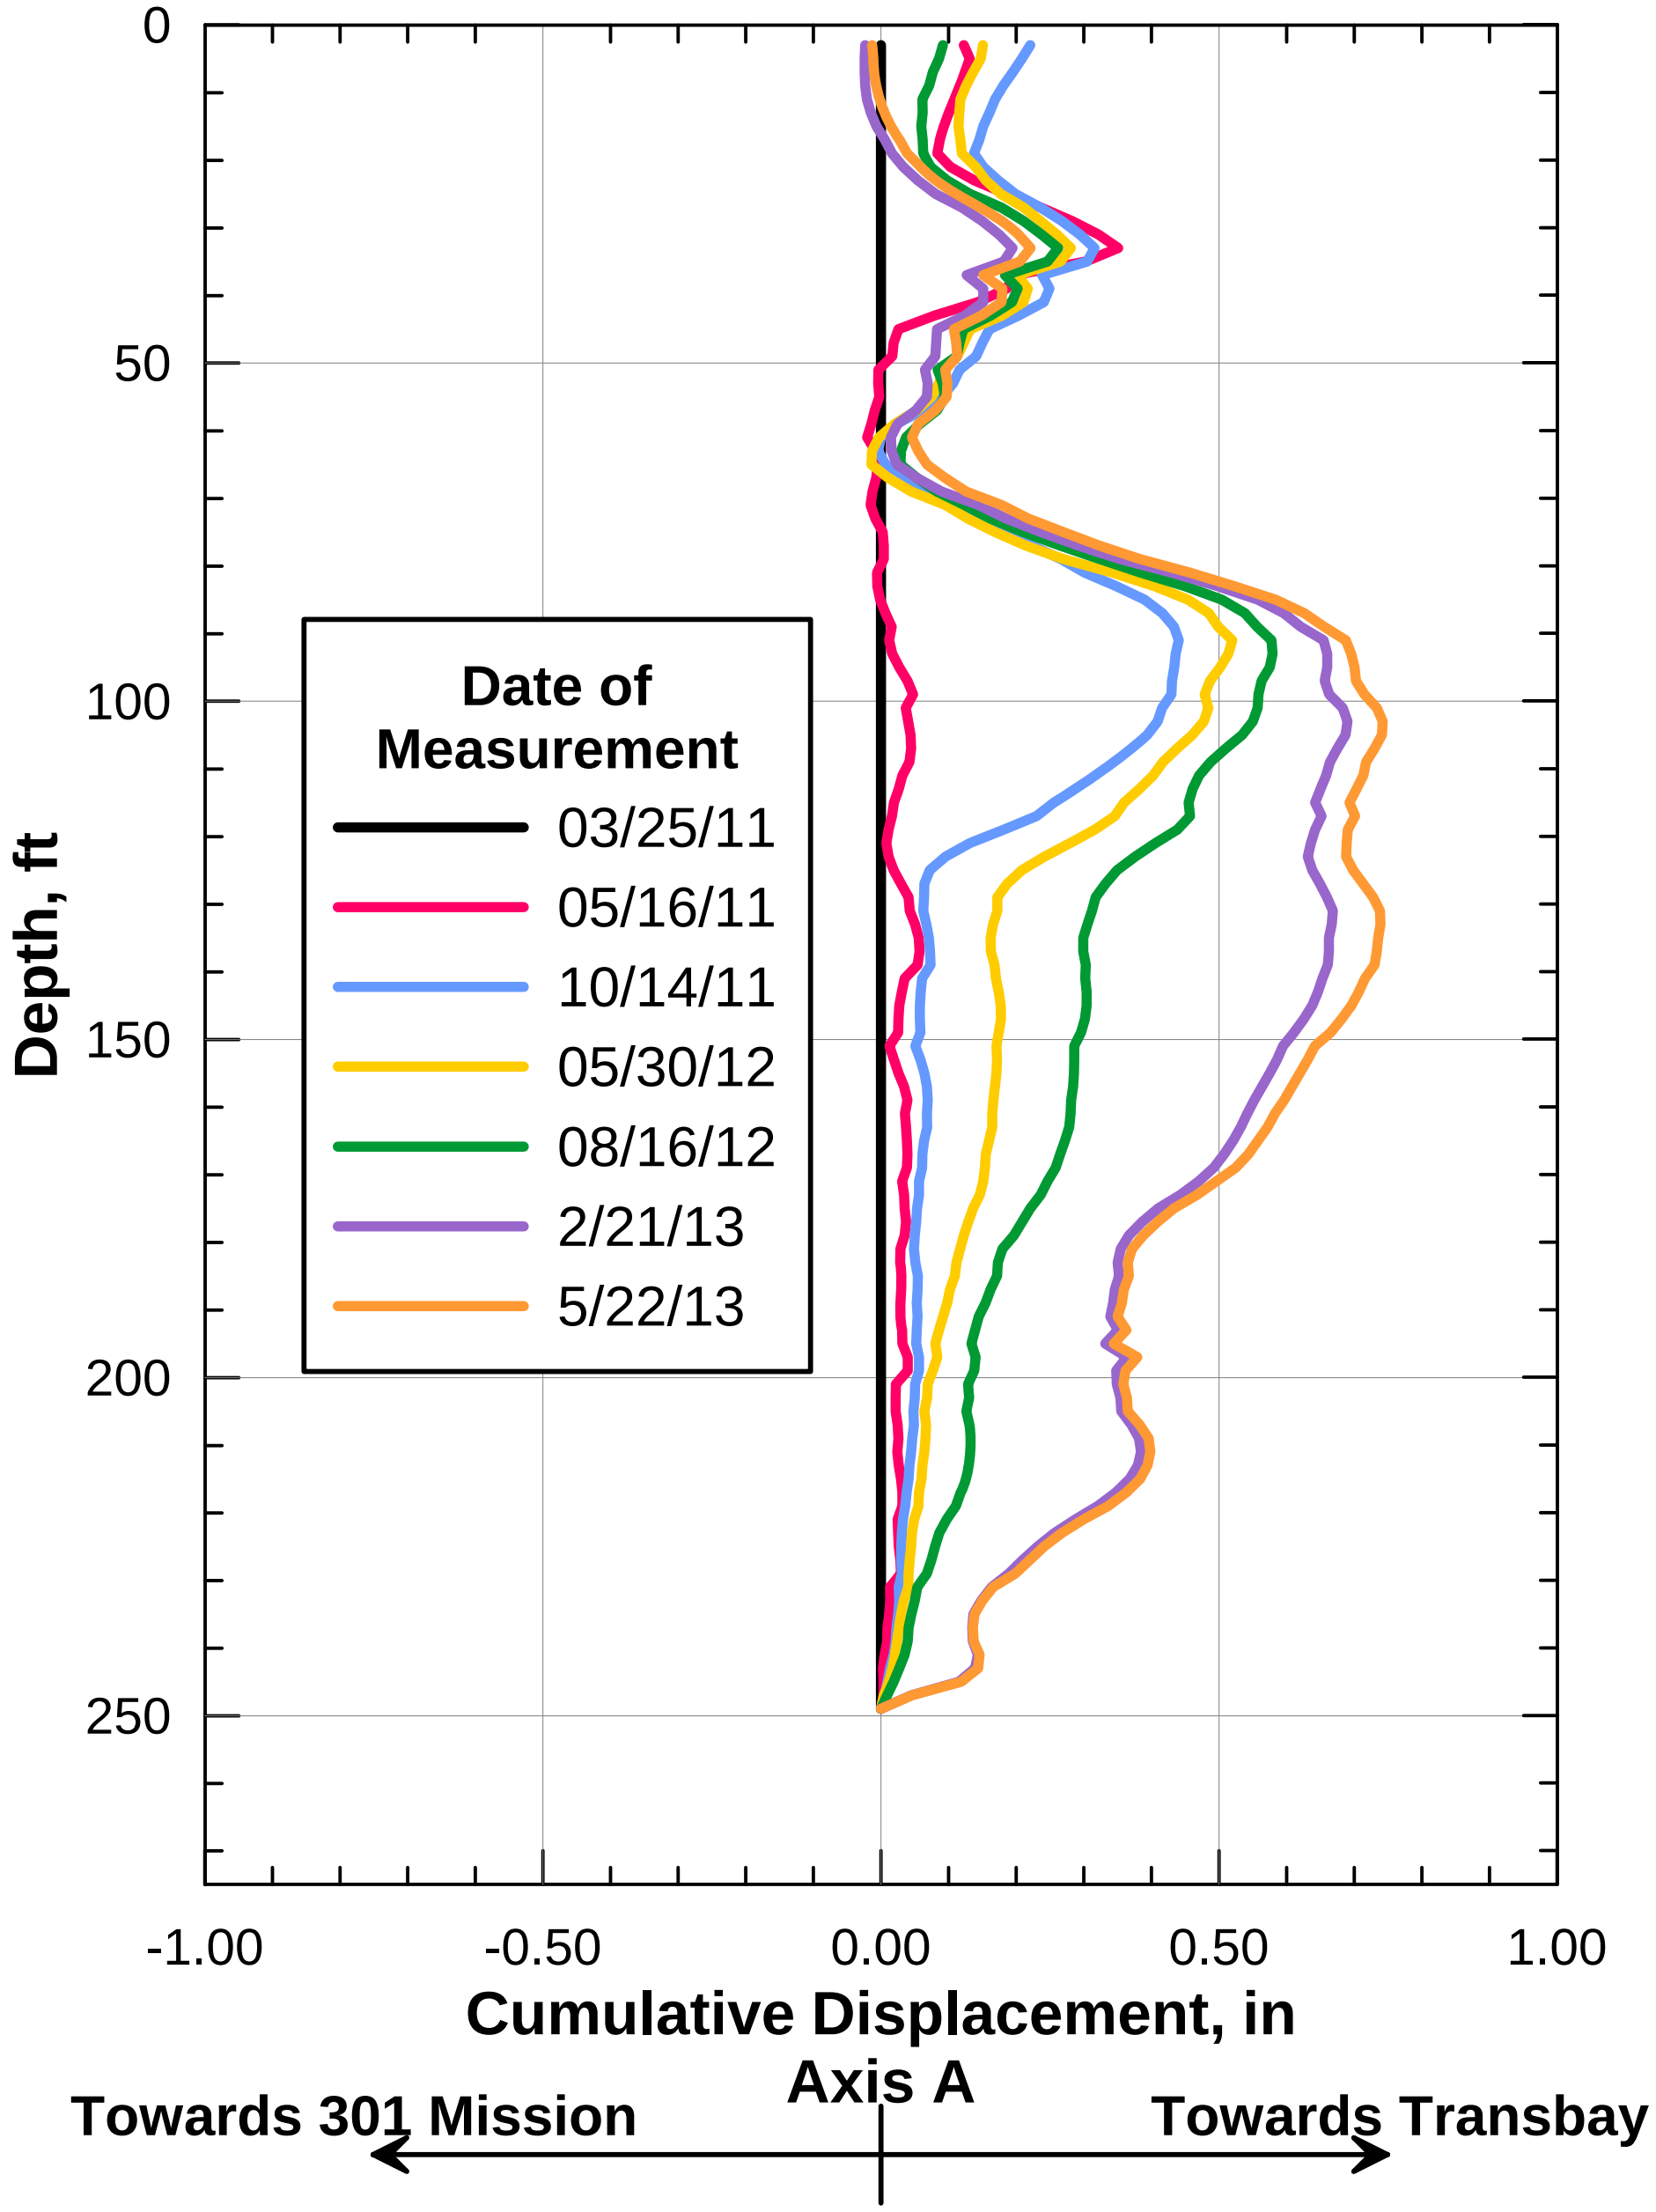
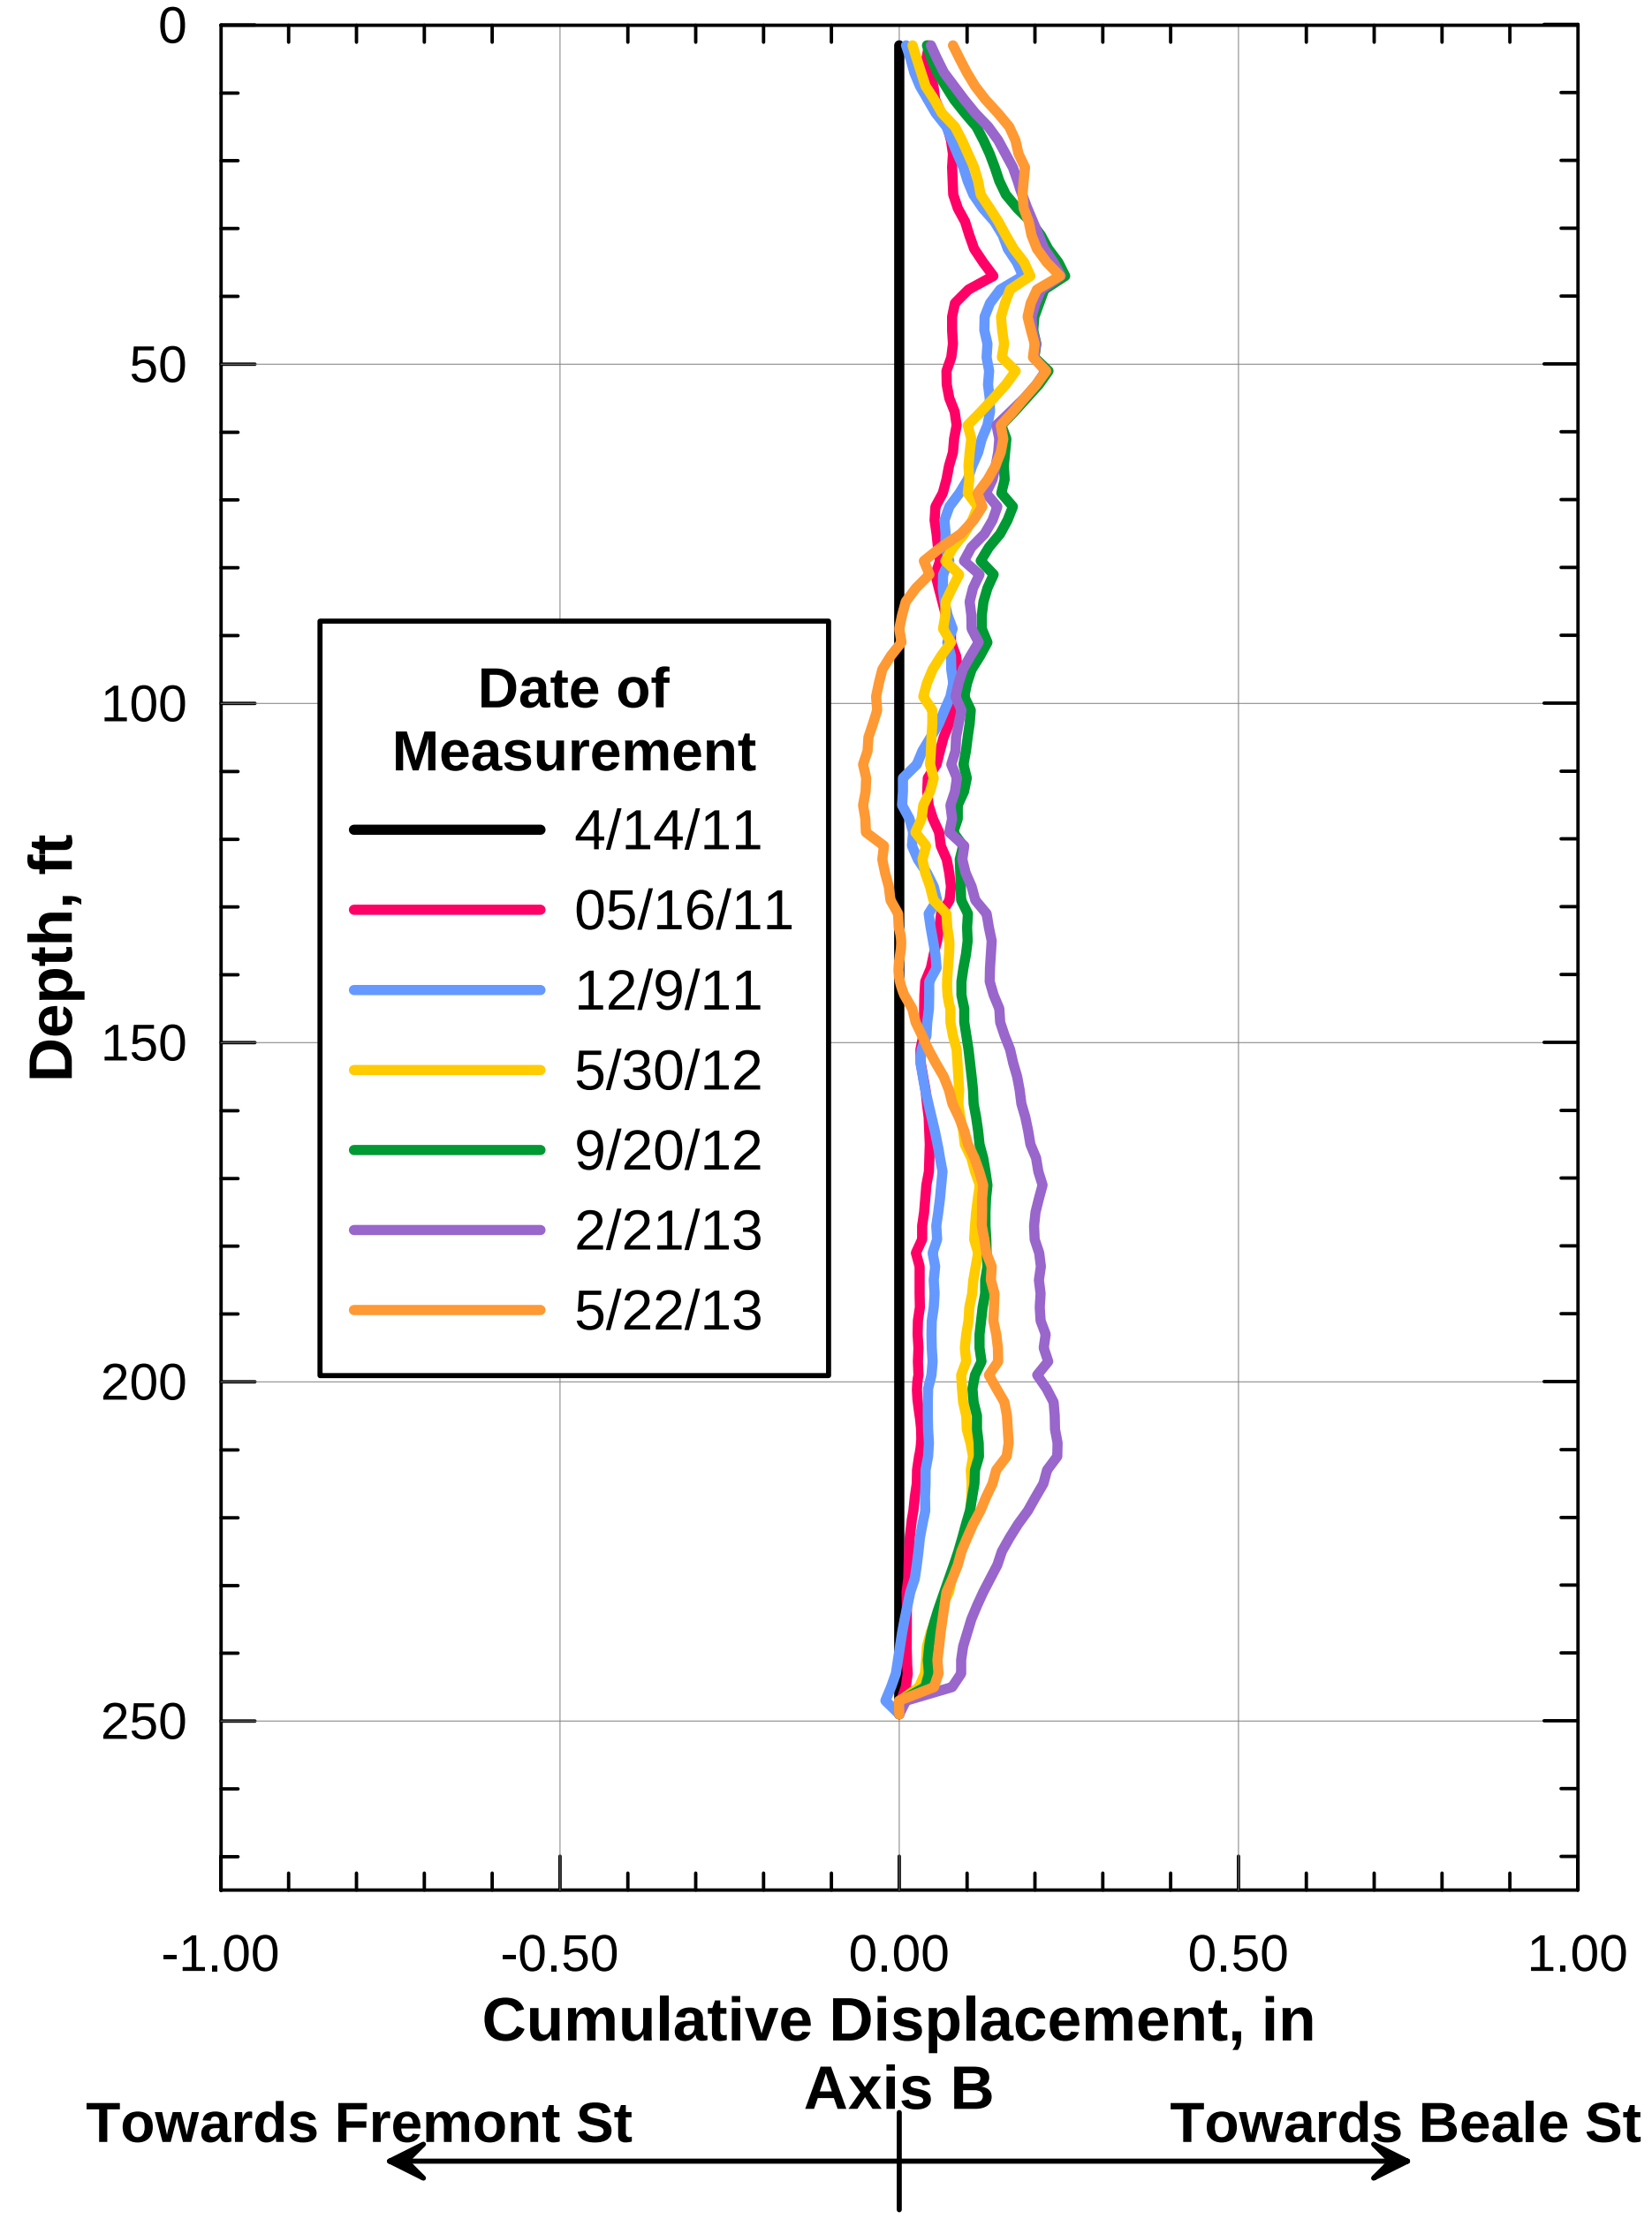
PLATE 2

Currently, inclinometer I-18M (formerly known as I-18) is being read using a standard manual method. Additionally, inclinometers I-21 and I-22 were read manually during maintenance on the in-place-inclinometers. Plates 2 through 4 show the readings taken on I-18M, I-21 and I-22, respectively. Inclinometer I-18M will continue to be read manually throughout the Transbay project.

MEASUREMENTS TAKEN AT INCLINOMETER I-18M

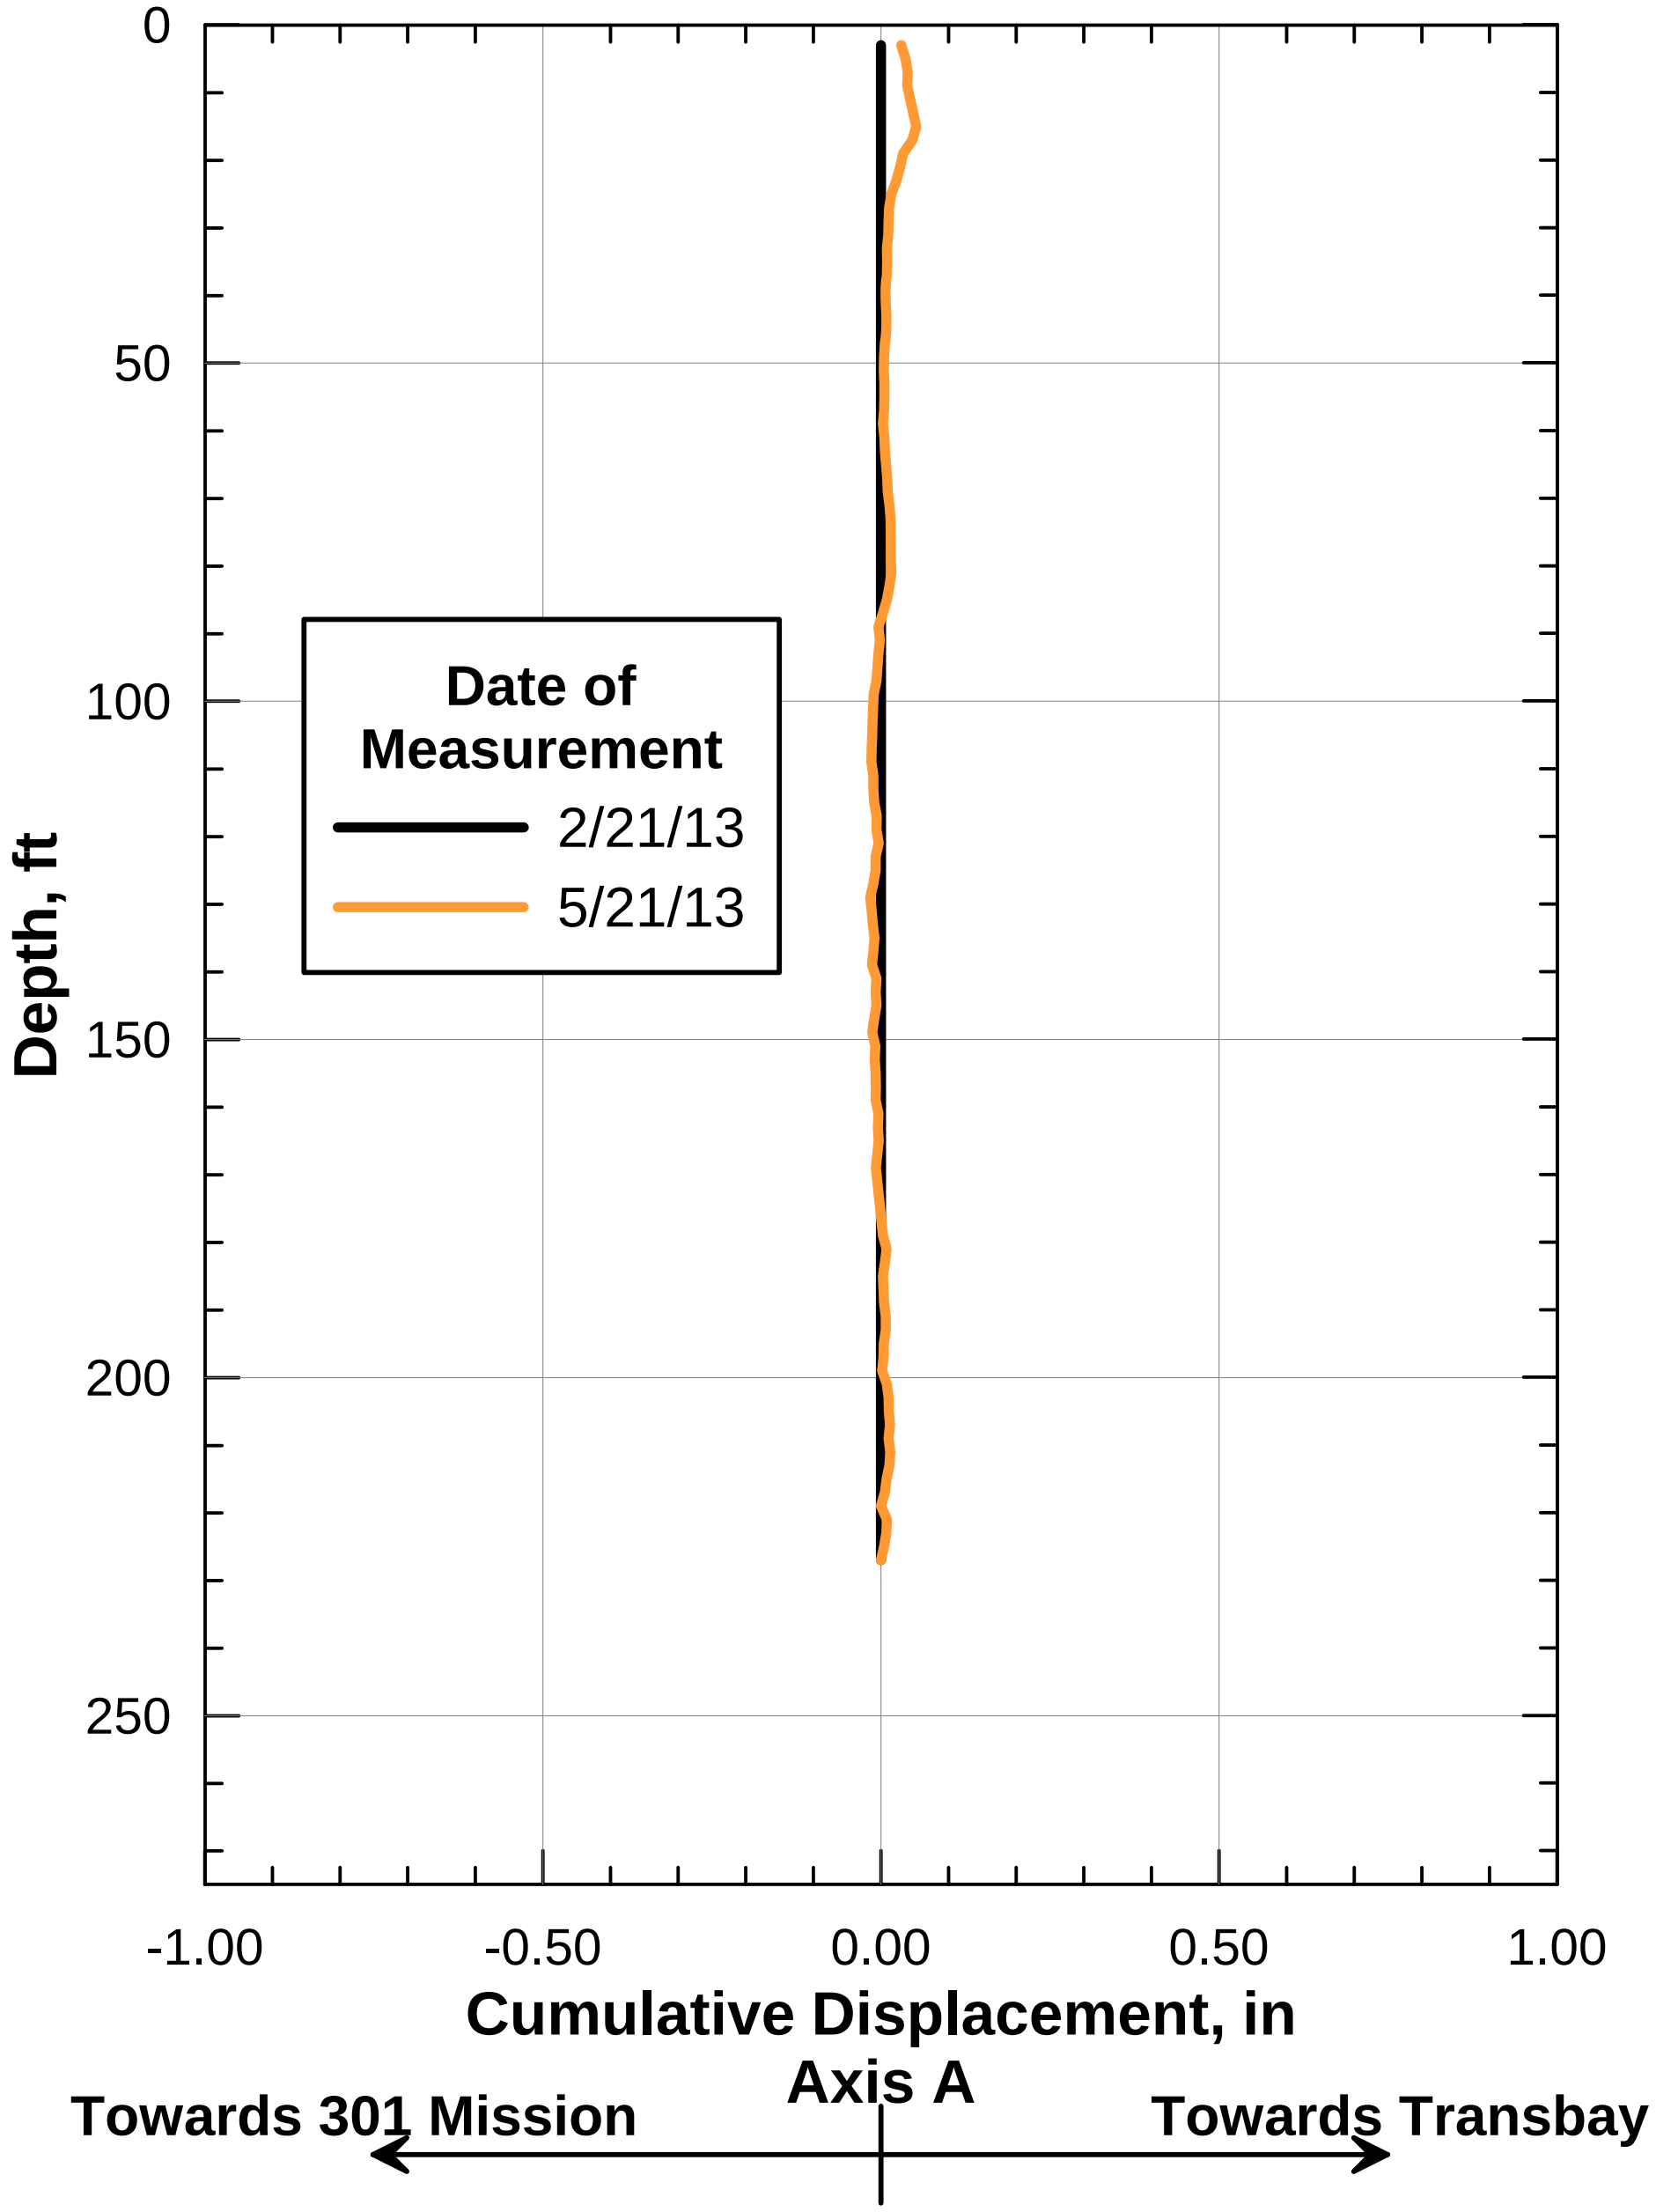
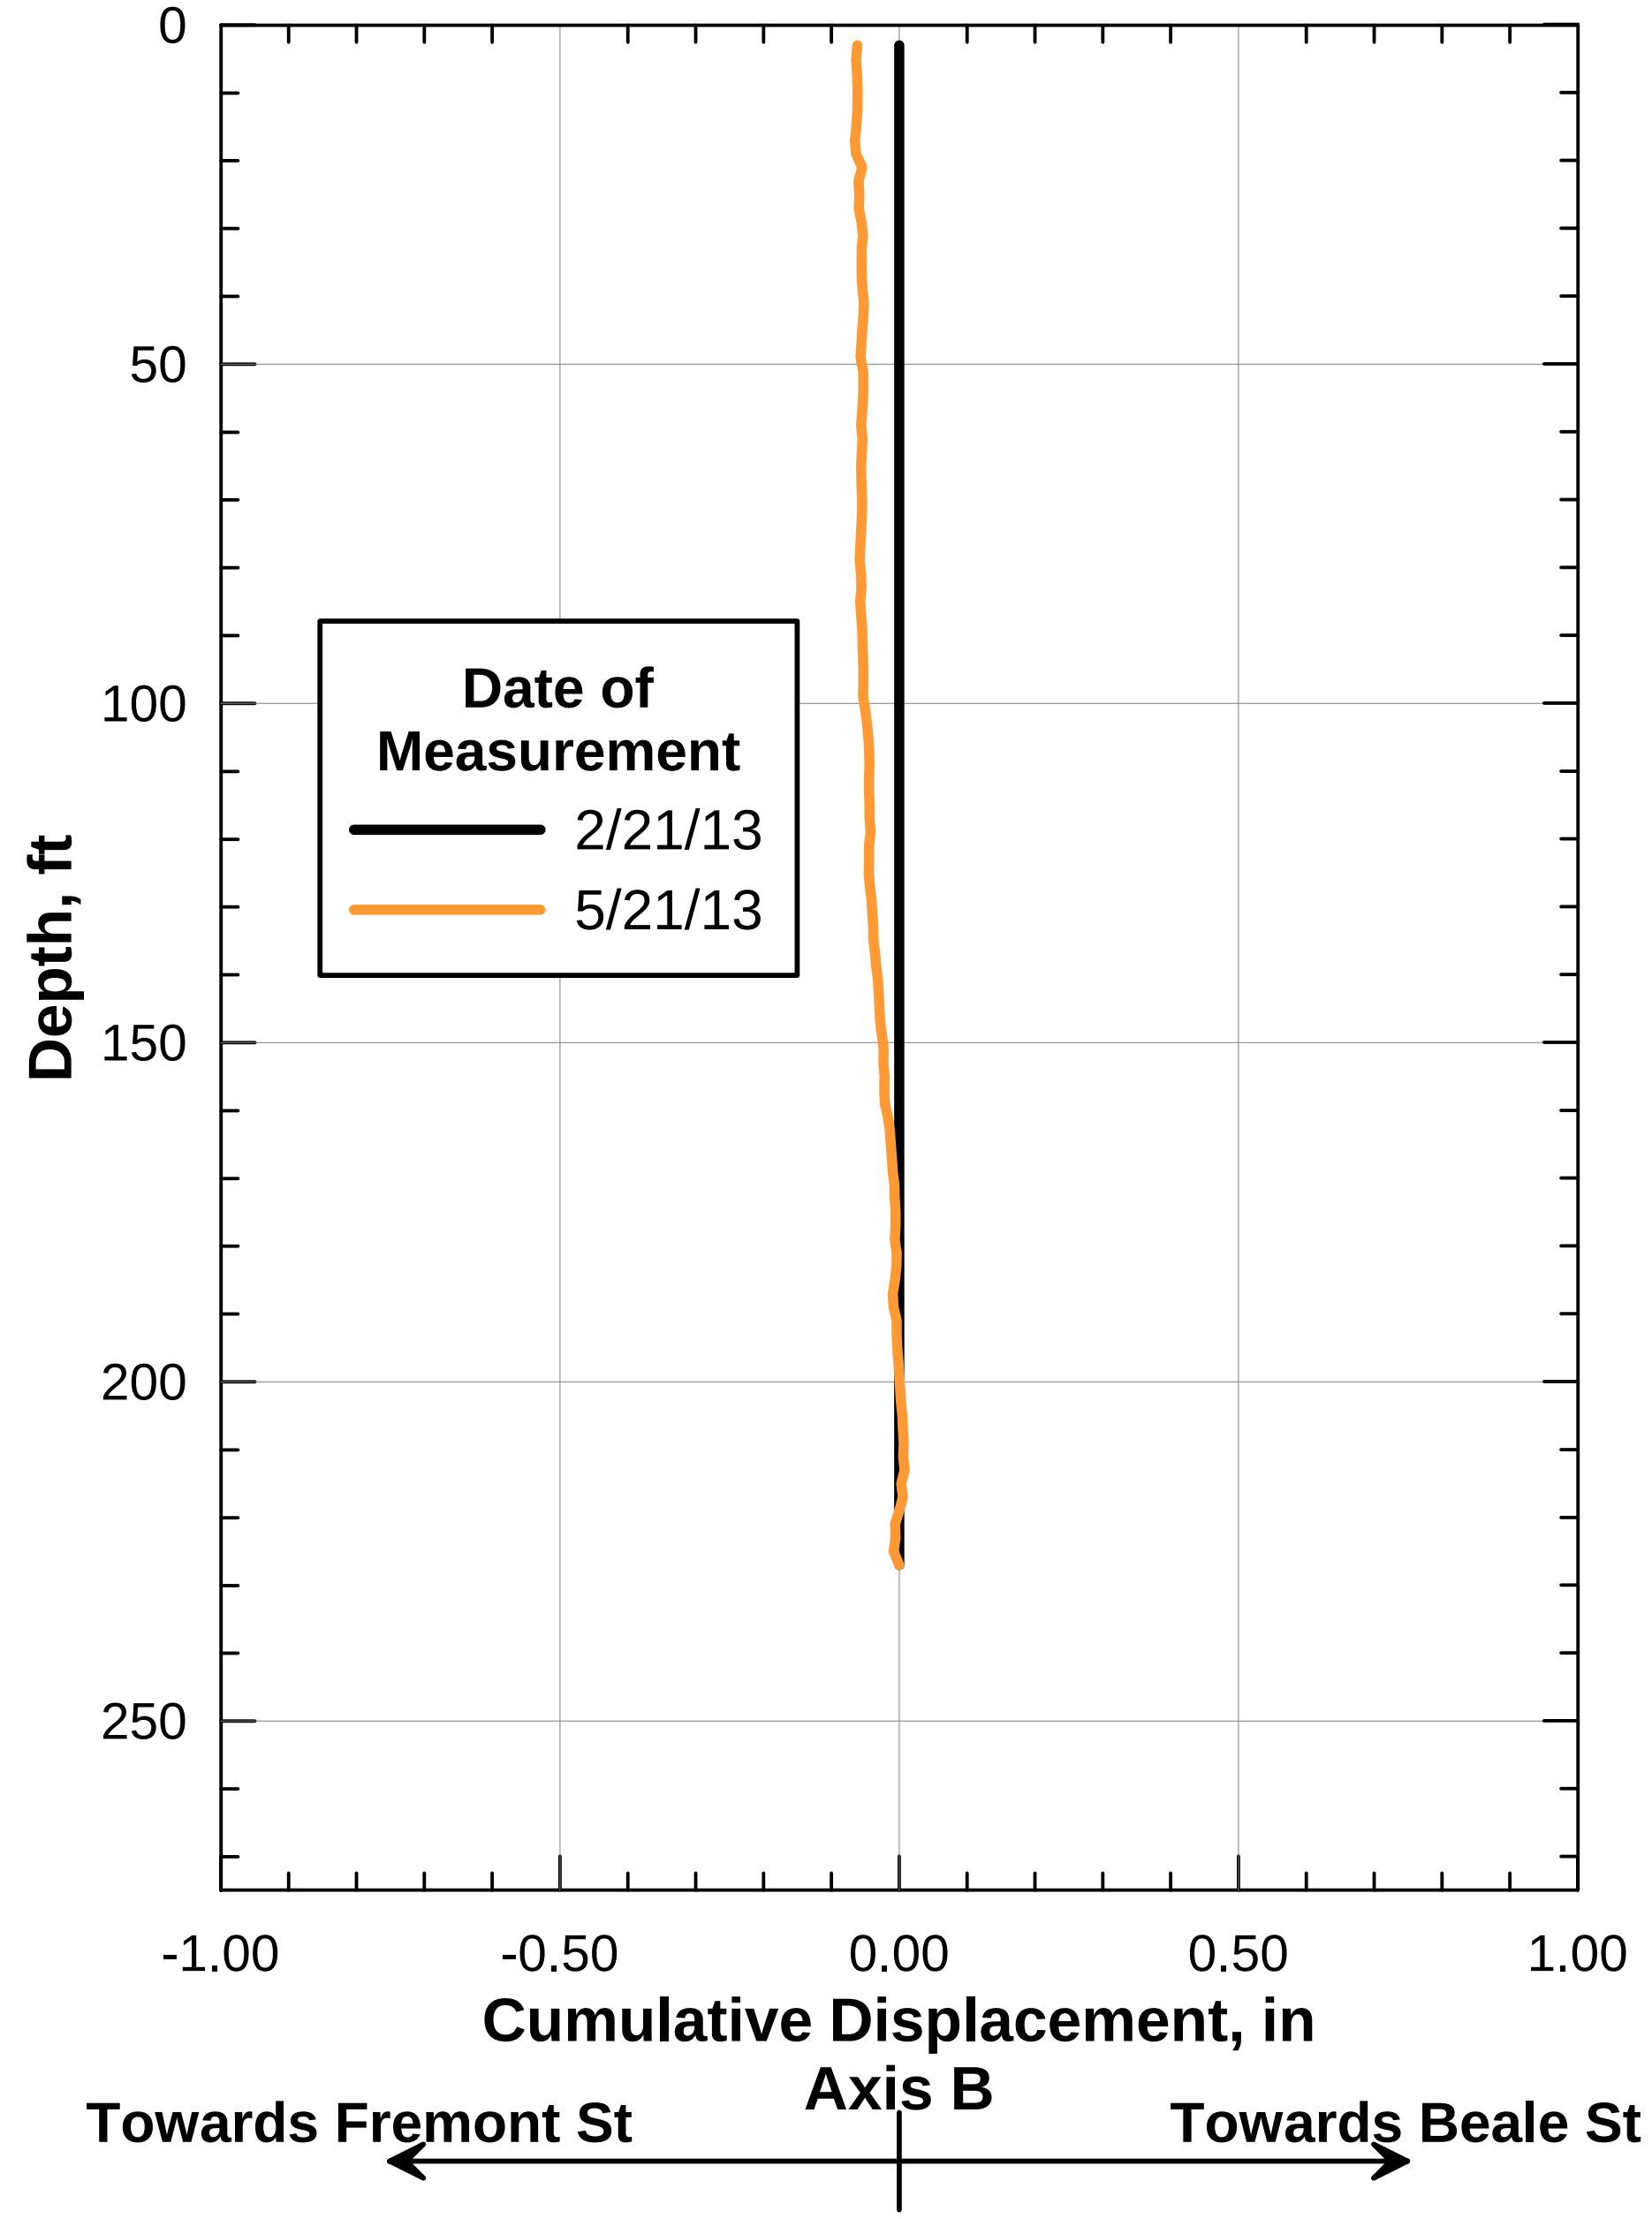
PLATE 3

MEASUREMENTS TAKEN AT INCLINOMETER I-21

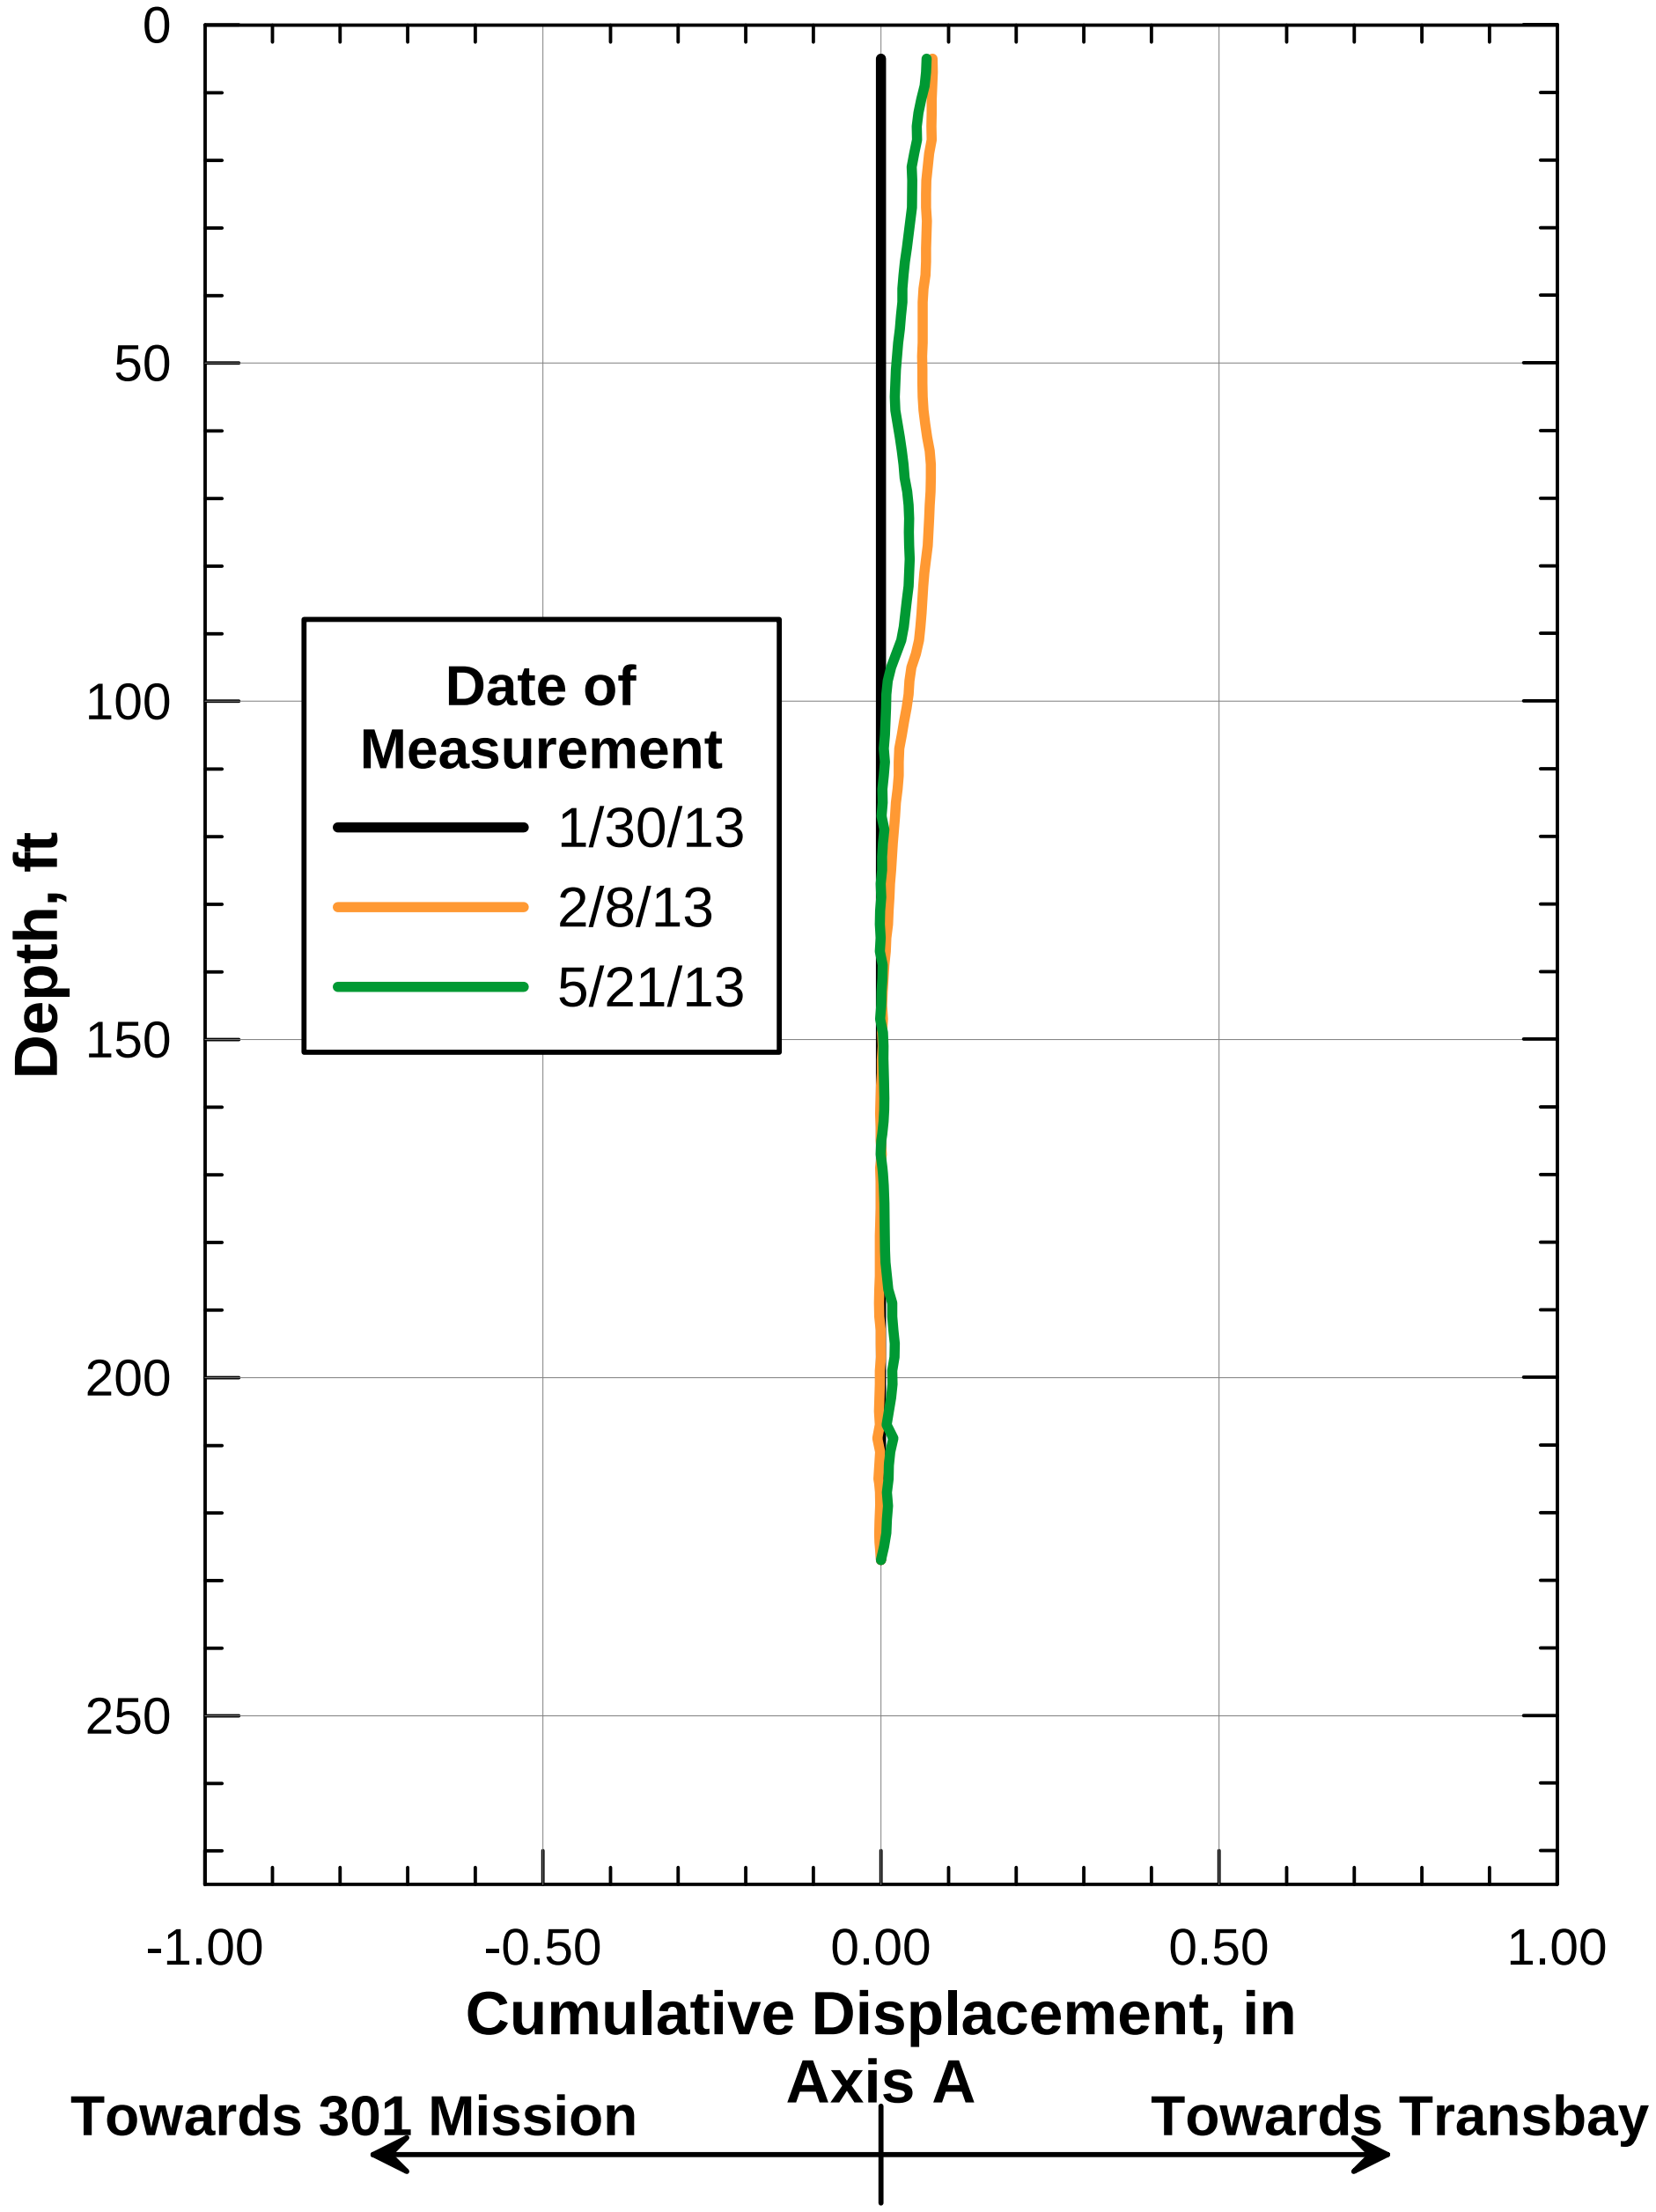
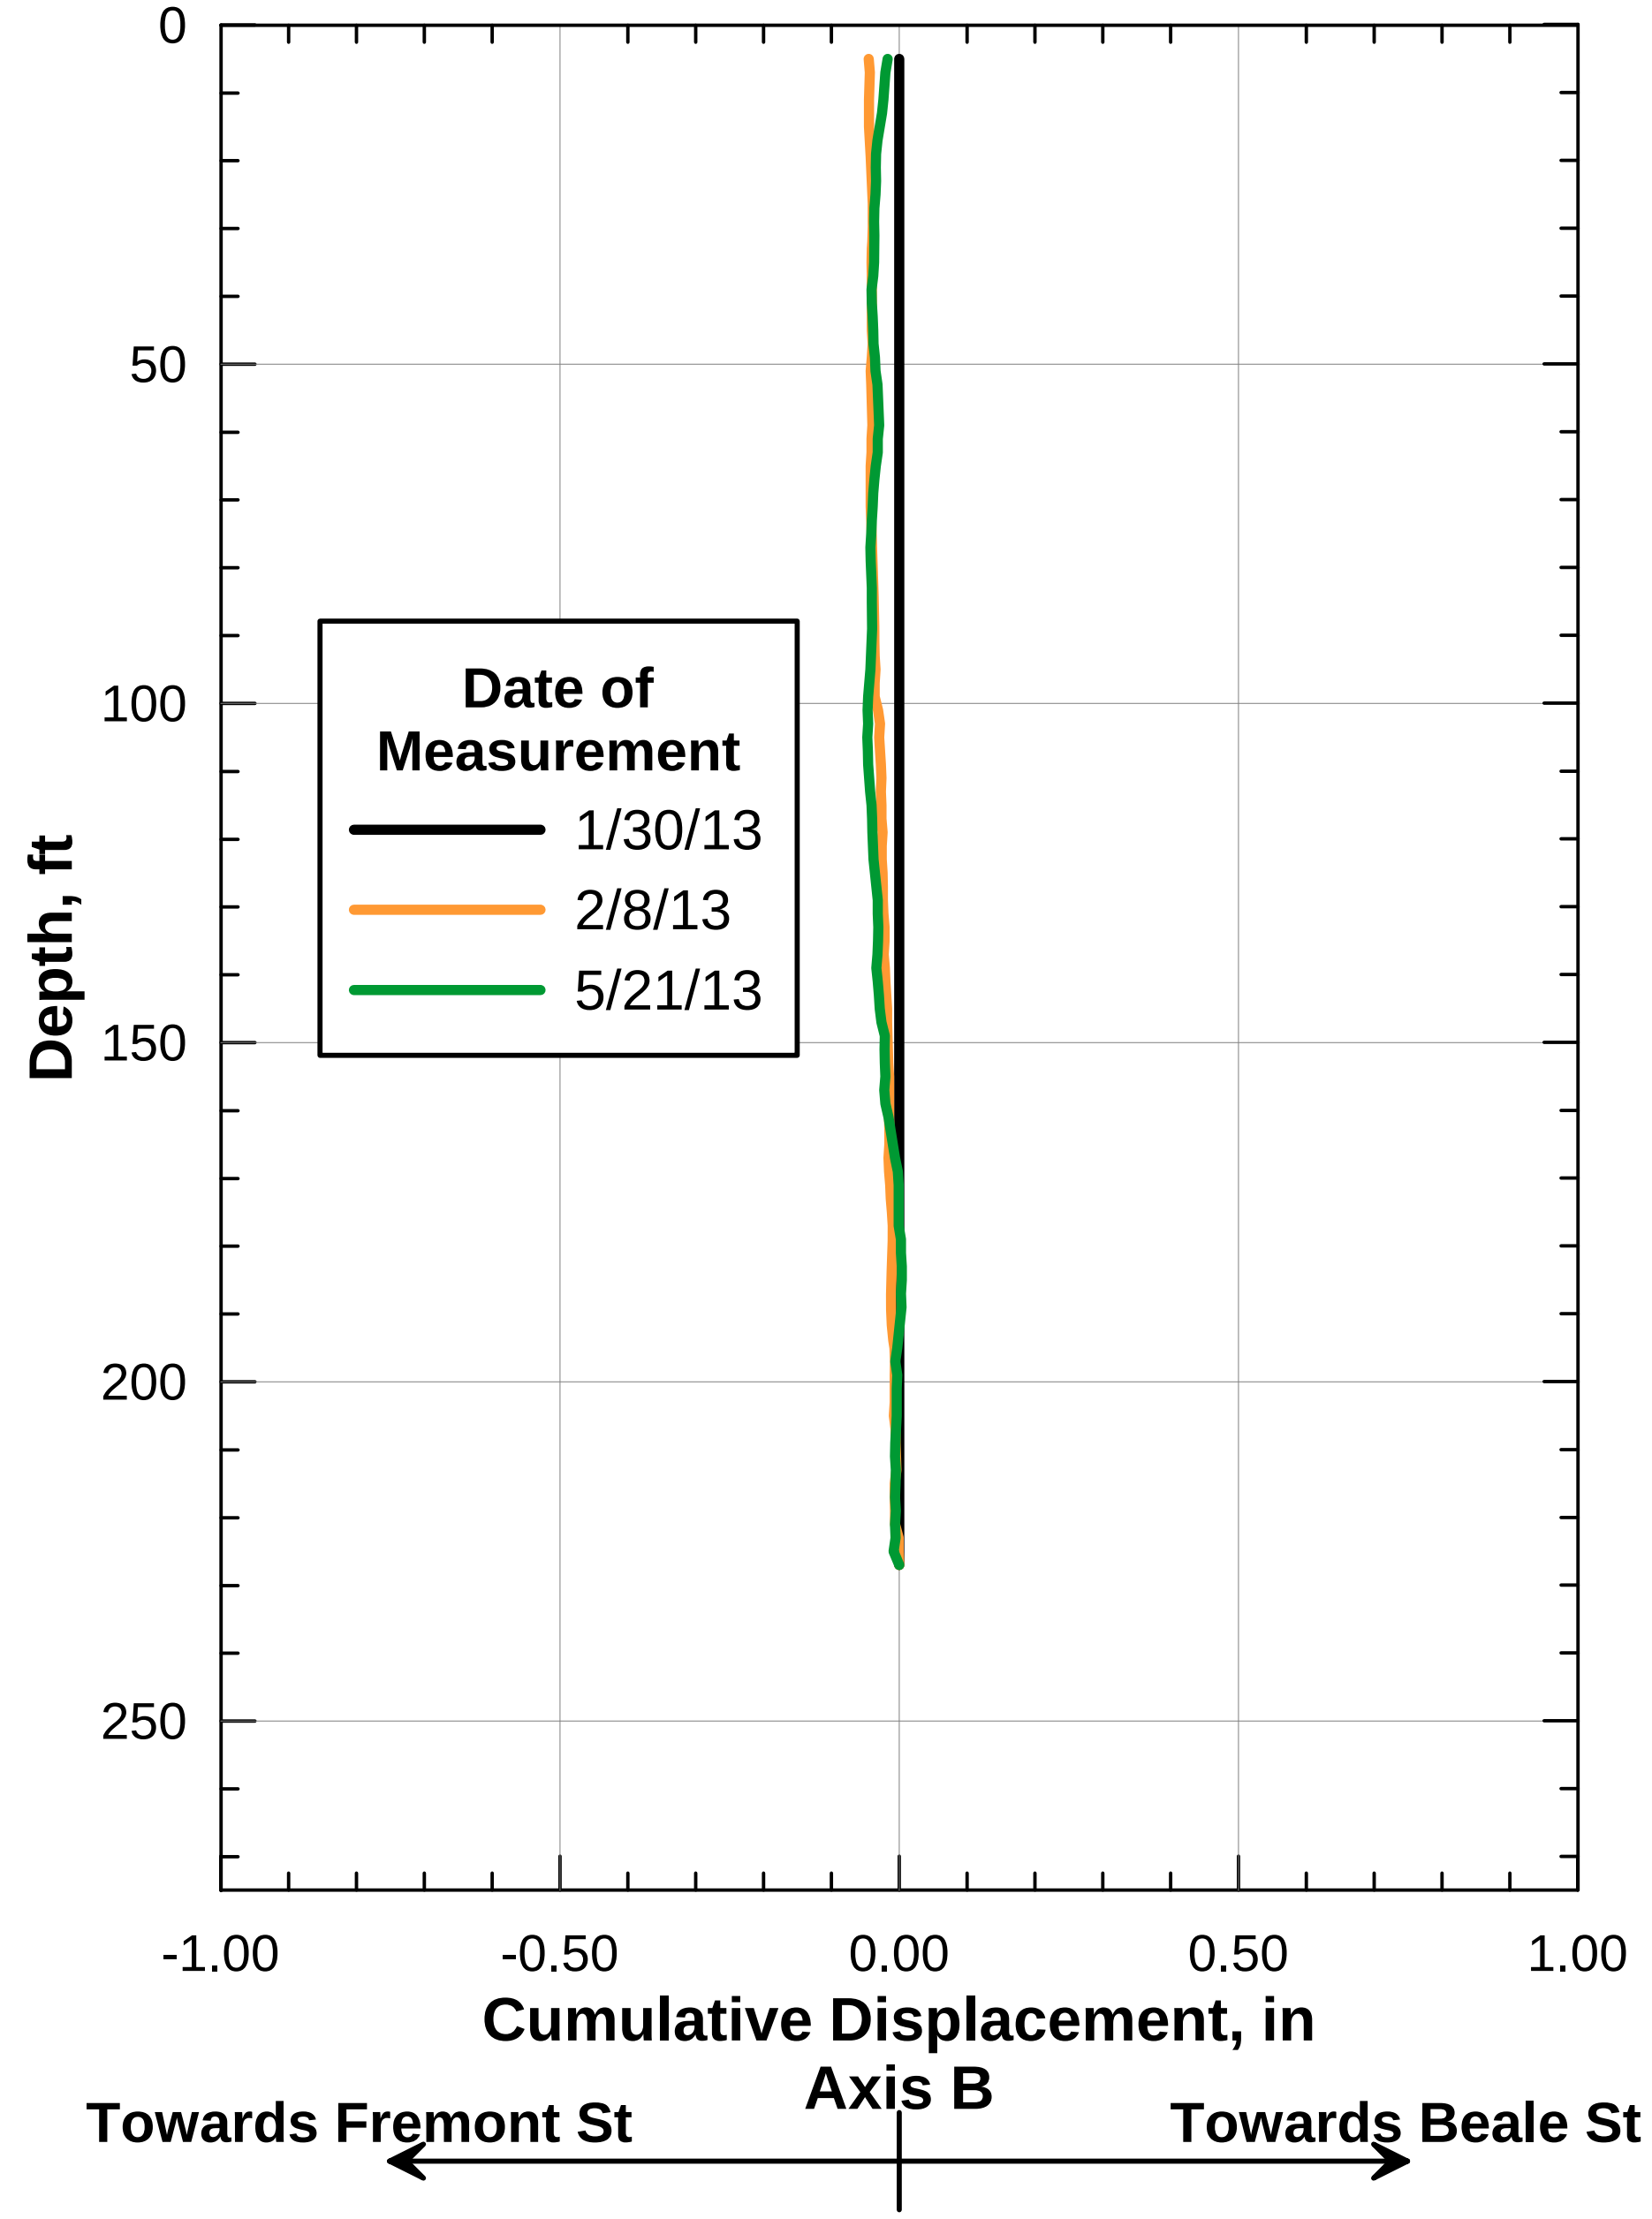
MEASUREMENTS TAKEN AT INCLINOMETER I-22
