File No. 160975 **Committee Item No.** 7
Board Item No. ________

AGENDA PACKET CONTENTS LIST

TALL BUILDINGS SAFETY STRATEGY

October 2018

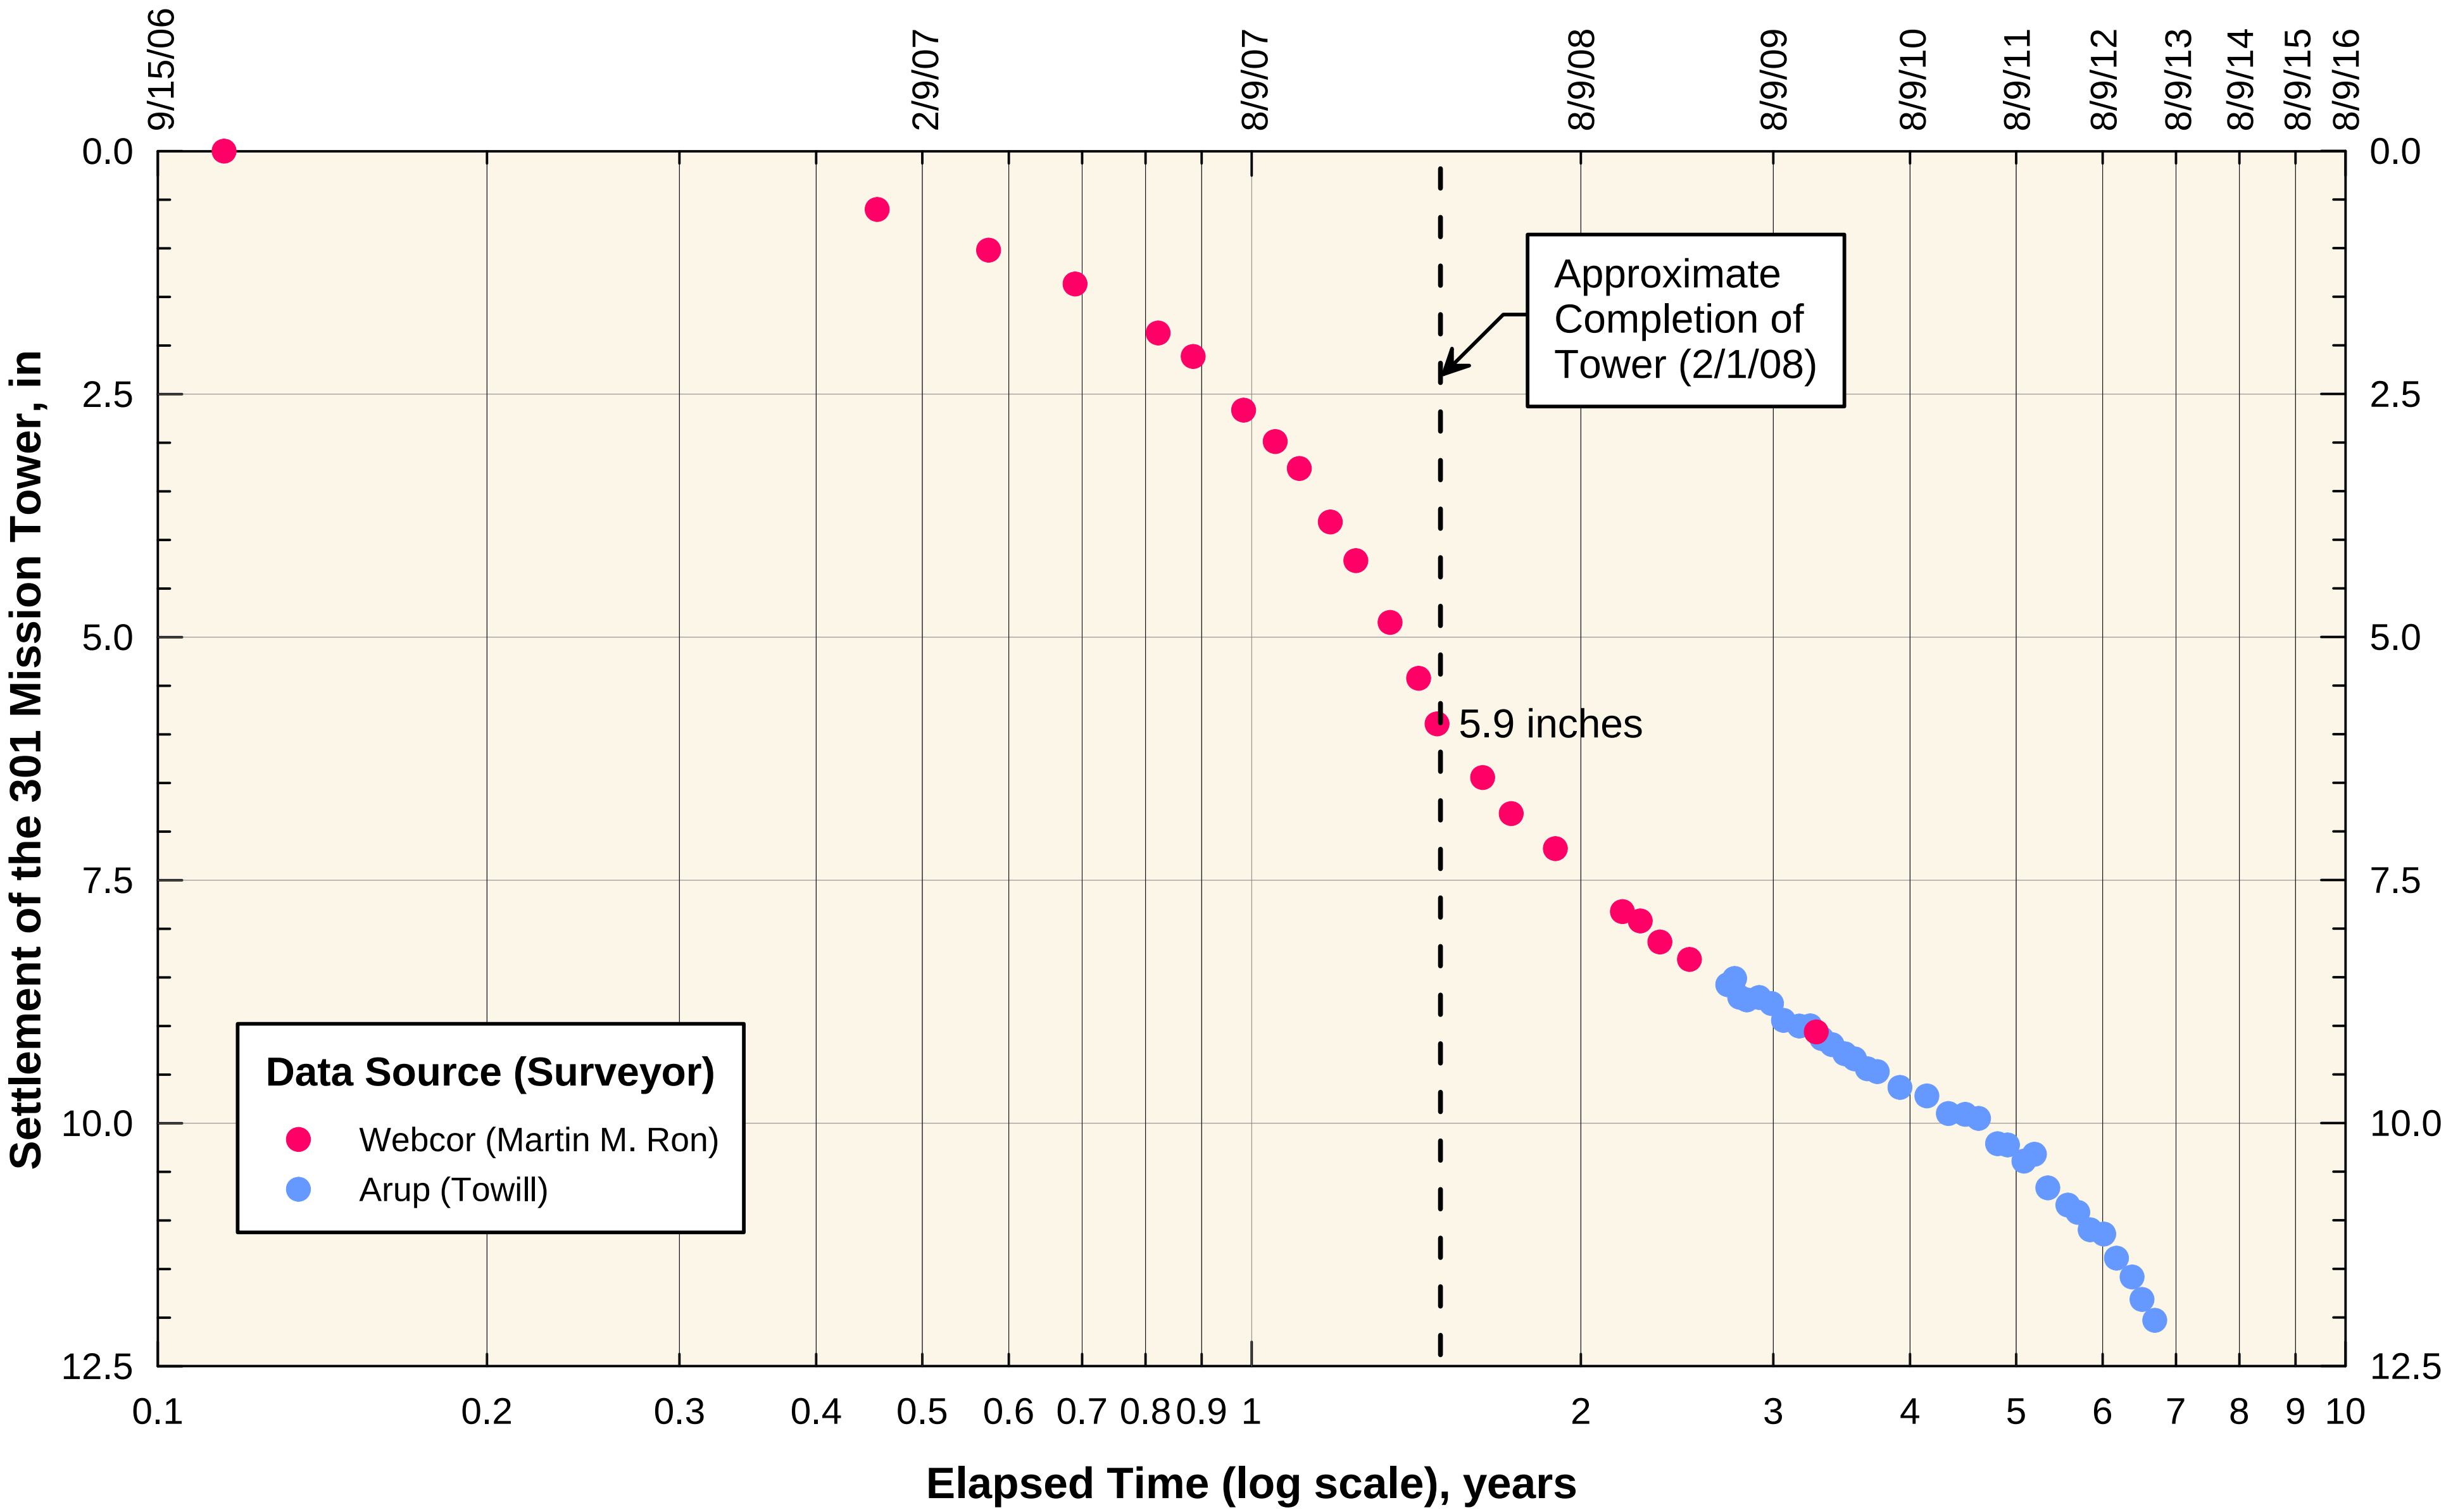
PLATE 6

Begining of Tower Construction: 8/9/06
End of Tower Construction: 2/1/08
Construction Duration: 542 days (1.5 years)

SETTLEMENTS OF THE 301 MISSION TOWER INCLUDING MONITORING DURING CONSTRUCTION

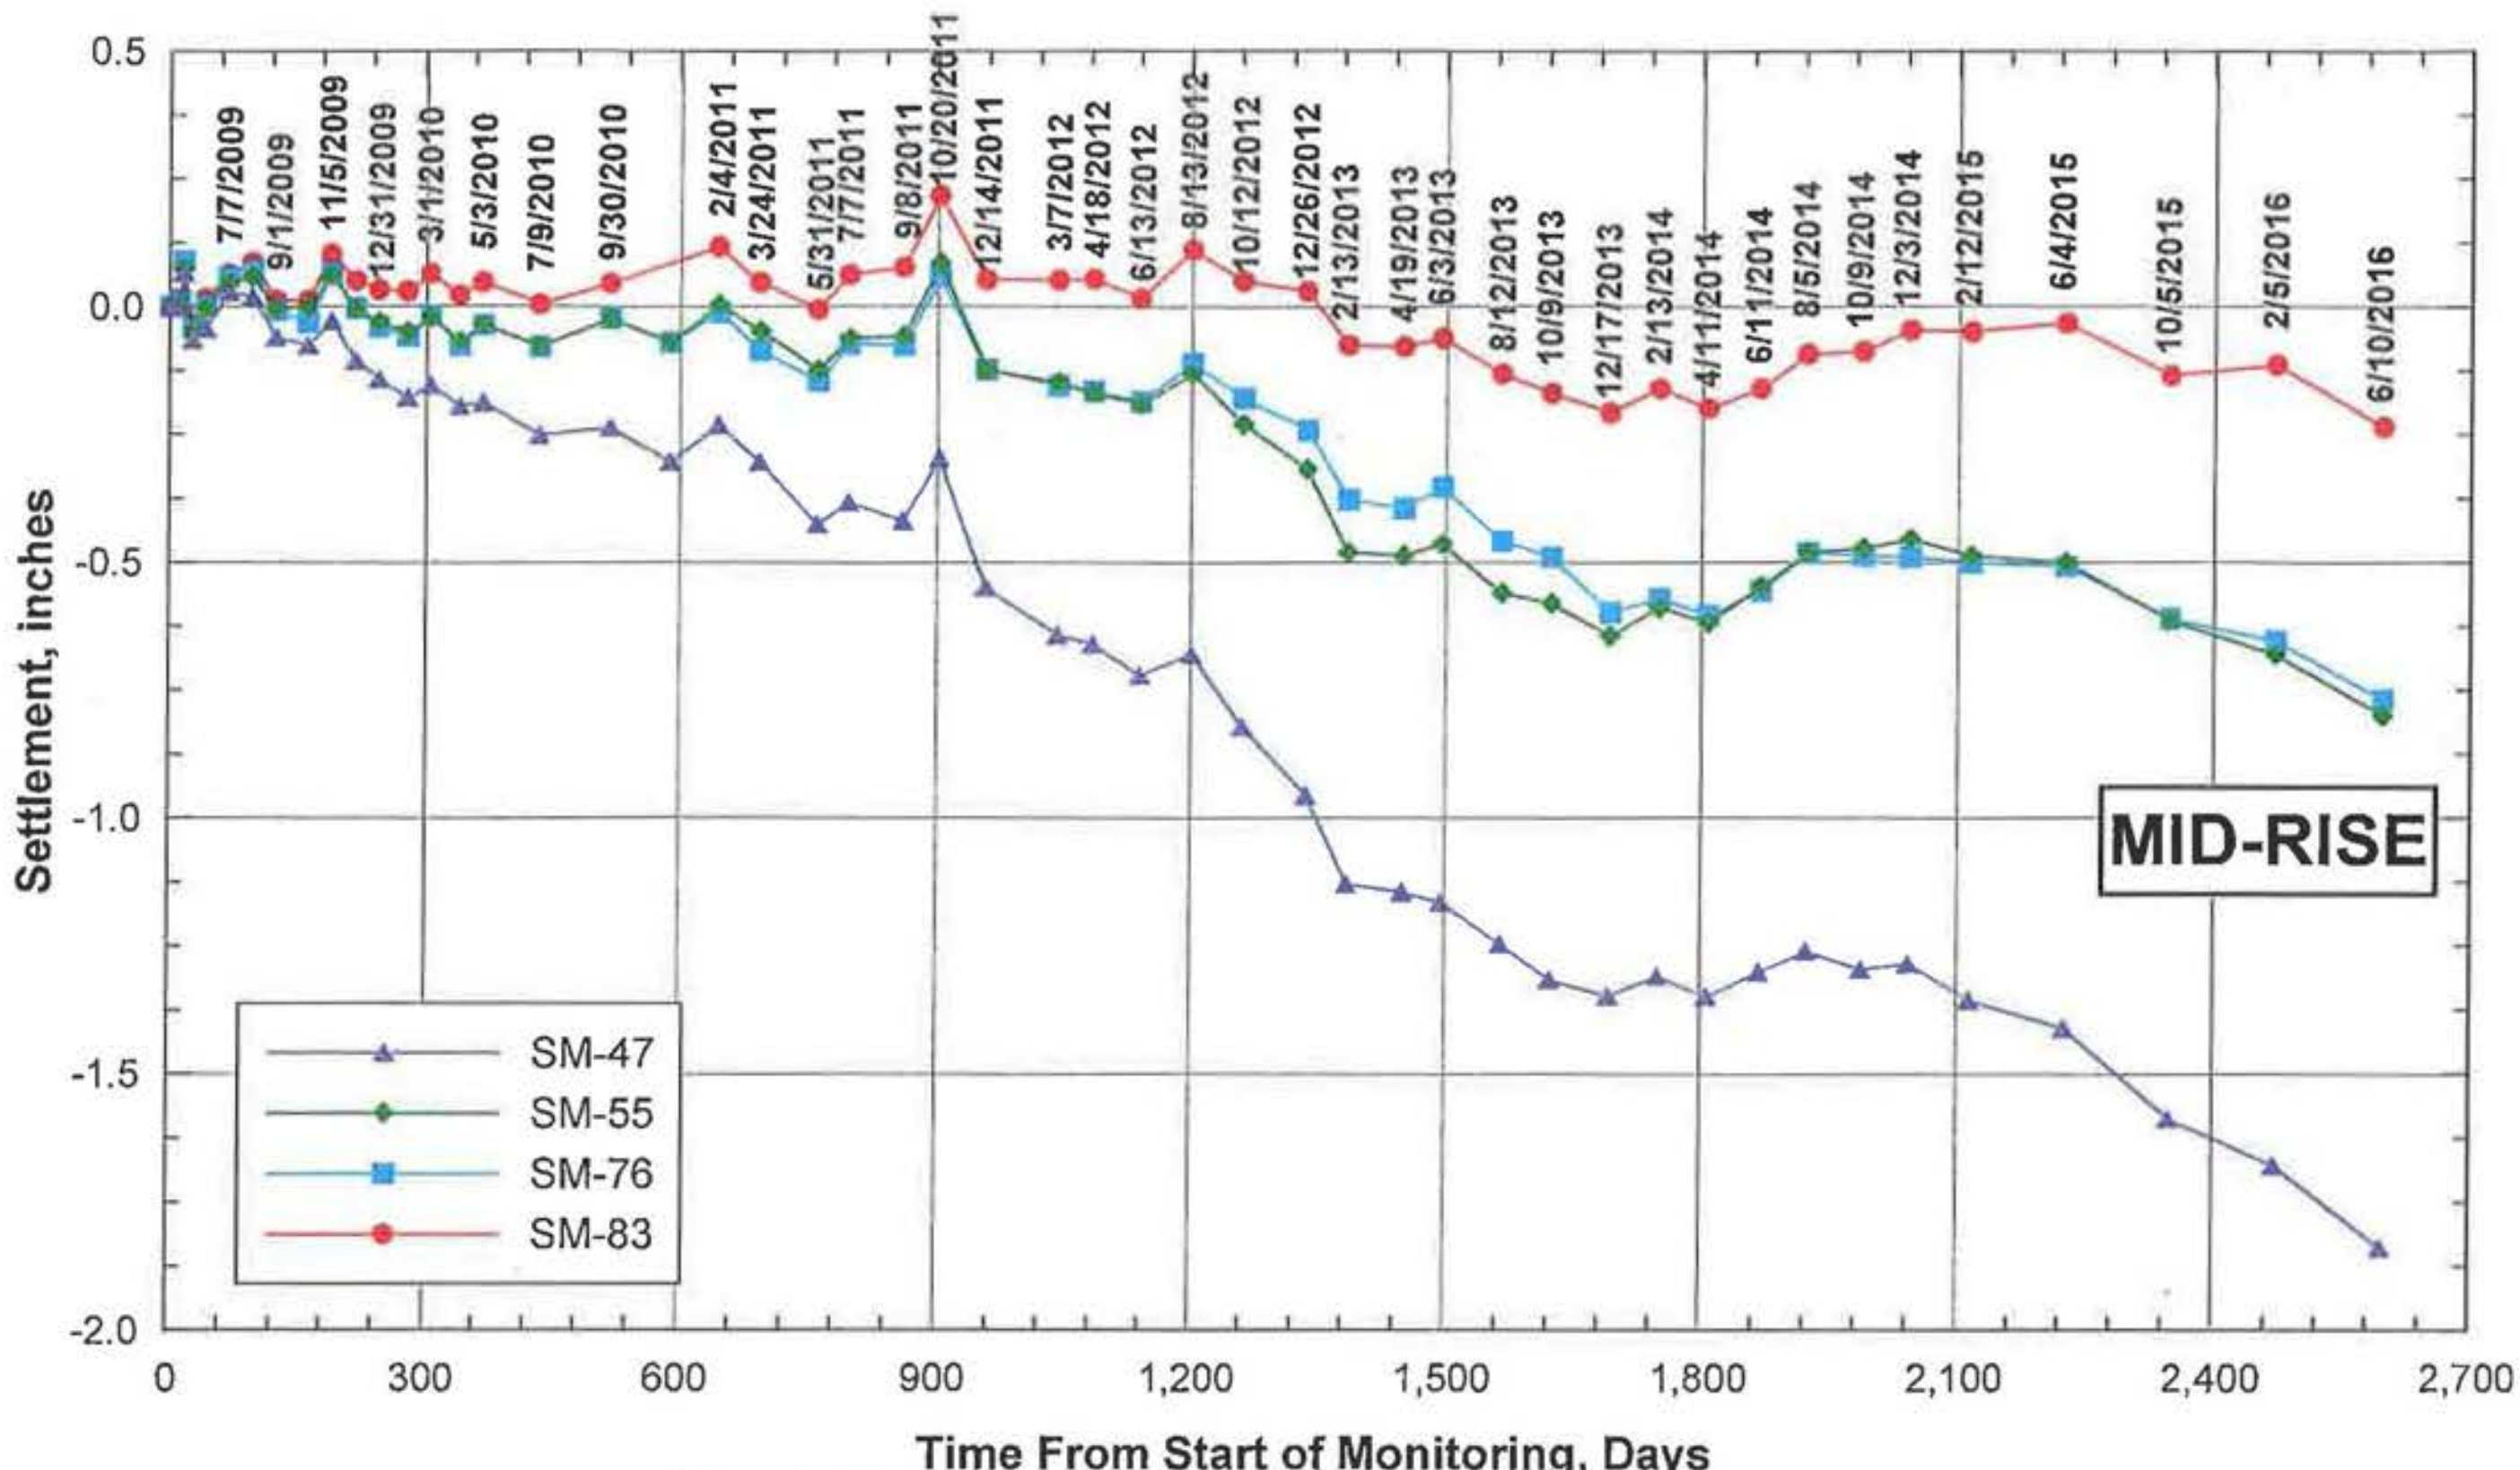
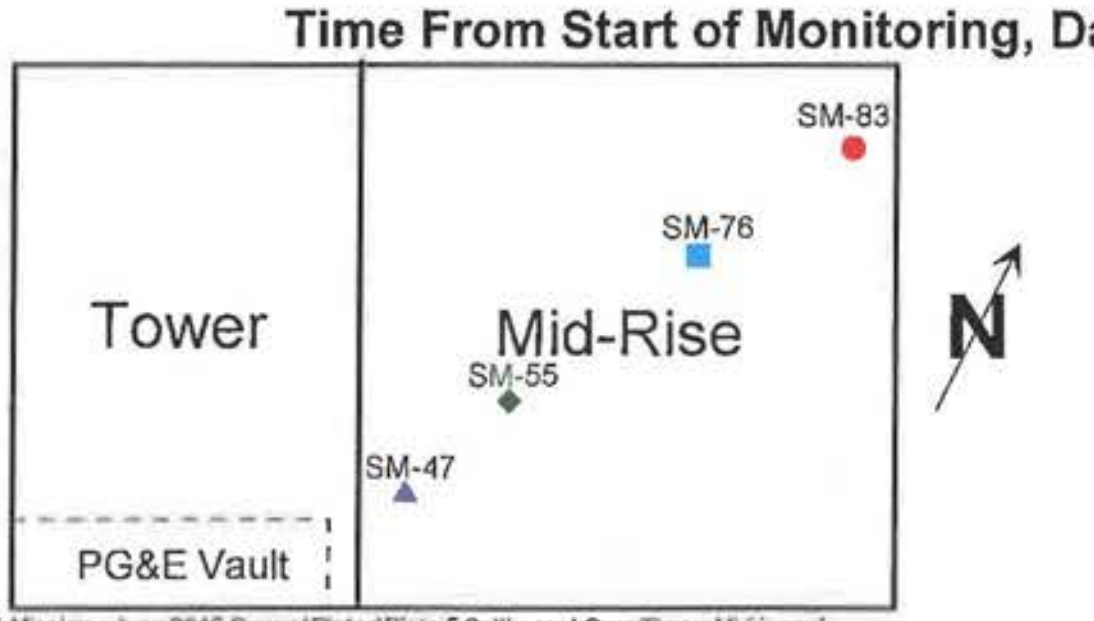
PLATE 4

SETTLEMENT OVER TIME
FLOOR ELEVATIONS AT LEVEL B-1
OF 301 MISSION PROPERTY- MID-RISE:
APRIL 30, 2009 THROUGH JUNE 10, 2016

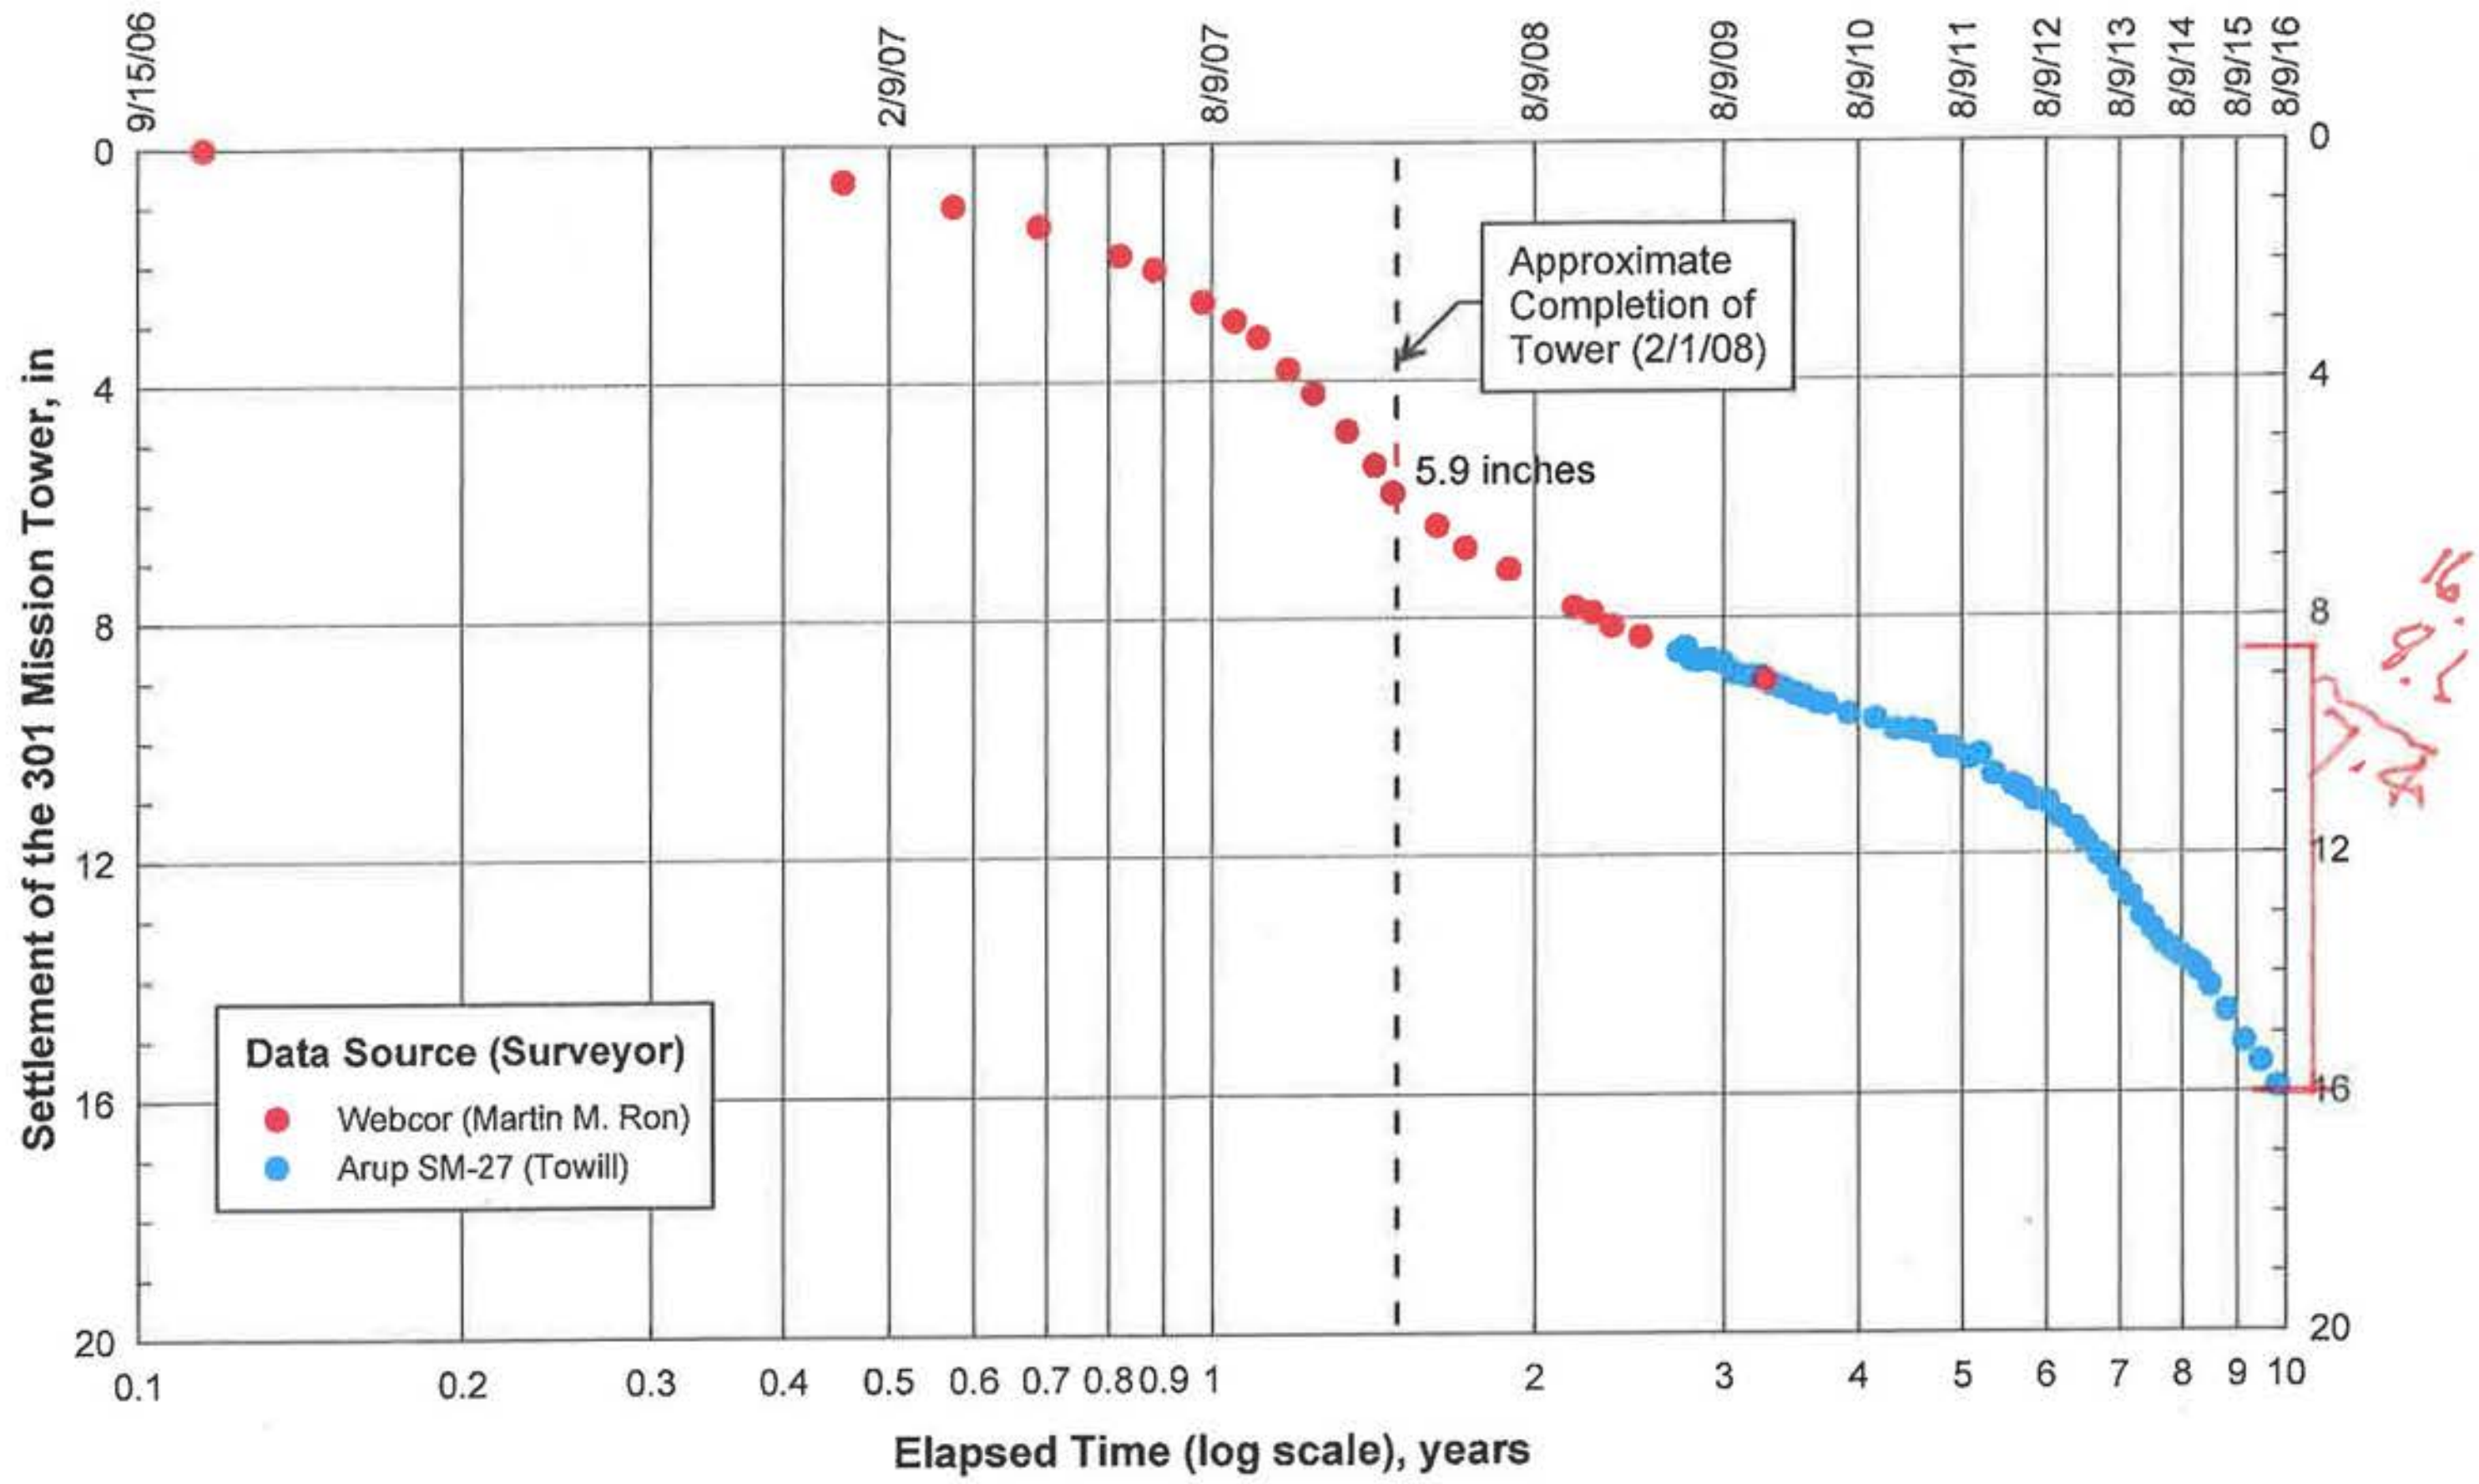
PLATE 5

Begining of Tower Construction: 8/9/06
End of Tower Construction: 2/1/08
Construction Duration: 542 days (1.5 years)

SETTLEMENTS OF THE 301 MISSION TOWER INCLUDING MONITORING DURING CONSTRUCTION

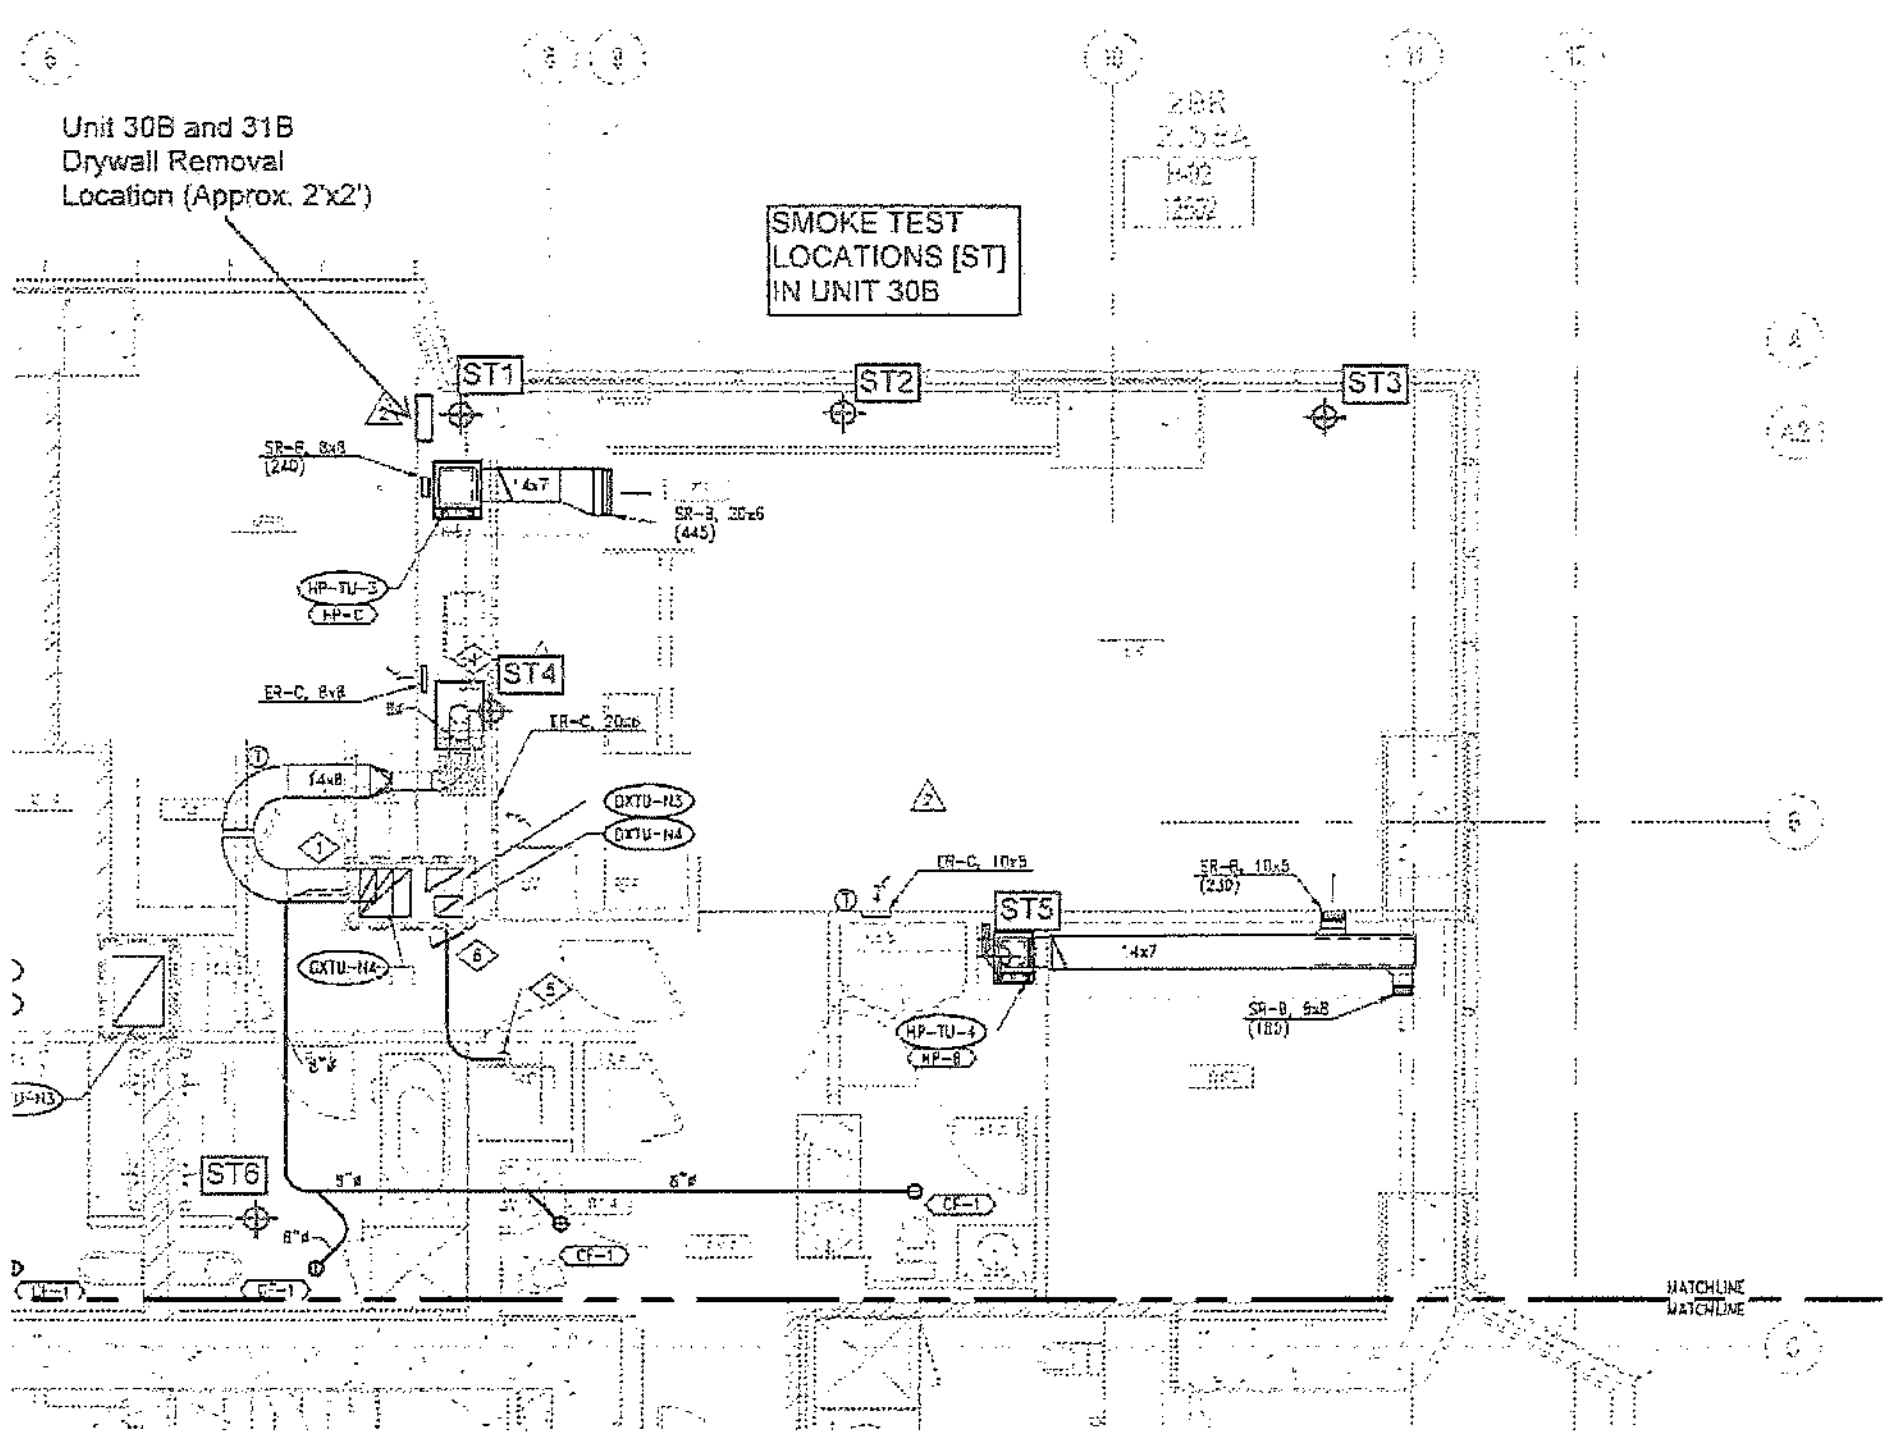
- Odor detected in Unit 31B kitchen area.
- Faint smoke haze in same area.

The smoke test results clearly verified the existence of air transfer pathways between Unit 30B and Unit 31B. Suspended particles in the air can communicate between these neighboring residences through the same air transfer pathways, resulting in odors from one unit detected in the adjoining unit.

1. At site ST1;
   Large gaps on the interior surface of the exterior wall (curtain wall) within the cavity behind the heat pump [HP-C]. This condition exists on both floors 30B and 31B. The location of air leak is directly across from the intake of the forced air heat pump unit. The odor transfer is enhanced and further distributed into the residence with the operation of the heat pump fan.

2. At site ST5;
   Gaps around the hydronic-piping floor penetrations in the closet of heat pump [HP-B]. Here too the location of air leaks are close to the intake of the forced air heat pump unit. The odor transfer again is enhanced and further distributed into the residence with the operation of the heat pump fan.

The recommended repair consists of providing an air tight seal of the identified air gaps causing leaks between Units 30B and 31B.

1. At site ST1;
   Seal the air gaps on the interior surface of the exterior wall (curtain wall) within the cavity behind the heat pump [HP-C]. This condition exists on both floors 30B and 31B:
   - Provide sufficient access opening in bedroom wall to perform work in subject area.
   - Prep, patch and seal exterior wall gaps in curtain wall, air tight.
   - Patch, seal and finish access opening.

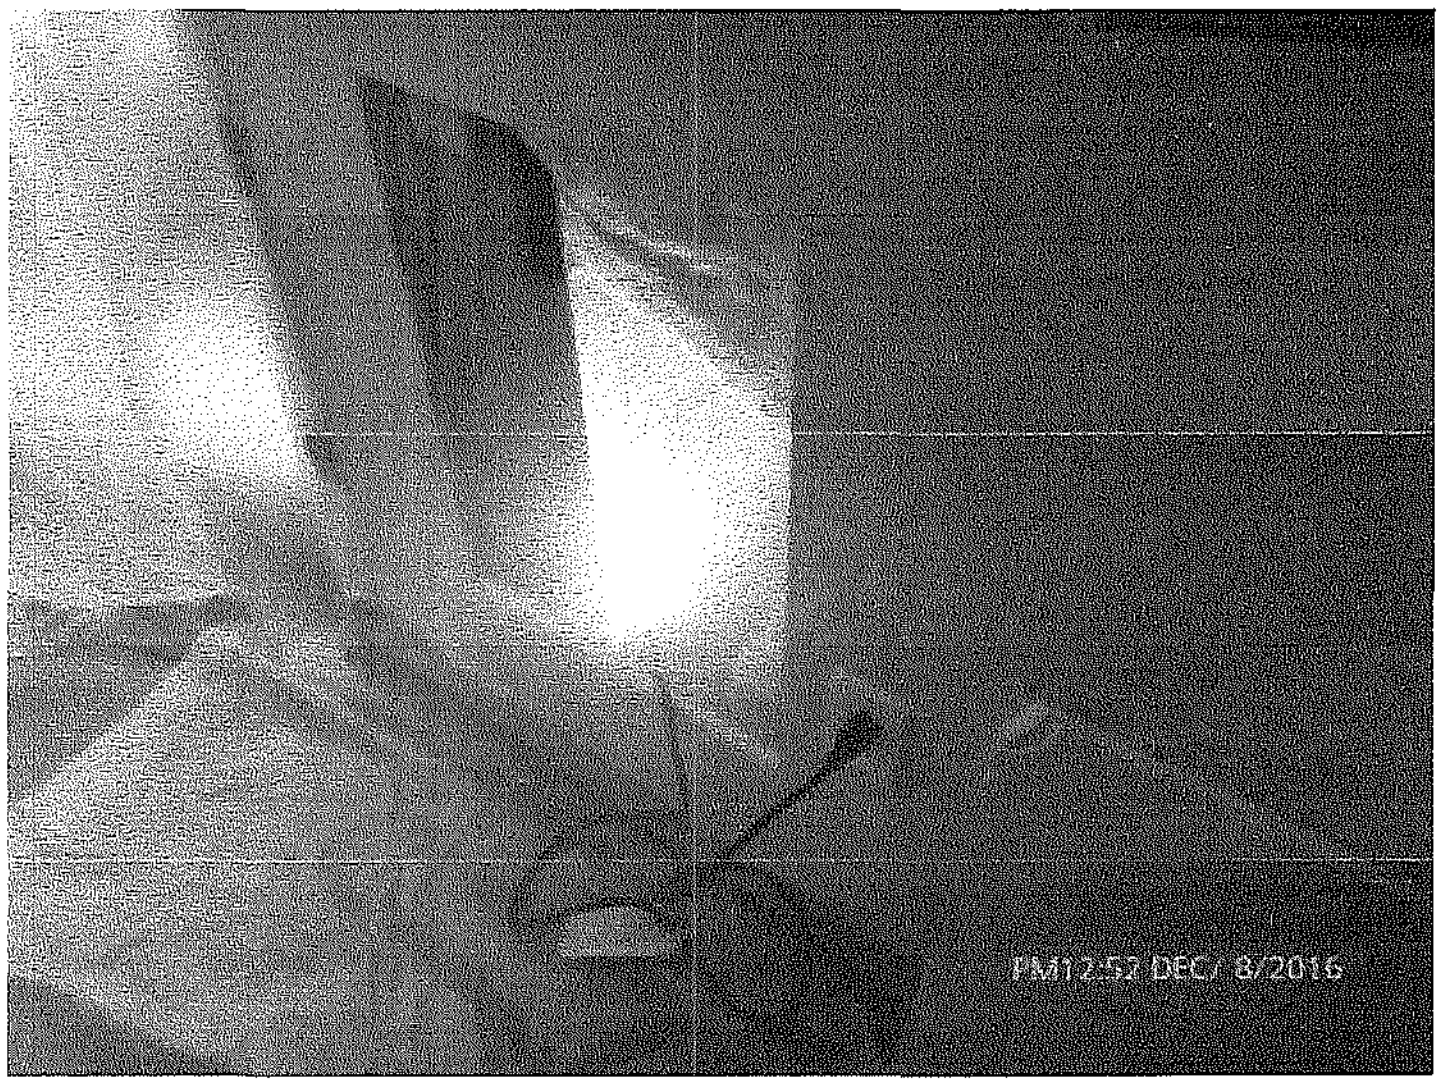
Test access opening in bedroom wall at site ST1 in unit 31B

Smoke test site ST1 in unit 31B

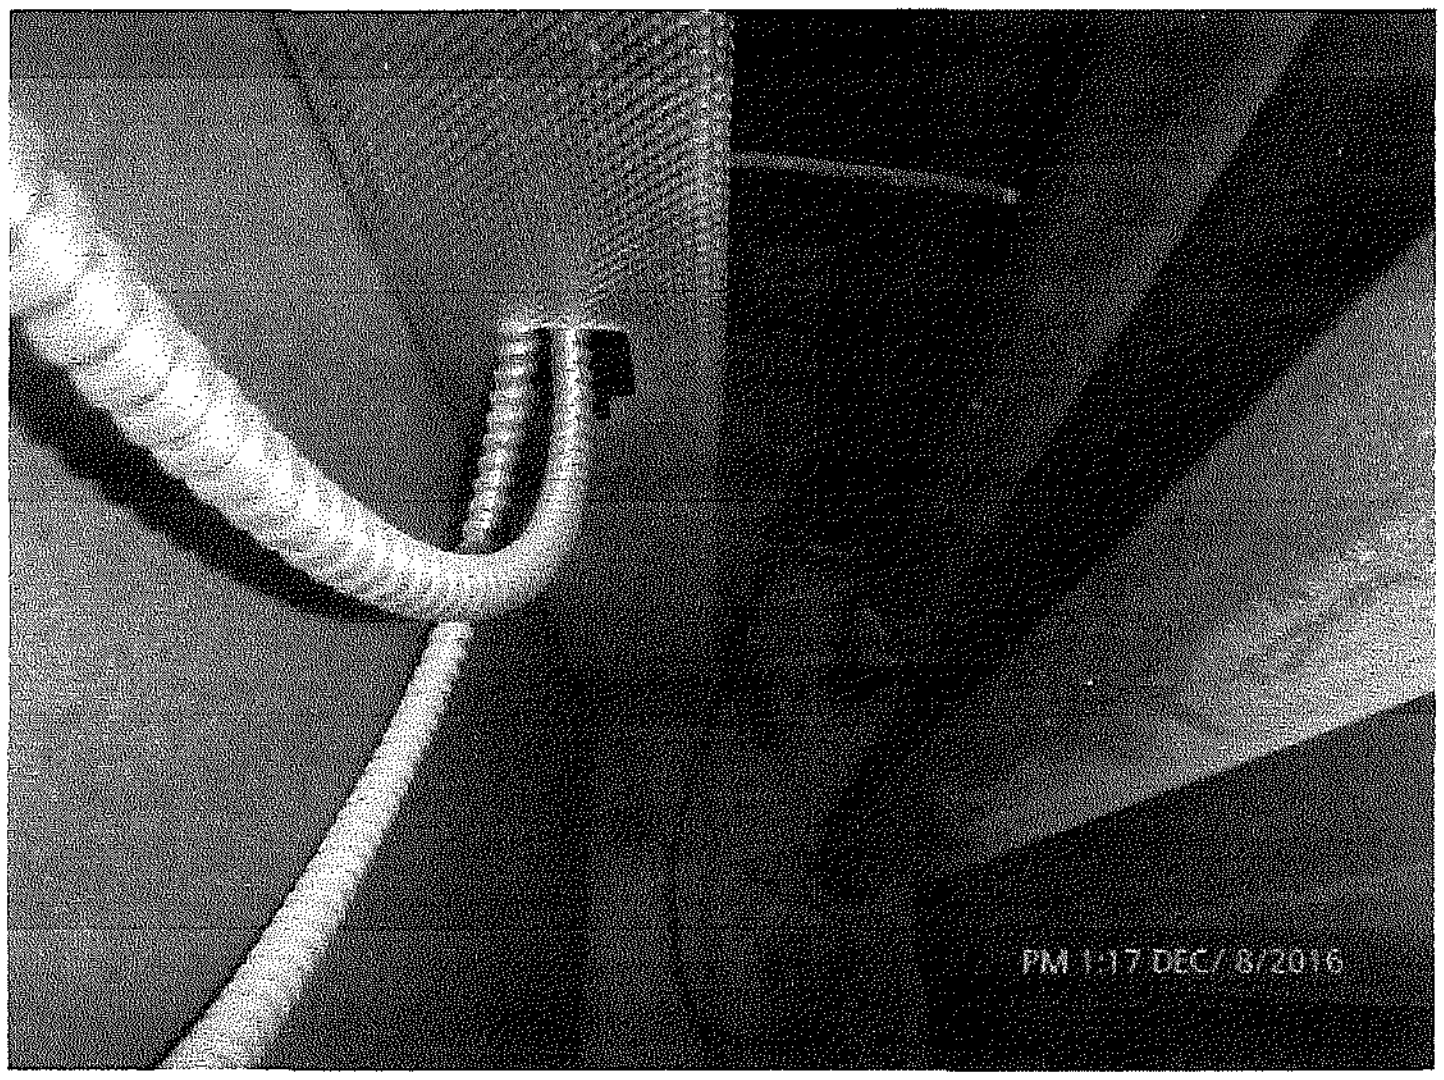
Pre-Test Conditions:
Test site ST5 in unit 31B heat pump closet.
Note pipe risers routed through closet floor

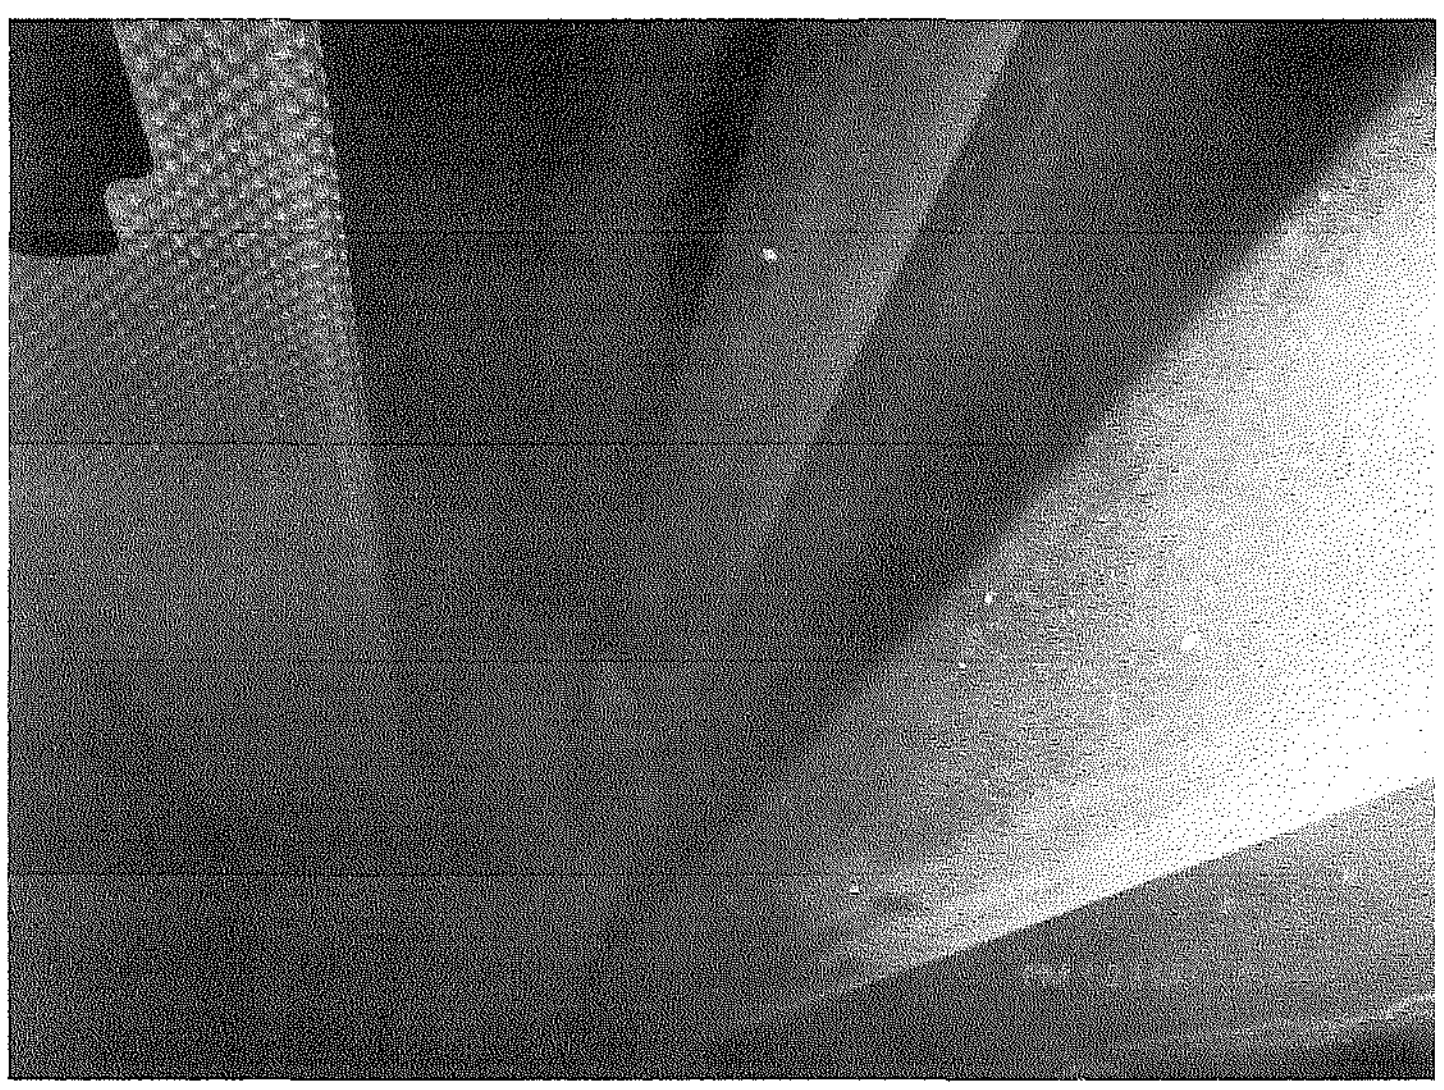
During Smoke Test Conditions – 1/2 minute from start:
Test site ST5 in unit 31B heat pump closet.
Note white test smoke at pipe risers routed through closet floor

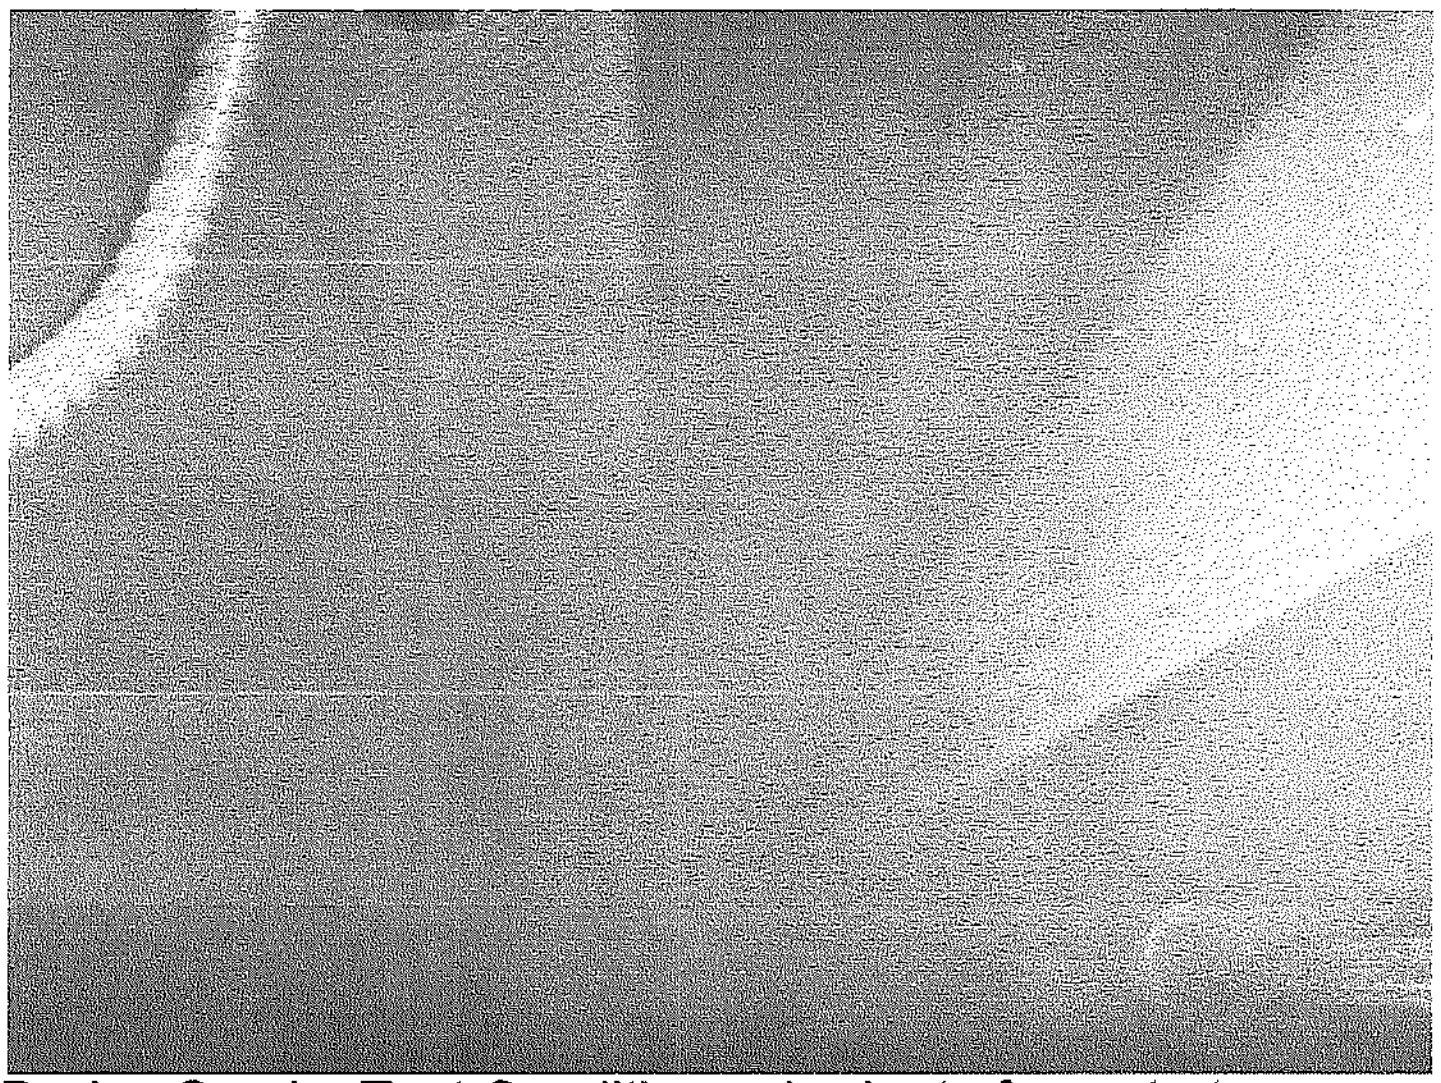
During Smoke Test Conditions- 1 minute from start:
Test site ST5 in unit 31B heat pump closet.
Note white test smoke completely filling closet
