[Mills Act Historical Property Contract - 101 Vallejo Street]

Address: 101 Vallejo Street
APN: 0141-013

MILLS ACT APPLICATION
101 VALLEJO STREET
SAN FRANCISCO, CALIFORNIA
[17038]

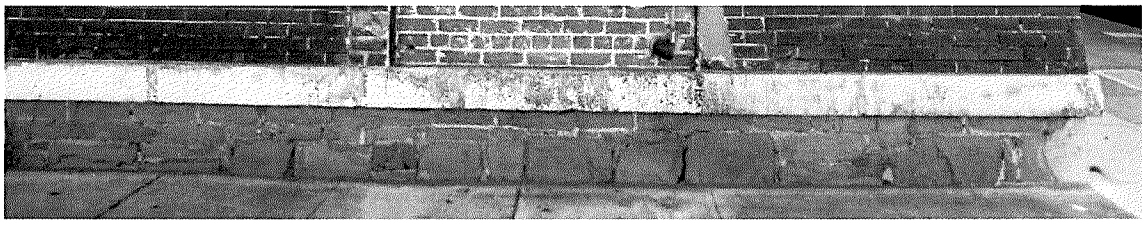
Mortar patches should be examined for proper adhesion. Failing patches should be removed and replaced with a new mortar patch that matches the field stones in appearance. Incompatible mortar should be removed and repointed with an appropriate mortar. Repoint areas where the mortar is missing. Remove areas of spalled, loose, or deteriorated stone and restore with patching compound.

Figure 4 Detail view of foundation stone on Front Street (photograph taken on 03/30/2017).

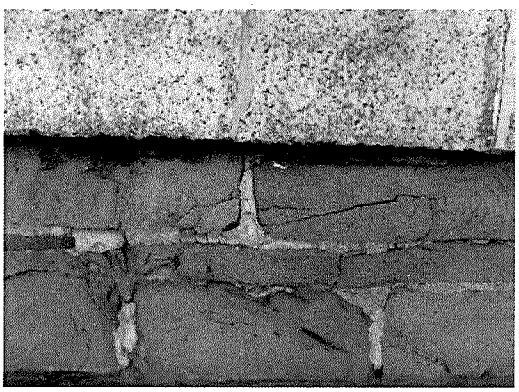
Figure 5 Detail view of foundation stone condition. Note cracking, fragmentation, insipient spalling, and failed mortar joints (photograph taken on 03/31/2017).

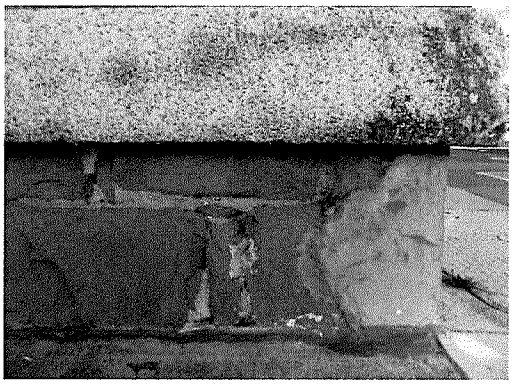
Figure 6 Detail of foundation condition. Note Portland cement mortar replacement and patching (photograph taken on 03/31/2017).

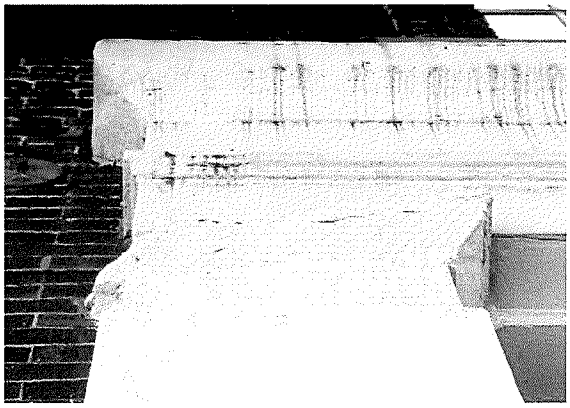
Figure 8 Detail view of deteriorated pilaster capital (photograph taken on 03/30/2017).

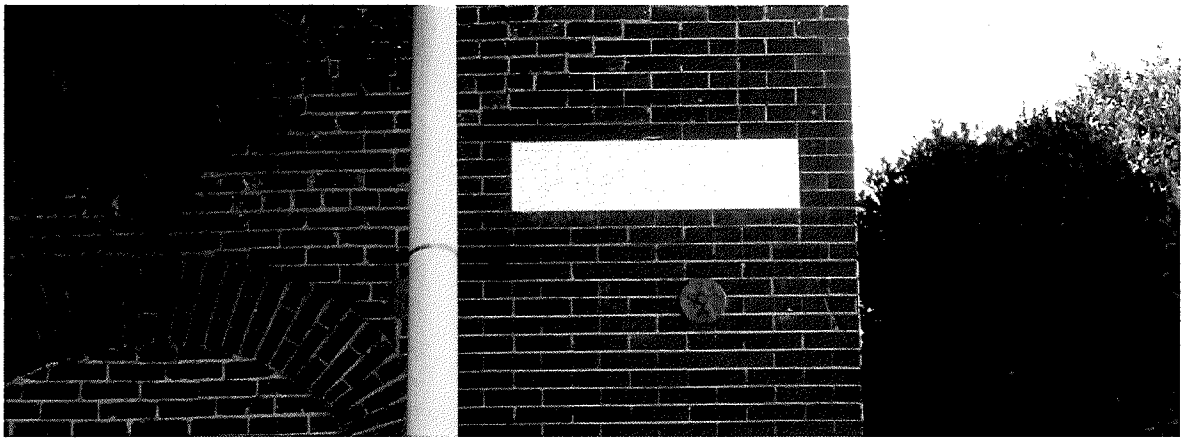
Each elevation includes an original marble insert with the street name incised in the marble. They are in good condition, and do not need rehabilitation.

Figure 17 Detail of street signage on the Front Street elevation (photography taken on 03/30/2017).

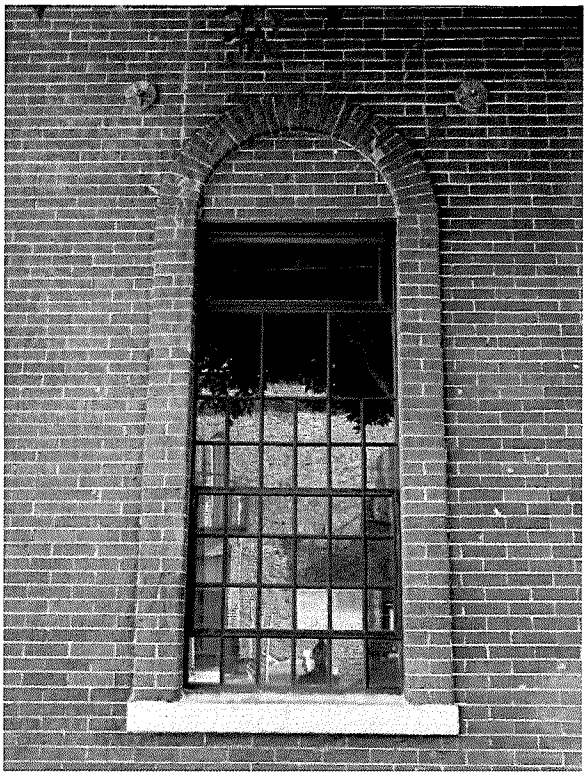
All of the sills have had parging coat repairs made to them on the interior. Seven of the sills (including both Front and Vallejo streets) show cracking of the stone, parging, or concrete/cement on the interior. All of the steel lintels show signs of corrosion and should be treated.

Figure 24 Historic ground level window type. Note transom glass, metal frame, brick surround, and granite sill (photography taken on 03/31/2017).

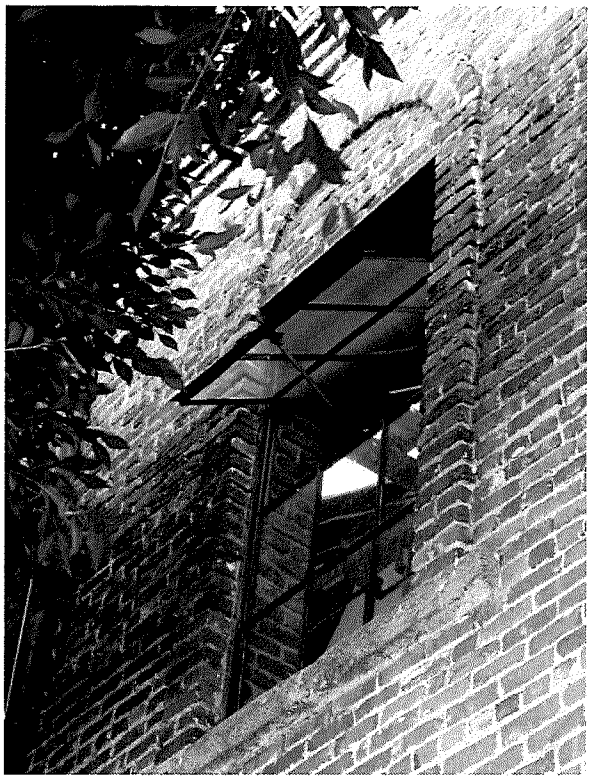
Figure 25 Upper story window type. Note non-historic use of concrete in the reconstruction of this sill (photography taken on 03/31/2017).

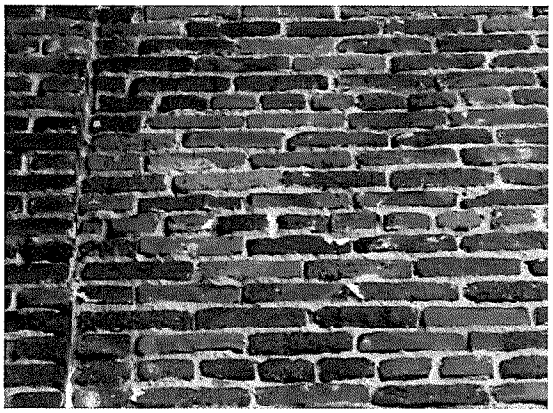
Figure 28 Detail of brick condition along Vallejo Street. Note differential erosion of the mortar joints. While this is preferable to ensure the longevity of the adjacent brick, it should, at this time, be repointed to return it to its historic profile (photography taken on 03/31/2017).

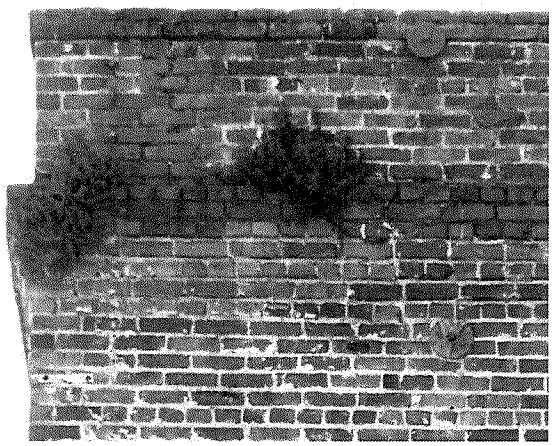
Figure 30 Detail of vegetation on corbeled cornice (location: Vallejo elevation at the corner of Vallejo and Front Streets (photography taken on 03/31/2017).

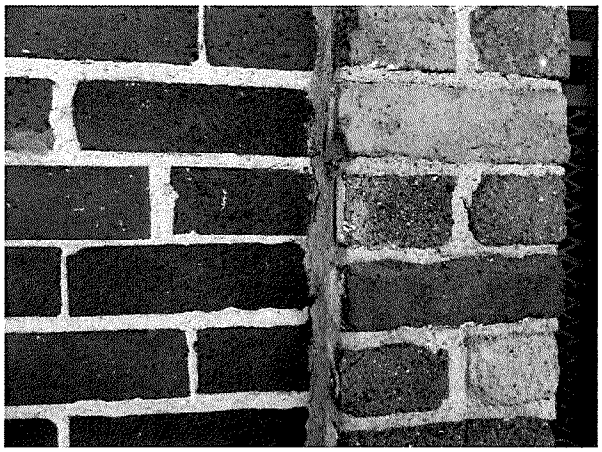
Figure 31 Detail of 111 Vallejo door surround and adjacent masonry. Note incompatible Portland cement mortar joints in the construction of the surround (right), and the previous mortar joints (left). Photography was taken on 03/31/2017.

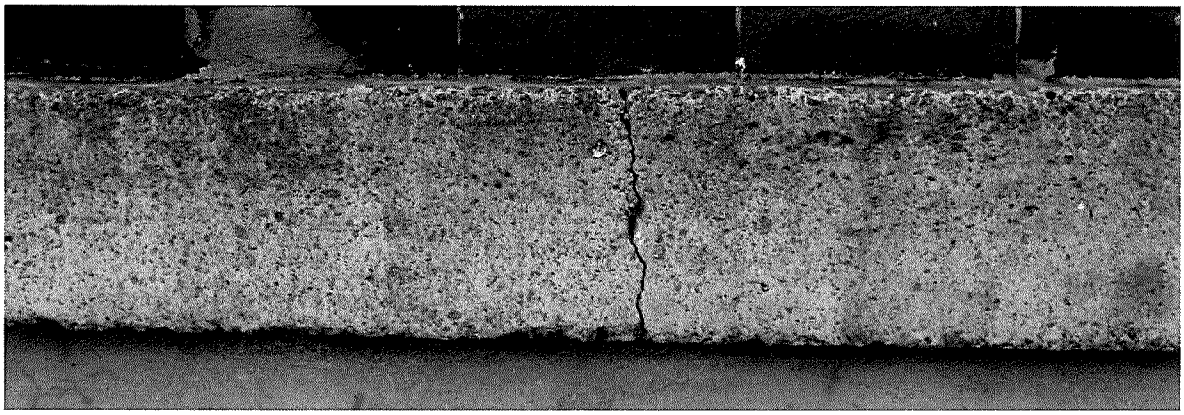
The granite water table on the Vallejo elevation shows signs of failing paint and material loss. Strip all paint off granite. There are two instances of insipient spalling, two large cracks that fragment the stones, one unbound mortar repair, and three failing repair joints. These areas need to be repaired with a compatible patching compound. There are several spalls in the granite that may be impacting its ability to properly shed water and will require repair with a compatible patching compound.

Figure 33 Detail of Vallejo Street water table. Note fragmentation of granite via through-cracking. Also note hairline cracking condition found in cement plaster stucco at foundation (photography taken on 03/31/2017).

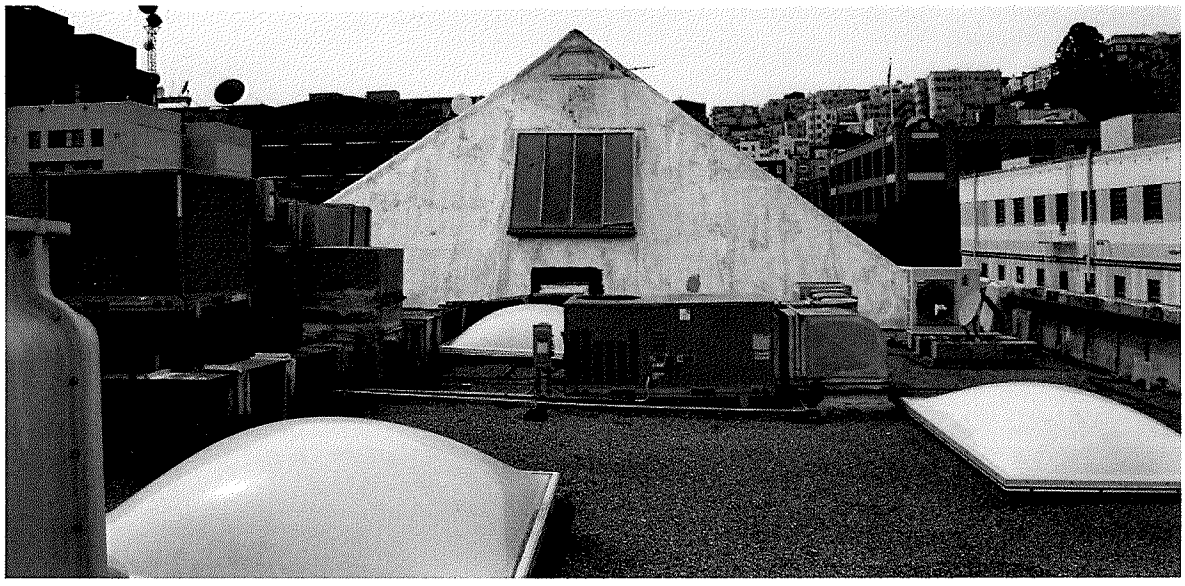
Flat roof: This part of the roof slopes to and drains water to the north side and has a built-up roof. This portion of the roof has several dome skylights. There are large areas of biological growth found on the tar and gravel surface, however somewhat localized. There is extant cracking where the roof transitions to the liquid membrane on the back of the parapet.

Figure 38 Overall photograph of existing roof, looking west (photography taken on 04/05/2017).

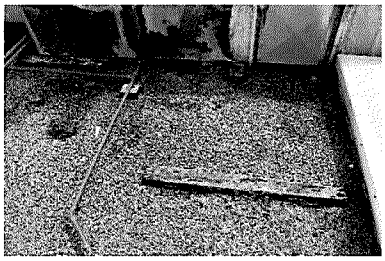
Figure 40 Detail Photograph showing bio-colonization amongst tar and gravel roof (photography taken on 04/05/2017).

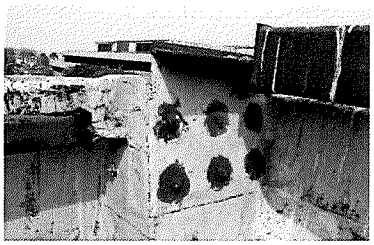
Figure 42 Detail of extant hollow-steel-beam, bolt plate, and concrete pier construction (photography taken on 04/05/2017).

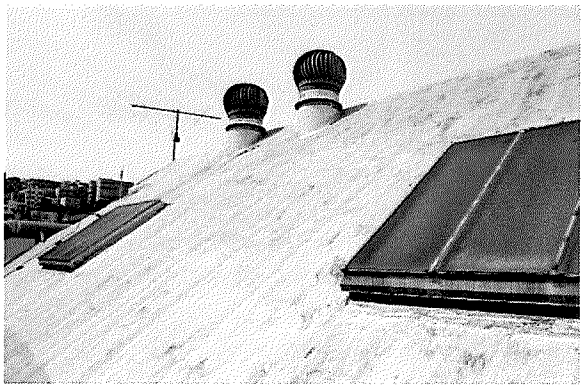
Figure 46 Photograph of roof, south facing hip. Note chicken-wire window panes set in an aluminum frame, and paired stacked ventilation exhausts (photography taken on 04/05/2017).

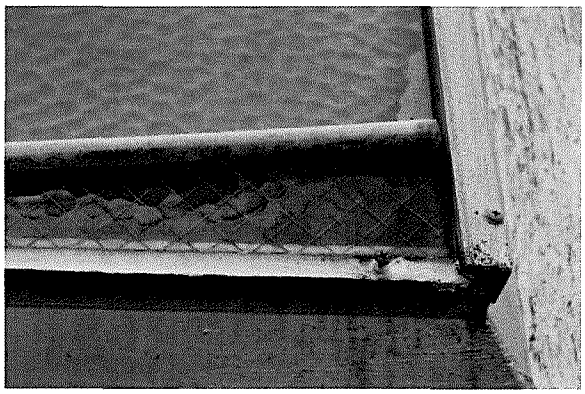
Figure 48 Detail photograph of chicken-wire glass and delaminated paint film (photography taken on 04/04/2017).

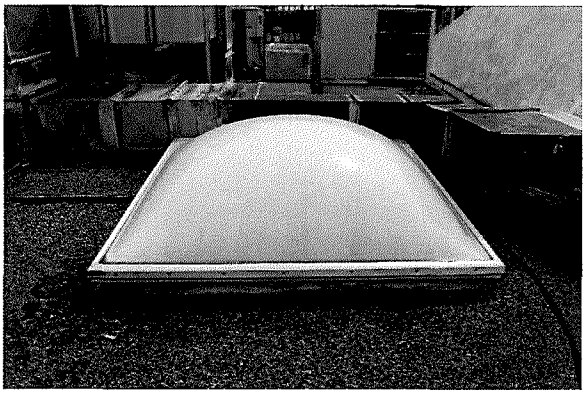
Figure 50 Detail of modern skylight (photography taken on 04/04/2017).

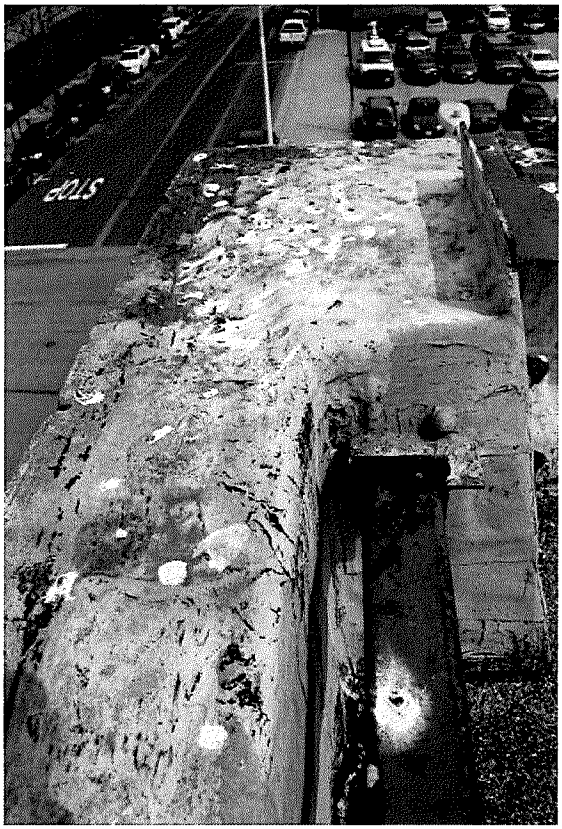
The backside of the parapets are coated with a liquid membrane roofing and are braced with steel tubes. The roof material on the parapets is in fair condition. There are two instances where expanding and contracting bolt plates have cracked the roof membrane. A more extensive cracking of the liquid membrane can be seen at the base of the north and east parapets where it meets the flat roof. The eastern half of the north parapet and the east parapet need to have the horizontal surfaces cleaned of biological growth, animal deposits, and atmospheric soiling. The transition between parapet and roof and repair should be inspected for areas that are cracked and deteriorated to ensure a watertight seal around all parapet faces and at steel attachment points. At the top of the parapet, inspect liquid applied membrane for deterioration and repair damaged and deteriorated areas. The parapet bracing should be inspected for signs of rust or failing paint and repaired as required.

Figure 51 Photograph of the northeast corner and horizontal surface on parapet. Note biological colonization, corrosion, atmospheric pollution, and animal deposits (photography taken on 04/04/2017).

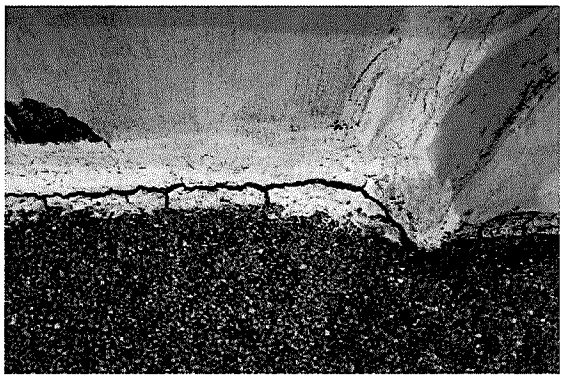
Figure 53 Detail at base of parapet wall. Note cracking of tar and paint (photography taken on 04/04/2017).

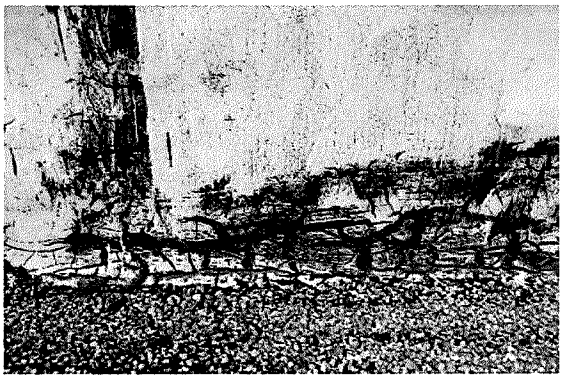
Figure 54 Detail at base of north parapet wall. Note cracking tar and paint (photography taken on 04/04/2017).

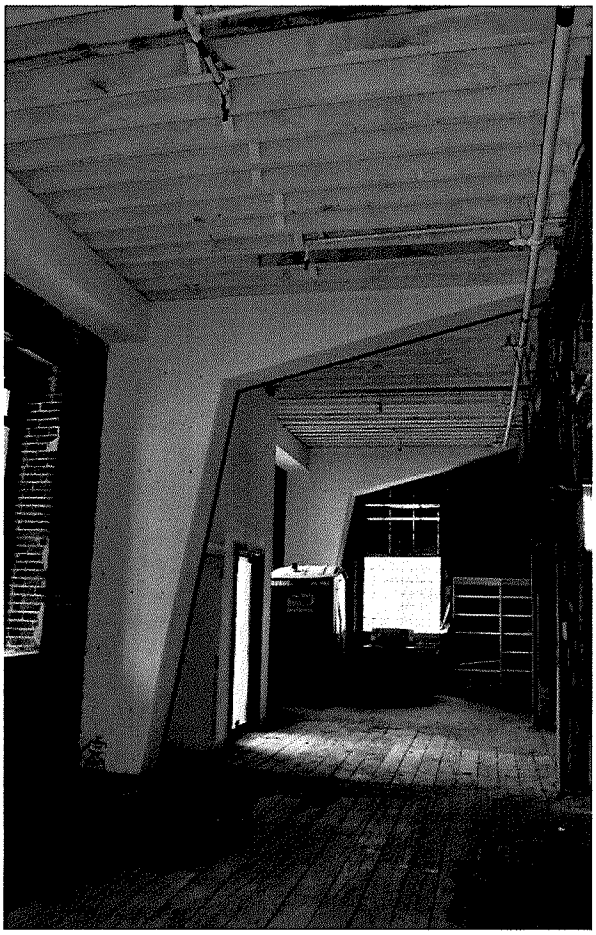
The primary structure of the building today is non-historic. A modern concrete moment frame was installed to seismically strengthen the building. The moment frames appear to be sound and in good condition.

Figure 56 Photograph of concrete piers, modern reinforcement Detail photograph of floor and sub-floor. Note inscription in sub-floor reads 1973 (photography taken on 04/04/2017).

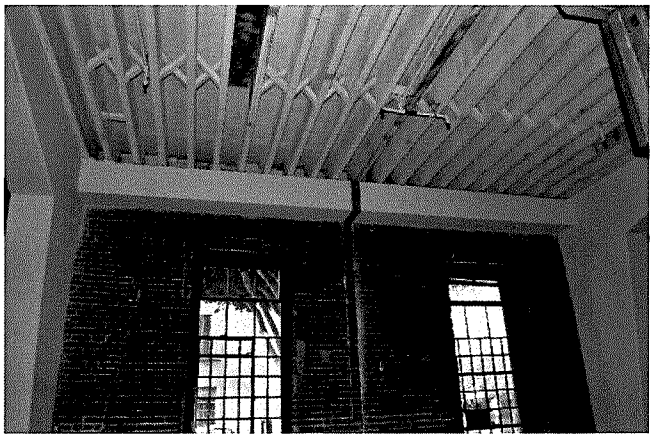
Figure 57 Photograph highlighting concrete beam-to-pier construction Detail photograph of floor and sub-floor. Note inscription in sub-floor reads 1973 (photography taken on 04/04/2017).

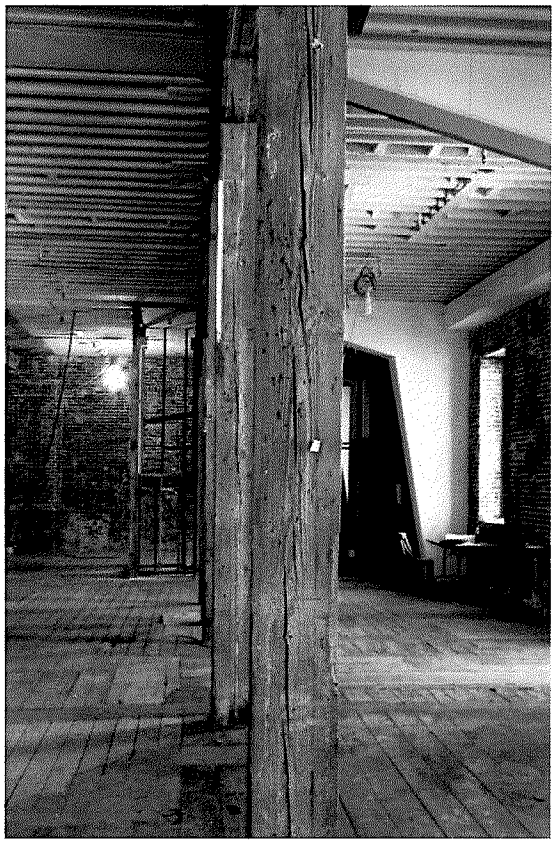
Figure 58 Interior photograph of vertical splitting present in several of the structural timber columns on the ground floor (photography taken on 04/10/2017).

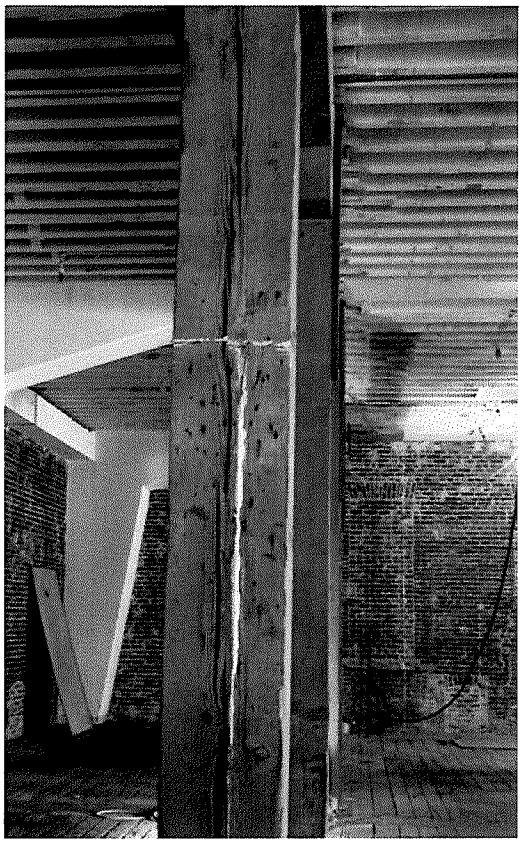
Figure 59 Interior photograph of vertical splitting present in several of the structural timber columns on the ground floor (photography taken on 04/05/2017).

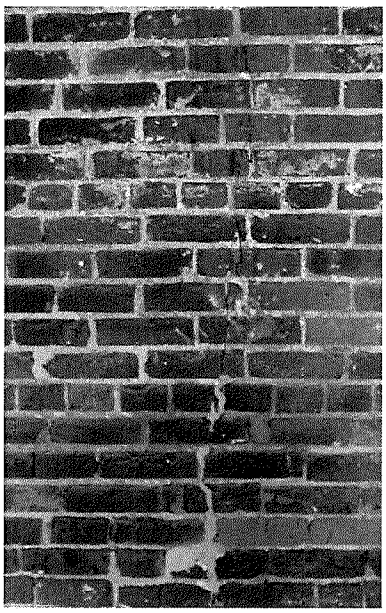
Figure 62 Detail of a crack propagated by a Portland cement repair. Crack originates at the Portland cement infill and runs the height of the wall (photography taken on 04/10/2017).

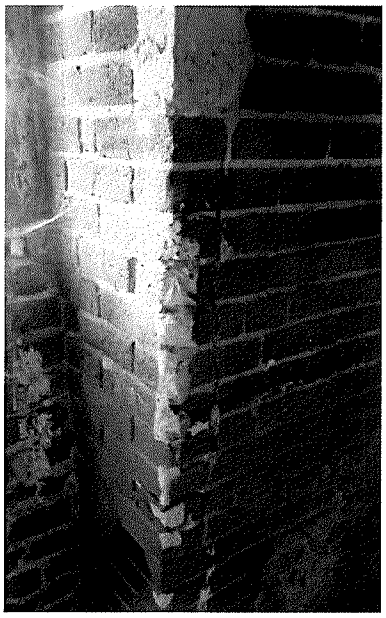
Figure 64 Detail photograph of brick deterioration adjacent to window openings. This is typical for 6 of the windows on this floor (photography taken on 04/10/2017).

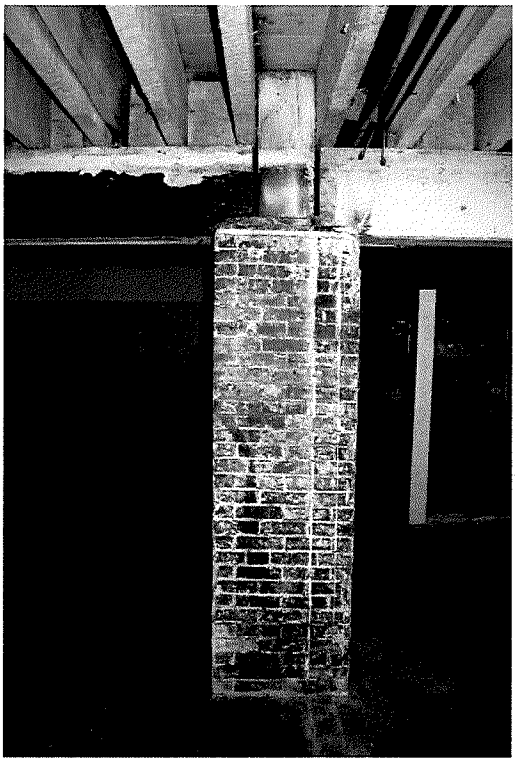
Masonry brick piers in the basement level carry the load from the floor above, and the perimeter of the building is reinforced with concrete beams. The extant brick piers appear to be original. Remnants of previous paint coatings are still present on some piers, while others have not had the paint stripped at all. Some piers have been reinforced with a cement parging mixture. In general, the piers appear to be in good condition.

Figure 69 Detail of structural brick pier. Note remnants of previous paint coatings (photography taken on 04/04/2017).

Figure 70 Detail of structural brick pier. Note parging cement (photography taken on 04/04/2017).

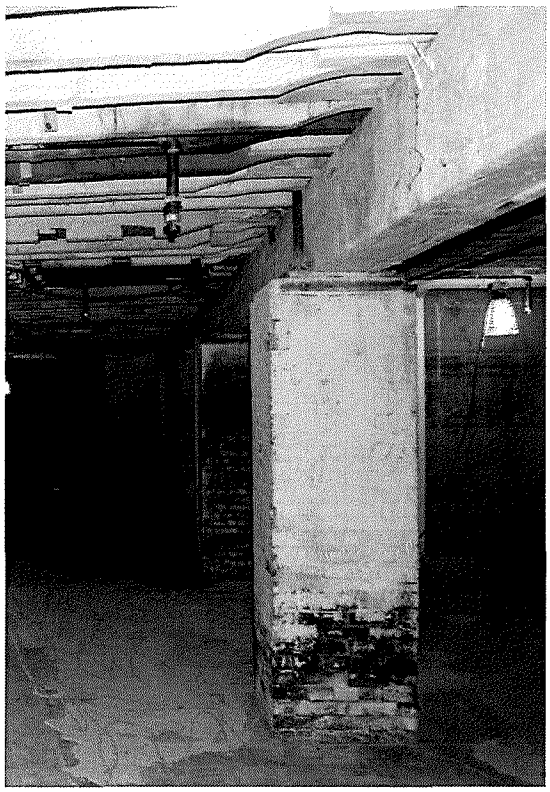
Considering its history, it is likely that the original beams burned in the Earthquake and Fire of 1906 and were replaced with the existing timber beams. These still have remnants of several different paint coatings and are in good condition.

Figure 71 Photograph of structural timber beam to brick pilaster connection (photography taken on 04/04/2017).

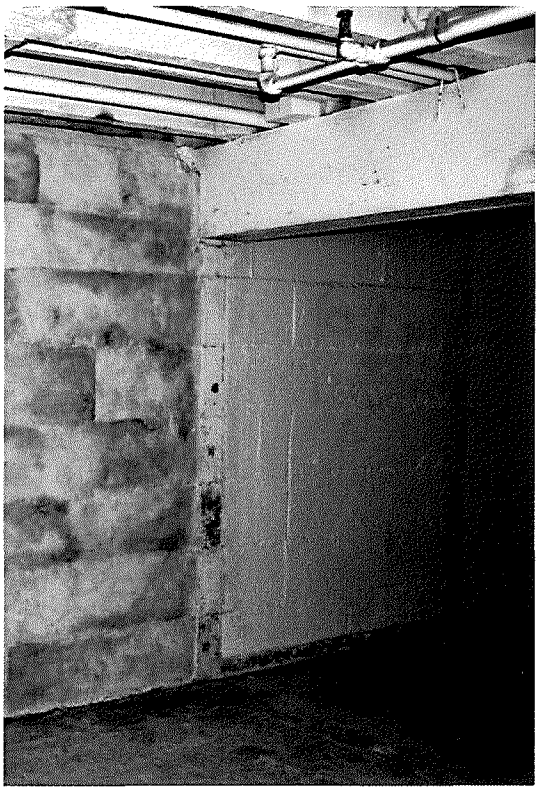
Figure 72 Detail of structural timber beam to foundation connection (photography taken on 04/04/2017).

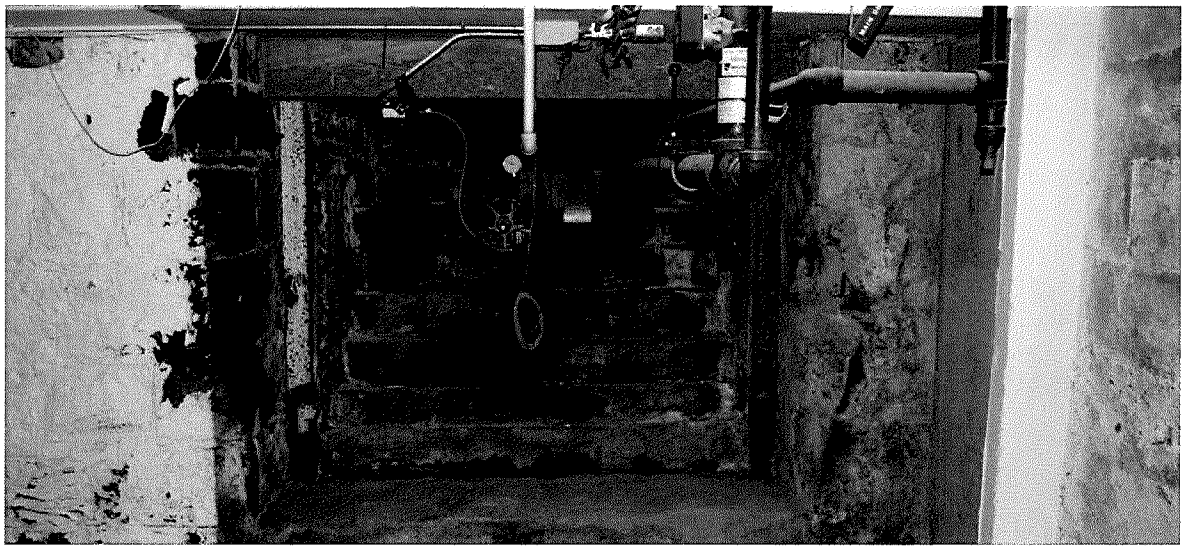
There are still remnants of the historic vault that was constructed under the Vallejo Street sidewalk in the late 19th century. A passageway constructed of brick walls and concrete steps connected the vault to 101 Vallejo. Even though filled-in, the remnants of this passageway are historically significant, discernable, and should be preserved. There is extensive efflorescence and iron staining on the walls of the west vault from nearby systems.

Figure 73 Historic passageway to underground opium vault under Vallejo Street Sidewalk, now partially filled-in (photography taken on 04/04/2017).

Figure 74 Detail of the intersection of the brick vault and foundation stone. Note iron staining and efflorescence (photography taken on 04/05/2017).

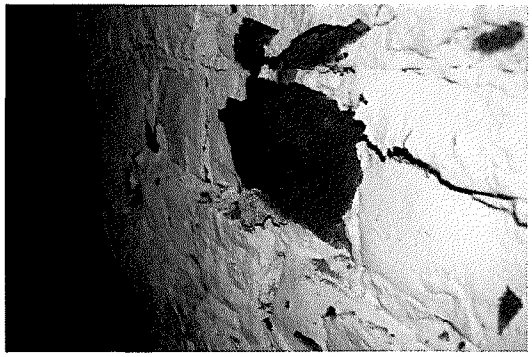
Figure 76 Detail photograph of south foundation wall. Note delamination of finish, spalling and disaggregation of fieldstone (photography taken on 04/04/2017).

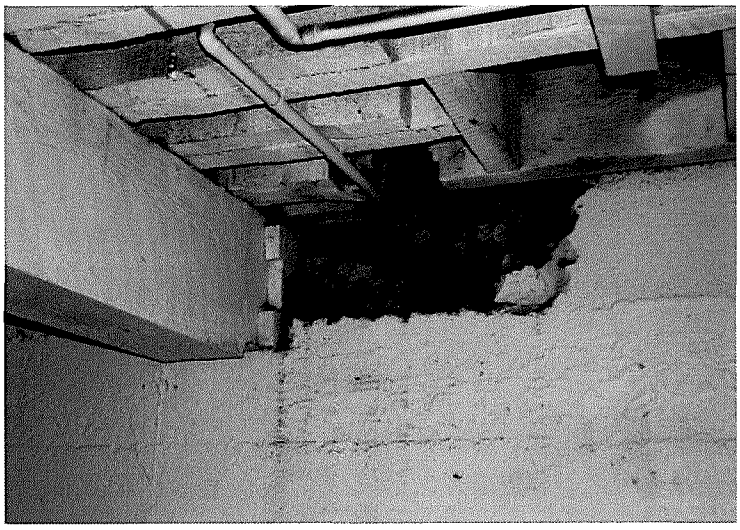
Figure 78 Detail photograph of eroded foundation on the east foundation wall (photography taken on 04/04/2017).

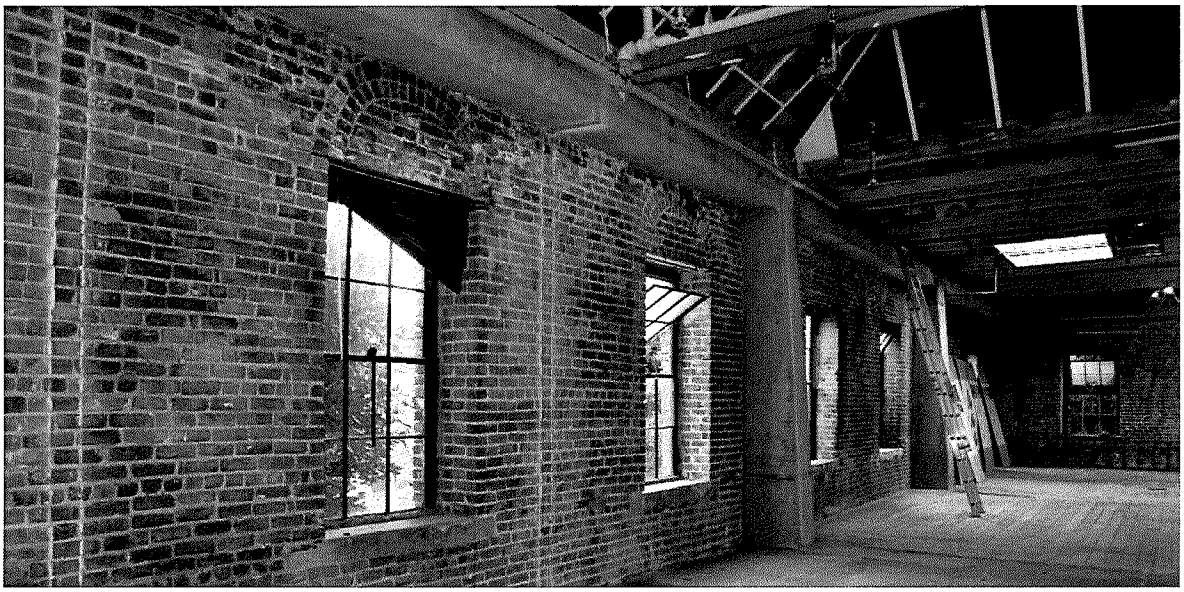
Figure 81 Photograph of north wall on the upper level. Note modern concrete pier and beam stabilization (photography taken on 04/04/2017).

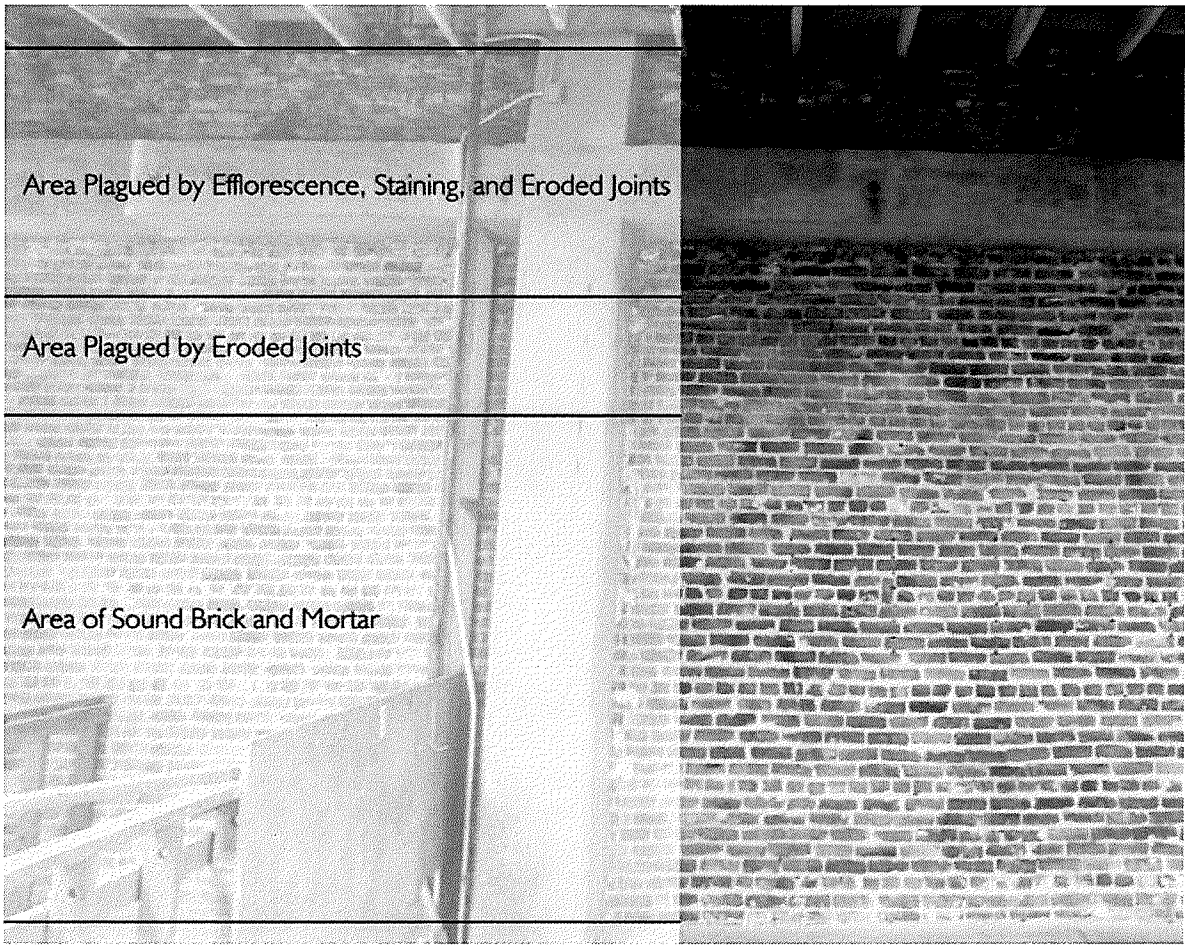
The interior brick on the upper level is in generally good condition. There is, however, evidence of water infiltration along the roofline that should be investigated at the facades on the south and west walls. (Note: north & east walls appear to be in good condition, however, were not able to be surveyed up close due to obstructions.) The upper brick courses show significant signs of efflorescence and discoloration in the form of iron staining. Both of these conditions, efflorescence and iron staining, are indicators of the degradation of the internal matrix of the brick. As water migrates from the exterior to the interior and dries, it brings with it salts and mineralogical inclusions of the brick. The staining is iron minerals that have gone into dissolution and are redeposited on the surface from which it is evaporating; and efflorescence results from the mobility of innate salts in the brick's matrix. While efflorescence itself can, in most cases, be a cosmetic issue; the mobilization of sub-florescence through the pore structure and to the surface can be problematic. Additionally, four window surrounds exhibit crack and deteriorated bricks. Three window surrounds require repointing. Brick below the sill of the southernmost window on the east wall has heavy amounts of efflorescence accompanied by deteriorated mortar. The source of water infiltration should be identified and appropriate repairs made to halt the water intrusion and make repairs to the brick wall.

Figure 84 Diagram of the typical condition found on the south and east walls of the upper level (photography taken on 04/04/2017).

Figure 85 Detail photograph of southernmost window on the east wall. Note occurrence of efflorescence and eroded mortar (photography taken on 04/04/2017).

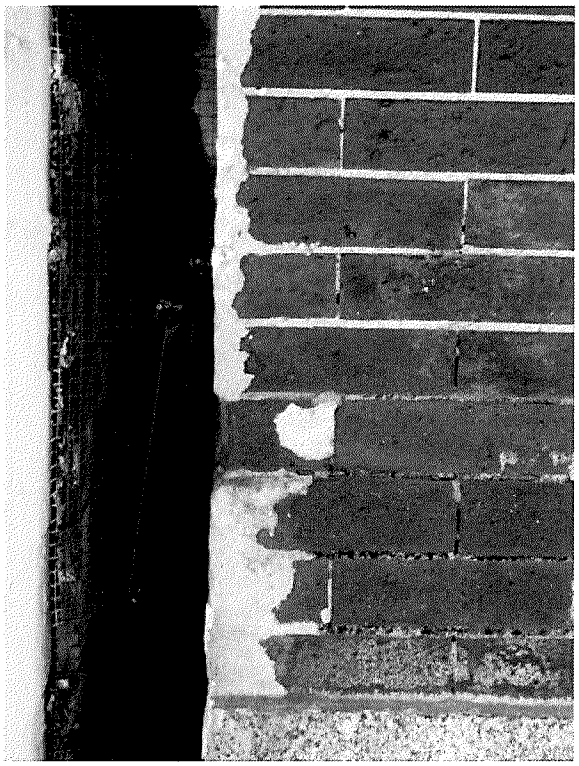
Figure 91 Detail view of incompatible repair along Front Street. Note dissimilarities between brick and repair, and note bio-colonization plaguing the joints (photograph taken on 03/31/2017).

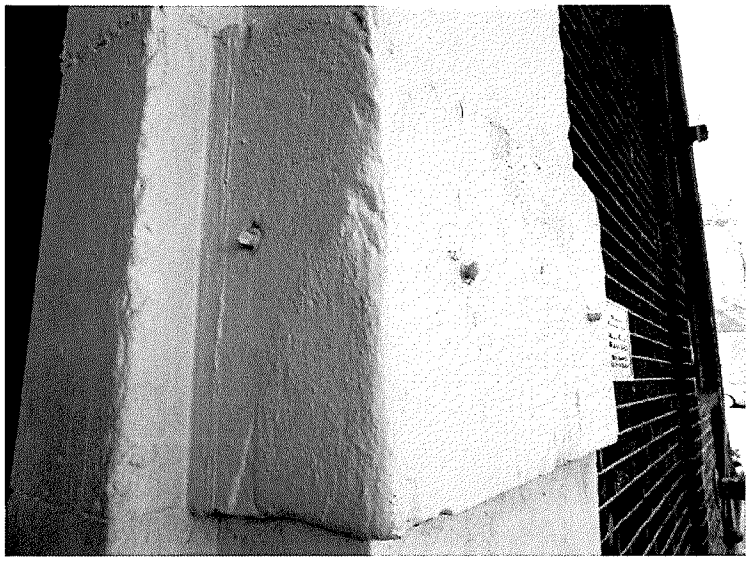
Figure 93 Photograph of threshold pilasters. Note old anchor/ attachment pins left in stone (photograph taken on 03/31/2017).

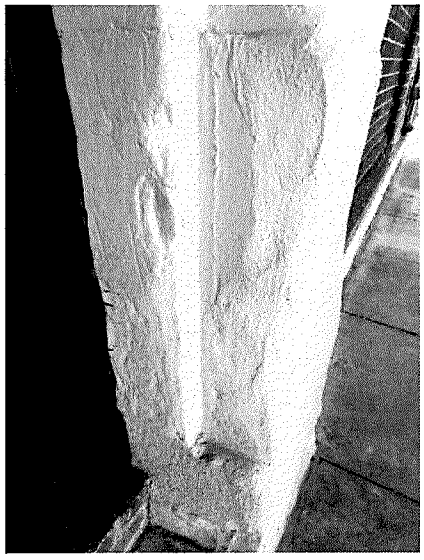
Figure 94 Detail view of cement parging repair on sandstone pilasters (photograph taken on 03/31/2017).

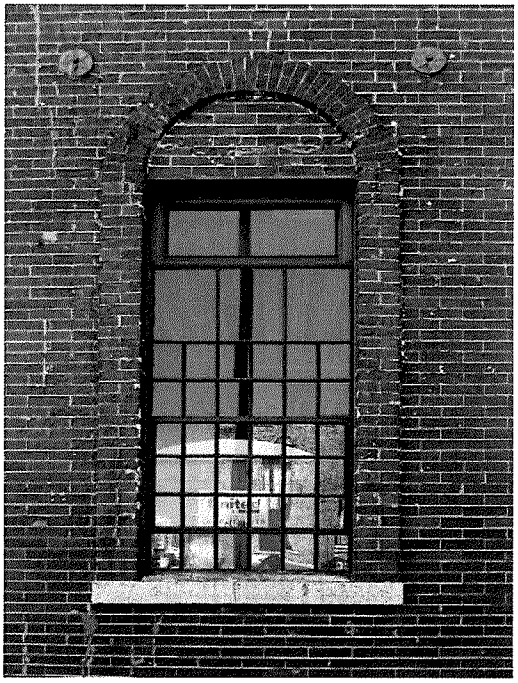
Figure 96 Detail view of opening along Vallejo Street. Note blind arch, brick tympanum, cast iron frame, and granite sill (photograph taken on 03/30/2017).

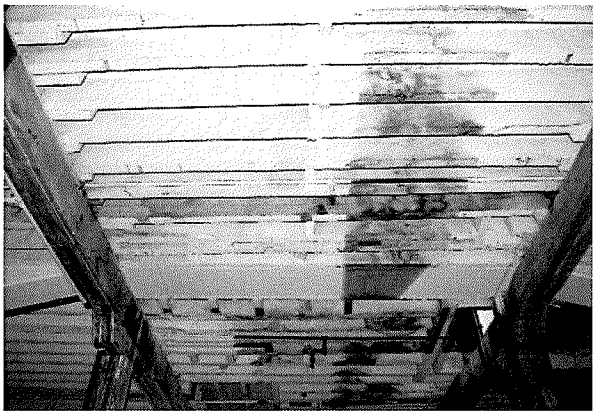
Figure 103 Photograph of ground floor ceiling joists. Note ghosts from old HVAC and water staining (photograph taken on 04/04/2017).

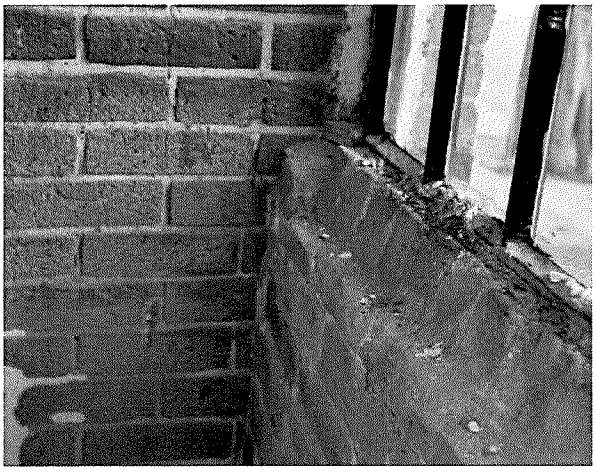
Figure 105 Detail view of brick sill construction, from the interior (photograph taken on 04/04/2017).

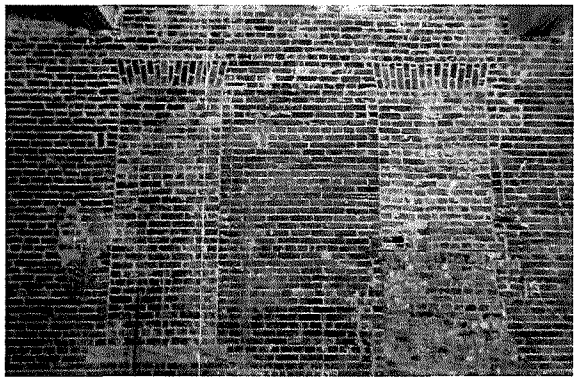
Figure 107 Interior photograph of west wall. Note brick-in windows and Portland cement mortar (photograph taken on 04/10/2017).

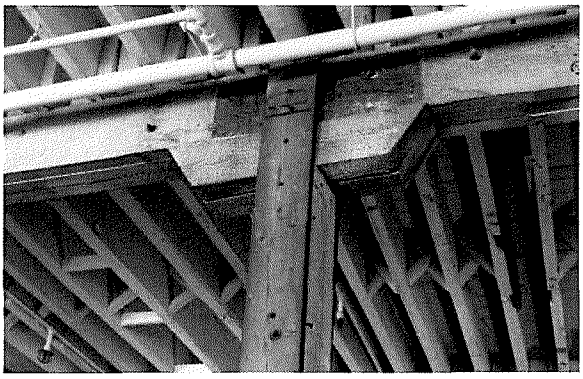
Figure 110 Interior ground floor detail of structural timber construction (photograph taken on 04/04/2017).

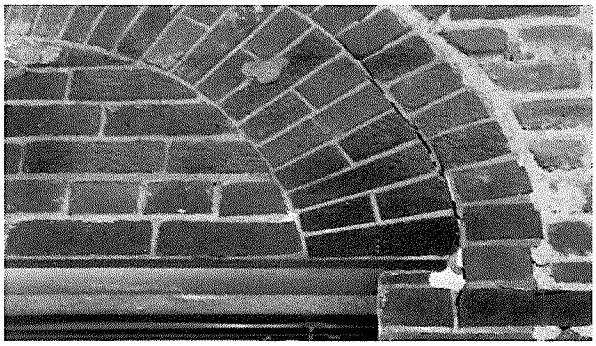
Figure 113 Detail view of cracked mortar and brick around window openings (photograph taken on 04/10/2017).

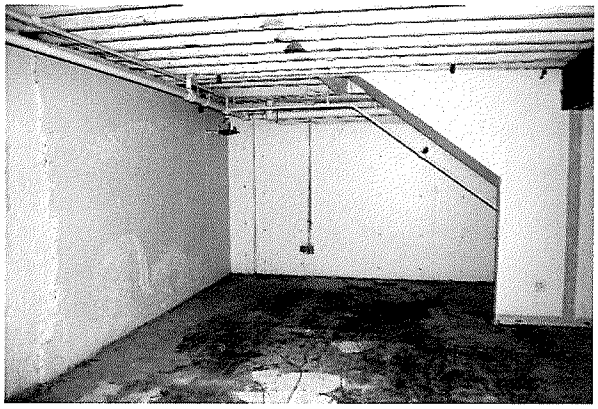
Figure 115 Interior photograph at the basement. Note seam between concrete and stone foundations (left). Photograph was taken on 04/04/2017.

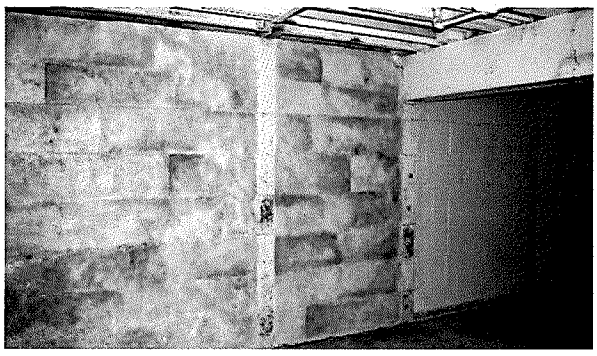
Figure 119 Interior photograph of the eastern foundation. Note regularly-cut and laid fieldstone (photograph taken on 04/04/2017).

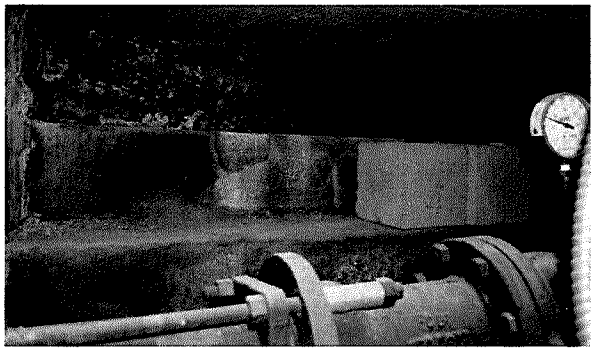
Figure 120 Detail view of historic stairway to 1879 opium vault (now filled in). Photograph was taken on 04/04/2017.

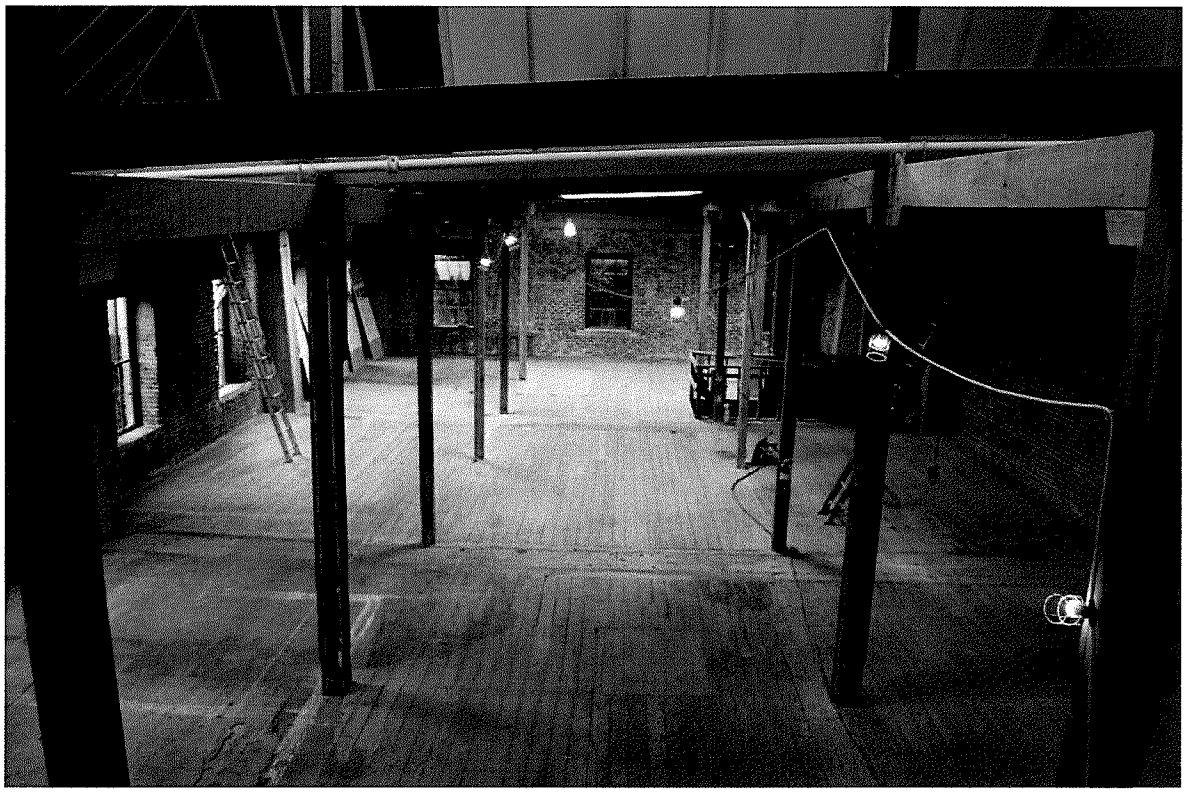
Figure 124 Interior photograph of upper level story, looking east (photograph taken on 04/04/2017).

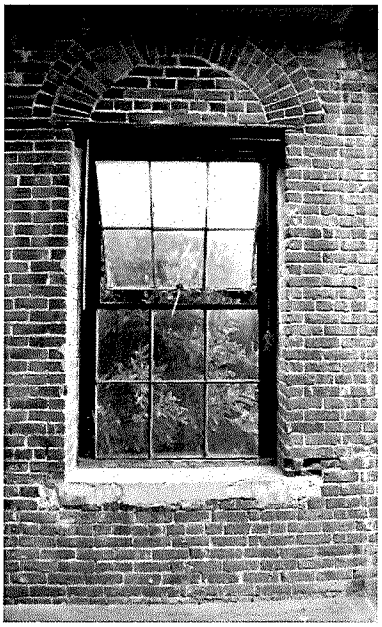
Figure 125 Interior photograph of typical deterioration around window opening (photograph taken on 04/04/2017).

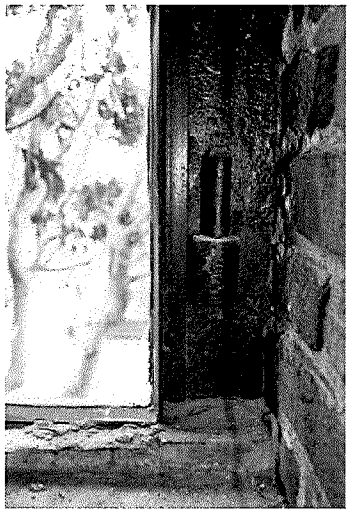
Figure 128 Detail photograph of window hardware on the second floor. Four of these are used in each window, two lower and two upper. This is believed to be the earliest construction type found for the windows (photograph taken on 04/04/2017).

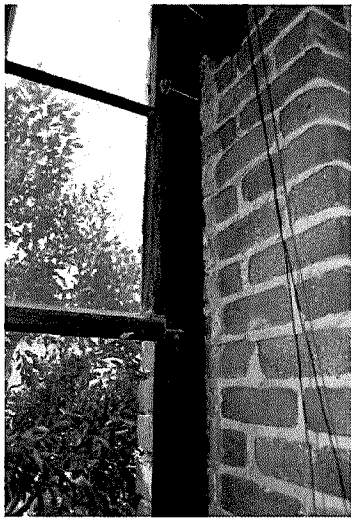
Figure 129 Detail photograph of window hardware on the second floor. Same window as left image. This is believed to be the earliest construction type found for the windows (photograph taken on 04/04/2017).

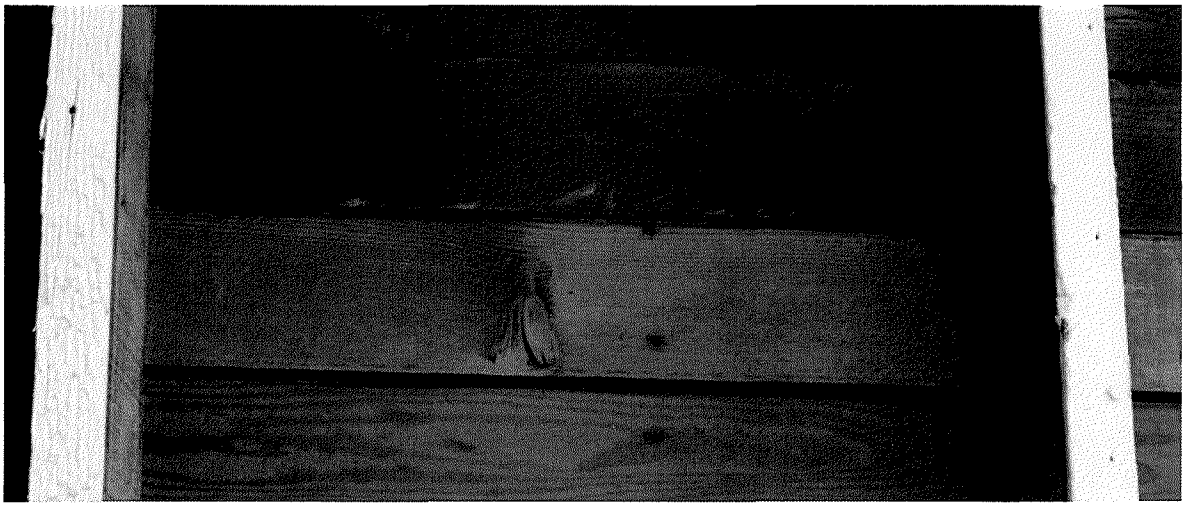
Figure 131 Detail view of cracking pattern found in the reinforced concrete member on the upper story. Note through-cracking: the crack runs the height of the beam and run perpendicular to its width all the way to the exterior brick wall. Stabilization of these structural member has been attempted with thin wooden planks. Also note bolt (right) from steel tie-back, which anchors the exterior walls to the reinforced concrete members (photograph taken on 04/05/2017).

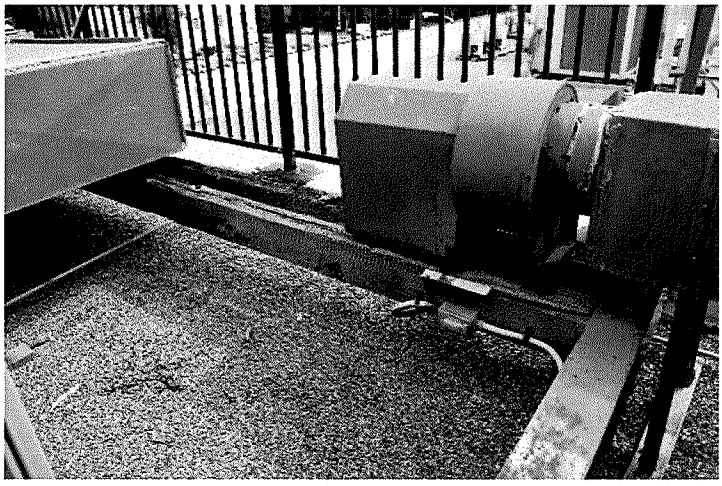
Figure 135 Detail photograph from the roof. Note use of steel I-beams and nominally cut wood to elevate and support HVAC (photograph taken on 04/05/2017).

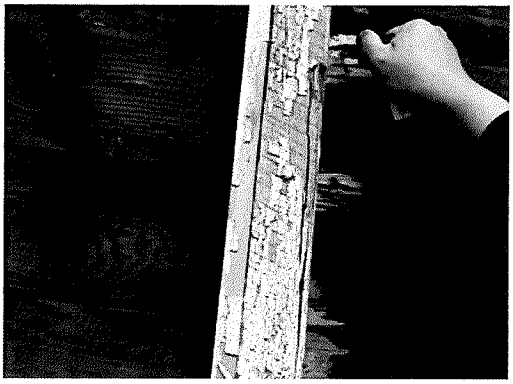
Photo 8: Severe decay in roof framing members.
