[Mills Act Historical Property Contract - 101 Vallejo Street]

Address: 101 Vallejo Street
APN: 0141-013

MILLS ACT APPLICATION
101 VALLEJO STREET
SAN FRANCISCO, CALIFORNIA
[17038]

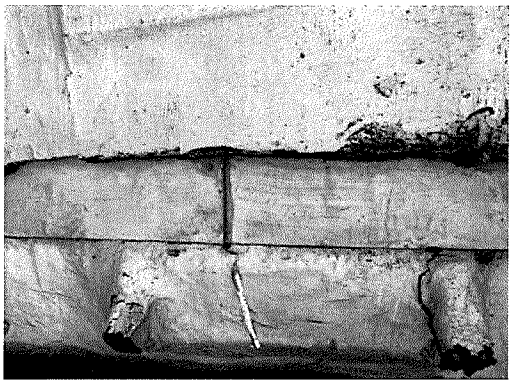
The steep slope roof ends in a perimeter drainage trough that runs along the roof side of the brick parapet (Photo 10). There is a sheet metal base flashing at the bottom of the steep slope roof (Photo 11). This sheet metal flashing was also observed on the interior of the building and did not appear to be set in sealant. MCA also observed that some of the sheathing is exposed and decaying at the base of the steep slope roof. The concrete columns that were used to seismically retrofit the building extend up the parapet and have blocked off drainage, and have created ponding within the perimeter drainage trough in several locations (Photo 12). Several leaks to the interior were observed around the perimeter of the steep slope roof.

Photo 11: Sheet metal base flashing below the base of the steep slope roofing at the perimeter drainage trough.

The sheet metal flashing at the base of the steep slope is not well sealed (Photo 11) and may be allowing water in behind the roofing at the perimeter of the steep slope roof. However, there appears to be sufficient overlap of the galvanized sheet metal flashing over the wood sheathing, which may be acceptable. Additionally, the ponding created by the retrofit concrete columns further exacerbates this problem by forcing water to build up and leak through open seams and holes in the concealed gutter.

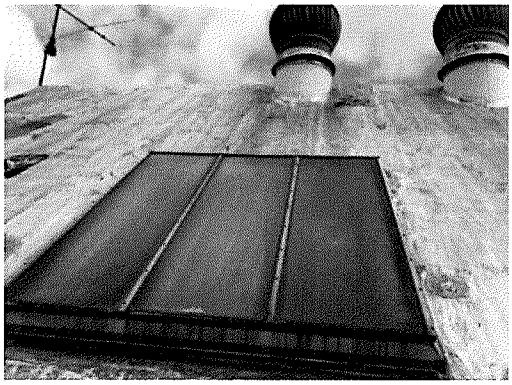
There are skylights located on the four (4) sides of the steep slope roof (Photos 13 – 14). Leaks were observed at the head and sill of these skylights. Bio-growth and decay were observed on the interior framing of some of the skylights.

Photo 13: Skylight through steep slope roofing.

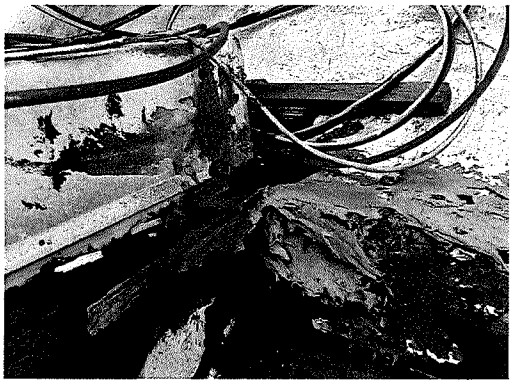
There is some equipment located on the West side of the steep slope roof that does not appear to be well sealed (Photos 15 – 16).

Photo 15: Equipment on West side of steep slope roof.

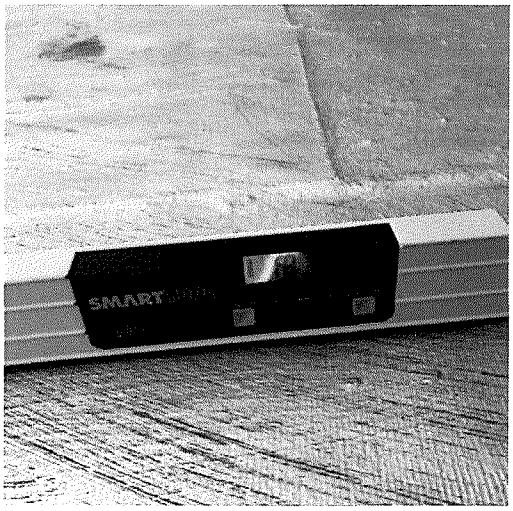
The roof drains to two (2) through-wall scuppers with downspouts on the North side of the building (Photo 21 – 23). The base of the downspouts free flow to the sidewalk below and do not have a splash guard. The slope on low slope roof was measured to be 5/8 inch in 12 inches (Photo 24). The slope on the steep slope roofs measured to be 8-7/8 inches in 12 inches on two (2) sides and 18-1/4 inches in 12 inches on two (2) sides (Photos 25 – 26).

Photo 25: Slope on steep slope.

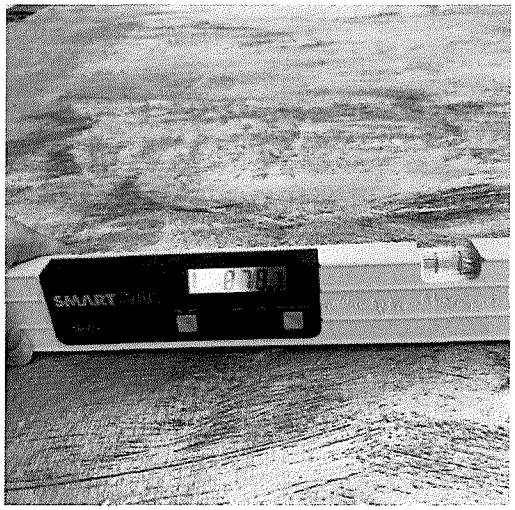
Photo 26: Slope on steep slope.
