File No. 160189 Committee Item No. 3
Board Item No. _____

Re: Application for Highway Bridge Replacement and Rehabilitation Program
Third Street Bridge (34C0025) Rehabilitation Project

Application for HBRRP Funds
Third Street Bridge Rehabilitation Project
February 2015 San Francisco, California

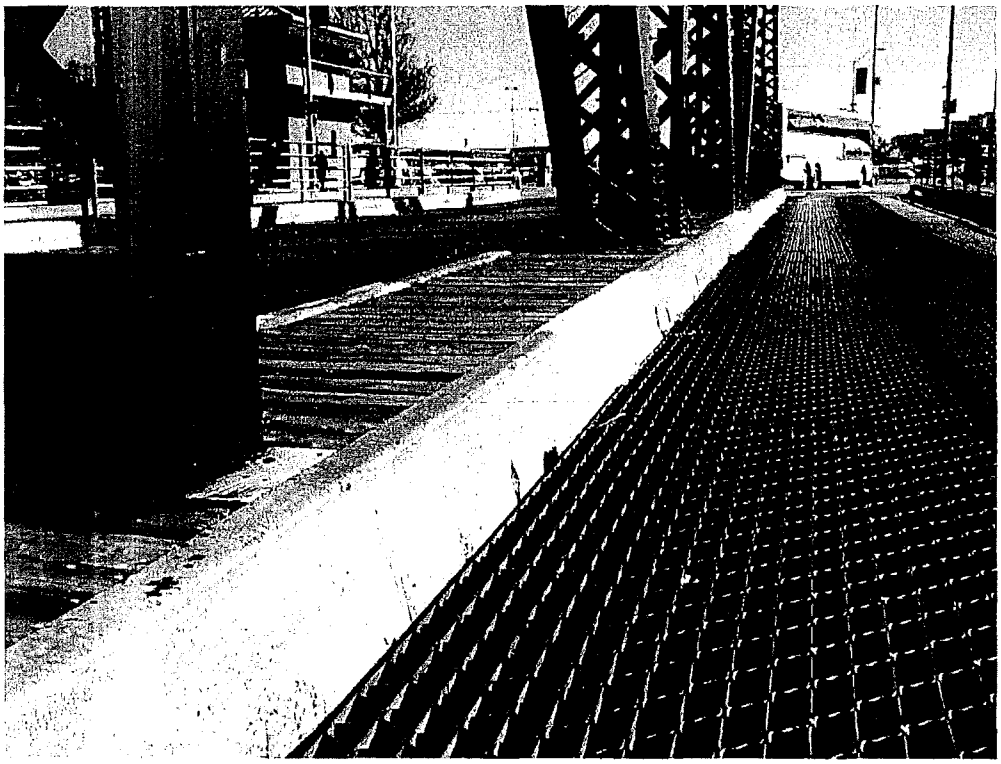
Photo No. 3

Rrepaired spalled curb areas, typical

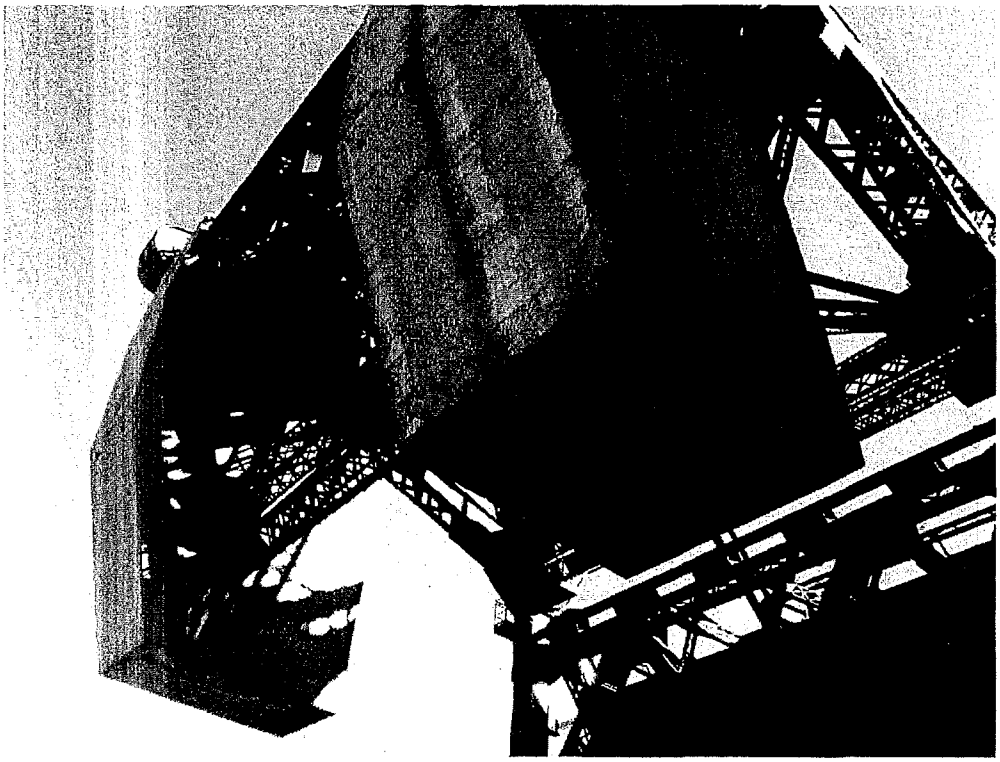
Photo No. 4

The concrete counterweights are cracking with efflorescent staining in areas and have areas with spalls with exposed corroded reinforcement up to 3 square feet in surface size. The cracked and delaminated areas easily spalled off with a light rock hammer. An estimated area of 10% of the surface area of the 2 counterweights is cracked and spalling.

Cracking and spalling on the above ground counterweights, typical

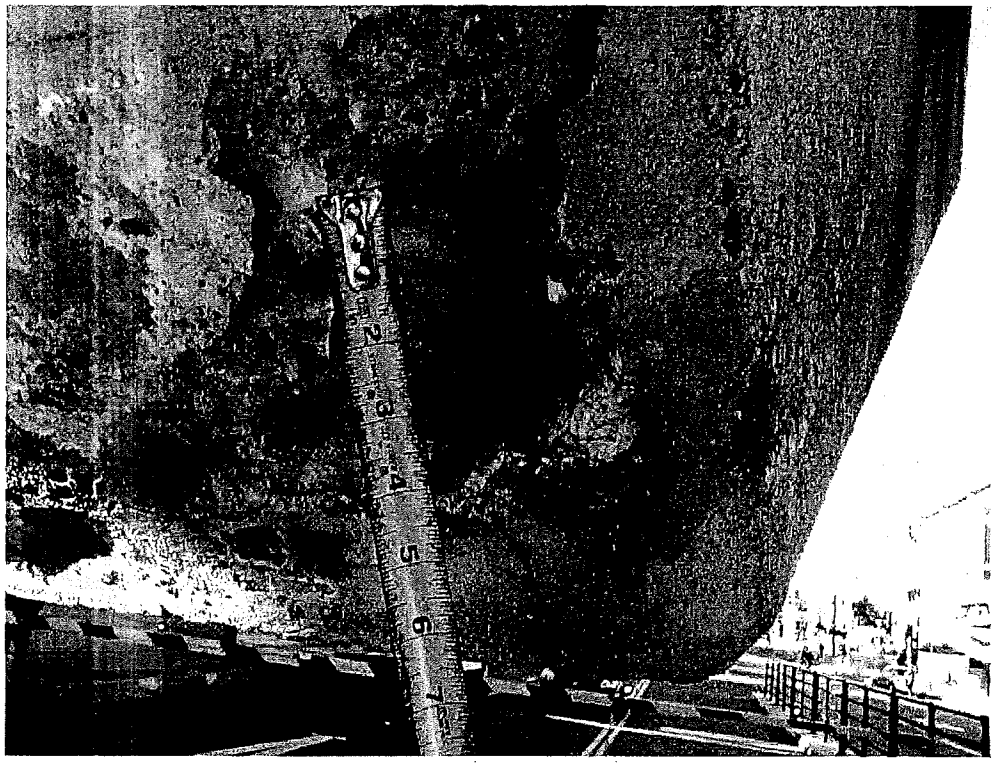
Photo No. 5

Cracking and spalling on the above ground counterweights, typical

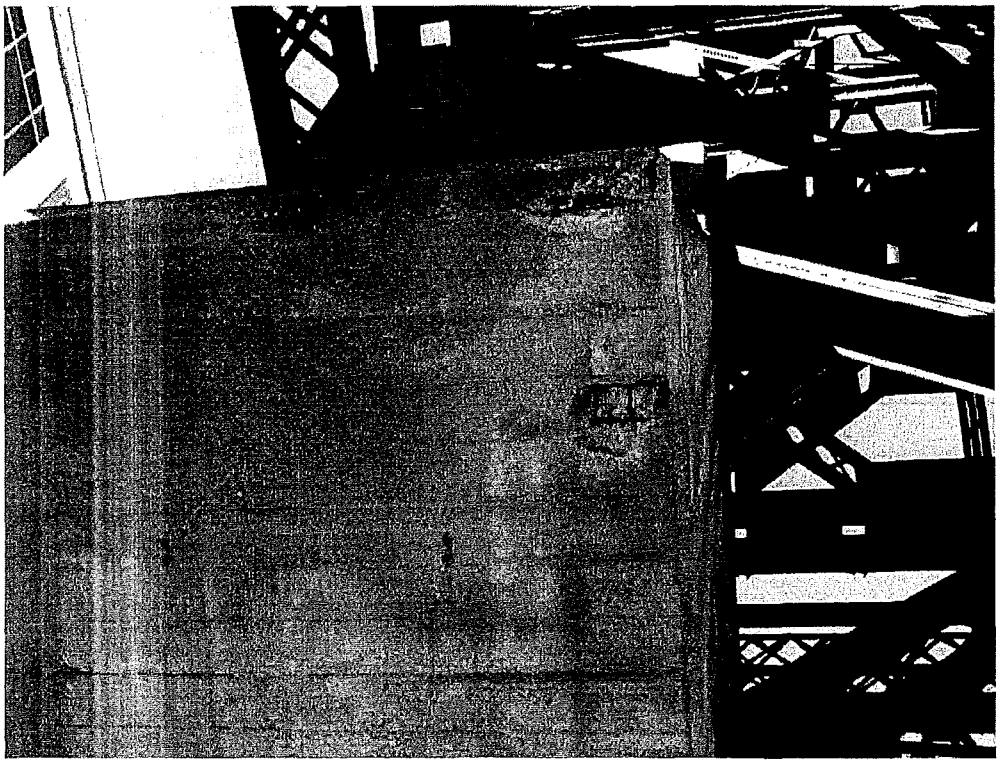
Photo No. 7

Cracking and spalling on the above ground counterweights, typical

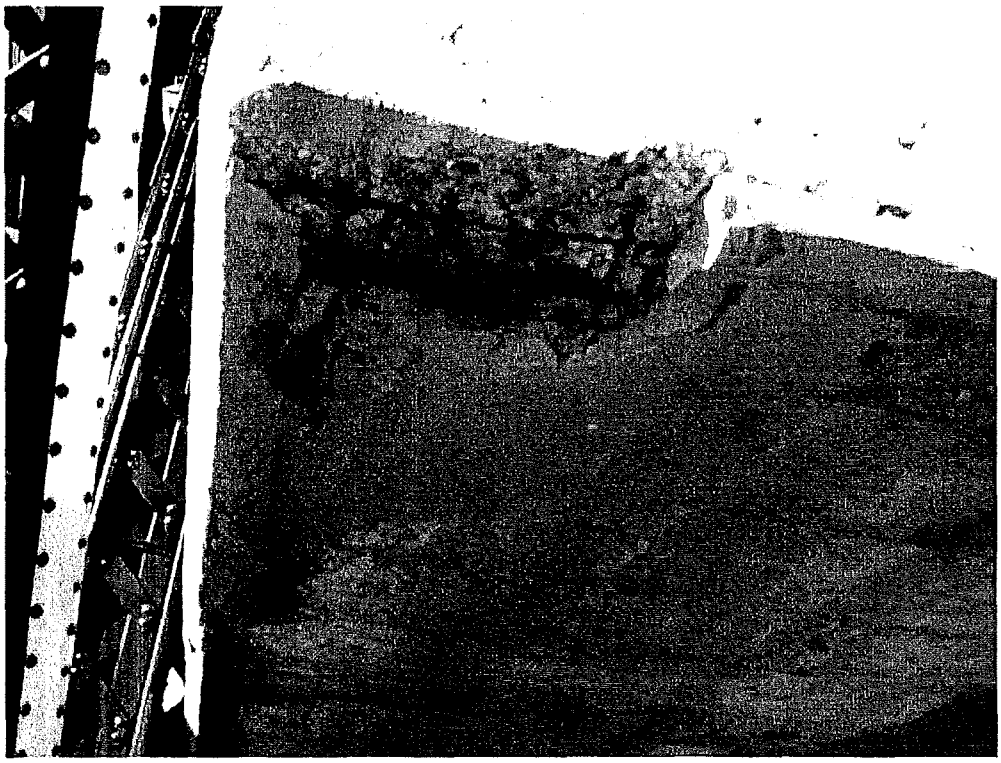
Photo No. 8

Cracking and spalling on the above ground counterweights, typical

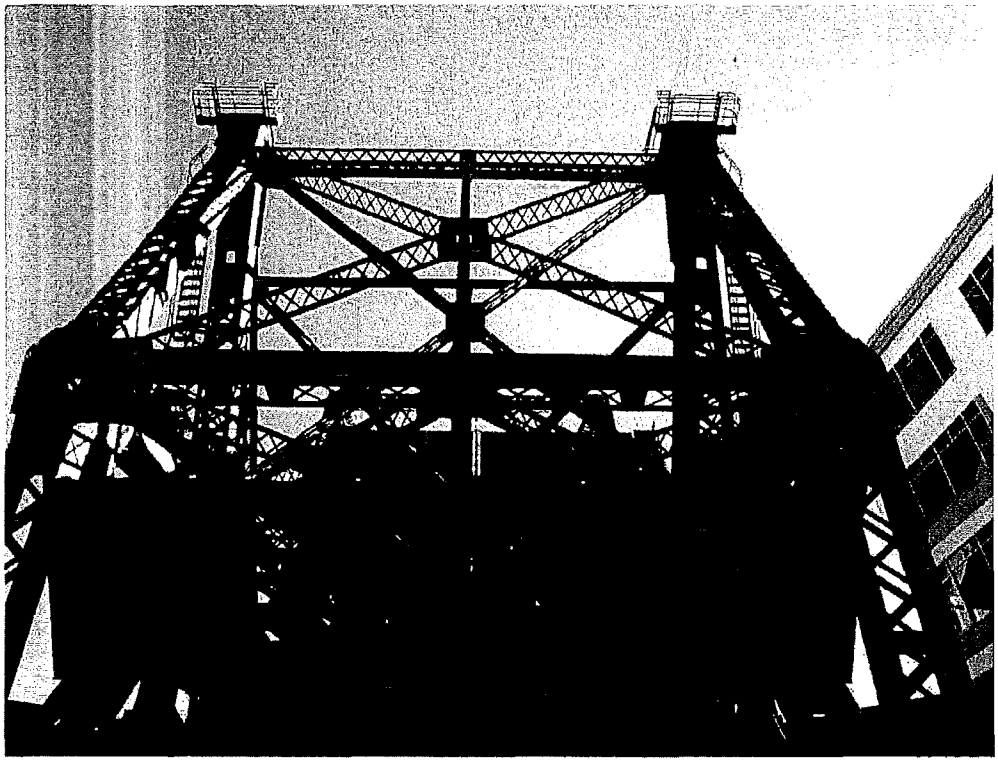
Photo No. 11

The top surface of the trunion portion of the truss is corroding with surface rust and surface pitting. The lift portion of the deck has a vertical offset of ½ of an inch as measured along the centerline of the two way traffic lanes. The underside of the superstructure in the lift span exhibits corrosion, pack rust and general distress along the bottom flanges of the bottom cord of the truss, the floor beams and the girders. The end bearing area of the bottom cord of the lift span along the left bay side has significant corrosion and pack rust for an area approximately 5 square yards at pier 3. There is a loss of section for an estimated area at 4 square feet along the built up bottom flange of the bottom cord of the truss along the bay side at this location.

Top corroding surface of the counterweight trunion portion of the truss, typical

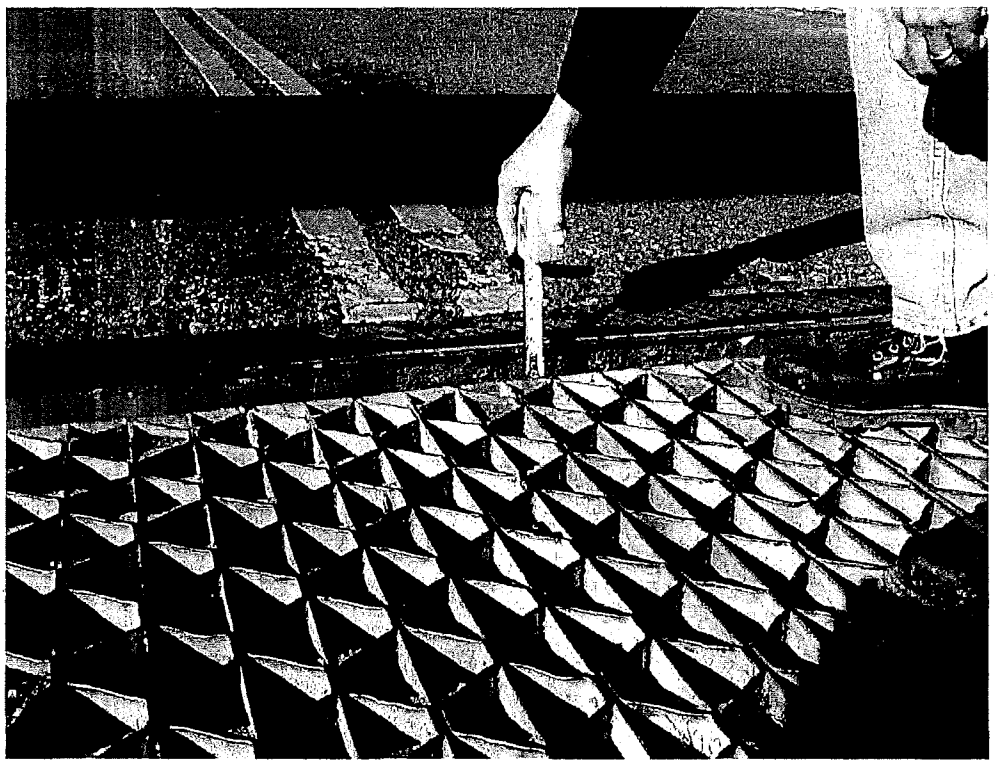
Photo No. 13

Vertical offset at Pier 2

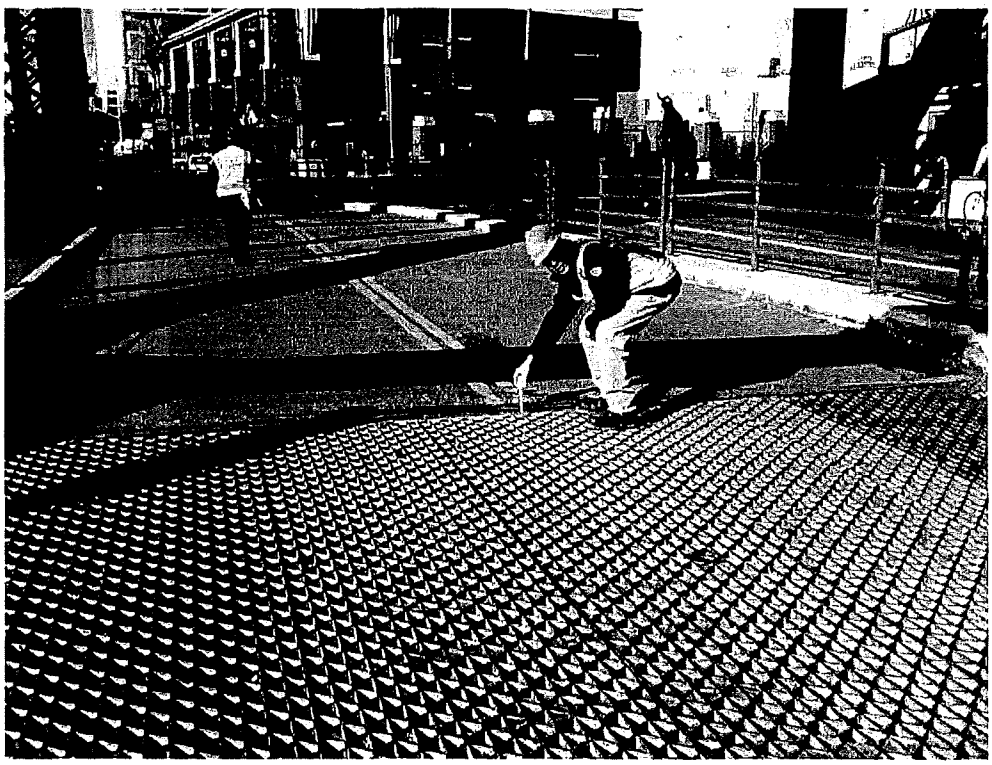
Photo No. 14

Vertical offset at Pier 2

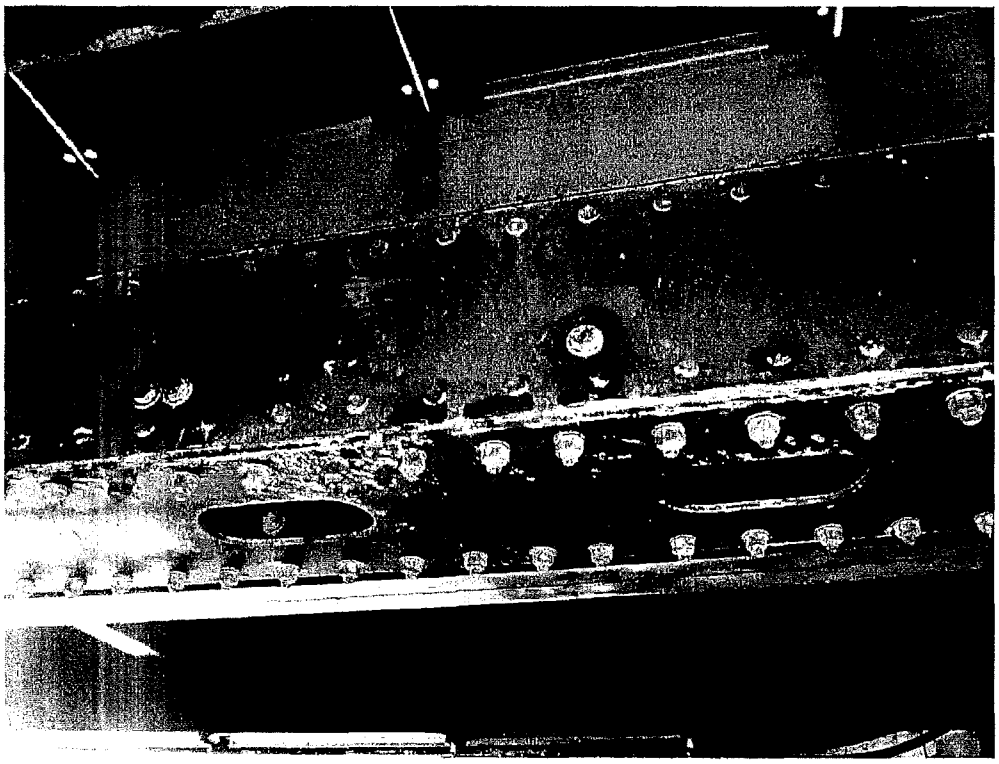
Photo No. 16

General distress to the underside of the superstructure lift span, typical

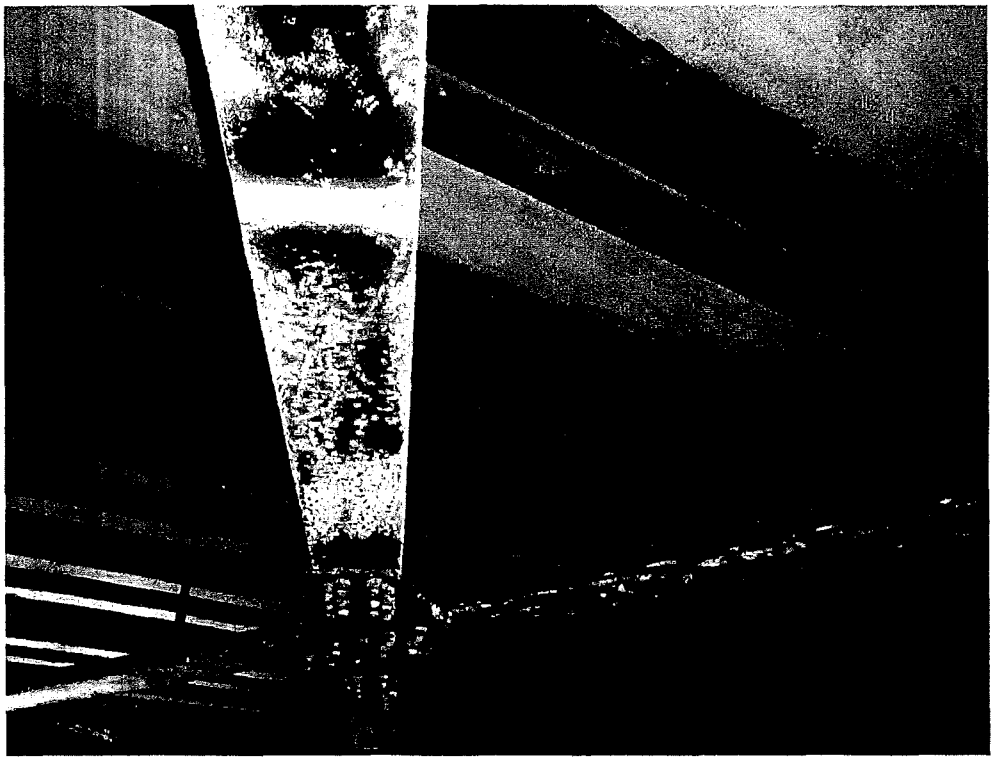
Photo No. 18

General distress to the underside of the superstructure lift span, typical

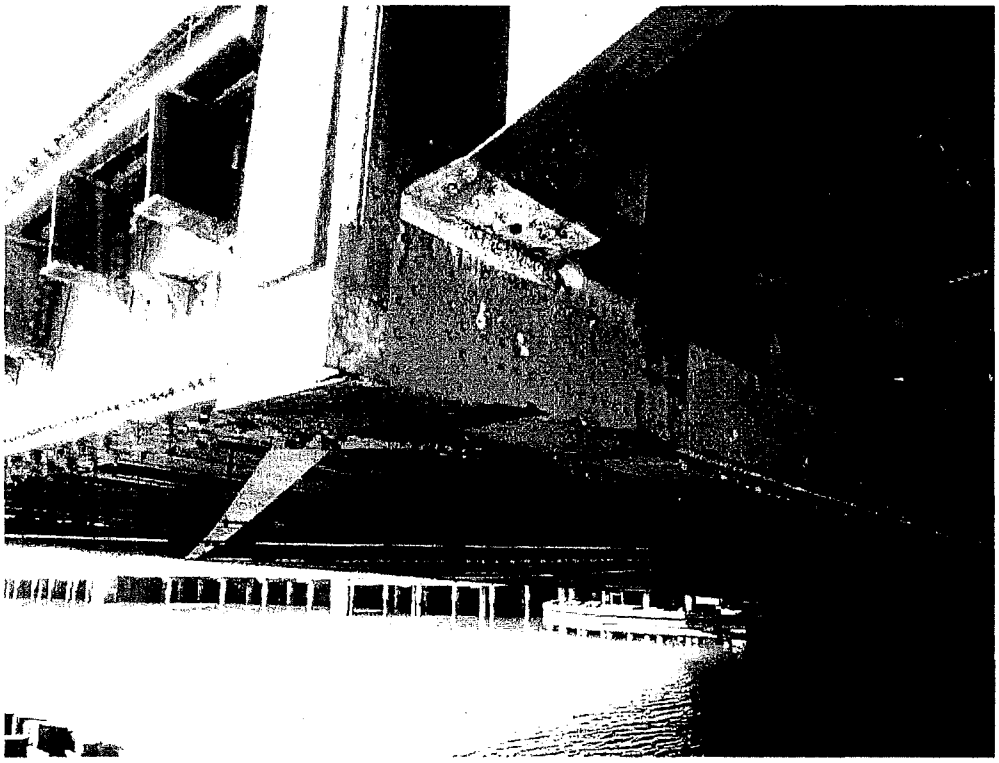
Photo No. 20

Distress and deterioration to the left bottom flange at Pier 3

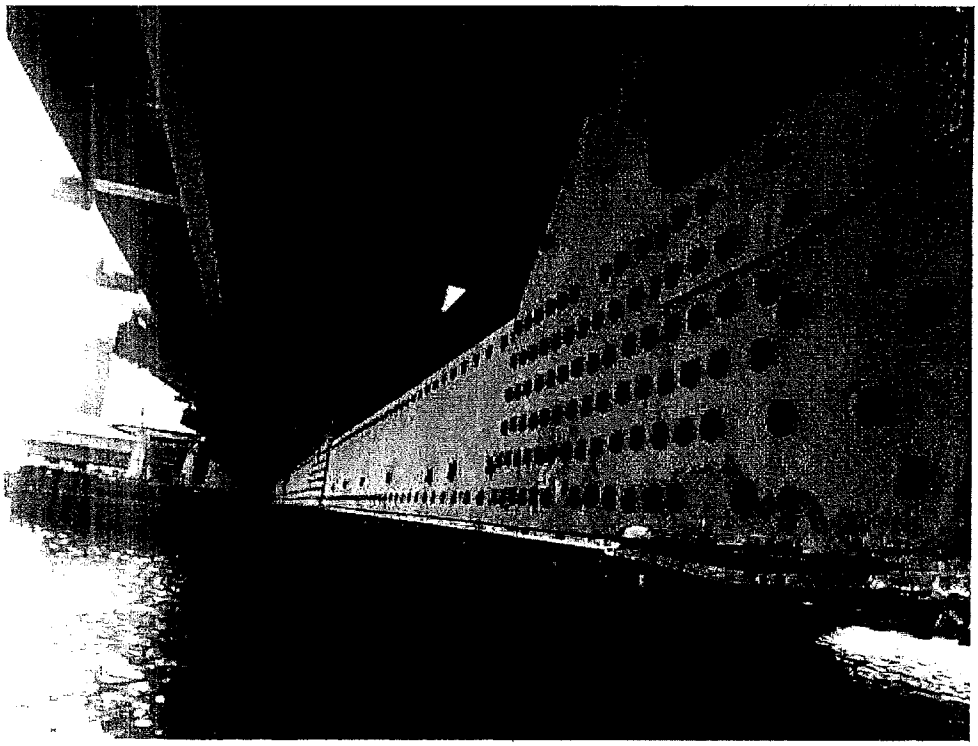
**Photo No. 2**

**Photo 2 (Batch 27675) Pack rust on the right bottom chord**
