# 530 JACKSON STREET FOCUSED HISTORIC STRUCTURE REPORT

SAN FRANCISCO, CALIFORNIA  
[24394]

PREPARED FOR  
Brick & Timber

May 1, 2025  
(Revised September 17, 2025)

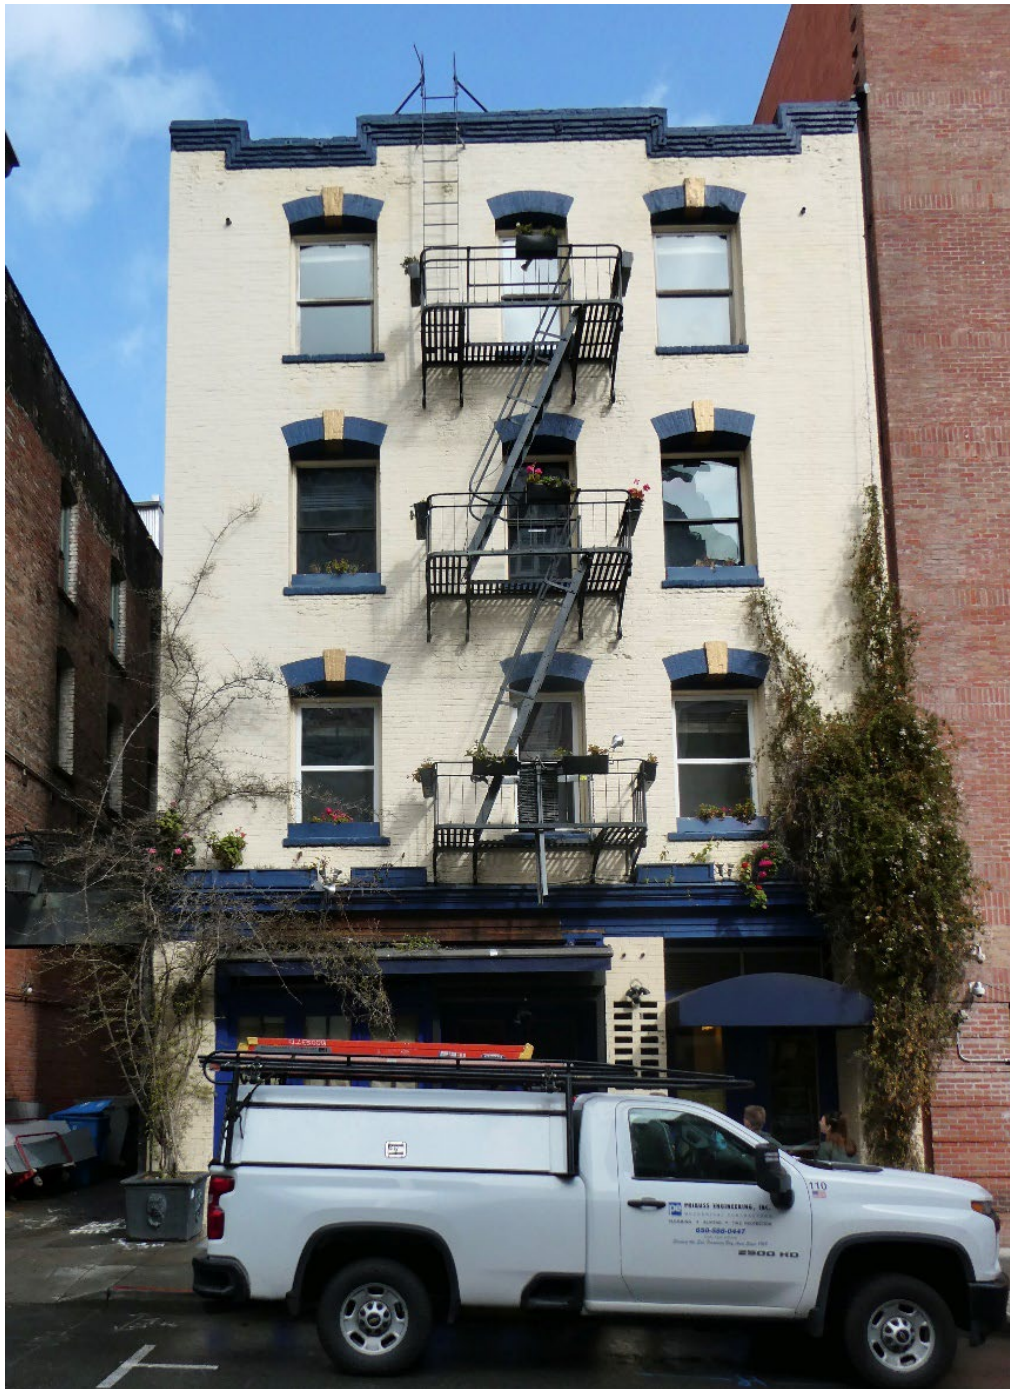
Figure 20: Overall view of the Jackson Street (south) façade, facing north.

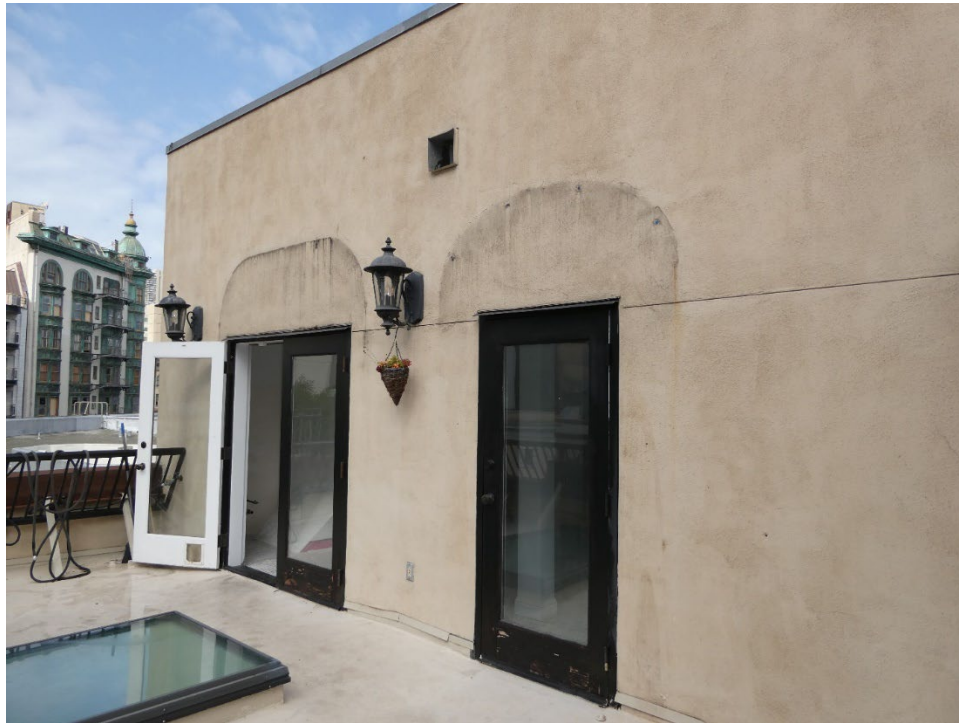
The stucco on the south façade of the set-back vertical addition is in good condition. There is one diagonal crack in the stucco originating from the corner of the east door (**Figure 28**). There is atmospheric staining around the two doors where awnings were once extant. The glazed doors exhibit paint loss and wood checking at the bottom rail, and the hinges and hardware have surface corrosion. (**Figure 29**). An open gap between the perimeter of the door frame and the adjacent stucco could allow water intrusion (**Figure 30**).

Figure 27: Overall view of south (vertical addition façade).

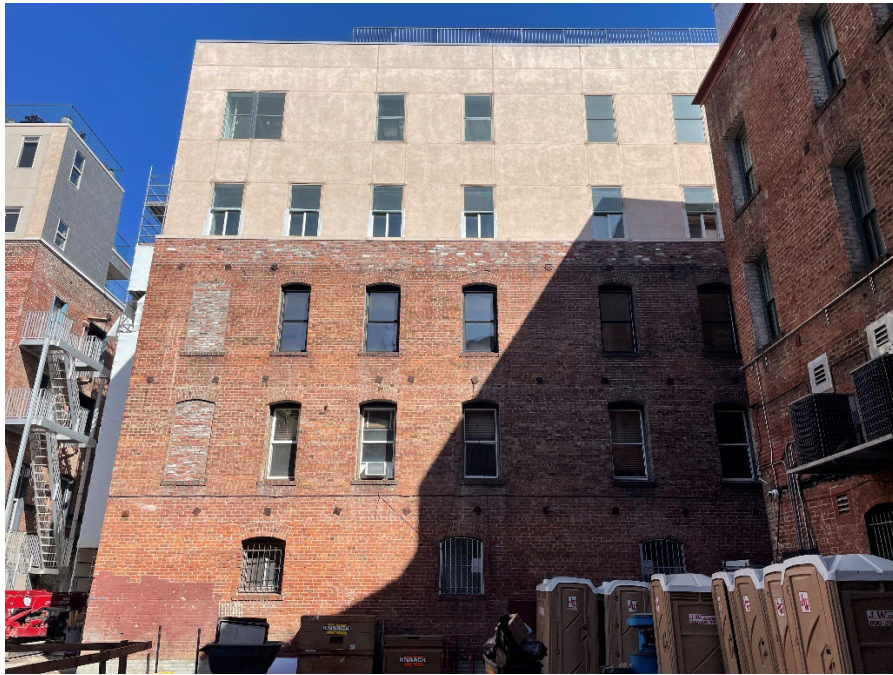
There are several types of windows at the west façade including wood, aluminum, vinyl, and steel. At the first floor, some original windows appear to be intact, including their wood frames and wood sash. These windows are obstructed by steel security grilles at the exterior, and a couple are covered at the interior. The windows at the second and third floors appear to have original wood frames with replacement vinyl and aluminum windows inserted into the original frames. The wood frames are in fair condition with some paint loss and wood checking at the sills. The non-historic insert windows are generally in fair condition but are incompatible with the historic character of the building (**Figure 36**). The fourth floor windows on the southern original portion have non-historic wood windows inserted into the original wood frames and are in good to fair condition. The windows have some operability issues and are difficult to open and close. They also exhibit some paint loss and wood checking at the sills. All the windows at the fifth floor are fixed steel sash windows with wire glass; some exhibit cracked glass at the steel frame and/or due to the embedded wire. The windows at the stuccoed (rear) portion of the fourth floor are similar to those at the fifth

floor, except they have been modified with the insertion of a vinyl slider window that replaces the fixed lower pane of the steel window. These windows are in poor condition. The slider windows were installed poorly and have a large build-up of sealant, including where they meet the exterior metal coping flashing (see coping description above). Perimeter sealants and waterproofing between the windows and the stucco have also failed, and water intrusion was noted around the interiors at several of these windows (**Figure 35**).

Figure 31: Overall view of west façade.

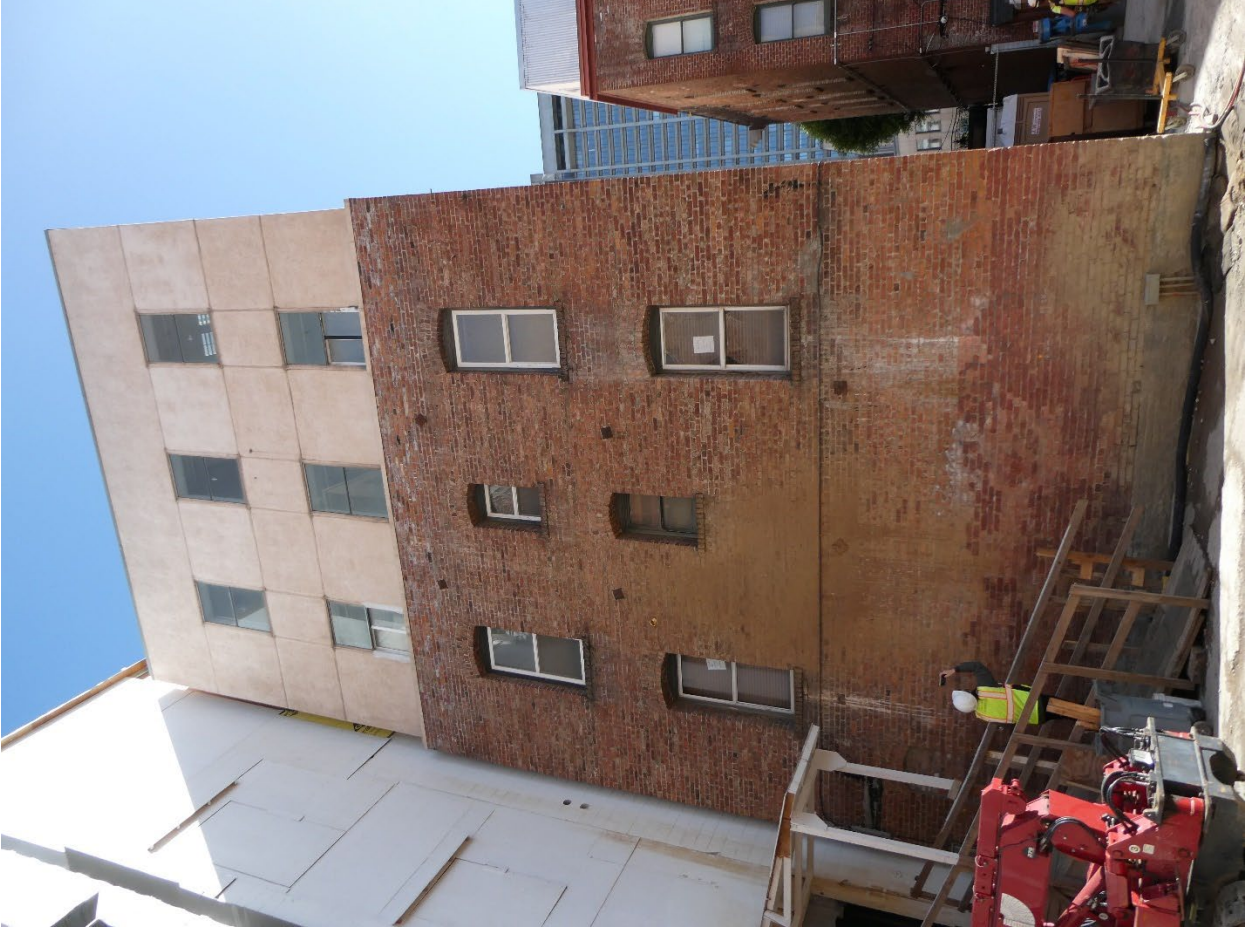
Like the west façade, the north façade consists of the lower original brick masonry portion and the stuccoed vertical addition at the fourth and fifth floors. The brick masonry is in fair overall condition. Generally, there is approximately 15-20% mortar deterioration across the façade. At the first floor, one window has been infilled with brick. The tie rods and pattress plates at this façade are of a similar condition to the tie rods on the west façade, with surface corrosion and some mortar loss around the tie rods. The window sills have a thin tapered cementitious parge coat which has mostly eroded away. Some of the exposed mortar joints at the sills are also eroded or deteriorated, and biological growth was also noted at the sills. There are several areas where the brick has been painted or is soiled. This paint is failing and may be trapping moisture in the masonry. There is poor drainage at this façade, evidenced by standing water abutting the base of the walls. Water is saturating the lower courses of brick. The lower 2 feet of the brick is coated in a painted thin cementitious slurry or parge coat. As with the west façade, the reason for installation of the parge coat is unknown, but it is assumed that it may have been an improper attempt at addressing some moisture infiltration seen at the interior or may be covering some damaged masonry and mortar loss along the ground. At the first few courses above the parge coat, 100% of the joints exhibit mortar loss (**Figure 38**). The stucco at the addition is in fair condition with some atmospheric staining, but the expansion/sealant joints appear to have failed in some locations and have reached the end of their useful life. The coping at the transition between the original masonry parapet and the stucco addition above has several areas of sealant smeared at the top face where it connects to the windows and adjacent stucco.

The windows at this façade include vinyl, wood, and steel. One window at the second floor of the lower brick masonry portion has an original wood frame with its original wood double hung sash. This window appears to be in fair condition with some paint loss, minor wood checking at the bottom rail of the sash, and glazing putty loss (**Figure 39**). The remaining windows at the second and third floors appear to have original wood frames with replacement vinyl and aluminum windows inserted into the original frames. The wood frames are in fair condition with some paint loss and wood checking. The non-historic insert windows are generally in fair condition but are incompatible with the historic character of the building. All the windows at the fifth floor are fixed steel sash windows with wire glass; some exhibit cracked glass at the steel frame and/or due to the embedded wire. The windows at the fourth floor are similar to those at the fifth floor, except they have been modified with the insertion of a vinyl slider window that replaces the fixed lower pane of the steel window. These windows are in poor condition. The slider windows were installed poorly and have a large build-up of sealant, including where they meet the exterior metal coping flashing (see coping description above). Perimeter sealants and waterproofing between the windows and the stucco have also failed, and water intrusion was noted around the interiors at some of these windows (**Figure 40**).

Figure 37: Overall view of the north façade.

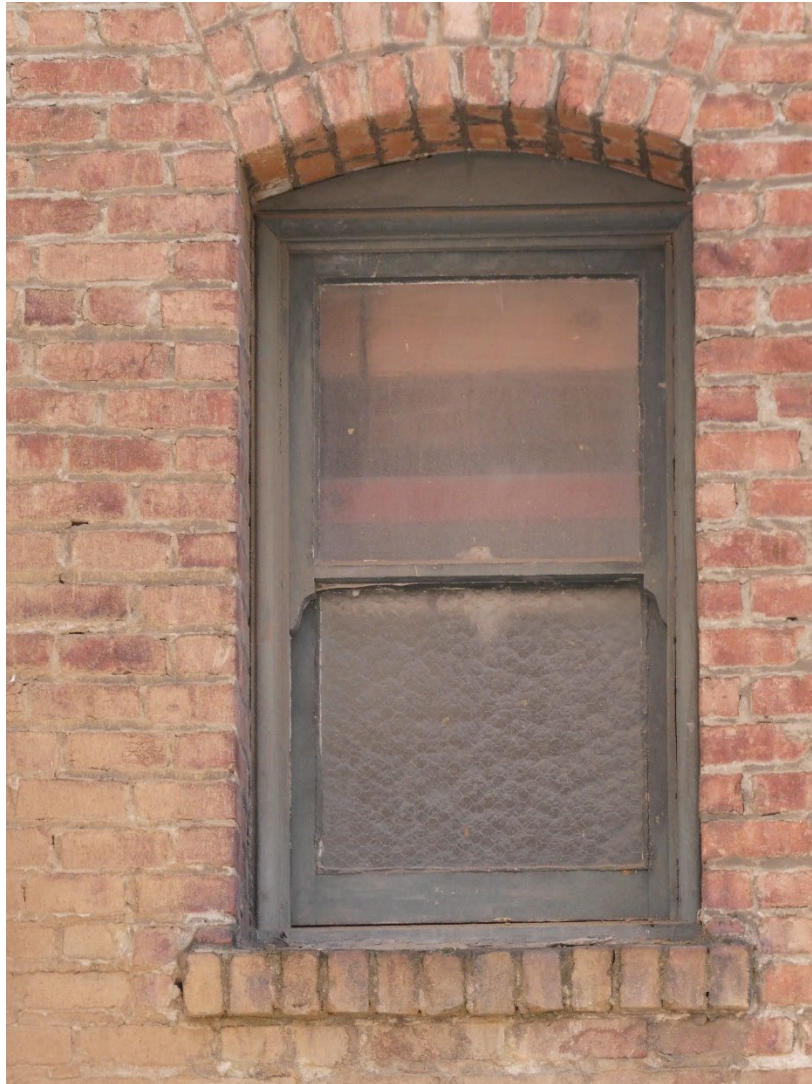
Figure 40: Original double-hung wood sash window at the second floor, north façade.

| <p>Description of work:</p> <p>Retain and repair historic wood window sashes and frames. Inspect and repair as needed. Repair wood by patching wood checking and deterioration on the frame, sash, and window sills. Replace glazing putty as needed. Properly prepare, prime, and paint the frame, sash, and sill. Restore operability of the sash and latches. Paint exterior security grilles on the first floor with rust inhibitive paint. There is an approved permit for replacement of three exterior windows with new rated windows.</p> <p>At the masonry portion, replace historically incompatible vinyl and aluminum windows at the second and third floors, and replace with historically compatible double-hung wood sash windows. Retain and repair the existing historic wood frames and sills, where extant. Repair wood frames and sills by patching wood checking and deterioration with an appropriate wood patching compound. Prepare, prime, and paint. There is an approved permit for replacement of three exterior windows with new rated windows.</p> | |

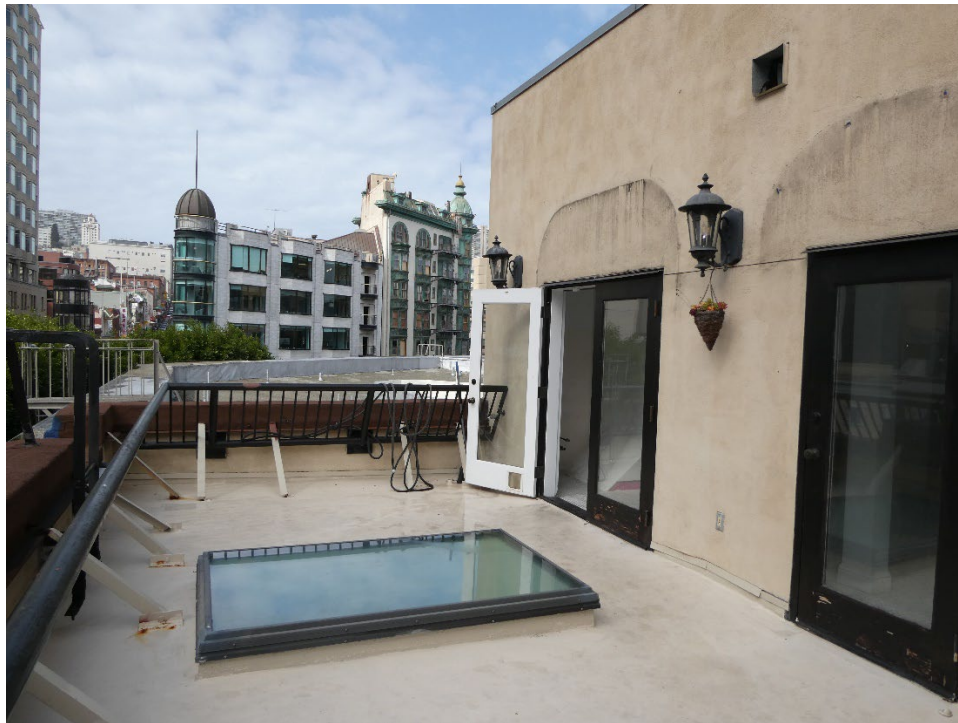
The fifth floor balcony on the south end of the building is in fair overall condition. At the south and west parapet walls, the asphalt sheet flashing exhibits puckered areas at a couple lap seams and may begin to allow water intrusion through to the masonry below (**Figure 42**). At the east parapet wall, the seismic expansion joint cover and associated metal flashing has surface corrosion and some denting (**Figure 43**). No issues were visually noted at the flexible rubber bumper. The steel parapet bracing and railing have minor surface corrosion and paint loss. The roof membrane on the balcony is in fair condition, as it exhibits a few cracks in the membrane (**Figure 44**). Build-up and debris were noted at the roof drains, and no drain covers were noted. There is no guard rail surrounding the skylight, which is a falling hazard (**Figure 45**).

Figure 41: Overall view of the fifth floor balcony.

| <p>Description of work:</p> <p>Inspect the balcony roofing and ensure there is no water intrusion into the interior. Recoat and patch the membrane roofing at the balcony. Remove the asphaltic coping at the south and west parapet walls and replace with G90 heavy galvanized or non-corroding metal coping and paint with a rust inhibitive paint. Install drain covers at the two roof drains at the north corners. Remove the corrosion from the seismic parapet bracing and metal parapet coping at the expansion joint cover (the expansion joint cover extends along the full east wall at the fifth floor balcony and the upper roof). Paint both with a rust-inhibitive paint to protect from future corrosion.</p> | |

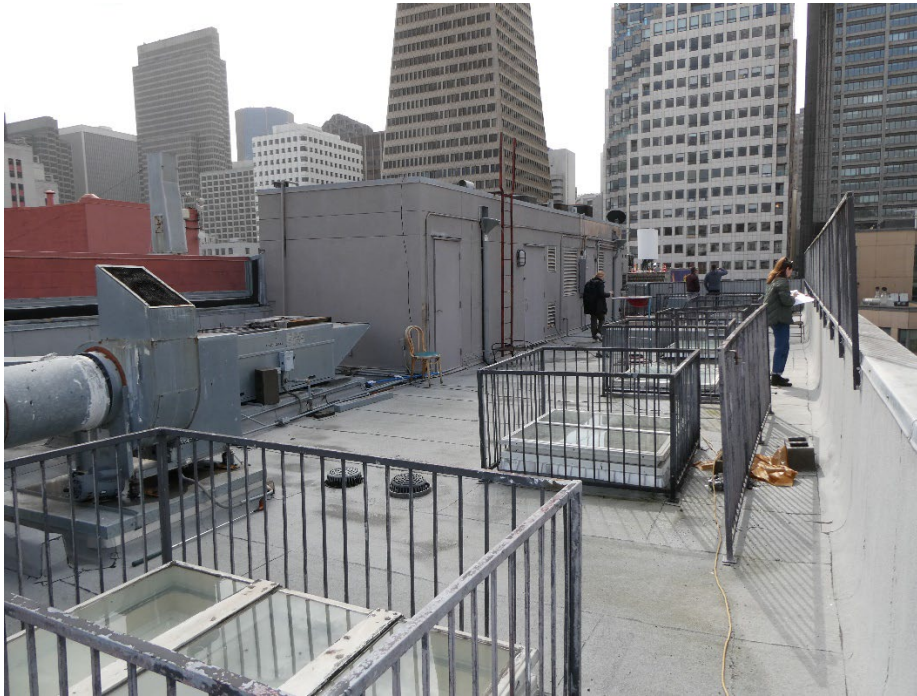
The penthouse stucco is in good condition. The stucco has been painted grey at one end, exhibiting two different paint campaigns. The hollow metal frame and door into the exhibits some surface corrosion but is in fair condition. The rubber threshold should be replaced. The ladder to the penthouse roof has paint loss and moderate superficial corrosion. Rusted fasteners were noted at the connection point between the ladder and the metal coping (**Figure 51**). The penthouse roof is covered with liquid applied asphaltic roofing and gravel that appears to be in fair condition. The exposed asphalt at upturns is cracking and alligatoring (**Figure 52**). No water intrusion was noted at the interior of the penthouse. The metal coping at the perimeter of the penthouse parapet appears to be in fair condition with minor corrosion and separation at some of the soldered seams (**Figure 53**).

Figure 46: Overall view of main roof, penthouse to center left.

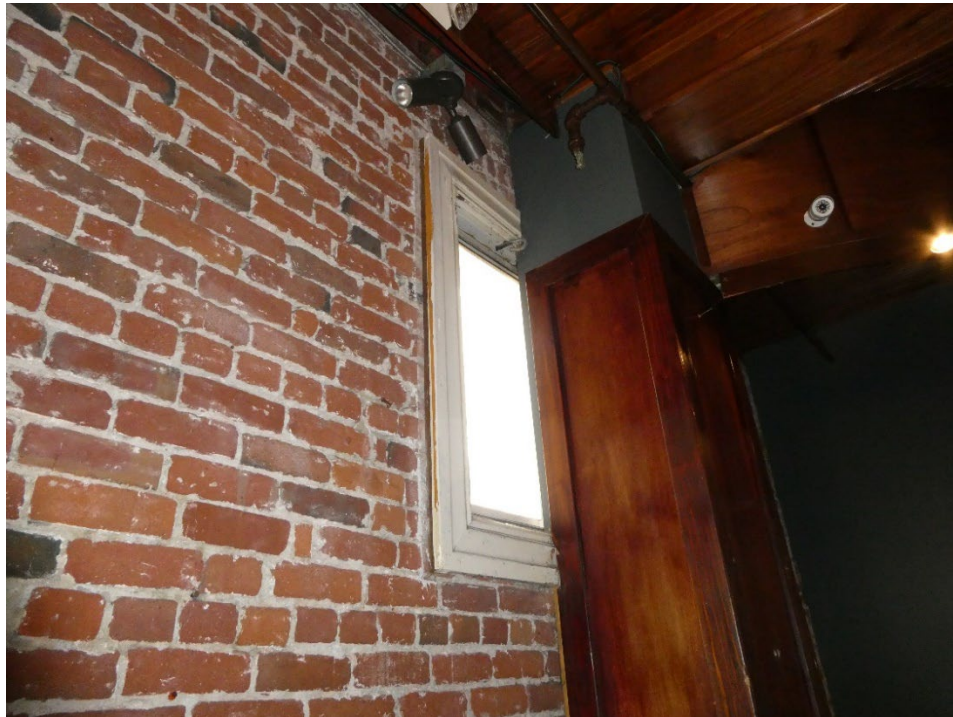
The wood flooring is not original and dates to a 1997 renovation. The flooring is generally in fair condition with some gouges, splitting, gaps, and dirt build up. A few areas appear to have patches or replacement wood. The original columns on the first floor are concealed by various types of cladding depending on the location, and the condition of the concealed columns was not accessible for observation (**Figure 61**). The windows appear to retain their original wood trim and frames (**Figure 62**).

Figure 62: Historic window frame and trim with inserted non-historic window, first floor, west wall.

| <p>Description of work:</p> <p>Retain and repair historic wood window sashes and frames at the first floor. Inspect and repair as needed. Repair wood by patching wood checking and deterioration on the frame, sash, and window sills. Replace glazing putty as needed. Properly prepare, prime, and paint the frame, sash, and sill. Restore operability of the sash and latches. Paint exterior security grilles on the first floor with rust inhibitive paint. There is an approved permit for replacement of three exterior windows with new rated windows.</p> <p>At the masonry portion, replace historically incompatible vinyl and aluminum windows at the first, second, and third floors; replace with historically compatible double-hung wood sash windows at the first and second floors and with window sash that match the original sash at the first floor. Replace non-historic wood windows inserted into original wood frames at the fourth floor with compatible double-hung wood sash windows. Retain and repair the existing historic wood frames and sills, where extant. Repair wood frames and sills by patching wood checking and deterioration with an appropriate wood patching compound. Prepare, prime, and paint. There is an approved permit for replacement of three exterior windows with new rated windows.</p> | |

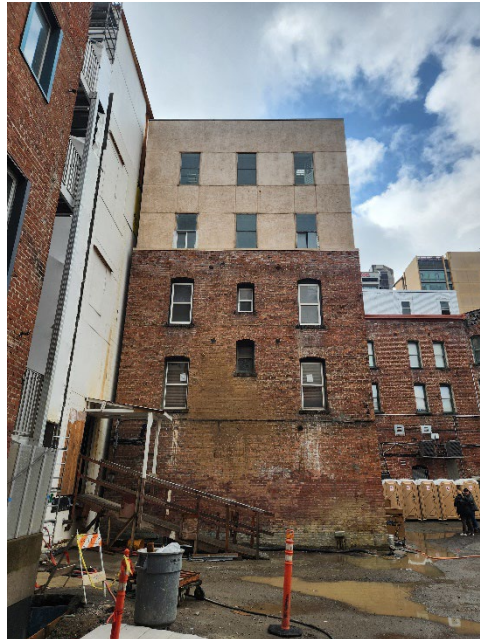
Image 3: View of 530 Jackson Street, north façade looking south. Historic masonry structure visible at floors one through three with stucco-clad metal stud structure at the fourth and fifth floors. (Photo taken by P&T 03/14/2025)

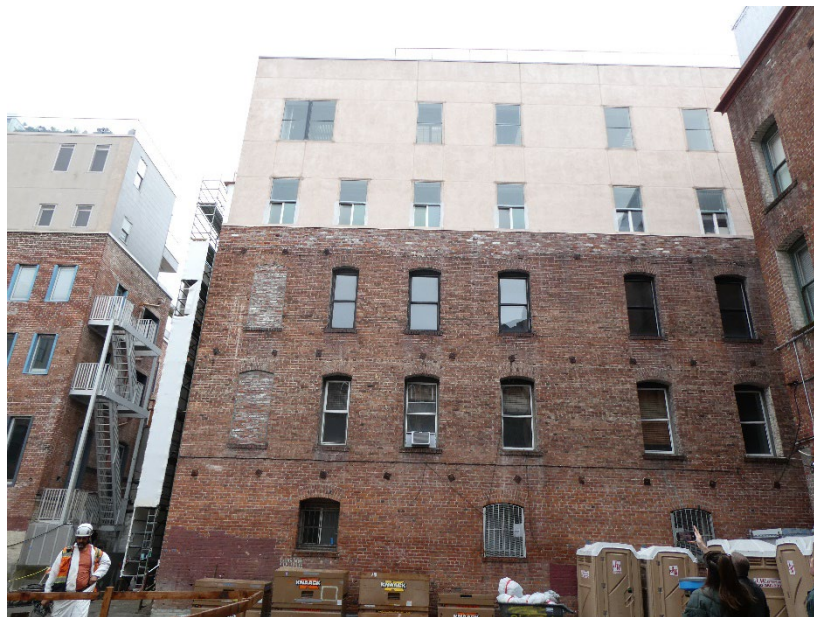
Image 4: View of 530 Jackson Street, west façade looking east. Historic masonry structure visible at floors one through three with stucco-clad metal stud structure at the fourth and fifth floors. (Photo taken by P&T 03/14/2025)

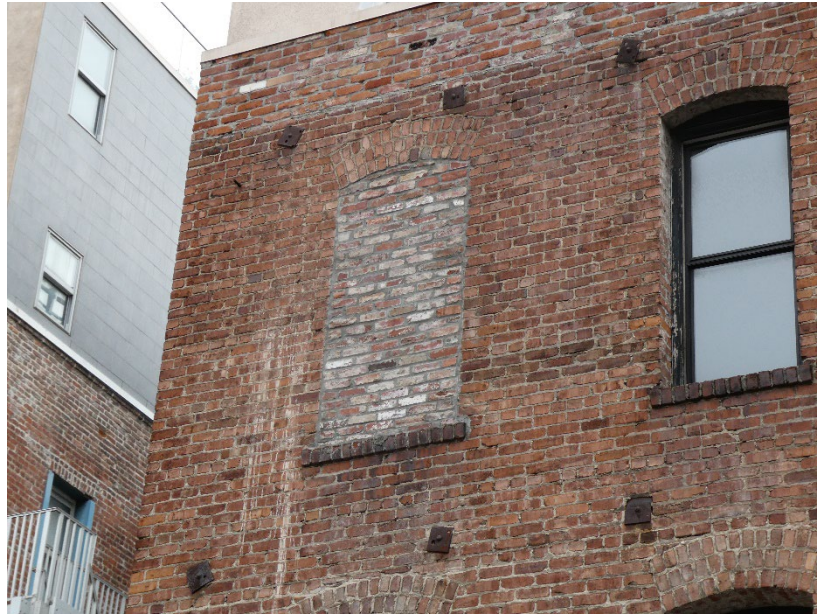
Image 13: Northwest exterior corner, looking east. Typical brick infill at historic masonry opening, third floor.  
(Photo taken by P&T 03/14/2025)

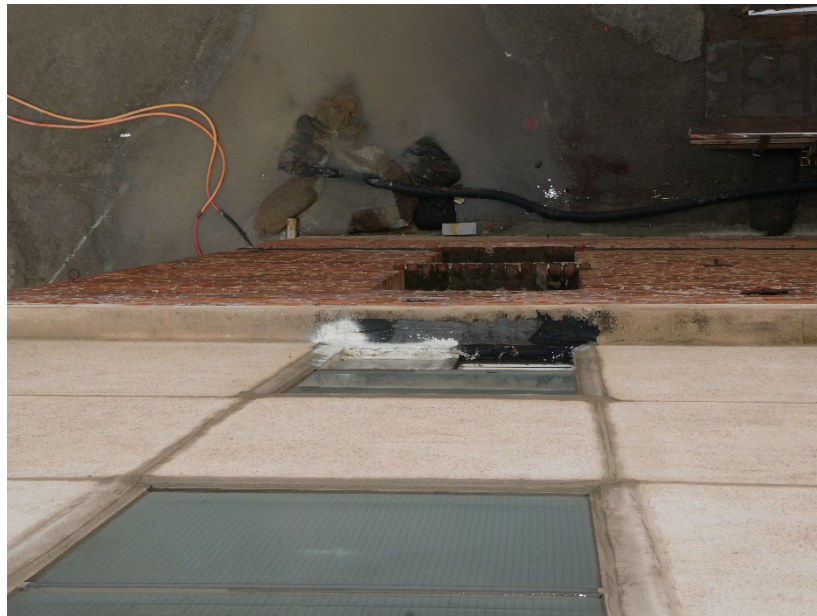
Image 14: North facade, looking down from roof. Flashing at horizontal junction between metal framed addition and historic masonry structure. (Photo taken by P&T 03/14/2025)

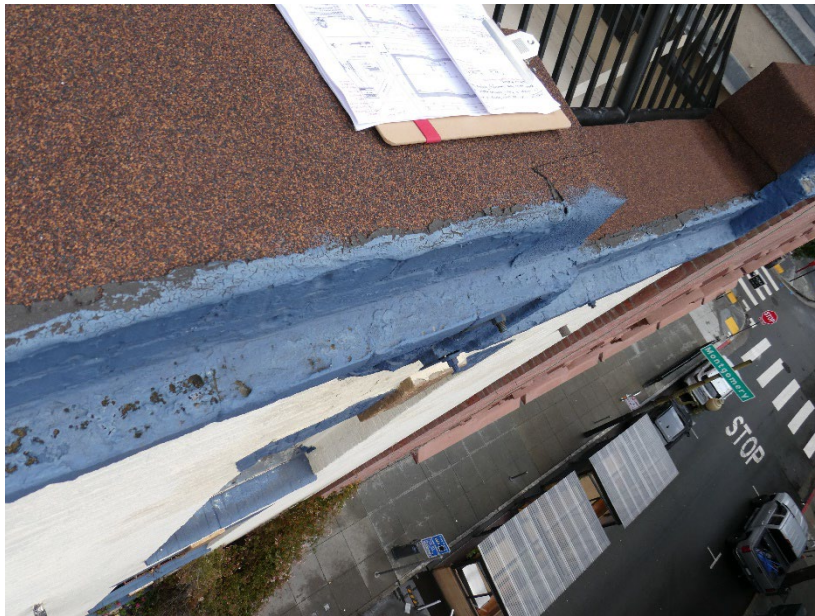
Image 18: Asphaltic roof flashing at masonry parapet, fifth floor balcony, looking down, east. (Photo taken by P&T 03/14/2025)

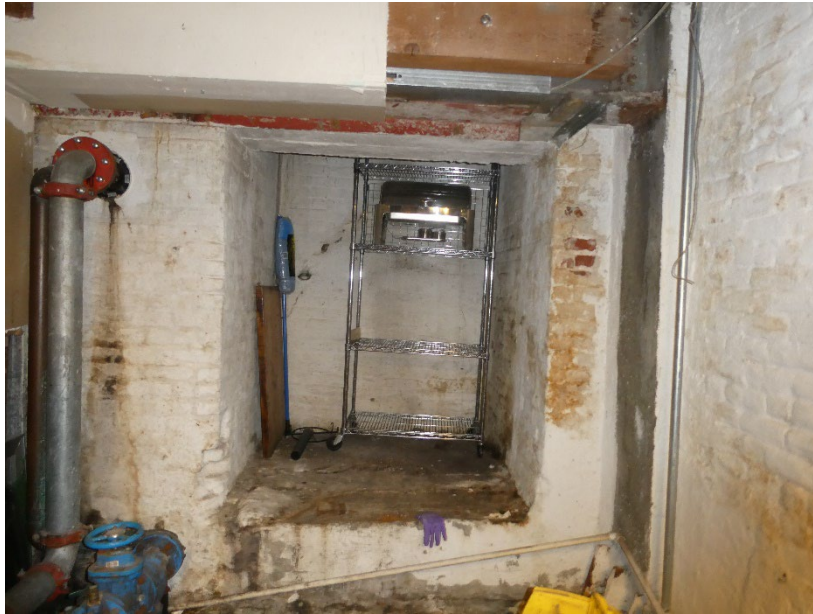
Image 28: View of typical area of water intrusion at west foundation wall, basement floor. (Photo taken by P&T 03/14/2025)

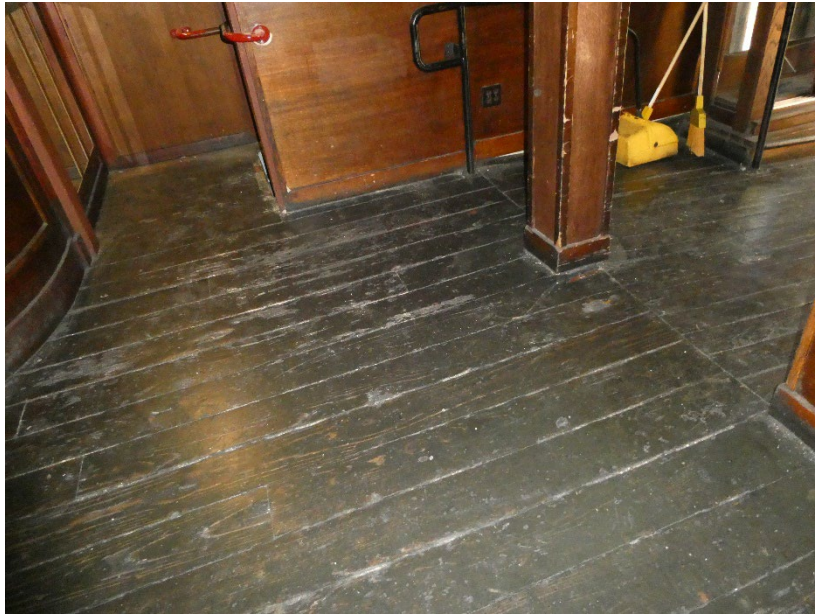
Image 34: View of wood frame deterioration at first floor, west wall. (Photo taken by P&T 03/14/2025)
