530 JACKSON STREET FOCUSED HISTORIC STRUCTURE REPORT

SAN FRANCISCO, CALIFORNIA [24394]

PREPARED FOR Brick & Timber

May 1, 2025 (Revised September 17, 2025)

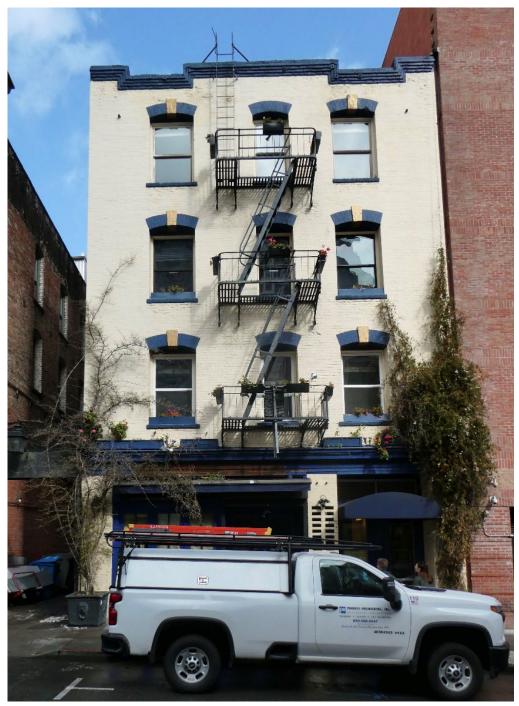
Figure 20: Overall view of the Jackson Street (south) façade, facing north.

The brick masonry on the primary façade is painted and appears to be in good overall condition. Generally, there are some locations with mortar loss, and there are areas of mortar loss and brick erosion/spalling at the parapet below the stepped, crenellated cornice that have been painted over (Figure 21). The erosion and rough texture through the paint may indicate that the wall had been previously sandblasted. Similar areas of erosion occur at various locations across the façade, but are less concentrated than at the parapet. The paint is in good condition. There are two climbing vines flanking the facade at the southwest and southeast corners, which appear to be bougainvillea and jasmine. The plant at the southeast corner appears to be supported by and climbing up a cable rather than the brick itself, and the vines do not appear to be causing damage to the masonry at this time. It is unknown if they hold any moisture in the masonry during the rainy season. The wood midband cornice across the top of the storefront between the first and second floors is in good condition. There is an area of missing paint, exposing bare wood where a former tenant sign once was located (Figure 22). The metal flashing on the mid-band cornice is in fair condition. The metal fire escape, which is original to construction, also appears to be in good condition. Minor surface corrosion and paint loss at the fire escape was noted. The connection points between the fire escape and the masonry appear to be in generally good condition except at the third floor, where one connection point exhibits some mortar, and paint loss (Figure 23). Behind the parapet, the fire escape is no longer anchored to the roof (Figure 24).

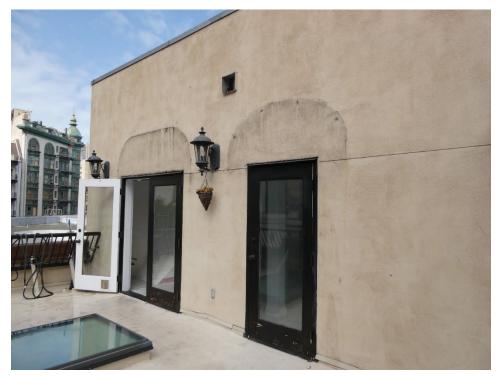
The stucco on the south façade of the set-back vertical addition is in good condition. There is one diagonal crack in the stucco originating from the corner of the east door (Figure 28). There is atmospheric staining around the two doors where awnings were once extant. The glazed doors exhibit paint loss and wood checking at the bottom rail, and the hinges and hardware have surface corrosion. (Figure 29). An open gap between the perimeter of the door frame and the adjacent stucco could allow water intrusion (Figure 30).

Figure 27: Overall view of south (vertical addition façade).

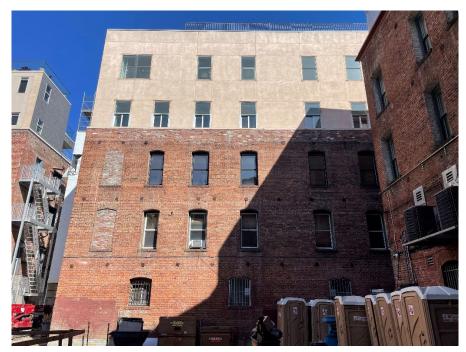
The west façade consists of the lower original brick masonry portion and the stuccoed vertical addition at the rear portion of the fourth floor and all of the fifth floor. The brick masonry is in fair overall condition. Generally, there is approximately 20-30% mortar deterioration across the façade (Figure 32). On the north and south ends, windows have been infilled with brick. Above the first, second, and third floors there are rows of tie rods and pattress plates that align with the interior floor structure. The tie rods and pattress plates have some surface corrosion. No visible rust jacking or spalling of the masonry is occurring, although there is some mortar loss around the tie rods (Figure 33). The window sills have a thin tapered cementitious parge coat which has mostly eroded away. Some of the exposed mortar joints at the sills are also eroded or deteriorated, and biological growth was also noted at the sills. The masonry is painted at the first floor (approximately 9 feet above the ground. The paint is failing in some areas and may be trapping moisture in the masonry. The brick in this area (first floor at the south end of the west wall) appears to have been sandblasted previously. There is a thin cementitious slurry or parge coat at the lower 2 feet of brick masonry along the length of the wall, which is also painted (Figure 34). The reason for installation of the parge coat is unknown, but it is assumed that it may have been an improper attempt at addressing some moisture infiltration seen at the interior or may be covering some damaged masonry and mortar loss along the ground. A couple areas of graffiti were noted, including graffiti that is covered with paint. The stucco at the addition is in fair condition with some atmospheric staining, but the expansion/sealant joints appear to have failed in some locations and have reached the end of their useful life. The coping at the transition between the original masonry parapet and the stucco addition above has several areas of sealant smeared at the top face where it connects to the windows and adjacent stucco. It, in conjunction with the windows along the top of the coping, may be contributing to leaks noted inside the building.

Figure 31: Overall view of west façade.

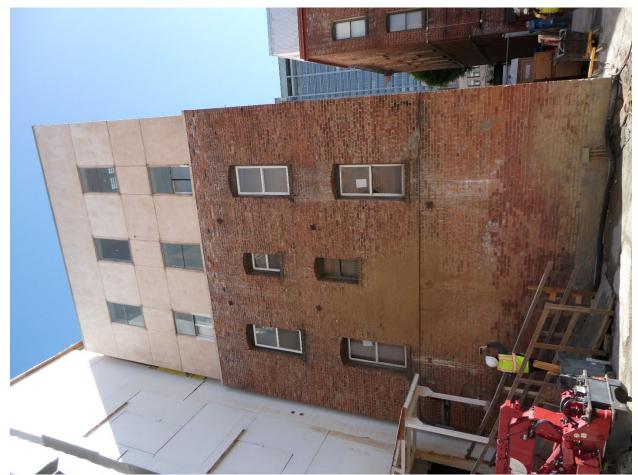
Like the west façade, the north façade consists of the lower original brick masonry portion and the stuccoed vertical addition at the fourth and fifth floors. The brick masonry is in fair overall condition. Generally, there is approximately 15-20% mortar deterioration across the façade. At the first floor, one window has been infilled with brick. The tie rods and pattress plates at this façade are of a similar condition to the tie rods on the west façade, with surface corrosion and some mortar loss around the tie rods. The window sills have a thin tapered cementitious parge coat which has mostly eroded away. Some of the exposed mortar joints at the sills are also eroded or deteriorated, and biological growth was also noted at the sills. There are several areas where the brick has been painted or is soiled. This paint is failing and may be trapping moisture in the masonry. There is poor drainage at this façade, evidenced by standing water abutting the base of the walls. Water is saturating the lower courses of brick. The lower 2 feet of the brick is coated in a painted thin cementitious slurry or parge coat. As with the west façade, the reason for installation of the parge coat is unknown, but it is assumed that it may have been an improper attempt at addressing some moisture infiltration seen at the interior or may be covering some damaged masonry and mortar loss along the ground. At the first few courses above the parge coat, 100% of the joints exhibit mortar loss (Figure 38). The stucco at the addition is in fair condition with some atmospheric staining, but the expansion/sealant joints appear to have failed in some locations and have reached the end of their useful life. The coping at the transition between the original masonry parapet and the stucco addition above has several areas of sealant smeared at the top face where it connects to the windows and adjacent stucco.

Figure 37: Overall view of the north façade.

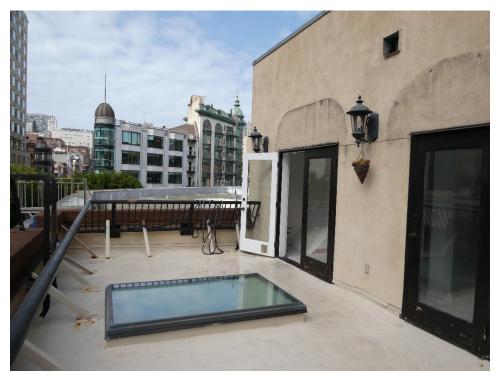
The fifth floor balcony on the south end of the building is in fair overall condition. At the south and west parapet walls, the asphalt sheet flashing exhibits puckered areas at a couple lap seams and may begin to allow water intrusion through to the masonry below (**Figure 42**). At the east parapet wall, the seismic expansion joint cover and associated metal flashing has surface corrosion and some denting (**Figure 43**). No issues were visually noted at the flexible rubber bumper. The steel parapet bracing and railing have minor surface corrosion and paint loss. The roof membrane on the balcony is in fair condition, as it exhibits a few cracks in the membrane (**Figure 44**). Build-up and debris were noted at the roof drains, and no drain covers were noted. There is no guard rail surrounding the skylight, which is a falling hazard (**Figure 45**).

Figure 41: Overall view of the fifth floor balcony.

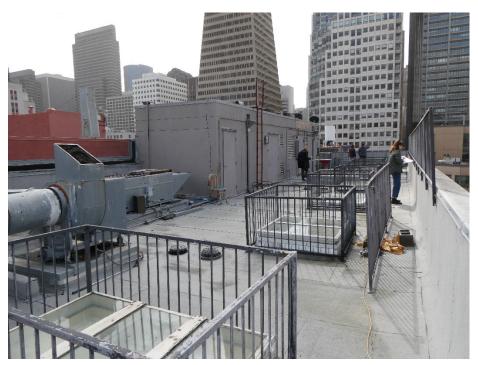
No major deficiencies were noted at the rolled asphalt sheet roofing at the main roof. From the interior of the fifth floor below, there is no visible evidence of water intrusion. The low-slope roof has several areas of negative slope, causing an uneven surface and water ponding after rainfall. Ponding was observed in several different areas (Figure 47). The mechanical equipment and penetrations on the roof have some surface corrosion, but these areas do not appear to be causing water infiltration. The drains on the roof have minor surface corrosion but were observed to be in relatively good condition. However, one drain on the main roof section is missing a drain cover (Figure 48). The guardrails and metal coping at the west, north, and south parapets are in good condition but exhibit minor surface corrosion and paint loss. At the east parapet expansion joint cover, standing water was noted to be causing some corrosion. At the south end of the joint cover, miscellaneous rusted metal pipes are sitting on the expansion joint and are contributing to corrosion staining (Figure 49). No signs of deterioration of the flexible rubber bumper were observed.

Figure 46: Overall view of main roof, penthouse to center left.

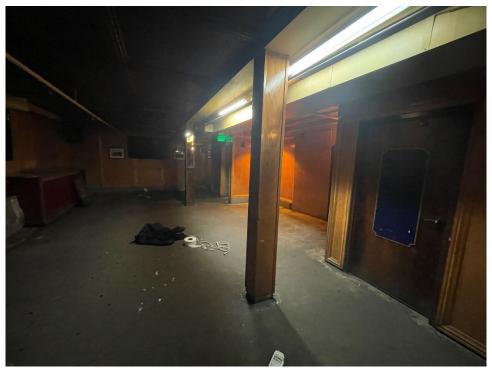
Active water intrusion was noted at various areas of the basement but was primarily noted at the west masonry wall. The water appears to be entering the basement at several locations near the base of the wall, where a concrete curb has been poured, and was observed to be seeping and pooling. The cast iron columns and base plates also have moderate to heavy surface corrosion and soiling (Figure 60). The presence of some trough drains along the west wall indicate that this is not a new issue. Active efflorescence build up, soiling, paint loss, and mortar loss throughout the west wall was noted (Figure 55, Figure 56, Figure 57). Generally, there is mortar loss, paint failure, and heavy soiling build-up on the masonry walls of the basement. An approximately 8 foot long diagonal crack was observed in the south masonry wall located at the sidewalk access hatch (Figure 58, Figure 59).

Figure 54: Overall view of the north end of the basement, looking north.

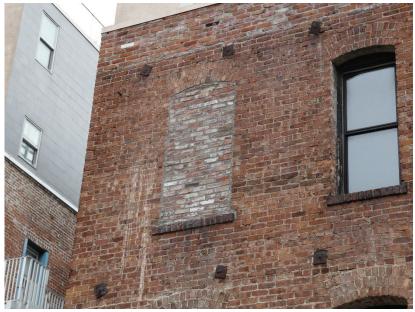
Image 13: Northwest exterior corner, looking east. Typical brick infill at historic masonry opening, third floor. (Photo taken by P&T 03/14/2025)

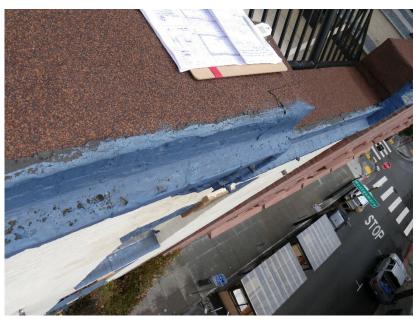
Image 18: Asphaltic roof flashing at masonry parapet, fifth floor balcony, looking down, east. (Photo taken by P&T 03/14/2025)

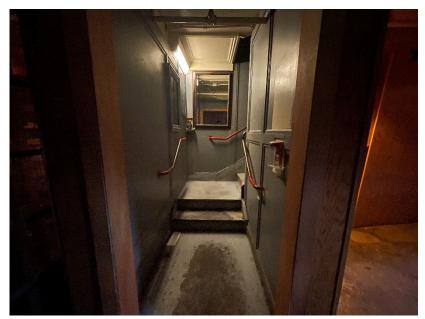
Image 26: View of stairs leading to first floor from basement. (Photo taken by P&T 03/14/2025)

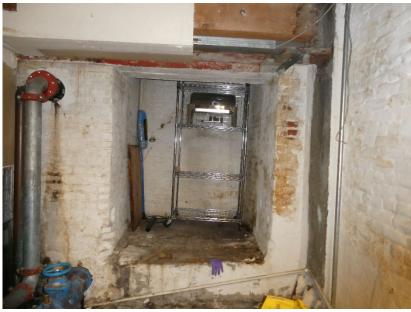
Image 29: View of basement extension under Jackson Street sidewalk, looking south. (Photo taken by P&T 03/14/2025)

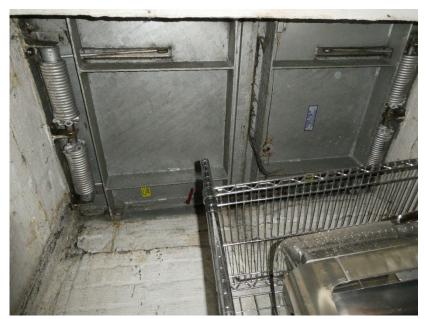
Image 30: View of basement extension under Jackson Street sidewalk, looking up at metal trap doors. (Photo taken by P&T 03/14/2025)

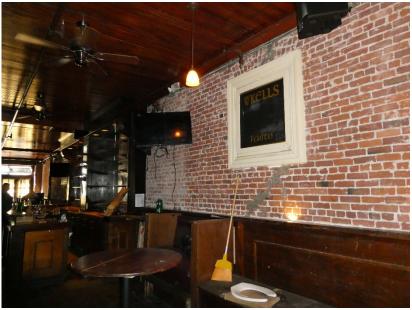
Image 31: View of first floor, looking southwest along west wall. (Photo taken by P&T 03/14/2025)

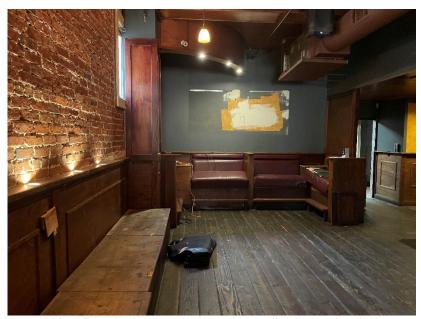
Image 32: View of first floor, looking north along west wall. (Photo taken by P&T 03/14/2025)

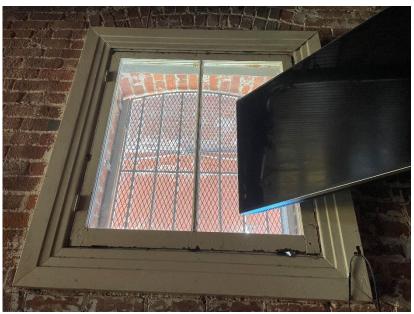
Image 33: View of typical wood casement window at first floor, west wall. (Photo taken by P&T 03/14/2025)

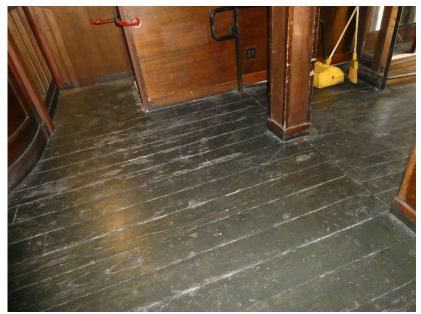
Image 35: Historic wood floors at first floor. (Photo taken by P&T 03/14/2025)

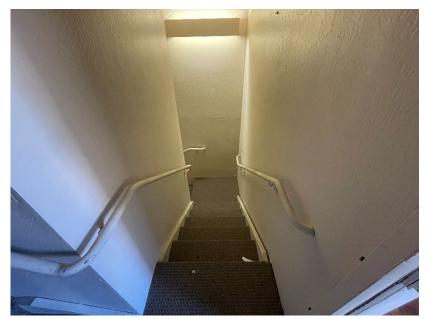
Image 36: Typical non-historic stair well, floors one through roof. (Photo taken by P&T 03/14/2025)

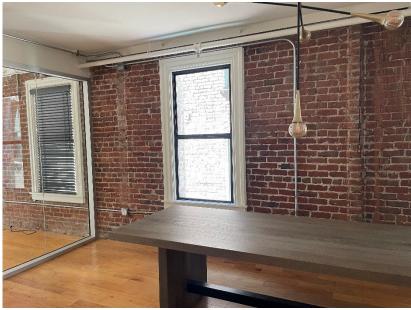
Image 37: Representative wall and window condition at third floor. (Photo taken by P&T 03/14/2025)

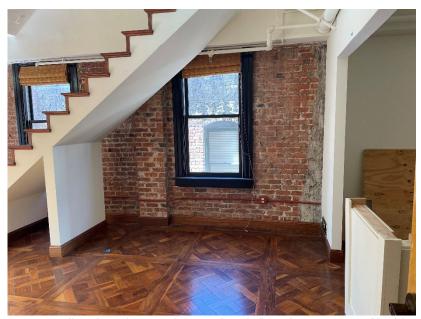
Image 38: Representative wall and window condition at fourth floor, historic area of building. (Photo taken by P&T 03/14/2025)
