**SF X (Mission)  
Substation Outage Event  
December 20, 2025**

**Direct Cause Evaluation**

*Prepared for:*

Pacific Gas and Electric Company  
300 Lakeside Drive  
Oakland, California 94612

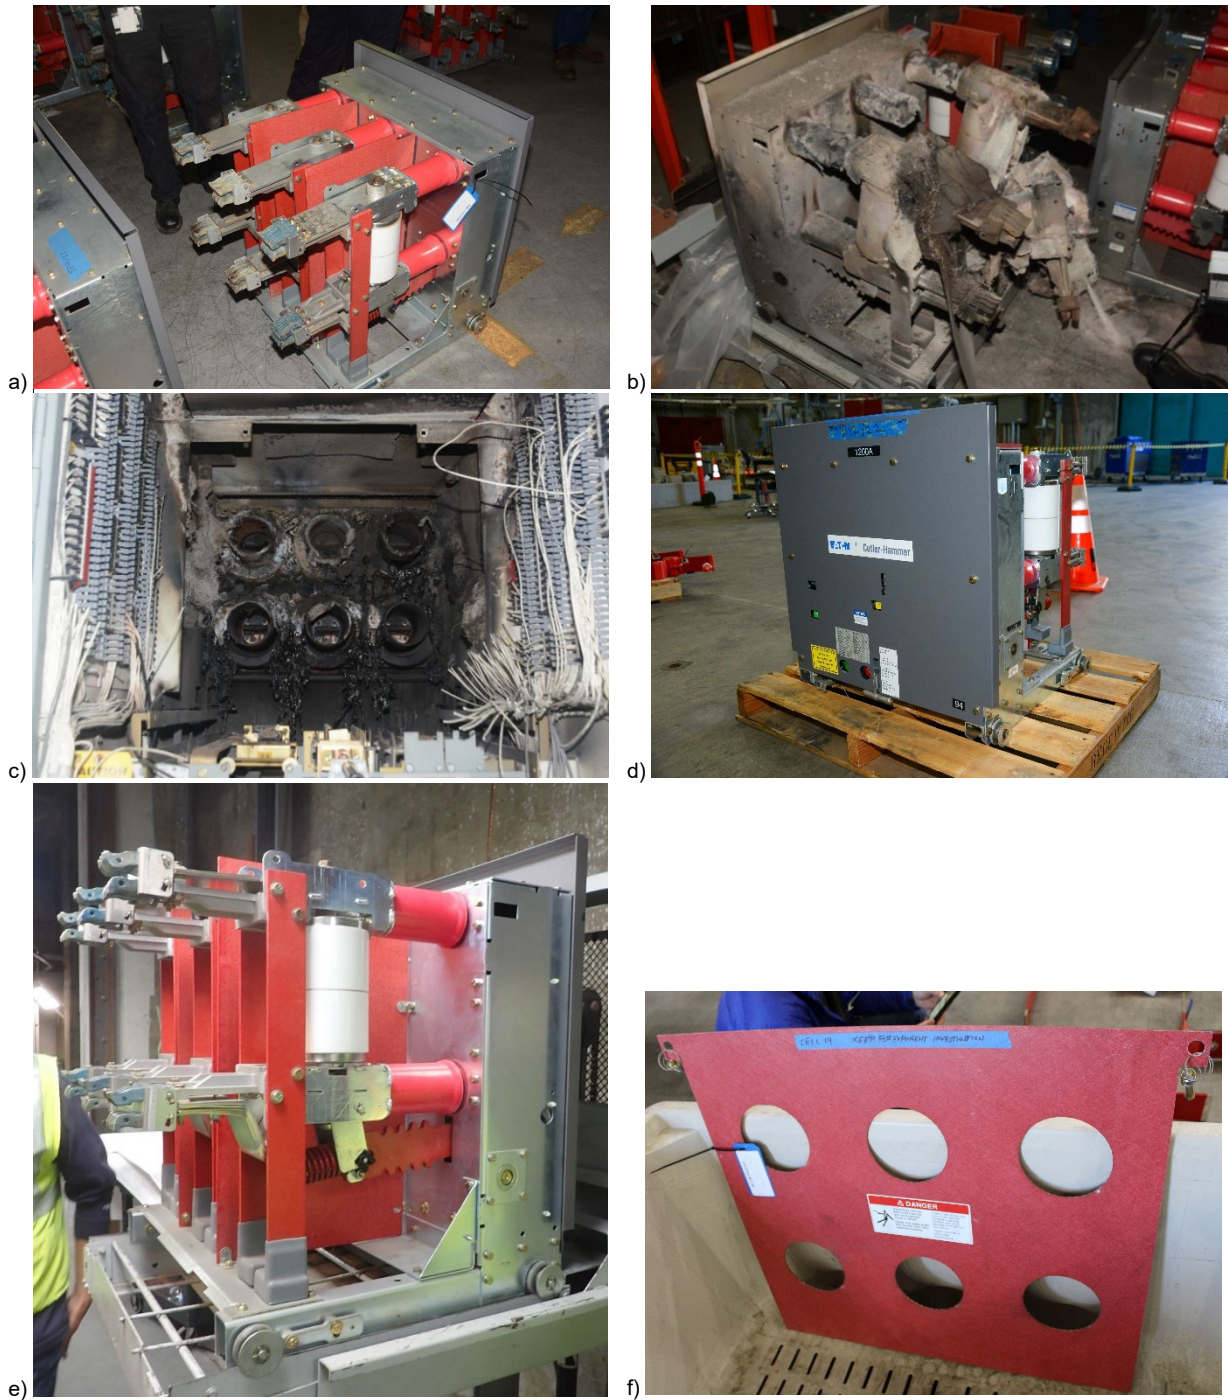
Exponent inspected the evidence at the PG&E ATS facility, including the Incident Breaker No. 52 and Cell No. 5, which contains two cubicles, including the upper 1112/12 breaker cubicle (the Incident Cubicle). Additional evidence included the circuit breaker from the lower cubicle of Cell No. 5 (Circuit Breaker No. 94) and a breaker that had been removed from the top of Cell No. 5 approximately one month before the arc-flash event (Circuit Breaker No. 56). Other collected items included the circuit breaker in Cell No. 19 associated with the station service transformer (Circuit Breaker No. 79), barrier insulating board from the bottom of Cell No. 19, collected bus work, damaged control cables, protective relays, and one of the heaters from Cell No. 5. Additionally, Exponent received barrier insulating boards from selected breaker cells at the 12 kV bus section D of the Mission Substation (“Additional Insulating Boards”). All Additional Insulating Boards were visually inspected, and a selected number of them were destructively examined in laboratory conditions. Photographs of some of the items inspected by Exponent are shown in Figure 11.

Figure 11. Examples of evidence collected by PG&E: a) Circuit Breaker No. 56 - Replaced from Top of Cell No. 5 prior to Incident; b) Circuit Breaker No. 52 from Top of Cell No. 5 (Incident Breaker No. 52); c) Cell No. 5 top cubicle (Incident Cubicle); d) Circuit Breaker No. 94 from the lower cubicle of Cell No. 5; e) Circuit Breaker No. 79 from Bottom of Cell No. 19; and f) Barrier insulating board from Bottom of Cell No. 19.
