File No. 150148

Re: Transmittal of Planning Department Case Number 2013.0910L:
149-155 9th Street, Article 11 Change of Designation
BOS File No: _____ (pending)
Historic Preservation Commission Recommendation: Approval

ARTICLE 11 HISTORIC BUILDING REPORT

MAINTENANCE PLAN

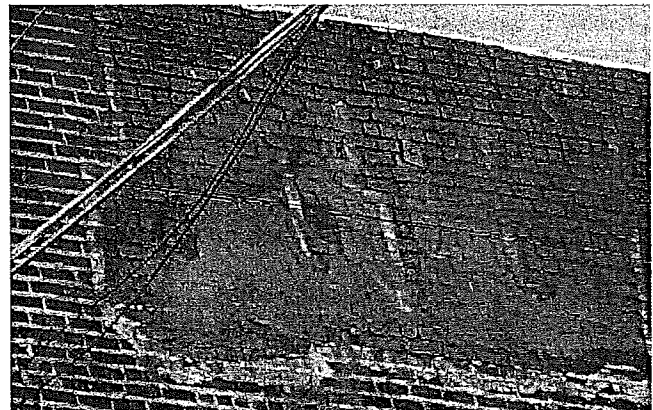
Figure 2. East Elevation; note graffiti & paint to be removed.

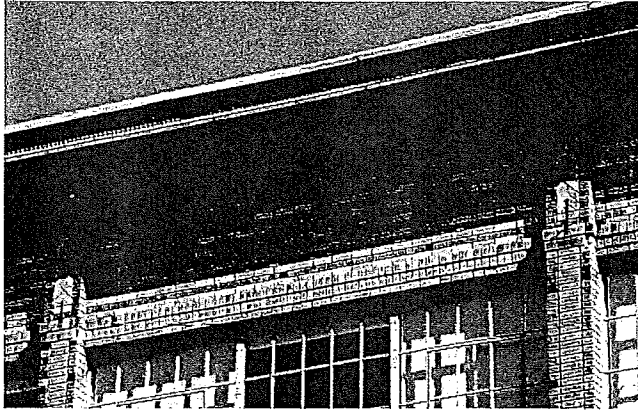
Figure 2. South Elevation; note dentils and decorative piers.

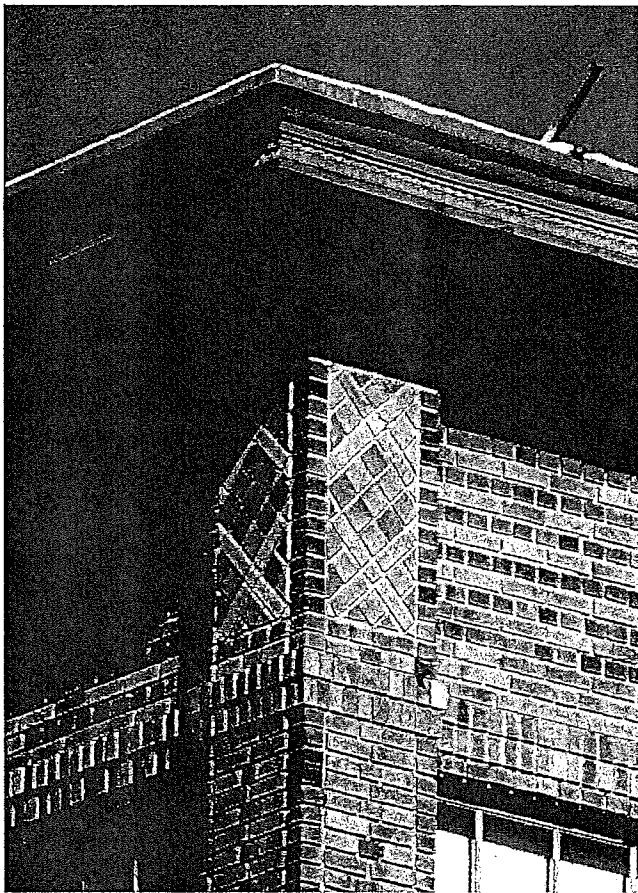
Figure 3. Southwest Corner; note decorative patterning and general brick pattern of elevation.

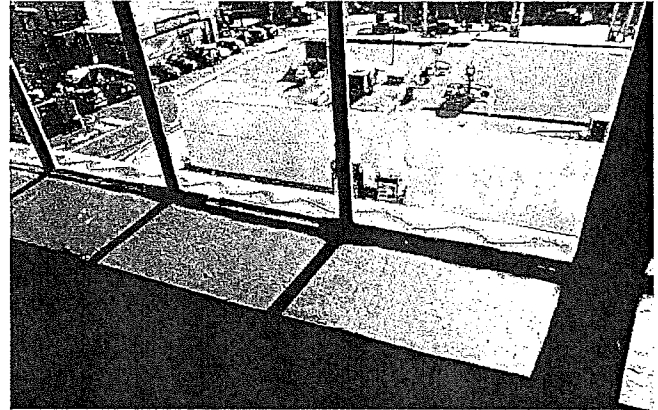
Figure 1: Window sills with concrete parge, typical.

Perform visual inspection of parged concrete with binoculars, spotting scope, or similar annually for cracks, spalls, and other signs of deterioration. Perform sounding of parge for indication of deterioration. Repair as needed.

Prepare, prime, & seal parged concrete and install new sealant every 10 years, or as needed.

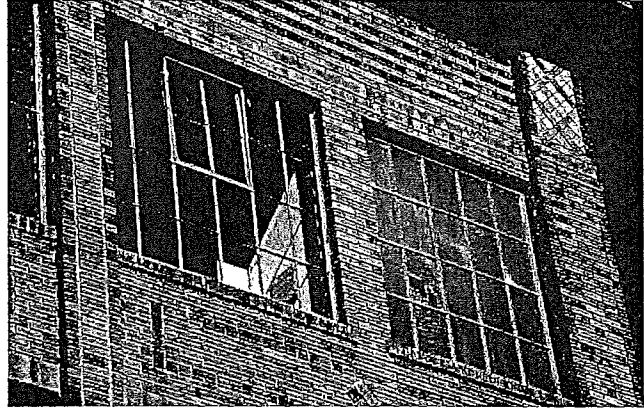
Steel multi-lite window sash are extant at primary facades (west above ground floor and at south) and facing the access alley along the north elevation. The windows are fixed sash with an operable awning-swing sash in the center of each window section. The size of each operable sash varies in certain locations. These windows are generally in good condition, with localized areas of cracked and deteriorated glazing putty. Clear glazing is installed in the majority of windows, though the windows in the eastern-most bay along the south elevation (Natoma Street) have wired glass.

Figure 1. Typical multi-lite steel windows; note operable sections and glazing types.

Define various types of glazing and determine original design. Remove existing broken or mismatched glass & replace with new to match original. Consider weight and profile of steel with regards to accommodating new glazing system. Explore potential for energy efficient replacement glass, laminated glass and/or glazing films.

Any window replacements should be made in kind, with new windows matching the materials, size, profiles, and dimensions of the original.

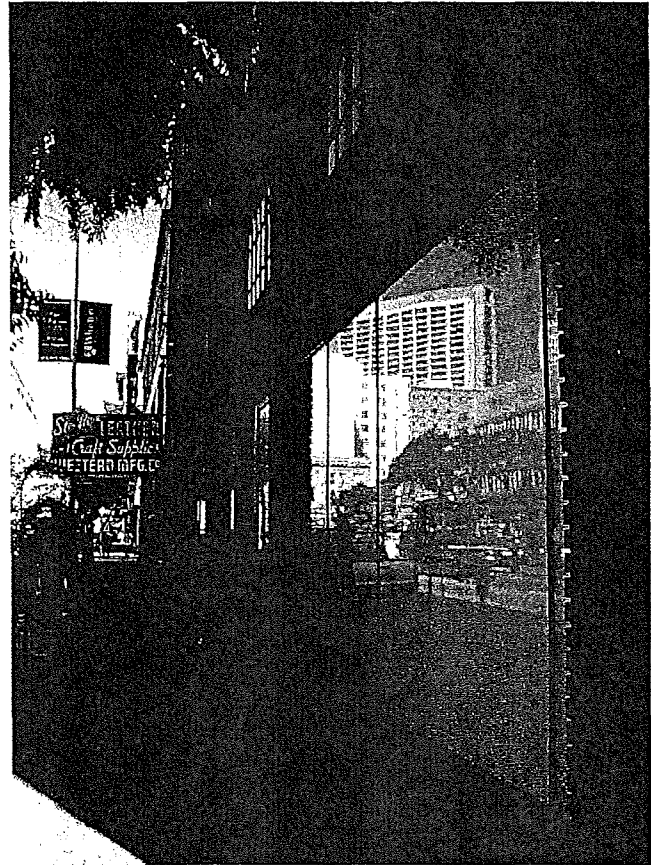
Figure 1. Typical Storefront at west elevation.

Inspect frames, glazing seals and sealants. Repair as needed.

Inspect framing, glazing seals and sealants for deterioration annually. Install new sealant every 10 years, or as needed. Prepare, prime, paint and seal every 5 years.

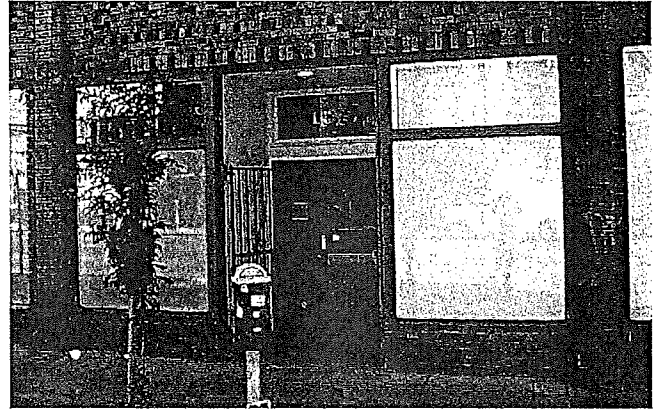
The wood frame storefront system occupies the center bay at the first floor west (9th Street) elevation, with a recessed entrance central at this location. The lower, larger panes of glass are set in a steel frame similar to those found within the other bays. The transoms are fixed with wood stops. The entire assembly is painted. The recessed entry has a concrete floor leading to a metal door with metal sidelight and transom (see Feature III-E: Exterior Door Type B – Metal). The entire assembly appears to be in good condition.

Figure 1. Storefront at west elevation.

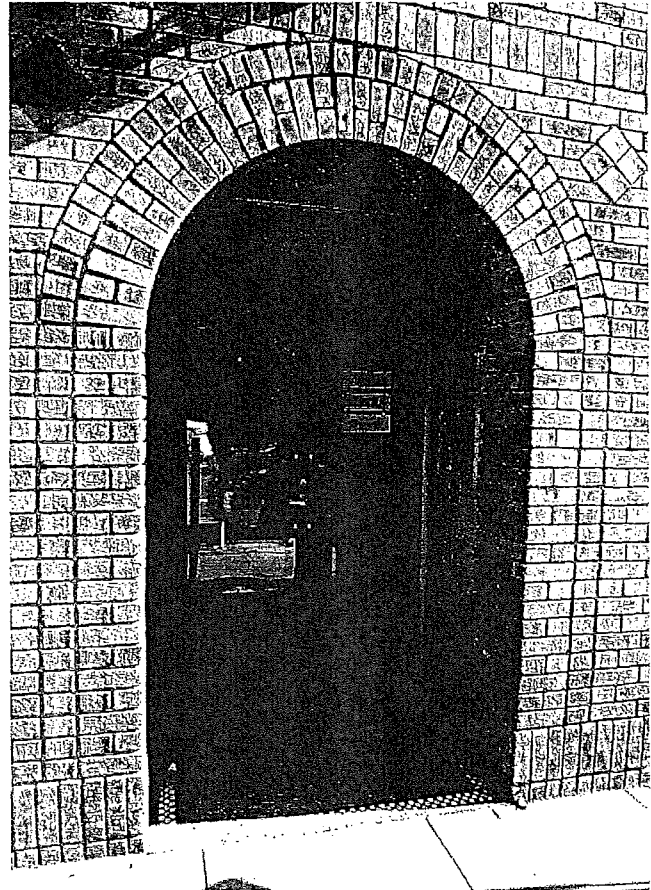
Figure 1. Entrance at northwest corner.

Due to noted security issues at northwest entrance door, consider replacement of security gates at entrances. Replacement gates should be comparable with existing gates along Natoma Street.

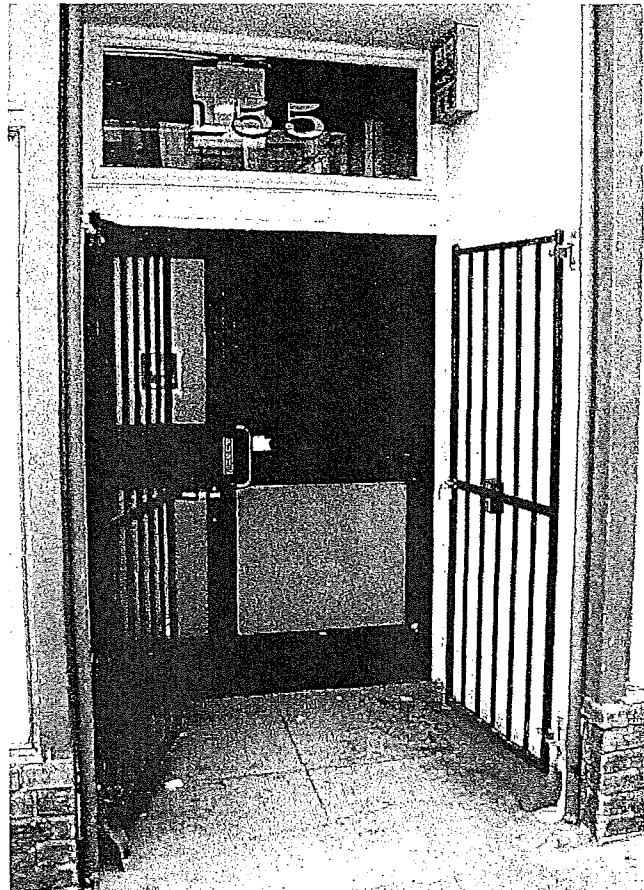
Figure 1. Metal entry door at west elevation.

Inspect door hardware, glazing seals and sealants. Lubricate doors and operating hardware. Install weather-stripping as required. Prepare, prime, paint and seal door and frames as needed.

Inspect door hardware, glazing seals, sealants and weather stripping for deterioration annually. Lubricate doors and operating hardware annually. Repaint doors and door frames as needed. Install new perimeter sealant every 10 years or as needed.

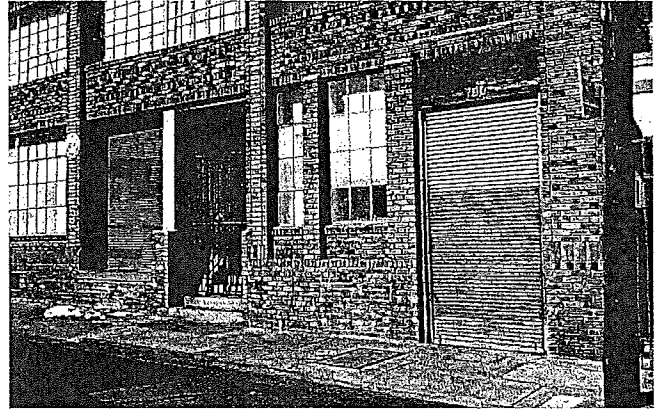
Figure 1. Service doors along south elevation.

Inspect door, door frame, door hardware and sealants. Repair as needed. Repaint doors and door frames.

Inspect door, door frame, door hardware and sealants for deterioration annually. Repair & repaint as needed.

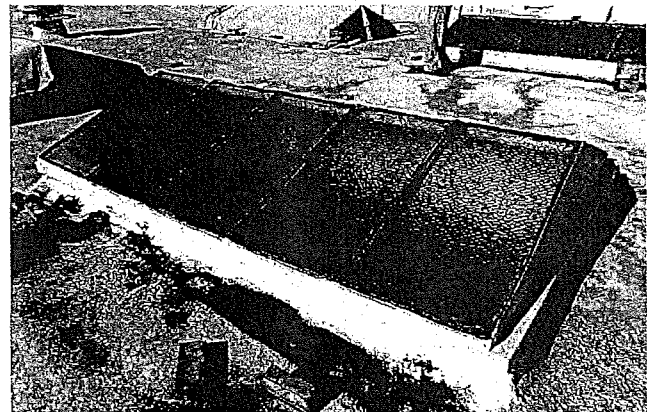
Figure 2. Typical skylight.

Inspect steel framed skylight for deterioration and water protection annually, including metal corrosion as well as paint and glazing sealant failure. Repair as needed. Install sealant and/or glazing putty as needed. Prepare, prime, paint and seal every 5 years.

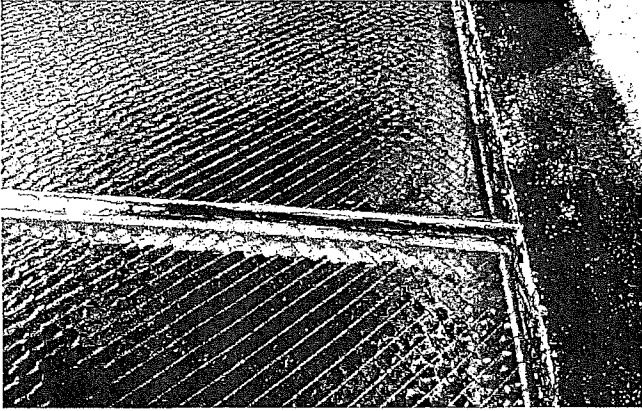
Figure 3. Skylight typical frame conditions.

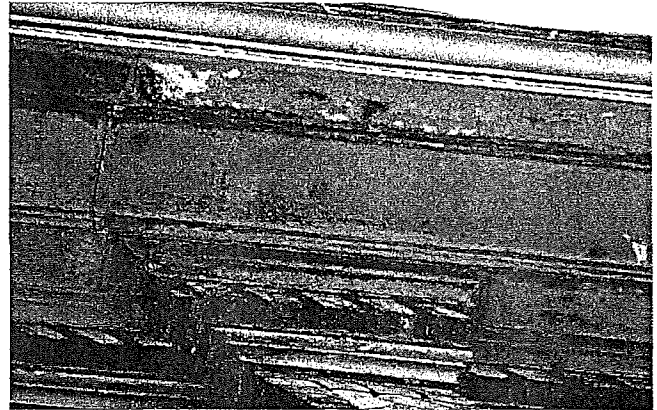
Figure 4. Cornice; conditions noted as typical.

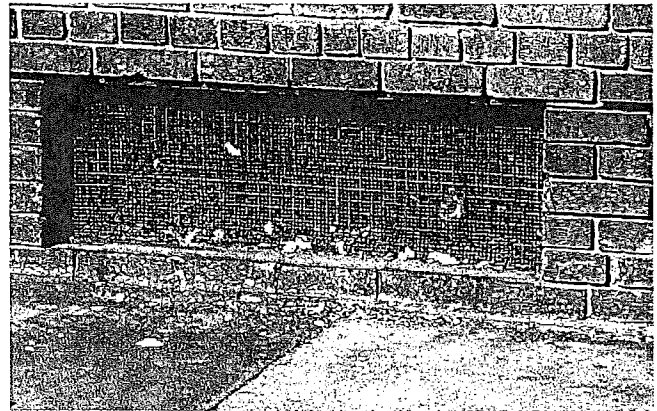
Figure 1. Ventilation grilles; note 1"x1" historic iron grille.

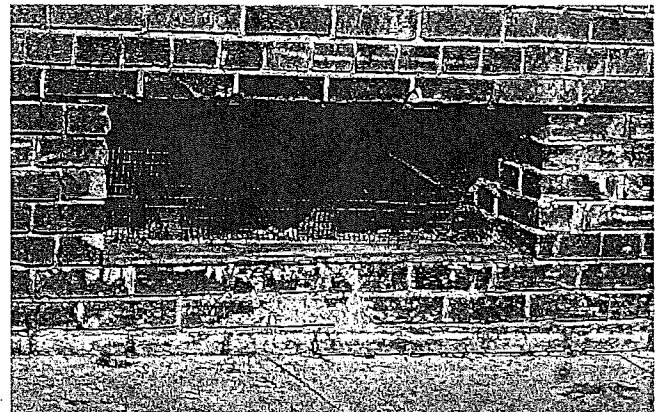
Figure 2. Ventilation grilles; replicate historic pattern from adjacent grille.

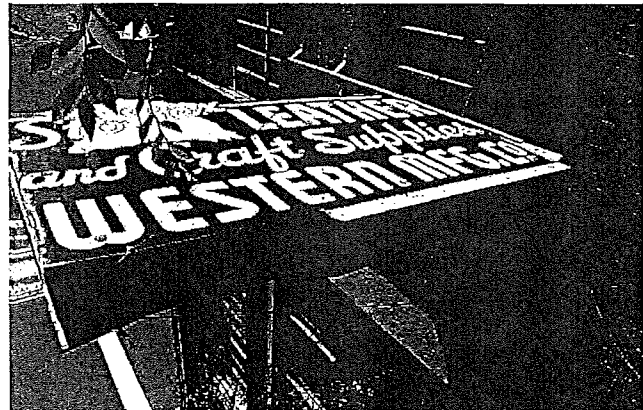
Figure 2. East Elevation, note graffiti & paint to be removed

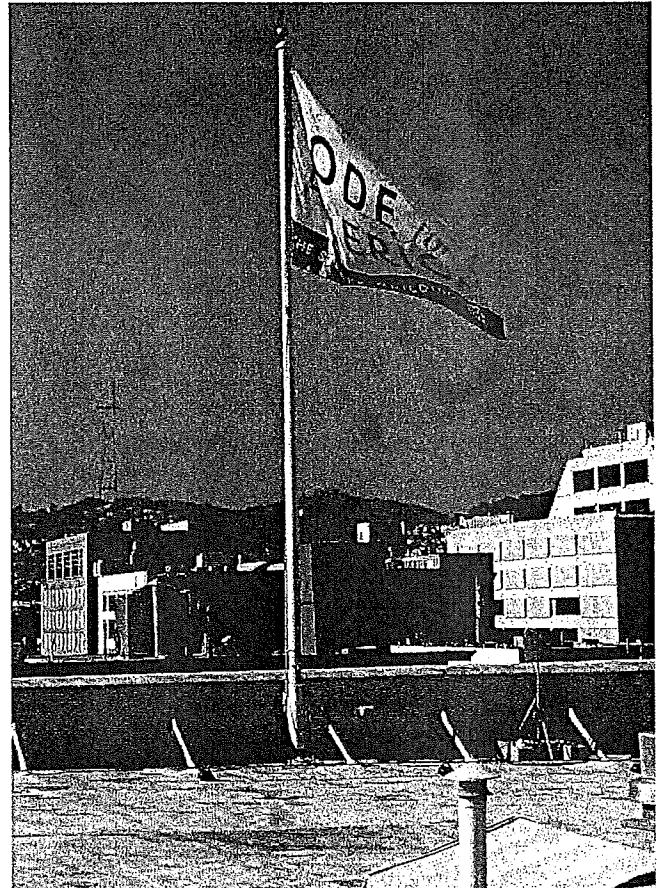
The flagpole is aligned with the center pier on the west (9th Street) elevation. The flagpole is anchored at its base to the roof parapet at this location and has a steel round metal finial at its top. The flagpole and base appear in good to fair condition.

Figure 1. Flagpole along west elevation.

Conditions of flagpole and base should be re-evaluated in coordination with any major roof work.

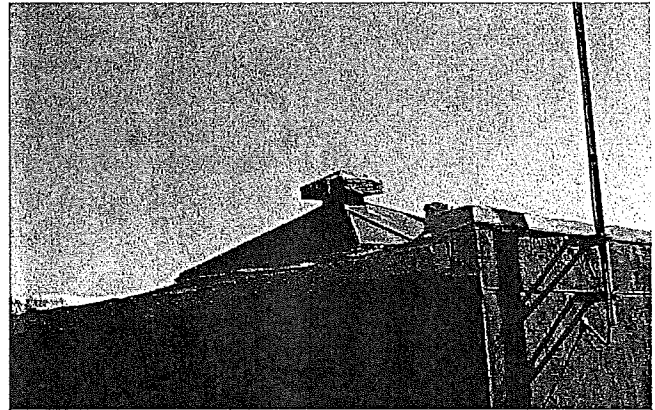
One steel framed skylight is located above the sheet metal penthouse at the southeastern corner of the roof. The skylight is pyramidal with a sheet metal vent at the apex. The skylight was not accessible but appears to be in fair condition, and there are no known water intrusion issues at the skylight. The sheet metal vent also appears to be in fair condition with failing paint.

Figure 1. Roof & ventilator at penthouse.

Inspect for broken/cracked glass and inspect sheet metal ventilator for deterioration. Patch sheet metal and repair as needed.

Inspect steel framed skylight for deterioration and water protection annually, including metal corrosion as well as paint and glazing sealant failure. Repair as needed. Install sealant and/or glazing putty as needed. Prepare, prime, paint and seal every 5 years.

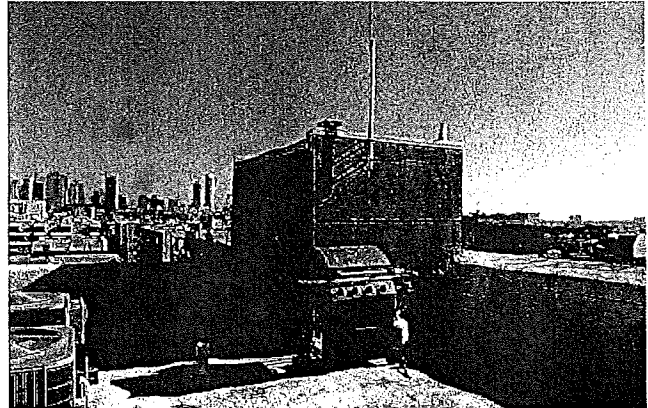
The painted sheet metal penthouse is located at the southeastern corner of the roof and appears to be in fair condition.

Figure 1. Penthouse from roof, typical.

Inspect sheet metal siding for deterioration and corrosion annually. Patch, repair or replace as needed to match original. Prepare, prime, paint and seal.

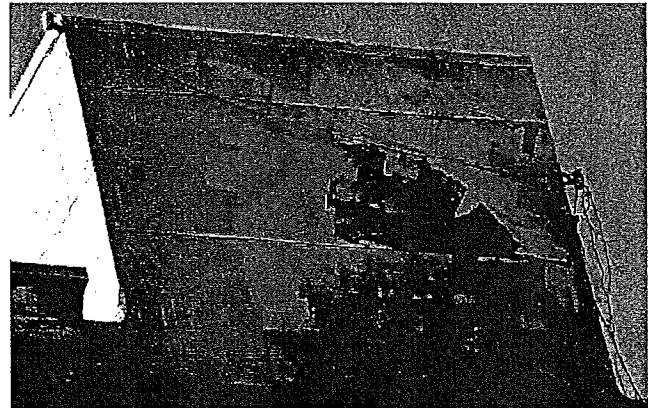
Figure 2. Penthouse from grade (east elevation).

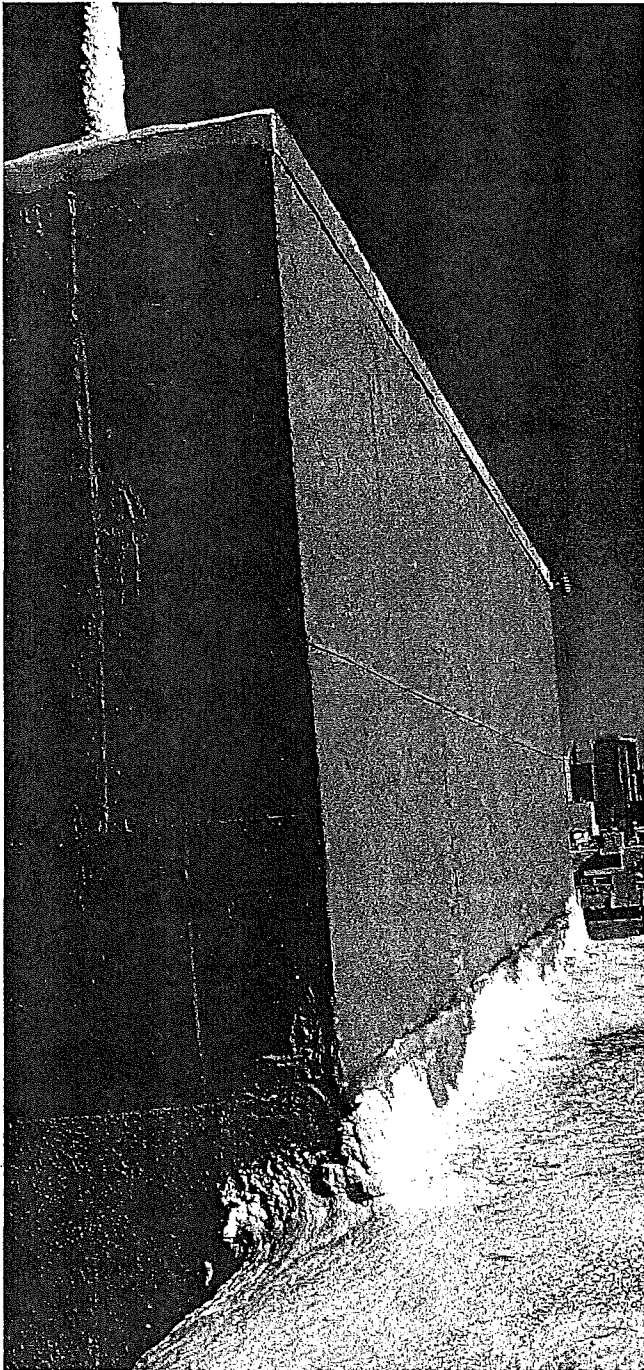
Figure 3. Enlarged view of penthouse.

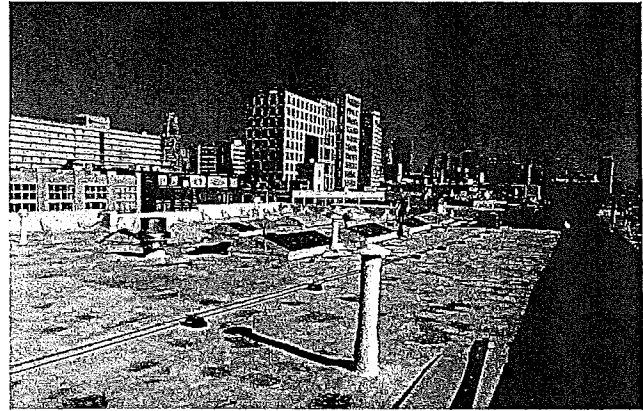
The roofing material is not original and is comprised of a membrane over a sprayed foam material. This material extends to the parapet bracing and laps the top edge of the parapet to act as parapet flashing. A few areas of bio growth and water indicate localized ponding. This is because the roof does not have a consistent slope. It was not immediately clear where all the roof drains are located, except for one scupper at the north wall.

A few locations of distress were noted at the roofing membrane, resulting in what appear to be small tears. A larger puncture below the flag pole appears to be related to installation/adjustment of the flag pole.

Figure 1. Roof of 149 9th Street, typical.

Inspect roofing membrane for signs of deterioration and water penetration annually. Install patches and repair as needed. Repair as needed.

If inspection reveals existing or potential greater damage, consider full replacement of roofing membrane. When replacement of the roofing membrane occurs, coordinate replacement with all necessary flashing and waterproofing, including at skylights, penetrations, parapet braces, etc., and install new sheet metal parapet flashing. Roof drainage and proper slope should also be coordinated during roofing replacement.

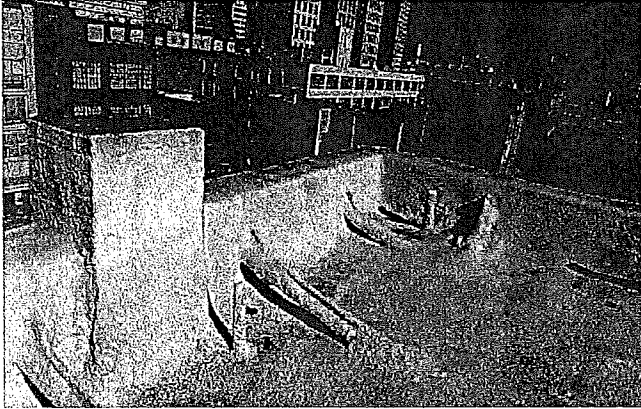
Figure 3. Roof at northeast corner, typical.

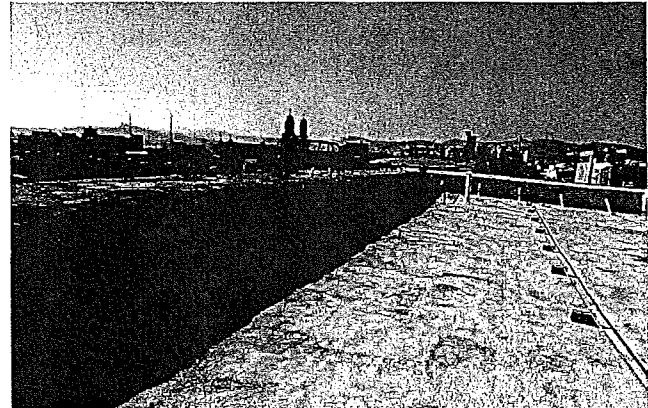
Figure 3. Parapet with bracing, typical.

Inspect parapet wall and copings for deterioration annually.
Repair as needed: Prepare, prime, paint and seal copings every 5 years, or as needed. Coordinate inspection and repair work in connection with general brick and roofing repairs.

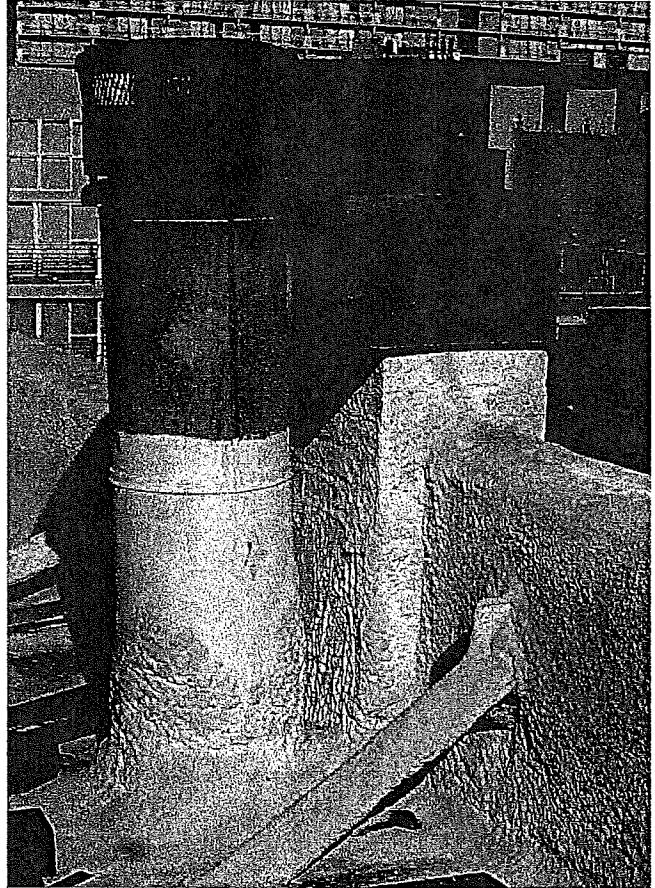
Figure 1. Unbraced ventilation stack with sheet metal cap, typical.

Inspect flashing and caps annually. Consider caps or flashing/protection for the vent stacks (if not in use). Prepare, prime, paint and seal. Inspect annually for cracks or other signs of movement at the stacks. Repair as needed.

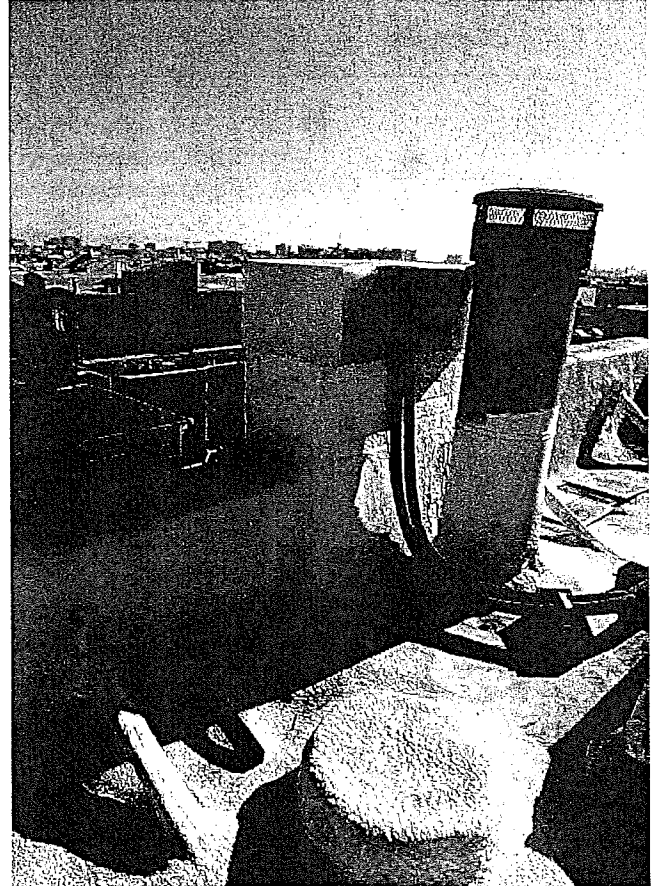
Figure 4. Capped ventilation stack and mechanical exhaust flue; note re-use of ventilation stack for services.
