# Appeal of Determination of Exemption from Environmental Review Embarcadero Fountain by Armand Vaillancourt (Vaillancourt Fountain)

January 13, 2026

San Francisco Arts Commission

San Francisco Recreation & Park Department

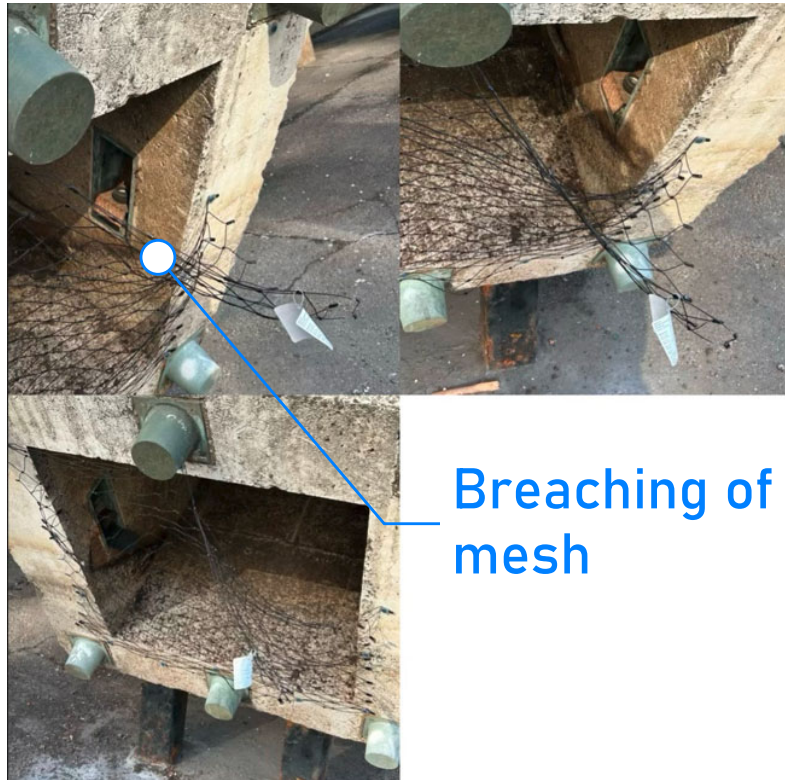
Breaching of mesh

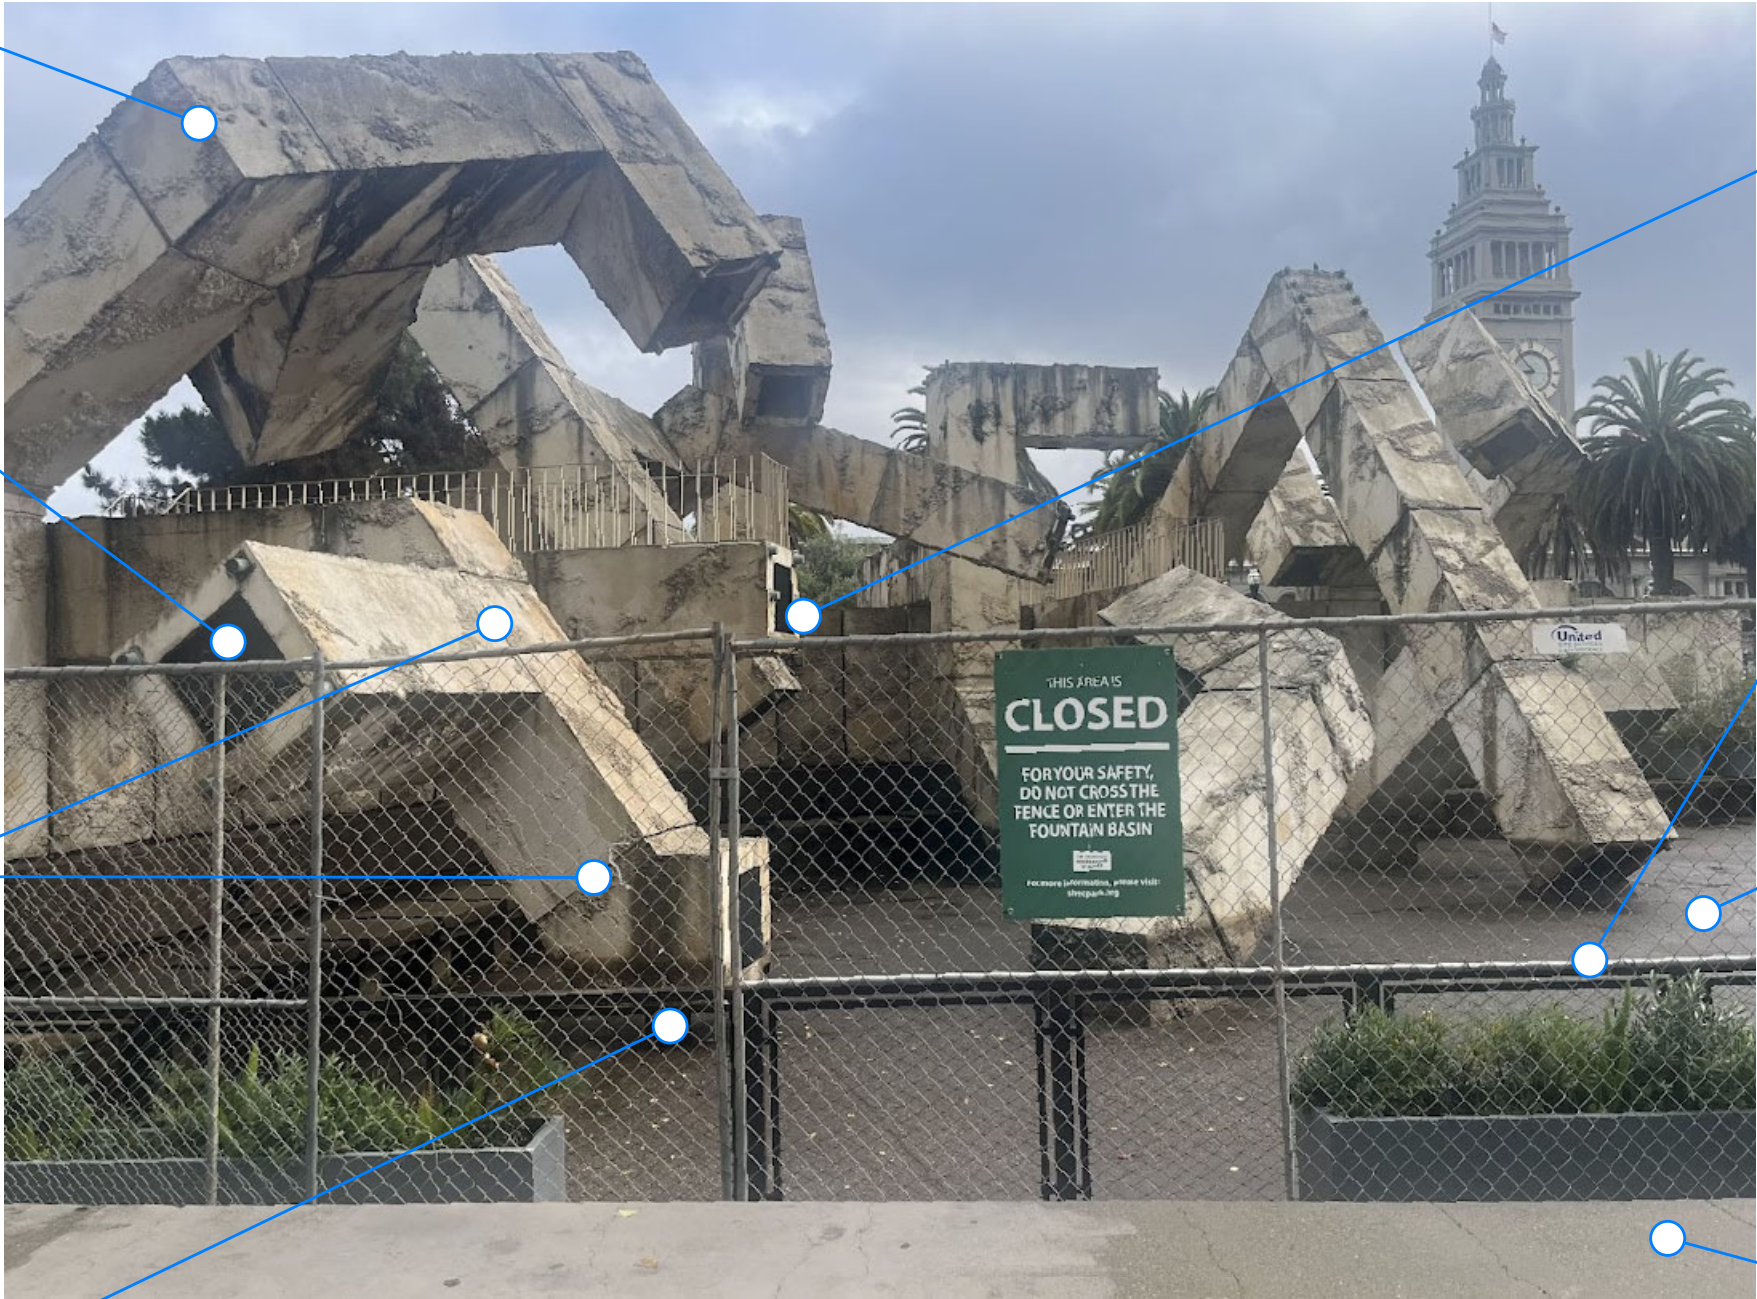
EVIDENCE OF  
INDIVIDUALS  
SLEEPING IN THE  
TUBES SINCE  
REINFORCEMENTS  
WERE IN PLACE

FENCING AND  
BACK GATE  
BREACHED

FAILED  
WATERPROOFING  
MEMBRANE AT  
BASIN

REMOVING ARMS ON  
SITE EXPOSES  
PUBLIC TO  
HAZARDOUS  
MATERIALS AND  
CLOSES OFF PLAZA
