SAN FRANCISCO PLANNING DEPARTMENT

PRE-APPROVAL INSPECTION REPORT

Report Date: May 24, 2019
Inspection Date: May 22, 2019; 11:00am
Filing Date: May 1, 2018
Case No.: 2019-006384MLS
Project Address: 1401 Howard Street
Block/Lot: 3517/035
Eligibility Article 10 Landmark No. 120: Saint Joseph's Church
National Register listed property
Zoning: RCD – Regional Commercial District
Height & Bulk: 40-X
Supervisor District: District 6 (Matt Haney)
Project Sponsor: Christopher Foley of 1401 Howard LLC
Address: 1401 Howard Street
San Francisco, CA 94103
415-305-4600
cfoley@groundmatrix.com
Staff Contact: Michelle Taylor – (415) 575-9197
michelle.taylor@sfgov.org
Reviewed By: Tim Frye – (415) 575-6822
tim.frye@sfgov.org

**MILLS ACT APPLICATION
1401 HOWARD STREET
SAN FRANCISCO, CALIFORNIA**

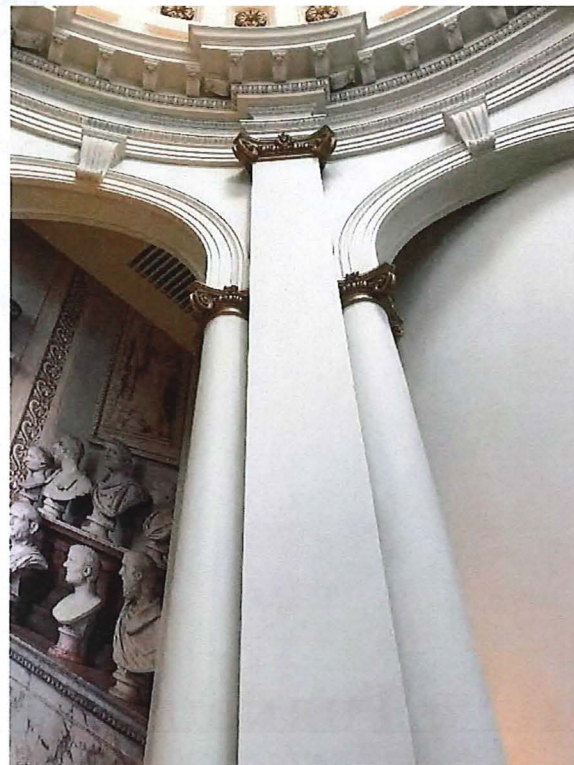
Detail of restored decorative plaster elements

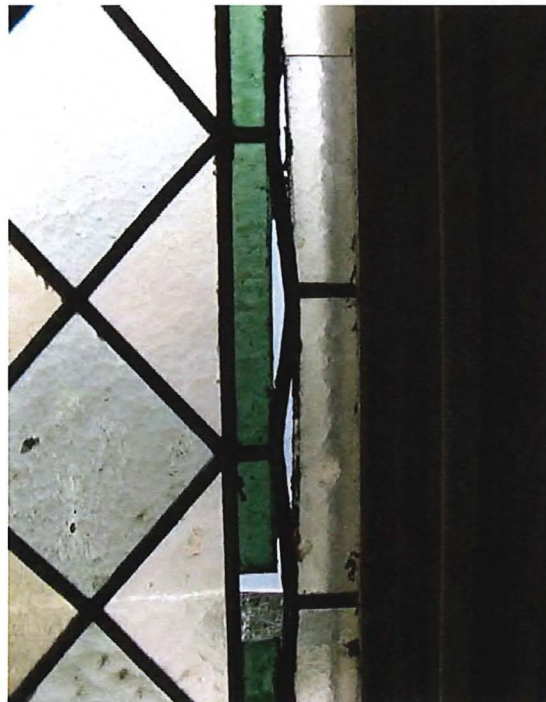
- Loss of the protective outer glazing.
- General soiling (Figure 42a, Figure 42b, and Figure 42c).
- Sagging and bowing of lead comes (Figure 42b and Figure 42c).
- Cracking, breakage and loss of panes (Figure 42c).
- Inappropriate additions (Figure 42d).
- Corrosion of saddle bars (Figure 42e).

Figure 42c. Breakage and loss of colored glass panes due to distortion of lead comes.

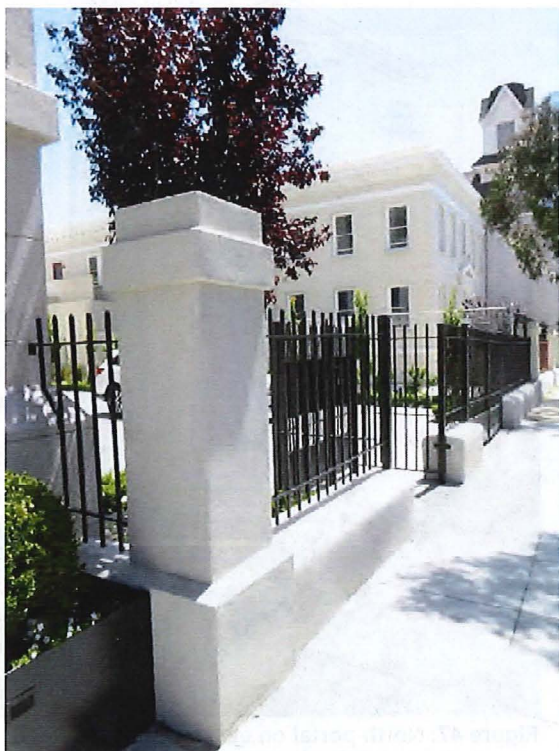
Figure 43. Perimeter fence and gate along Howard Street. View southwest. (Page & Turnbull, 05/25/2018)
