## FIRST AMENDMENT TO LEASE NO. L-16274

# RAPID STRUCTURAL ASSESSMENT REPORT

We are pleased to submit this report summarizing the findings and recommendations of our Rapid Structural Assessment of Pier 33 in San Francisco, California.

Subject: Permit No. B 2018-0121  
Pier 31.5 Substructure Repair, San Francisco

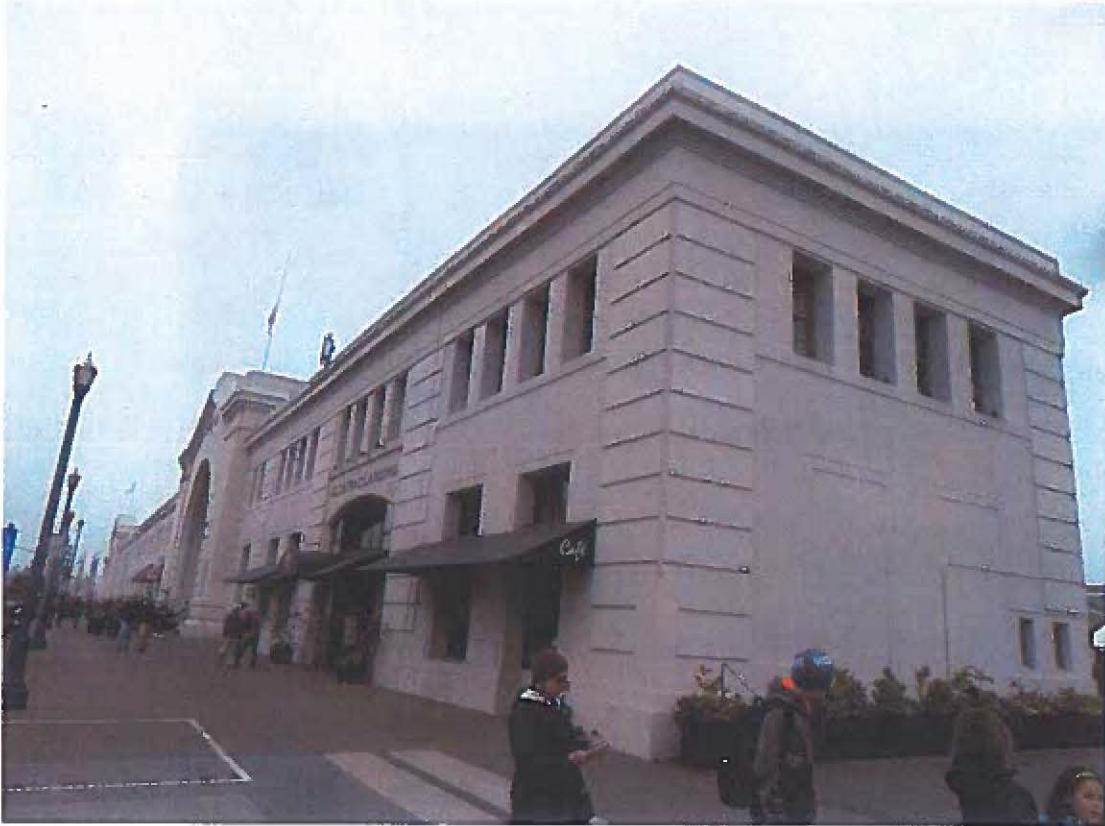
Figure 2 - Bulkhead Exterior

Superstructure on Pier 33 includes a bulkhead fronting on the sea wall and a shed extending the length of the finger pier (See Figures 1-3). Project north is such that Embarcadero end is west and bay end is east. Geographic north is closer to bay end of pier, with Embarcadero at south end. Bulkhead exterior walls are framed plaster over diagonal wood sheathing backed by blocked wood stud reinforced with wood wind girts and heavy posts (Fig. 7) supporting wood

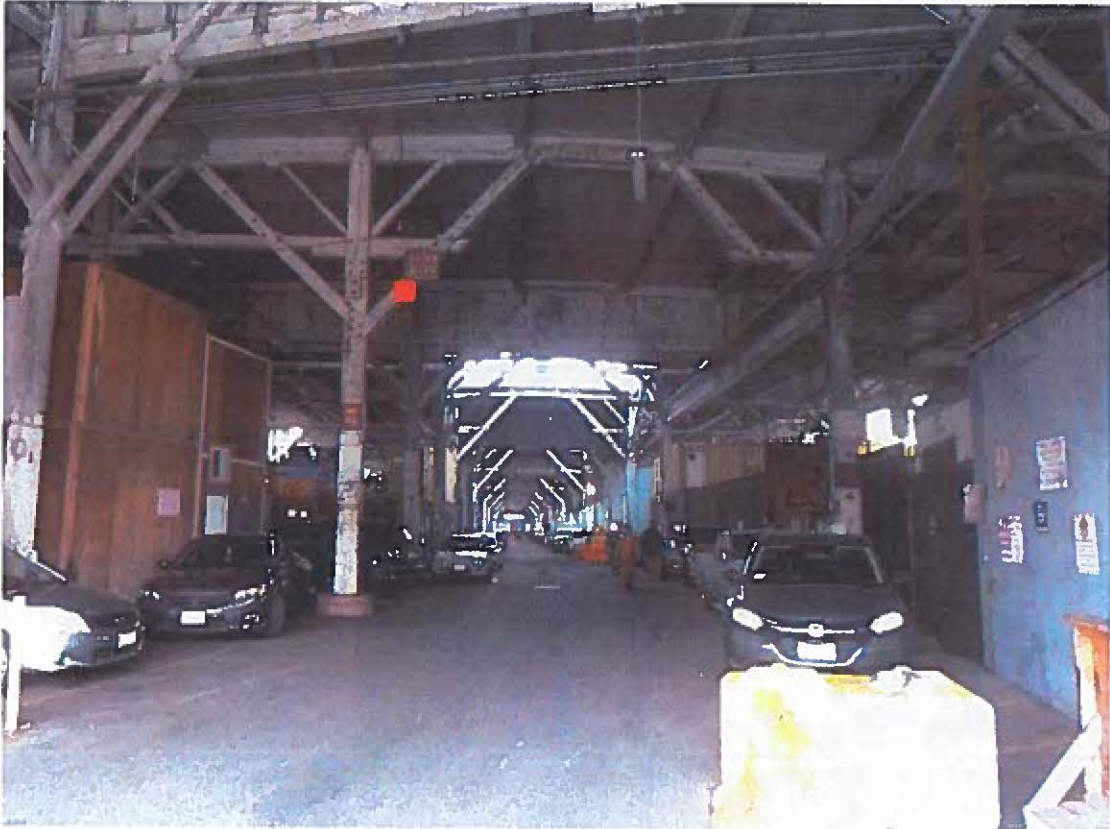
Shed exterior walls are typically 4" thick reinforced concrete backed by wood posts supporting wood trusses spanning transverse to shed length. Trusses support sawn wood joists laid solid over sawn wood purlins (Fig. 6). Occupancy appears to be primarily fish processing, storage, and light industrial uses.

Figure 6 - Main aisle of shed

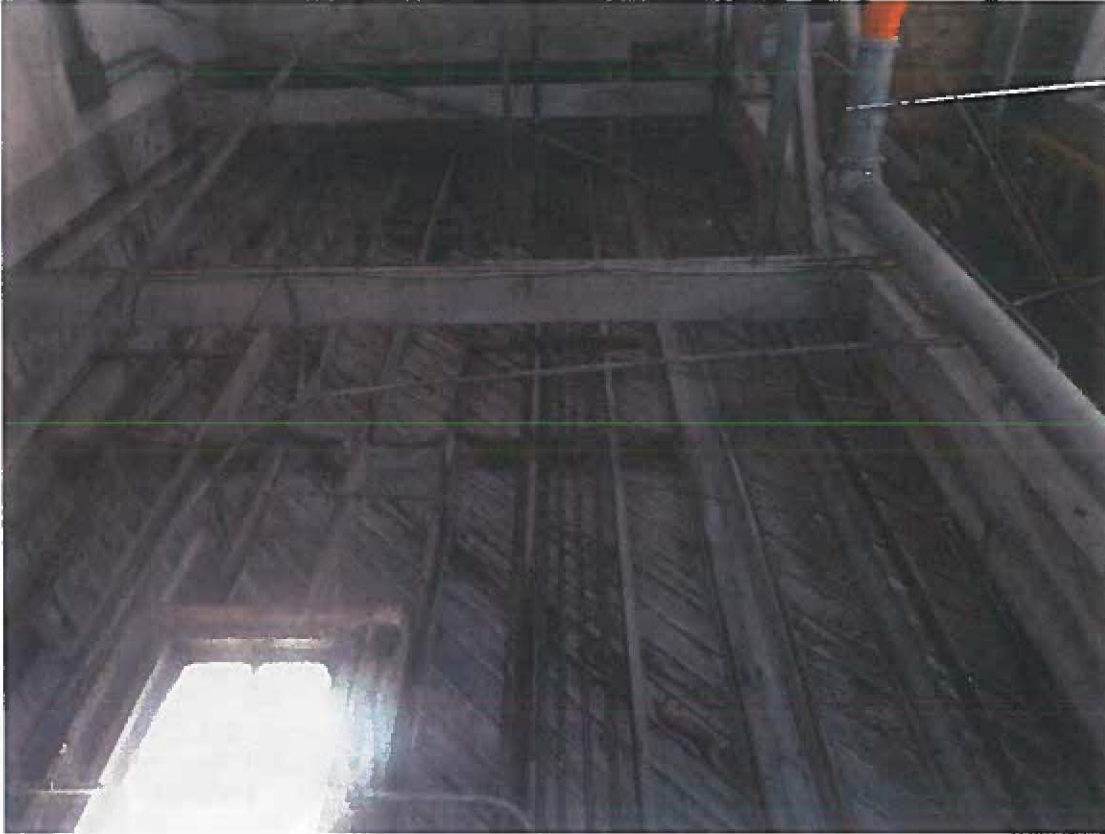
**Figure 7 - Bulkhead Wall Framing**

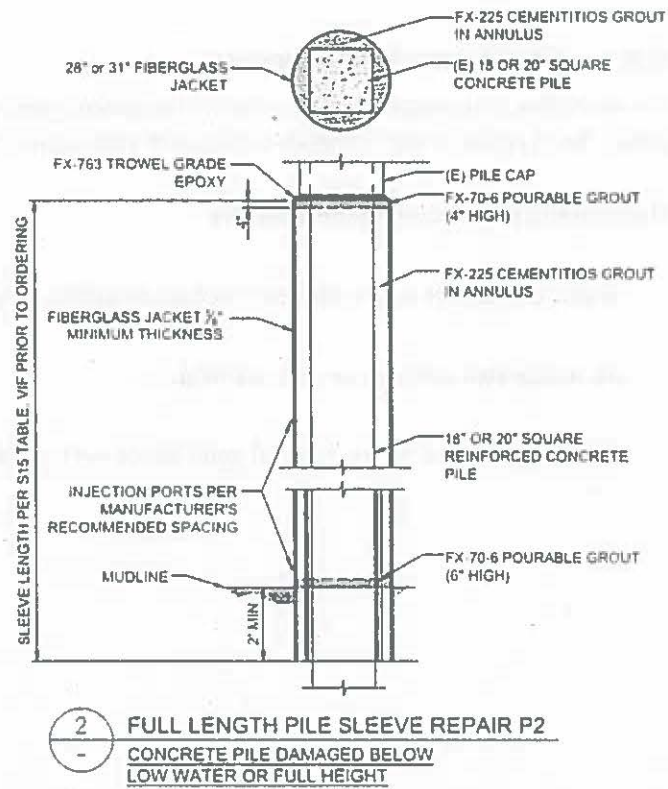
Figure 7 - Pile Sleeve Design Details

The pile sleeve repair were performed in accordance with design details. The design details and photo of typical repair are shown in Figure 7 and Figure 8.

- ✓ Chamfer at top to prevent water pooling
- ✓ Pile sleeve installed with general conformance with drawings
- ✓ Pile sleeve left on to increase durability

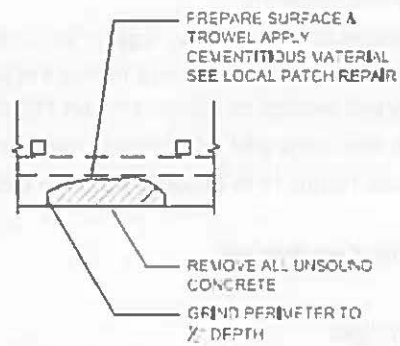
Figure 11 - Local Slab Repair Detail

The slab patch repairs are in conformance with the design details. Slab design details and typical photo is shown in Figure 11 and Figure 12

- ✓ Clear perimeter indicating 1/2" saw cut around edges.
- ✓ No damage, rust stains, or noticeable cracks.
- ✓ General conformance with design detail

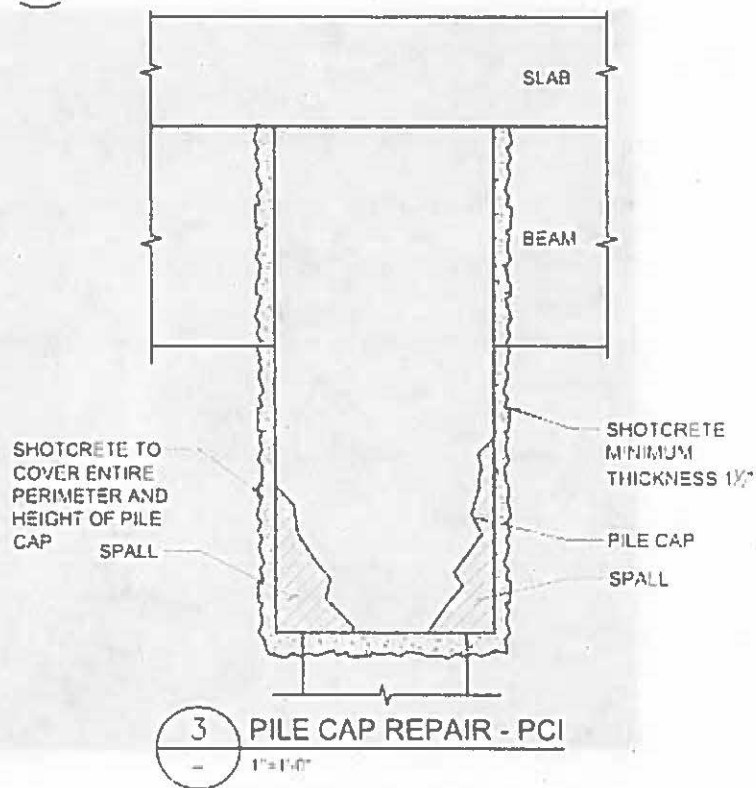
Figure 13 -Shotcrete Cap Beam Repair (Alternative not shown, notes as shown below)

The contractor chose the alternative option to form and pour the pile cap repairs. The form and pour details are outlined in the details in Figure 13 and Figure 14. Photos of repairs are shown in Figure 15 and Figure 16. The drawing shows shotcrete repair; the form and pour repair method was not drawn but outlined in notes. The pile cap repair is in accordance with design drawings.

- ✓ Chamfered Edges
- ✗ Cover looks to be adequate
- ✗ General conformance with design drawings
- ✓ No damage or rust staining

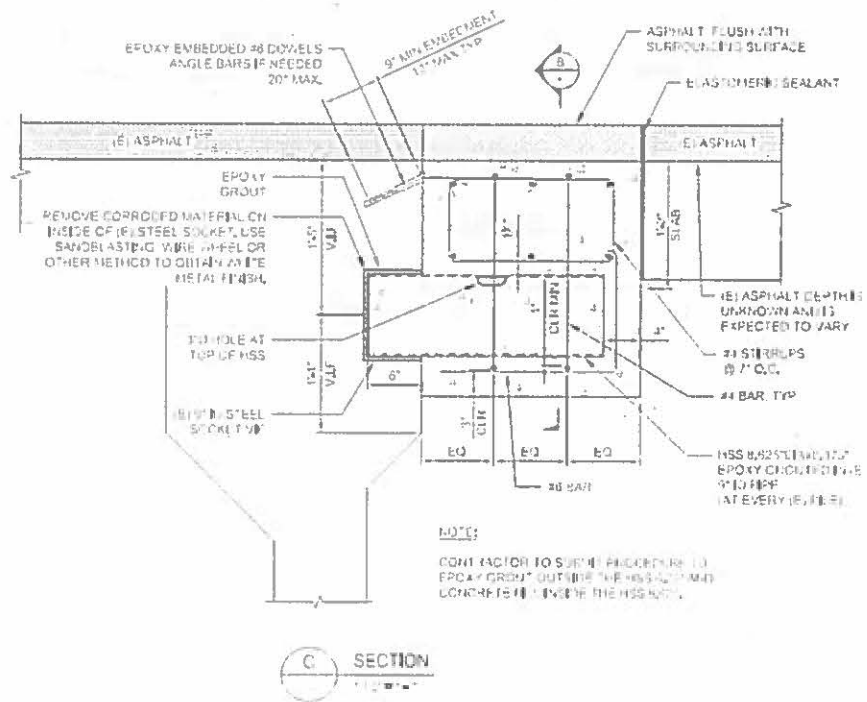
Figure 20 - Cantilever Repair Detail

The Asphalt and expansion joint look to be in accordance with design drawings. The detail and typical repair photo is shown in Figure 20 and Figure 21.

- ✓ Elastomeric Sealant
- ✓ Asphalt graded to match existing
- ✓ No tripping hazards
