File No. 260035

Hearing to discuss the cause(s), escalation, response, and impacts of the widespread power outages that began on December 20, 2025, and which have disproportionately affected residents and small businesses in the Richmond, Sunset, Presidio, Civic Center, South of Market (SOMA), and other San Francisco neighborhoods, to understand how a localized substation incident escalated to affect nearly one-third of the City; to assess communication failures and gaps in emergency response protocols; to evaluate economic impacts on small businesses and hardships faced by seniors, persons with disabilities, and other vulnerable residents; to discuss and understand the remedies, claims processes and support being provided to affected residents and businesses; and requesting the Pacific Gas and Electric Company (PG&E) to report.

Direct Cause Evaluation

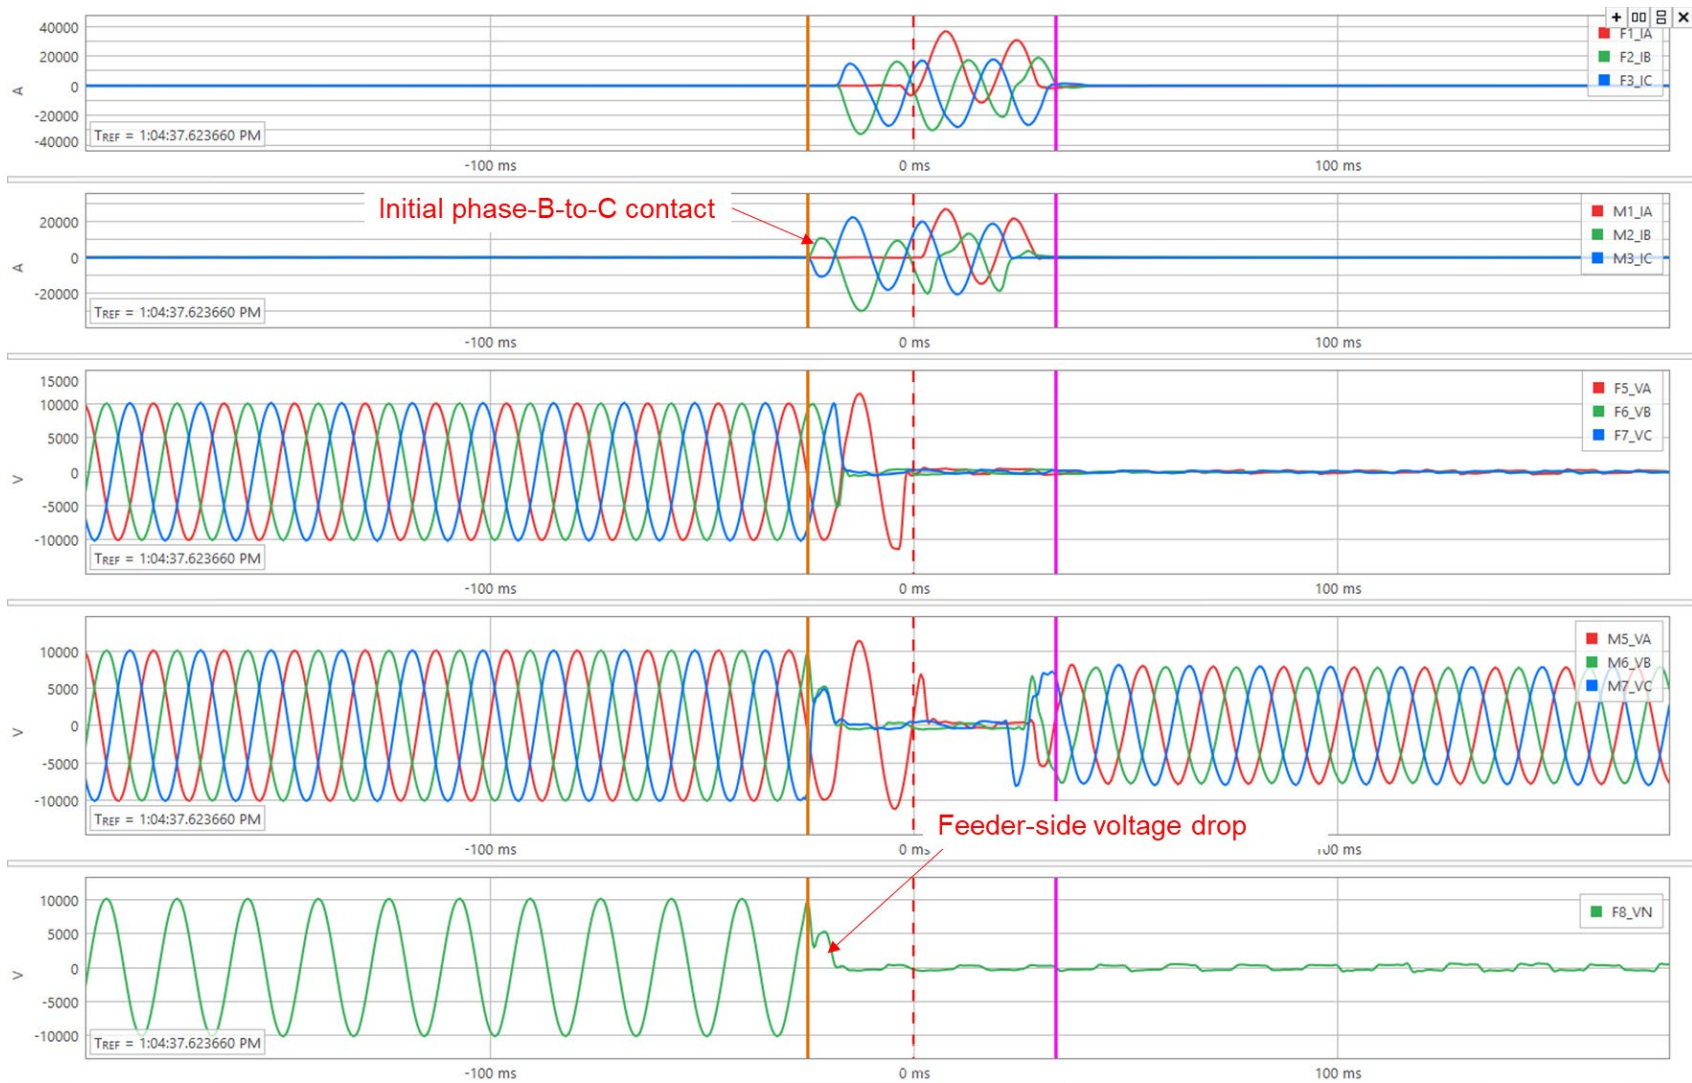
occurred approximately half a cycle before the involvement of phase A and ground. The feeder-side voltage also dropped simultaneously. This information is displayed in Figure 7.

Figure 7. Captured protection data during the initial fault.

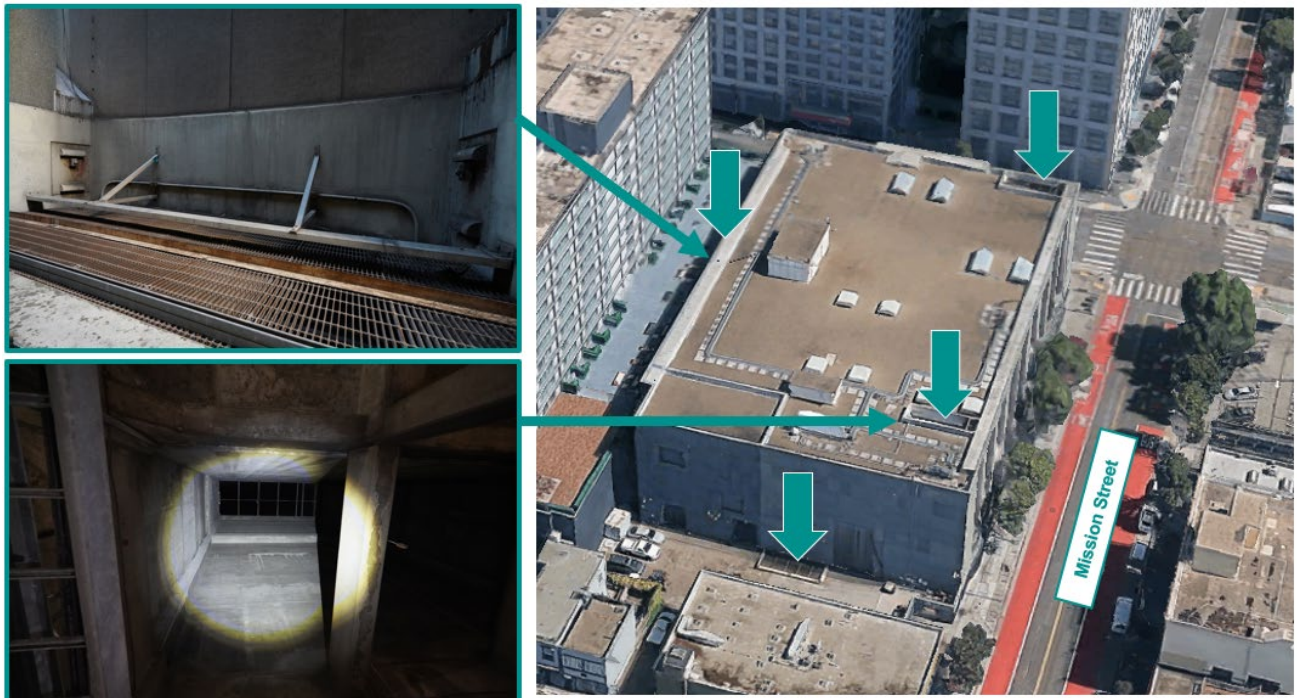
Based on Exponent’s site observations and review of mechanical drawings for the building, the building is intended to be mechanically ventilated with unconditioned outside air via a variety of supply fans located in the basement and exhaust fans located in a rooftop penthouse. The northwest side of the building (containing high-voltage switchgear) and the southeast side of the building (containing the transformers) have separate mechanical ventilation systems. Review of the ventilation diagram indicates that the design intent was for four supply fans in the basement to draw in ventilation air for the incident switchgear room through a below-grade opening (air intake pit) and a filter bank, then route it upward through floor openings into the switchgear room (see Figure 9). Exponent’s investigation found that the four supply fans were non-operational and air was being drawn through them, presumably by the rooftop exhaust fans.

Figure 8. North is to the left of the aerial image. Indicated by vertical arrows are four exterior intake locations; two large openings at the roof and two below grade locations (one along the north elevation and one at the west elevation).

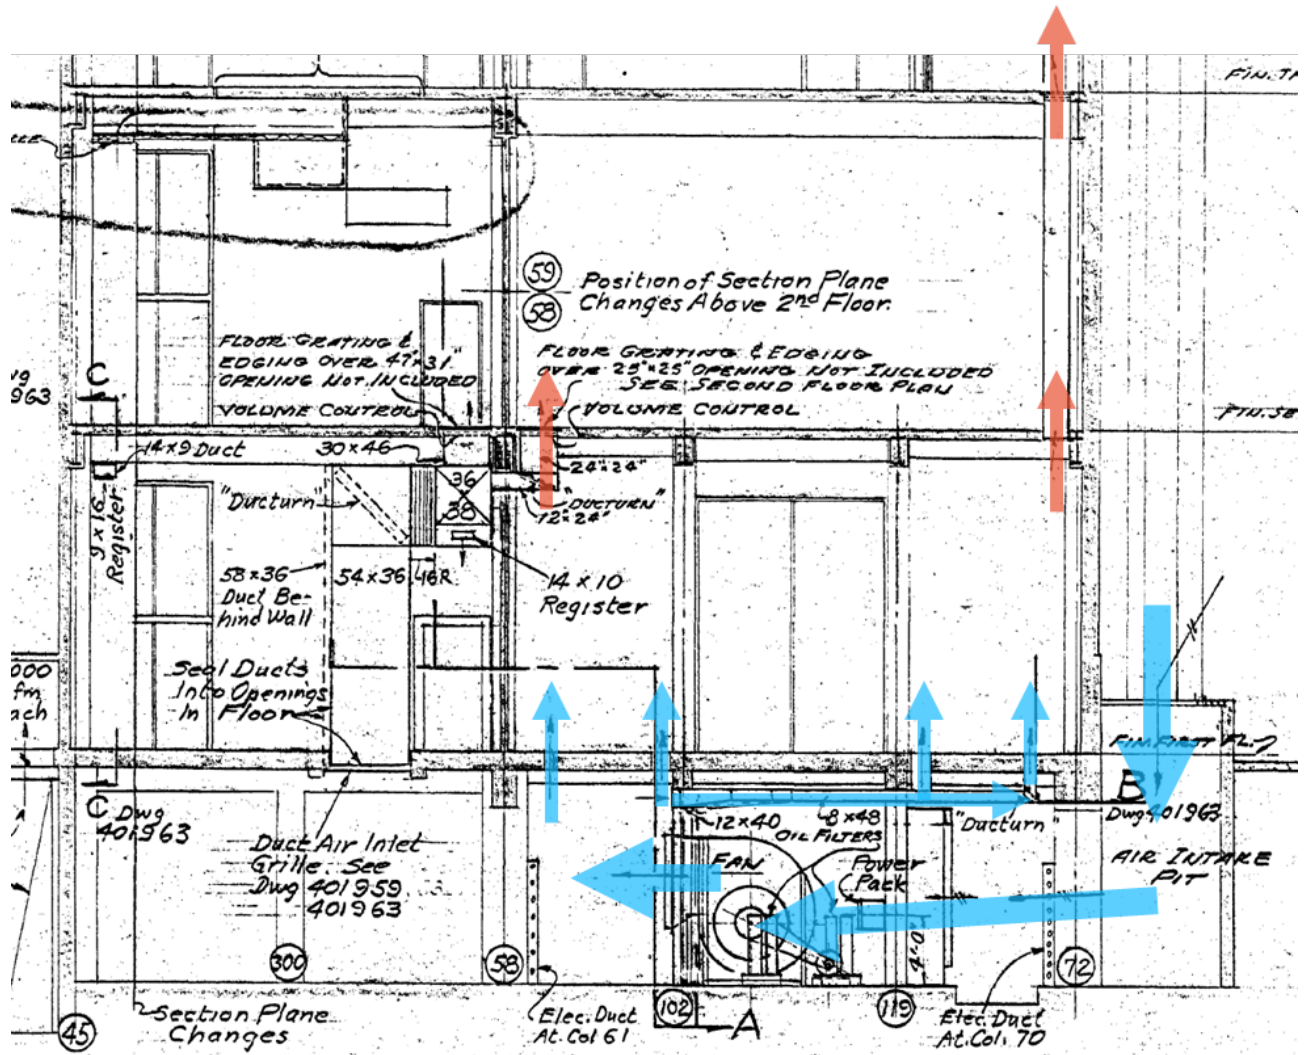
Figure 9. Diagram of intended outside air flow path for the ventilation of the switchgear room.³⁵

Because the ventilation air is unconditioned, there is no control over the temperature or moisture content of the ventilation air, and it will have similar properties (temperature, humidity, dew point, etc.) to the outside air. The lack of heating, cooling, and humidity control exposes the building interior to the variability of the outdoor climate, including high relative humidity, large/uncontrolled temperature swings, and potentially condensation under certain conditions. For example, it is known³⁶ that condensation can occur on building surfaces and electrical equipment in the event of a

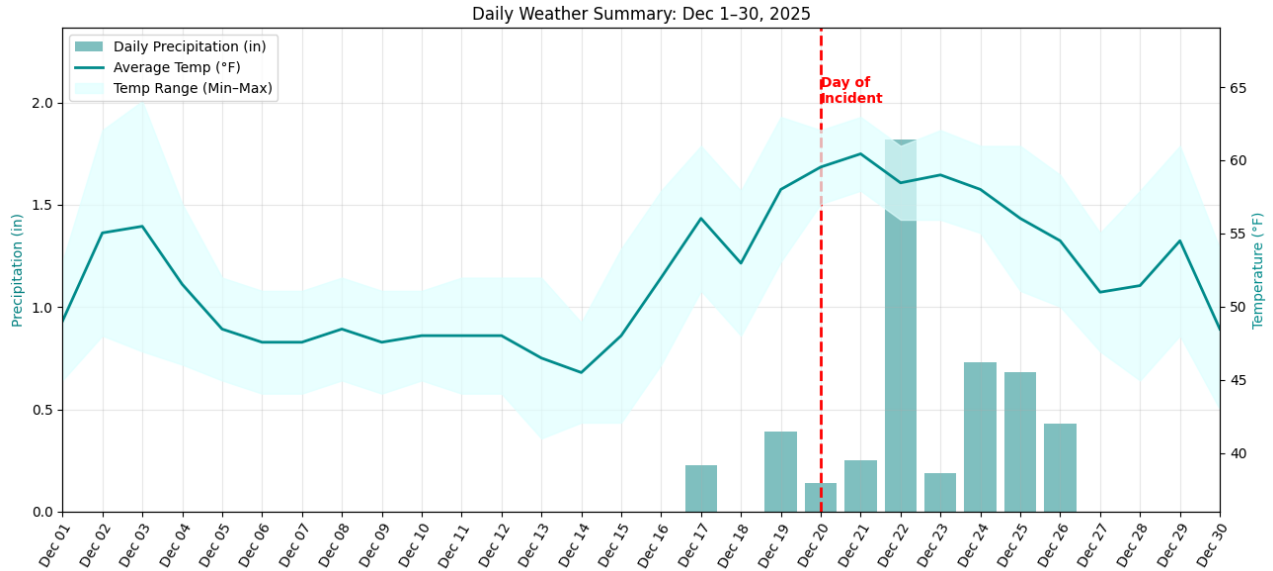
As shown in Figure 10, this is exactly the weather pattern that preceded the arc-flash event: two weeks of cool temperatures (averaging around 50°F) from December 1 through December 15, followed by a storm front that brought in higher temperatures (close to 60°F) and rain starting on December 17. The high dew points associated with that warmer rain event (close to 60°F) may have resulted in condensation on cool, unheated surfaces within the building that had come into thermal equilibrium with the approximate 50°F temperatures of the prior two weeks and were below the dew point of the ventilation air. Such cool surfaces could include electrical equipment that is either de-energized and/or not supplied with supplemental heat (as was the case for the Incident Cubicle). Weather data collected from the official National Weather Service San Francisco Airport Weather Station (NWS Code: KSFO), located approximately 13 miles from Mission Substation, indicate that the conditions at the time of the arc-flash event were around 57°F and 94% humidity, which corresponds to a dew point of 55°F.³⁷ A dew point of 55°F means that condensation will occur on any surface that is below 55°F. It should be noted that weather data from a personal weather station (PWS Code: KCASANFR1753³⁸) located less than one mile from Mission Substation indicates the conditions at the time of the event were around 59.9°F and 99% humidity, with a dew point of 59.5°F.³⁹

Figure 10. Daily Precipitation and Temperature data.⁴⁰

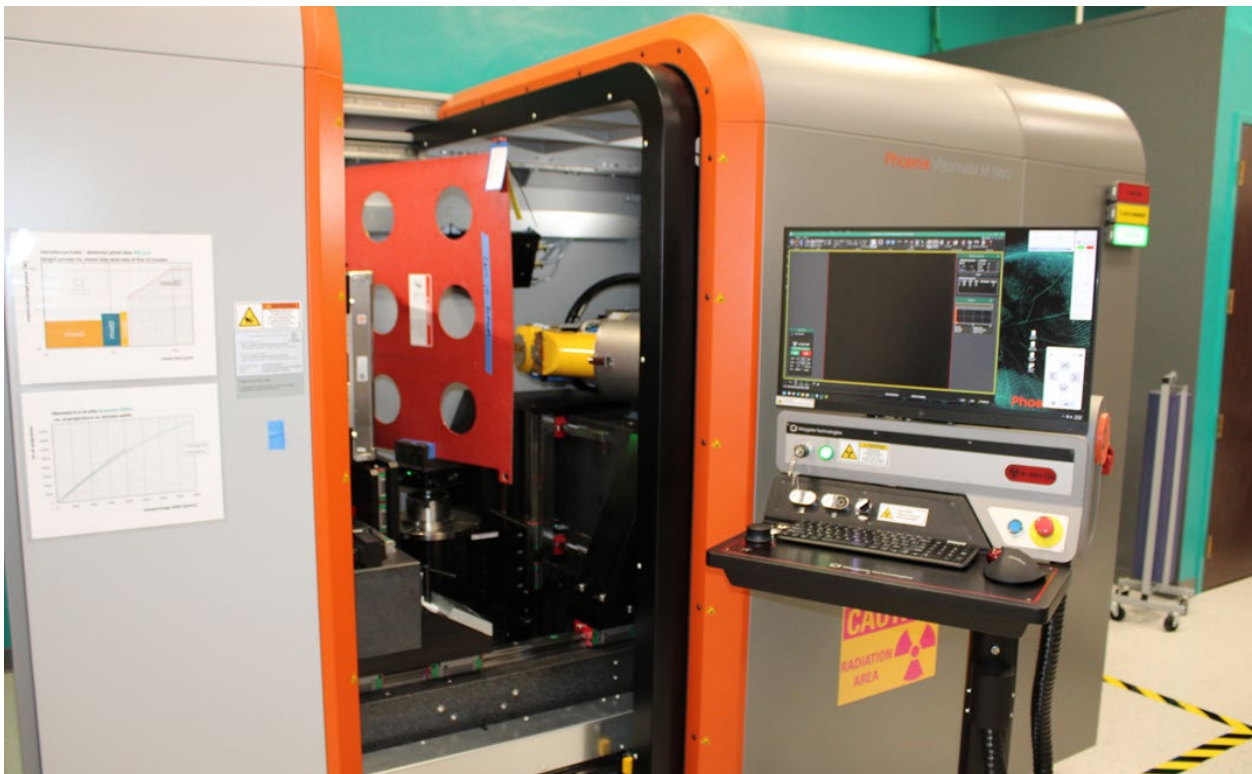
Exponent performed X-ray imaging on the barrier insulating boards from Cell No. 6 and Cell No. 10, focusing on the areas with visible physical damage. However, the damaged locations did not appear clearly in the X-ray scans due to the low-density composition of the boards and the nature of the damage. Figure 32 shows a barrier insulating board positioned inside the X-ray machine.

Figure 32. Barrier insulating board positioned inside the X-ray machine.

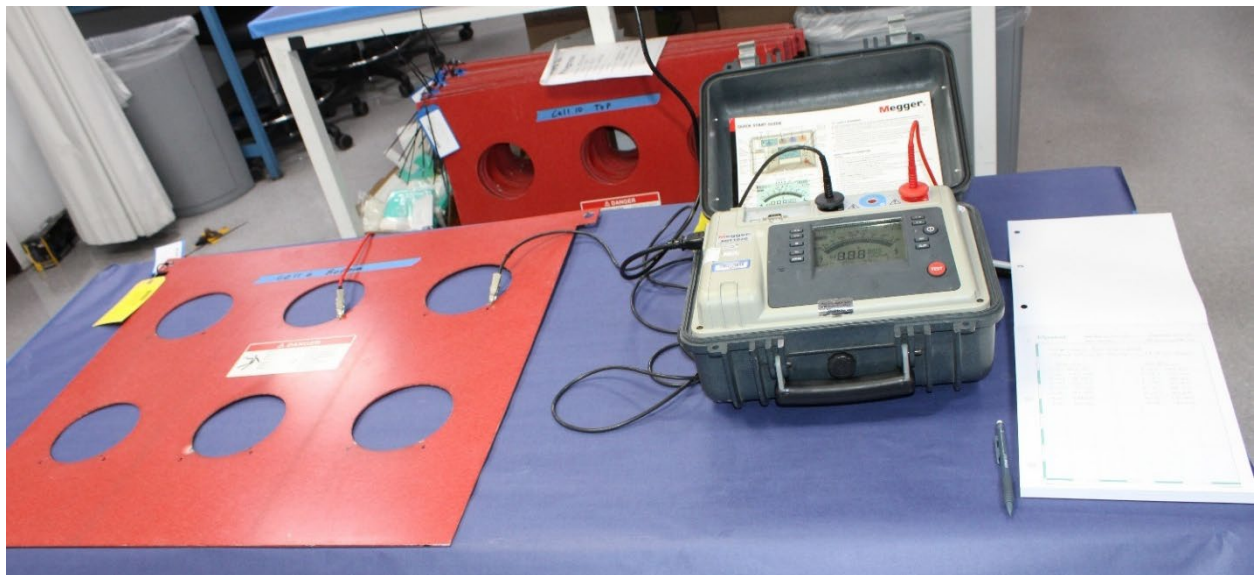
Exponent also performed insulation-resistance testing between selected locations near the edges of the through-holes on the barrier insulating boards from Cell No. 6 and Cell No. 10. Figure 33 shows the general setup for the insulation-resistance testing using a calibrated insulation tester. Figure 34 depicts the selected test locations on the barrier insulating boards. The marked locations corresponding to the insulation-resistance measurements for the barrier insulating boards from Cell No. 10 and Cell No. 6 are presented in Table 1 and Table 2, respectively. The insulation resistance tests were performed at 5 kV DC for the duration of one minute. The measured insulation resistances were all in the range of Giga Ohms (billion Ohms). Therefore, no meaningful differences between damaged and undamaged locations could be observed.

Figure 33. Insulation resistance test set up between selected locations on a barrier insulation board.

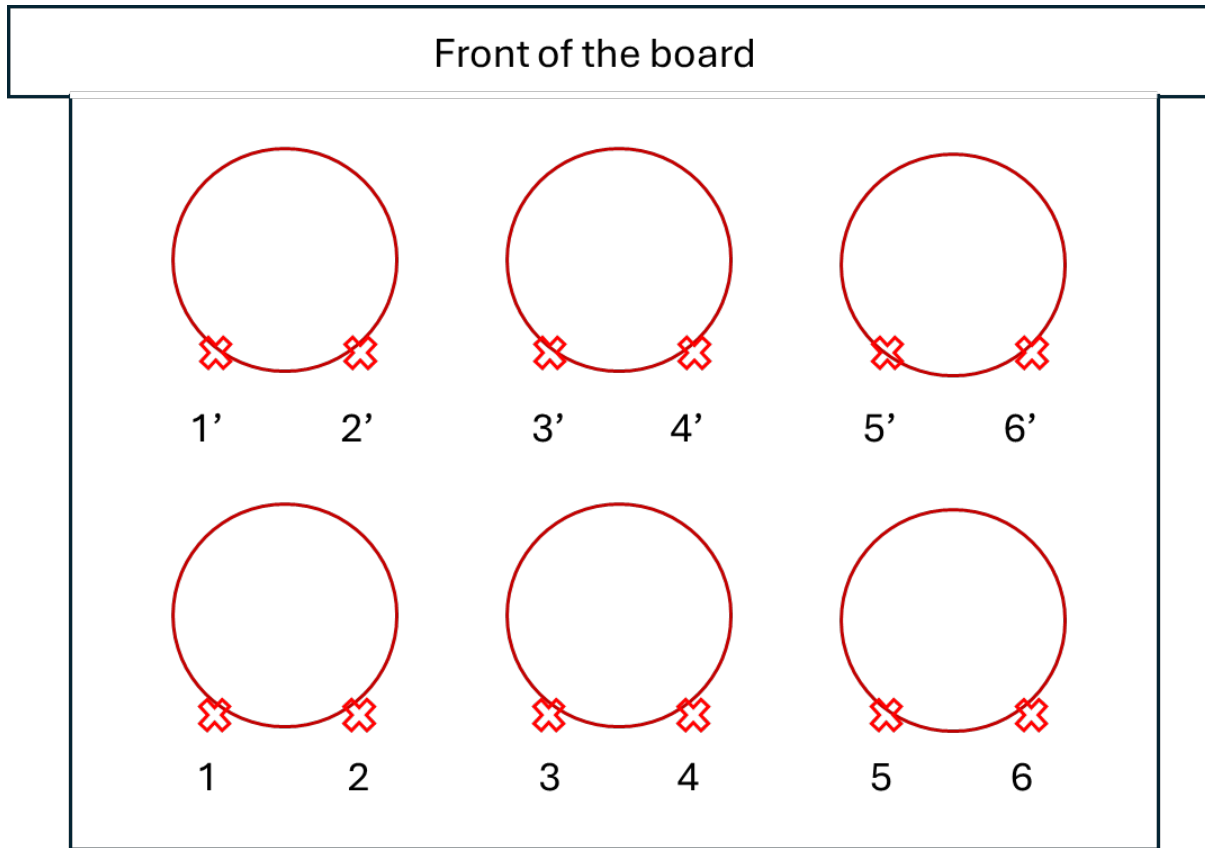
Figure 34. Schematic diagram of a barrier insulating board with numbering of the select locations for insulation resistance testing.

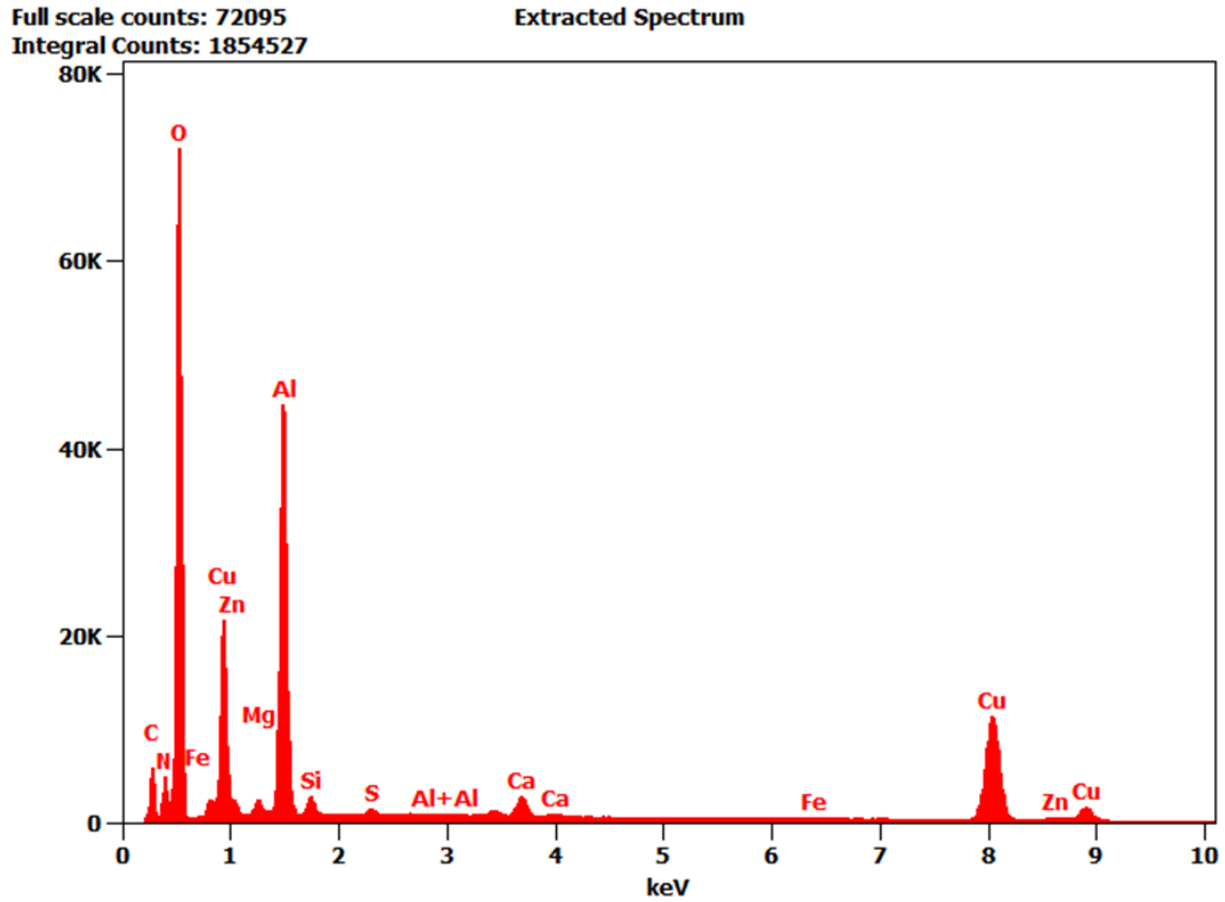
elements at a selected surface of the cut samples are presented in Figure 39. The elemental composition analysis did not reveal any unusual foreign species in the tested samples.

Figure 39. The EDS spectrum and the identified elements at a selected surface on the damaged area of the barrier insulating board from Cell No. 10 (bottom)

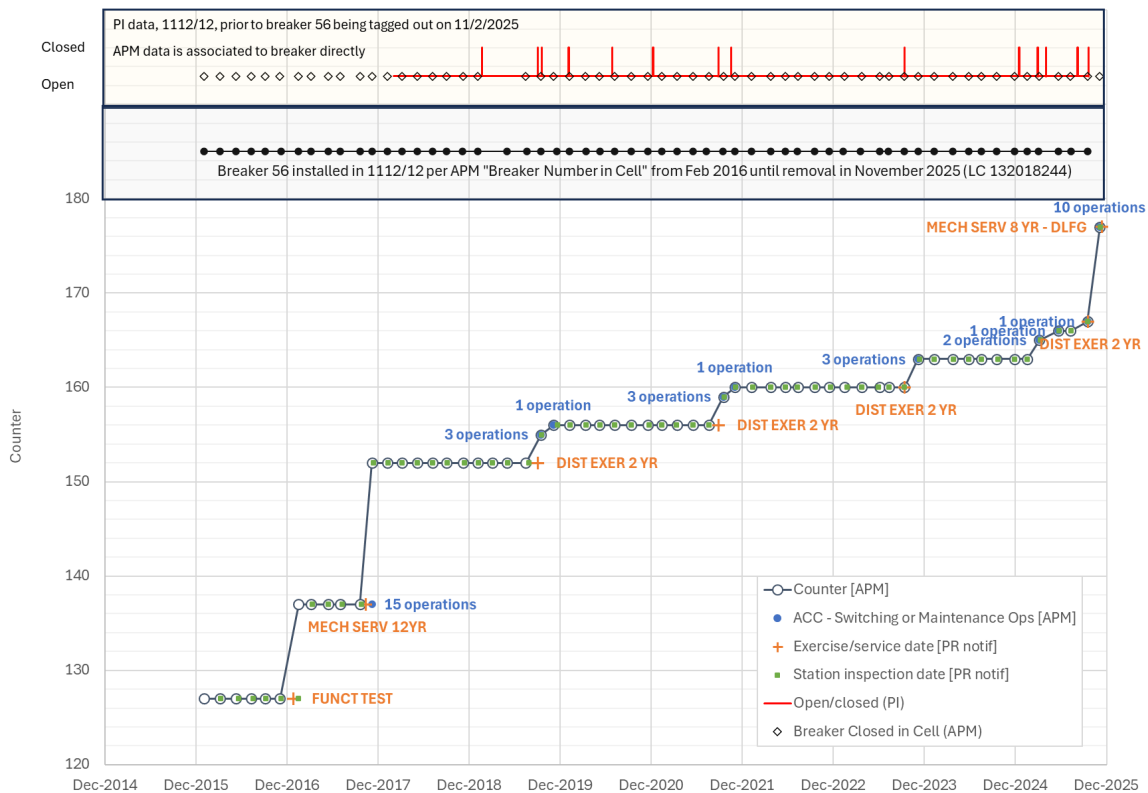
Figure 43. Circuit Breaker No. 56's operational history.

Figure 43 summarizes the operational history of Circuit Breaker No. 56. All operations in APM for Circuit Breaker No. 56 were under the “ACC – Switching or Maintenance Ops” indicator; any fault operation or counter discrepancy indicators had values of zero. In all cases, the number of recorded operations matches the change in the counter readings between successive inspections, and all changes in the counter coincide with preventative maintenance (exercise or mechanism service) at the intervals described in Section 5.2.1 below. EDPI shows that the breaker was only closed for short durations, consistent with the station inspection data in APM showing the breaker position as open (also see the details of the previous year in Figure 42). While most operations in EDPI occur at a similar time as counter changes reported in APM, there are some operations, such as in early 2019, that do not appear to have a corresponding change in the APM counter.

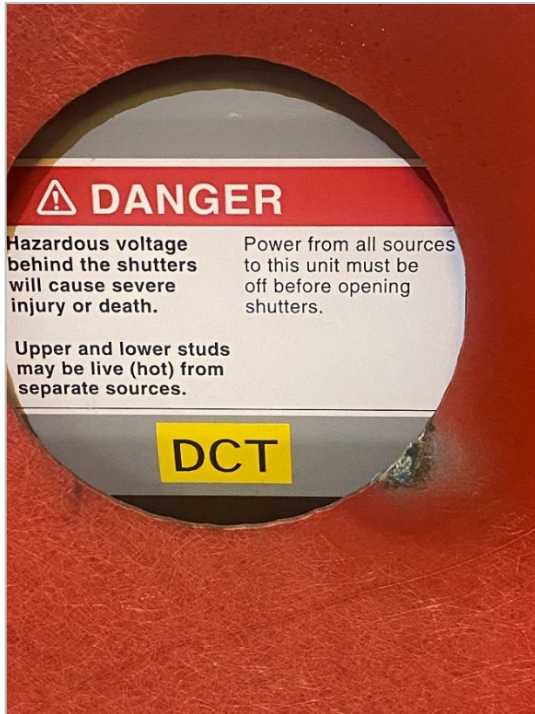
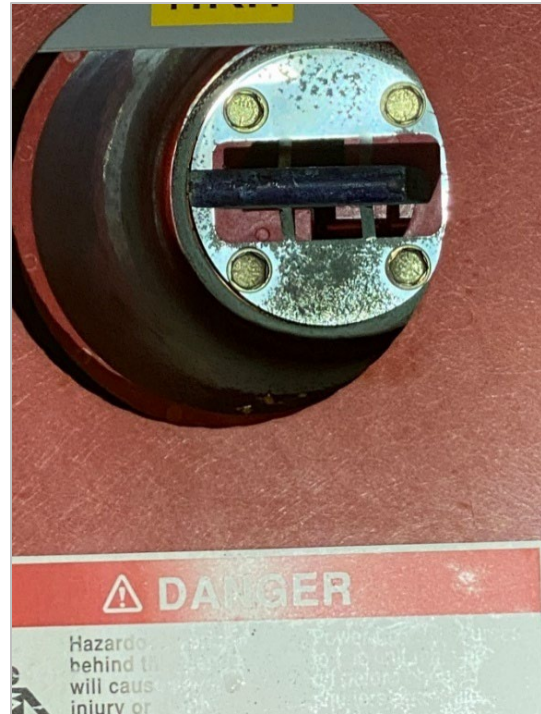
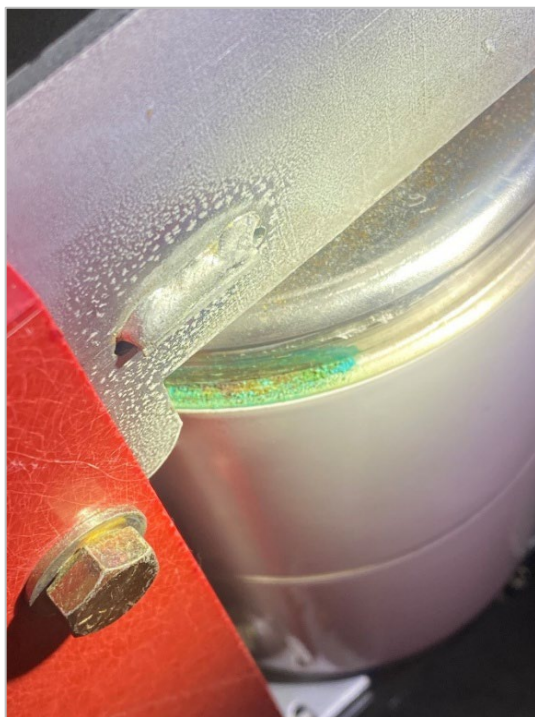
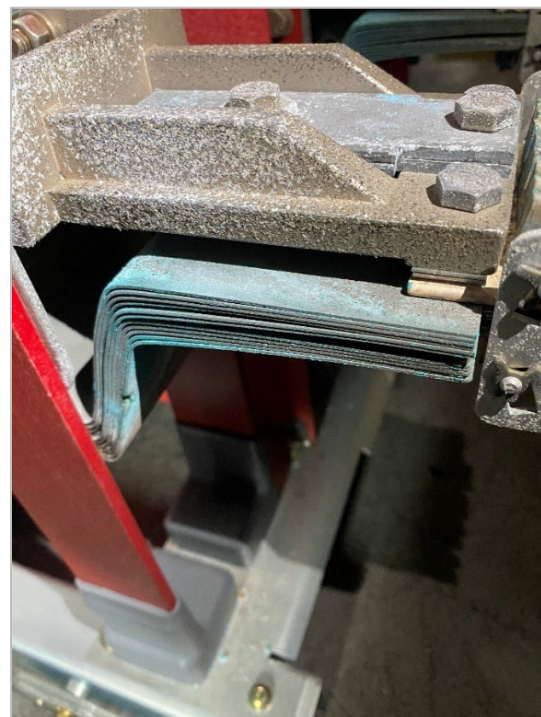
Figure 45. Photos of identified damage to Incident Cubicle and Circuit Breaker No. 56. a) Incident Insulating Board feeder side (bottom row) B-phase (middle) through-hole, b) Line side (top row) B-phase bus contact, c) B-phase vacuum bottle-top view, d) Feeder side (bottom row) C-phase breaker arm. Photo taken November 2, 2025 (courtesy PG&E).
