November 19, 2017

Prepared for San Francisco Arts Commission

Condition Assessment

This site specific artwork is the Diamond Heights Safety Wall, 1968, by Stefan Alexander Novak (b.1918-2006).

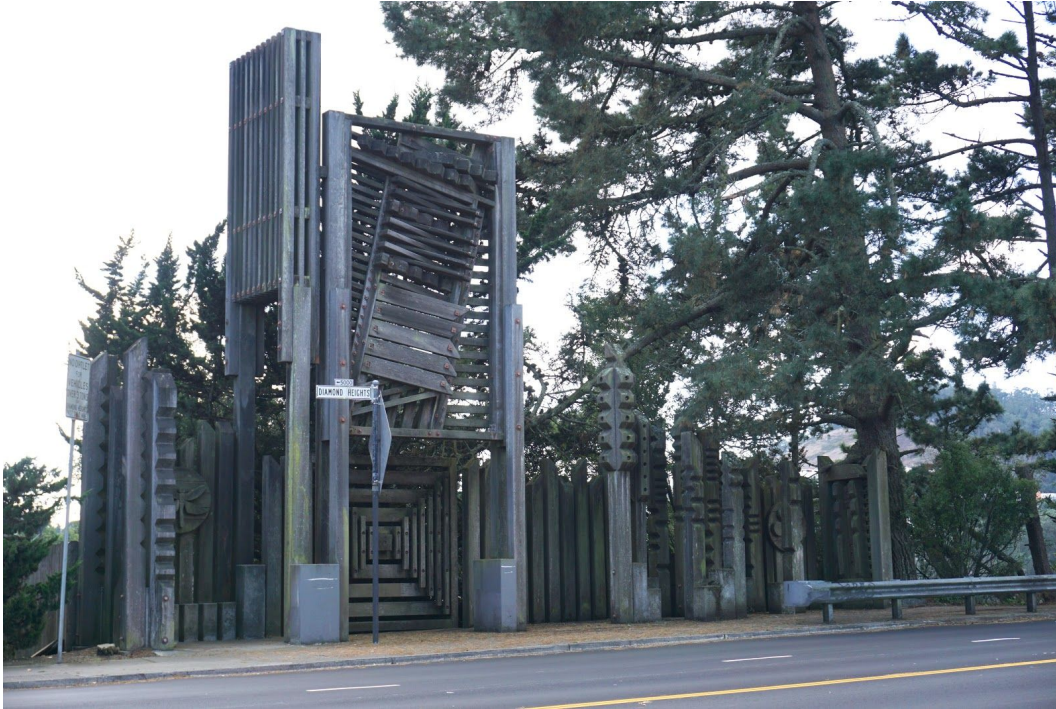
Overall Front View

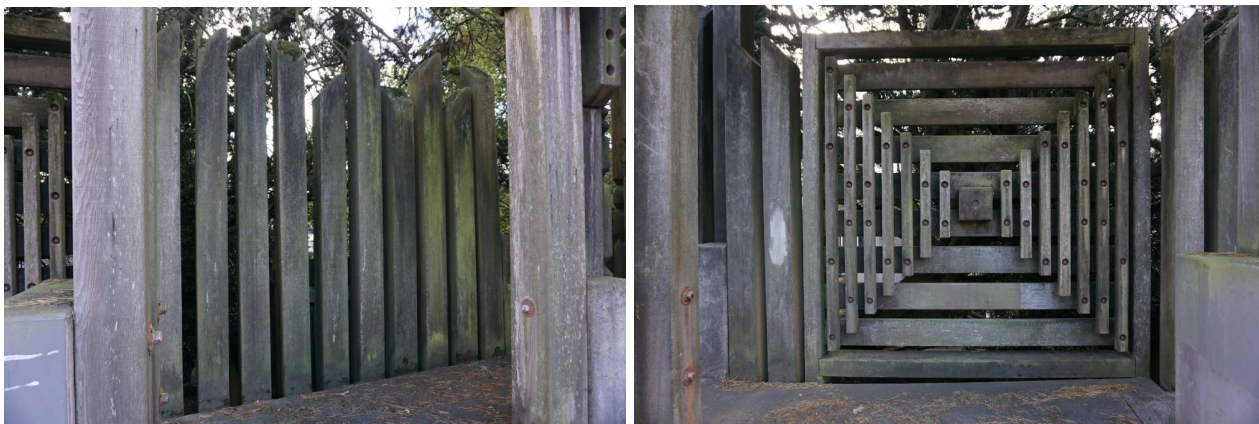
Group 5 (Left) and Group 6 (Right)

- Structural: Corner brackets helping to keep Group 6 in square were rusted with deteriorated paint layers.
- Structural: The redwood posts are generally in remarkably good condition with no signs of wood rot or beetle infestation.

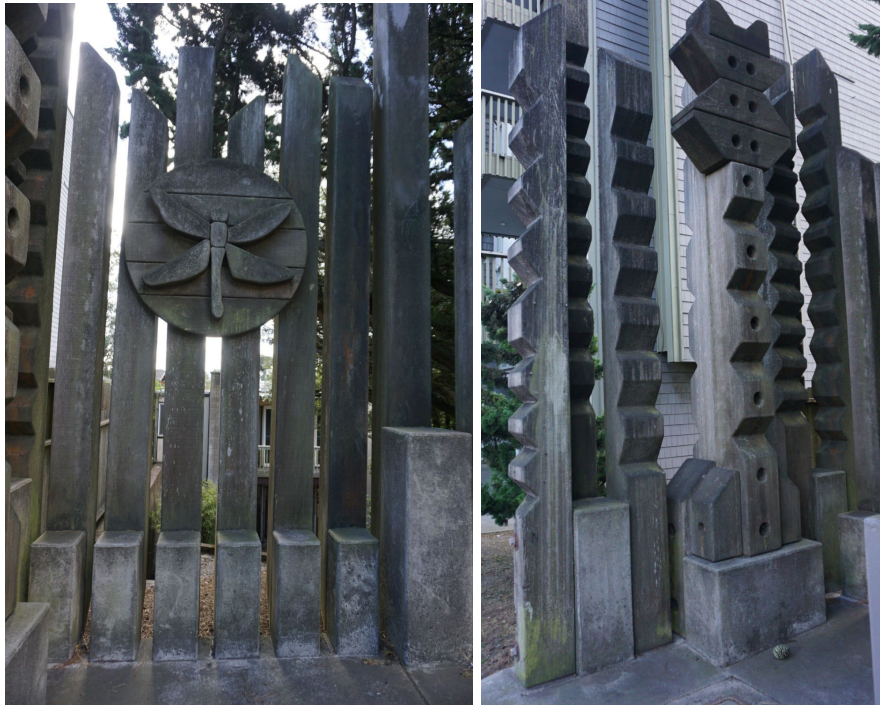
Group 7 (Left) and Group 8 (Right)

- The outermost post of group 8 that faces the road, has a large loss to the timber at the bottom of the post. This is possibly from a collision or vandalism, and does not appear to appear to be from wood rot or infestation. (See Figure 5)

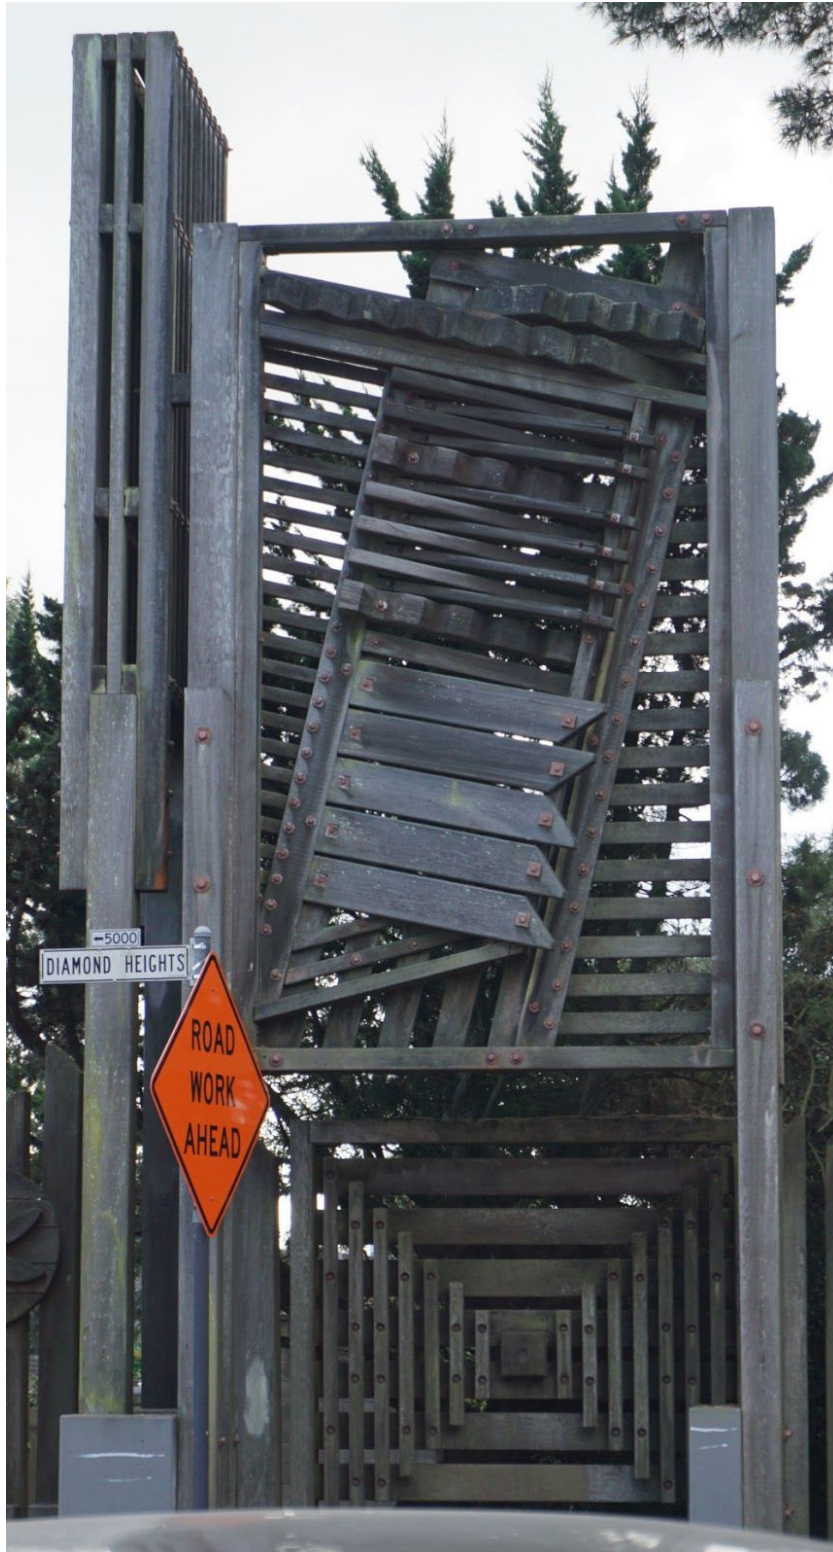
Main Group, 'Tower'

- There are a number of areas where graffiti has been scratched in and tags painted over. Painted over tags were noted on both redwood posts and most of the concrete blocks. It also appears that people may have climbed the 'tower' and graffitied in white paint on upper areas. (See Figure 6)
