1 [Planning Code - Designation of 149-155 9th Street (aka the Western Manufacturing  
2 Company Building)]

**ARTICLE 11 HISTORIC BUILDING REPORT**

Detailed Exterior Cleaning Recommendations

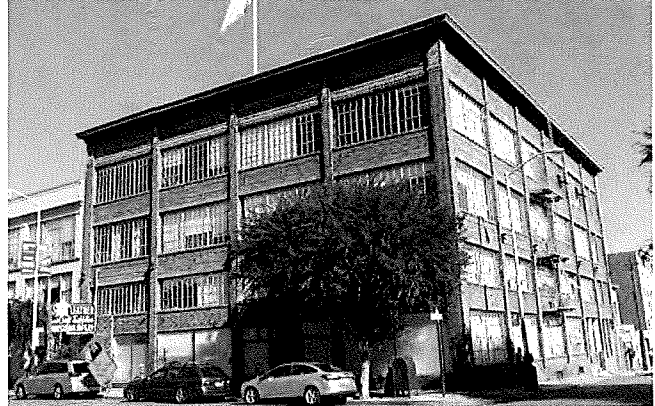
General building features appear in good to fair condition. Any specific concerns or points of note are detailed within each individual section. There is some noticeable soiling of the building base and trash/debris at sidewalks along both the south and west (Natoma Street and 9<sup>th</sup> Street respectively). The north and east elevations have some locations of noted paint/graffiti.

Figure 1. 149 9th Street; view from 9th Street looking east.

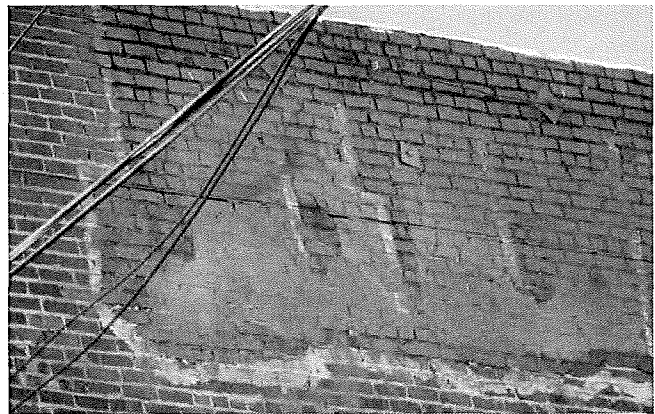
Figure 2. East Elevation; note graffiti & paint to be removed.

Power wash exterior of building prior to maintenance work. Utilize low-pressure spray only (100-800 psi), keeping fan tip nozzle minimum of 6 inches away from surface being cleaned. Higher pressure washing can damage masonry.

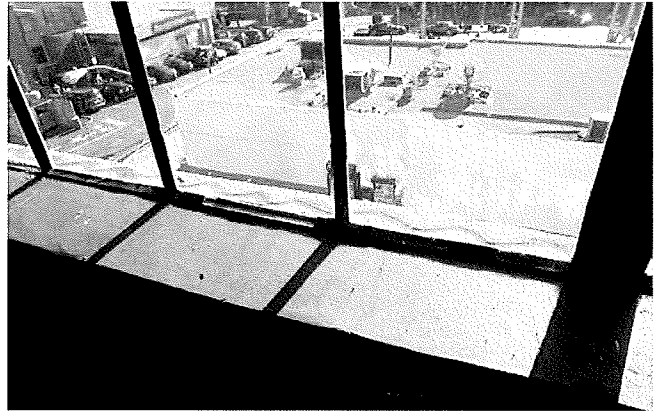
Figure 1: Window sills with concrete parge, typical.

Perform visual inspection of parged concrete with binoculars, spotting scope, or similar annually for cracks, spalls, and other signs of deterioration. Perform sounding of parge for indication of deterioration. Repair as needed.

Prepare, prime, & seal parged concrete and install new sealant every 10 years, or as needed.

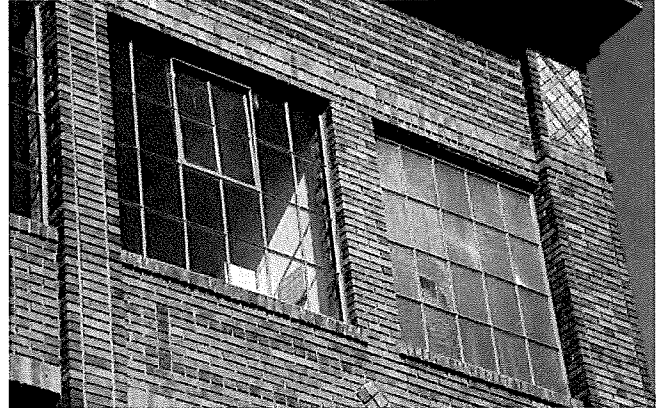
Steel multi-lite window sash are extant at primary facades (west above ground floor and at south) and facing the access alley along the north elevation. The windows are fixed sash with an operable awning-swing sash in the center of each window section. The size of each operable sash varies in certain locations. These windows are generally in good condition, with localized areas of cracked and deteriorated glazing putty. Clear glazing is installed in the majority of windows, though the windows in the eastern-most bay along the south elevation (Natoma Street) have wired glass.

Figure 1. Typical multi-lite steel windows; note operable sections and glazing types.

Define various types of glazing and determine original design. Remove existing broken or mismatched glass & replace with new to match original. Consider weight and profile of steel with regards to accommodating new glazing system. Explore potential for energy efficient replacement glass, laminated glass and/or glazing films.

Any window replacements should be made in kind, with new windows matching the materials, size, profiles, and dimensions of the original.

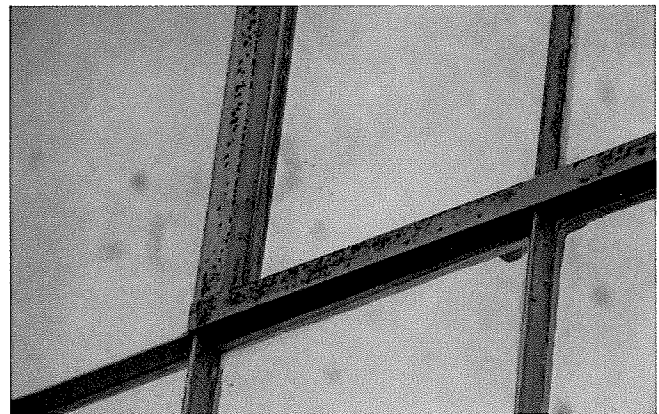
Figure 2. Steel window frame details

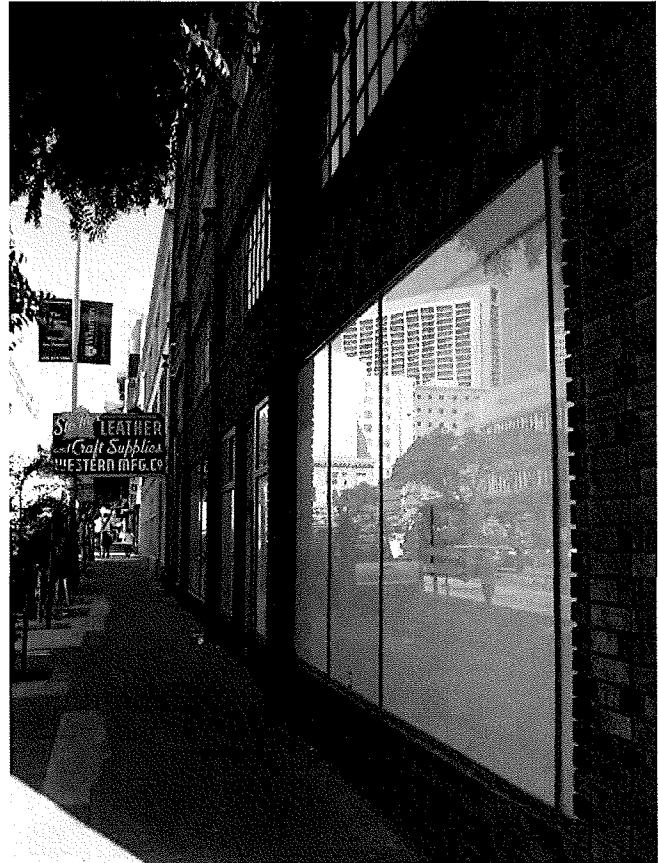
Figure 1. Typical Storefront at west elevation.

Inspect frames, glazing seals and sealants. Repair as needed.

Inspect framing, glazing seals and sealants for deterioration annually. Install new sealant every 10 years, or as needed. Prepare, prime, paint and seal every 5 years.

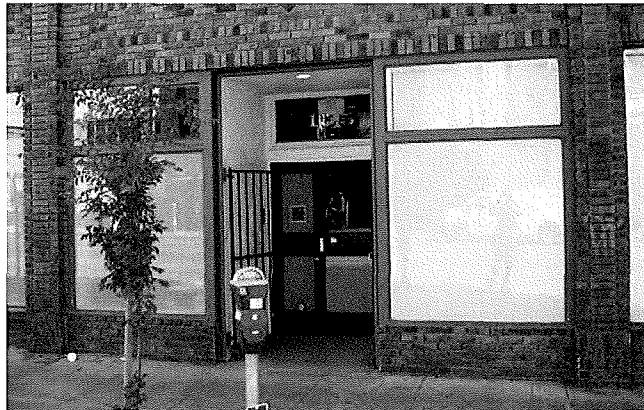
The wood frame storefront system occupies the center bay at the first floor west (9th Street) elevation, with a recessed entrance central at this location. The lower, larger panes of glass are set in a steel frame similar to those found within the other bays. The transoms are fixed with wood stops. The entire assembly is painted. The recessed entry has a concrete floor leading to a metal door with metal sidelight and transom (see *Feature III-E: Exterior Door Type B – Metal*). The entire assembly appears to be in good condition.

Figure 1. Storefront at west elevation.

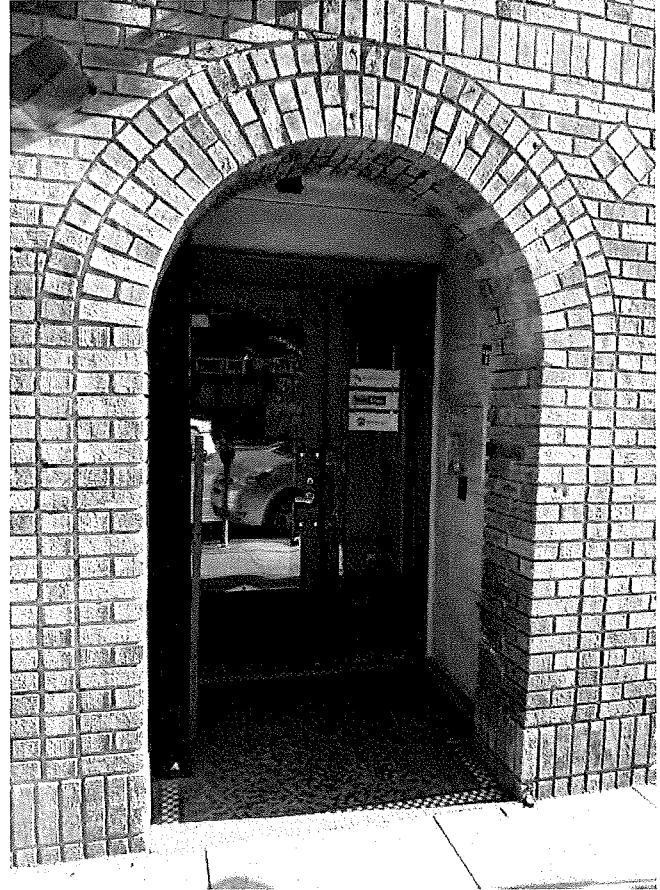
Figure 1. Entrance at northwest corner.

Due to noted security issues at northwest entrance door, consider replacement of security gates at entrances. Replacement gates should be comparable with existing gates along Natoma Street.

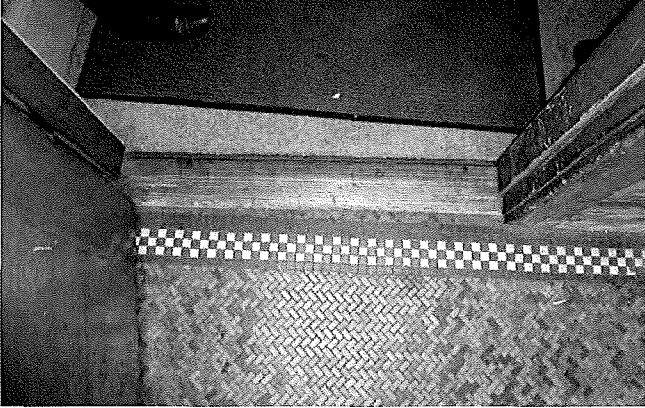
**Figure 2. Threshold at wood entry door.**

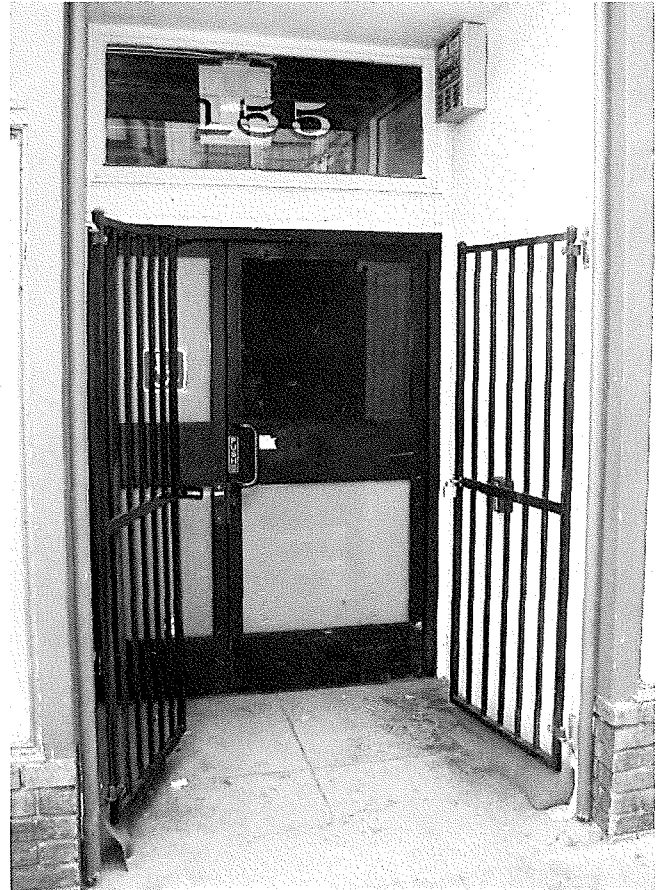
Figure 1. Metal entry door at west elevation.

Inspect door hardware, glazing seals and sealants. Lubricate doors and operating hardware. Install weather-stripping as required. Prepare, prime, paint and seal door and frames as needed.

Inspect door hardware, glazing seals, sealants and weather stripping for deterioration annually. Lubricate doors and operating hardware annually. Repaint doors and door frames as needed. Install new perimeter sealant every 10 years or as needed.

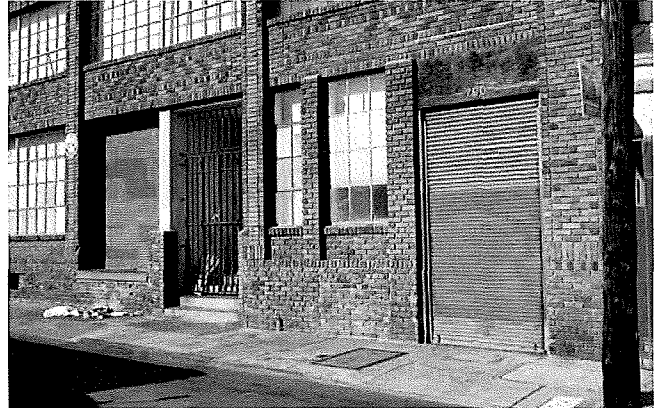
**Figure 1. Service doors along south elevation.**

Inspect door, door frame, door hardware and sealants. Repair as needed. Repaint doors and door frames.

Inspect door, door frame, door hardware and sealants for deterioration annually. Repair & repaint as needed.

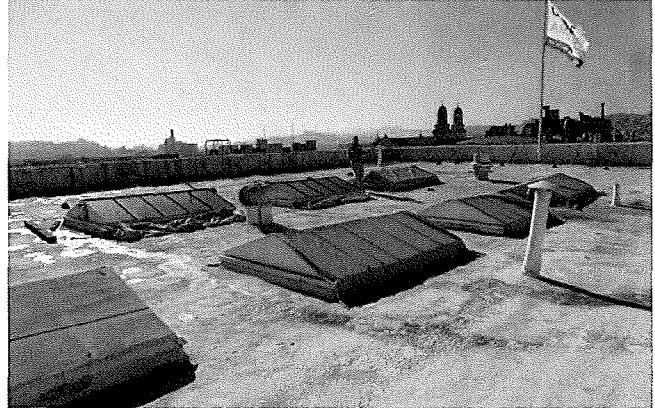
Figure 1. Roof overview; note skylights.

Inspect steel framed skylight for deterioration and water protection annually, including metal corrosion as well as paint and glazing sealant failure. Repair as needed. Install sealant and/or glazing putty as needed. Prepare, prime, paint and seal every 5 years.

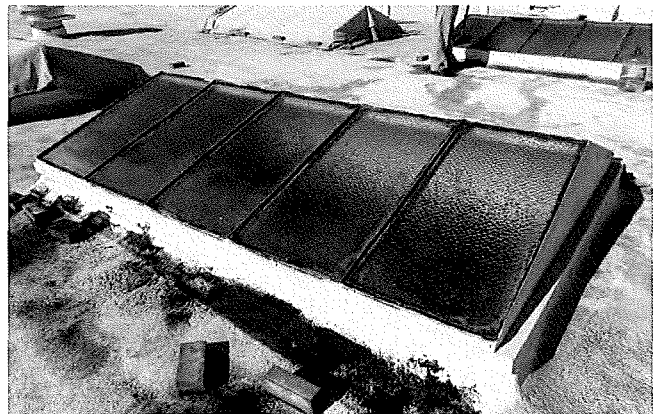
Figure 2. Typical skylight.

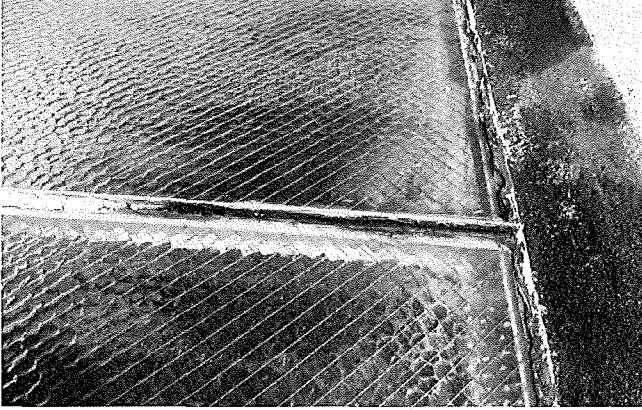
*Figure 3. Skylight typical frame conditions.*

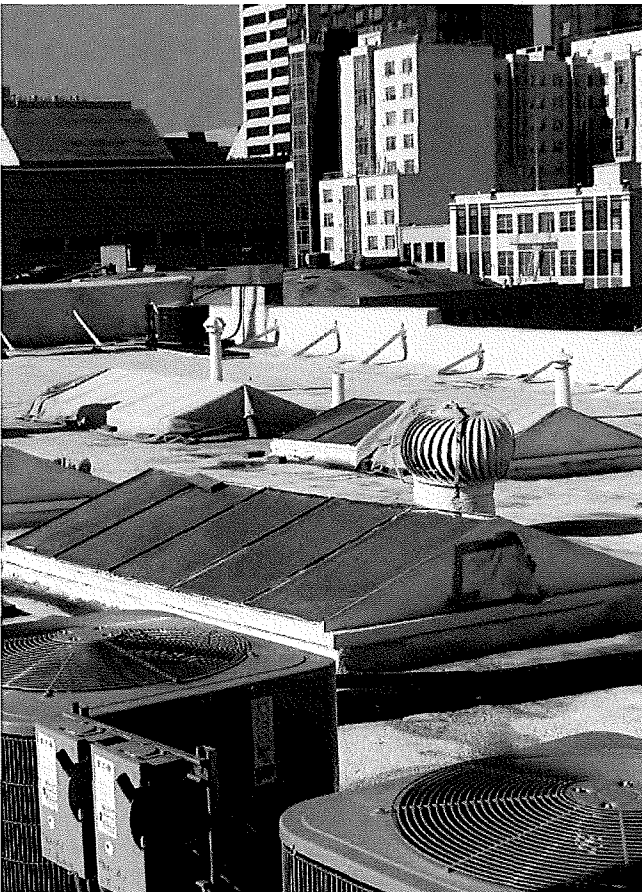
*Figure 4. Skylight; note covered ventilation grilles.*

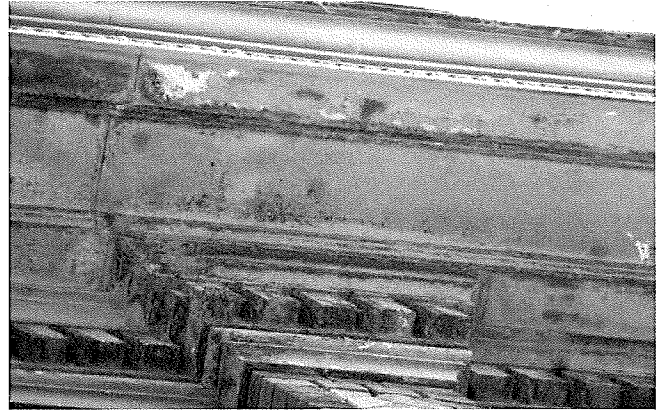
**Figure 4. Cornice; conditions noted as typical.**

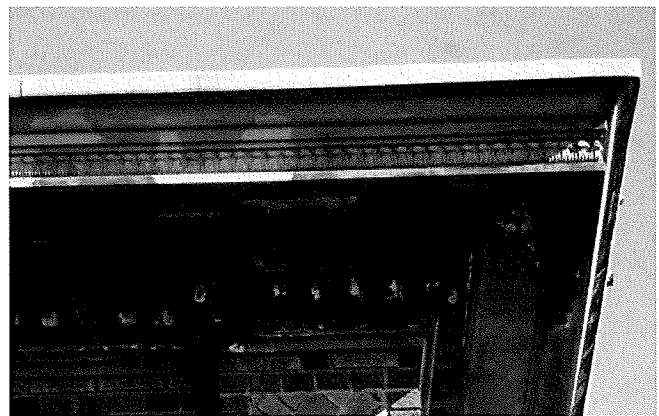
**Figure 5. Cornice at southwest corner.**

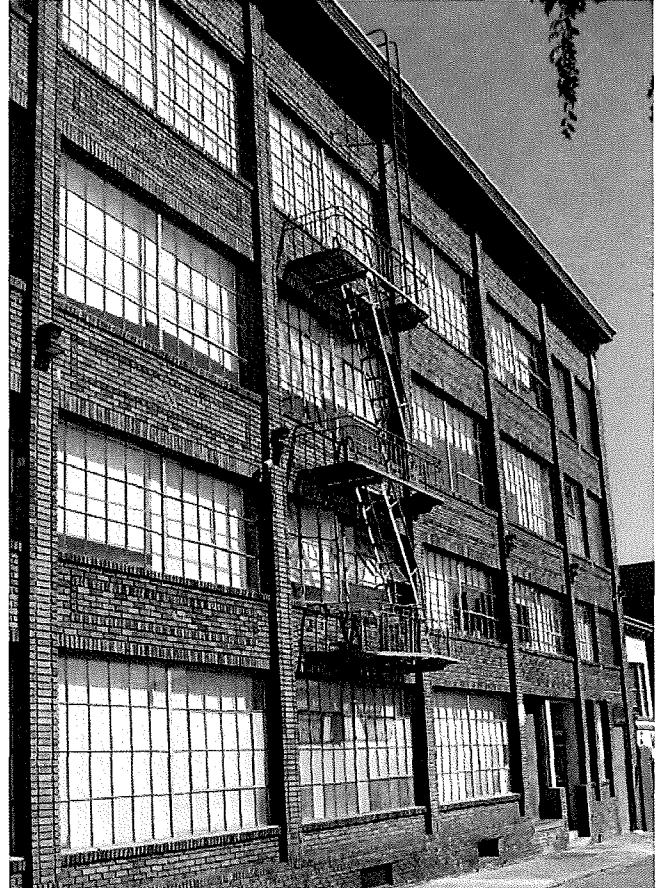
Figure 1. Metal fire escape at south elevation.

Metals should be compatible with, or isolated from, adjacent materials to avoid galvanic action and corrosion.

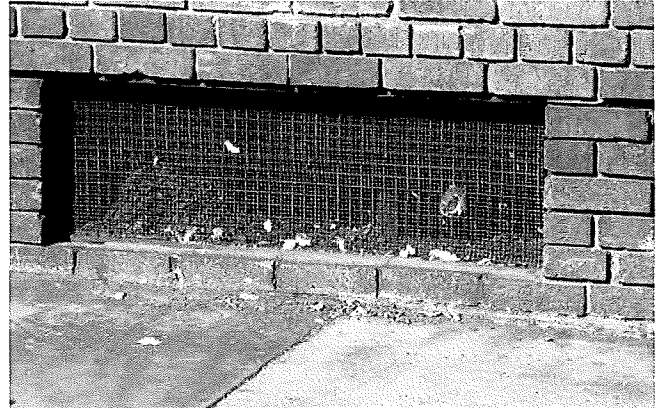
**Figure 1. Ventilation grilles; note 1"x1" historic iron grille.**

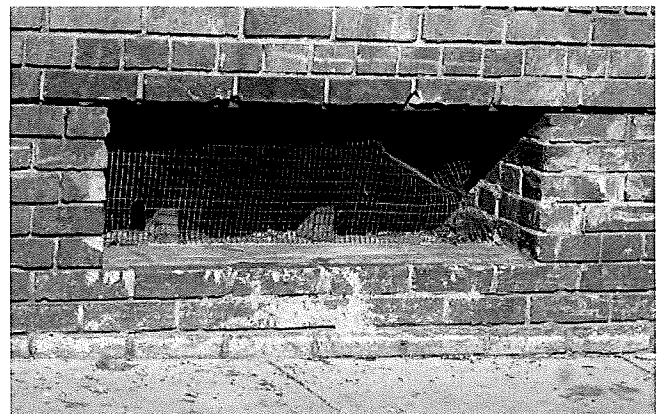
**Figure 2. Ventilation grilles; replicate historic pattern from adjacent grille.**

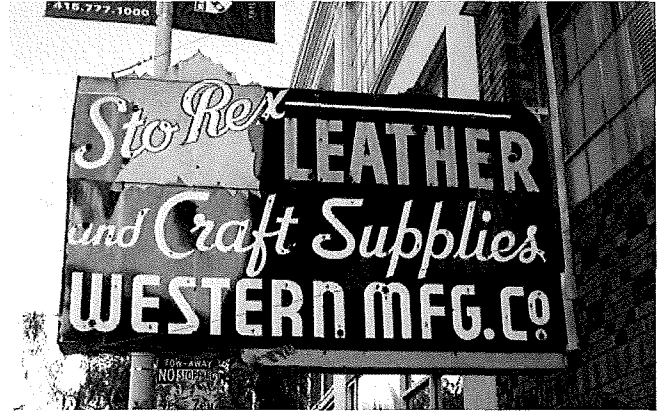
Figure 1. Projecting Sign along 9th Street (west elevation).

Perform visual inspection of sign annually for corrosion, paint and other signs of deterioration. Repair as needed.

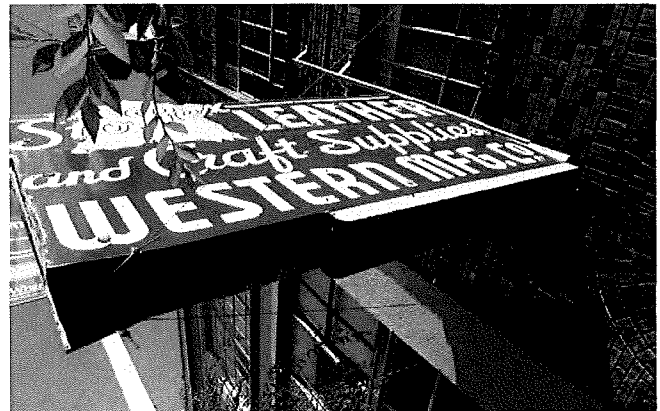
Figure 2. East Elevation, note graffiti & paint to be removed

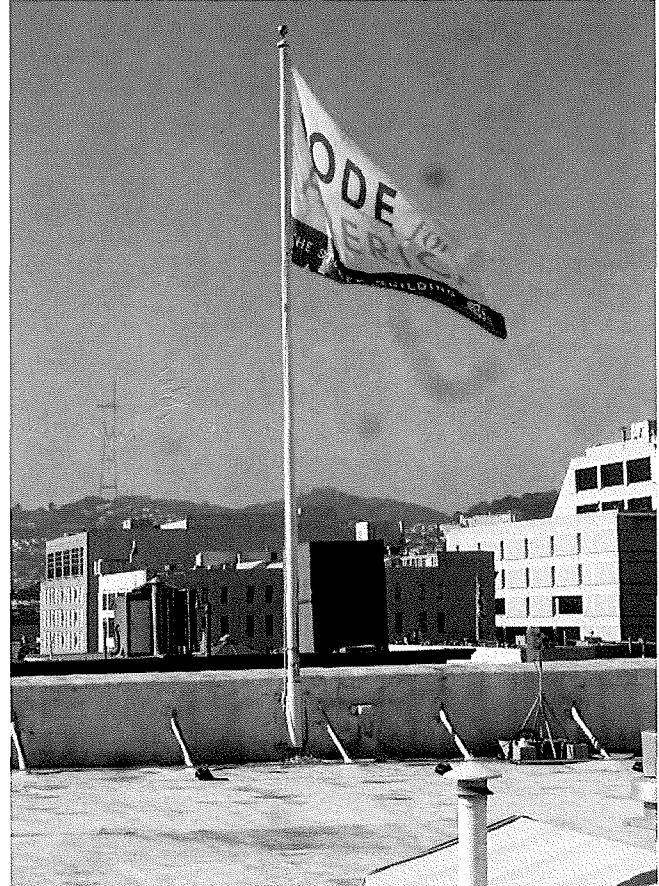
The flagpole is aligned with the center pier on the west (9<sup>th</sup> Street) elevation. The flagpole is anchored at its base to the roof parapet at this location and has a steel round metal finial at its top. The flagpole and base appear in good to fair condition.

Figure 1. Flagpole along west elevation.

Conditions of flagpole and base should be re-evaluated in coordination with any major roof work.

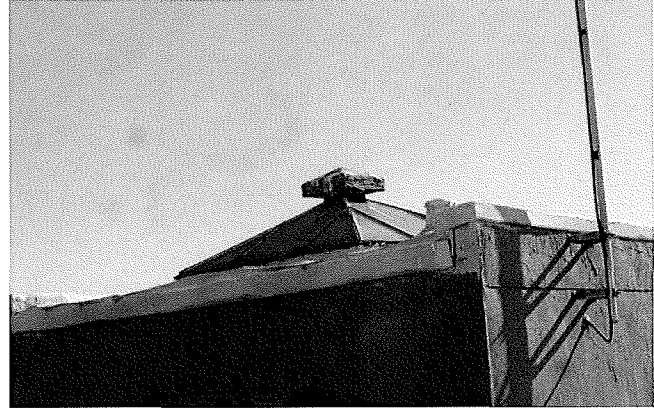
One steel framed skylight is located above the sheet metal penthouse at the southeastern corner of the roof. The skylight is pyramidal with a sheet metal vent at the apex. The skylight was not accessible but appears to be in fair condition, and there are no known water intrusion issues at the skylight. The sheet metal vent also appears to be in fair condition with failing paint.

**Figure 1. Roof & ventilator at penthouse.**

Inspect for broken/cracked glass and inspect sheet metal ventilator for deterioration. Patch sheet metal and repair as needed.

Inspect steel framed skylight for deterioration and water protection annually, including metal corrosion as well as paint and glazing sealant failure. Repair as needed. Install sealant and/or glazing putty as needed. Prepare, prime, paint and seal every 5 years.

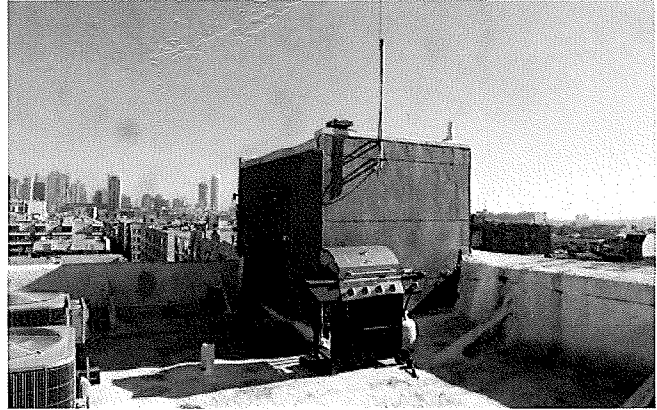
The painted sheet metal penthouse is located at the southeastern corner of the roof and appears to be in fair condition.

**Figure 1. Penthouse from roof, typical.**

Inspect sheet metal siding for deterioration and corrosion annually. Patch, repair or replace as needed to match original. Prepare, prime, paint and seal.

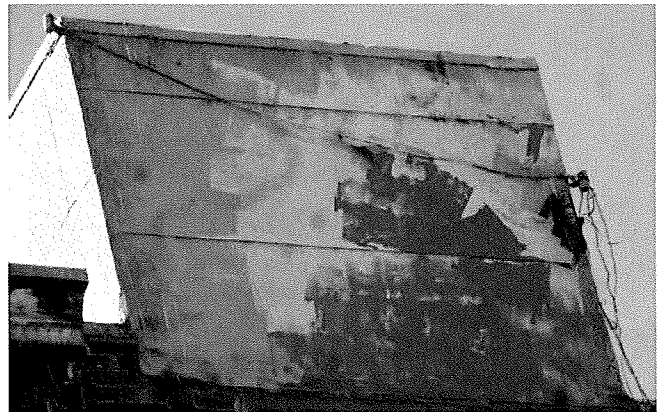
**Figure 2. Penthouse from grade (east elevation).**

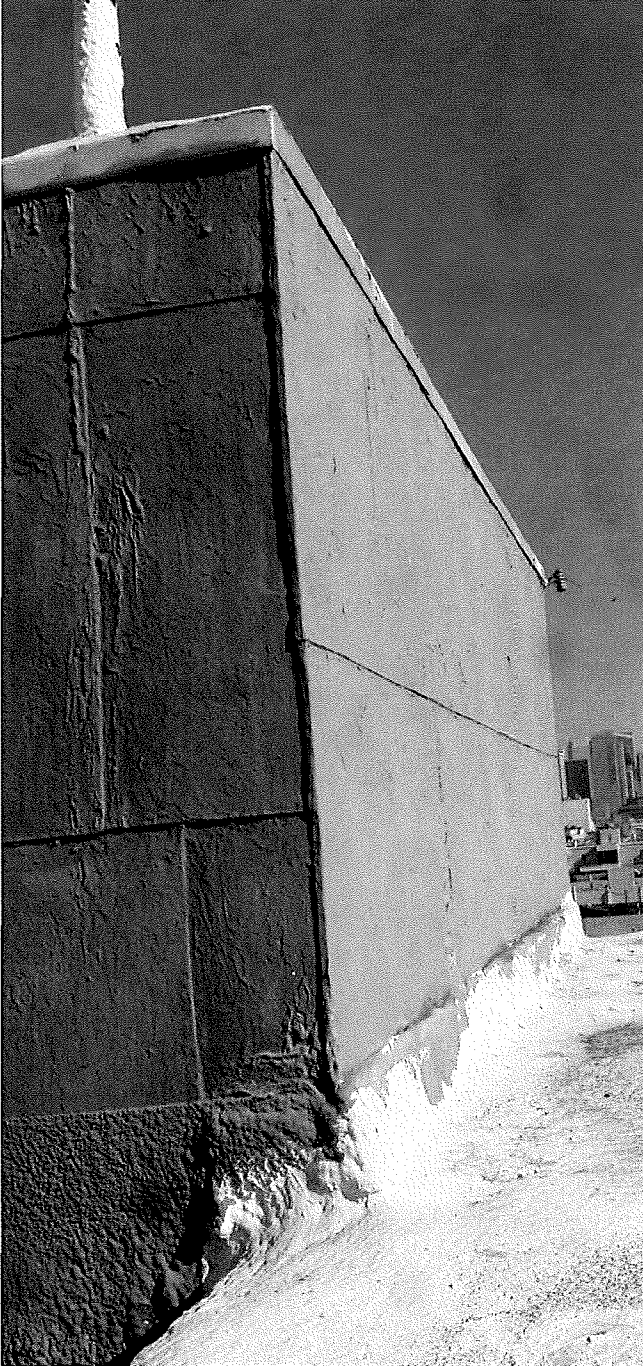
*Figure 3. Enlarged view of penthouse.*

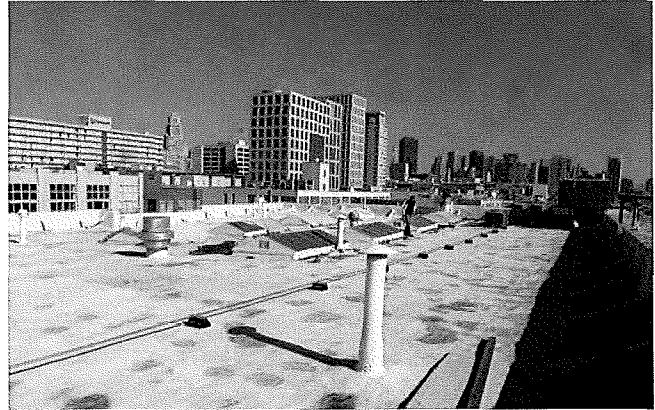
A few locations of distress were noted at the roofing membrane, resulting in what appear to be small tears. A larger puncture below the flag pole appears to be related to installation/adjustment of the flag pole.

Figure 1. Roof of 149 9th Street, typical.

Inspect roofing membrane for signs of deterioration and water penetration annually. Install patches and repair as needed. Repair as needed.

If inspection reveals existing or potential greater damage, consider full replacement of roofing membrane. When replacement of the roofing membrane occurs, coordinate replacement with all necessary flashing and waterproofing, including at skylights, penetrations, parapet braces, etc., and install new sheet metal parapet flashing. Roof drainage and proper slope should also be coordinated during roofing replacement.

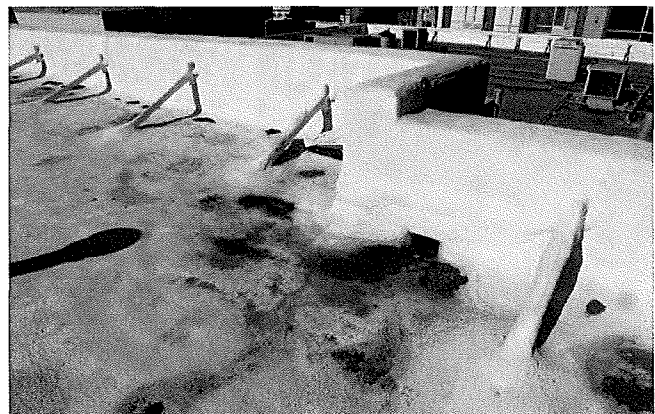
Figure 2. Roof at drainage opening in parapet; note parapet bracing and conditions near opening.

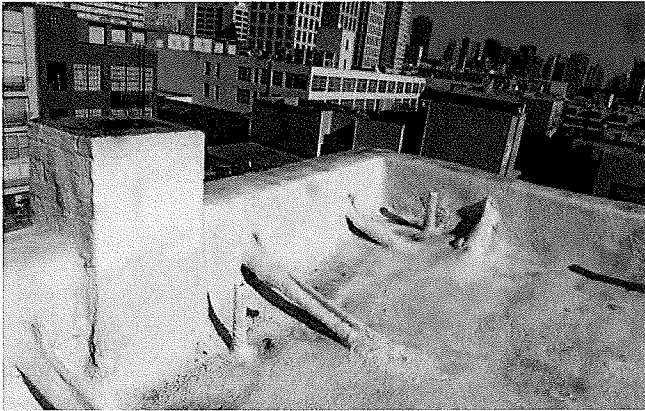
**Figure 3. Roof at northeast corner, typical.**

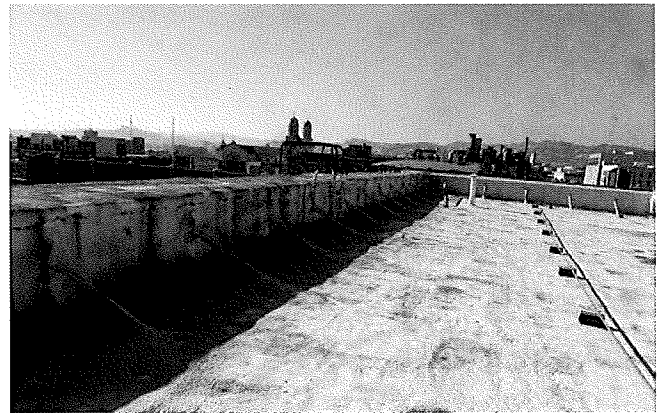
Figure 3. Parapet with bracing, typical.

Inspect parapet wall and copings for deterioration annually. Repair as needed. Prepare, prime, paint and seal copings every 5 years, or as needed. Coordinate inspection and repair work in connection with general brick and roofing repairs.

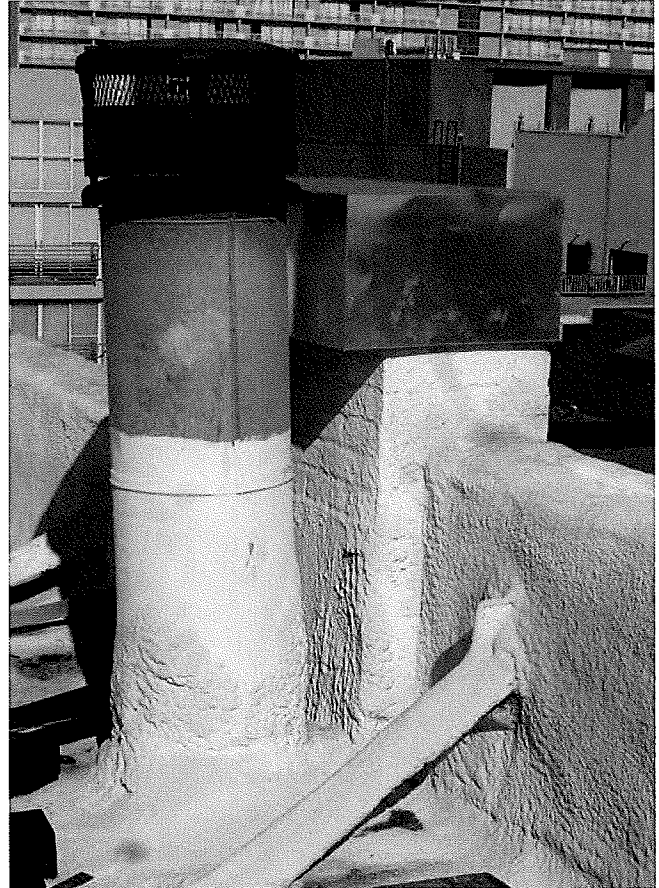
Figure 1. Unbraced ventilation stack with sheet metal cap, typical.

Inspect flashing and caps annually. Consider caps or flashing/protection for the vent stacks (if not in use). Prepare, prime, paint and seal. Inspect annually for cracks or other signs of movement at the stacks. Repair as needed.

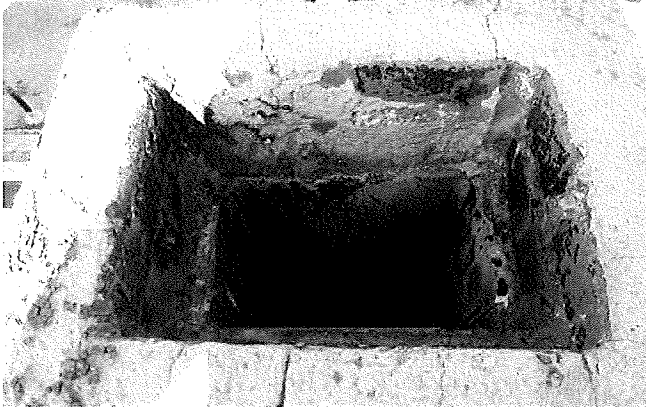
**Figure 2. Open ventilation stack on north wall; cover with sheet metal as needed.**

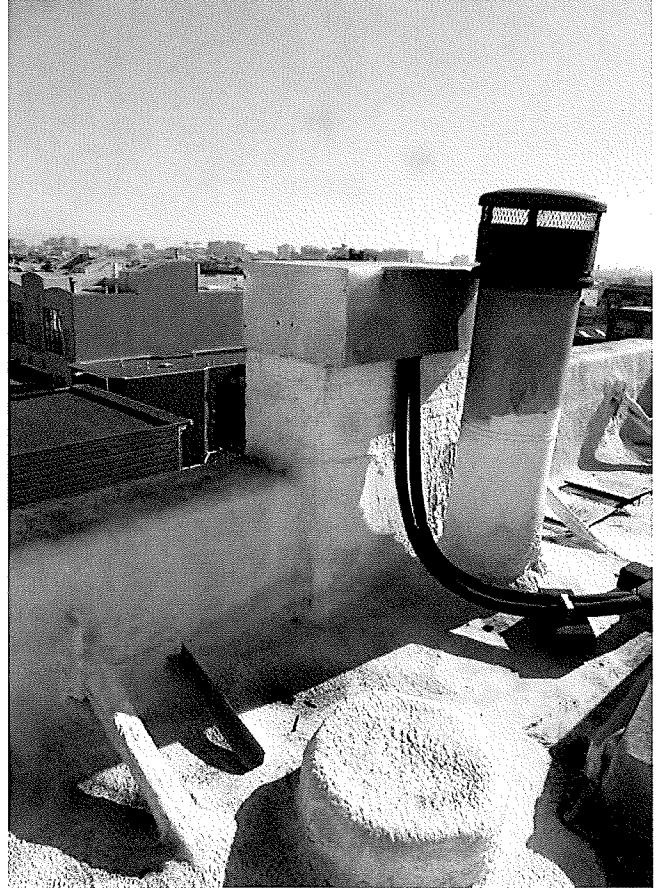
**Figure 4. Capped ventilation stack and mechanical exhaust flue; note re-use of ventilation stack for services.**
