Re: Transmittal of Planning Department Case Number 2013.0910L:
149-155 9th Street, Article 11 Change of Designation
BOS File No: _____ (pending)
Historic Preservation Commission Recommendation: Approval

RESOLUTION TO RECOMMEND TO THE BOARD OF SUPERVISORS AN ARTICLE 11 CHANGE OF DESIGNATION FOR 149-155 9TH STREET, LOT 048 IN ASSESSOR'S BLOCK 3728, AS A CATEGORY III (CONTRIBUTORY) BUILDING PURSUANT TO SECTION 1106 OF THE PLANNING CODE

ARTICLE II HISTORIC BUILDING REPORT

MAINTENANCE PLAN

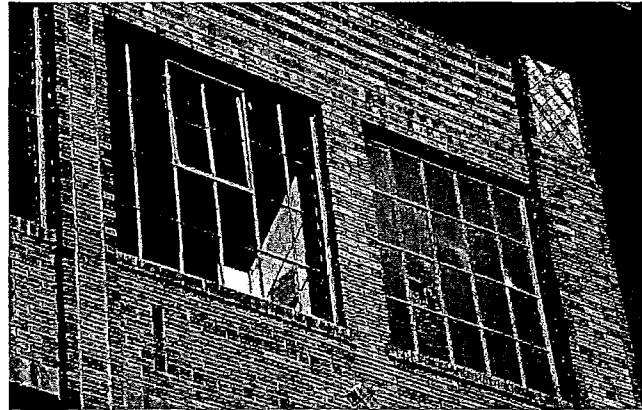
Steel multi-lite window sash are extant at primary facades (west above ground floor and at south) and facing the access alley along the north elevation. The windows are fixed sash with an operable awning-swing sash in the center of each window section. The size of each operable sash varies in certain locations. These windows are generally in good condition, with localized areas of cracked and deteriorated glazing putty. Clear glazing is installed in the majority of windows, though the windows in the eastern-most bay along the south elevation (Natomia Street) have wired glass.

Figure 1. Typical multi-lite steel windows; note operable sections and glazing types.

Define various types of glazing and determine original design. Remove existing broken or mismatched glass & replace with new to match original. Consider weight and profile of steel with regards to accommodating new glazing system. Explore potential for energy efficient replacement glass, laminated glass and/or glazing films.

Any window replacements should be made in kind, with new windows matching the materials, size, profiles, and dimensions of the original.

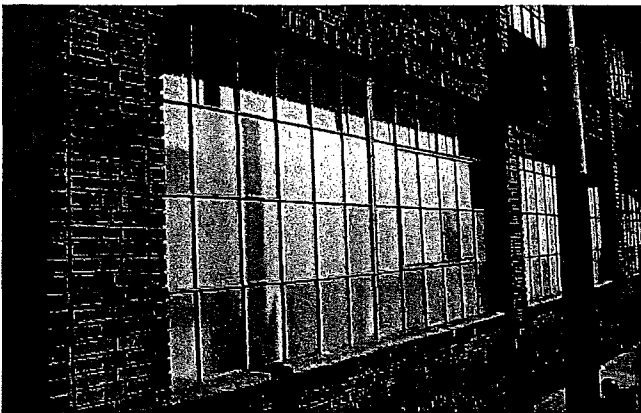
Figure 4. Typical multi-light steel windows at grade.

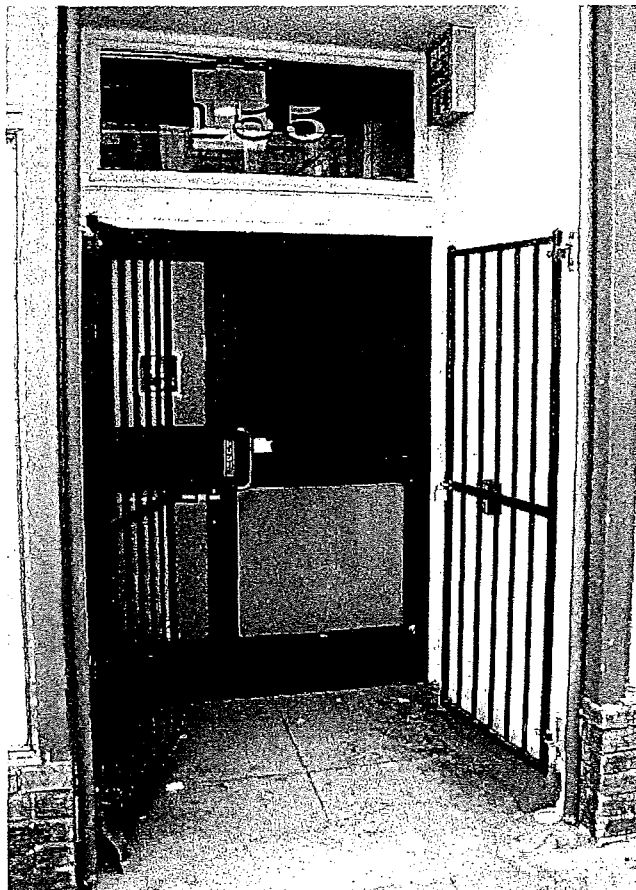
Figure 1. Metal entry door at west elevation.

Inspect door hardware, glazing seals and sealants. Lubricate doors and operating hardware. Install weather-stripping as required. Prepare, prime, paint and seal door and frames as needed.

Inspect door hardware, glazing seals, sealants and weather stripping for deterioration annually. Lubricate doors and operating hardware annually. Repaint doors and door frames as needed. Install new perimeter sealant every 10 years or as needed.

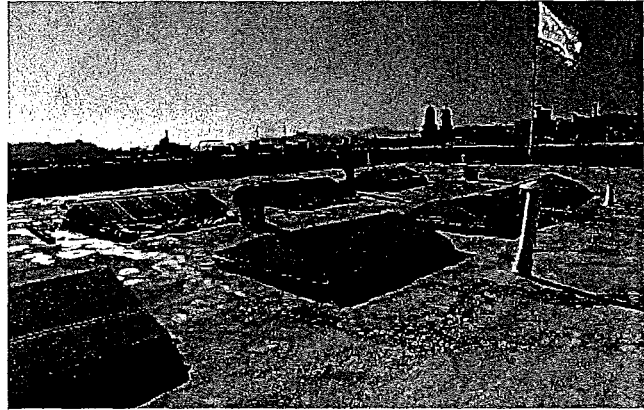
Figure 1. Roof overview; note skylights.

Inspect steel framed skylight for deterioration and water protection annually, including metal corrosion as well as paint and glazing sealant failure. Repair as needed. Install sealant and/or glazing putty as needed. Prepare, prime, paint and seal every 5 years.

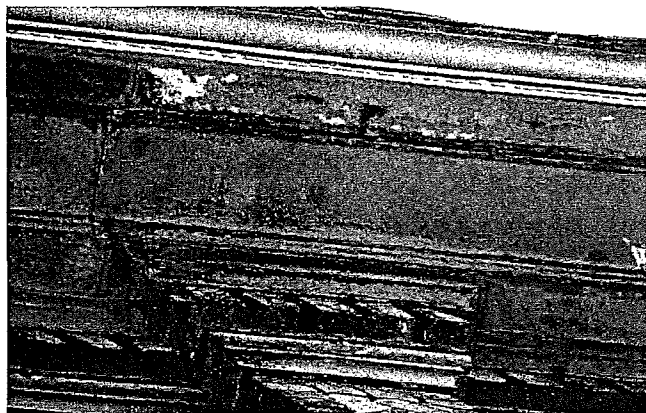
Figure 4. Cornice; conditions noted as typical.
