# HISTORICAL STRUCTURE REPORT

1338 Filbert LLC

LANDMARK DESIGNATION REPORT  
DATE: JULY 12, 2001  
CASE NO.: 2001.0232L

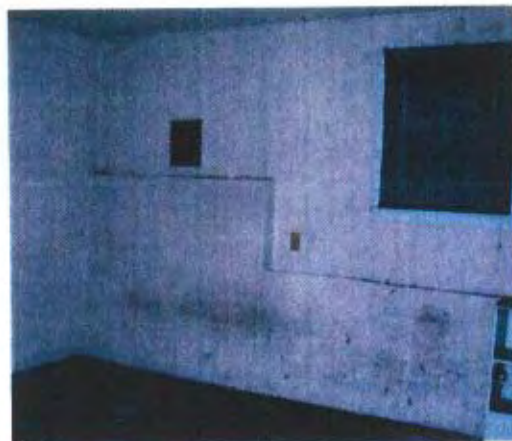
**Figure 16 (left):**  
 Battered, stepped  
 foundation wall exposed  
 at lower unit interiors.

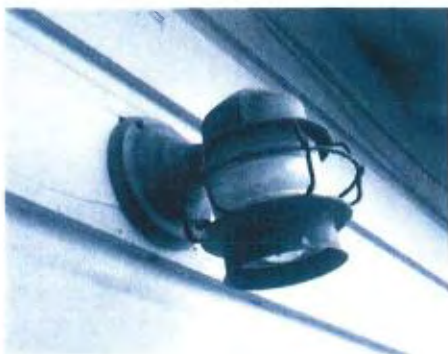
**Figure 28:**  
Wall mounted industrial  
entry porch light.

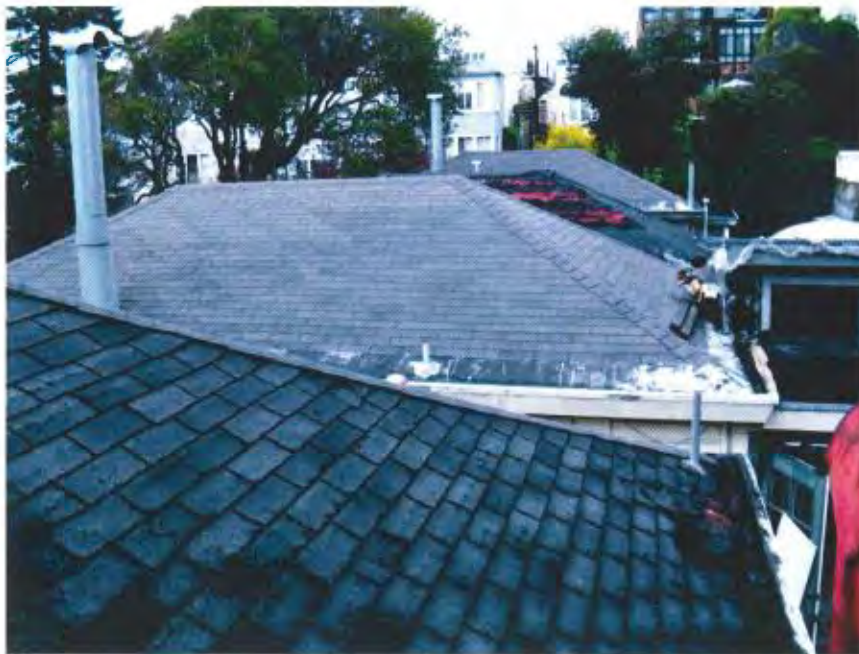
Cottages A, B, C and D are each capped by a hipped roof with boxed eaves (**Figure 5**). The roof assemblies consist of common rafters with purlins with hip rafters and a ridge board. Wood shingles, six to eight inches in width, are fastened directly to the purlins with a

Figure 5. Detail of cottage roofs. Note the round metal flues on the cottages.

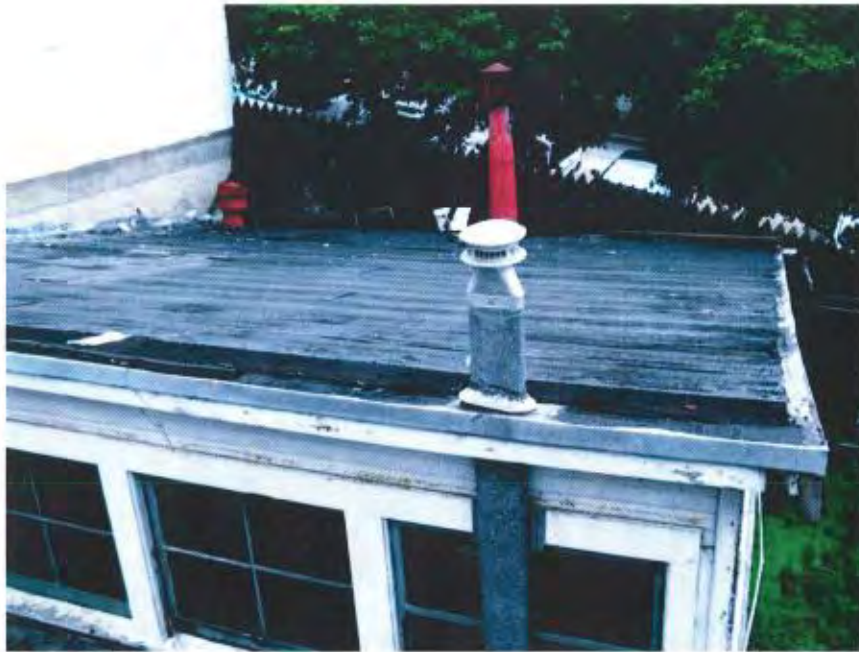
Figure 6. Detail of Studio roof. Note the round metal flue in the background.

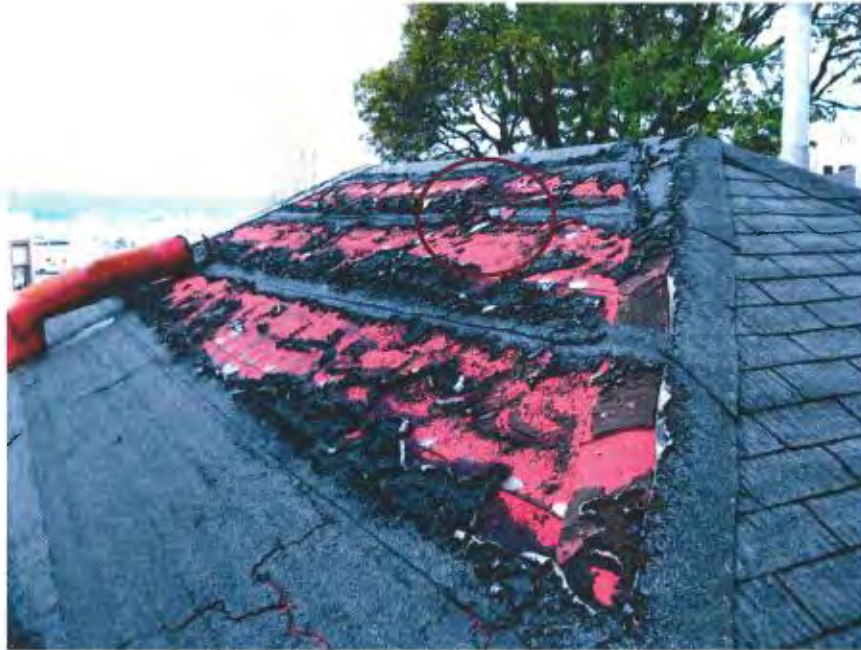
Figure 8. Location of Sample 3 at the ridge of Cottage C. Sample area is circled in red.

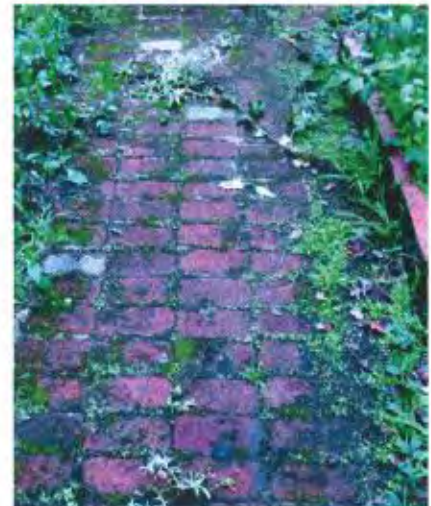
- All pavers are set in a “stacked” coursing pattern. Garden plots are bordered by raised brick planters (figure 4).
- Grout was used in all joints between the brick units

Figure 4: Walkway showing “stacked” coursing and raised brick planter

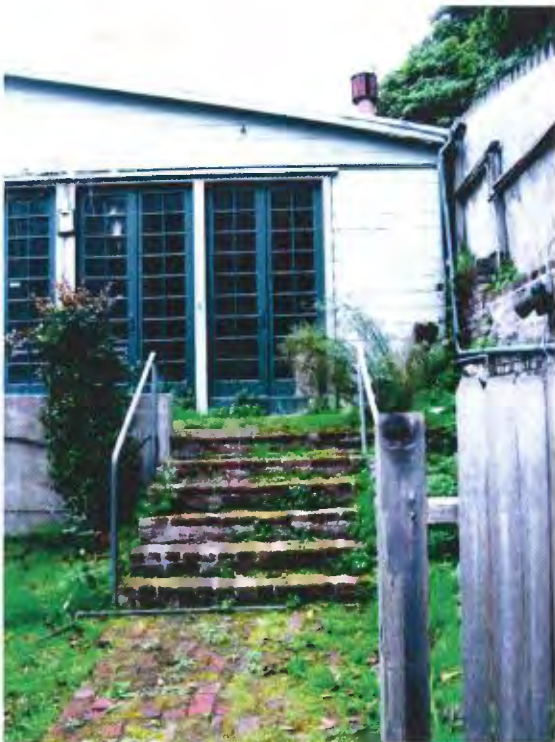
**Figure 6.** Detail of brick steps to be relocated. View north.
