149-155 9TH STREET  
SAN FRANCISCO, CA

ARTICLE 11 CHANGE OF DESIGNATION DOCUMENTS

- ARTICLE 11 HISTORIC BUILDING REPORT
- MAINTENANCE PLAN

JULY 25, 2014

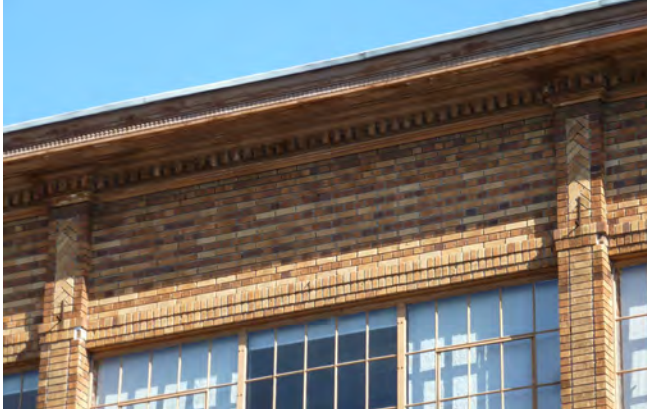
**Figure 2. South Elevation; note dentils and decorative piers.**

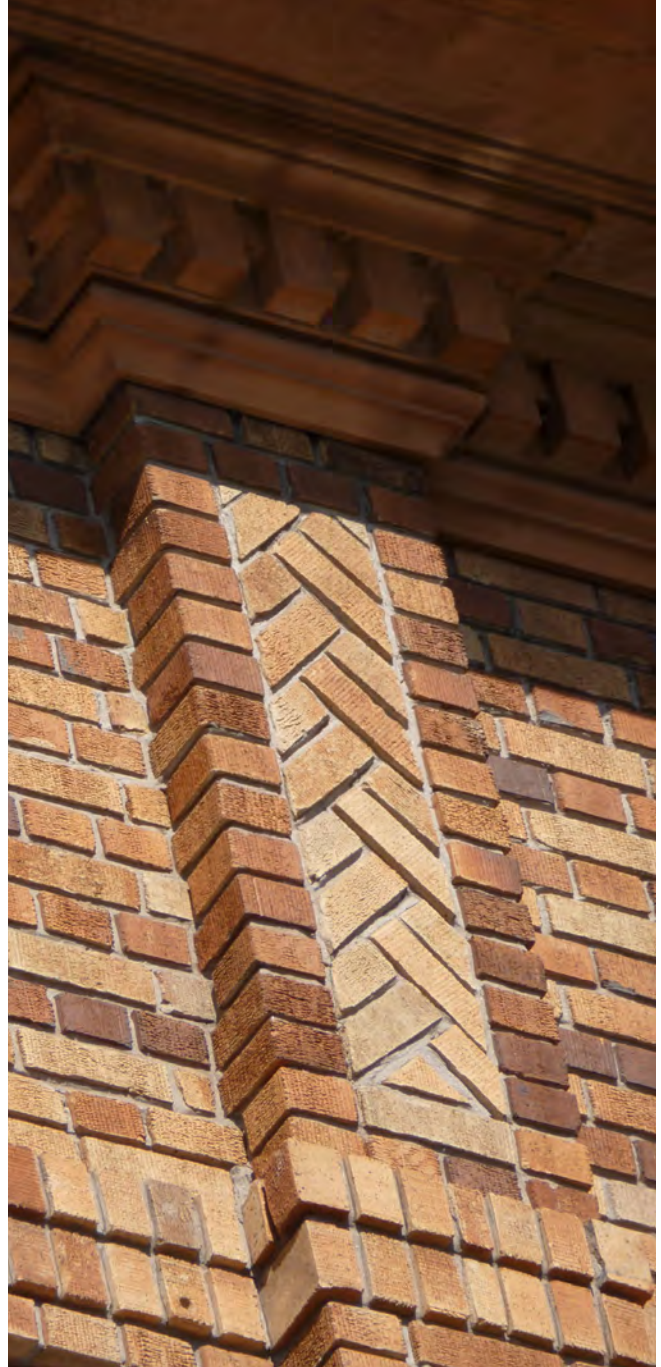
**Figure 4. Detail of decorative brickwork at piers.**

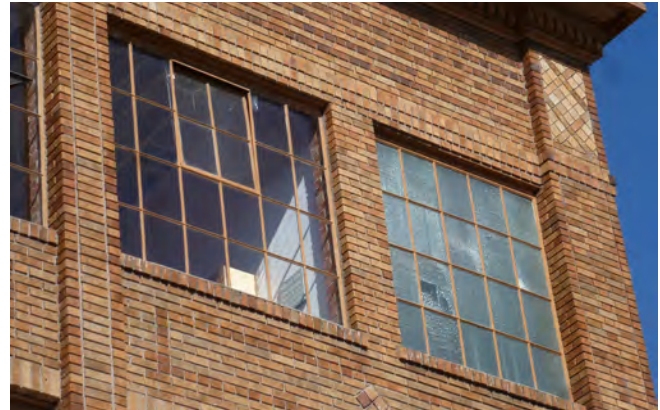
Steel multi-lite window sash are extant at primary facades (west above ground floor and at south) and facing the access alley along the north elevation. The windows are fixed sash with an operable awning-swing sash in the center of each window section. The size of each operable sash varies in certain locations. These windows are generally in good condition, with localized areas of cracked and deteriorated glazing putty. Clear glazing is installed in the majority of windows, though the windows in the eastern-most bay along the south elevation (Natoma Street) have wired glass.

Figure 1. Typical multi-lite steel windows; note operable sections and glazing types.

Define various types of glazing and determine original design. Remove existing broken or mismatched glass & replace with new to match original. Consider weight and profile of steel with regards to accommodating new glazing system. Explore potential for energy efficient replacement glass, laminated glass and/or glazing films.

Any window replacements should be made in kind, with new windows matching the materials, size, profiles, and dimensions of the original.

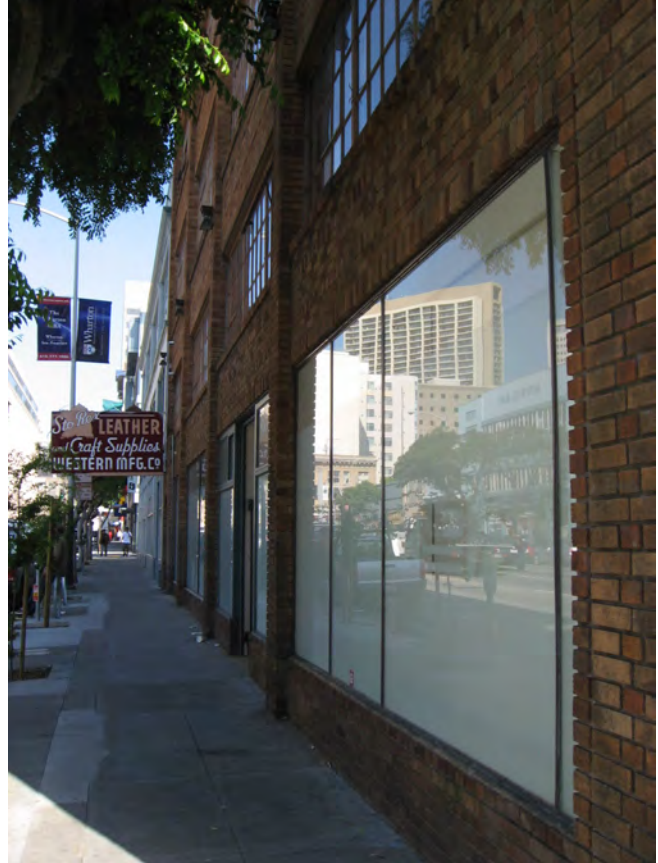
Figure 1. Typical Storefront at west elevation.

Inspect frames, glazing seals and sealants. Repair as needed.

Inspect framing, glazing seals and sealants for deterioration annually. Install new sealant every 10 years, or as needed. Prepare, prime, paint and seal every 5 years.

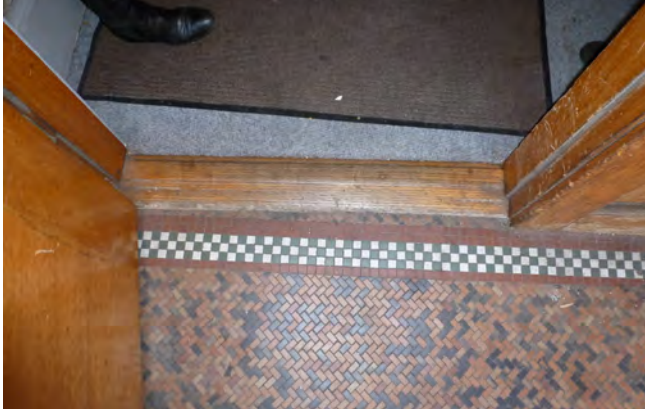
**Figure 2. Threshold at wood entry door.**

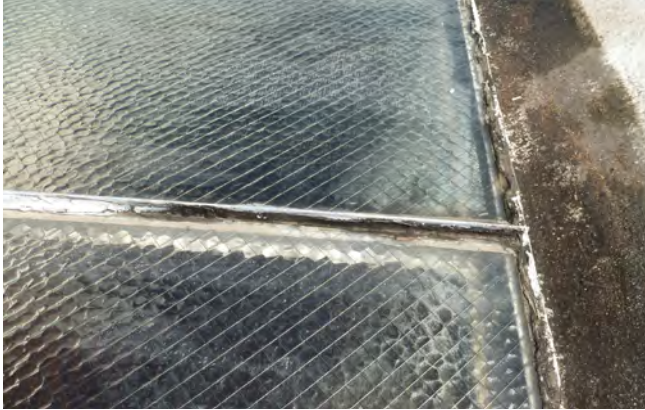
**Figure 3. Skylight typical frame conditions.**

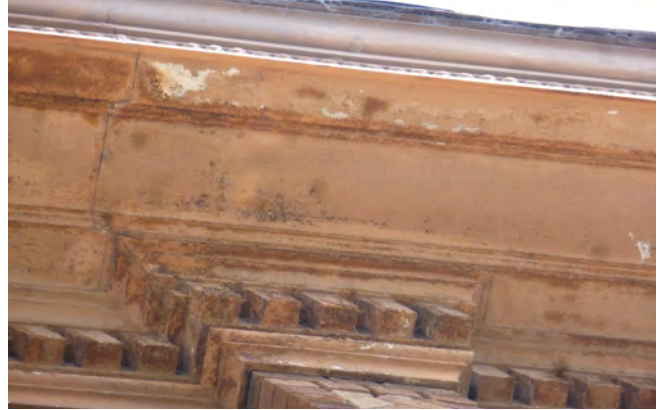
**Figure 4. Cornice; conditions noted as typical.**

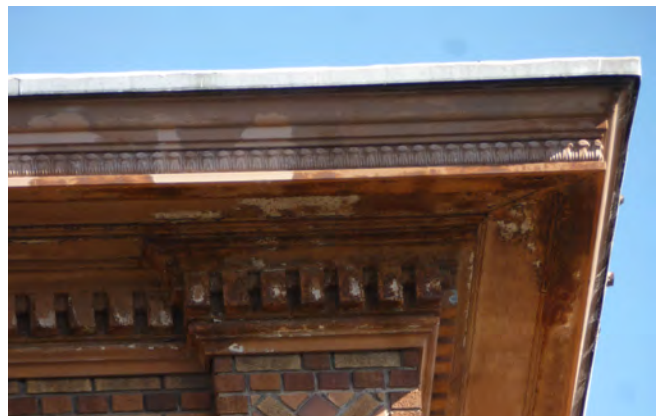
**Figure 5. Cornice at southwest corner.**

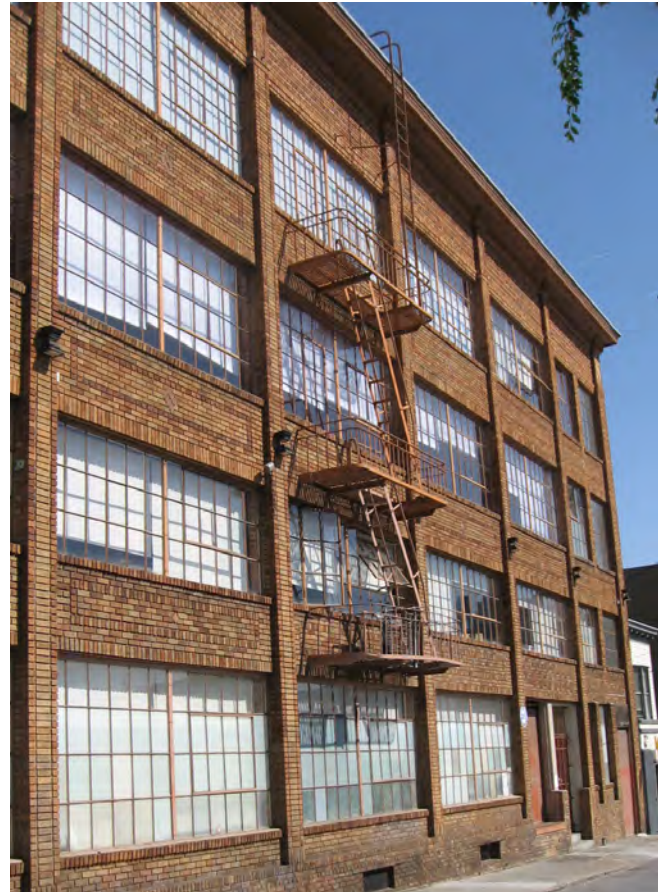
**Figure 1. Metal fire escape at south elevation.**

Metals should be compatible with, or isolated from, adjacent materials to avoid galvanic action and corrosion.

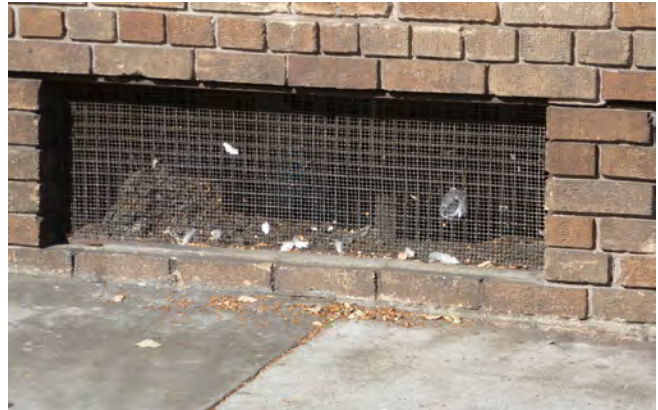
**Figure 1. Ventilation grilles; note 1'x1' historic iron grille.**

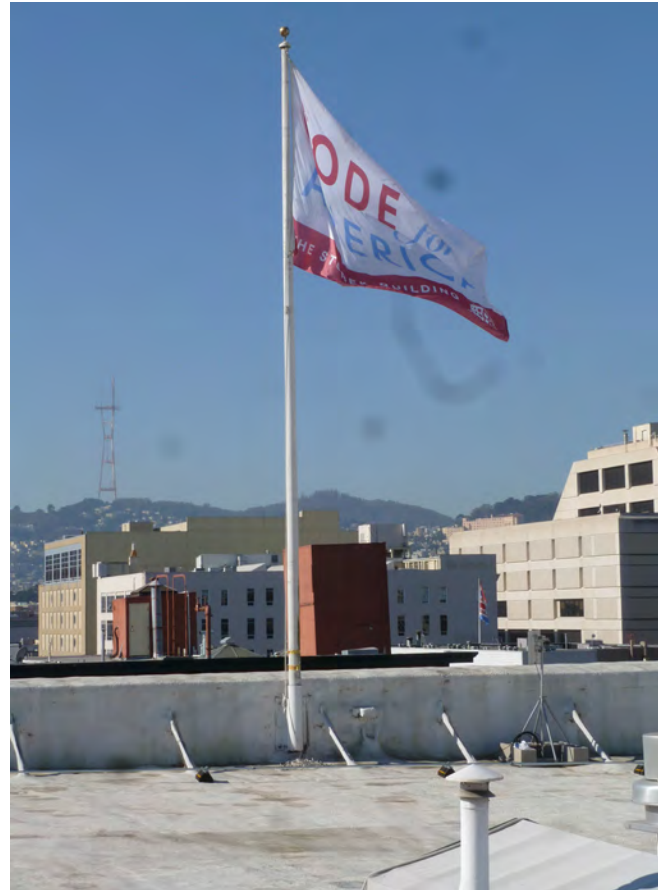
The flagpole is aligned with the center pier on the west (9<sup>th</sup> Street) elevation. The flagpole is anchored at its base to the roof parapet at this location and has a steel round metal finial at its top. The flagpole and base appear in good to fair condition.

**Figure 1. Flagpole along west elevation.**

Conditions of flagpole and base should be re-evaluated in coordination with any major roof work.

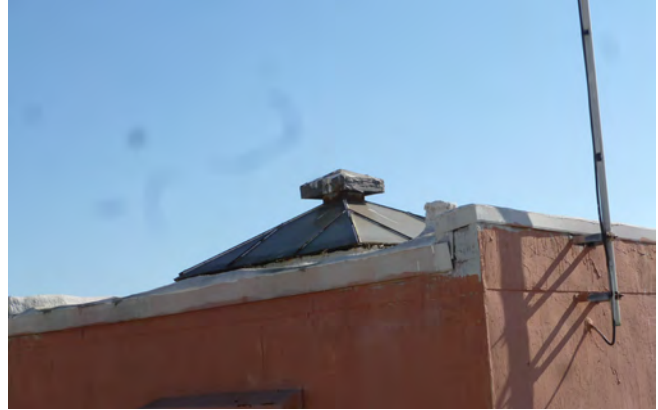
One steel framed skylight is located above the sheet metal penthouse at the southeastern corner of the roof. The skylight is pyramidal with a sheet metal vent at the apex. The skylight was not accessible but appears to be in fair condition, and there are no known water intrusion issues at the skylight. The sheet metal vent also appears to be in fair condition with failing paint.

Figure 1. Roof & ventilator at penthouse.

Inspect for broken/cracked glass and inspect sheet metal ventilator for deterioration. Patch sheet metal and repair as needed.

Inspect steel framed skylight for deterioration and water protection annually, including metal corrosion as well as paint and glazing sealant failure. Repair as needed. Install sealant and/or glazing putty as needed. Prepare, prime, paint and seal every 5 years.

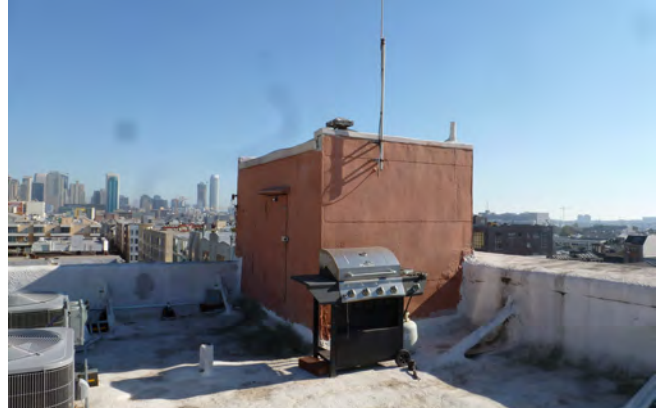
The painted sheet metal penthouse is located at the southeastern corner of the roof and appears to be in fair condition.

Figure 1. Penthouse from roof, typical.

Inspect sheet metal siding for deterioration and corrosion annually. Patch, repair or replace as needed to match original. Prepare, prime, paint and seal.

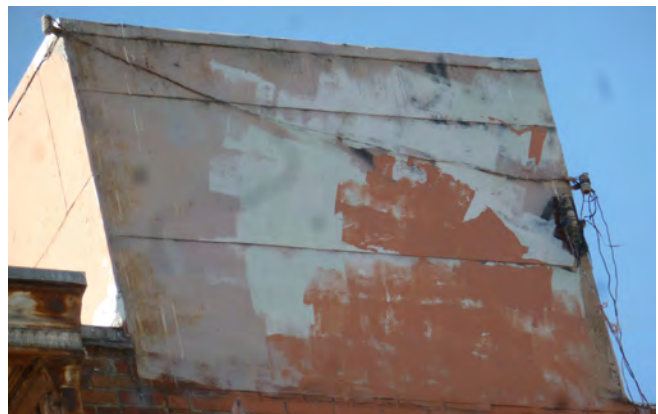
Figure 2. Penthouse from grade (east elevation).
