FOCUSED HISTORIC STRUCTURE REPORT
WOODS HALL
WOODS HALL ANNEX
SAN FRANCISCO, CALIFORNIA
[17112]

PREPARED FOR: WOOD PARTNERS

APRIL 2017

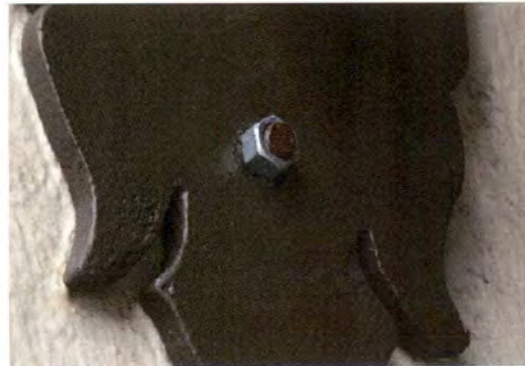
The current aluminum doors at the exterior are new, having been replaced as part of the rehabilitation; they are in good condition. At the entry pavilion, the cast metal grillwork and sconces are also in good repair. The bolts securing the sconces into the concrete entry portal, however, are already showing rust and should be checked regularly for security.

Figure 16 - (left) The entry pavilion. Photo by Page & Turnbull, 2017

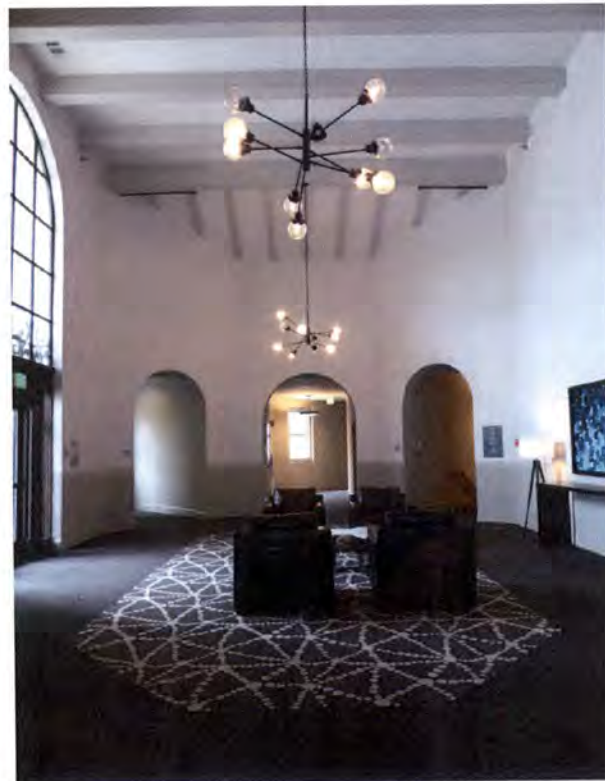
Significant interior spaces are limited to the hallways and main lobby beyond the entry pavilion; all are in good condition. In the historic lobby and hallways floors are carpeted and walls are painted. In the main lobby, the pendant light fixtures are missing a bulb and have two that are not working. Light fixtures, especially those hanging over seating areas, should be regularly inspected for proper function and safety.

Figure 19 - The main lobby interior carpeted and painted. Photo by Page & Turnbull, 2017

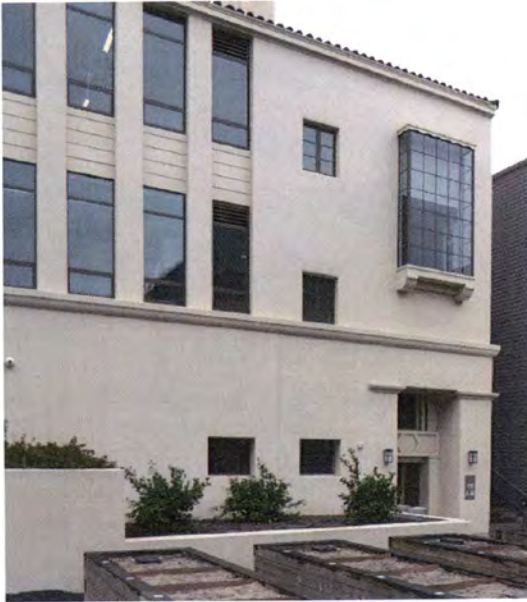
Figure 20 - Variety of windows on the south facade, all in good condition after the rehabilitation. Photo by Page & Turnbull

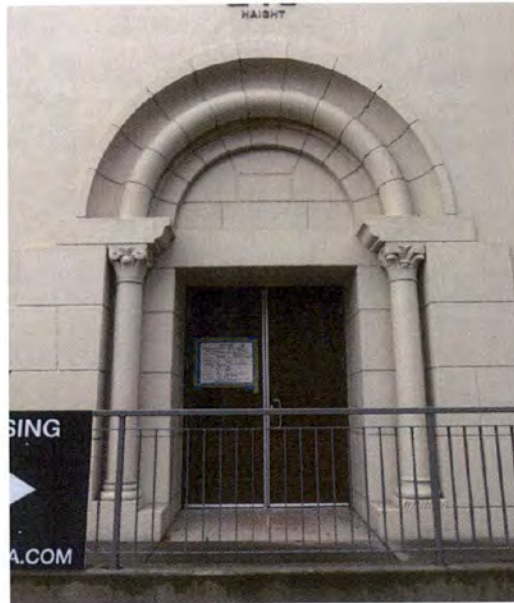
Figure 21 - The street entry with replaced doors. Photo by Page & Turnbull, 2017

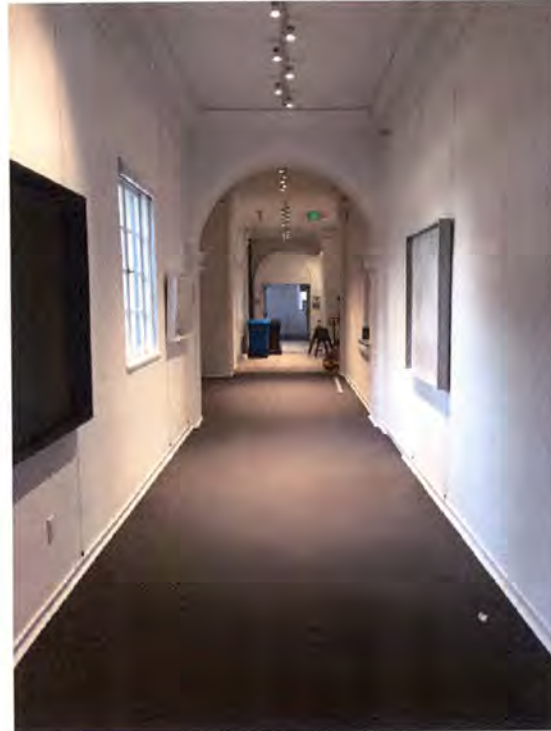
Figure 25 - First floor corridor.

The interiors of the Woods Hall Annex are in good condition. Rehabilitation construction was nearing completion at the time of the survey. Interior plaster work was freshly painted and installed carpet protected against ongoing work. Final cleaning and mechanical installations were the tasks remaining. As the building will function as an artists' studio and gallery, care should be taken not to damage features with the frequent installation and removal of art pieces, and plasterwork regularly evaluated after each major move and repaired as necessary.

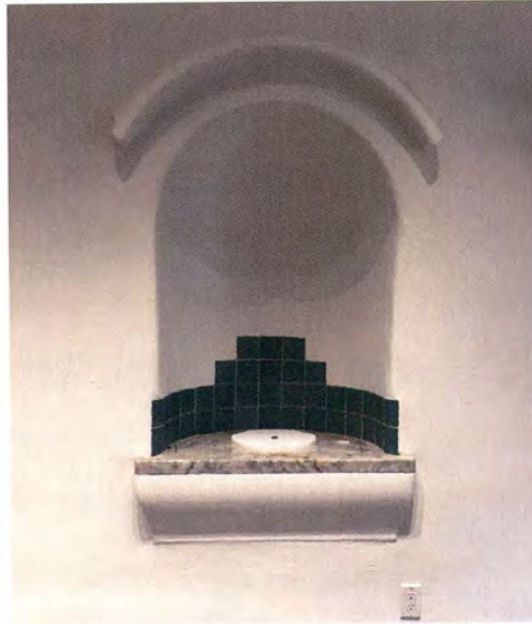
The decorative water fountain niches remain in good, inoperable condition, as in both locations the sink and spouts had been previously removed. Interior doors have been replaced with new glazed or solid wood doors, and any new partition walls are similarly in great condition.

Figure 27 - Remains of the marble water fountain, first floor

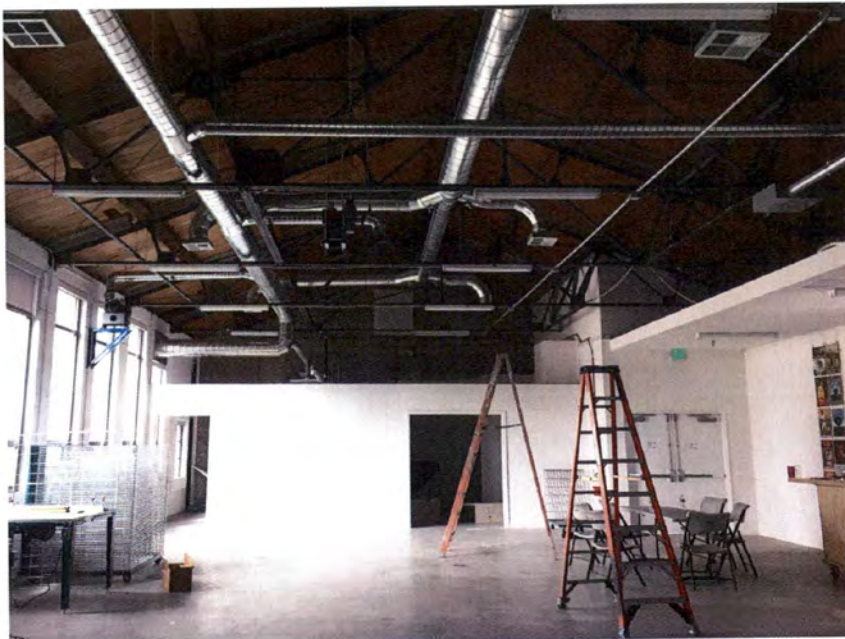
Figure 28 - Second floor workspace with exposed trusses and sheathing
