## FIRST AMENDMENT TO LEASE NO. L-16274

# RAPID STRUCTURAL ASSESSMENT REPORT

We are pleased to submit this report summarizing the findings and recommendations of our Rapid Structural Assessment of Pier 33 in San Francisco, California.

Subject: Permit No. B 2018-0121  
Pier 31.5 Substructure Repair, San Francisco

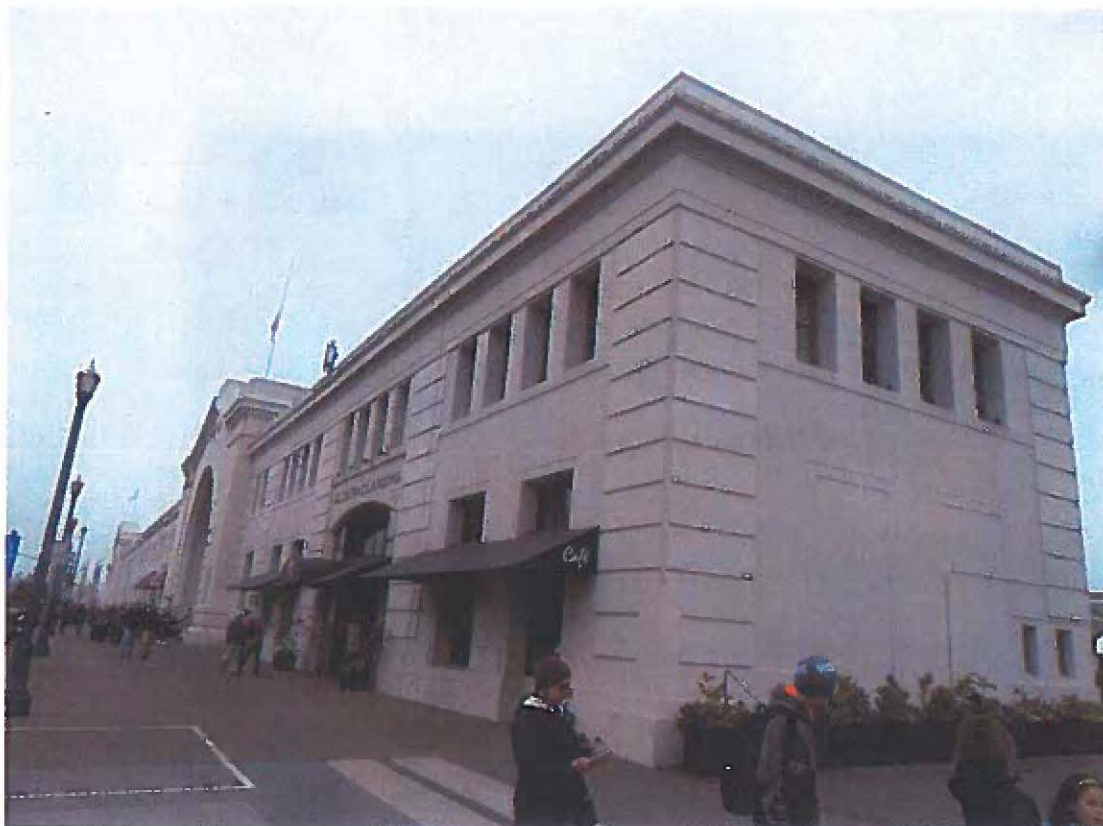
Figure 2 - Bulkhead Exterior

Superstructure on Pier 33 includes a bulkhead fronting on the sea wall and a shed extending the length of the finger pier (See Figures 1-3). Project north is such that Embarcadero end is west and bay end is east. Geographic north is closer to bay end of pier, with Embarcadero at south end. Bulkhead exterior walls are framed plaster over diagonal wood sheathing backed by blocked wood stud reinforced with wood wind girts and heavy posts (Fig. 7) supporting wood

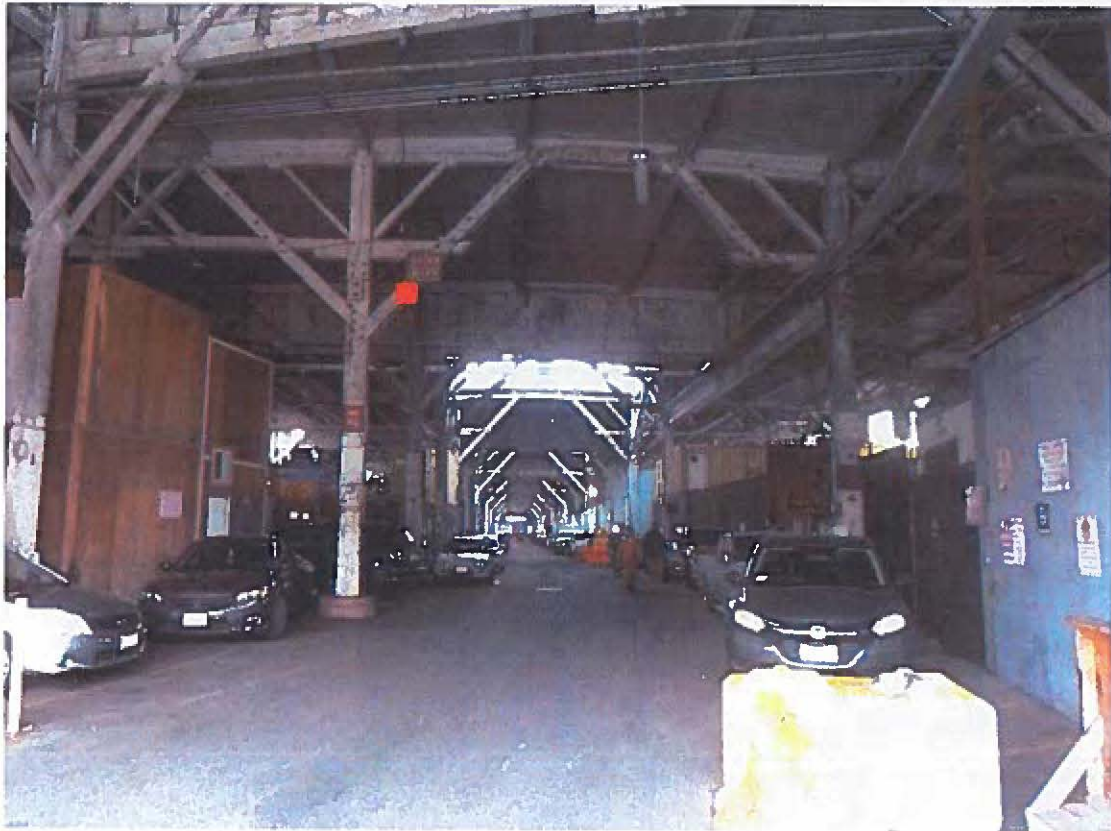
Figure 6 - Main aisle of shed

Shed exterior walls are typically 4" thick reinforced concrete backed by wood posts supporting wood trusses spanning transverse to shed length. Trusses support sawn wood joists laid solid over sawn wood purlins (Fig. 6). Occupancy appears to be primarily fish processing, storage, and light industrial uses.

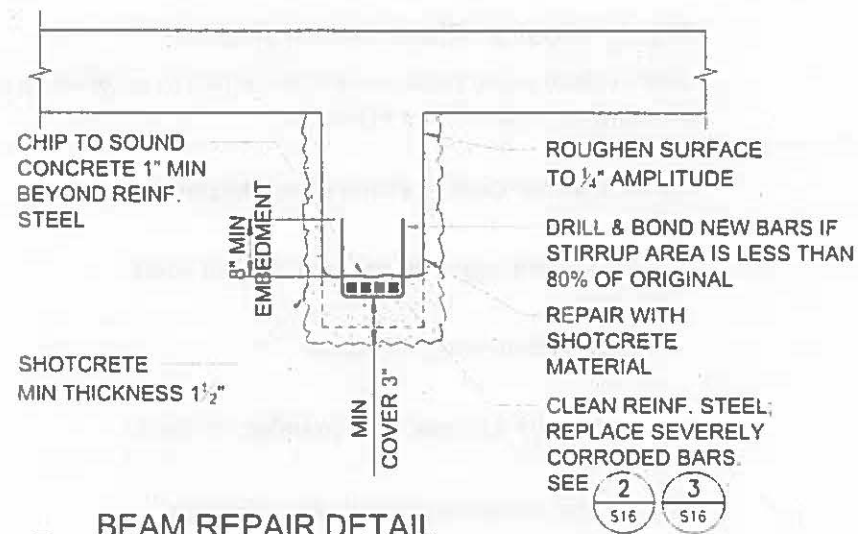
Figure 3 - Shotcrete Design Drawing Detail

The shotcrete beams are in conformance with the design drawings. Design drawing and photograph of typical repair are shown in Figure 3 and Figure 4.

- ✓ Shotcrete Repair is full length and height as noted on Drawing S17, Beam Repair Notes Note 1.
- ✓ Shotcrete Repair looks as intended on drawings
- ✓ No noticed damage, significant cracks, or rust stains.

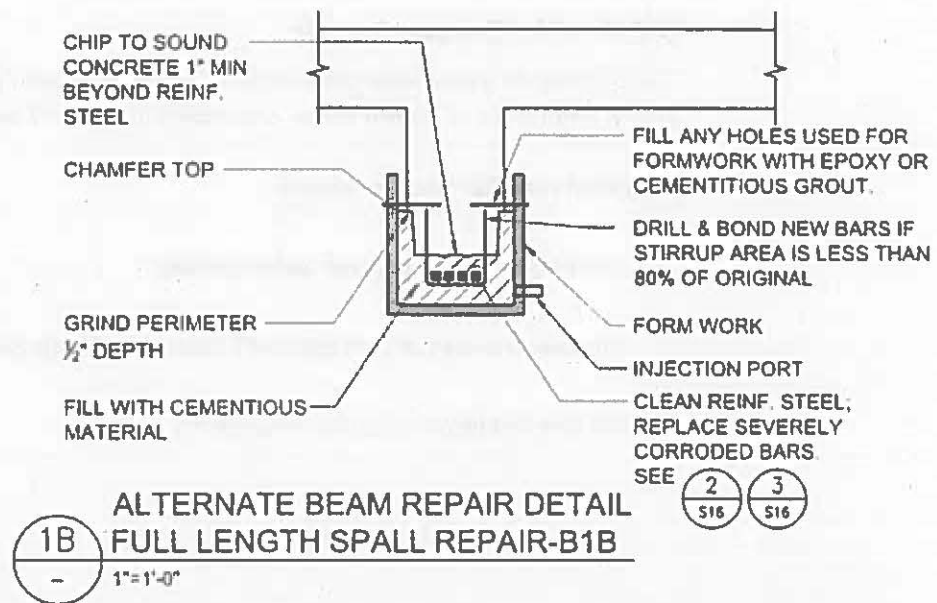
Figure 5 - Beam Repair

Cast in place beam repairs were performed in accordance with the following detail as shown in Figure 5 and Figure 6.

- ✓ Chamfered edges as noted in general notes
- ✓ Approximate adequate cover
- ✓ No noticed damage, rust straining, or cracks
- ✓ General conformance with design details

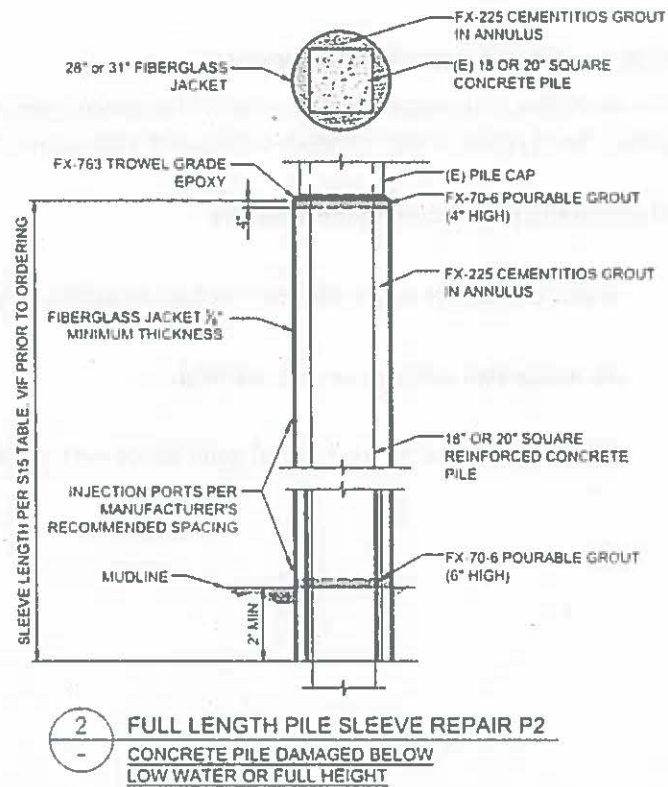
Figure 7 - Pile Sleeve Design Details

The pile sleeve repair were performed in accordance with design details. The design details and photo of typical repair are shown in Figure 7 and Figure 8.

- ✓ Chamfer at top to prevent water pooling
- ✓ Pile sleeve installed with general conformance with drawings
- ✓ Pile sleeve left on to increase durability

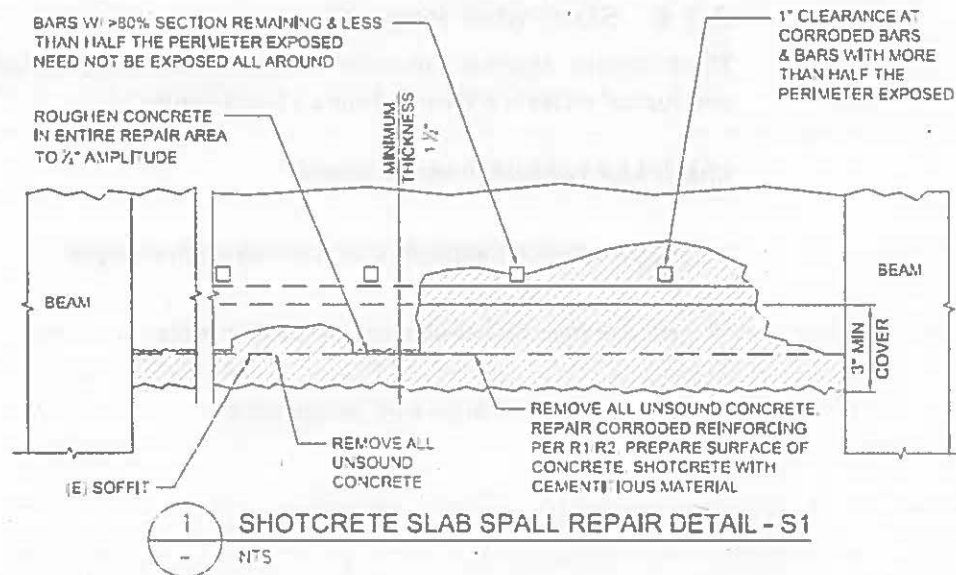
Figure 9 - Shotcrete Detail

The shotcrete slab repairs were performed in conformance with the drawings. Repair details and typical photo is shown in Figure 9 and Figure 10

- ✓ Shotcrete covers entire bay as noted on Drawing S16.
- ✓ No noticeable damage or rust staining.
- ✓ Shotcrete repairs are in general compliance with details.

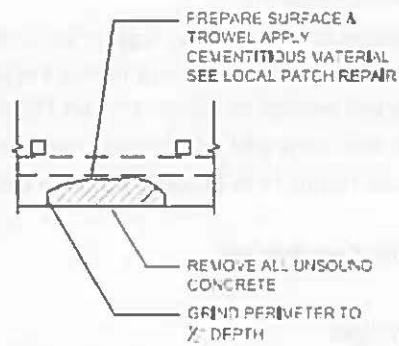
Figure 11 - Local Slab Repair Detail

The slab patch repairs are in conformance with the design details. Slab design details and typical photo is shown in Figure 11 and Figure 12

- ✓ Clear perimeter indicating 1/2" saw cut around edges.
- ✓ No damage, rust stains, or noticeable cracks.
- ✓ General conformance with design detail

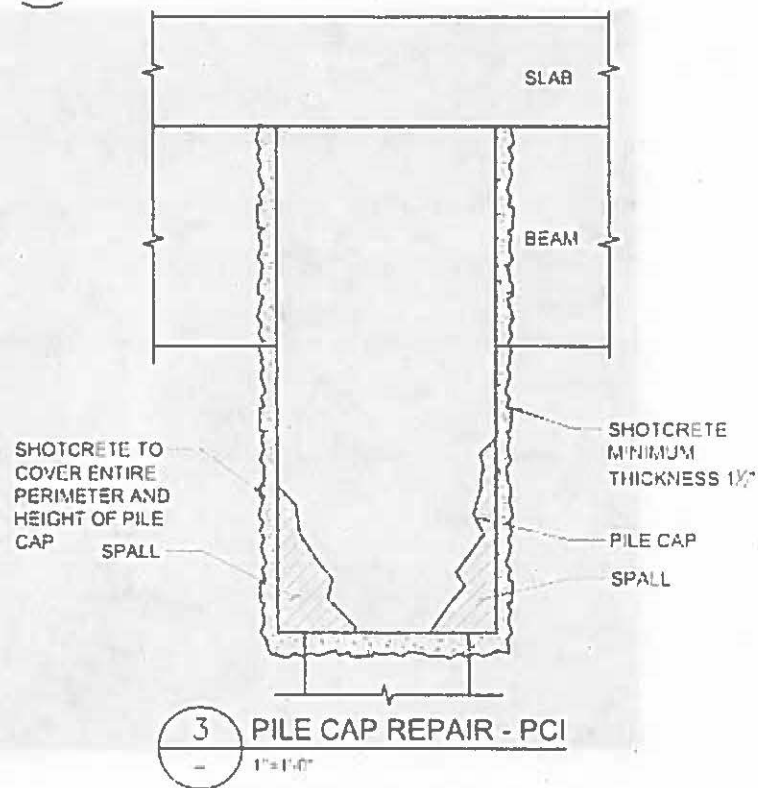
Figure 13 -Shotcrete Cap Beam Repair (Alternative not shown, notes as shown below)

The contractor chose the alternative option to form and pour the pile cap repairs. The form and pour details are outlined in the details in Figure 13 and Figure 14. Photos of repairs are shown in Figure 15 and Figure 16. The drawing shows shotcrete repair; the form and pour repair method was not drawn but outlined in notes. The pile cap repair is in accordance with design drawings.

- ✓ Chamfered Edges
- ✗ Cover looks to be adequate
- ✗ General conformance with design drawings
- ✓ No damage or rust staining

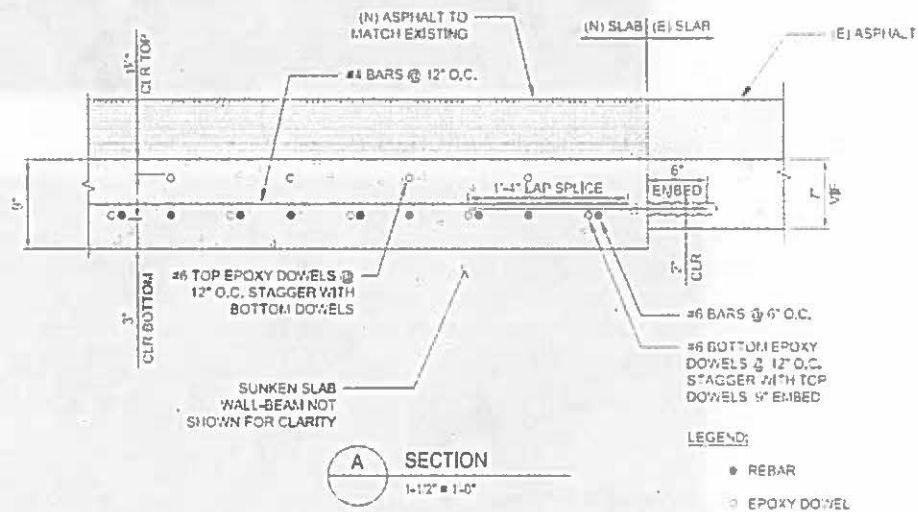
Figure 17 - Replacement Slab Detail

The access hole replacement slab and the top sunken slab replacement were in conformance with the design details. See detail and photos in Figure 17, Figure 18, and Figure 19.

- ✓ Chamfered Edges
- ✓ General conformance with design drawings
- ✓ No damage or rust staining

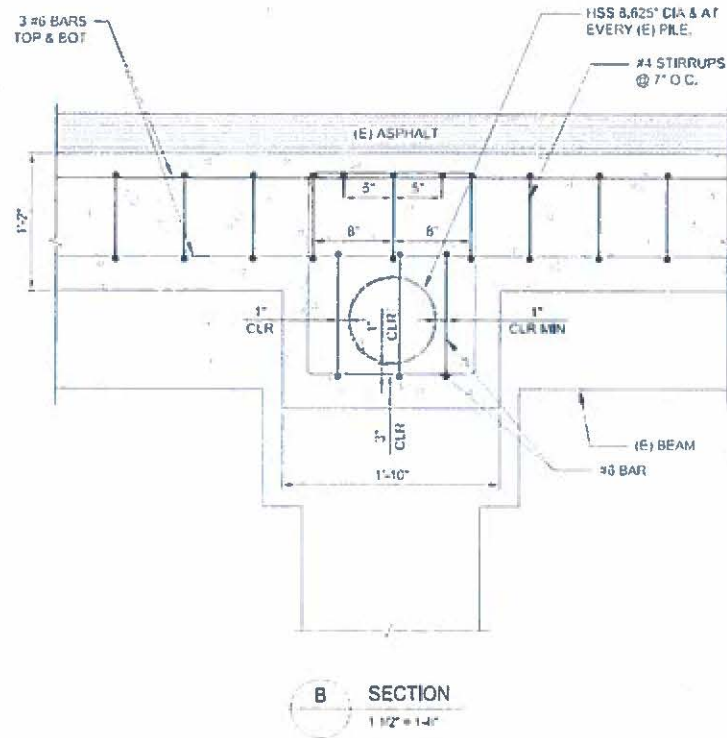
Figure 22 - Cantilever Beam Repair

The cantilever repair is in conformance with the design drawings. The design detail and photo are shown in Figure 22 and Figure 23.

- ✓ Chamfered edges
- ✓ General Conformance with design drawings
- ✓ No visible rust staining, significant cracking, or damage

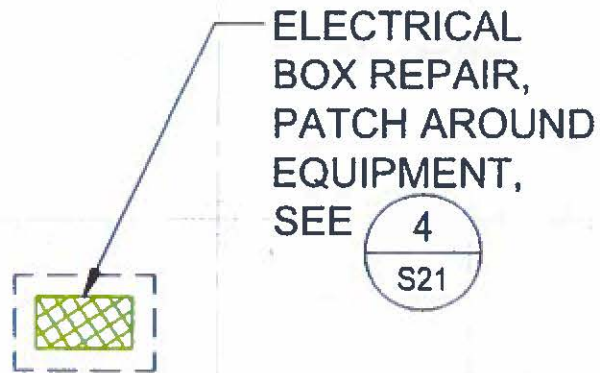
Figure 24 - Electrical Box Repair

The electrical box repair is in conformance with the design drawings/notes as shown in Figure 24 and Figure 25.

- ✓ Patch around equipment
- ✓ Equipment looks undamaged
- ✓ Patch follows general requirements of patch repair
- ✓ No rust staining, damage, or significant cracking

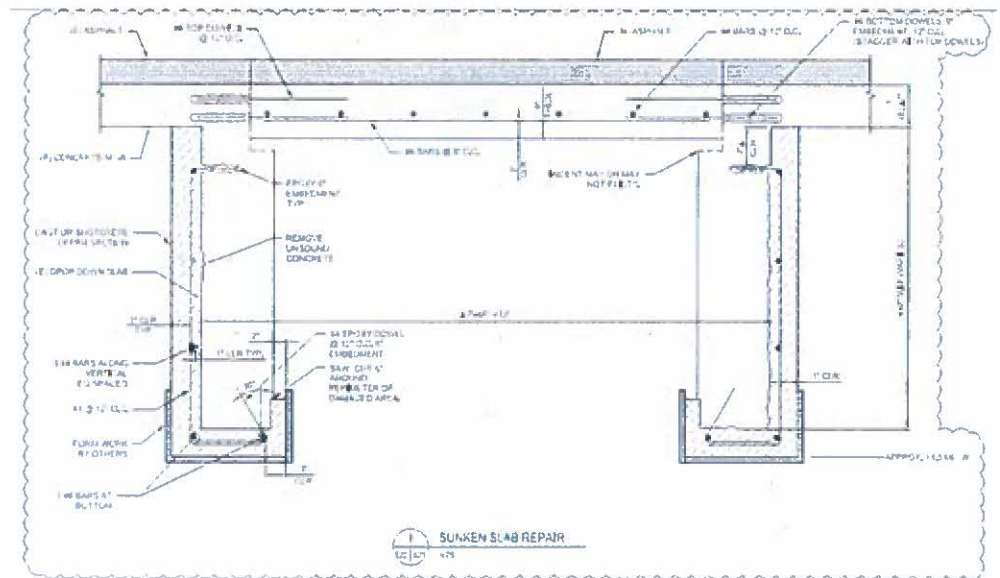
Figure 26 - Sunken Slab Detail

The sunken slab repair is in conformance with the design drawings. The detail and photos are shown in Figure 26, Figure 27, and Figure 28.

- ✓ Form lower section and shotcrete upper section
- ✓ Chamfer Corners
- ✓ No visible rust staining or significant cracking
