Supplemental Report for Foundation Settlement Investigation

The building at 301 Mission Street, San Francisco, California is a fifty-eight-story residential structure founded on a pile-supported mat foundation. The building, which was completed in 2009, has experienced and continues to experience significant foundation settlement. Paul Hastings, LLP retained Simpson Gumpertz & Heger Inc. in 2014 to conduct an evaluation of the impact of site settlement on the building's structural stability and earthquake resistance. We performed initial evaluations in 2014 and updated these in 2016 to consider additional settlement that occurred in the interim period. In an October 2016 report we concluded that settlement had not compromised the building's stability or its ability to resist strong earthquakes.

**SUPPLEMENTAL REPORT
FOUNDATION SETTLEMENT INVESTIGATION
301 MISSION STREET
SAN FRANCISCO, CALIFORNIA**

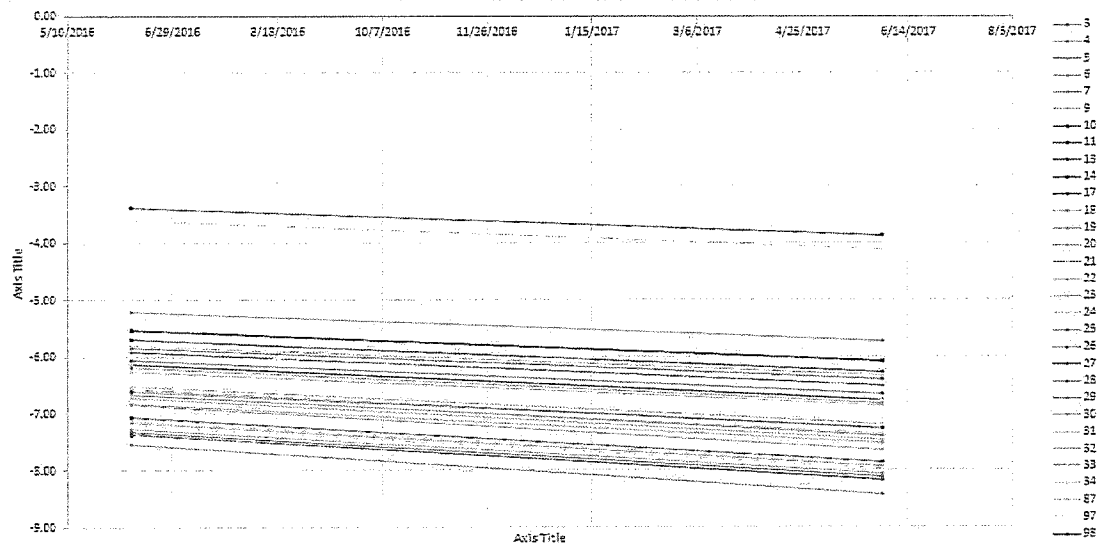
Figure 11. Settlement data, June 2016 through June 2017

We are pleased to send the attached report documenting supplemental evaluations performed by us in response to requests forwarded by Professor Gregory Deierlein, Chair of the City of San Francisco-appointed review panel for the Millennium Tower. This revised report includes a corrected plot of ground motion spectra used in our analysis, plots for shear wall strain demand capacities and residual drift, and a discussion of settlement that has occurred since the readings upon which our analyses are based.

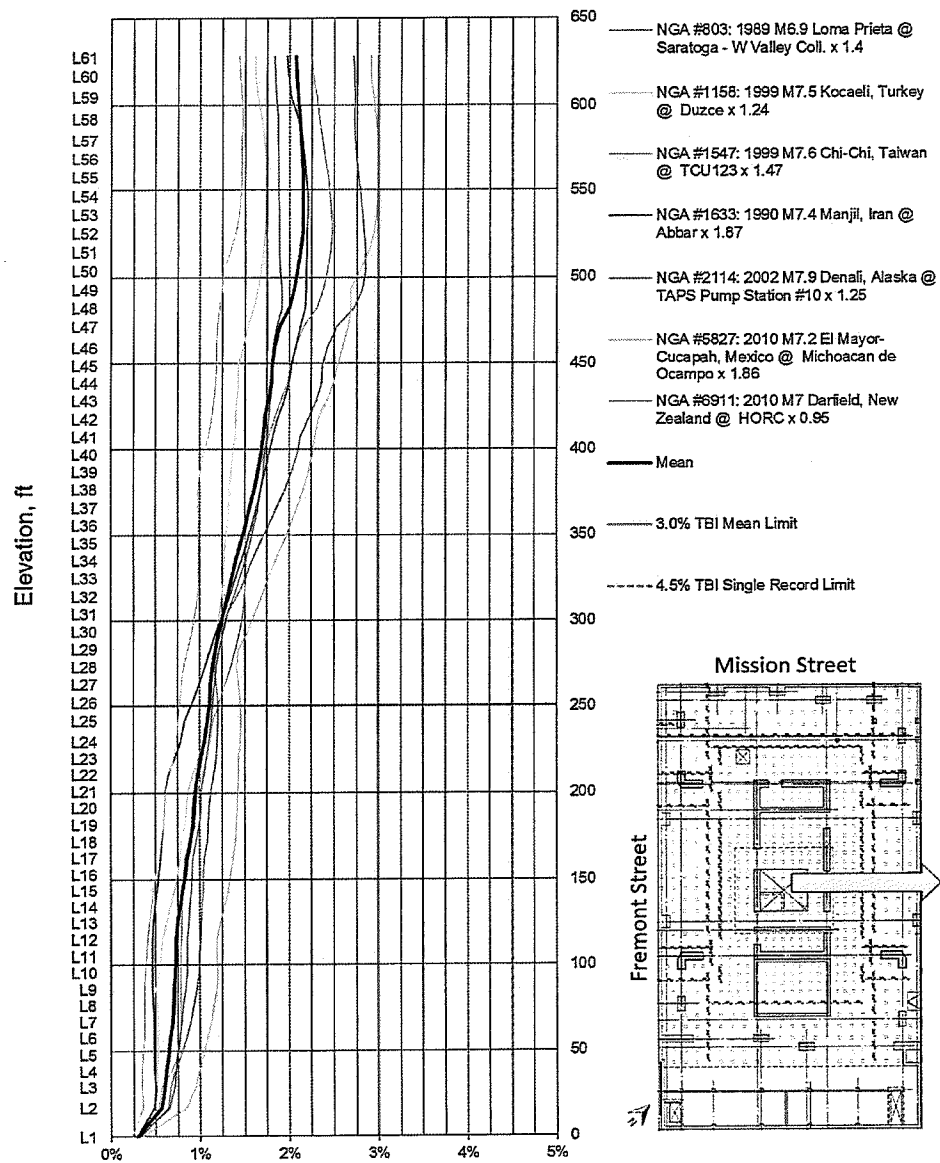
Figure 23. East-West Transient Story Drift, Fixed Translation Model

Figure 23 and Figure 24 respectively present the predicted peak absolute value story drift obtained from the analysis in the east-west and north-south directions. Mean drift in each direction is substantially below the 3% limit recommended by the PEER Tall Buildings Design

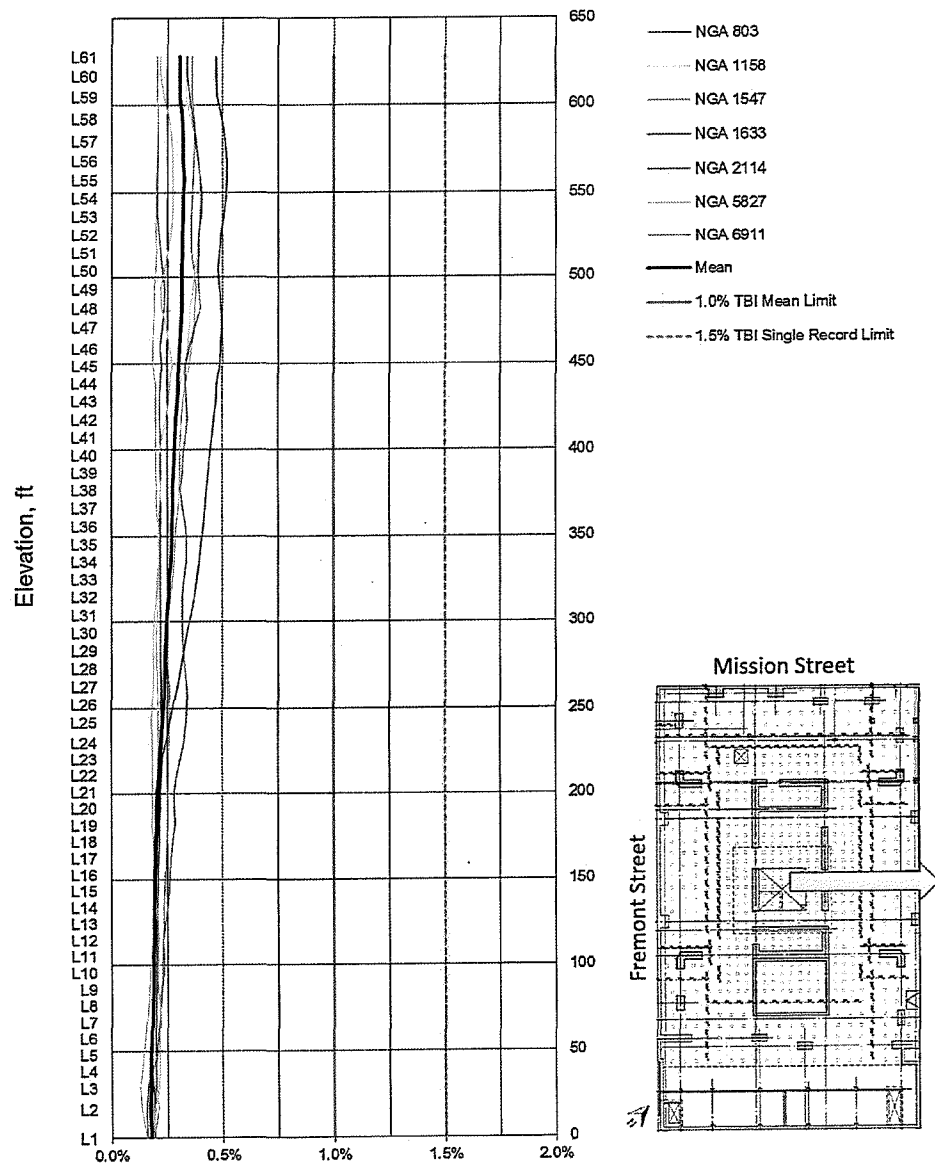
Figure 25. Residual Story Drift East-West Response

Figure 25 and Figure 26 present the residual drift obtained for each of the seven ground motions for response in the east-west and north-south directions, respectively. Average and individual drifts for the seven records are all substantially less than the 1% limit for mean residual drift recommended by the PEER Guidelines.

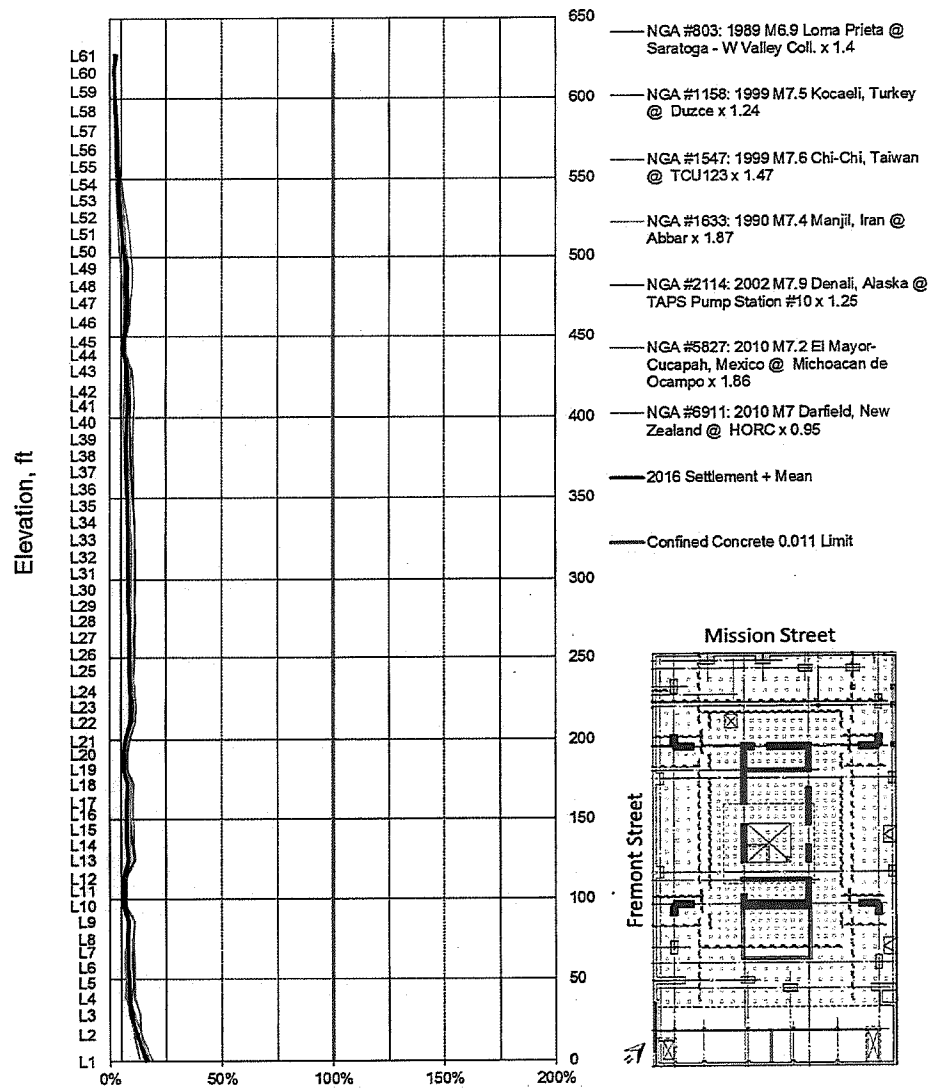
Figure 28. Demand to Capacity Ratio, Core Wall and Outrigger Column Compressive Strain, Fixed Translation Model

Figure 28 presents the demand to capacity ratios, in percent, for compressive strains in concrete walls and also outrigger columns, which were also modeled using shell elements. As extreme fibers of the walls and the columns at all levels are confined, an acceptable value of strain is taken as 0.011. Demands are substantially below these values at all levels and for all ground motions.

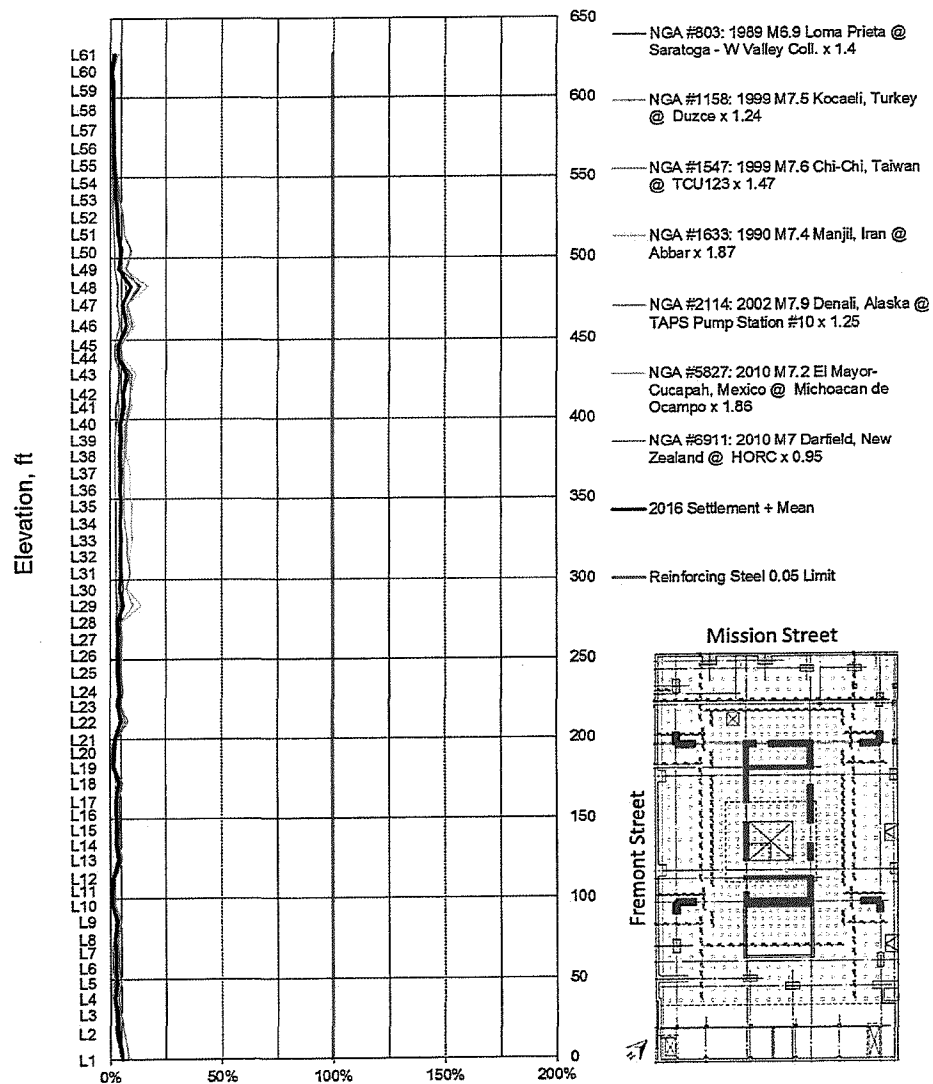
Figure 29. Demand to Capacity Ratio, Core Wall and Outrigger Column Tensile Strain, Fixed Translation Model

Figure 29 presents the demand to capacity ratios, in percent, for concrete core wall and outrigger column reinforcing tensile strains. An acceptable value of 0.05 is used. Demands are substantially below these values at all levels and for all ground motions.

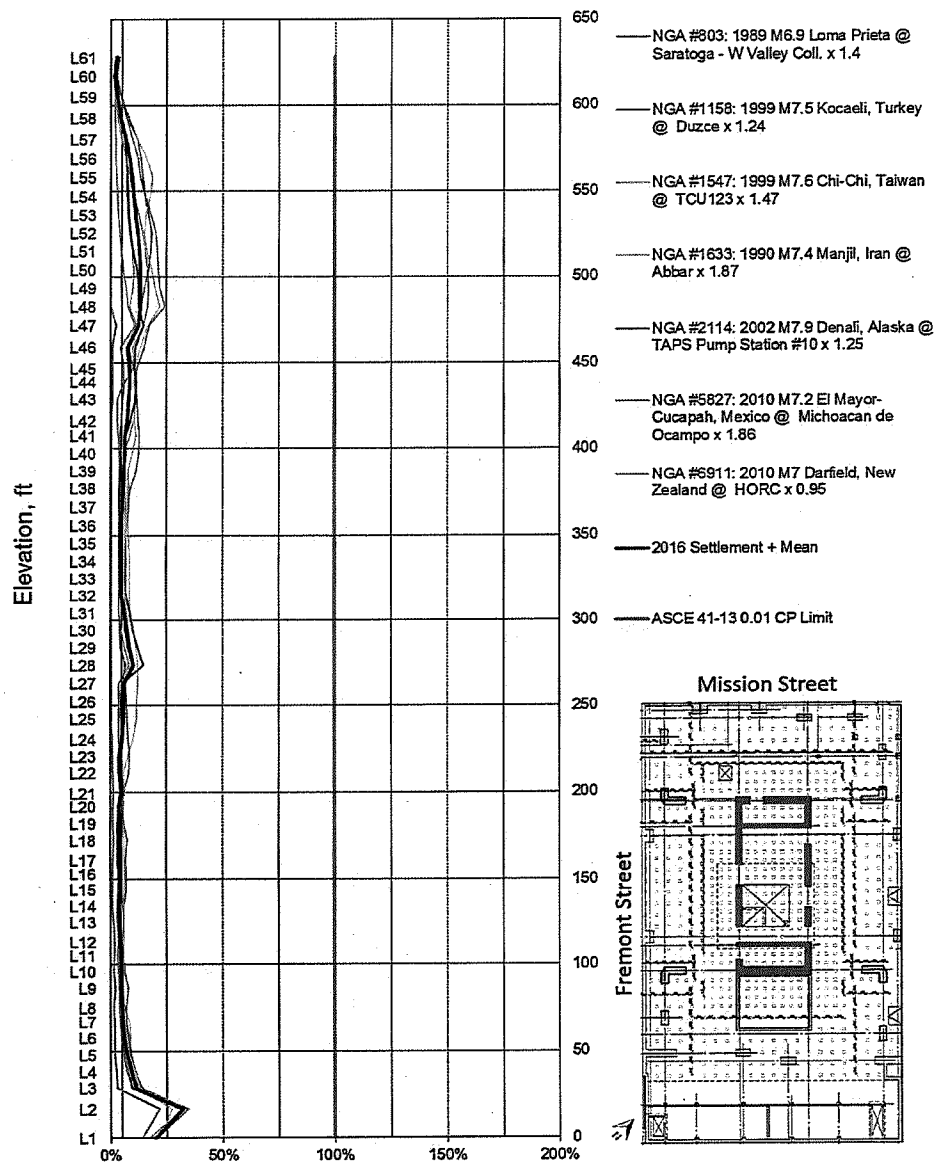
Figure 30. Demand to Capacity Ratio, Core Wall Shear Strain

Figure 30 shows the demand to capacity ratios for core wall shear strain. Strain for all records is substantially less than the 0.01 permitted by ASCE 41.

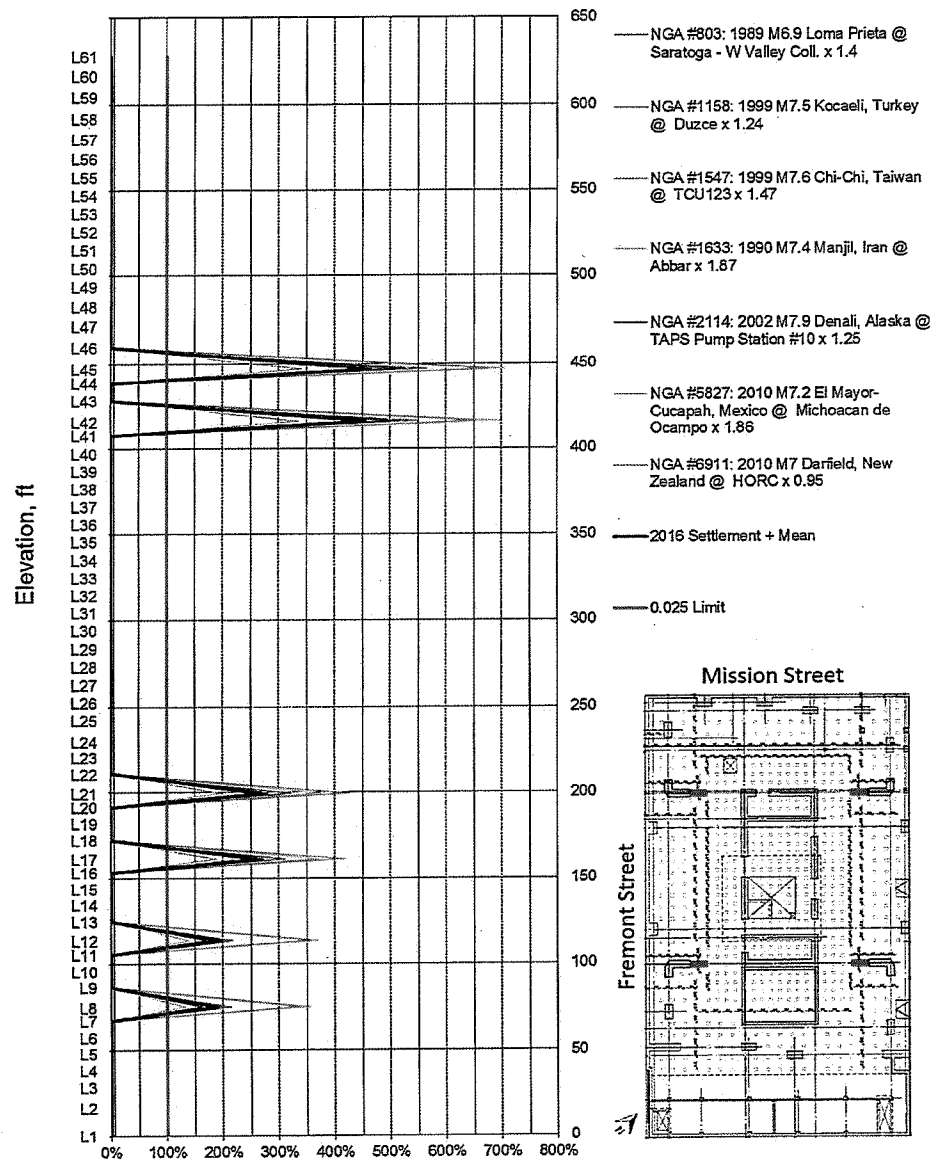
Figure 31. Demand to Capacity Ratios, Outrigger Coupling Beam Rotation, Fixed Translation Model

Figure 31 shows the demand to capacity ratios for coupling beams in outriggers. A value of 100% represents a chord rotation of 0.025 radian and the hysteretic relationship illustrated in Figure 13. All coupling beams degrade in strength without negative impact on other elements or overall stability.

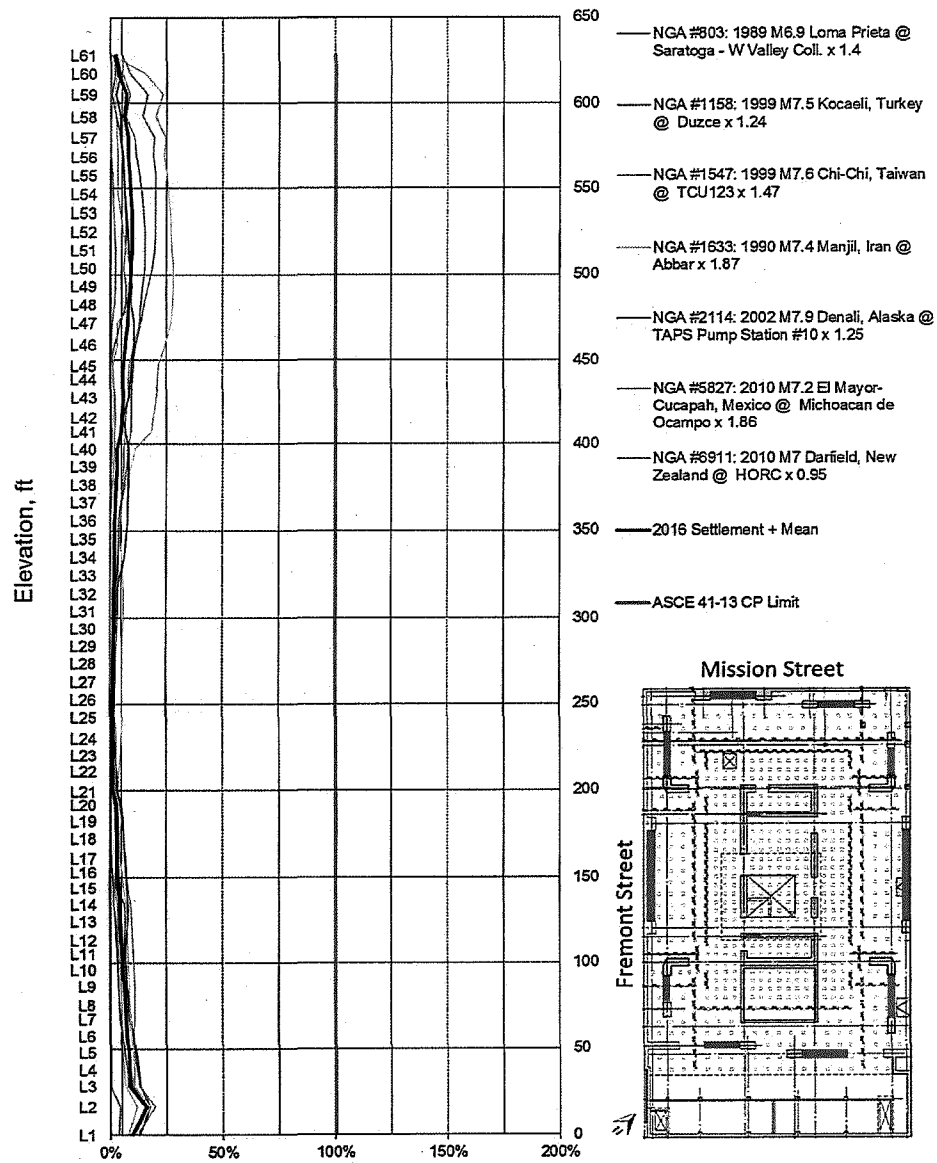
Figure 32. Demand to Capacity Ratios, Concrete Beams, Fixed Translation Model

Figure 32 presents demand to capacity ratios for reinforced concrete beams in moment frames and core walls. Acceptable values range from 0.03 radians to 0.05 radians depending on the

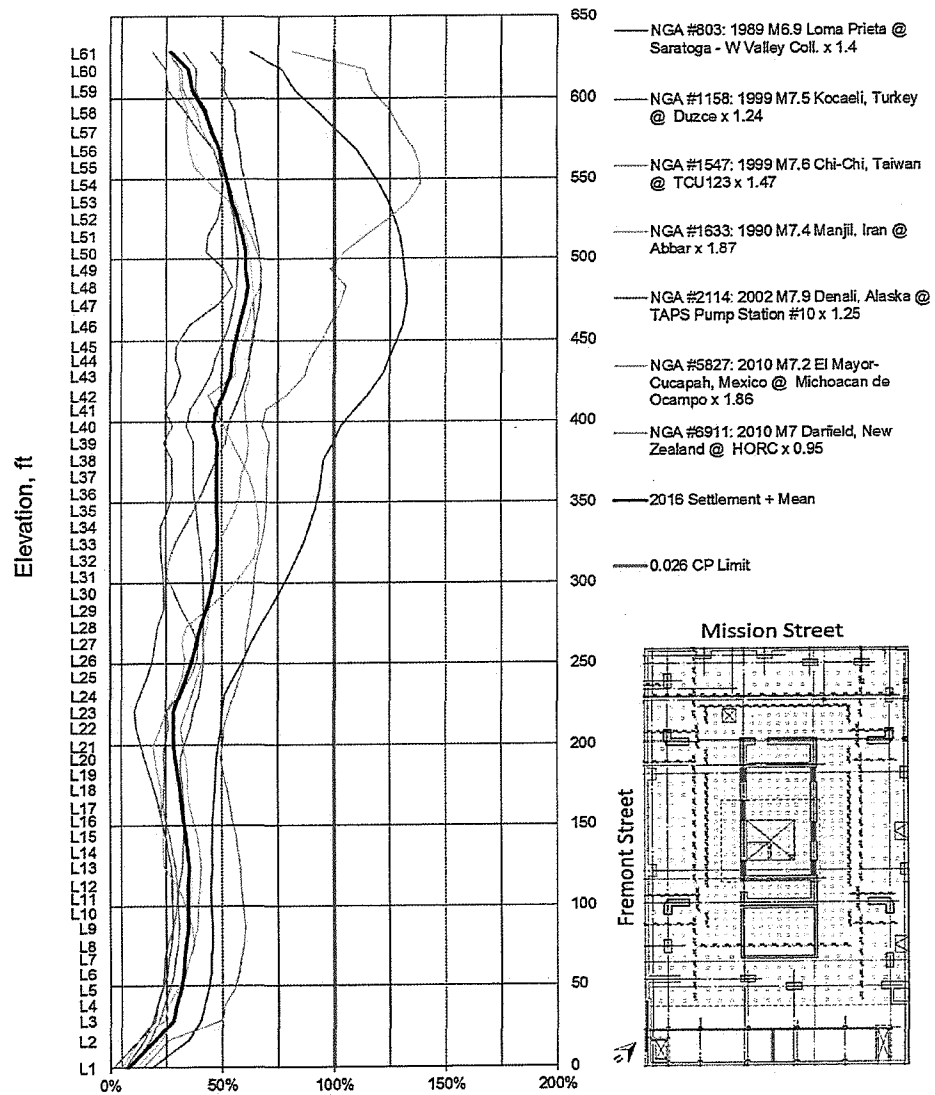
Figure 33. Demand to Capacity Ratios, Steel Coupling Beams, Fixed Translation Model

Figure 33 presents demand to capacity ratios for steel coupling beams. A value of 100% corresponds to a plastic hinge rotation of 0.03 radians. Mean demands are substantially less than this amount although two ground motions do produce locally somewhat higher demands at upper levels. The predicted demands are within the valid modeling range at all levels for all ground motions.

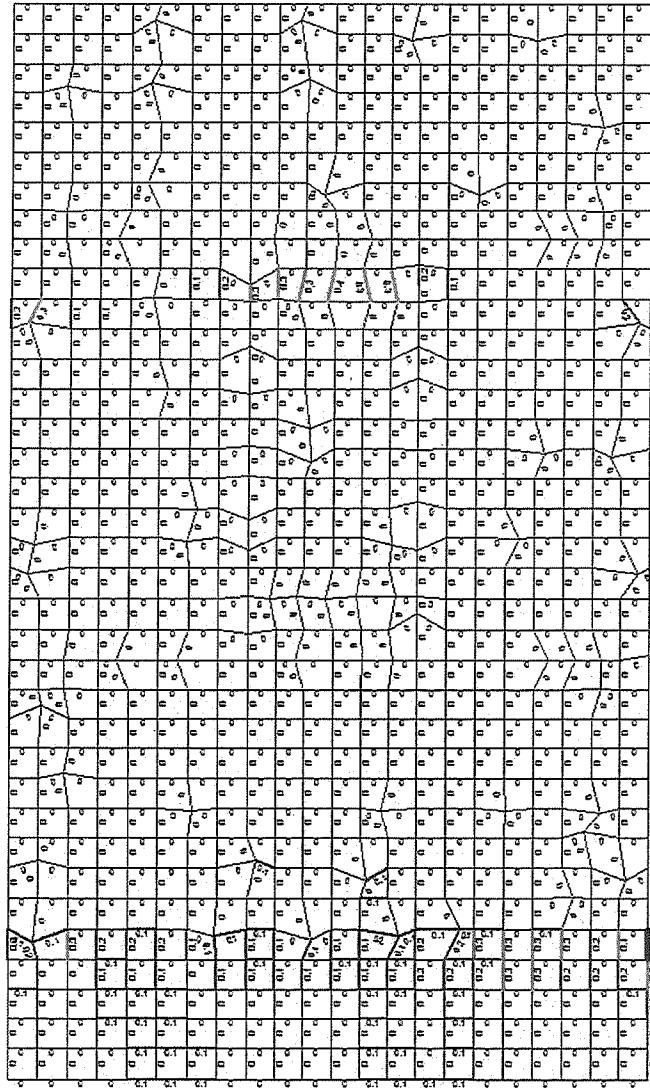
Figure 34. Peak Plastic Hinge Rotations (1999 Chi Chi, TCU3), Mat Grillage, Fixed Translation Model

Figure 34 shows the peak mat grillage beam plastic rotation demands from the 1999 Chi Chi Taiwan, TCU3 record, which of the suite of records evaluated, was the most taxing on the mat. The peak value at any location is 0.003 radians. A value of 0.01 is taken as acceptable. All values are substantially less than this.

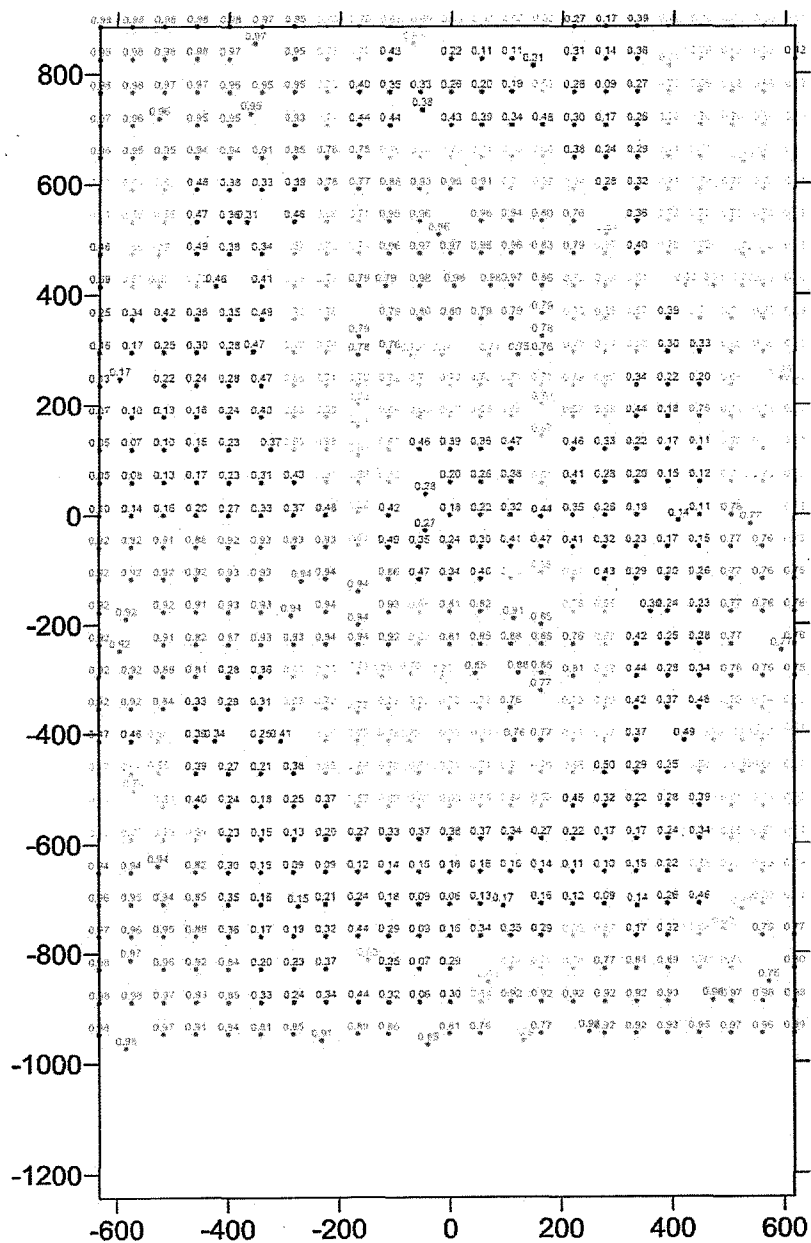
Figure 35. Pile Compressive Demand to Capacity Ratios, Maximum of Seven Ground Motions, Fixed Translation Model

Figure 35 shows the peak compressive demand to capacity ratio for piles. A value of 1.0 indicates that a pile has achieved its estimated geotechnical capacity as indicated in Figure 8 and Figure 9. It is important to note that this plot shows the peak value obtained for all ground motions. Individual ground motions would have lower peak values at most piles. Regardless, no piles exceed a value of 0.98. Also, since pile geotechnical capacity exceeds pile structural capacity, a value of 1.0 would indicate the onset of a yielding mode of behavior, rather than failure.

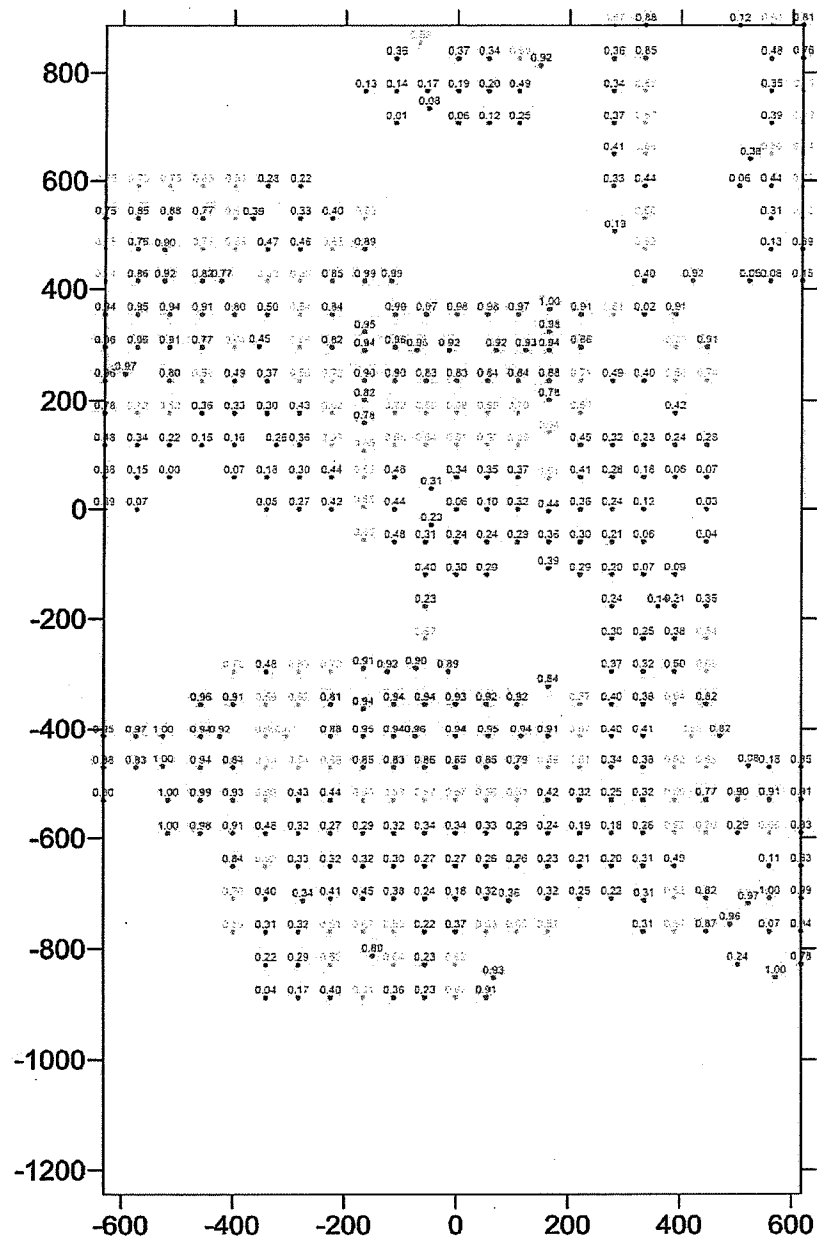
Figure 36. Peak Pile Tensile Demands to Capacity Ratios, Maximum of Seven Ground Motions, Fixed Translation Model

Figure 36 indicates peak pile uplift demand to capacity ratios for all ground motions. As with Figure 35, any one ground motion will produce lower values for most piles. For an individual pile spring, a value of 1.0 represents the lesser of the pile geotechnical seismic capacity, as given by Figure 8 and Figure 9 or the steel yield strength, whichever is less. Several piles are predicted to have a peak demand equal to their capacity. This is suggestive of a benign yielding mode of behavior.

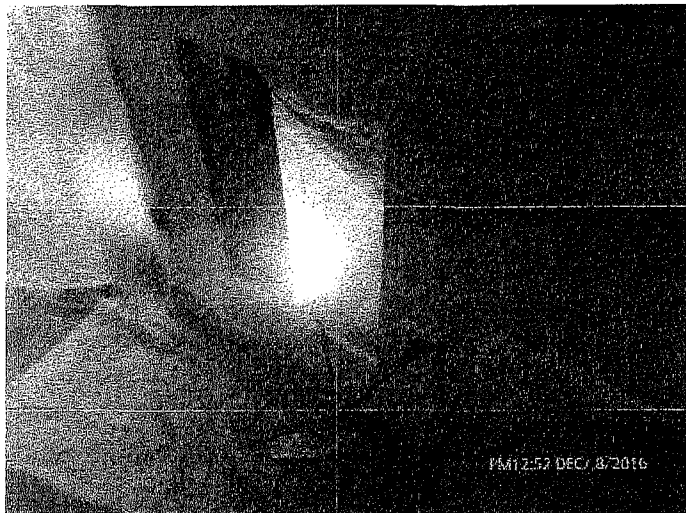
Test access opening in bedroom wall at site ST1 in unit 31B

1. At site ST1;
Seal the air gaps on the interior surface of the exterior wall (curtain wall) within the cavity behind the heat pump [HP-C]. This condition exists on both floors 30B and 31B:
 - Provide sufficient access opening in bedroom wall to perform work in subject area.
 - Prep, patch and seal exterior wall gaps in curtain wall, air tight.
 - Patch, seal and finish access opening.
2. At site ST5;

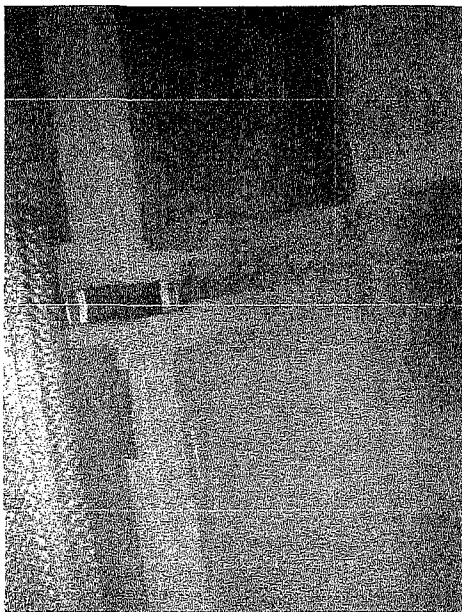
1. At site ST1;
Large gaps on the interior surface of the exterior wall (curtain wall) within the cavity behind the heat pump [HP-C]. This condition exists on both floors 30B and 31B. The location of air leak is directly across from the intake of the forced air heat pump unit. The odor transfer is enhanced and further distributed into the residence with the operation of the heat pump fan.
2. At site ST5;
Gaps around the hydronic-piping floor penetrations in the closet of heat pump [HP-B]. Here too the location of air leaks are close to the intake of the forced air heat pump unit. The odor transfer again is enhanced and further distributed into the residence with the operation of the heat pump fan.

**AIR GAP IN CURTAIN
WALL**

Smoke test site ST1 in unit 31B

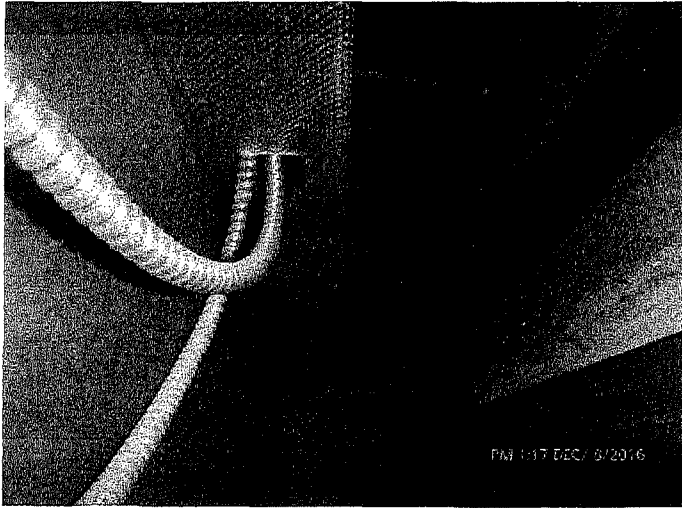
Pre-Test Conditions:
Test site ST5 in unit 31B heat pump closet.
Note pipe risers routed through closet floor

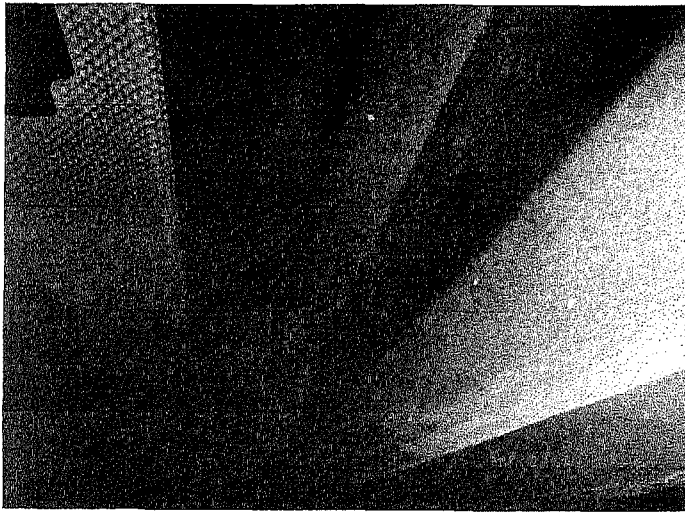
During Smoke Test Conditions – 1/2 minute from start:
Test site ST5 in unit 31B heat pump closet.
Note white test smoke at pipe risers routed through closet floor

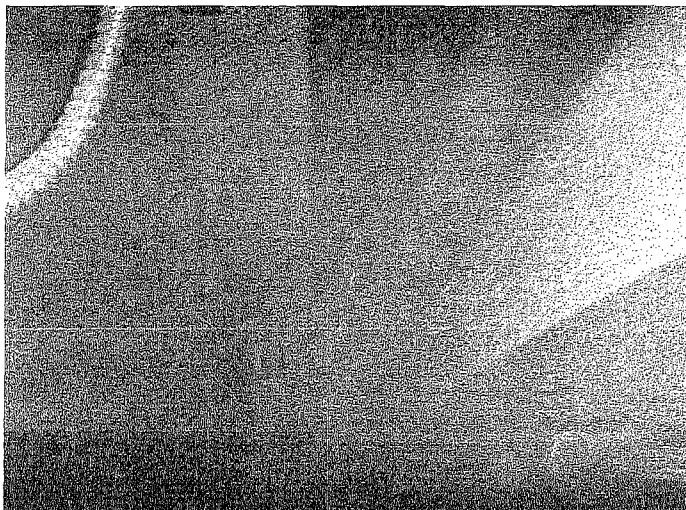
During Smoke Test Conditions- 1 minute from start:
Test site ST5 in unit 31B heat pump closet.
Note white test smoke completely filling closet

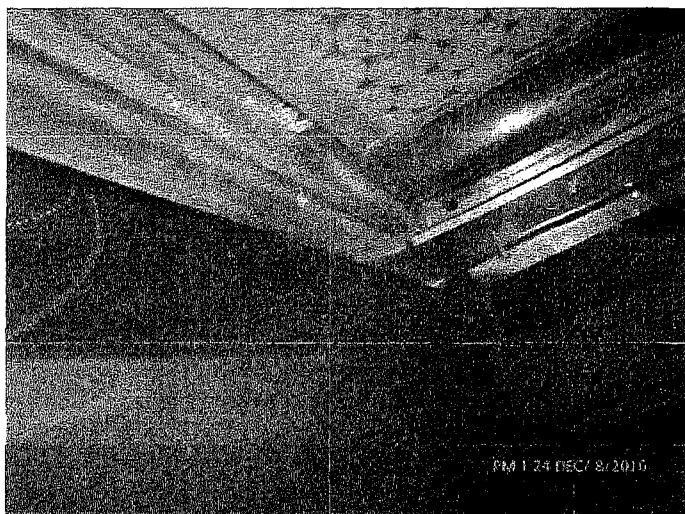
Test site ST5 in unit 31B heat pump closet.
Note test smoke flowing up through heat pump closet door opening

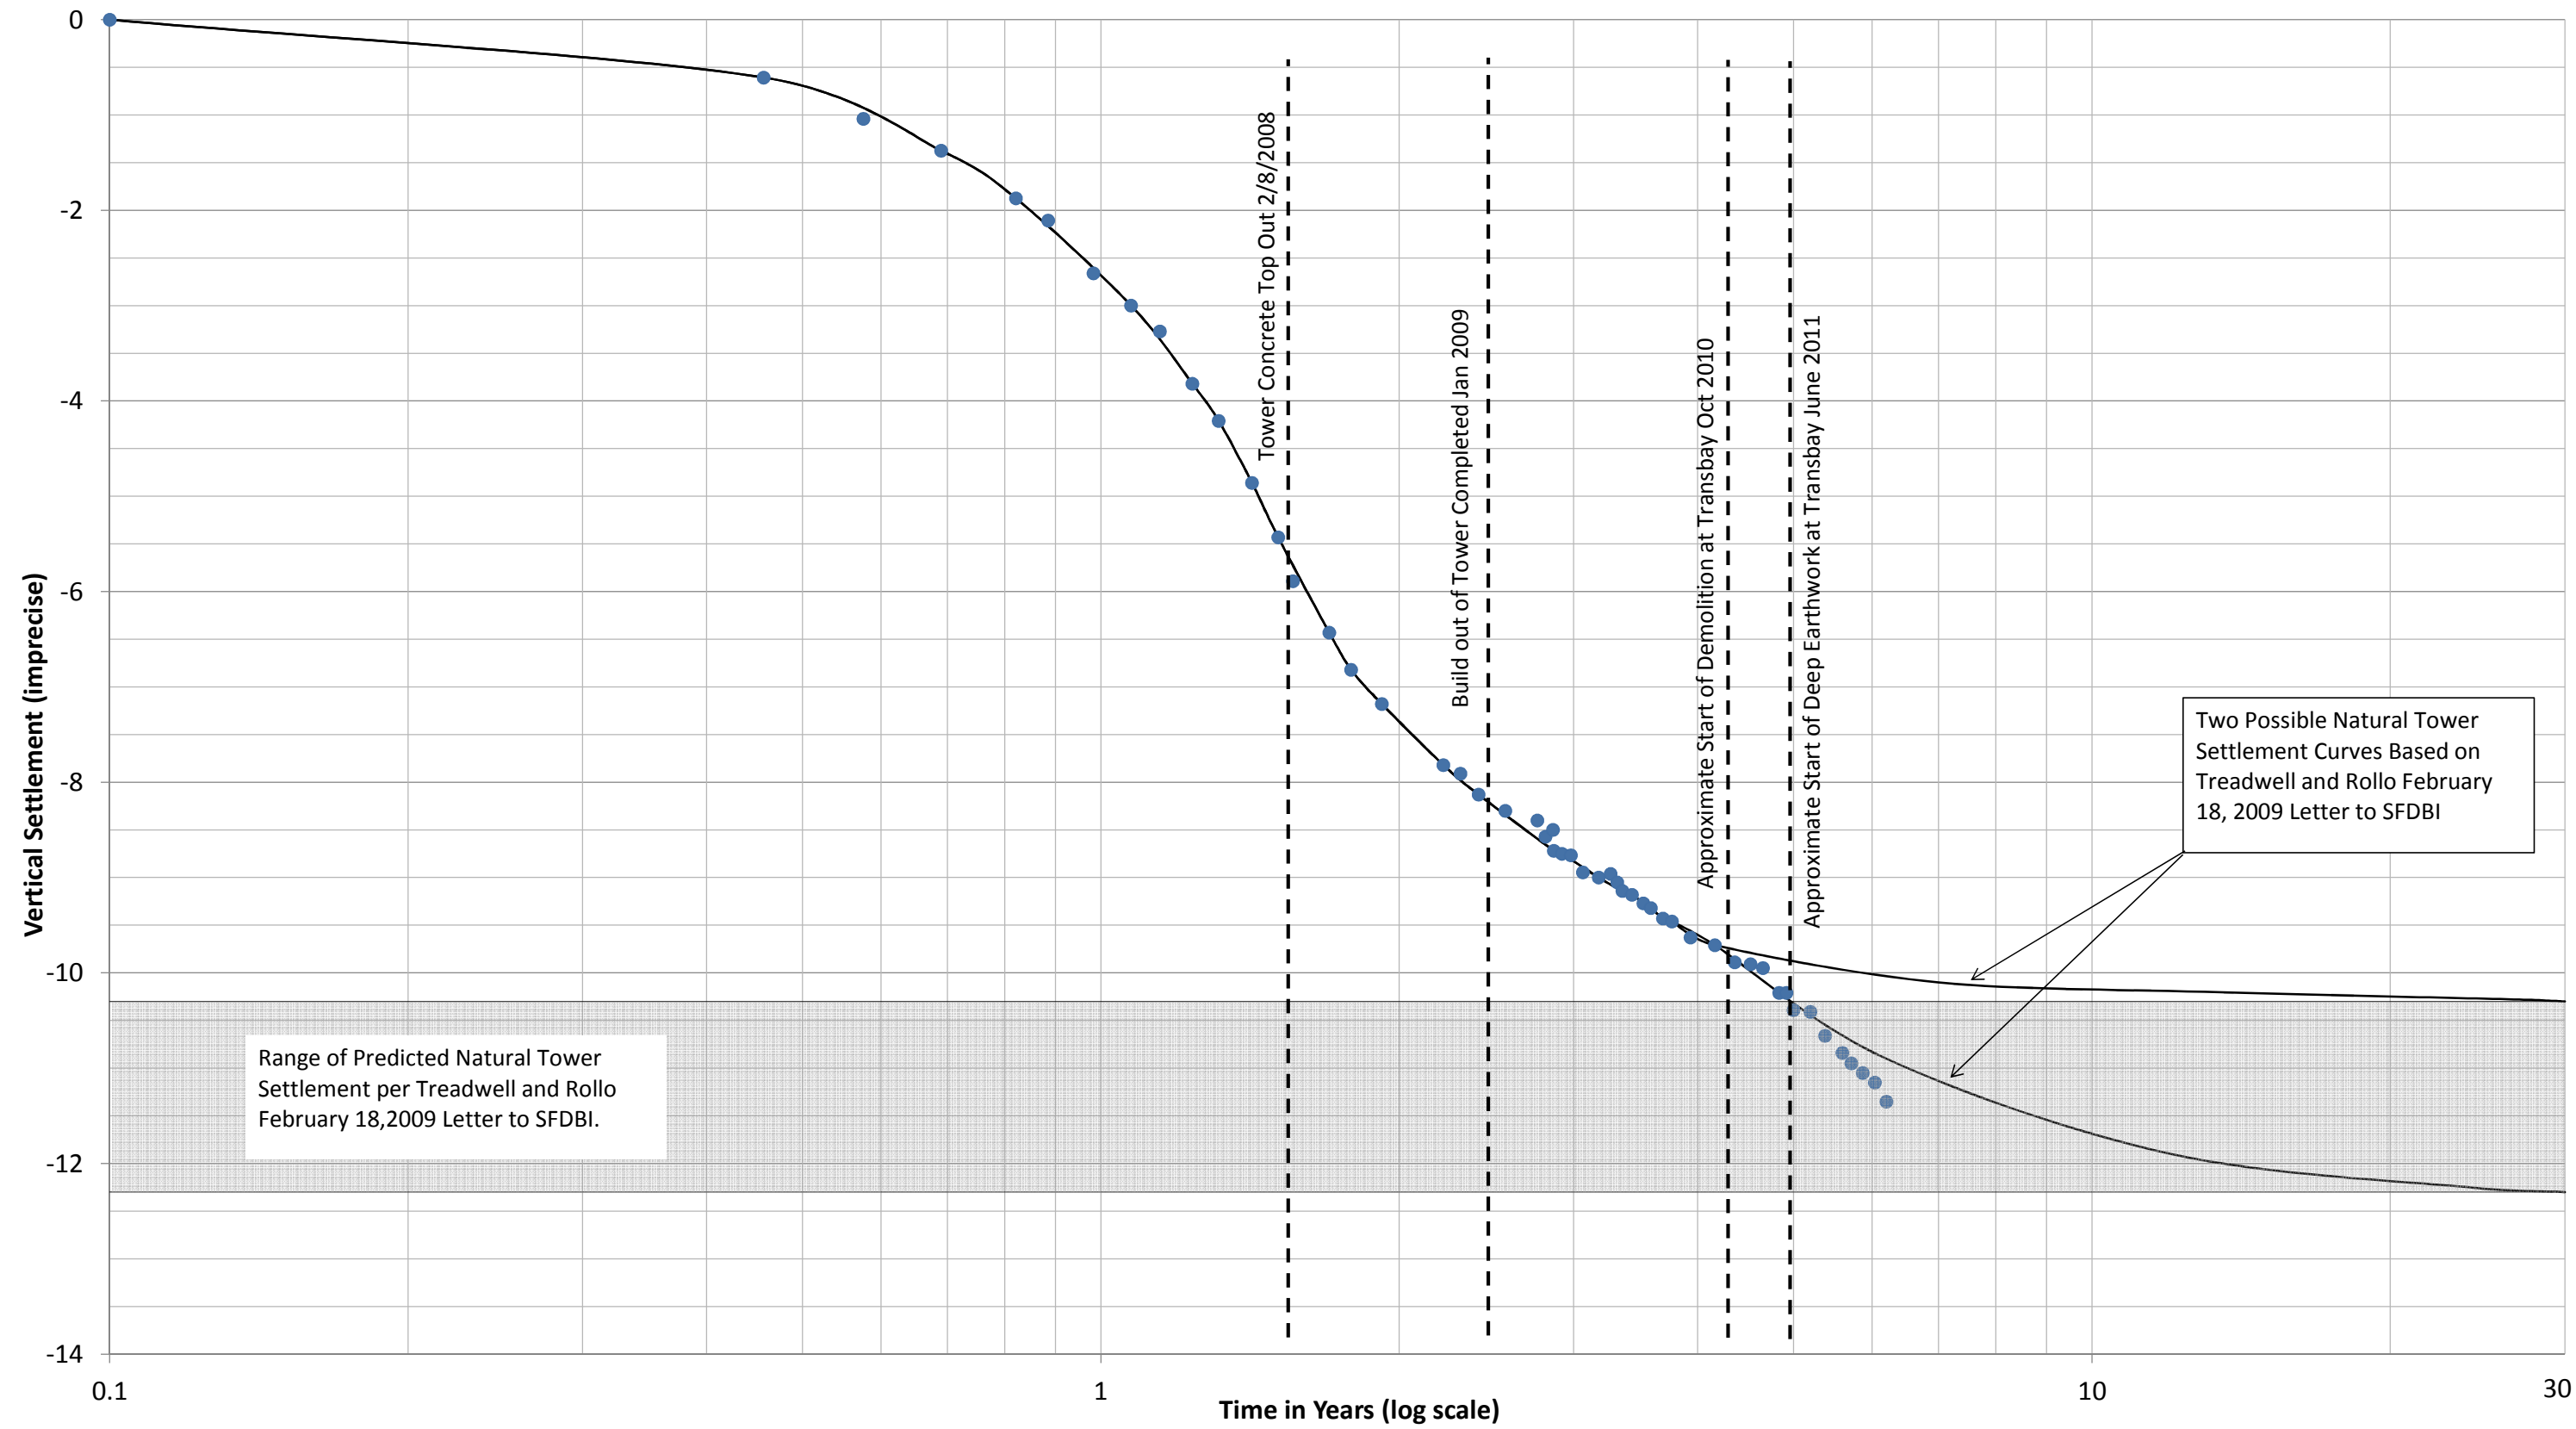
RECORDED SETTLEMENTS OF THE 301 MISSION TOWER

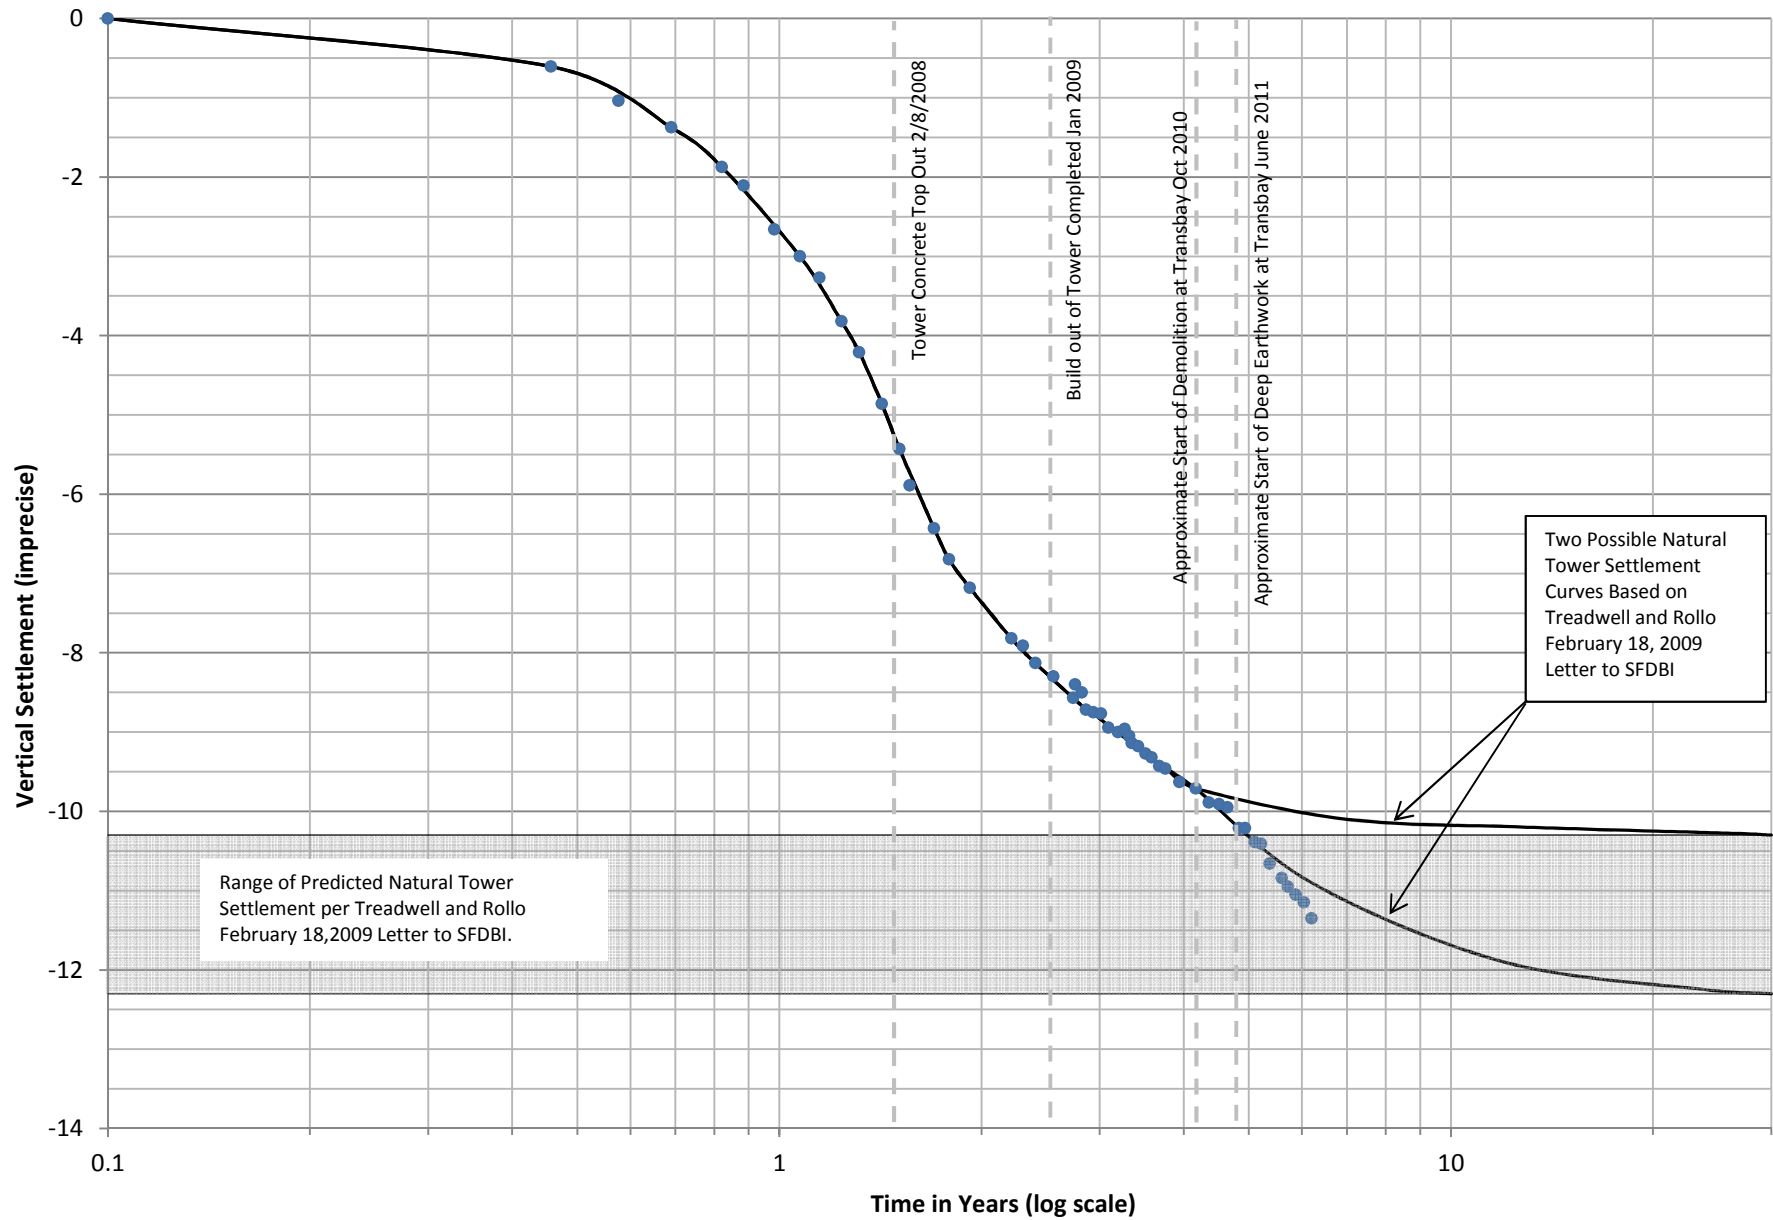
Figure 1

SETTLEMENT OF 301 MISSION TOWER
