Supplemental Report for Foundation Settlement Investigation

The building at 301 Mission Street, San Francisco, California is a fifty-eight-story residential structure founded on a pile-supported mat foundation. The building, which was completed in 2009, has experienced and continues to experience significant foundation settlement. Paul Hastings, LLP retained Simpson Gumpertz & Heger Inc. in 2014 to conduct an evaluation of the impact of site settlement on the building's structural stability and earthquake resistance. We performed initial evaluations in 2014 and updated these in 2016 to consider additional settlement that occurred in the interim period. In an October 2016 report we concluded that settlement had not compromised the building's stability or its ability to resist strong earthquakes.

**SUPPLEMENTAL REPORT
FOUNDATION SETTLEMENT INVESTIGATION
301 MISSION STREET
SAN FRANCISCO, CALIFORNIA**

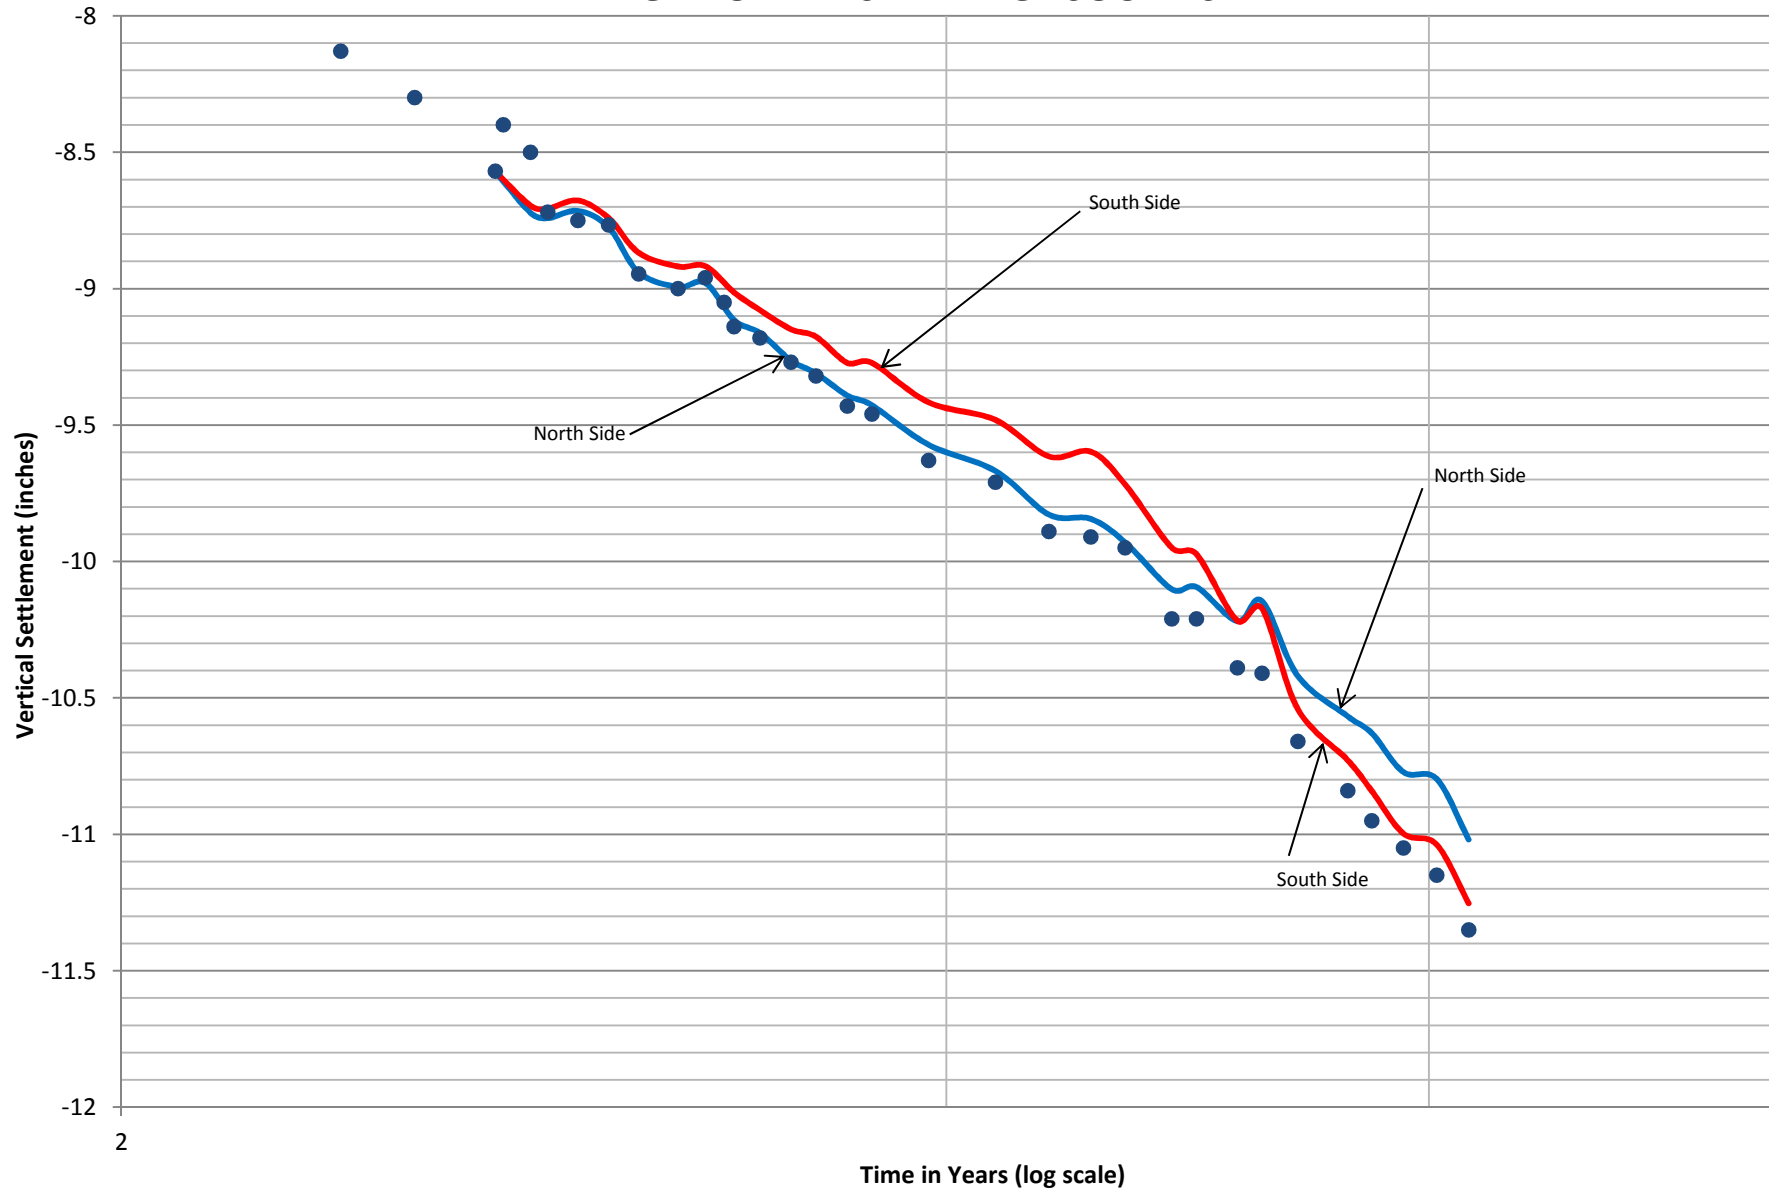
Figure 2

**SETTLEMENT OF 301 MISSION TOWER
AVERAGE NORTH VS AVERAGE SOUTH SIDE**

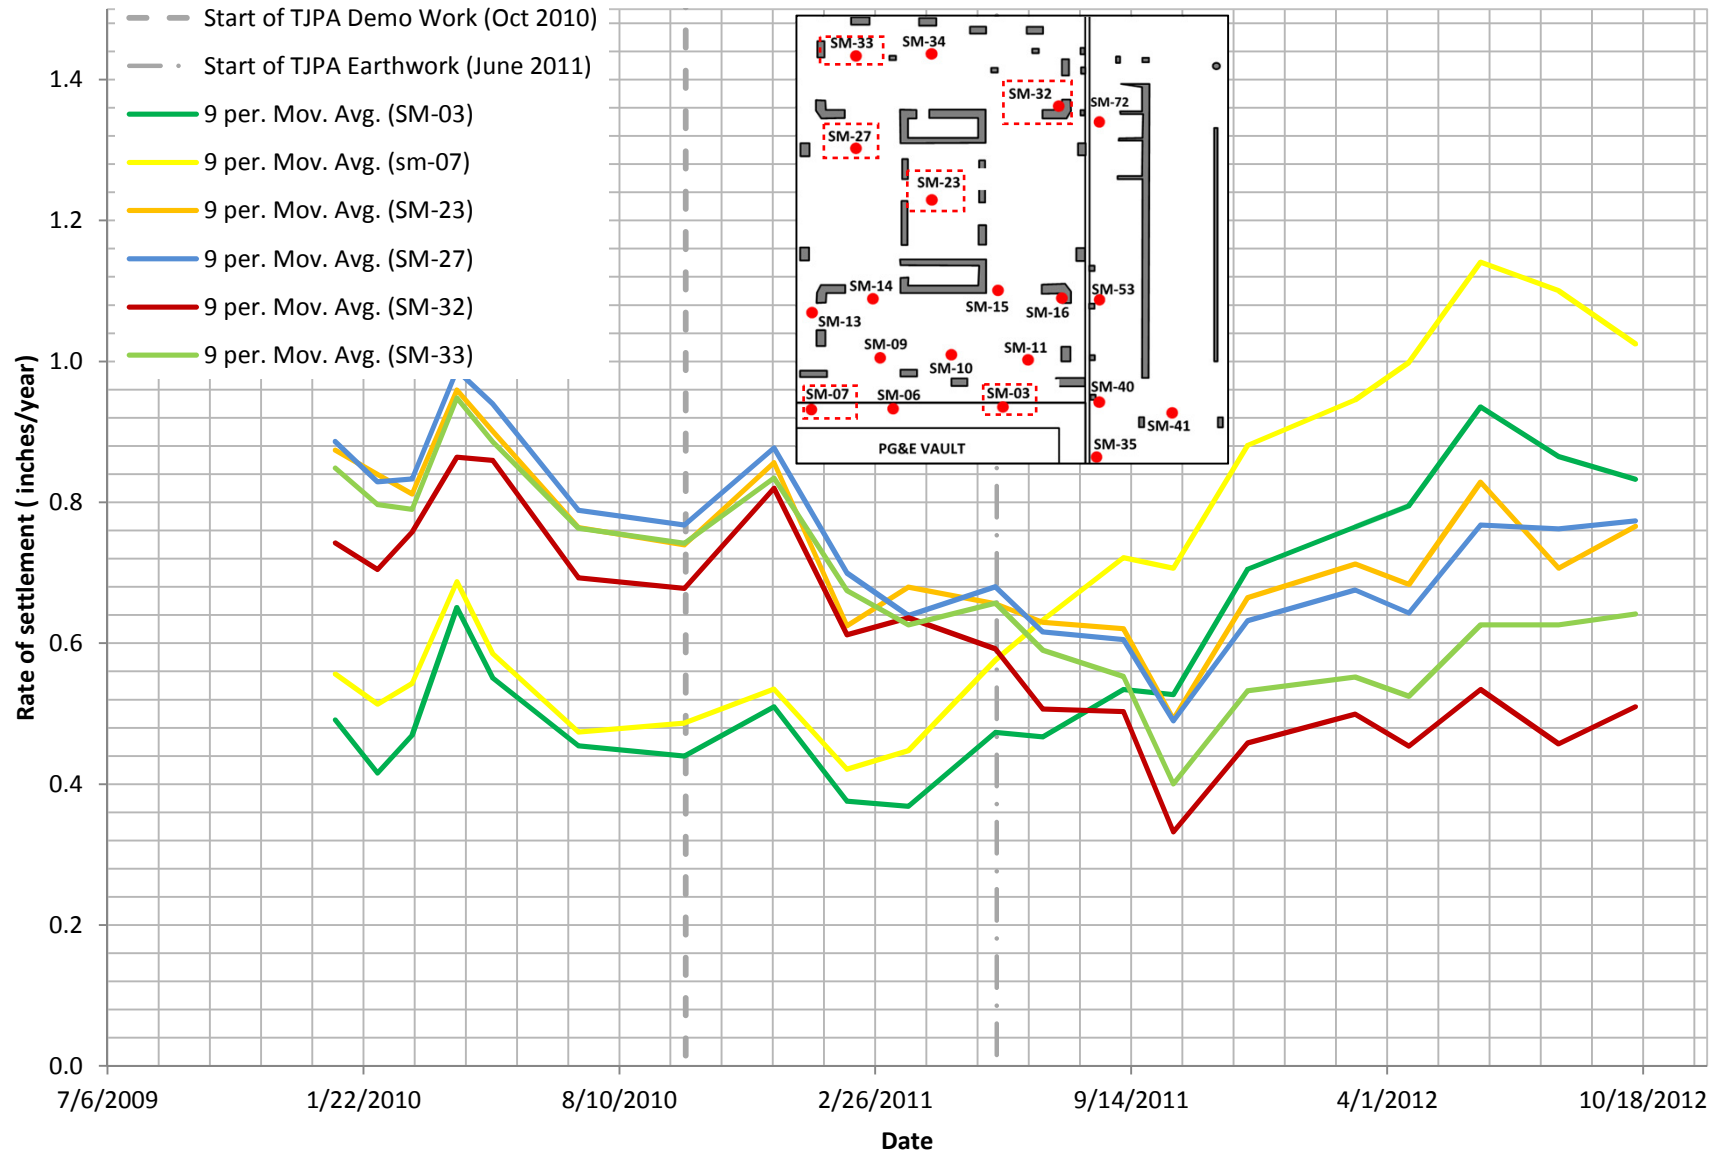
Figure 9

SETTLEMENT OF 301 MISSION TOWER RATE OF SETTLEMENT OVER TIME

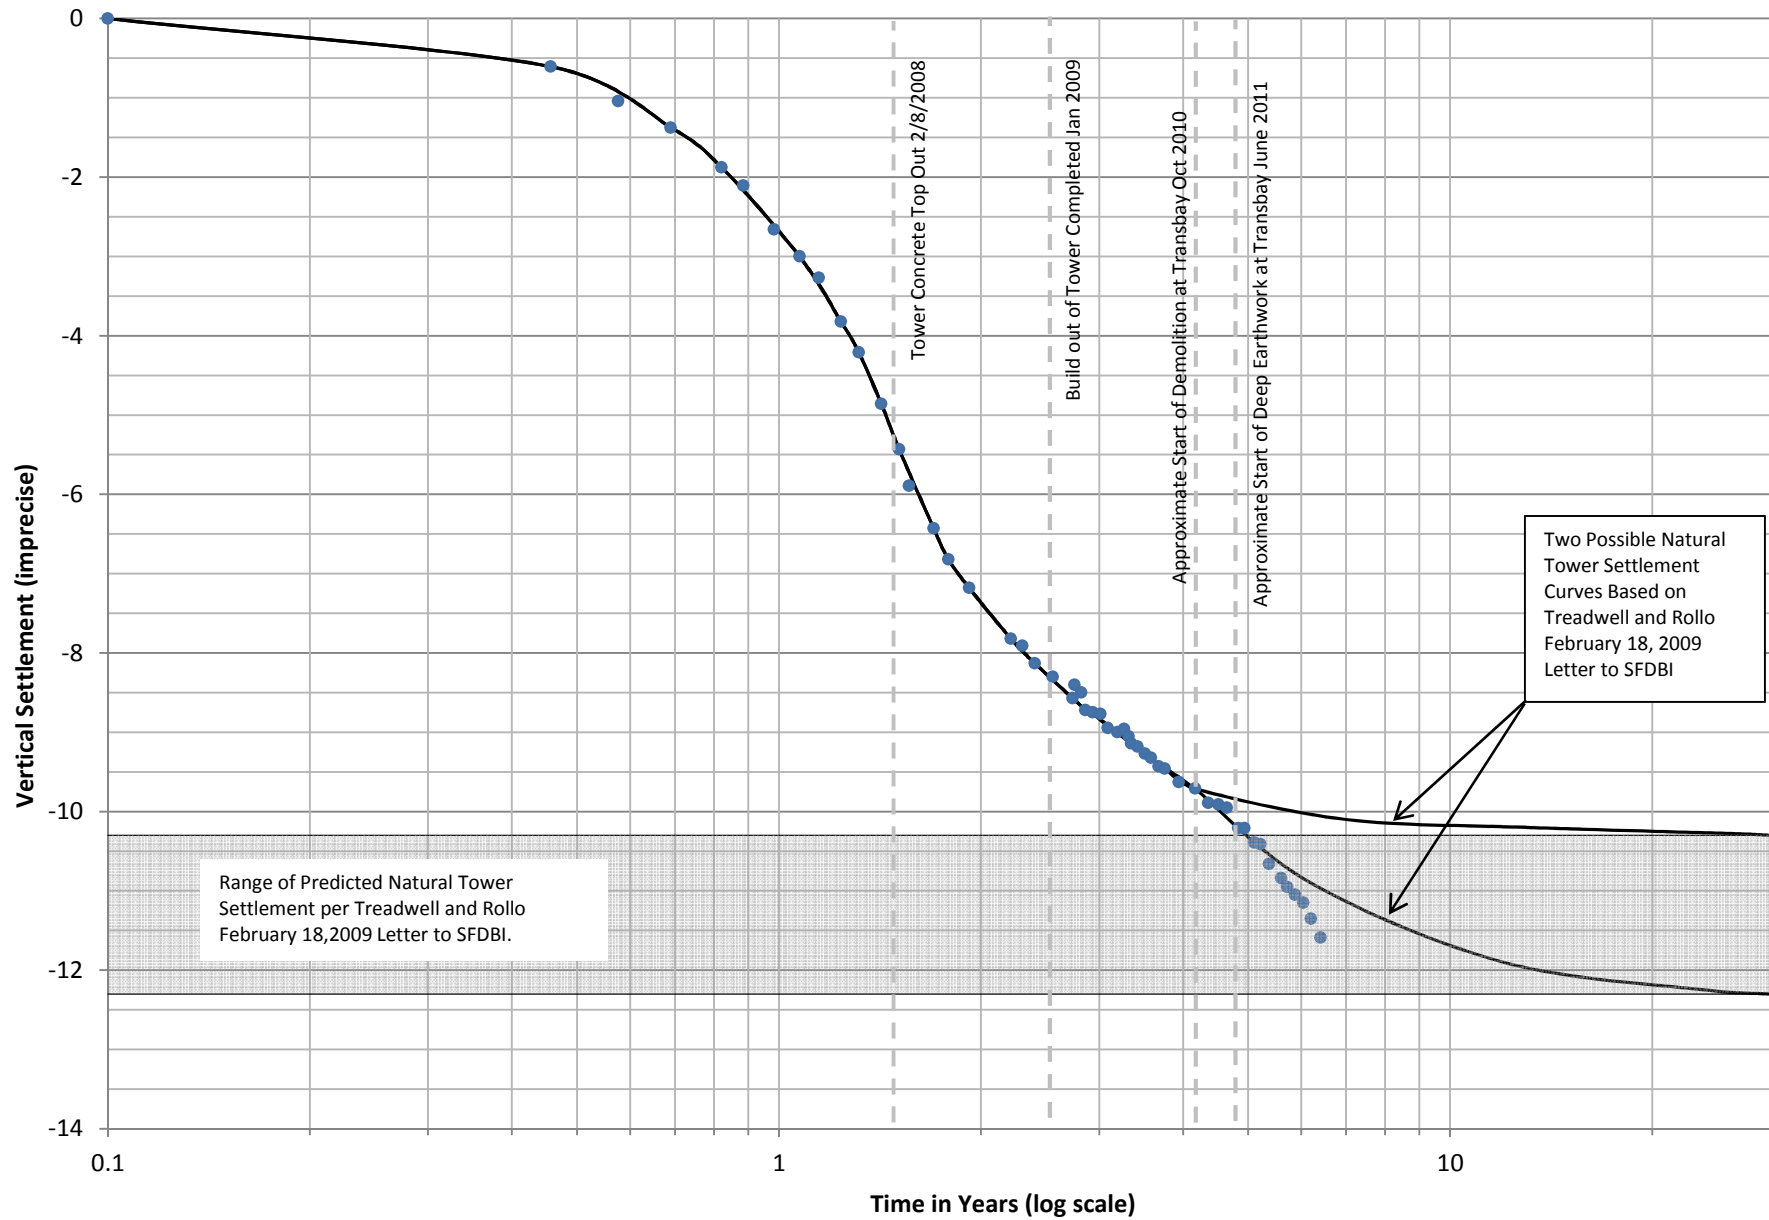
Figure 1

SETTLEMENT OF 301 MISSION TOWER

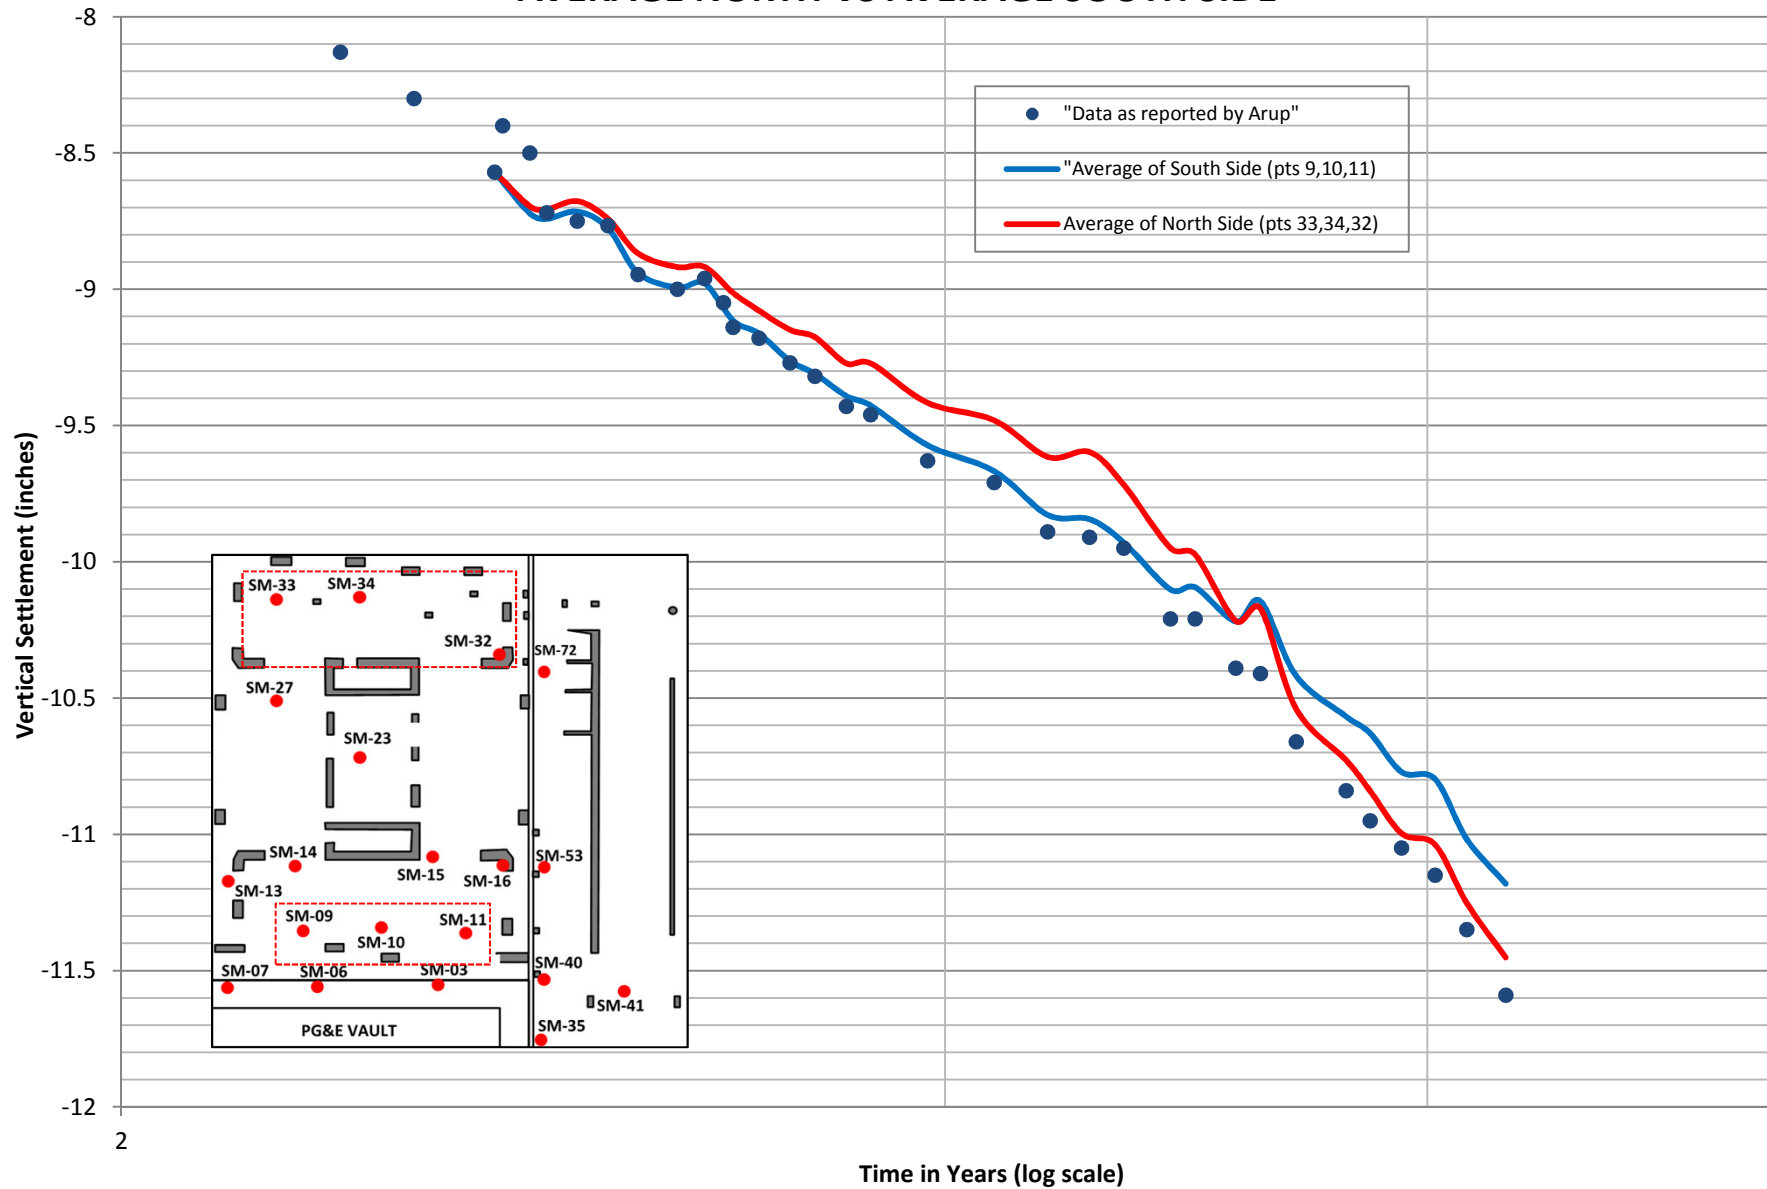
Figure 2

SETTLEMENT OF 301 MISSION TOWER AVERAGE NORTH VS AVERAGE SOUTH SIDE

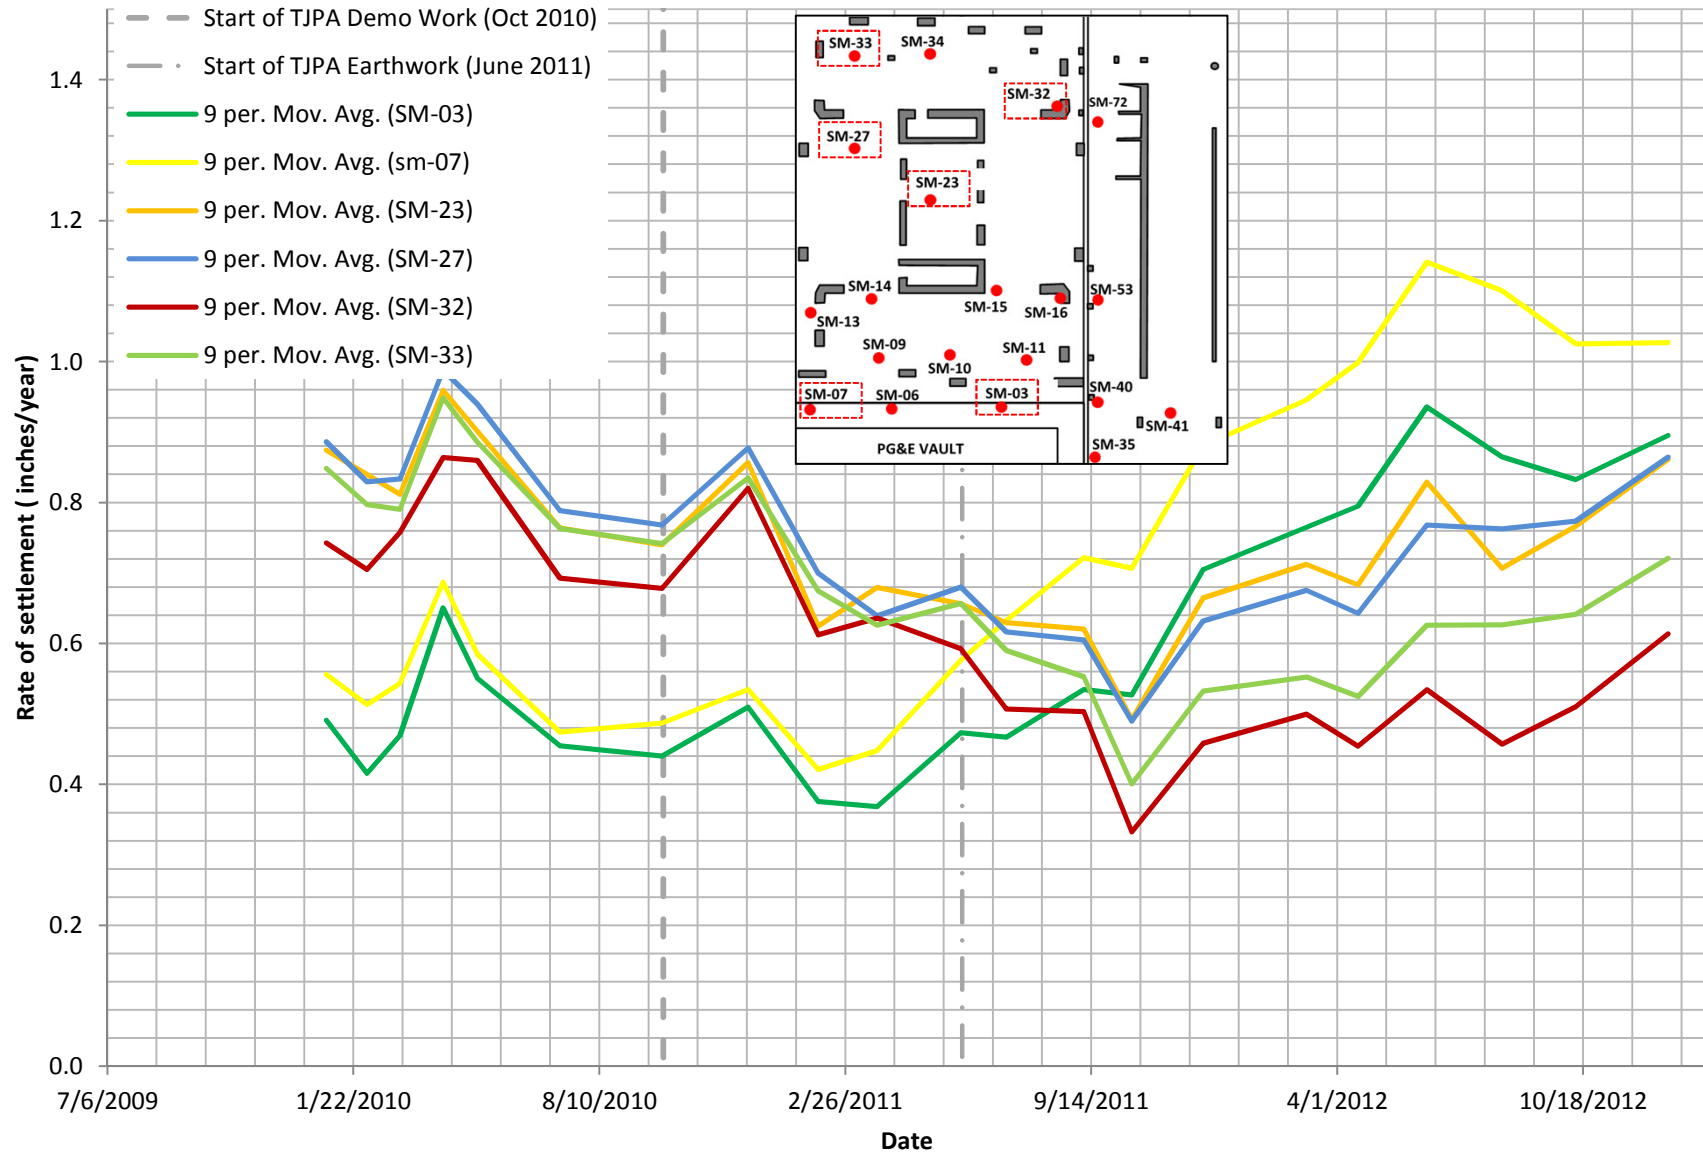
Figure 9

SETTLEMENT OF 301 MISSION TOWER RATE OF SETTLEMENT OVER TIME

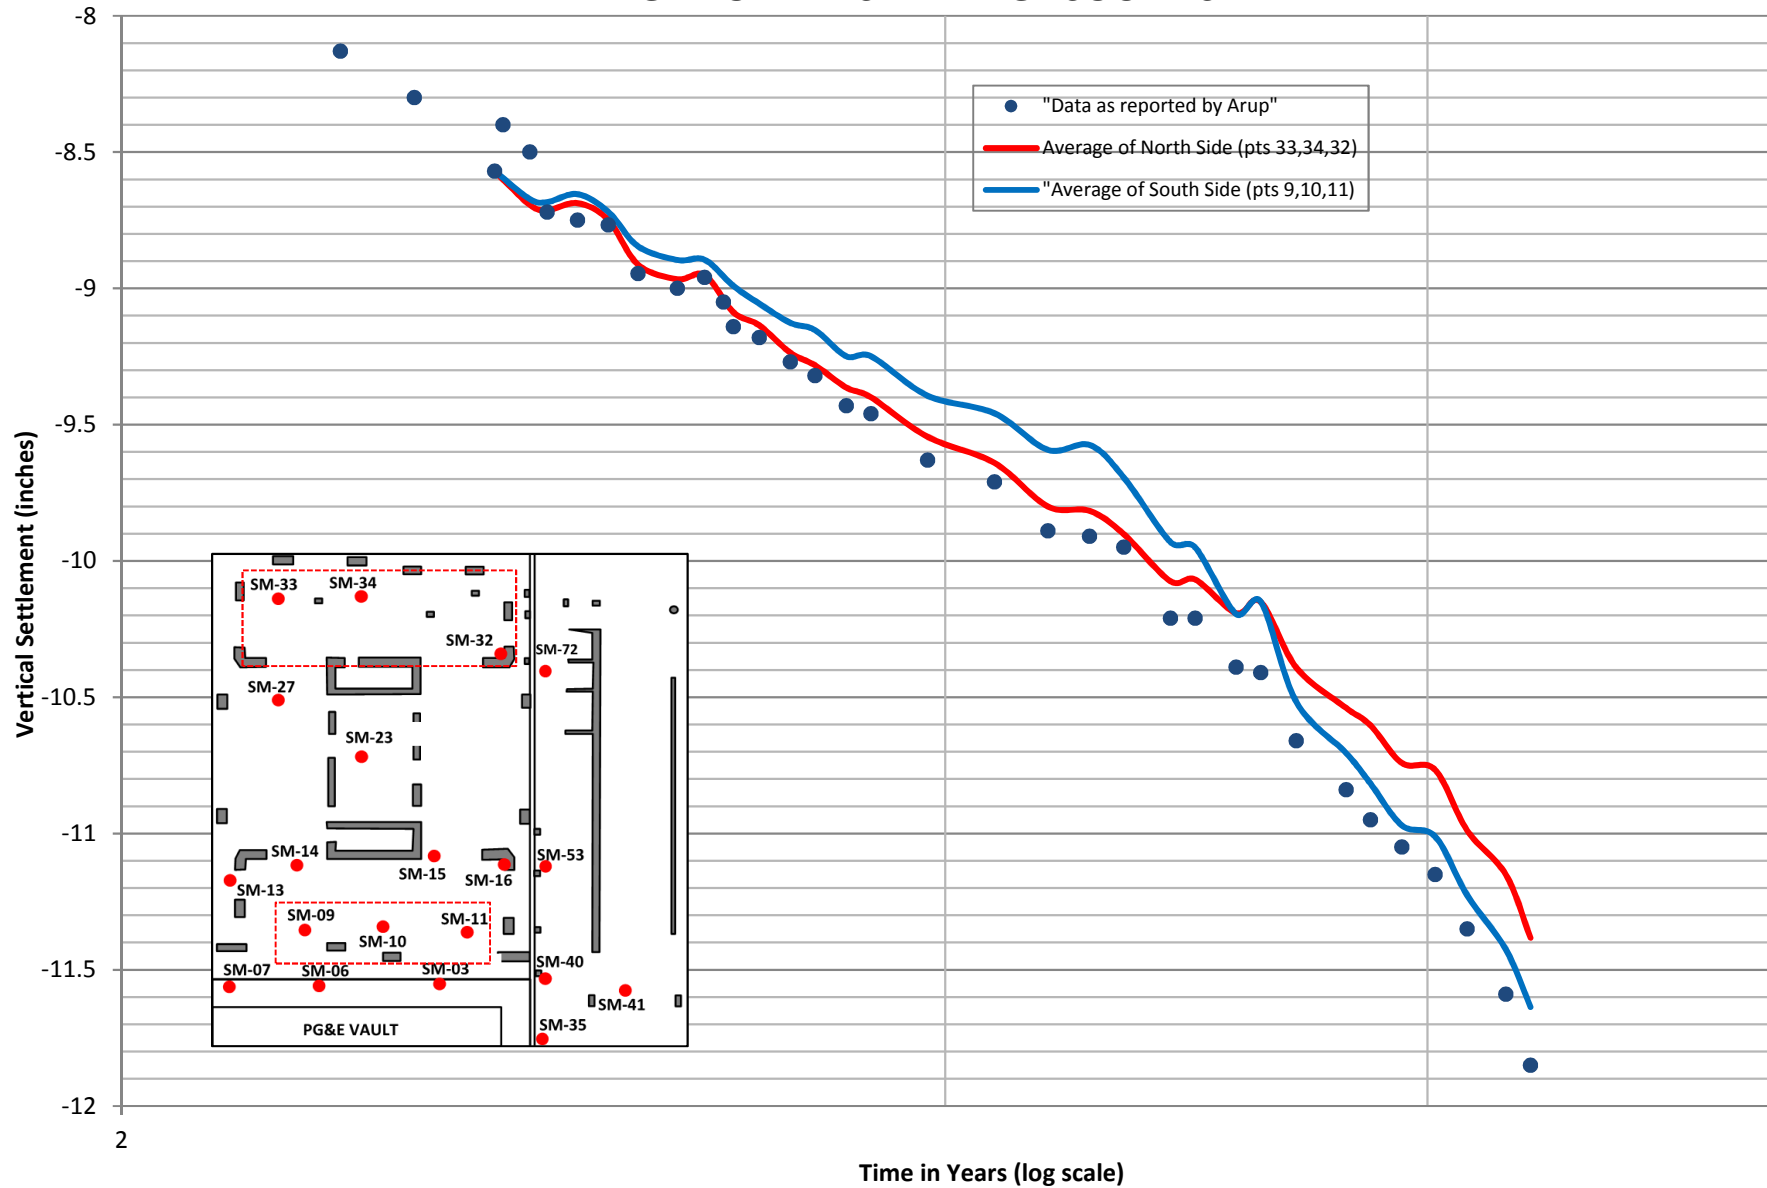
Figure 2 includes an average of settlement on the north side of the tower and on the south end of the tower. Before construction activities began at Transbay we observe that the north side had settled at a greater rate than the south. After construction activities started, we now observe a greater rate of settlement on the south side. The foundation has rotated slightly towards the Transbay project. Since the south end of the foundation seems now to be moving faster than the north, it follows that the activities at Transbay have caused the additional settlement.

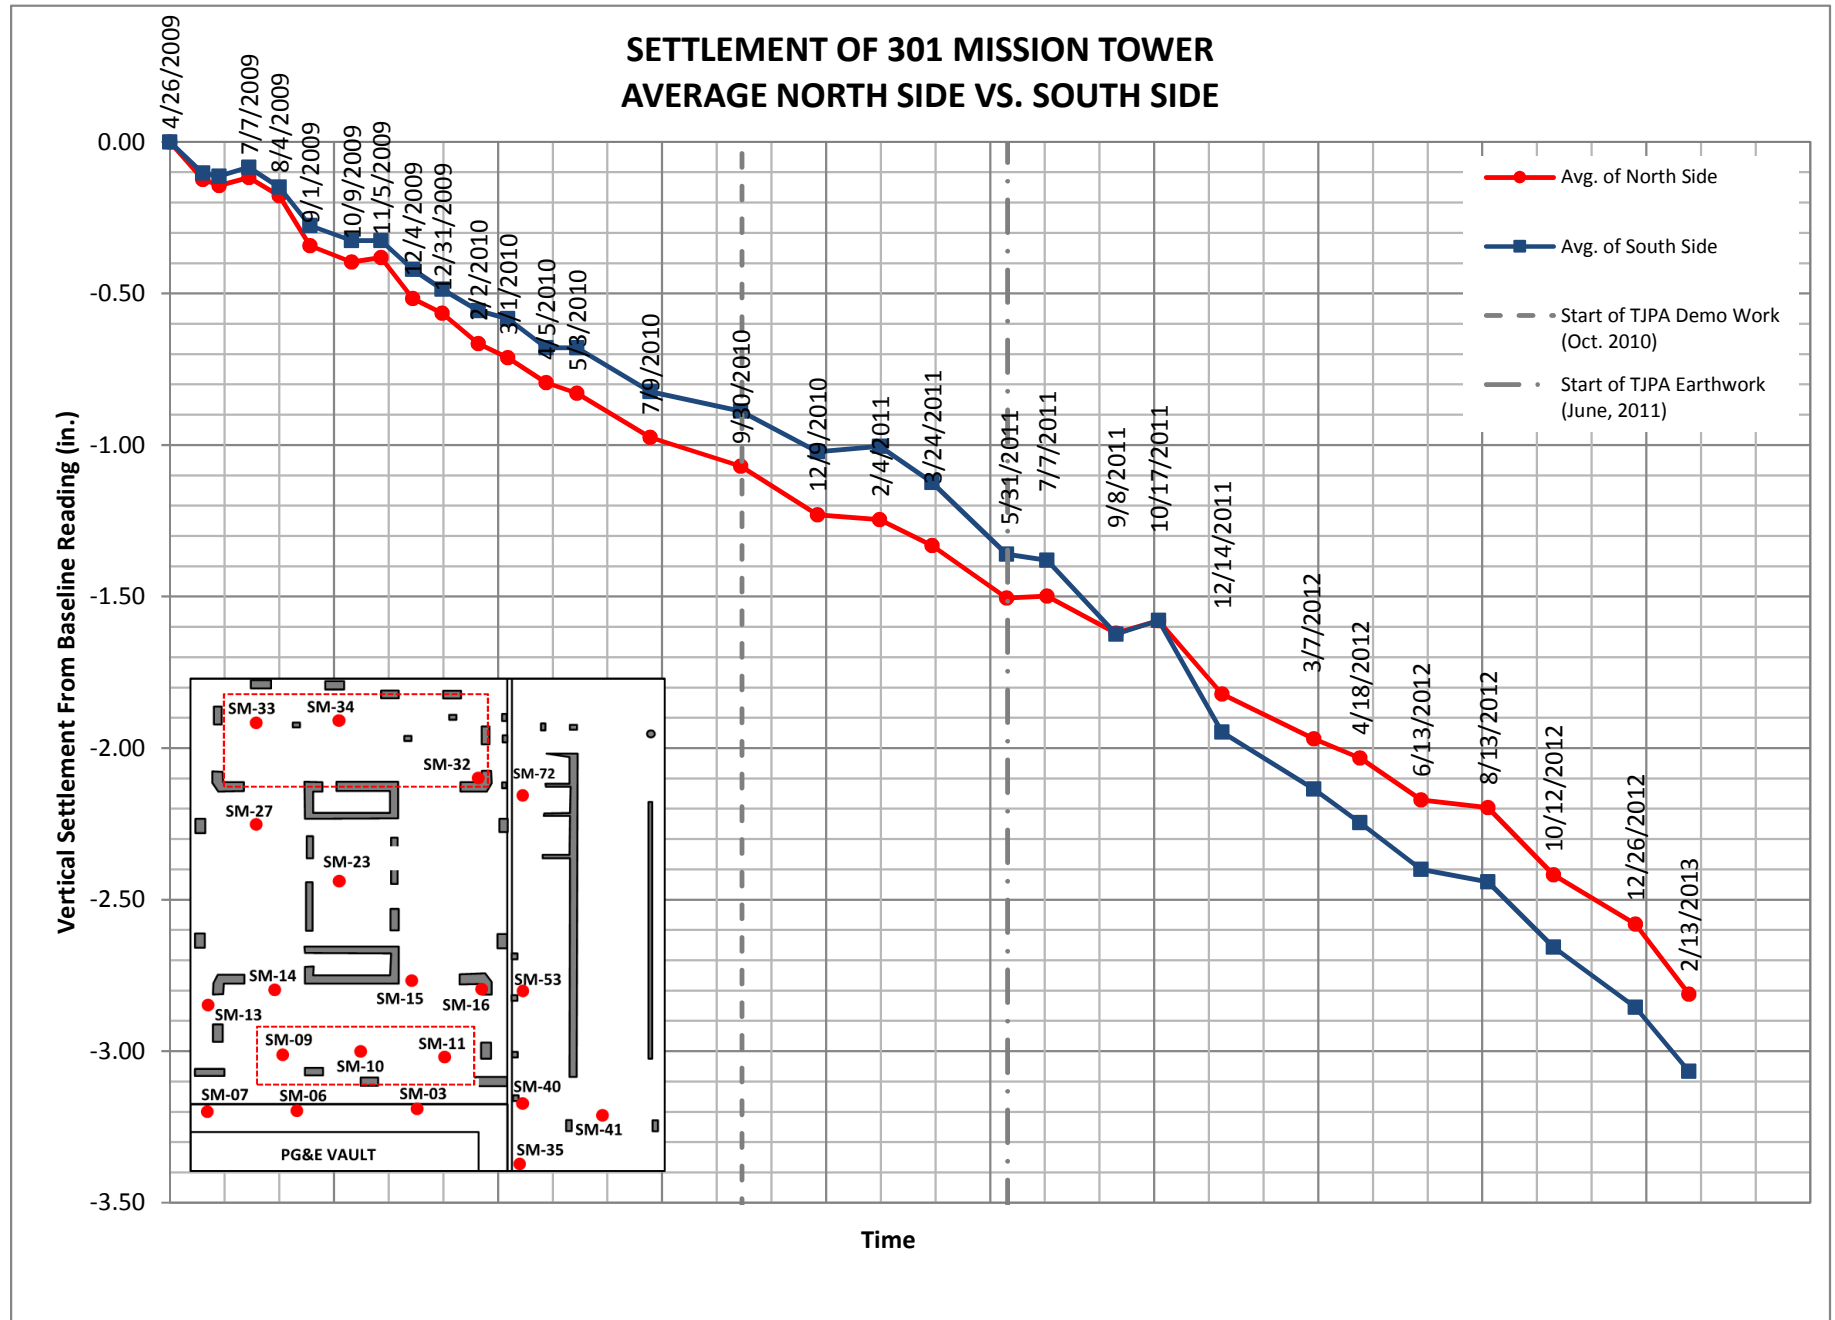
Figure 4

Settlement of the North vs. South Side of the Foundation (Figure 4)

Before construction at Transbay began, the North Side was settling more, and now, after construction has been going for some time, the south side is settling more. This seems to clearly show that the construction has caused a change. It is recommended that Millennium seek an explanation for this from Transbay.

It should also be noted that this figure shows differential movement across the foundation causing a tilt to the building. This kind of movement can cause damage to the structure which reduces the buildings reserve strength for earthquakes.

The last two readings show an overall slowing of settlement on the South side of the site while the North side of the site has had a steady increase in settlement. This change is coincidental with the finishing of the Transbay buttress installation and the lack of deep foundation work on site.

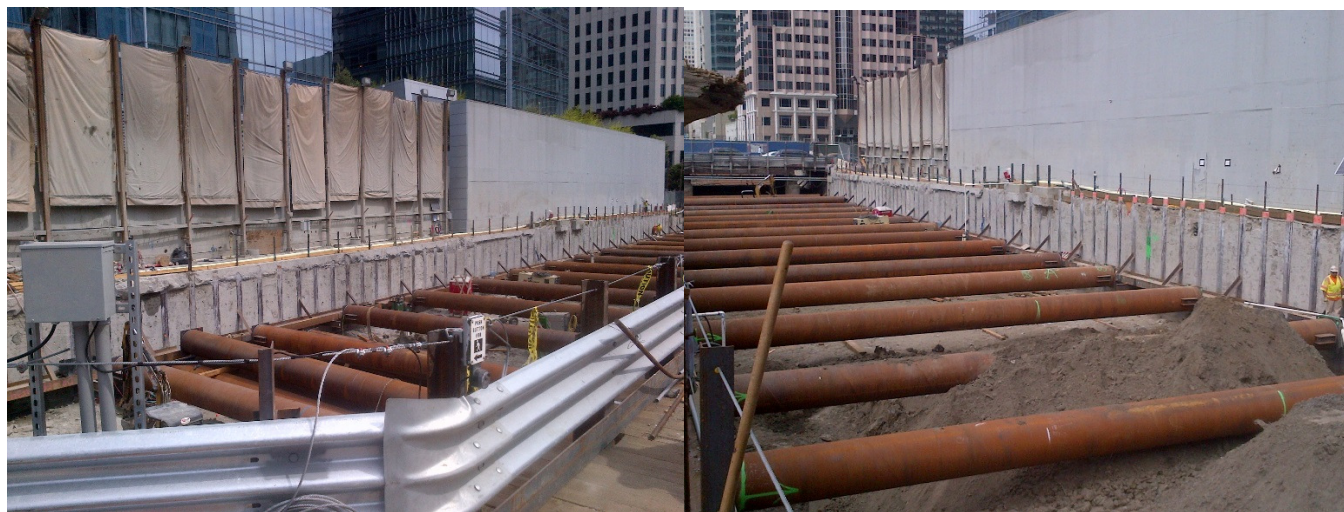
A major Transbay construction milestone has recently occurred. Excavation has begun as of May 2013. The excavation is approximately 15 feet below grade at the current time, immediately below the elevation of the first set of cross lot bracing. The cross-lot bracing has begun to be installed but has not yet been connected to the far side.

Construction progress immediately adjacent to 301 Mission Street. Photos taken July 22, 2013.

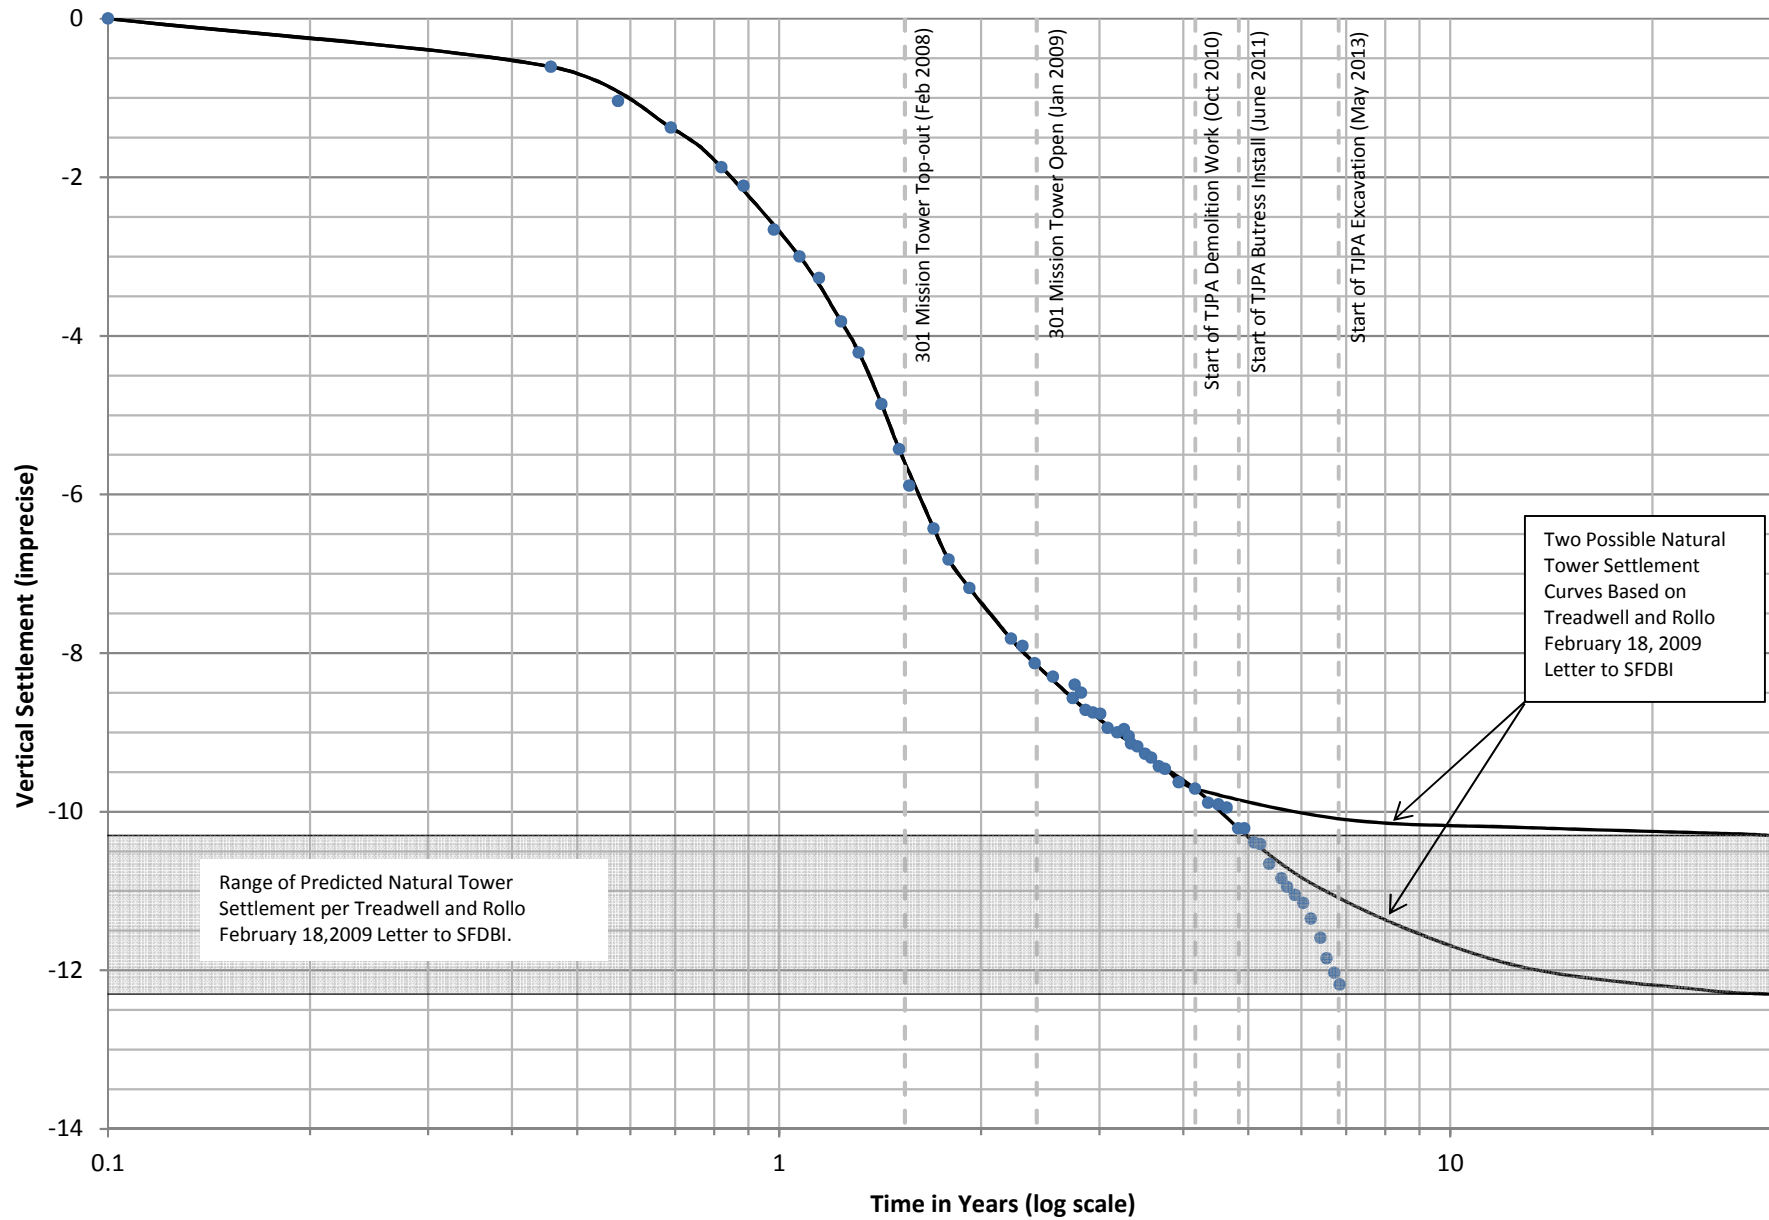
Figure 1

If we use Treadwell and Rollo's (Langan) predicted range of total settlement and read the difference between the measured displacement data points and the settlement prediction curves (Figure 1), the additional settlement is between 1.5 to 2.8 inches. Since 0.75 inches is the "Action Trigger Level" for "other buildings" as described in the Transbay Specification, it is recommended, as we had recommended in earlier reports, that Millennium Partners (Millennium) obtain a response from Transbay regarding this discrepancy in predicted settlement. Furthermore, Transbay revised their specification (the Dec 10, 2010 version) to exclude the 301 Mission Tower from all action trigger levels. It is unclear why Transbay would have changed their specification after construction had begun. The rationale behind this action should be both understood and carefully considered by Millennium.

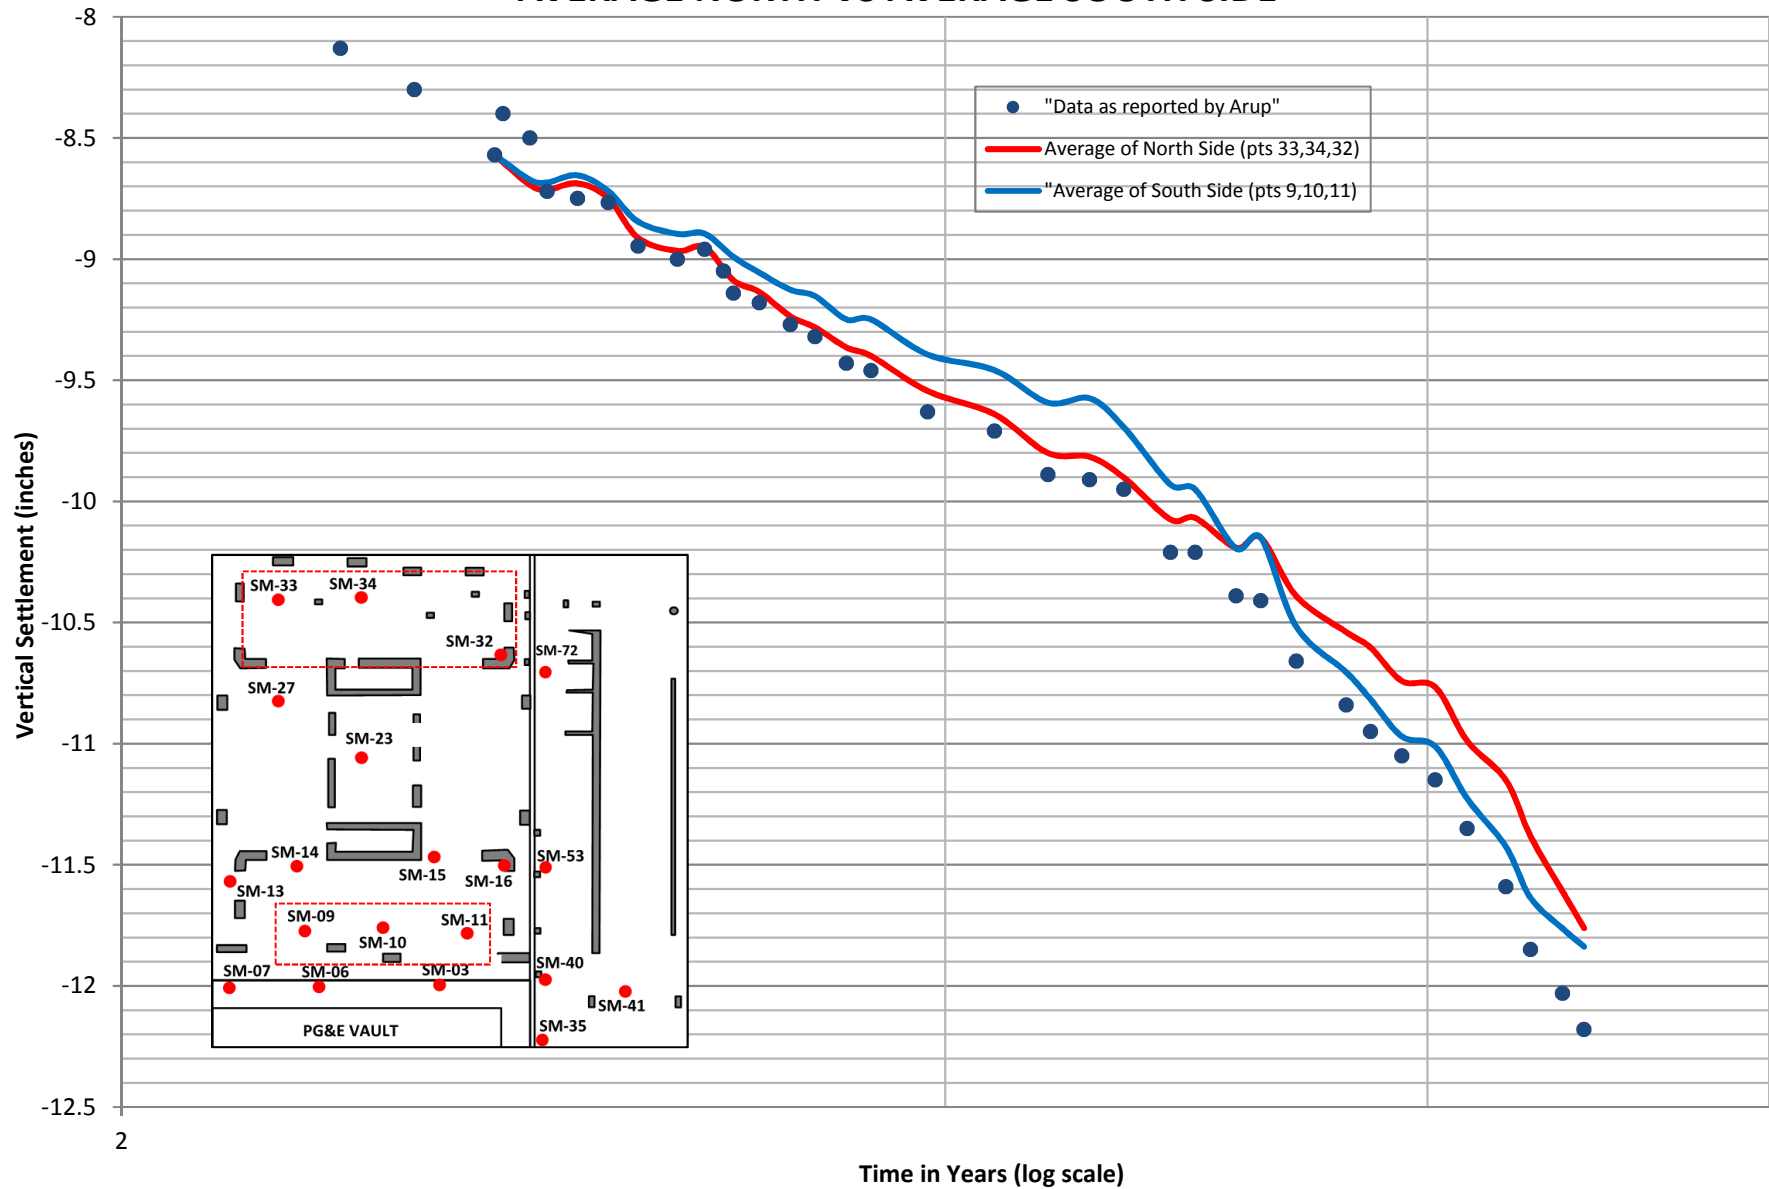
Settlement of the North vs. South Side of the Foundation - Logarithmic Scale (Figure 2)

Figure 2 presents an average of settlement on the north side of the tower versus the south end of the tower, as measured in logarithmic scale. Before construction activities began at Transbay we observed that the north side had settled at a greater rate than the south. After buttress installation activities started, we observed a greater rate of settlement on the south side. After June 2013, the north side again shows to have a higher rate of settlement than the south side. The foundation has rotated slightly away from the south side. Since the south end of the foundation now seems to be moving faster than the north, this suggests that the activities at Transbay have caused the additional settlement.

Figure 2 also shows that the overall settlement reported by ARUP (duplicated in Figure 1) is the worst case settlement anywhere across the foundation (about 12.7 inches) and does not accurately represent the average. The average overall settlement for the north side currently shows about 12.3 inches. The average overall settlement for the south side currently shows about 12.1 inches.
