Supplemental Report for Foundation Settlement Investigation

The building at 301 Mission Street, San Francisco, California is a fifty-eight-story residential structure founded on a pile-supported mat foundation. The building, which was completed in 2009, has experienced and continues to experience significant foundation settlement. Paul Hastings, LLP retained Simpson Gumpertz & Heger Inc. in 2014 to conduct an evaluation of the impact of site settlement on the building's structural stability and earthquake resistance. We performed initial evaluations in 2014 and updated these in 2016 to consider additional settlement that occurred in the interim period. In an October 2016 report we concluded that settlement had not compromised the building's stability or its ability to resist strong earthquakes.

**SUPPLEMENTAL REPORT
FOUNDATION SETTLEMENT INVESTIGATION
301 MISSION STREET
SAN FRANCISCO, CALIFORNIA**

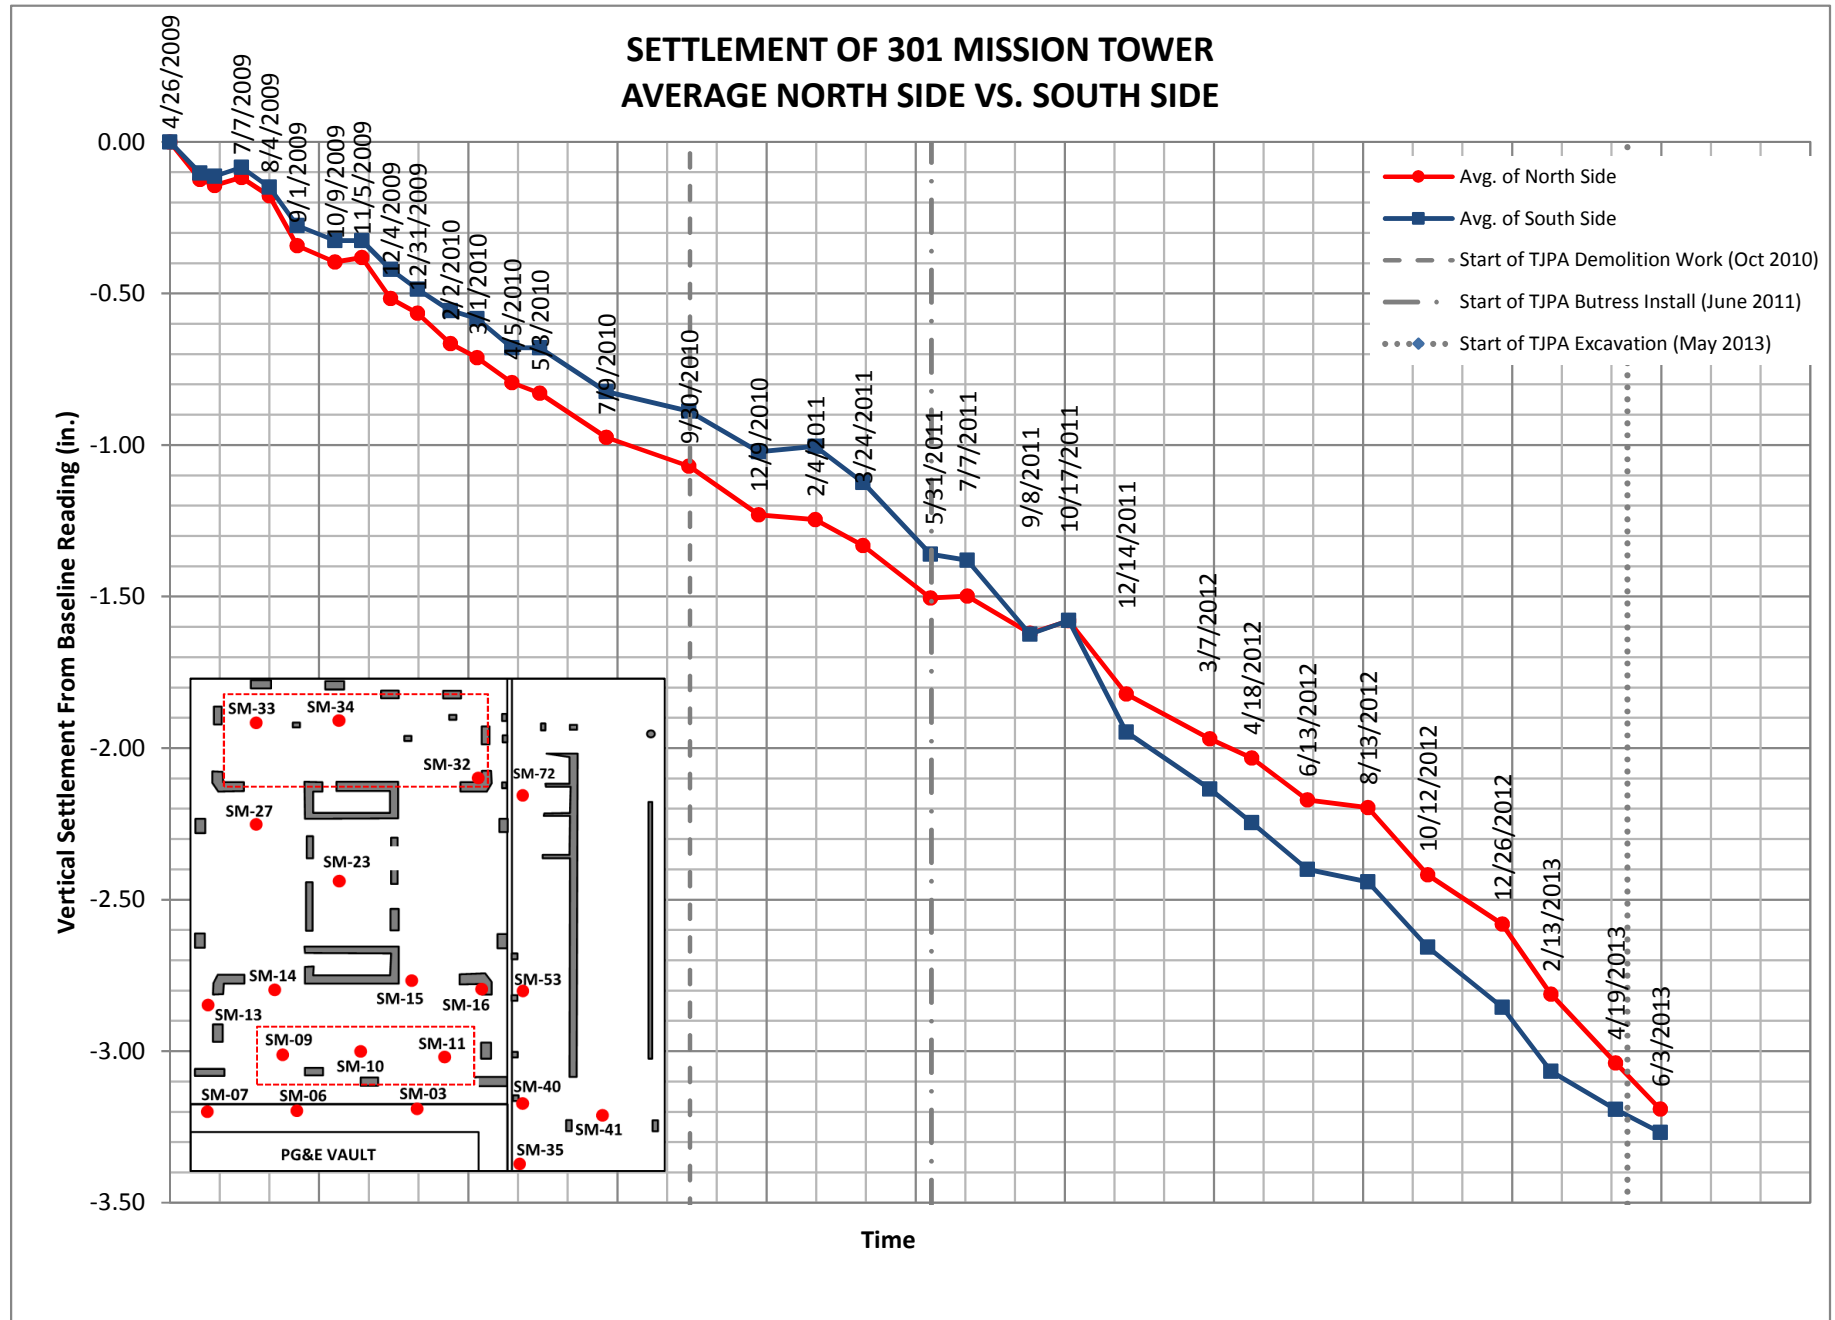
Figure 4

Settlement of the North vs. South Side of the Foundation (Figure 4)

It should also be noted that this figure indicates differential movement across the foundation in the north-south direction causing a slight tilt to the building. If this movement was larger, damage to the structure can occur. In general the tilt, while measurable, is generally small and not of the type which would cause damage.

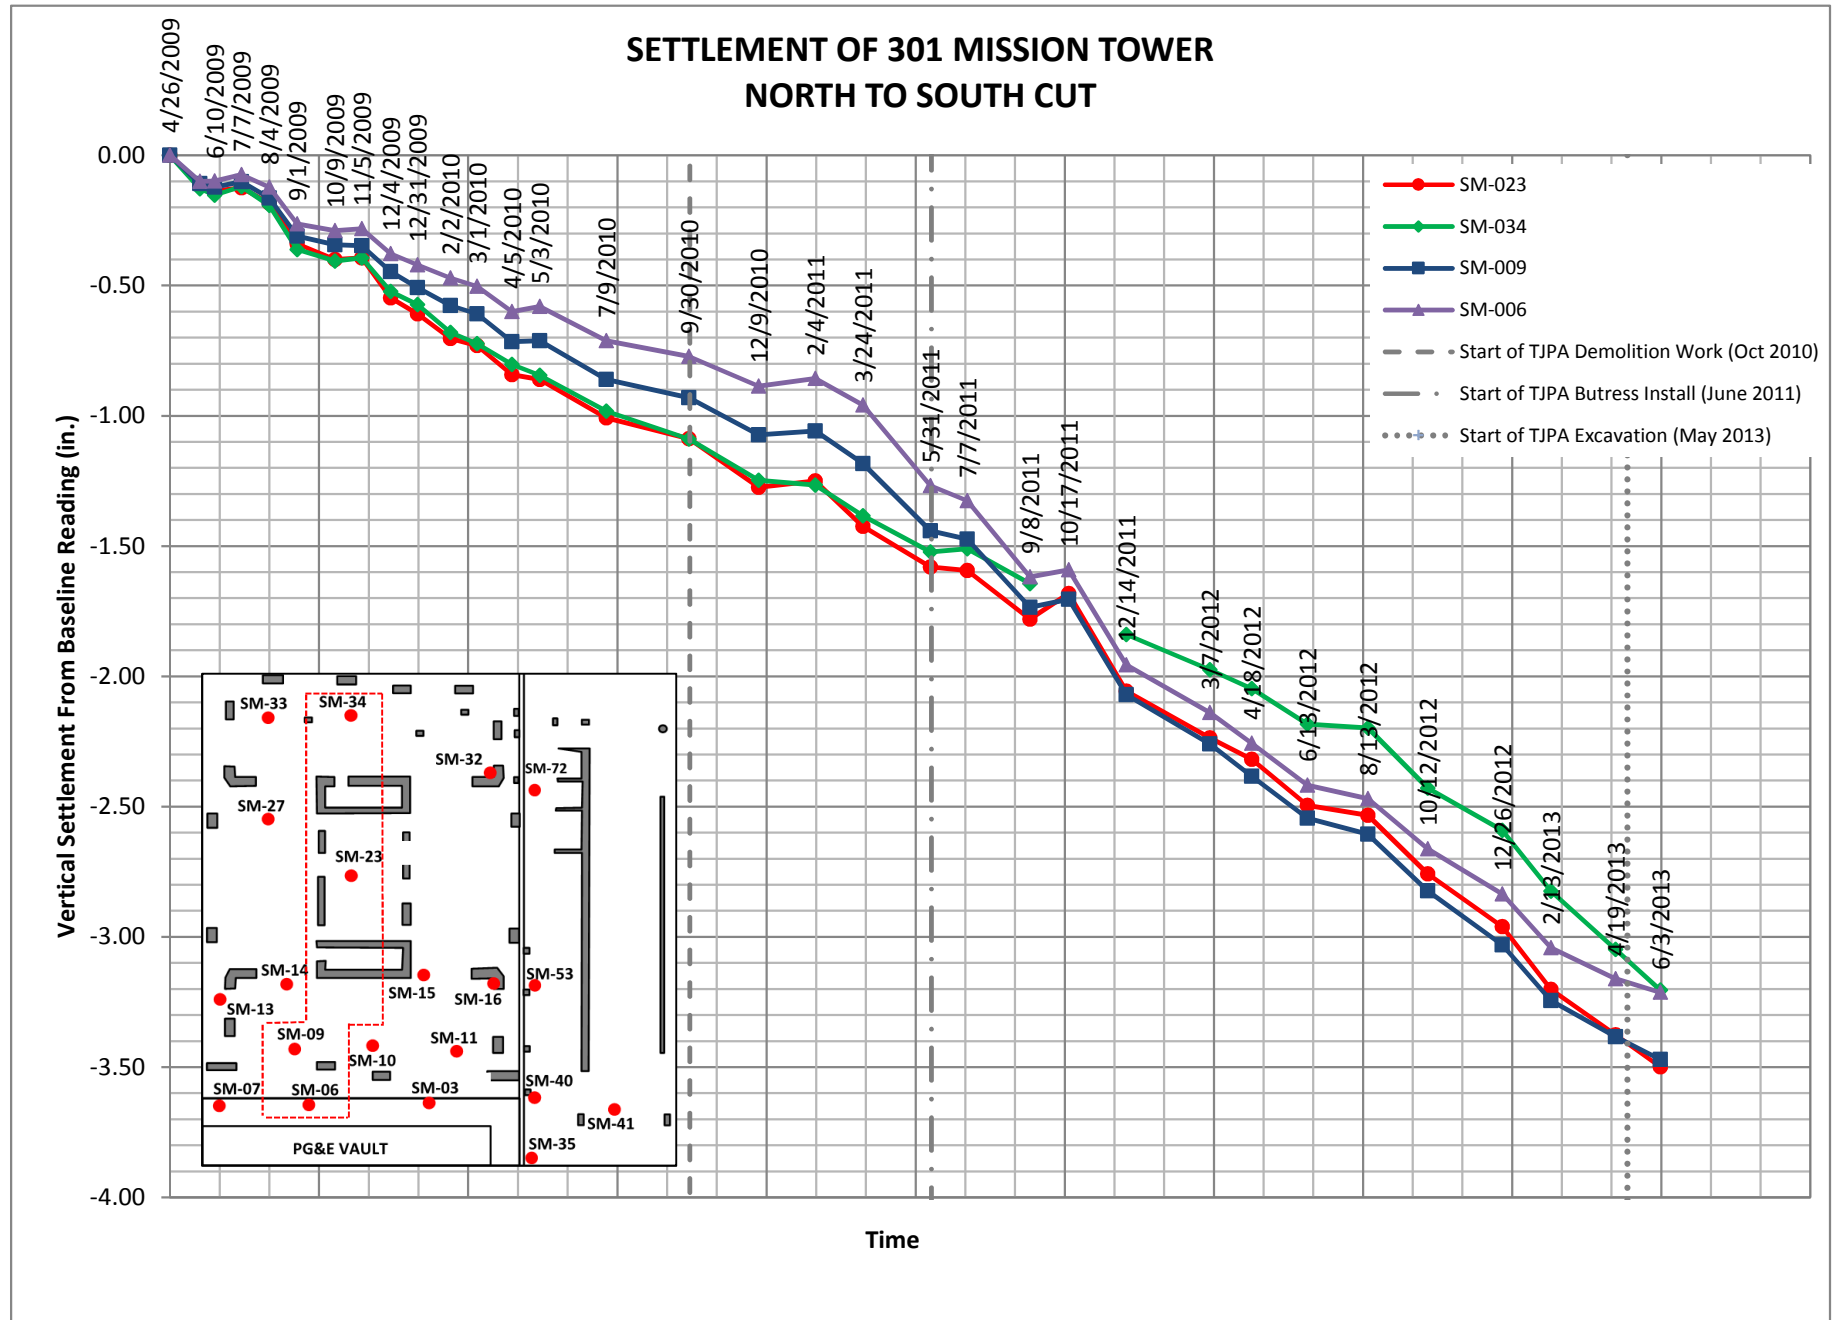
Figure 5

Settlement across a North-South Section Cut of the Foundation (Figure 5)

Before buttress installation activities began, the Tower was settling more at the north side and at a consistent rate. After buttress installation activities began, the settlement in the south started settling faster than the ones in the north. At present time, following the last of the buttress installation, the highest settlement along the north-south direction is nearly at the center of the foundation. DeSimone considers the change in location of highest settlement as directly correlated to the Transbay buttress installation activities.

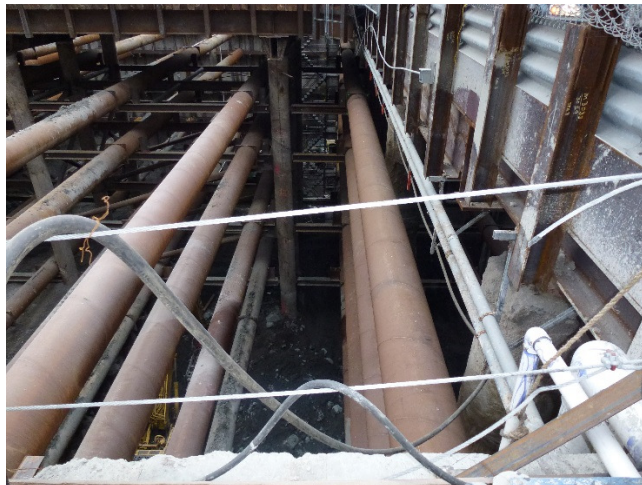
As part of the settlement evaluation by DeSimone, a site visit to the Transbay project site was performed on December 6, 2013. The purpose of this visit was to review current construction progress on adjacent sites. The Transbay excavation directly south of 301 Mission is approximately 90% complete with 52 feet of excavated soil. The buttress piles that were installed next to the 301 Mission south foundation wall were visible at the surface. The new salesforce.com tower at 350 Mission has been excavated to approximately 60 feet, and the new tower construction has progressed from the bottom of the excavation back up to street level.

December 6, 2013 Excavation progress at Transbay site.
Photo taken on Beale St. between Mission St. and Howard St.

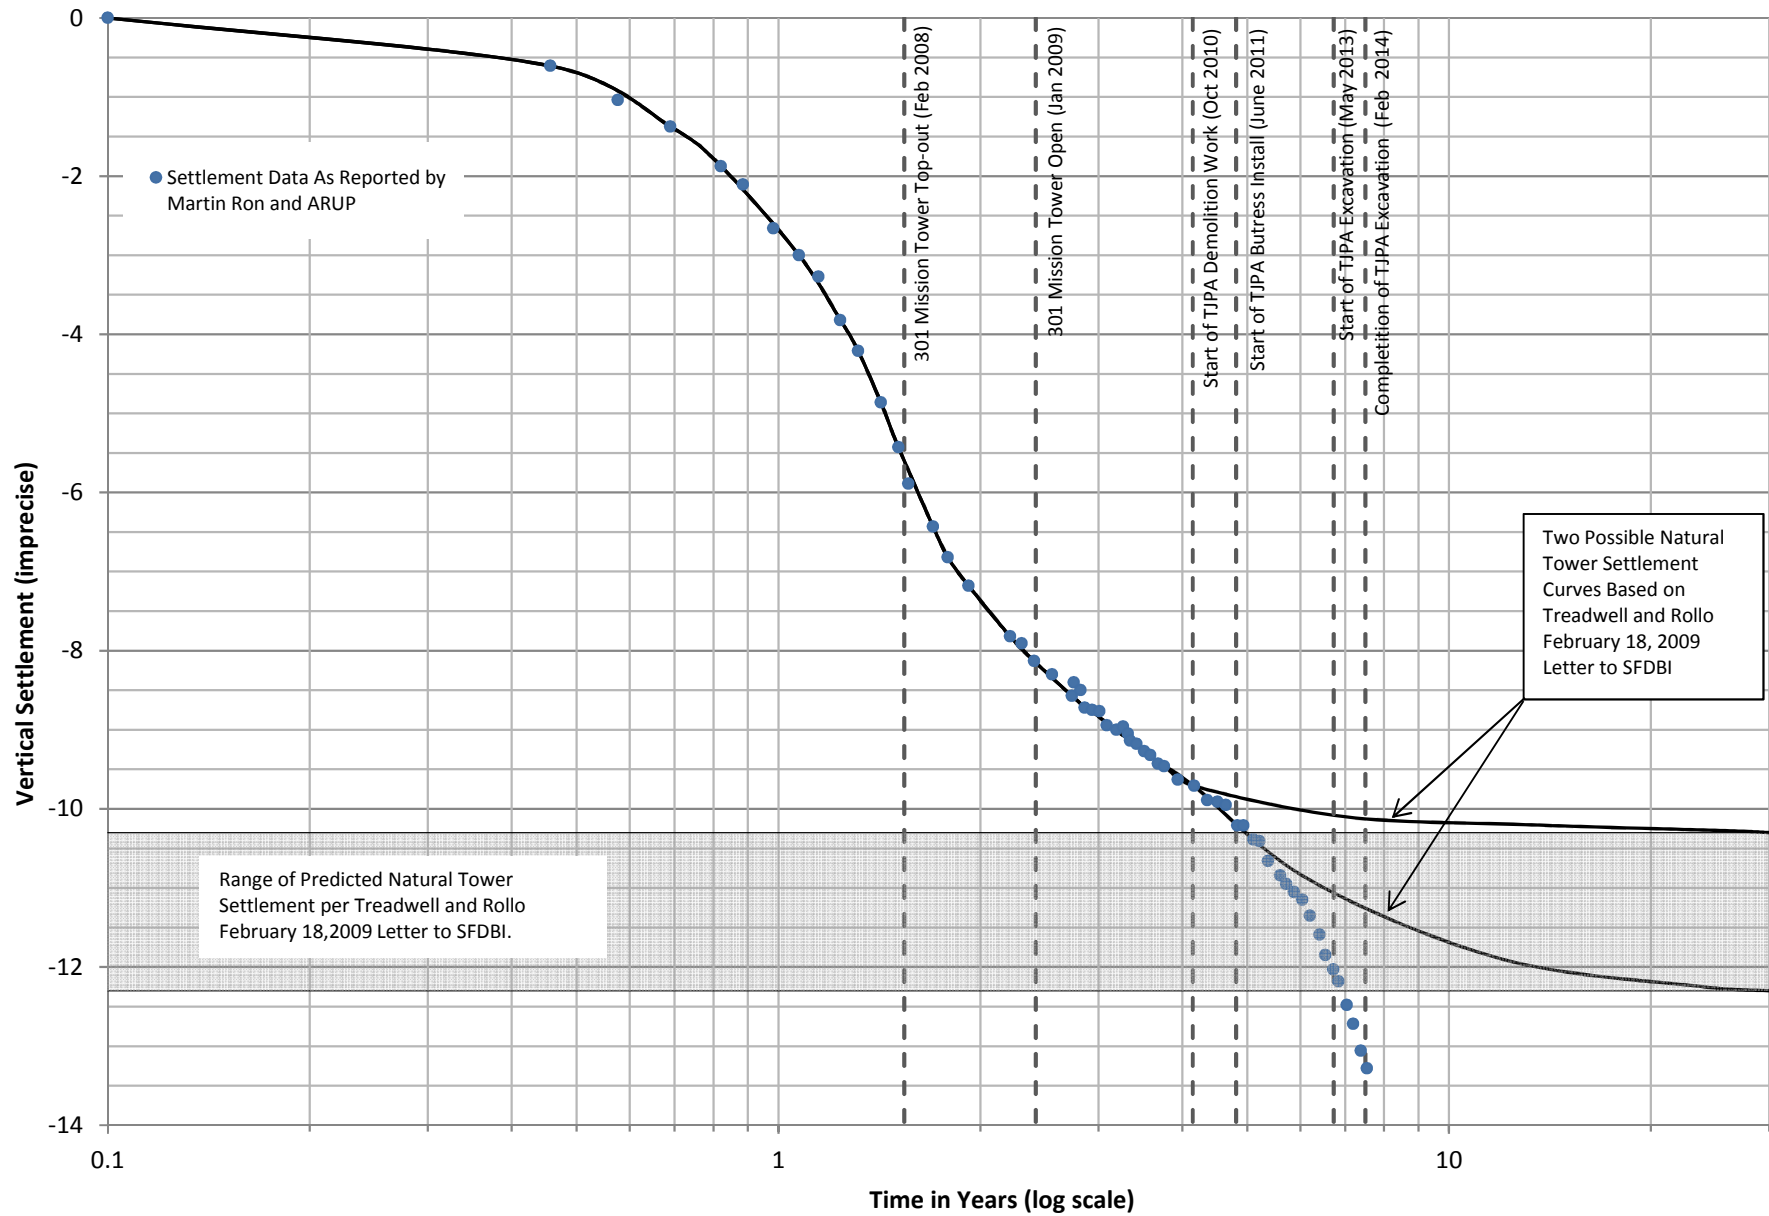
Figure 1

If we use Langan Treadwell Rollo's predicted range of total settlement and read the difference between the measured displacement data points and the settlement prediction curves (Figure 1), the additional settlement is between 2.0 to 3.3 inches. Since 0.75 inches is the "Action Trigger Level" for "other buildings" as described in the Transbay Specification, it is recommended, as we had recommended in earlier reports, that Millennium Partners (Millennium) obtain a response from Transbay regarding this discrepancy in predicted settlement. Furthermore, Transbay revised their specification (the Dec 10, 2010 version) to exclude the 301 Mission Tower from all action trigger levels. It is unclear why Transbay would have changed their specification after construction had begun and why no action trigger limit for this site has since been published by TJPA.

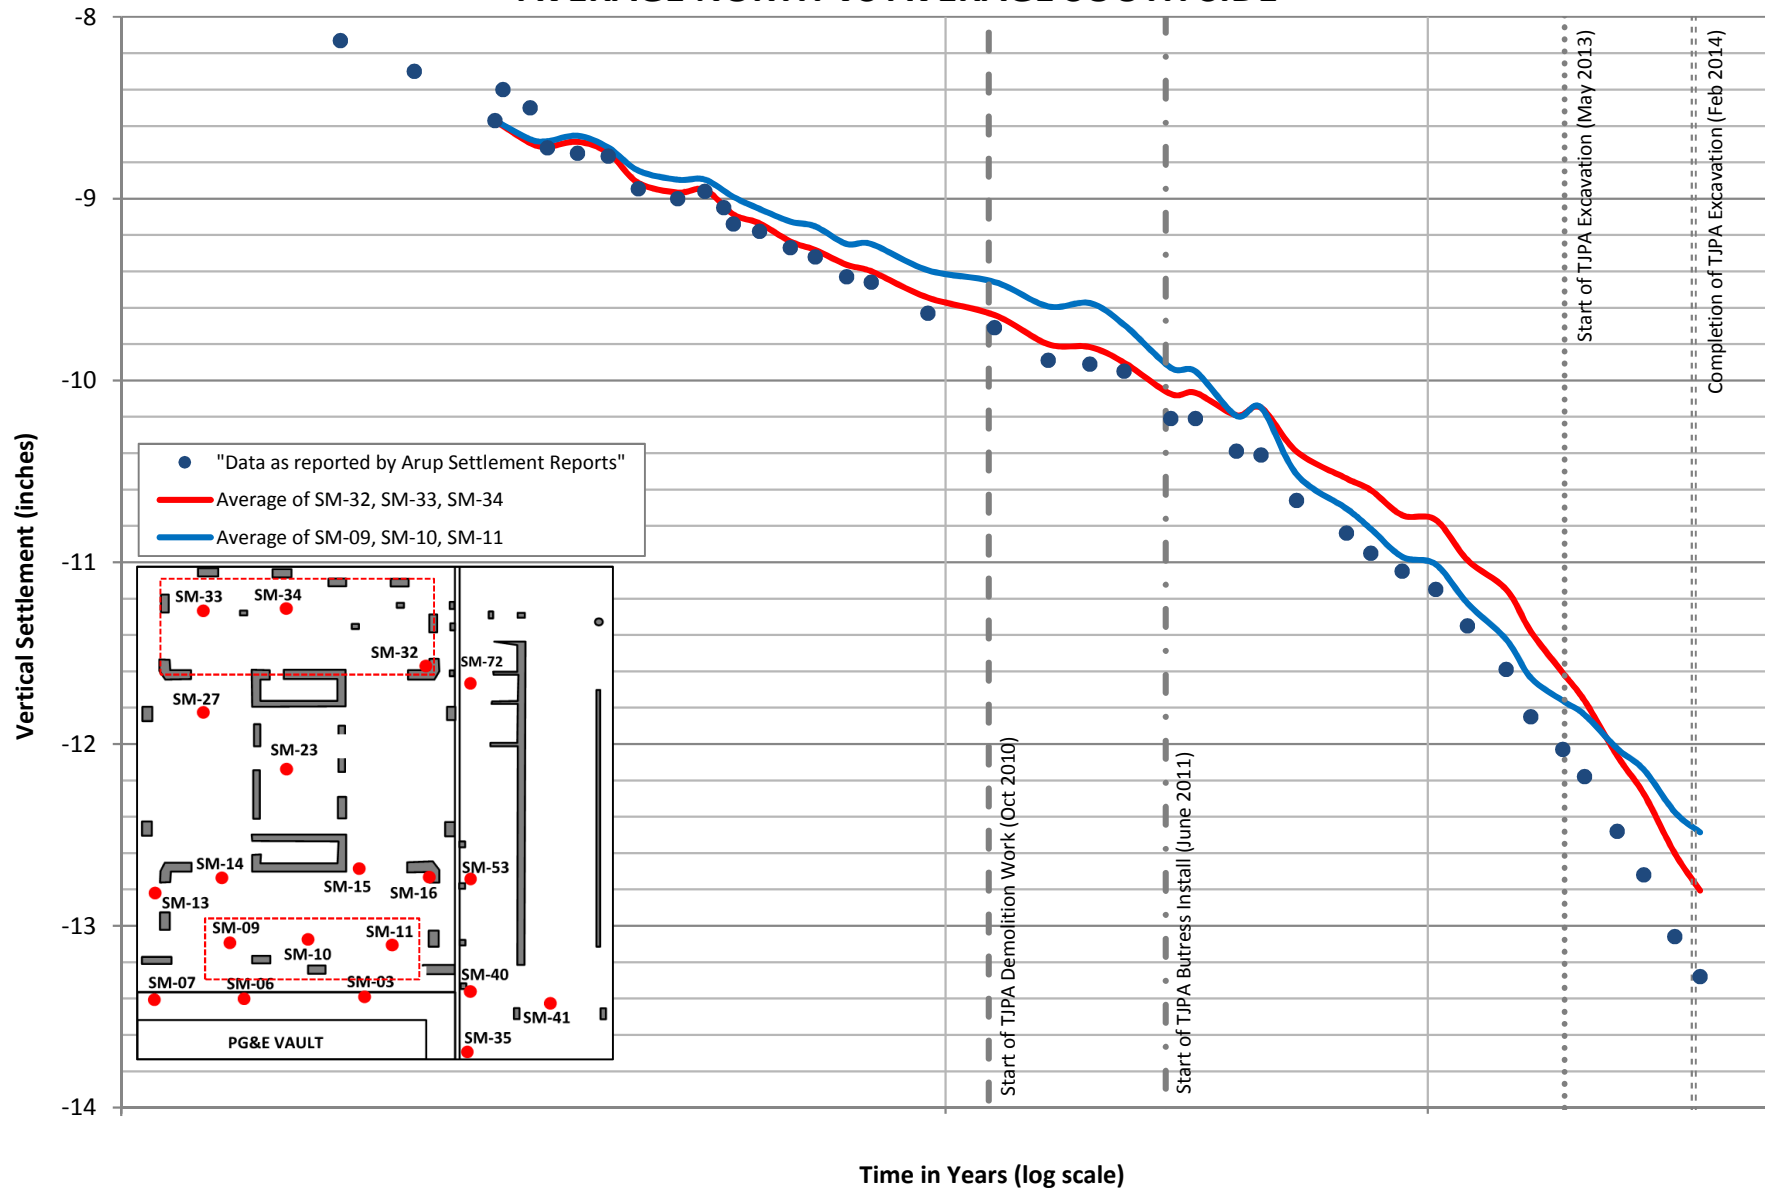
Figure 2 presents an average of settlement on the north side of the tower versus the south end of the tower, as measured in logarithmic scale. Before construction activities began at Transbay we observed that the north side had settled at a greater rate than the south. After buttress installation activities started, we observed a greater rate of settlement on the south side. After June 2013, the north side again shows a higher rate of settlement than the south side. The foundation has rotated slightly away from the south side.

Figure 2 also shows that the overall settlement reported by ARUP (duplicated in Figure 1) is the worst case settlement anywhere across the foundation (13.1 inches) and does not accurately represent the average. The average overall settlement for the north side currently shows about 12.8 inches. The average overall settlement for the south side currently shows about 12.5 inches.

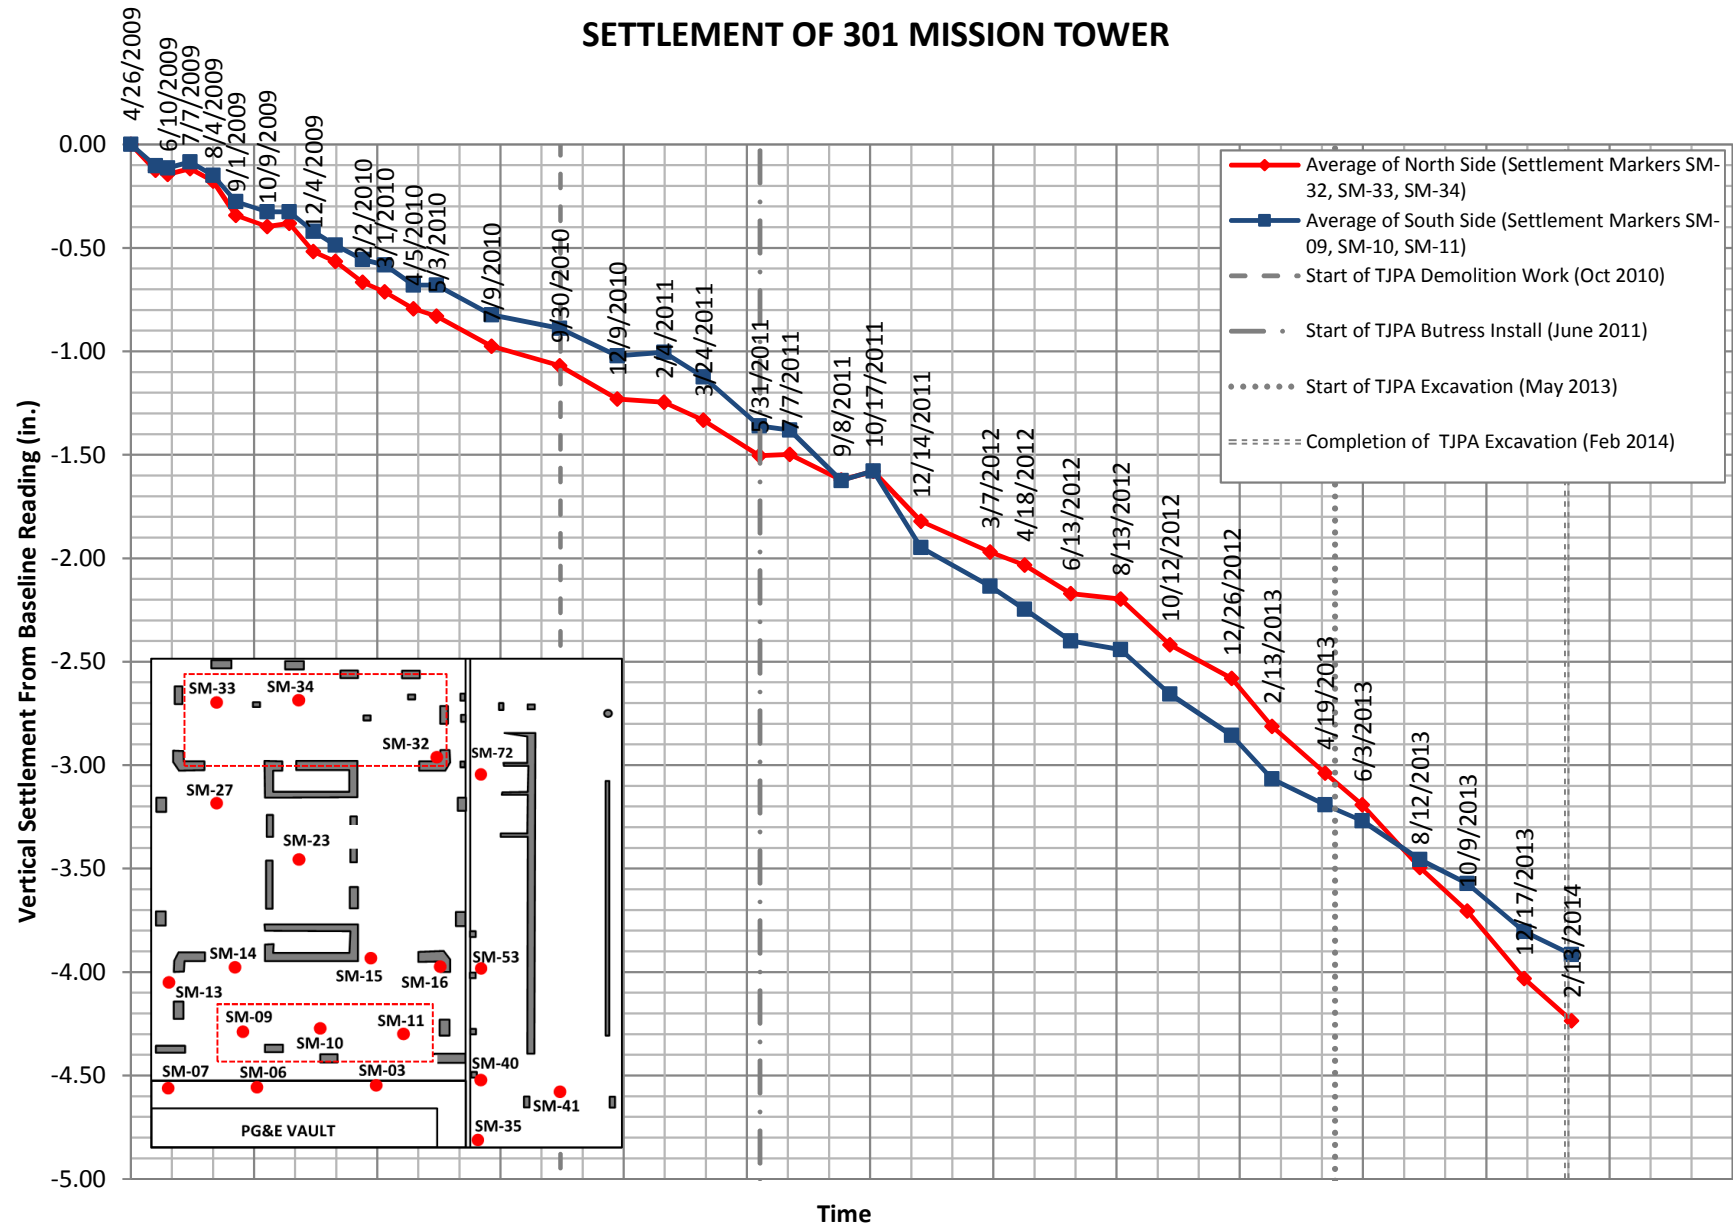
Figure 4

It should also be noted that this figure indicates differential movement across the foundation in the north-south direction causing a slight tilt to the building. If this movement was larger, damage to the structure can occur. In general the tilt, while measurable, is generally small and not of the type which would cause damage.

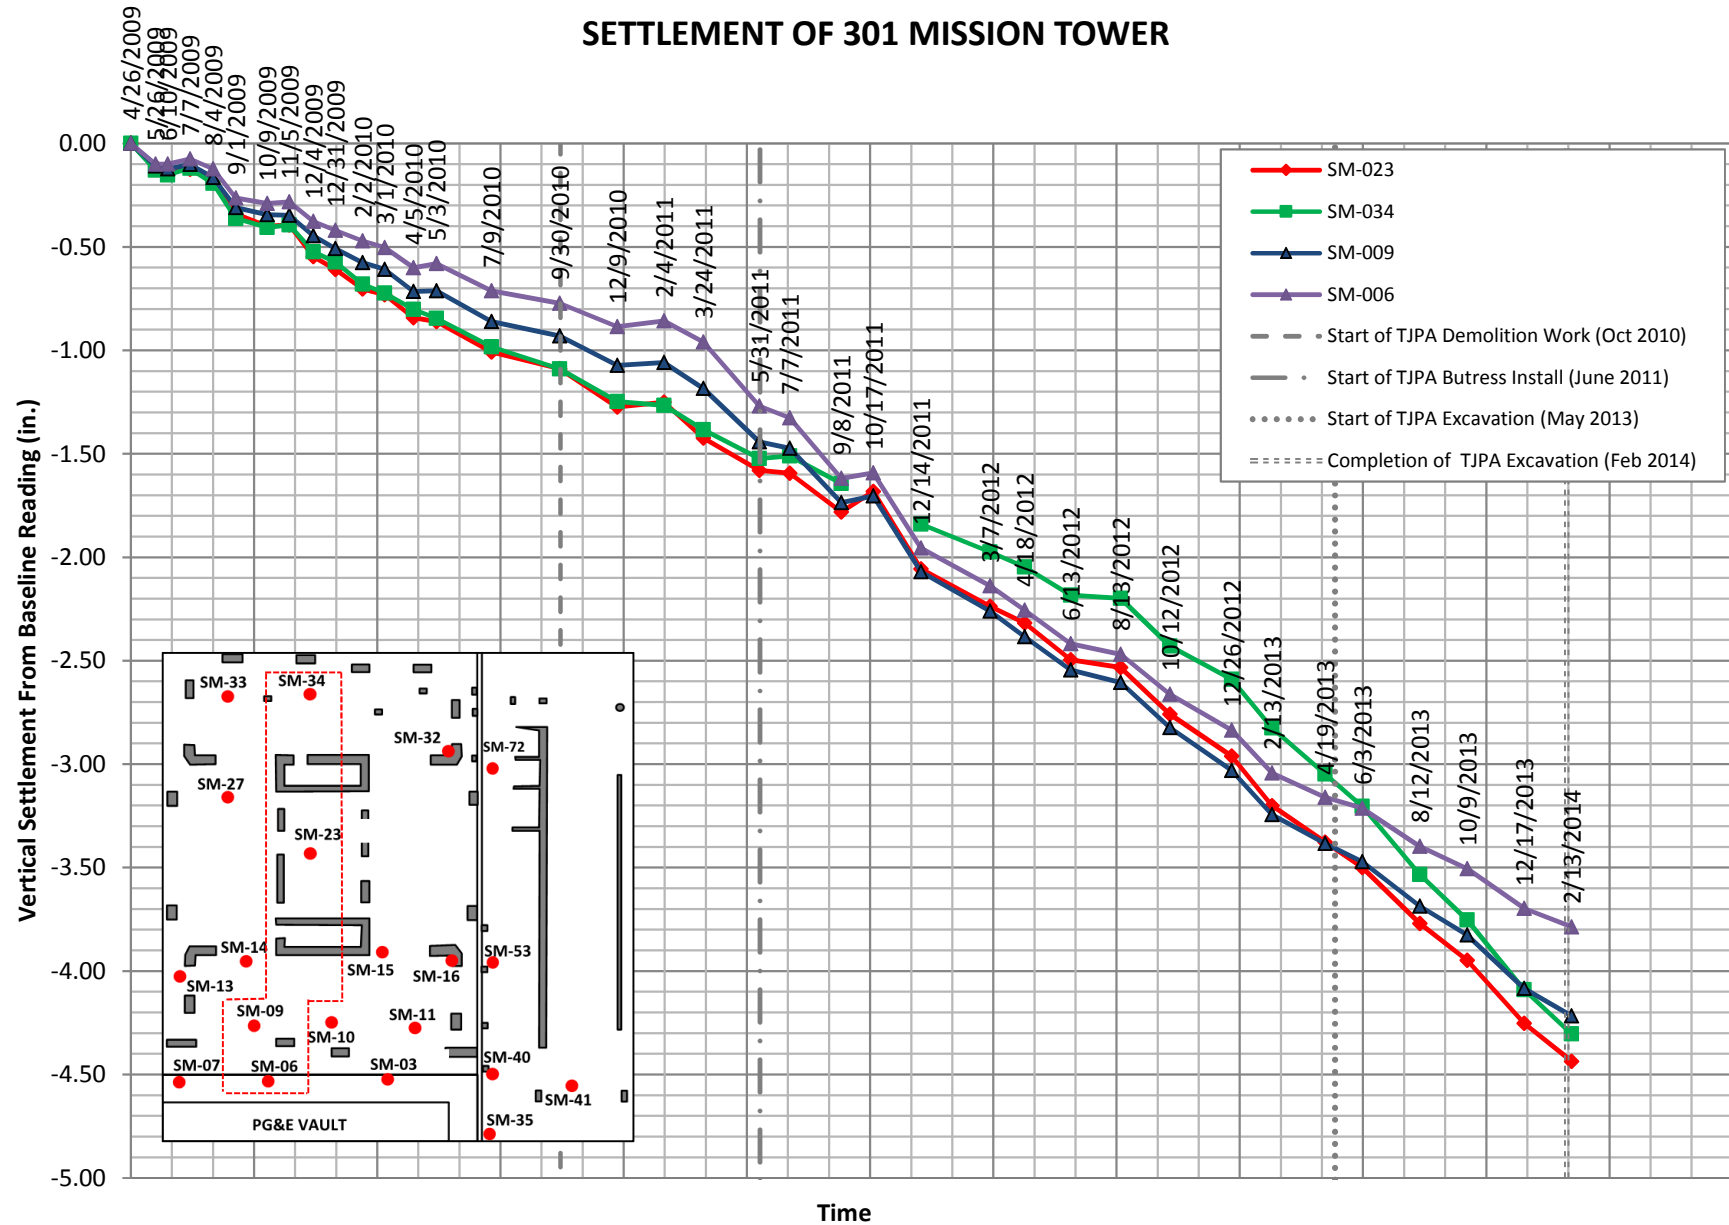
Figure 5

Before buttress installation activities began, the Tower was settling more at the north side and at a consistent rate. After buttress installation activities began, the settlement in the south started settling faster than the ones in the north. At present time, following the completion of the excavation, the highest settlement along the north-south direction is nearly at the center of the foundation.

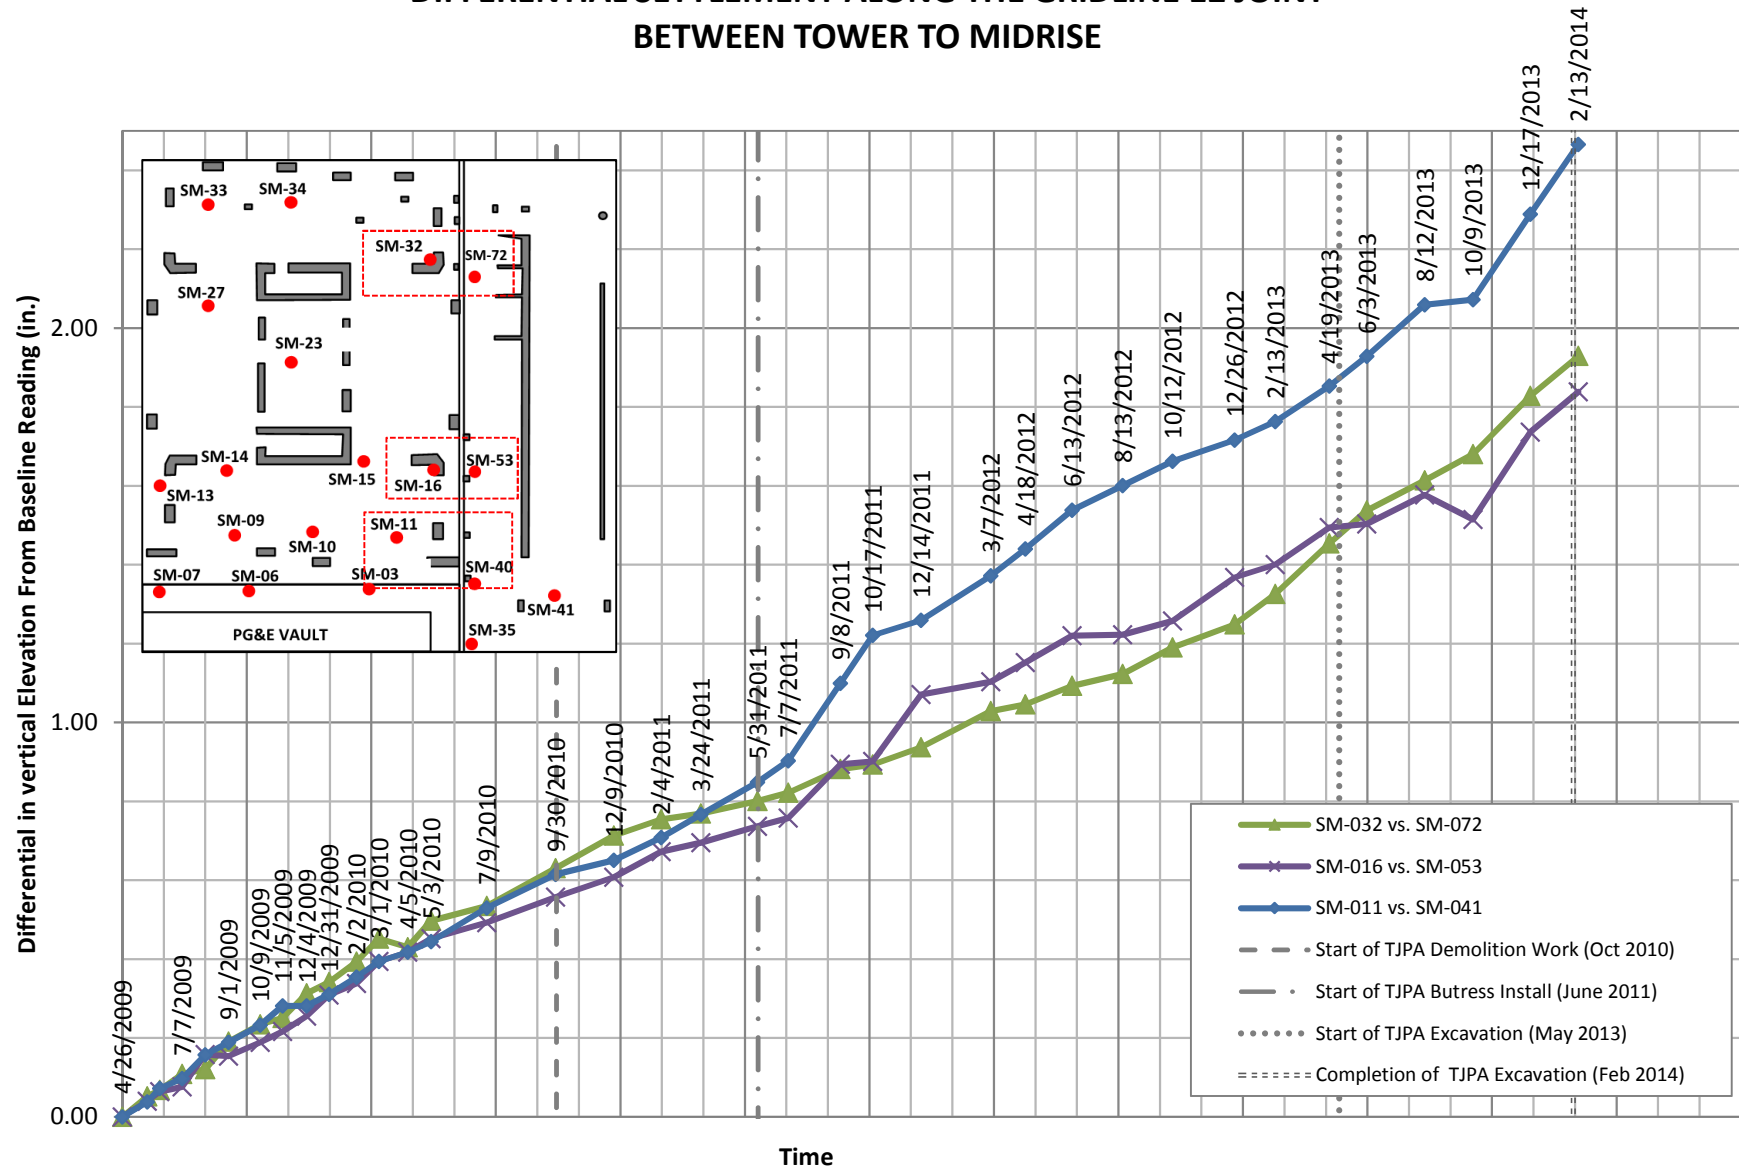
Several settlement markers were reviewed at the building separation joint between the Tower and Mid-Rise along gridline 12. It can be clearly observed in Figure 7 that since Transbay buttress installation activities have begun, that there is increasing differential settlement (increase in rate of settlement) across the joint. This settlement is more than what was naturally occurring prior to the beginning of Transbay construction.

The largest observed differential settlement across the joint is near the south side of the building, and less differential settlement on the north side. It does appear that the joint is performing as expected and allowing free movements between both structures. Continued on-site observation of the joint should be made to ensure its intended performance is being met.

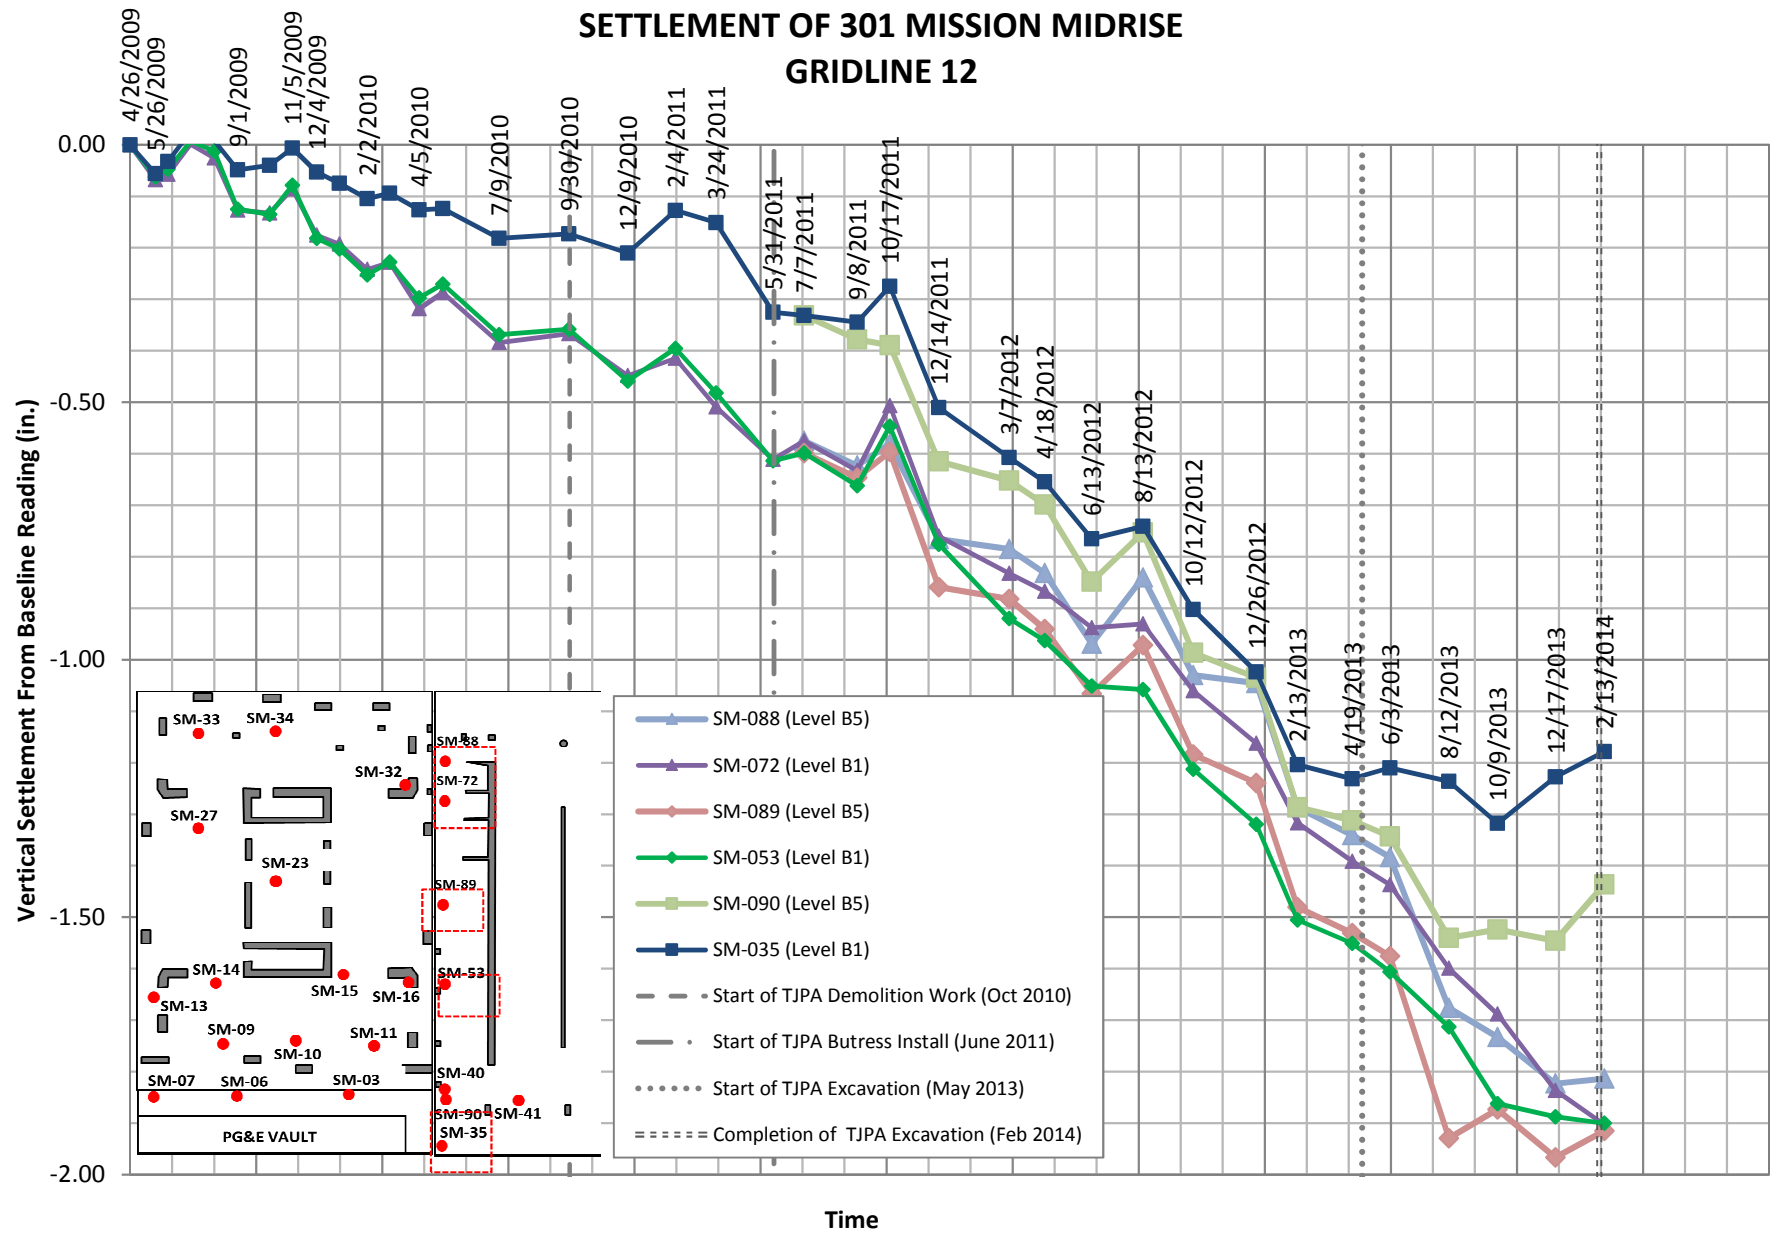
Figure 10

As can be seen in Figure 10, the foundation has settled along gridline 12 of the Mid-Rise since 2009. The highest level of settlement occurs near the middle of the site, with slightly less at the north and south edges. The settlement is of such a magnitude that the tie-downs may no longer be functioning as intended. DeSimone recommends that Langan Treadwell Rollo address this issue.

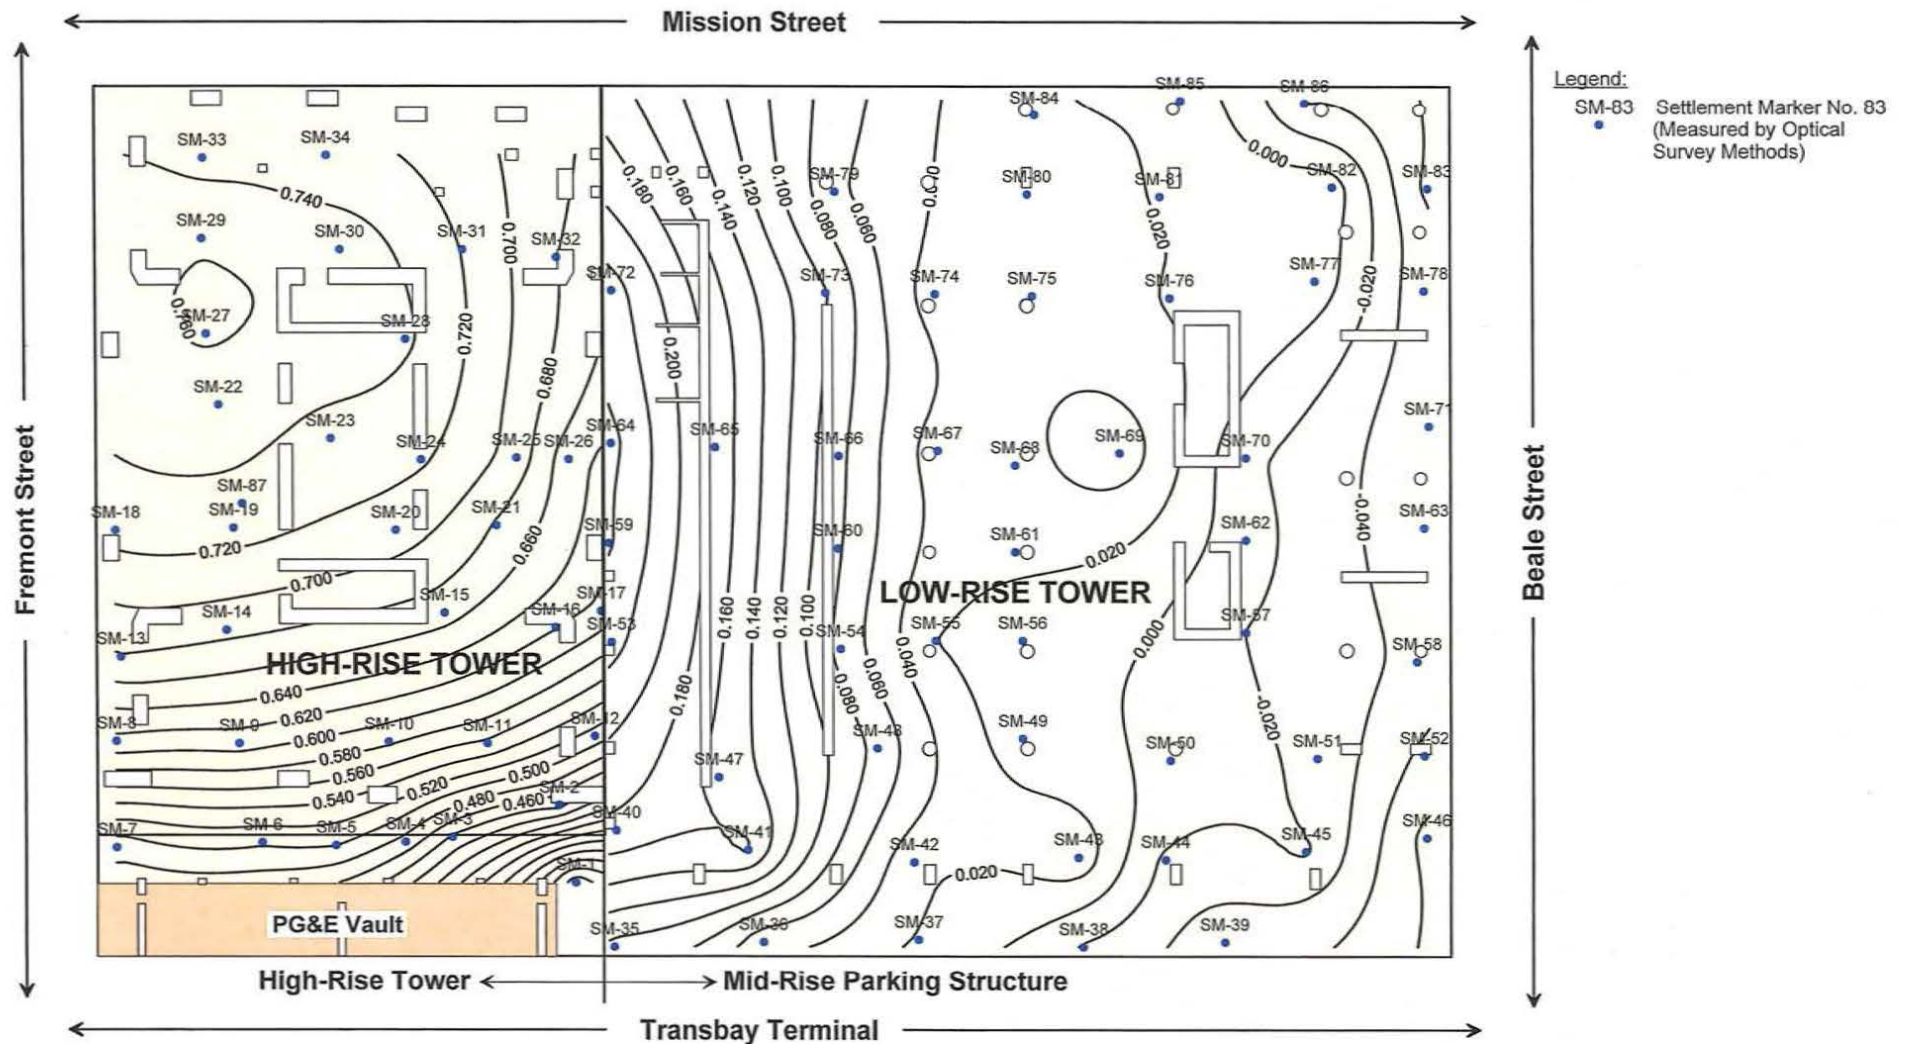
PLATE 3

Contours represent elevation change, in inches, between Baseline survey (April 30, 2009) and readings taken on March 1, 2010.
