Supplemental Report for Foundation Settlement Investigation

The building at 301 Mission Street, San Francisco, California is a fifty-eight-story residential structure founded on a pile-supported mat foundation. The building, which was completed in 2009, has experienced and continues to experience significant foundation settlement. Paul Hastings, LLP retained Simpson Gumpertz & Heger Inc. in 2014 to conduct an evaluation of the impact of site settlement on the building's structural stability and earthquake resistance. We performed initial evaluations in 2014 and updated these in 2016 to consider additional settlement that occurred in the interim period. In an October 2016 report we concluded that settlement had not compromised the building's stability or its ability to resist strong earthquakes.

**SUPPLEMENTAL REPORT
FOUNDATION SETTLEMENT INVESTIGATION
301 MISSION STREET
SAN FRANCISCO, CALIFORNIA**

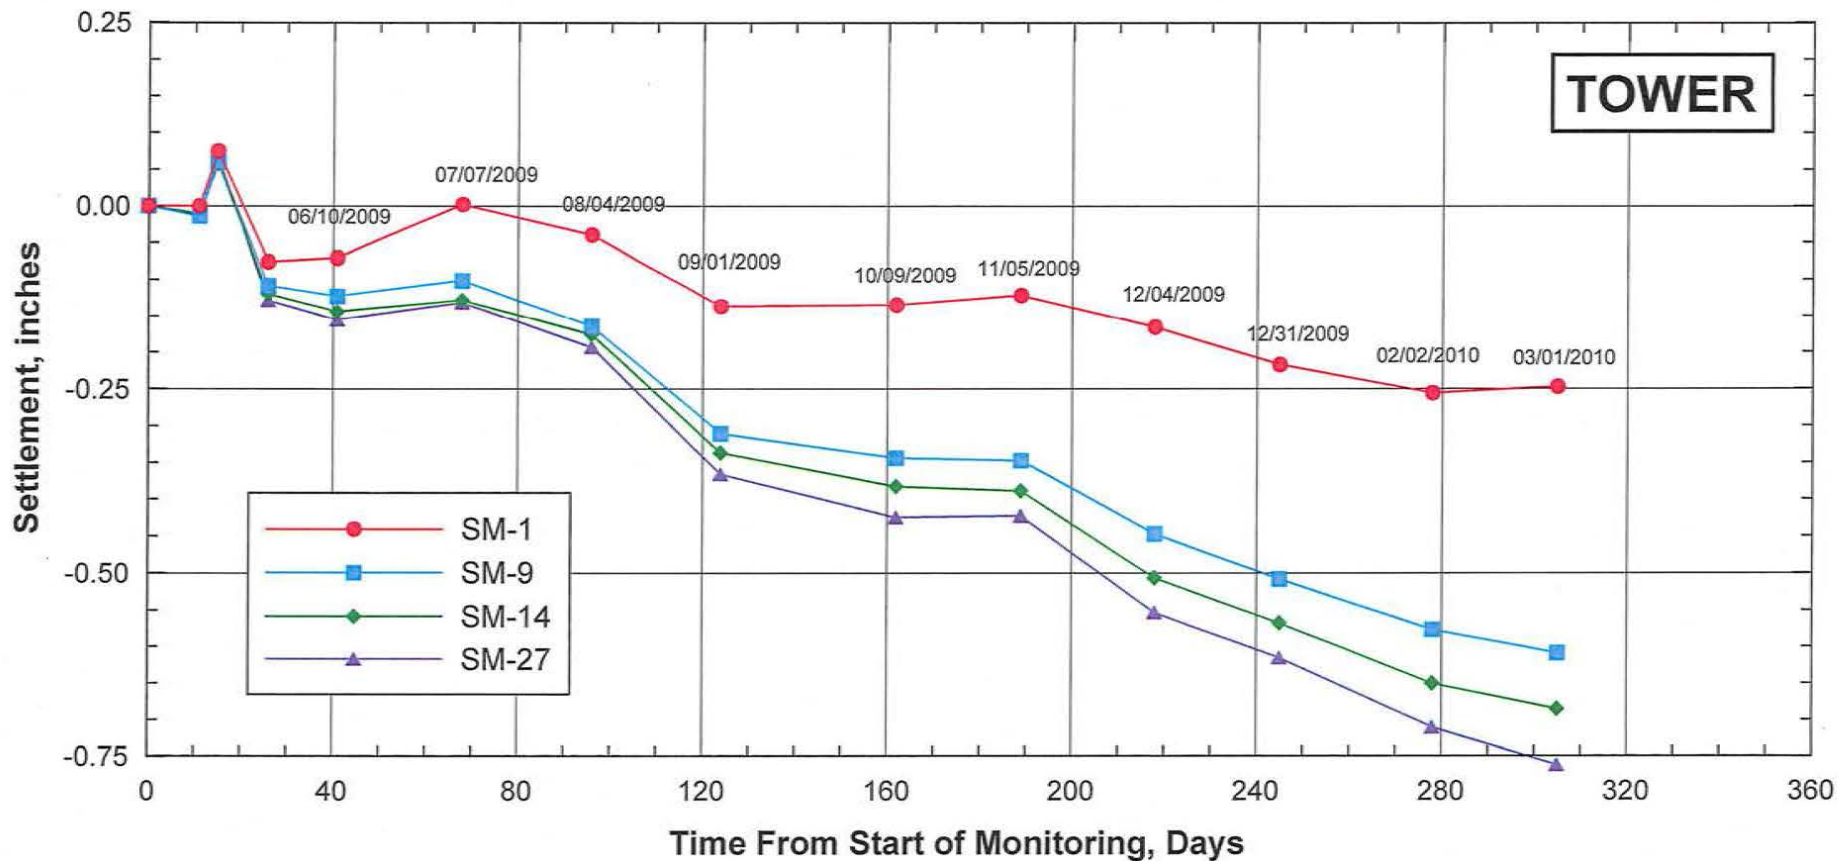
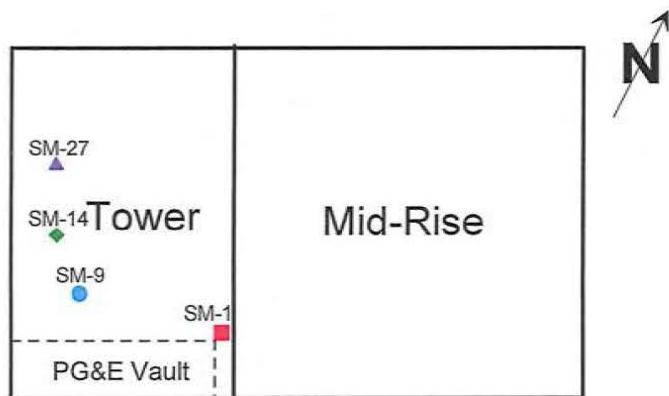
PLATE 4

**SETTLEMENT OVER TIME
FLOOR ELEVATIONS AT LEVEL B-1
OF 301 MISSION PROPERTY- TOWER:
APRIL 30, 2009 THROUGH MARCH 1, 2010**

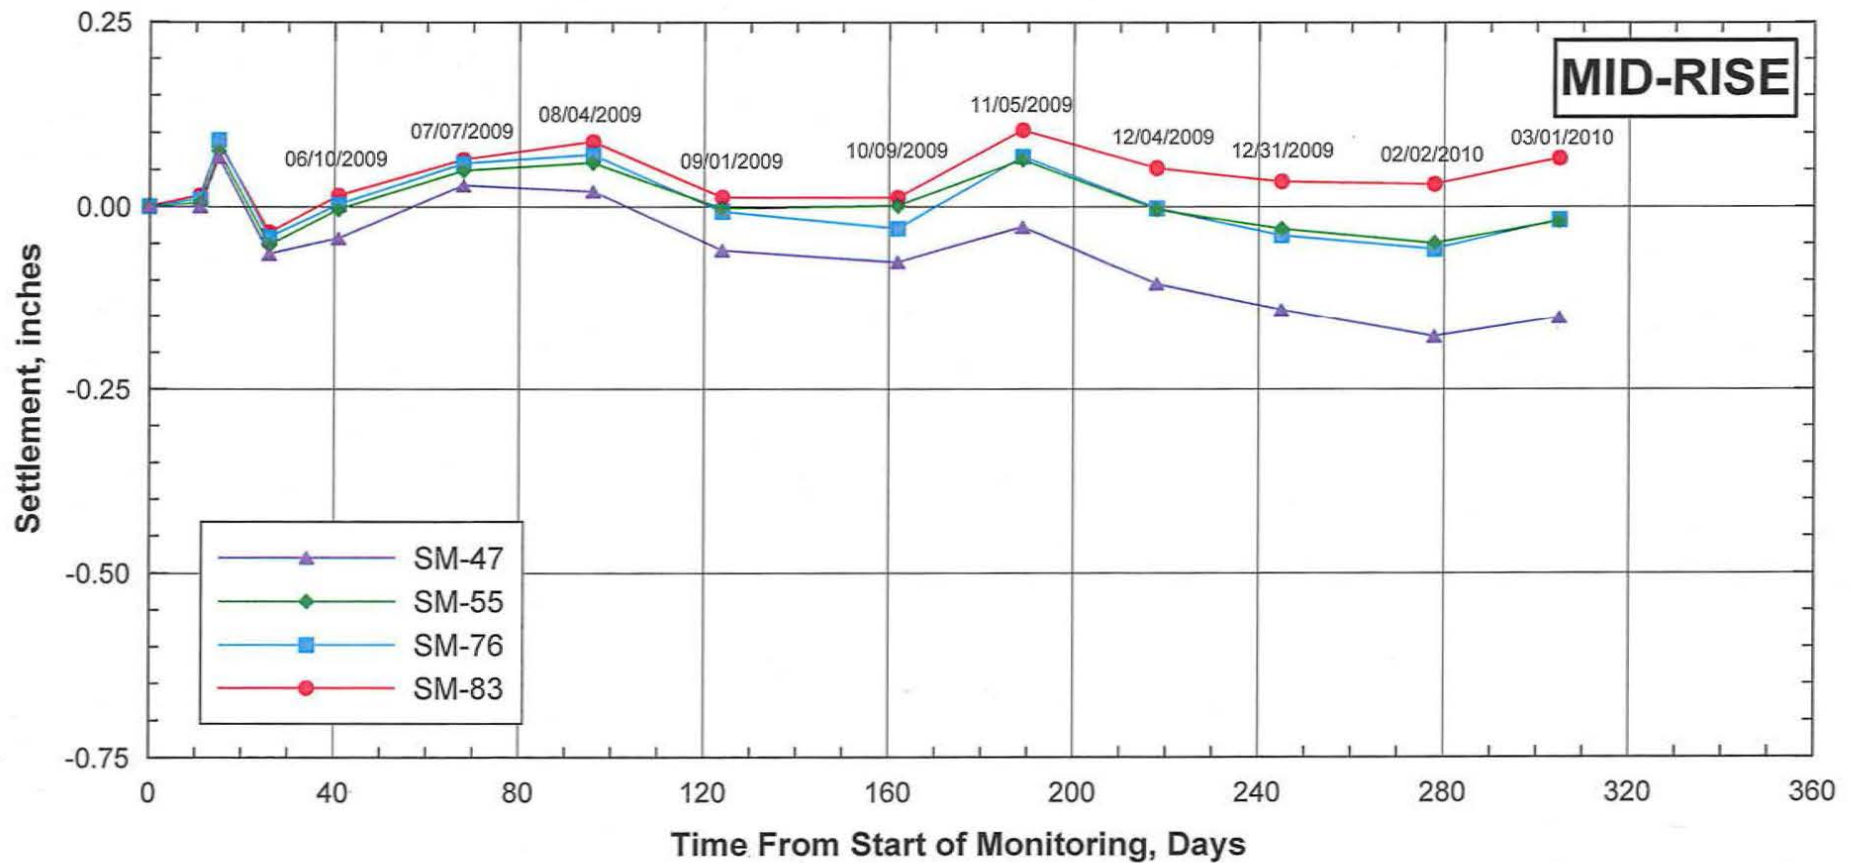
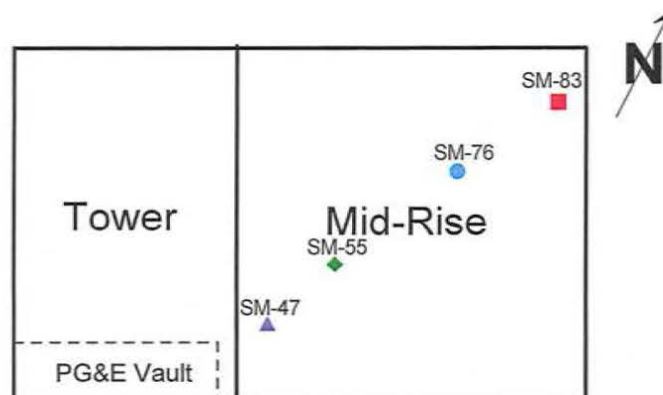
PLATE 5

**SETTLEMENT OVER TIME
FLOOR ELEVATIONS AT LEVEL B-1
OF 301 MISSION PROPERTY- MIDRISE:
APRIL 30, 2009 THROUGH MARCH 1, 2010**

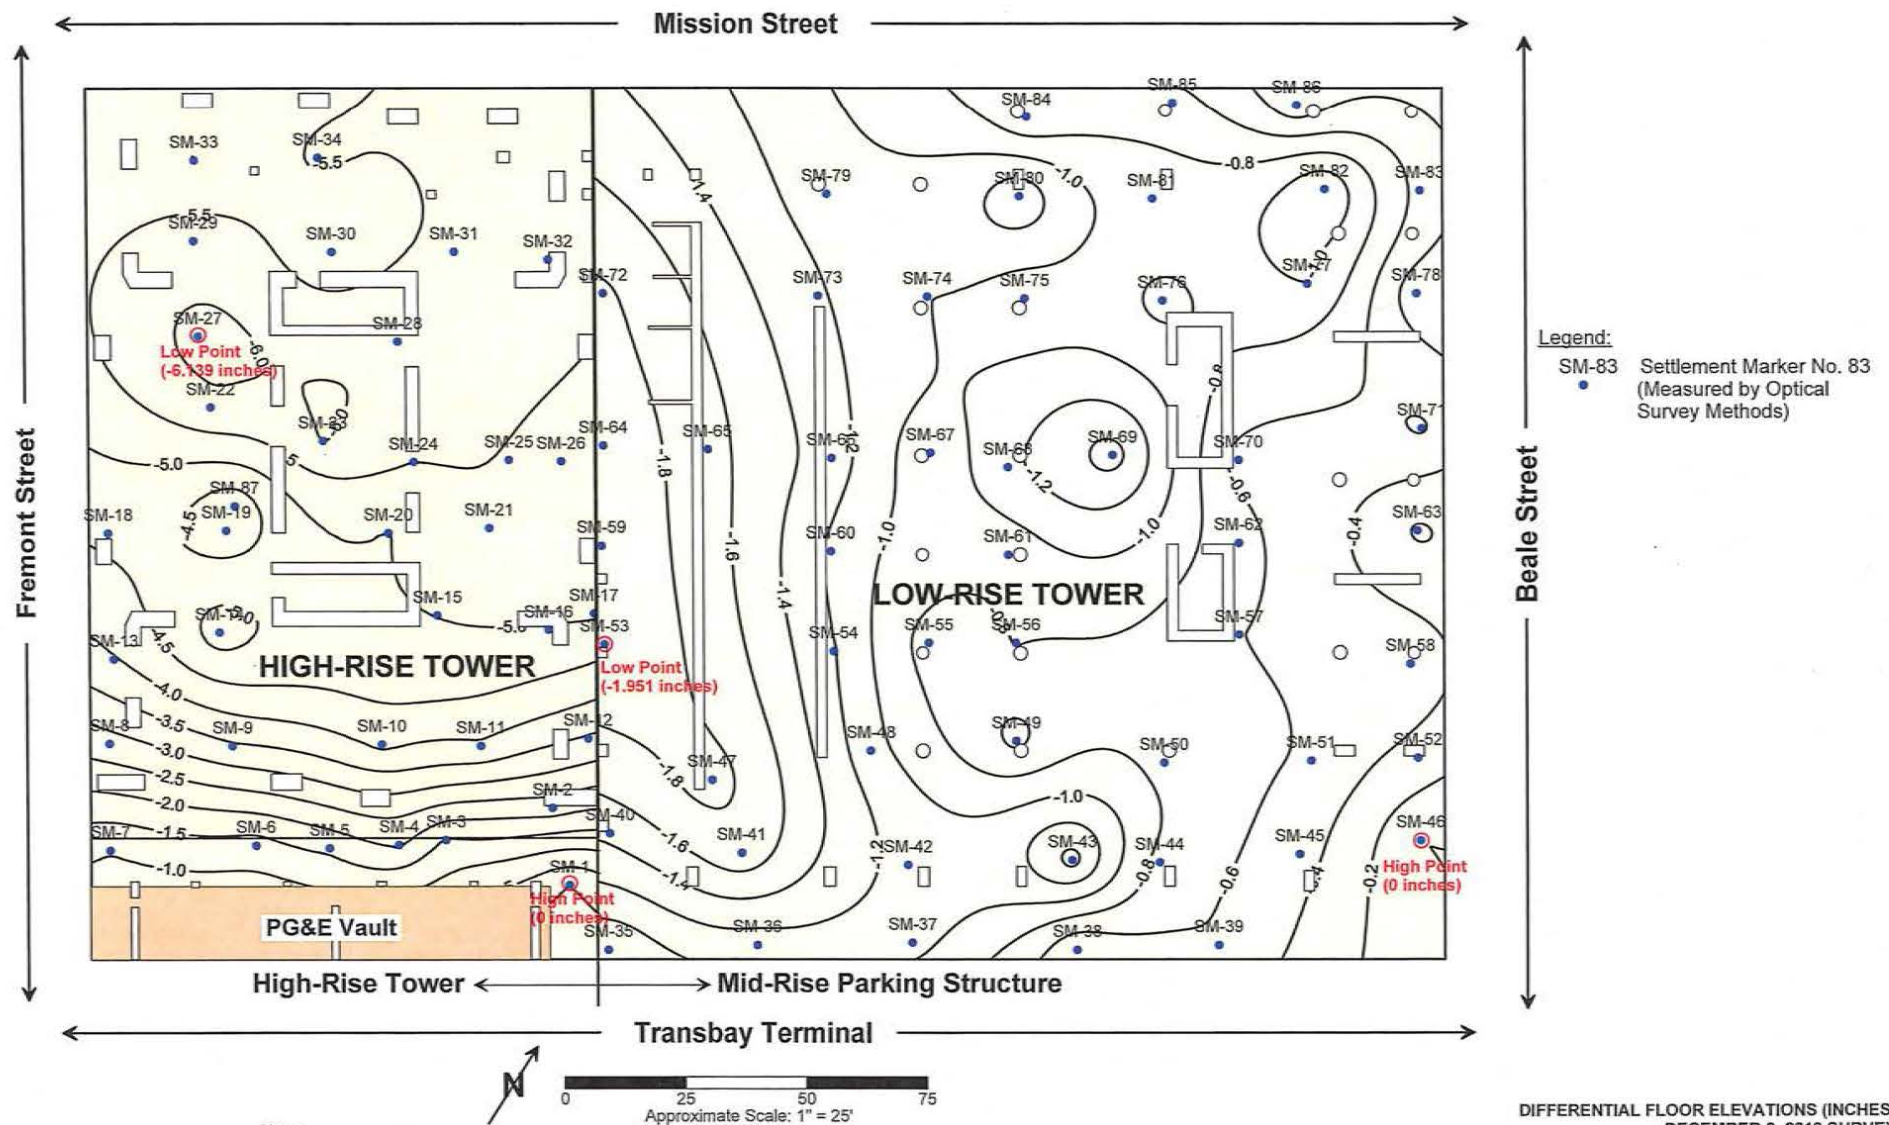
Contours represent differential elevation, in inches, between the highest point and all other points taken on December 9, 2010.
 Level B-1 at Mid-Rise Parking portion of survey site is approximately 4 inches higher than Level B-1 at High-Rise Tower portion.
 The PG&E vault is inaccessible for monitoring.
 Contour intervals are different between the High-Rise Tower and the Low-Rise Tower.

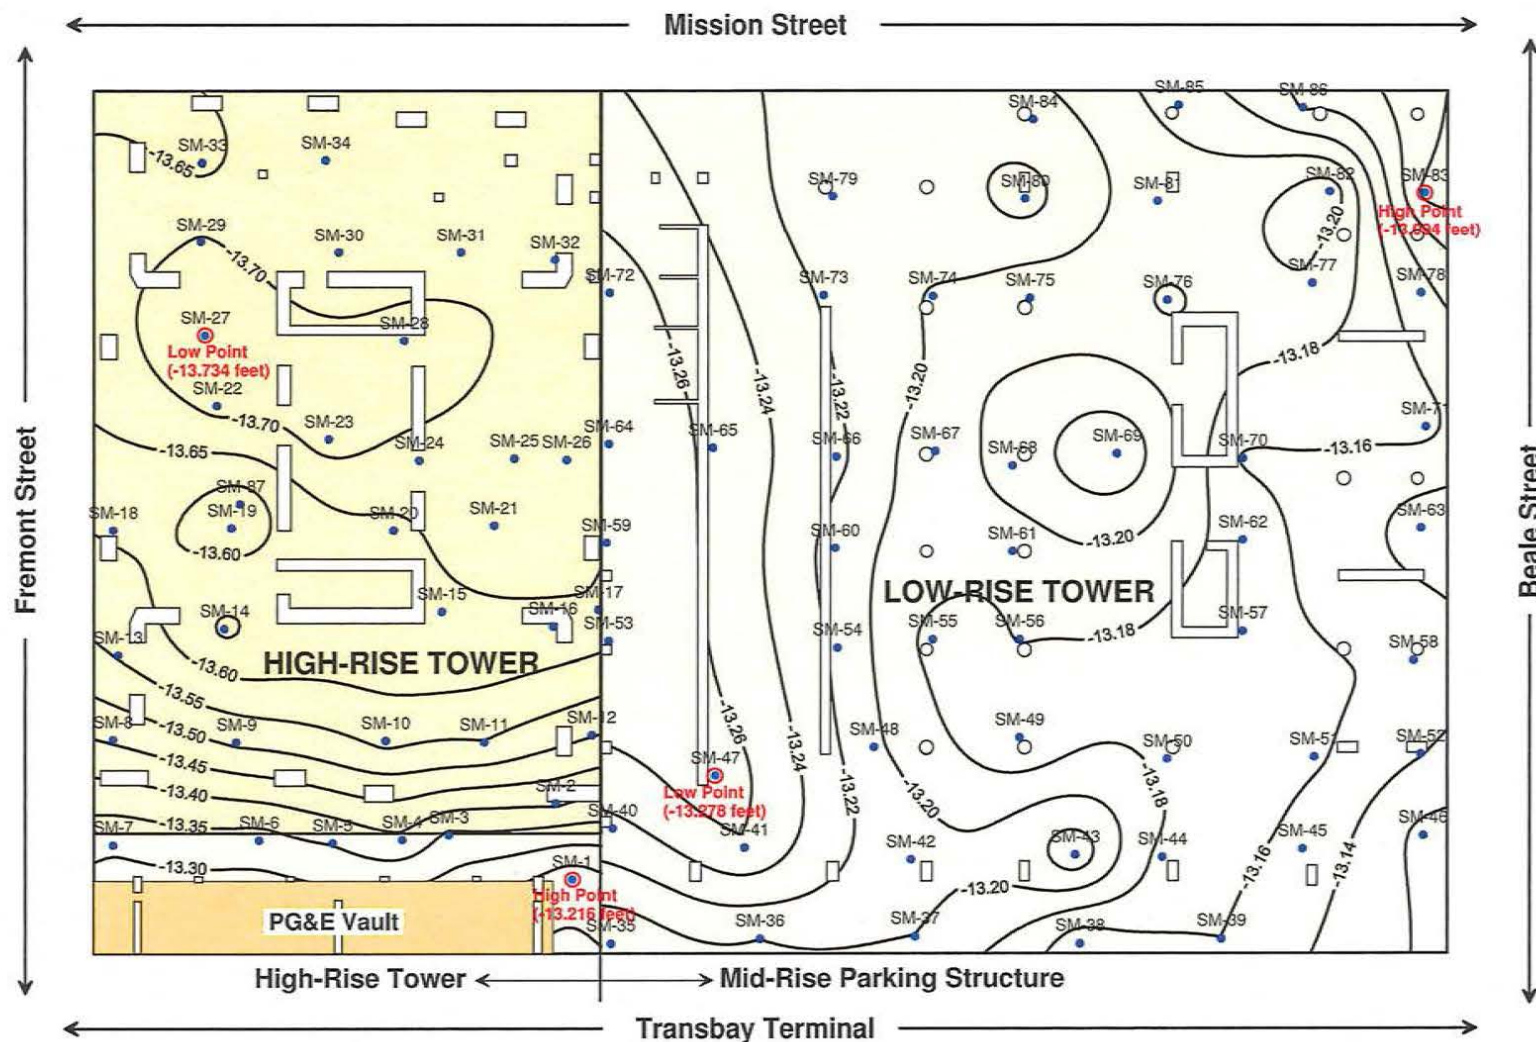
PLATE 1

Maximum Differential	
High-Rise Tower	Low-Rise Tower
0.518 feet (6.22 inches)	0.184 feet (2.21 inches)

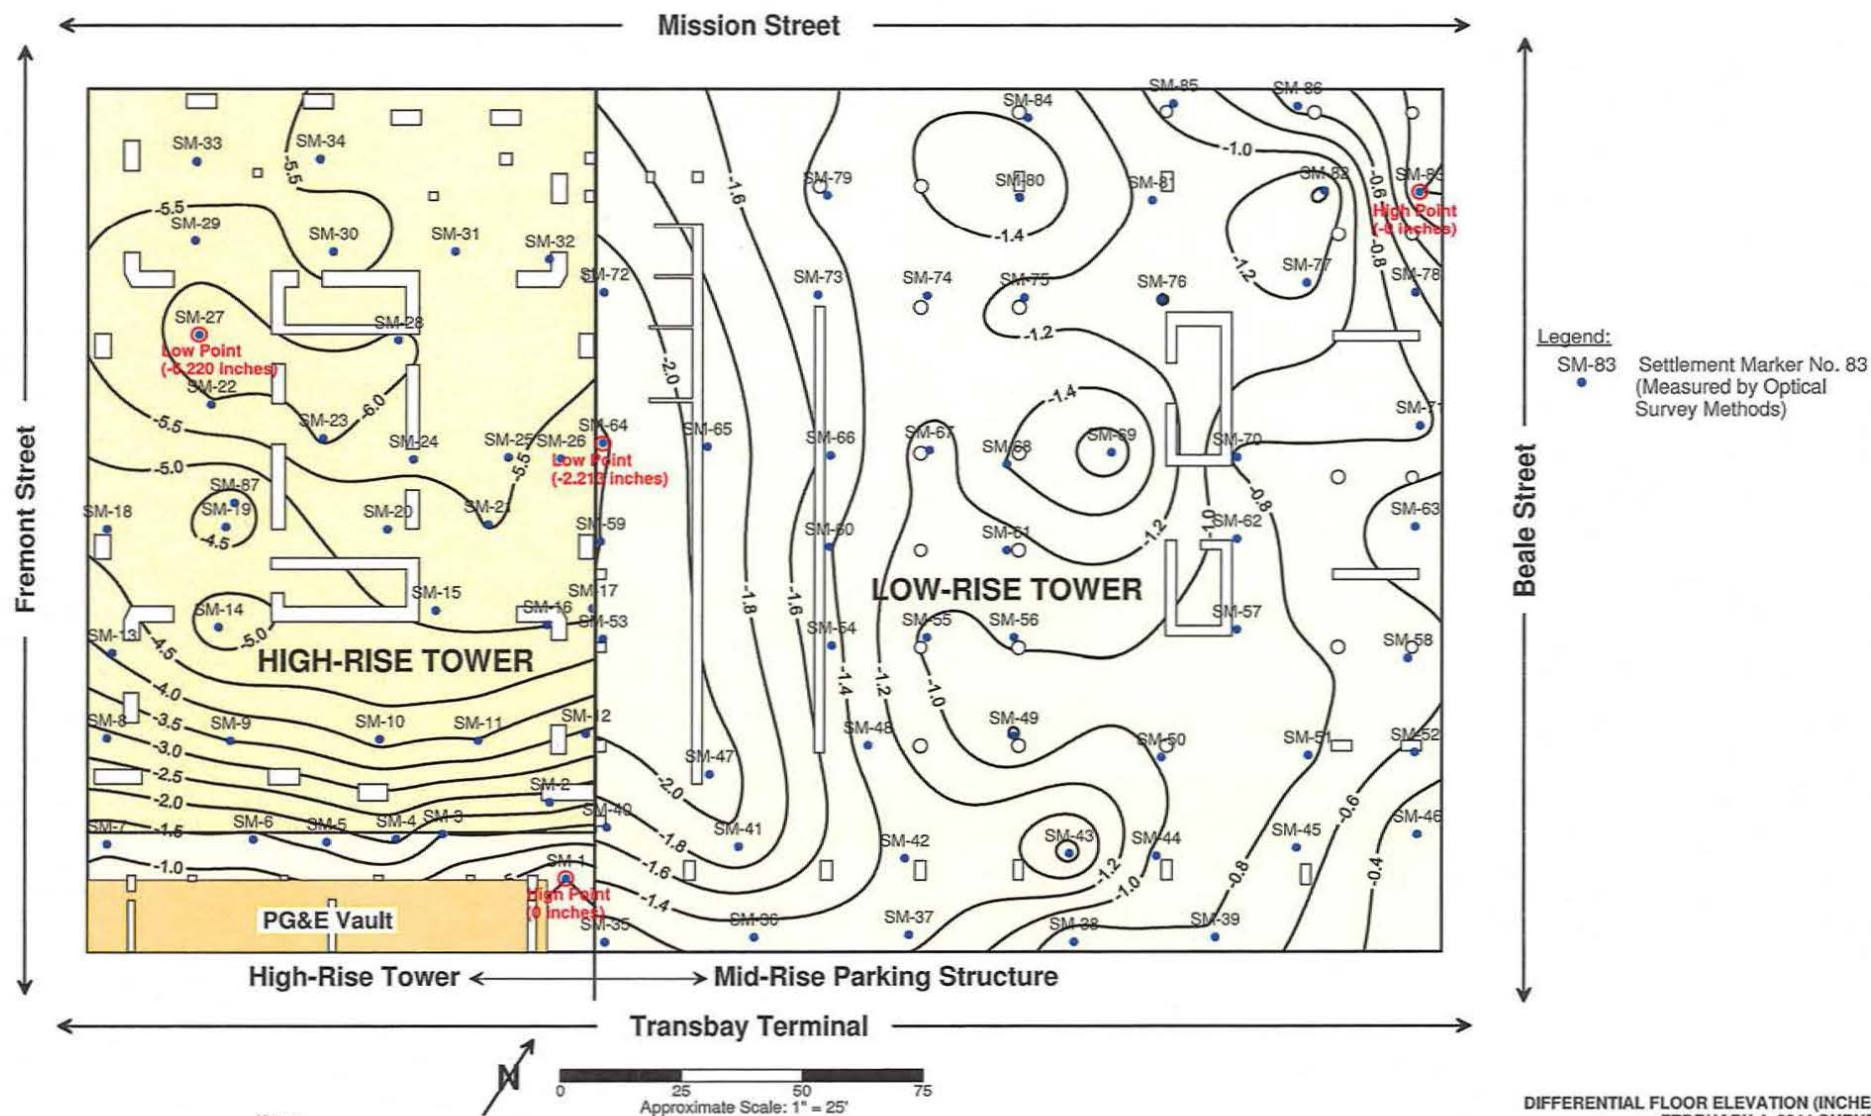
PLATE 2

Contours represent differential elevation, in inches, between the highest point and all other points taken on February 4, 2011.
 Level B-1 at Mid-Rise Parking portion of survey site is approximately 4 inches higher than Level B-1 at High-Rise Tower portion.
 The PG&E vault is inaccessible for monitoring.
 Contour intervals are different between the High-Rise Tower and the Low-Rise Tower.

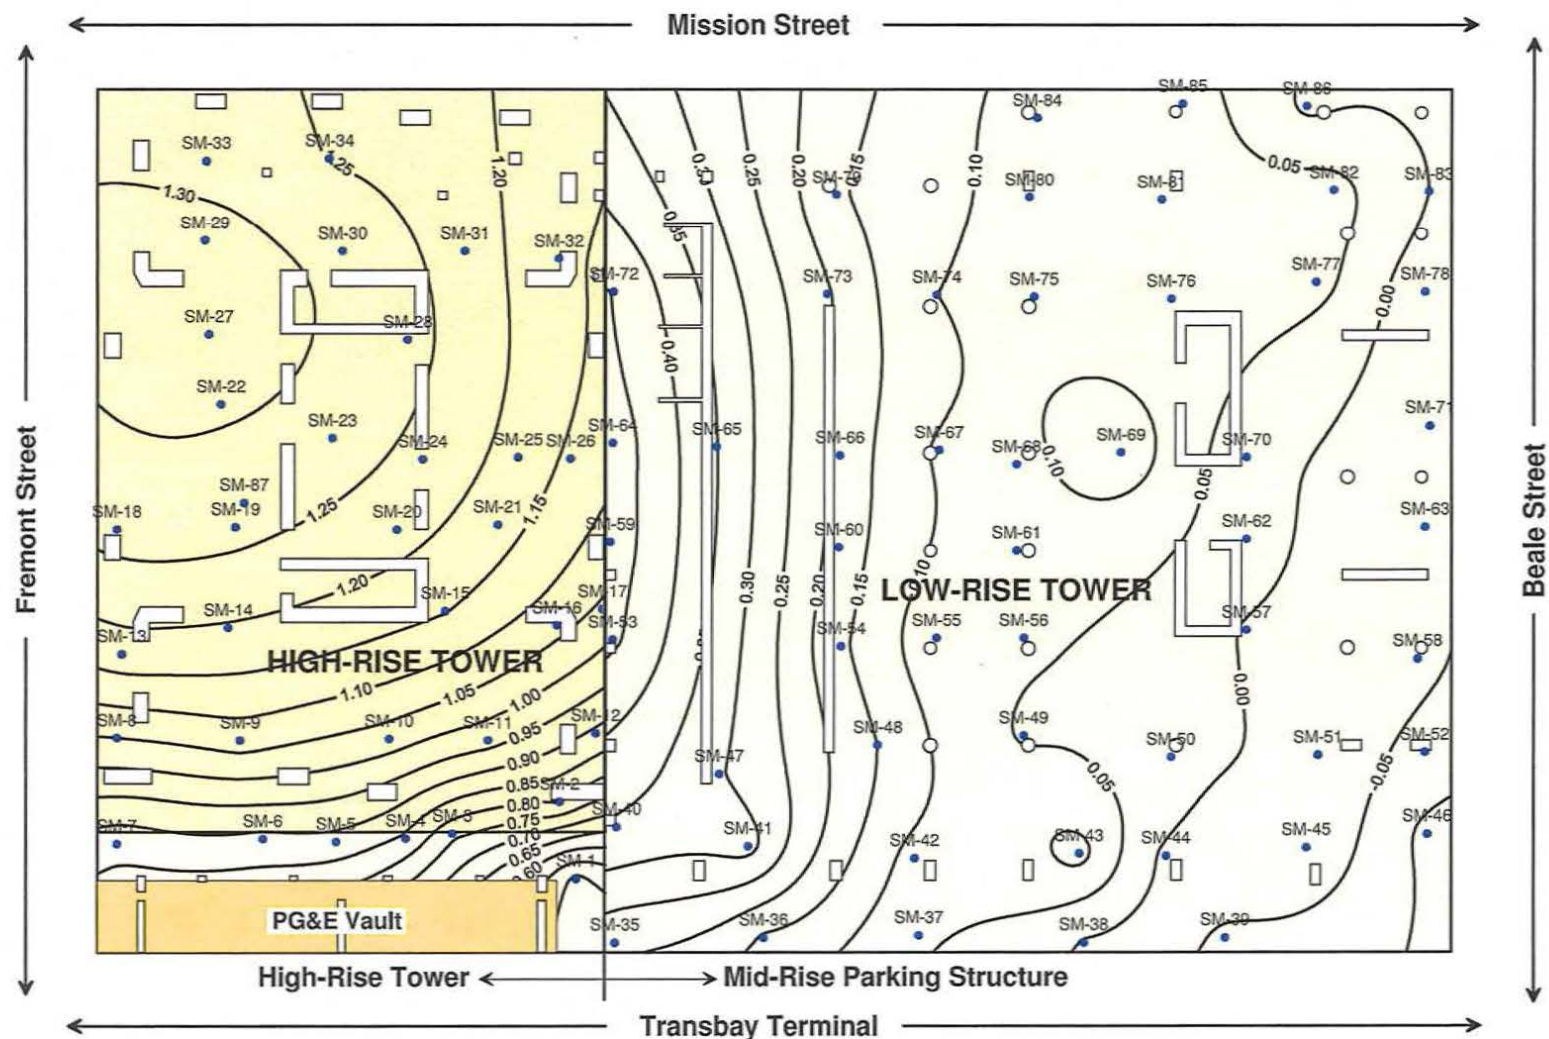
PLATE 3

Notes:
 Contours represent elevation change, in inches, between Baseline survey (April 30, 2009) and readings taken on February 4, 2011.
 Level B-1 at Mid-Rise Parking portion of survey site is approximately 4 inches higher than Level B-1 at High-Rise Tower portion.
 The PG&E vault is inaccessible for monitoring.
 Negative values of settlement (within Low-rise Tower) indicate uplift.

CONTOURS OF SETTLEMENTS MEASURED AT THE
 FIRST LEVEL BASEMENT OF THE 301 MISSION STREET
 STRUCTURE BETWEEN APRIL 30, 2009 AND FEBRUARY 4, 2011

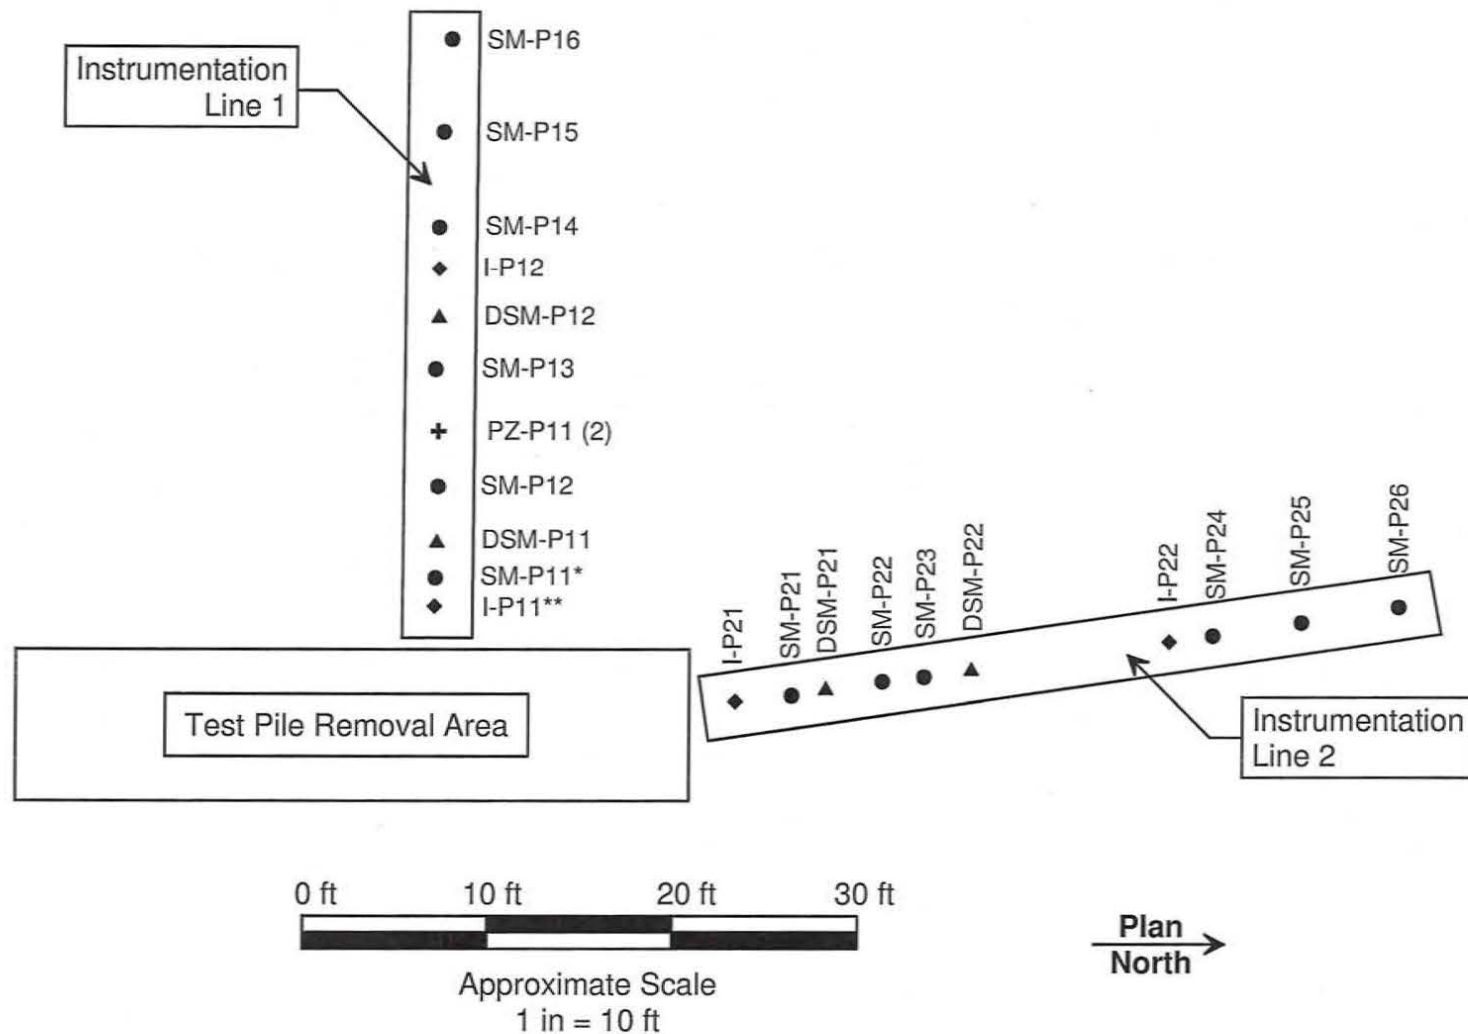
*SM-P11 was destroyed due to the excavation for the pile removal on 4/4/2011.

**I-P11 was damaged due to the excavation for the pile removal on 4/4/2011.

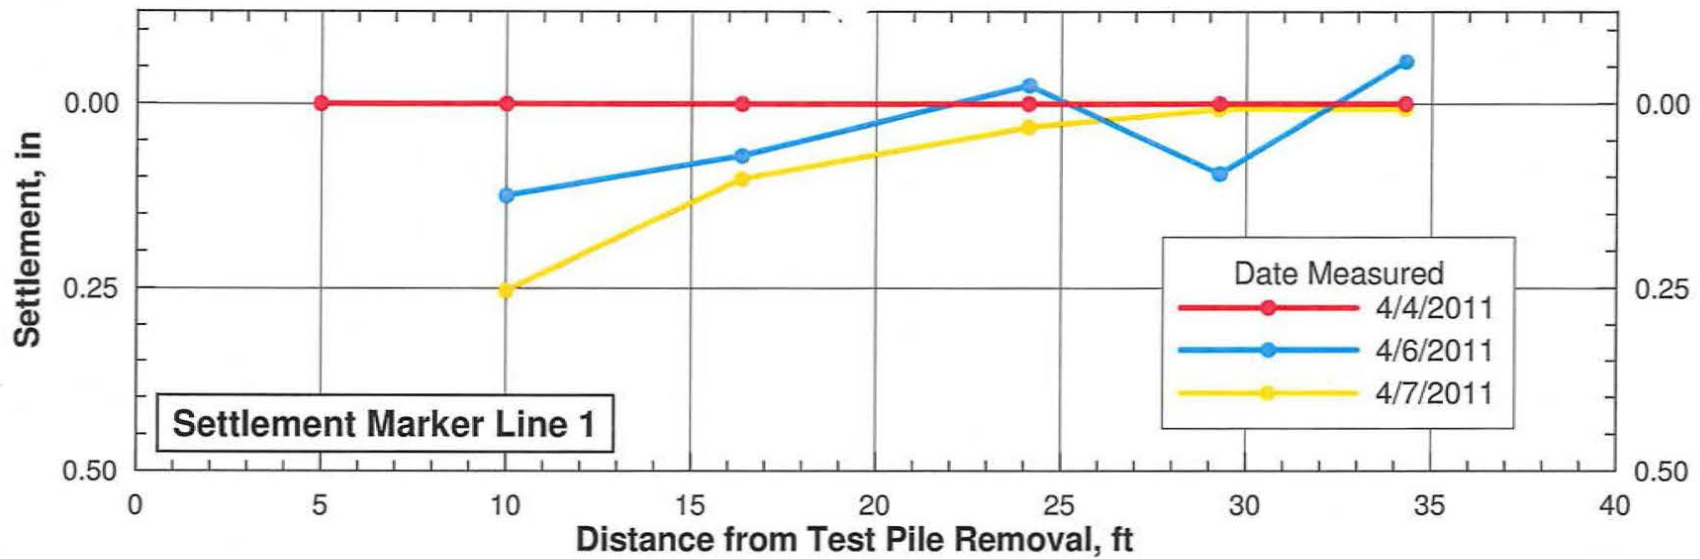
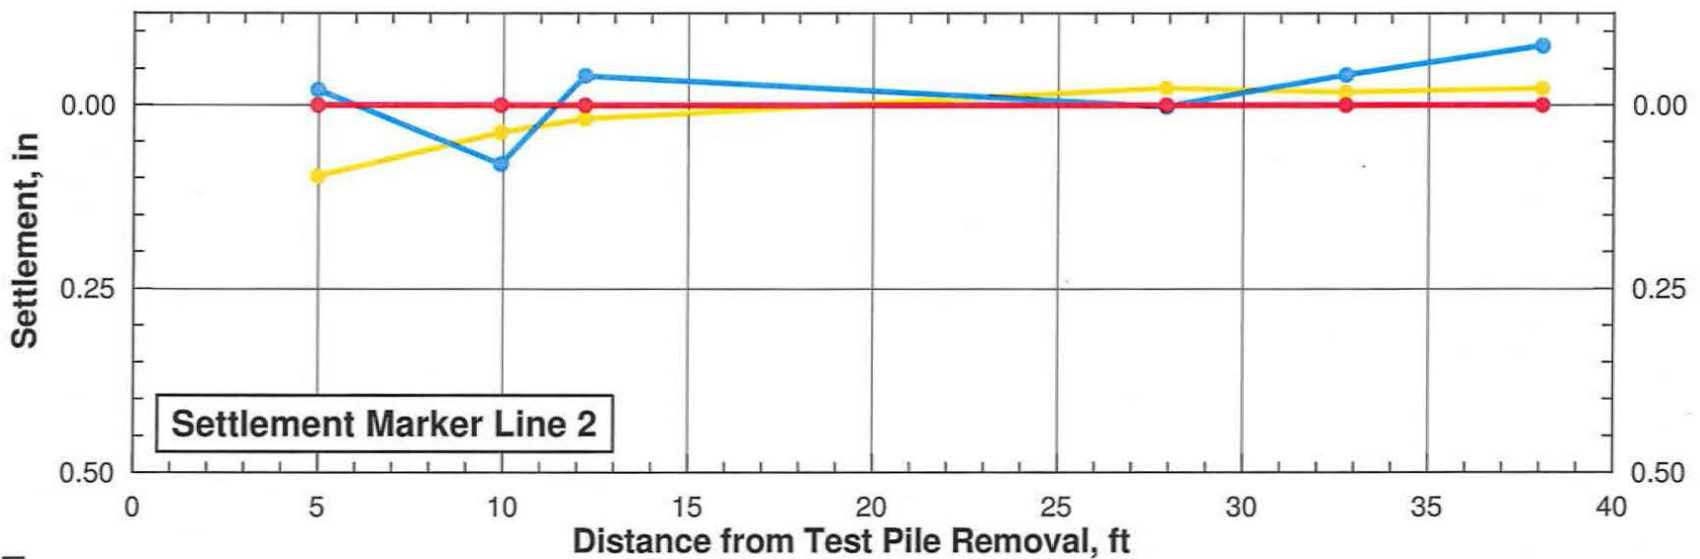
PLATE 1

SETTLEMENT MARKERS

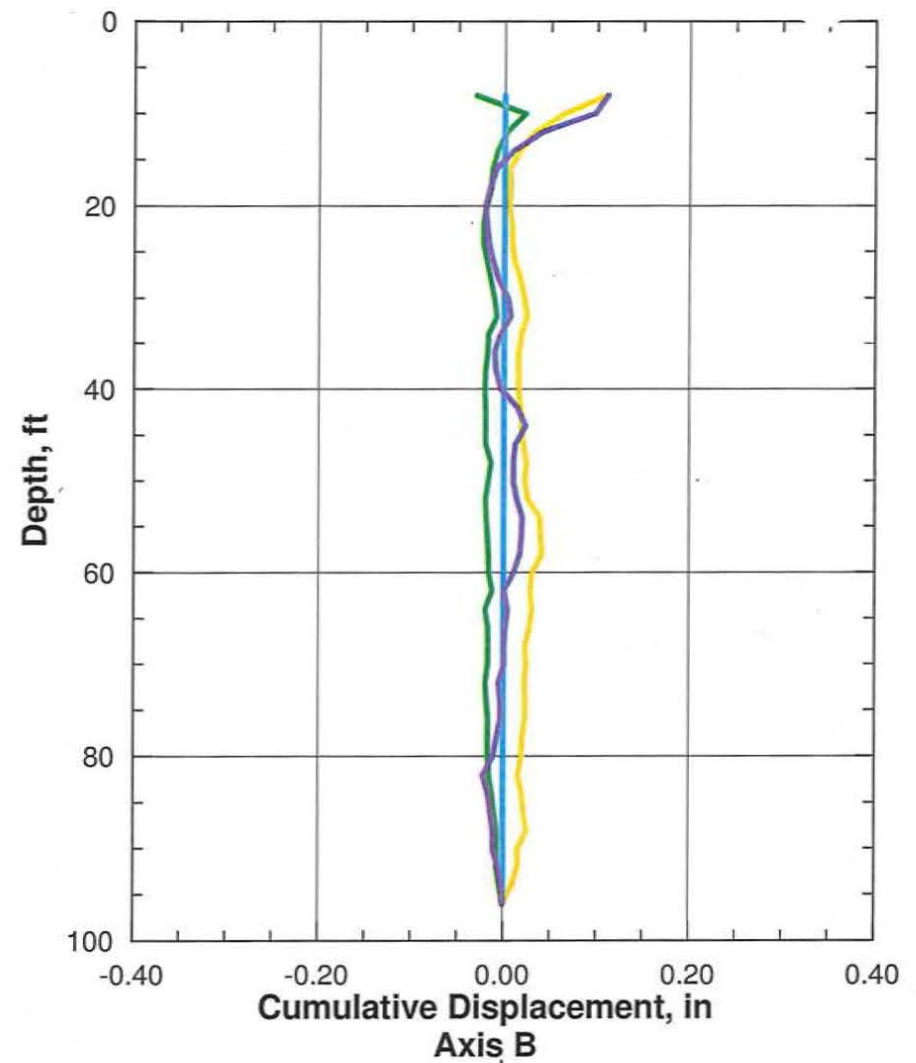
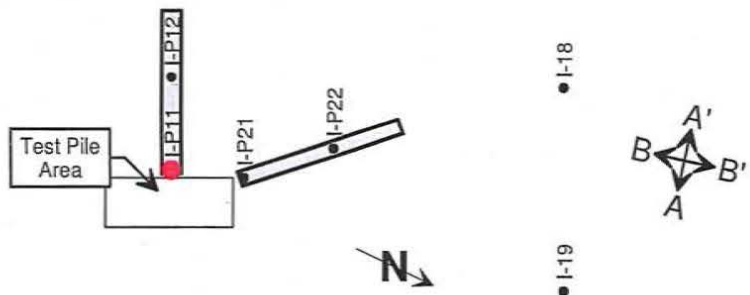
PLATE 3-2

NOTE: Inclinator was damaged during work on 4/5/11. It collapsed about 7 feet below the surface. The inclinometer was dug out and cut-off. A new baseline reading was taken after it was fixed on 4/5/11. Large movements may be from it not being protected at the surface and sloughing ground due to excavation for pile removal.

INCLINOMETER DATA FOR PILE EXTRACTION TEST SITE INCLINOMETER READING I-P11

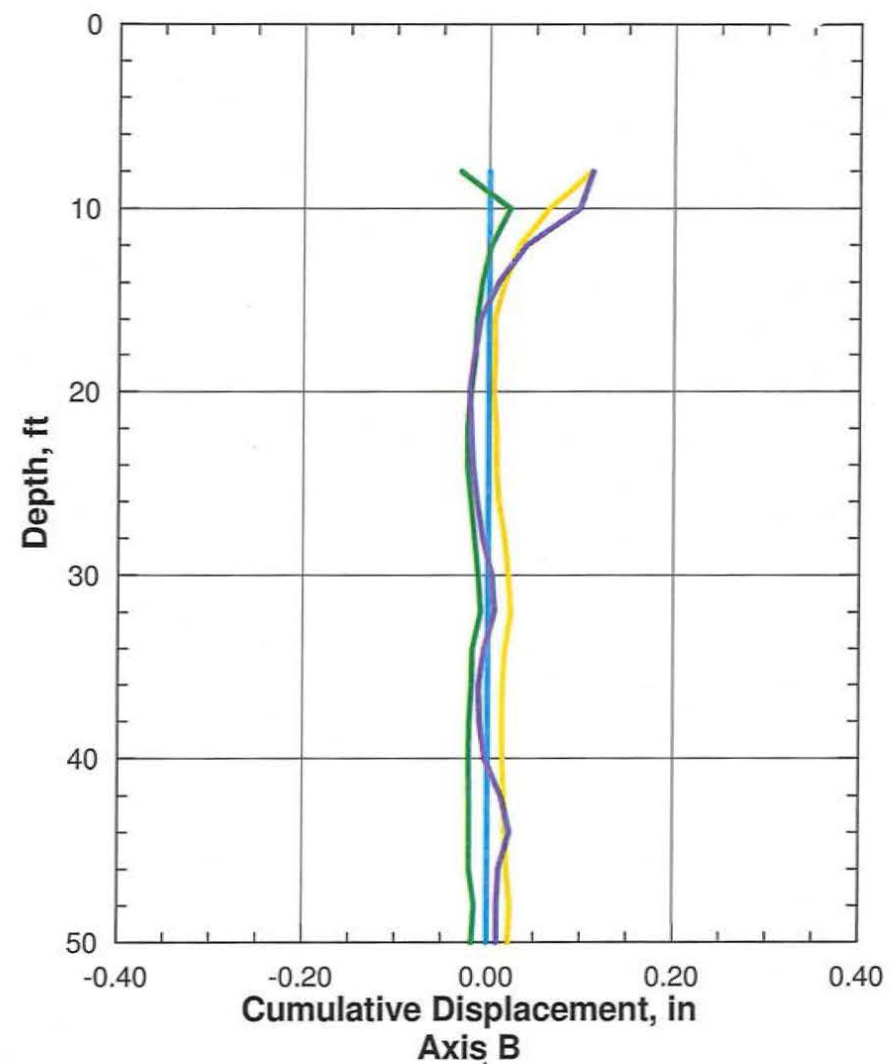
PLATE 4-1

NOTE: Inclinator was damaged during work on 4/5/11. It collapsed about 7 feet below the surface. The inclinometer was dug out and cut-off. A new baseline reading was taken after it was fixed on 4/5/11. Large movements may be from it not being protected at the surface and sloughing ground due to excavation for pile removal.

**INCLINOMETER DATA FOR PILE EXTRACTION
TEST SITE INCLINOMETER READING I-P11:
TOP 50 FEET OF THE INCLINOMETER ONLY**

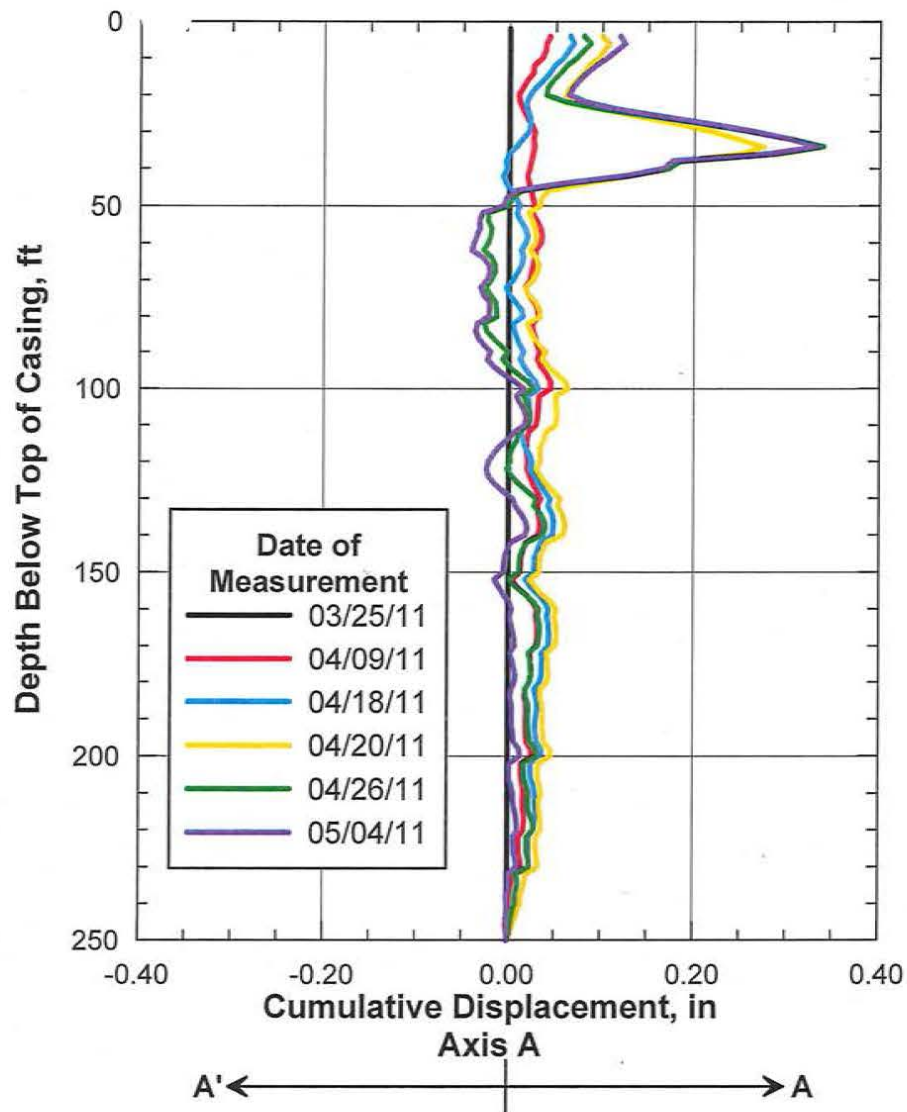
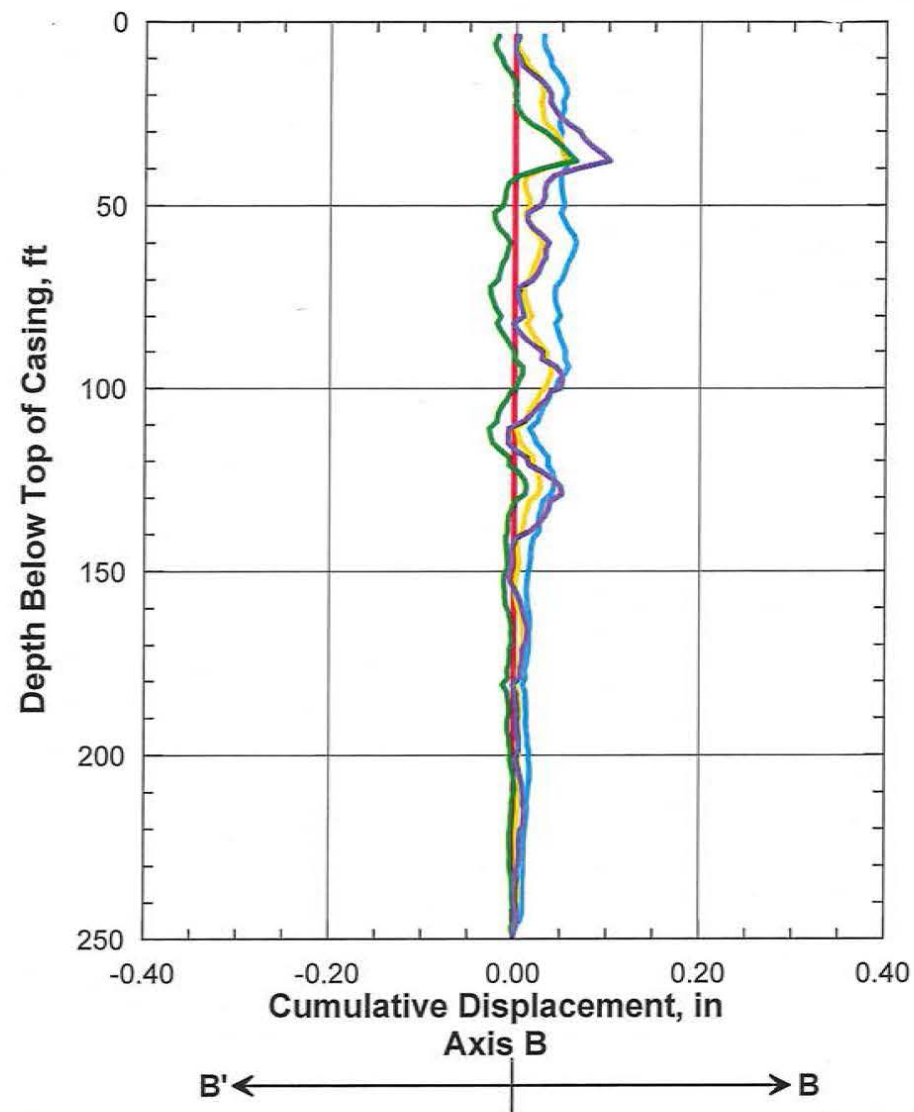
PLATE 1-1

Plates 1-1 and 2-1 illustrate the lateral deflection measured in each inclinometer. The movements are measured over two axes described as A-A' and B-B'. The orientations of these axes are shown in the small figure at the bottom of the plate.

Overall, the lateral movements recorded to date are within the tolerances prescribed in the Specification.

**INCLINOMETER DATA FOR PILE EXTRACTION
TEST SITE INCLINOMETER READING I-18**

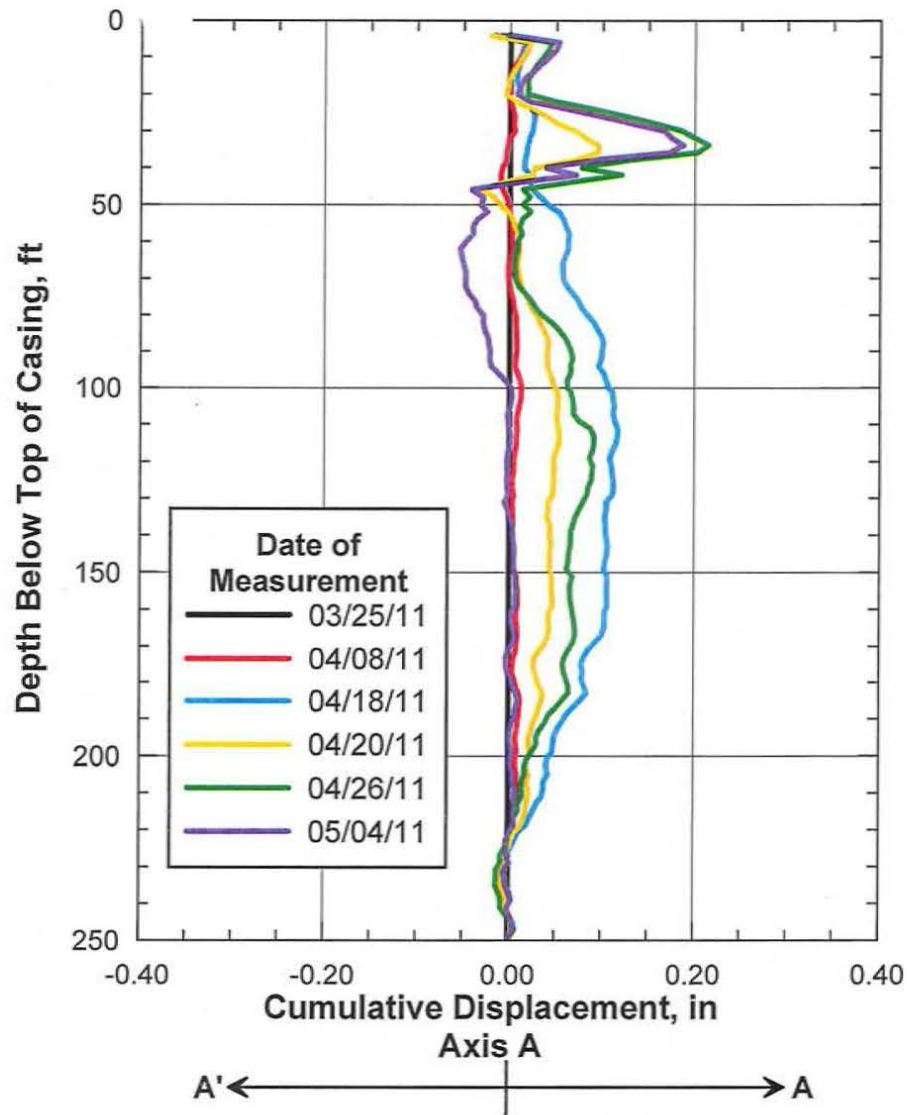
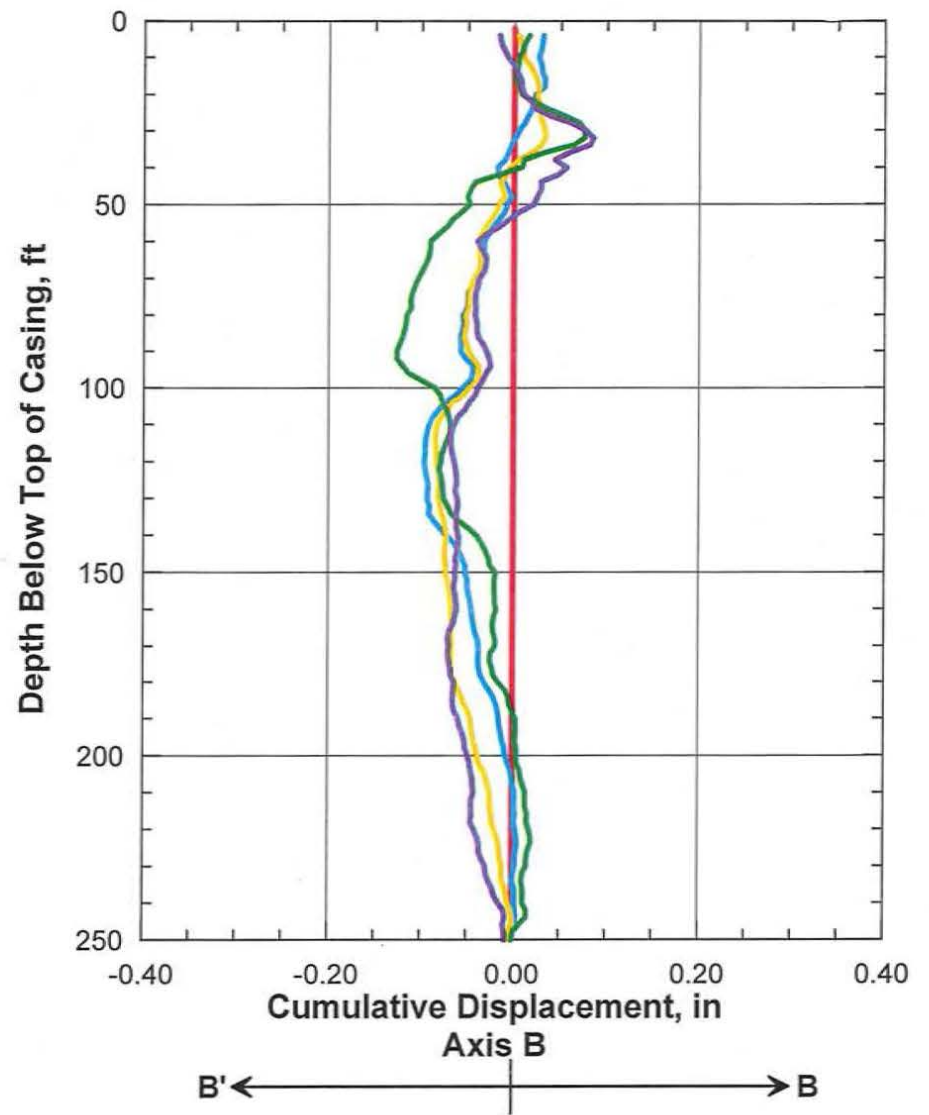
PLATE 2-1

**INCLINOMETER DATA FOR PILE EXTRACTION
TEST SITE INCLINOMETER READING I-19**
