Supplemental Report for Foundation Settlement Investigation

The building at 301 Mission Street, San Francisco, California is a fifty-eight-story residential structure founded on a pile-supported mat foundation. The building, which was completed in 2009, has experienced and continues to experience significant foundation settlement. Paul Hastings, LLP retained Simpson Gumpertz & Heger Inc. in 2014 to conduct an evaluation of the impact of site settlement on the building's structural stability and earthquake resistance. We performed initial evaluations in 2014 and updated these in 2016 to consider additional settlement that occurred in the interim period. In an October 2016 report we concluded that settlement had not compromised the building's stability or its ability to resist strong earthquakes.

**SUPPLEMENTAL REPORT
FOUNDATION SETTLEMENT INVESTIGATION
301 MISSION STREET
SAN FRANCISCO, CALIFORNIA**

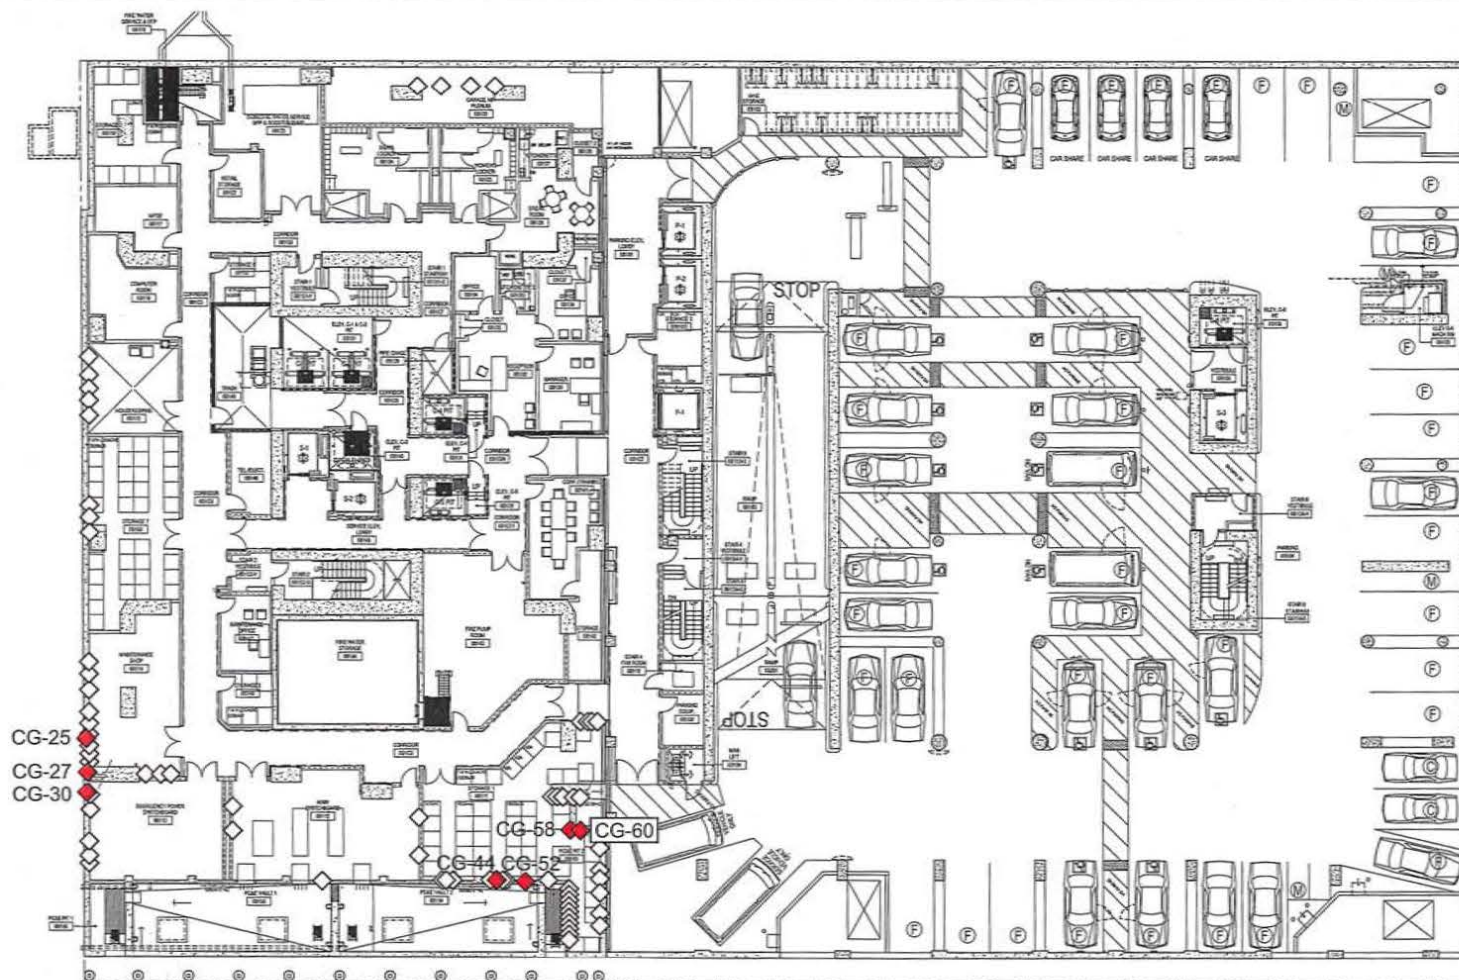
CRACK GAUGES SHOWING MOVEMENT: 301 MISSION STREET BASEMENT LEVEL B-1

The movement recorded was less than 0.1 millimeters on all of the gauges except for seven of the gauges. For these seven gauges, the attached plate and table describe their location and the recorded movements.

Crack Gauge	Distance of Movement	Direction of movement, relative to the Crack
CG-25	0.2 mm	Perpendicular
CG-27	0.4 mm	Parallel
CG-30	0.4 mm	Parallel
CG-44	0.2 mm	Perpendicular
CG-52	0.4 mm	Parallel
CG-58	0.2 mm	Perpendicular
CG-60	0.1 mm	Perpendicular

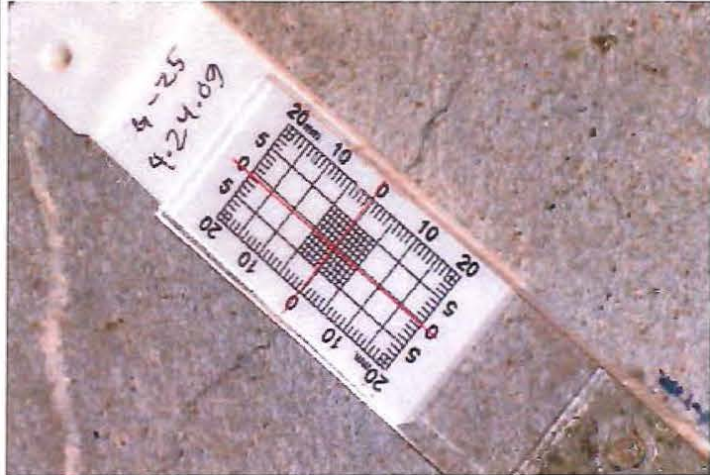
Crack Gauge	Distance of Movement	Direction of movement, relative to the Crack	Picture of Movement
CG-25	0.2 mm 0.4 mm	Perpendicular Parallel

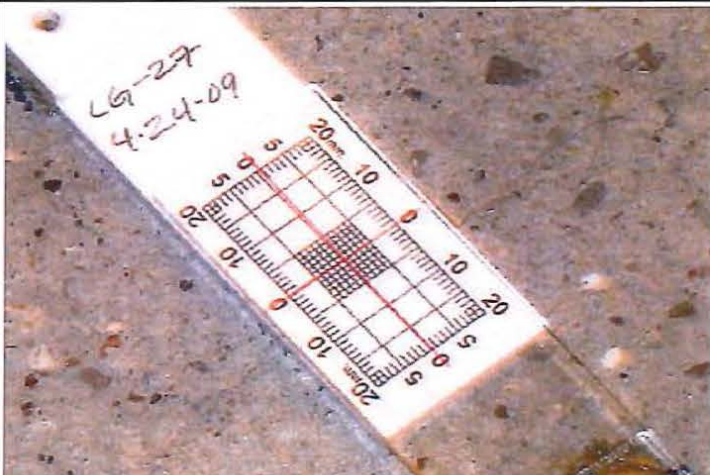
CG-27	0.4 mm	Parallel

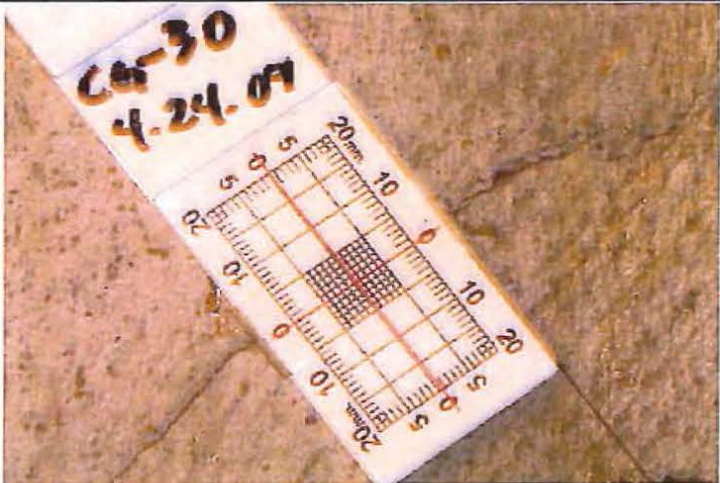
Crack Gauge	Distance of Movement	Direction of movement, relative to the Crack	Picture of Movement
CG-30	0.4 mm	Parallel

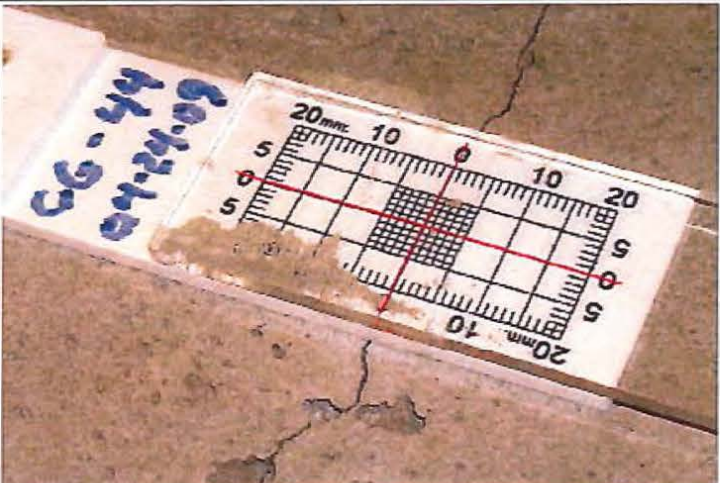
CG-44	0.2 mm	Perpendicular

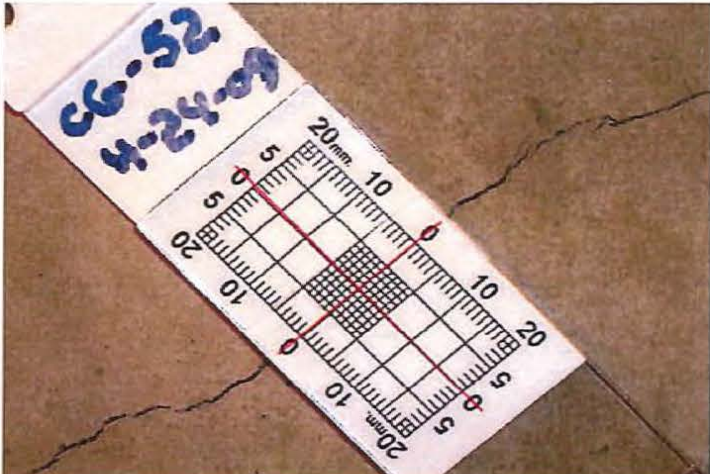
Crack Gauge	Distance of Movement	Direction of movement, relative to the Crack	Picture of Movement
CG-52	0.4 mm	Parallel

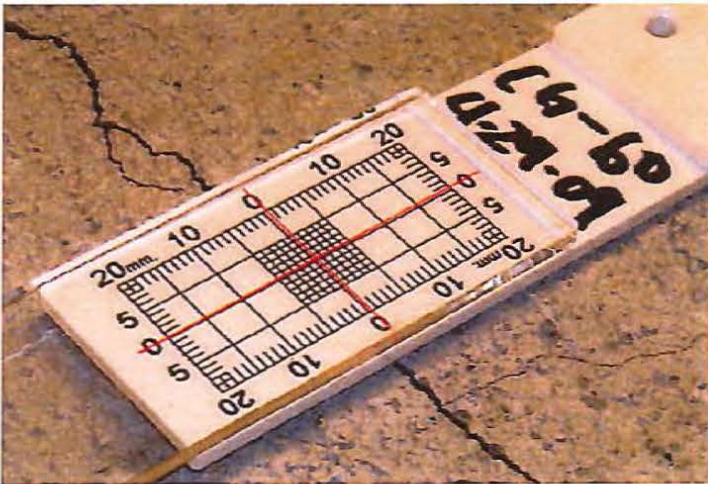
Crack Gauge	Distance of Movement	Direction of movement, relative to the Crack	Picture of Movement
CG-60	0.1 mm	Perpendicular

<p>Head on photograph was not available.</p>

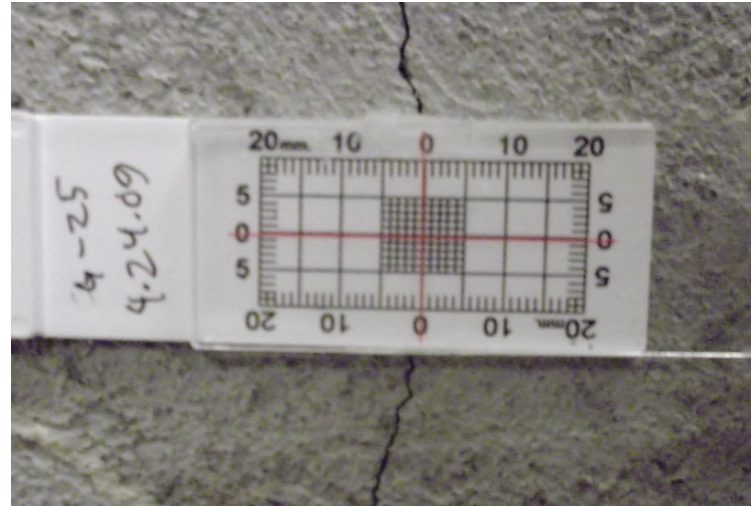
Crack Gauge	Distance of Movement	Direction of movement, relative to the Crack	Variation from previous reading	Picture of Movement
CG-25	0.5 mm	Parallel	+0.1 mm

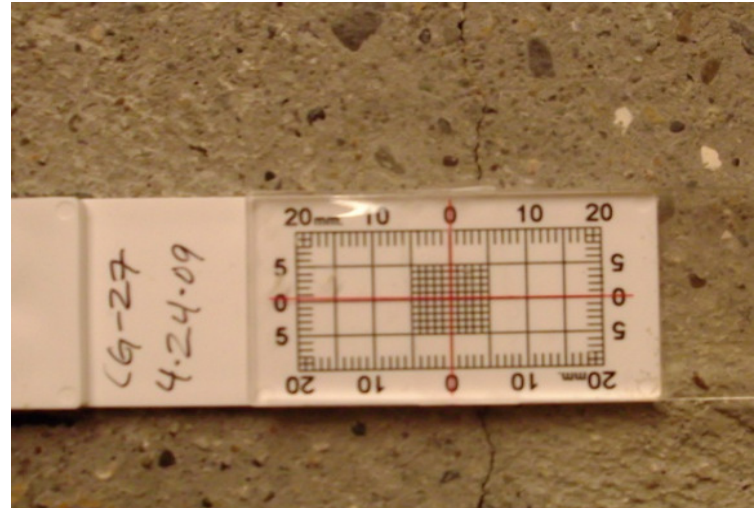
CG-27	0.5 mm	Parallel	Same as previous reading

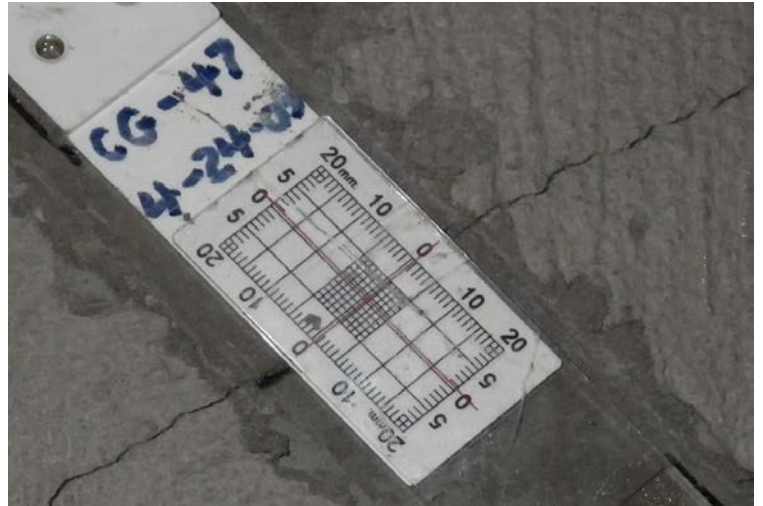
Crack Gauge	Distance of Movement	Direction of movement, relative to the Crack	Variation from previous reading	Picture of Movement
CG-47	0.5 to 0.8 mm 0.5 to 0.8 mm	Parallel Perpendicular	+0.5 to +0.8 mm +0.5 to +0.8 mm

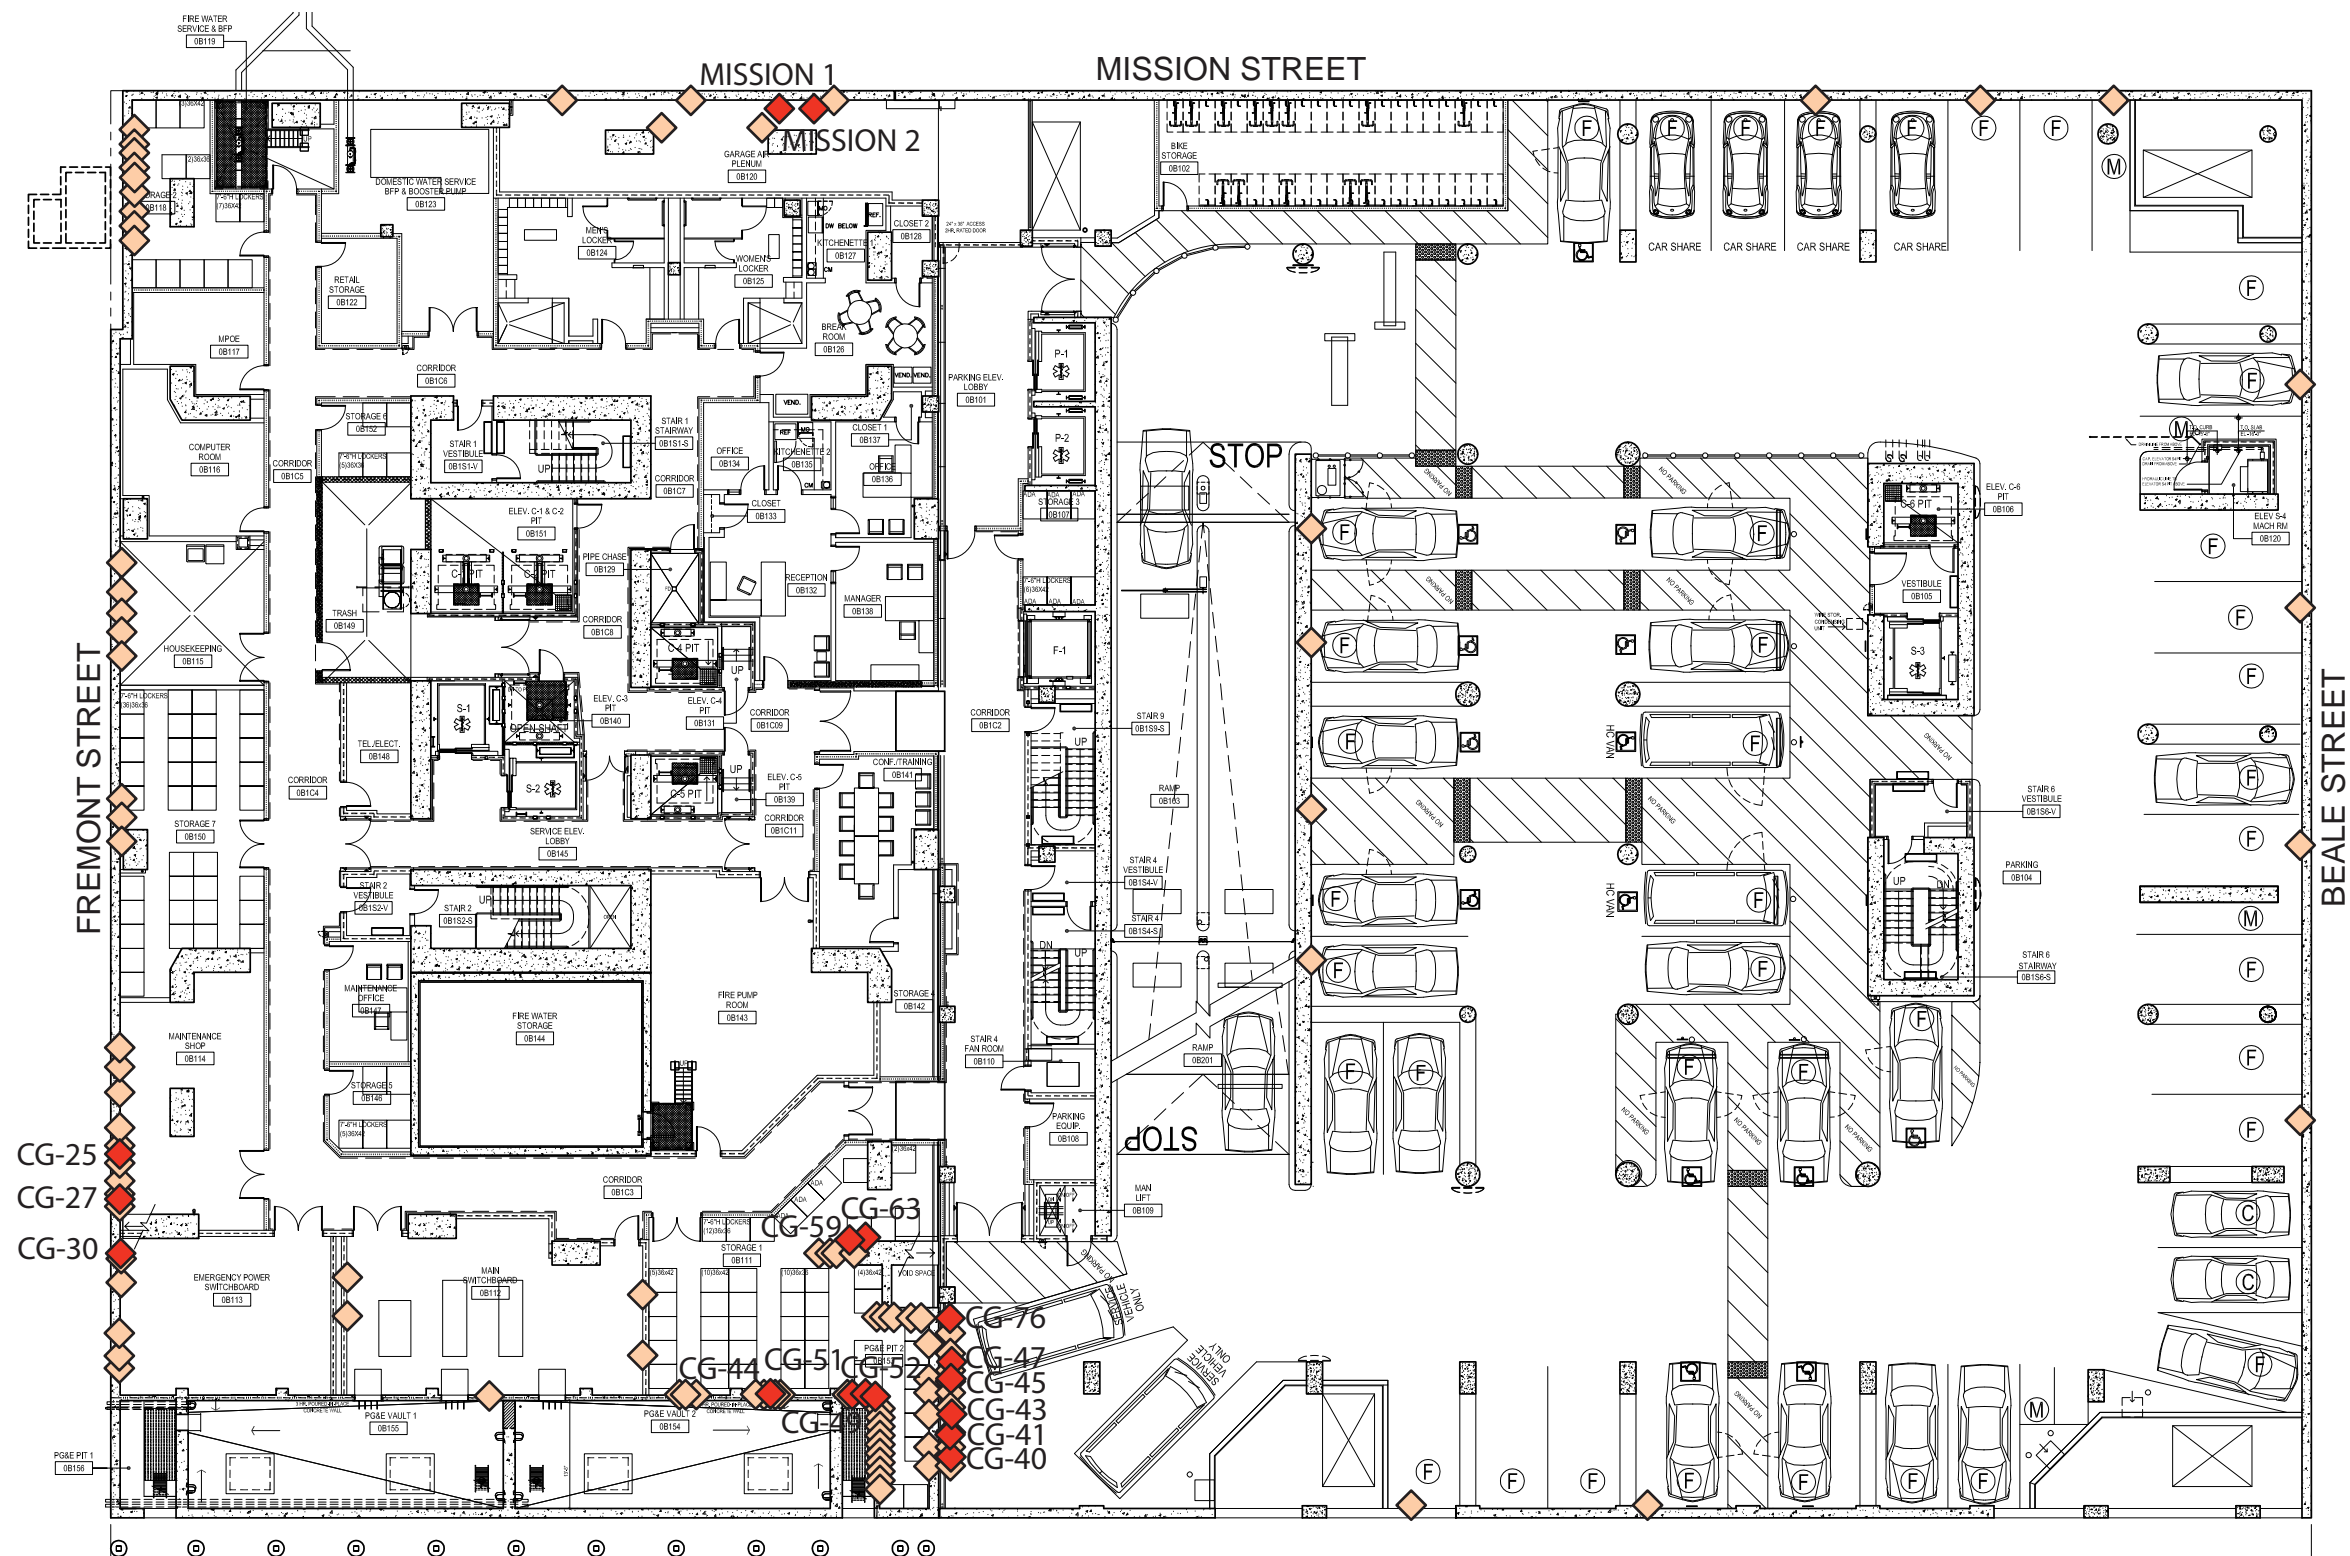
PLATE 1

CRACK GAUGES SOWING MOVEMENT: 301 MISSION STREET BASEMENT LEVEL B-1

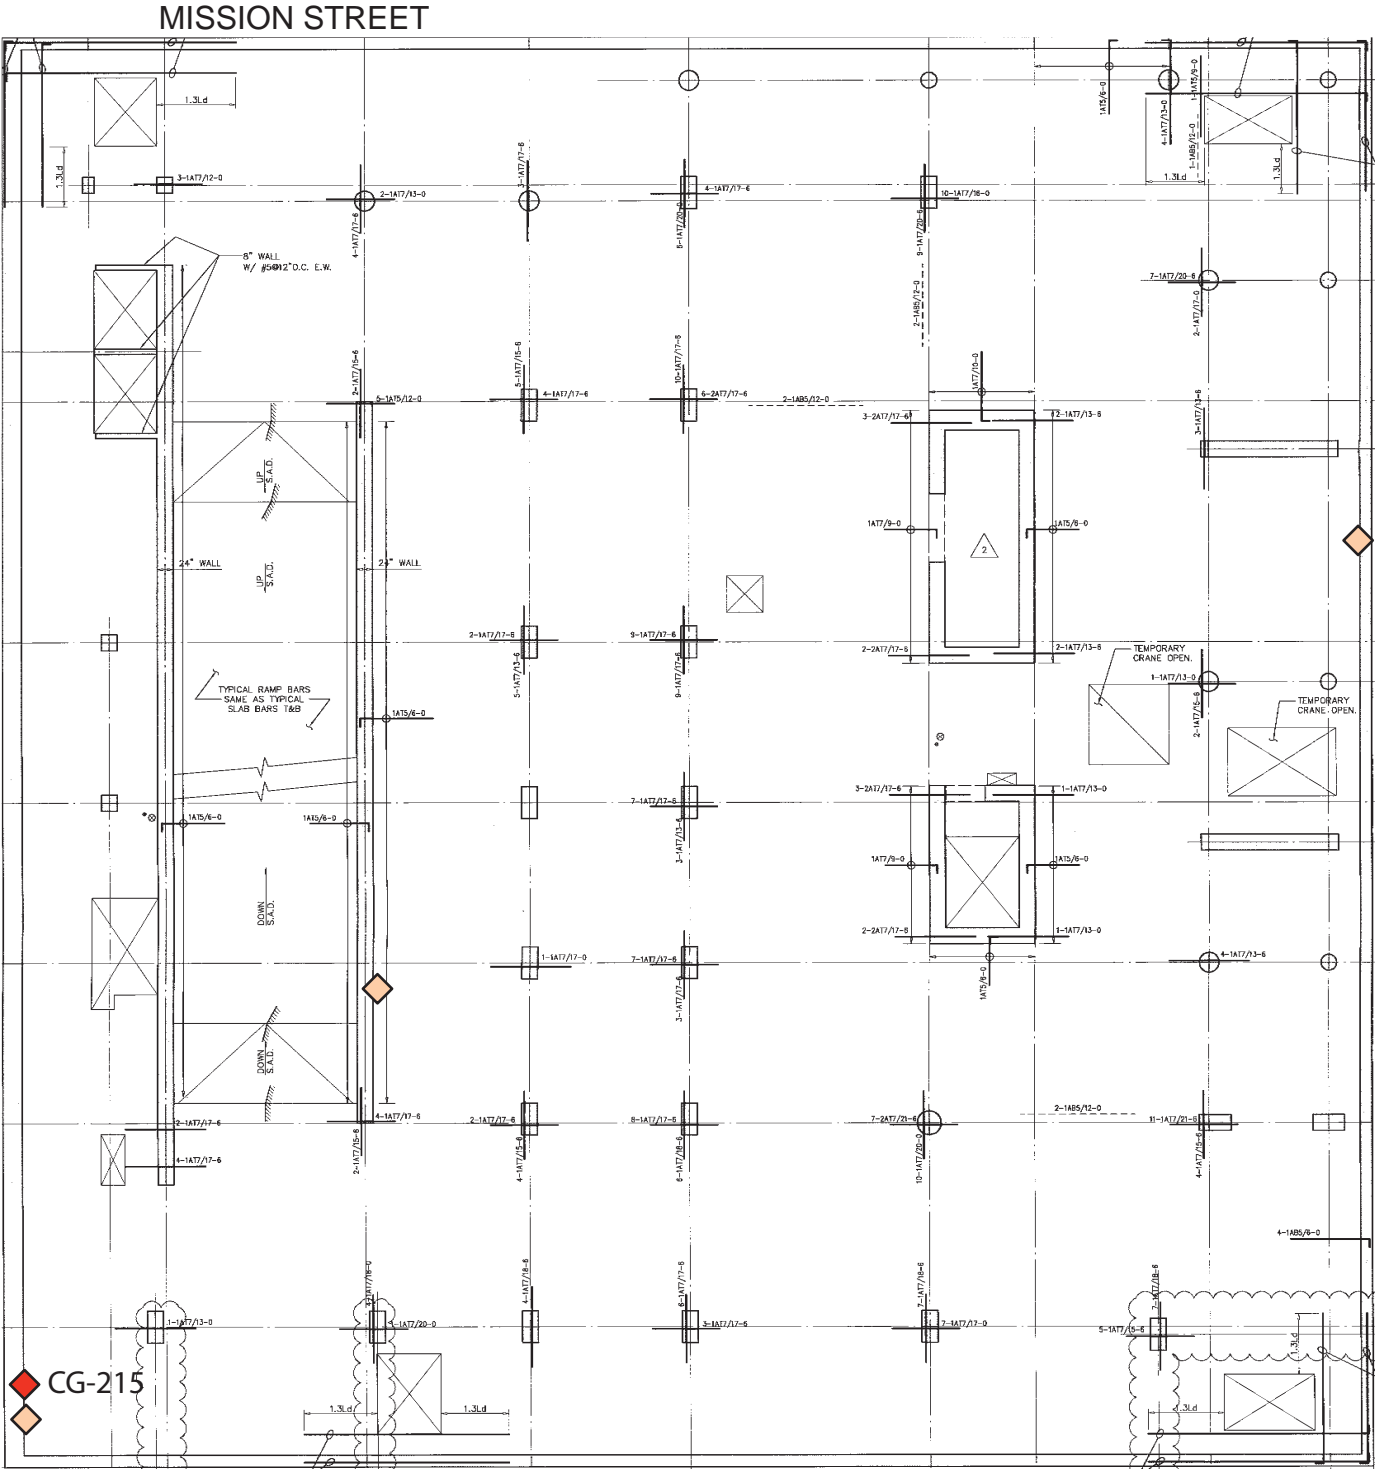
CRACK GAUGES SHOWING MOVEMENT:
301 MISSION STREET BASEMENT LEVEL B-3

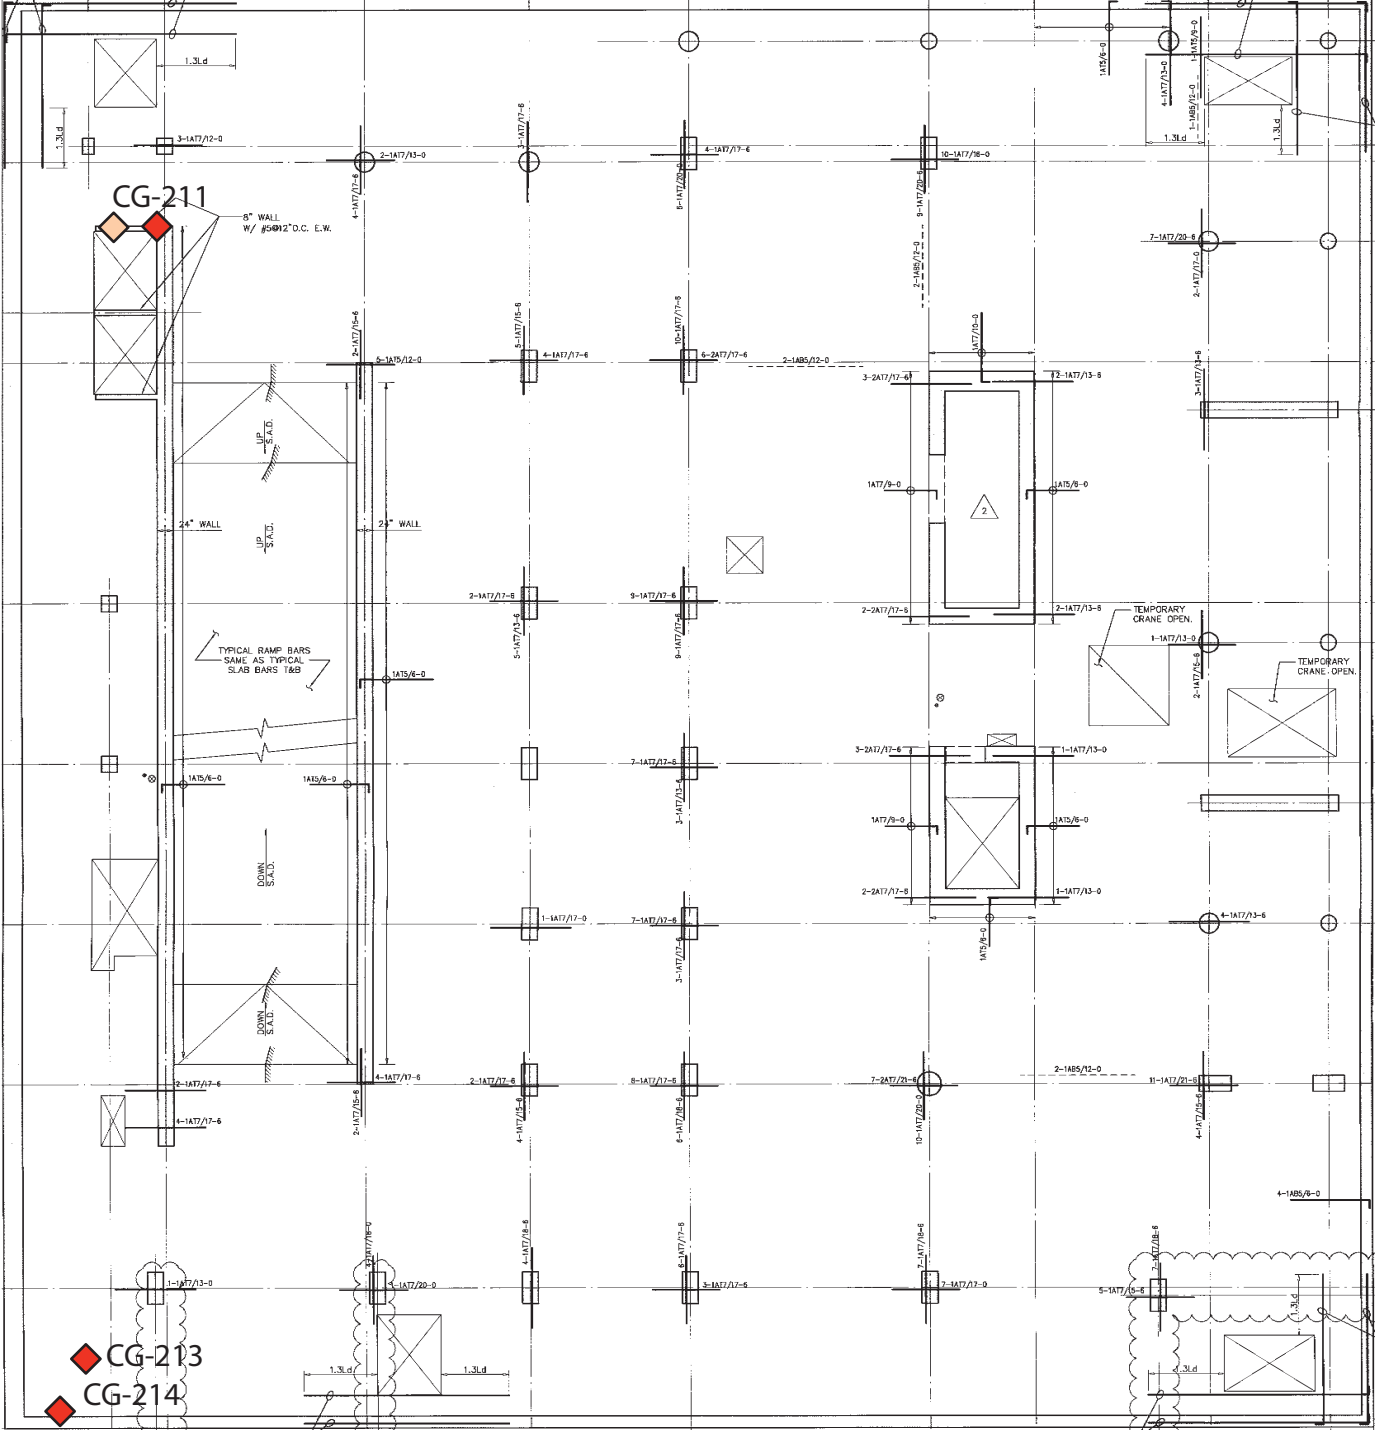
**CRACK GAUGES SHOWING MOVEMENTS:
301 MISSION STREET BASEMENT LEVEL B-4**

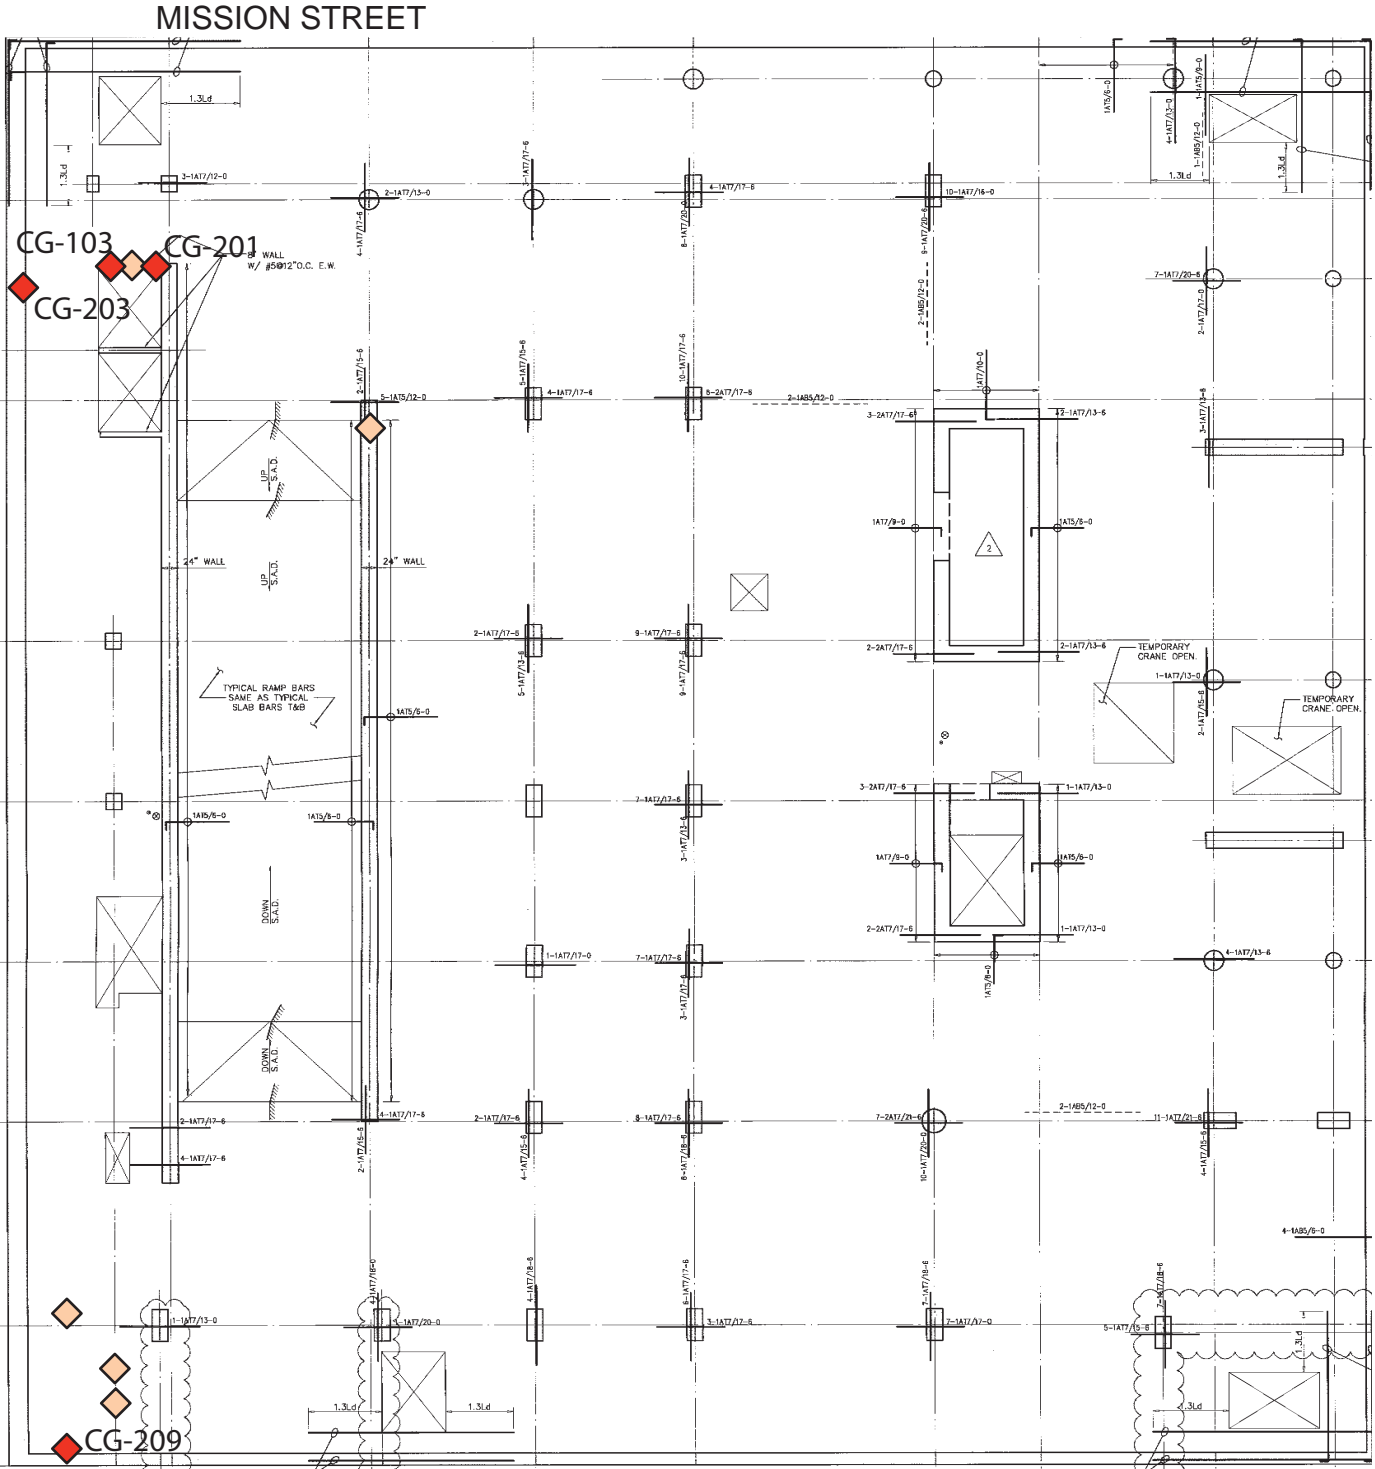
PLATE 3

CRACK GAUGES SHOWING MOVEMENTS:
301 MISSION STREET BASEMENT LEVEL B-5

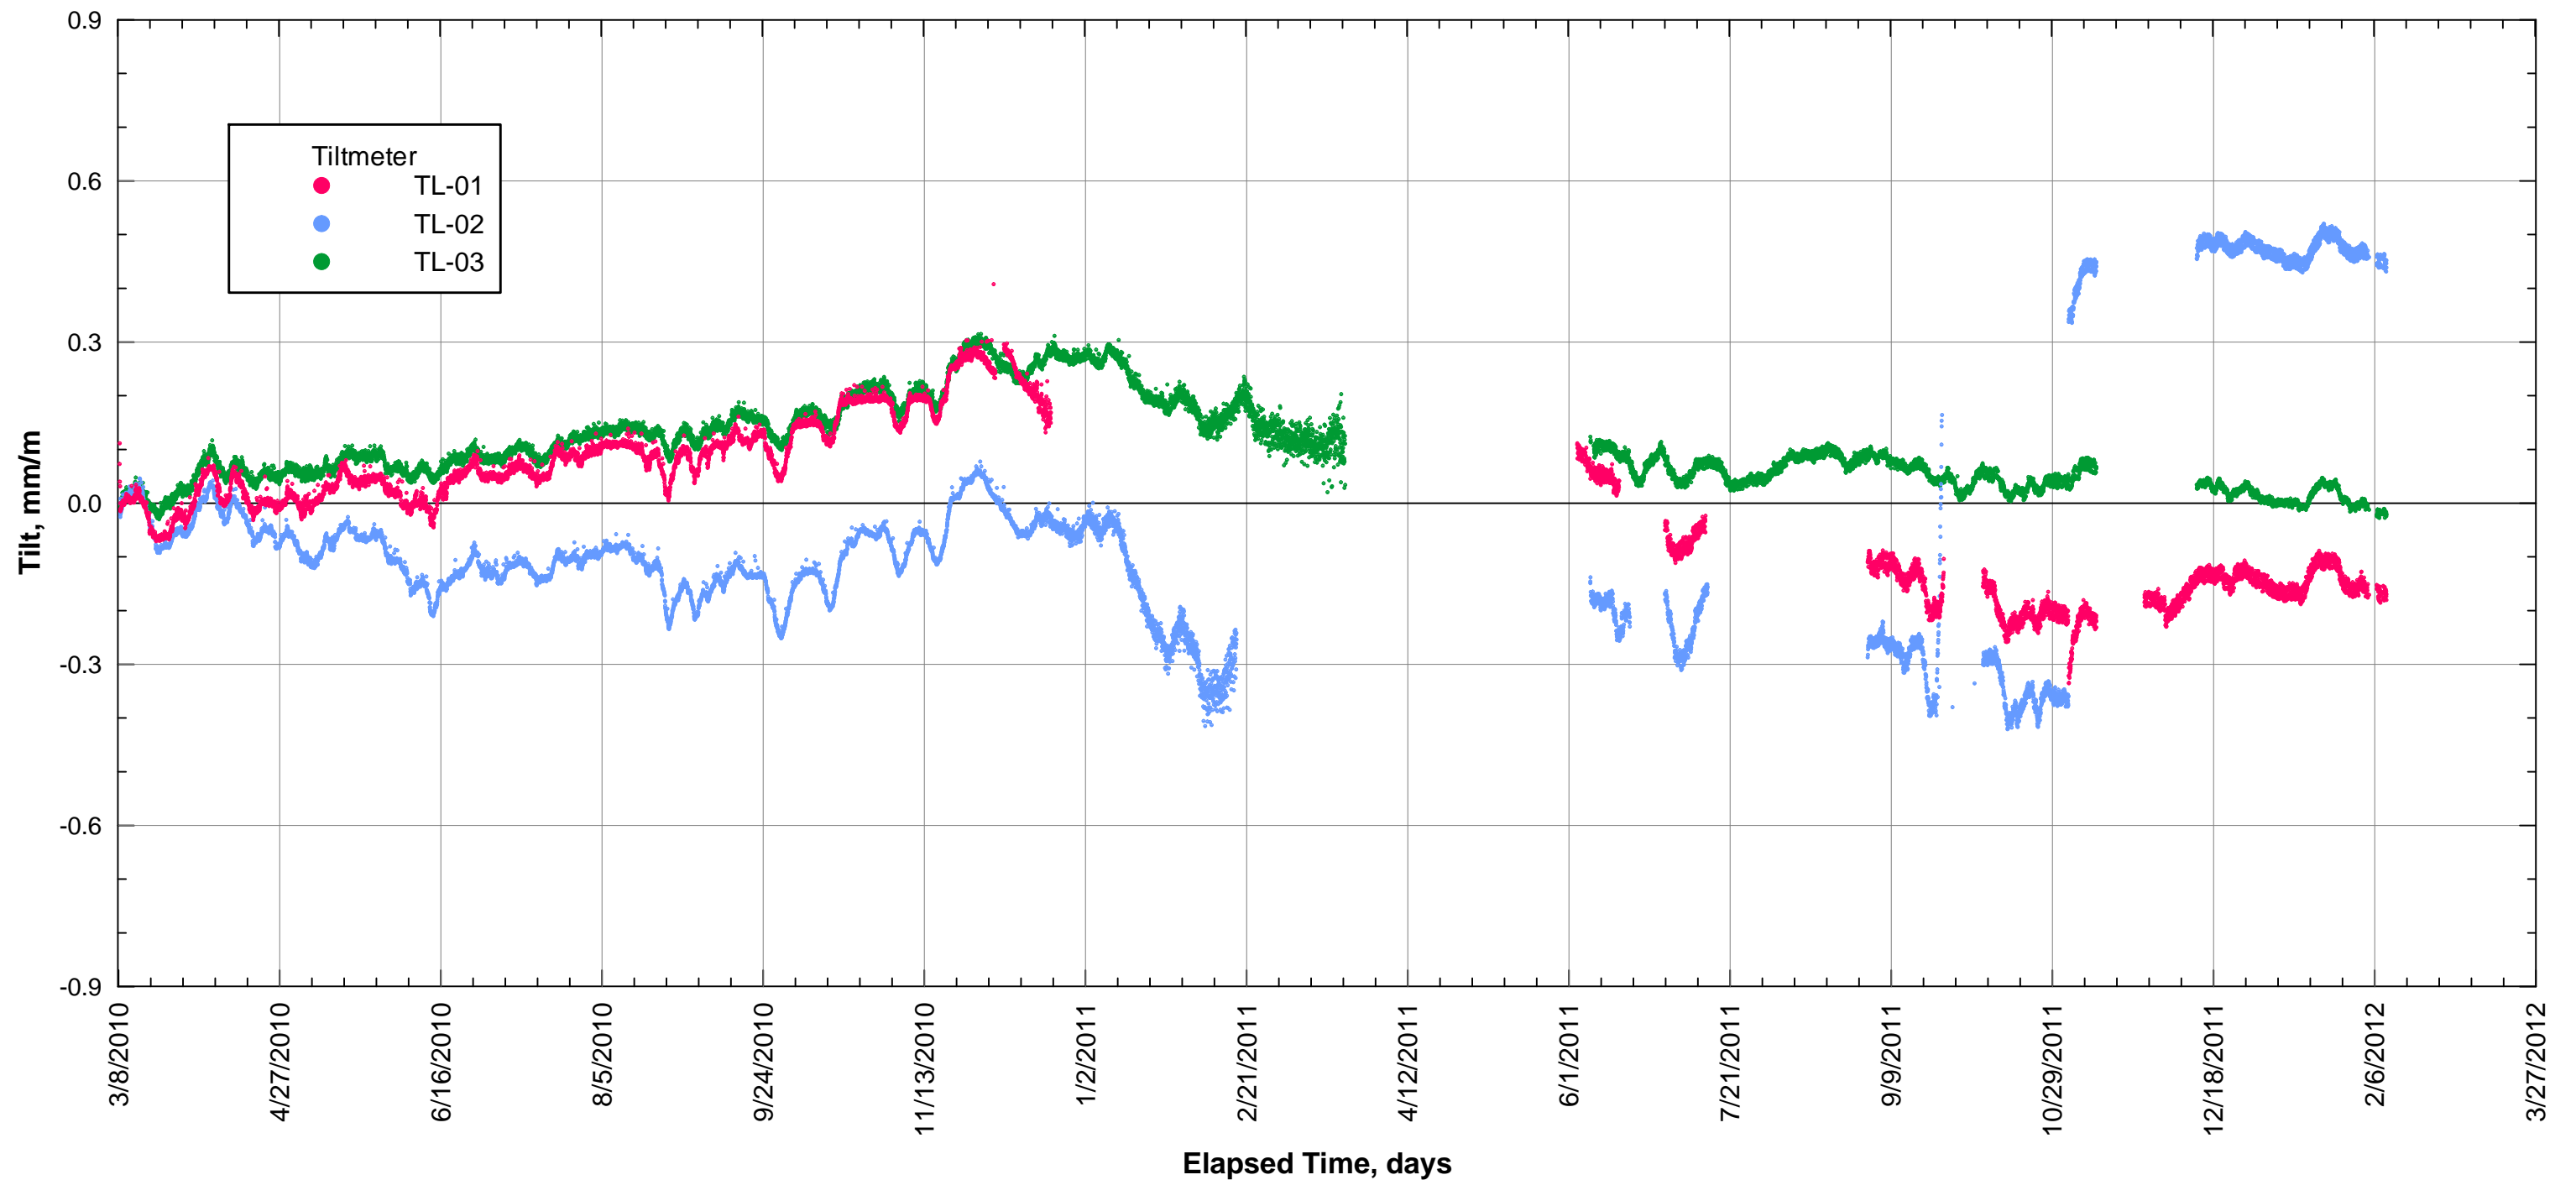
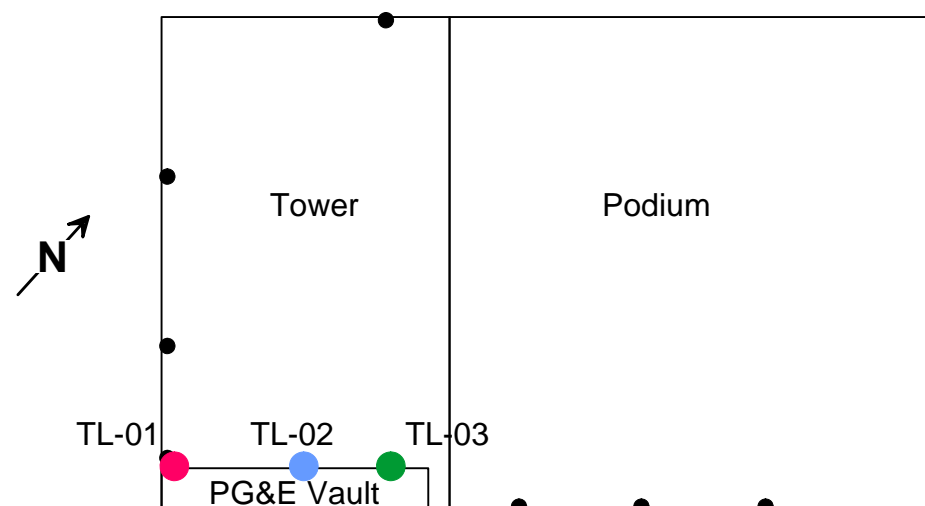
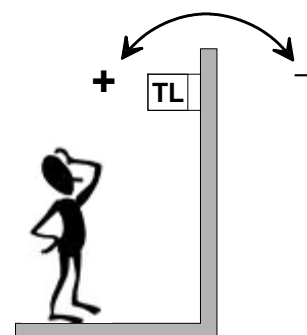
Positive tilt represents movement of the top of the wall towards the inside of the room.

TILT RECORDED IN TILTMETERS TL-01, TL-02, AND TL-03: BASEMENT LEVEL B-1

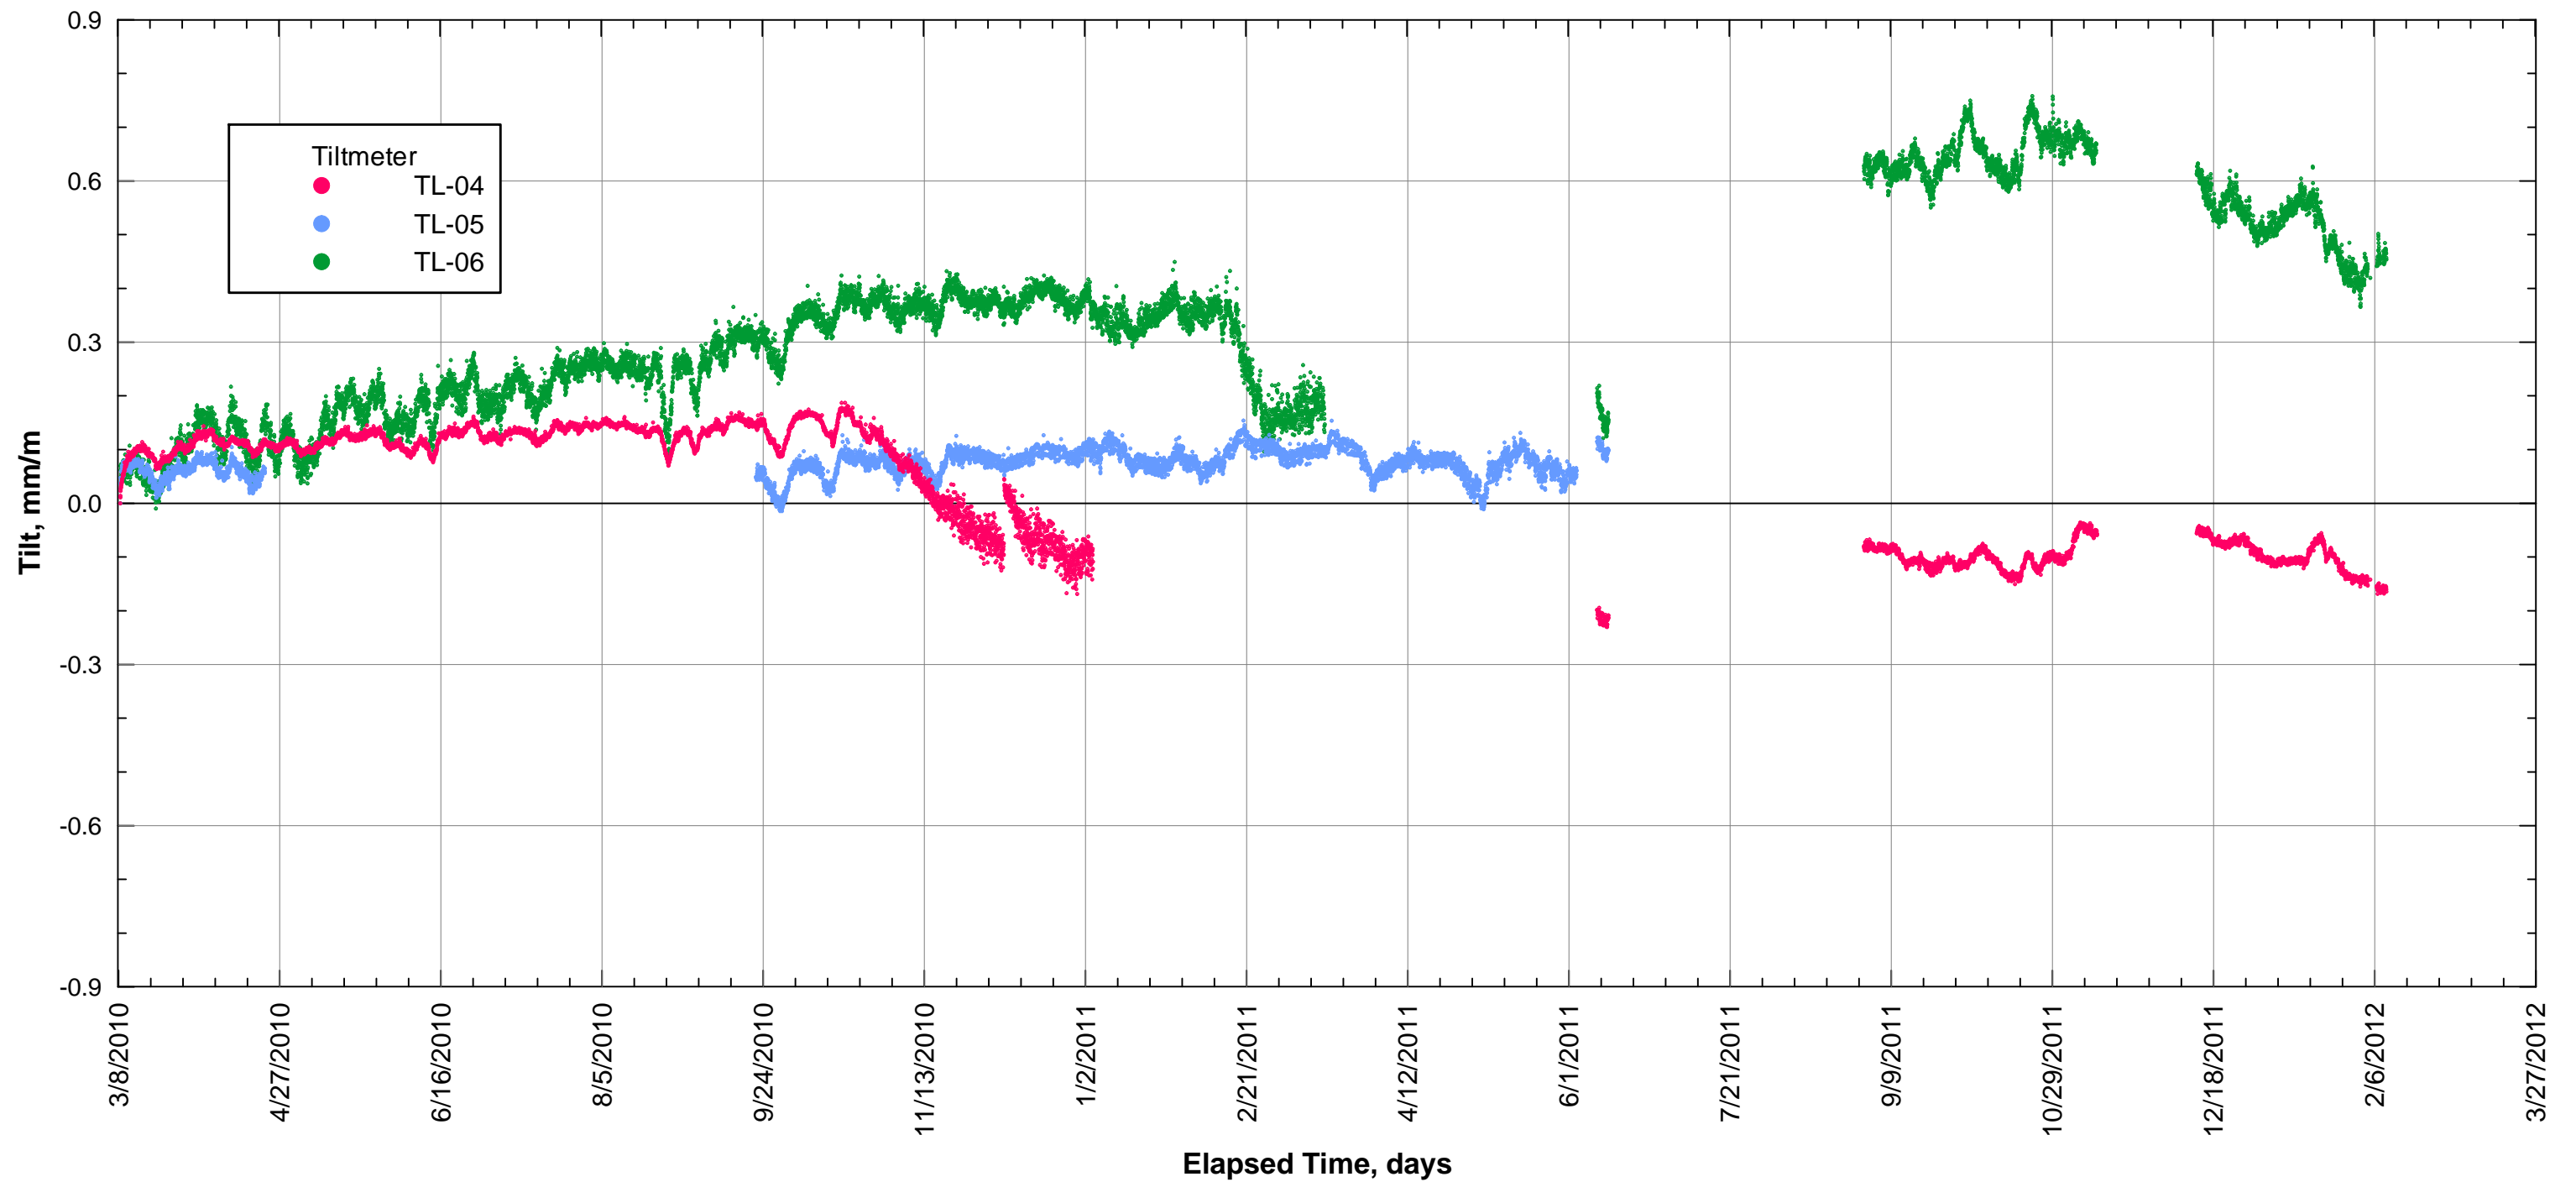
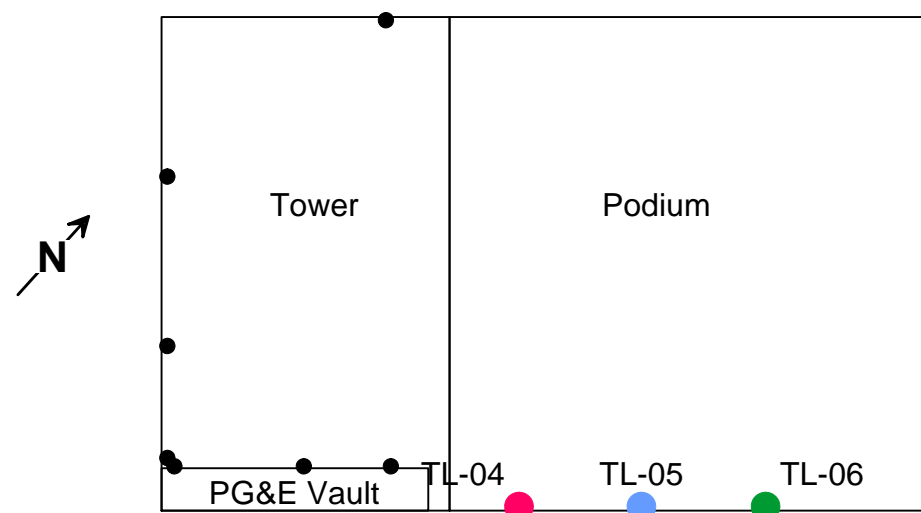
PLATE 2

Positive tilt represents movement of the top of the wall towards the inside of the room.

TILT RECORDED IN TILTMETERS TL-04, TL-05, AND TL-06: BASEMENT LEVEL B-1
