Supplemental Report for Foundation Settlement Investigation

The building at 301 Mission Street, San Francisco, California is a fifty-eight-story residential structure founded on a pile-supported mat foundation. The building, which was completed in 2009, has experienced and continues to experience significant foundation settlement. Paul Hastings, LLP retained Simpson Gumpertz & Heger Inc. in 2014 to conduct an evaluation of the impact of site settlement on the building's structural stability and earthquake resistance. We performed initial evaluations in 2014 and updated these in 2016 to consider additional settlement that occurred in the interim period. In an October 2016 report we concluded that settlement had not compromised the building's stability or its ability to resist strong earthquakes.

**SUPPLEMENTAL REPORT
FOUNDATION SETTLEMENT INVESTIGATION
301 MISSION STREET
SAN FRANCISCO, CALIFORNIA**

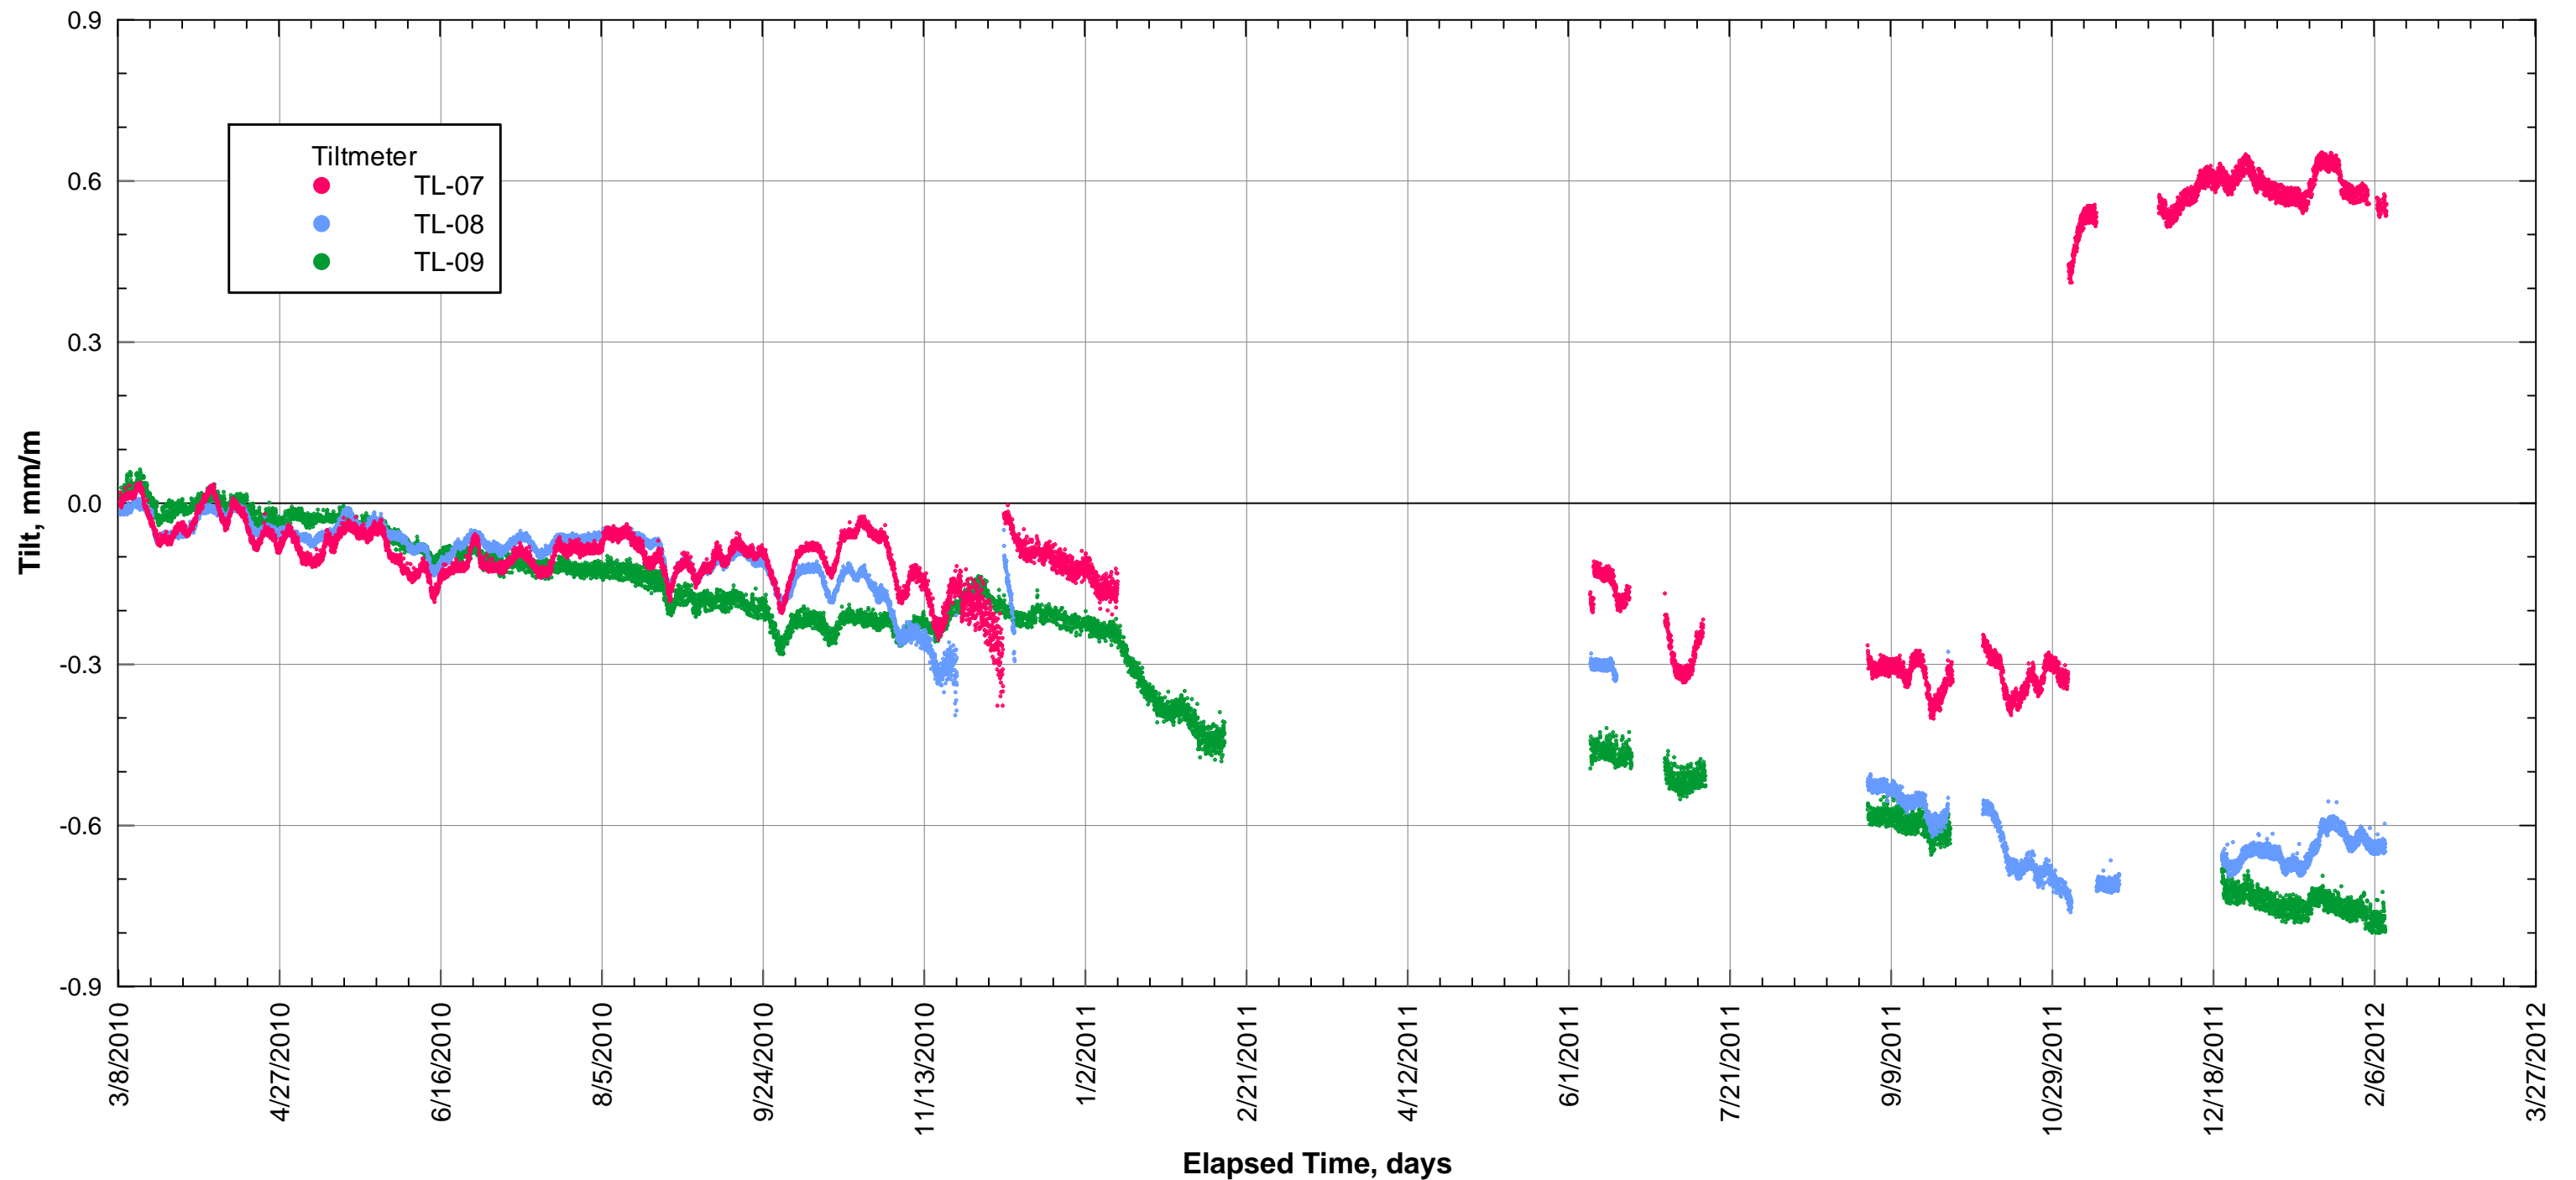
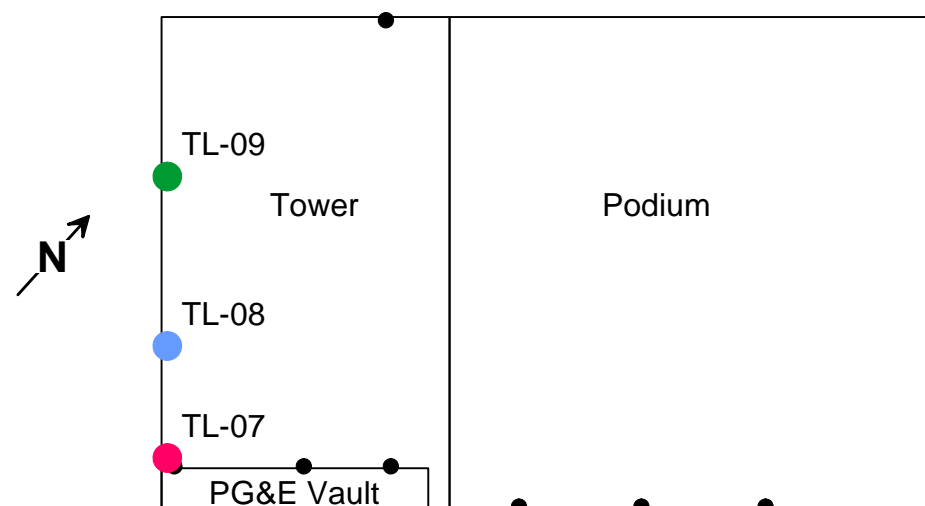
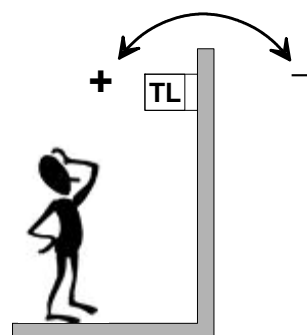
PLATE 3

TILT RECORDED IN TILTMETERS TL-07, TL-08, AND TL-09: BASEMENT LEVEL B-1

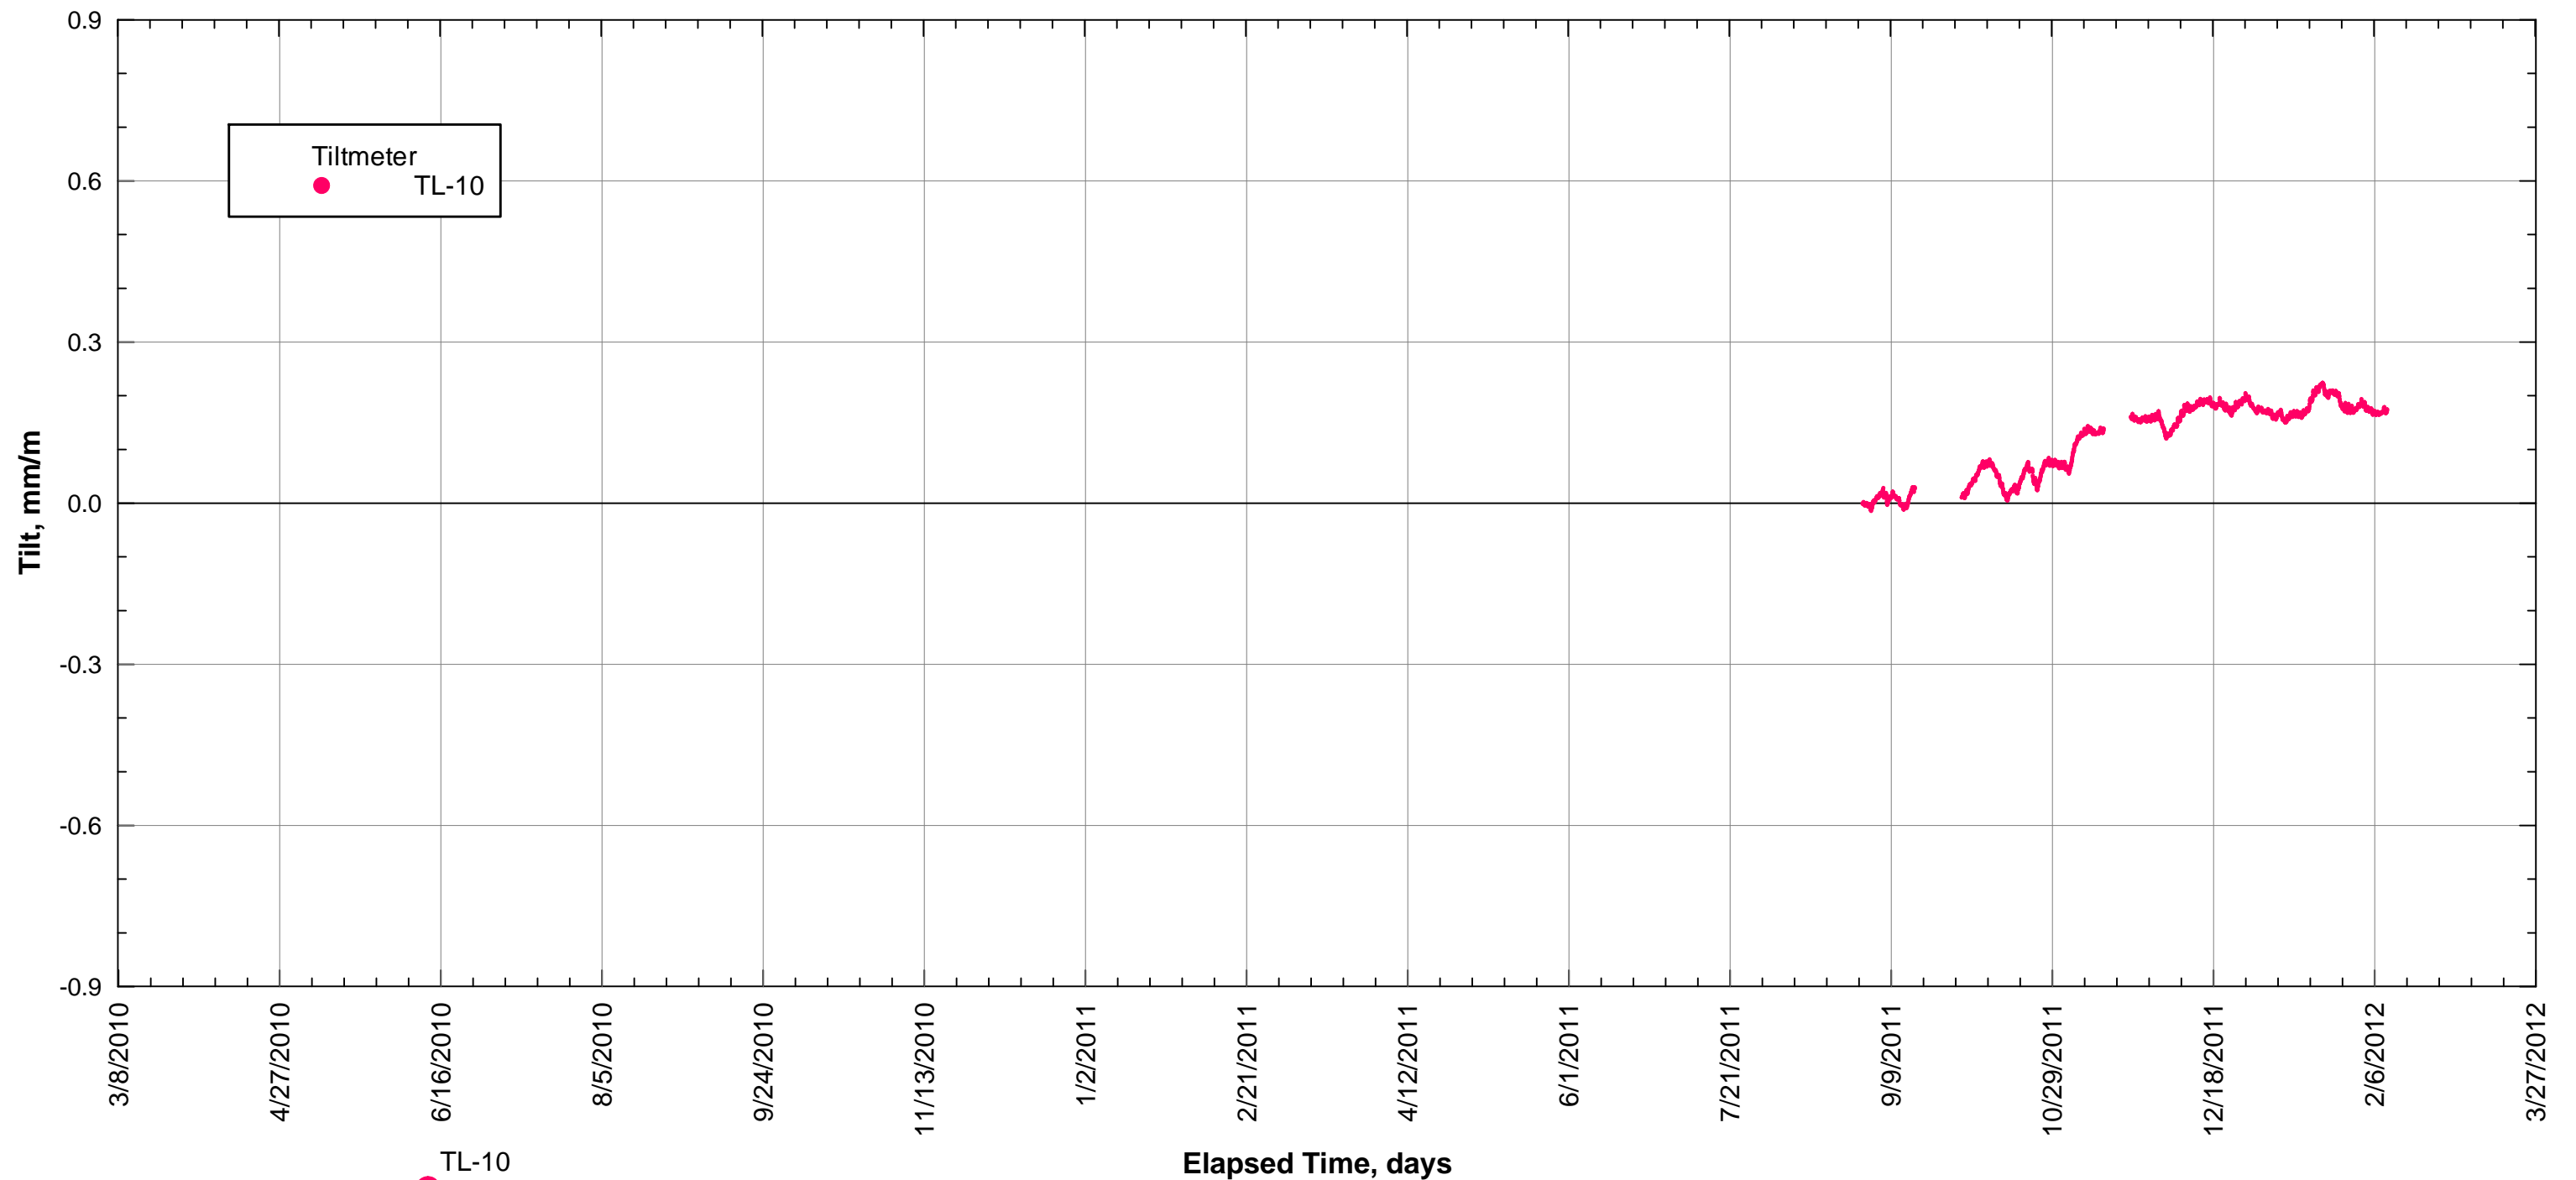
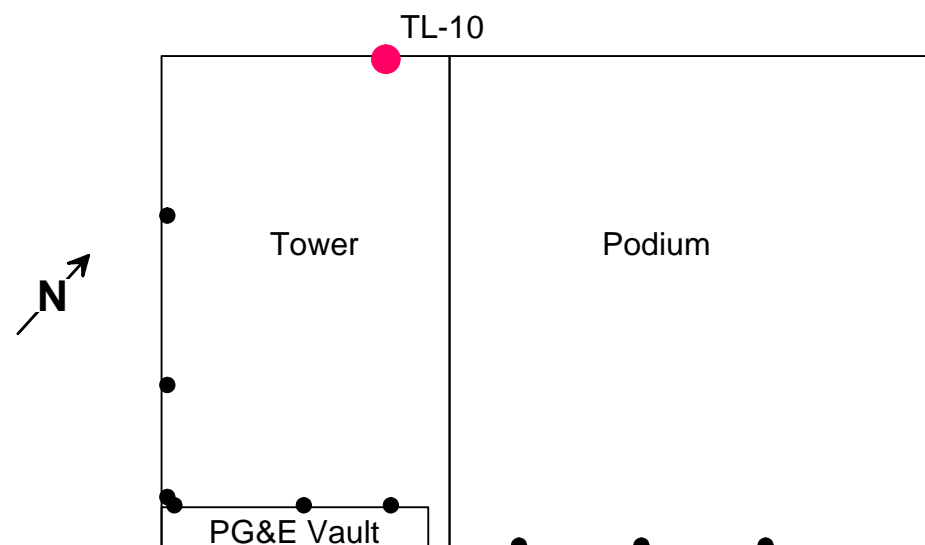
PLATE 4

**TILT RECORDED IN TILTMETER TL-10:
BASEMENT LEVEL B-1**

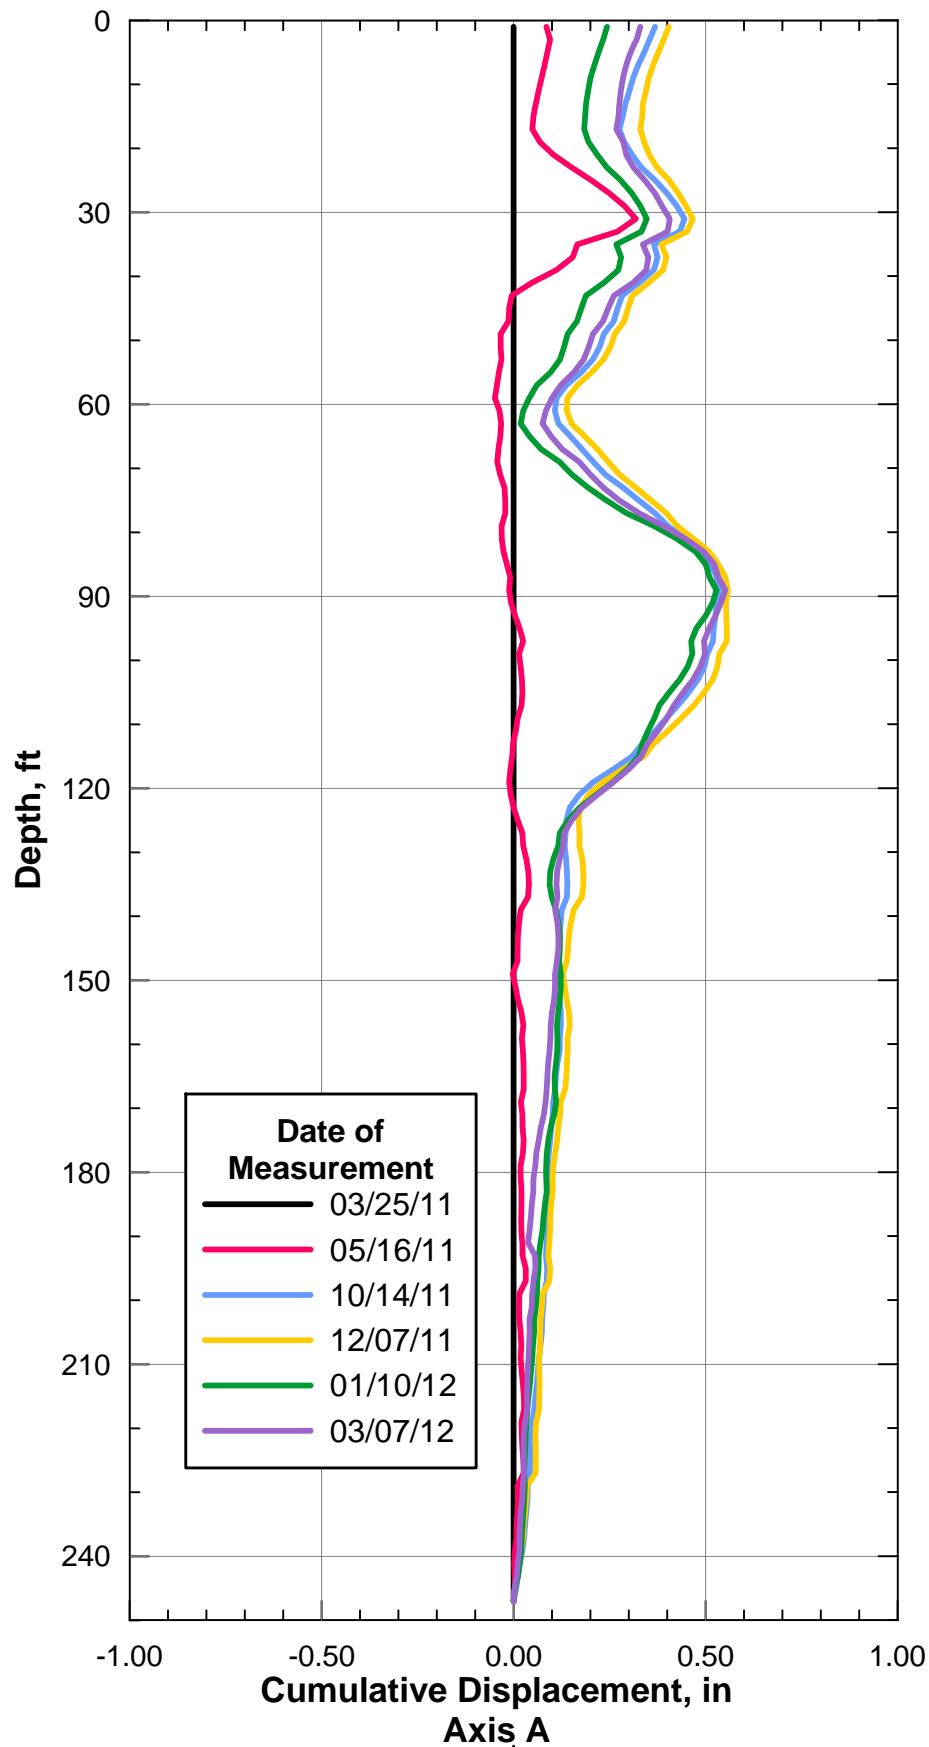
MEASUREMENTS TAKEN AT INCLINOMETER I-18M

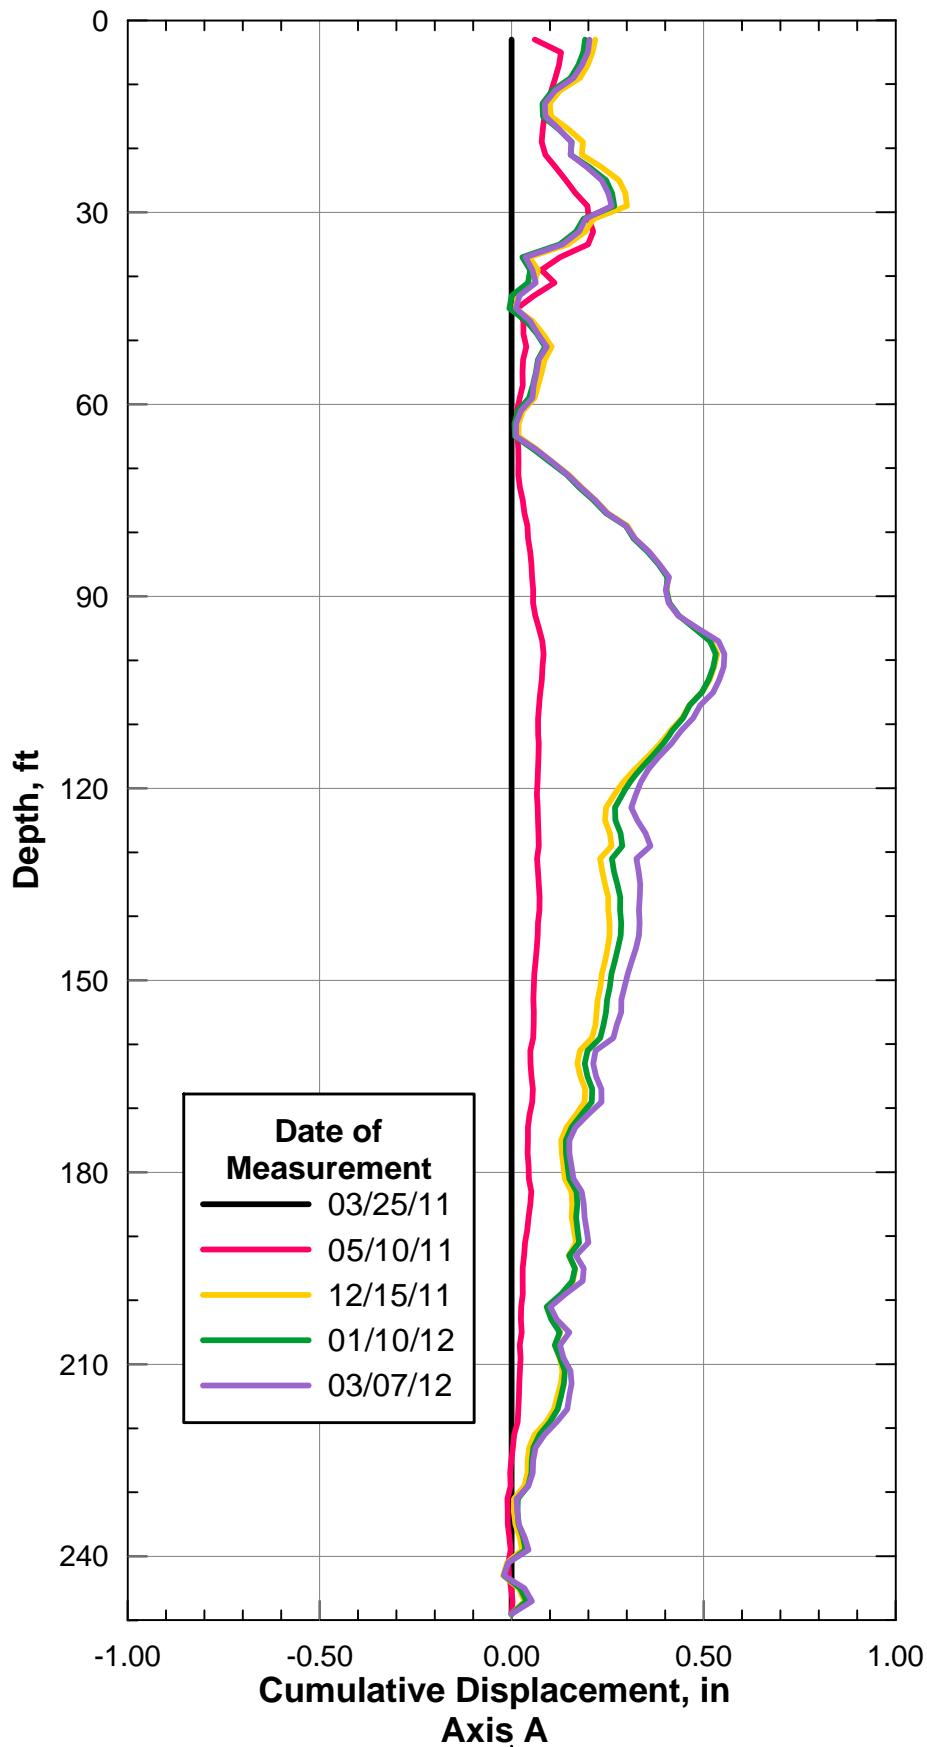
MEASUREMENTS TAKEN AT INCLINOMETER I-19

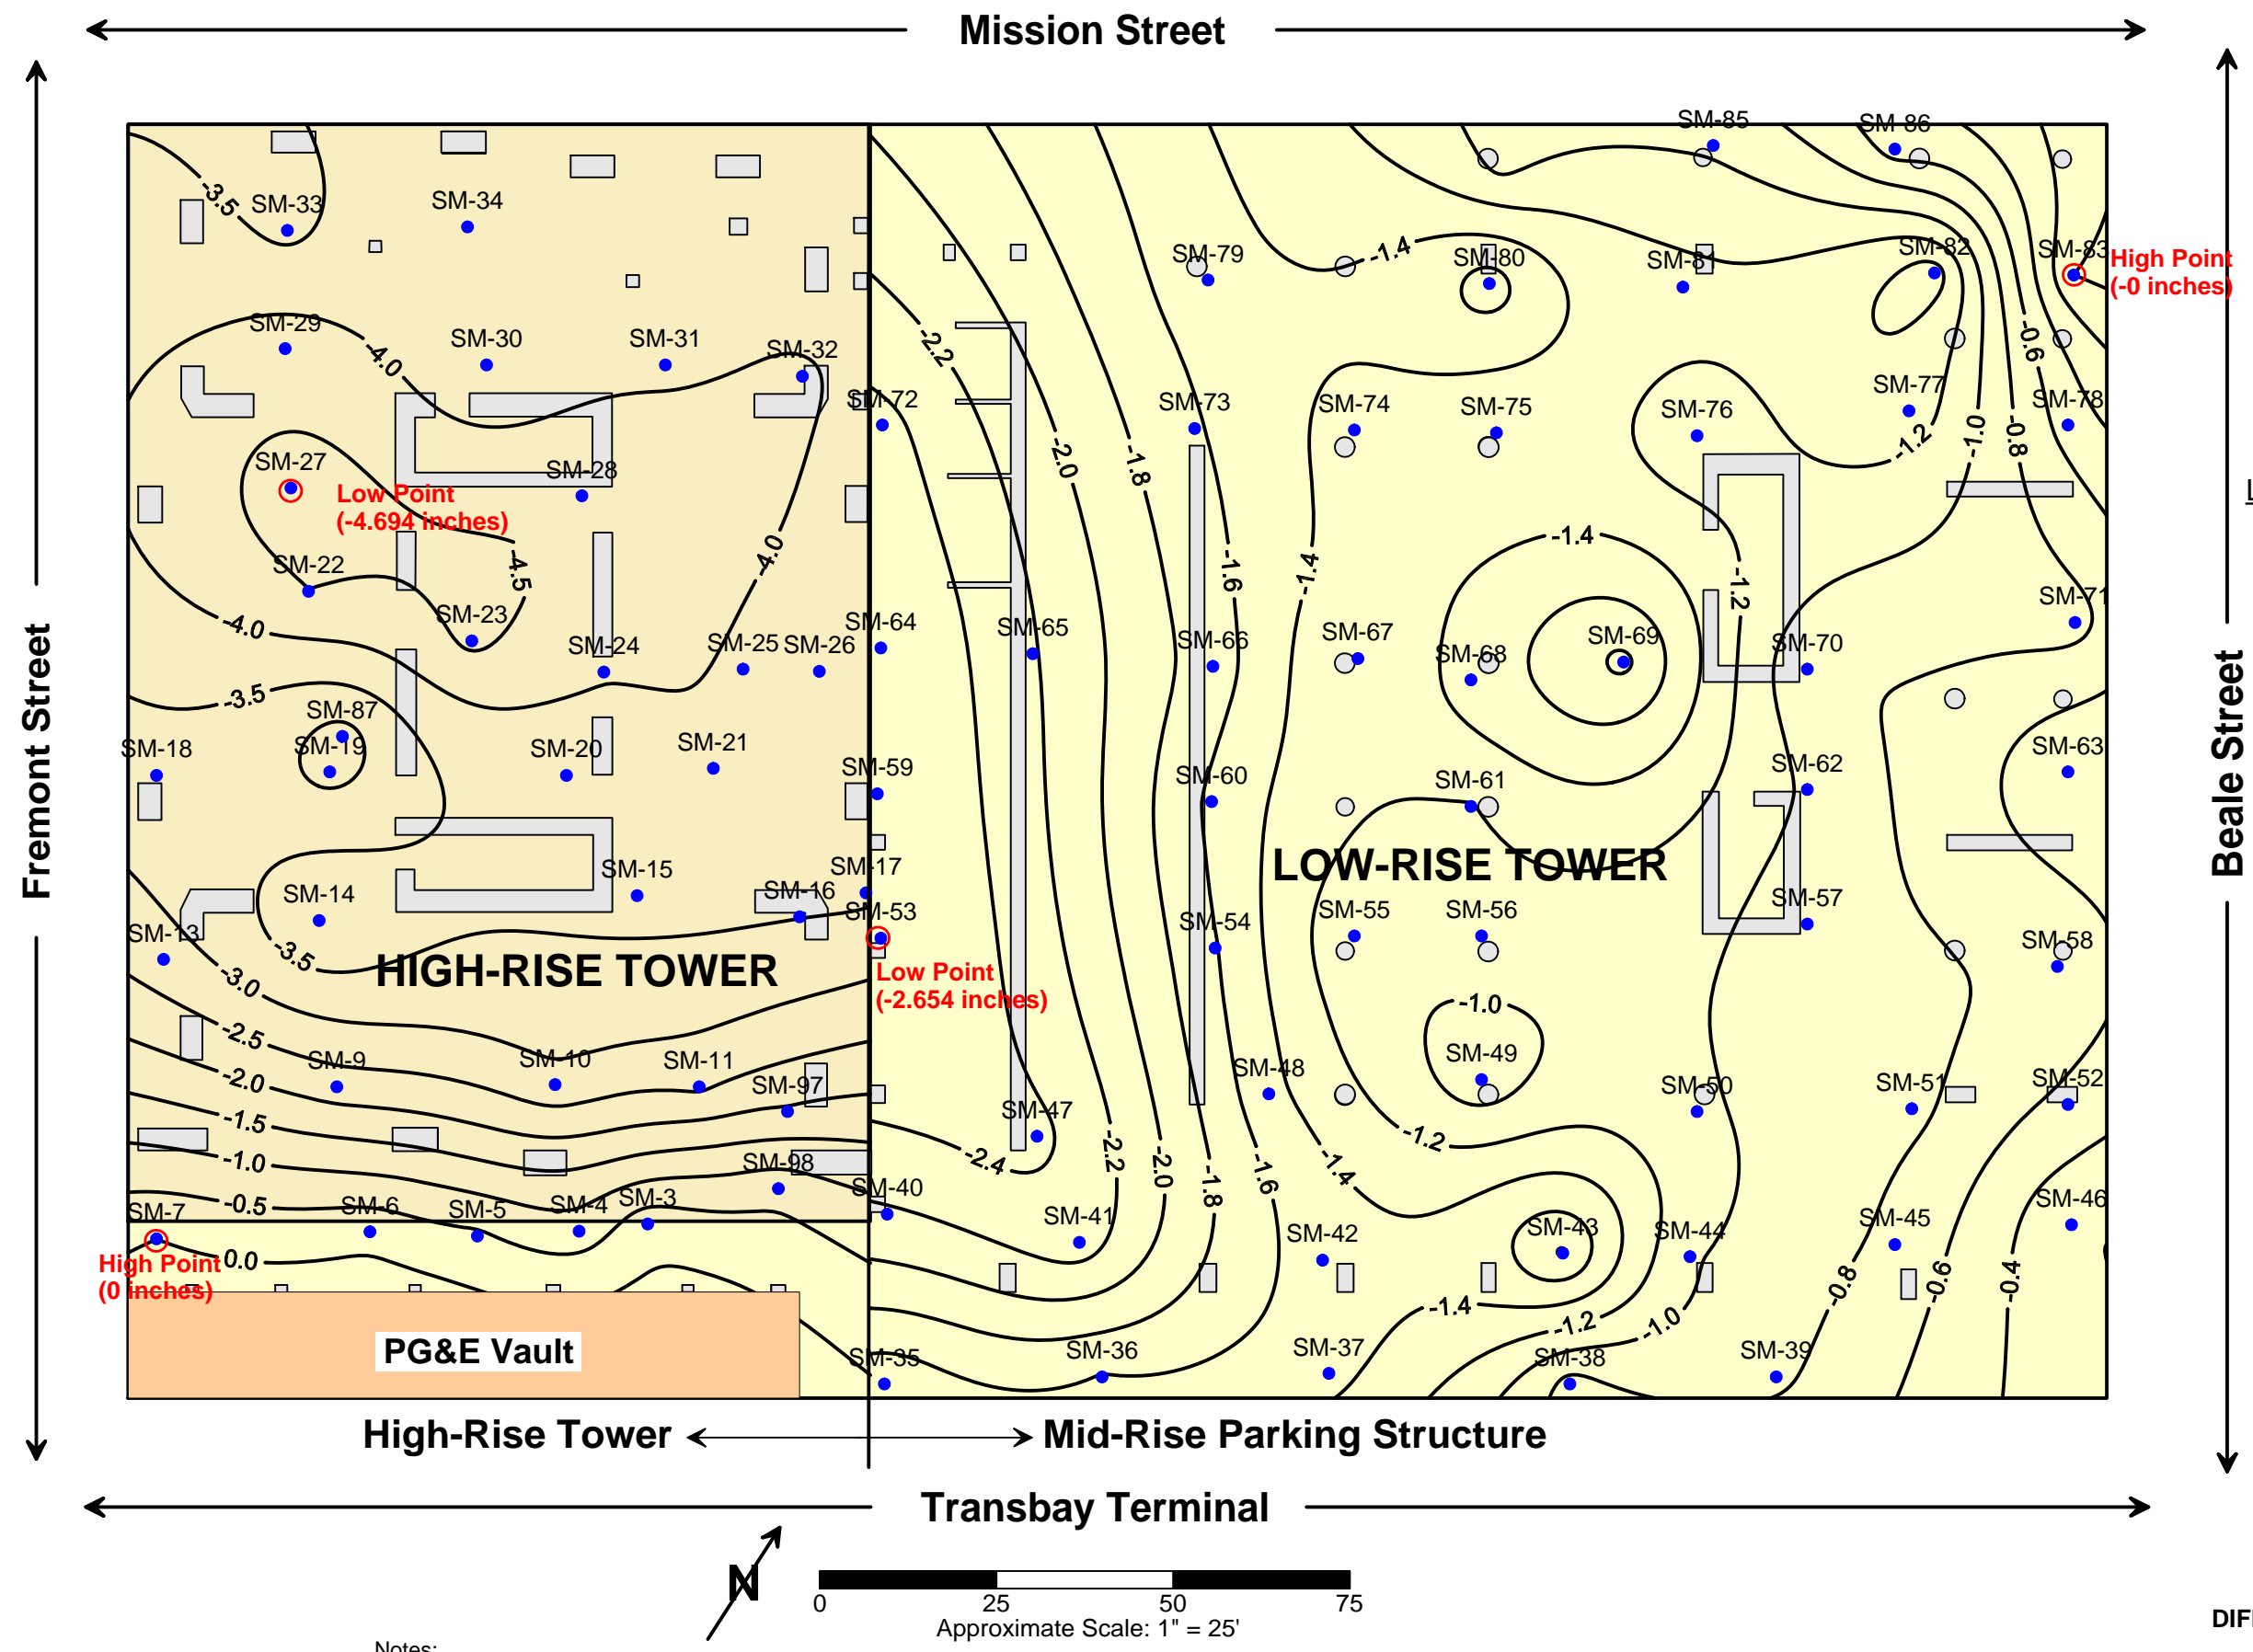
Notes:
 Contours represent differential elevation, in inches, between the highest point and all other points taken on March 7, 2012.
 Level B-1 at Mid-Rise Parking portion of survey site is approximately 4 inches higher than Level B-1 at High-Rise Tower portion.
 The PG&E vault is inaccessible for monitoring.
 Contour intervals are different between the High-Rise Tower and the Low-Rise Tower.

DIFFERENTIAL FLOOR ELEVATIONS (INCHES)
MARCH 7, 2012 SURVEY
 Transbay Transit Center
 301 Mission Monitoring
 Transbay Joint Powers Authority
 San Francisco, California

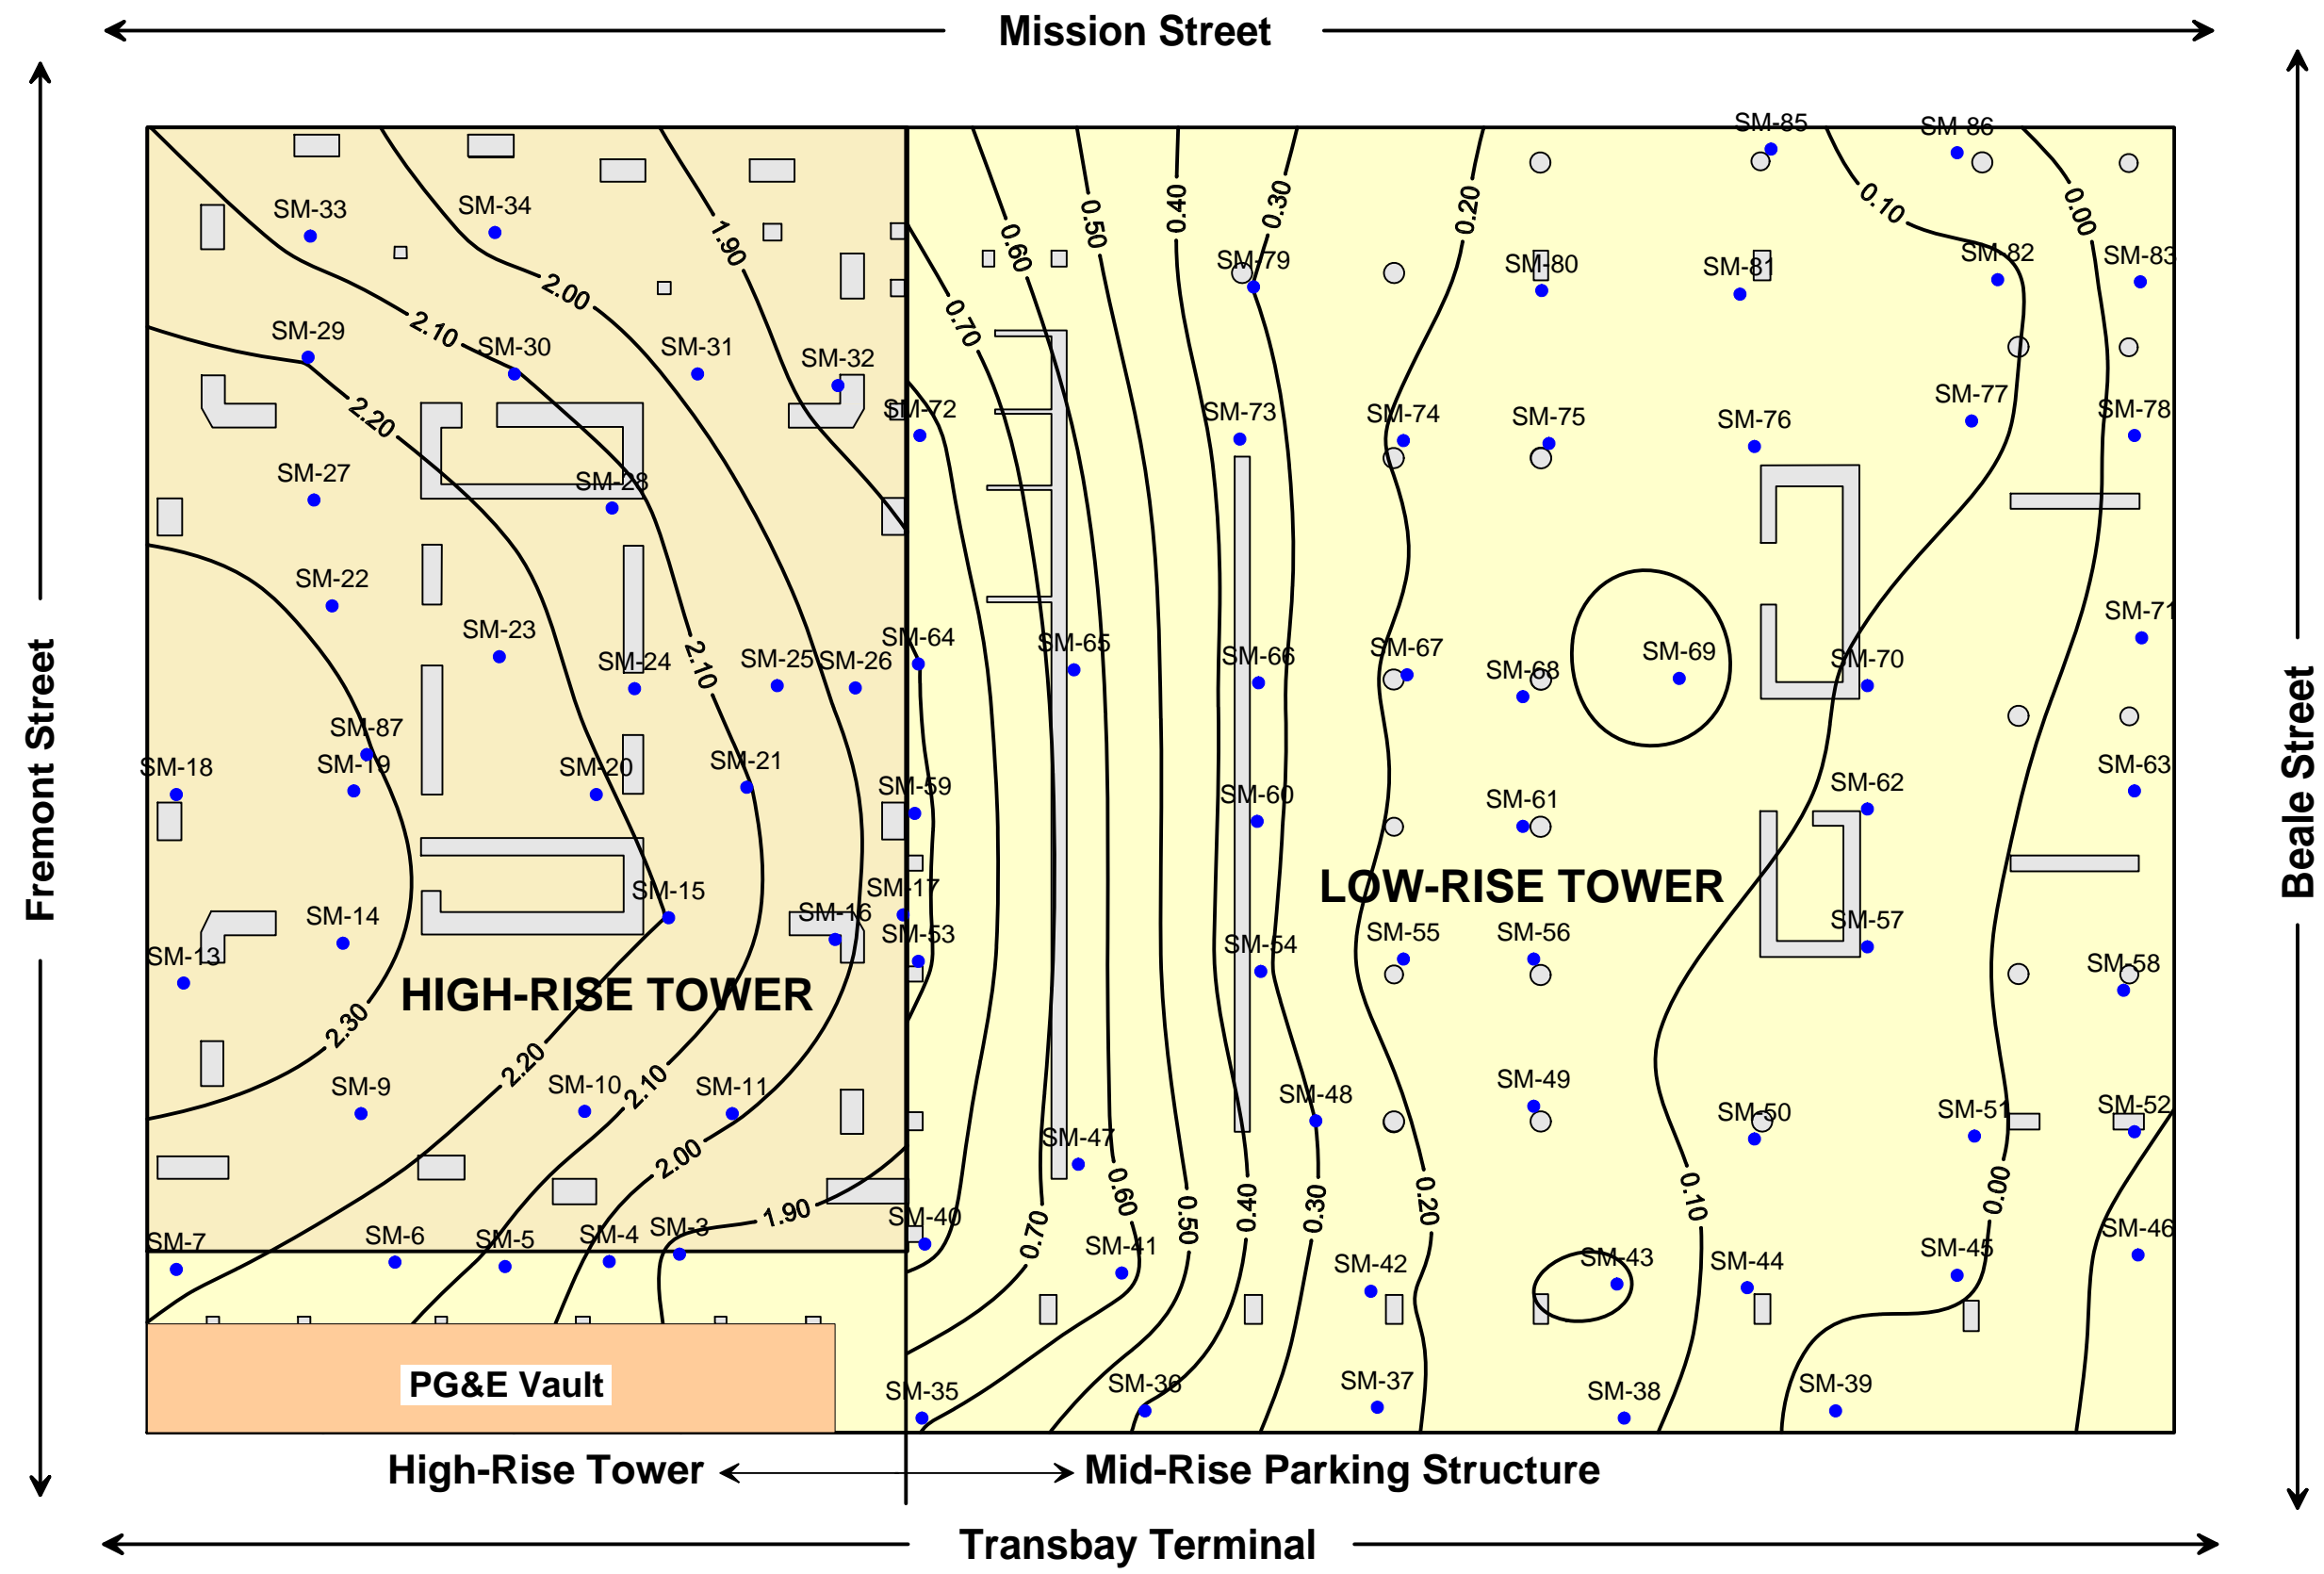
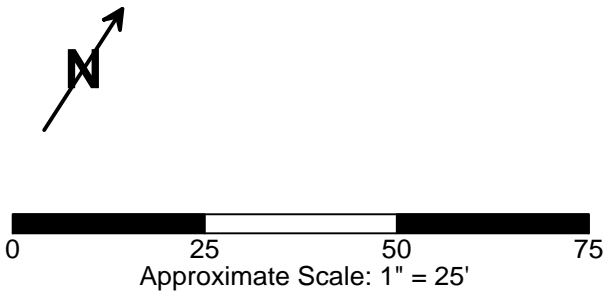
Notes:
 Contours represent elevation change, in inches, between Baseline survey (April 30, 2009) and readings taken on March 7, 2012.
 Level B-1 at Mid-Rise Parking portion of survey site is approximately 4 inches higher than Level B-1 at High-Rise Tower portion.
 The PG&E vault is inaccessible for monitoring.
 Negative values of settlement (within Low-rise Tower) indicate uplift.

CONTOURS OF SETTLEMENTS MEASURED AT THE FIRST LEVEL BASEMENT OF THE 301 MISSION STREET STRUCTURE BETWEEN APRIL 30, 2009 AND MARCH 7, 2012

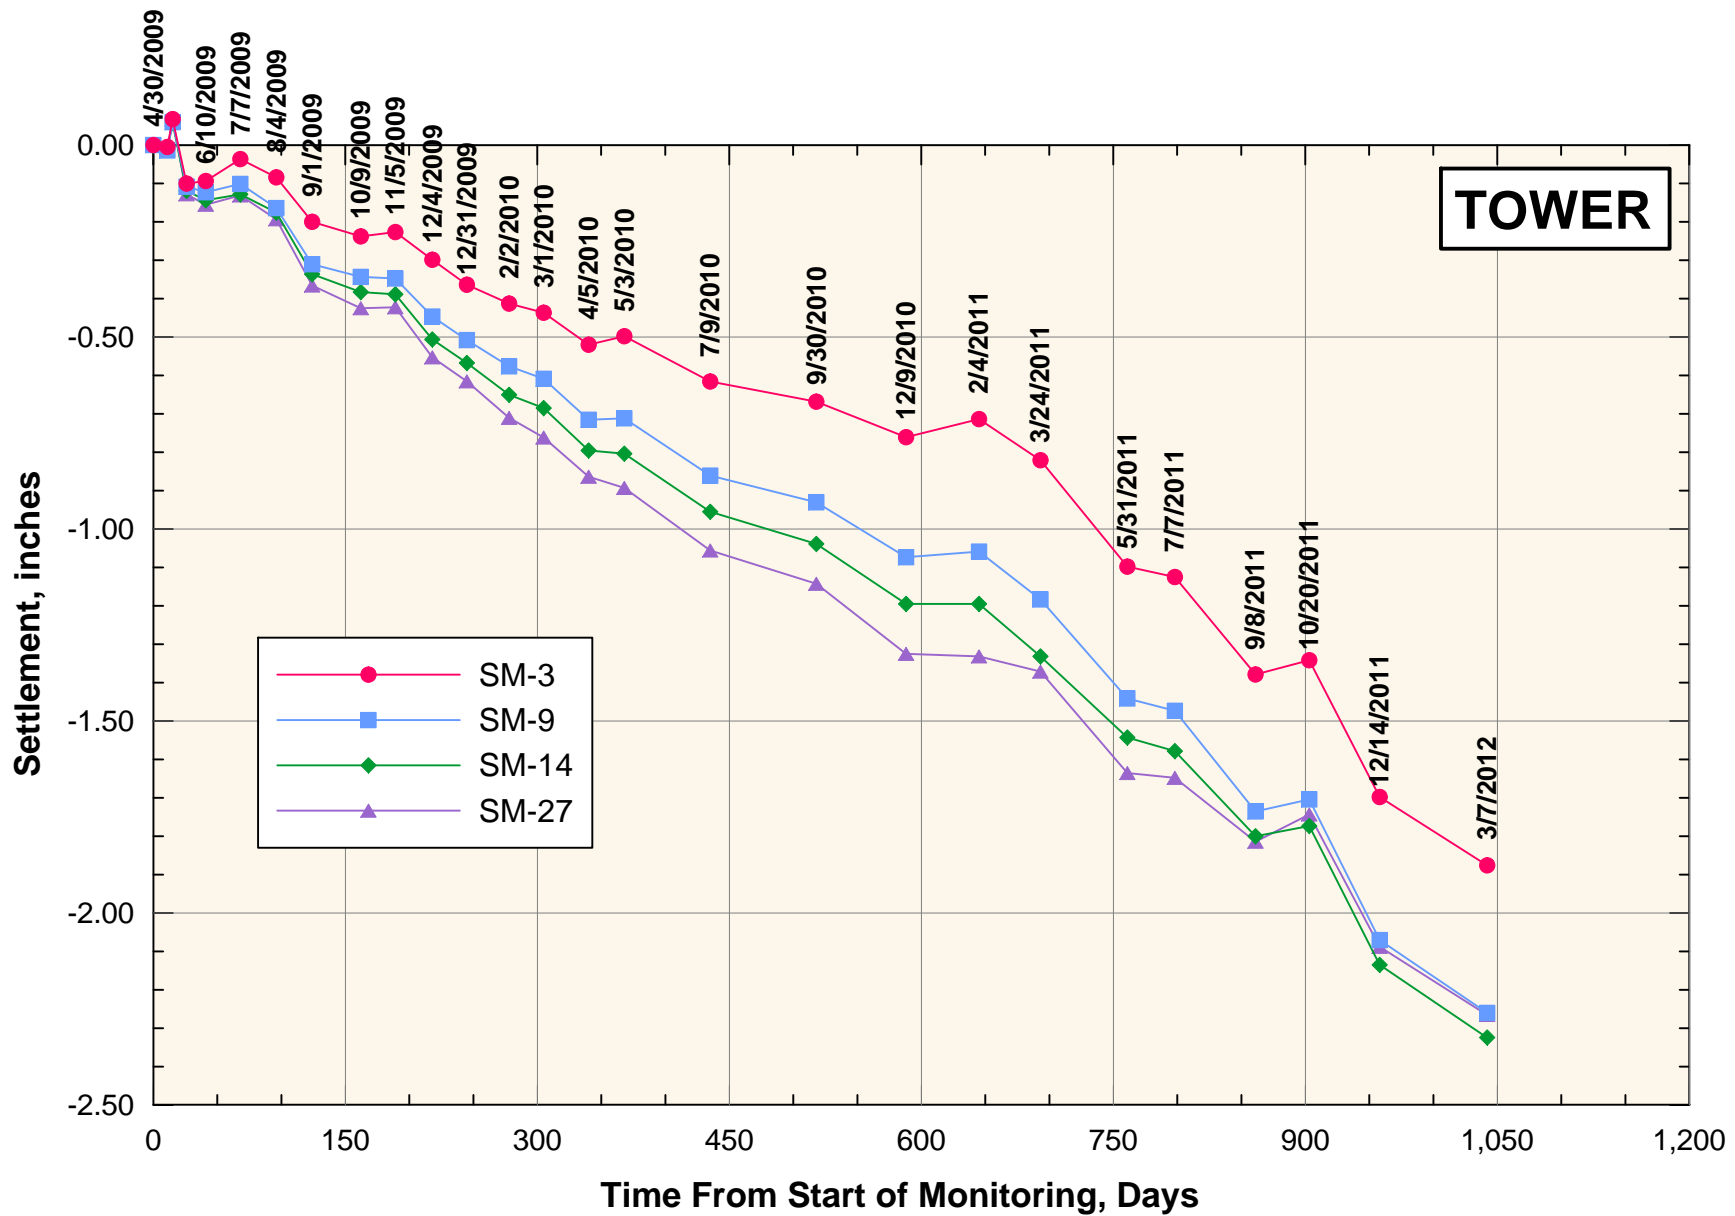
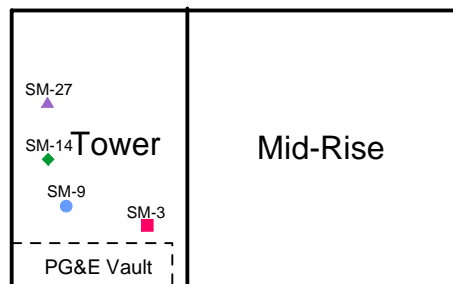
**SETTLEMENT OVER TIME
FLOOR ELEVATIONS AT LEVEL B-1
OF 301 MISSION PROPERTY- TOWER:
APRIL 30, 2009 THROUGH MARCH 7, 2012**

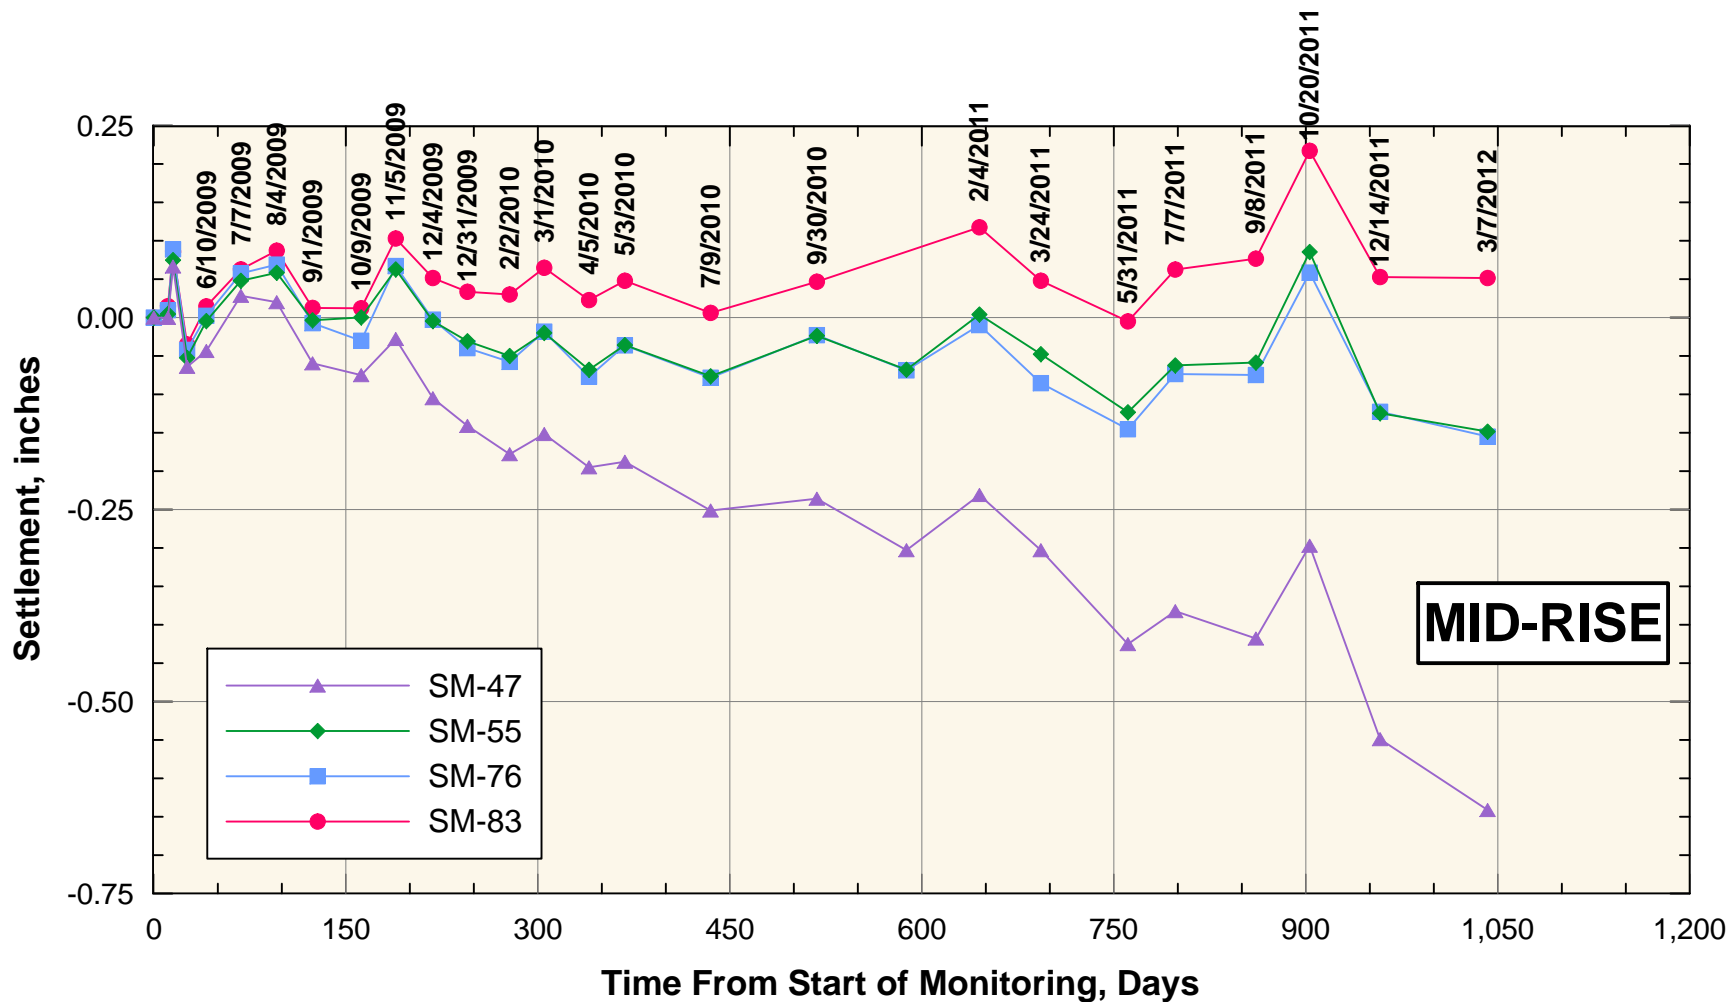
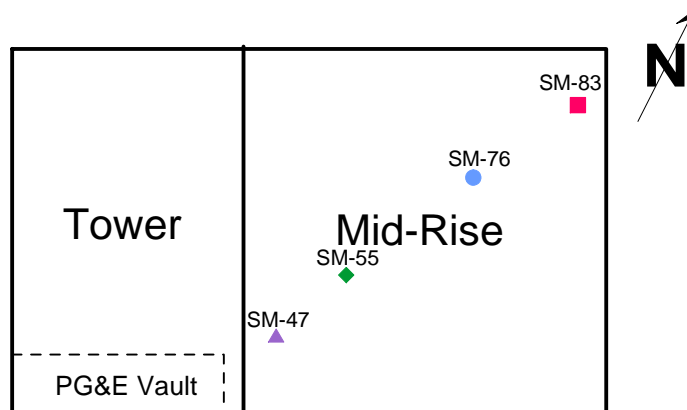
**SETTLEMENT OVER TIME
FLOOR ELEVATIONS AT LEVEL B-1
OF 301 MISSION PROPERTY- MID-RISE:
APRIL 30, 2009 THROUGH MARCH 7, 2012**
