Supplemental Report for Foundation Settlement Investigation

The building at 301 Mission Street, San Francisco, California is a fifty-eight-story residential structure founded on a pile-supported mat foundation. The building, which was completed in 2009, has experienced and continues to experience significant foundation settlement. Paul Hastings, LLP retained Simpson Gumpertz & Heger Inc. in 2014 to conduct an evaluation of the impact of site settlement on the building's structural stability and earthquake resistance. We performed initial evaluations in 2014 and updated these in 2016 to consider additional settlement that occurred in the interim period. In an October 2016 report we concluded that settlement had not compromised the building's stability or its ability to resist strong earthquakes.

**SUPPLEMENTAL REPORT
FOUNDATION SETTLEMENT INVESTIGATION
301 MISSION STREET
SAN FRANCISCO, CALIFORNIA**

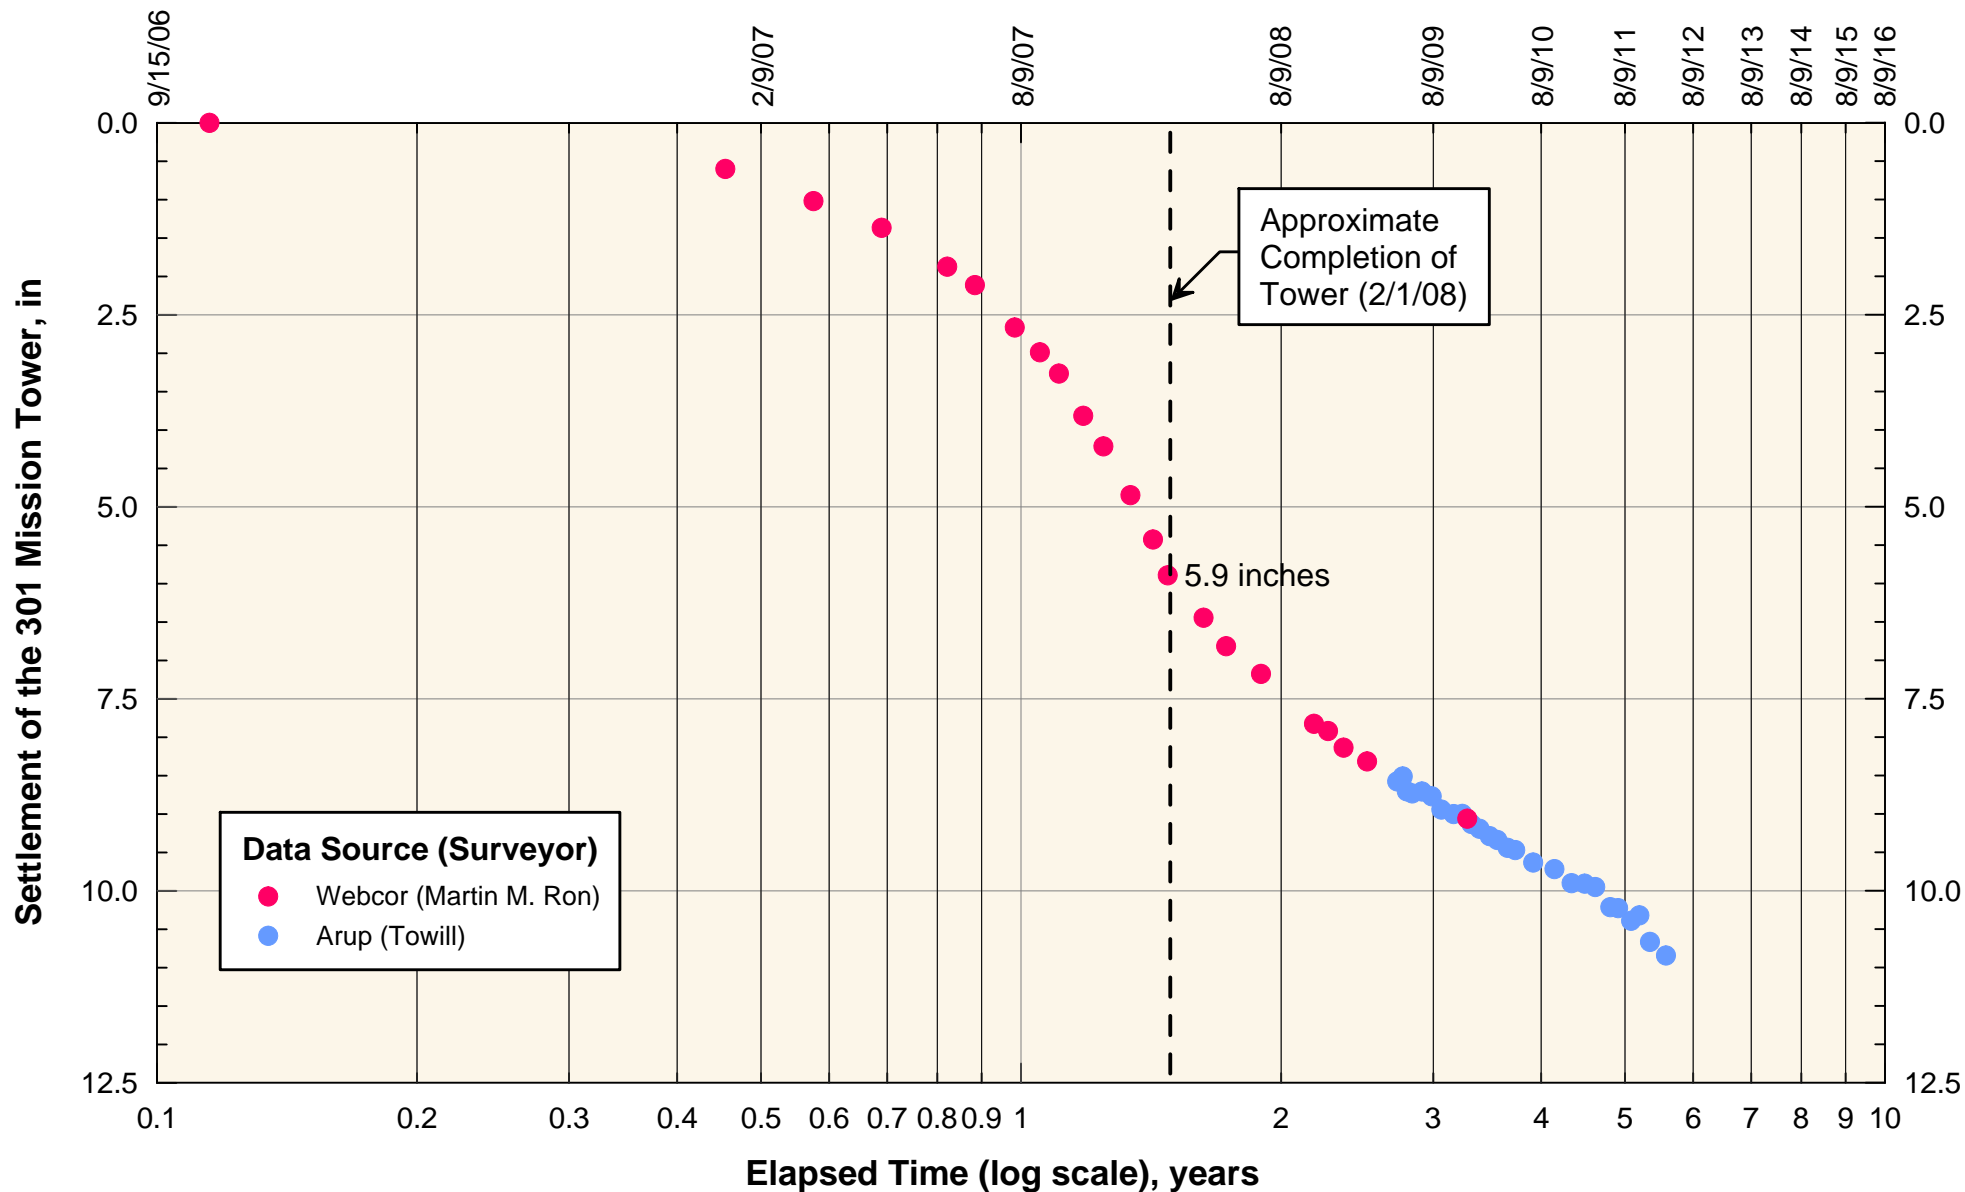
Beginning of Tower Construction: 8/9/06
 End of Tower Construction: 2/1/08
 Construction Duration: 542 days (1.5 years)

**SETTLEMENTS OF THE 301 MISSION TOWER
 INCLUDING MONITORING DURING CONSTRUCTION**

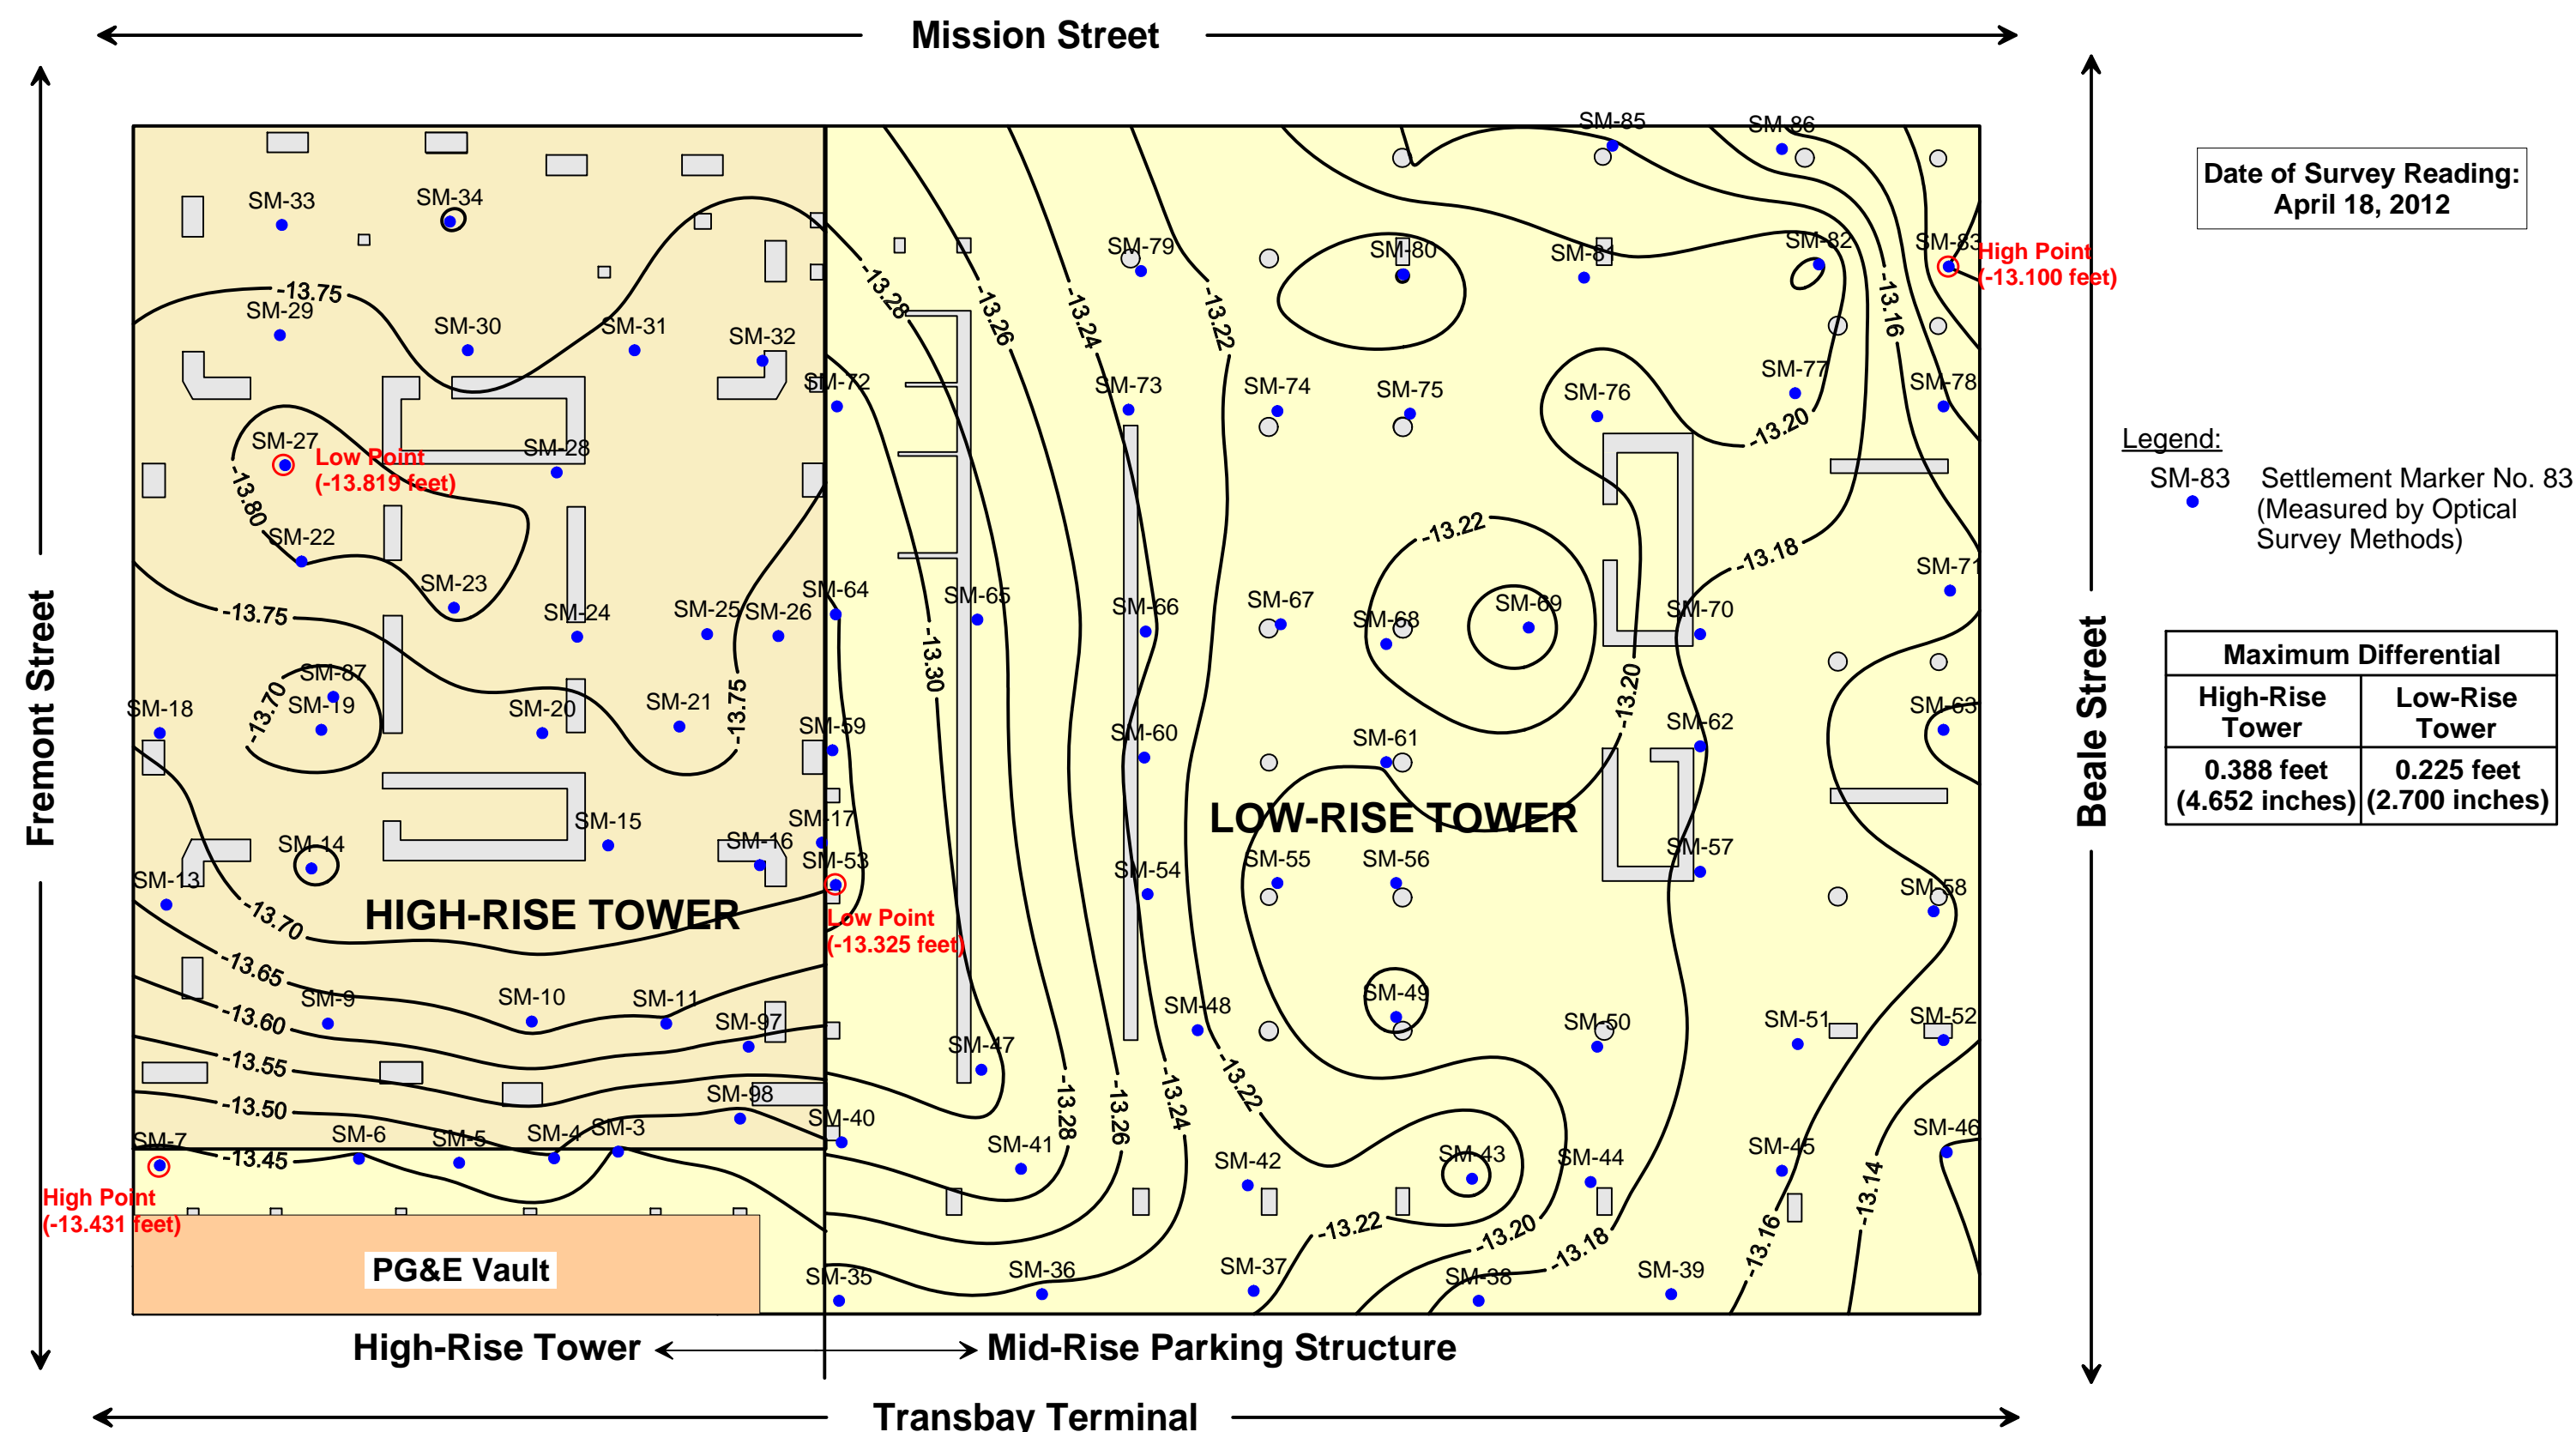
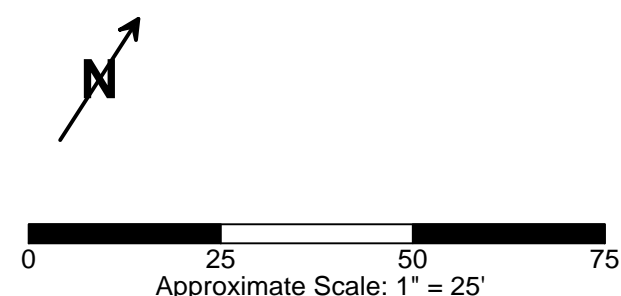
Maximum Differential	
High-Rise Tower	Low-Rise Tower
0.388 feet (4.652 inches)	0.225 feet (2.700 inches)

Notes:
Contours represent elevation, in feet (CCSF Datum), from survey readings taken on April 18, 2012.
Level B-1 at Mid-Rise Parking portion of survey site is approximately 4 inches higher than Level B-1 at High-Rise Tower portion.
The PG&E vault is inaccessible for monitoring.

FLOOR ELEVATIONS AT LEVEL B-1
OF 301 MISSION PROPERTY
PERIODIC SURVEY - APRIL 18, 2012
Transbay Transit Center
301 Mission Monitoring
Transbay Joint Powers Authority
San Francisco, California
April 2012

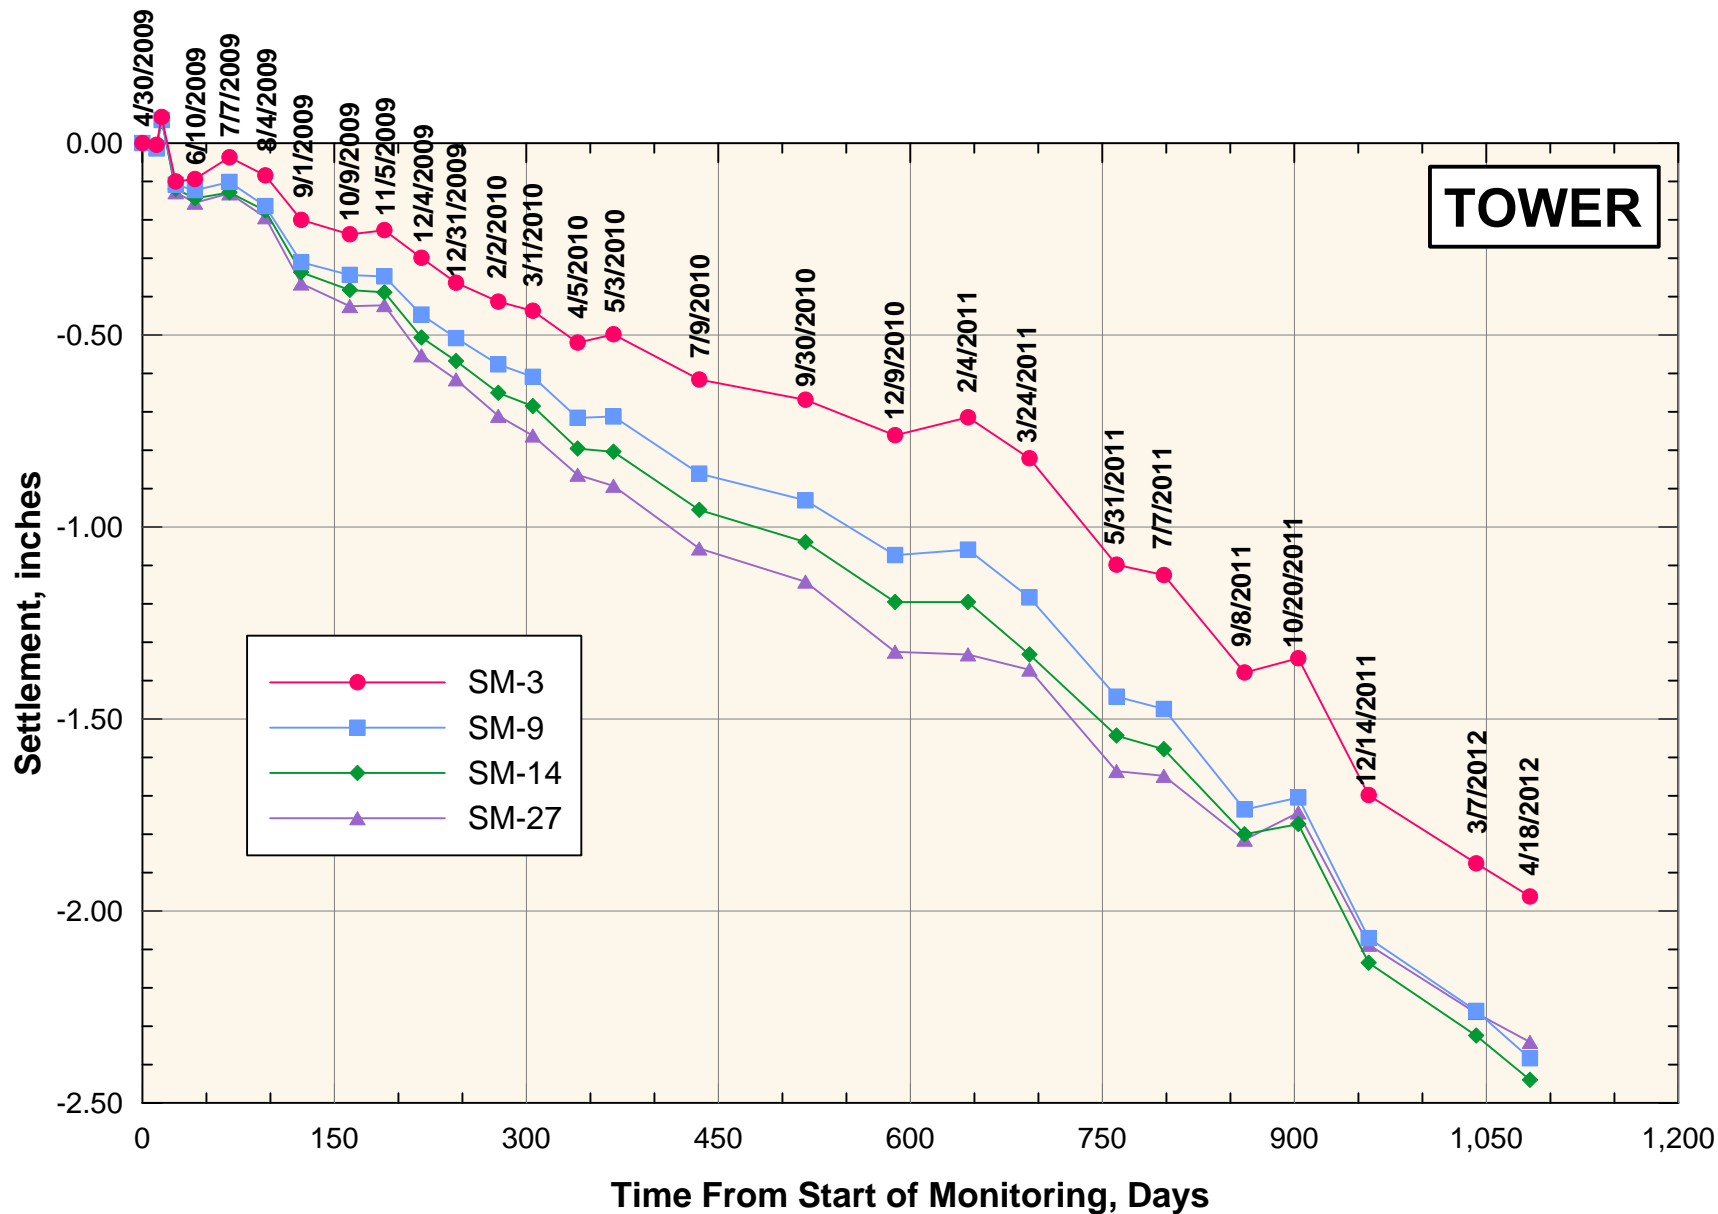
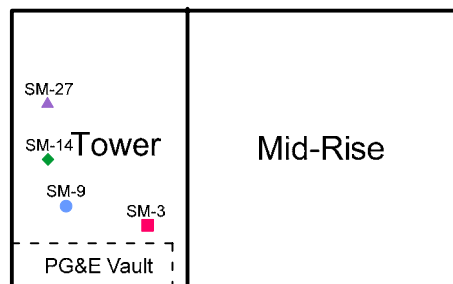
**SETTLEMENT OVER TIME
FLOOR ELEVATIONS AT LEVEL B-1
OF 301 MISSION PROPERTY- TOWER:
APRIL 30, 2009 THROUGH APRIL 18, 2012**

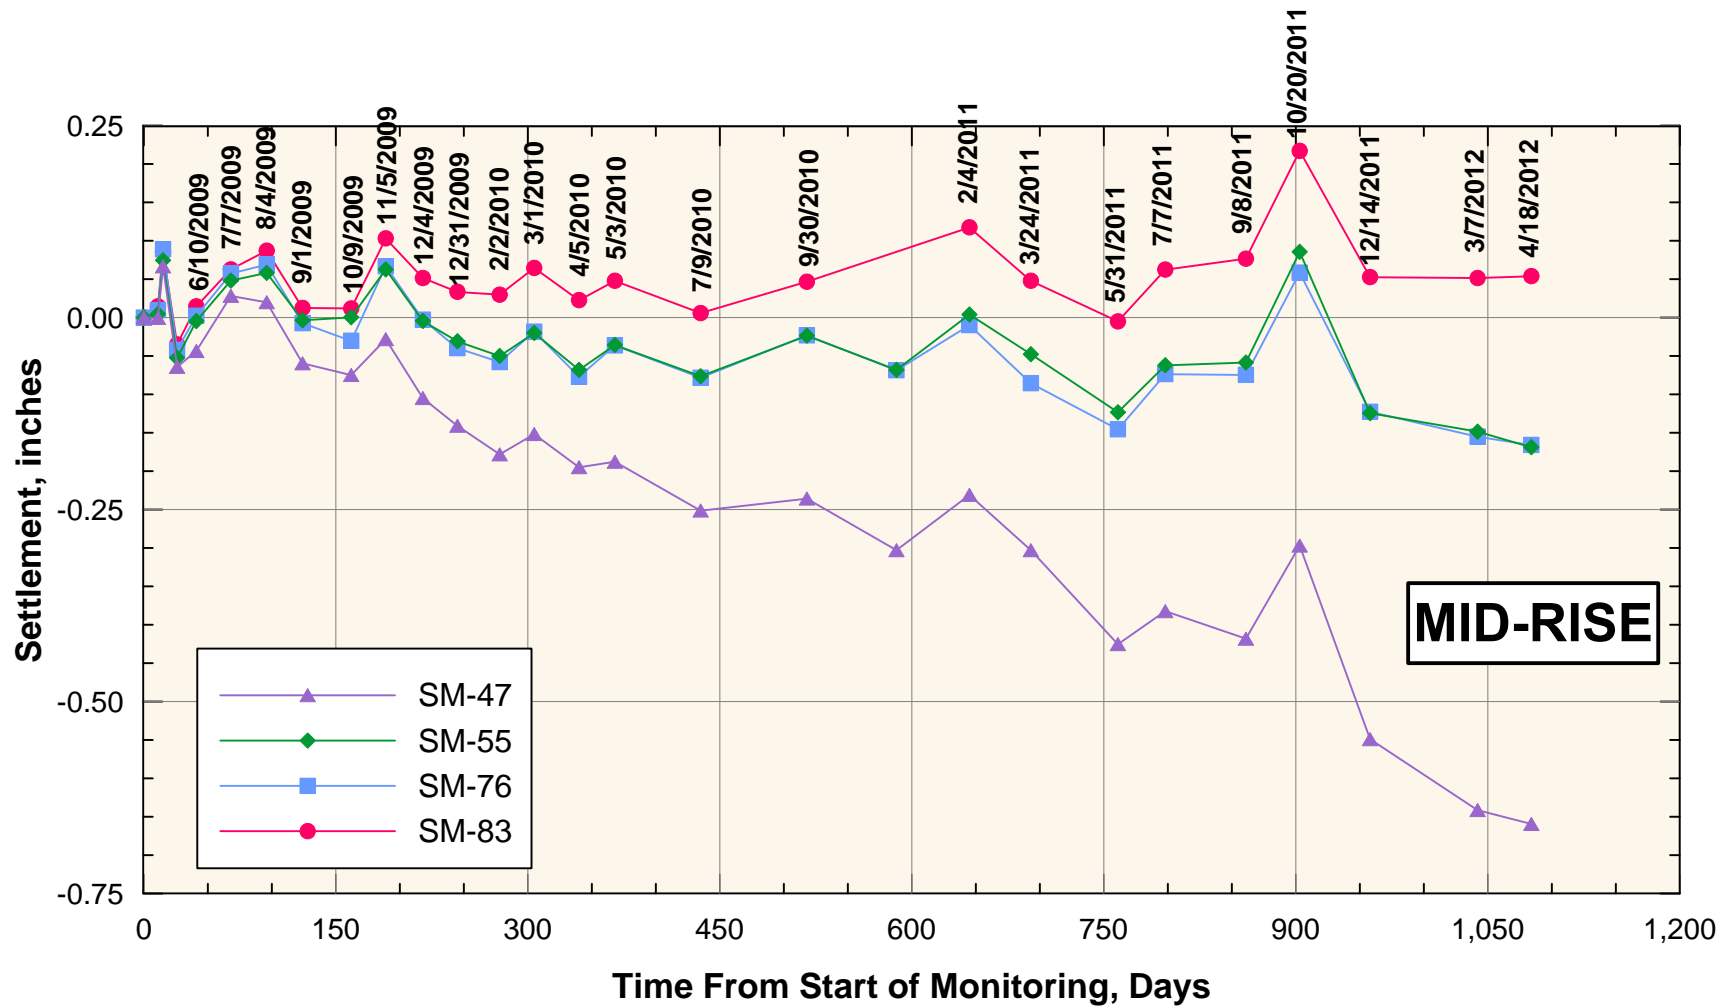
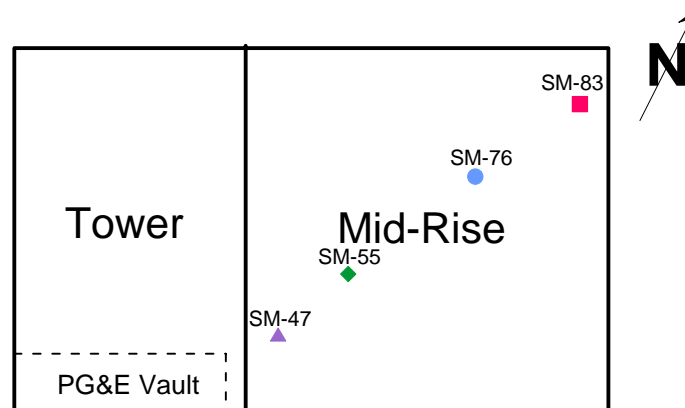
**SETTLEMENT OVER TIME
FLOOR ELEVATIONS AT LEVEL B-1
OF 301 MISSION PROPERTY- MID-RISE:
APRIL 30, 2009 THROUGH APRIL 18, 2012**

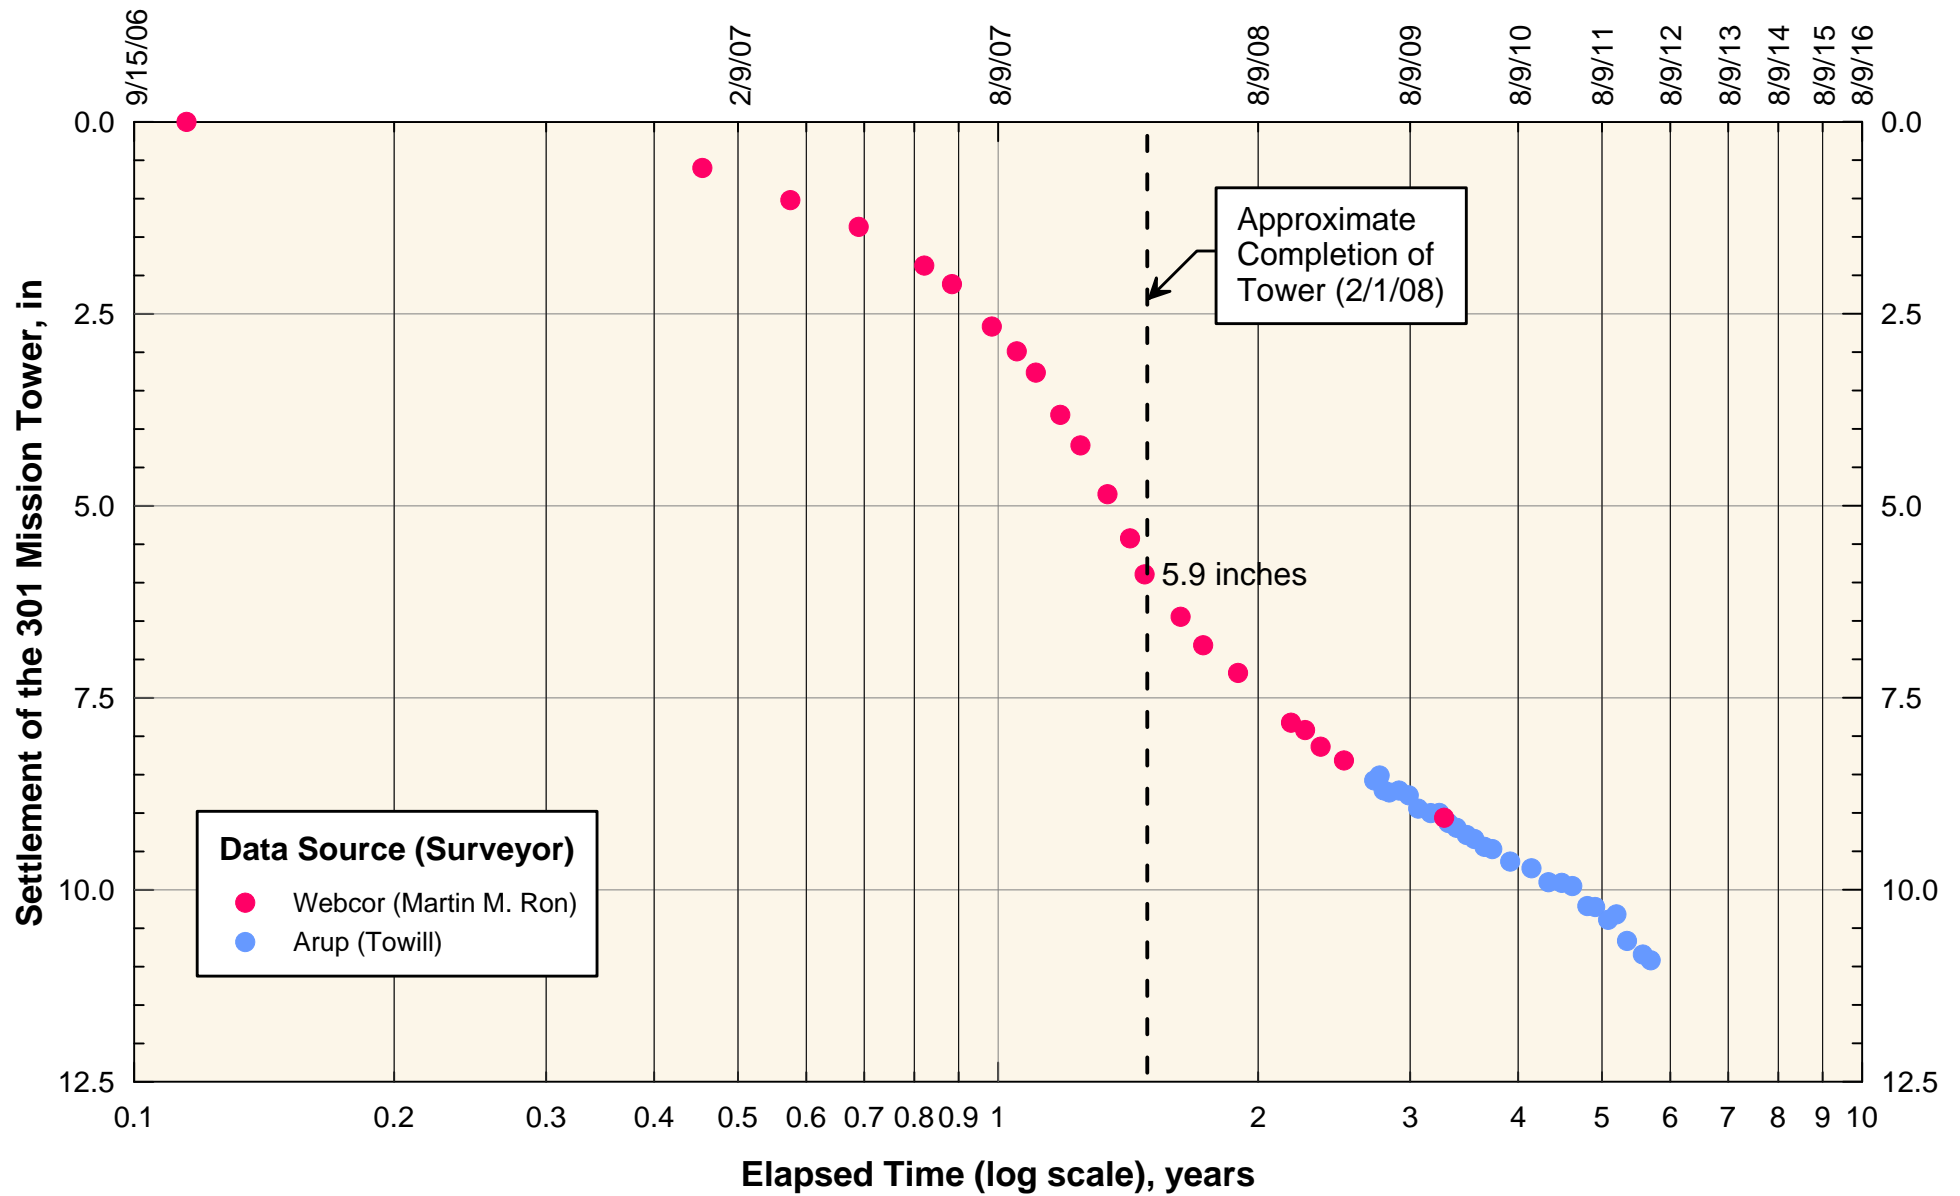
Beginning of Tower Construction: 8/9/06
 End of Tower Construction: 2/1/08
 Construction Duration: 542 days (1.5 years)

**SETTLEMENTS OF THE 301 MISSION TOWER
 INCLUDING MONITORING DURING CONSTRUCTION**

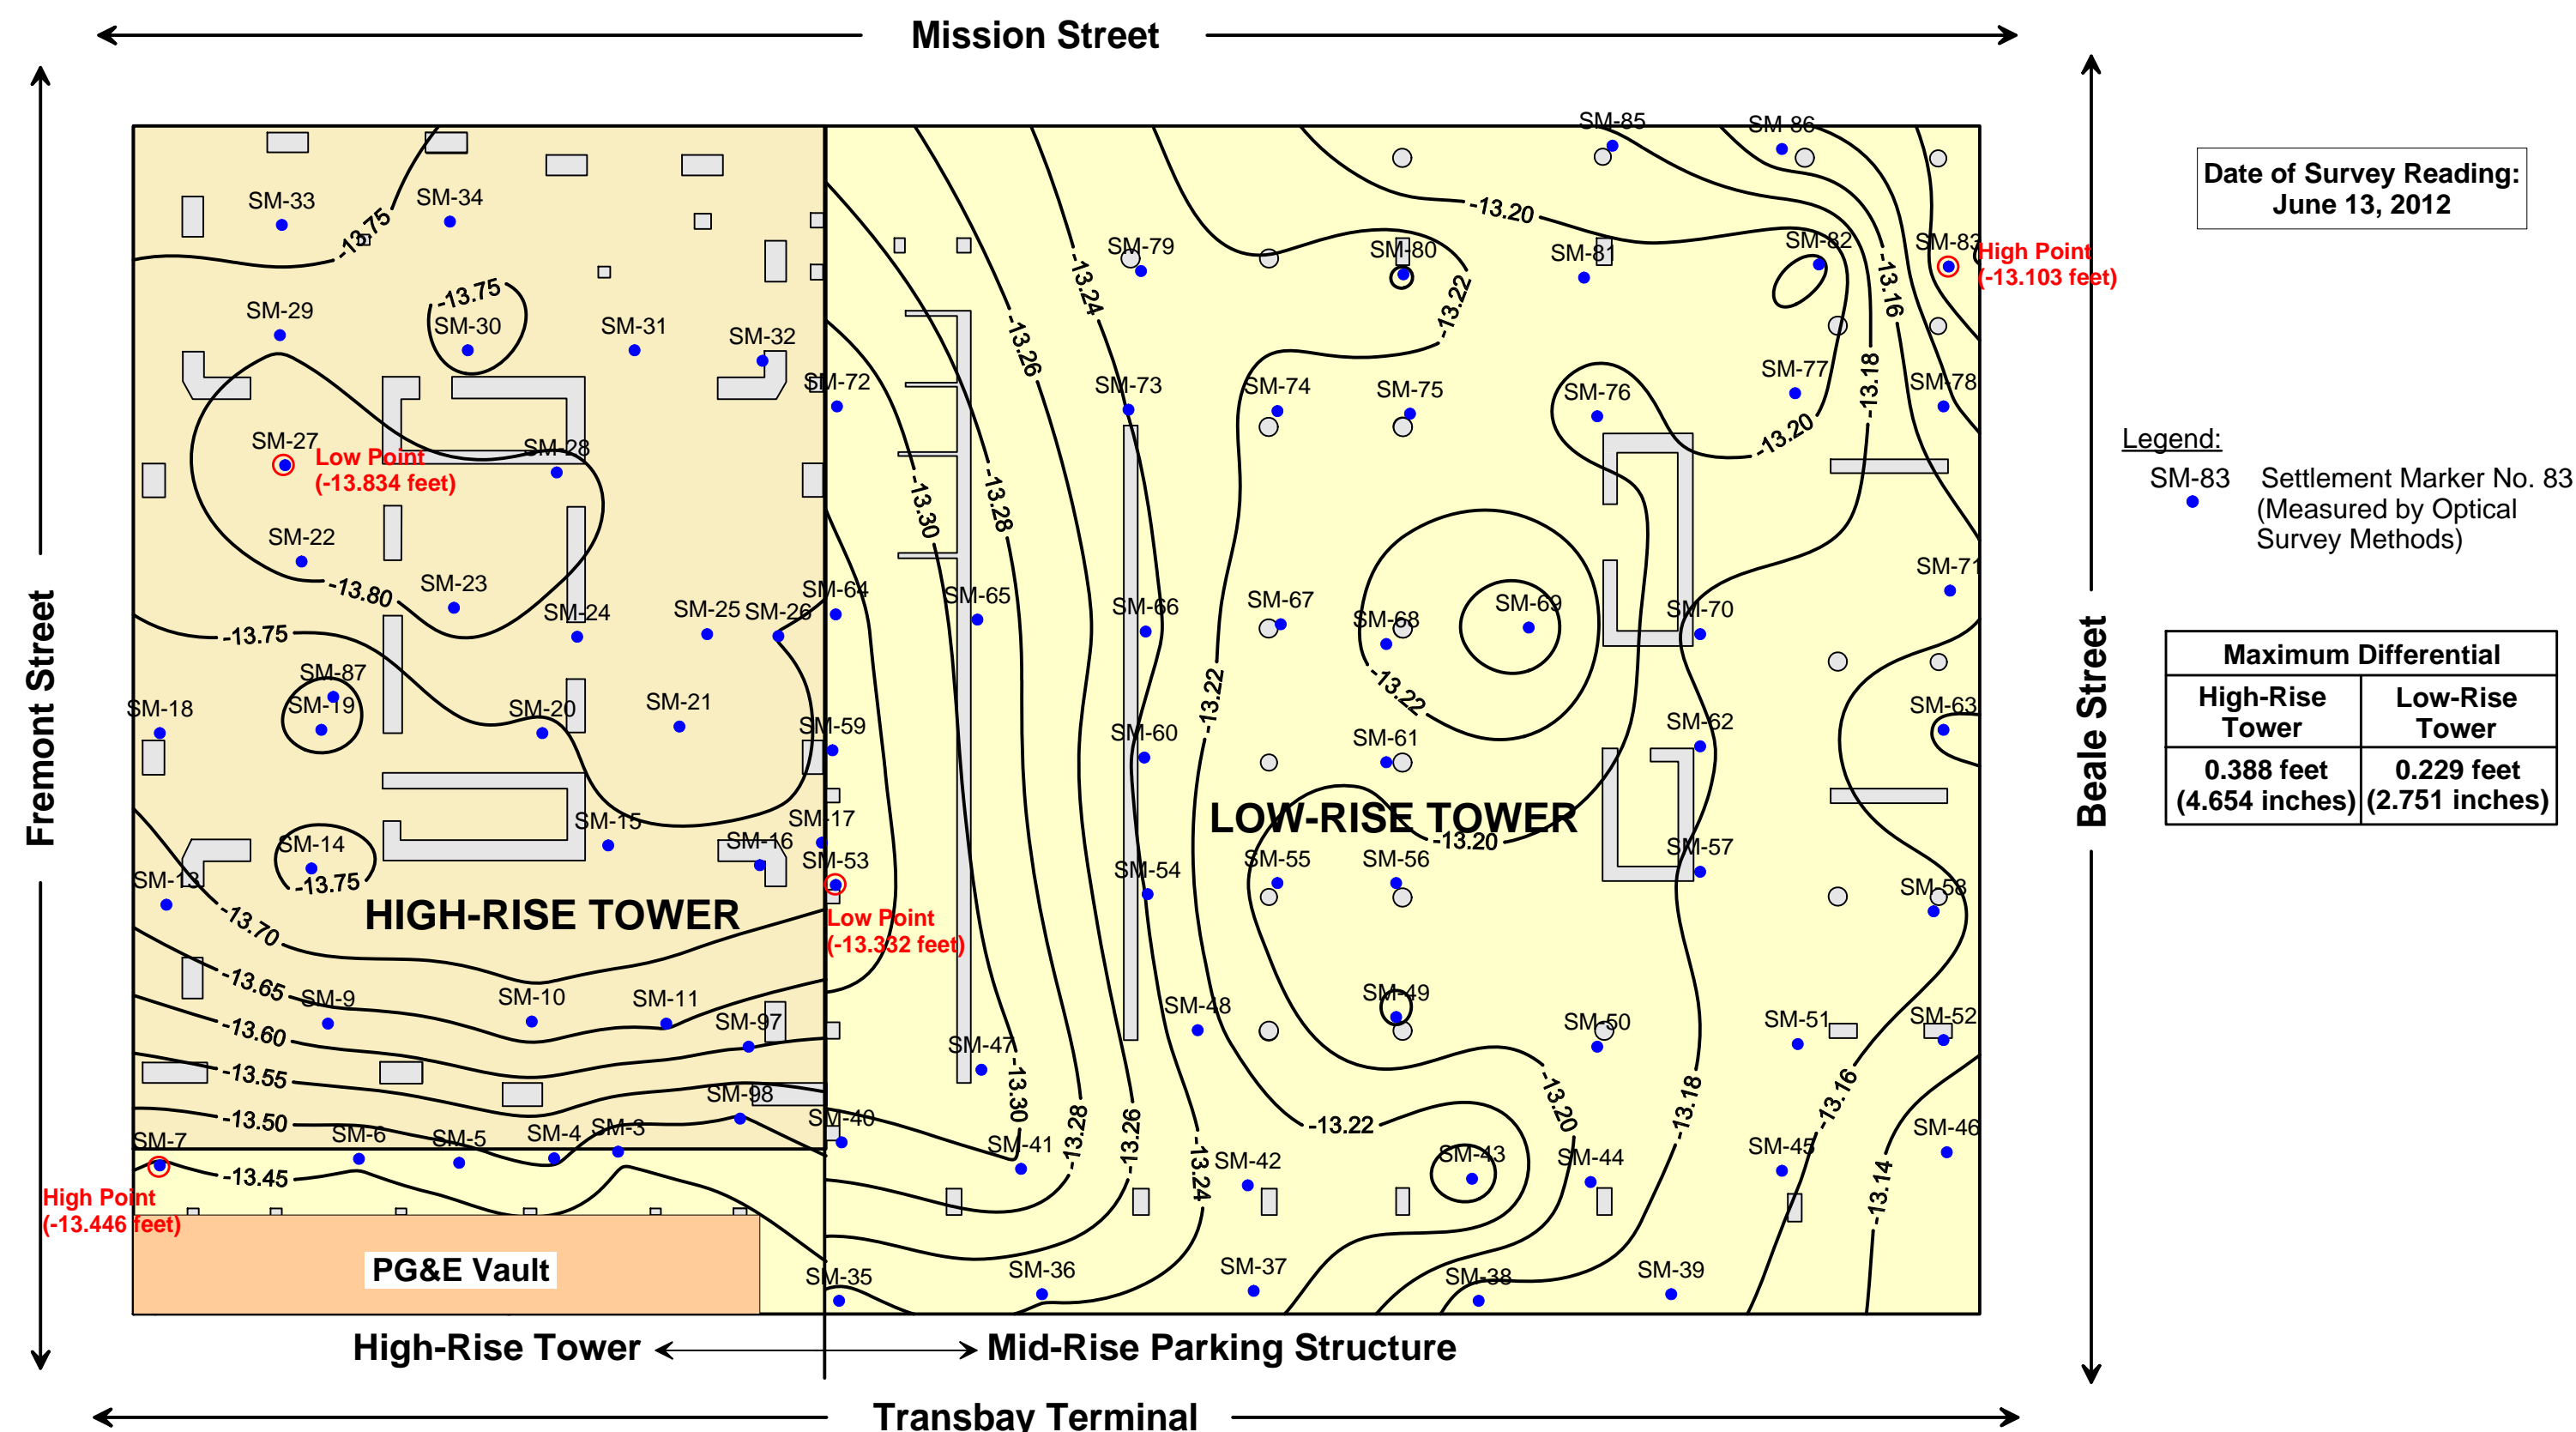
FLOOR ELEVATIONS AT LEVEL B-1
OF 301 MISSION PROPERTY:
PERIODIC SURVEY - JUNE 13, 2012
Transbay Transit Center
301 Mission Monitoring
Transbay Joint Powers Authority
San Francisco, California

Maximum Differential	
High-Rise Tower	Low-Rise Tower
0.388 feet (4.654 inches)	0.229 feet (2.751 inches)

Notes:
Contours represent elevation, in feet (CCSF Datum), from survey readings taken on June 13, 2012.
Level B-1 at Mid-Rise Parking portion of survey site is approximately 4 inches higher than Level B-1 at High-Rise Tower portion.
The PG&E vault is inaccessible for monitoring.

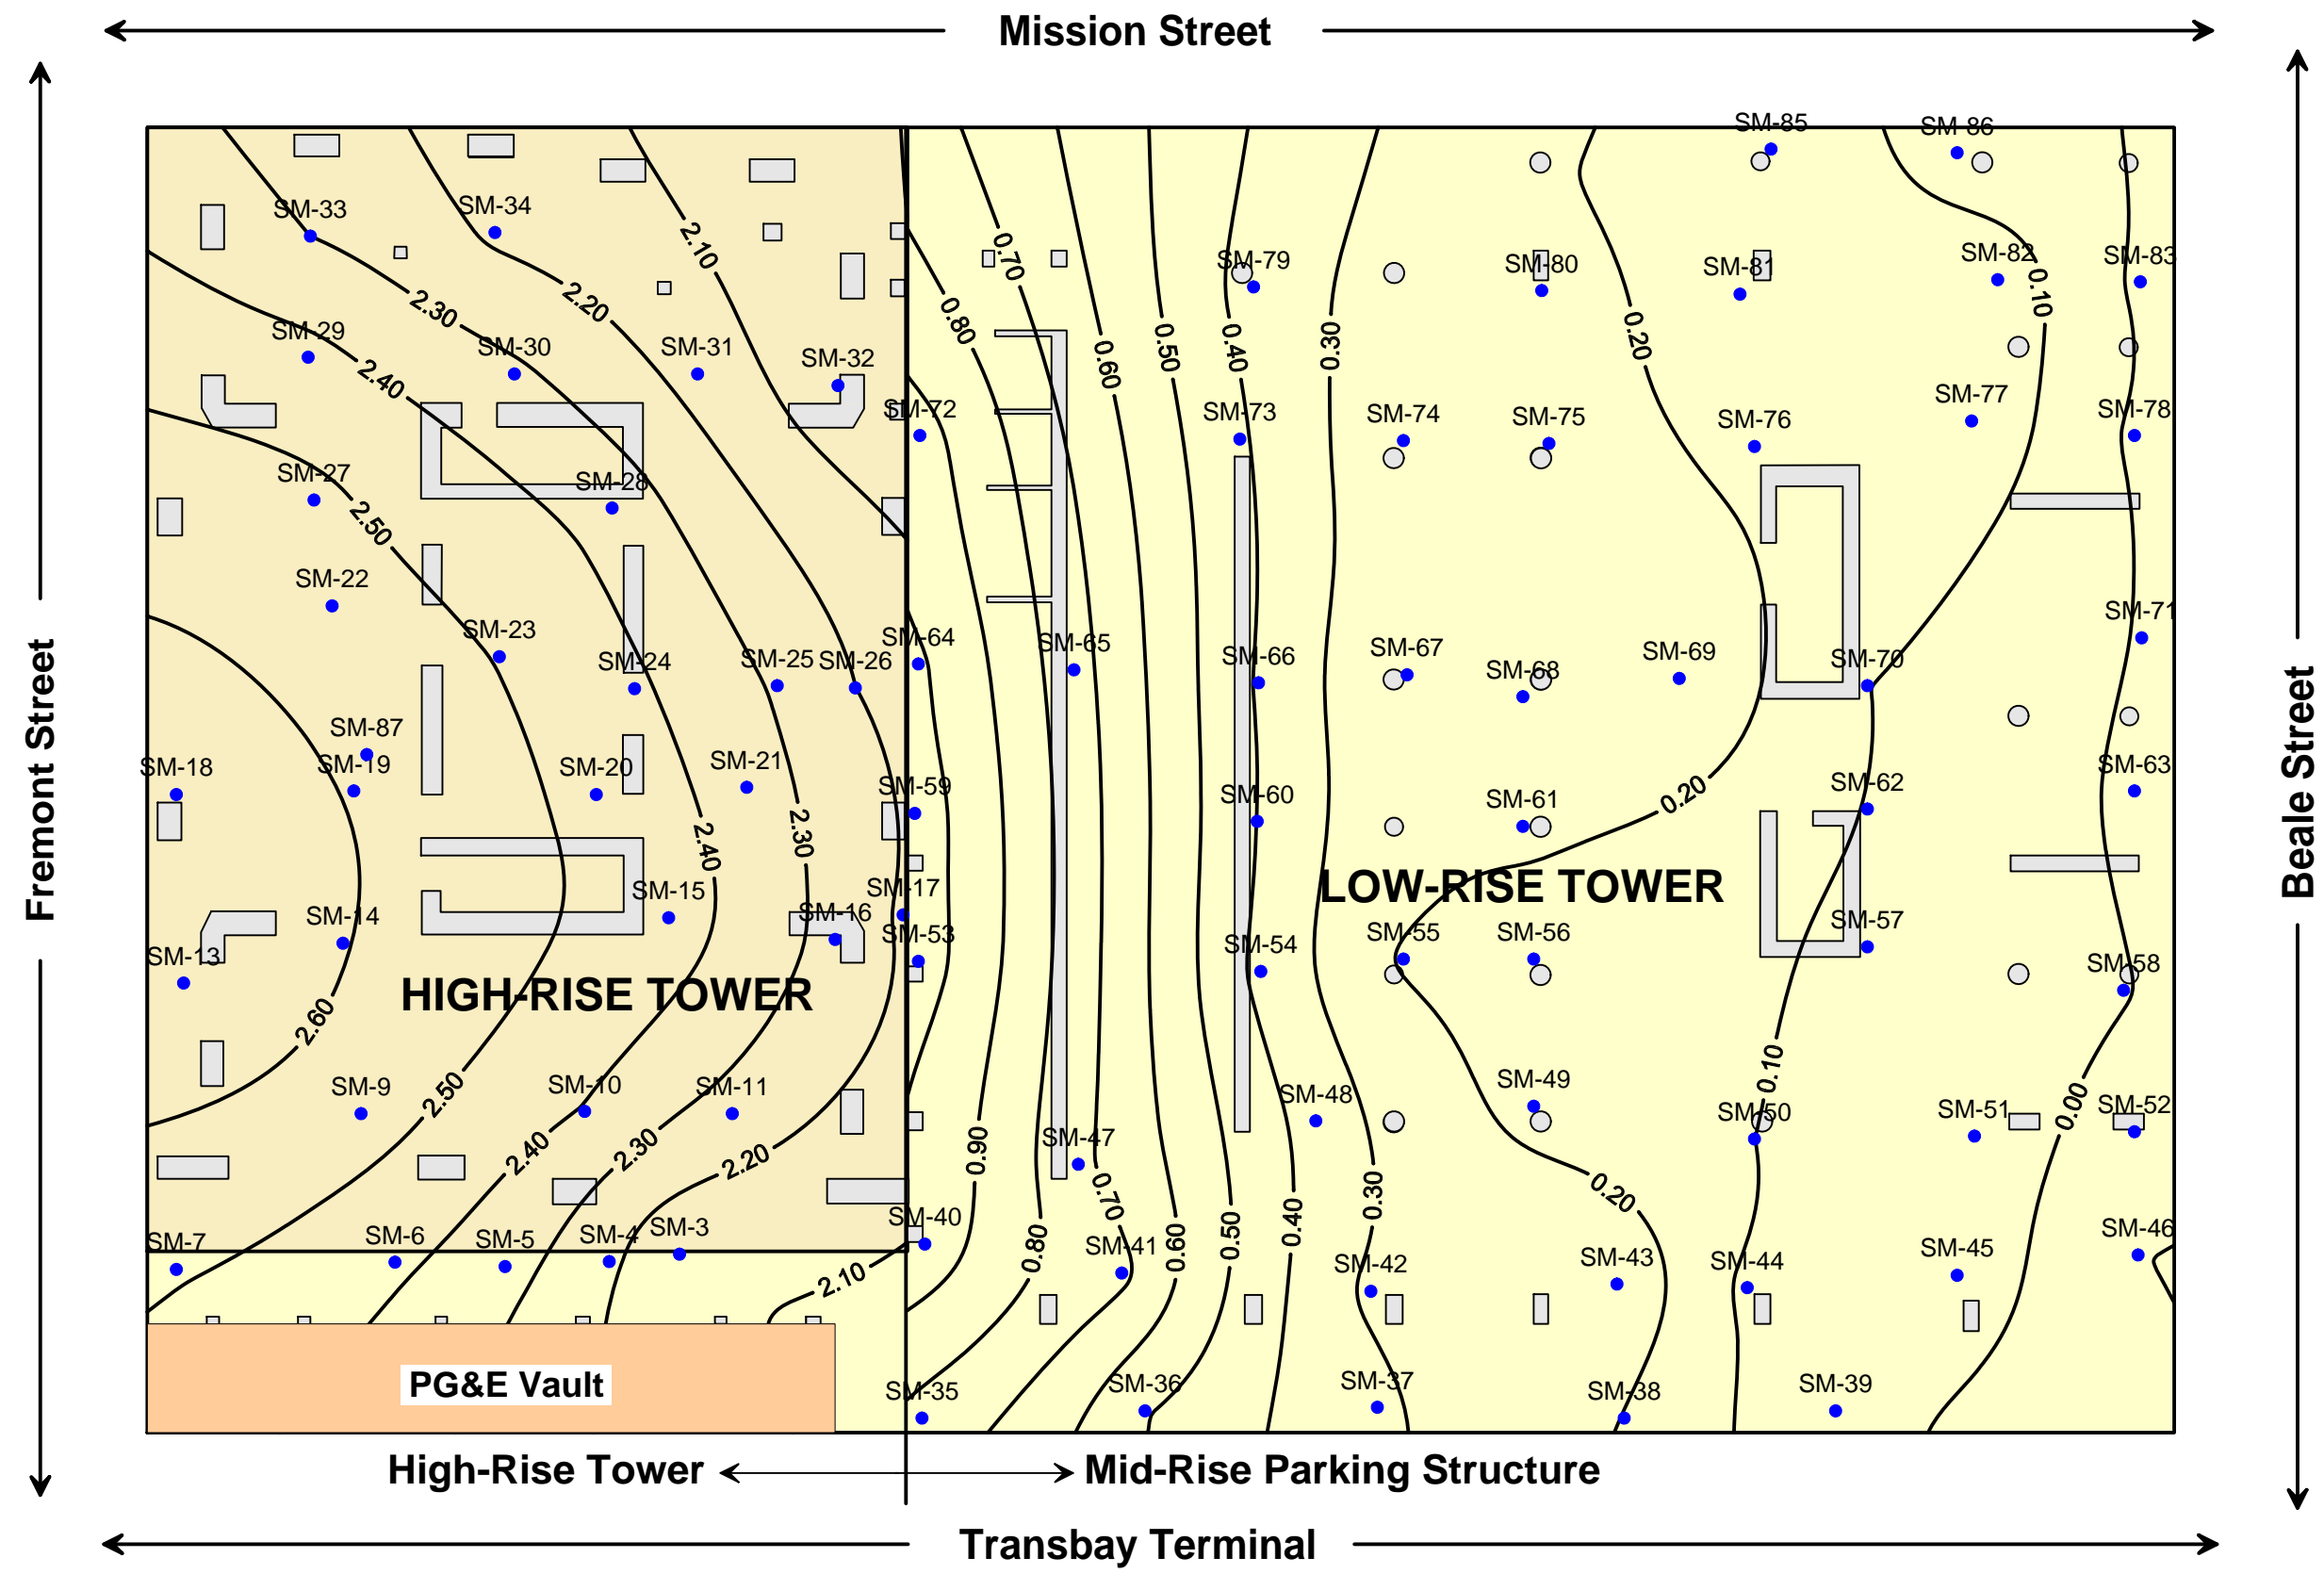
CONTOURS OF SETTLEMENTS MEASURED AT THE FIRST LEVEL BASEMENT OF THE 301 MISSION STREET STRUCTURE BETWEEN APRIL 30, 2009 AND JUNE 13, 2012
 Transbay Transit Center
 301 Mission Monitoring
 Transbay Joint Powers Authority
 San Francisco, California
 July 2012

Notes:
 Contours represent elevation change, in inches, between Baseline survey (April 30, 2009) and readings taken on June 13, 2012.
 Level B-1 at Mid-Rise Parking portion of survey site is approximately 4 inches higher than Level B-1 at High-Rise Tower portion.
 The PG&E vault is inaccessible for monitoring.
 Negative values of settlement (within Low-rise Tower) indicate uplift.
