Supplemental Report for Foundation Settlement Investigation

The building at 301 Mission Street, San Francisco, California is a fifty-eight-story residential structure founded on a pile-supported mat foundation. The building, which was completed in 2009, has experienced and continues to experience significant foundation settlement. Paul Hastings, LLP retained Simpson Gumpertz & Heger Inc. in 2014 to conduct an evaluation of the impact of site settlement on the building's structural stability and earthquake resistance. We performed initial evaluations in 2014 and updated these in 2016 to consider additional settlement that occurred in the interim period. In an October 2016 report we concluded that settlement had not compromised the building's stability or its ability to resist strong earthquakes.

**SUPPLEMENTAL REPORT
FOUNDATION SETTLEMENT INVESTIGATION
301 MISSION STREET
SAN FRANCISCO, CALIFORNIA**

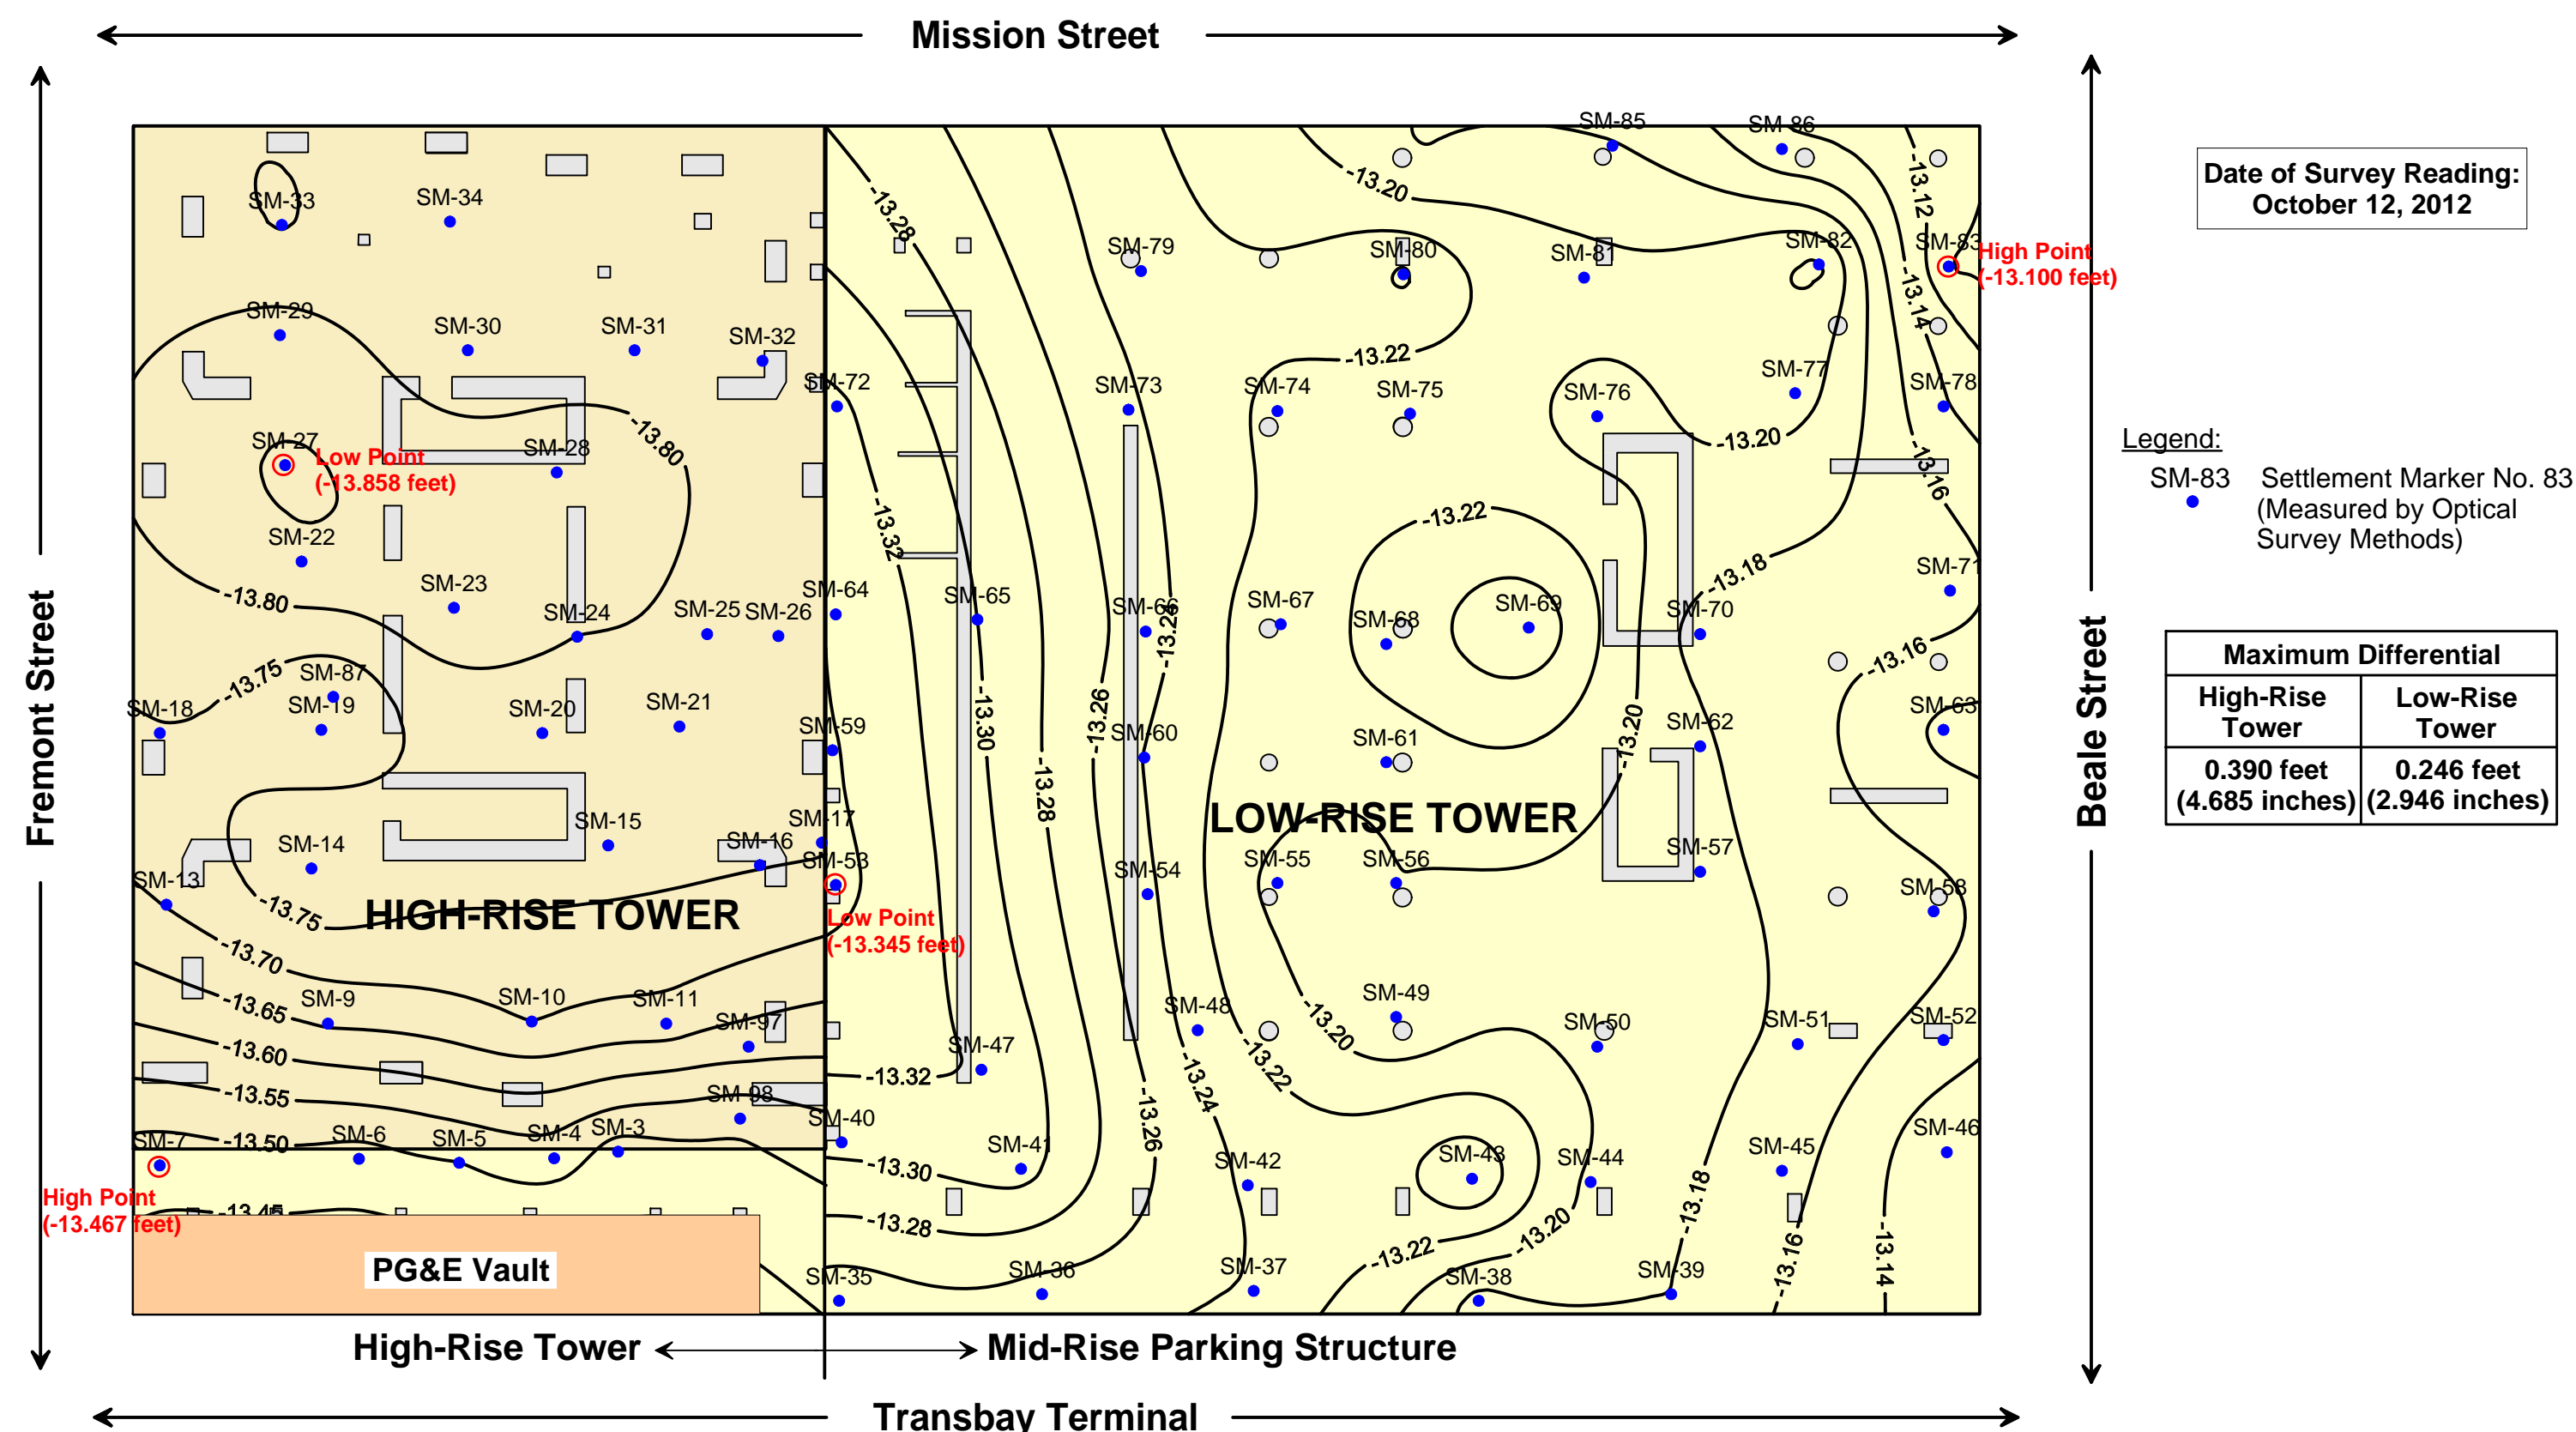
**FLOOR ELEVATIONS AT LEVEL B-1
OF 301 MISSION PROPERTY:
PERIODIC SURVEY - OCTOBER 12, 2012**

Notes:
Contours represent elevation, in feet (CCSF Datum), from survey readings taken on October 12, 2012.
Level B-1 at Mid-Rise Parking portion of survey site is approximately 4 inches higher than Level B-1 at High-Rise Tower portion.
The PG&E vault is inaccessible for monitoring.

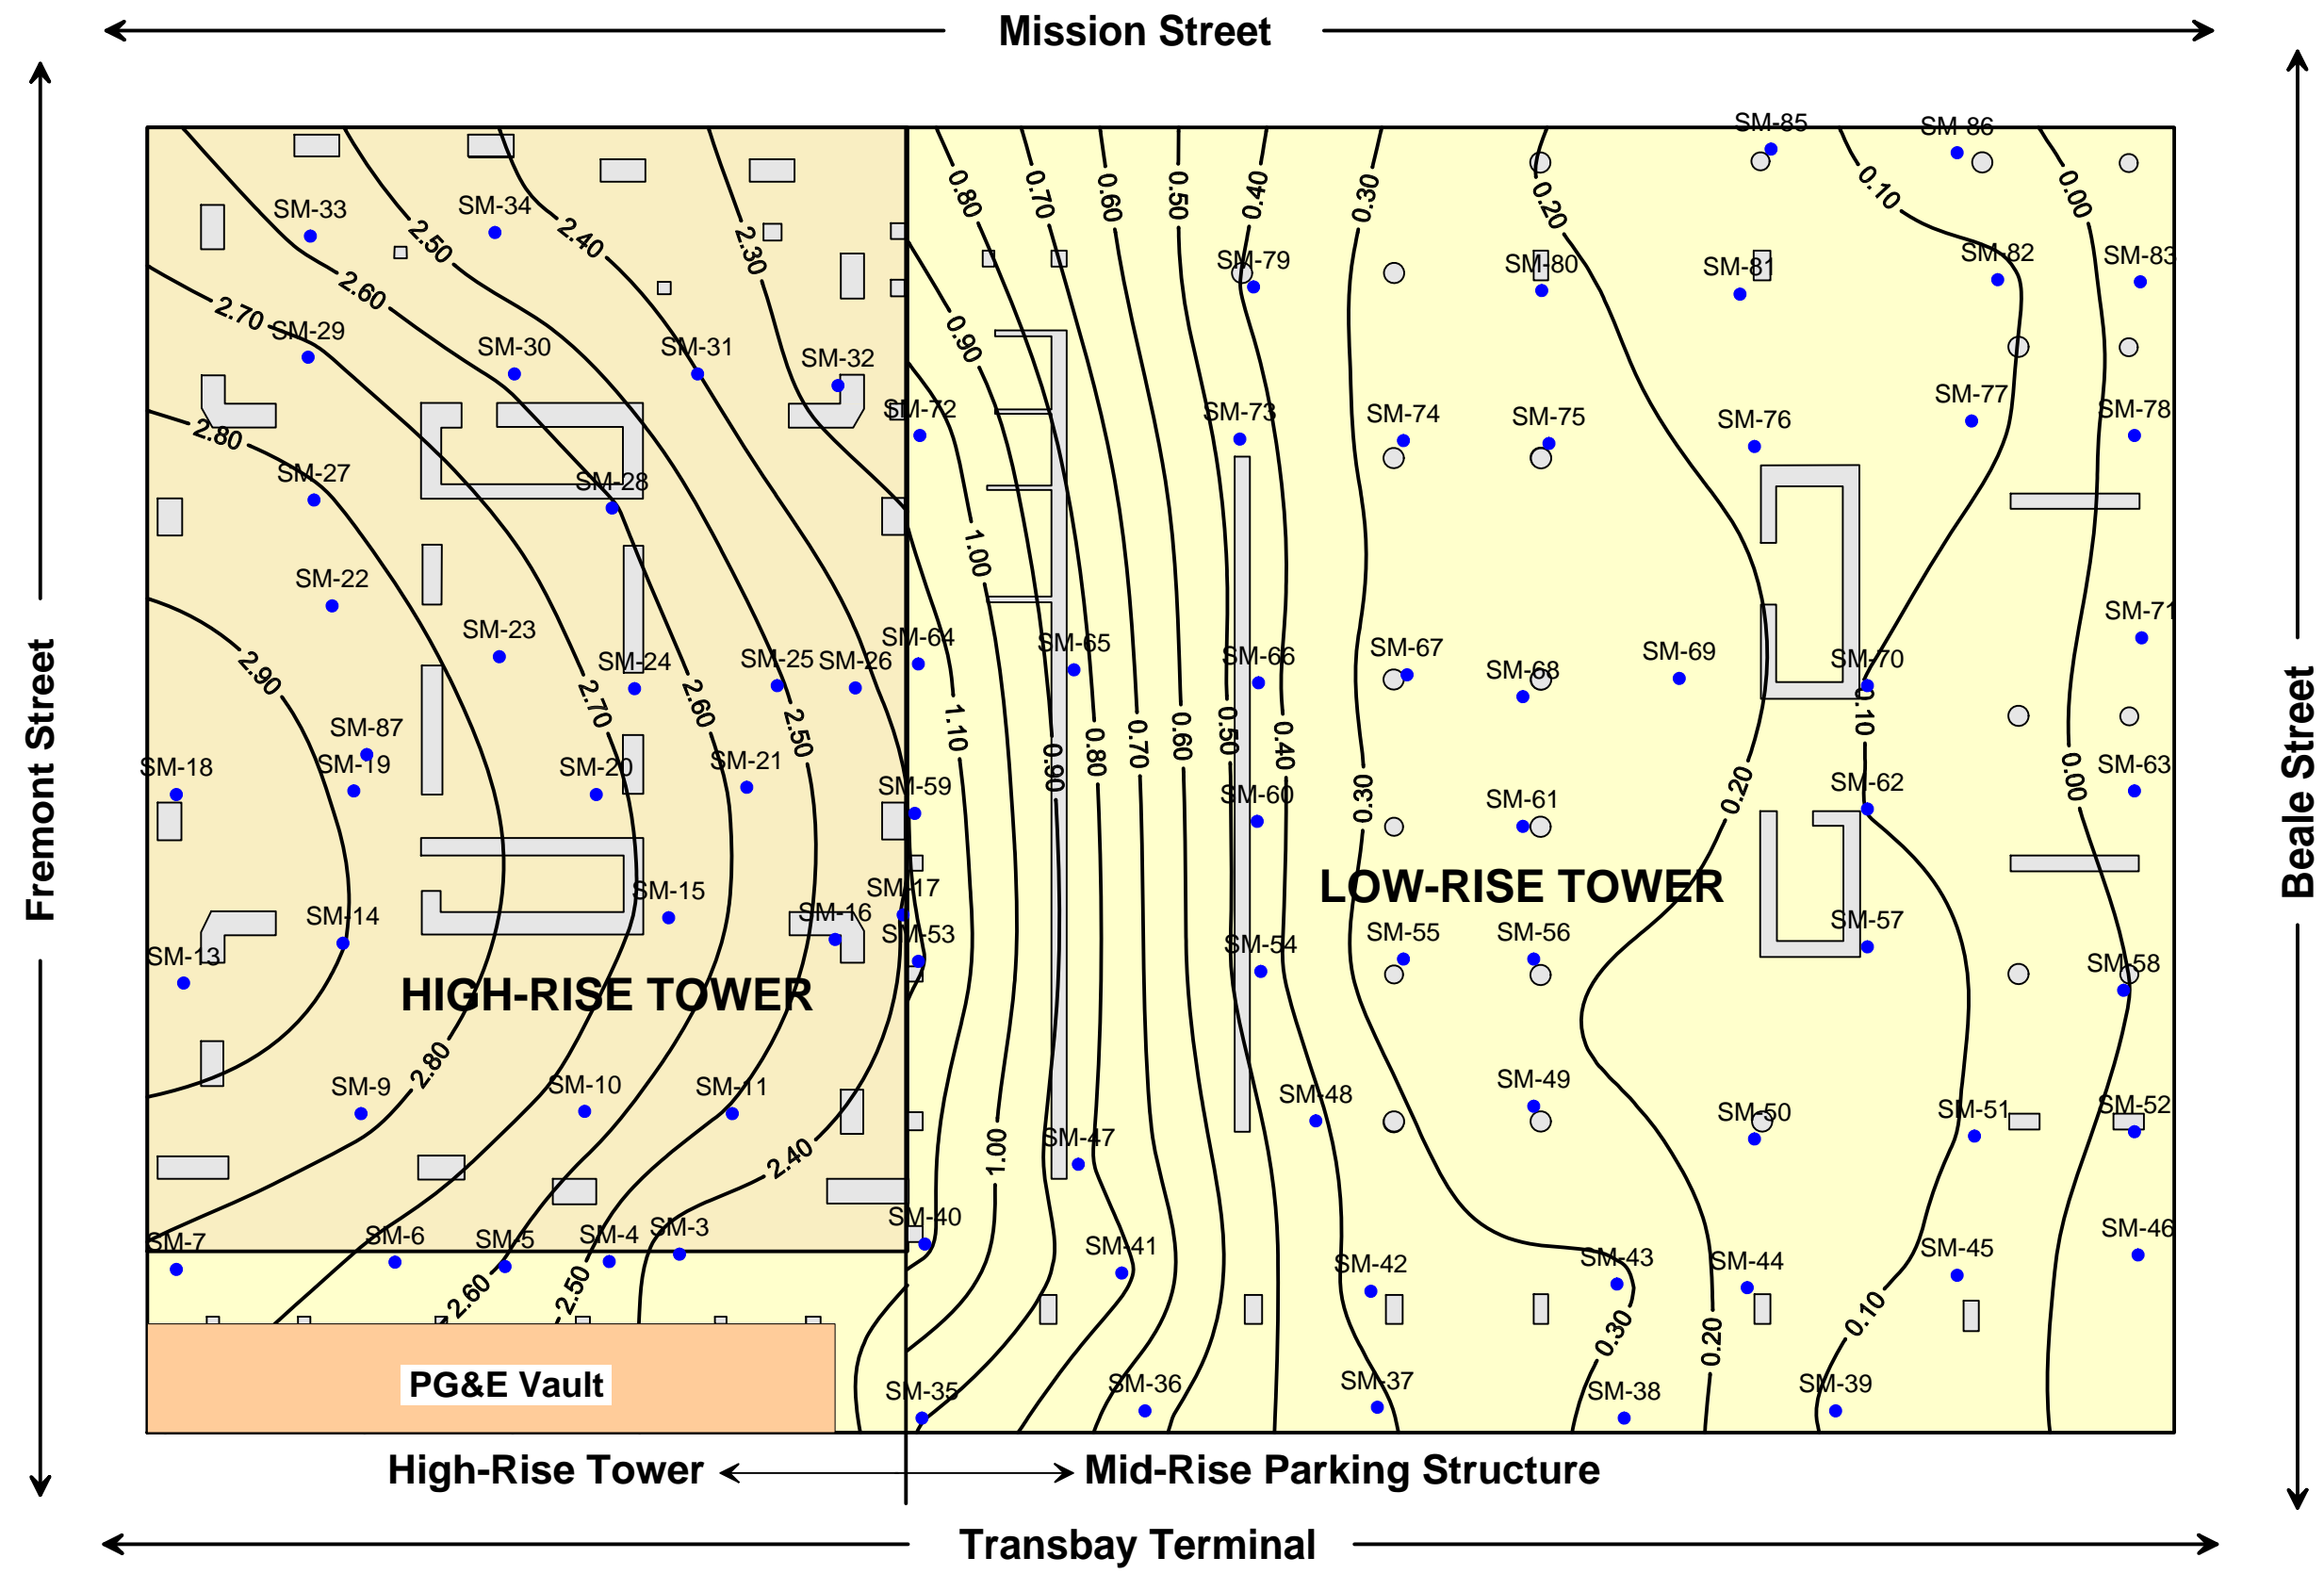
CONTOURS OF SETTLEMENTS MEASURED AT THE
FIRST LEVEL BASEMENT OF THE 301 MISSION STREET
STRUCTURE BETWEEN APRIL 30, 2009 AND OCT
November 2012
Transbay Transit Center
301 Mission Monitoring
Transbay Joint Powers Authority
San Francisco, California

Notes:
Contours represent elevation change, in inches, between Baseline survey (April 30, 2009) and readings taken on October 12, 2012.
Level B-1 at Mid-Rise Parking portion of survey site is approximately 4 inches higher than Level B-1 at High-Rise Tower portion.
The PG&E vault is inaccessible for monitoring.
Negative values of settlement (within Low-rise Tower) indicate uplift.

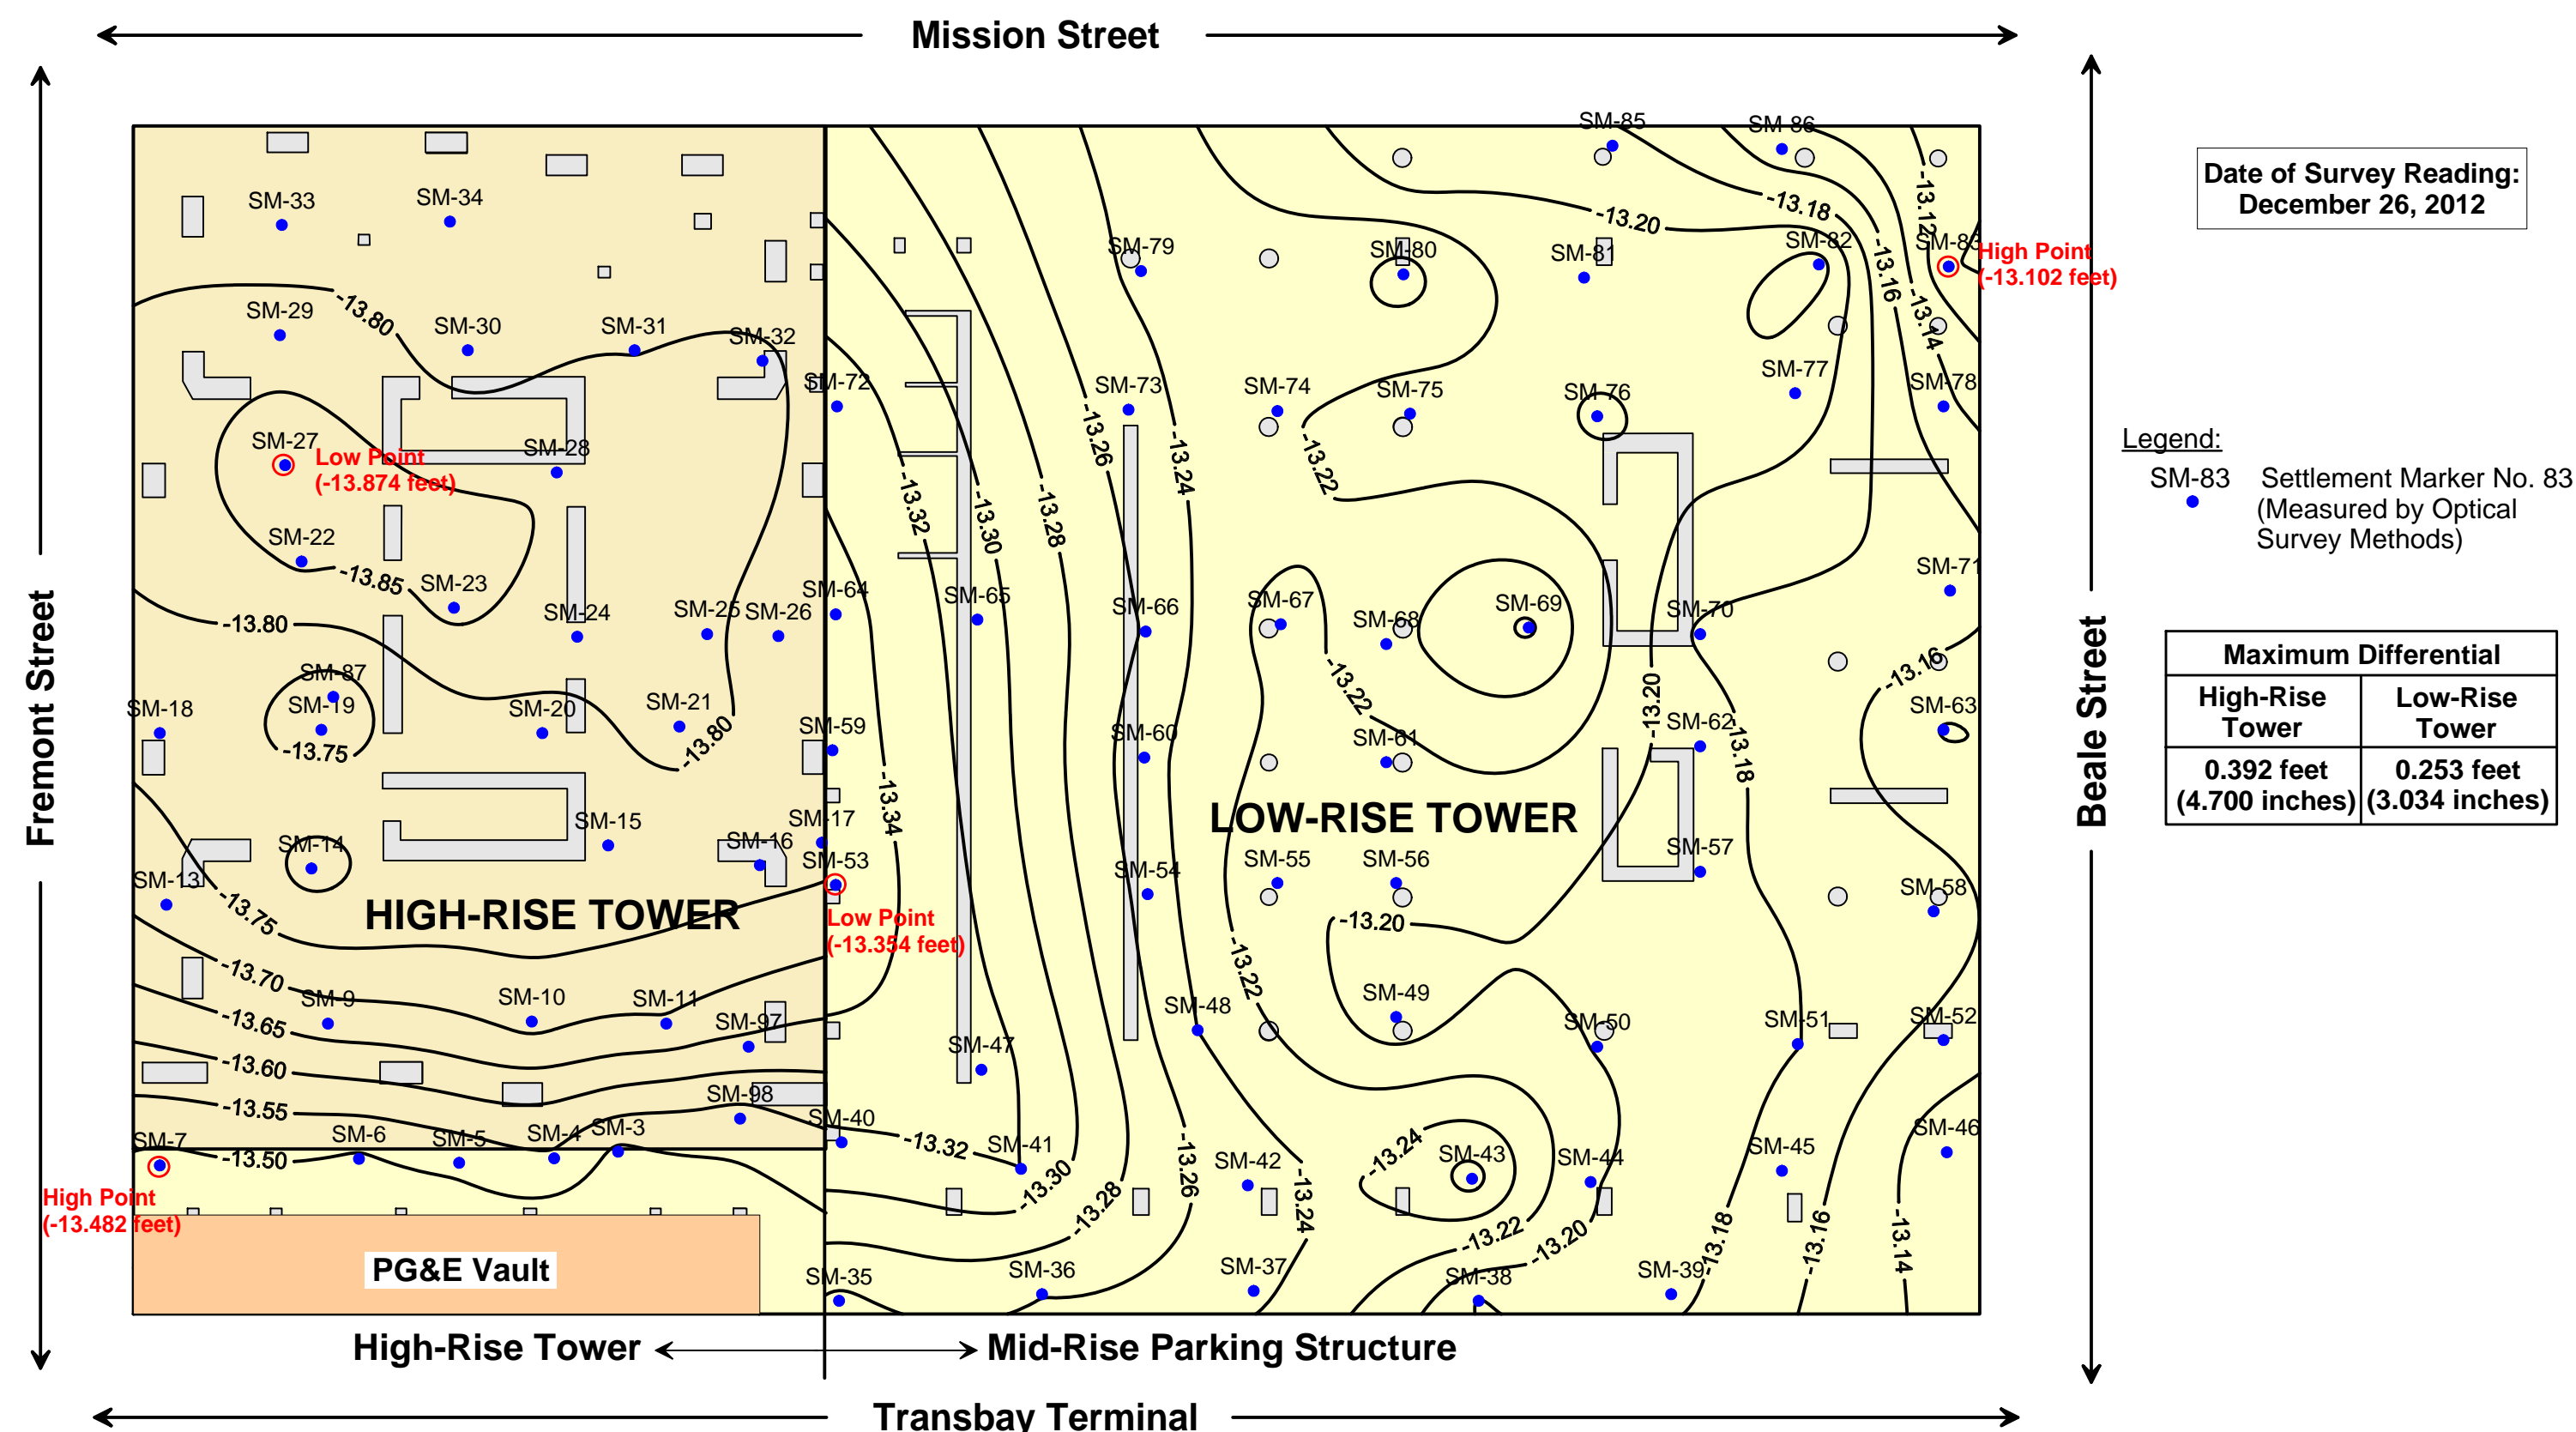
Maximum Differential	
High-Rise Tower	Low-Rise Tower
0.392 feet (4.700 inches)	0.253 feet (3.034 inches)

Notes:
Contours represent elevation, in feet (CCSF Datum), from survey readings taken on December 26, 2012.
Level B-1 at Mid-Rise Parking portion of survey site is approximately 4 inches higher than Level B-1 at High-Rise Tower portion.
The PG&E vault is inaccessible for monitoring.

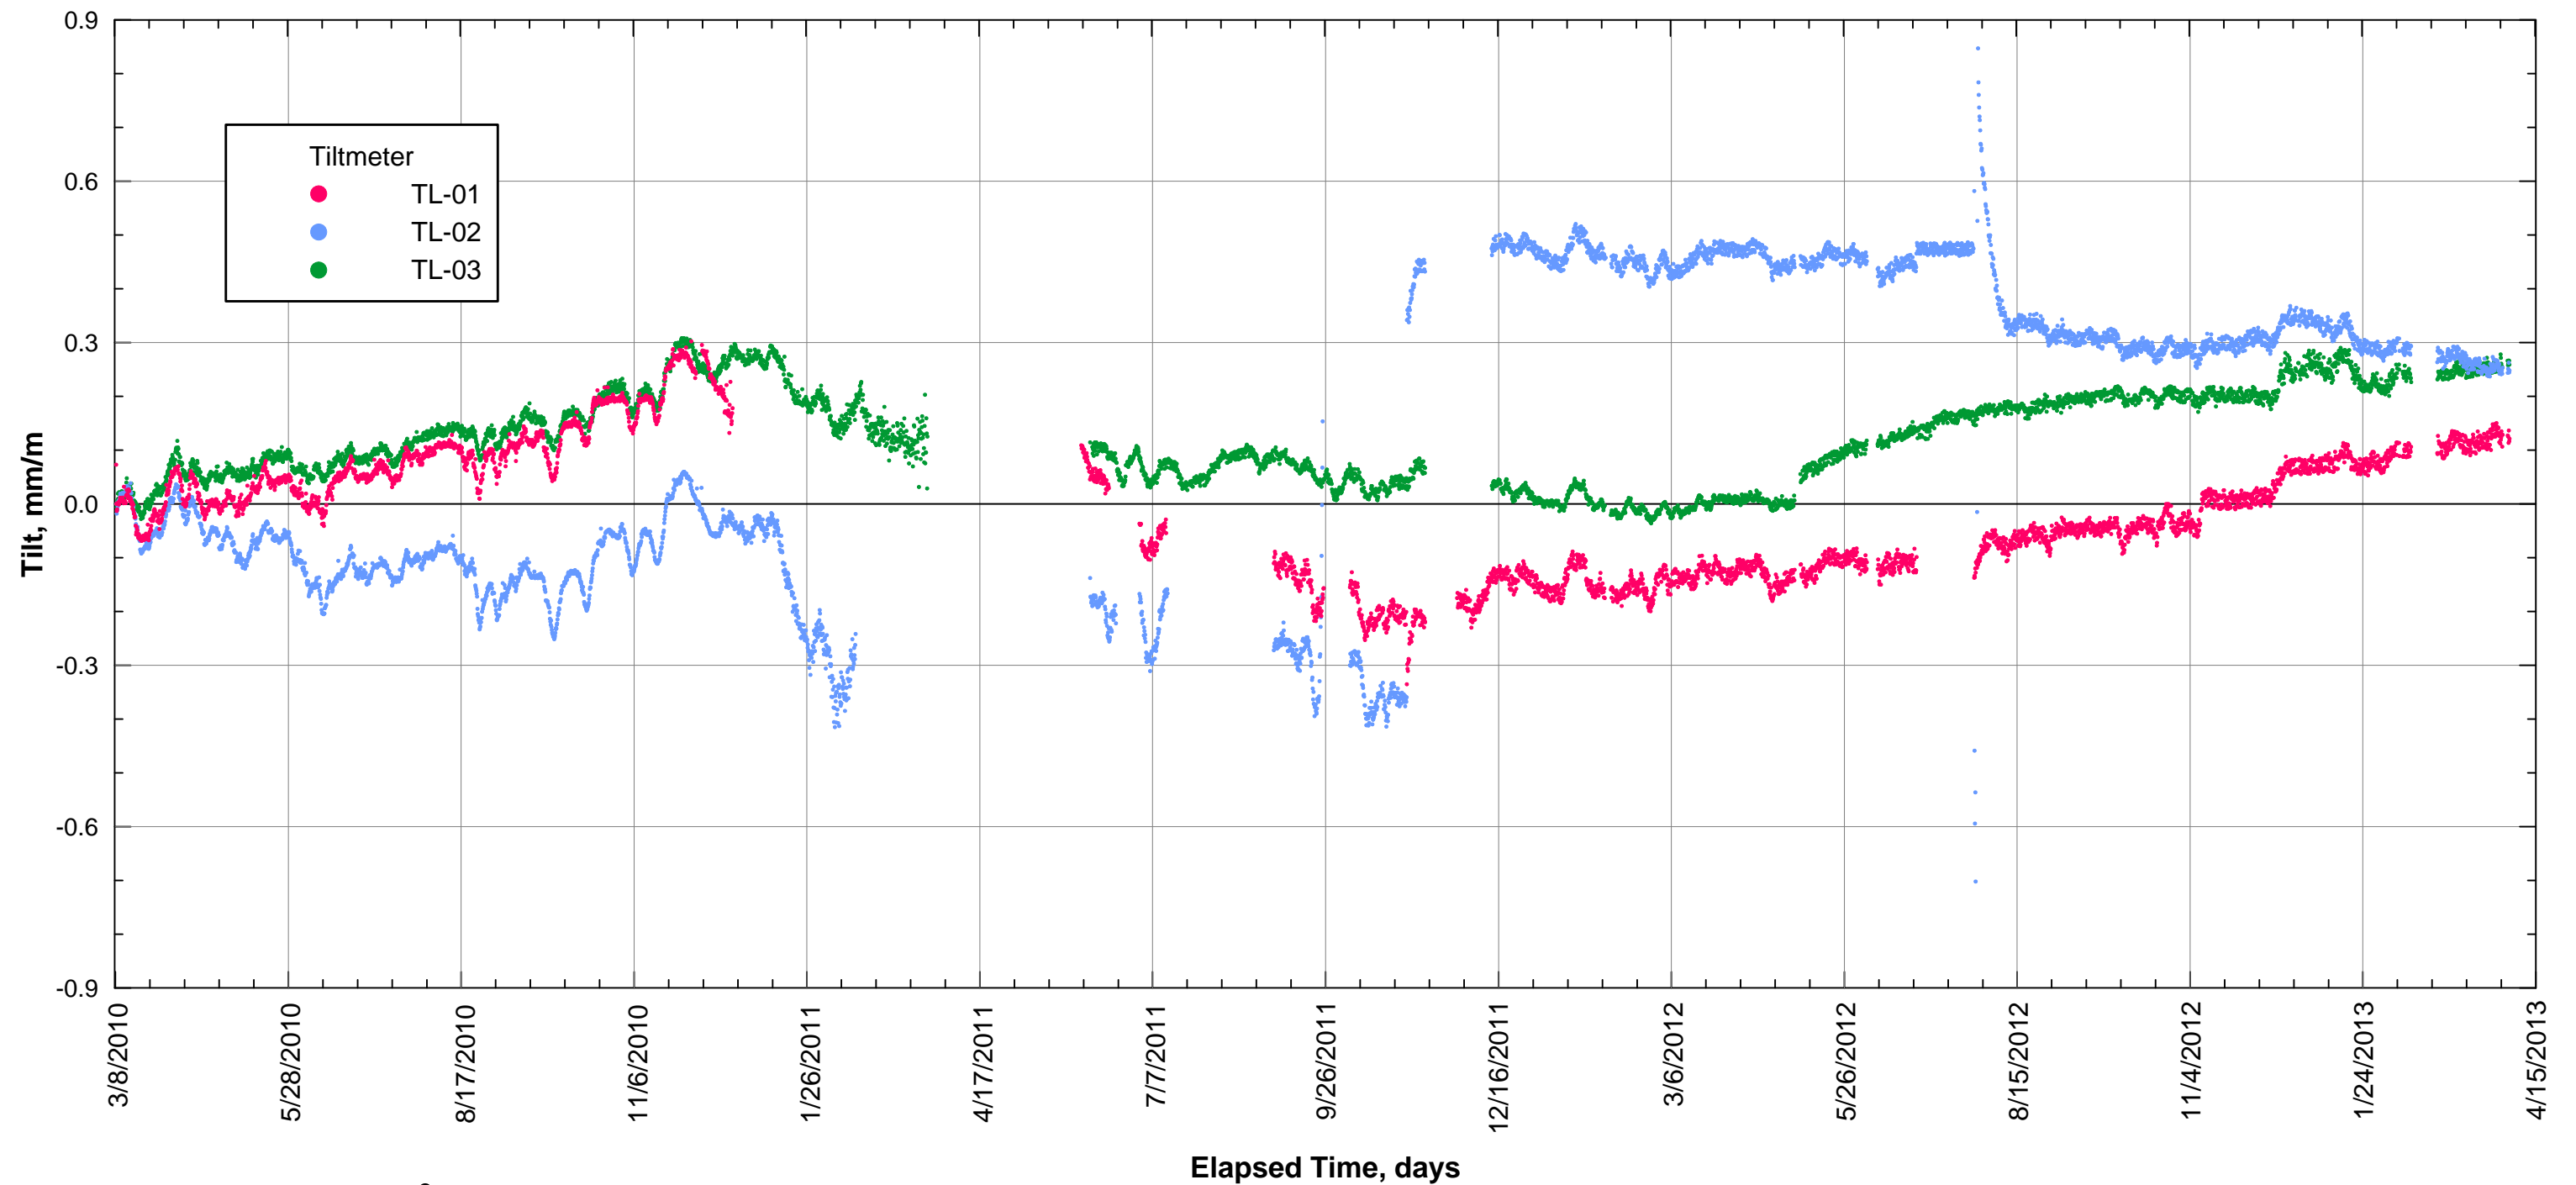
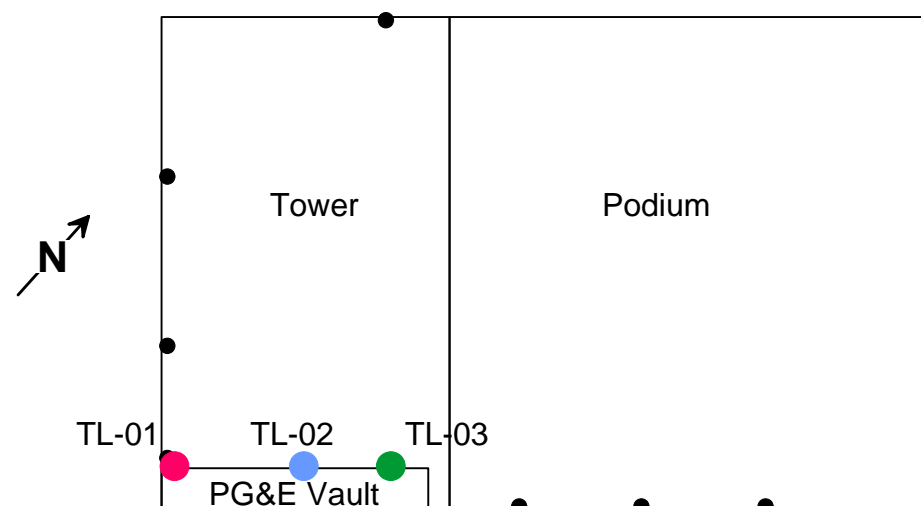
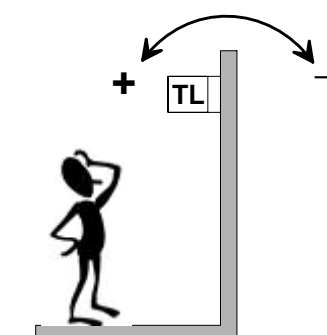
TILT RECORDED IN TILTMETERS TL-01, TL-02, AND TL-03: BASEMENT LEVEL B-1

Positive tilt represents movement of the top of the wall towards the inside of the room.

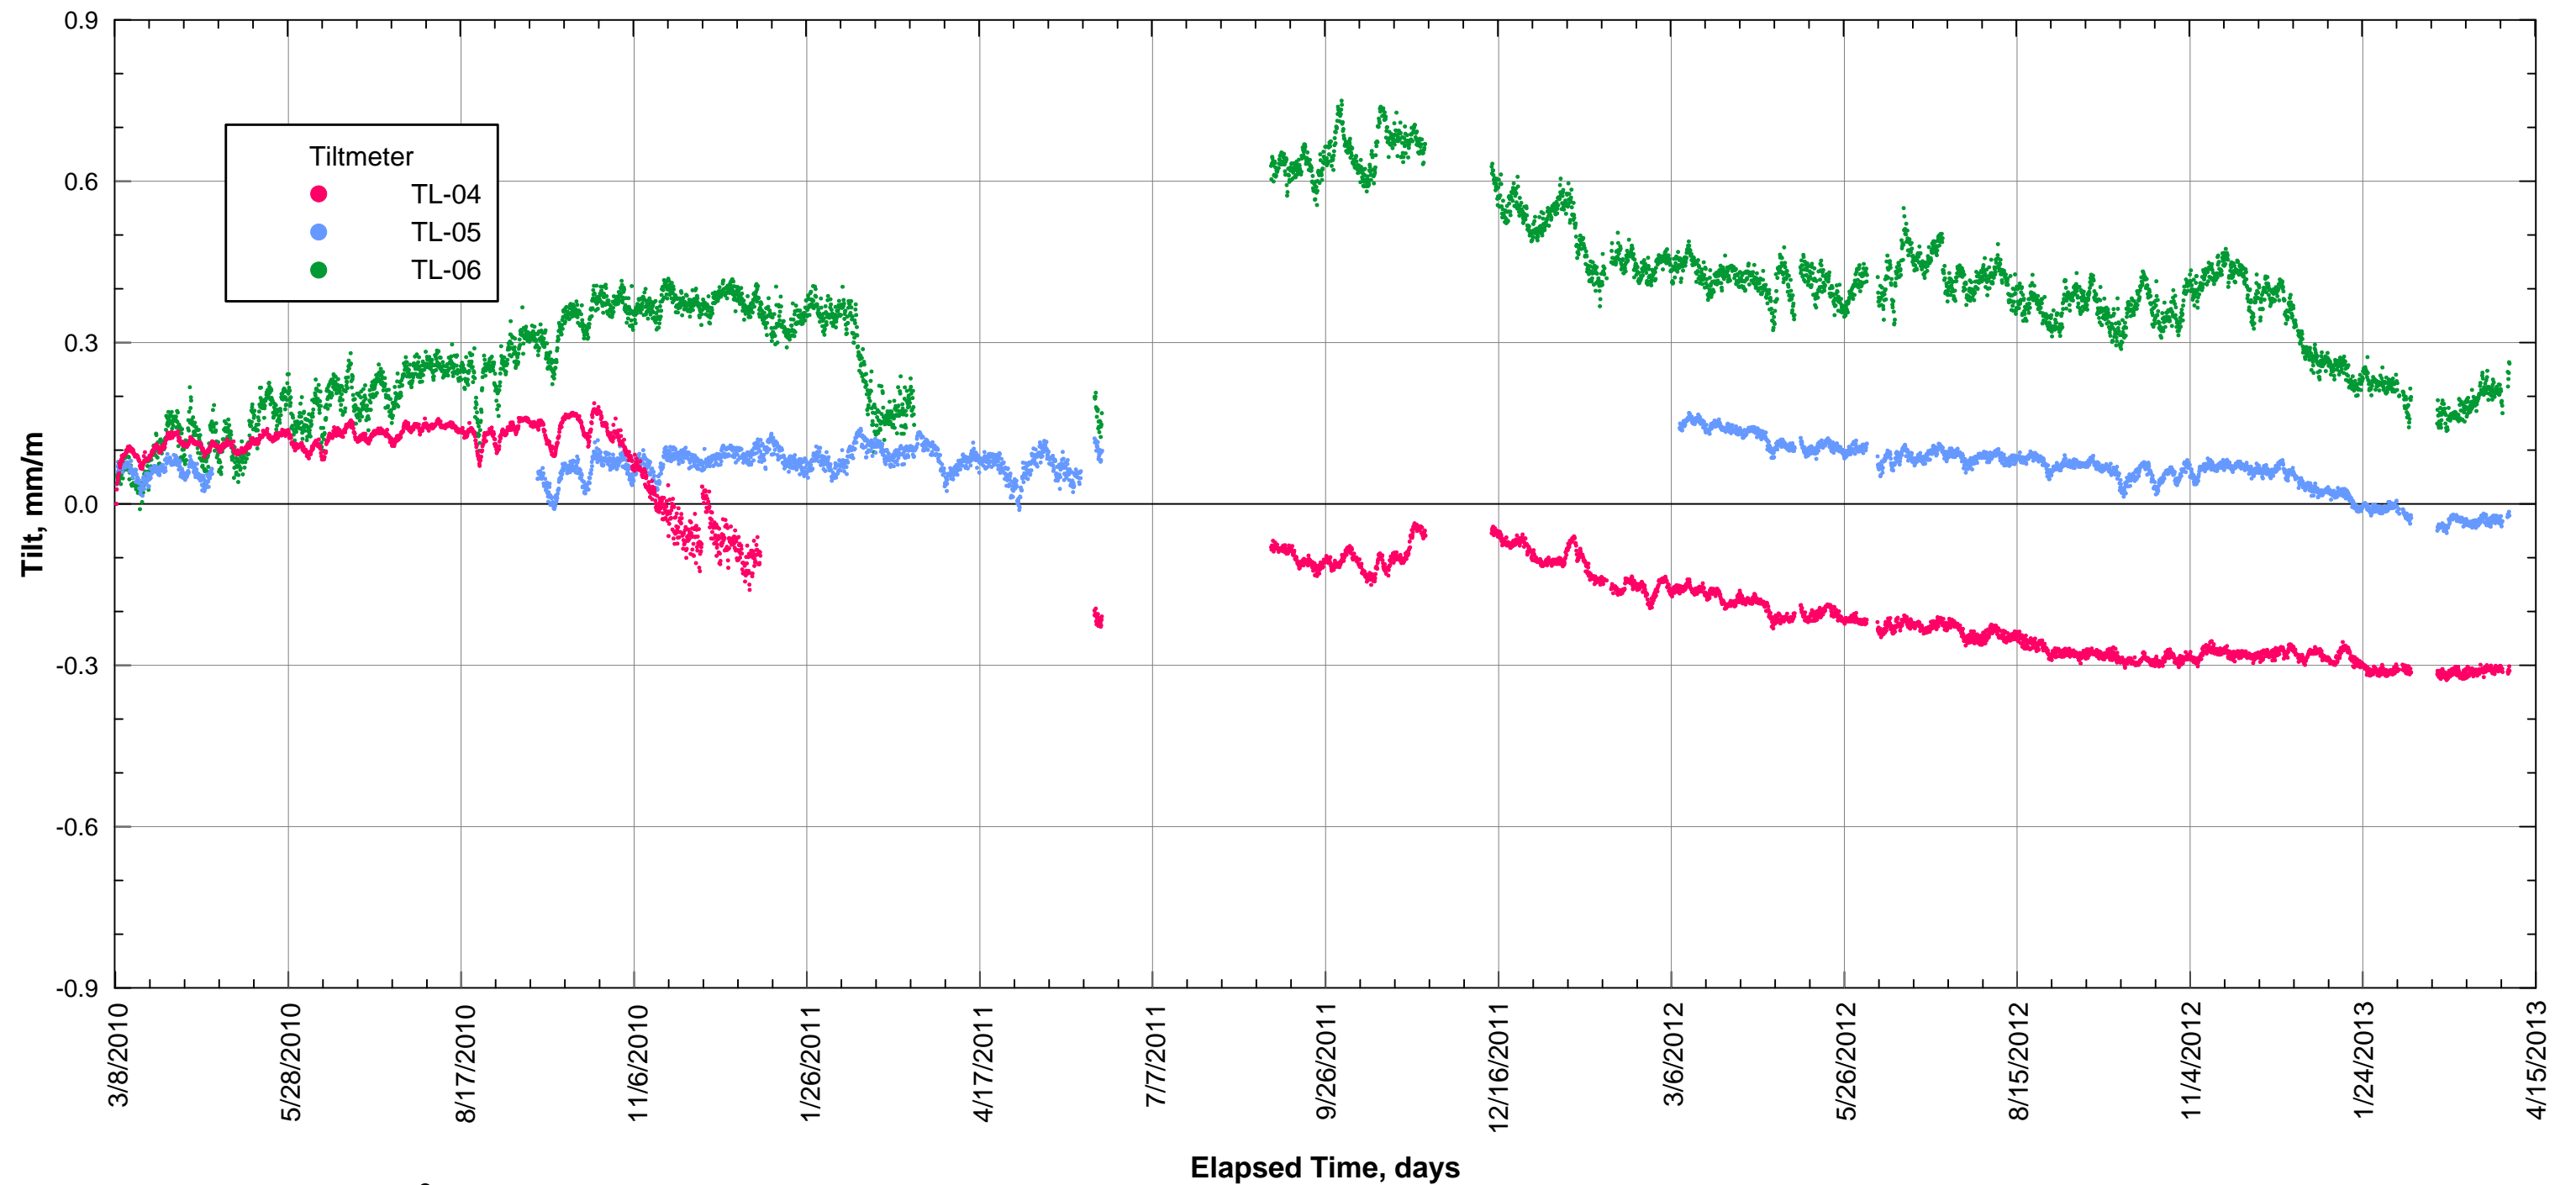
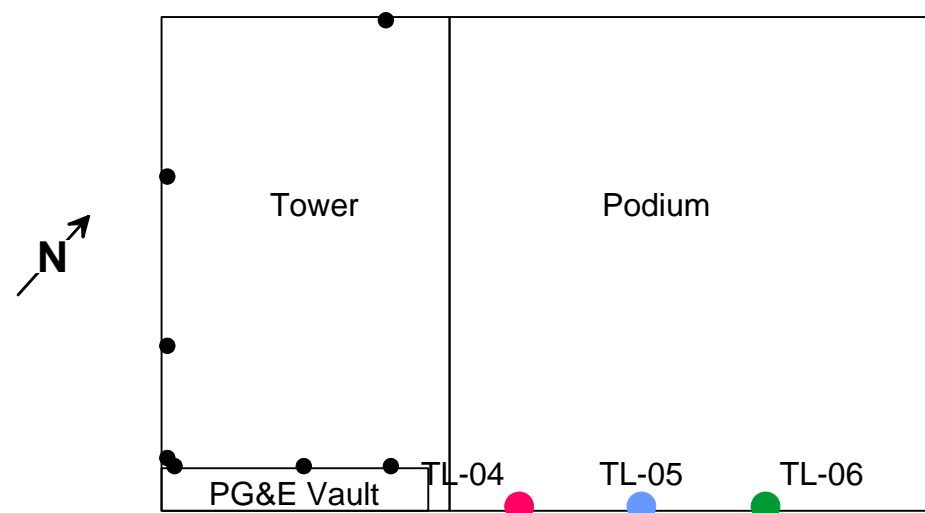
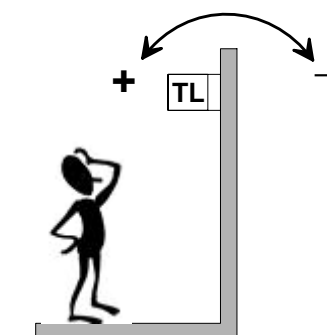
TILT RECORDED IN TILTMETERS TL-04, TL-05, AND TL-06: BASEMENT LEVEL B-1

Positive tilt represents movement of the top of the wall towards the inside of the room.

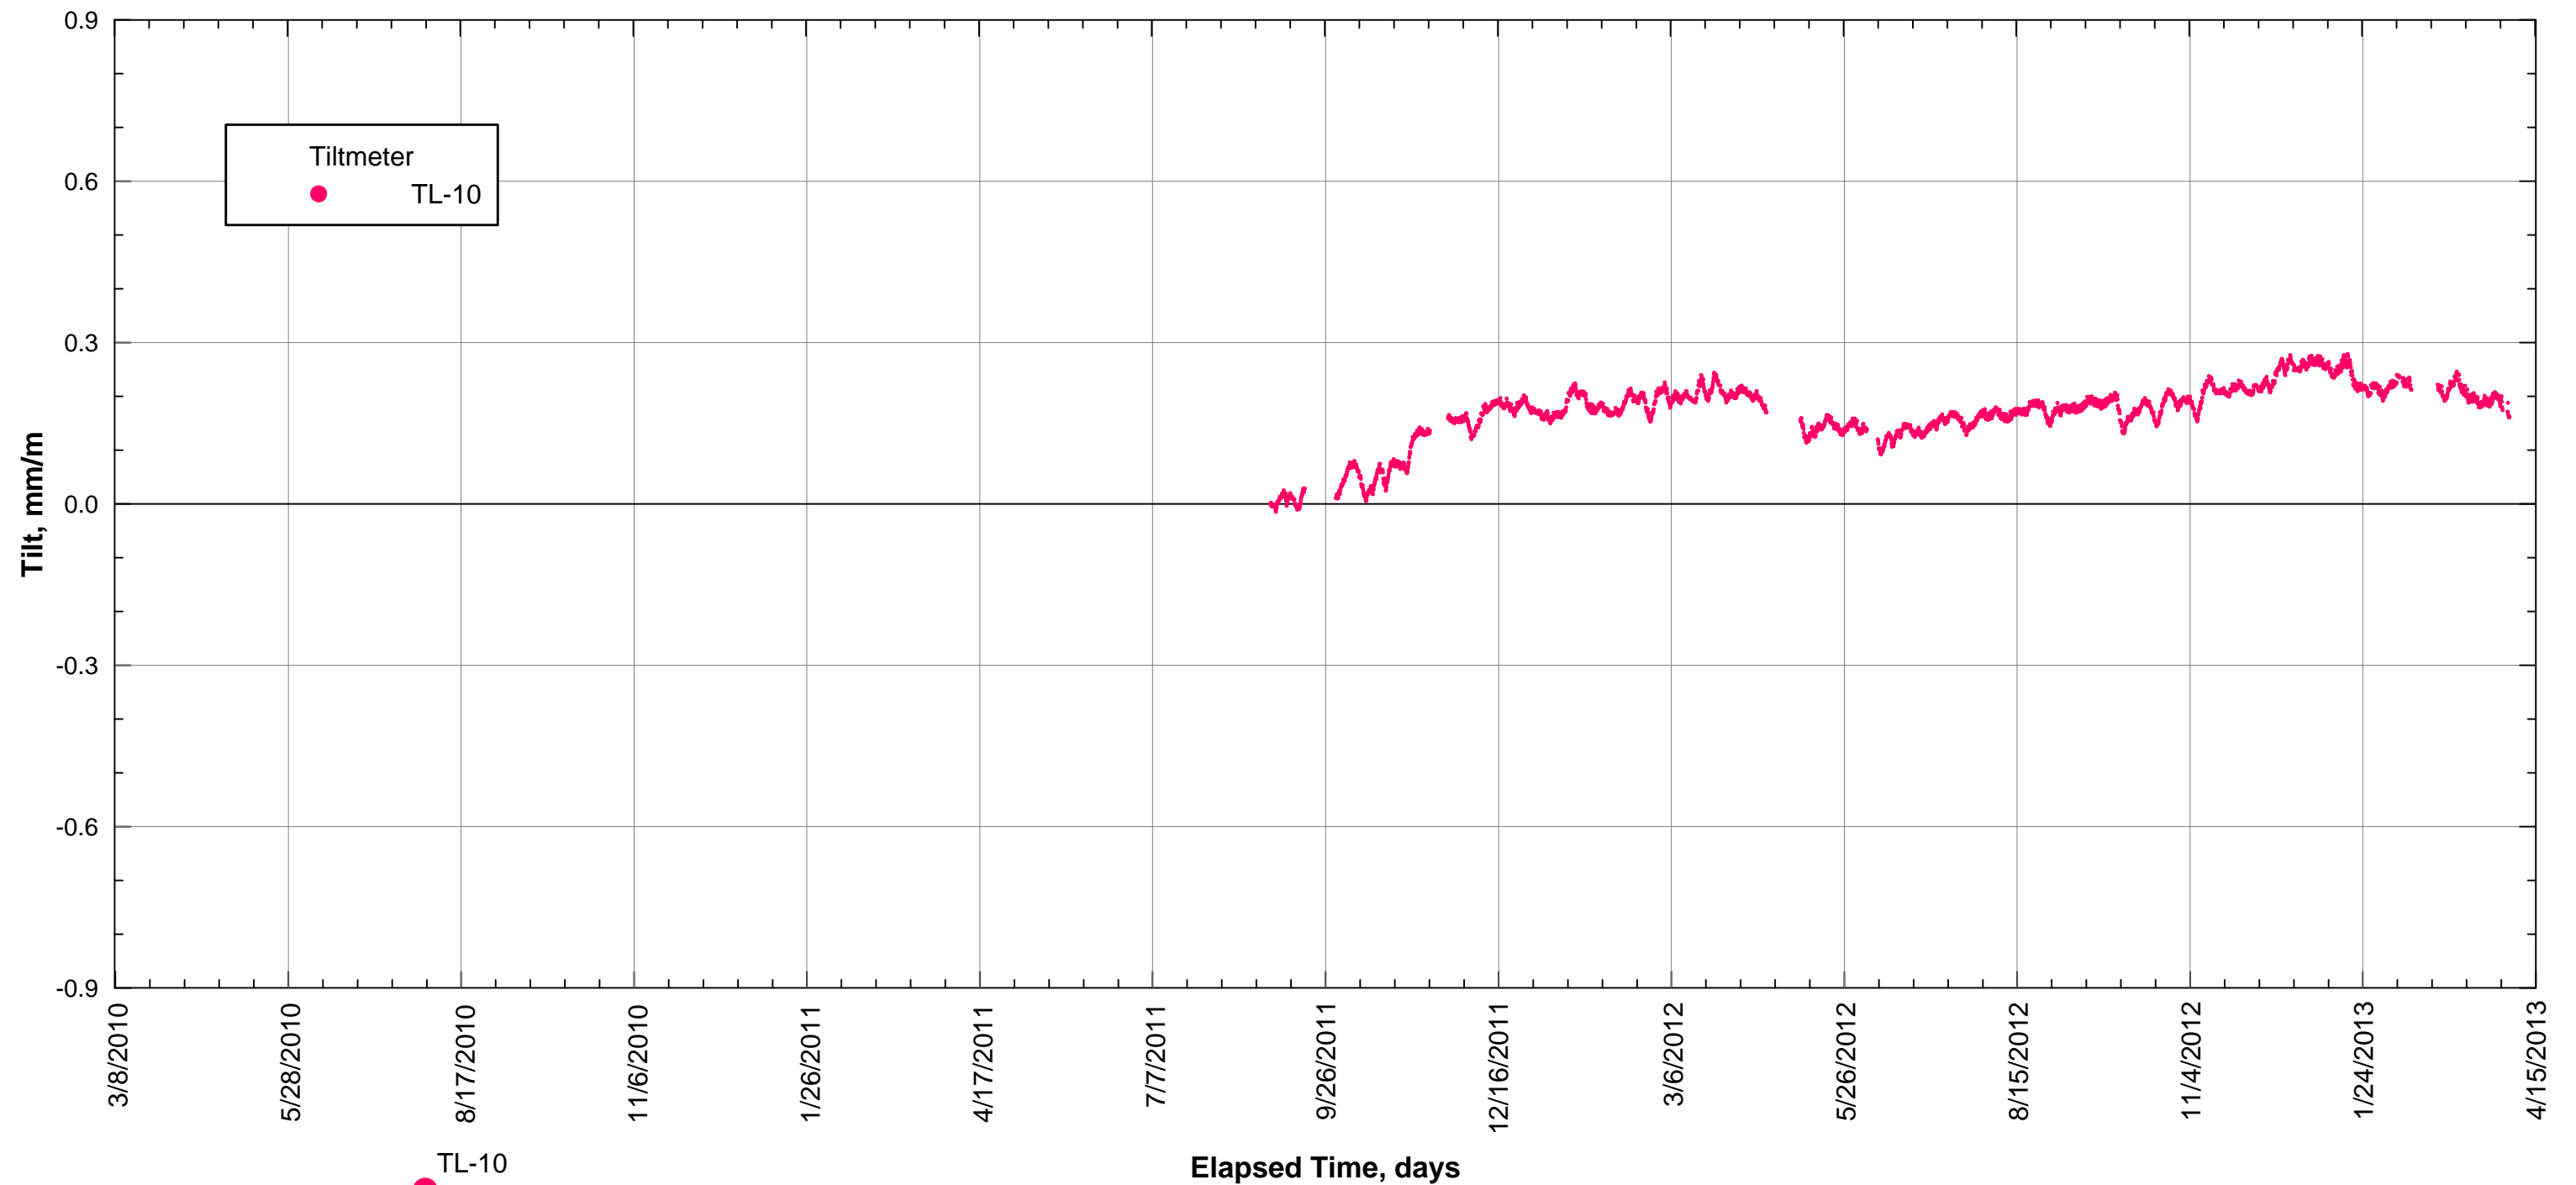
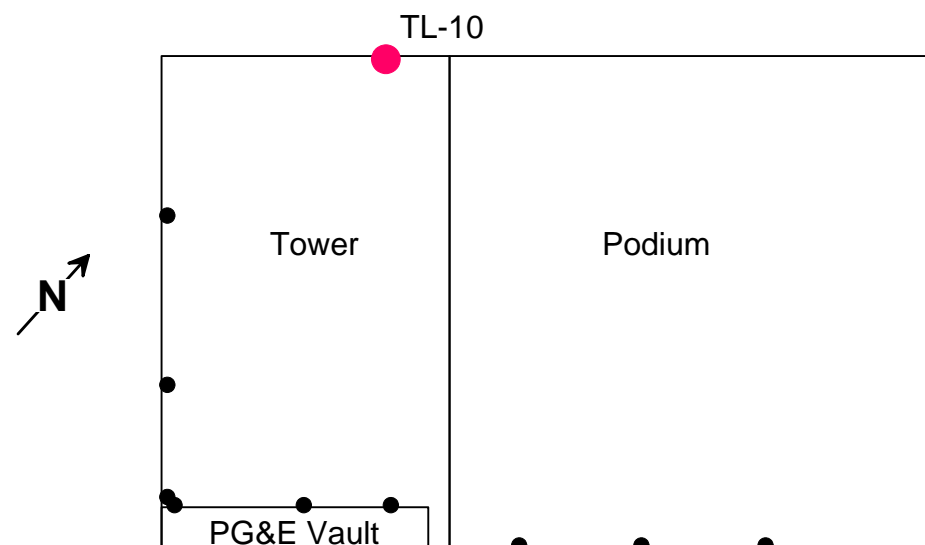
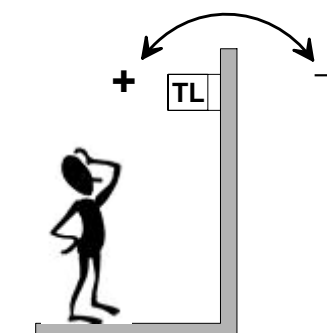
**TILT RECORDED IN TILTMETER TL-10:
BASEMENT LEVEL B-1**

Positive tilt represents movement of the top of the wall towards the inside of the room.
