Supplemental Report for Foundation Settlement Investigation

The building at 301 Mission Street, San Francisco, California is a fifty-eight-story residential structure founded on a pile-supported mat foundation. The building, which was completed in 2009, has experienced and continues to experience significant foundation settlement. Paul Hastings, LLP retained Simpson Gumpertz & Heger Inc. in 2014 to conduct an evaluation of the impact of site settlement on the building's structural stability and earthquake resistance. We performed initial evaluations in 2014 and updated these in 2016 to consider additional settlement that occurred in the interim period. In an October 2016 report we concluded that settlement had not compromised the building's stability or its ability to resist strong earthquakes.

**SUPPLEMENTAL REPORT
FOUNDATION SETTLEMENT INVESTIGATION
301 MISSION STREET
SAN FRANCISCO, CALIFORNIA**

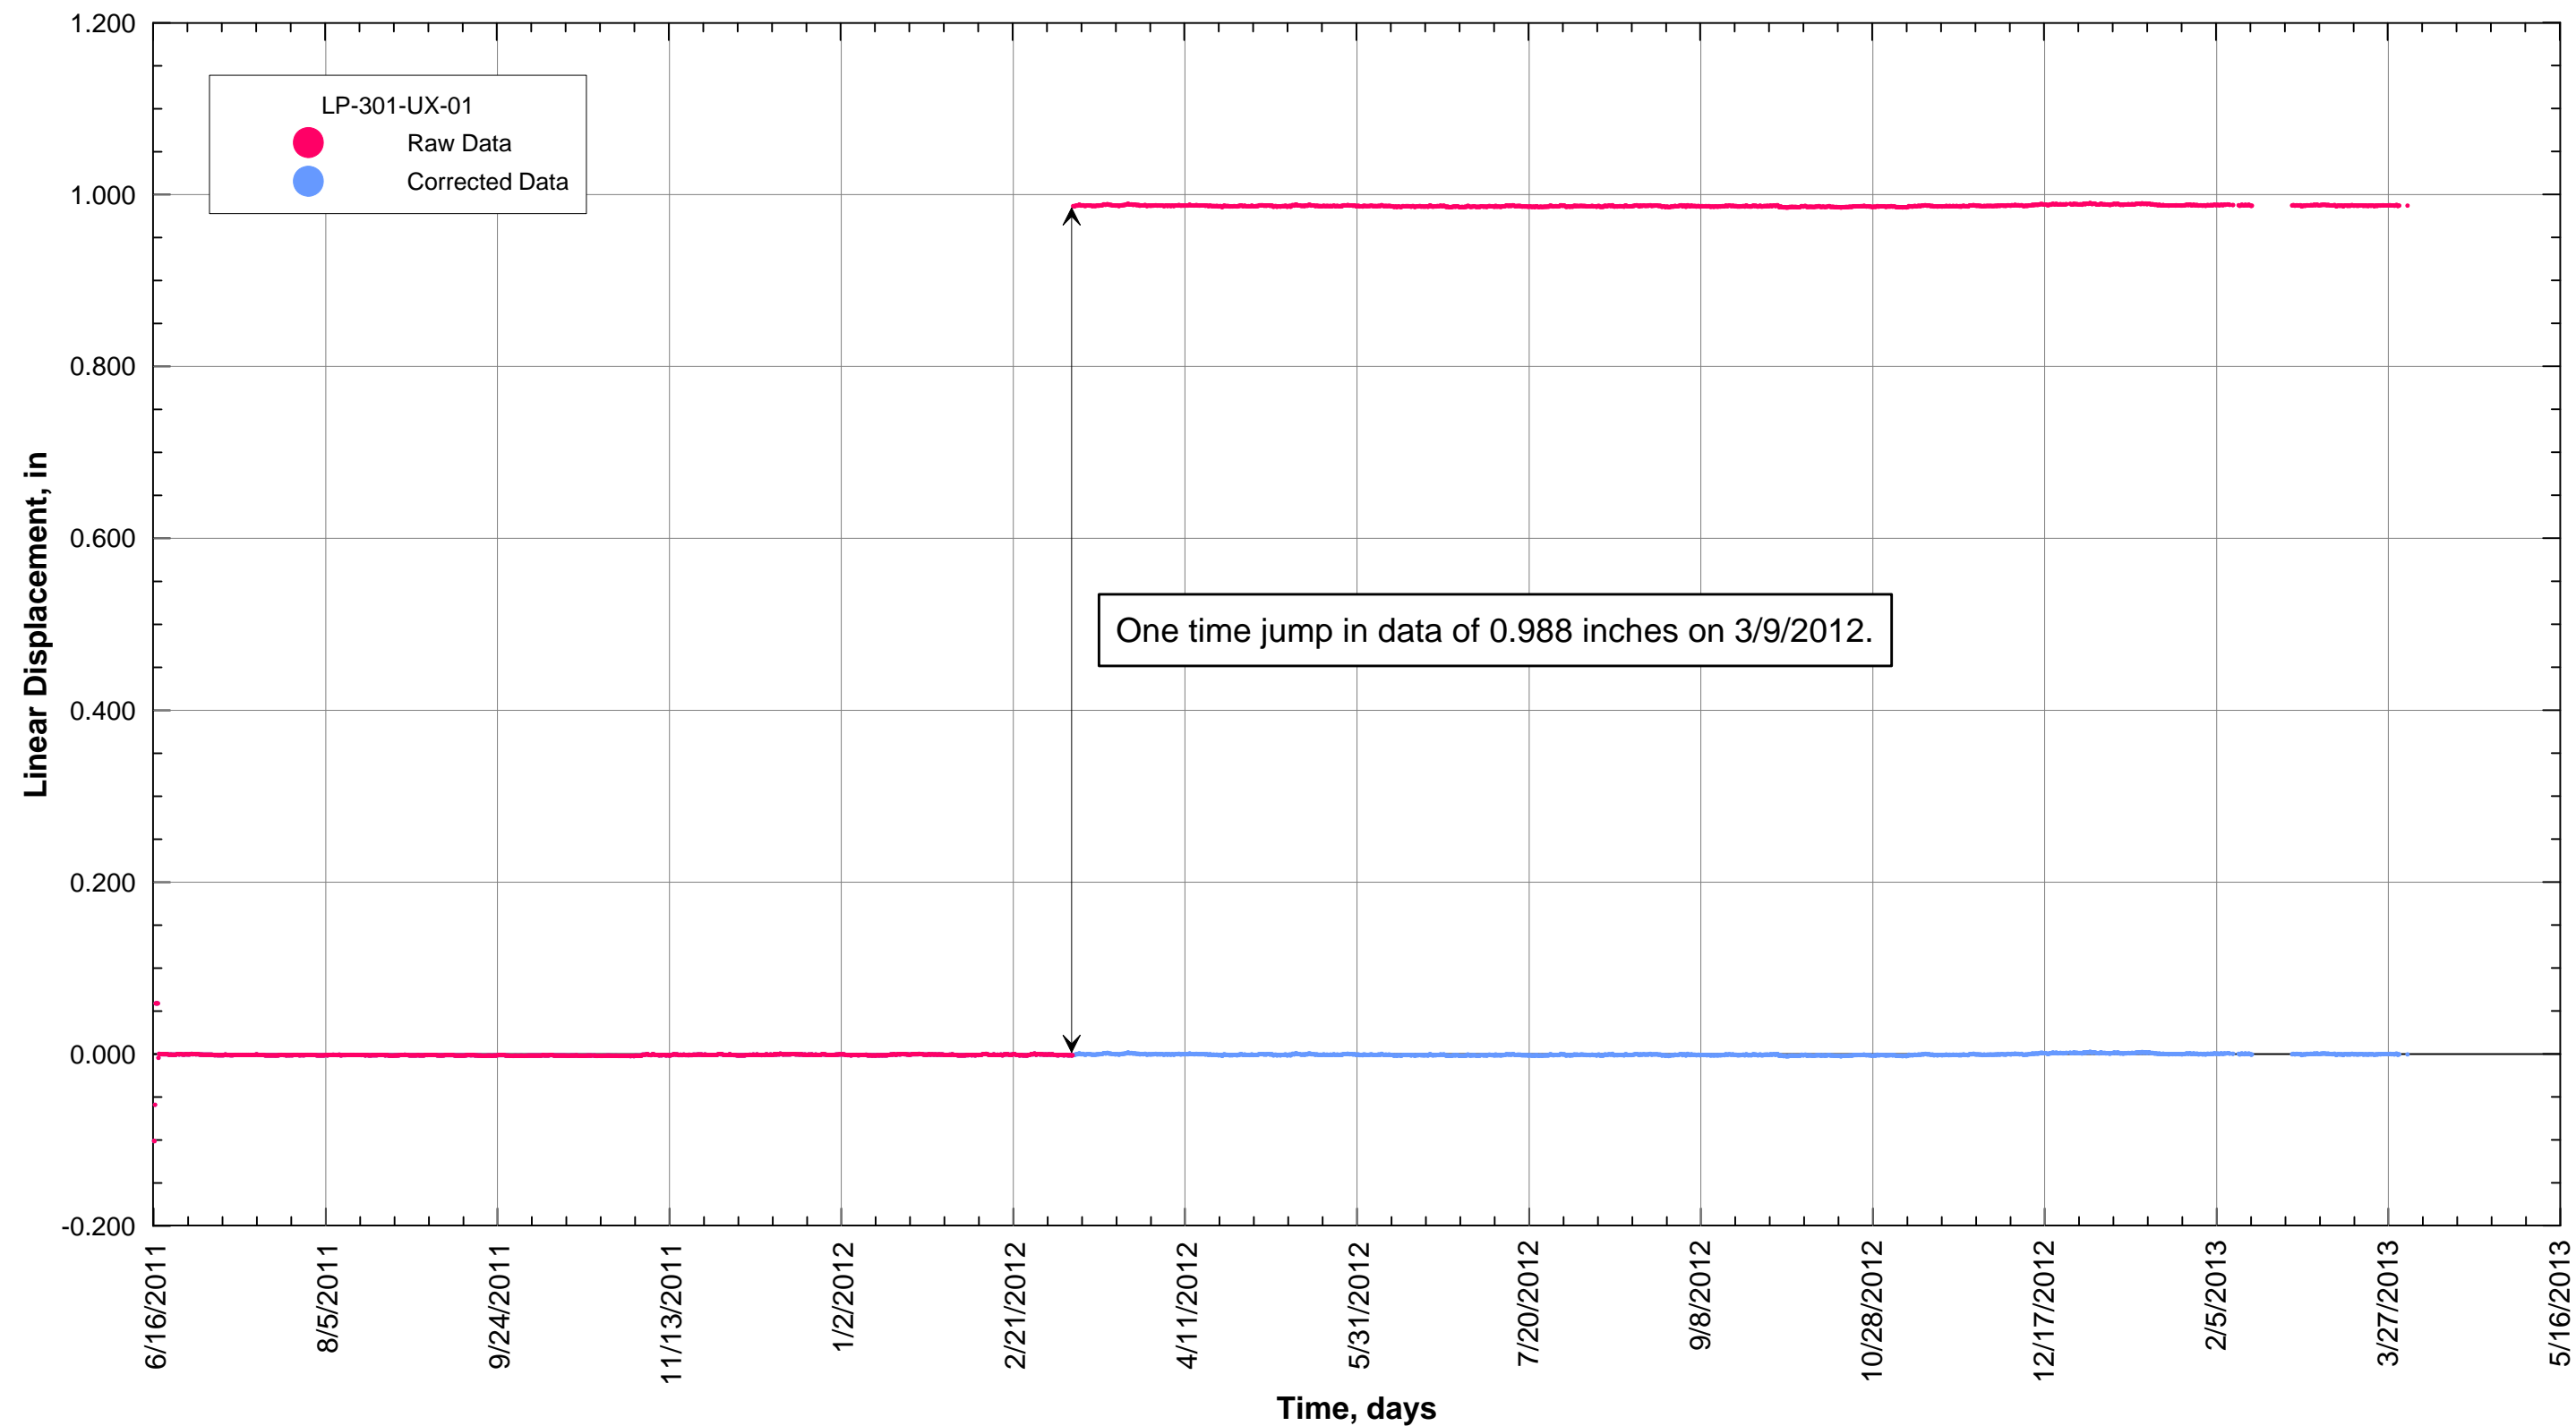
BASELINE CORRECTION EXAMPLE: UC-01

original baseline. An example of the baseline correction for UC-01 is presented on Plate 13 which displays the raw and corrected data as well as the magnitude of the jump. The jump on UC-01 and UC-03 occurred on the same day and was likely caused by the same event given their proximity. The jump on UC-07 occurred during the manual gauge length measurements on 3/19/2013 and was likely inadvertently bumped while the measurement was taken.

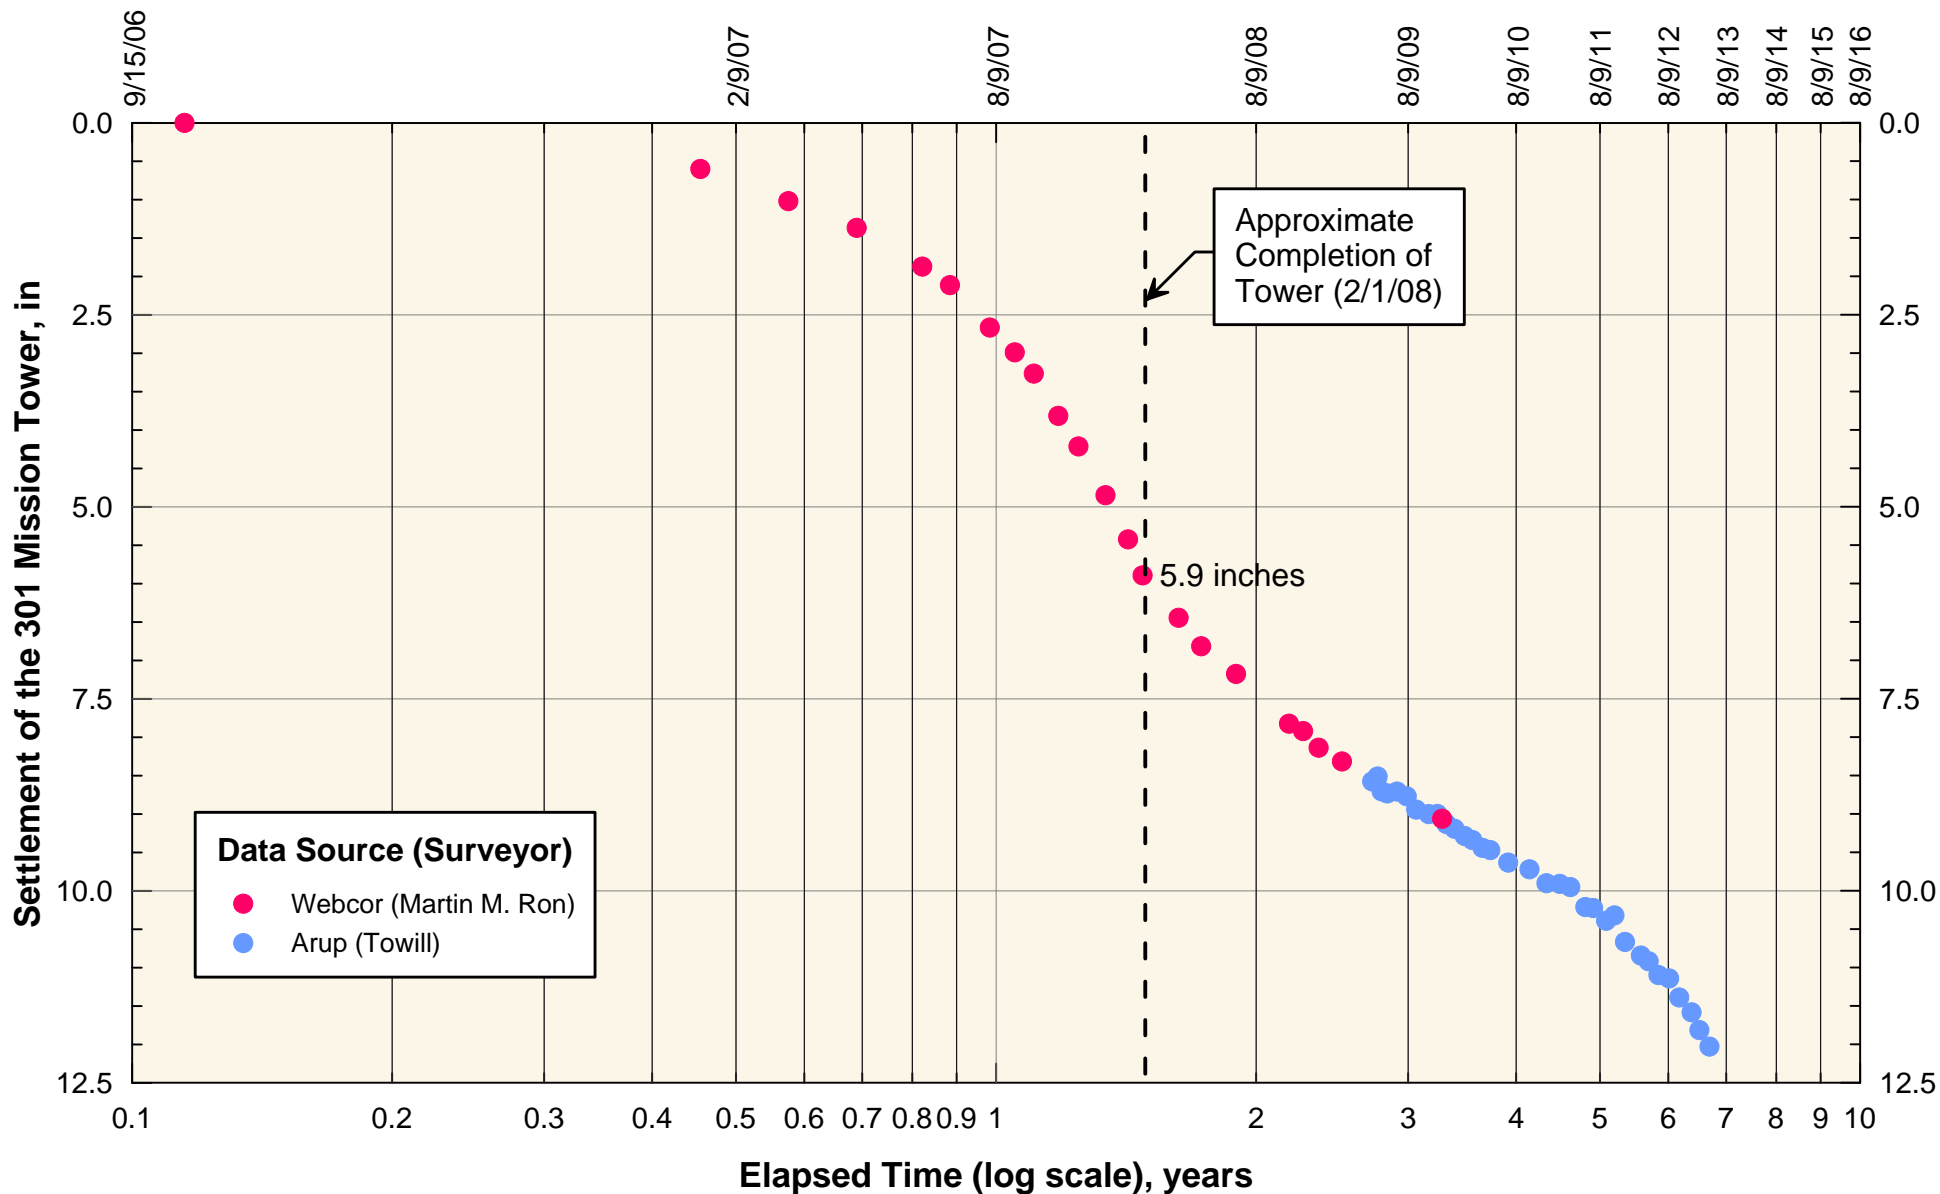
**SETTLEMENTS OF THE 301 MISSION TOWER
 INCLUDING MONITORING DURING CONSTRUCTION**

Beginning of Tower Construction: 8/9/06
 End of Tower Construction: 2/1/08
 Construction Duration: 542 days (1.5 years)

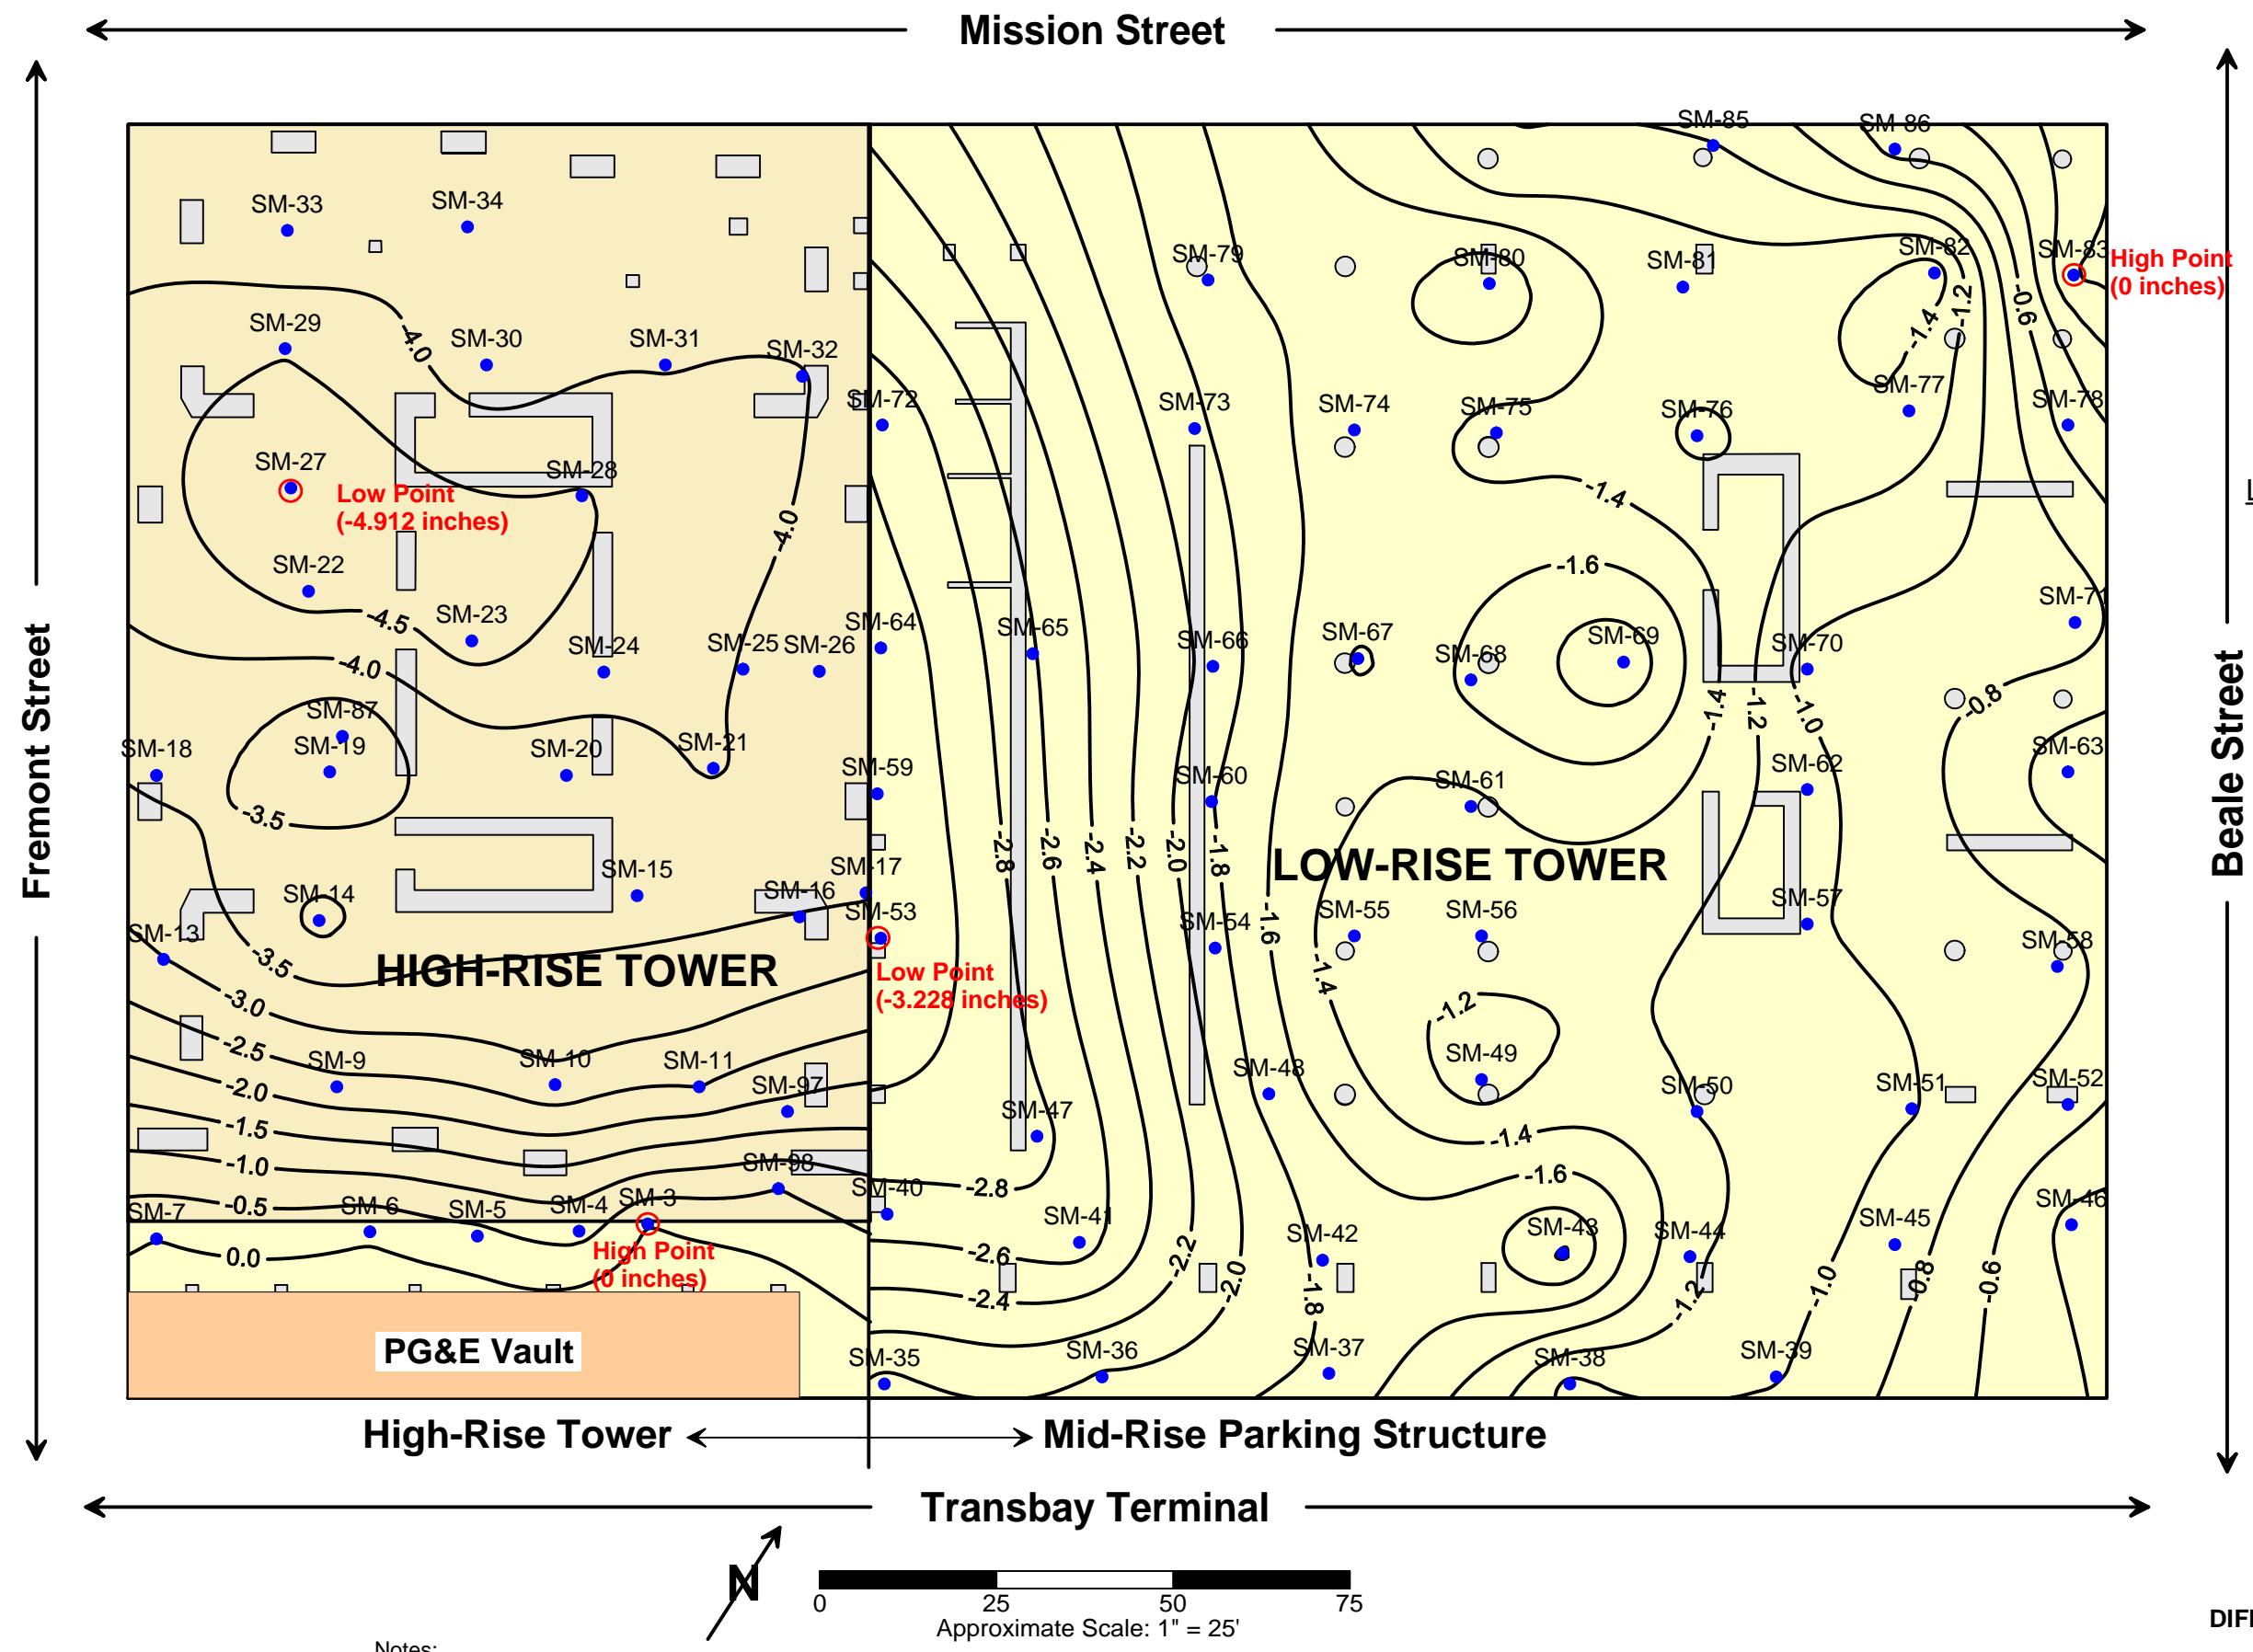
DIFFERENTIAL FLOOR ELEVATIONS (INCHES)
JUNE 03, 2013 SURVEY
Transbay Transit Center
301 Mission Monitoring
Transbay Joint Powers Authority
San Francisco, California
June 2013

Notes:
Contours represent differential elevation, in inches, between the highest point and all other points taken on June 3, 2013.
Level B-1 at Mid-Rise Parking portion of survey site is approximately 4 inches higher than Level B-1 at High-Rise Tower portion.
The PG&E vault is inaccessible for monitoring.
Contour intervals are different between the High-Rise Tower and the Low-Rise Tower.

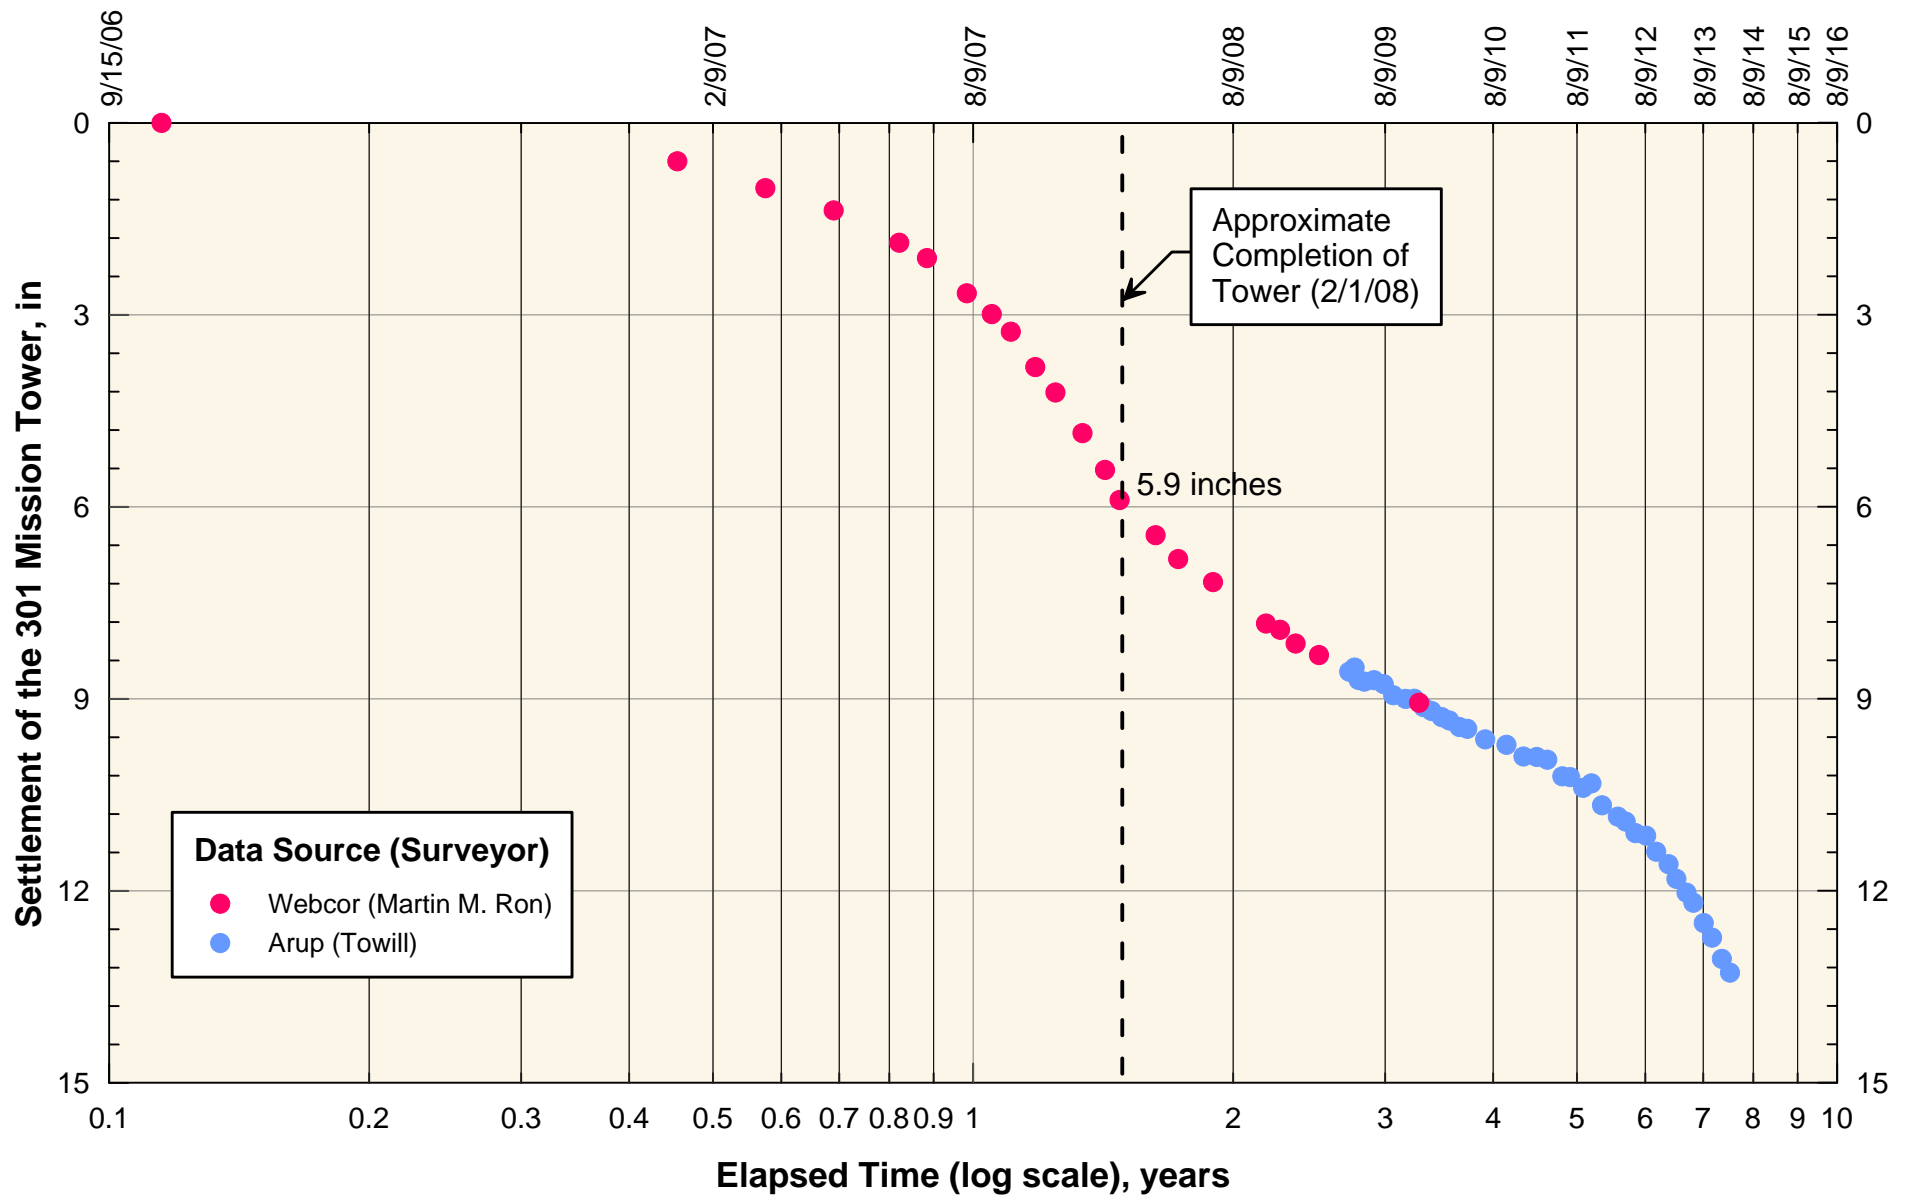
Beginning of Tower Construction: 8/9/06
 End of Tower Construction: 2/1/08
 Construction Duration: 542 days (1.5 years)

**SETTLEMENTS OF THE 301 MISSION TOWER
 INCLUDING MONITORING DURING CONSTRUCTION**

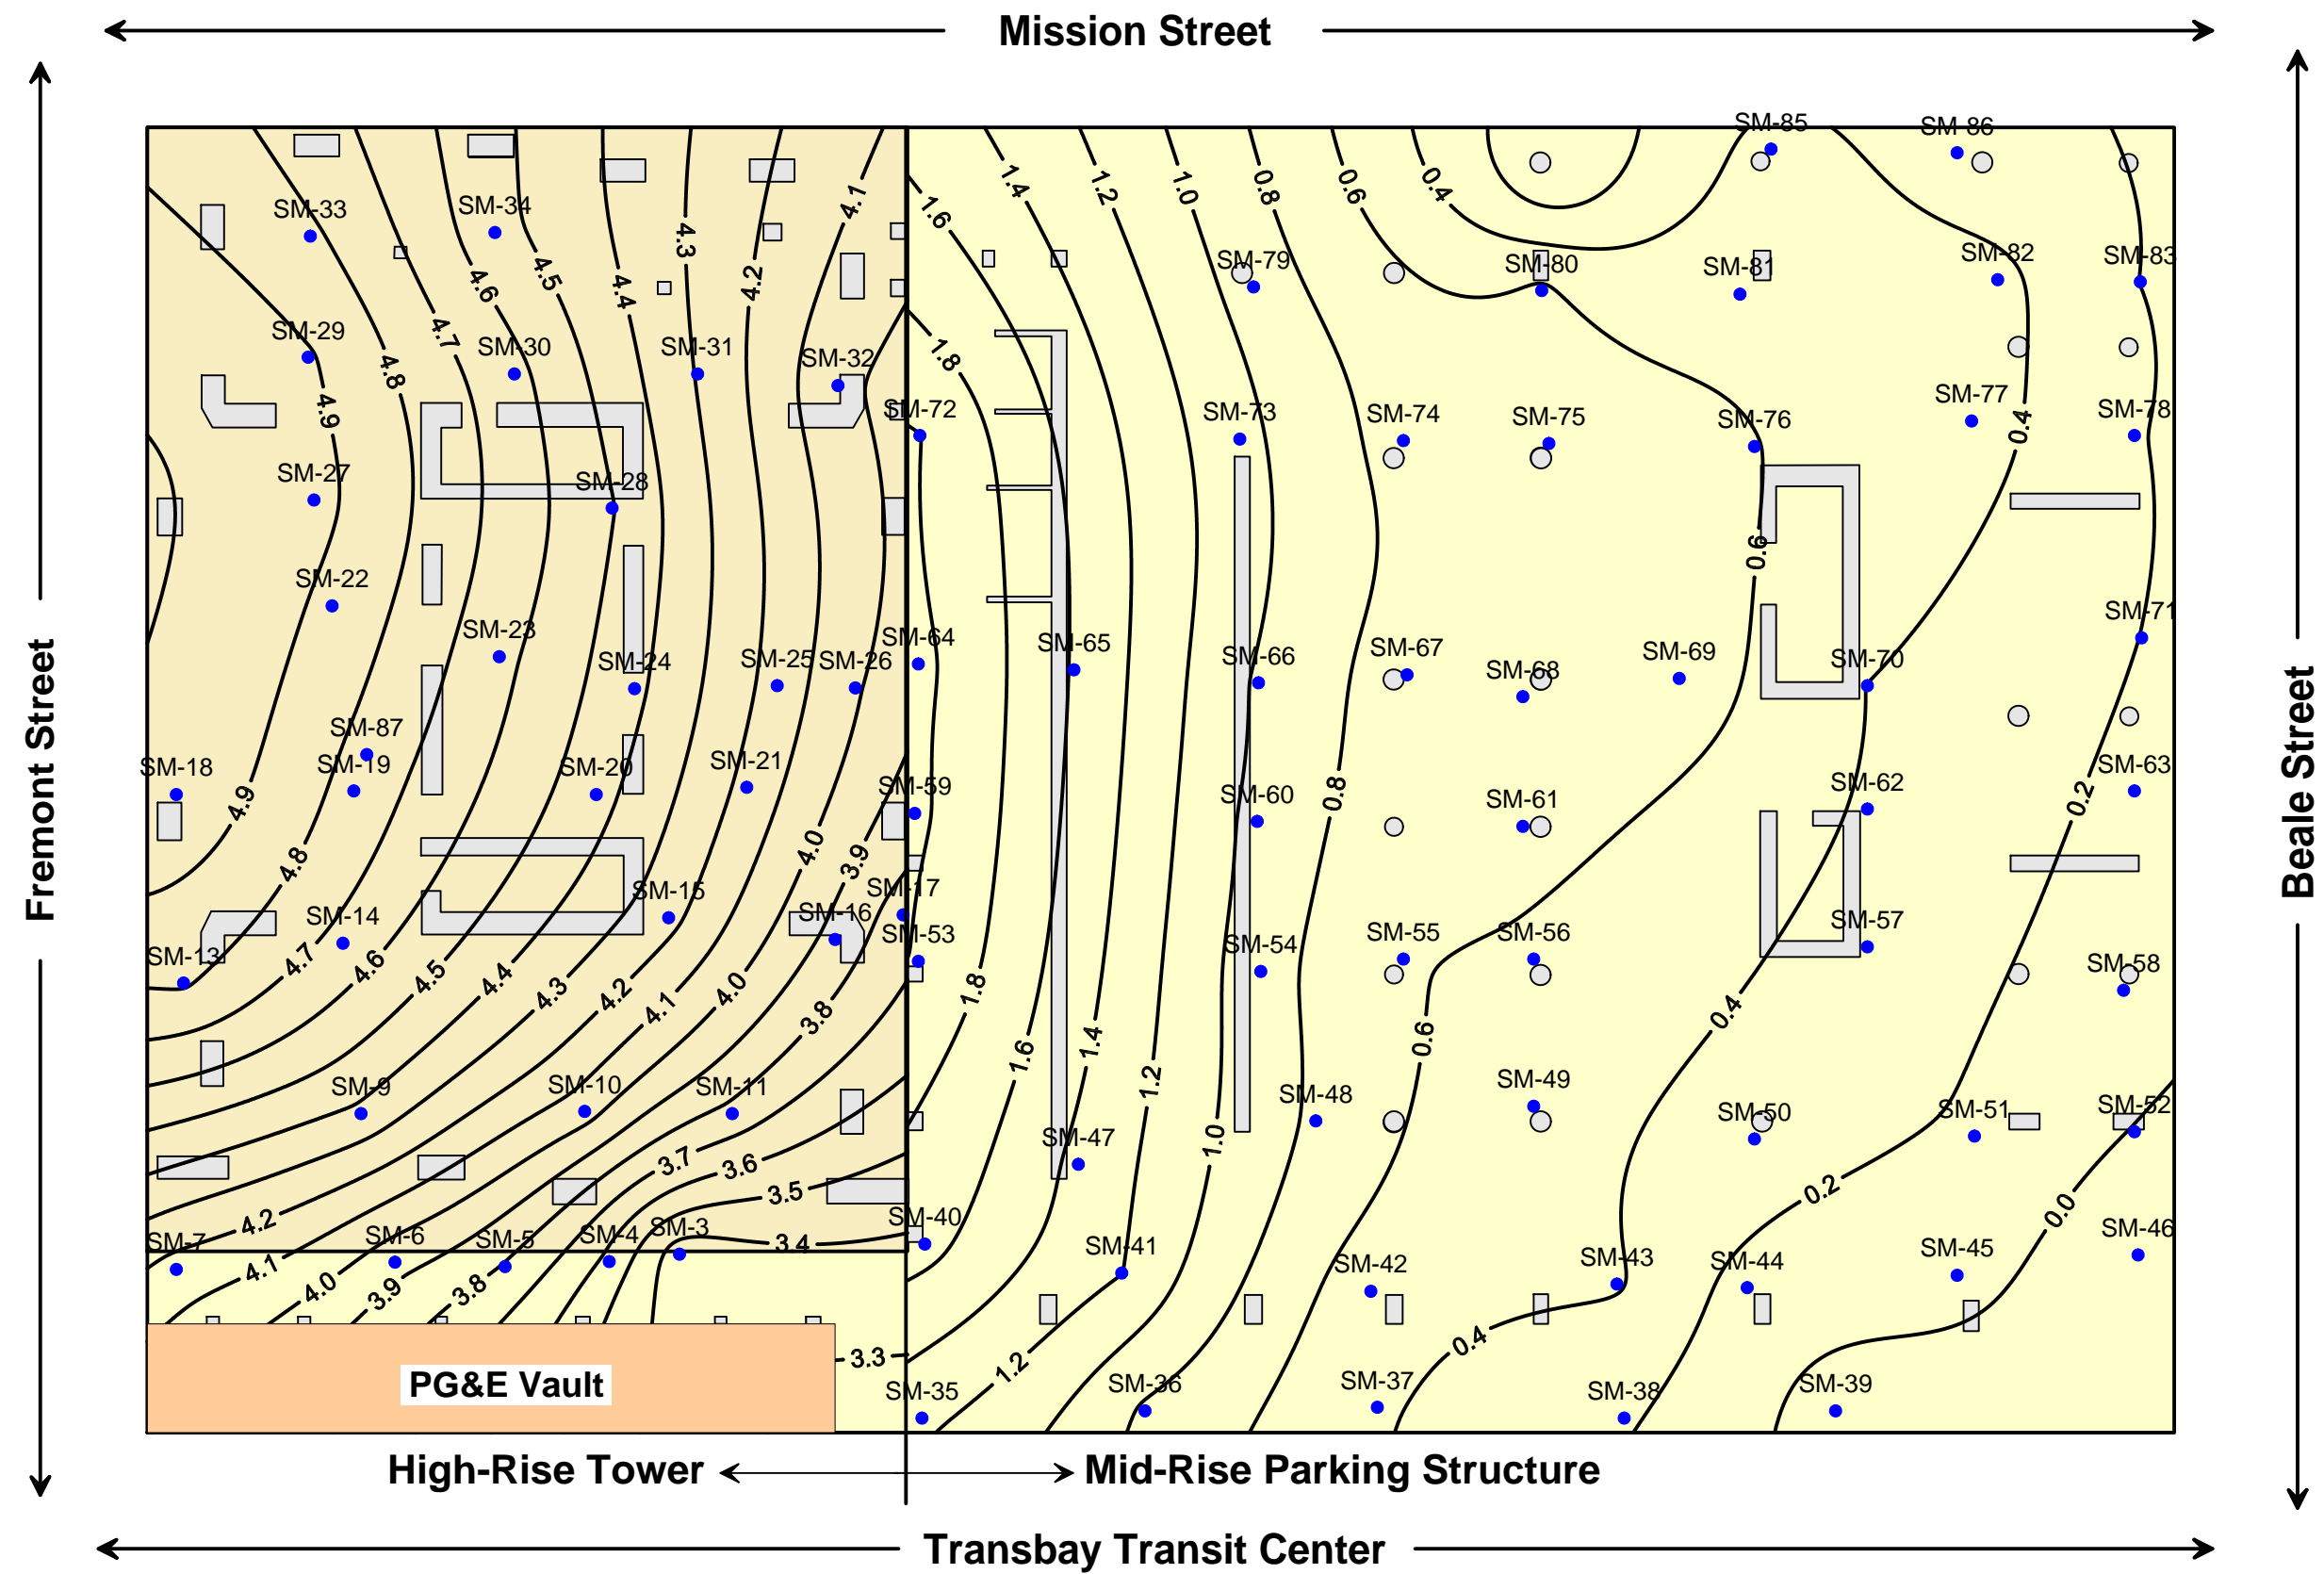
Notes:
 Contours represent elevation change, in inches, between Baseline survey (April 30, 2009) and readings taken on April 11, 2014.
 Level B-1 at Mid-Rise Parking portion of survey site is approximately 4 inches higher than Level B-1 at High-Rise Tower portion.
 The PG&E vault is inaccessible for monitoring.
 Negative values of settlement (within Low-rise Tower) indicate uplift.

**CONTOURS OF SETTLEMENTS MEASURED AT THE
 1ST LEVEL BASEMENT OF THE 301 MISSION ST
 STRUCTURE BETWEEN 04/30/2009 & 4/11/2014**
 Transbay Transit Center
 301 Mission Monitoring
 Transbay Joint Powers Authority
 San Francisco, California
 May 2014

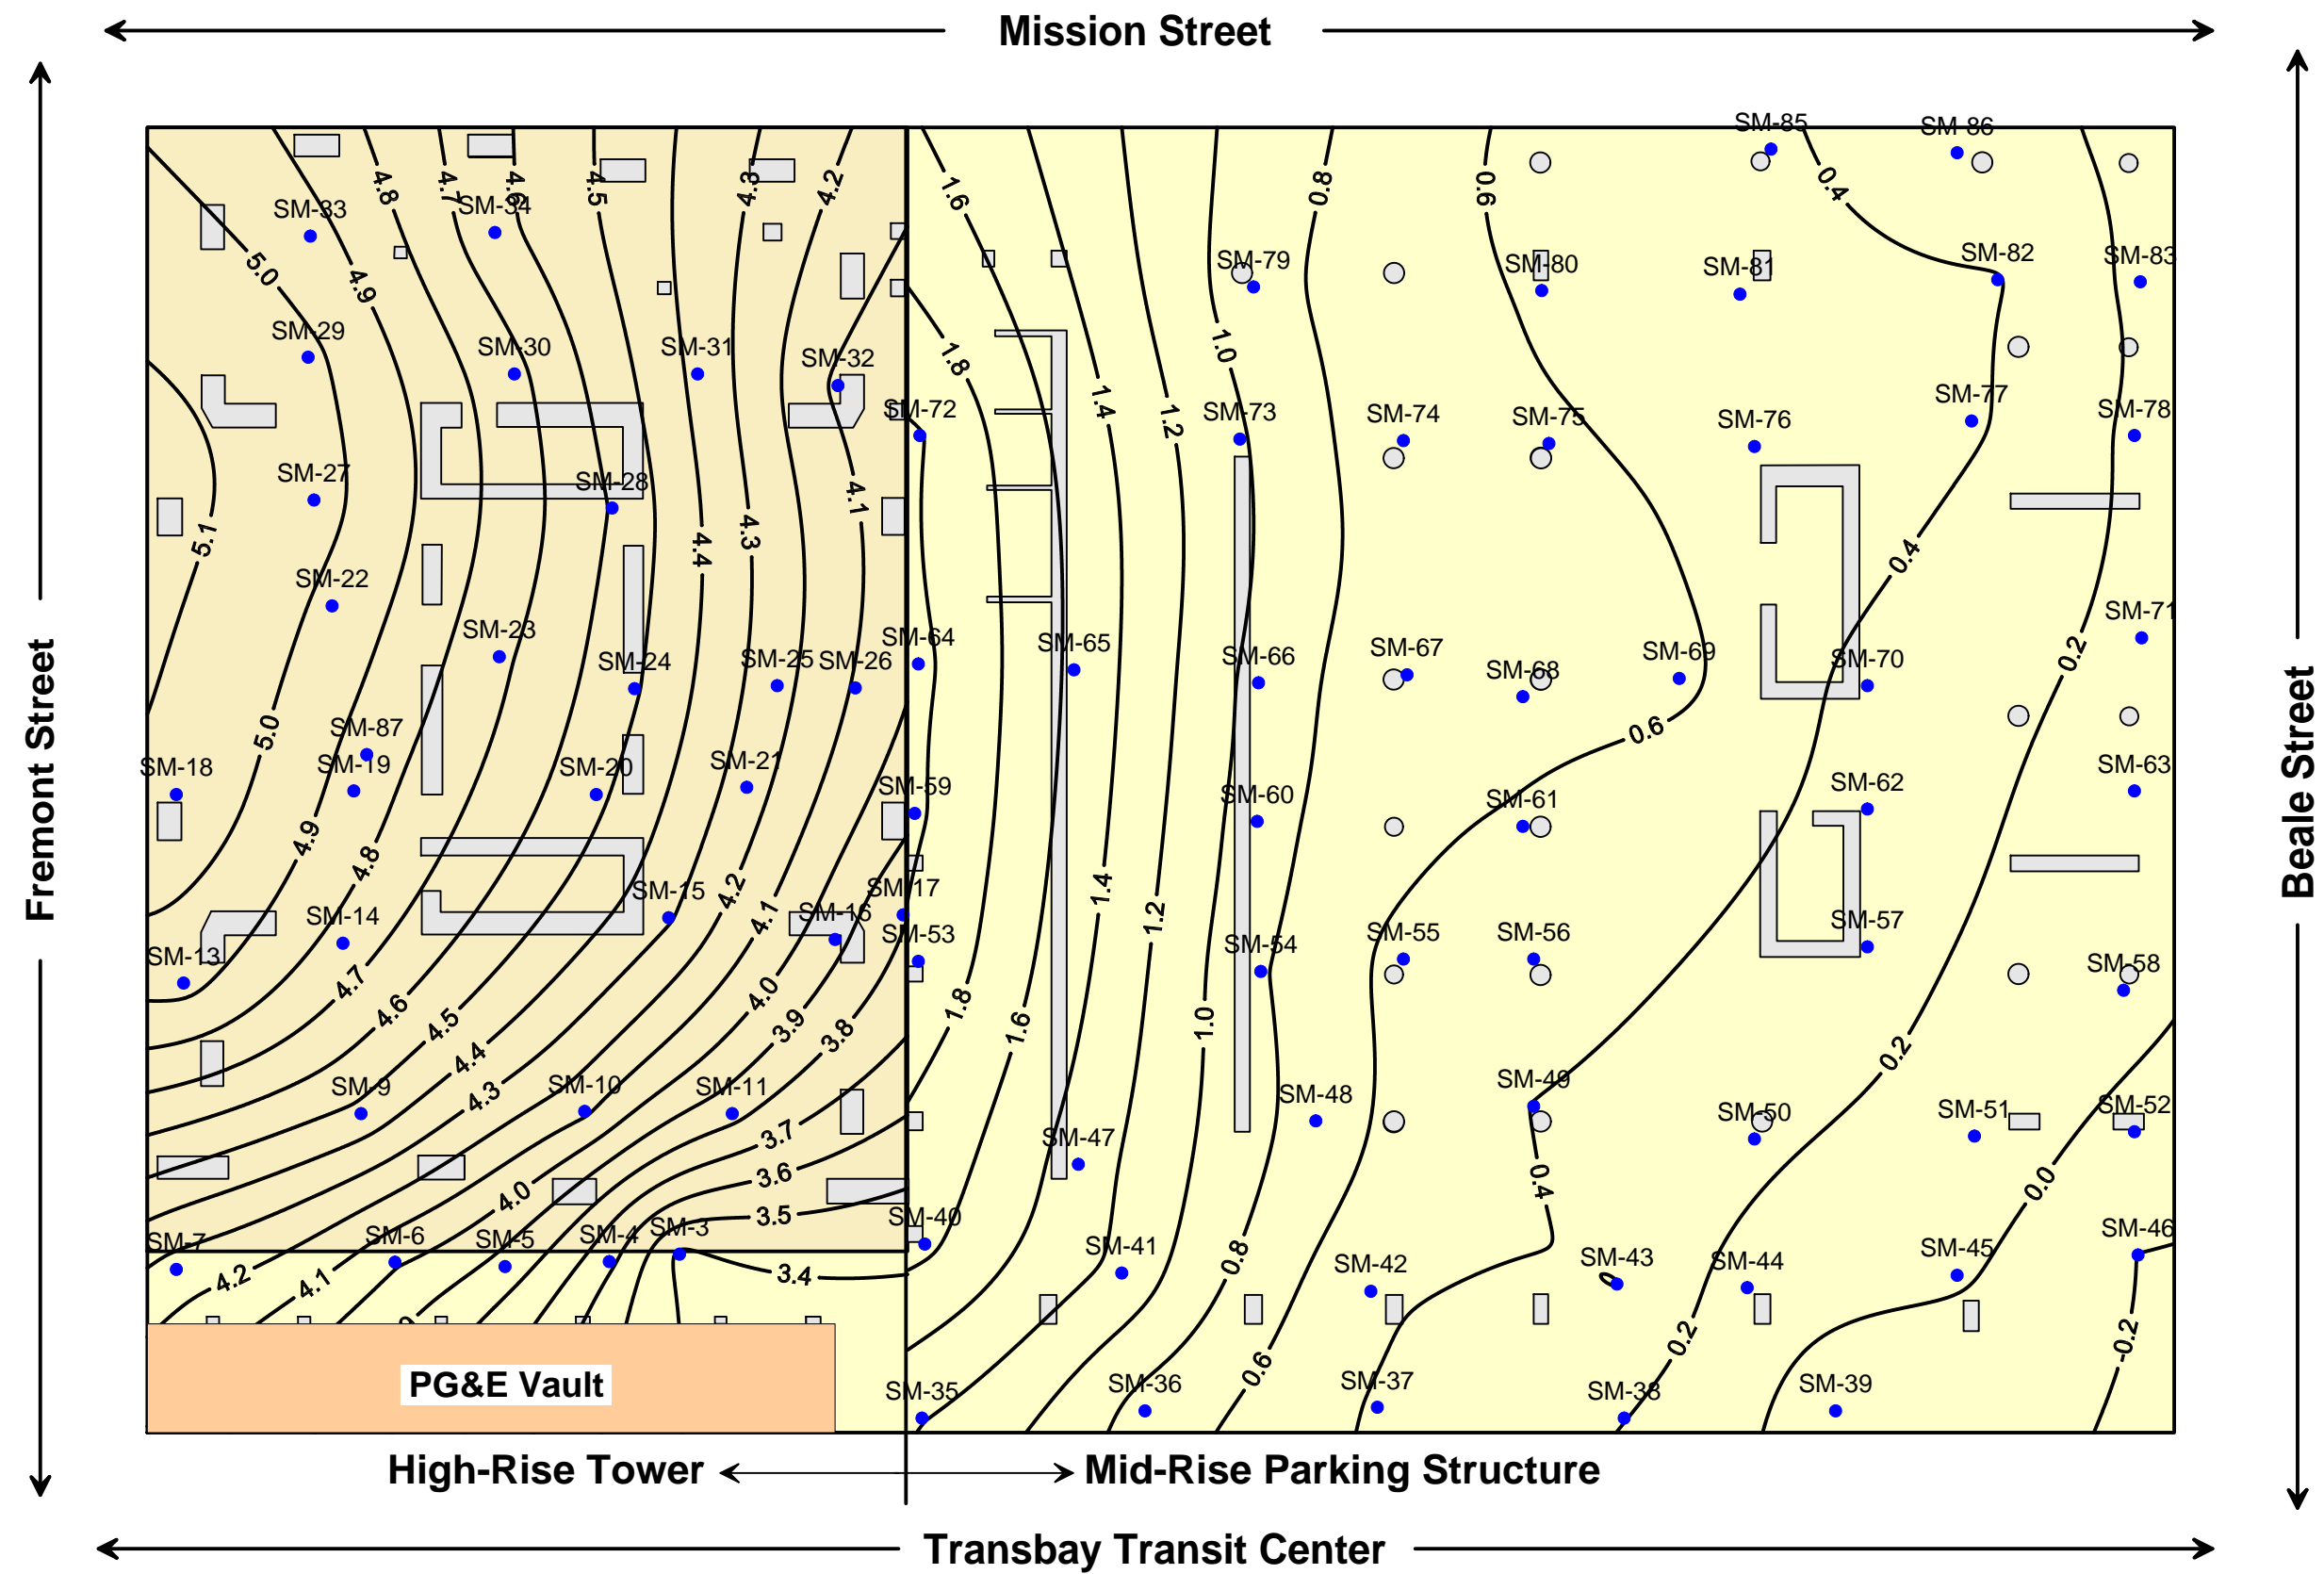
Notes:
 Contours represent elevation change, in inches, between Baseline survey (April 30, 2009) and readings taken on June 11, 2014.
 Level B-1 at Mid-Rise Parking portion of survey site is approximately 4 inches higher than Level B-1 at High-Rise Tower portion.
 The PG&E vault is inaccessible for monitoring.
 Negative values of settlement (within Low-rise Tower) indicate uplift.

CONTOURS OF SETTLEMENTS MEASURED AT THE 1ST LEVEL BASEMENT OF THE 301 MISSION ST STRUCTURE BETWEEN 04/30/2009 & 6/11/2014
 Transbay Transit Center
 301 Mission Monitoring
 Transbay Joint Powers Authority
 San Francisco, California
 June 2014

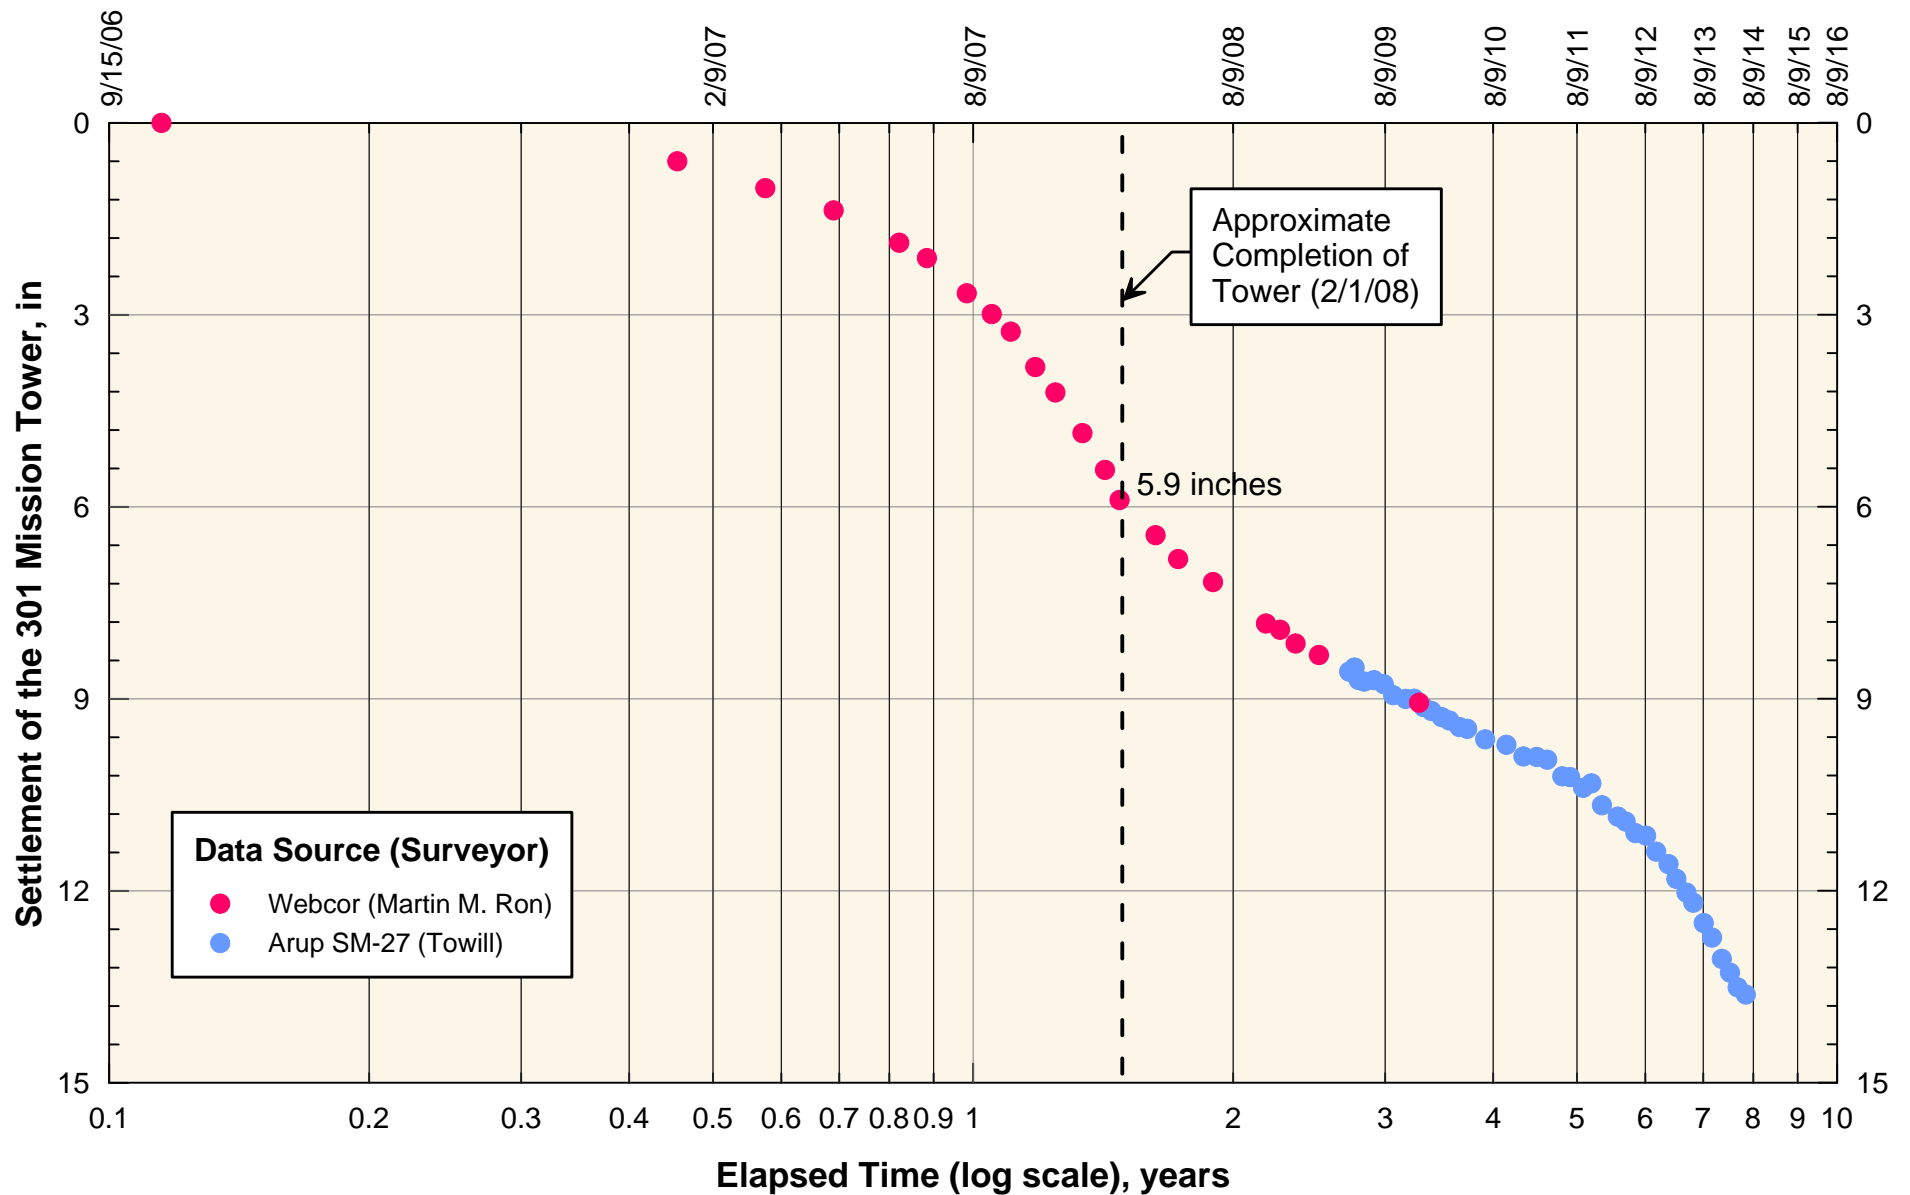
Beginning of Tower Construction: 8/9/06
 End of Tower Construction: 2/1/08
 Construction Duration: 542 days (1.5 years)

**SETTLEMENTS OF THE 301 MISSION TOWER
 INCLUDING MONITORING DURING CONSTRUCTION**
