Supplemental Report for Foundation Settlement Investigation

The building at 301 Mission Street, San Francisco, California is a fifty-eight-story residential structure founded on a pile-supported mat foundation. The building, which was completed in 2009, has experienced and continues to experience significant foundation settlement. Paul Hastings, LLP retained Simpson Gumpertz & Heger Inc. in 2014 to conduct an evaluation of the impact of site settlement on the building's structural stability and earthquake resistance. We performed initial evaluations in 2014 and updated these in 2016 to consider additional settlement that occurred in the interim period. In an October 2016 report we concluded that settlement had not compromised the building's stability or its ability to resist strong earthquakes.

**SUPPLEMENTAL REPORT
FOUNDATION SETTLEMENT INVESTIGATION
301 MISSION STREET
SAN FRANCISCO, CALIFORNIA**

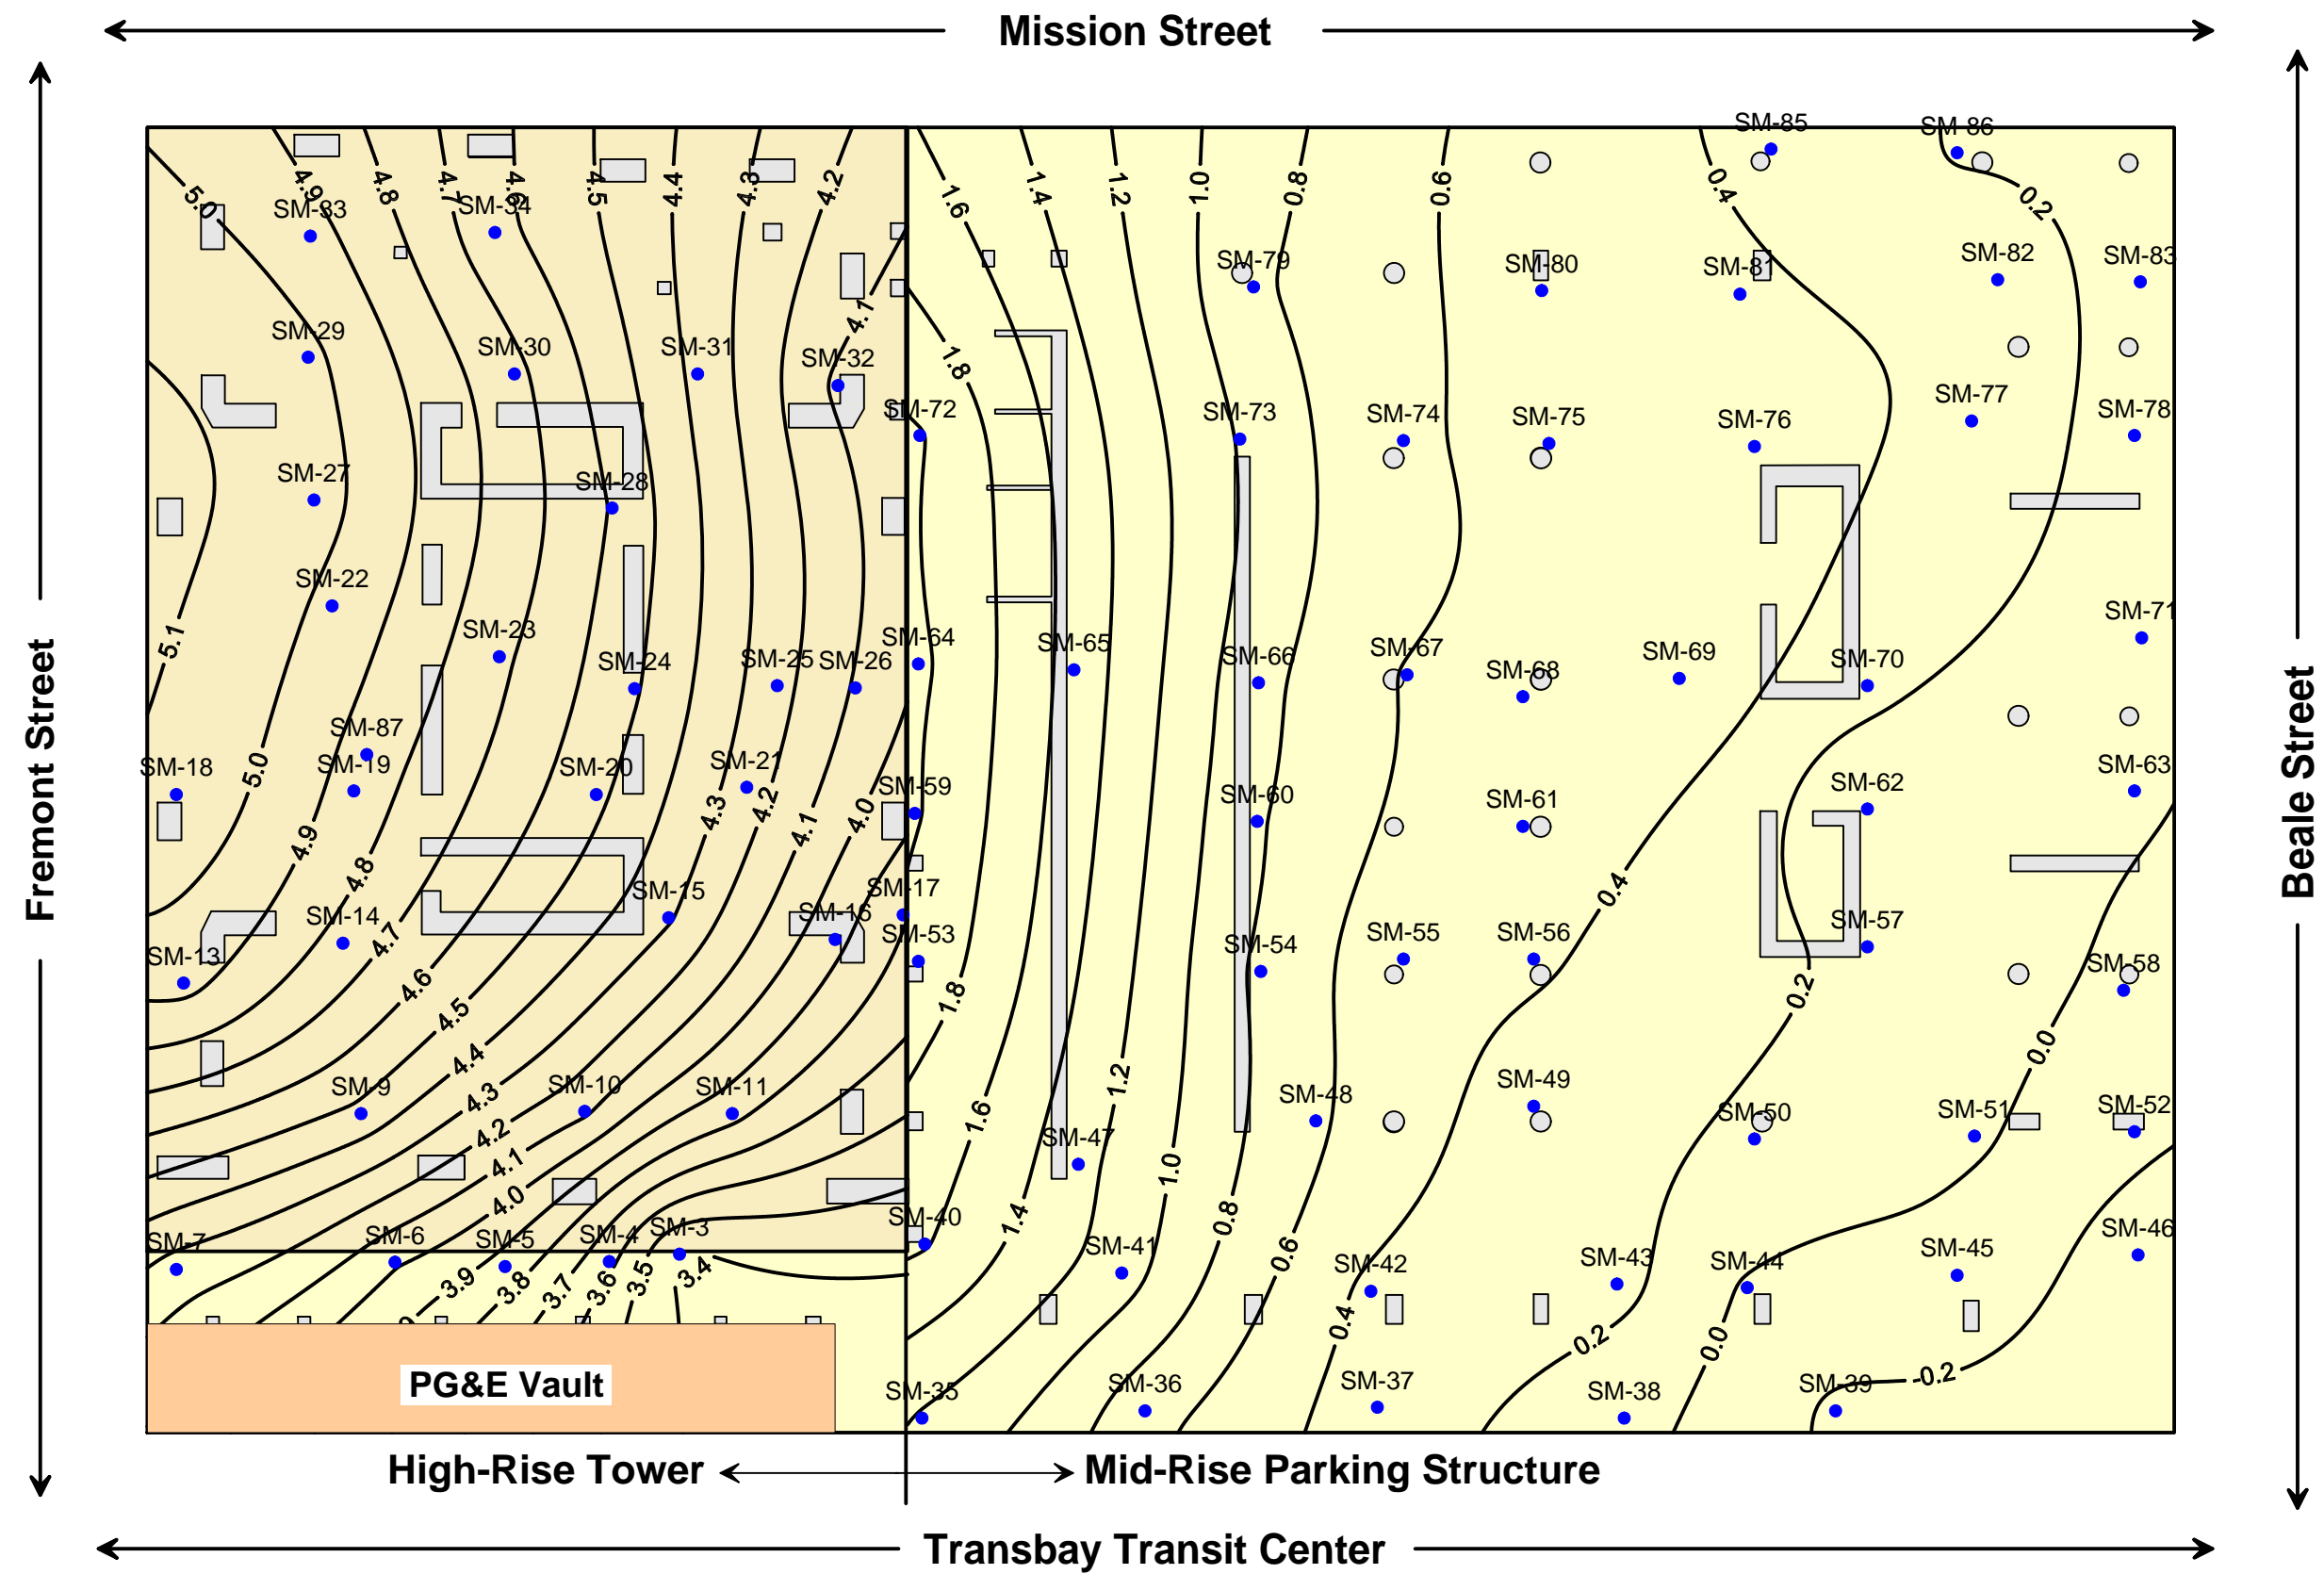
Notes:
 Contours represent elevation change, in inches, between Baseline survey (April 30, 2009) and readings taken on August 5, 2014.
 Level B-1 at Mid-Rise Parking portion of survey site is approximately 4 inches higher than Level B-1 at High-Rise Tower portion.
 The PG&E vault is inaccessible for monitoring.
 Negative values of settlement (within Low-rise Tower) indicate uplift.

**CONTOURS OF SETTLEMENTS MEASURED AT THE
 1ST LEVEL BASEMENT OF THE 301 MISSION ST
 STRUCTURE BETWEEN 04/30/2009 & 8/5/2014**

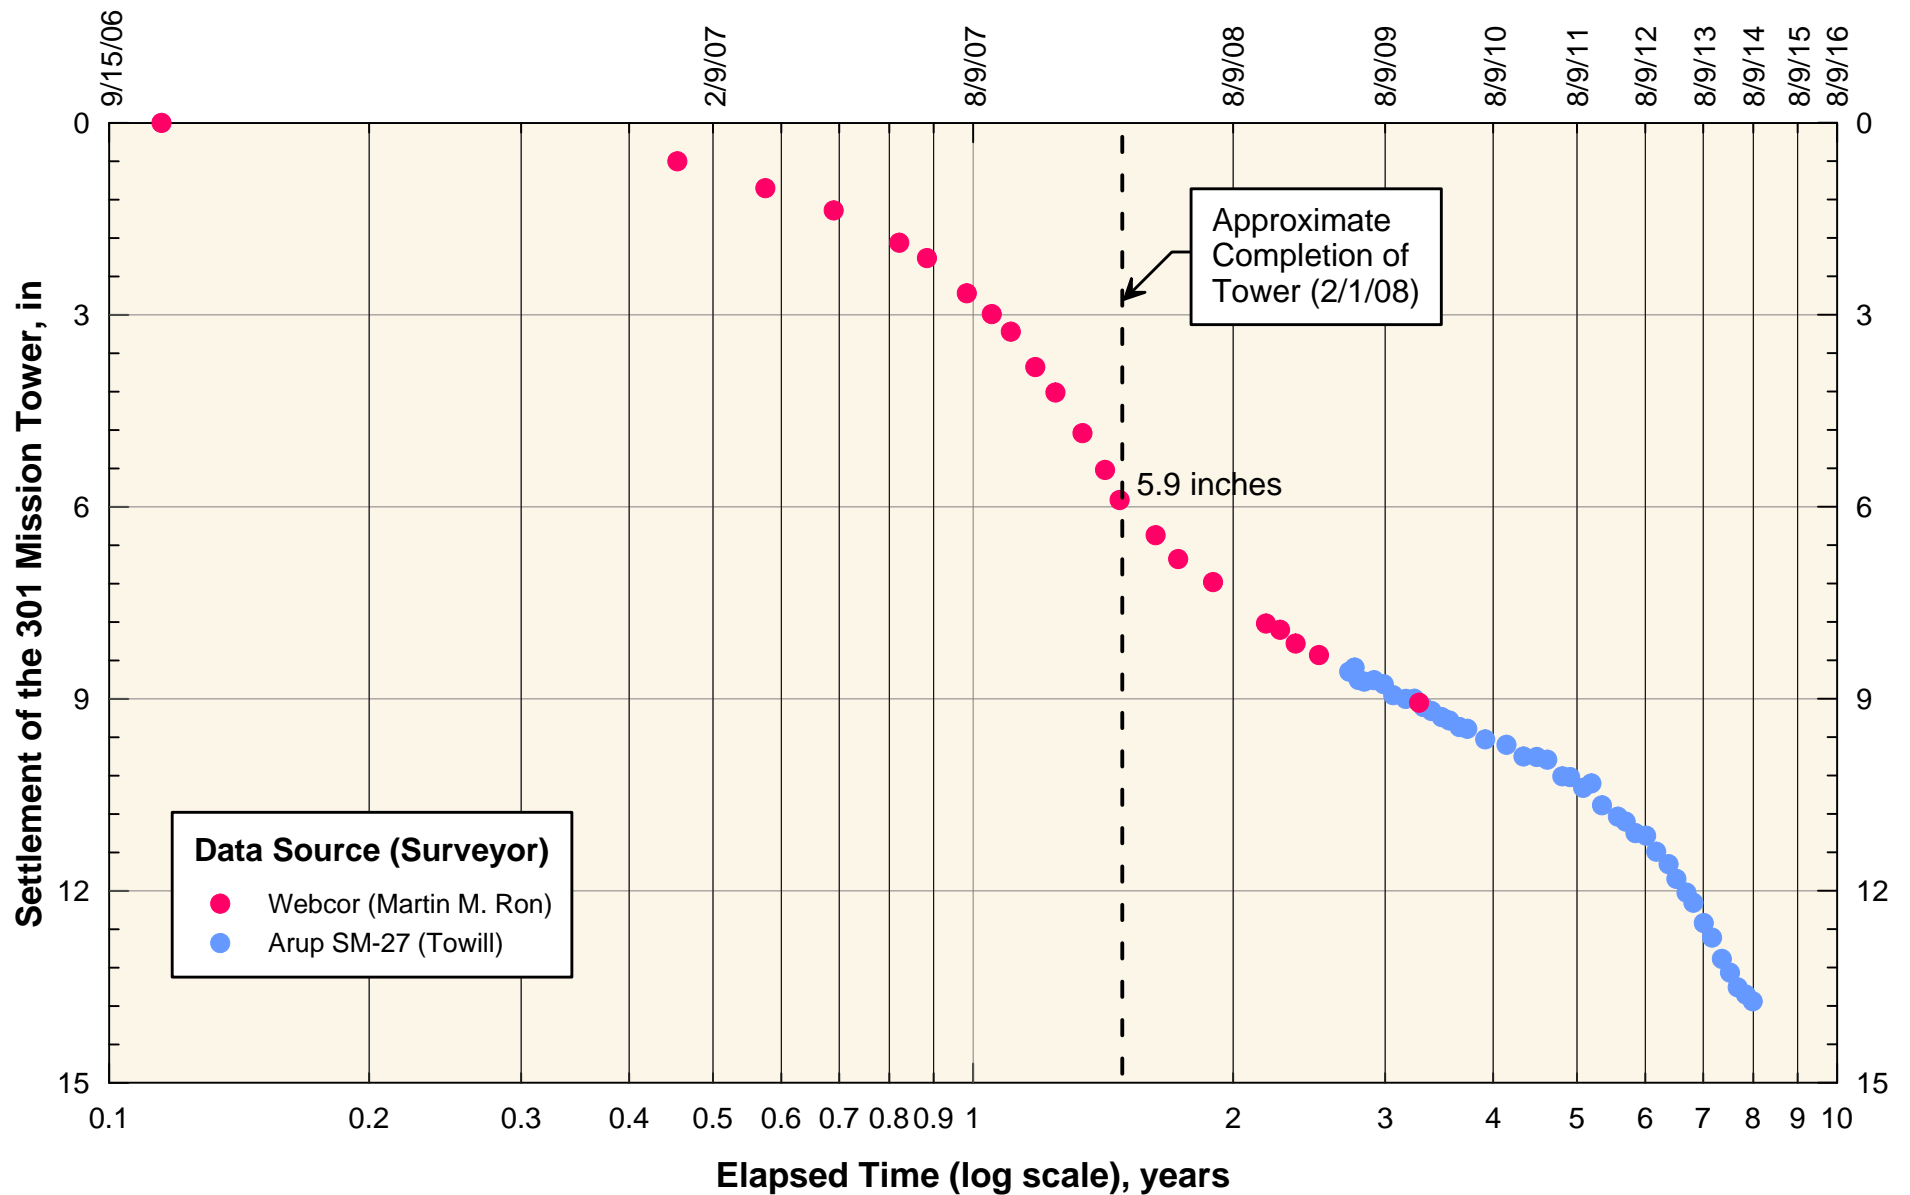
Beginning of Tower Construction: 8/9/06
 End of Tower Construction: 2/1/08
 Construction Duration: 542 days (1.5 years)

SETTLEMENTS OF THE 301 MISSION TOWER INCLUDING MONITORING DURING CONSTRUCTION

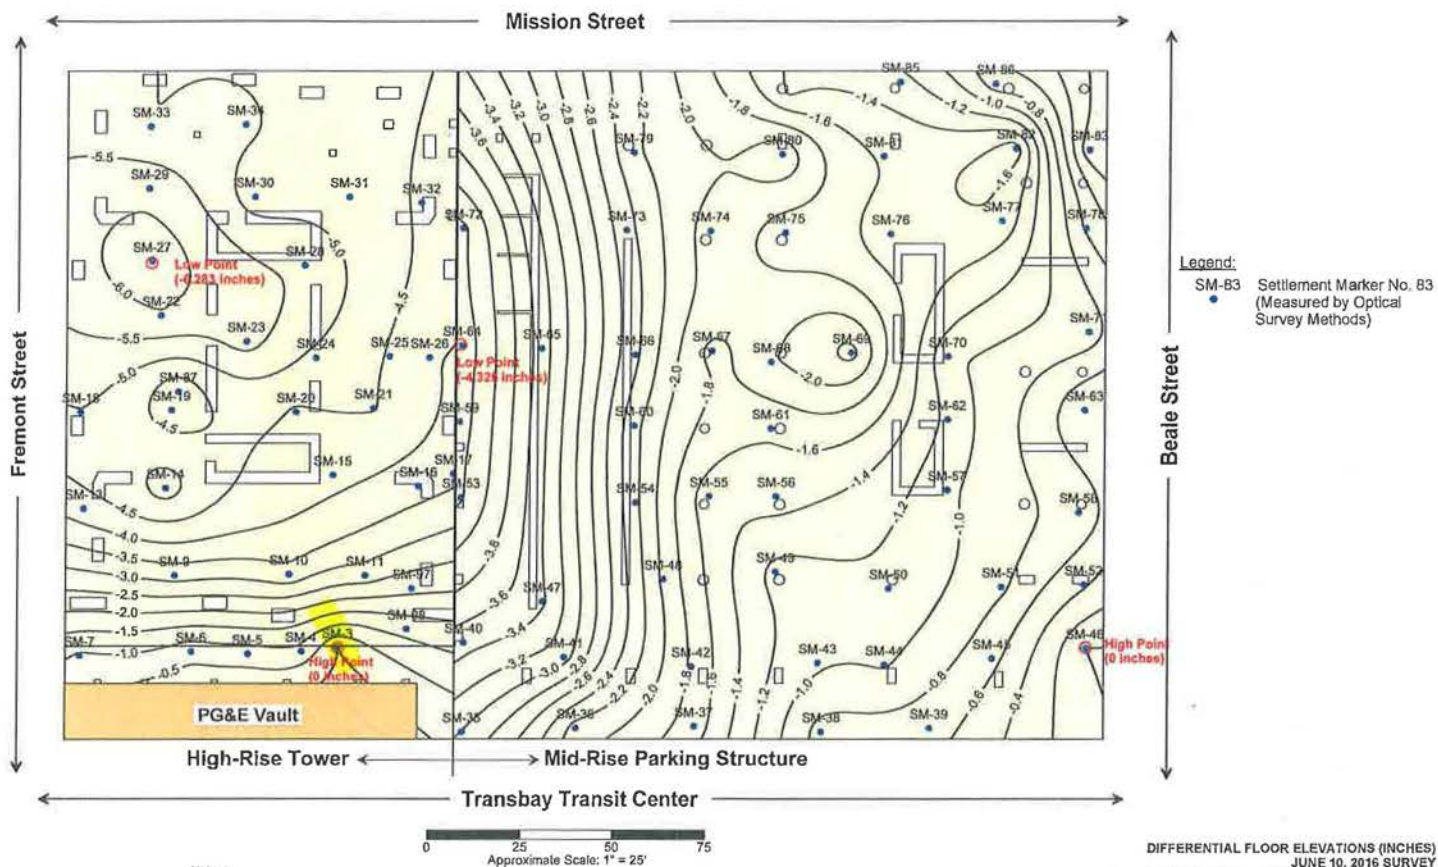
PLATE 2

Notes:
 Contours represent differential elevation, in inches, between the highest point and all other points taken on June 10, 2016.
 Level B-1 at Mid-Rise Parking portion of survey site is approximately 4 inches higher than Level B-1 at High-Rise Tower portion.
 The PG&E vault is inaccessible for monitoring.
 Contour intervals are different between the High-Rise Tower and the Low-Rise Tower.

DIFFERENTIAL FLOOR ELEVATIONS (INCHES)
 JUNE 10, 2016 SURVEY
 Transbay Transit Center
 301 Mission Monitoring
 Transbay Joint Powers Authority
 San Francisco, California

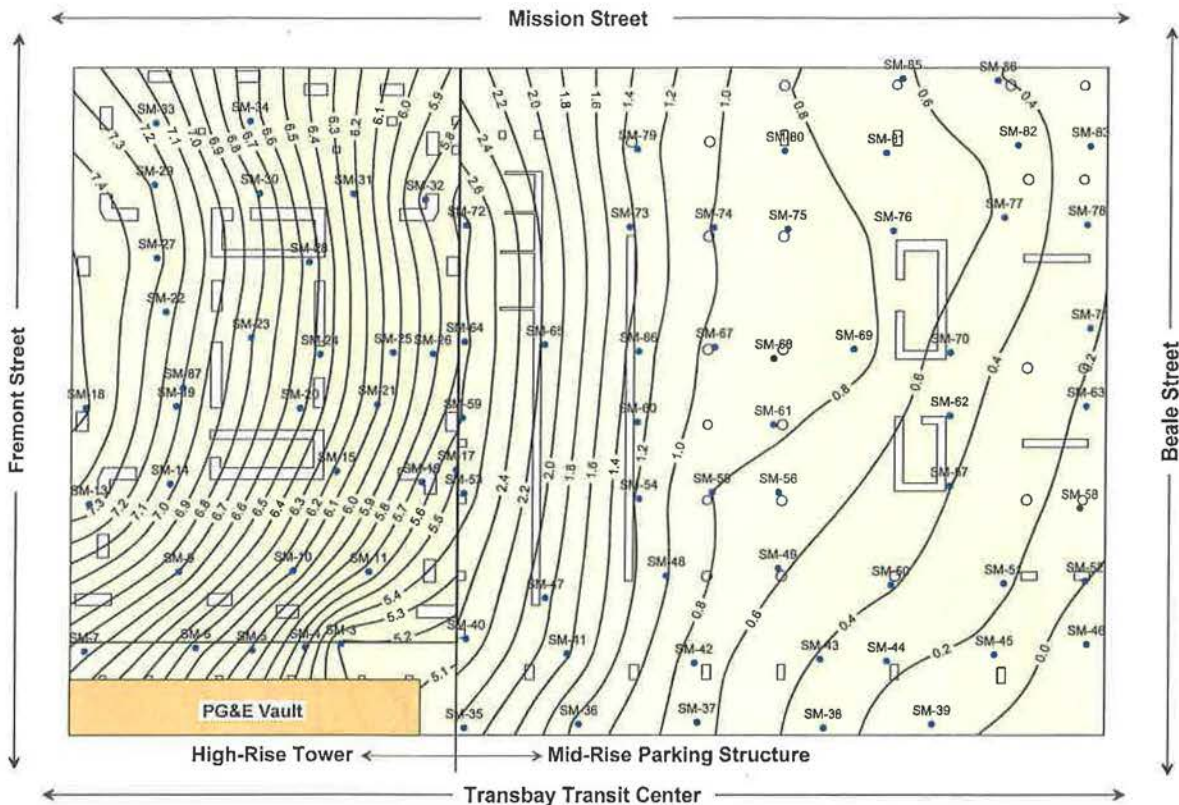
PLATE 3

Notes:
Contours represent elevation change, in inches, between Baseline survey (April 30, 2009) and readings taken on June 10, 2016.
Level B-1 at Mid-Rise Parking portion of survey site is approximately 4 inches higher than Level B-1 at High-Rise Tower portion.
The PG&E vault is inaccessible for monitoring.
Negative values of settlement (within Low-rise Tower) indicate uplift.

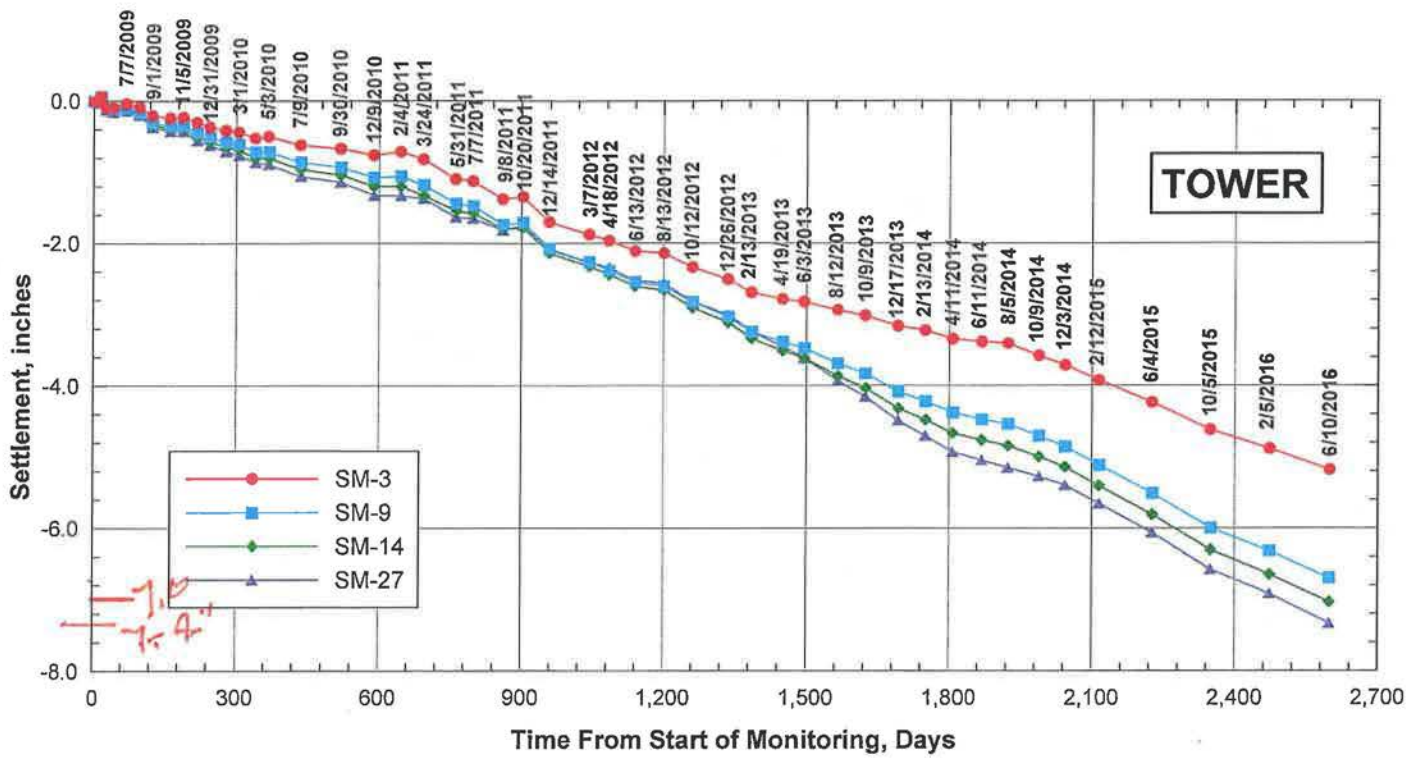
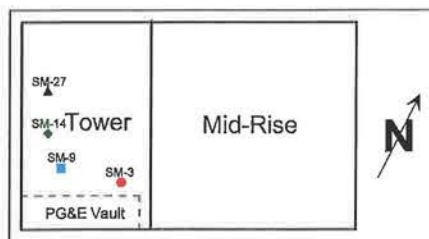
PLATE 4

**SETTLEMENT OVER TIME
FLOOR ELEVATIONS AT LEVEL B-1
OF 301 MISSION PROPERTY- TOWER:
APRIL 30, 2009 THROUGH JUNE 10, 2016**

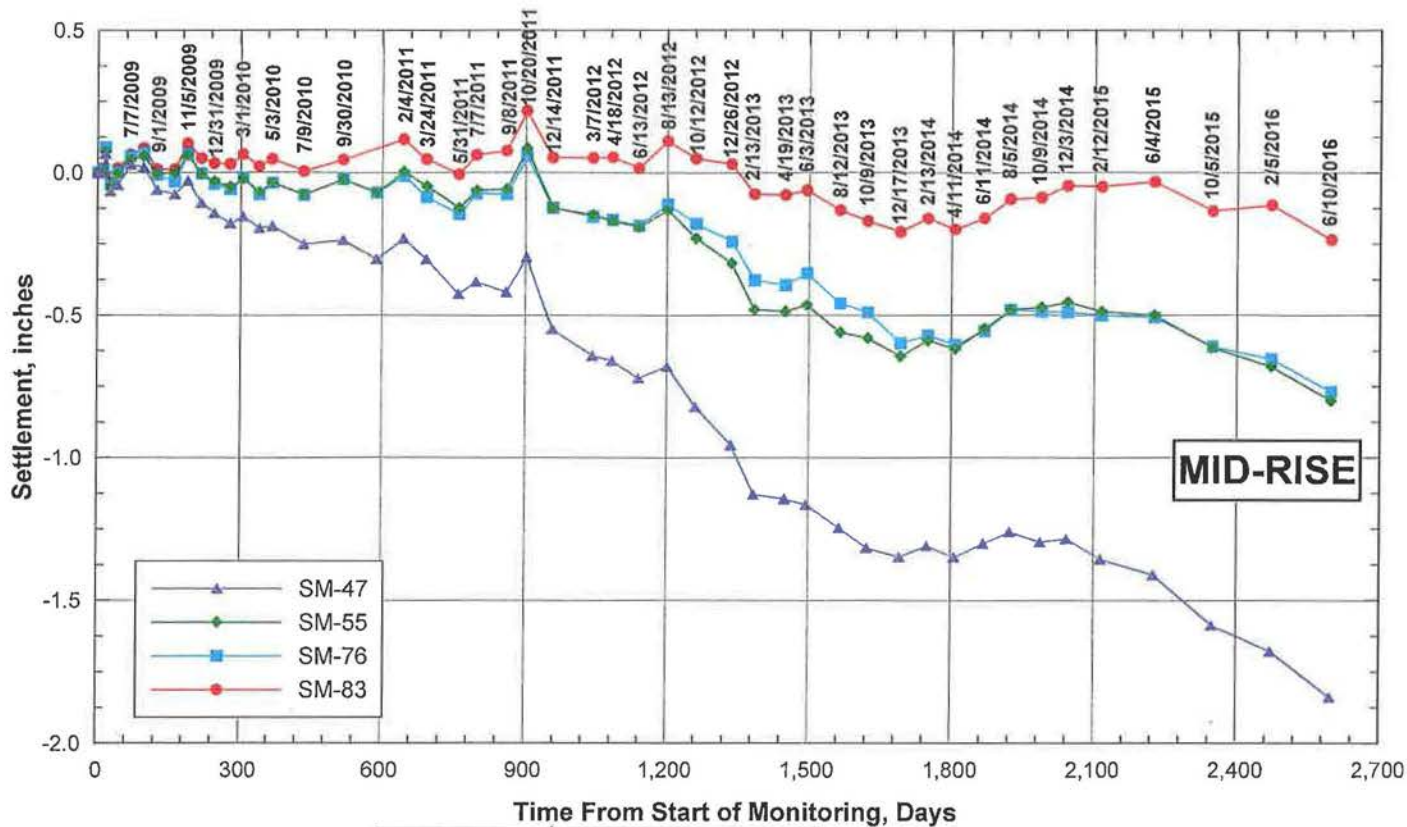
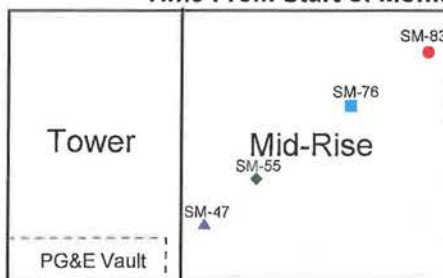
PLATE 5

SETTLEMENT OVER TIME
FLOOR ELEVATIONS AT LEVEL B-1
OF 301 MISSION PROPERTY- MID-RISE:
APRIL 30, 2009 THROUGH JUNE 10, 2016

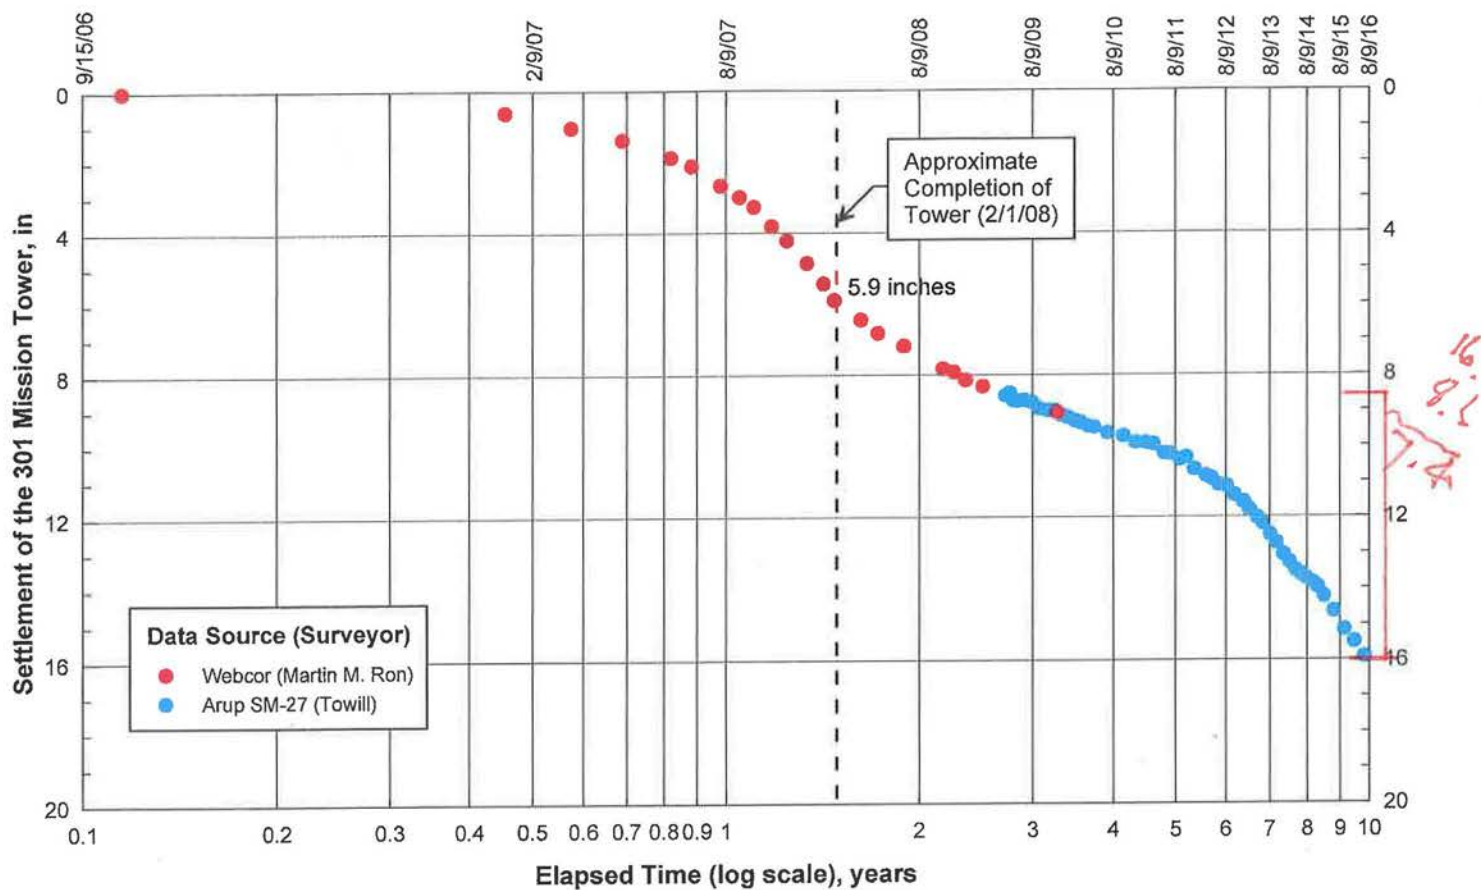
PLATE 6

Beginning of Tower Construction: 8/9/06
 End of Tower Construction: 2/1/08
 Construction Duration: 542 days (1.5 years)

**SETTLEMENTS OF THE 301 MISSION TOWER
INCLUDING MONITORING DURING CONSTRUCTION**
