*Board of Supervisors
City and County of San Francisco*

Government Audit and Oversight Committee

Supplemental Report for Foundation Settlement Investigation

**SUPPLEMENTAL REPORT
FOUNDATION SETTLEMENT INVESTIGATION
301 MISSION STREET
SAN FRANCISCO, CALIFORNIA**

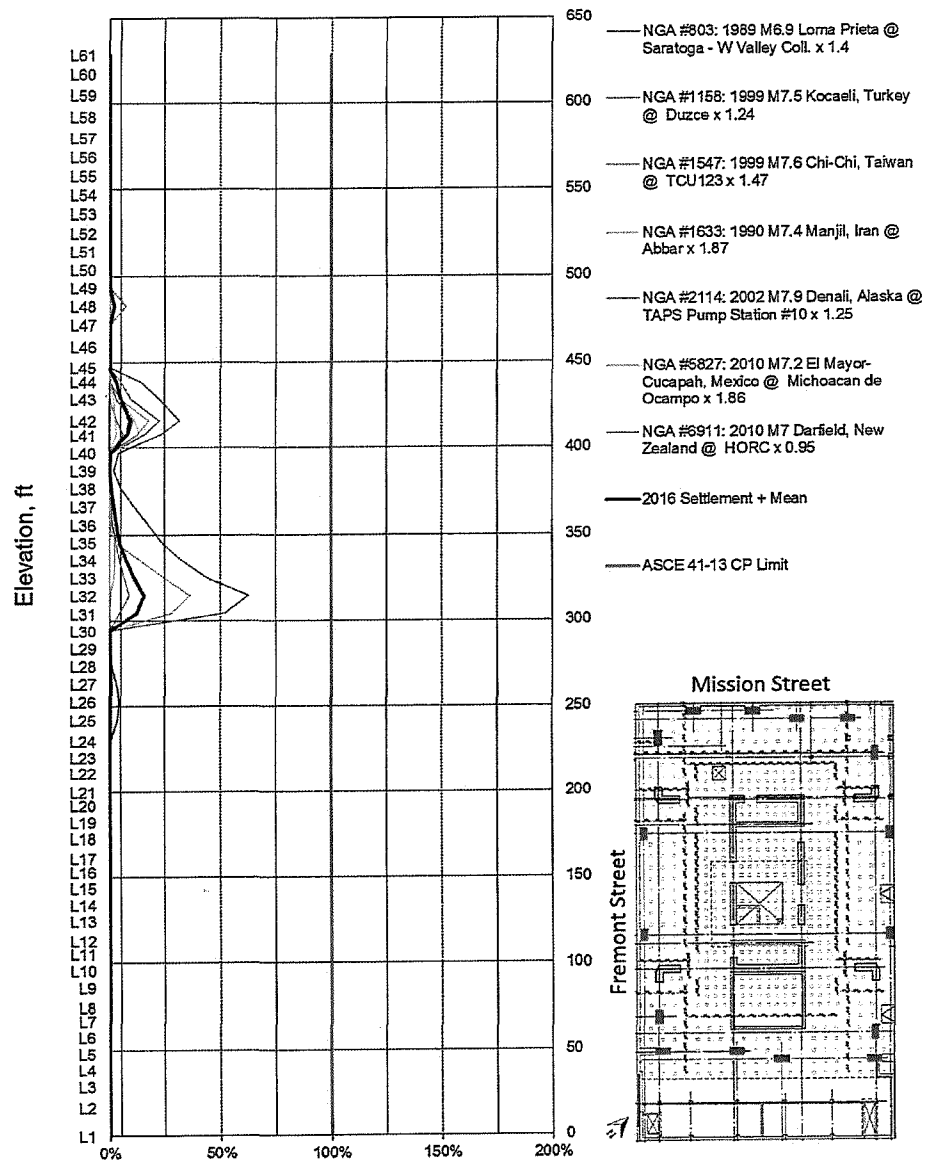
Figure 27. Demand to Capacity Ratios, Column Plastic Rotation, Fixed Translation Model

Figure 27 presents the demand to capacity ratios, in percent, for column plastic rotation. A value of 100% represents the ASCE 41-13 CP limit, which ranges from 0.008 to 0.009 radians for columns in this structure. The figure shows the maximum predicted value for any of the columns at each story, for each ground motion, and also the average peak value for all ground motions.

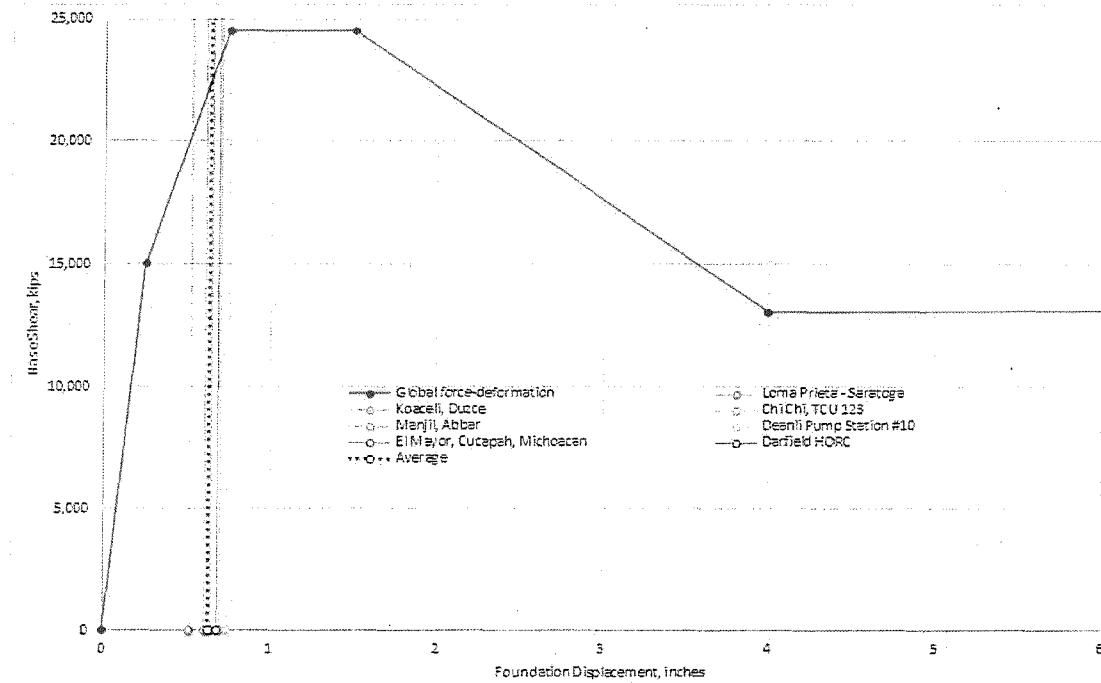
Figure 37. Peak East-West Pile Lateral Displacement Demand from Seven ground motions

Figure 37 and Figure 38 respectively present the peak lateral displacement demands on the pile cap in the east-west and north-south directions, overlain on the global pile nonlinear force-displacement behavior previously shown in Figure 22. Predicted pile lateral displacement is typically less than 1 inch and does not approach the displacement at which foundation strength degradation initiates.

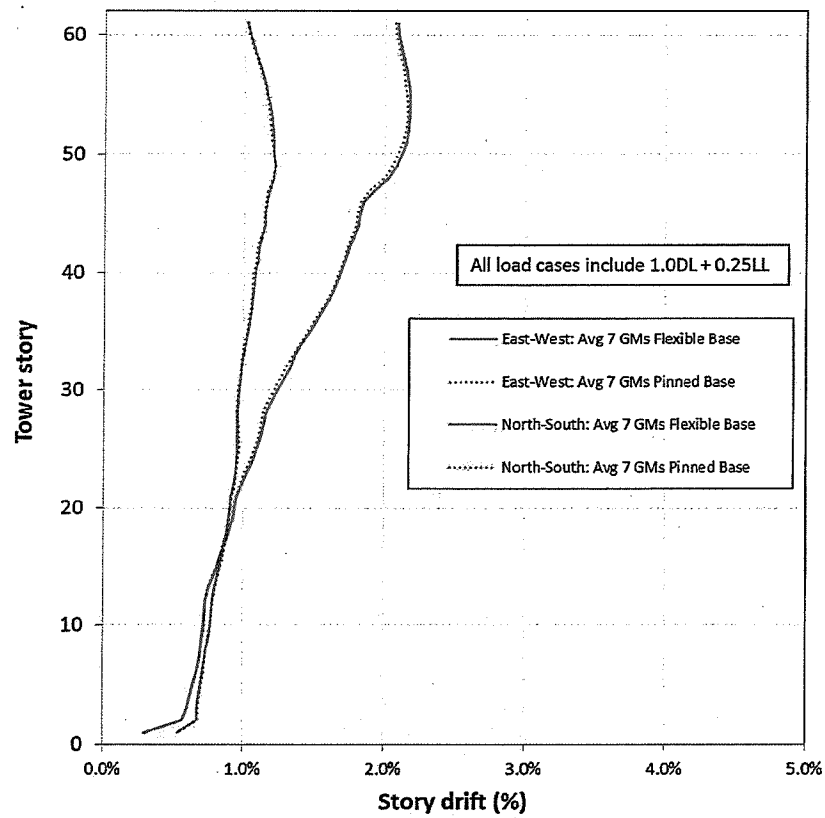
Figure 39. Comparison of Story Drift Ratios for Fixed Translation and Nonlinear Pile Models

Figure 39 compares plots of mean story drift in the east-west and north-south directions for the model fixed against lateral translation at the base and the model with nonlinear lateral translational pile springs. In each of the two directions, the story drift predicted by our analyses is nearly identical for the two models.

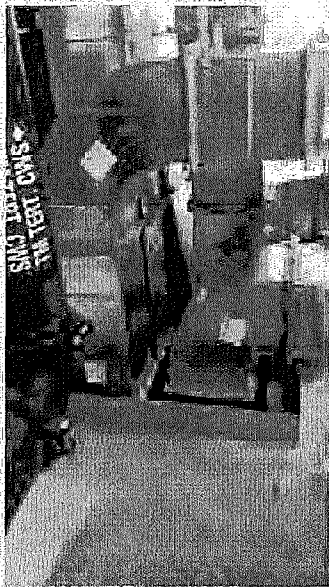
Curbs are provided in mechanical rooms where water piping is present. Most curbs are 6-inch high concrete with one metal curb observed around the metal dryer ducts on the 26th floor.

Metal Curb around Dryer Ducting

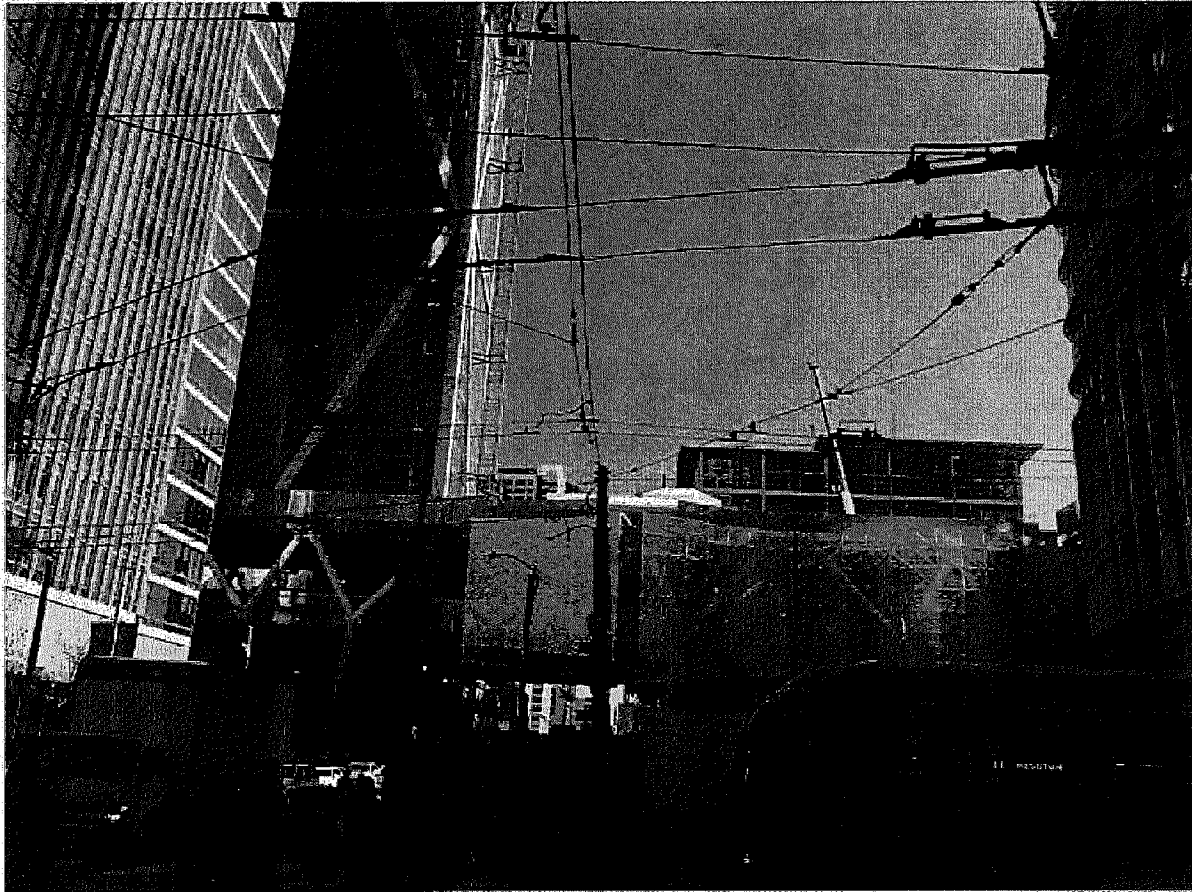
New Buildings to East and South. Light Rail Construction Immediately South

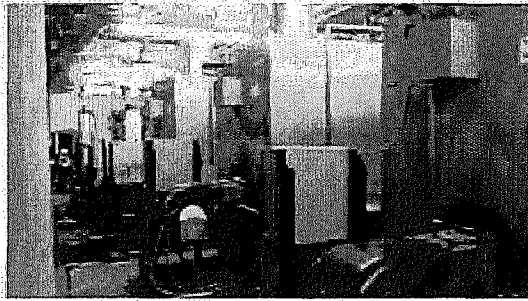
Podium Boilers

There are three natural gas fired hot water boilers provided for the common area and the twelve story mid-rise. These boilers are rated at 4,000,000 btu/hr each. All boilers are equipped with flame failure, double block and bleed safety shut-off valves and high and low gas pressure switches. In addition the boilers are provided with low water cut-off.

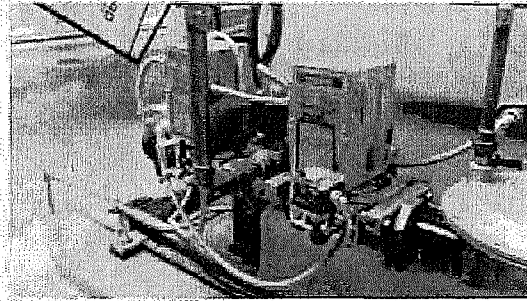
Double Safety Shut-off Valves with Vent Line Between

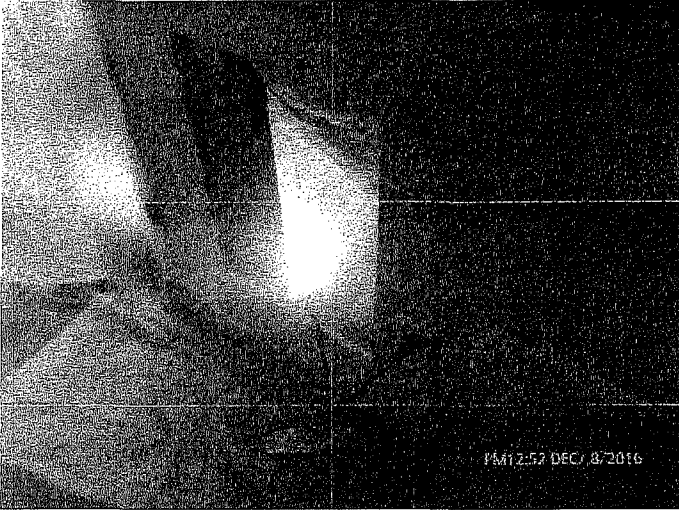
Test access opening in bedroom wall at site ST1 in unit 31B

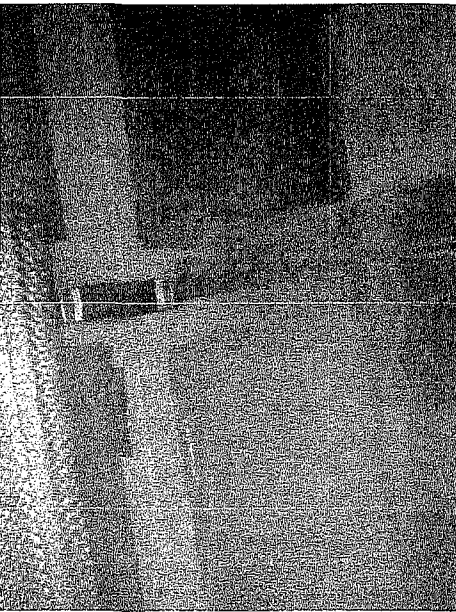
**AIR GAP IN CURTAIN
WALL**

1. At site ST1;
Large gaps on the interior surface of the exterior wall (curtain wall) within the cavity behind the heat pump [HP-C]. This condition exists on both floors 30B and 31B. The location of air leak is directly across from the intake of the forced air heat pump unit. The odor transfer is enhanced and further distributed into the residence with the operation of the heat pump fan.
2. At site ST5;
Gaps around the hydronic-piping floor penetrations in the closet of heat pump [HP-B]. Here too the location of air leaks are close to the intake of the forced air heat pump unit. The odor transfer again is enhanced and further distributed into the residence with the operation of the heat pump fan.

Smoke test site ST1 in unit 31B

The recommended repair consists of providing an air tight seal of the identified air gaps causing leaks between Units 30B and 31B.

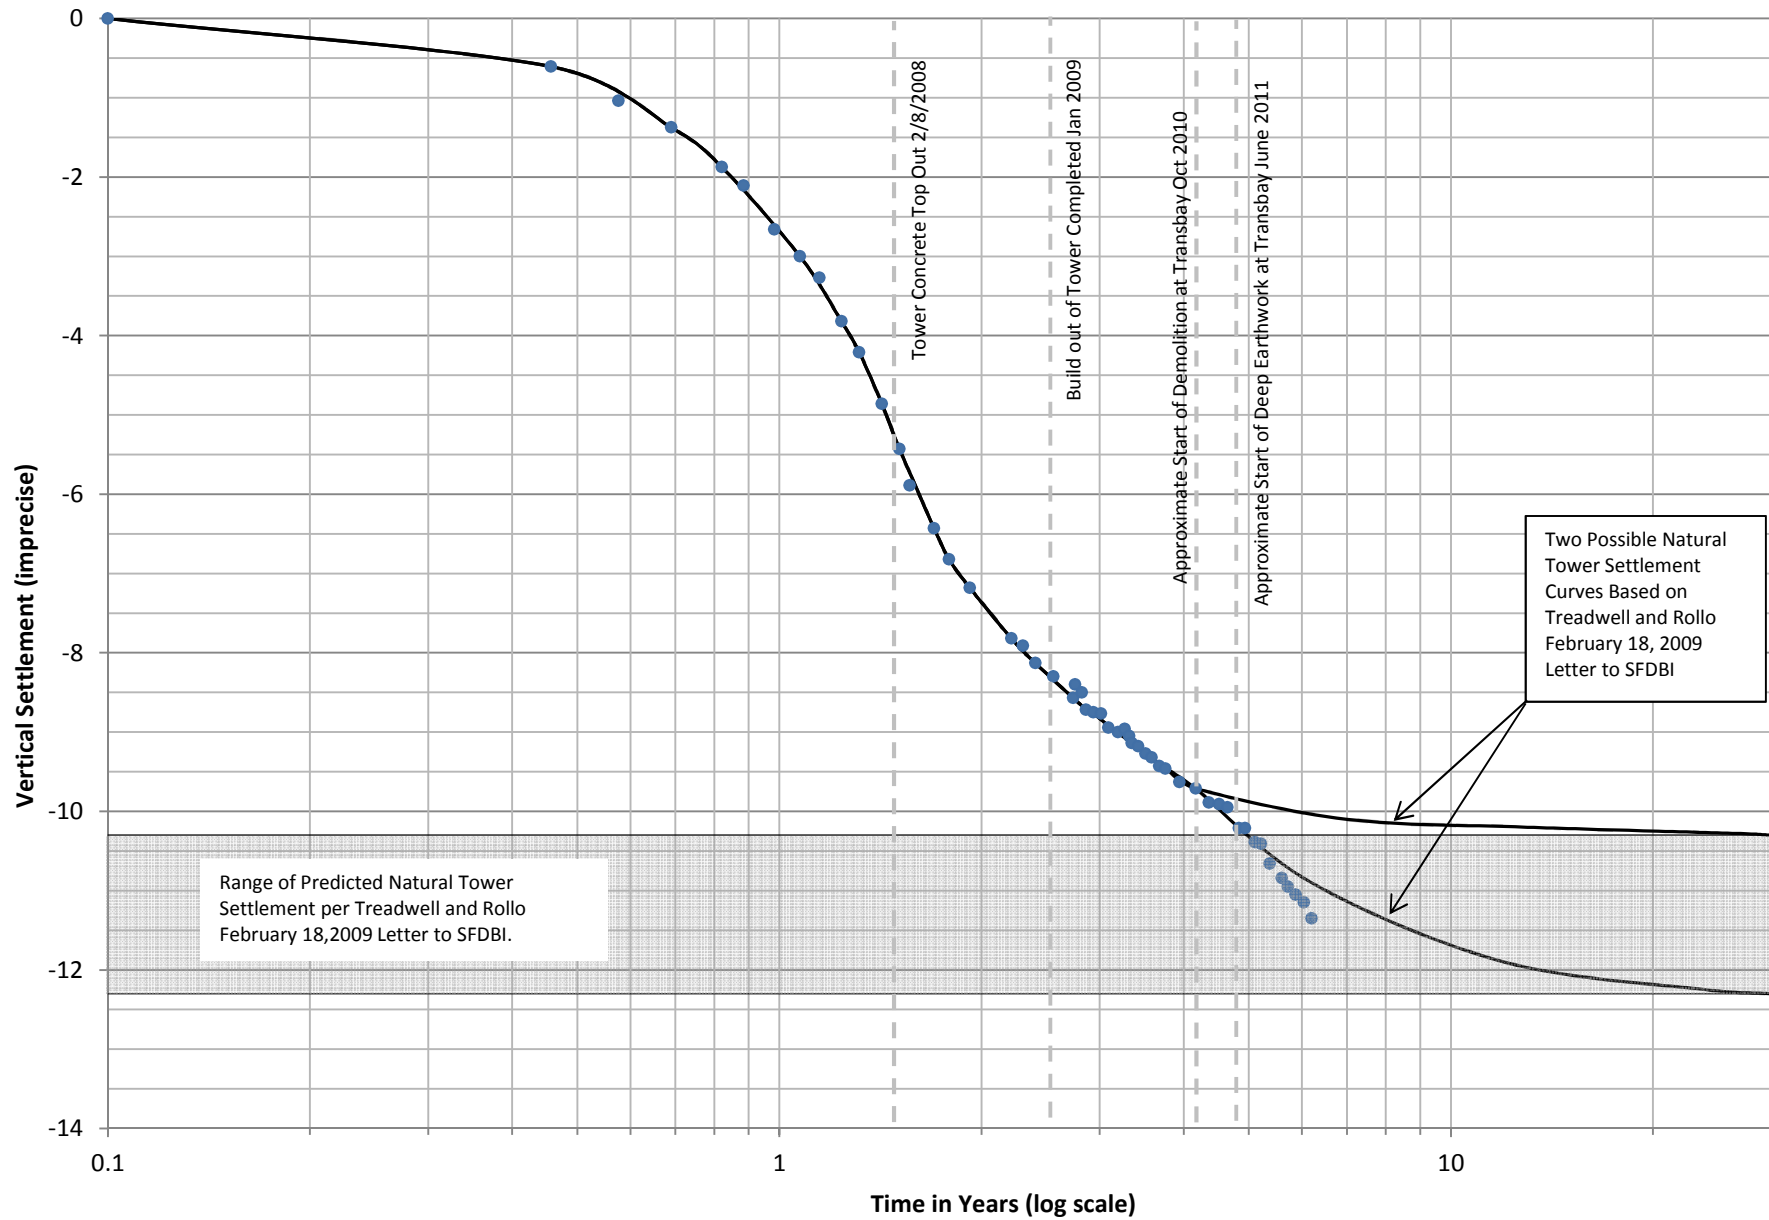
Figure 1

SETTLEMENT OF 301 MISSION TOWER

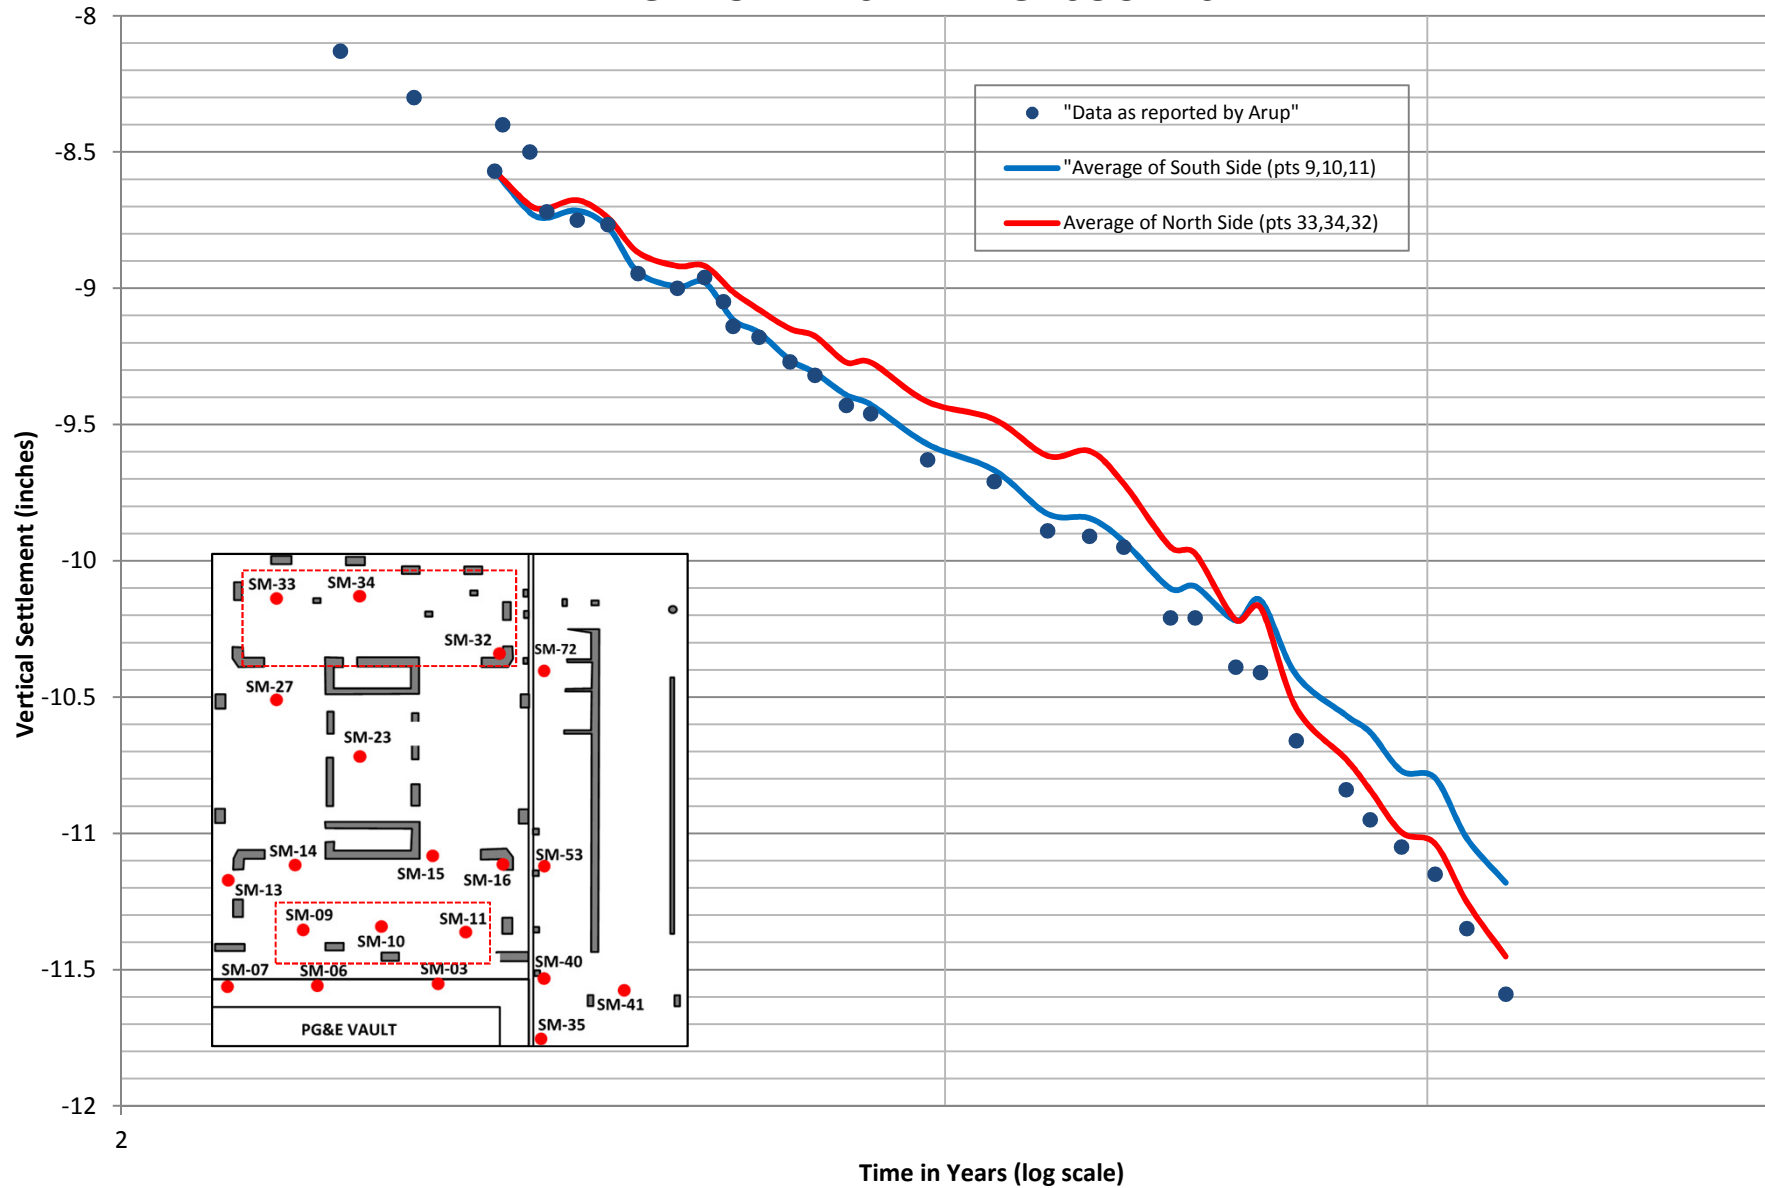
SETTLEMENT OF 301 MISSION TOWER AVERAGE NORTH VS AVERAGE SOUTH SIDE

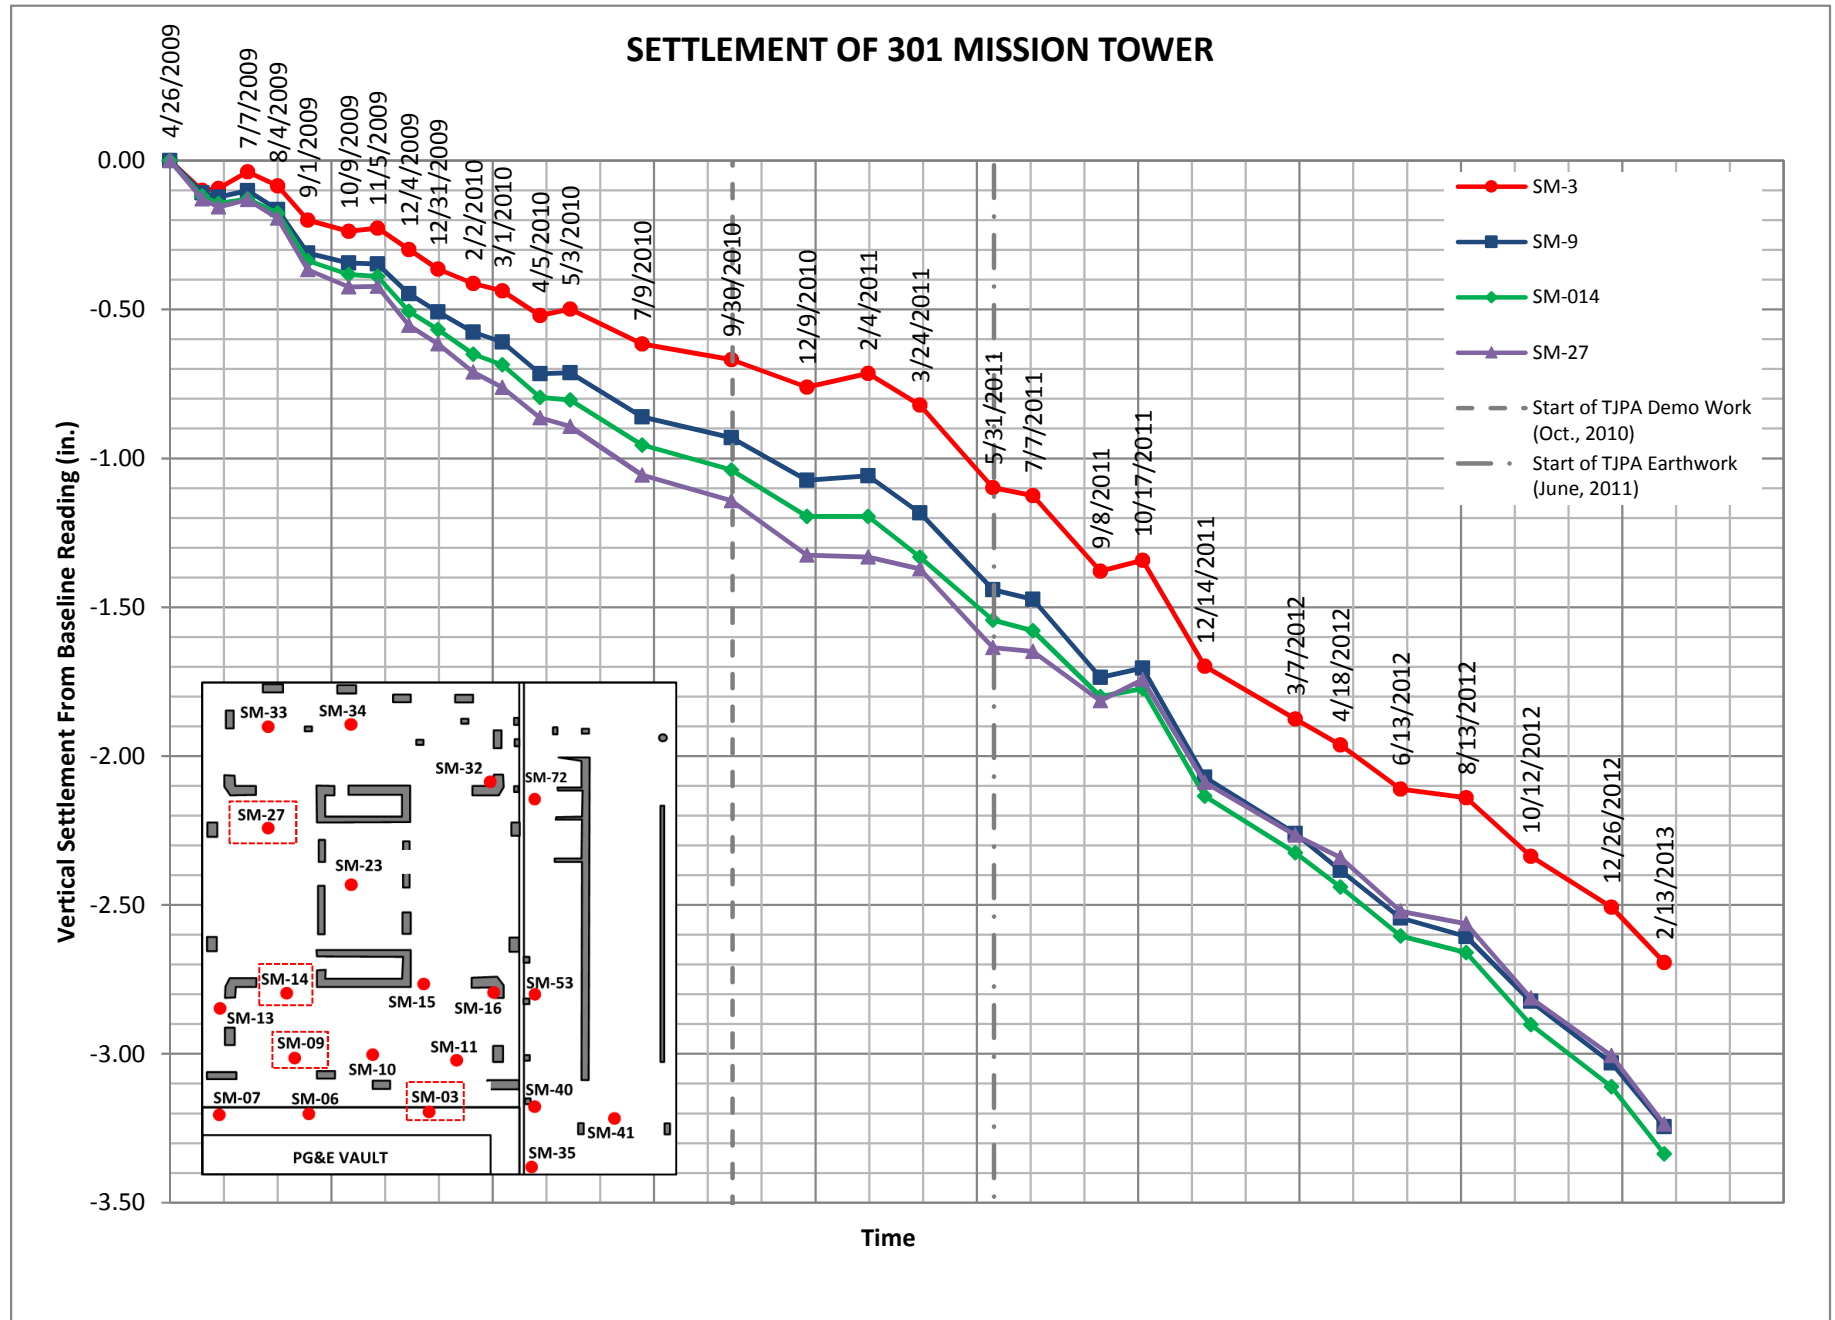
Figure 2 includes an average of settlement on the north side of the tower and on the south end of the tower. Before construction activities began at Transbay we observe that the north side had settled at a greater rate than the south. After construction activities started, we now observe a greater rate of settlement on the south side. The foundation has rotated slightly towards the Transbay project. Since the south end of the foundation seems now to be moving faster than the north, it follows that the activities at Transbay have caused the additional settlement.

Figure 2 also shows that the overall settlement reported by ARUP (and duplicated in Figure 1) is the worst case settlement anywhere across the foundation (about 11.85") and does not represent the average. Based on this plot, the average overall settlement on the site is currently about 11.5 overall inches.

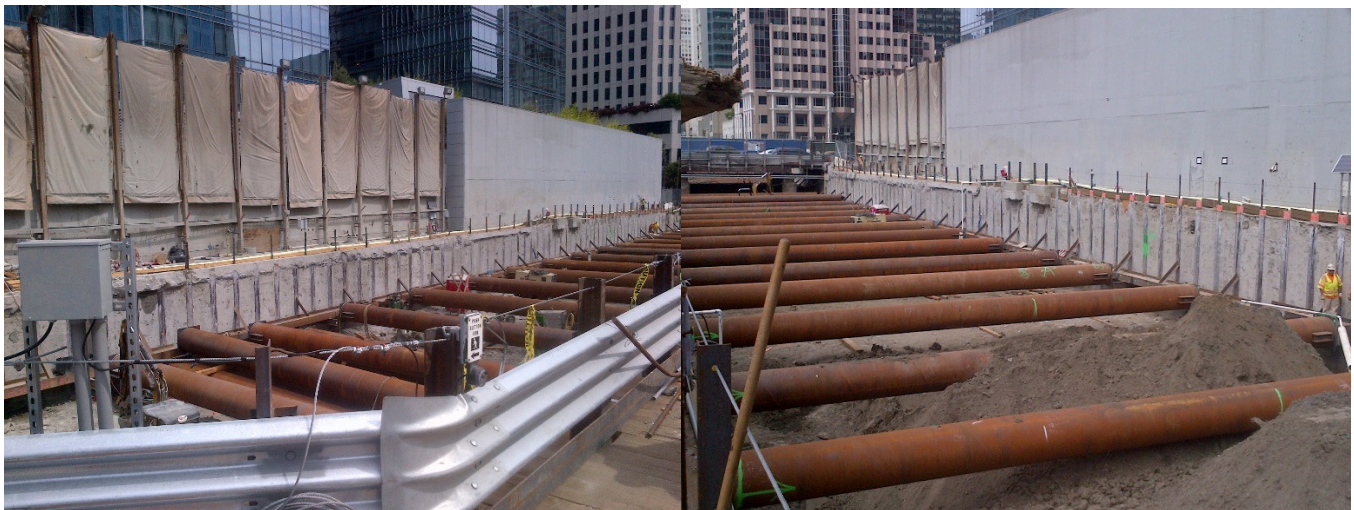
A major Transbay construction milestone has recently occurred. Excavation has begun as of May 2013. The excavation is approximately 15 feet below grade at the current time, immediately below the elevation of the first set of cross lot bracing. The cross-lot bracing has begun to be installed but has not yet been connected to the far side.

Construction progress immediately adjacent to 301 Mission Street. Photos taken July 22, 2013.

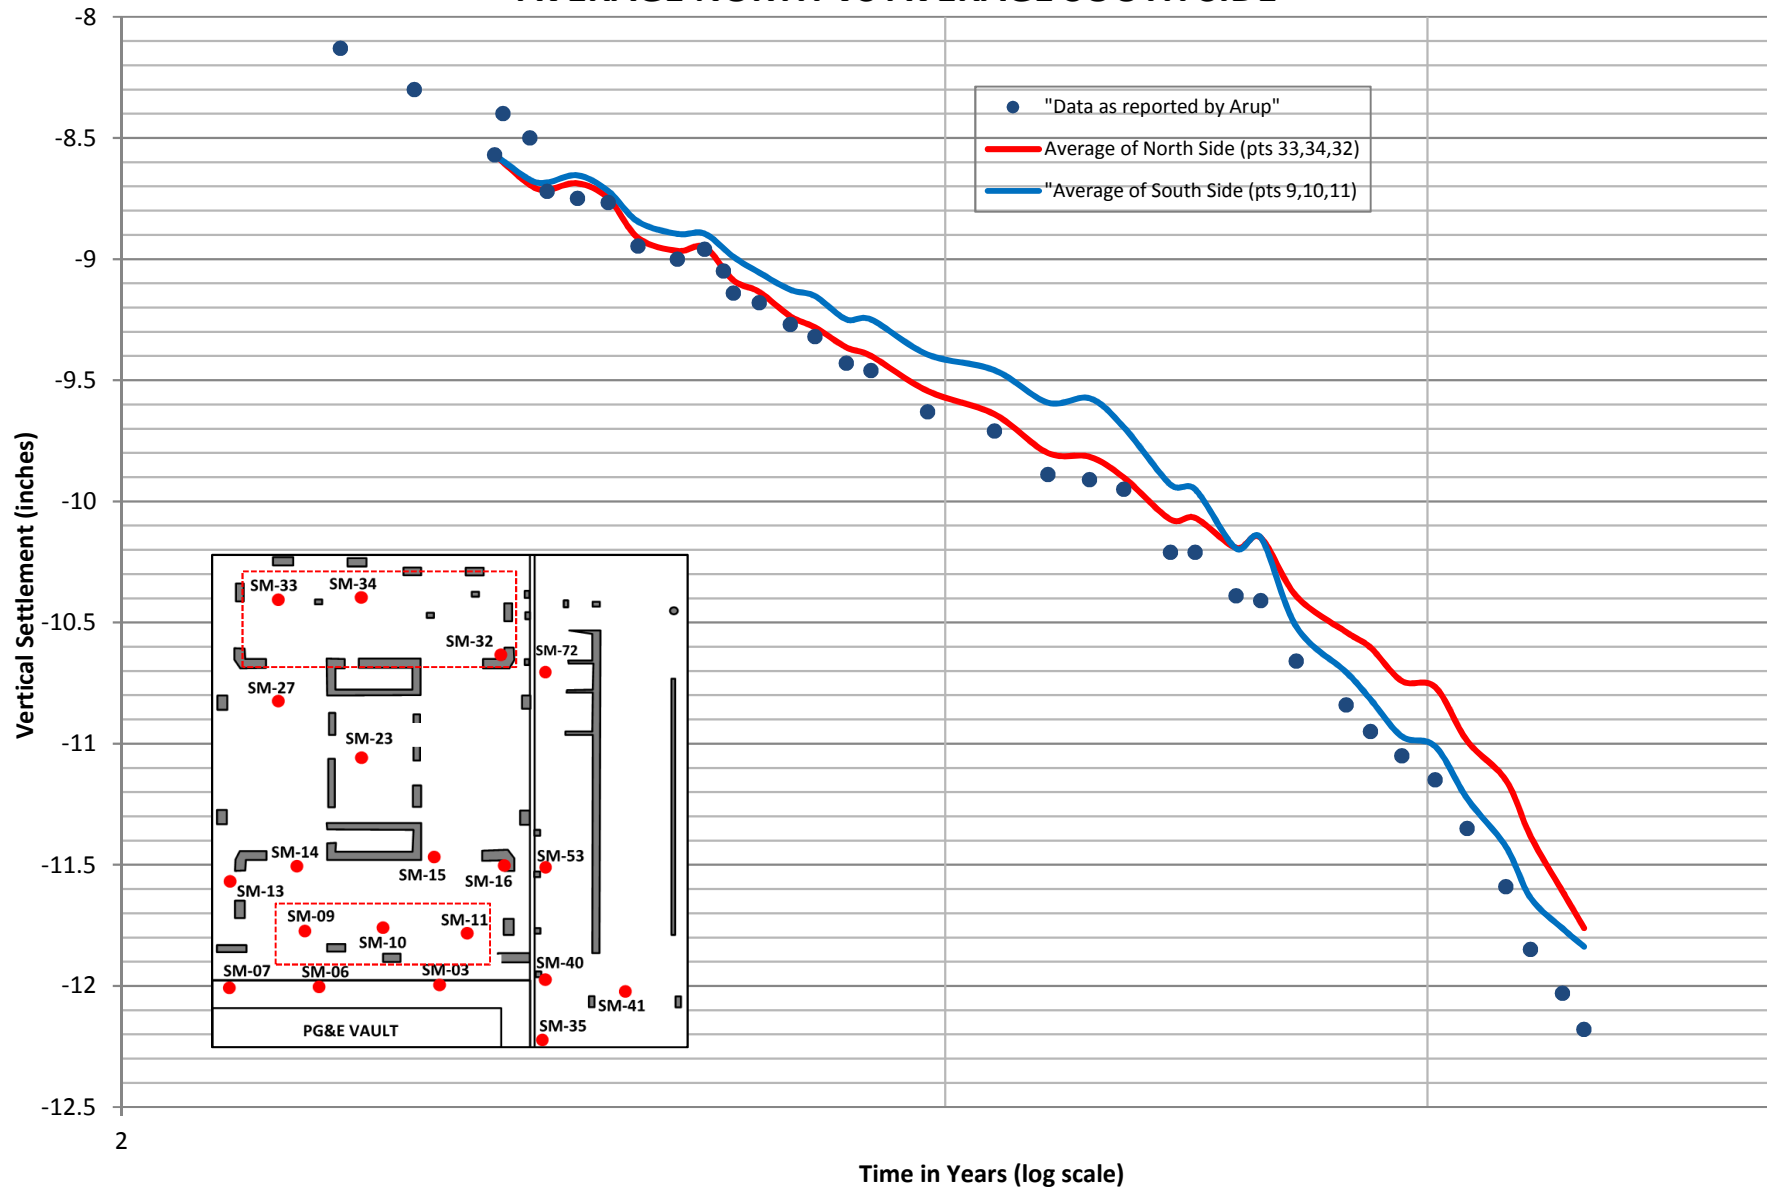
Figure 2 includes an average of settlement on the north side of the tower and on the south end of the tower. Before construction activities began at Transbay we observe that the north side had settled at a greater rate than the south. After construction activities started, we now observe a greater rate of settlement on the south side. The foundation has rotated slightly towards the Transbay project. Since the south end of the foundation seems now to be moving faster than the north, it follows that the activities at Transbay have caused the additional settlement.

worst case settlement anywhere across the foundation (about 12.2") and does not represent the average. Based on this plot, the average overall settlement on the site is currently about 11.8 overall inches.

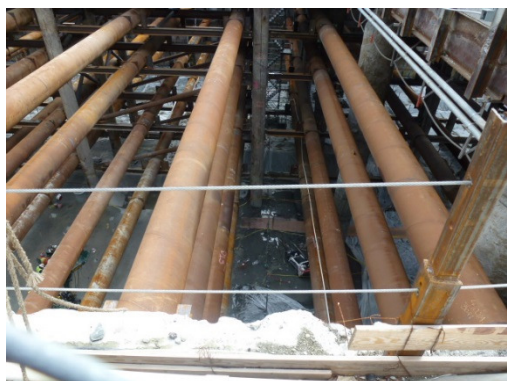
Photo of TJP site from 301 Mission, 3/6/14

south of 301 Mission is approximately 100% complete, has been since Feb. 7, 2014. Micro piles were visible at the surface. The new Kilroy tower development at 350 Mission has been excavated to approximately 60 feet, and the new tower construction has progressed from the bottom of the excavation back up to street level, and now is built up to approximately 3 stories.

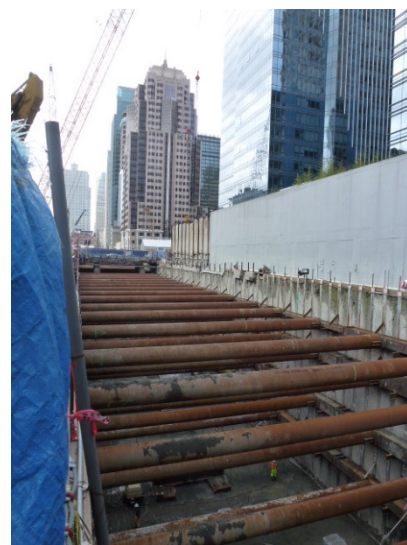
Photo of TJP site from Beale Street, 3/6/14

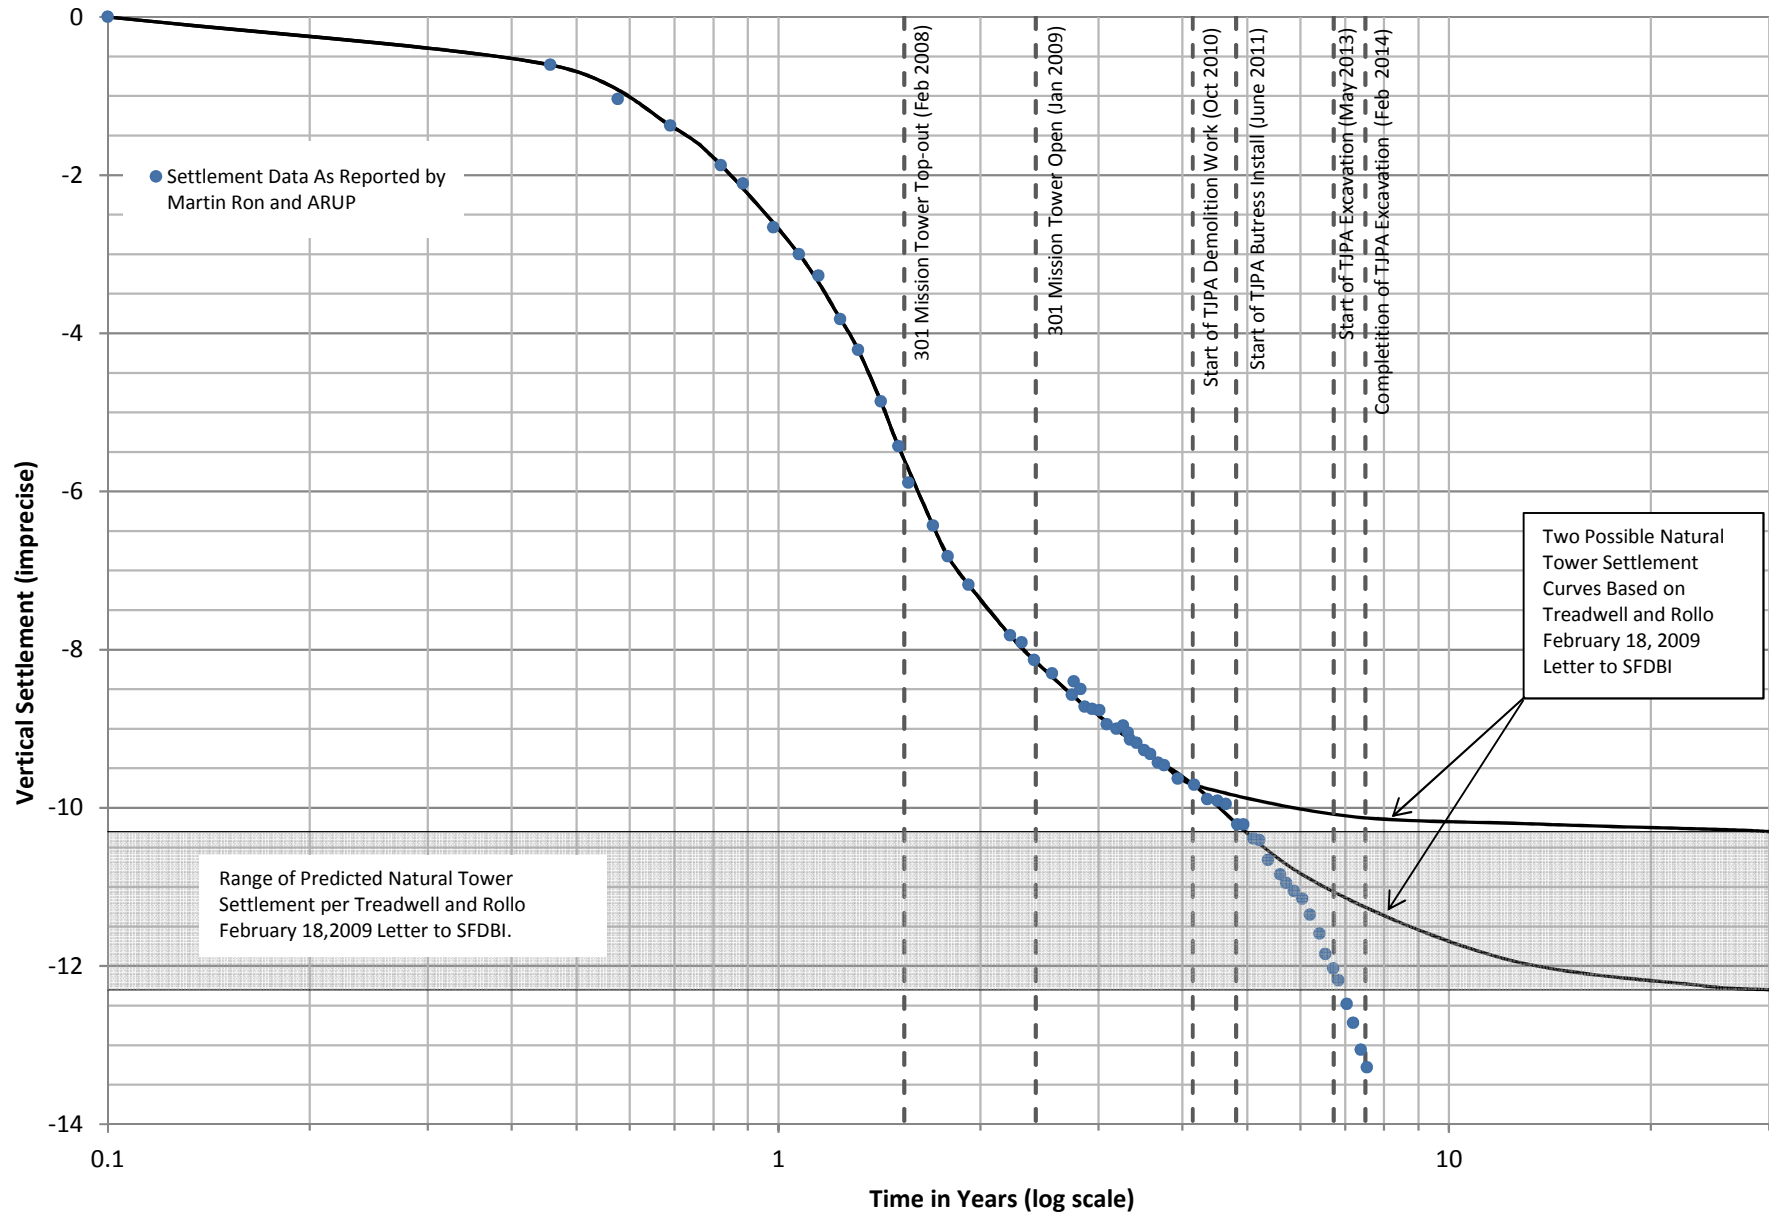
Figure 1

If we use Langan Treadwell Rollo's predicted range of total settlement and read the difference between the measured displacement data points and the settlement prediction curves (Figure 1), the additional settlement is between 2.0 to 3.3 inches. Since 0.75 inches is the "Action Trigger Level" for "other buildings" as described in the Transbay Specification, it is recommended, as we had recommended in earlier reports, that Millennium Partners (Millennium) obtain a response from Transbay regarding this discrepancy in predicted settlement. Furthermore, Transbay revised their specification (the Dec 10, 2010 version) to exclude the 301 Mission Tower from all action trigger levels. It is unclear why Transbay would have changed their specification after construction had begun and why no action trigger limit for this site has since been published by TJPA.

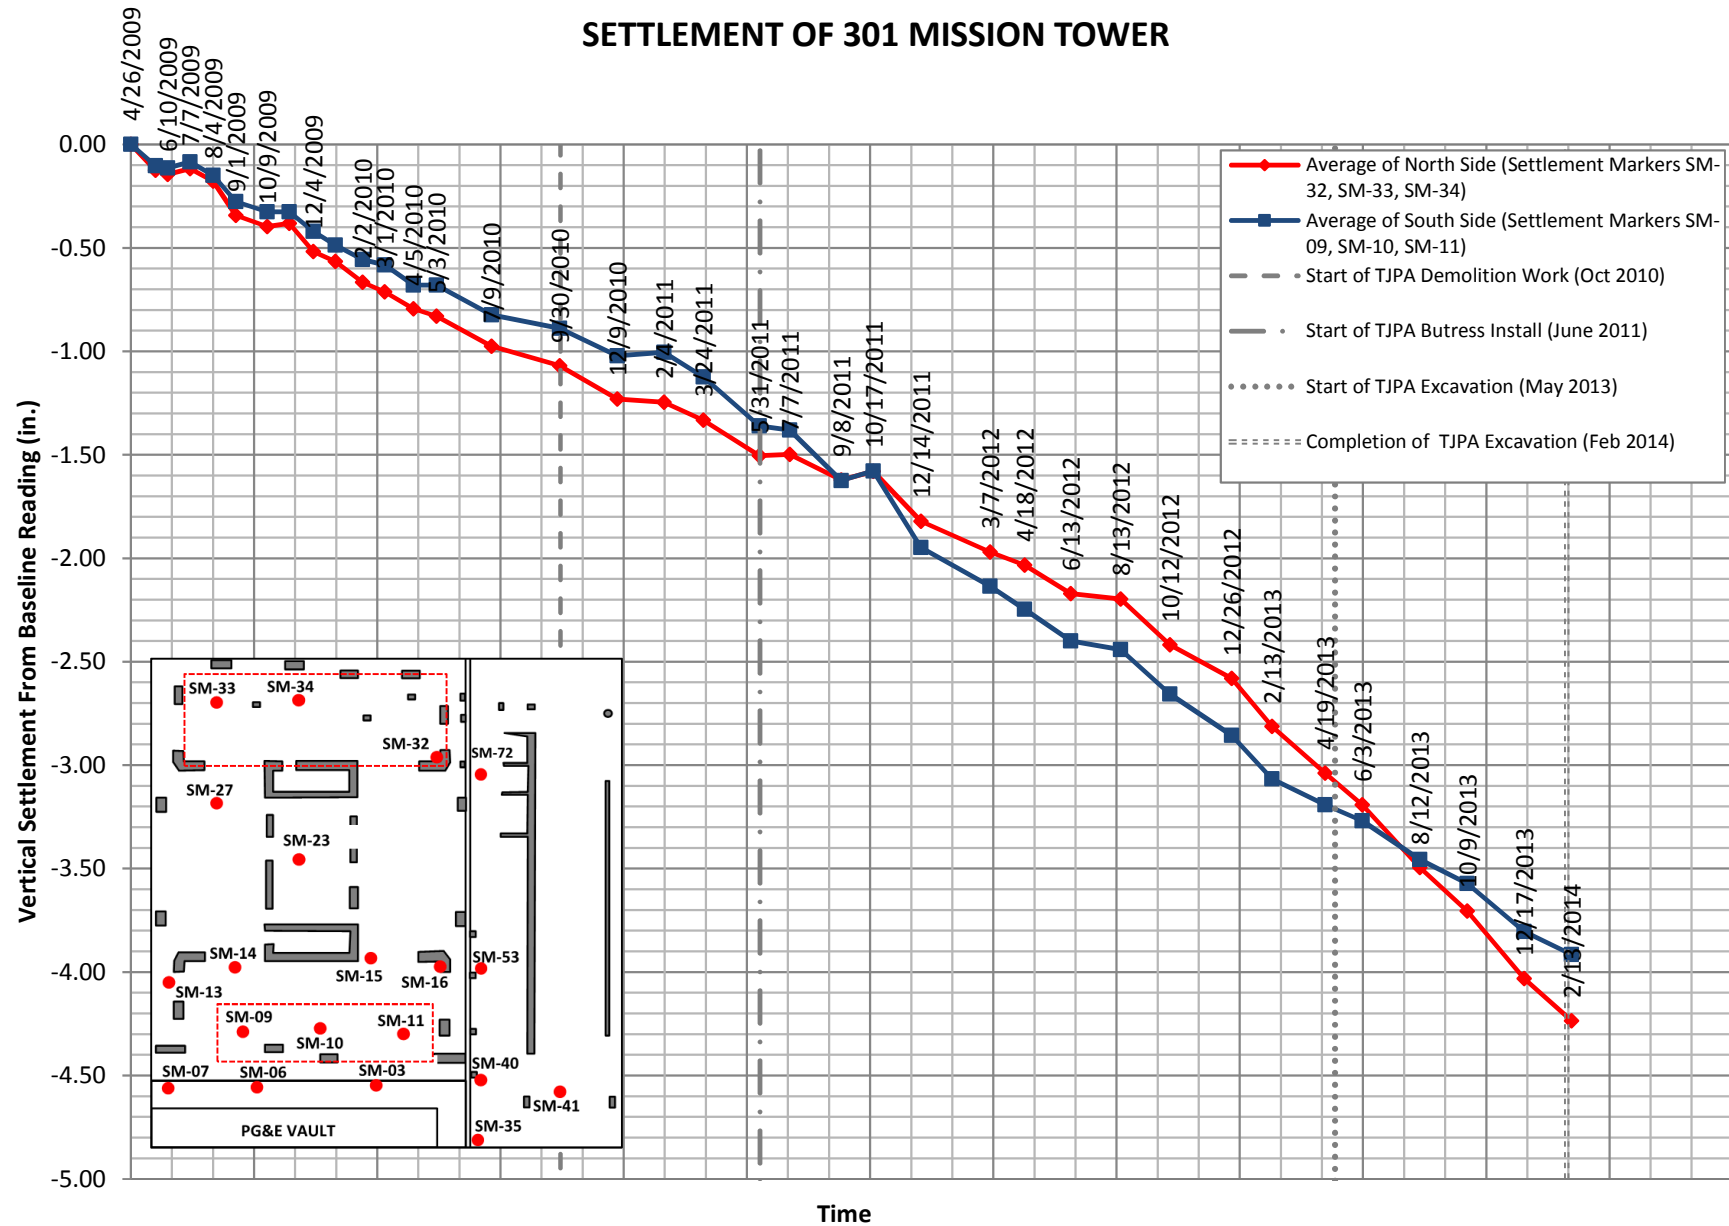
Figure 4

Settlement of the North vs. South Side of the Foundation (Figure 4)

It should also be noted that this figure indicates differential movement across the foundation in the north-south direction causing a slight tilt to the building. If this movement was larger, damage to the structure can occur. In general the tilt, while measurable, is generally small and not of the type which would cause damage.

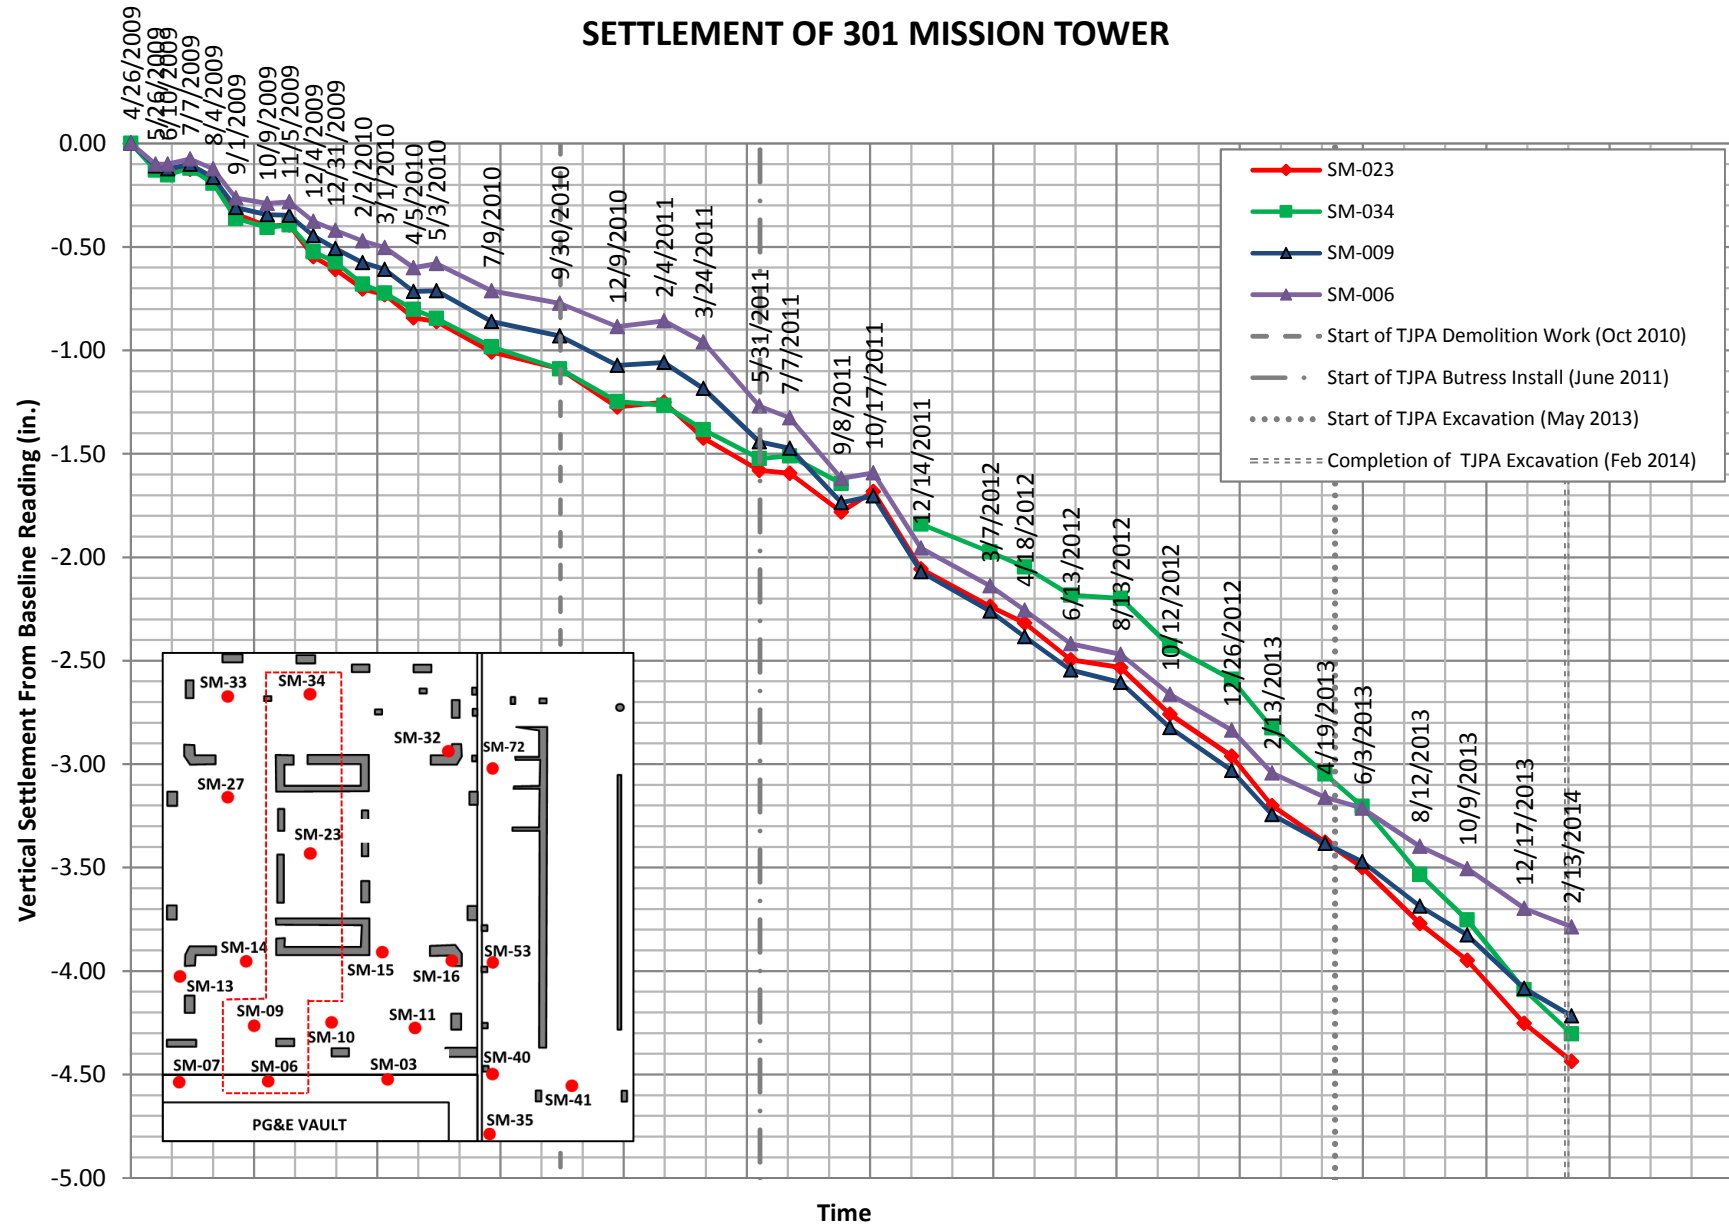
Figure 5

Settlement across a North-South Section of the Foundation (Figure 5)

Before buttress installation activities began, the Tower was settling more at the north side and at a consistent rate. After buttress installation activities began, the settlement in the south started settling faster than the ones in the north. At present time, following the completion of the excavation, the highest settlement along the north-south direction is nearly at the center of the foundation.
