*Board of Supervisors
City and County of San Francisco*

Government Audit and Oversight Committee

Supplemental Report for Foundation Settlement Investigation

**SUPPLEMENTAL REPORT
FOUNDATION SETTLEMENT INVESTIGATION
301 MISSION STREET
SAN FRANCISCO, CALIFORNIA**

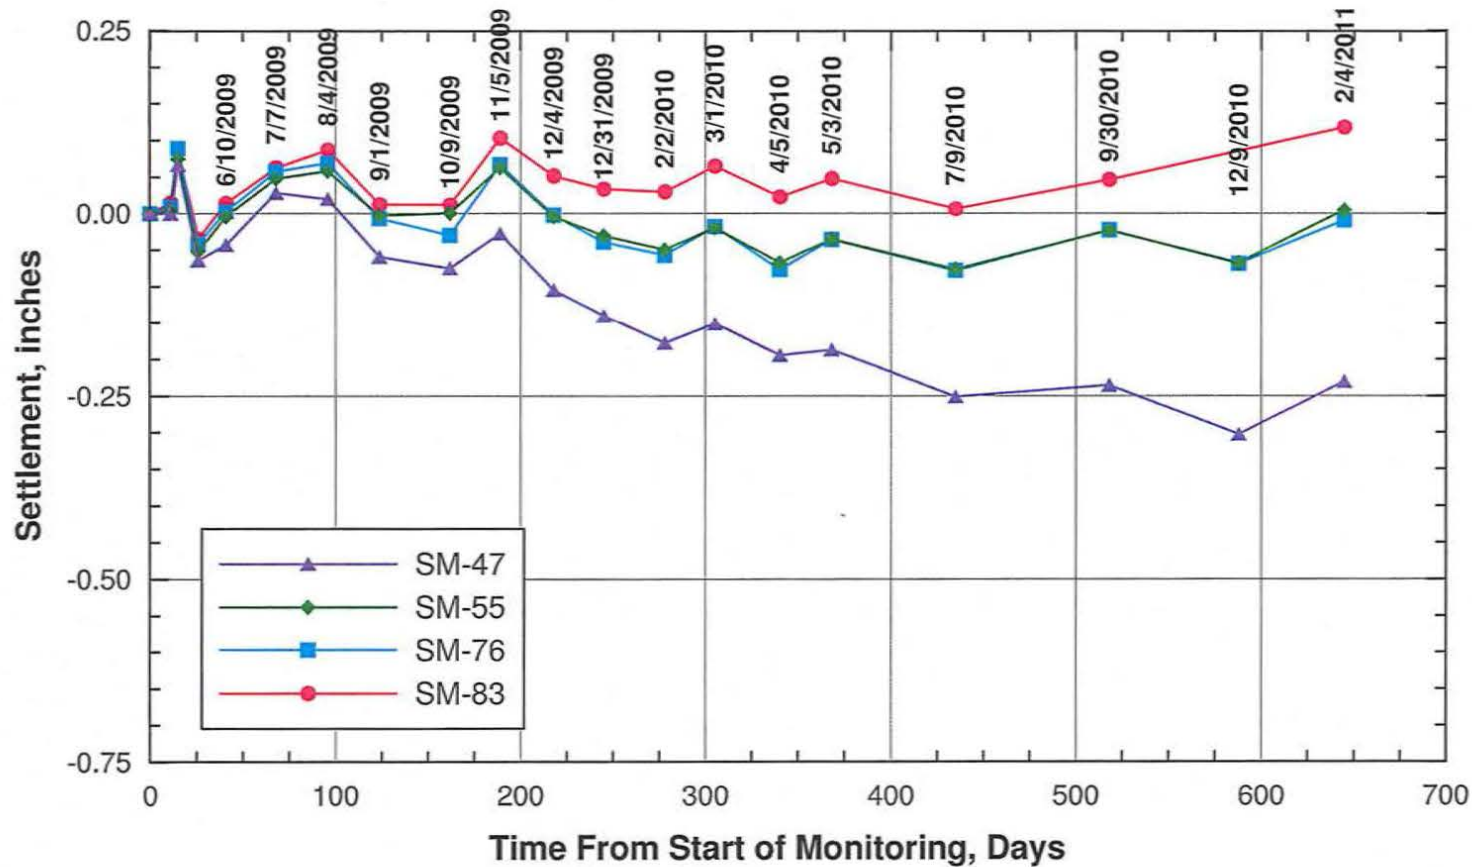
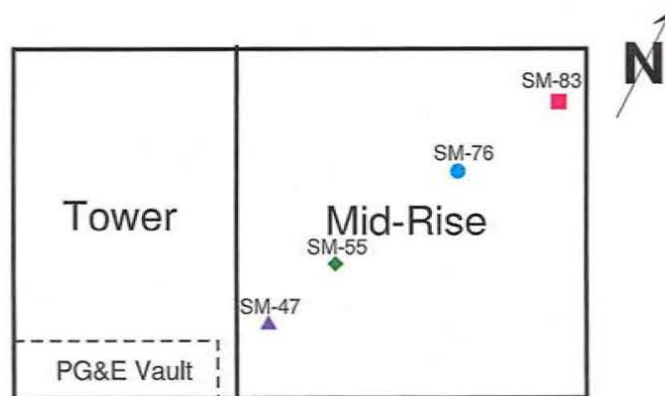
PLATE 4

**SETTLEMENT OVER TIME
FLOOR ELEVATIONS AT LEVEL B-1
OF 301 MISSION PROPERTY- MID-RISE:
APRIL 30, 2009 THROUGH FEBRUARY 4, 2011**

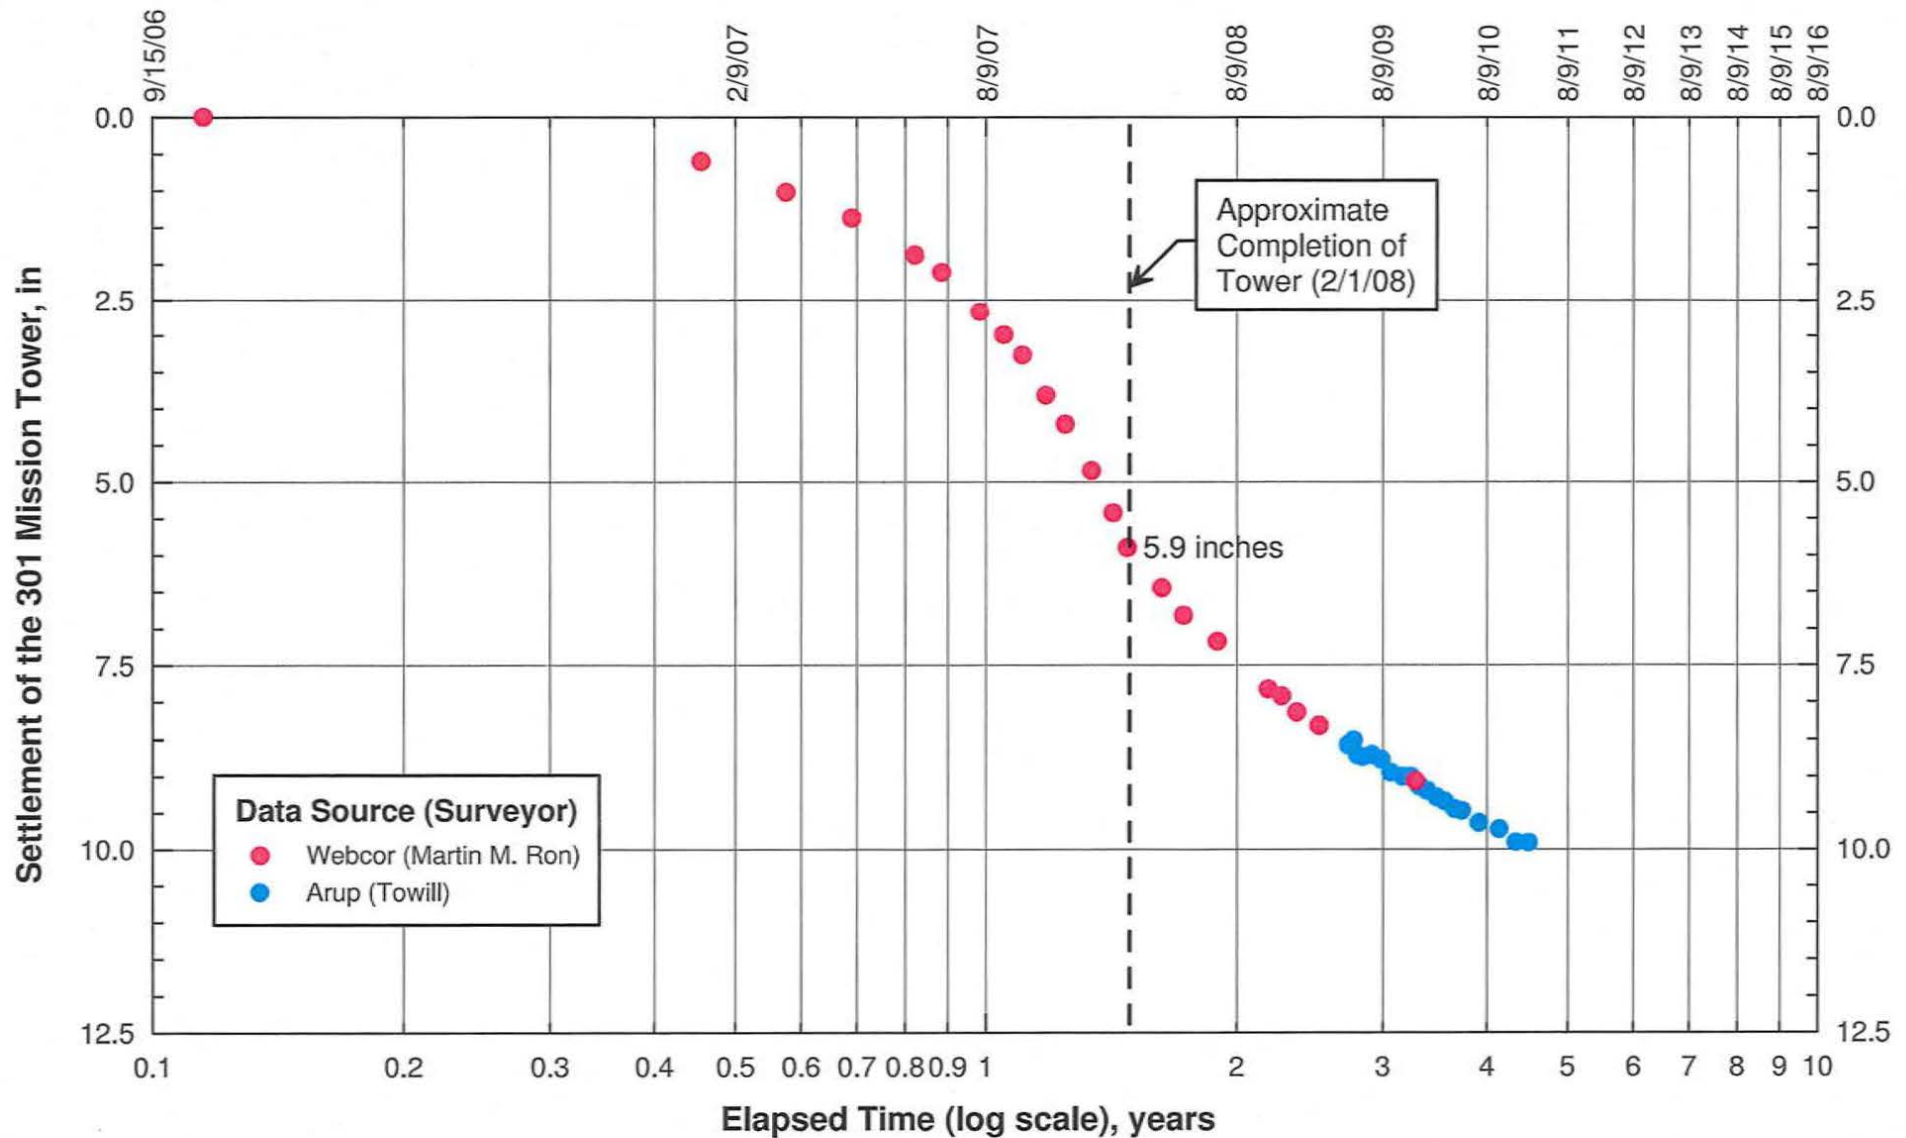
PLATE 5

**SETTLEMENTS OF THE 301 MISSION TOWER
 INCLUDING MONITORING DURING CONSTRUCTION**

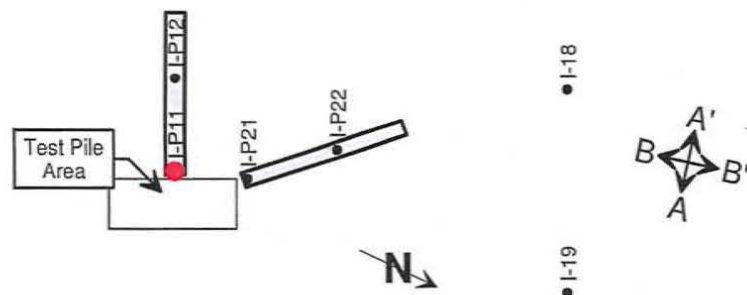
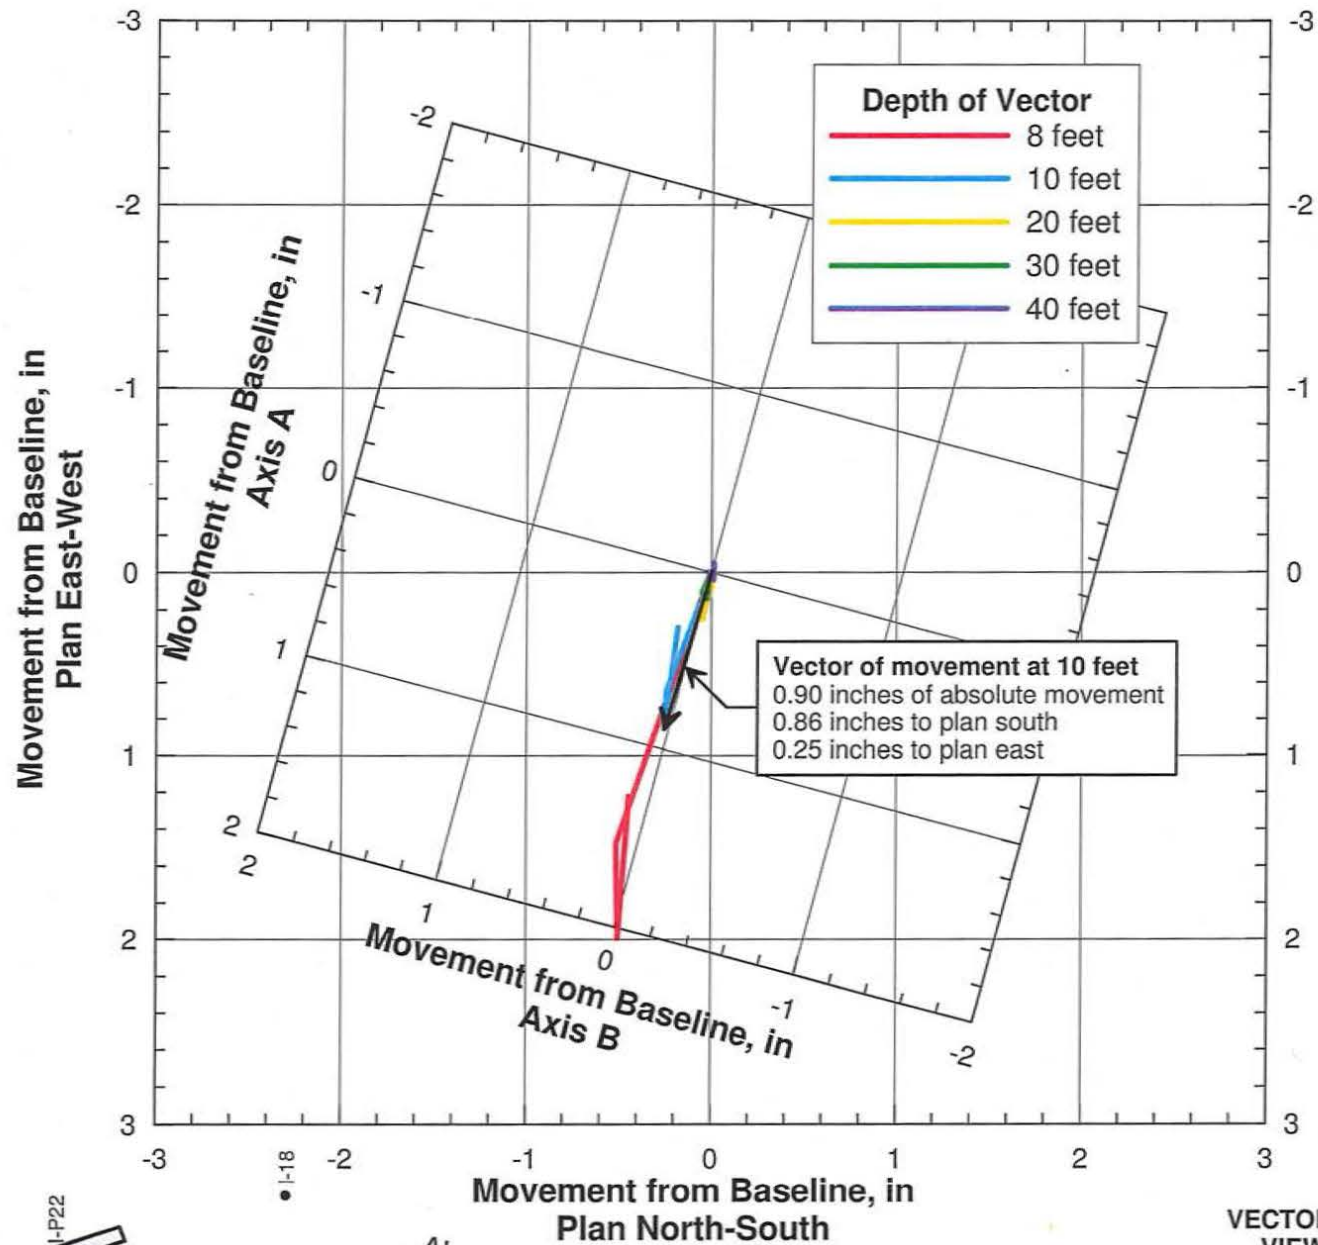
PLATE 4-2

**VECTORS OF MOVEMENT IN PLAN
VIEW FOR INCLINOMETER I-P11**

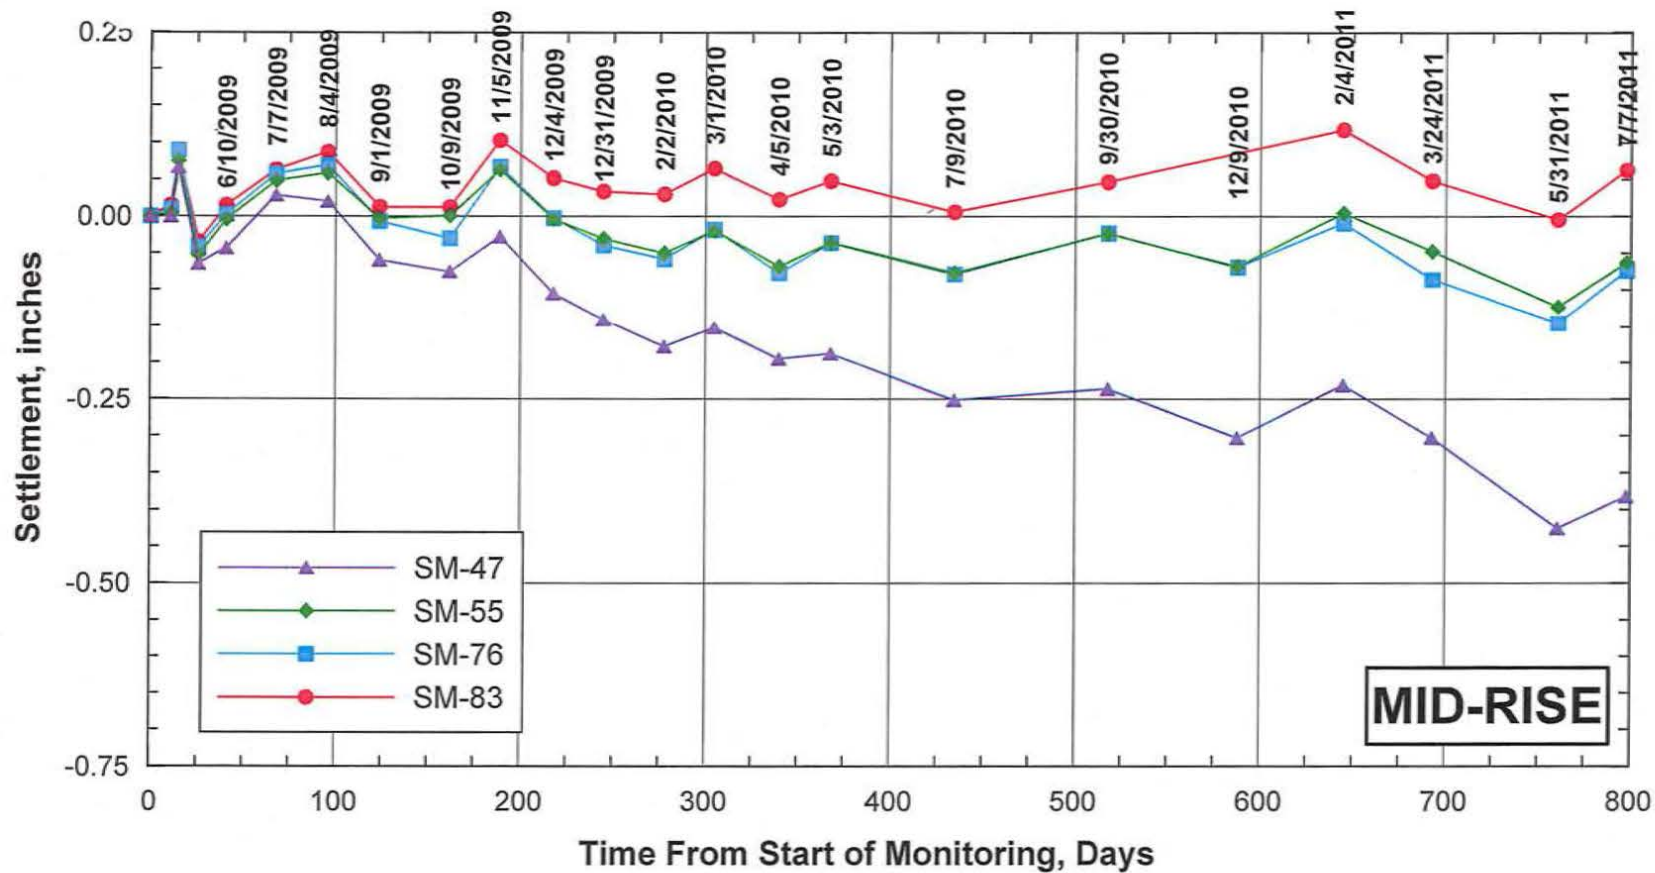
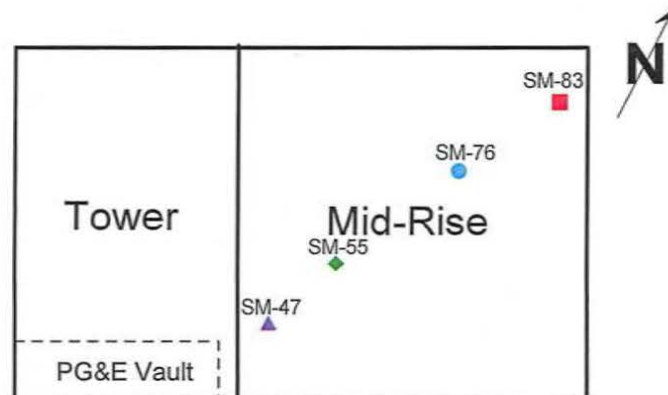
PLATE 4

**SETTLEMENT OVER TIME
FLOOR ELEVATIONS AT LEVEL B-1
OF 301 MISSION PROPERTY- MID-RISE:
APRIL 30, 2009 THROUGH JULY 7, 2011**

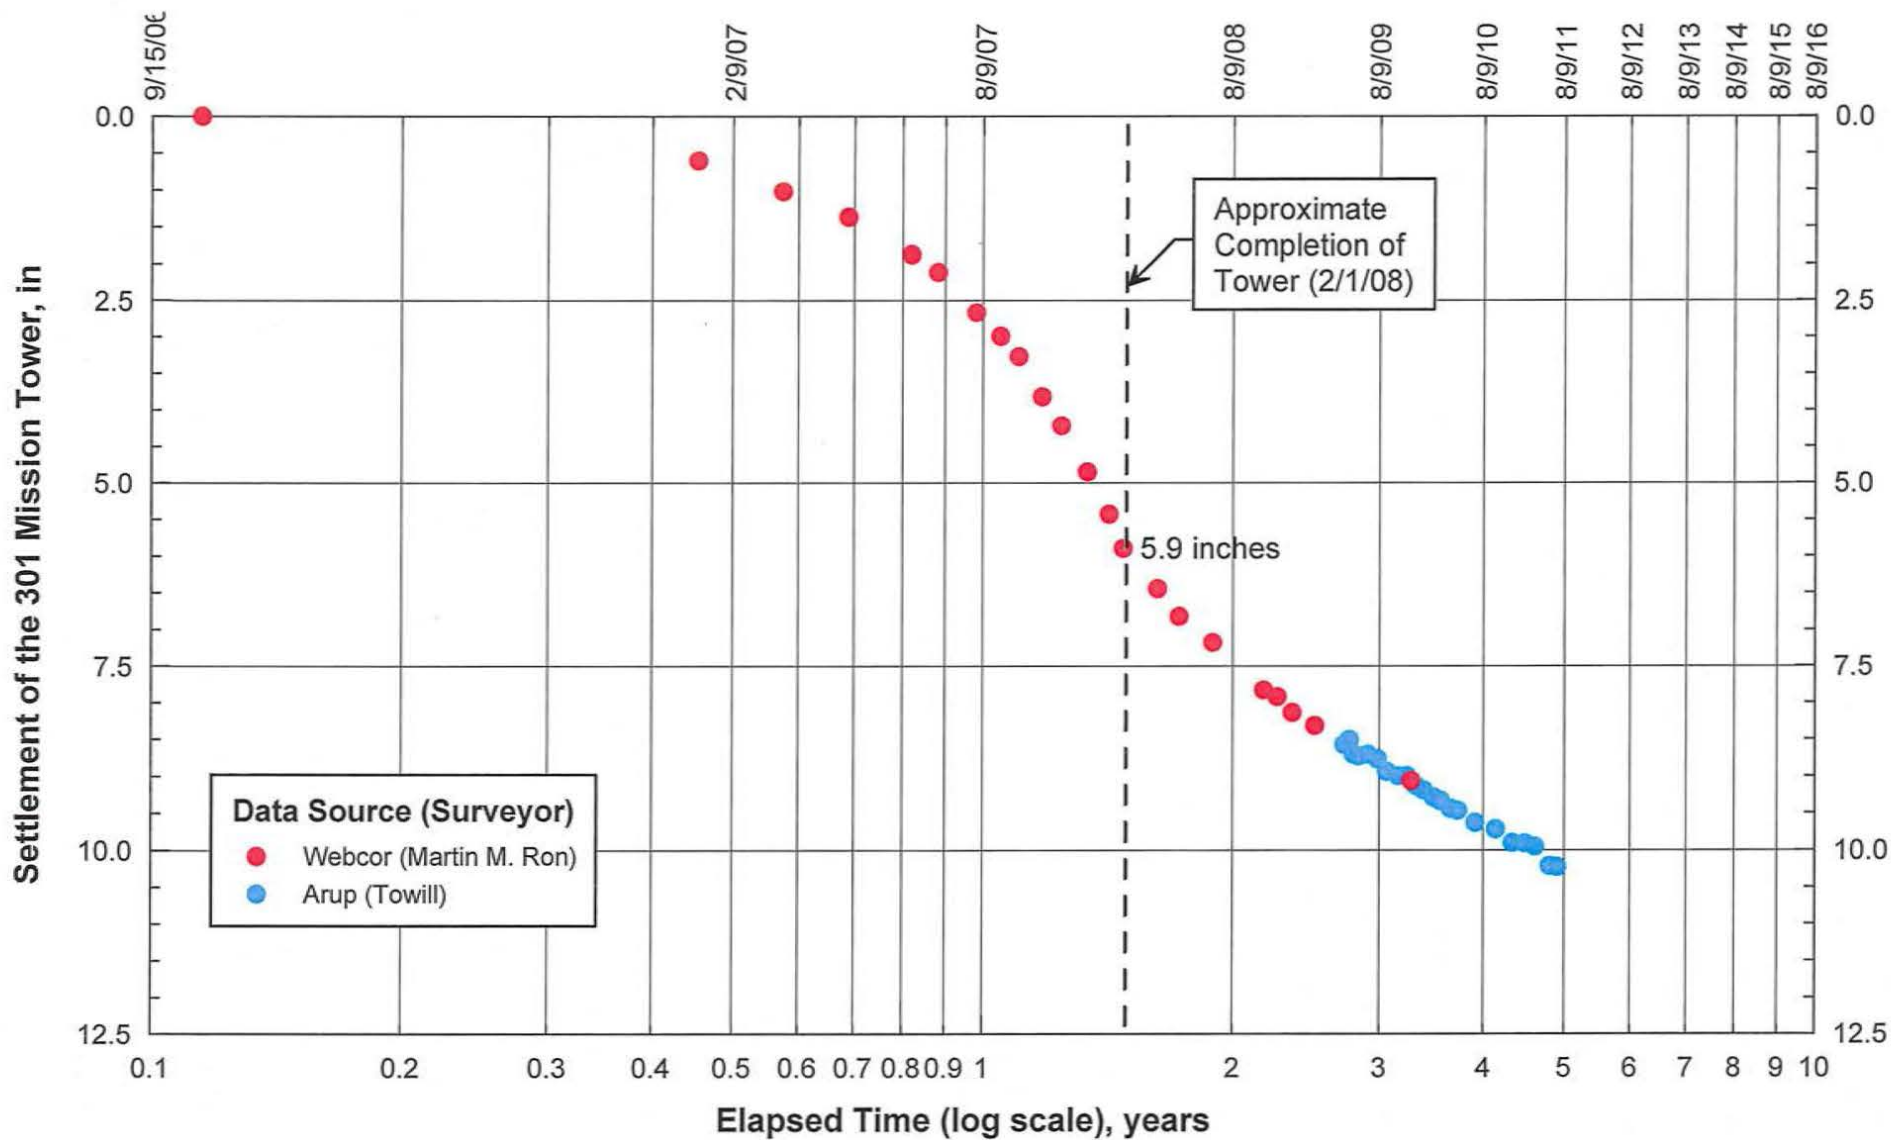
PLATE 5

**SETTLEMENTS OF THE 301 MISSION TOWER
 INCLUDING MONITORING DURING CONSTRUCTION**

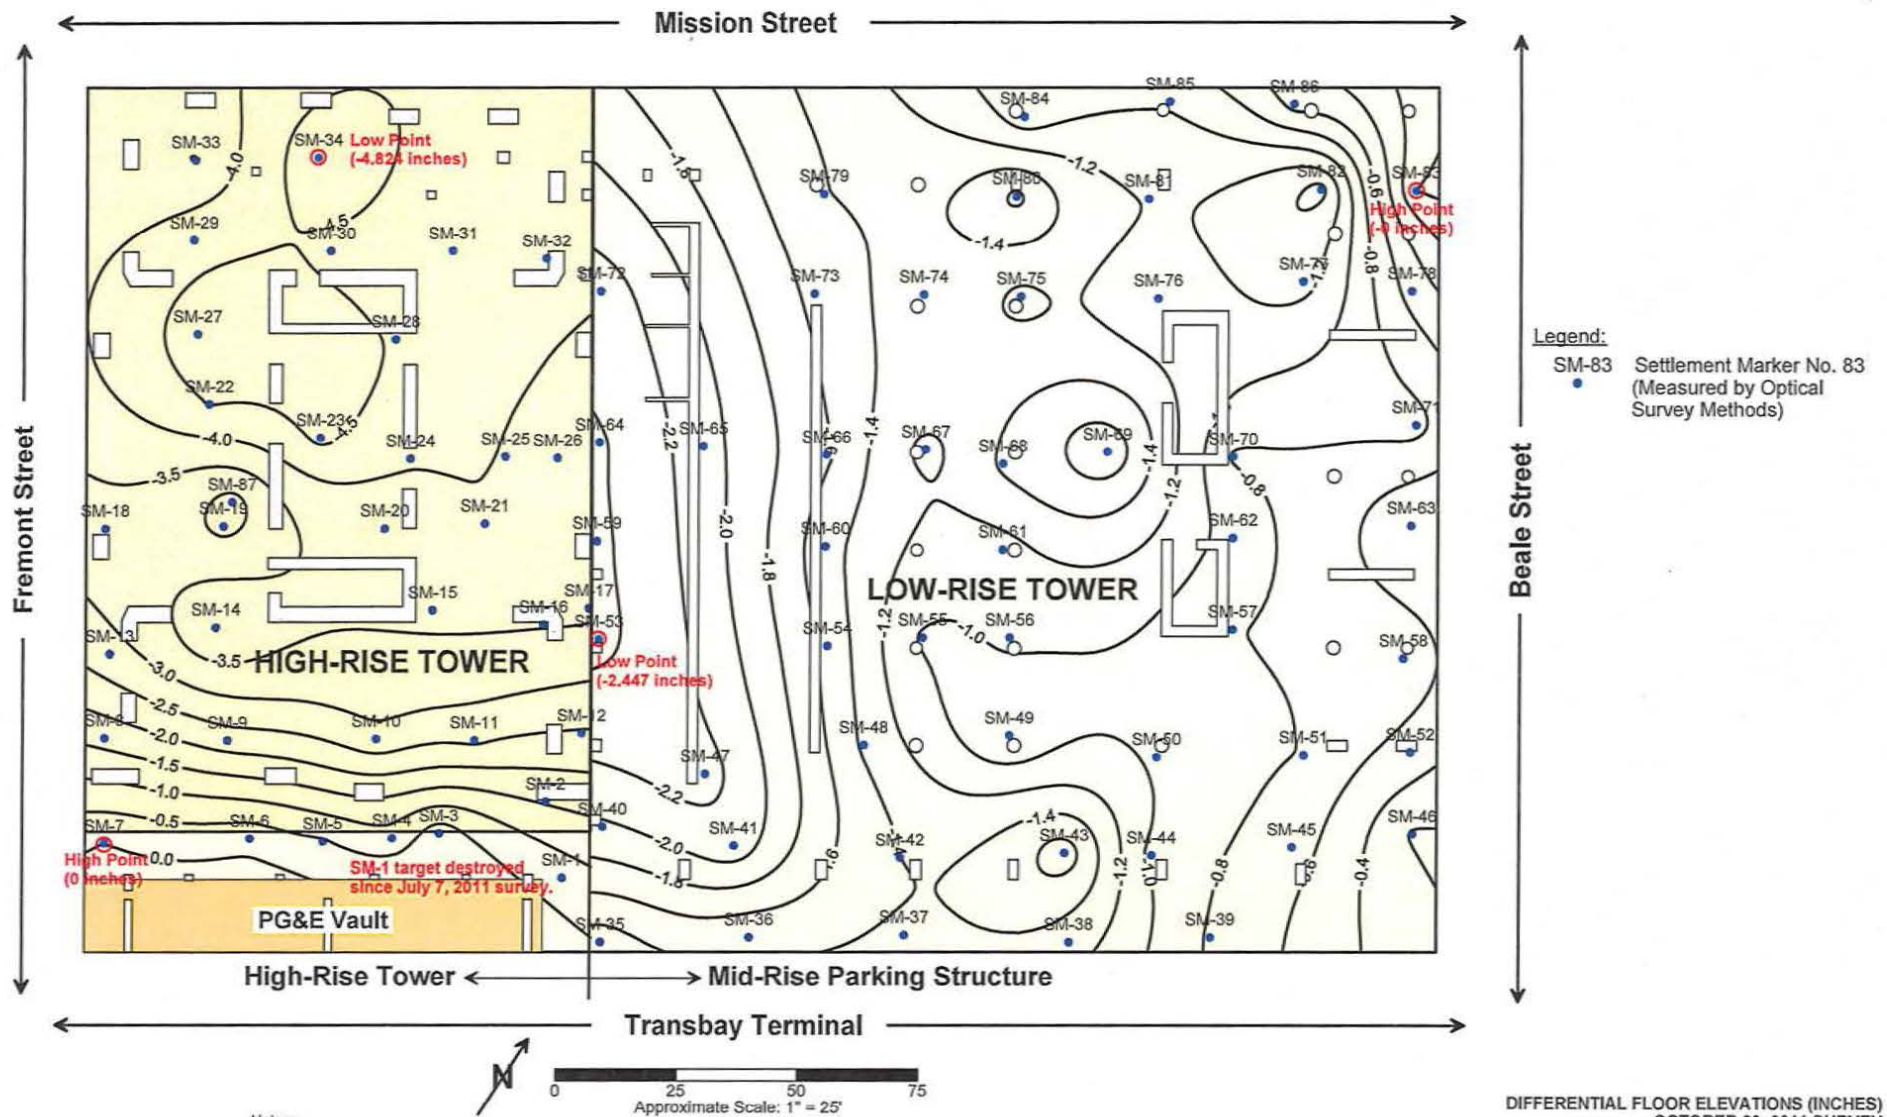
Contours represent differential elevation, in inches, between the highest point and all other points taken on October 20, 2011.
 Level B-1 at Mid-Rise Parking portion of survey site is approximately 4 inches higher than Level B-1 at High-Rise Tower portion.
 The PG&E vault is inaccessible for monitoring.
 Contour intervals are different between the High-Rise Tower and the Low-Rise Tower.

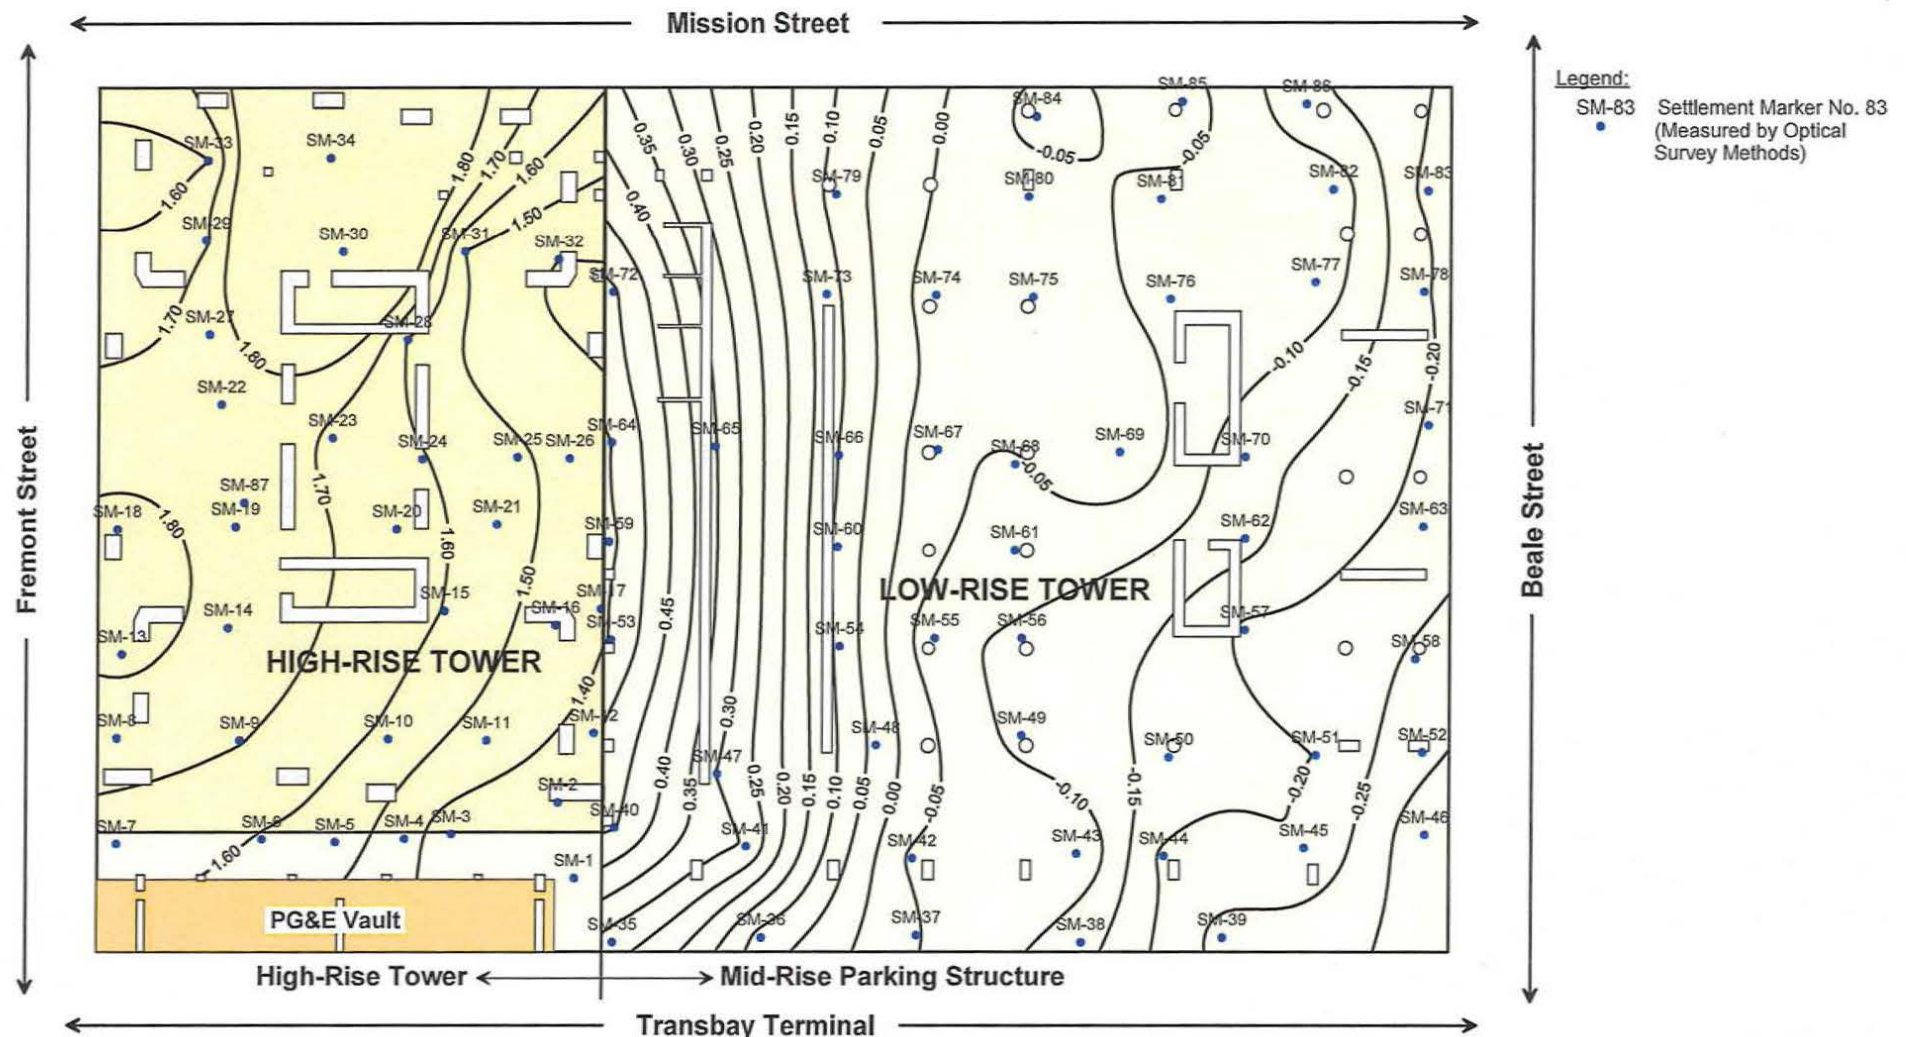
Contours represent elevation change, in inches, between Baseline survey (April 30, 2009) and readings taken on October 20, 2011.

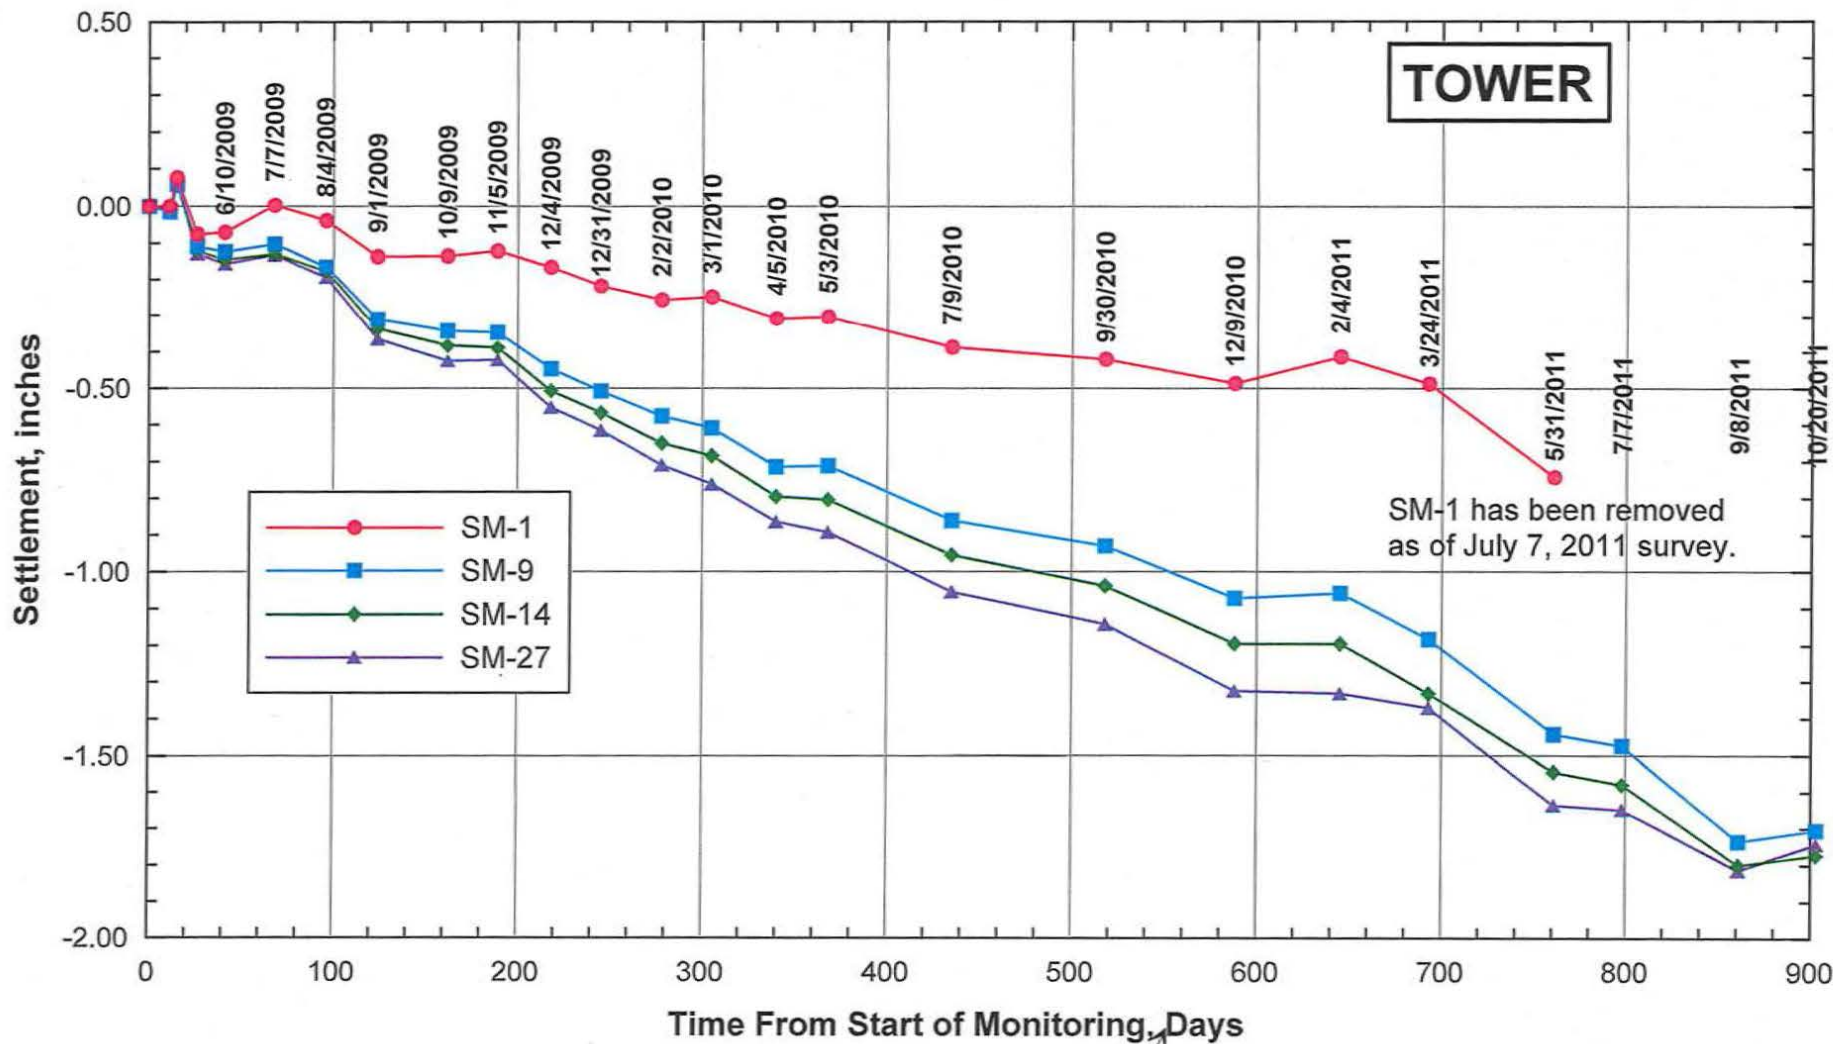
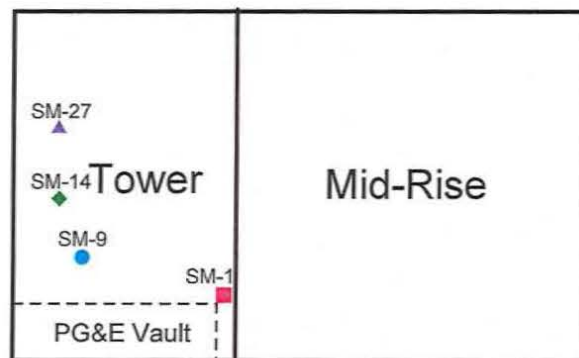
PLATE 3

**SETTLEMENT OVER TIME
FLOOR ELEVATIONS AT LEVEL B-1
OF 301 MISSION PROPERTY- TOWER:
APRIL 30, 2009 THROUGH OCTOBER 20, 2011**

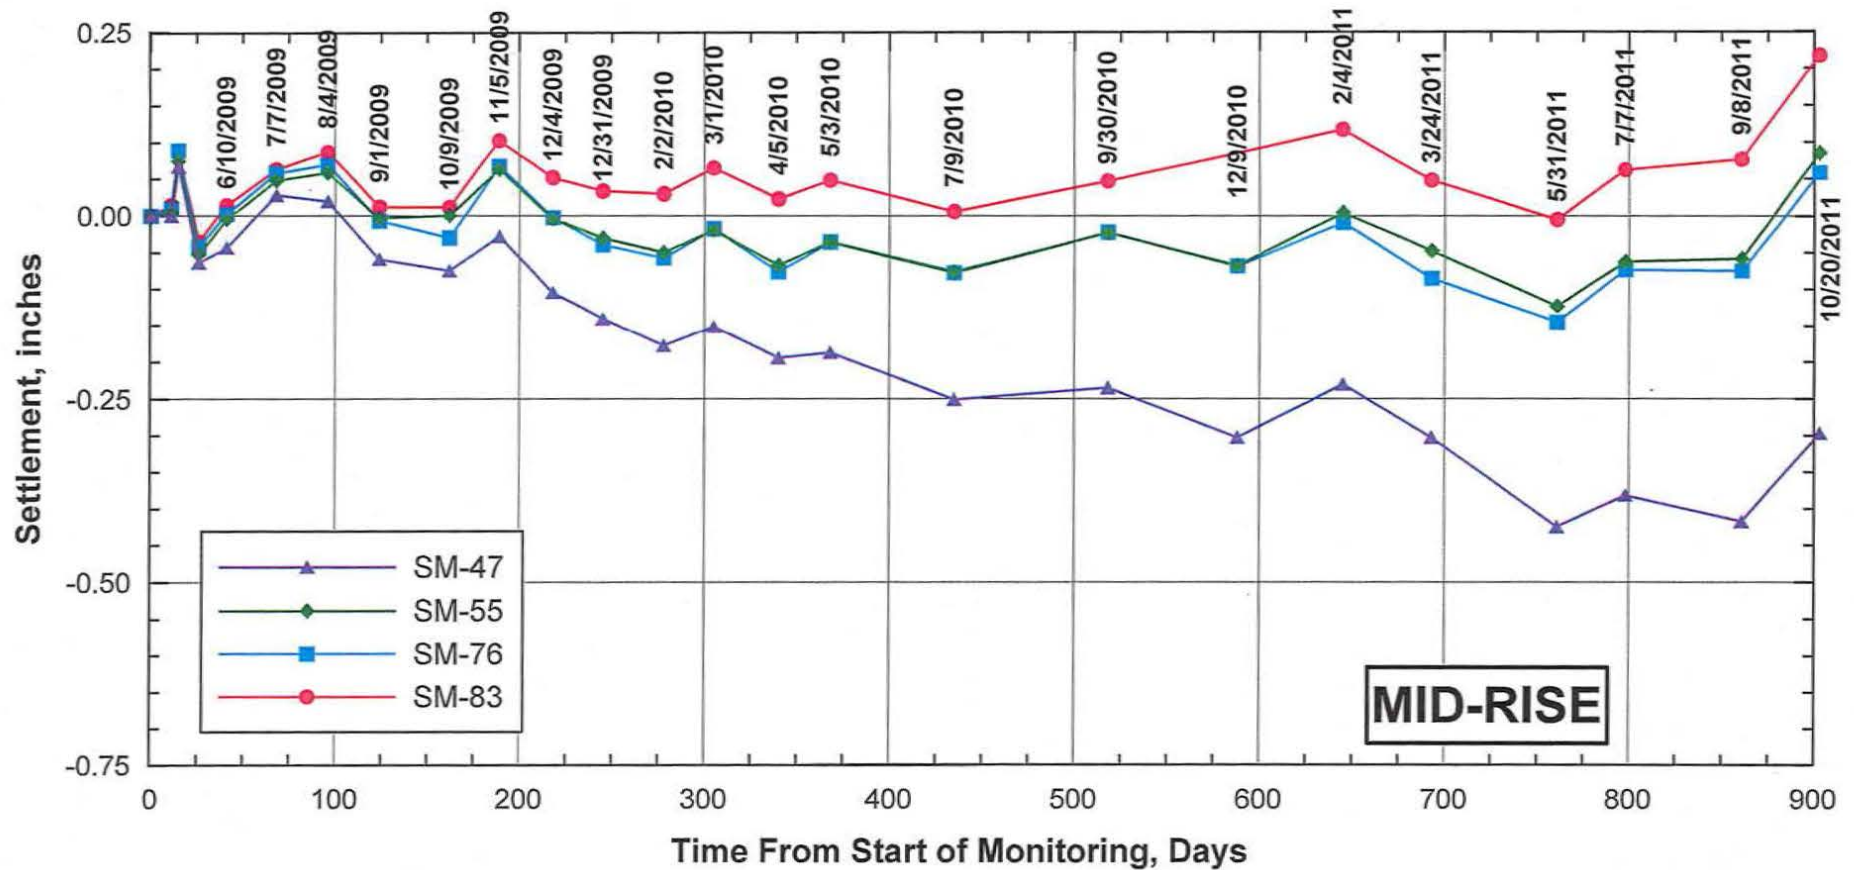
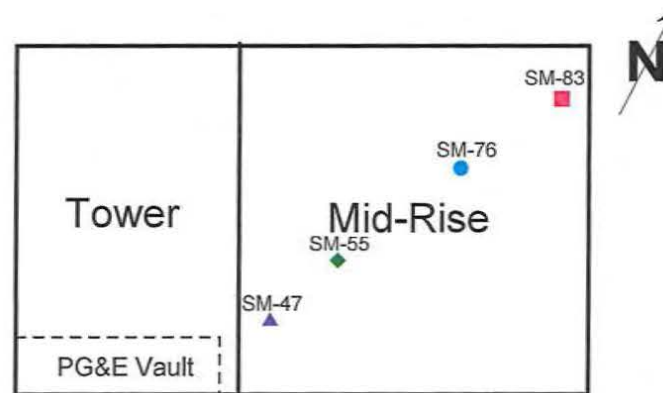
PLATE 4

**SETTLEMENT OVER TIME
FLOOR ELEVATIONS AT LEVEL B-1
OF 301 MISSION PROPERTY- MID-RISE:
APRIL 30, 2009 THROUGH OCTOBER 20, 2011**

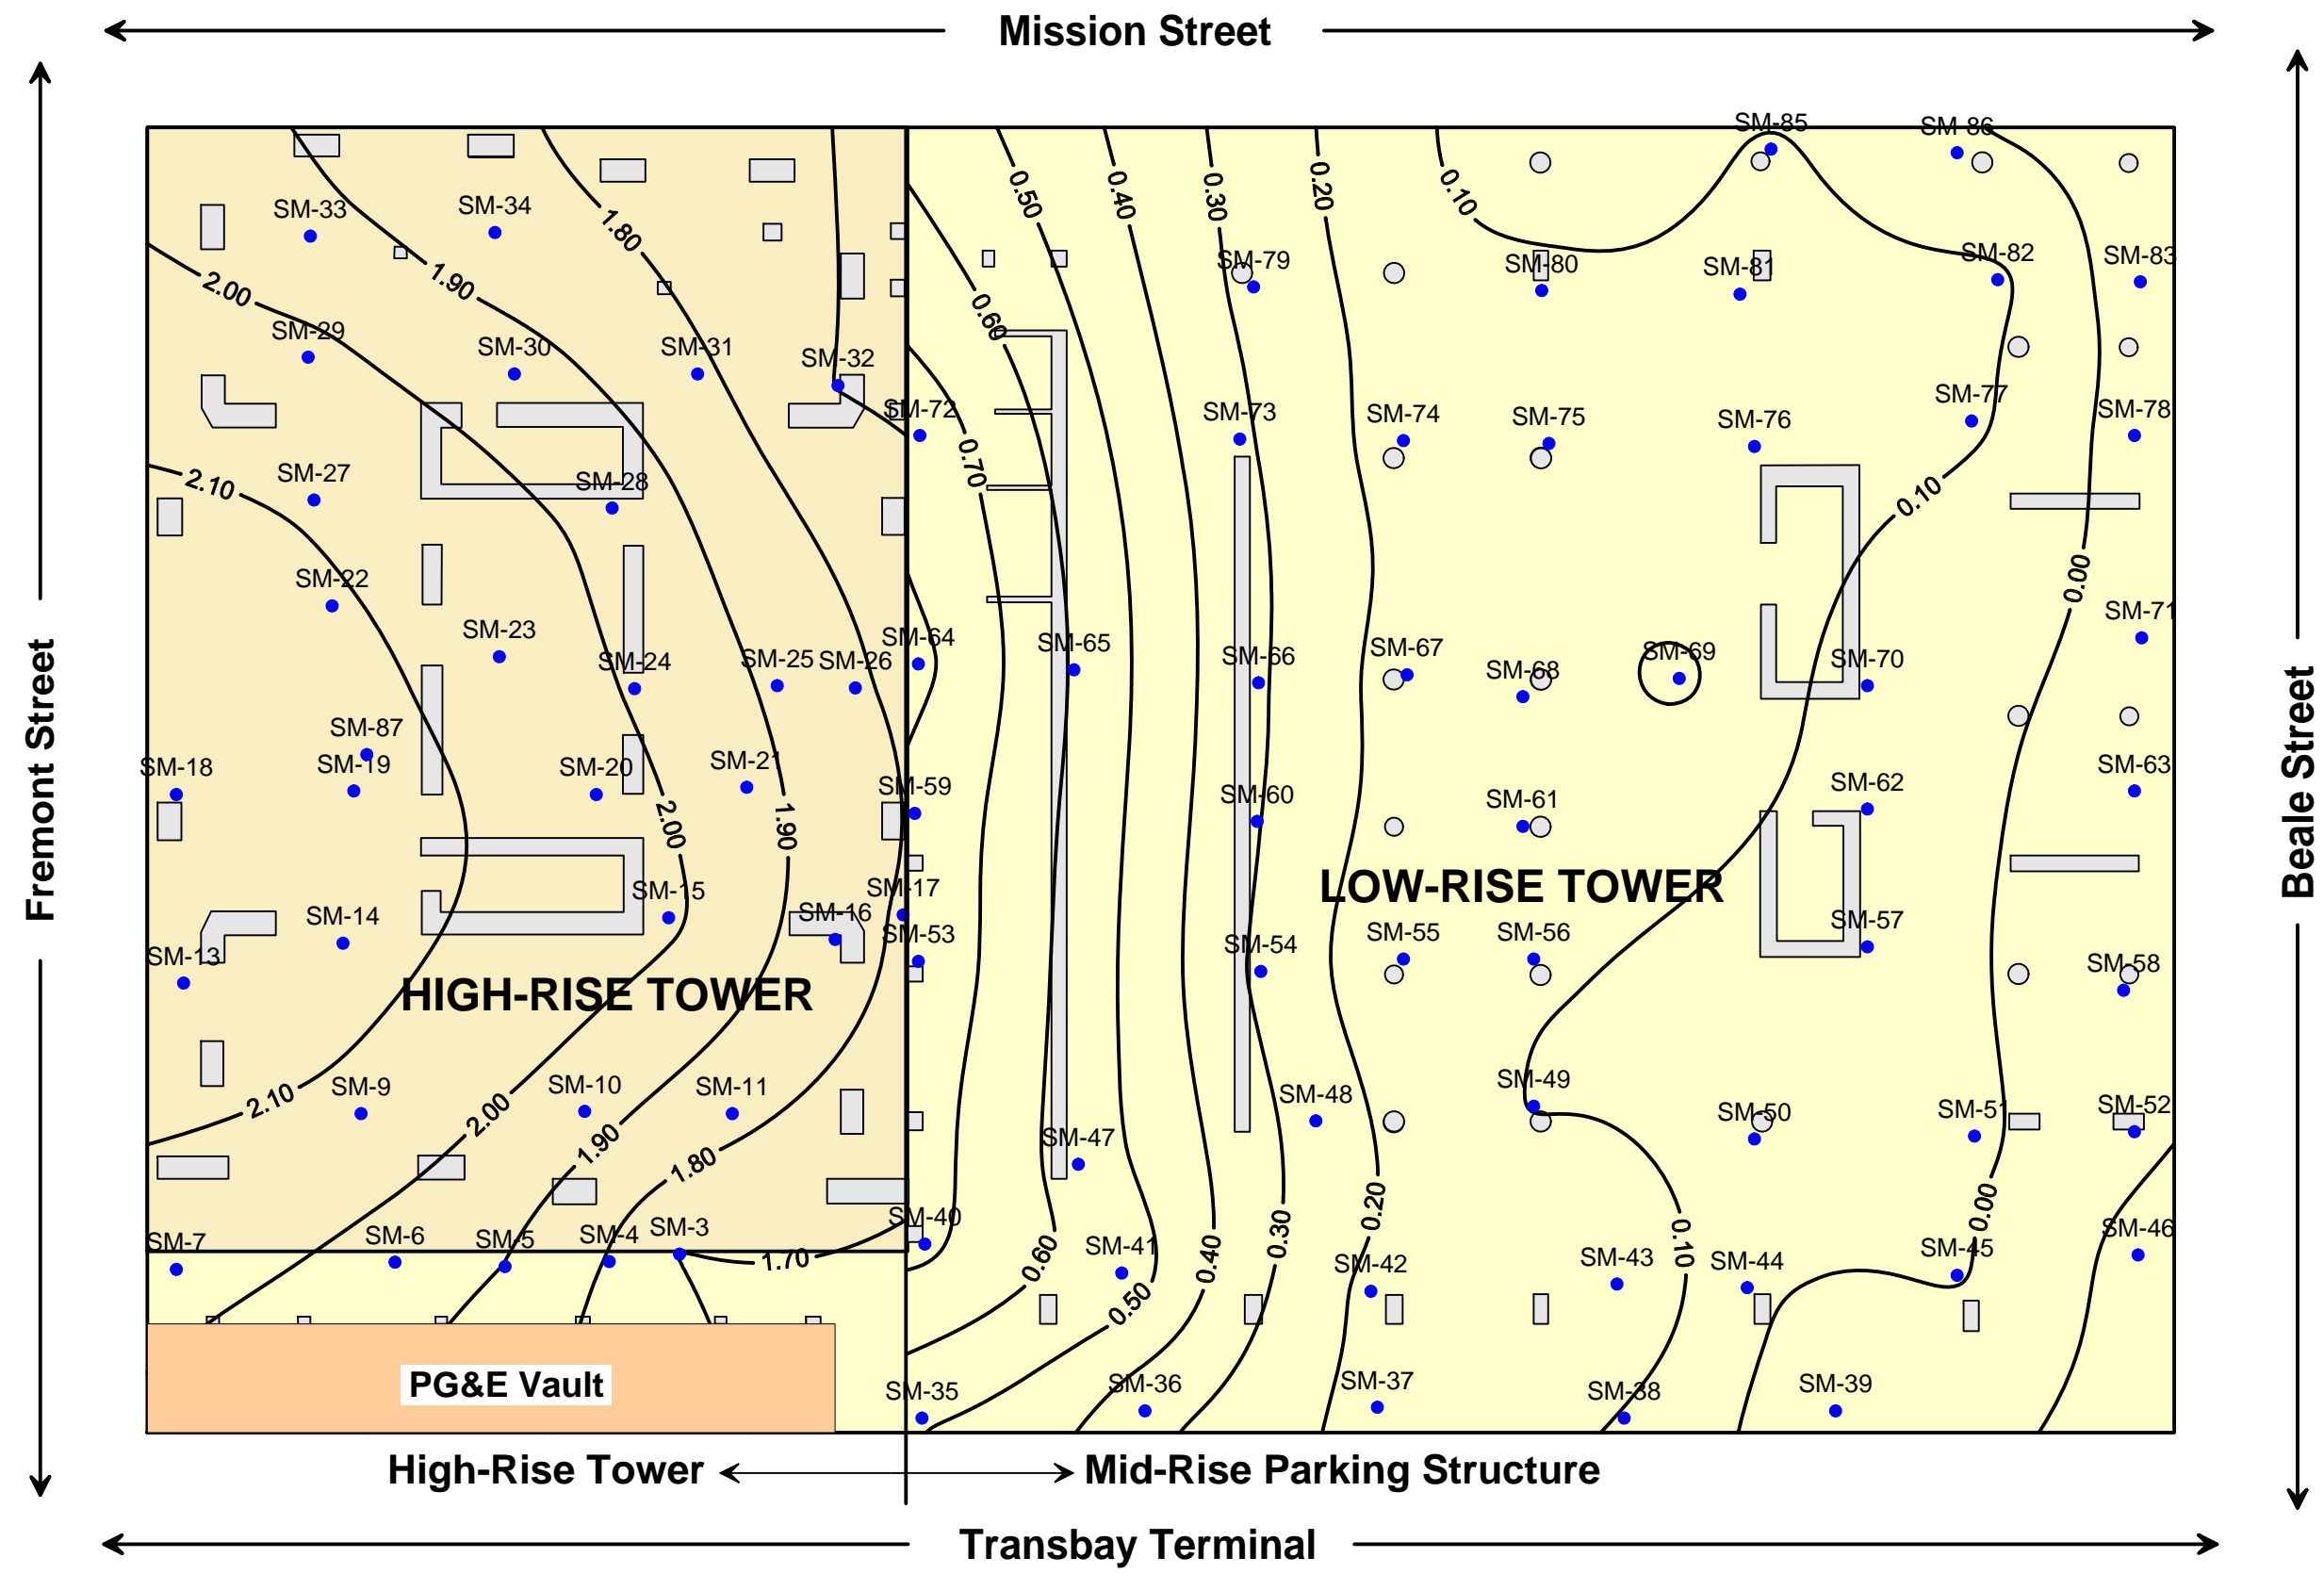
Notes:
 Contours represent elevation change, in inches, between Baseline survey (April 30, 2009) and readings taken on December 14, 2011.
 Level B-1 at Mid-Rise Parking portion of survey site is approximately 4 inches higher than Level B-1 at High-Rise Tower portion.
 The PG&E vault is inaccessible for monitoring.
 Negative values of settlement (within Low-rise Tower) indicate uplift.

**CONTOURS OF SETTLEMENTS MEASURED AT THE
 FIRST LEVEL BASEMENT OF THE 301 MISSION STREET
 STRUCTURE BETWEEN APRIL 30, 2009 AND DECEMBER 14, 2011**
