*Board of Supervisors
City and County of San Francisco*

Government Audit and Oversight Committee

Supplemental Report for Foundation Settlement Investigation

**SUPPLEMENTAL REPORT
FOUNDATION SETTLEMENT INVESTIGATION
301 MISSION STREET
SAN FRANCISCO, CALIFORNIA**

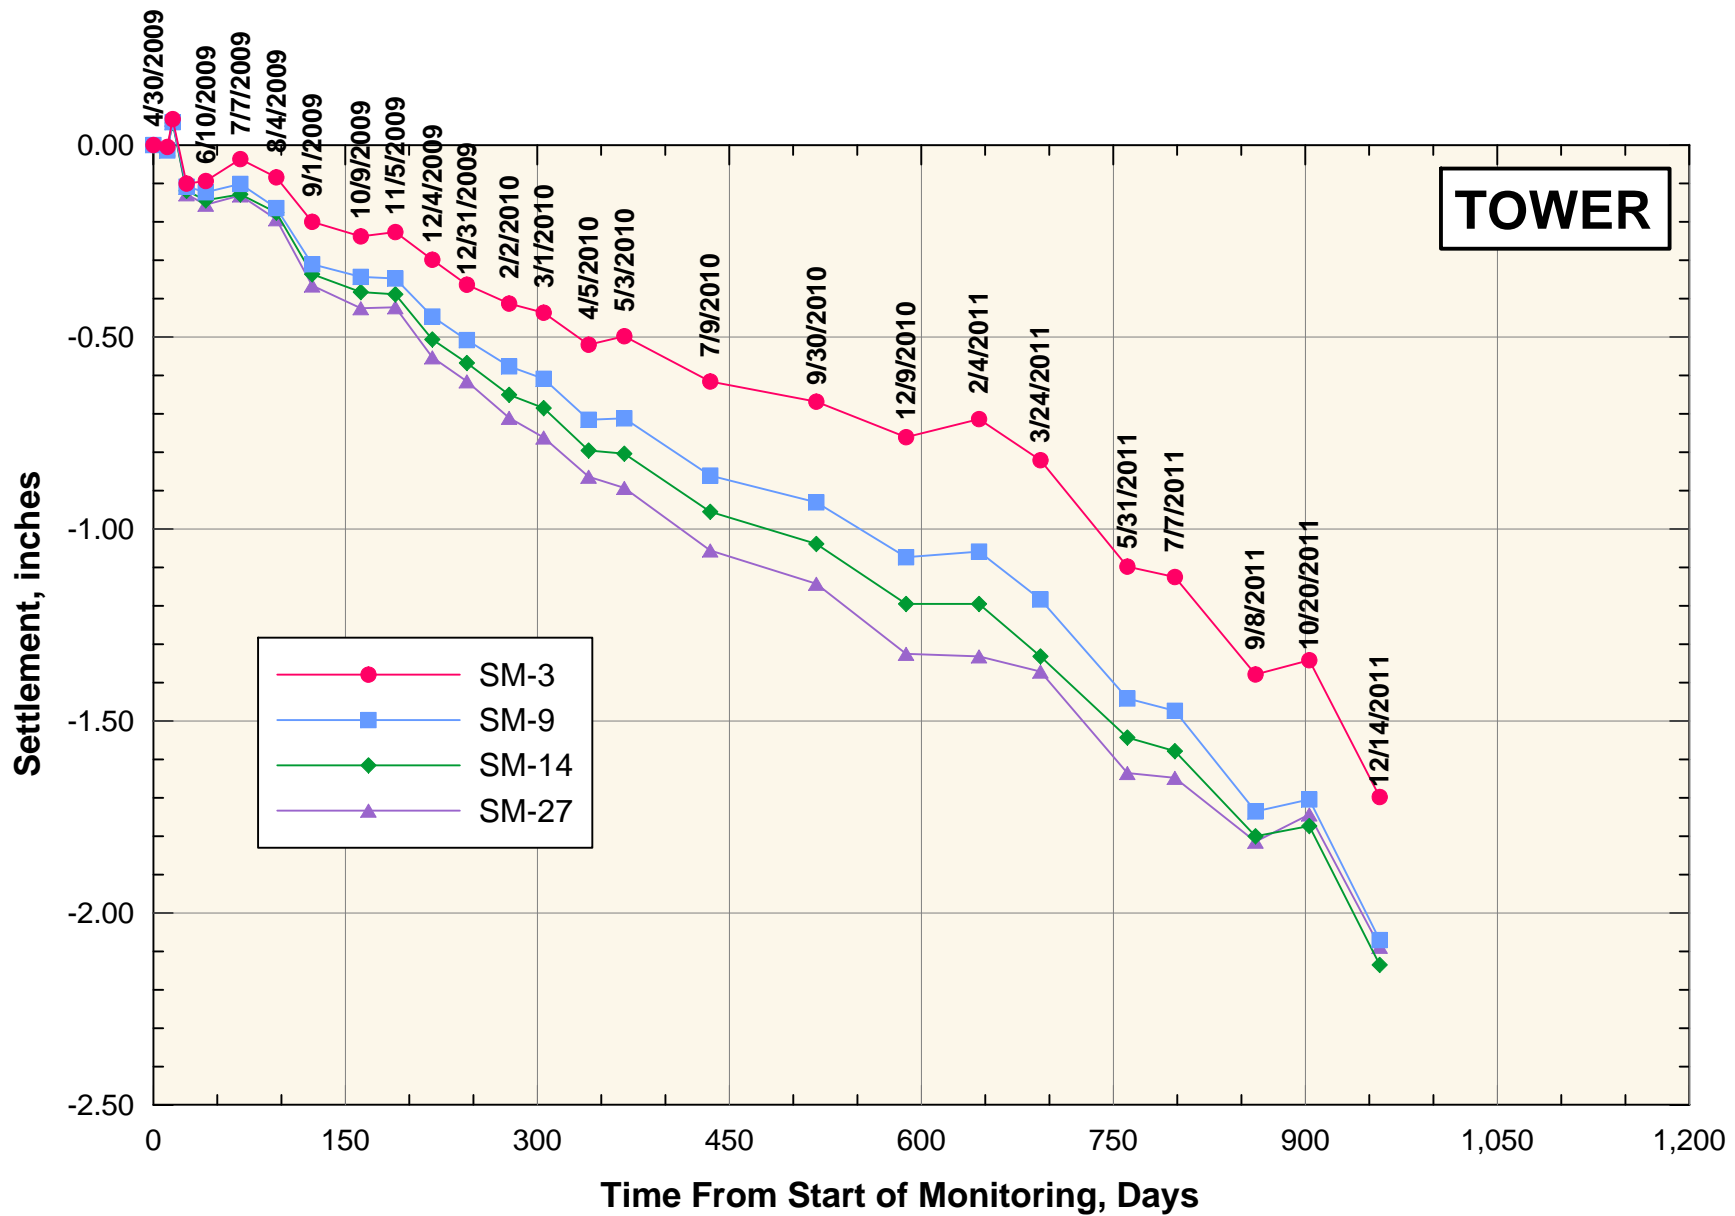
**SETTLEMENT OVER TIME
FLOOR ELEVATIONS AT LEVEL B-1
OF 301 MISSION PROPERTY- TOWER:
APRIL 30, 2009 THROUGH DECEMBER 14, 2011**

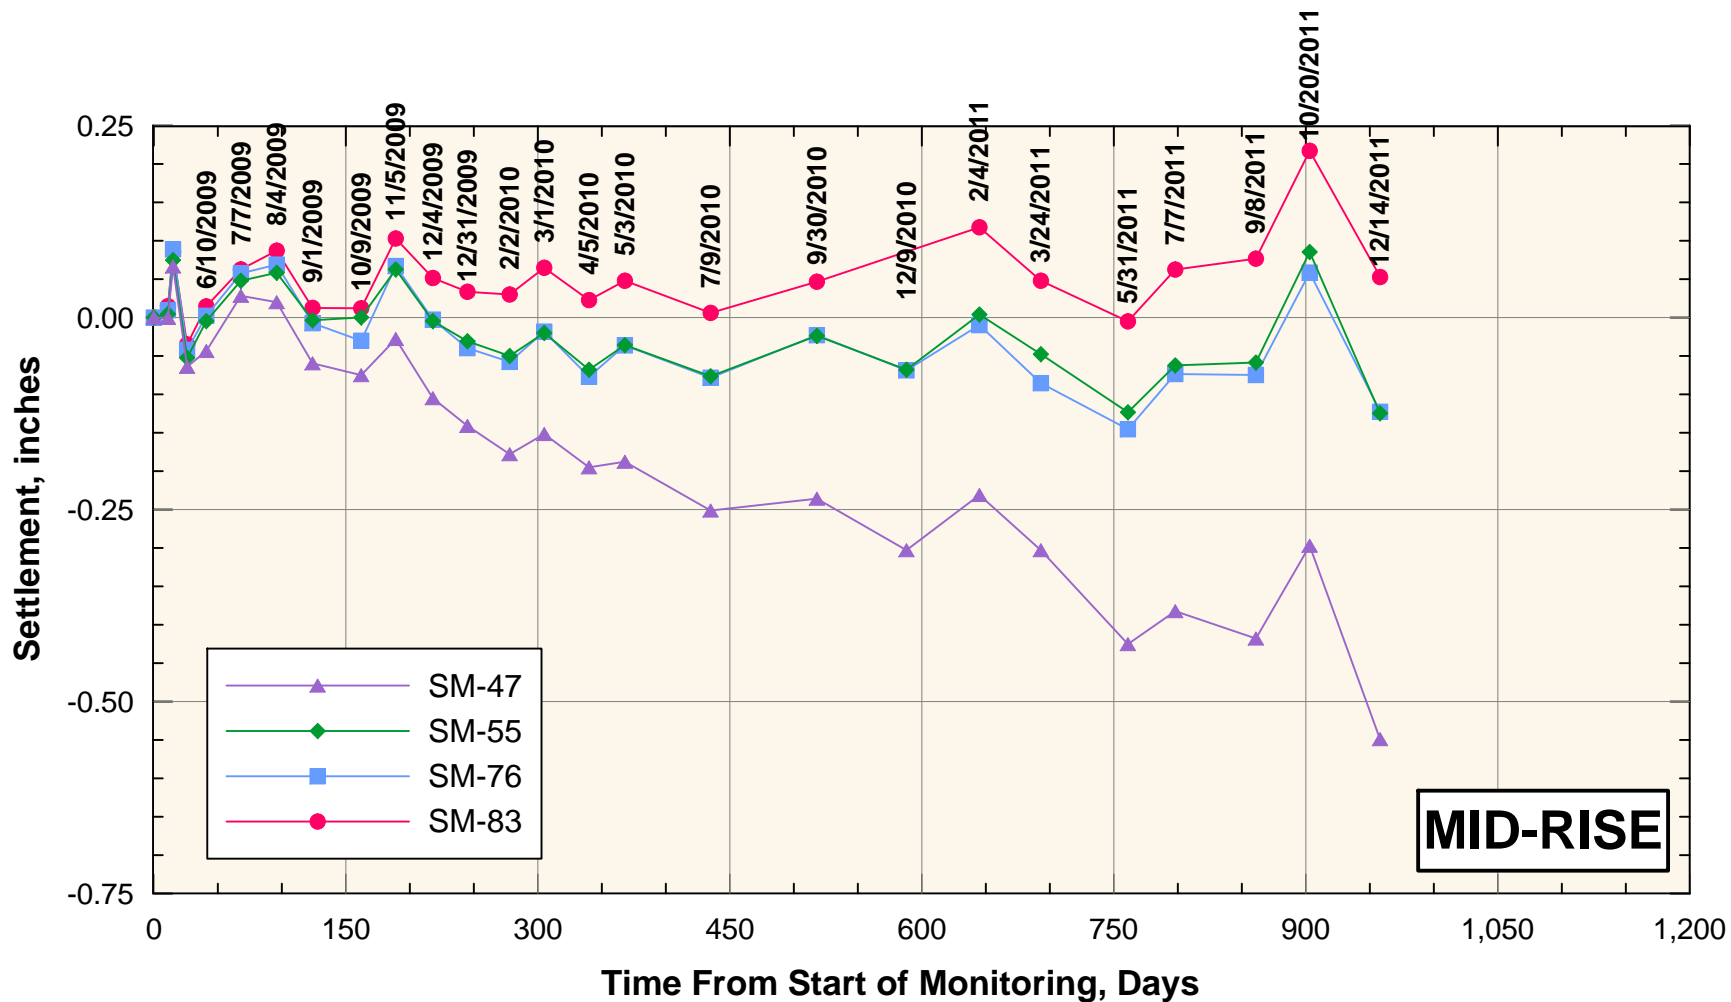
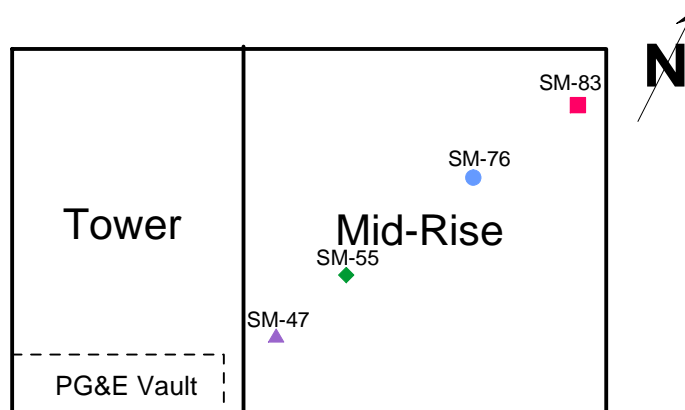
**SETTLEMENT OVER TIME
FLOOR ELEVATIONS AT LEVEL B-1
OF 301 MISSION PROPERTY- MID-RISE:
APRIL 30, 2009 THROUGH DECEMBER 14, 2011**

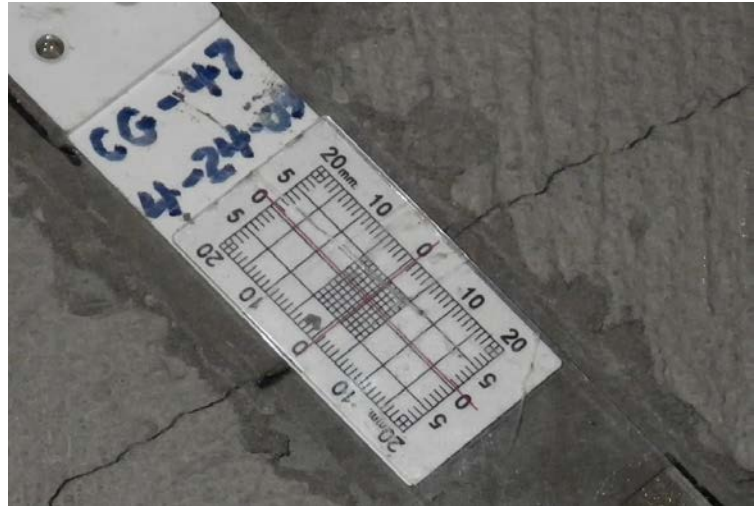
Crack Gauge	Distance of Movement	Direction of movement, relative to the Crack	Variation from previous reading	Picture of Movement
CG-47	0.5 to 0.8 mm 0.5 to 0.8 mm	Parallel Perpendicular	+0.5 to +0.8 mm +0.5 to +0.8 mm

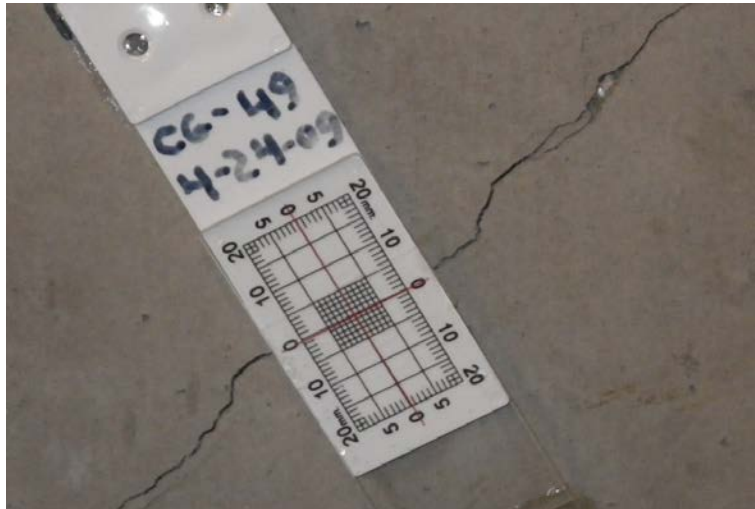
CG-49	0.4 mm	Perpendicular	+0.4 mm

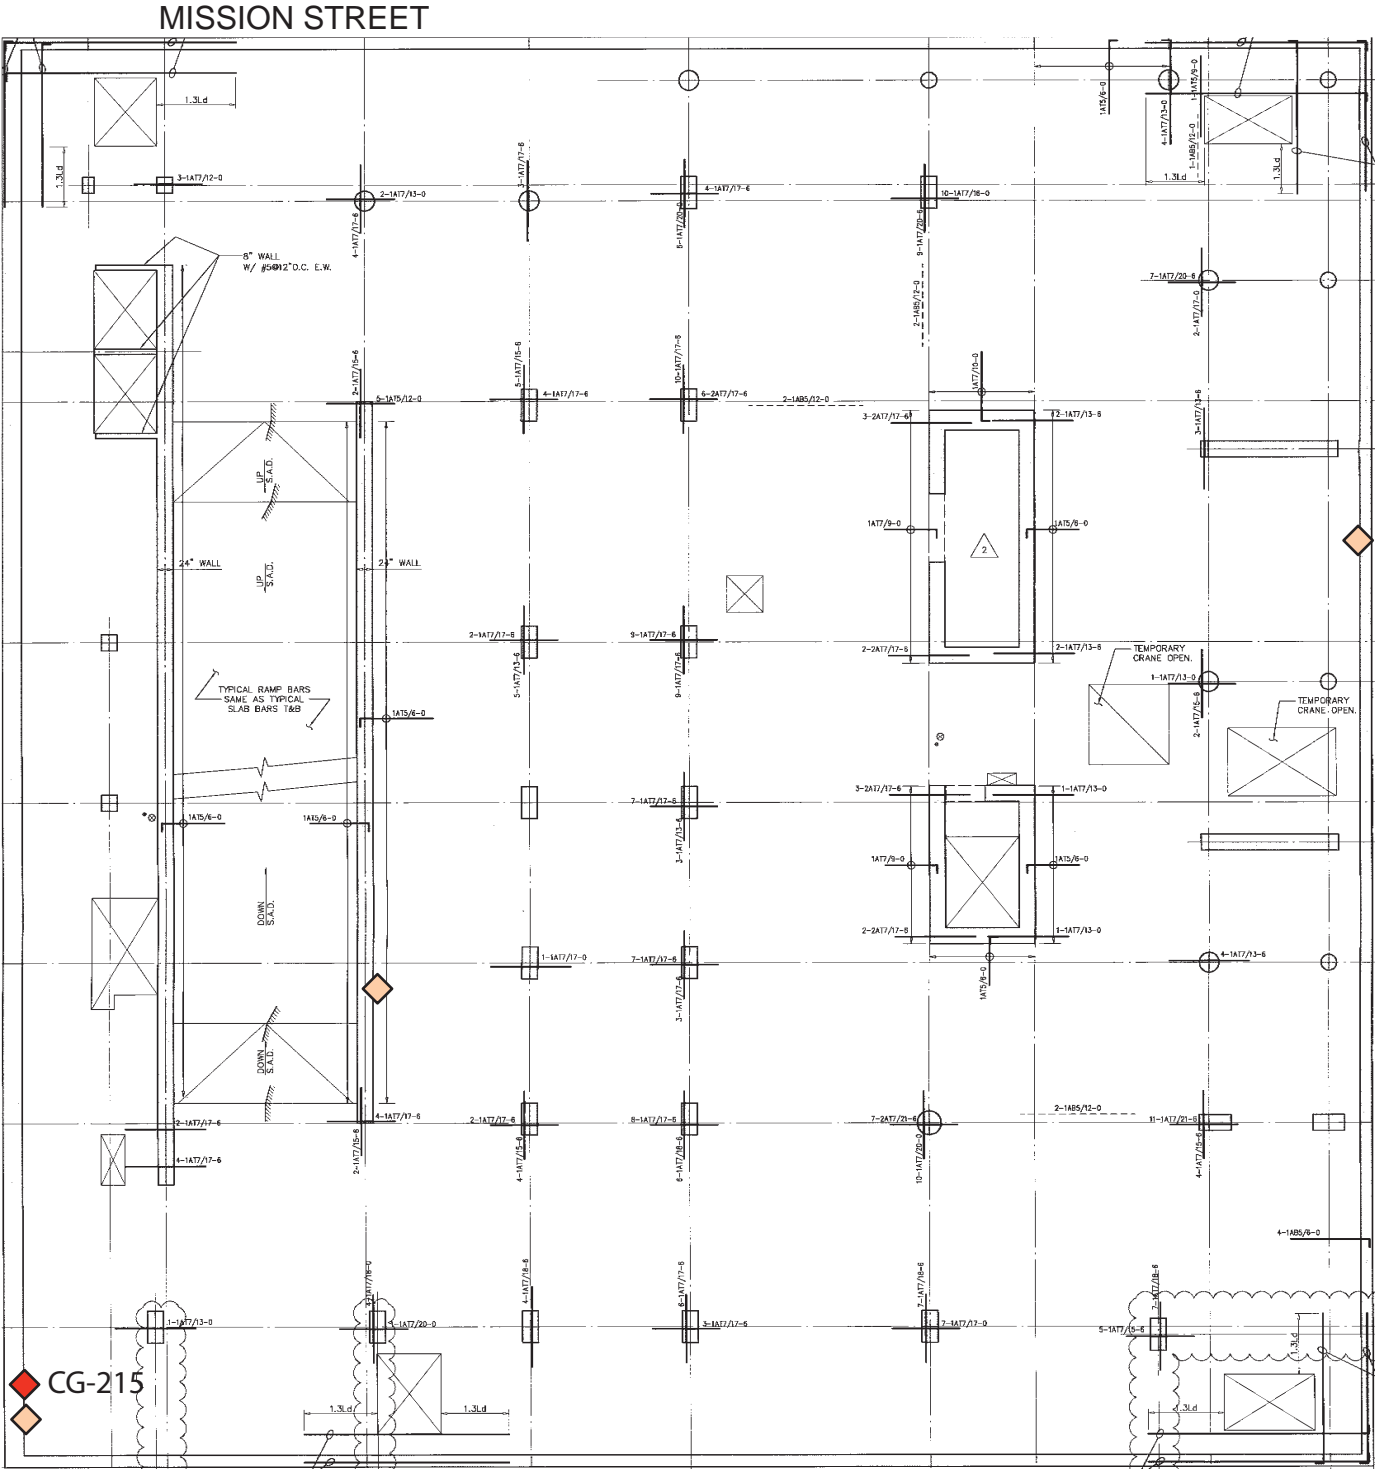
CRACK GAUGES SHOWING MOVEMENT:
301 MISSION STREET BASEMENT LEVEL B-3

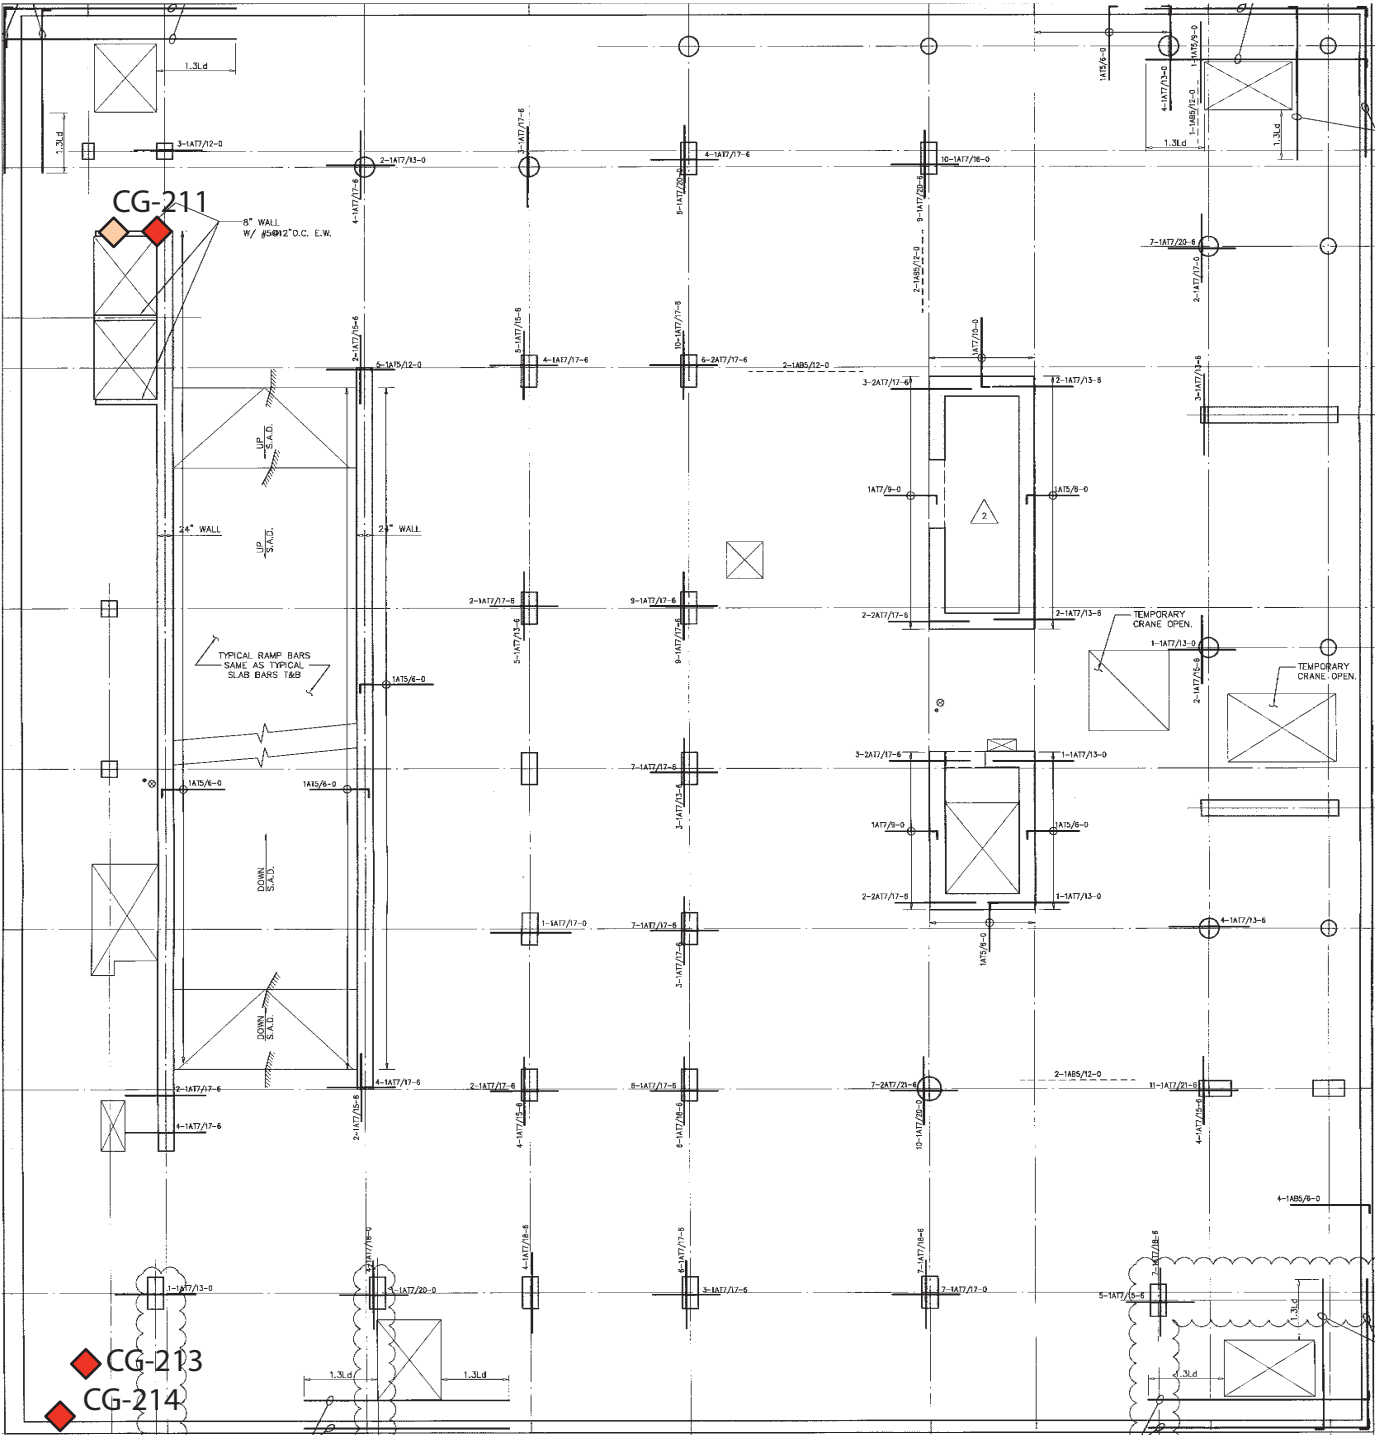
PLATE 3

**CRACK GAUGES SHOWING MOVEMENTS:
301 MISSION STREET BASEMENT LEVEL B-4**

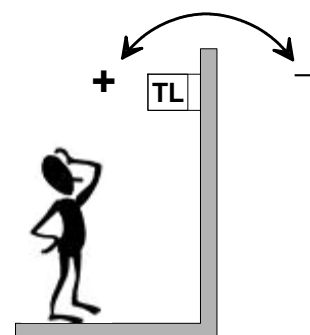
PLATE 3

TILT RECORDED IN TILTMETERS TL-04, TL-05, AND TL-06: BASEMENT LEVEL B-1

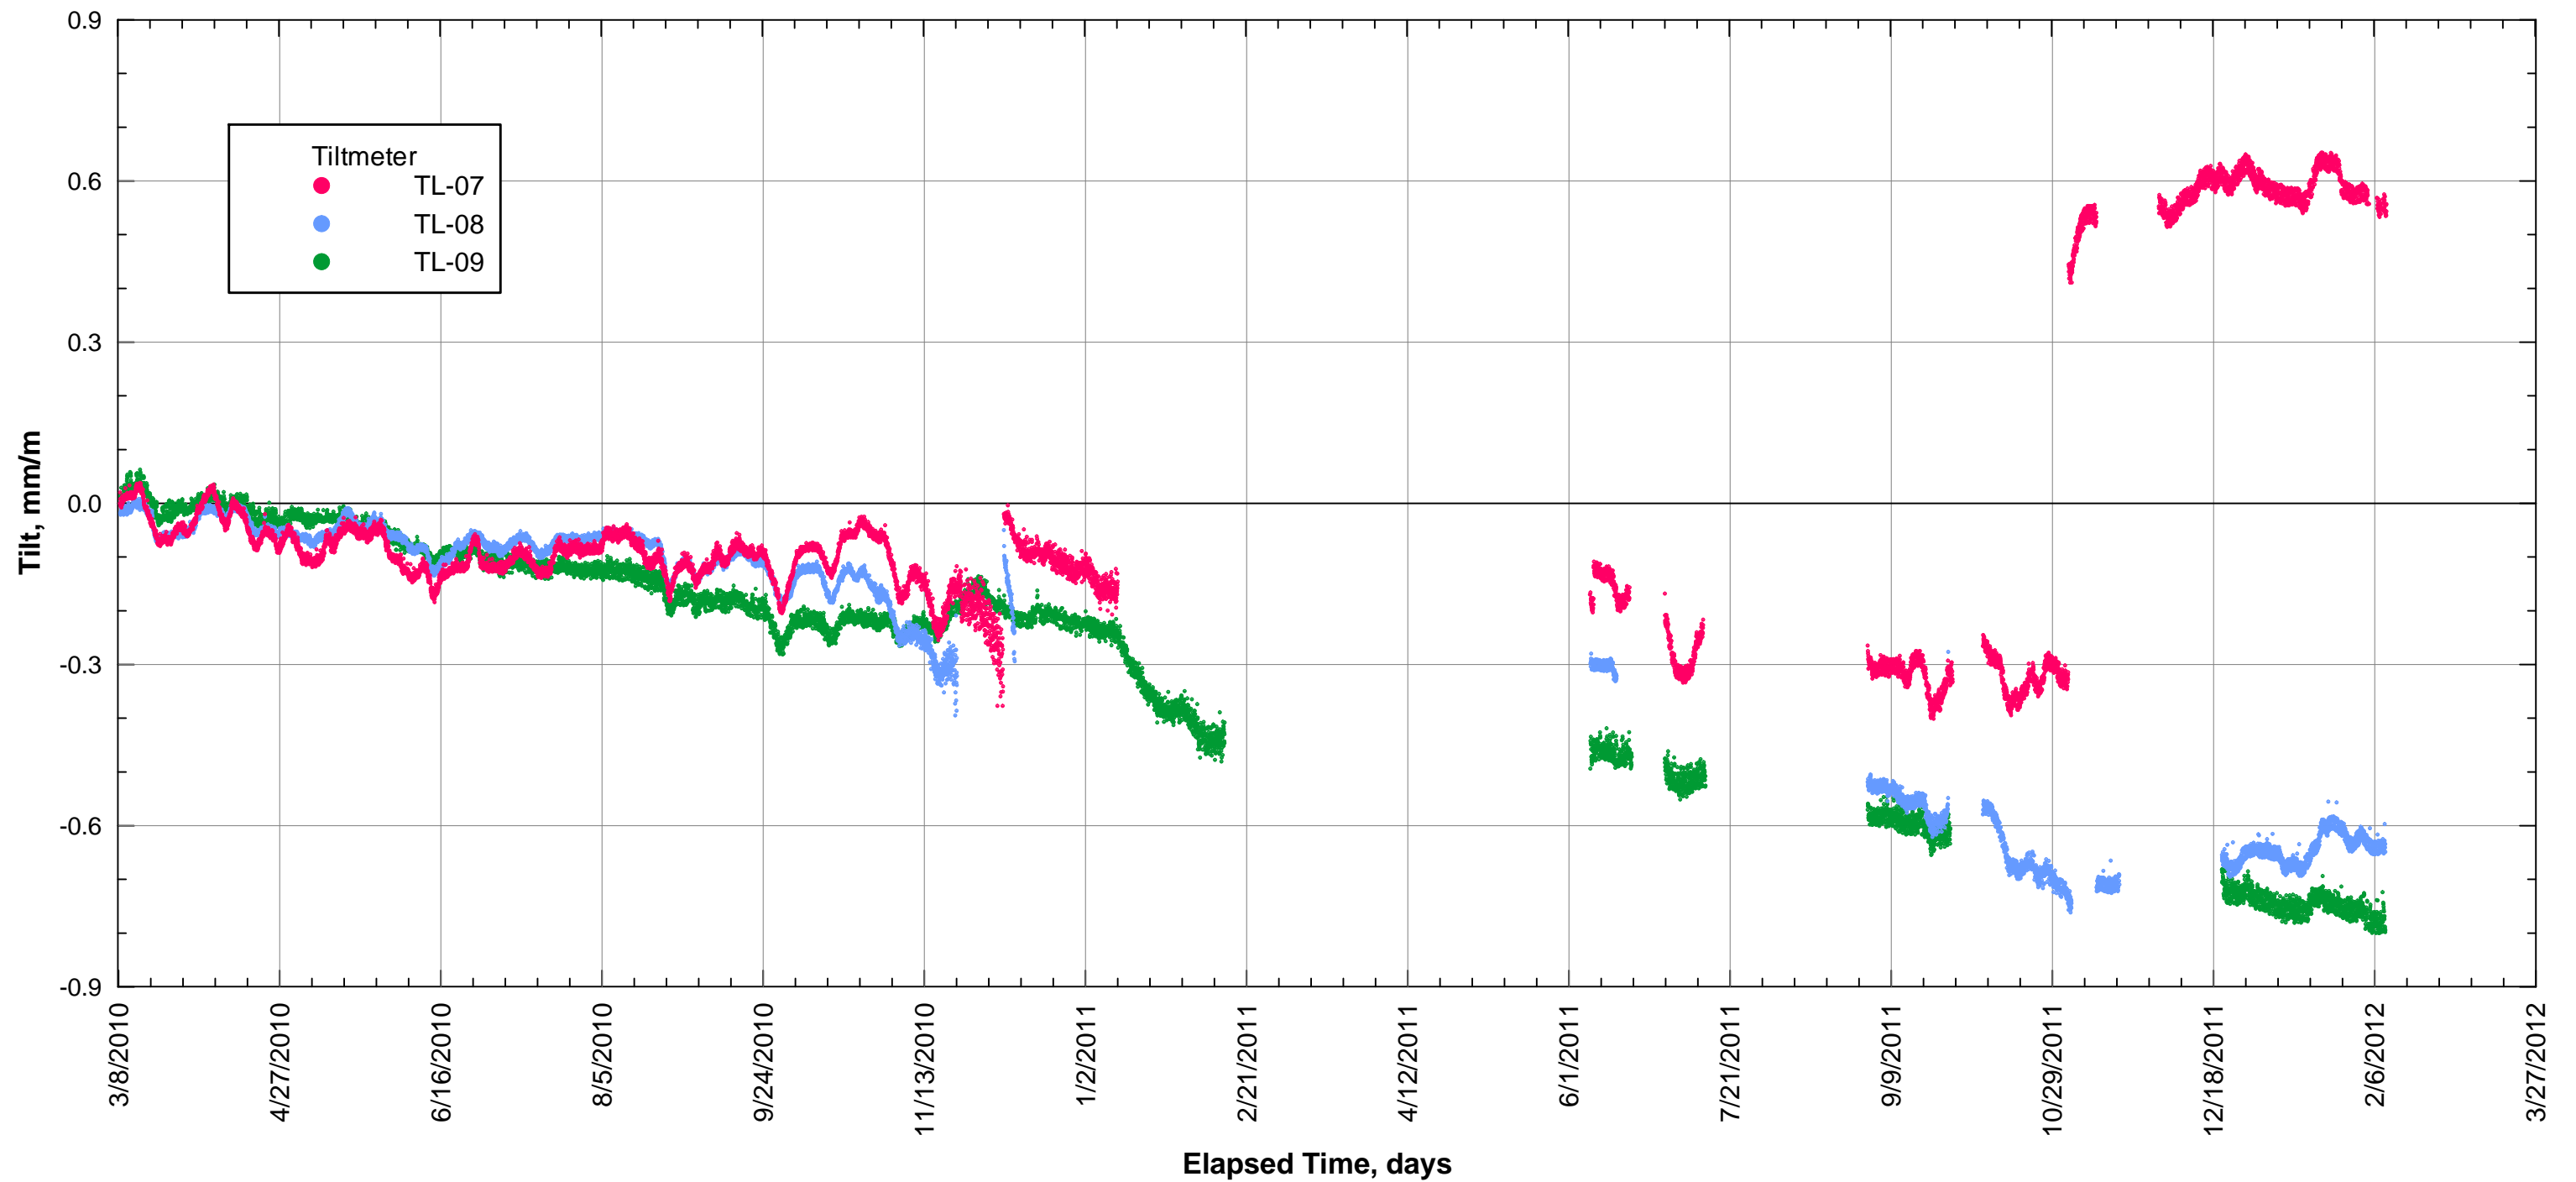
PLATE 4

TILT RECORDED IN TILTMETERS TL-07, TL-08, AND TL-09: BASEMENT LEVEL B-1

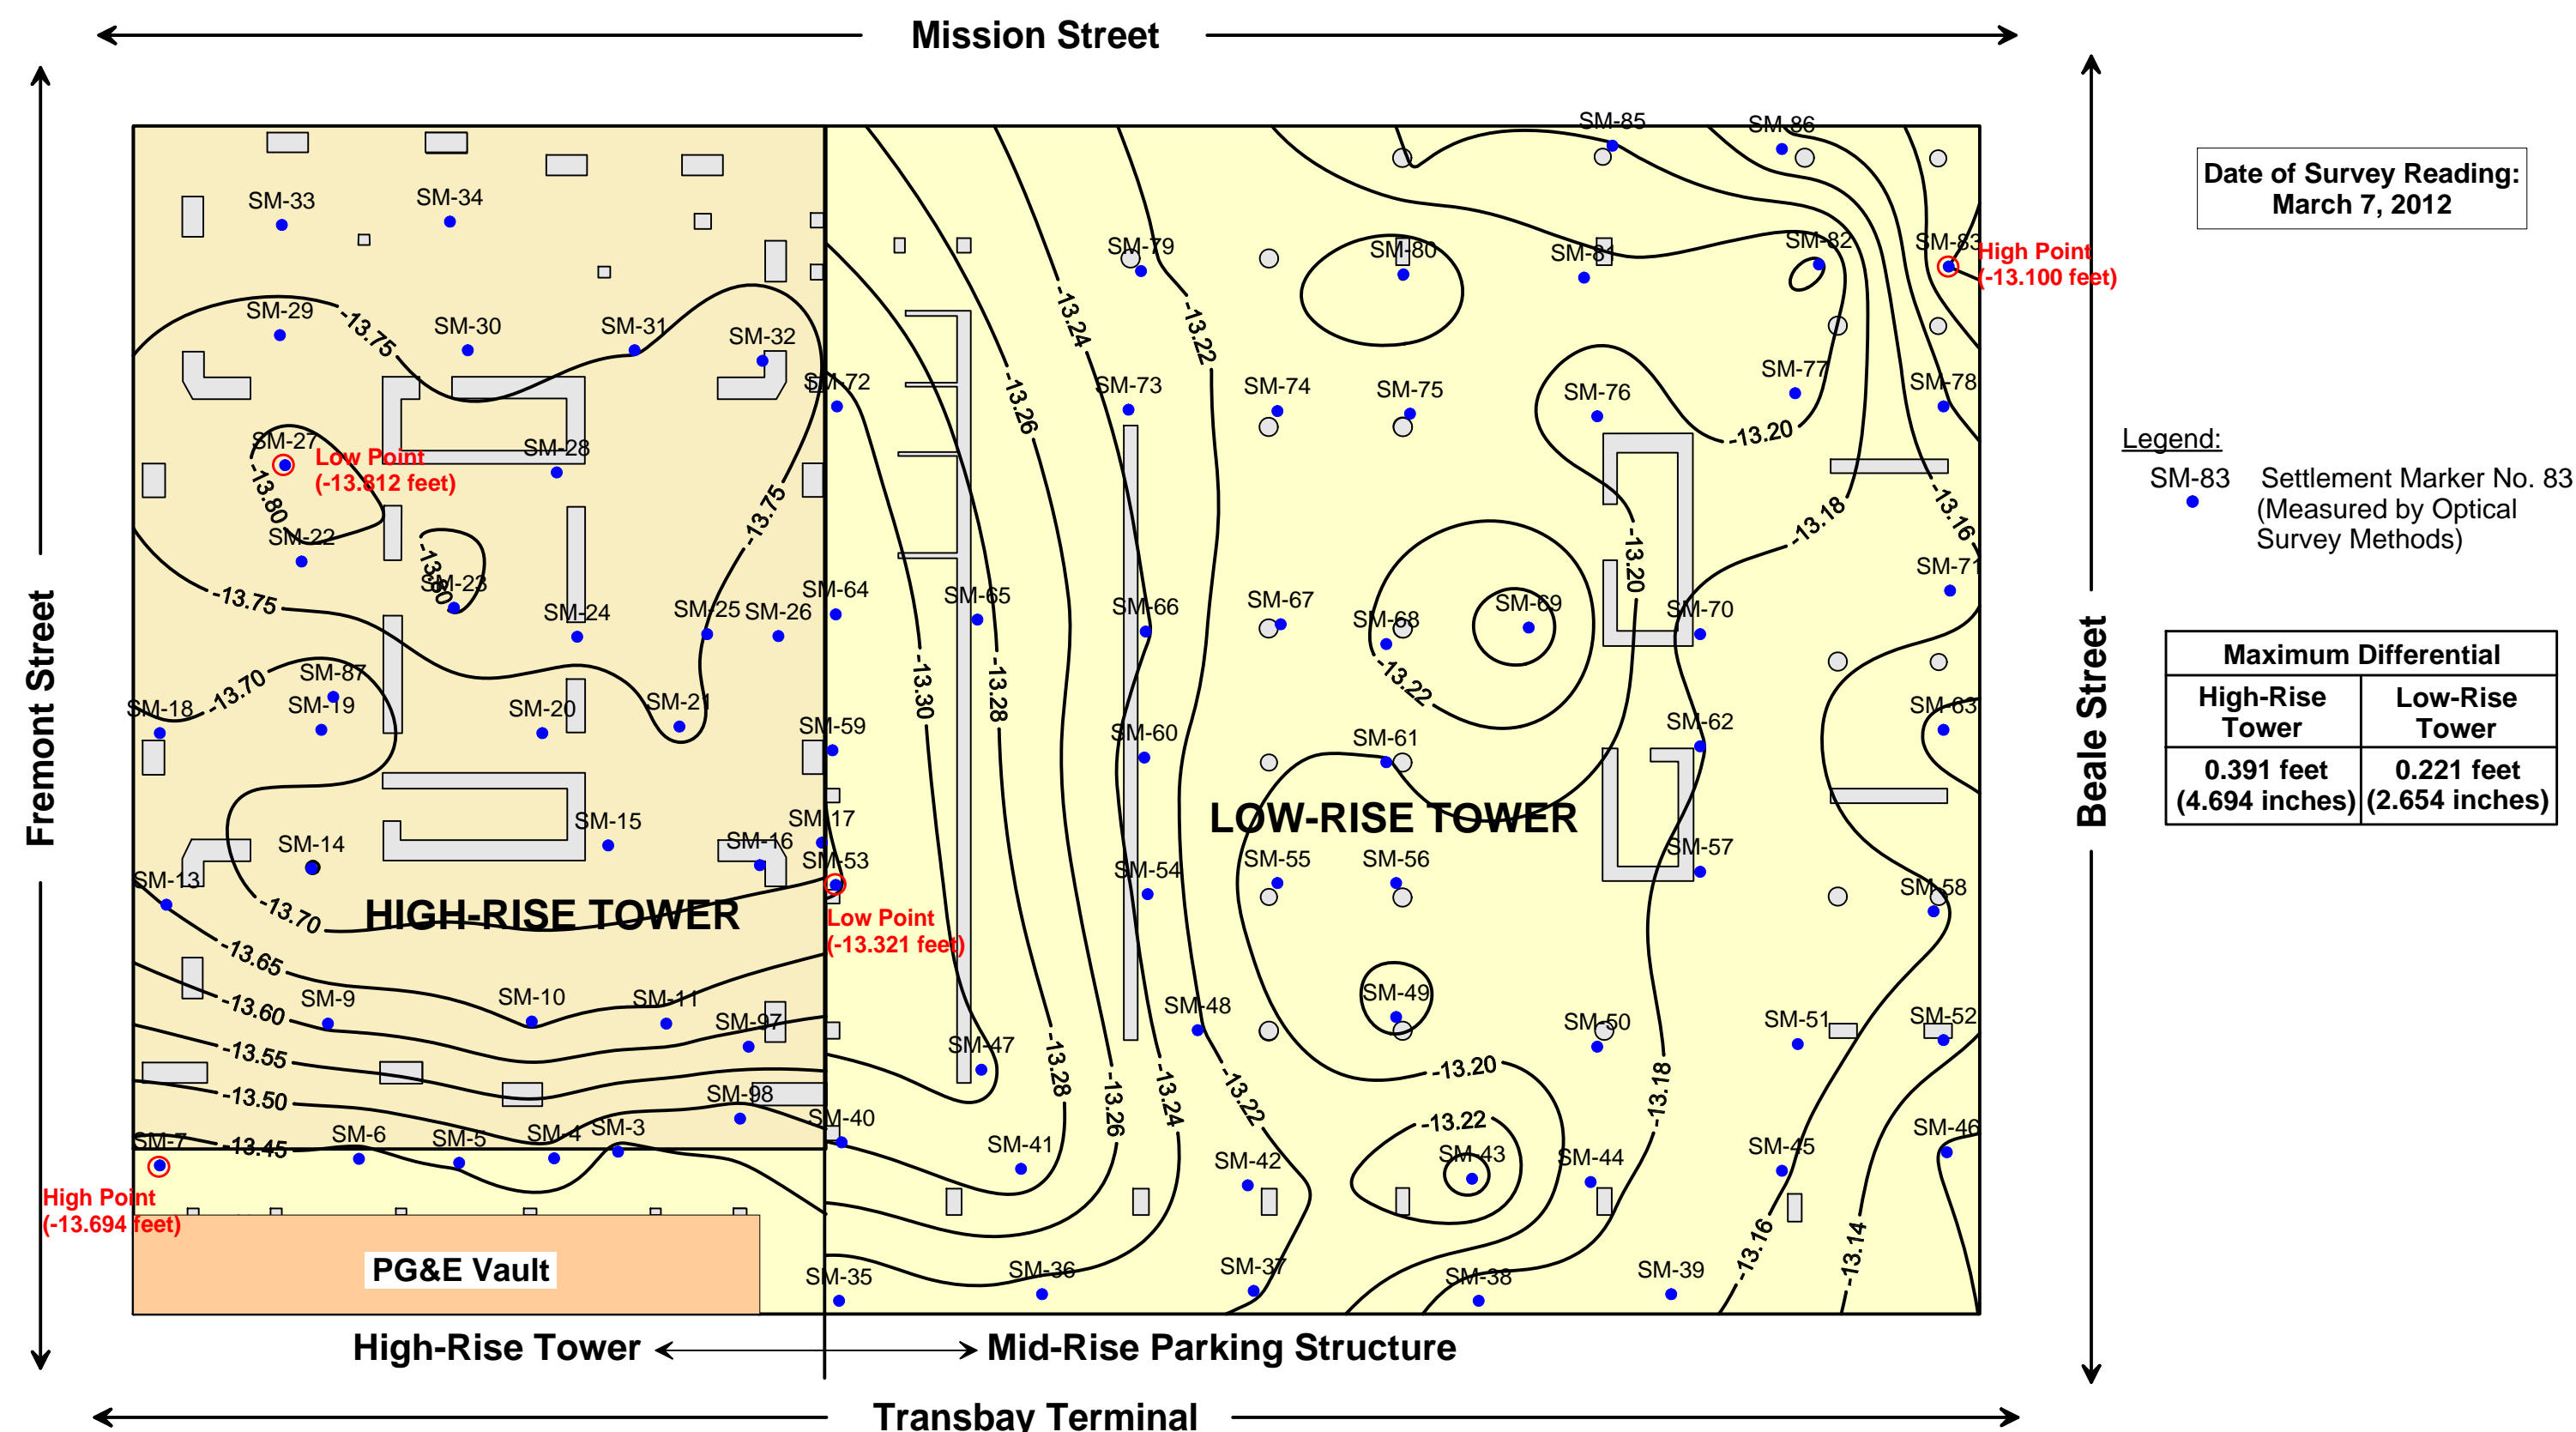
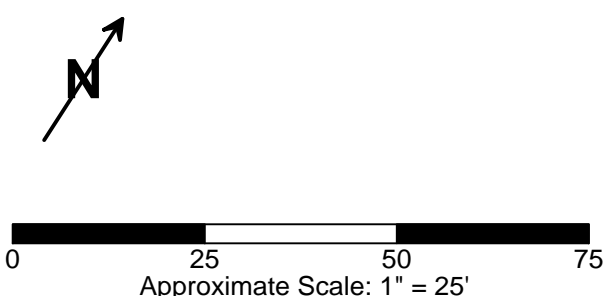
Maximum Differential	
High-Rise Tower	Low-Rise Tower
0.391 feet (4.694 inches)	0.221 feet (2.654 inches)

Notes:
Contours represent elevation, in feet (CCSF Datum), from survey readings taken on March 7, 2012.
Level B-1 at Mid-Rise Parking portion of survey site is approximately 4 inches higher than Level B-1 at High-Rise Tower portion.
The PG&E vault is inaccessible for monitoring.

FLOOR ELEVATIONS AT LEVEL B-1
OF 301 MISSION PROPERTY:
PERIODIC SURVEY - MARCH 7, 2012

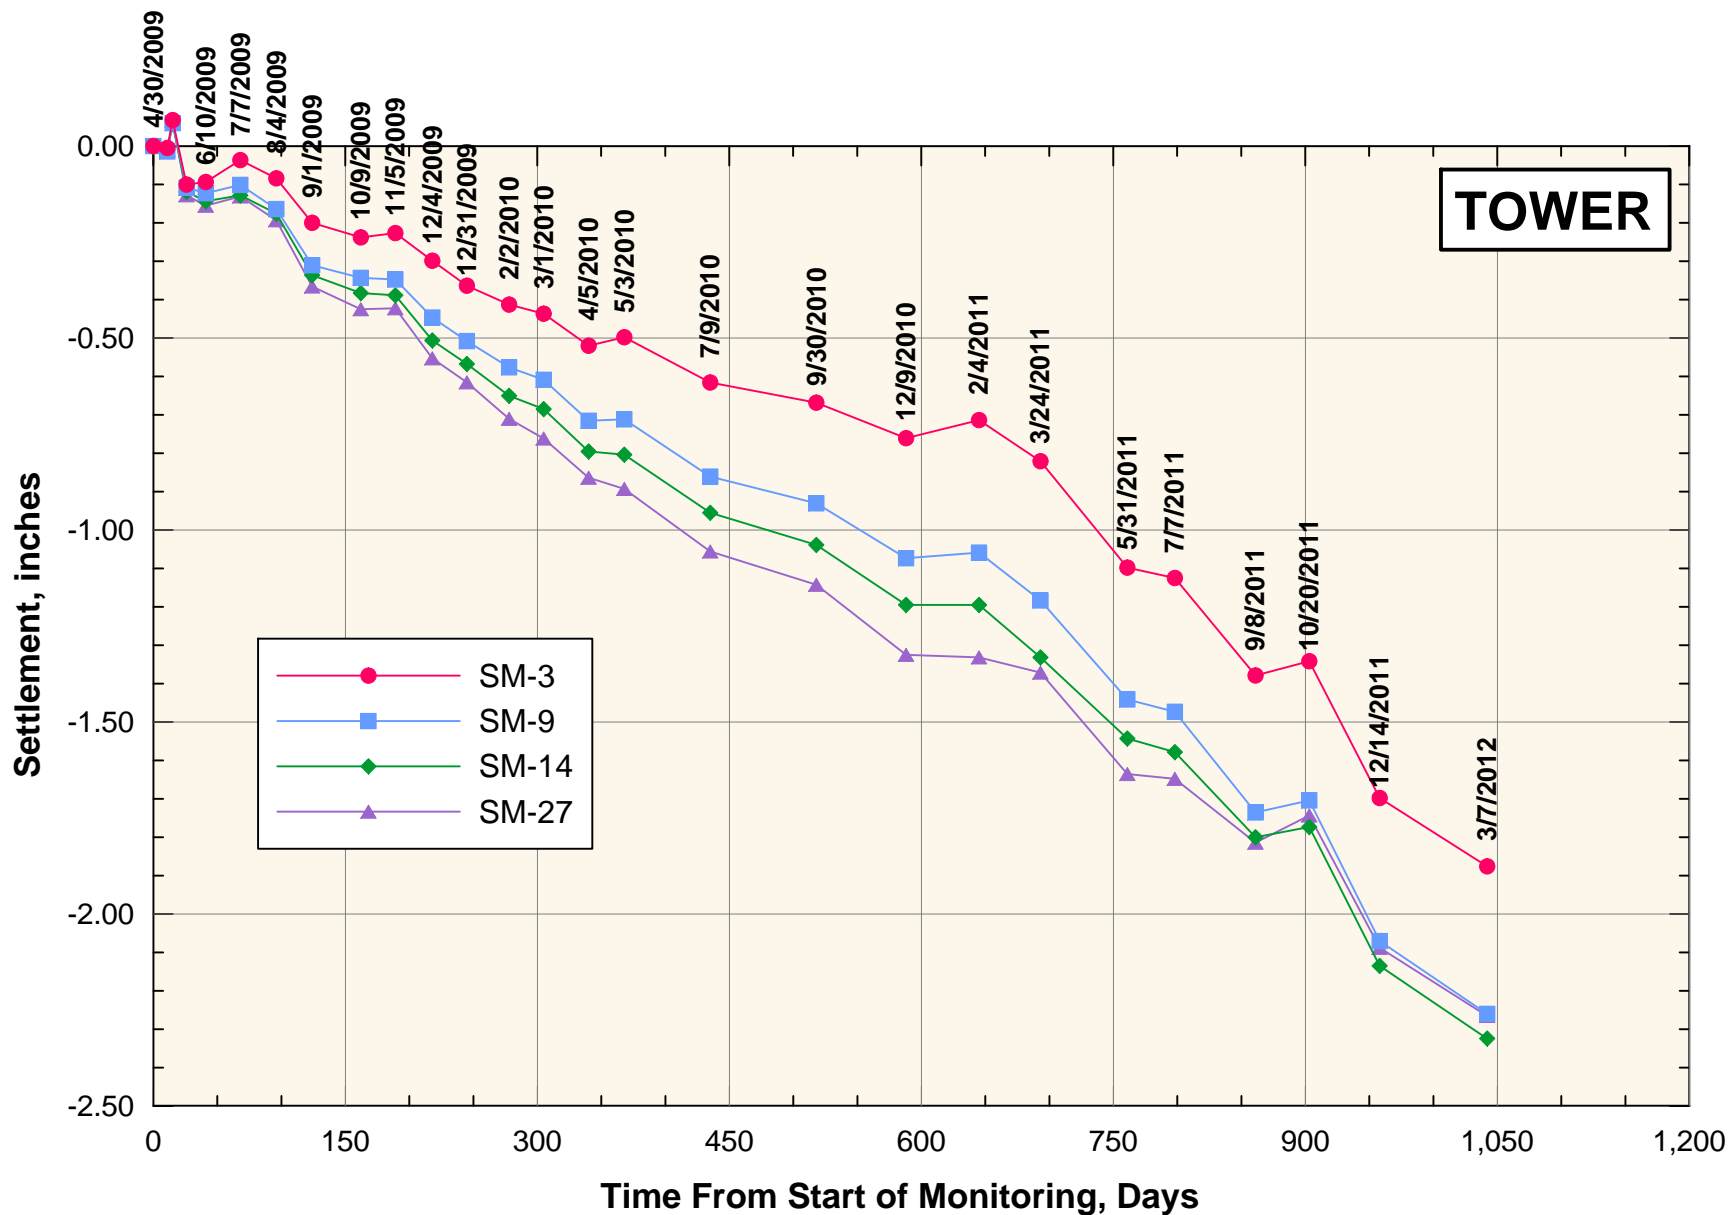
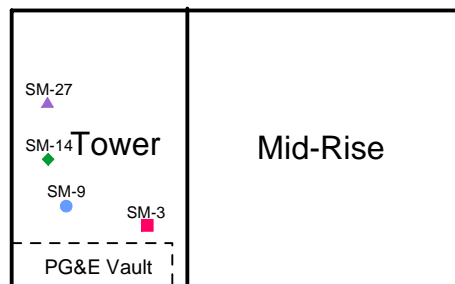
**SETTLEMENT OVER TIME
FLOOR ELEVATIONS AT LEVEL B-1
OF 301 MISSION PROPERTY- TOWER:
APRIL 30, 2009 THROUGH MARCH 7, 2012**

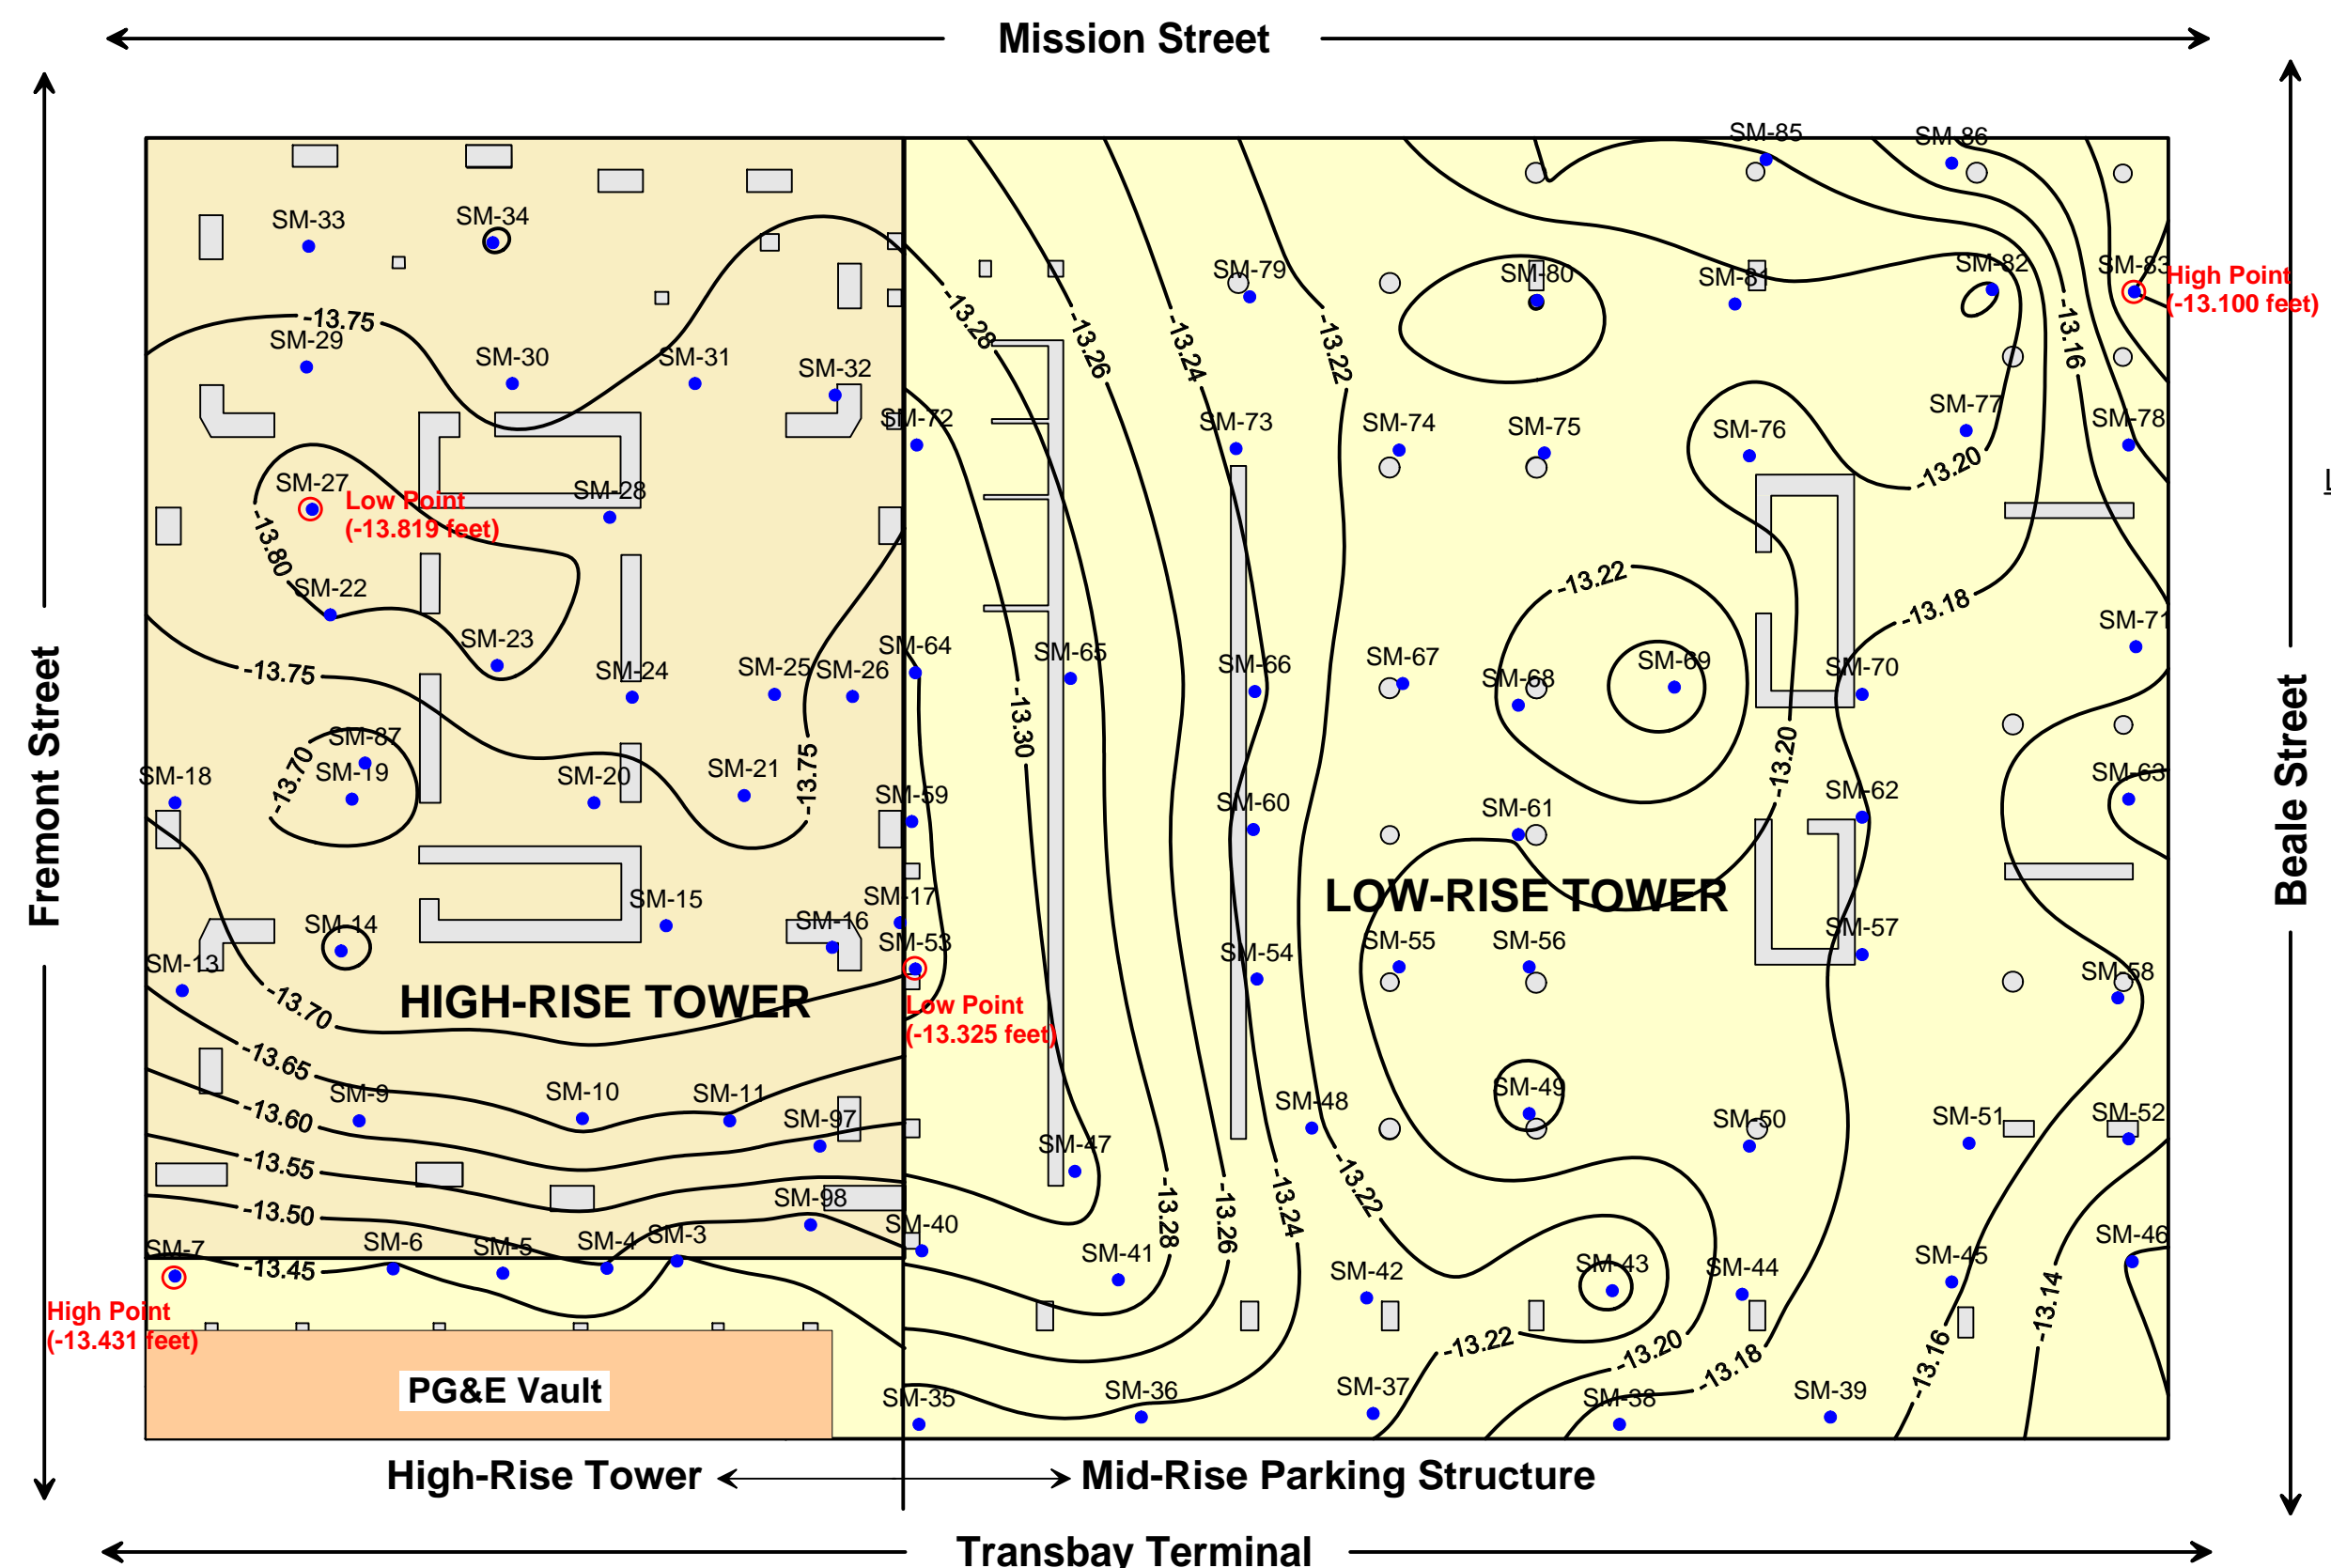
FLOOR ELEVATIONS AT LEVEL B-1
OF 301 MISSION PROPERTY
PERIODIC SURVEY - APRIL 18, 2012
