*Board of Supervisors
City and County of San Francisco*

Government Audit and Oversight Committee

Supplemental Report for Foundation Settlement Investigation

**SUPPLEMENTAL REPORT
FOUNDATION SETTLEMENT INVESTIGATION
301 MISSION STREET
SAN FRANCISCO, CALIFORNIA**

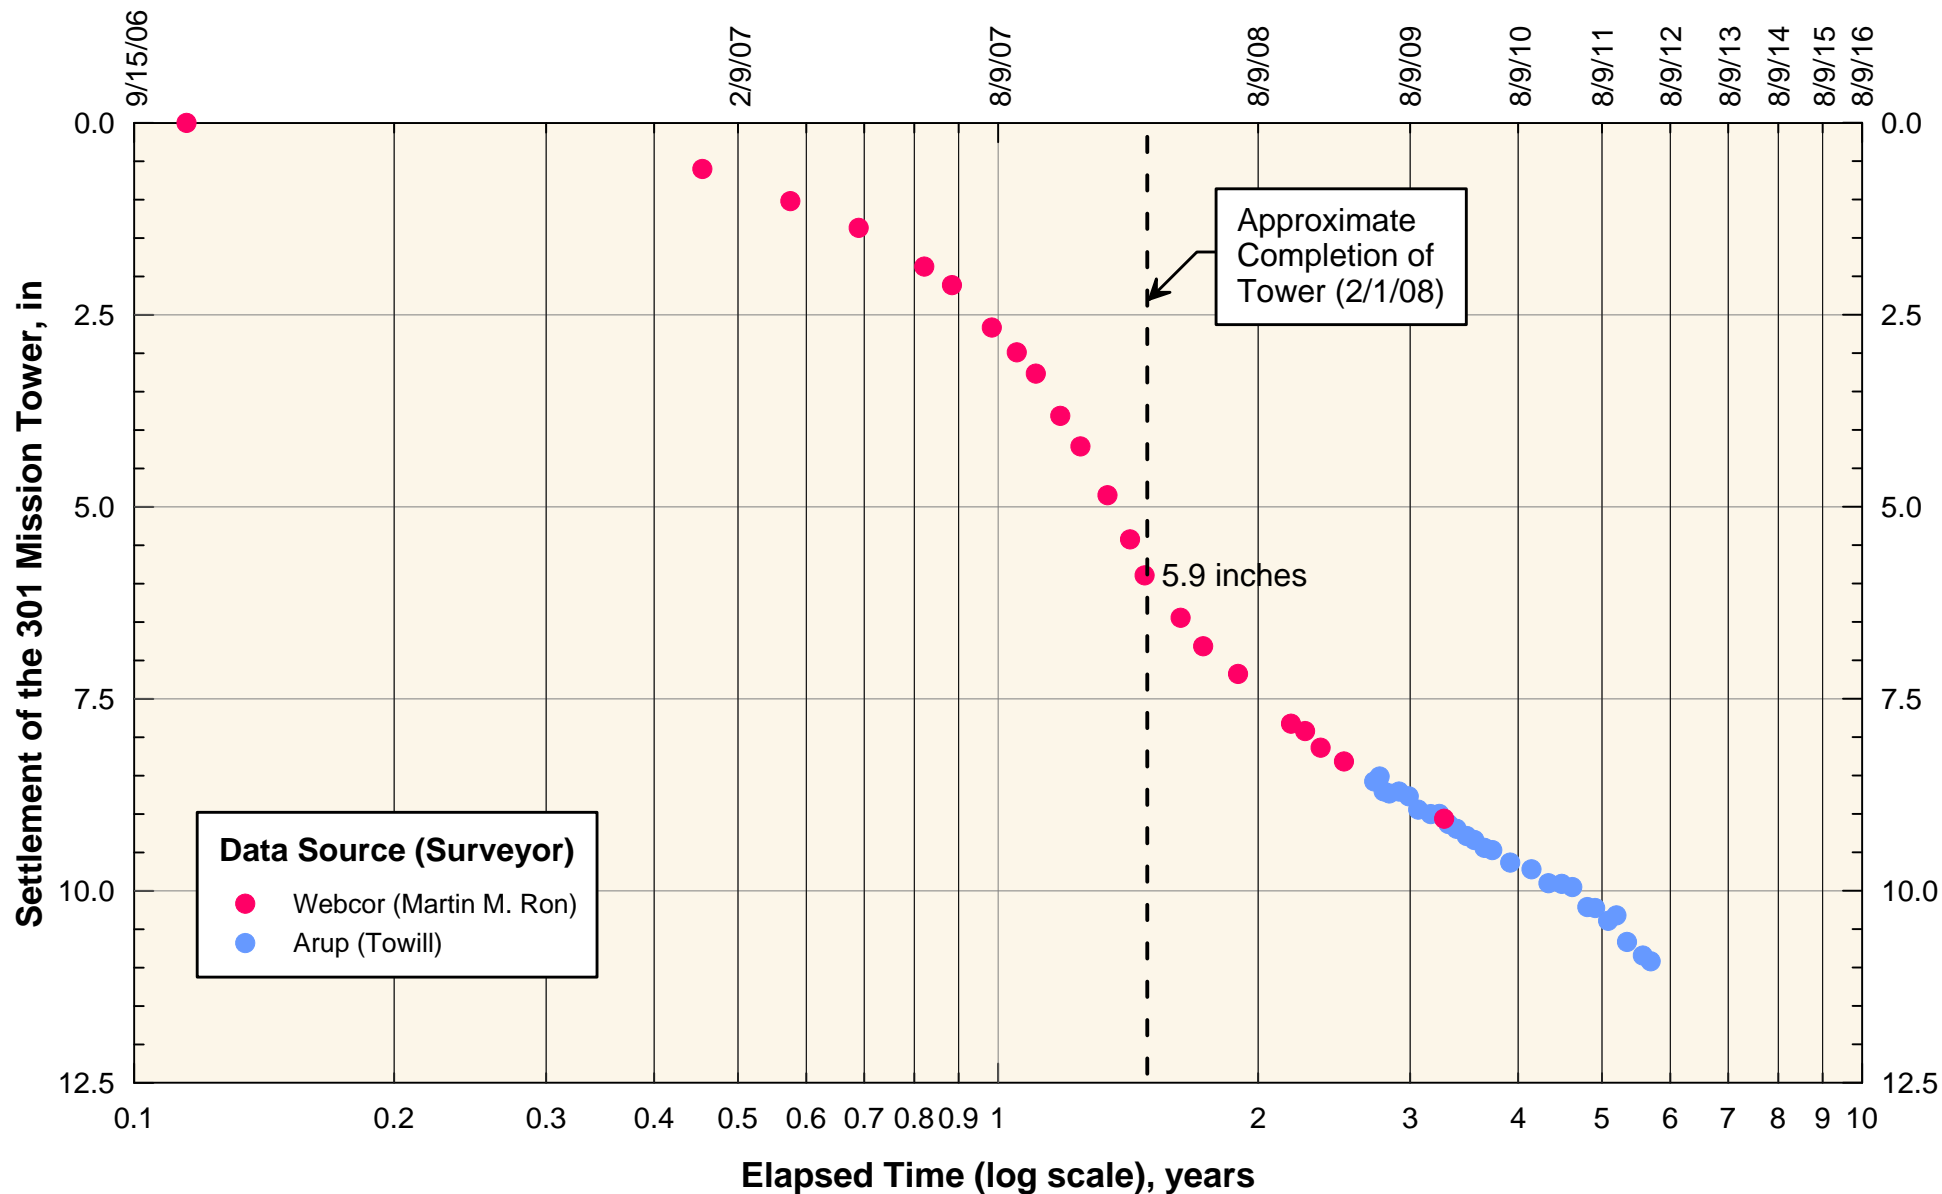
**SETTLEMENTS OF THE 301 MISSION TOWER
 INCLUDING MONITORING DURING CONSTRUCTION**

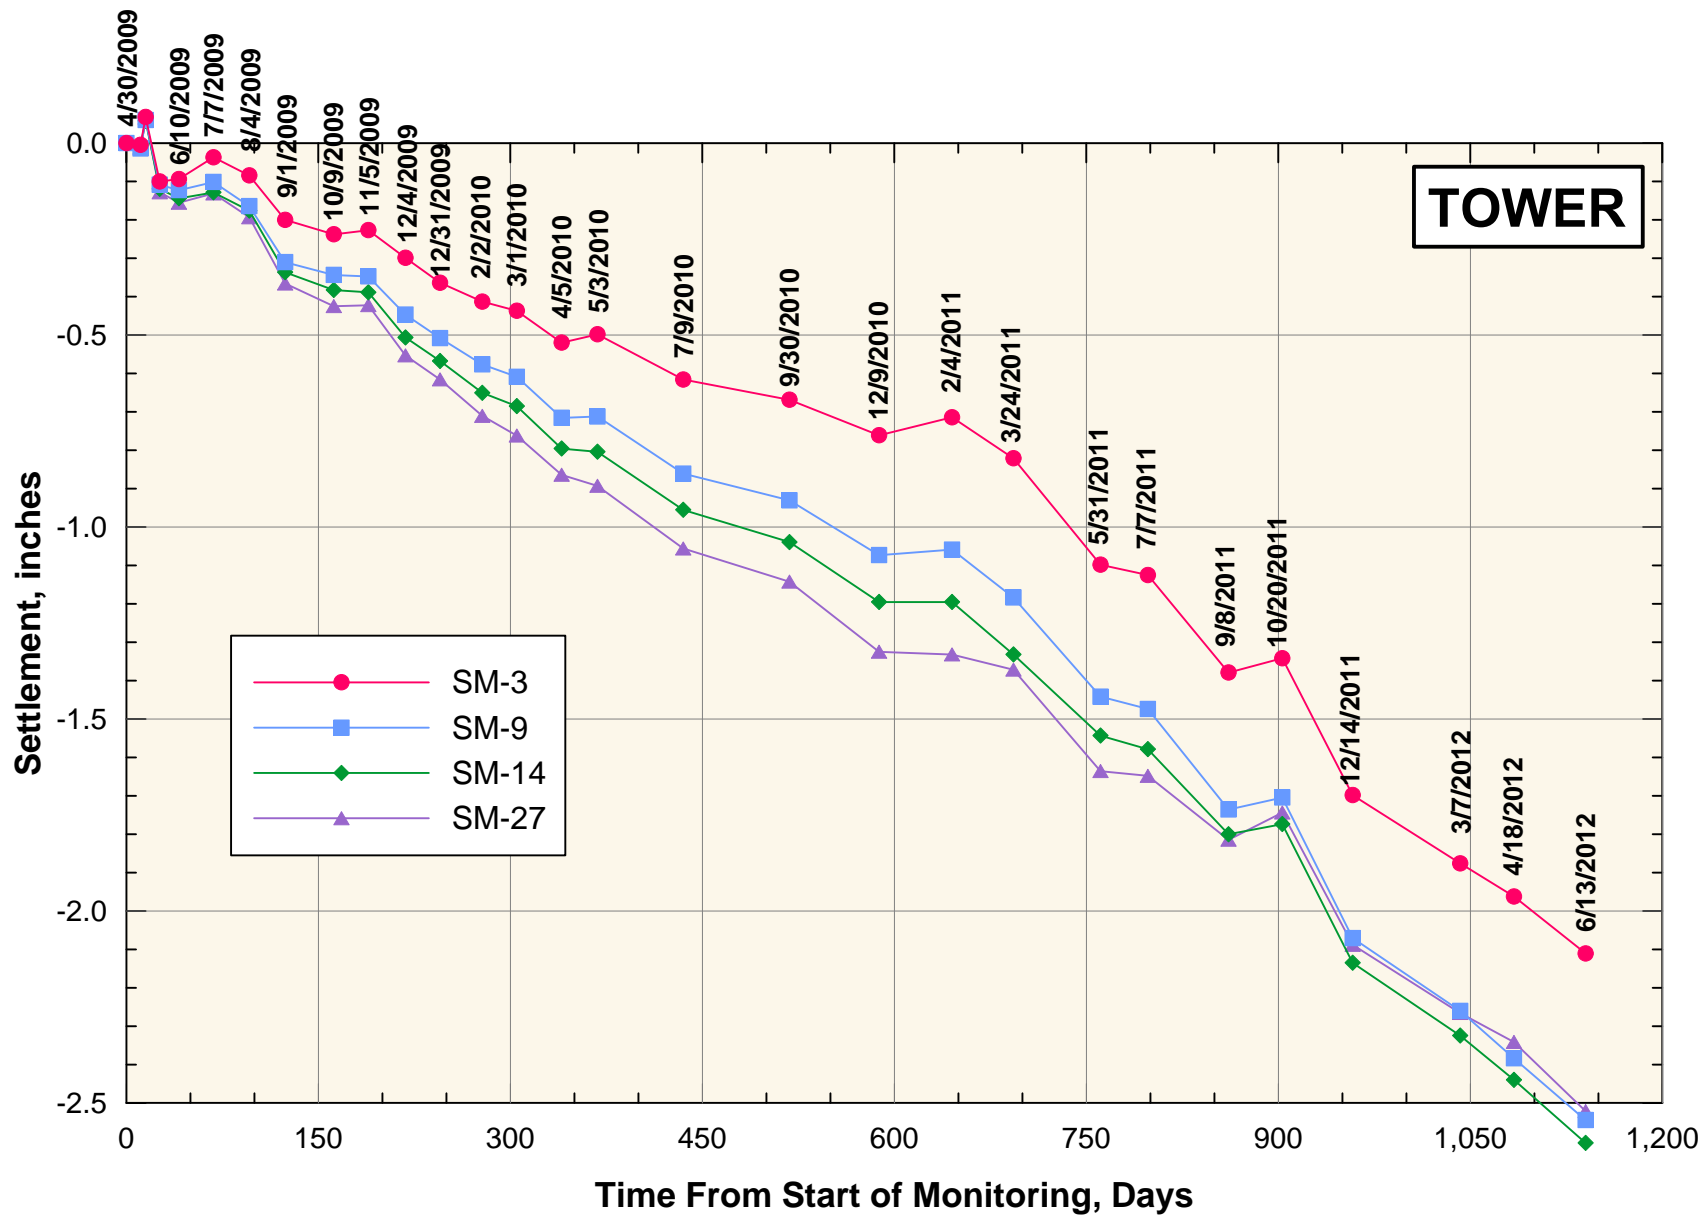
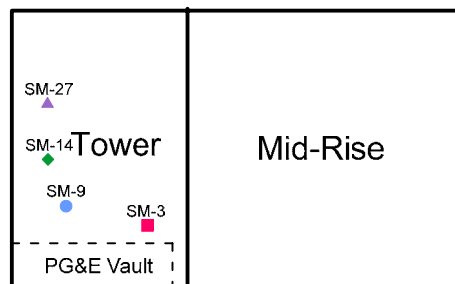
**SETTLEMENT OVER TIME
FLOOR ELEVATIONS AT LEVEL B-1
OF 301 MISSION PROPERTY- TOWER:
APRIL 30, 2009 THROUGH JUNE 13, 2012**

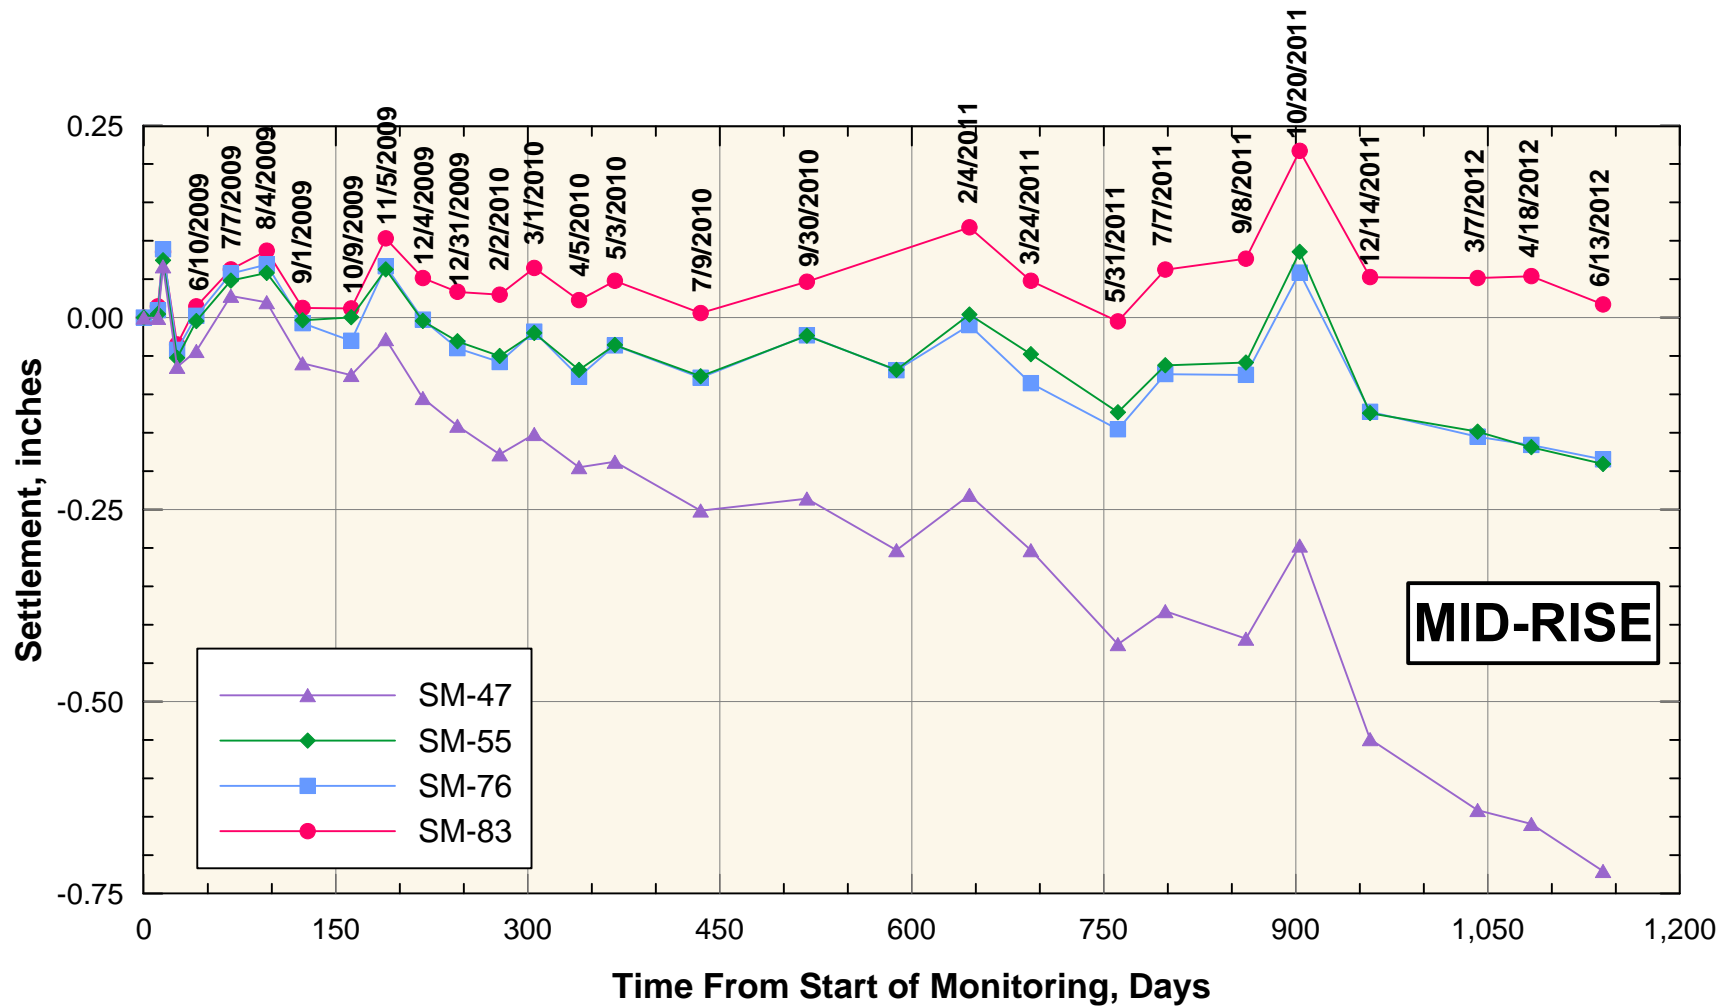
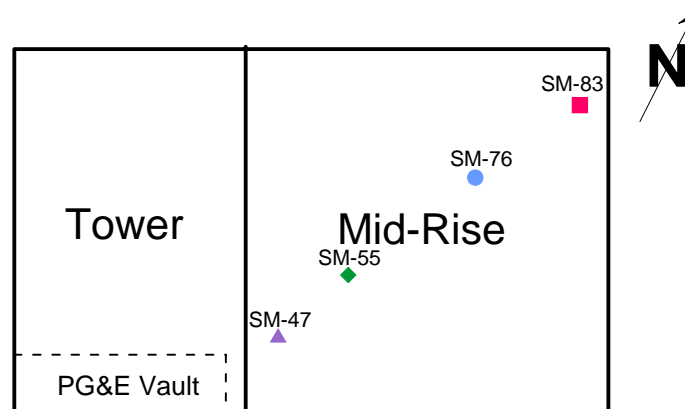
PLATE 4

**SETTLEMENT OVER TIME
FLOOR ELEVATIONS AT LEVEL B-1
OF 301 MISSION PROPERTY- MID-RISE:
APRIL 30, 2009 THROUGH JUNE 13, 2012**

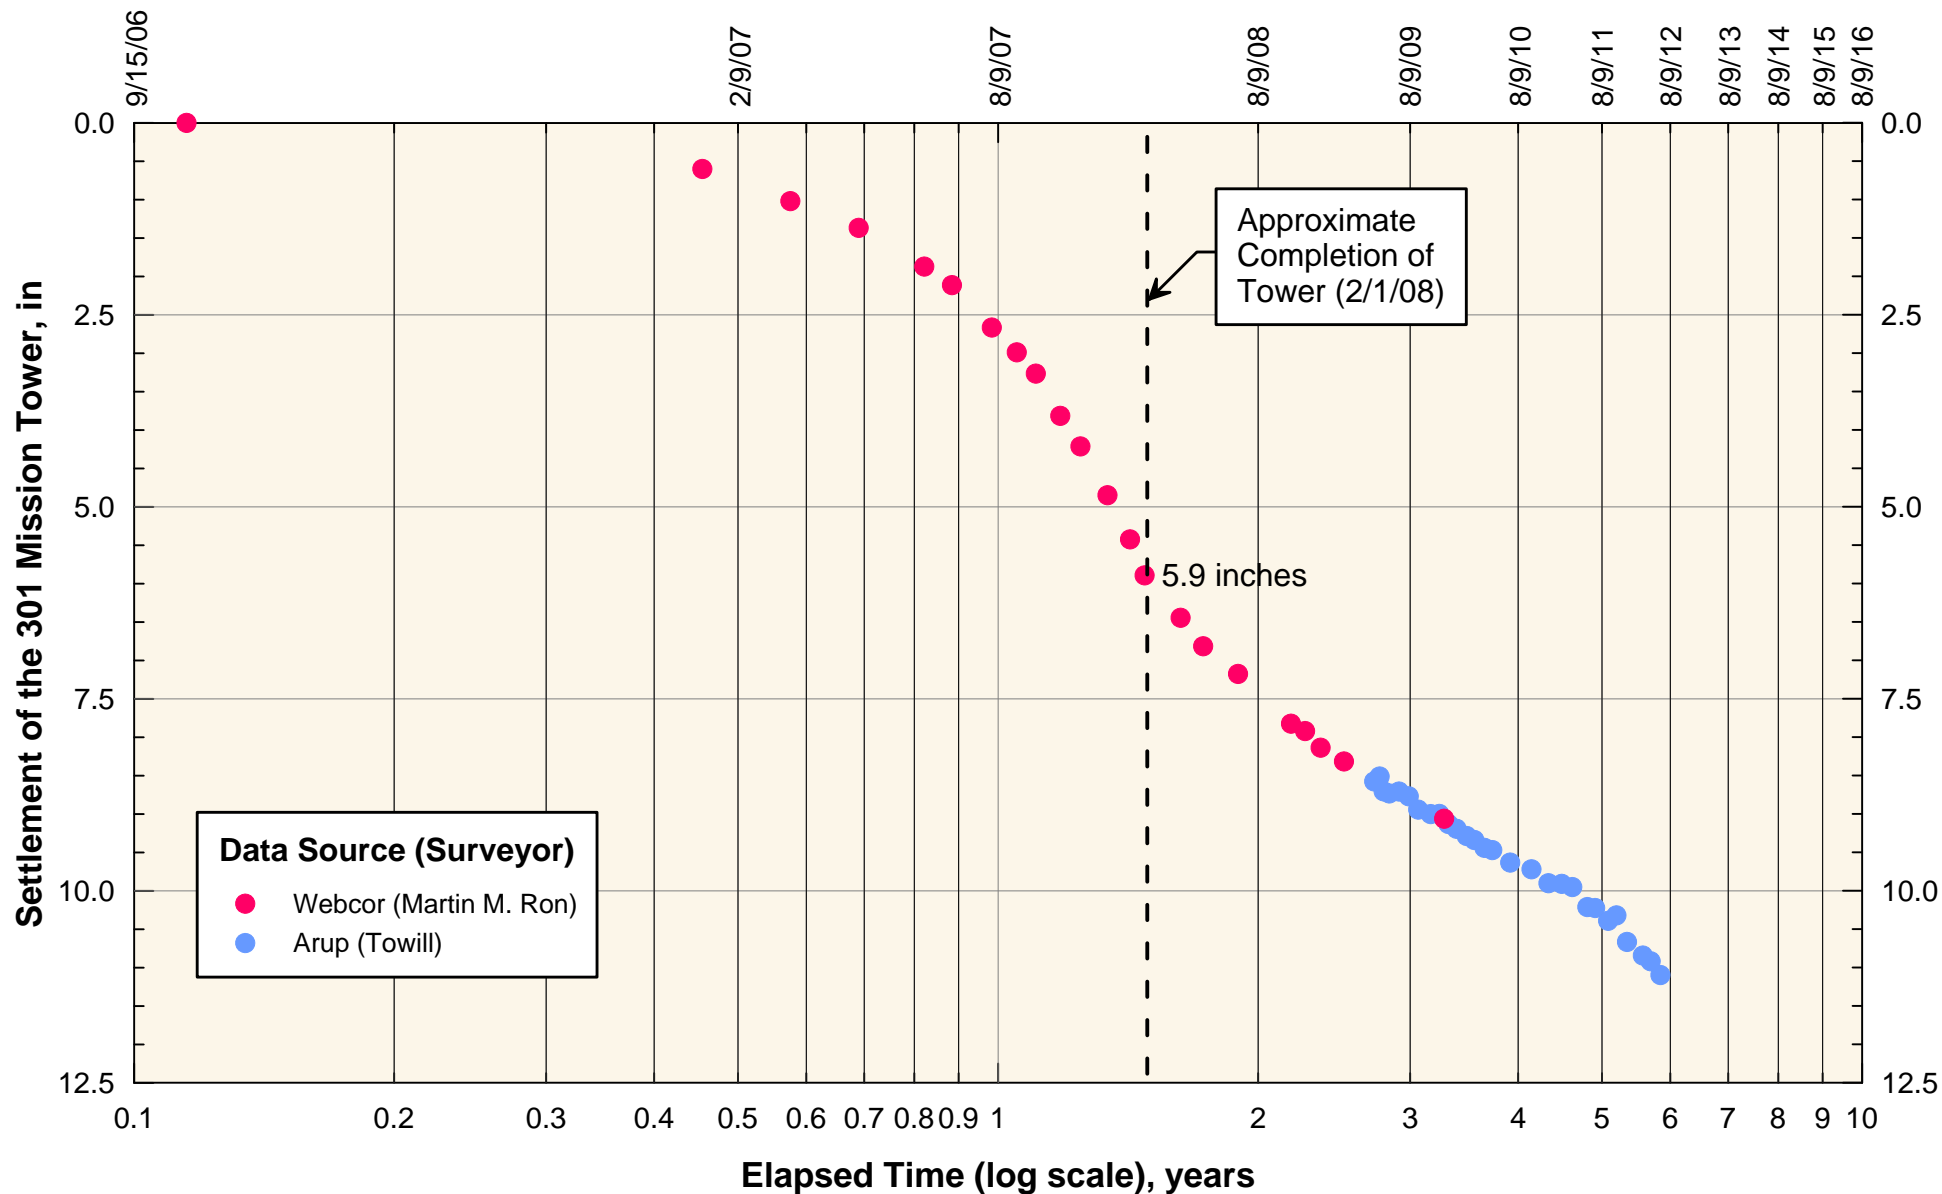
**SETTLEMENTS OF THE 301 MISSION TOWER
 INCLUDING MONITORING DURING CONSTRUCTION**

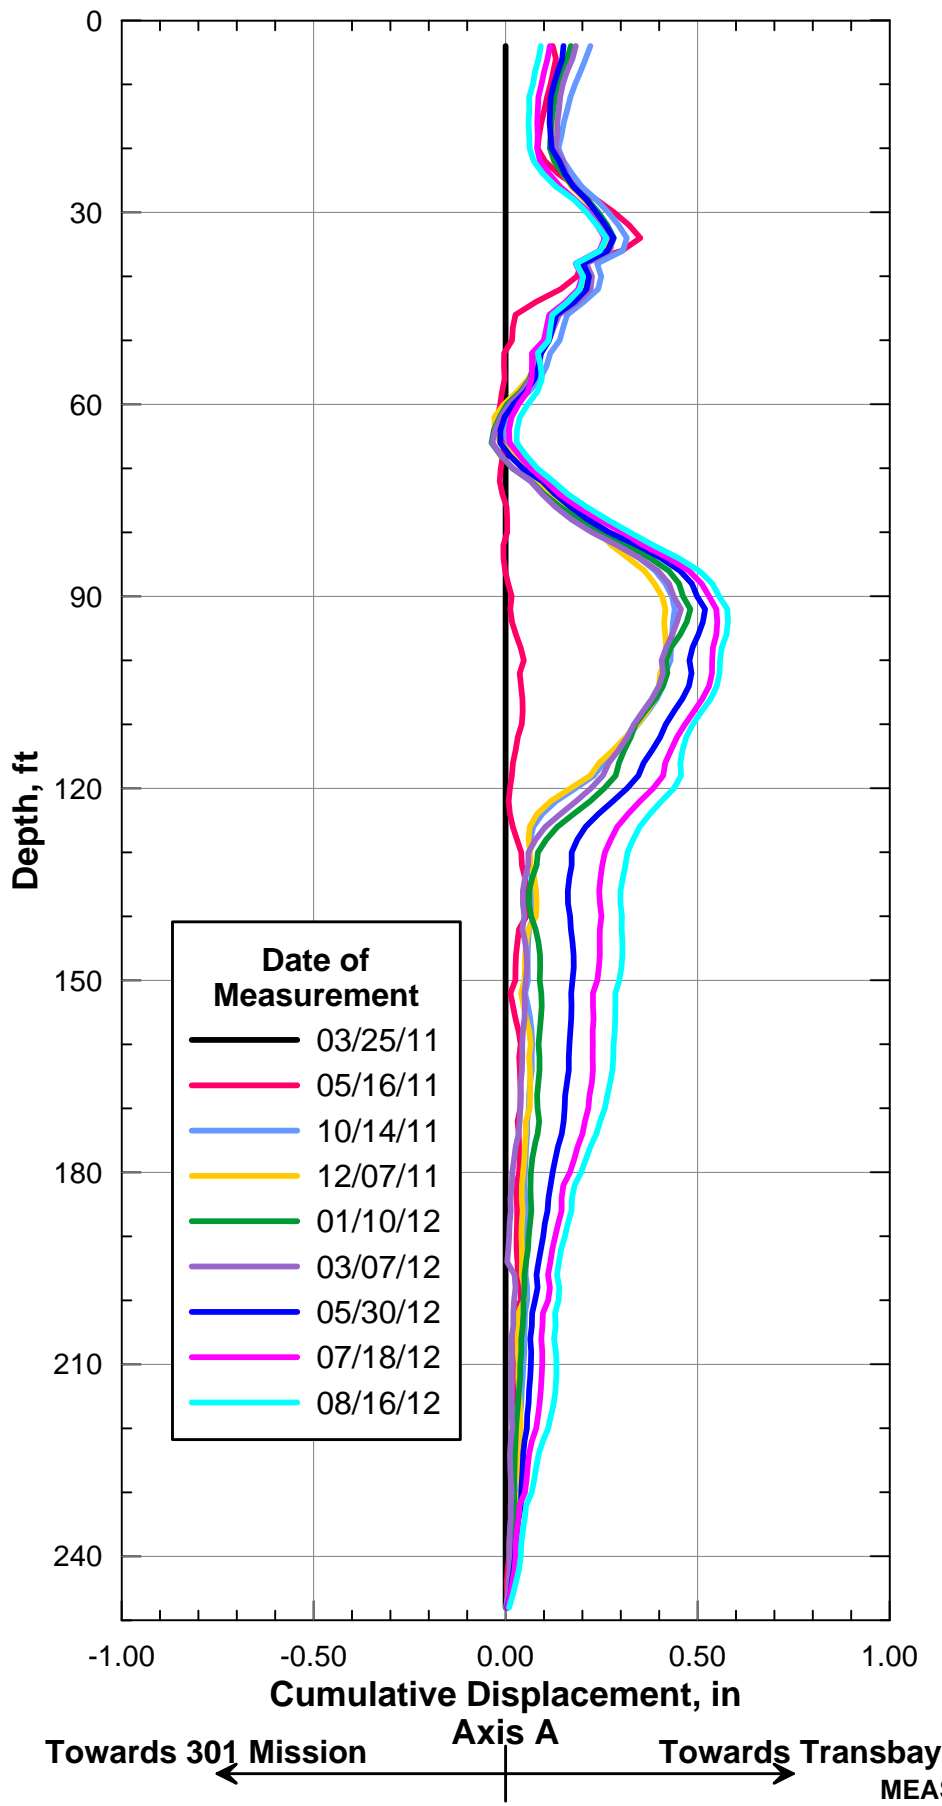
MEASUREMENTS TAKEN AT INCLINOMETER I-18M

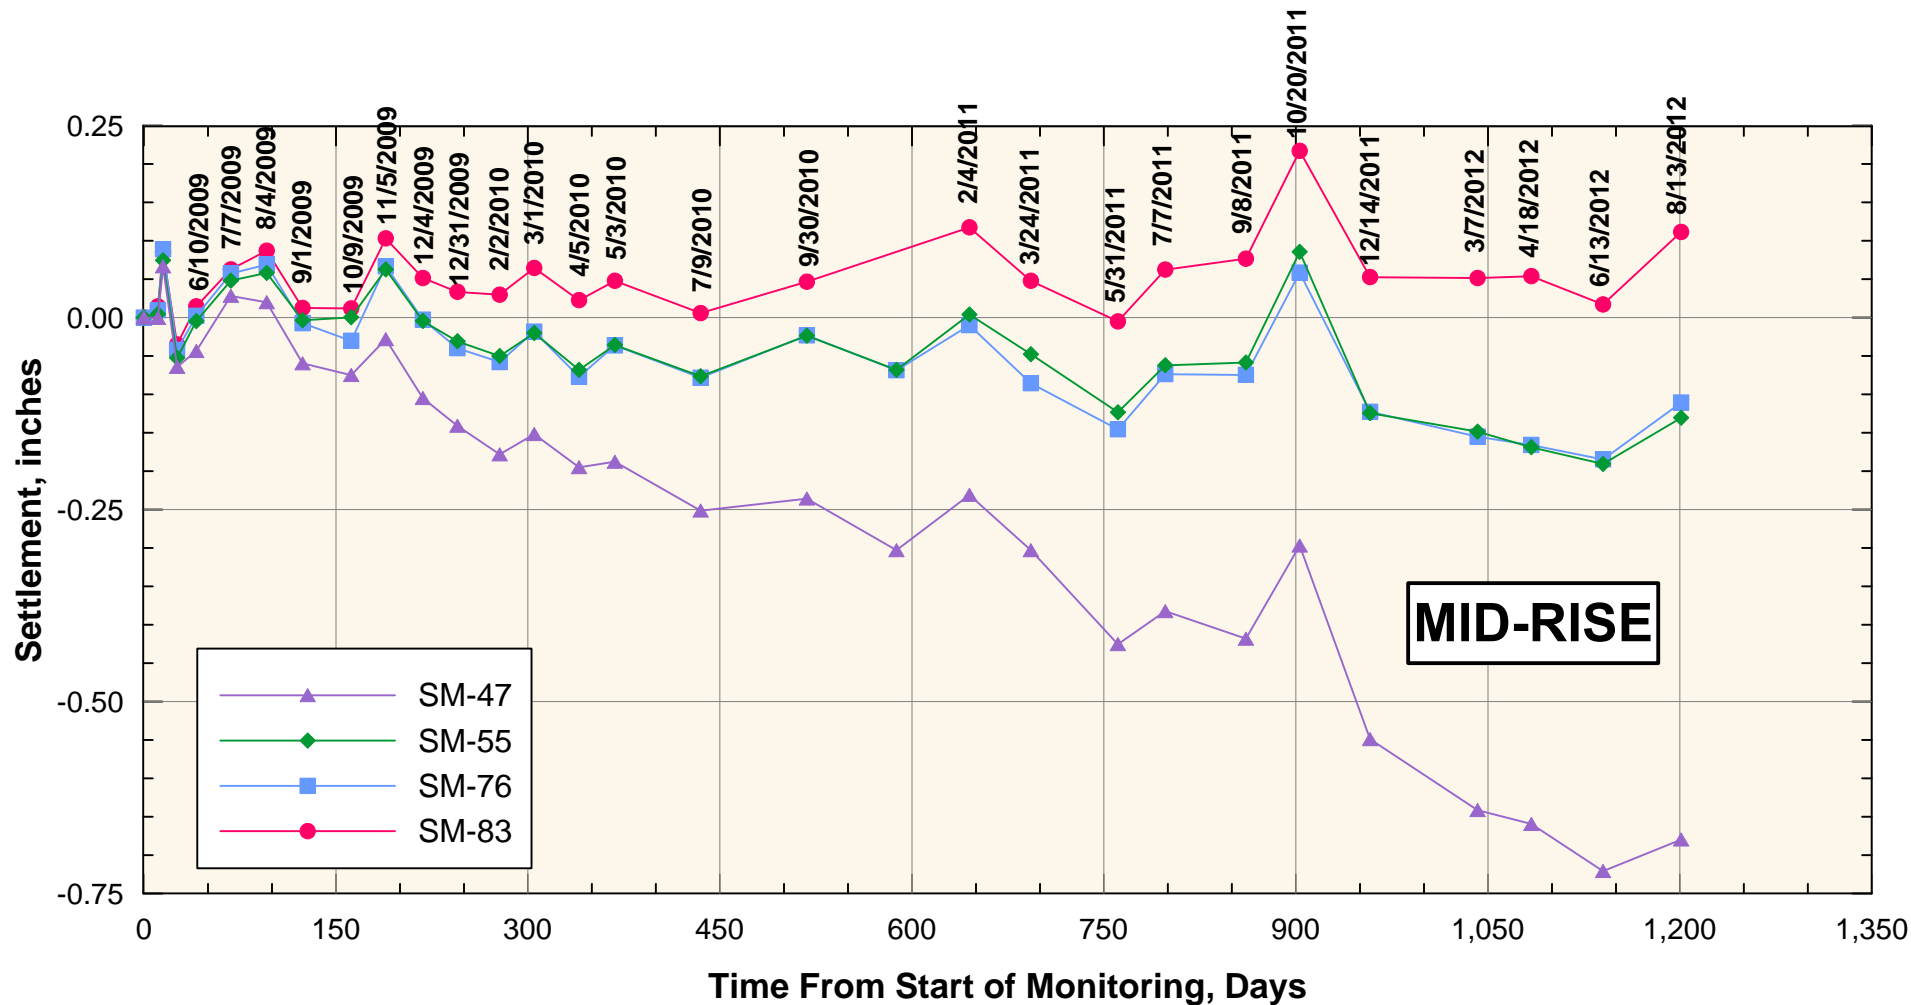
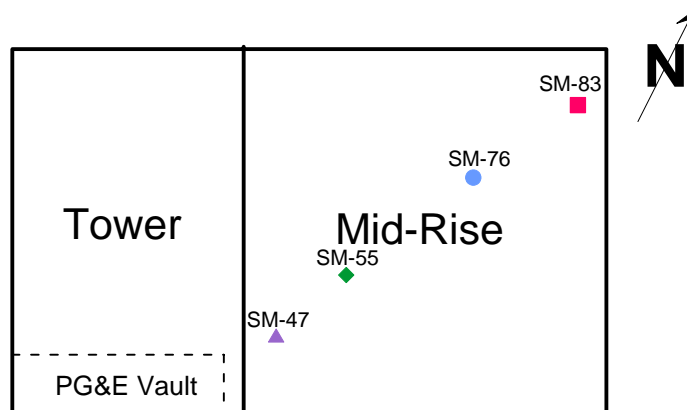
PLATE 4

**SETTLEMENT OVER TIME
FLOOR ELEVATIONS AT LEVEL B-1
OF 301 MISSION PROPERTY- MID-RISE:
APRIL 30, 2009 THROUGH AUGUST 13, 2012**

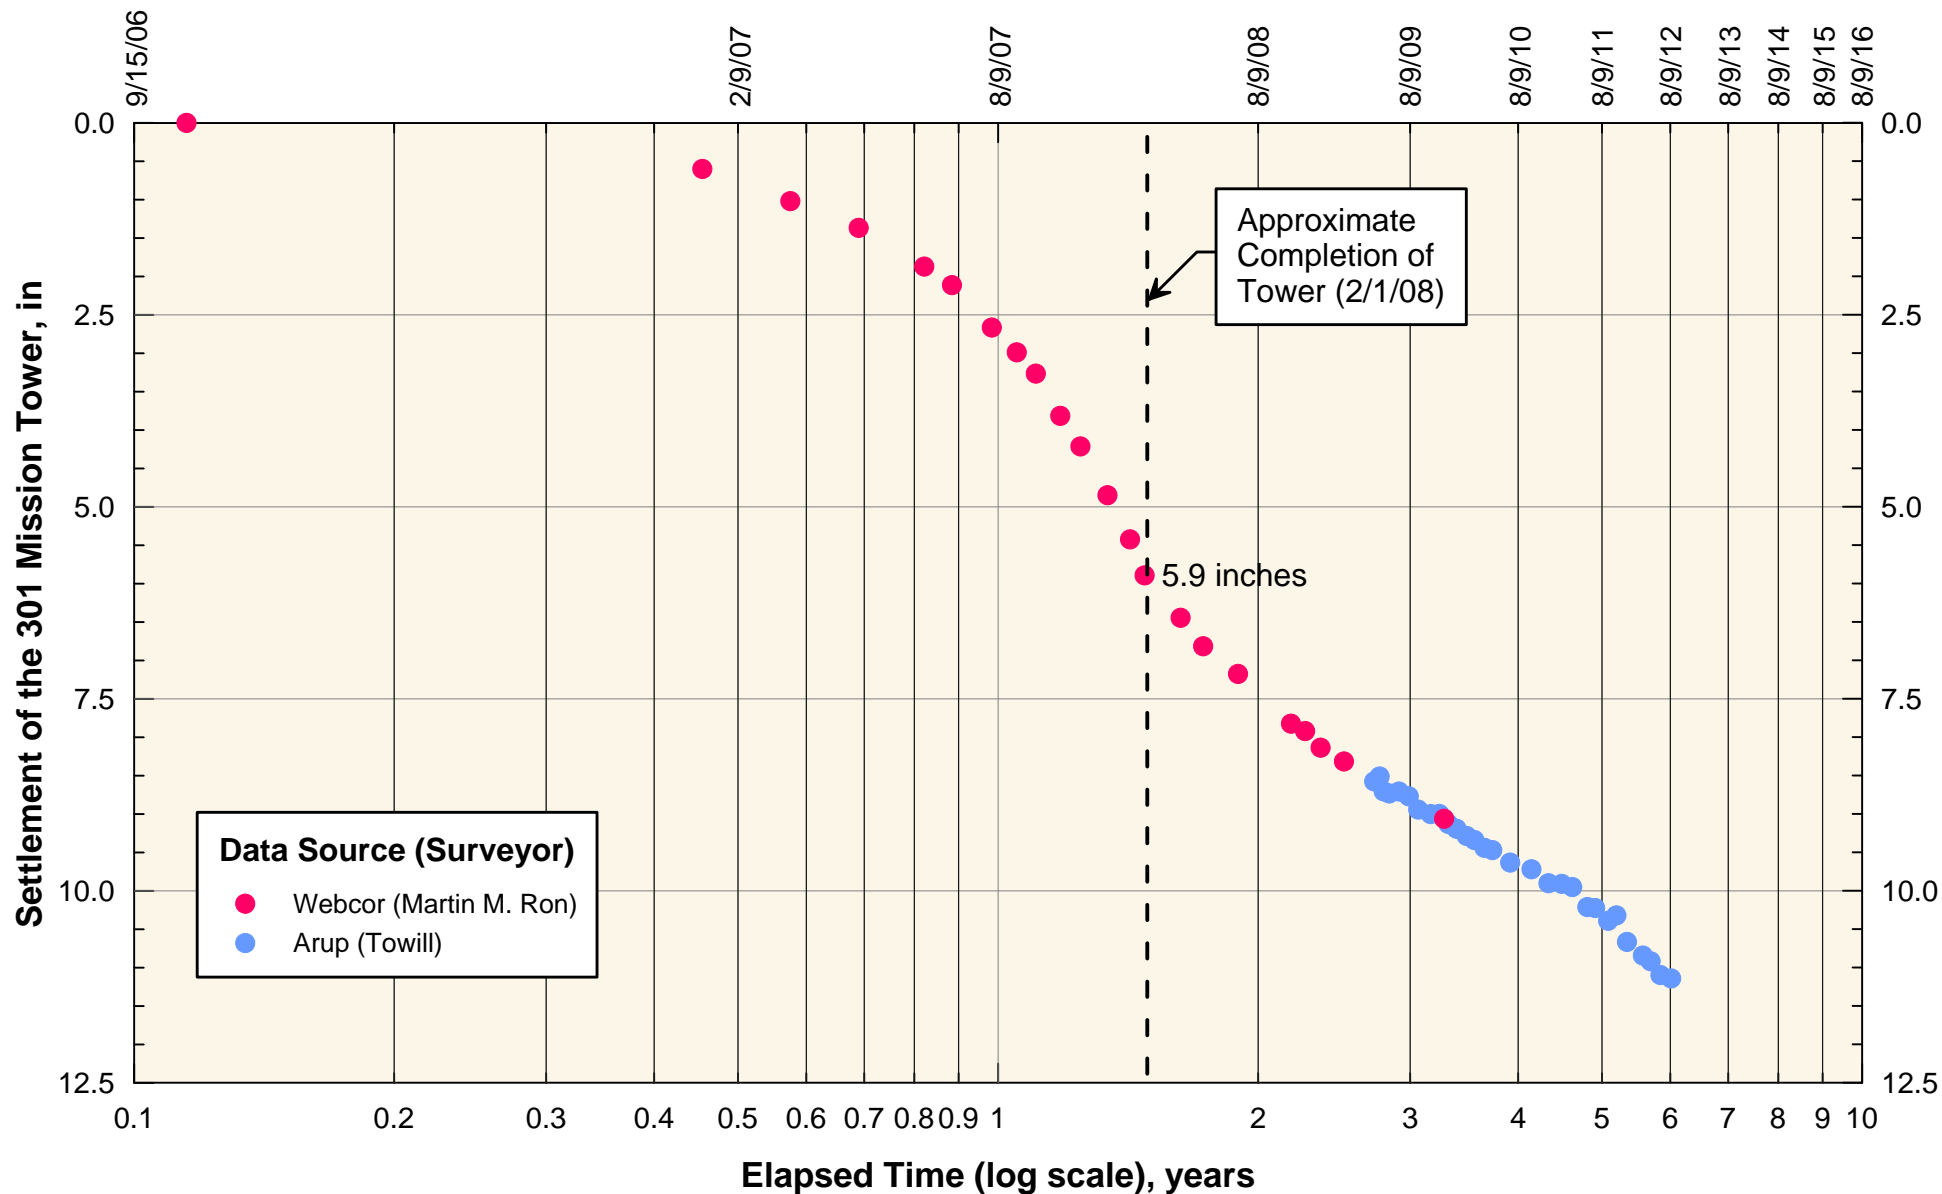
**SETTLEMENTS OF THE 301 MISSION TOWER
 INCLUDING MONITORING DURING CONSTRUCTION**

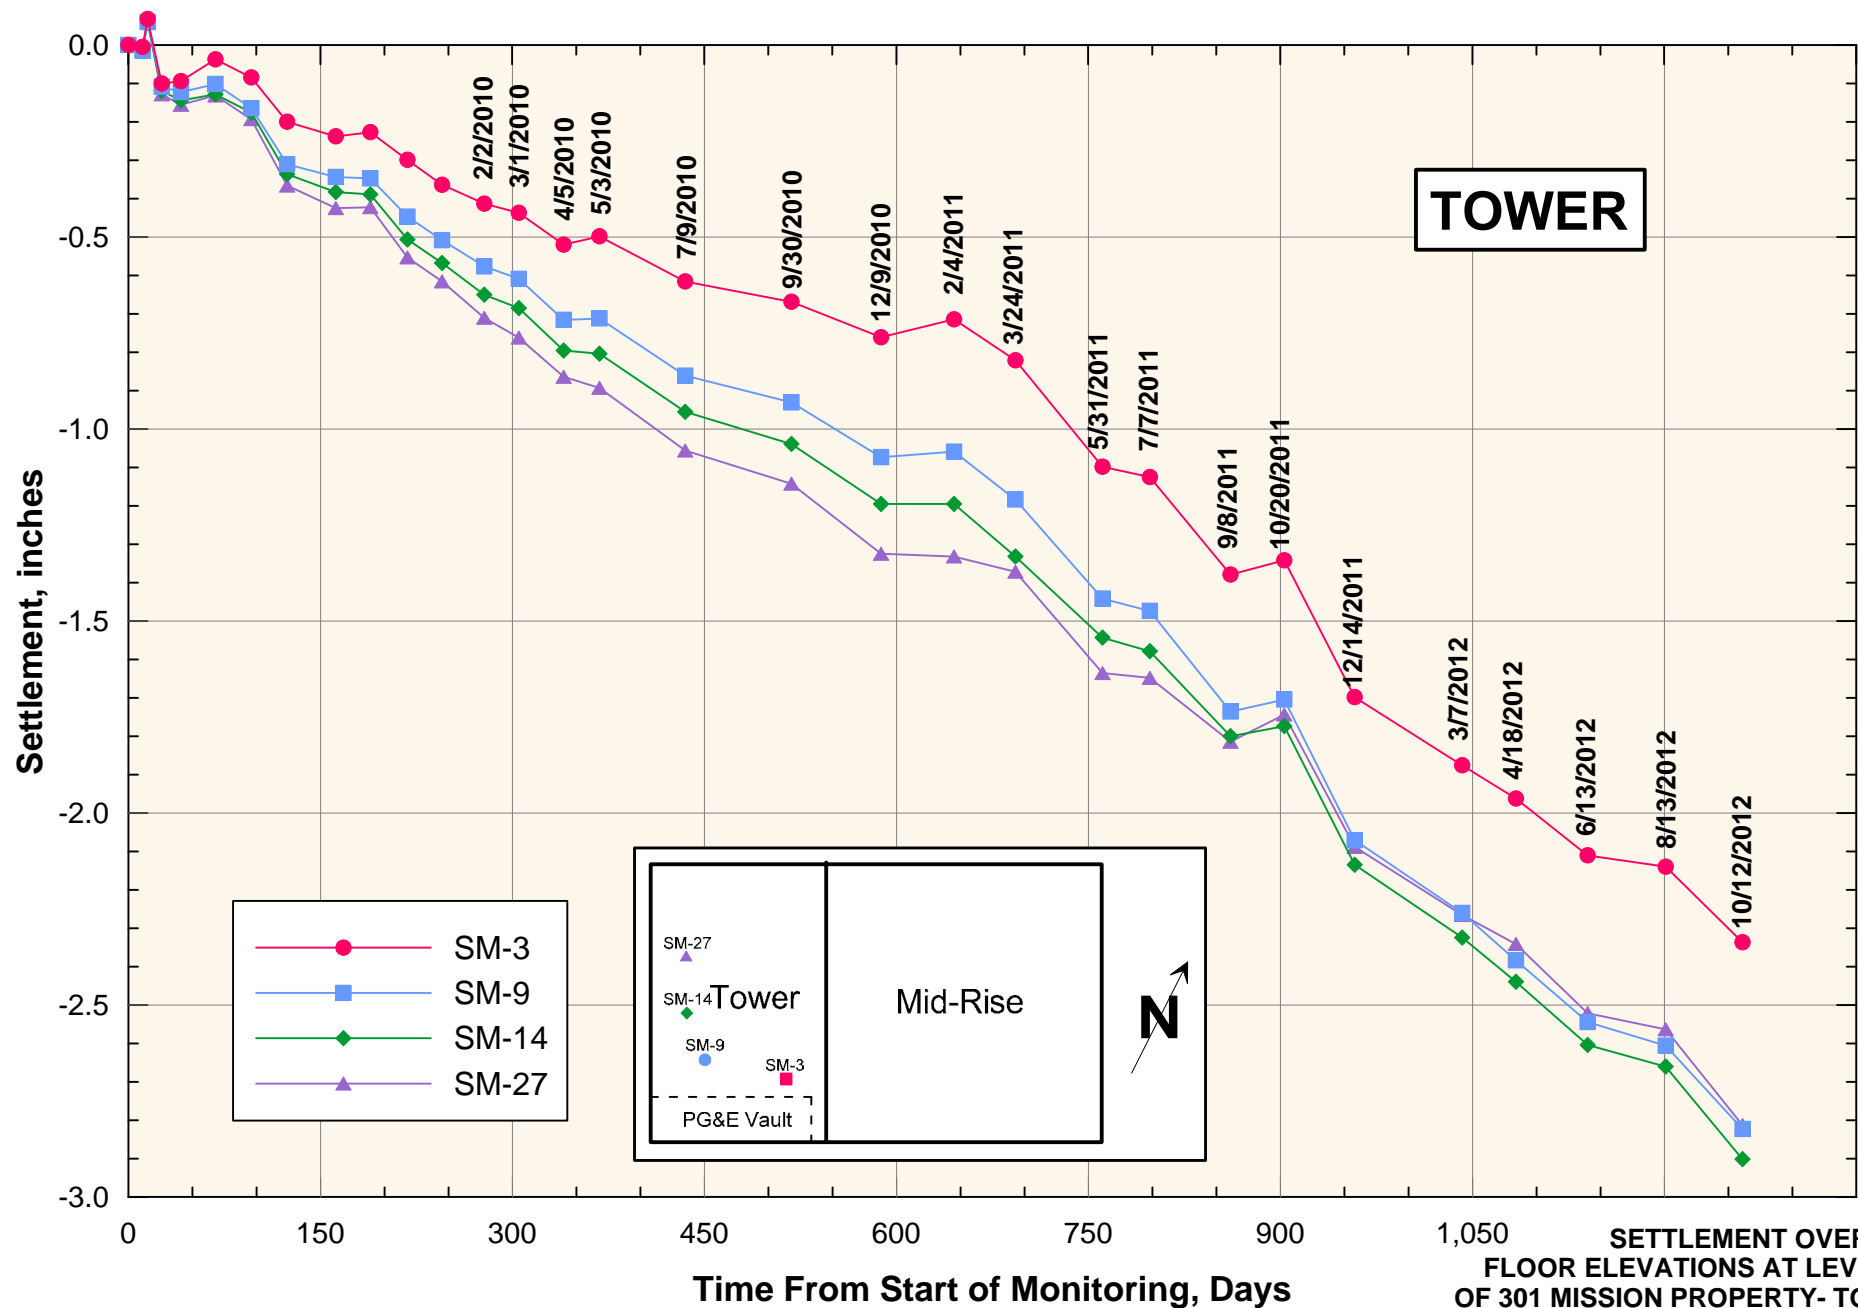
**SETTLEMENT OVER TIME
FLOOR ELEVATIONS AT LEVEL B-1
OF 301 MISSION PROPERTY- TOWER:
APRIL 30, 2009 THROUGH OCTOBER 12, 2012**

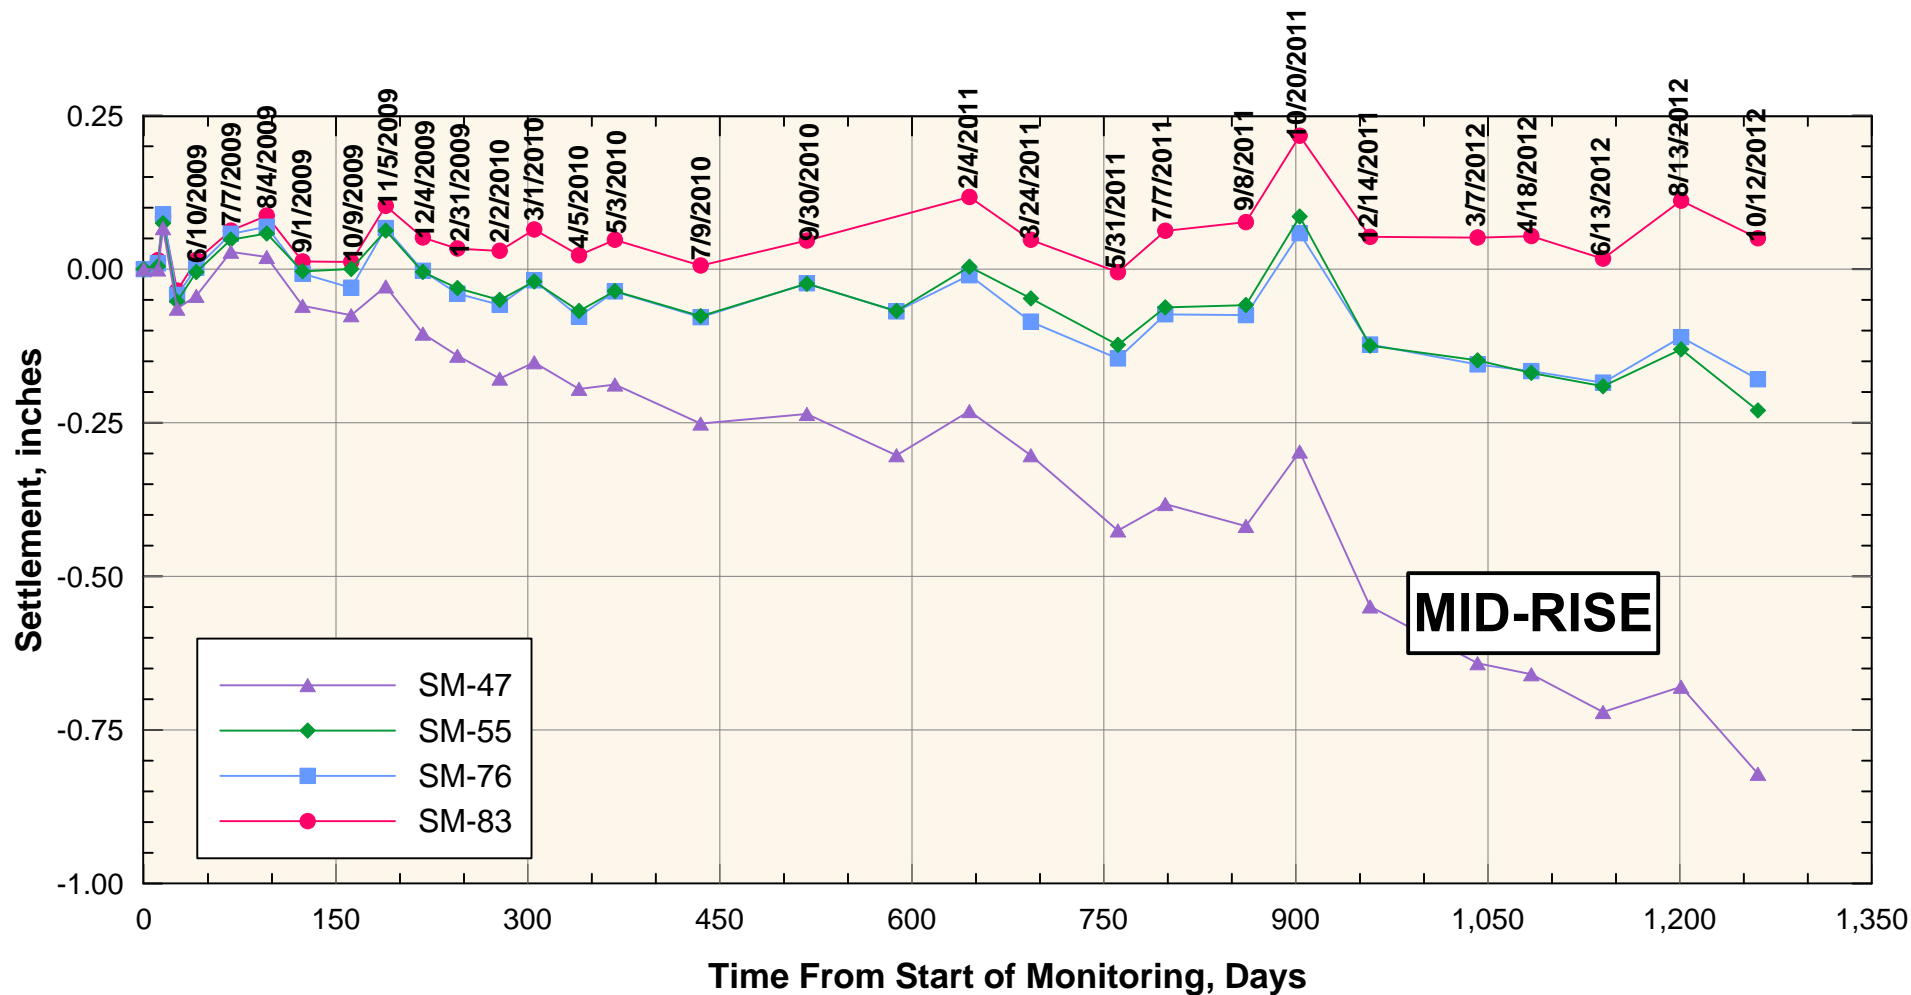
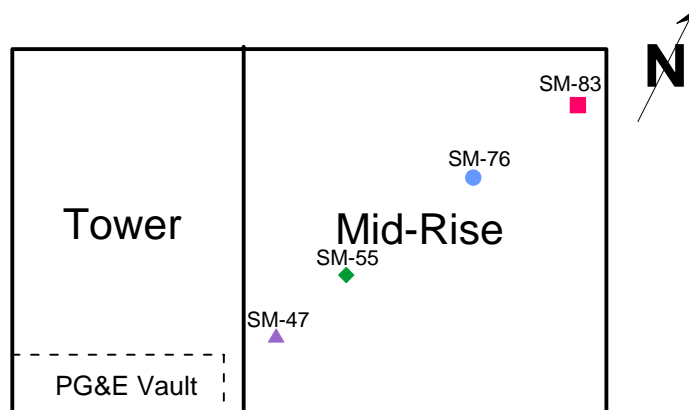
PLATE 4

**SETTLEMENT OVER TIME
FLOOR ELEVATIONS AT LEVEL B-1
OF 301 MISSION PROPERTY- MID-RISE:
APRIL 30, 2009 THROUGH OCTOBER 12, 2012**

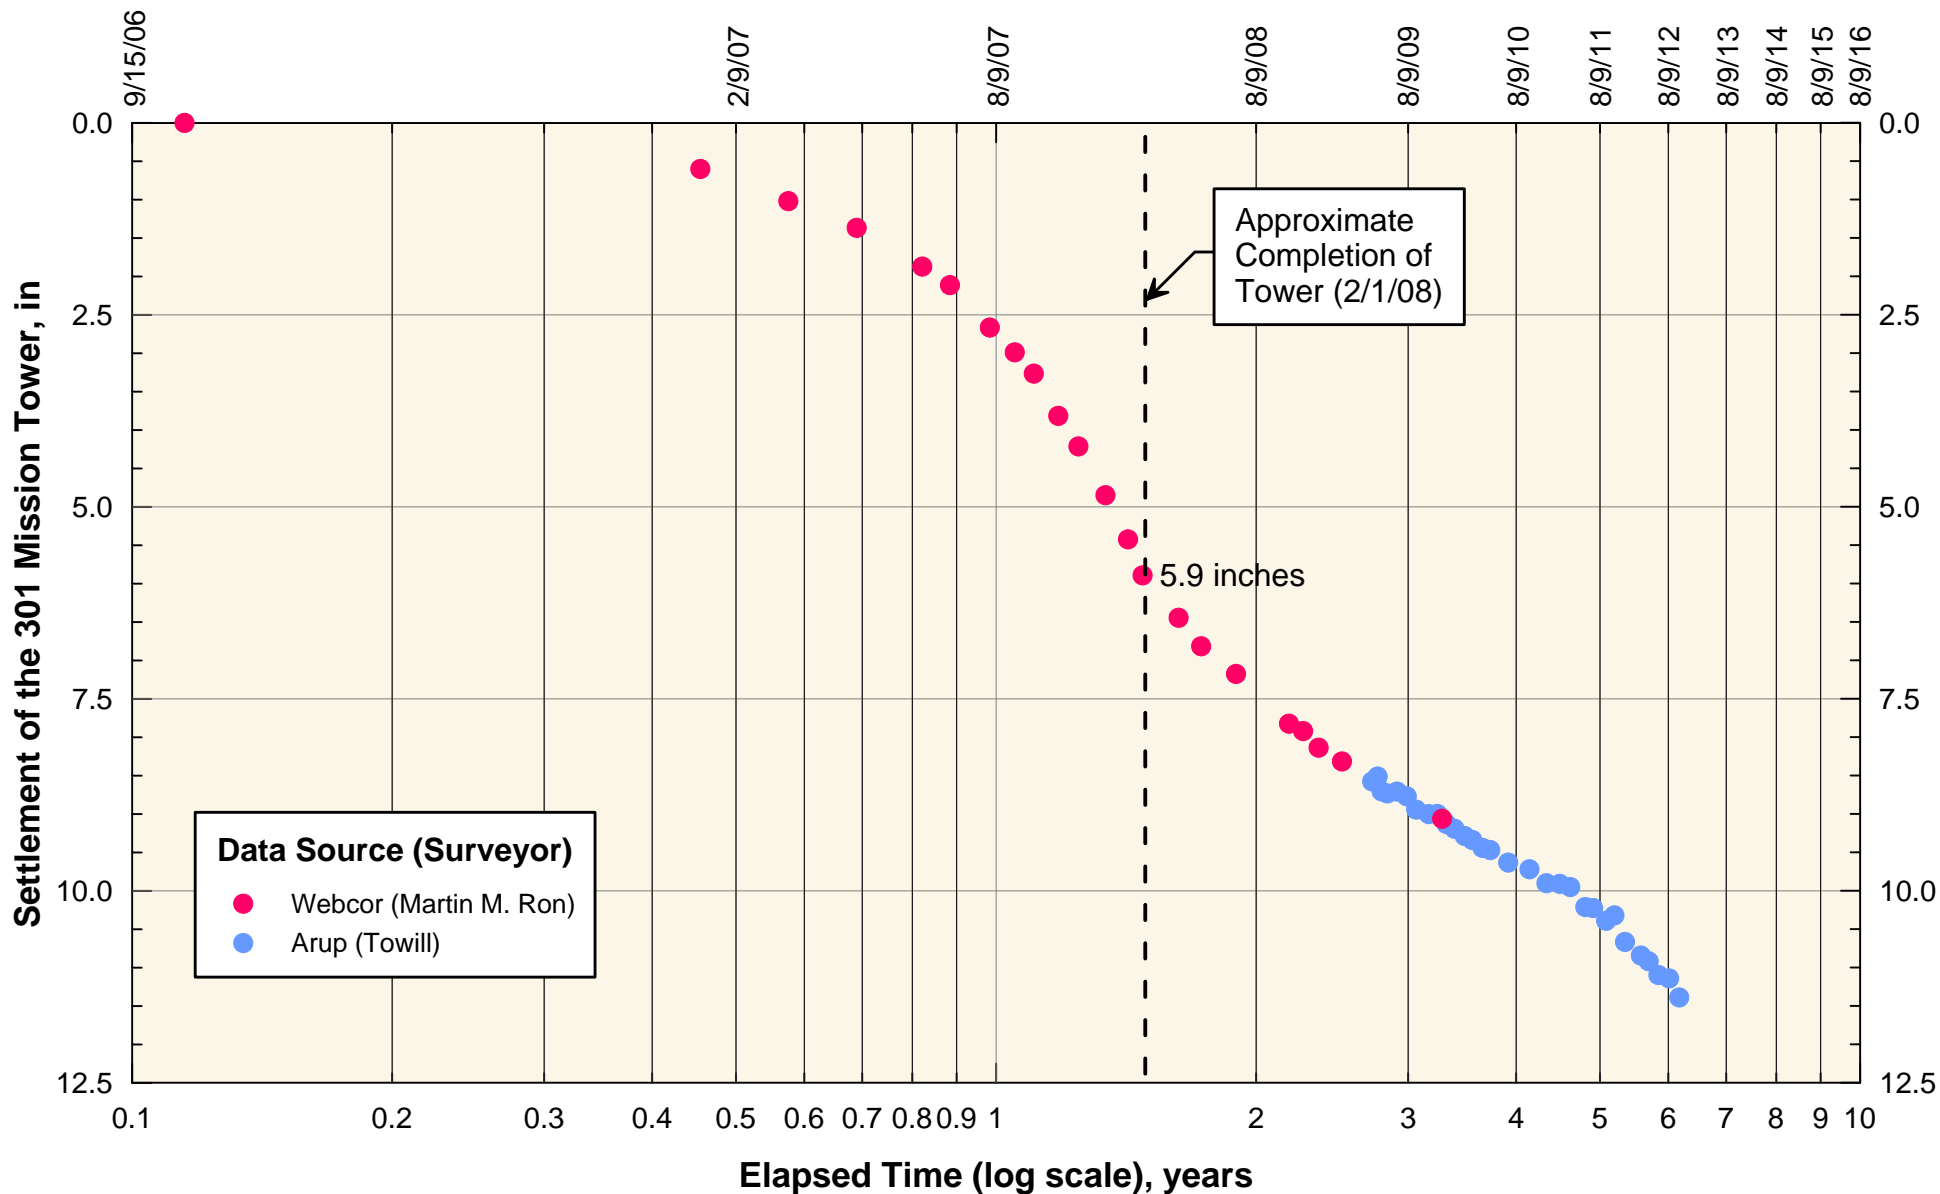
**SETTLEMENTS OF THE 301 MISSION TOWER
 INCLUDING MONITORING DURING CONSTRUCTION**
